Your Ref: TP/IP/29253/2020
Our Ref : CI/TPD20009194/P

30th November 2020

MECHANICAL INSPECTION REPORT OF MOTOR LORRY YP 4458G

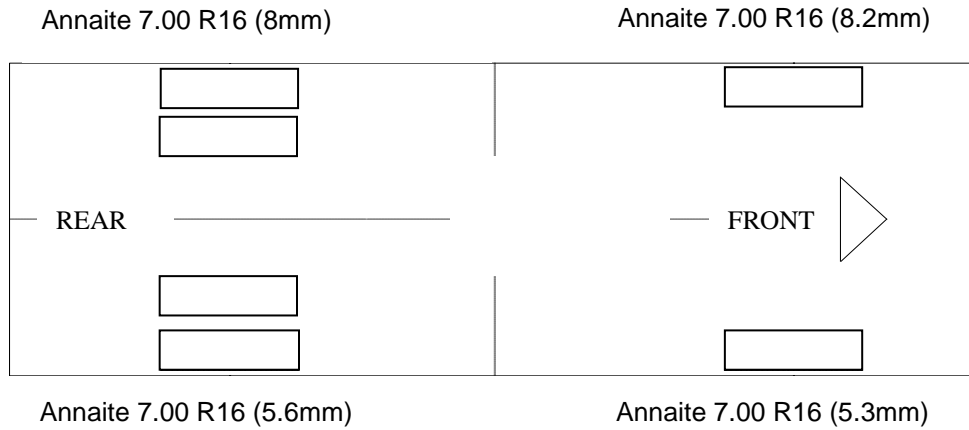
6. The condition of the 6 tyres of the Motor Lorry were observed to be in serviceable condition and sufficiently inflated for vehicular operation. I did not find any tear, cut or burst mark(s) on the outer and the inner sidewalls as well as across the tread of the 6 tyres. The tyre brand, tyre size and remaining tread depth of the 6 tyres of the Motor Lorry were recorded as follows:-

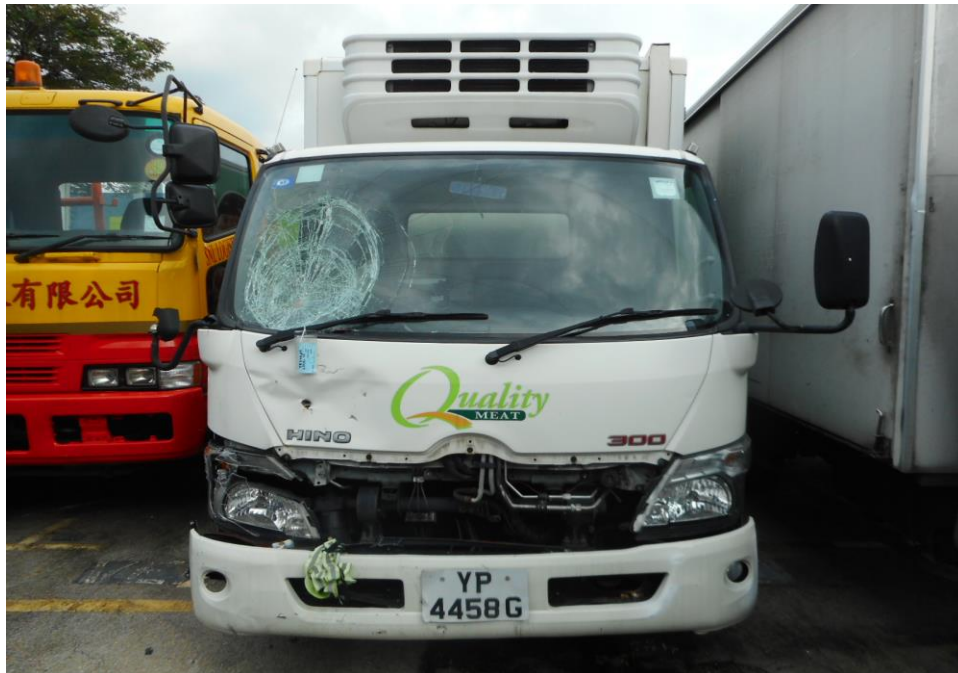
4. The mileage of the Motor Lorry at the time of my inspection was not recorded despite multiple attempts to start the engine of the Motor Lorry.
5. The Motor Lorry was observed to have sustained damage at its front portion. Its front windscreen, front body panel, front right rear view mirror and front right headlamp were damaged as a result of the accident.

Photo 1 shows a general view of the Motor Lorry's frontal portion at the time of my inspection. The Motor Lorry was observed to sustained damage at its front portion. Its front windscreen, front body panel, front right rear view mirror and front right headlamp were damaged as a result of the accident.

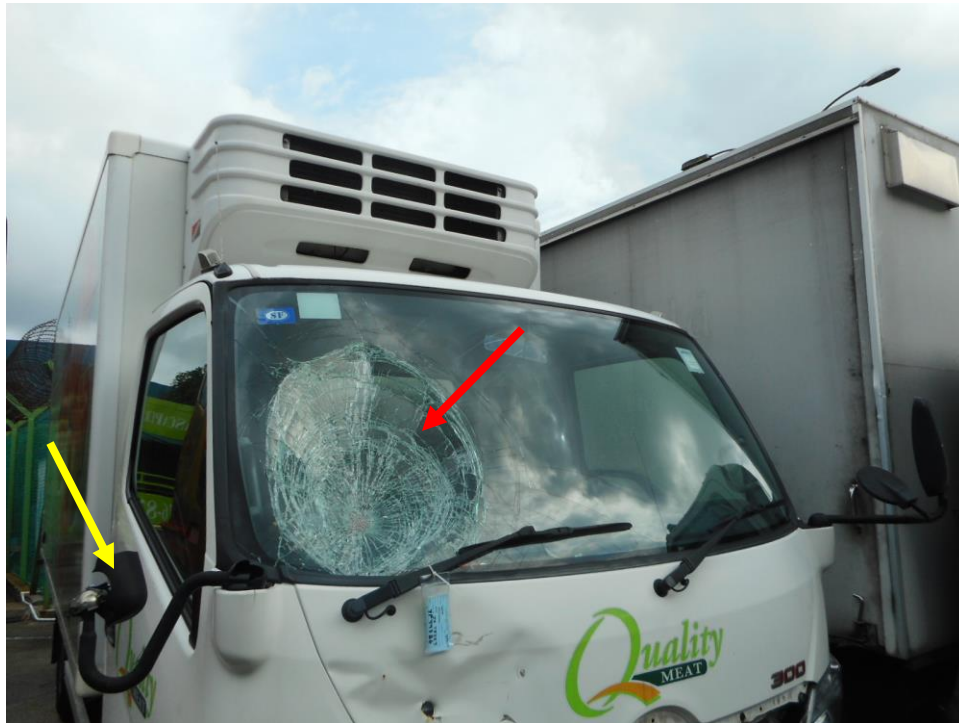
Photo 2 shows a close up view of the Motor Lorry's frontal portion at the time of my inspection. The Motor Lorry was observed to sustained damage at its front portion. Its front windscreen (red arrow) and front right rear view mirror (yellow arrow) were damaged as a result of the accident.

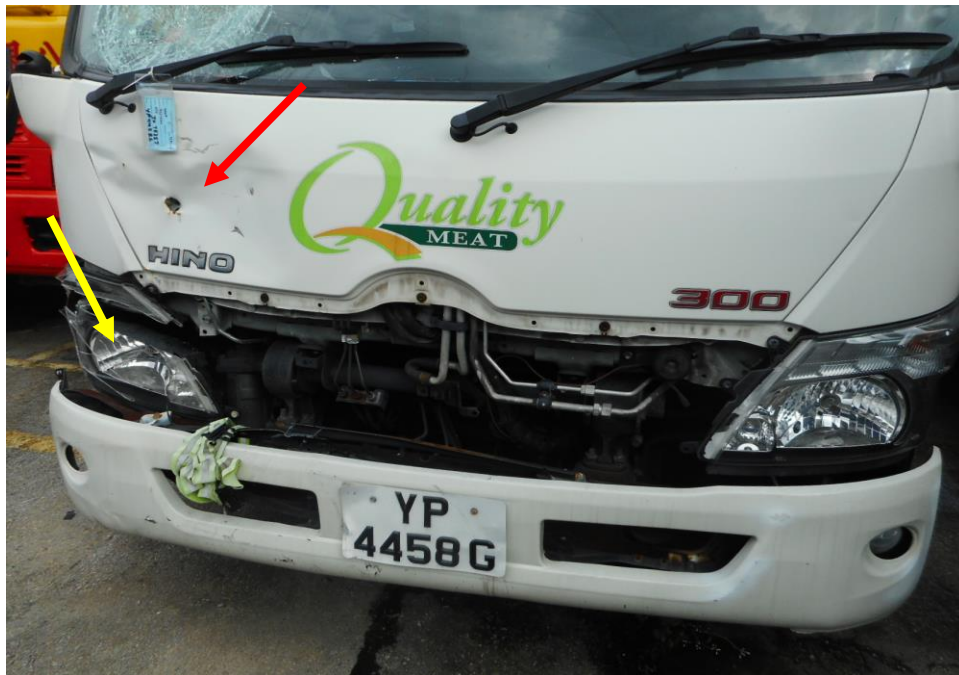
Photo 3 shows a close up view of the Motor Lorry's frontal portion at the time of my inspection. The Motor Lorry was observed to sustained damage at its front portion. Its front body panel (red arrow) and front right headlamp (yellow arrow) were damaged as a result of the accident.

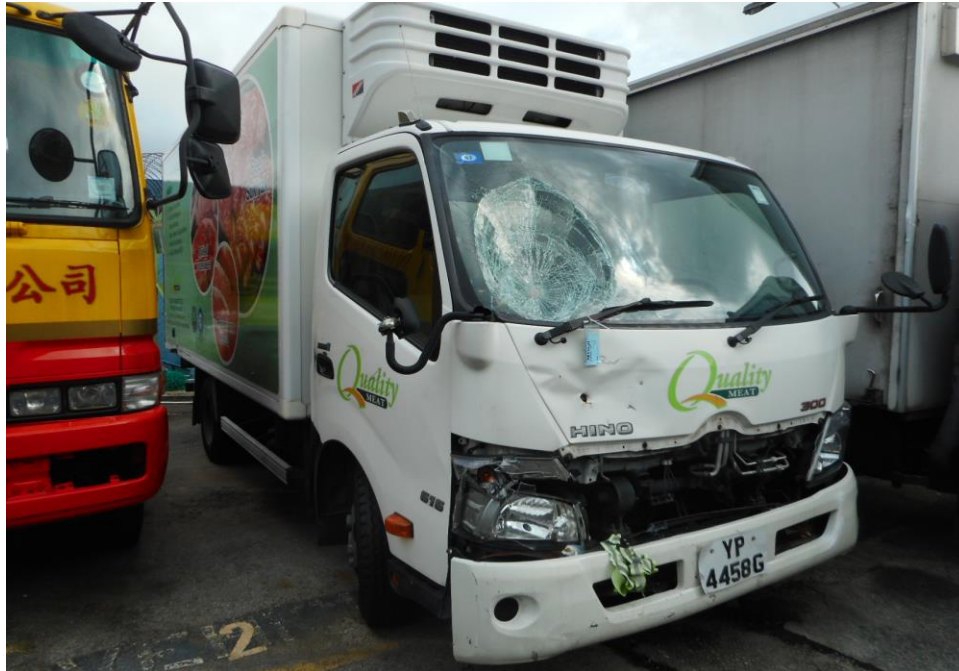
Photo 4 shows a general view of the front right body of the Motor Lorry at the time of my inspection. The Motor Lorry was observed to be intact and unaffected by the accident.

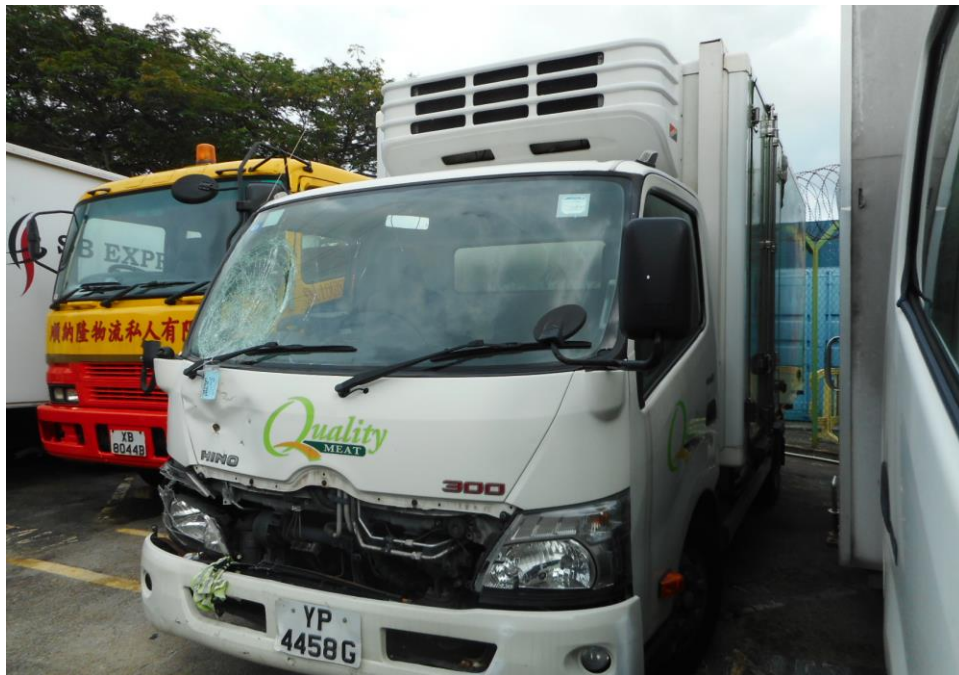
Photo 5 shows a general view of the front left body of the Motor Lorry at the time of my inspection. The Motor Lorry was observed to be intact and unaffected by the accident.

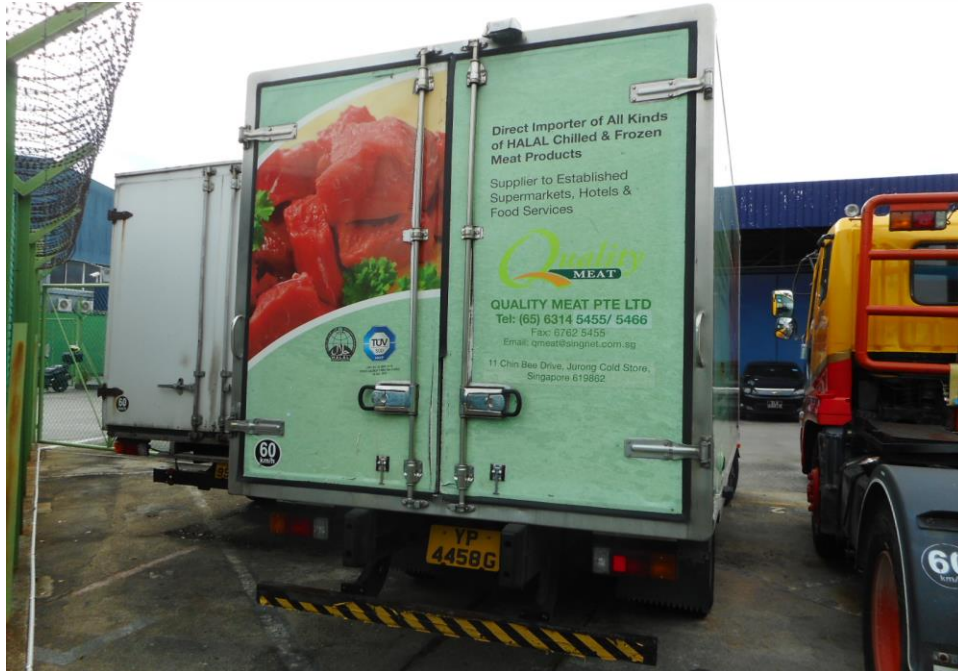
Photo 6 shows a general view of the rear body of the Motor Lorry at the time of my inspection. The Motor Lorry was observed to be intact and unaffected by the accident.

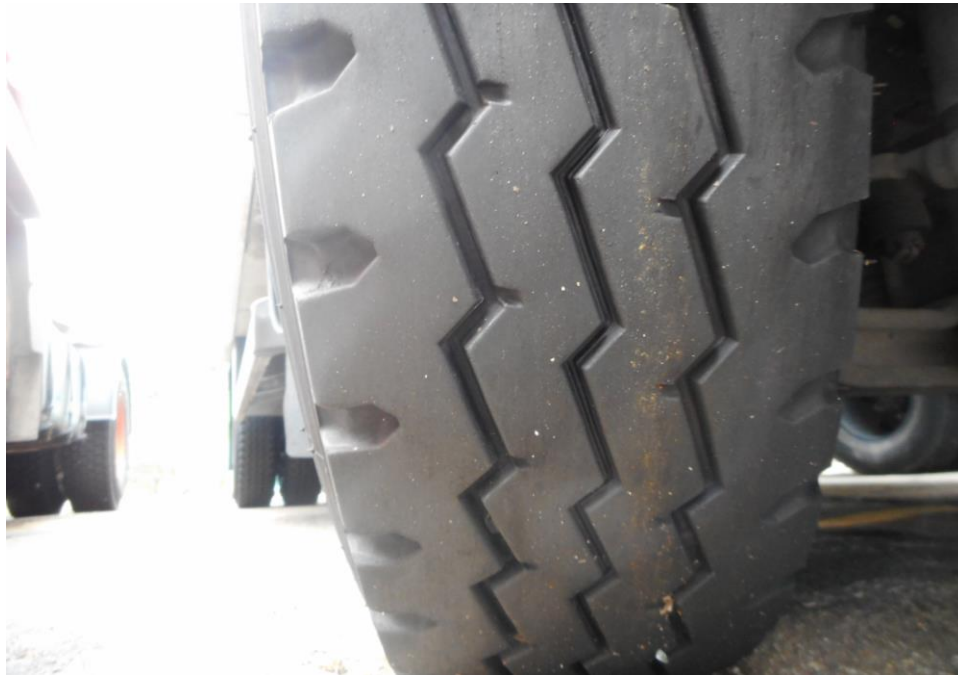
Photo 7 shows the condition of the front right tyre of the Motor Lorry, which was observed to be in serviceable condition with remaining tread depth of approximately 5.3mm. The tyre, which was wrapped around standard steel wheel rim, was also observed to be sufficiently inflated for vehicular operation. There was no tear, cut or burst mark(s) on the outer and the inner sidewalls as well as across the tread of the 6 tyres that were fitted on the Motor Lorry.

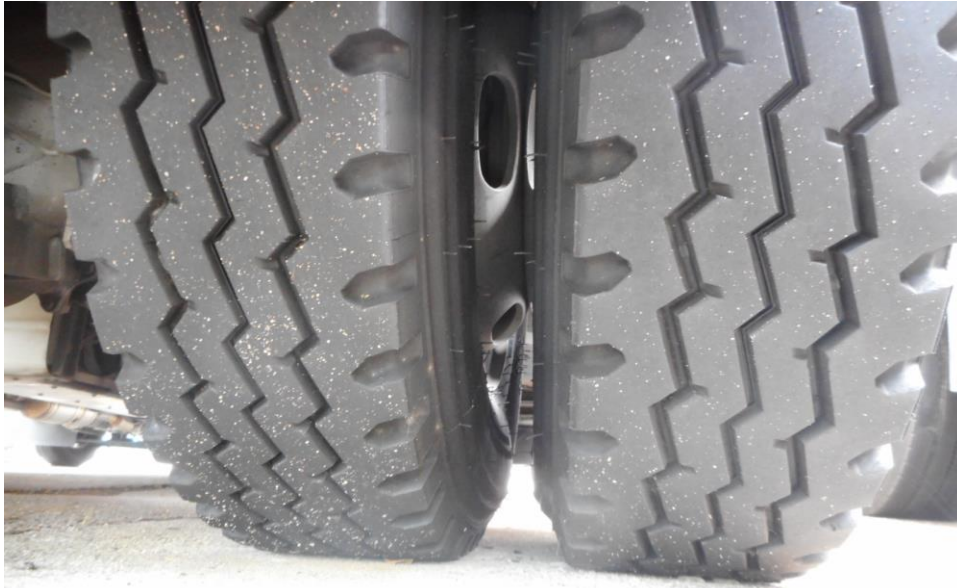
Photo 8 shows the condition of the rear right tyres of the Motor Lorry, which was observed to be in serviceable condition with remaining, tread depth of approximately 5.6mm. The tyres, which were wrapped around standard steel wheel rim, were also observed to be sufficiently inflated for vehicular operation. There was also no damage found on all 6 steel wheel rims of the Motor Lorry.

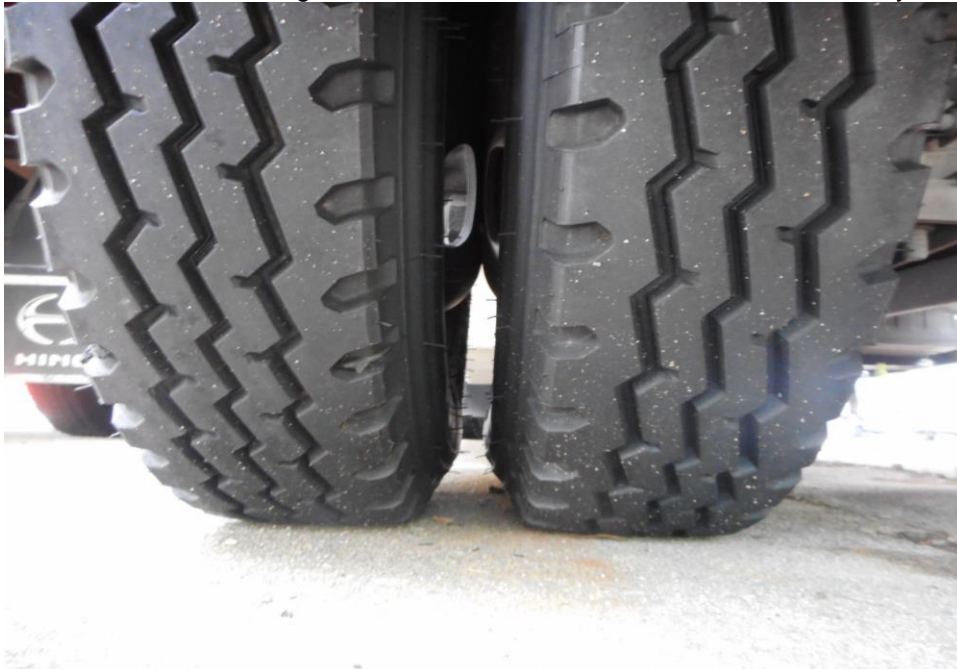
Photo 9 the condition of the rear left tyres of the Motor Lorry, which was observed to be in serviceable condition with remaining, tread depth of approximately 8mm. The tyres, which were wrapped around standard steel wheel rim, were also observed to be sufficiently inflated for vehicular operation. There was also no damage found on all 6 steel wheel rims of the Motor Lorry.

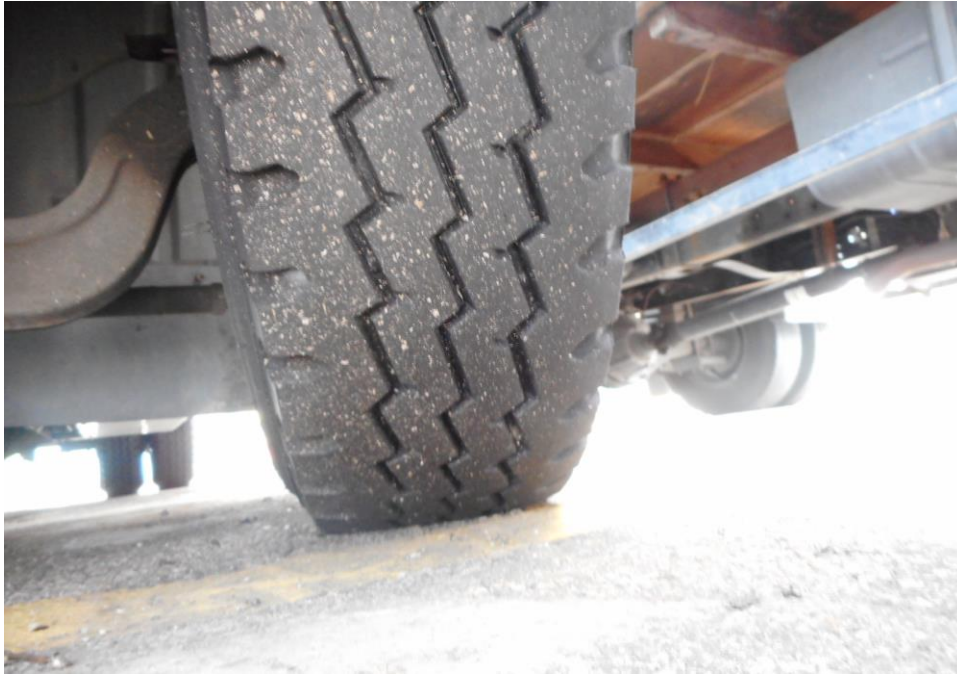
Photo 10 shows the condition of the front left tyre of the Motor Lorry, which were observed to be in serviceable condition with remaining, tread depth of approximately 8.2mm. There was also no tear, cut or burst mark(s) on the outer and the inner sidewalls as well as across the tread of the 6 tyres that were fitted on the Motor Lorry.

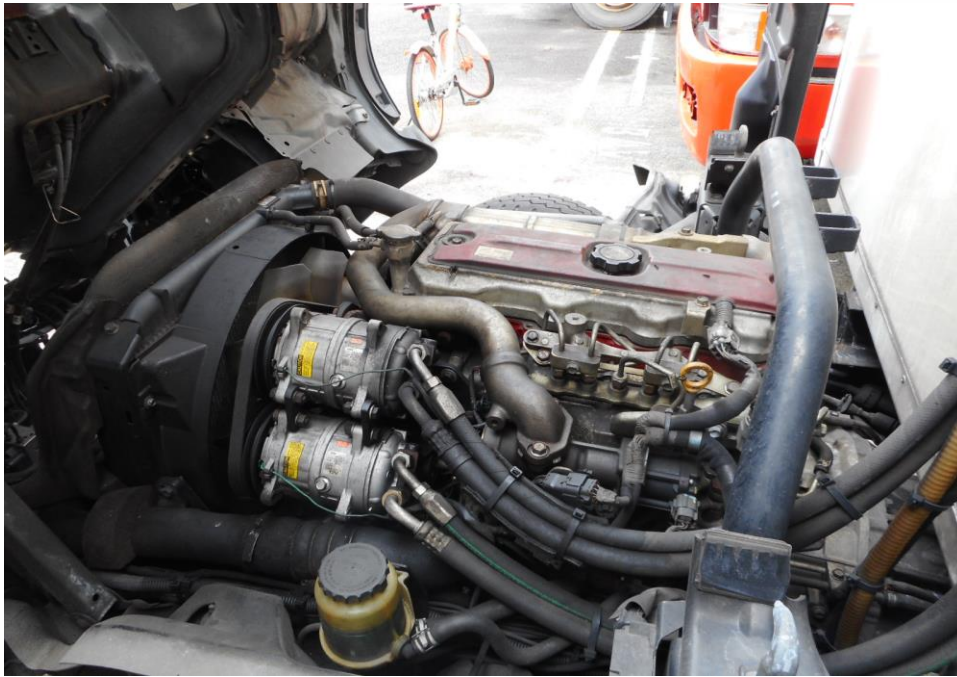
Photo 11 shows a general view of the Motor Lorry's engine compartment, which was accessed by lifting the front cabin of the Motor Lorry. The various parts and components inside the engine compartment were unaffected by the accident. There was also no sign(s) or indication(s) of fresh fluid leakage and/or fluid stain within the engine compartment

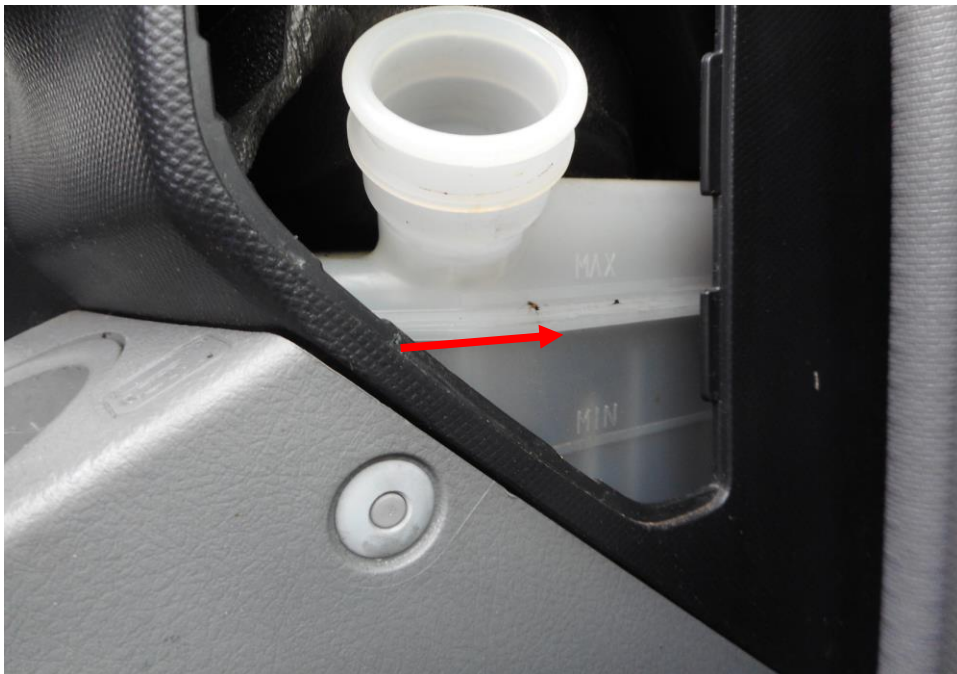
Photo 12 shows the brake fluid reservoir of the Motor Lorry at the time of my inspection. The brake fluid was observed to be of sufficient level (arrowed) and without any visible contamination.

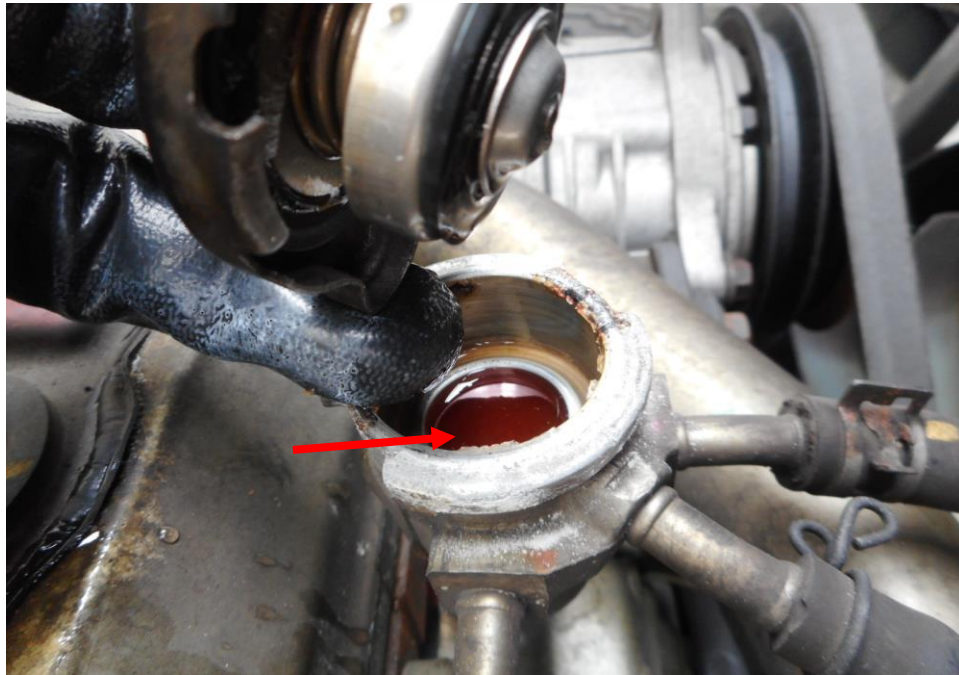
Photo 13 shows the engine coolant reservoir of the Motor Lorry at the time of my inspection. The engine coolant was observed to be of sufficient level (arrowed) and without any visible contamination.

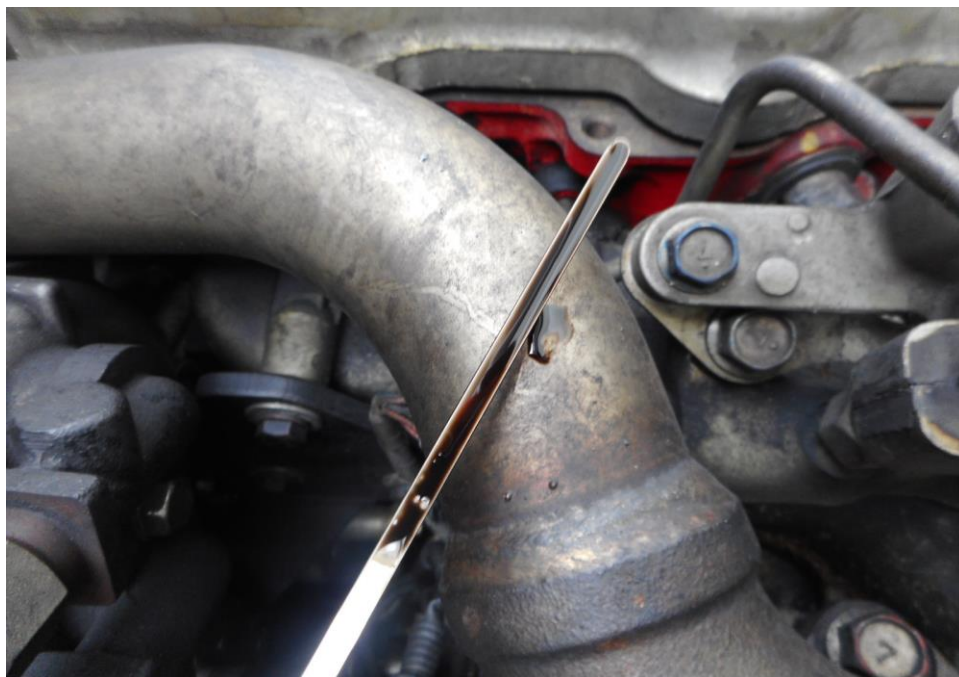
Photo 14 shows the engine oil dip stick of the Motor Lorry at the time of my inspection. The engine oil was observed to be of sufficient level and without any visible contamination.

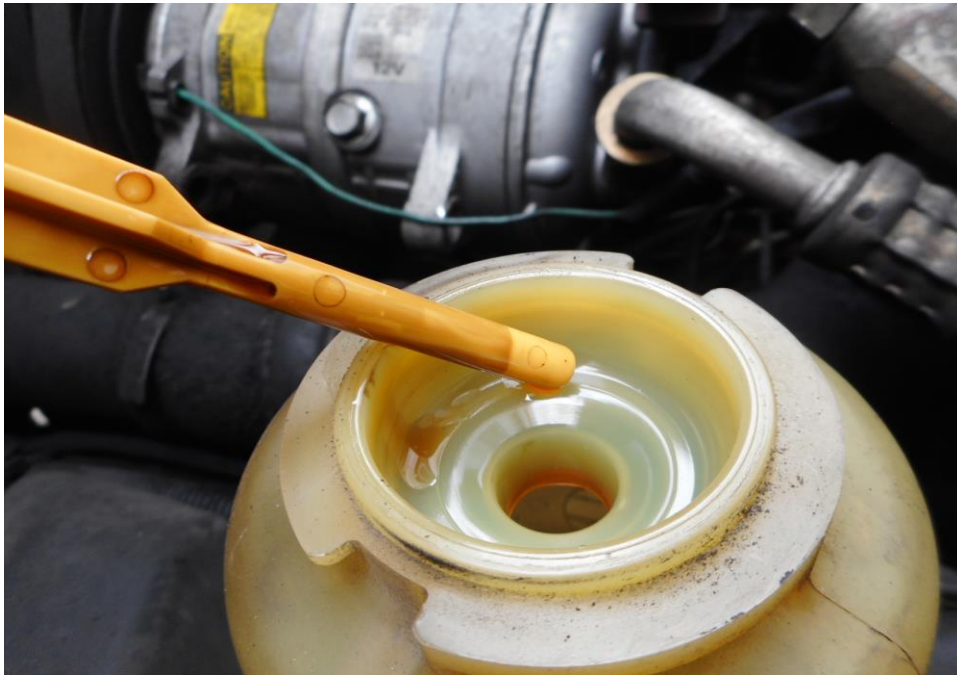
Photo 15 shows the power steering fluid dip stick of the Motor Lorry at the time of my inspection. The power steering fluid was observed to be of sufficient level and without any visible contamination.

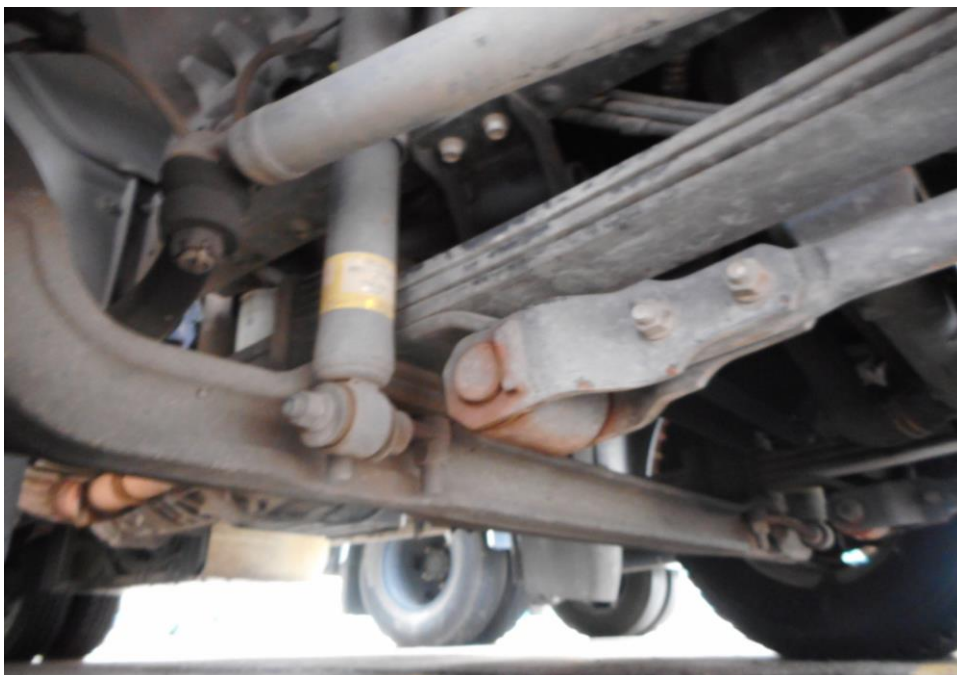
Photo 16 shows the undercarriage of the Motor Lorry, at the area where the engine housing and transmission housing are located. I did find old fluid stain on the underside of the Motor Lorry.

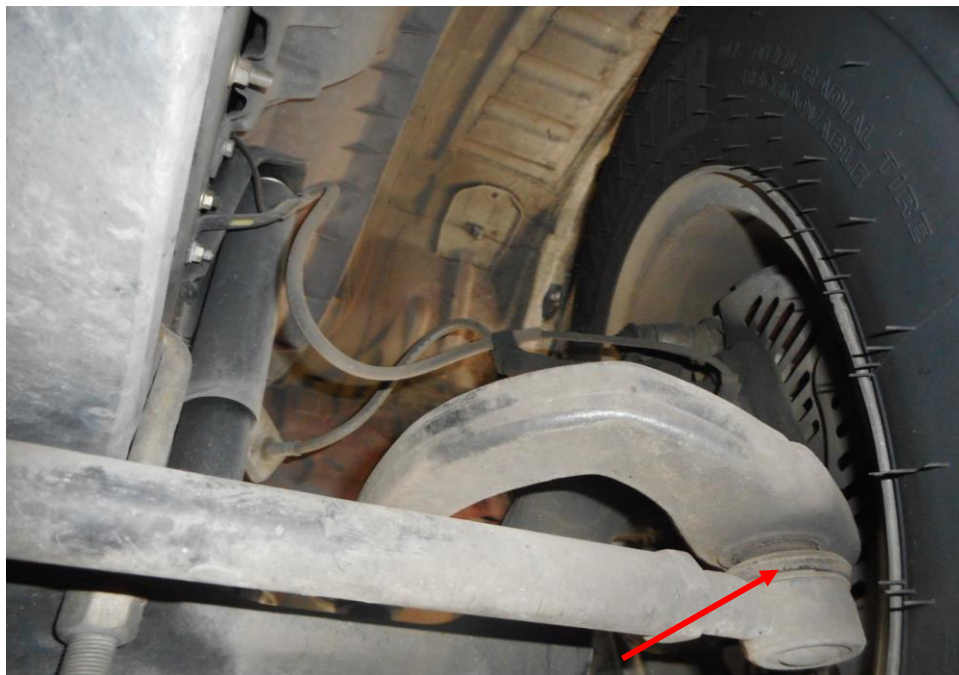
Photo 17 shows the various undercarriage components at the front right wheel of the Motor Lorry, in particular the steering tie rod end (arrowed). The various steering components were all found to be intact, suggesting that the steering system of the Motor Lorry was likely to be in serviceable condition at the material time of accident. There was also no sign of fluid stain(s) observed on the various undercarriage components.

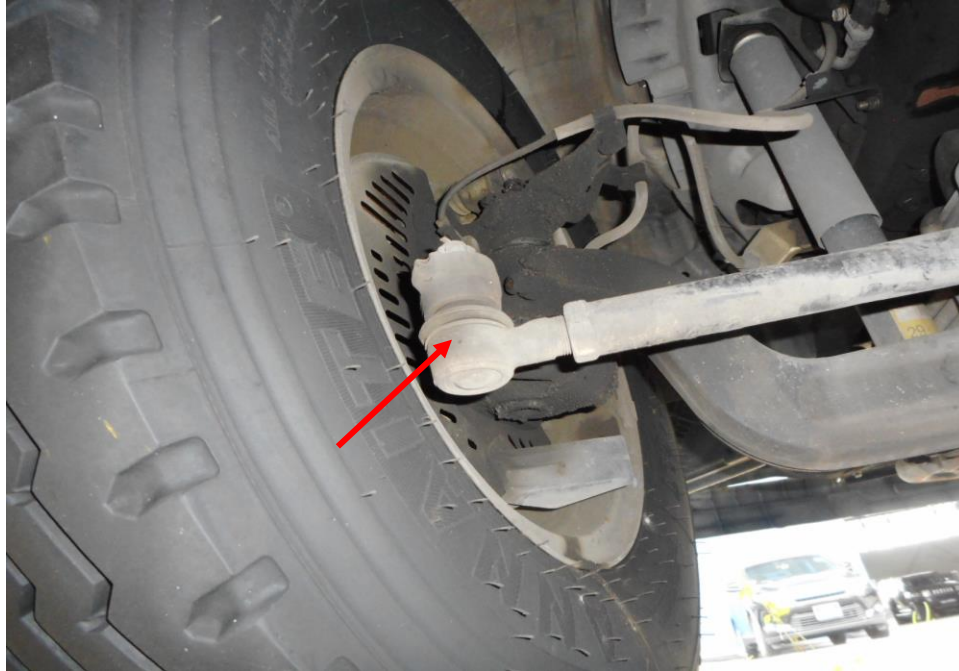
Photo 18 shows the various undercarriage components at the front left wheel of the Motor Lorry, in particular the steering tie rod end (arrowed). The various Undercarriage components of the Motor Lorry were all found to be intact without any visible damage. There was also no sign of fluid stain(s) observed on the various undercarriage components.

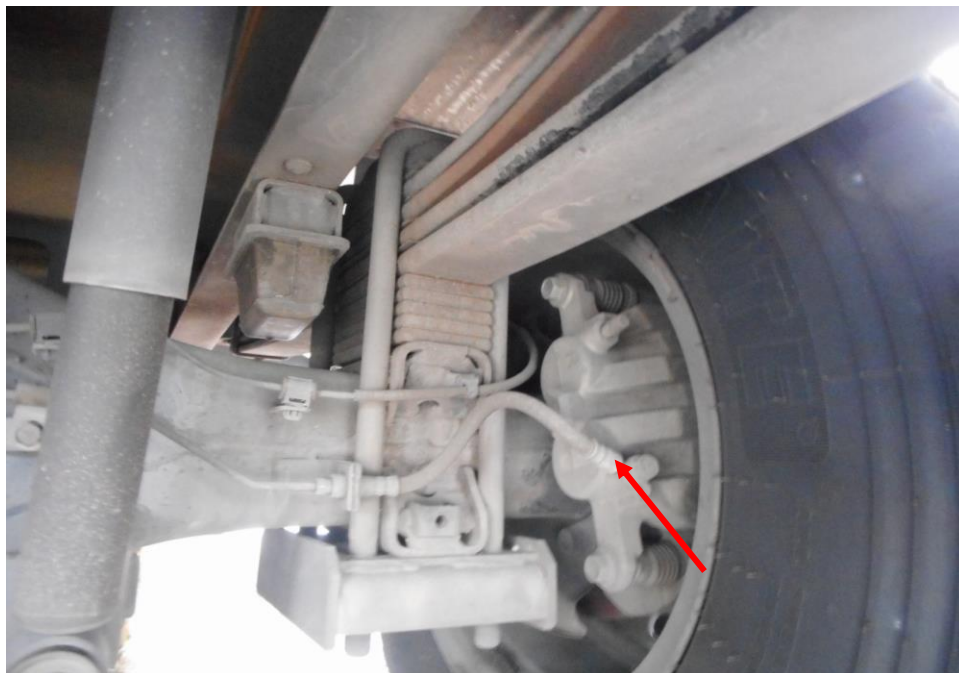
Photo 19 shows the brake pipe (arrowed) at the rear right wheel of the Motor Lorry. I did not observe any leakage of brake fluid at the time of my inspection of the Motor Lorry. My static tests of the Motor Lorry's braking system, along with my visual examination of the various mechanical components in the braking system, had indicated that there was no internal leakage of pressure/vacuum. Hence the braking system of the Motor Lorry was likely to be in serviceable condition at the material time of accident.

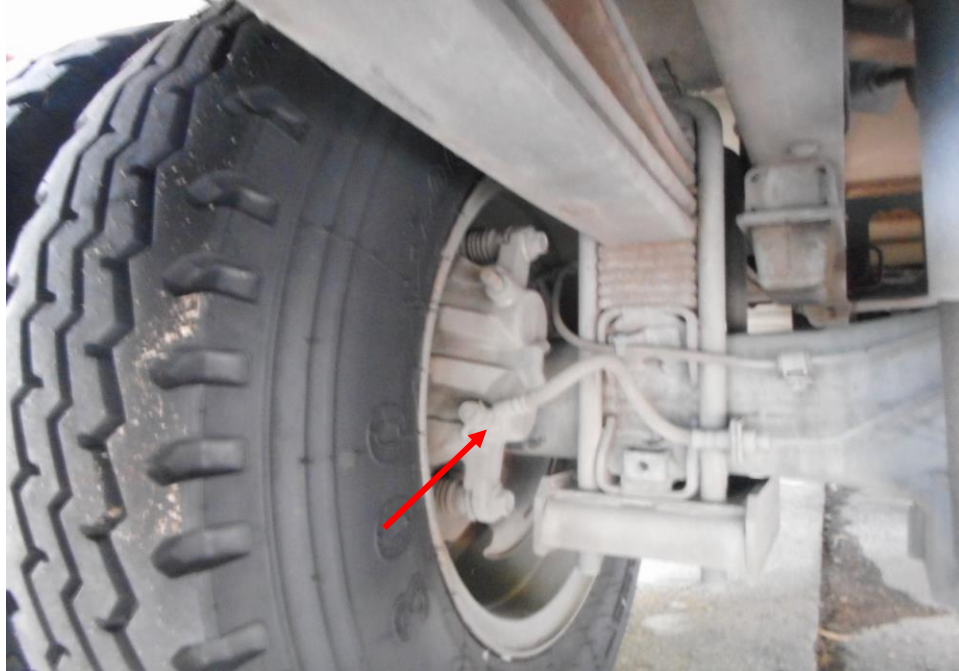
Photo 20 shows the brake pipe (arrowed) at the rear left wheel of the Motor Lorry. I did not observe any leakage of brake fluid at the time of my inspection of the Motor Lorry. My static tests of the Motor Lorry's braking system, along with my visual examination of the various mechanical components in the braking system had indicated that there was no internal leakage of pressure/vacuum. Hence the braking system of the Motor Lorry was likely to be in serviceable condition at the material time of accident.

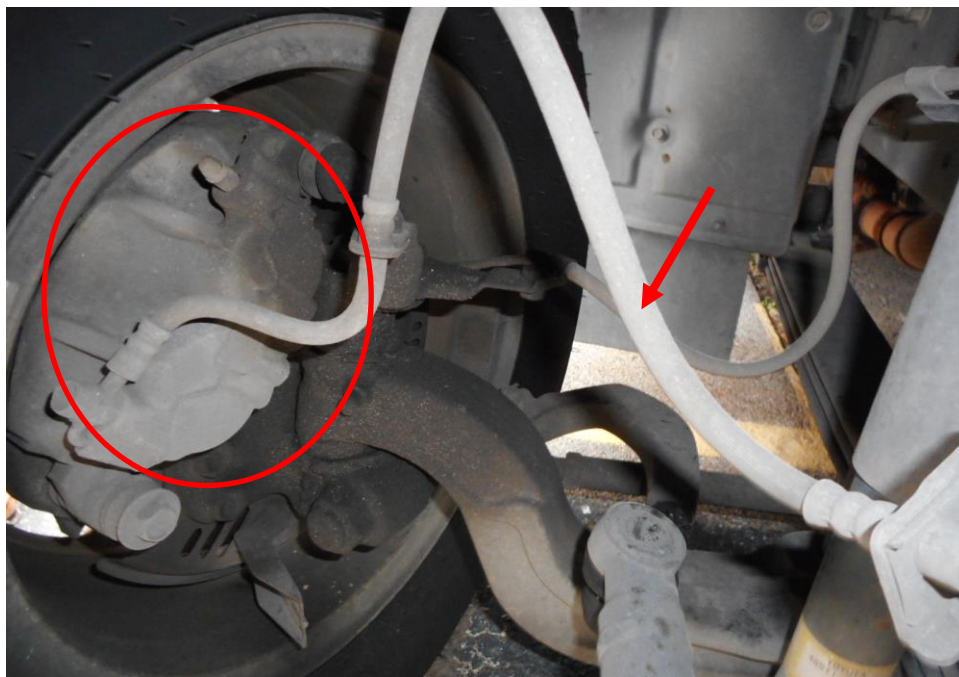
Photo 21 shows the brake hose/pipe (arrowed) at the front right wheel of the Motor Lorry. No leakage of brake fluid was observed. Visual examination of the various components of the braking system like the brake caliper (circled), brake booster, brake pedal etc had revealed all to be intact and without visible damage at the time of accident. There was also no sign of fluid stain(s) observed on the various undercarriage components.

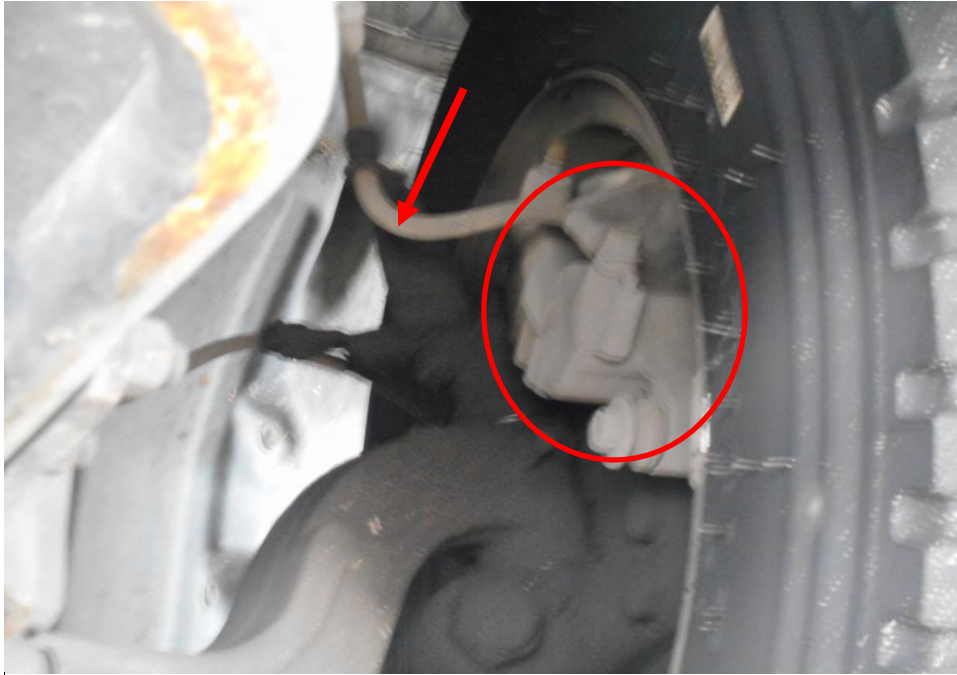
Photo 22 shows the brake hose/pipe (arrowed) at the front left wheel of the Motor Lorry. No leakage of brake fluid was observed. Visual examination of the various components of the braking system like the brake caliper (circled), brake booster, brake pedal etc had revealed all to be intact and without visible damage at the time of accident. There was also no sign of fluid stain(s) observed on the various undercarriage components.
