Your Ref: TP/IP/35397/2020
Our Ref: CI/TPD20009195/P

Fatal Accident Investigation Team

MECHANICAL INSPECTION REPORT OF MOTOR LORRY GU 5156H

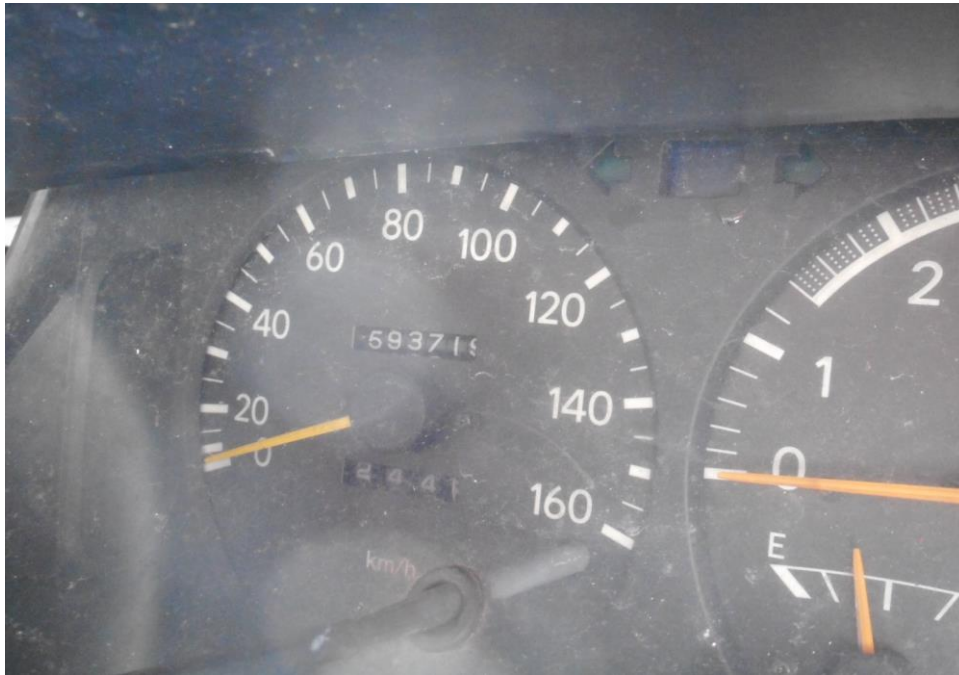
4. The mileage of the Motor Lorry at the time of my inspection was 593,719km.
5. The Motor Lorry was observed to have sustained major damage at its front cabin & windscreen portion as well as its left and right doors as a result of the accident.

Photo 1 shows no mileage of the Motor Lorry at the time of my inspection. The mileage observed was 593,719km.

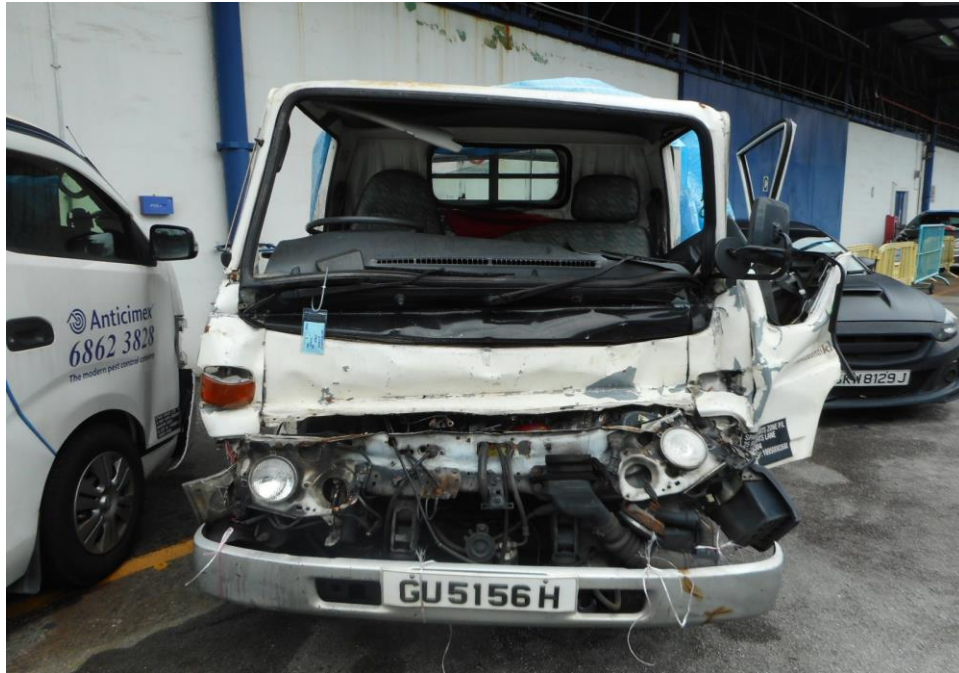
Photo 2 shows a general view of the front windscreen and body panel of the Motor Lorry at the time of our inspection. The Motor Lorry was observed sustained major damages to its frontal likely due to the accident's impact.

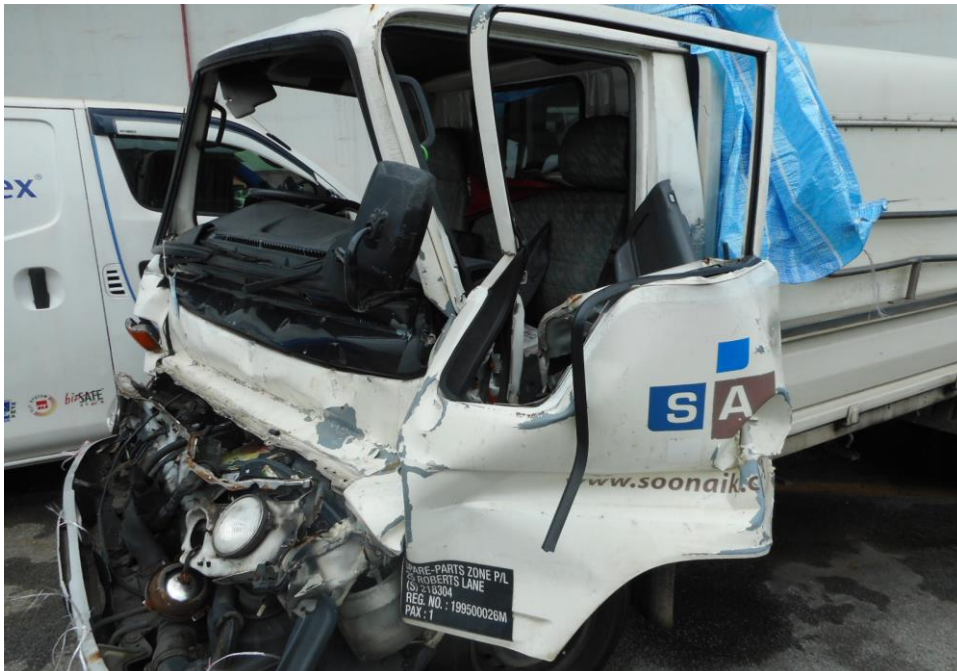
Photo 3 shows the close up view of the left door of the Motor Lorry at the time of our inspection. The Motor Lorry was observed to have sustained major damages to its doors that was crushed due to the accident's impact.

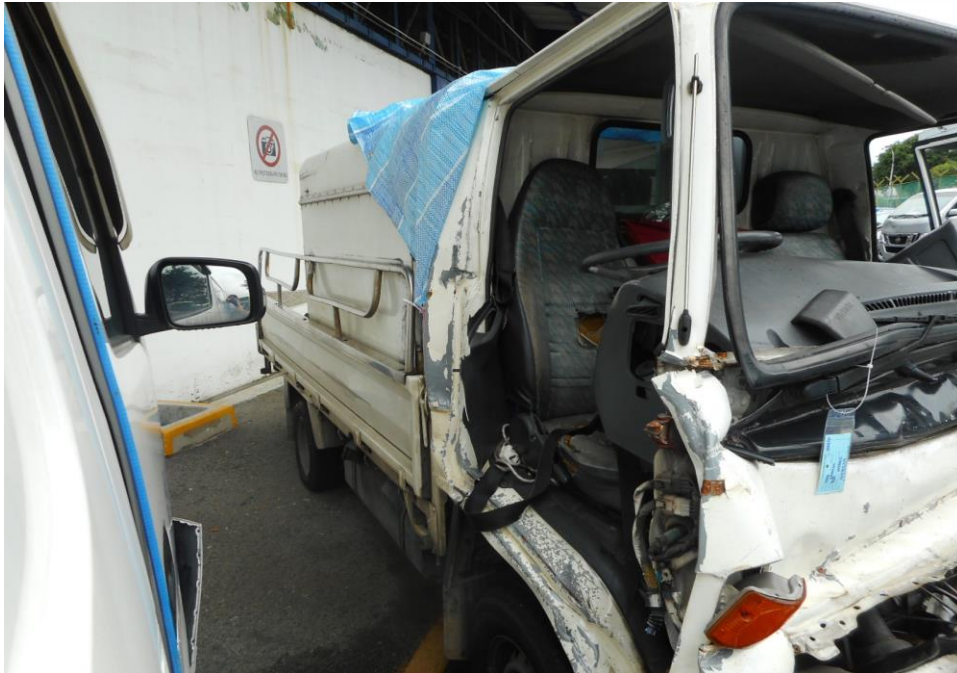
Photo 4 shows the close up view of the right door of the Motor Lorry at the time of our inspection. The Motor Lorry was observed to have sustained major damages to its doors that was crushed and dislodged due to the accident's impact.

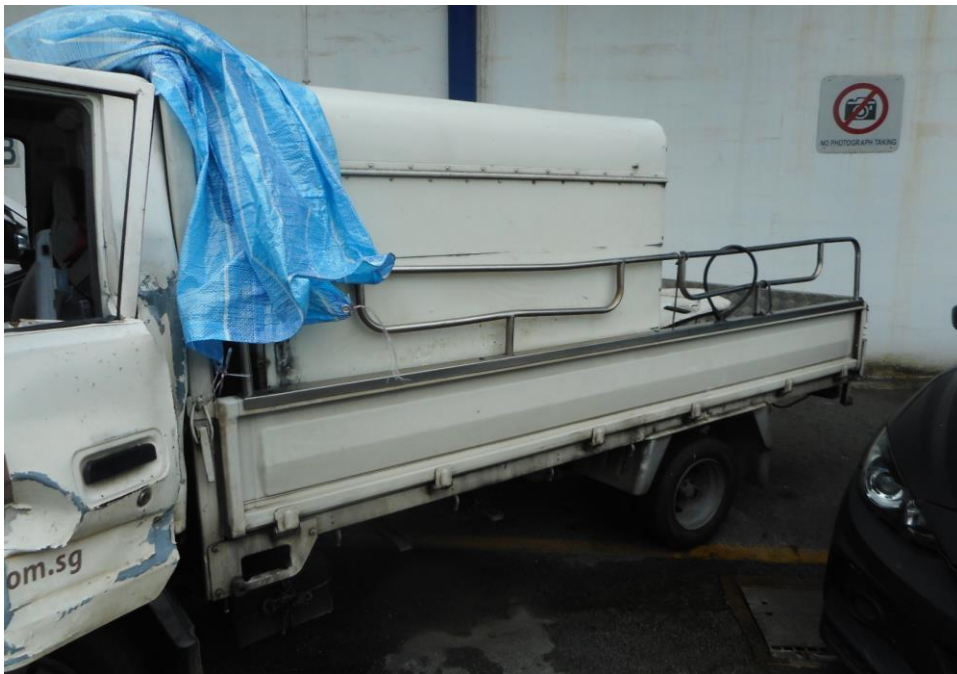
Photo 5 shows a general view of the Motor Lorry's left body at the time of my inspection. The left portion of the Motor Lorry was observed to have been unaffected by the accident.

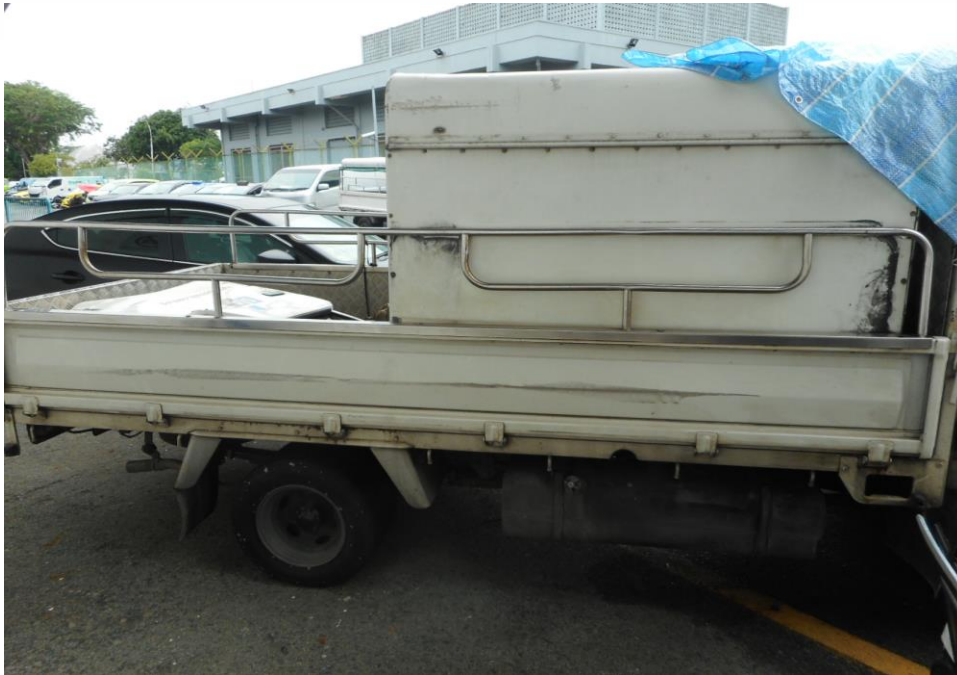
Photo 6 shows a general view of the Motor Lorry's right body at the time of my inspection. The right portion of the Motor Lorry was observed to have been unaffected by the accident.

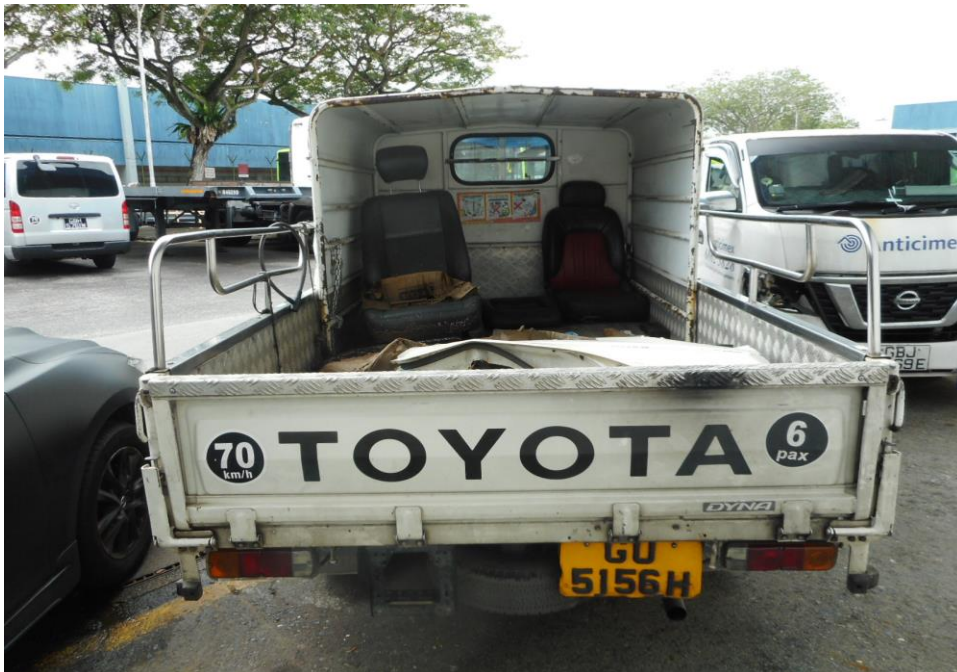
Photo 7 shows the general view of the Motor Lorry's rear body at the time of my inspection. The Motor Lorry rear was observed to be unaffected by the accident.

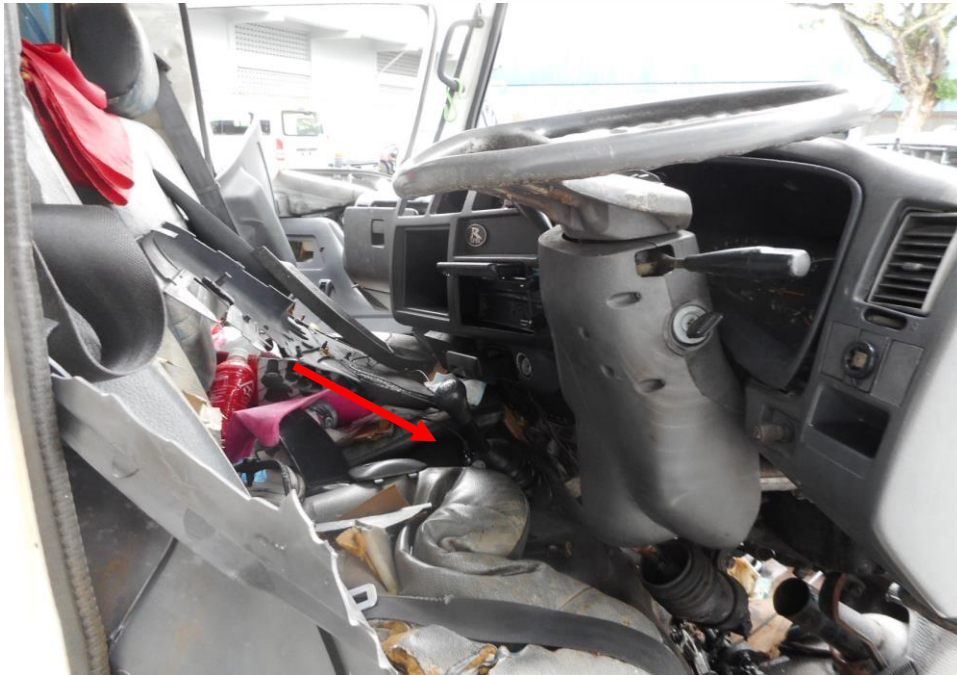
Photo 8 shows the close up view of the interior cabin of the Motor Lorry. It was observed to have sustained extensive induced damages to the dashboard, foot well as a result of the accident.

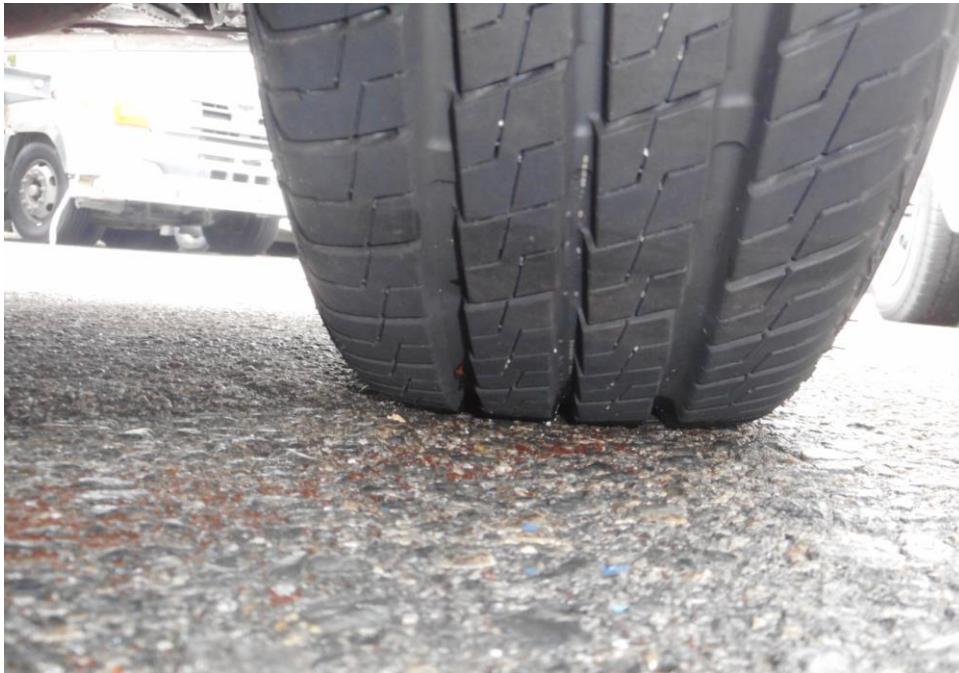
Photo 9 shows the condition of the front right tyre of the Motor Lorry, which was observed to be in serviceable condition with remaining tread depth of approximately 7.4mm. The tyre, which was wrapped around standard steel wheel rim, was also observed to be sufficiently inflated for vehicular operation.

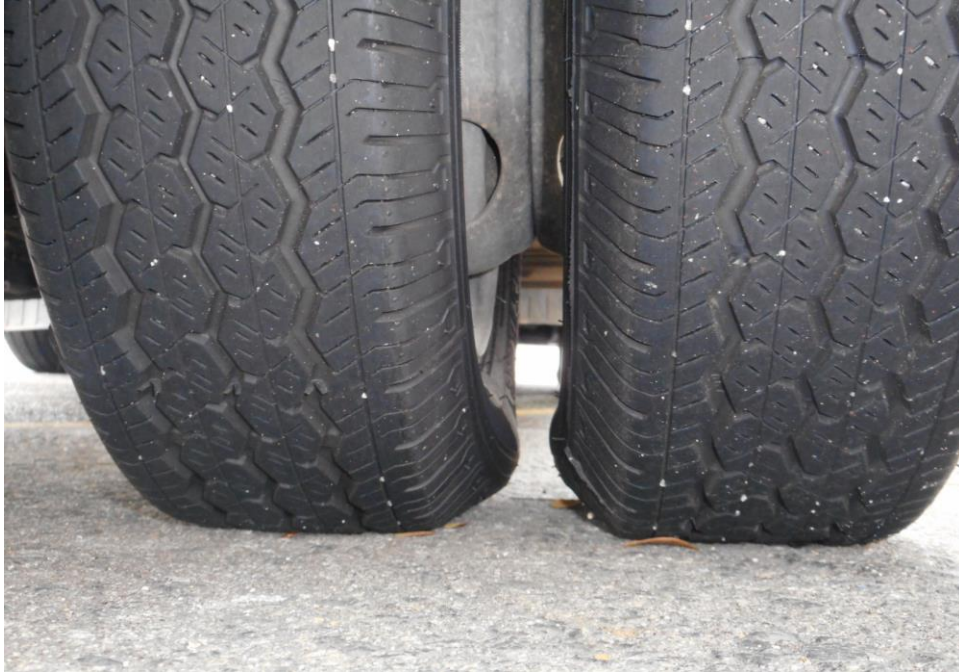
Photo 10 shows the condition of the rear right tyres of the Motor Lorry, which observed to be in serviceable condition with remaining tread depth of approximately 4.6mm. The tyres, which were wrapped around standard steel wheel rim, were also observed to be sufficiently inflated for vehicular operation.

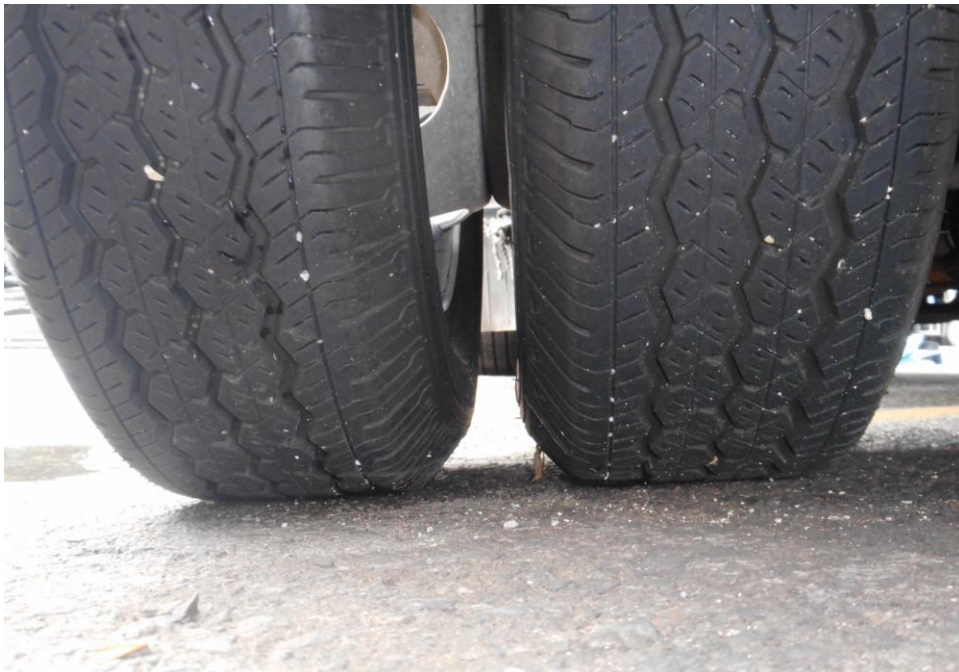
Photo 11 shows the condition of the rear left tyres of the Motor Lorry, which were observed to be in serviceable condition with remaining, tread depth of approximately 1.7mm. See above.

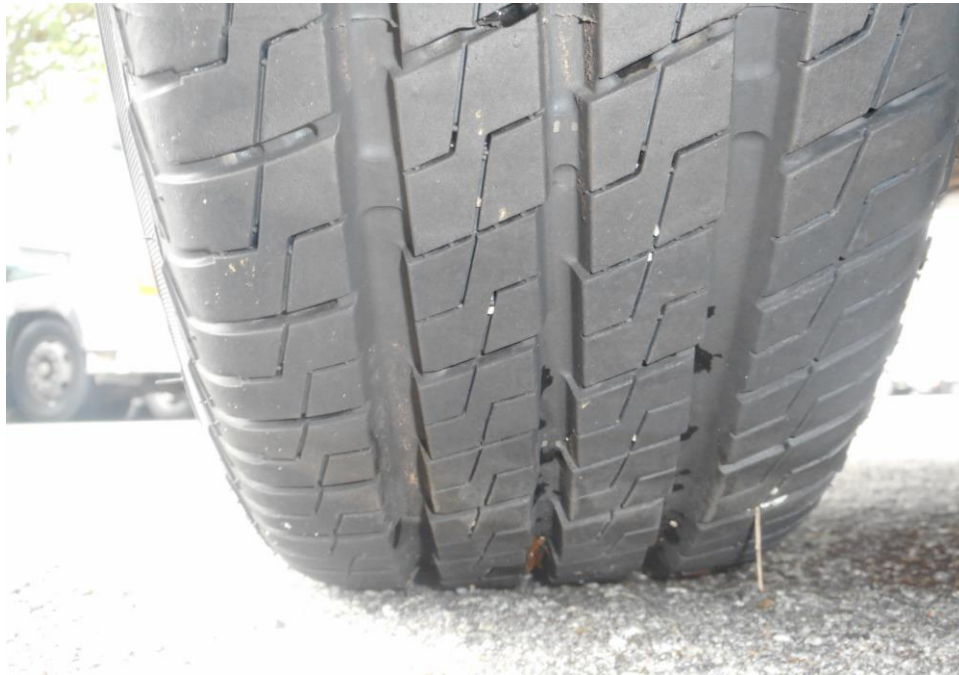
Photo 12 shows the condition of the front right tyre of the Motor Lorry, which was observed to be in serviceable condition with remaining tread depth of approximately 7.6mm. The tyre, which was wrapped around standard steel wheel rim, was also observed to be sufficiently inflated for vehicular operation.

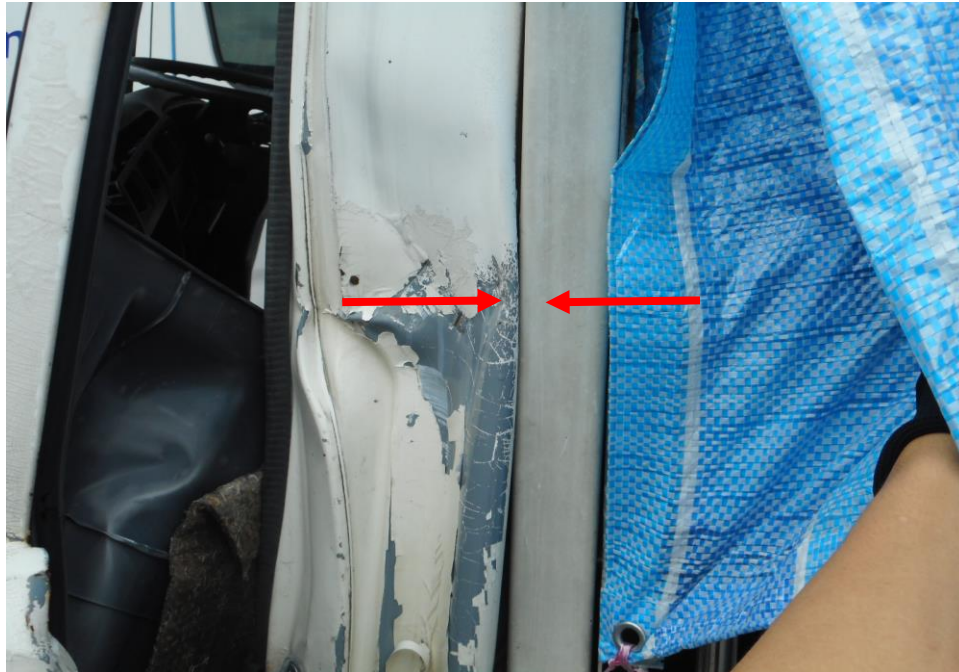
8. Upon examination of the Motor Lorry's engine compartment, we had observed that all the parts, components and fluids could not be inspection as due to the damage induced has crushed and deformed the cabin of the Motor Lorry which immobilized its opening and viewing, however we are able to observed the brake fluid and engine coolant reservoir of the Motor Lorry and was observed to be sufficient level without any visible contamination.
9. Our subsequent checks on the underside of the Motor Lorry also revealed sign of old fluid stain. Visually, the various undercarriage components of the Motor Lorry were all observed to be intact and without any visible damage. See photo 13 – 16 below.

Photo 13 shows the induced damage to the cabin (arrowed) of the Motor Lorry's which immobilised the opening and viewing of the various parts and components inside the engine compartment, a result of the accident.

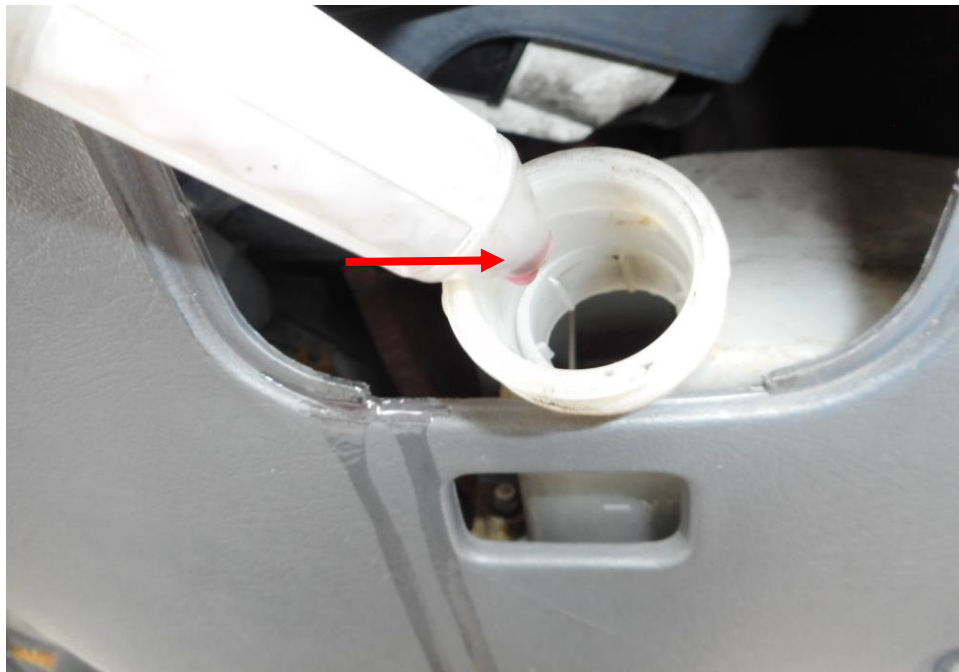
Photo 14 shows the brake fluid reservoir of the Motor Lorry at the time of our inspection. The brake fluid was observed to be of sufficient level and without any visible contamination (arrowed).

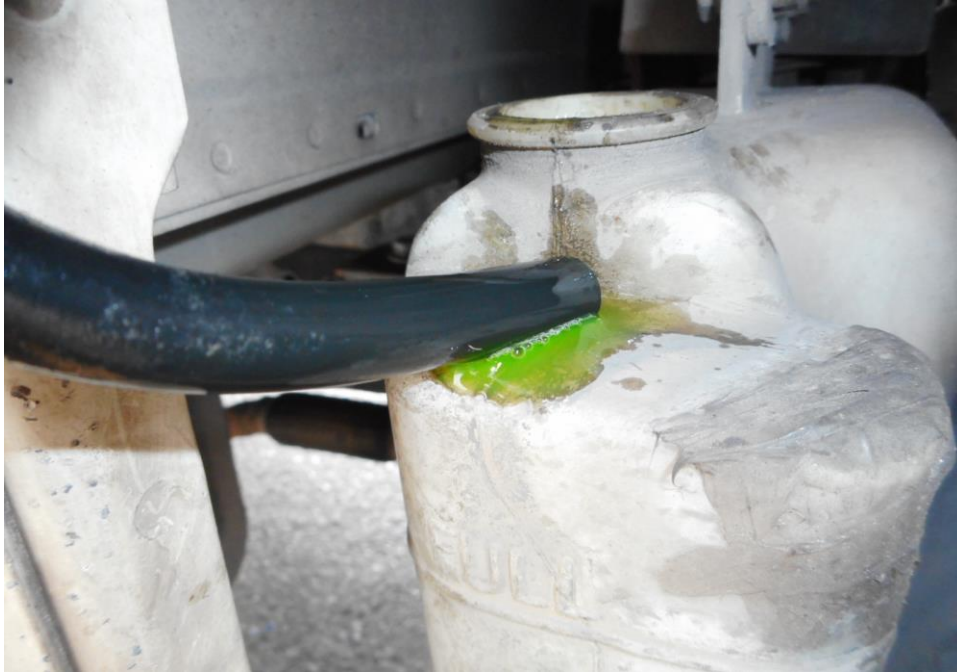
Photo 15 shows the engine coolant reservoir of the Motor Lorry at the time of our inspection. The coolant fluid was observed to be of sufficient level and without any visible contamination (arrowed).

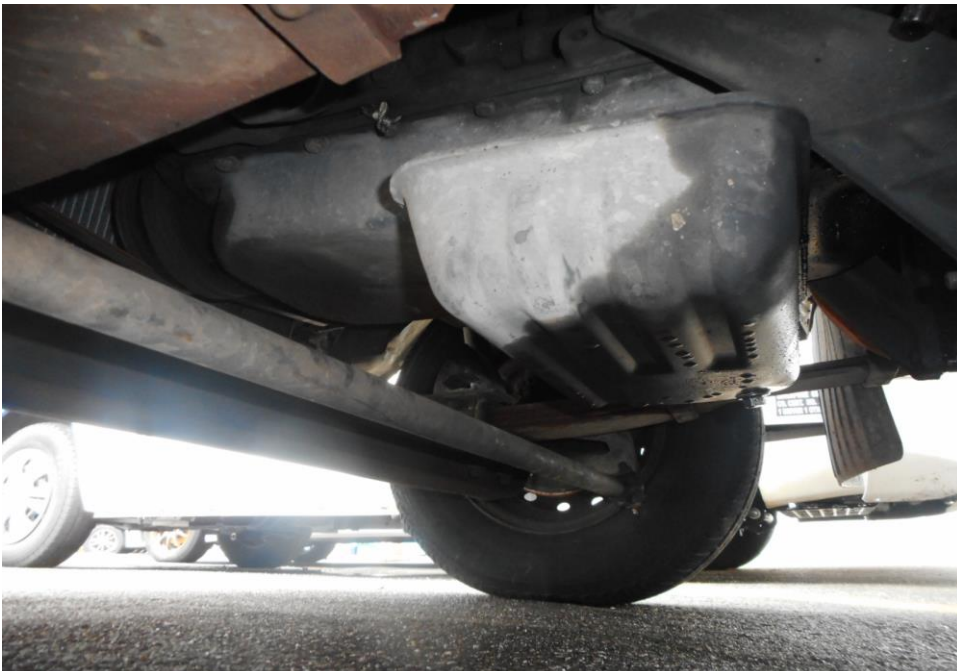
Photo 16 shows the undercarriage of the engine of the Motor Lorry at the time of our inspection. There was also sign(s) and indication(s) of old fluid stain within the engine undercarriage area.

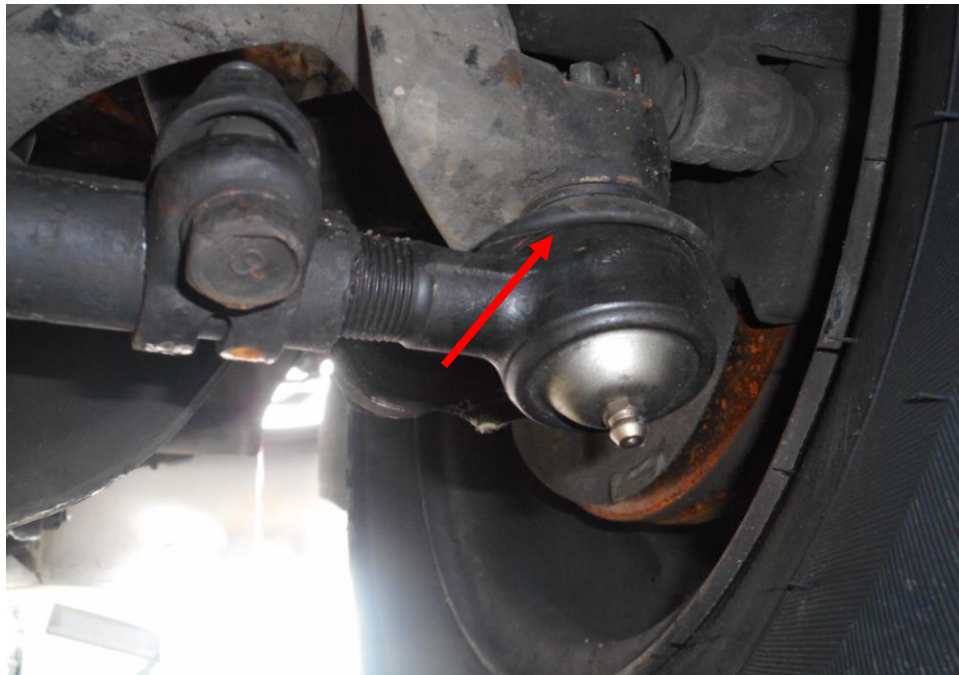
Photo 17 shows the various undercarriage components at the front right wheel of the Motor Lorry, in particular the steering tie rod end and ball joints (arrowed). The various undercarriage components of the Motor Lorry were all found to be intact without any visible damage. There was also no sign of fluid stain(s) observed on the various undercarriage components.

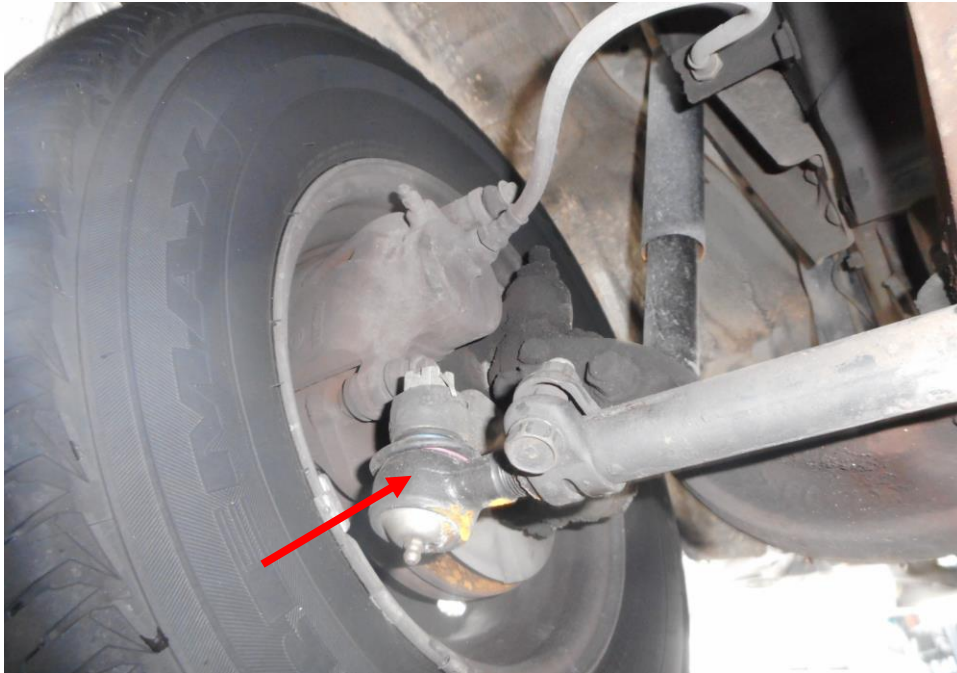
Photo 18 shows the various undercarriage components at the front left wheel of the Motor Lorry, in particular the steering tie rod end and ball joints (arrowed) were observed to be damaged.

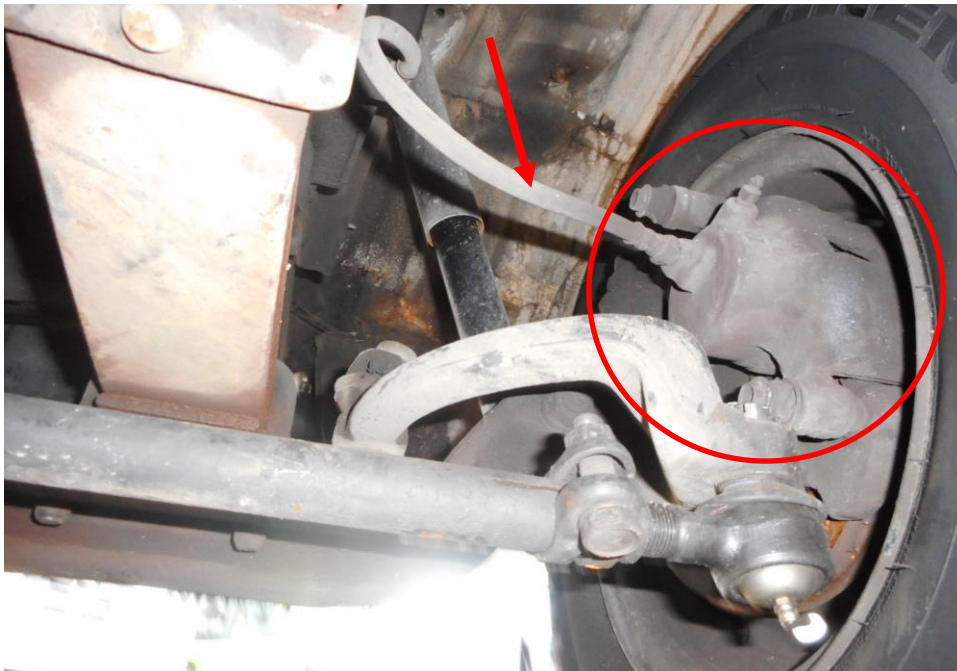
Photo 19 shows the various undercarriage components at the front right wheel of the Motor Lorry, in particular the brake hose (arrowed) and callipers (circled). The various undercarriage components of the Motor Lorry were all found to be intact without any visible damage. There was also no sign of fluid stain(s) observed on the various undercarriage components.

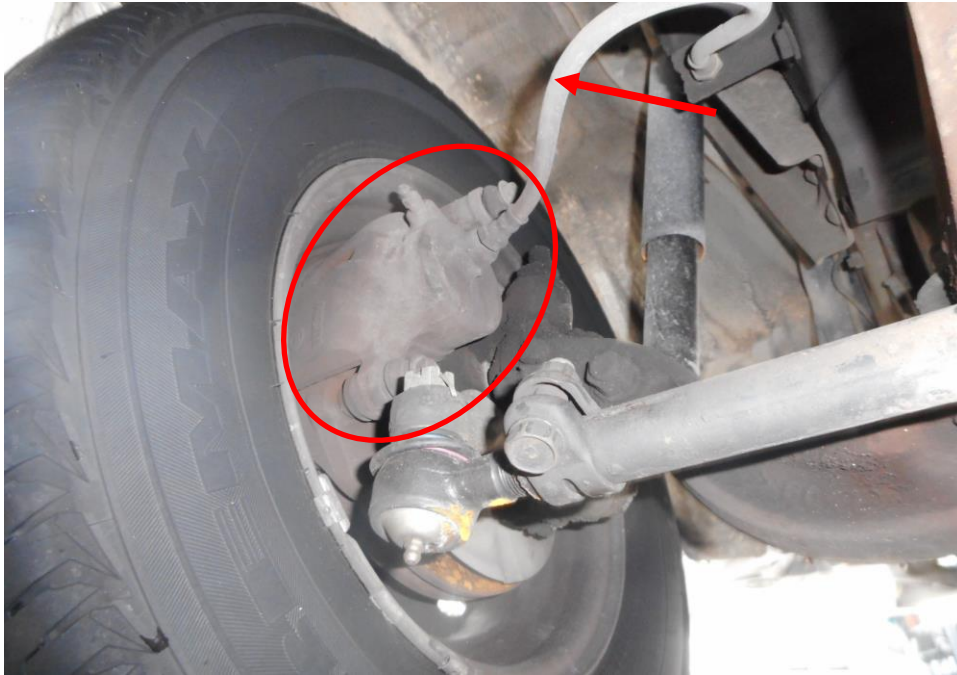
Photo 20 shows the various undercarriage components at the front left wheel of the Motor Lorry, in particular the brake hose (arrowed) and callipers (circled). The various undercarriage components of the Motor Lorry were all found to be intact without any visible damage. There was also no sign of fluid stain(s) observed on the various undercarriage components.

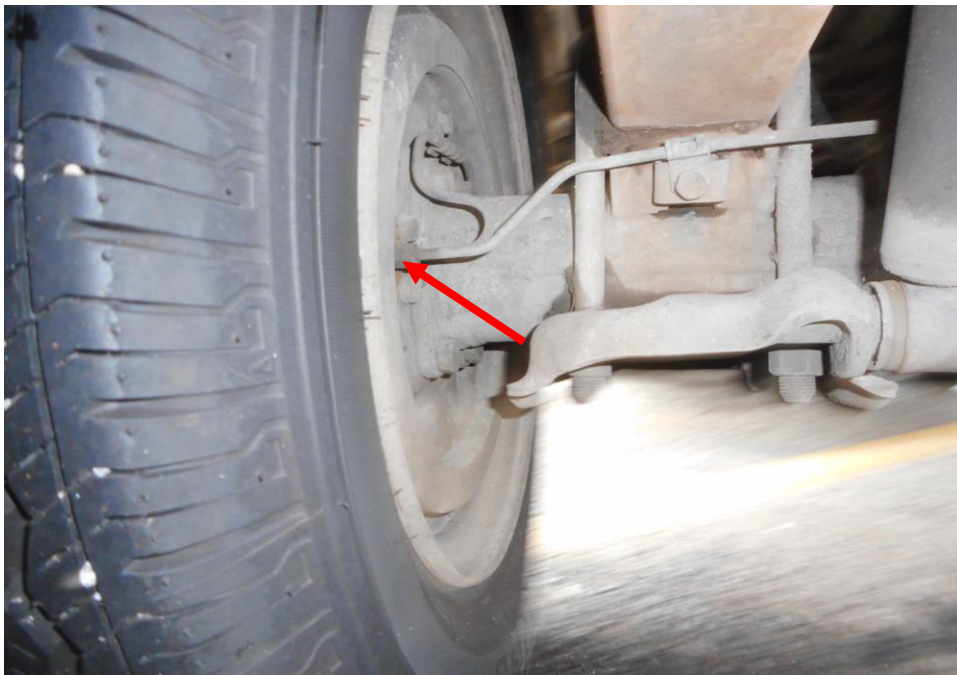
Photo 21 shows the various undercarriage components at the rear left wheel of the Motor Lorry, in particular the brake hose and drum brake (arrowed). The various undercarriage components of the Motor Lorry were all found to be intact without any visible damage. There was also no sign of fluid stain(s) observed on the various undercarriage components.

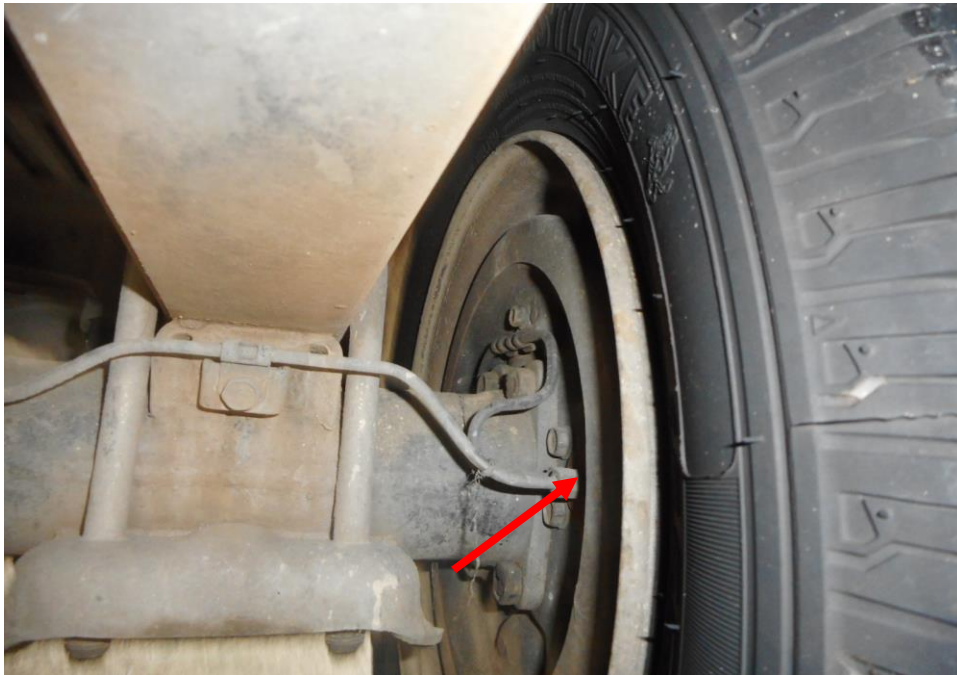
Photo 22 shows the various undercarriage components at the rear right wheel of the Motor Lorry, in particular the brake hose and drum brake (arrowed). The various undercarriage components of the Motor Lorry were all found to be intact without any visible damage. There was also no sign of fluid stain(s) observed on the various undercarriage components.

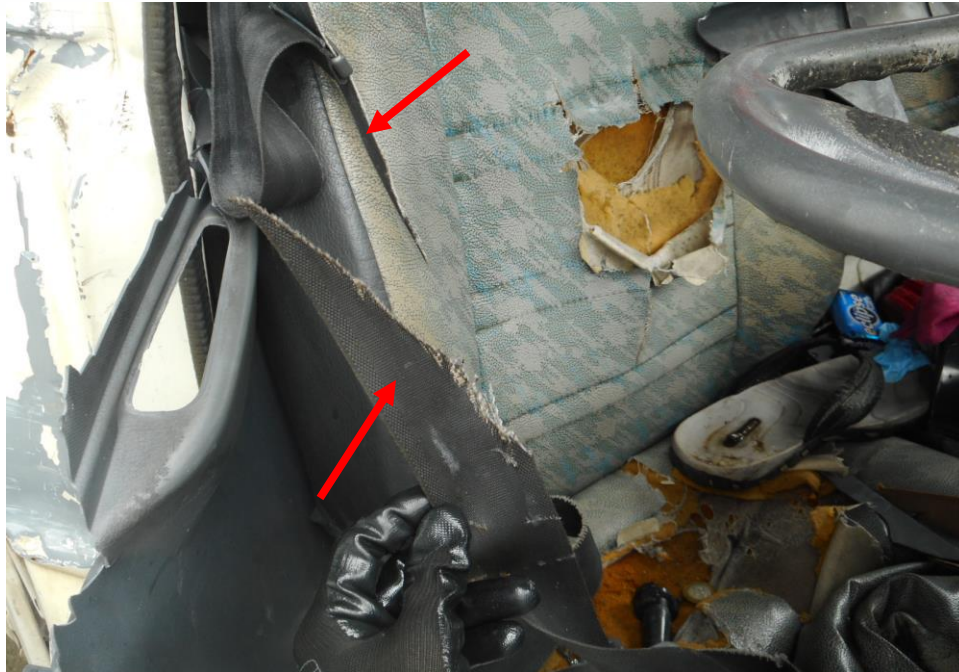
15. The front right seat belts of the "Motor lorry" were worn at the material time of accident as the respective pre-tensioners that were fitted at the sides of each seat was activated upon the material time and there was signs of an extrication conducted. See photo 23 below.

Photo 23 shows that the seat belt on the right seat was worn at the material time of accident as the safety pre-tensioners was activated at the moment of impact and caused the seat belts to be locked into the last position of the user and there was signs an extrication conducted (arrowed)
