Your Ref: SBE 338B  
Our Ref : CI/TP20009233/D

01 September 2020

### **AUTOMOBILE INSPECTION REPORT OF MOTOR CAR SBE 338B**

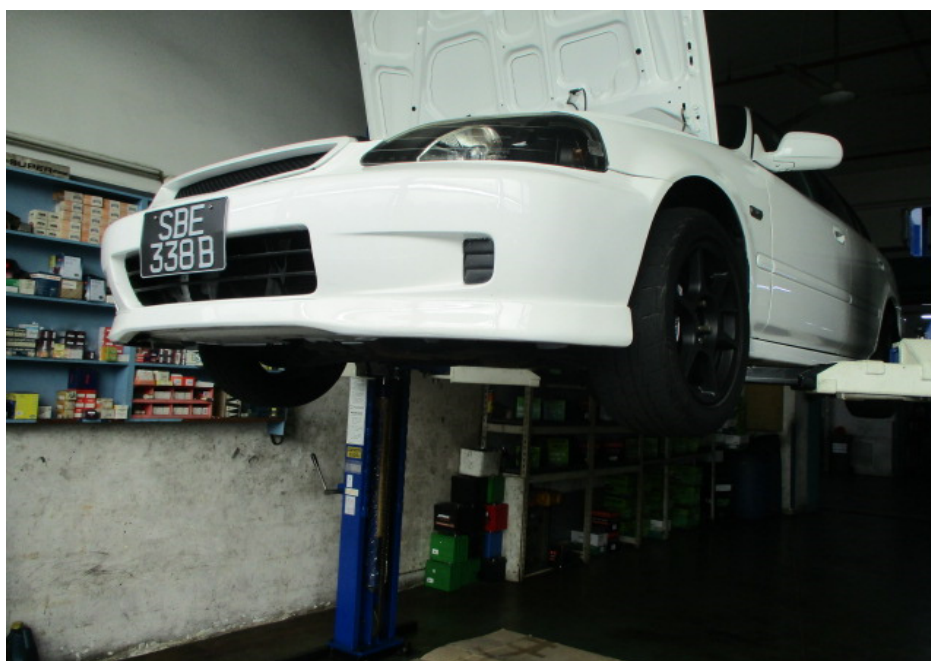
**Photo 1** shows the Motor Car hoisted up at the time of my inspection. The mileage of the Motor Car recorded was 190,486km.

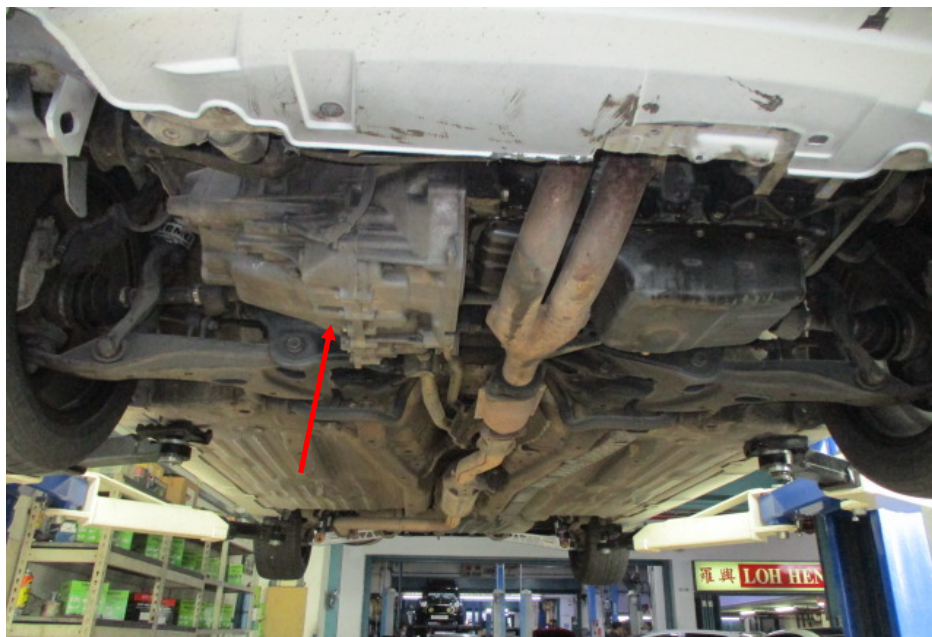
6. The Motor Car was fitted with a 5-speed manual transmission assembly. The input side of the transmission is bolted to the crankshaft side of the engine block. The left and right drive shafts were observed to be securely fitted from the main shaft, located inside the transmission, to the front left wheel and front right wheel respectively. There was also no crack and/or hole observed on the transmission housing.

**Photo 2** shows a general view of the transmission assembly (arrowed) that was fitted on the Motor Car. The input side of the transmission is bolted to the crankshaft side of the engine block. The left and right drive shafts were observed to be securely fitted from the main shaft, located inside the transmission, to the front left wheel and front right wheel respectively. There was also no crack and/or hole observed on the transmission housing.

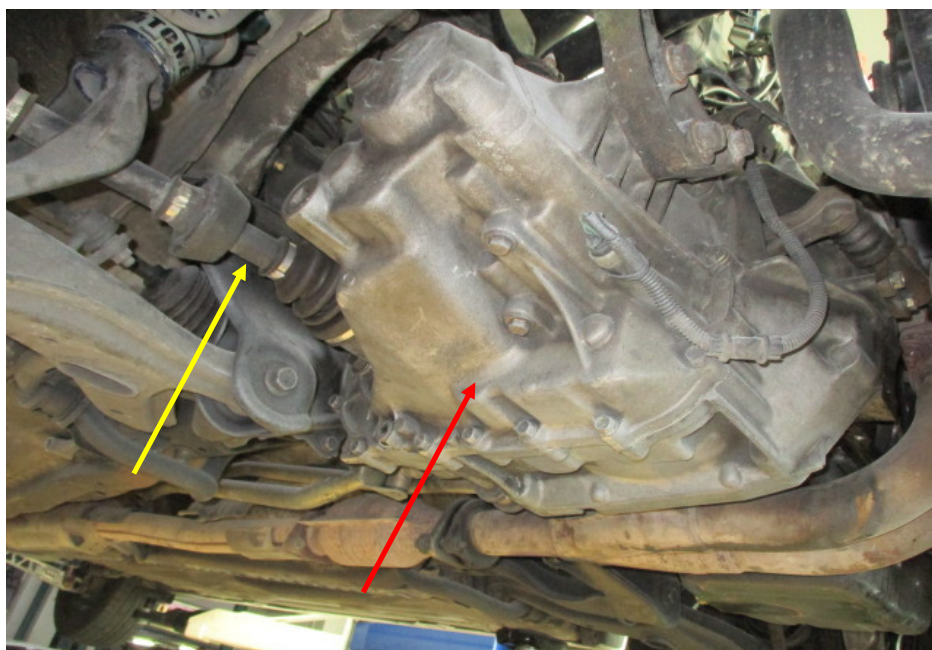
**Photo 3** shows a general view of the transmission assembly (red arrow) that was fitted on the Motor Car. There was also no crack and/or hole observed on the transmission housing. The left and right drive shafts were observed to be securely fitted from the main shaft, located inside the transmission, to the front left wheel and front right wheel respectively. The right drive shaft is highlighted by the yellow arrow.

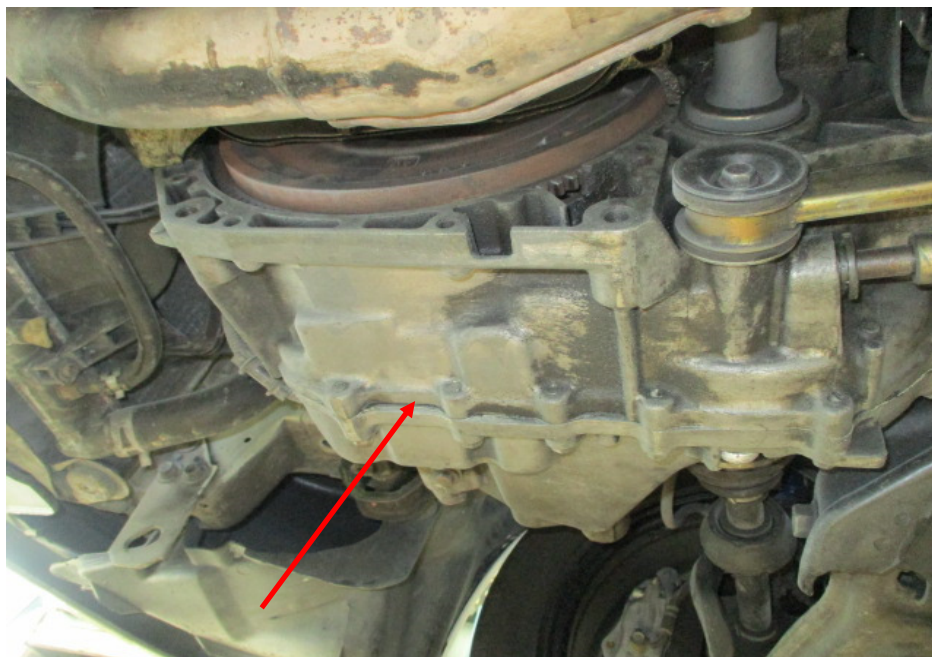
**Photo 4** shows another view of the transmission assembly (arrowed) that was fitted on the Motor Car. This was at the input side where the transmission is bolted onto the crankshaft side of the engine block.

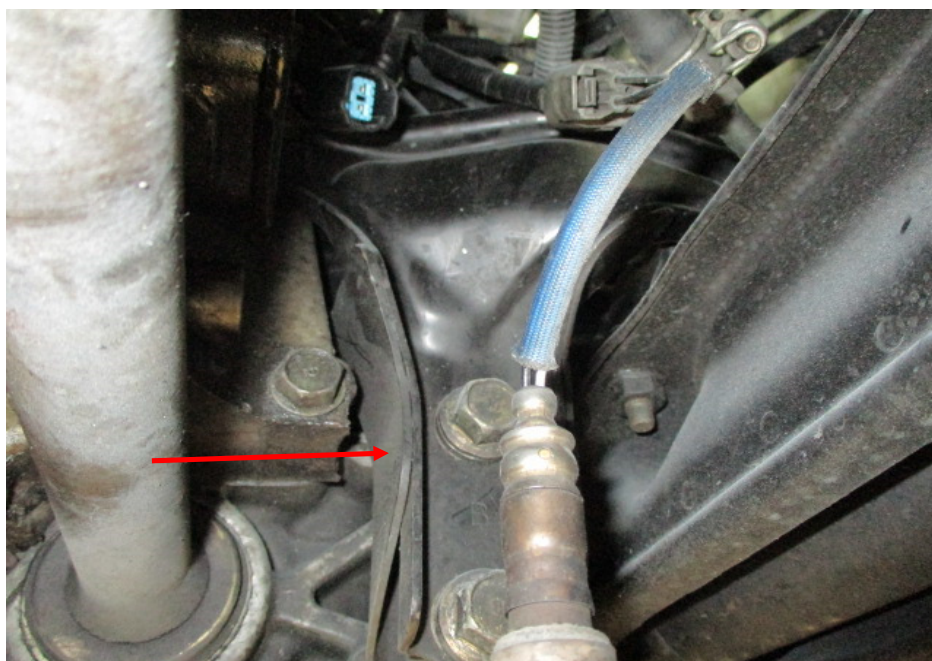
7. The transmission of the Motor Car was supported by 2 brackets. One was at the rear of the transmission while the other was at the right side of the transmission. The bracket at the rear of the transmission was mounted onto the engine cross member while the bracket at the right side was mounted onto the right side front chassis, adjacent to the right side front wheel house. Both brackets are with rubber bushings, which absorbs any vibrations arising from the rotation of the transmission gears, minimising any stress to the bracket and correspondingly also minimise any stress to the engine crossmember and right side front chassis that these brackets are mounted onto.

**Photo 5** shows the bracket (arrowed) supporting the rear of the Motor Car's transmission. This bracket was mounted onto the engine cross member. The bracket was with rubber bushings that absorbs any vibrations arising from the rotation of the transmission gears, minimising any stress to the bracket and correspondingly also minimise any stress to the engine crossmember.

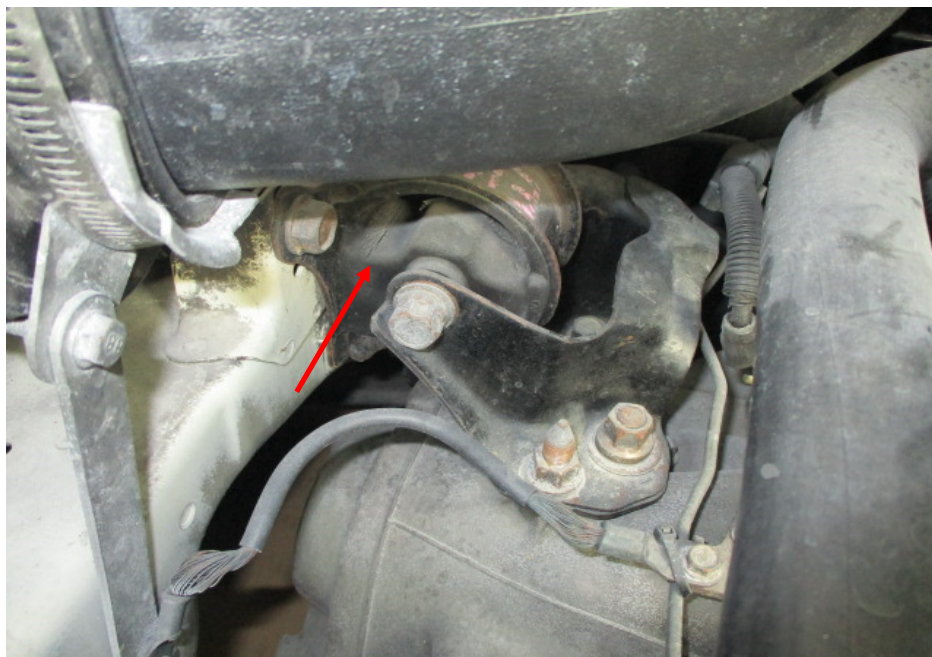
**Photo 6** shows the bracket supporting the right side of the Motor Car's transmission. This bracket was mounted onto the right side front chassis, adjacent to the right side front wheel house. The bracket was with rubber bushings (arrowed) that absorbs any vibrations arising from the rotation of the transmission gears, minimising any stress to the bracket and correspondingly also minimise any stress to the right side front chassis member.

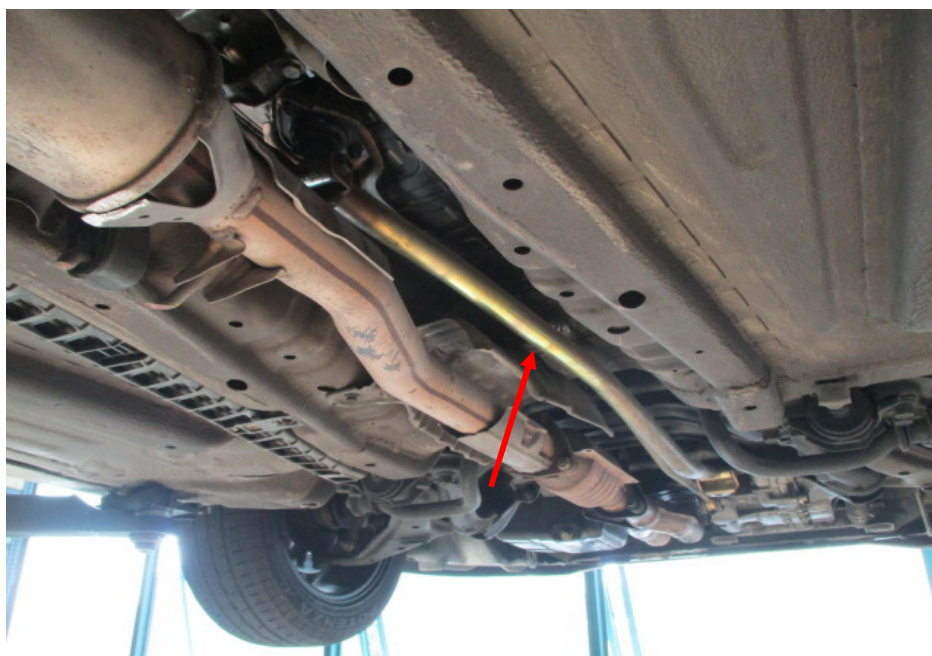
8. The gear selector fork from the transmission to the gear shifter of the Motor Car was observed to be securely fitted on the underside of the Motor Car. The gear selector fork connects to the gear shifter in the interior compartment of the Motor Car through the floorboard. See photo 1 – 8 below.

**Photo 7** shows the gear selector fork (arrowed) from the transmission to the gear shifter of the Motor Car. The gear selector fork was observed to be securely fitted on the underside of the Motor Car. This gear selector fork connects to the gear shifter in the interior compartment of the Motor Car through the floorboard

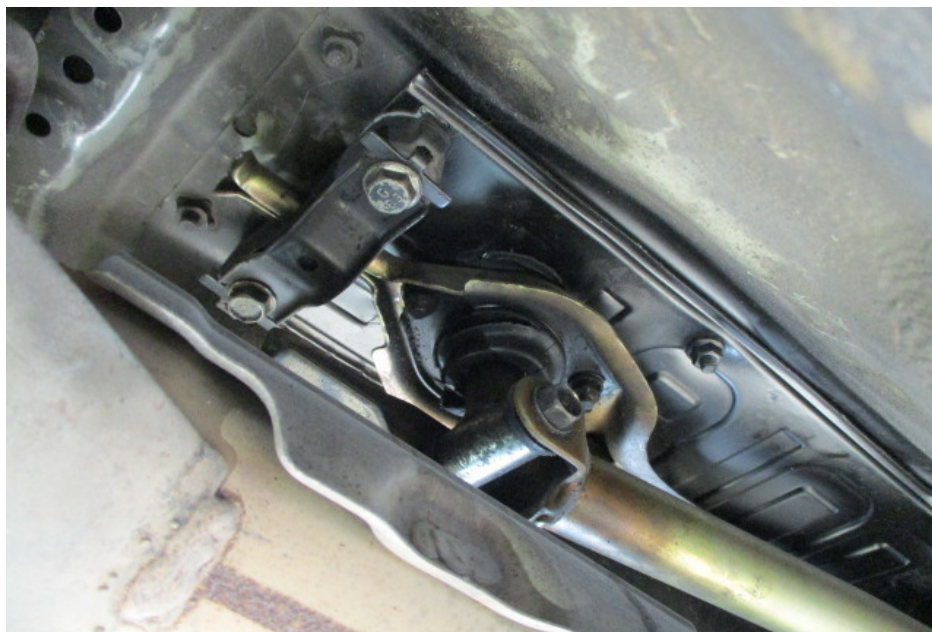
**Photo 8** shows the gear selector fork, at the side where it connects to the gear shifter in the interior compartment of the Motor Car through the floorboard.

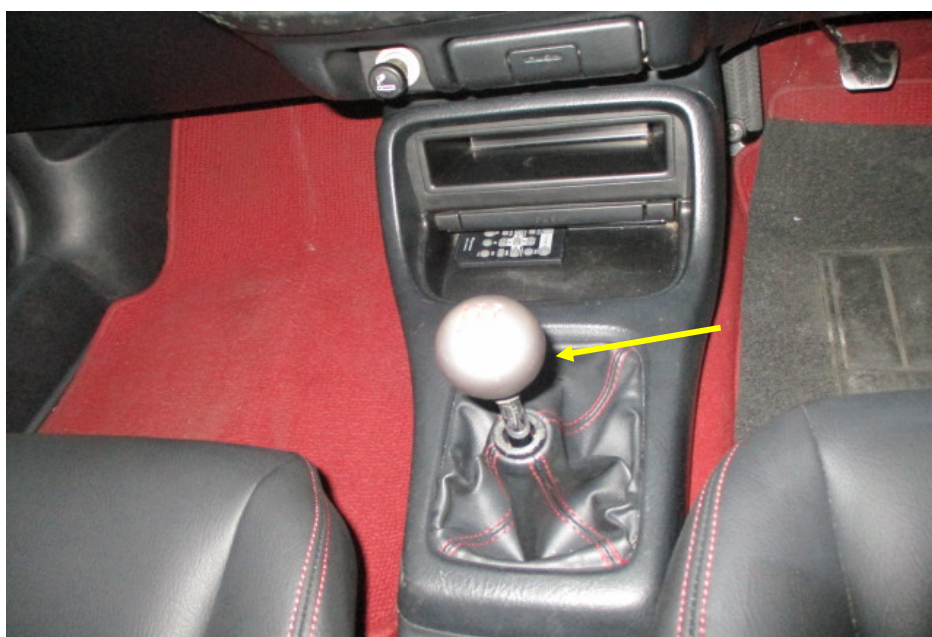
**Photo 9** shows the gear shifter (arrowed) that was fitted on the Motor Car, for manually selecting the transmission gear to be engaged. The gear selector fork from the underside of the Motor Car (refer to photograph 7 above) connects to this gear shifter through the floorboard.

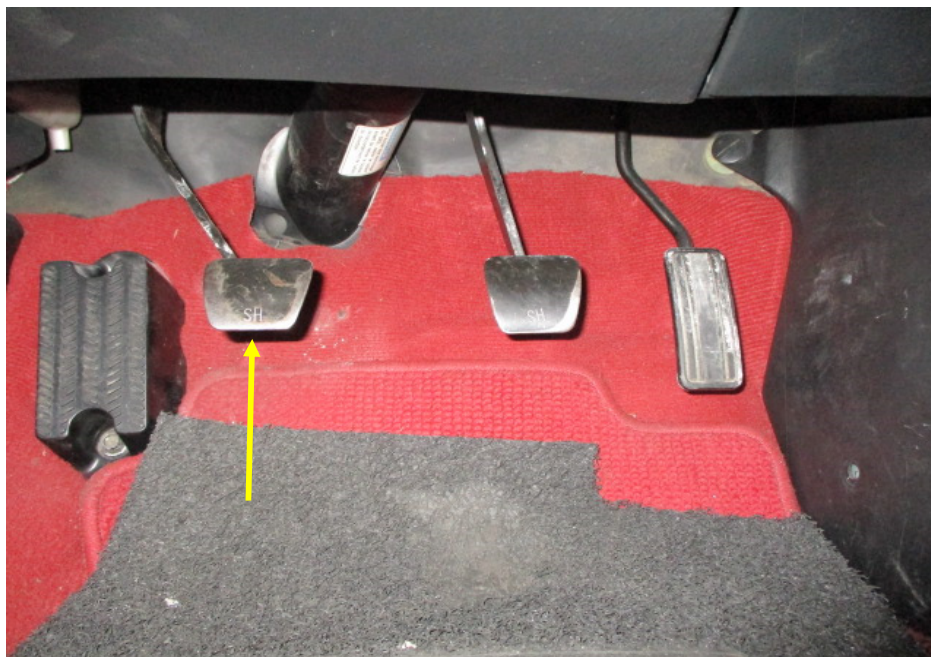
**Photo 10** shows the clutch pedal (arrowed) of the Motor Car, for engaging and disengaging the transmission gears.

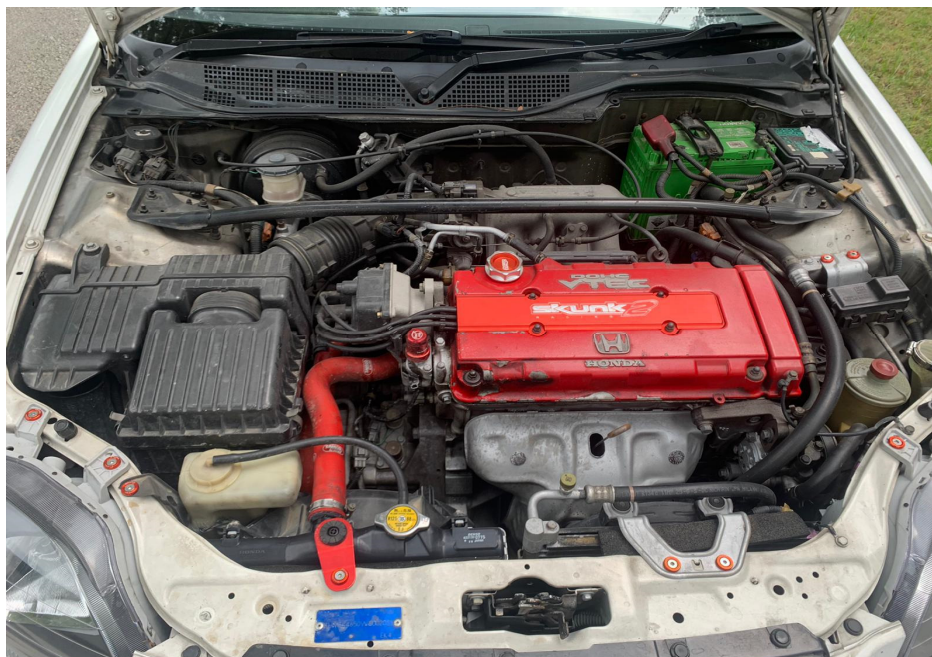
**Photo 11** shows the engine bay of a similar make and model motor car that was fitted with an automatic transmission. This was for comparison of the mounting point of the right side bracket for the manual transmission that was fitted on the Motor Car.

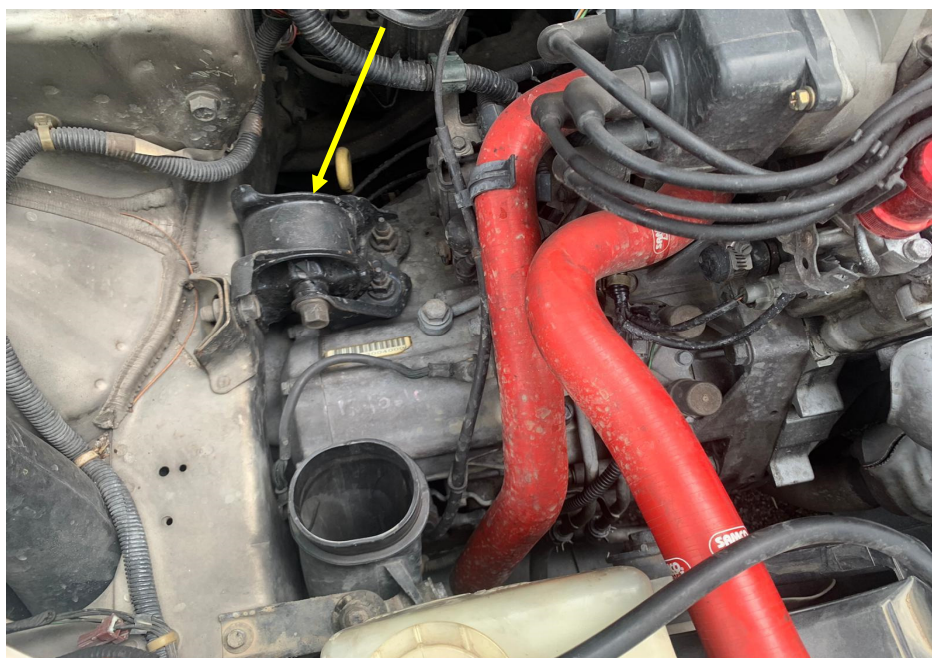
12. In summary, the transmission of the Motor Car was found to be secured properly. It was observed to be supported by 2 brackets with all related components forming a complete manual transmission system, securely fitted/attached. The mounting of the bracket at the right side of the transmission onto the right side front chassis of the Motor Car is the original mounting point for the bracket as my comparison of an automatic transmission of a similar make and model motor car showed the same mounting location. See photo 11 & 12 below.

**Photo 12** shows the bracket (arrowed) at the right side of the automatic transmission that was fitted on the similar make and model motor car. The mounting location was observed to be the same as the mounting location for the bracket at the right side of the manual transmission that was fitted on the Motor Car (refer to photograph 6 above).
