Your Ref: S0M02SZ3/HW
Our Ref : CS4/ASM20009244/N

**TECHNICAL INVESTIGATION REPORT OF FIRE INCIDENT INVOLVING THE
INSURED VEHICLE SLC 5931Y ON 28 AUGUST 2020**

Vehicle Registration No.	: SLC 5931Y
Make / Model	: Honda VEZEL 1.5X A
Chassis No	: RU11108080
Year of Registration	: May 2016
Mileage	: N.A (battery melted)

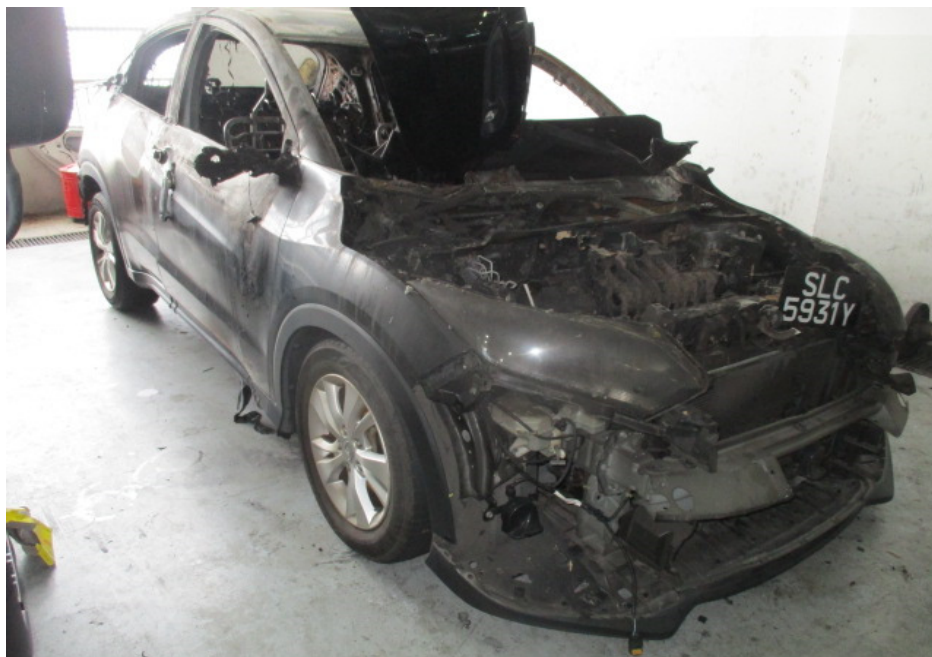
Photo 1 shows a general view of the front right body of the Insured Vehicle at the time of inspection. The Insured Vehicle was observed to have sustained extensive fire damage. The body panels at the front body and the undercarriage components at the front underside were all found to have been burnt to char.

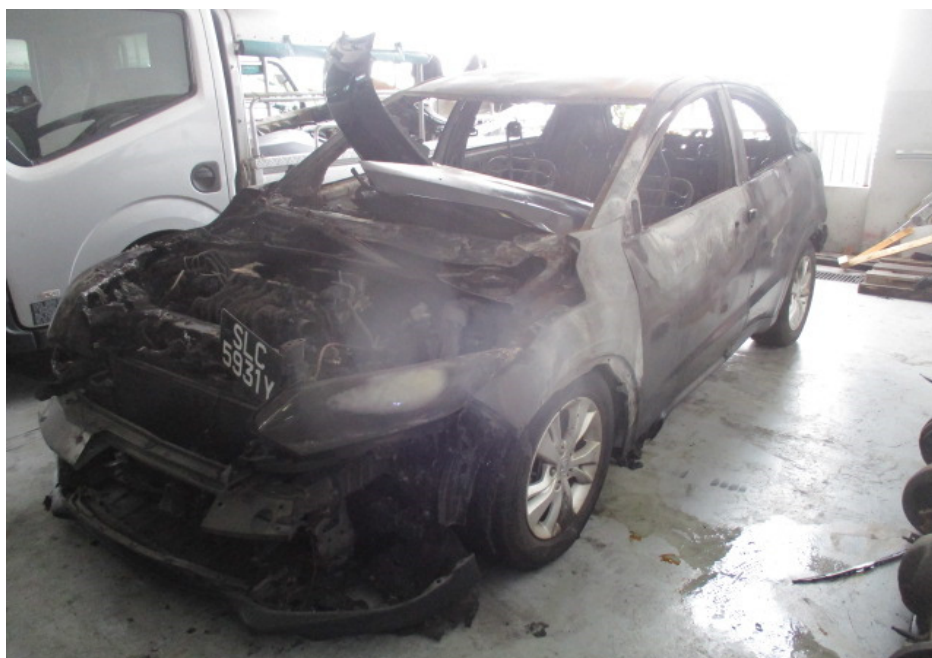
Photo 2 shows a general view of the front left body of the Insured Vehicle at the time of inspection. The Insured Vehicle was observed to have sustained extensive fire damage. The body panels at the front body like the front bonnet, front fenders, front door amongst others were all burnt to bare metal state.

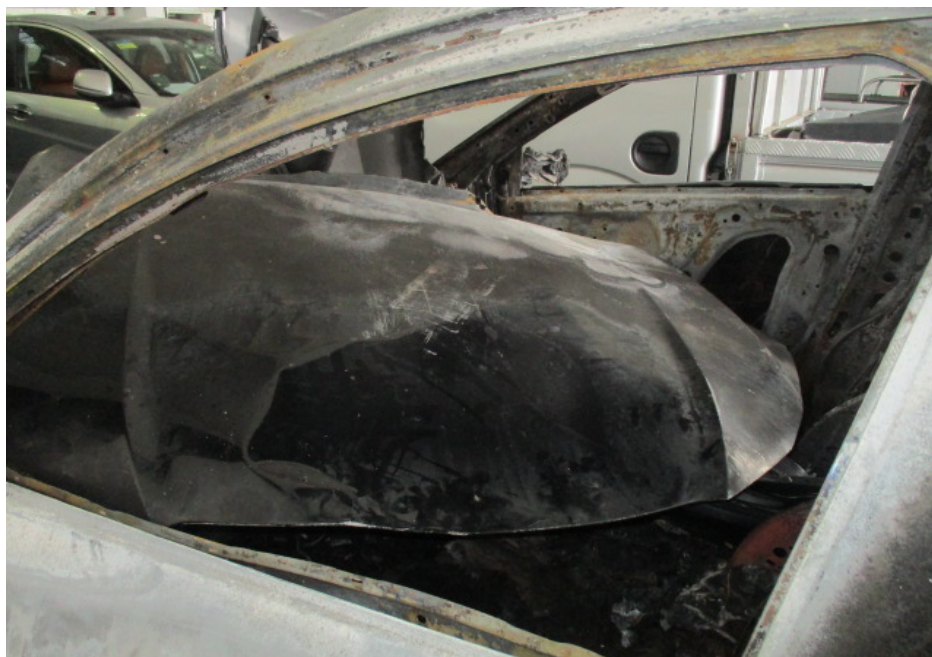
Photo 3 shows the interior compartment of the Insured Vehicle. All the parts inside the interior compartment were found to be extensively burnt. Its front seats, rear seats, roof upholstery, carpet and various trims were all burnt and/or melted, leaving charred skeletal remains.

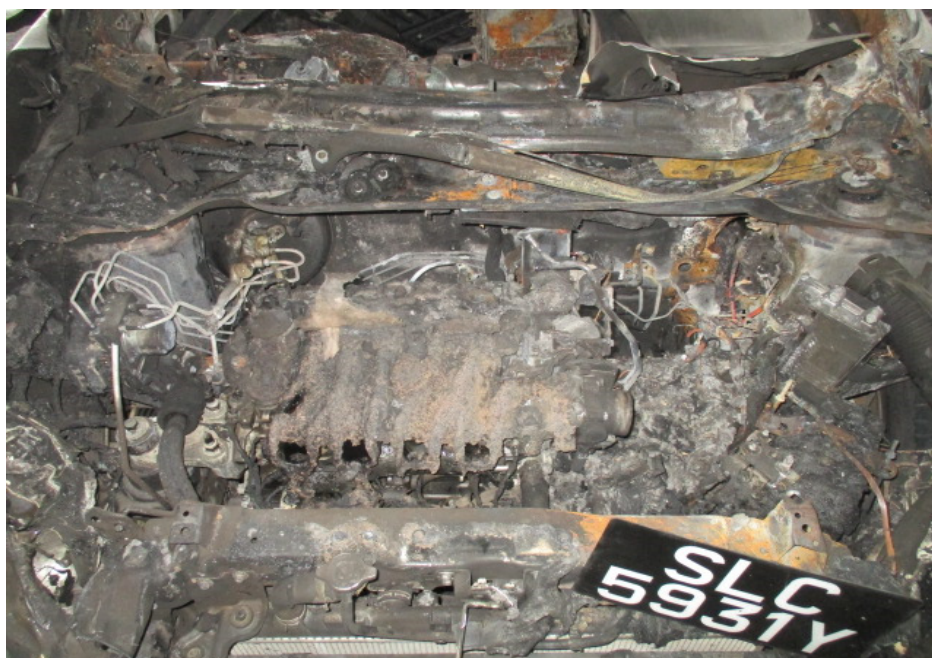
Photo 4 shows the engine compartment of the Insured Vehicle. The various parts and components within the engine compartment of the Insured Vehicle were all extensively affected by the fire. This had included the engine and transmission of the Insured Vehicle.

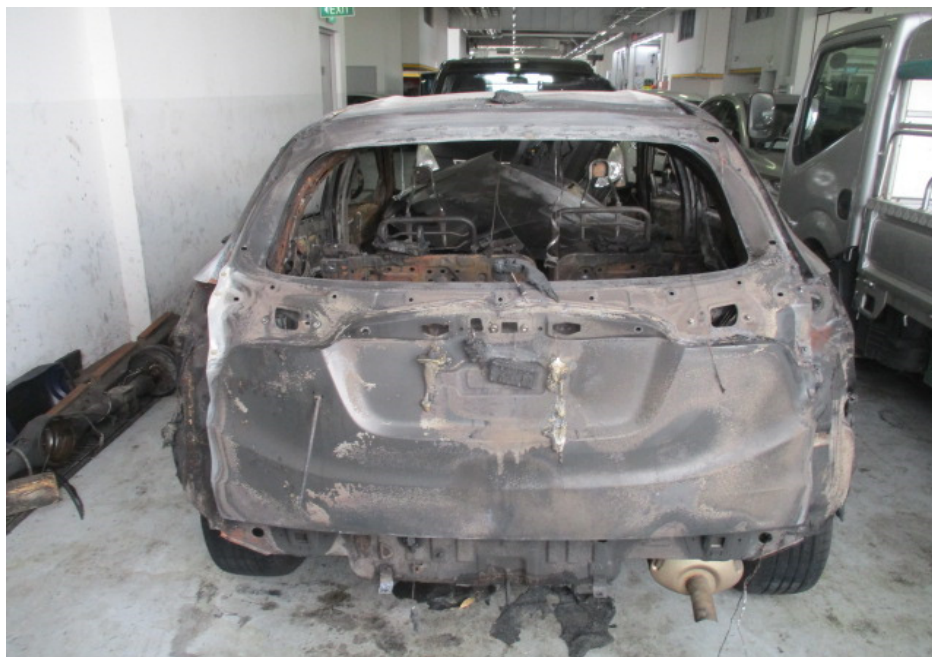
Photo 5 shows the rear body of the Insured Vehicle. Comparing the overall extent of fire damage like the rear tyres vs the front tyres, condition of rear body panels vs front body panels etc, it would appear that the front body of the Insured Vehicle was more severely affected than its rear portion.

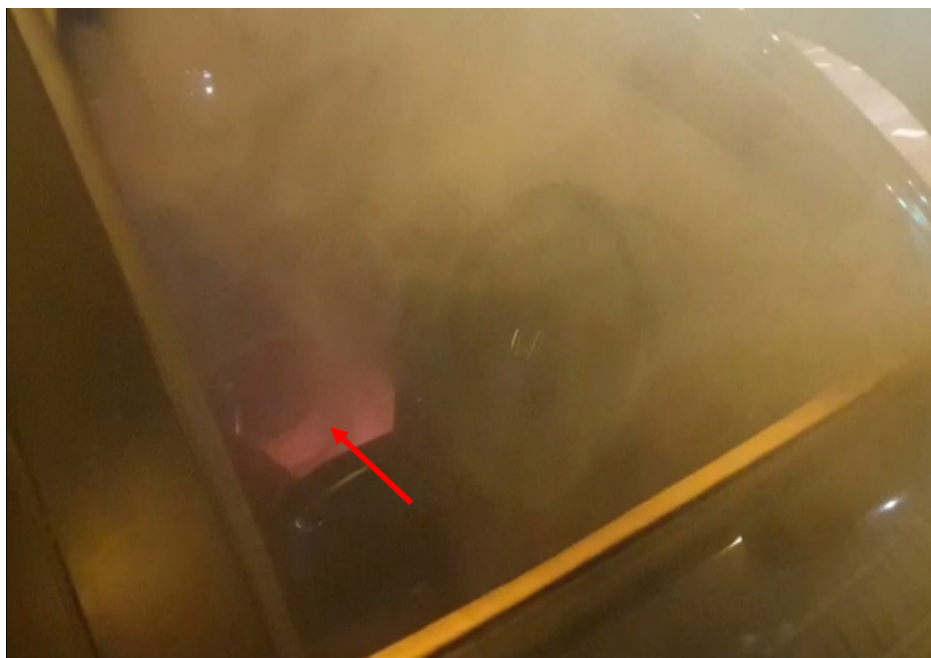
Photo 7 shows screenshot taken from the video recording that was provided by Mr See. The Insured Vehicle could be seen with intense smoke emitting from the left passenger side (arrowed).

16. For this case, Mr See first saw smoke coming out from the gaps surrounding the dashboard. Taking Mr See's observations into consideration, the fire to the Insured Vehicle had originated around the left side of the dashboard, at or near the glove compartment area; with the cause of fire related to a defective originally fitted component. The following paragraphs discuss this aspect.
17. The Insured Vehicle was involved in a manufacturer recall campaign in year 2016. The recall was for issue relating to a capacitor used in the engine idling stop system of the Insured Vehicle, which may be insufficient to protect against an overcurrent. Notably, the records had indicated that rectification to address the issue has not been carried out to the Insured Vehicle prior to this incident. See search result below obtained from LTA.

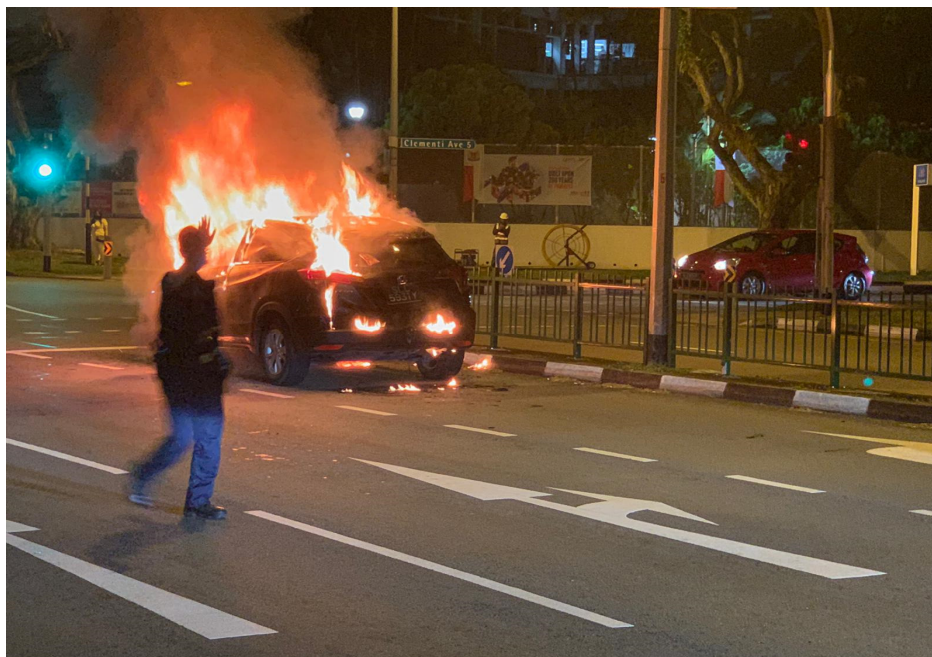
Photo 8 shows the rear body of the Insured Vehicle on fire. Comparing the overall extent of fire damage like the rear tyres vs the front tyres, condition of rear body panels vs front body panels etc, it would appear that the front body of the Insured Vehicle was more severely affected than its rear portion.

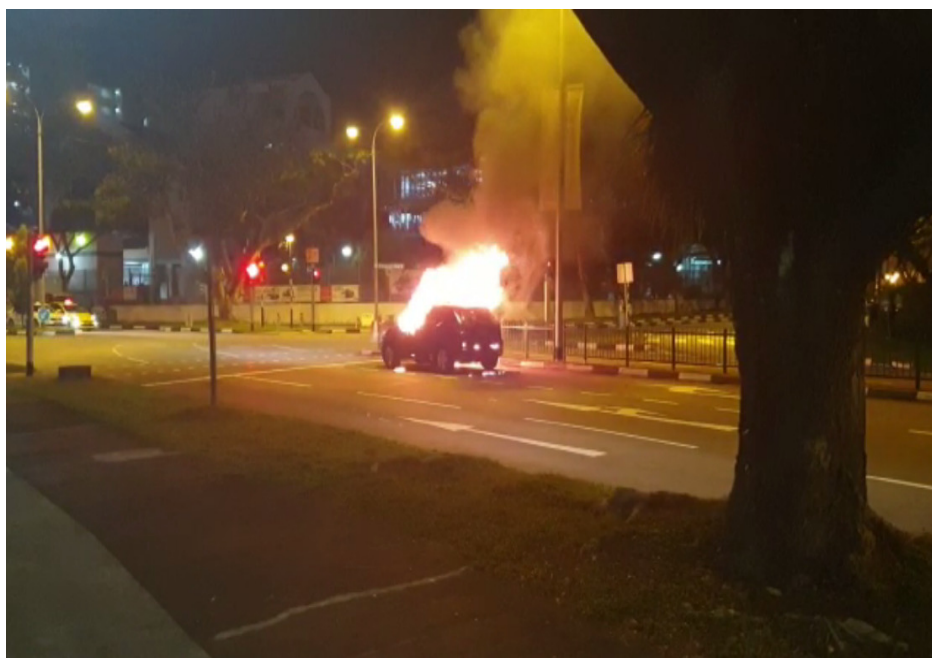
Photo 9 shows screenshot taken from the video recording that was provided by Mr See. The Insured Vehicle could be seen with flames engulfing its front body and interior compartment.

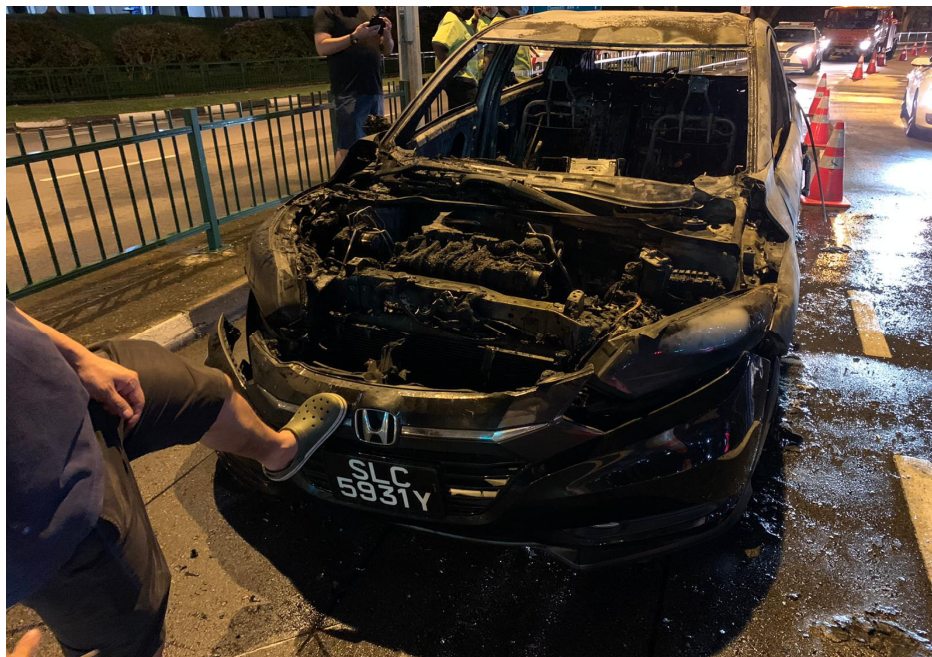
Photo 10 shows the Insured Vehicle after the fire was extinguished. Generally, the information that we were able to gather from the video recordings and photographs provided by Mr See had corresponded to the information that he had related to us during our telephone conversation on 8 September 2020.

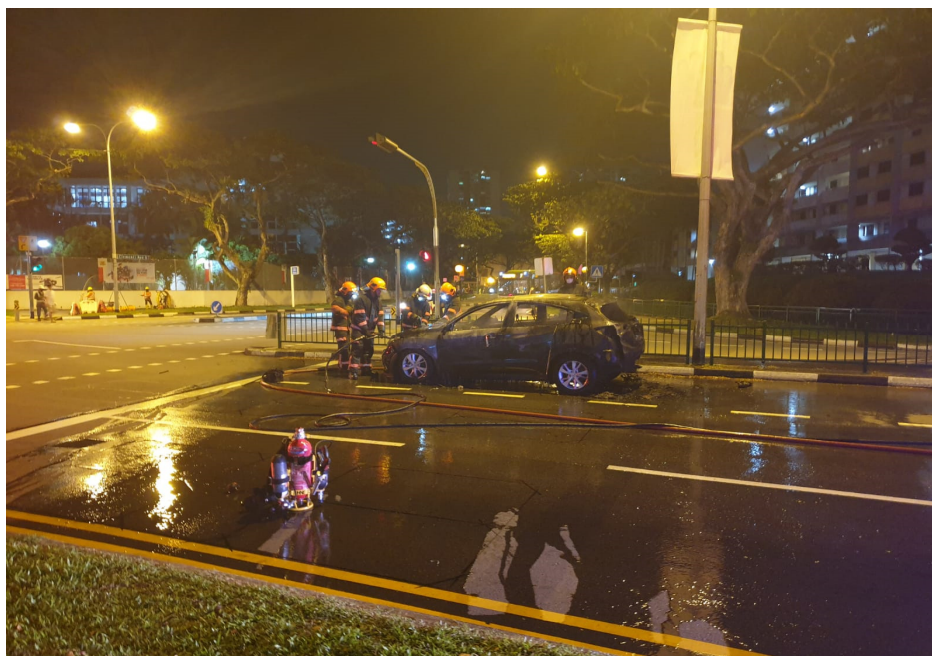
Photo 11 shows the Insured Vehicle after the fire was extinguished. The extent of fire damage was similar to what we observed when we inspected the Insured Vehicle. The background seen from the photographs had also corresponded to the incident occurring at the traffic junction of Clementi Ave 4 and Clementi Ave 5.

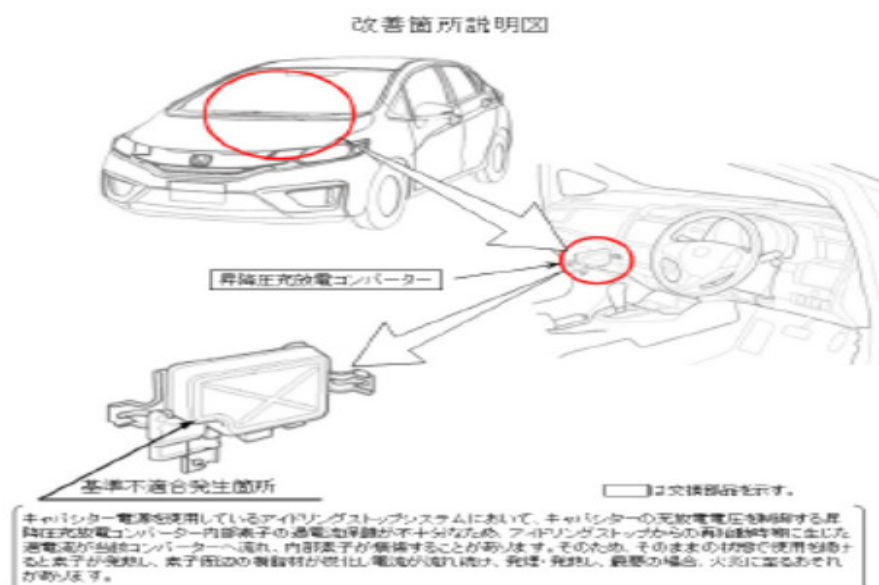
Honda recalled 160,000 Fit subcompact and Vezel sport-utility vehicles in Japan because of defective power steering and a part that controls the electric current in the vehicles. The recall does not affect any Honda models sold abroad.

There have been no injuries related to the problems. Six fires were reported related to the faulty part that controls electricity for capacitors, and two minor accidents were reported to the defect in the steering, according to Honda Motor Co.

Screenshot 1 shows the write up that we were able to gather pertaining to the manufacturer recall campaign of similar make and model vehicles as the Insured Vehicle.

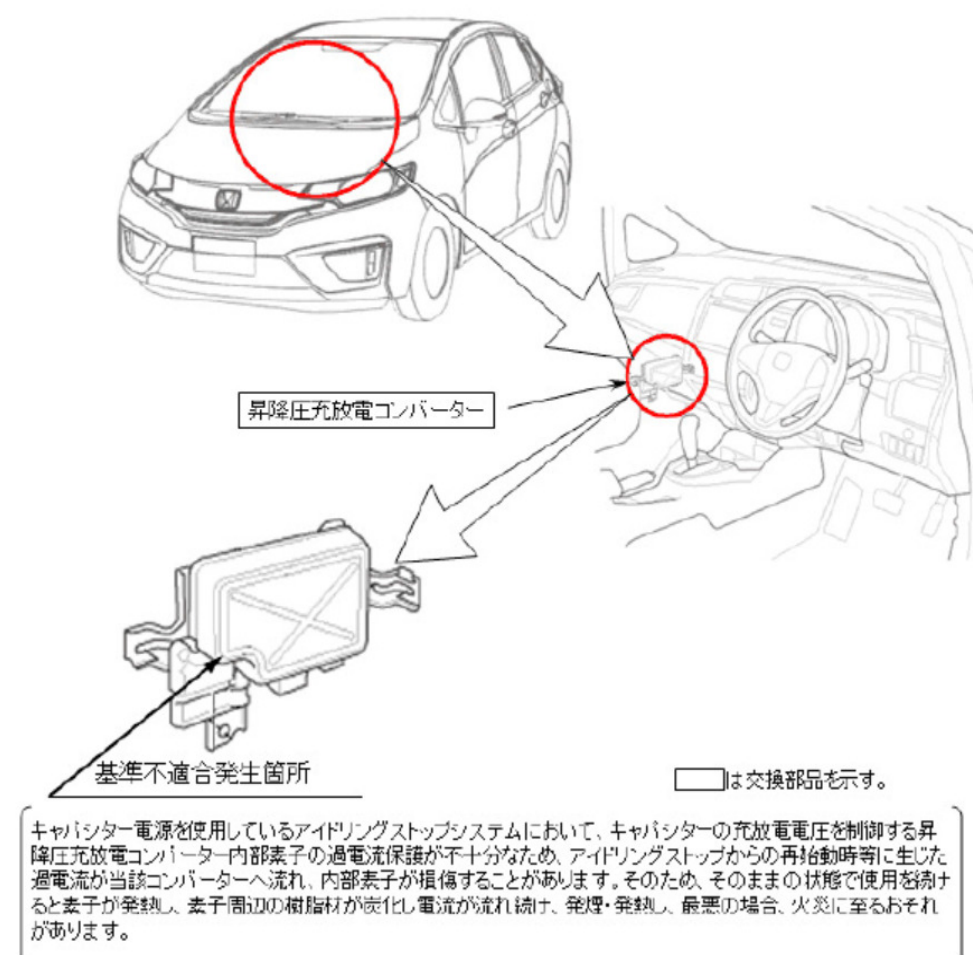
改善箇所説明図

18. Our further research and checks on the capacitor that was mentioned in the recall details of the LTA search result revealed that this capacitor is a component that is fitted onto the inner side of the Insured Vehicle's front left "A" pillar, towards the left and below the glove compartment of the Insured Vehicle. We note that this location is at or near the location where Mr See had seen the most smoke. Basing on the information gathered pertaining to the capacitor; and given that no rectification to address the capacitor issue was carried out to the Insured Vehicle (as per LTA records), it can be determined that the fire to the Insured Vehicle is related to the purpose of the manufacturer recall campaign that involved the Insured Vehicle. See screenshots 1 & 2 showing the search result below gathered from our further research and checks.

Screenshot 2 shows a zoom in view of the schematic diagram pertaining to the manufacturer recall campaign of similar make and model vehicles as the Insured Vehicle. The component, circled in the schematic diagram, is the capacitor that was mentioned in the recall details of the LTA search result. The location where this component was fitted was also at or near the location where Mr See had seen smoke.

21. Having investigated and technically analysed the damages of burnt nature to the Insured Vehicle, we are of the view that the cause of fire to the Insured Vehicle was of electrical in nature. For this particular case, the fire was due to an originally fitted component that was defective.

22. Our investigations revealed that this fire incident is related to a manufacturer recall campaign that involved the Insured Vehicle as the purpose of the recall was due to a fault in an originally fitted component, which was referred to as a capacitor. Our findings appear to indicate that the cause of fire was related to this component although the rectification to address the purpose of the recall campaign had been carried out to the Insured Vehicle prior to this incident.
