LKK Auto Consultants Pte Ltd

Vehicle No. SKV 7029B
Insured Veh. YP 9456D
Claim No. DM20HO01224 / SG
Policy No. DMCPHQ19-004727
Accident Date 19/08/2020
Inspection Date 09/09/2020

ADJUSTMENT ON REPAIR COST FOR VEHICLE NO. SKV 7029B

PHOTOGRAPHS FOR VEHICLE NO. SKV 7029B

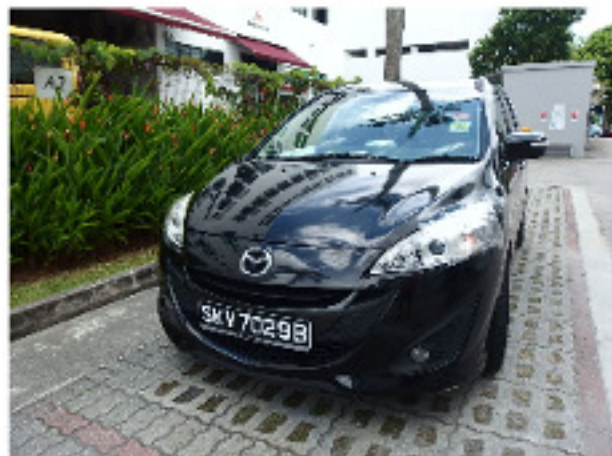
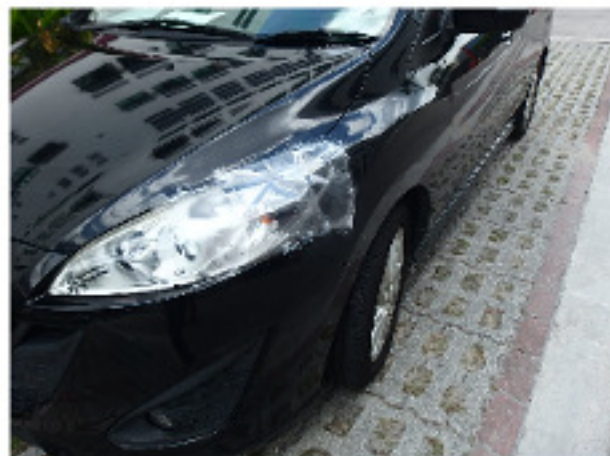
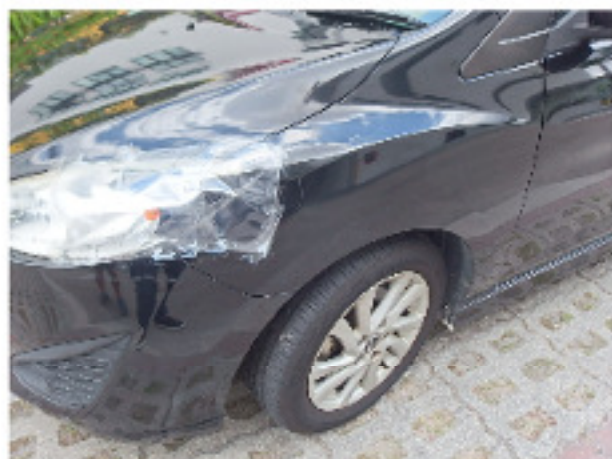
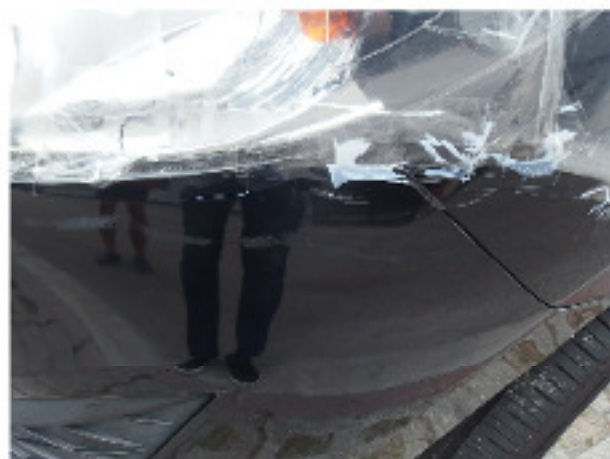
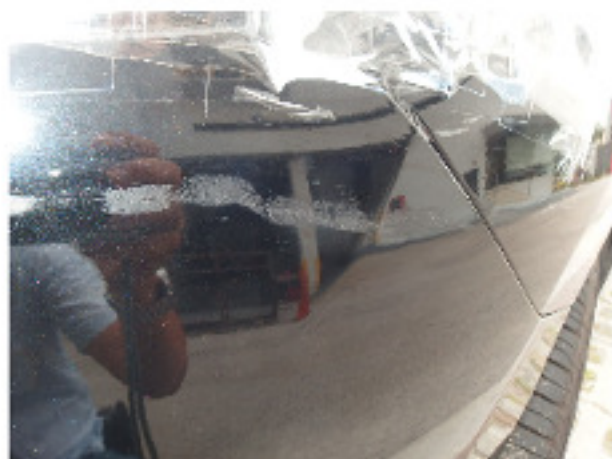
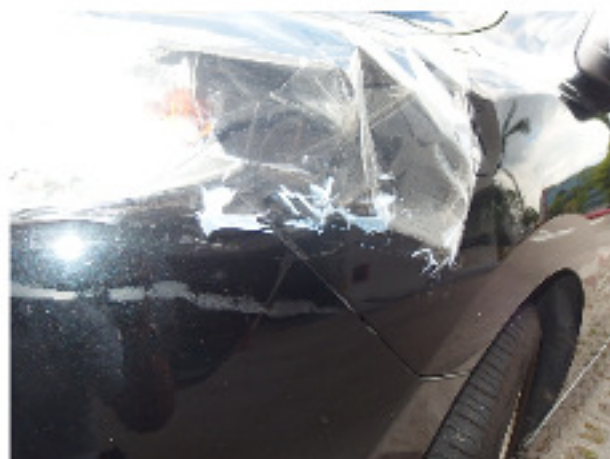
INSPECTION

THE VEHICLE SUSTAINED DAMAGES AT THE N/S FRONT PORTION. DAMAGES SEE DETAILS.
