Your Ref: J/20190706/2041
Our Ref : CI/SPF20009396/N

**INSPECTION REPORT OF ELECTRIC SCOOTER - TRAFFIC POLICE POUND
REPORT NO. J/20190706/2041**

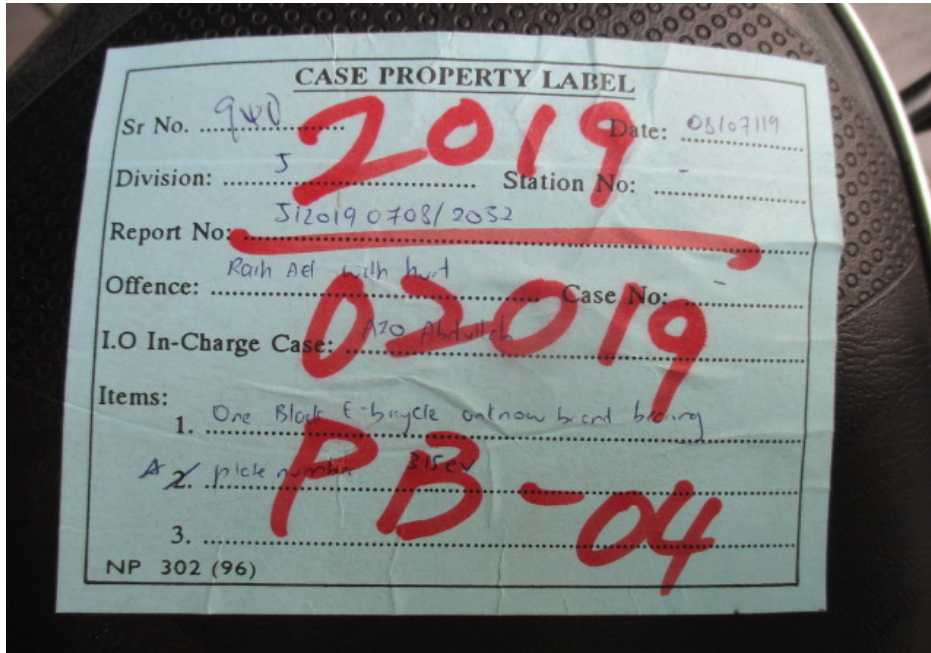
Photo 1 shows the identification of the Electric Scooter with reference to the Singapore Police Force.

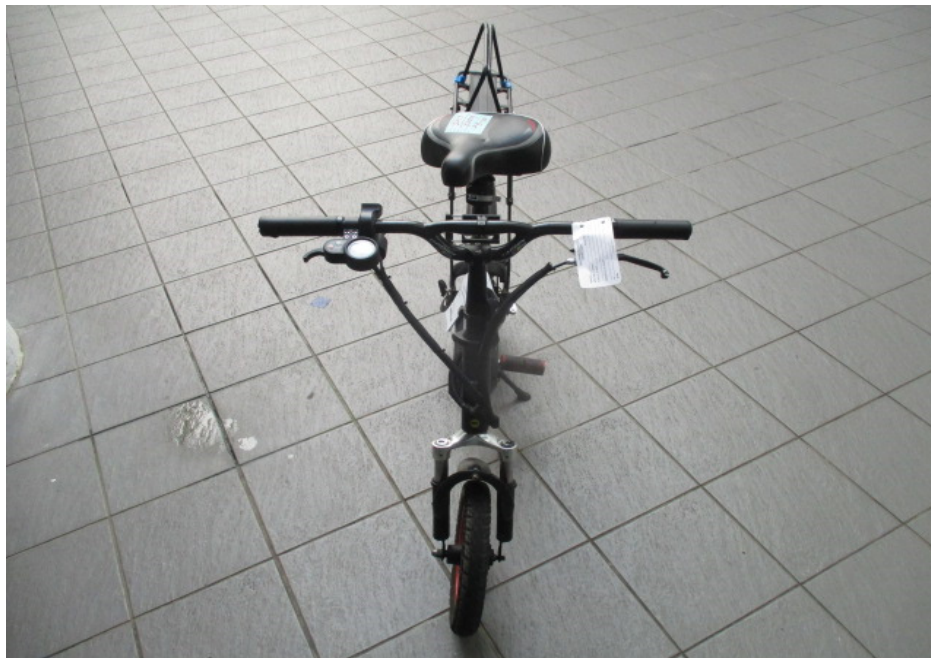
Photo 2 shows the front portion of the Electric Scooter at the time of our inspection. The Electric Scooter was observed to have sustained damages all around.

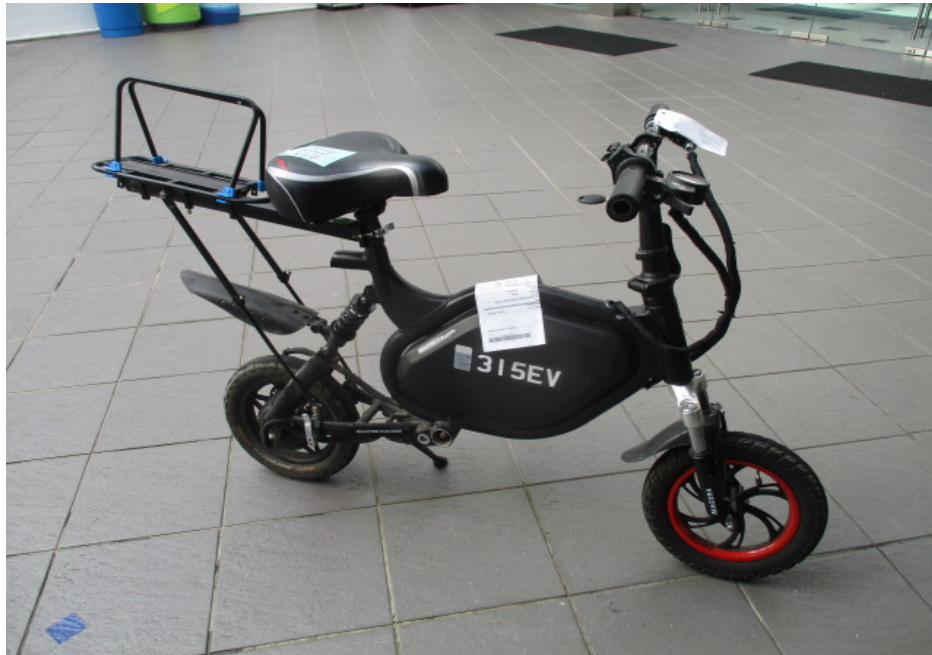
Photo 3 shows the right body of the Electric Scooter at the time of our inspection. The Electric Scooter was observed to have sustained damages all around.

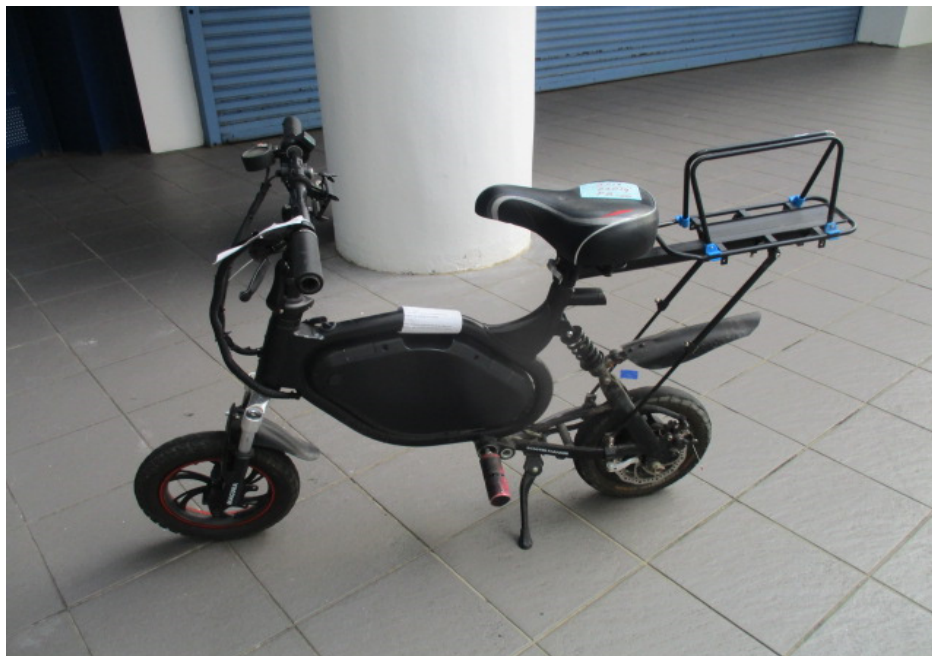
Photo 4 shows the left body of the Electric Scooter at the time of our inspection. The Electric Scooter was observed to have sustained damages all around.

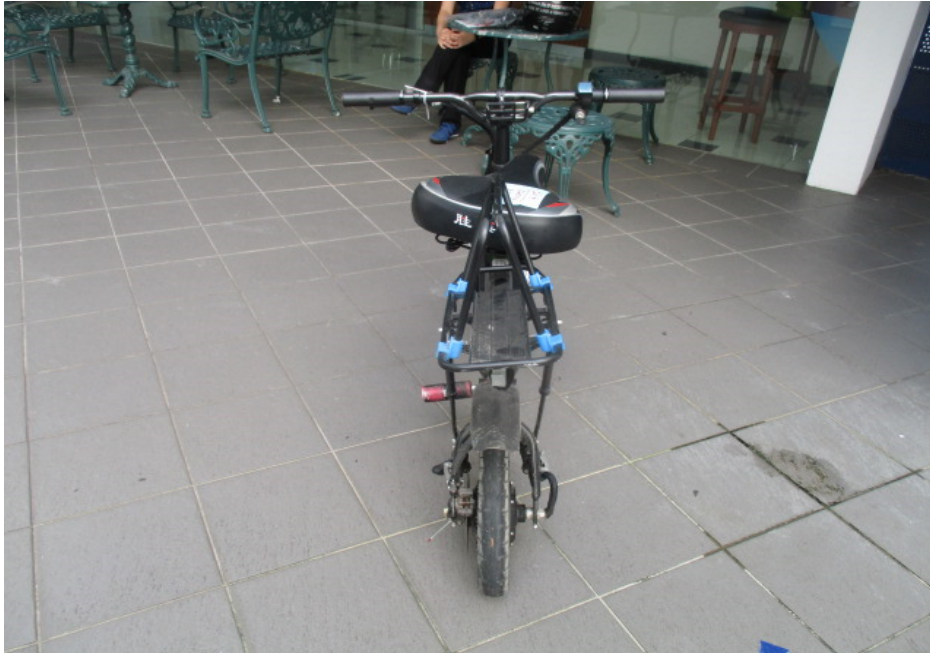
Photo 5 shows the rear portion of the Electric Scooter at the time of our inspection. The Electric Scooter was observed to have sustained damages all around. The body parts that were found to have been damaged include its handlebar ends, left hand brake lever, seat, right foot peg, right cowling and top rack, amongst others as a result of the accident.

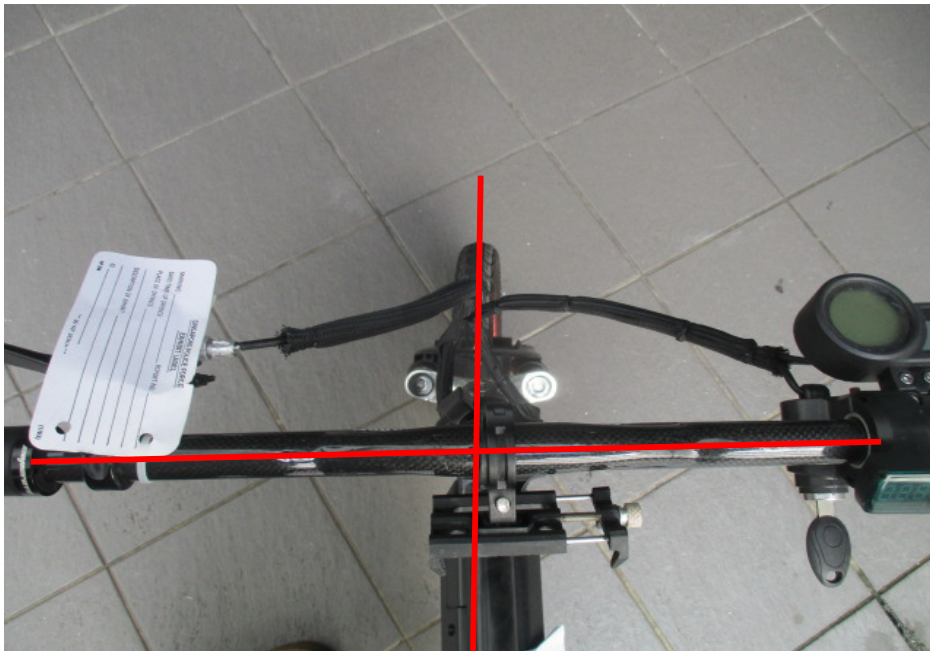
Photo 6 shows the frontal portion of the Electric Scooter (top view) at the time of our inspection. A slight misalignment of the handle bar & front tyre was observed.

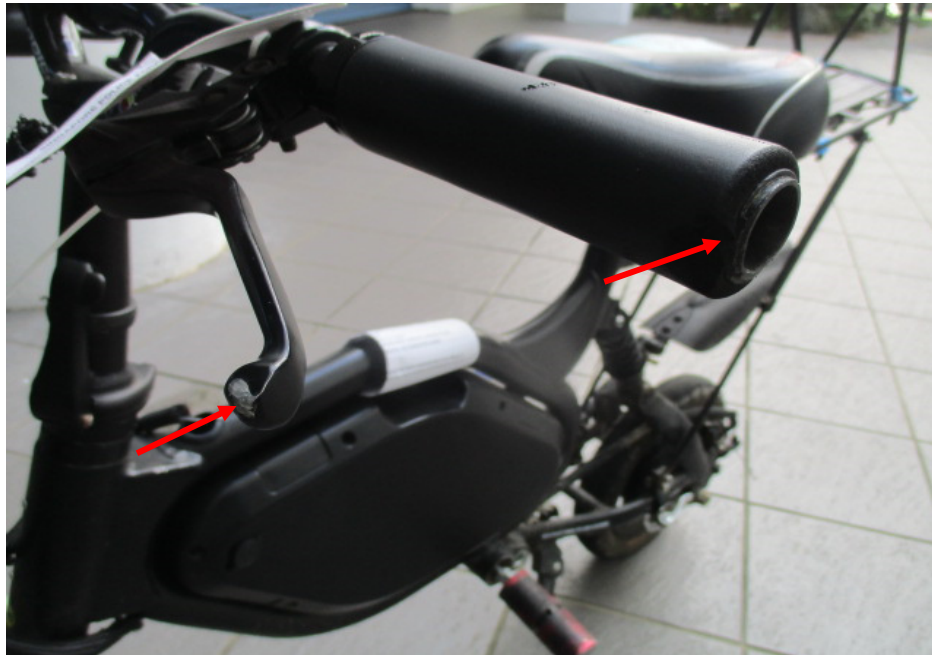
Photo 7 shows the damages on the left handlebar end and left hand brake lever (arrowed) of the Electric Scooter as a result of the accident.

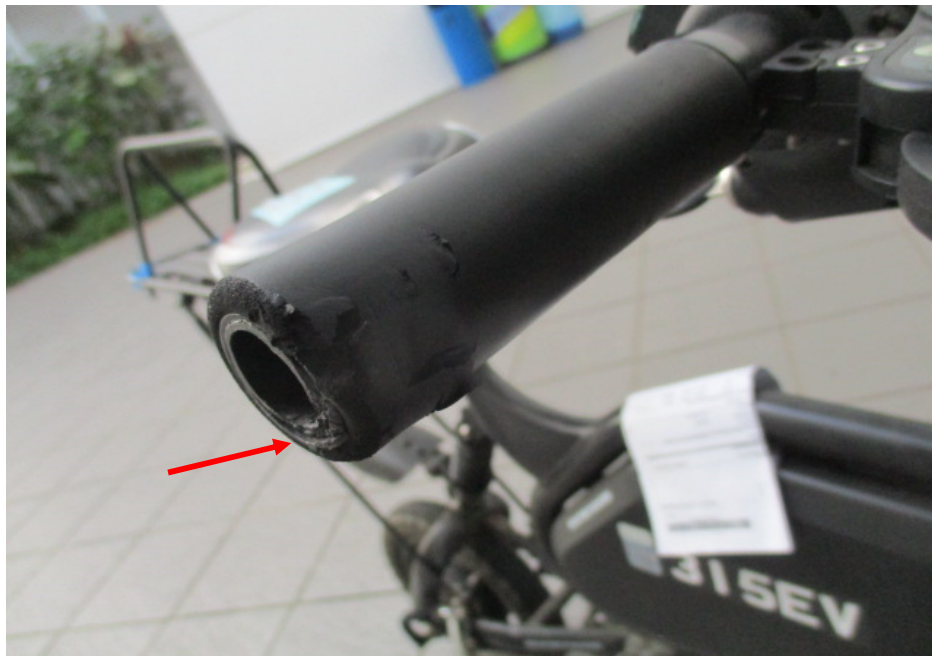
Photo 8 shows damages on the right handlebar end (arrowed) of the Electric Scooter as a result of the accident.

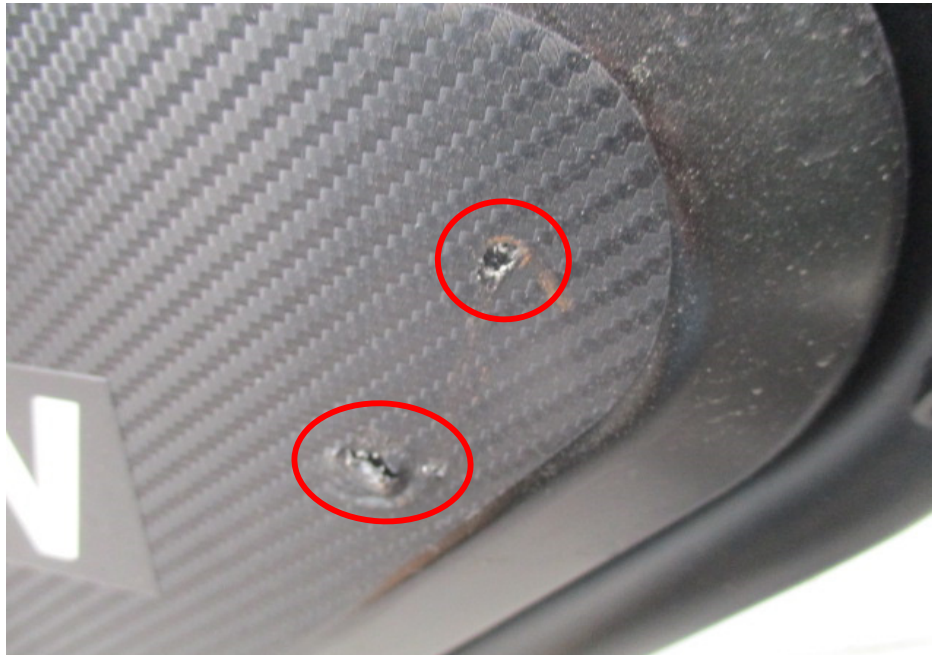
Photo 9 shows the damages on the right cowling (circled) of the Electric Scooter as a result of the accident.

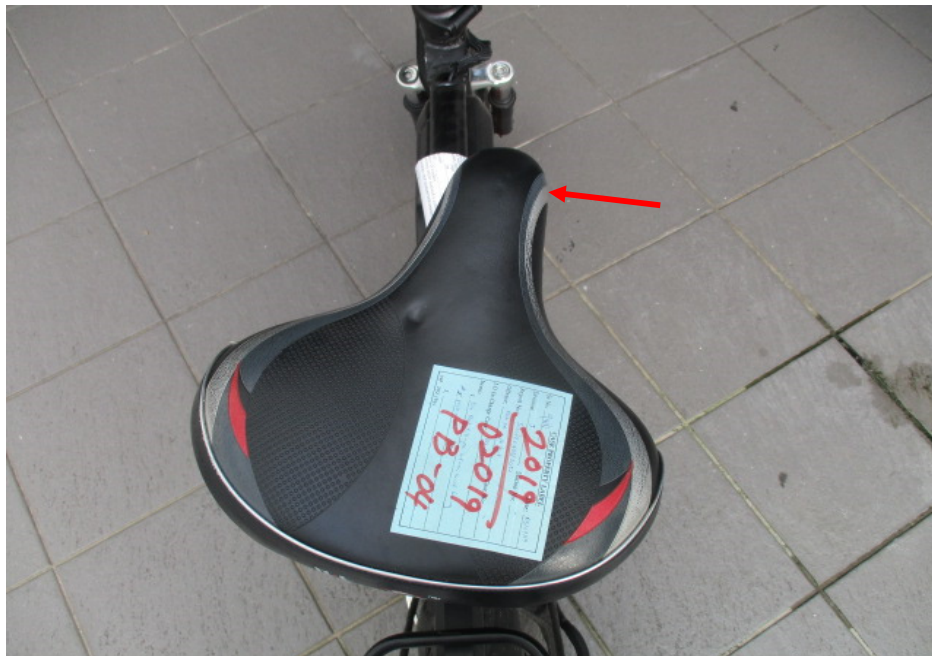
Photo 10 shows the deformed seat of the Electric Scooter (arrowed) at the time of our inspection.

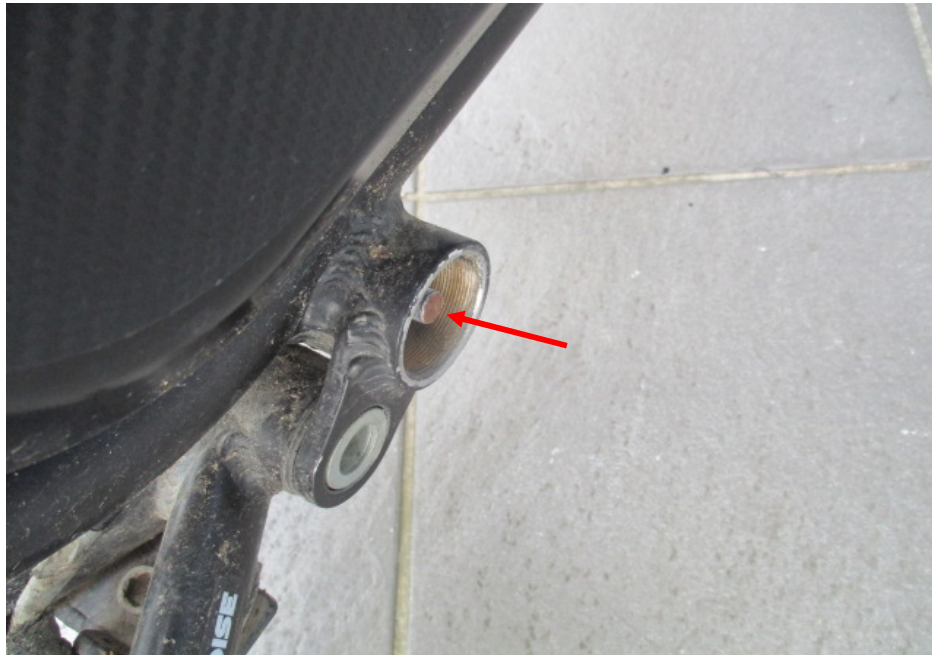
Photo 11 shows the missing right foot peg of the Electric Scooter at the time of our inspection (arrowed).

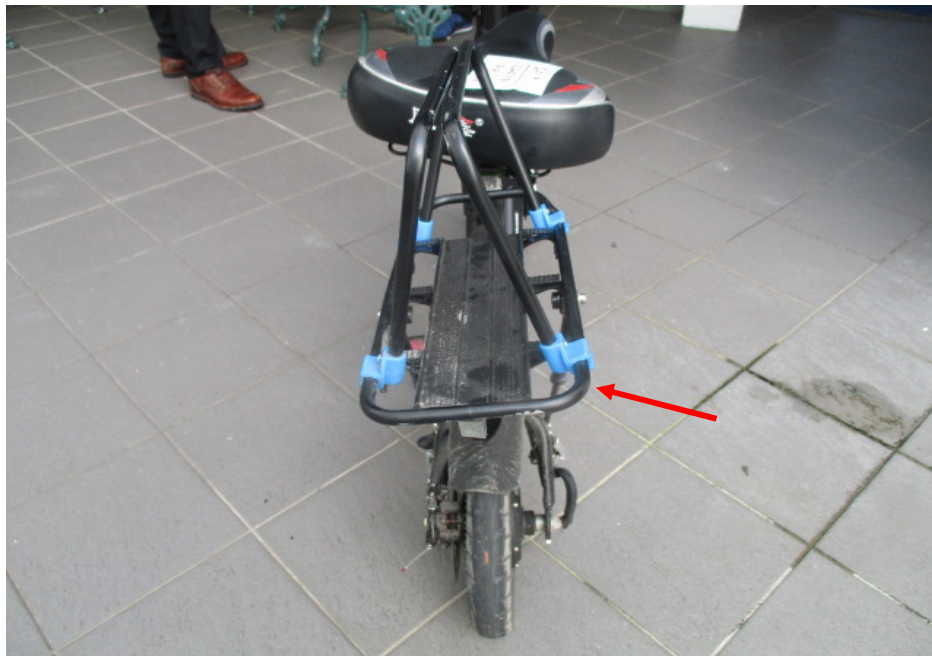
Photo 12 shows the deformed top rack of the Electric Scooter at the time of our inspection (arrowed).

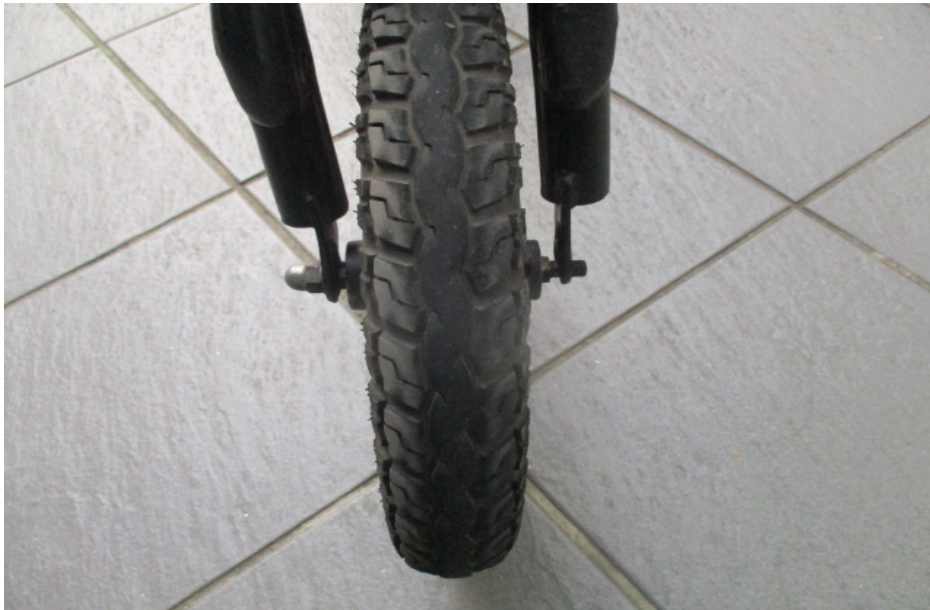
Photo 13 shows the front tyre of the Electric Scooter at the time of our inspection. The front tyre was observed to be in serviceable condition with remaining tread depth of approximately 3mm. The tyre was also observed to be sufficiently inflated for vehicular operation. We did not observe any tear, burst mark(s) and/or punctured hole(s) on the sidewalls as well as across the tread of the front tyre.

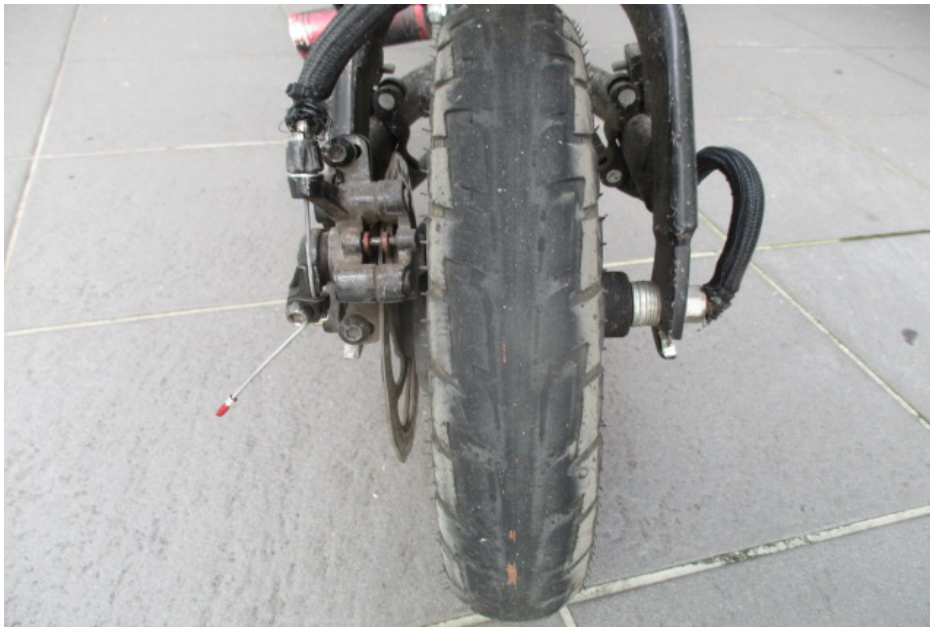
Photo 14 shows the rear tyre of the Electric Scooter at the time of our inspection. The rear tyre was observed to be in serviceable condition with remaining tread depth of approximately 3mm. The tyre was also observed to be sufficiently inflated for vehicular operation. We did not observe any tear, burst mark(s) and/or punctured hole(s) on the sidewalls as well as across the tread of the rear tyre.

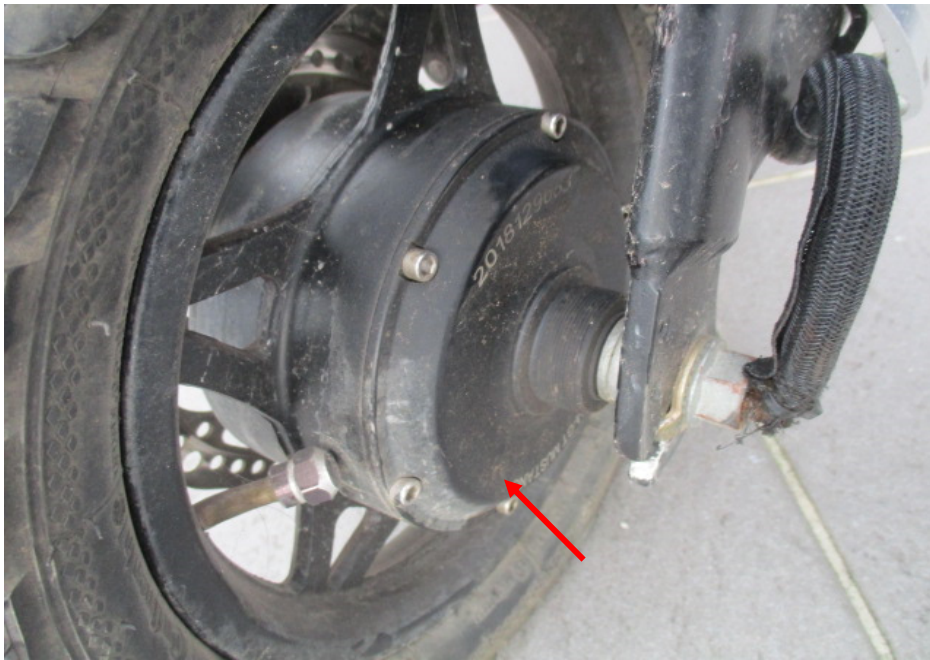
Photo 15 shows the general view of the drive motor (arrowed) of the Electric Scooter which was observed to be intact with no misalignment.

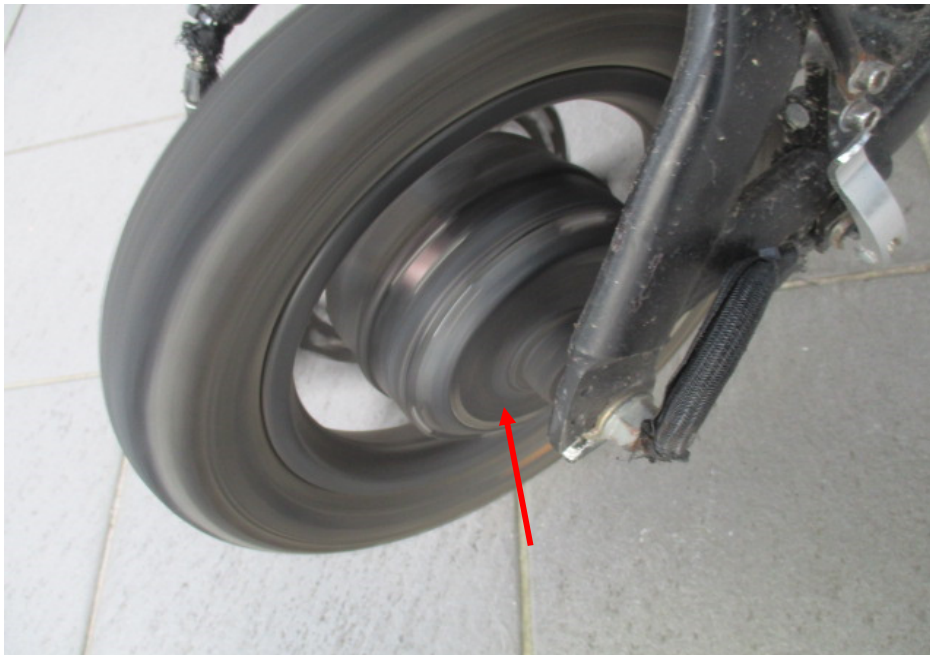
Photo 16 shows the general view of the drive motor of the Electric Scooter which was observed to be in operational condition (arrowed).

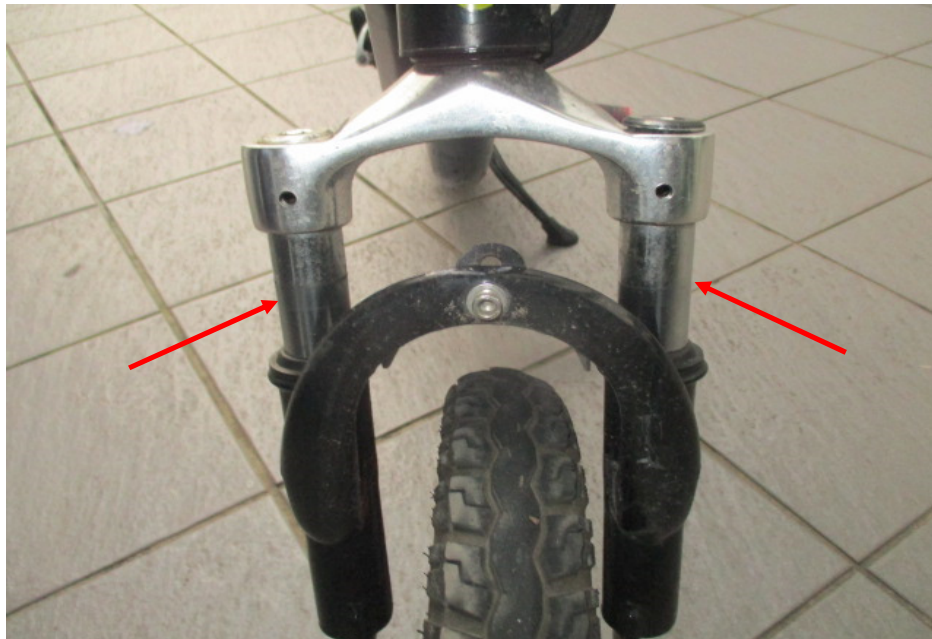
Photo 17 shows the front fork (arrowed) of the Electric Scooter. The front fork and fork bracket of the Electric Scooter were both found to be intact and undamaged. Turning the Electric Scooter's handle bar towards the left and right did not produce any abnormal free play. The steering system of the Electric Scooter was in serviceable condition at the time of our inspection.

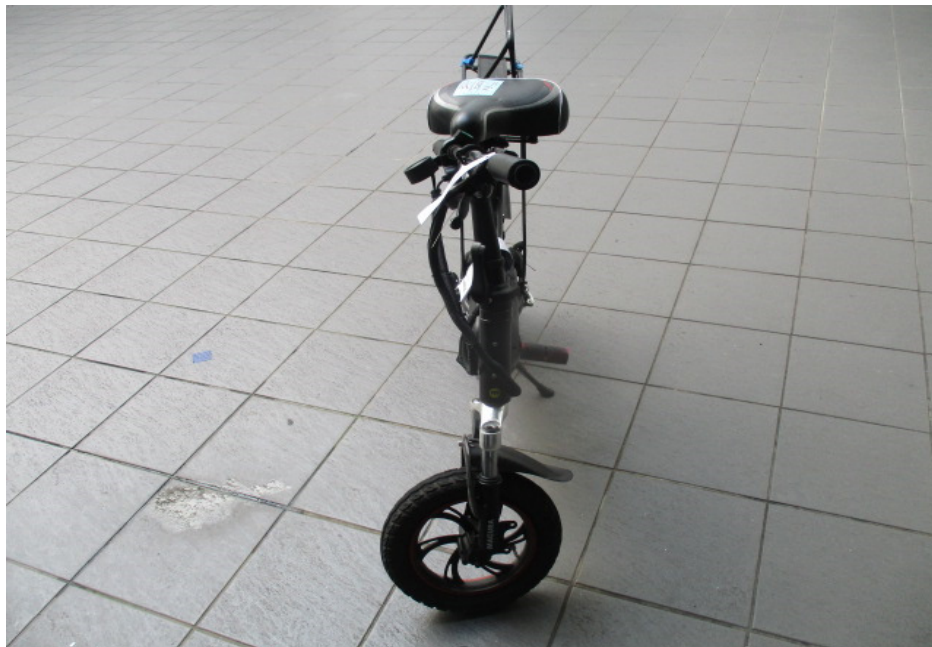
Photo 18 shows the front wheel of the Electric Scooter turned towards its full right. Turning the Electric Scooter's handle bar towards the right did not produce any abnormal free play and/or resistance. This would indicate that the steering system of the Electric Scooter was in serviceable condition at the time of our inspection.

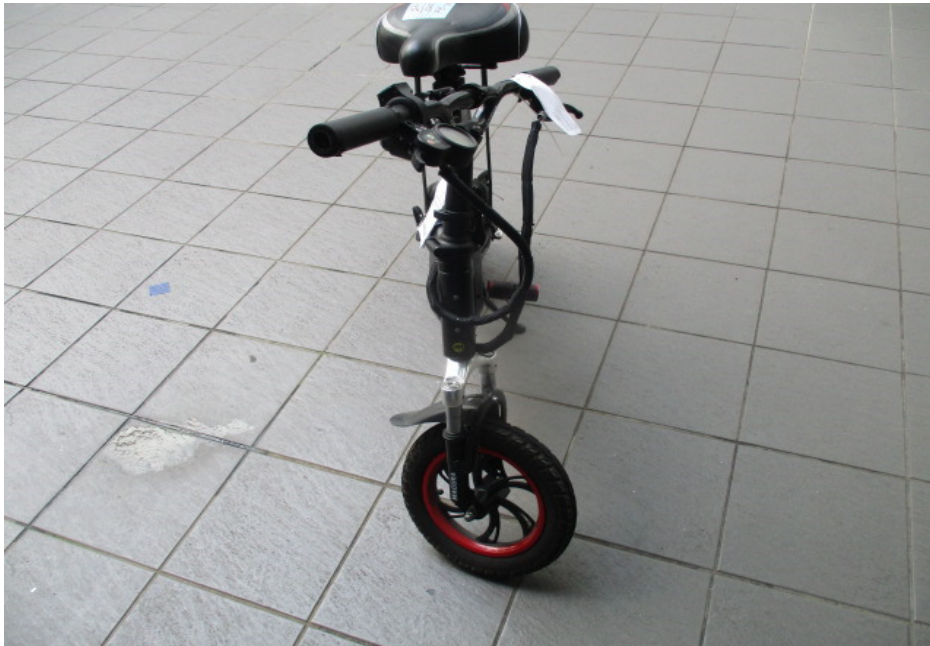
Photo 19 shows the front wheel of the Electric Scooter turned towards its full left. Turning the Electric Scooter's handle bar towards the left did not produce any abnormal free play and/or resistance. This would indicate that the steering system of the Electric Scooter was in serviceable condition at the time of our inspection.

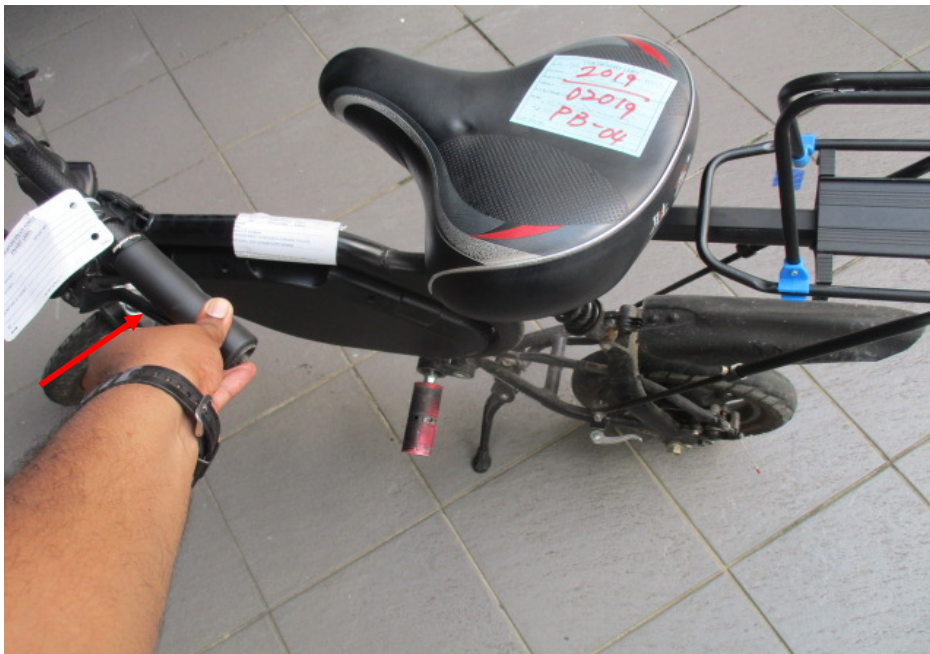
10. A static brake test was conducted on the Electric Scooter's braking system. The test was conducted by lifting the rear wheel above ground & rotating the rear wheel. The left hand brake lever was then gripped in order to stop the spinning rear tyre. The result was unsatisfactory. It did not stop after gripping the left hand brake to the fullest due to the worn brake pads.

Photo 20 shows a static brake test conducted on the Electric Scooter's rear brake. There was some resistance felt upon pressing the left hand brake lever (arrowed).

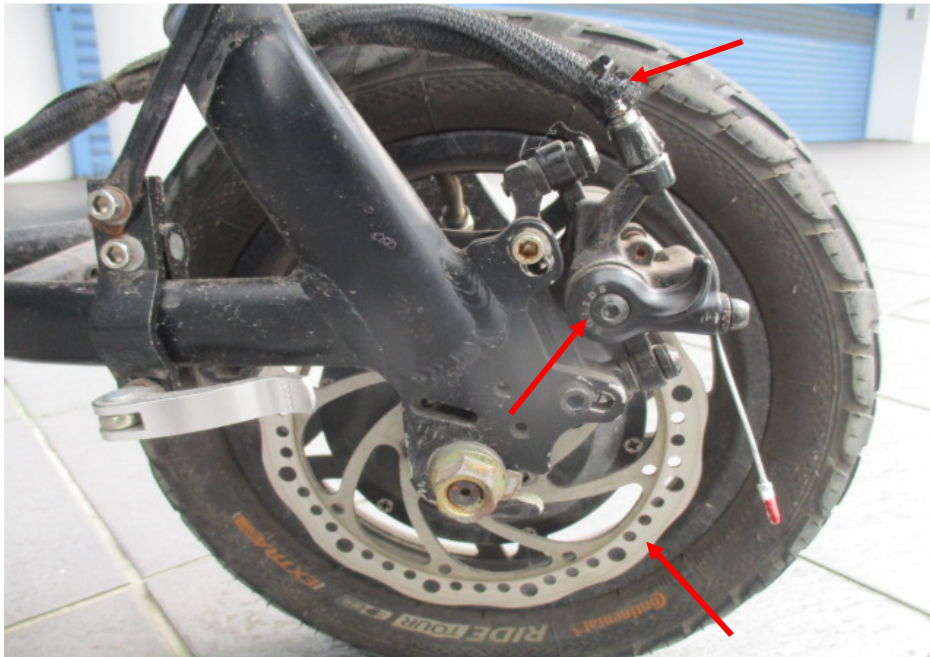
Photo 21 shows the rear wheel of the Electric Scooter. The type of brake system for the rear wheel was of a mechanical type, controlled by the left hand lever of the Electric Scooter. Our checks on the cable, calliper and brake disc which are all part of the components in the rear brake system of the Electric Scooter reveal all to be intact and without damage (arrowed).

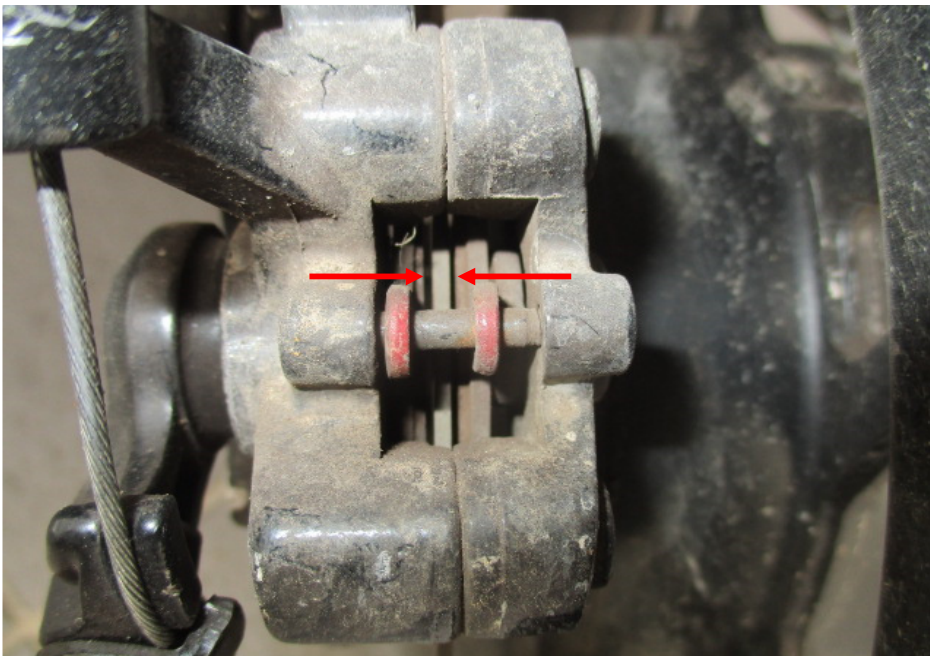
9. The braking system of the Electric Scooter was controlled by mechanical means (cables, calliper, brake disc and brake pads). Our visual examination of the various components in the brake system, like the left hand brake lever, brake disc and rear brake calliper, revealed all to be intact and without damage. There was also no visible tear or cut observed on the connecting hoses and cables. However, the brake pads were observed to be worn.

11. This had appeared to indicate that the braking system of the Electric Scooter was not in a serviceable condition. See photos 17 - 22 below.

Photo 22 shows the close-up view of the rear brake calliper of the Electric Scooter, which was observed to be intact with no damages. However, the brake pads were observed to be worn (arrowed). Hence the rear tyre was unable to come to a stop after gripping the left hand brake to the fullest.
