Your Ref: SGT 8898K  
Our Ref : CI/TP20009517/D

10 September 2020

**AUTOMOBILE TECHNICAL INSPECTION REPORT OF A MERCEDES BENZ  
E250 COUPE WITH REGISTRATION NUMBER SGT 8898K**

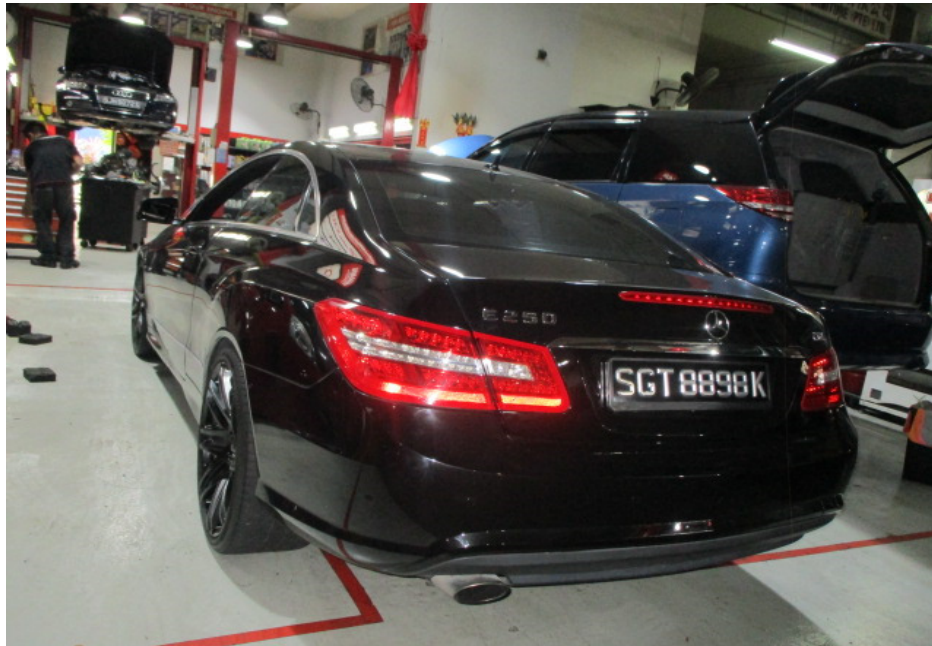
**Photo 1** shows the rear left body of the Motor Car at the time of my inspection. The Motor Car was observed to be in relatively good general condition with no loose exterior fittings observed.

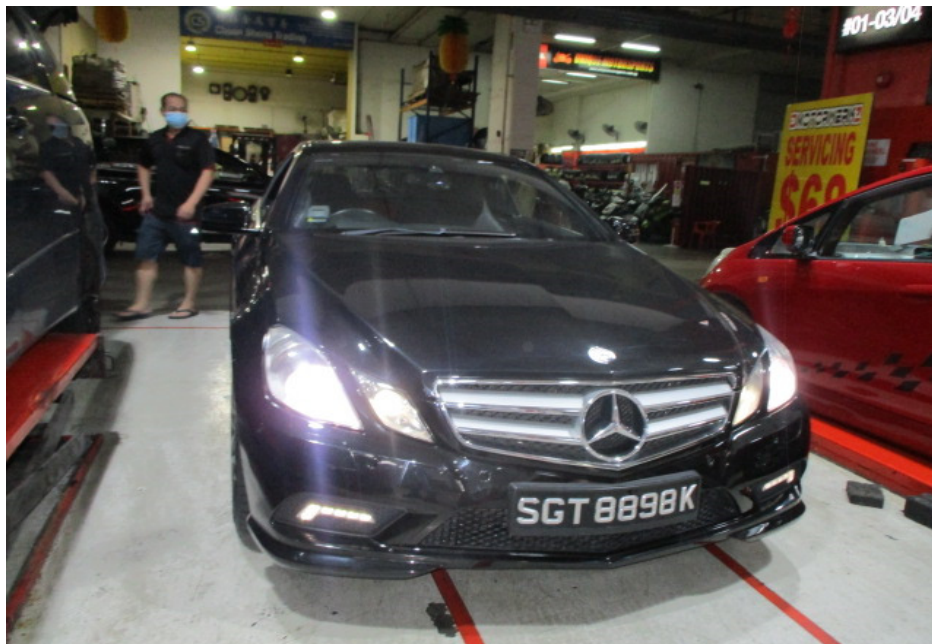
**Photo 2** shows the front right body of the Motor Car at the time of my inspection. The Motor Car was observed to be in relatively good general condition with no loose exterior fittings observed. The mileage of the Motor Car at the time of my inspection was recorded to be 134,187km.

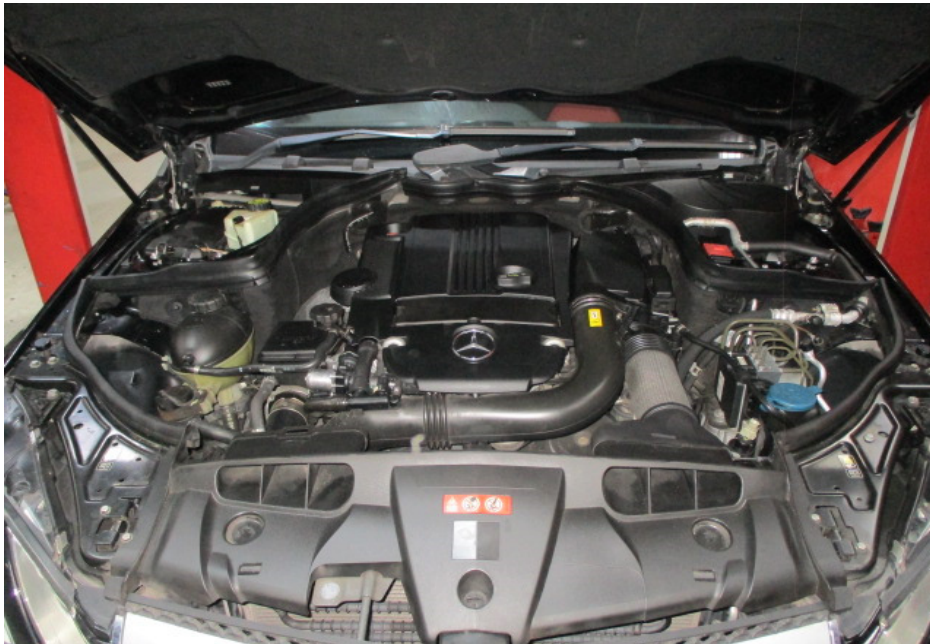
**Photo 3** shows a general view of the engine compartment of the Motor Car at the time of my inspection. The various parts and components inside the engine compartment were all observed to be intact and properly fitted. There was also no sign(s) or indication(s) of fluid leak and/or fluid stain found inside the engine compartment. The engine oil, brake fluid and engine coolant were all found to be of sufficient level for operating purposes. Visually, there was also no contamination found to these fluids

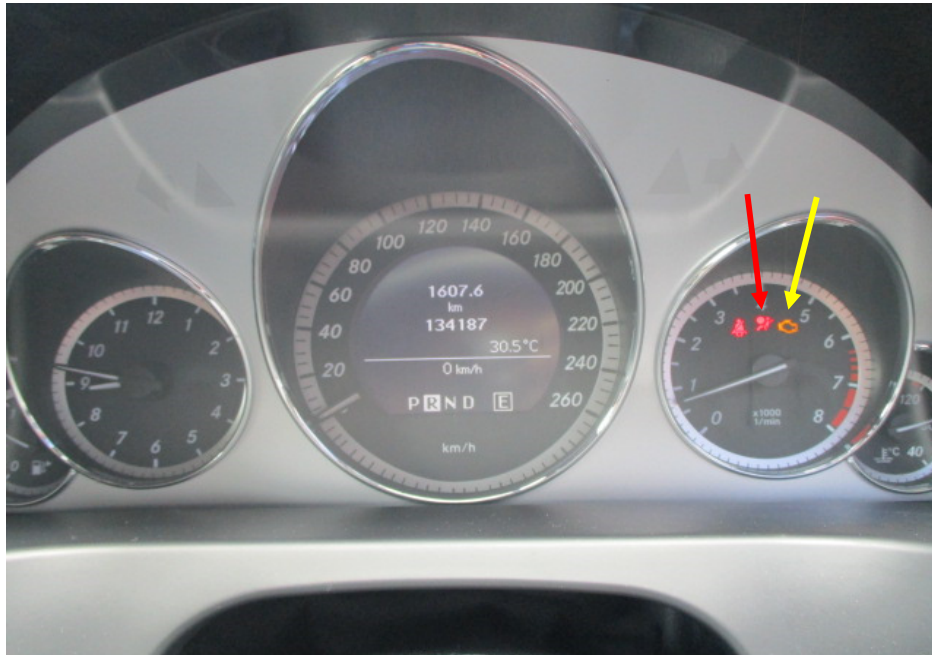
11. Upon starting the engine of the Motor Car, I had noted that the check engine light and SRS light (Supplemental Restraint System) were illuminated on the instrument panel. The illumination of these lights indicates a fault(s) in the engine system and a fault(s) in the SRS of the Motor Car.

**Photo 4** shows the check engine light (yellow arrow) and SRS light (red arrow) illuminated on the Motor Car's instrument panel. The illumination of these lights indicates a fault(s) in the engine system and a fault(s) in the Supplemental Restraint System of the Motor Car.

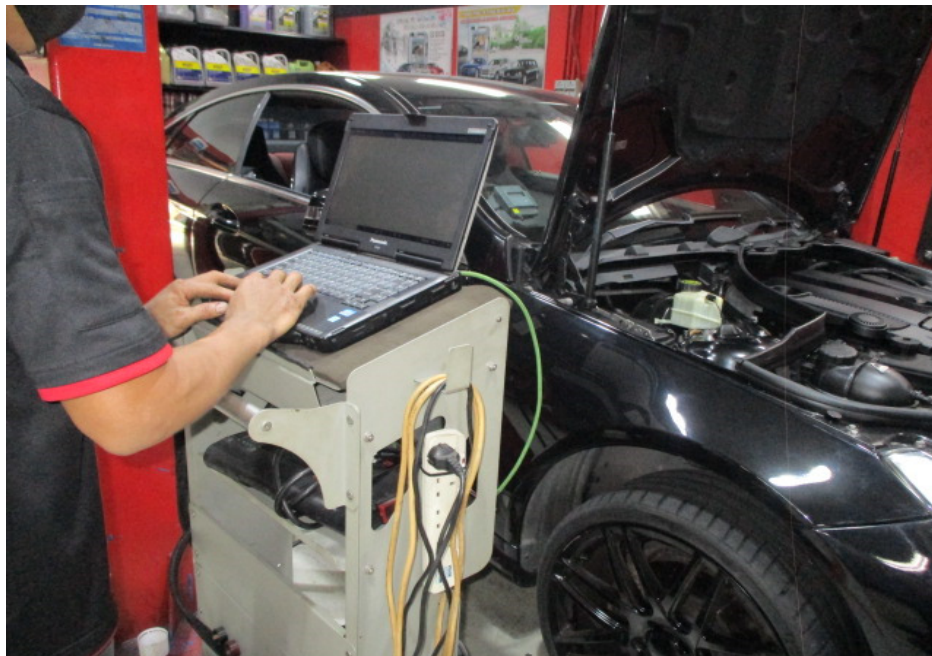
13. The result at the end of the OBD scan revealed transmission gear slippage in the Motor Car's transmission system causing the check engine light to be illuminated, and a faulty front right seat belt buckle, which caused the SRS light to be illuminated. See photo 4 - 7 below.

**Photo 5** shows the OBD scan being carried out to the Motor Car to establish the cause(s) of the check engine light and the SRS light that were illuminated on the instrument panel of the Motor Car. The result at the end of the OBD scan revealed transmission gear slippage in the Motor Car's transmission system causing the check engine light to be illuminated, and a faulty front right seat belt buckle, causing the SRS light to be illuminated.

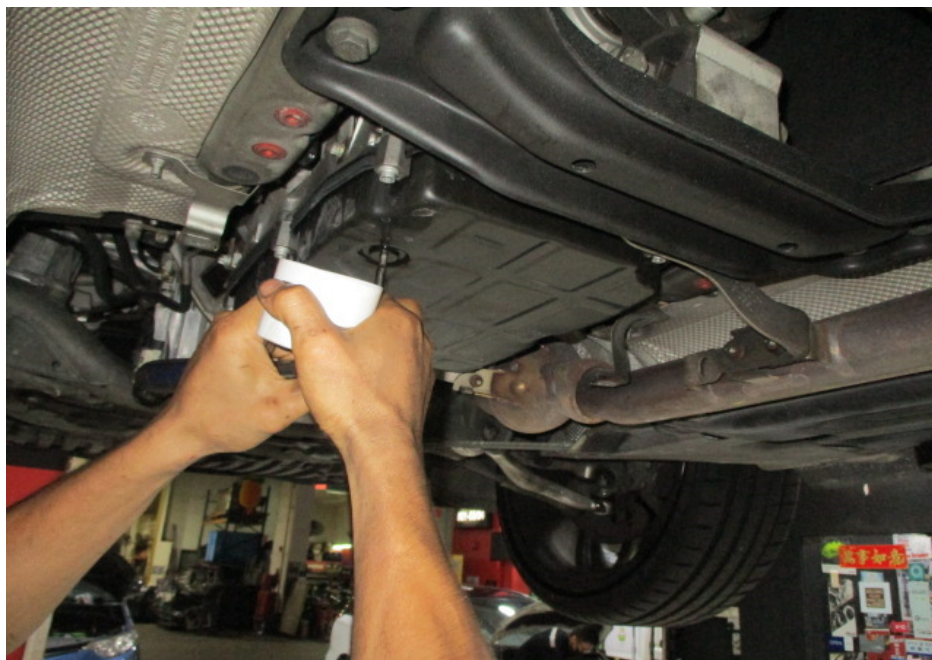
**Photo 8** shows removal of the transmission fluid drain plug for checks on the transmission fluid of the Motor Car. This was during my inspection of the Motor Car.

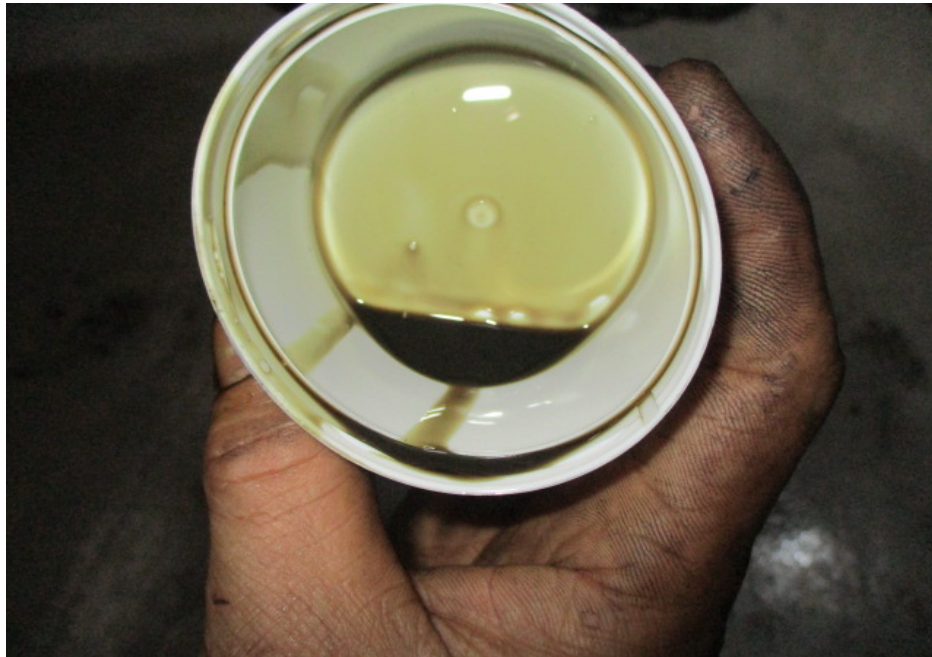
15. Common cause(s) of transmission gear slippage includes low, worn or burnt transmission fluid, worn clutch plate or gear set, worn transmission bands, faulty torque convertor and faulty solenoids amongst others. For the Motor Car, I had found the condition of its transmission fluid to be burnt/blackened when checks were carried out during my inspection of the Motor Car. Automatic transmission fluid is typically reddish in colour. See photo 8 & 9 below.

**Photo 9** shows the transmission fluid that was collected from the Motor Car. The transmission fluid of the Motor Car was observed to be burnt/blackened. A typical automatic transmission fluid colour is reddish.

21. On the other hand, the transmission gear slippage of the Motor Car could have also been caused by the condition of the transmission fluid of the Motor Car as seen at the time of my inspection. Transmission fluid that has not been replaced at regular interval will similarly lose its viscosity characteristic. As commented in the preceding paragraph, there will be inadequate protective film (lubrication) between moving gears and shafts within the transmission assembly, which would lead to frictional heat generating when the transmission is in operation. The clutch plate correspondingly wears off due to the inadequate protective film (lubrication) causing slippage in the transmission gears of the Motor Car.

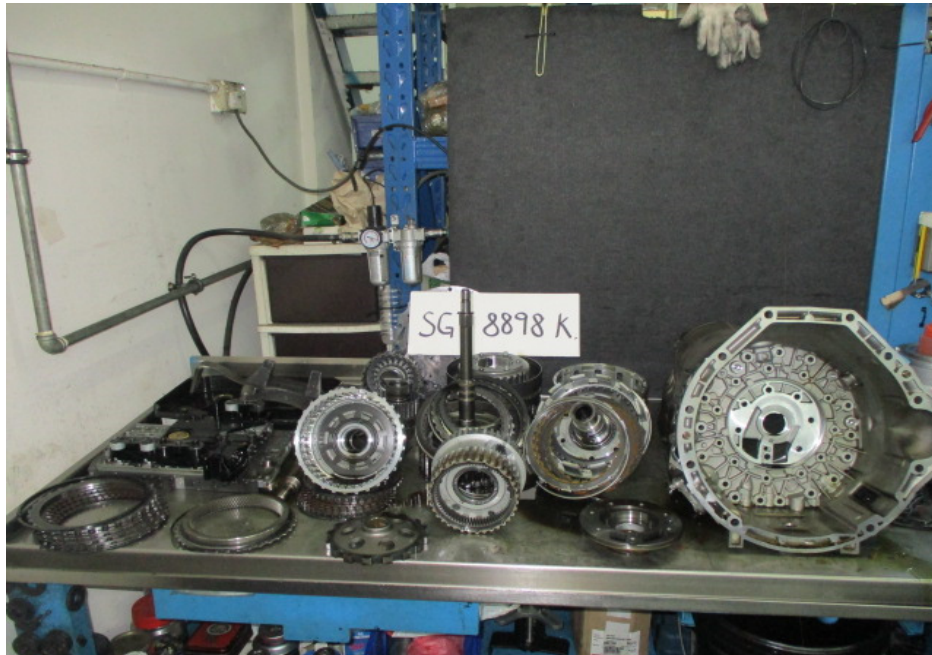
16. Arrangement was made to dismantle the Motor Car's transmission assembly and a further inspection was carried out by me on 24 August 2020 after all mechanical parts inside the transmission housing were dismantled and separated.
17. At this inspection, I had found several clutch plates worn, burnt marks on several gear set, worn bushing and a broken input shaft diaphragm. Such condition are signs that the transmission of the Motor Car had overheated. See photo 10 – 15 below.

**Photo 10** shows the Motor Car's transmission assembly dismantled with all mechanical parts inside the transmission housing dismantled and separated. This was on 24 August 2020. Examination of these mechanical parts revealed signs that the transmission of the Motor Car had overheated.

18. Basing on the observations gathered during the course of my inspection of the Motor Car and its dismantled transmission assembly, it would appear to me that the transmission of the Motor Car had overheated. The overheating was either a result of transmission gear slippage as seen from the worn clutch plates after the Motor Car's transmission assembly was dismantled, or from the condition of the Motor Car's transmission fluid, which was found to be in a burnt/blackened condition.

26. The failure/breakdown of the Motor Car's transmission system and faulty front right seat belt buckle renders the Motor Car not road worthy as the Motor Car may potentially become immovable posing a danger to the driver and other road users, and potentially fail to restrain a driver to the driver seat when the SRS is activated. To return the Motor Car to a road worthy condition, its transmission assembly needs to be overhauled (at minimum) or replaced with a new unit. The front right seat belt buckle needs to be replaced with a new part.

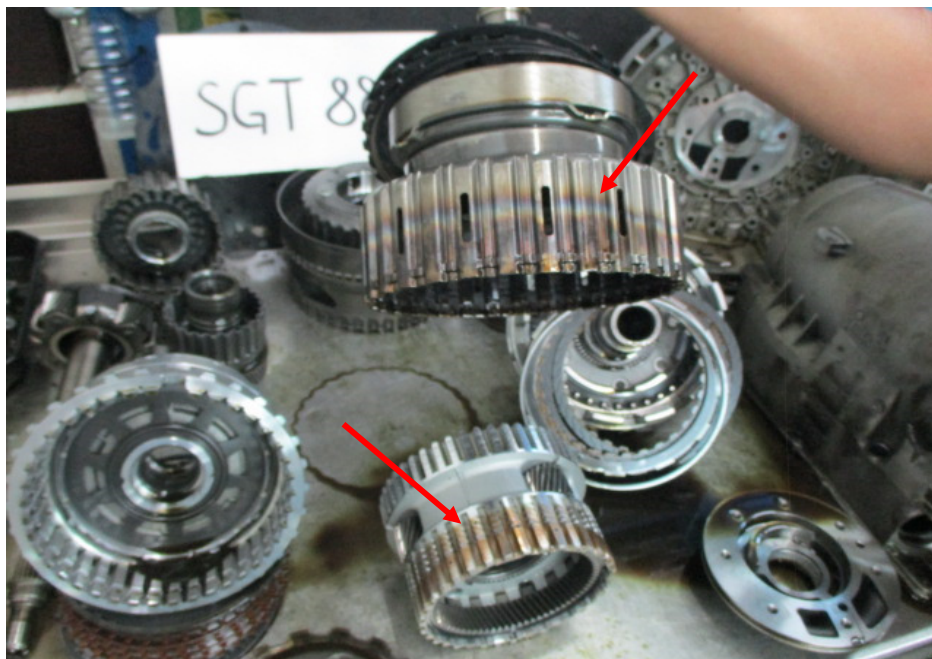
**Photo 11** shows burnt marks (arrowed) found on several transmission gear set. This is an indication of an overheated transmission.

20. Transmission fluid that is burnt loses its viscosity and is not able to provide adequate protective film (lubrication) between the moving gears and shafts that are within the transmission assembly. This creates additional frictional heat, leaving the burnt marks as seen on some of the gear sets after the transmission assembly of the Motor Car was dismantled.

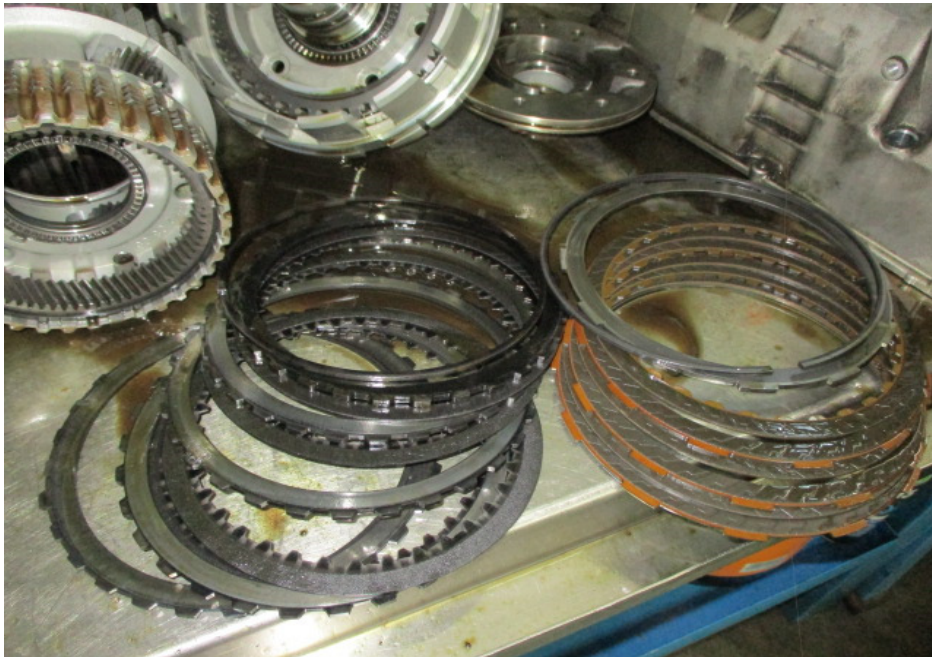
**Photo 12** shows the clutch plates and clutch discs that were removed from the Motor Car's transmission assembly.

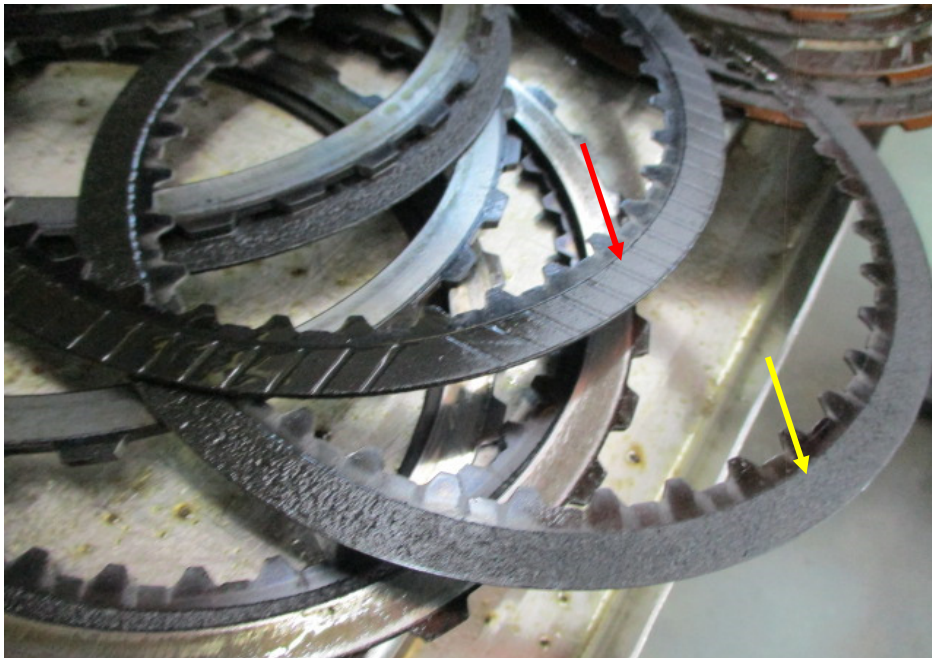
**Photo 13** shows signs of worn clutch plate. The lines (red arrow) on the frictional surface of the clutch plate were no longer visible (yellow arrow) on some of the Motor Car's clutch plate. This is an indication of a worn clutch plate.

19. For the first possible cause (transmission gear slippage), the worn clutch plates were not able to hold or engage the gear set adequately, causing the Motor Car's transmission to slip. The inability to hold or engage the gear set adequately creates an extensive amount of heat arising from frictional resistance when the clutch plates rub against each other (unable to be held in place). This heat burns the transmission fluid flowing along the various gears, clutches, shafts etc that are within the transmission assembly.

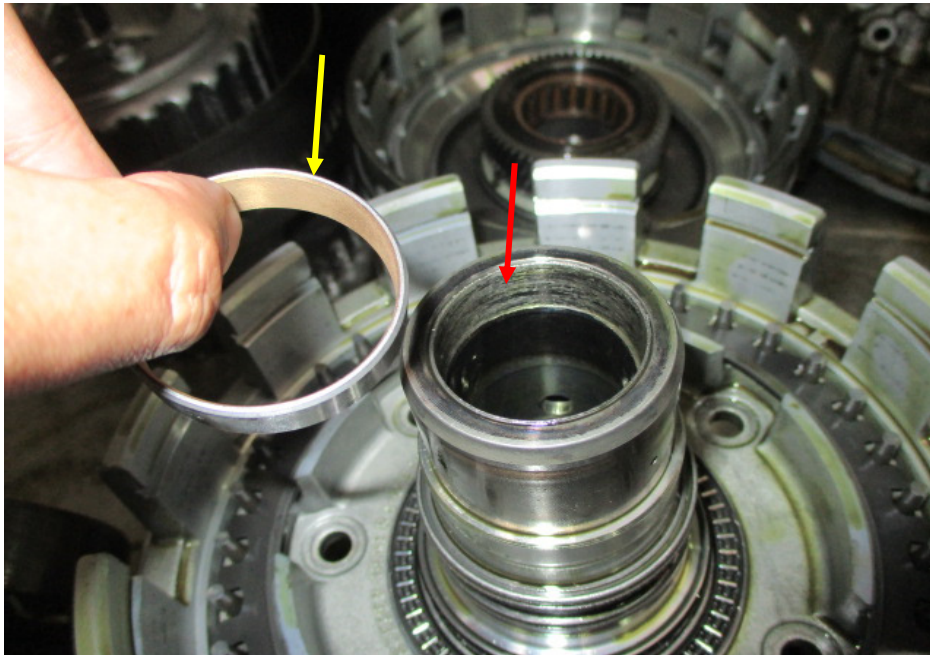
**Photo 14** shows scoring marks (red arrow) seen on the inner circumference of the worn bushing as compared to a new bushing (yellow arrow). The scoring marks seen on the worn bushing is an indication of overheating.

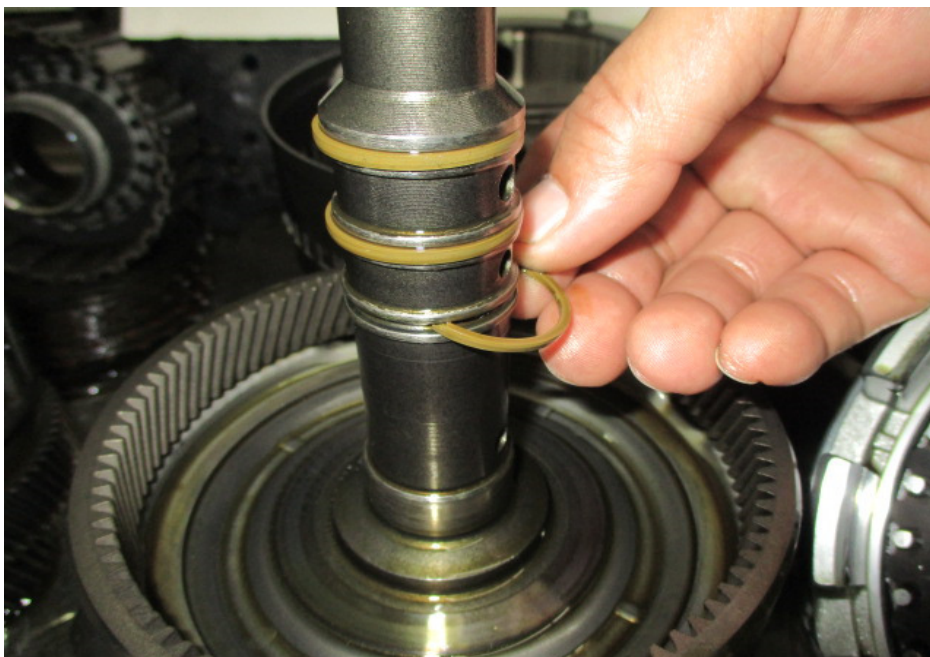
**Photo 15** shows one of the diaphragms attached to the transmission input shaft broken.
