## LKK Auto Consultants Pte Ltd

Vehicle No. SMJ 9129Y  
Insured Veh. SKF 2008D  
Claim No. C10007218/ST  
Policy No.  
Accident Date 06/09/2020  
Inspection Date 08/09/2020

## ADJUSTMENT ON REPAIR COST FOR VEHICLE NO. SMJ 9129Y

PHOTOGRAPHS FOR VEHICLE NO. SMJ 9129Y

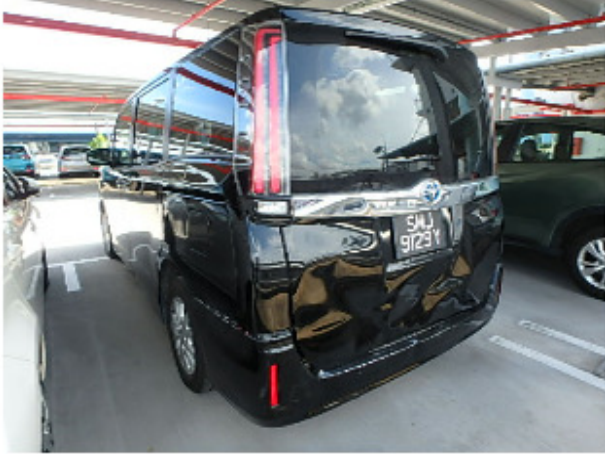
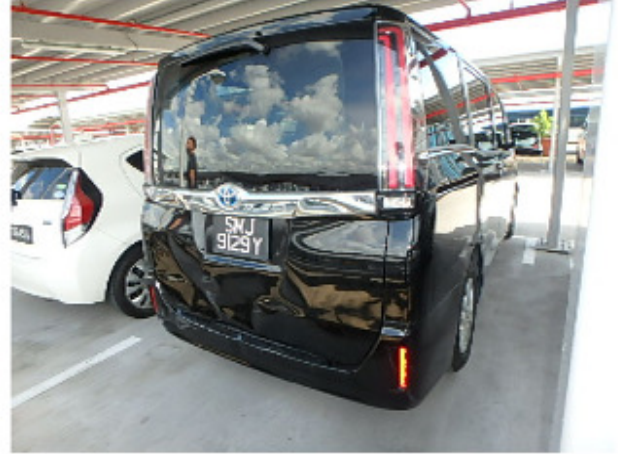
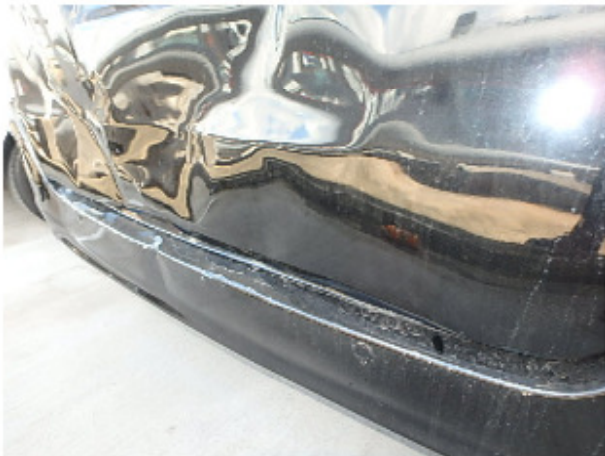
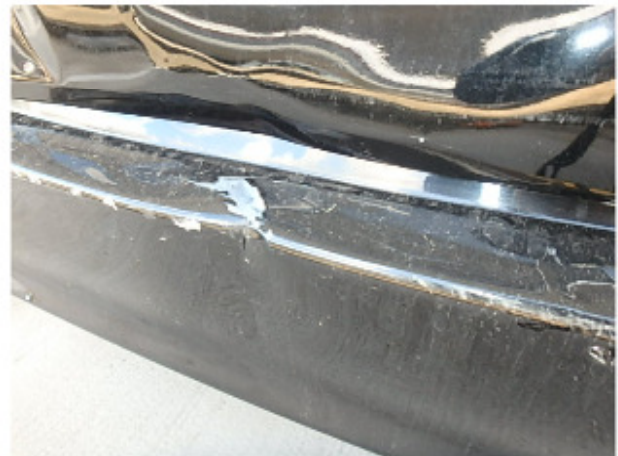
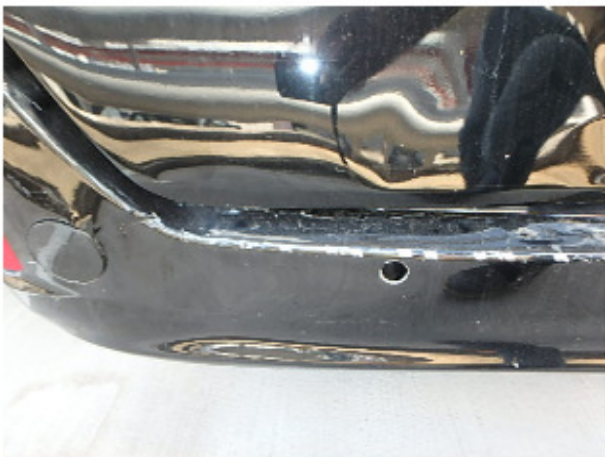
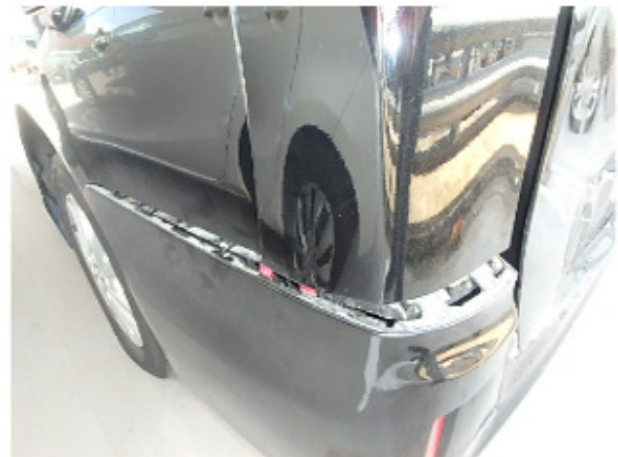
INSPECTION

THE VEHICLE SUSTAINED DAMAGES AT THE REAR PORTION.
