Your Ref: PNPV2019-00008113-01  
Our Ref : CS4/FWD20009638/P

16<sup>th</sup> September 2020

**TECHNICAL INVESTIGATION REPORT OF FIRE INCIDENT INVOLVING THE INSURED VEHICLE SKB 7080G ON 6<sup>th</sup> September 2020**

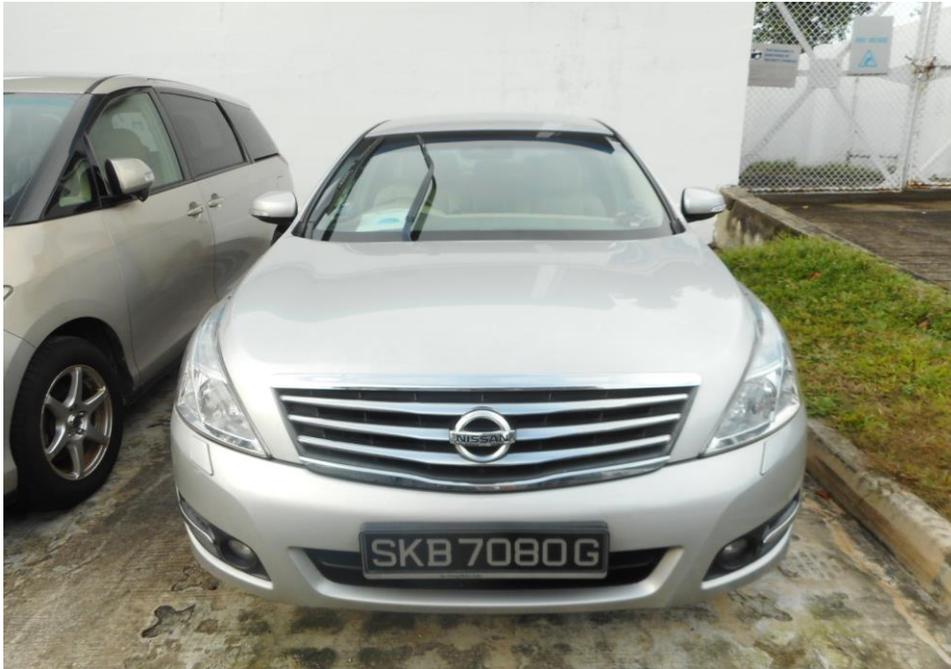
**Photo 2** shows the general view of the front portion of the Insured Vehicle at the time of our inspection. The fire damage to the Insured Vehicle was confined to its interior portion. Its exterior is observed to be unaffected by the fire.

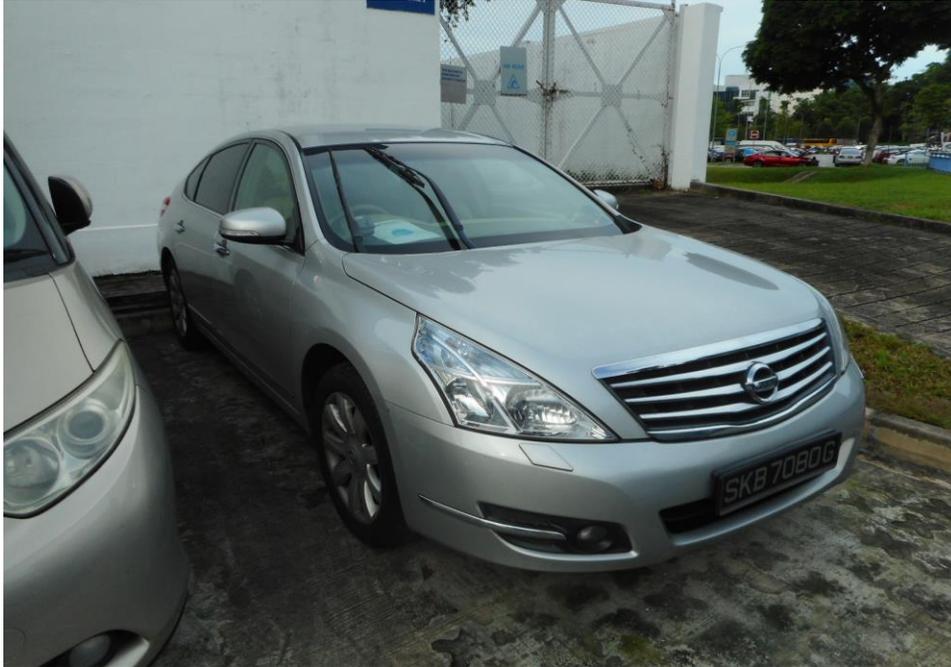
**Photo 3** shows the general view of the right portion of the Insured Vehicle at the time of our inspection. The fire damage to the Insured Vehicle was confined to its interior portion. Its exterior is observed to be unaffected by the fire.

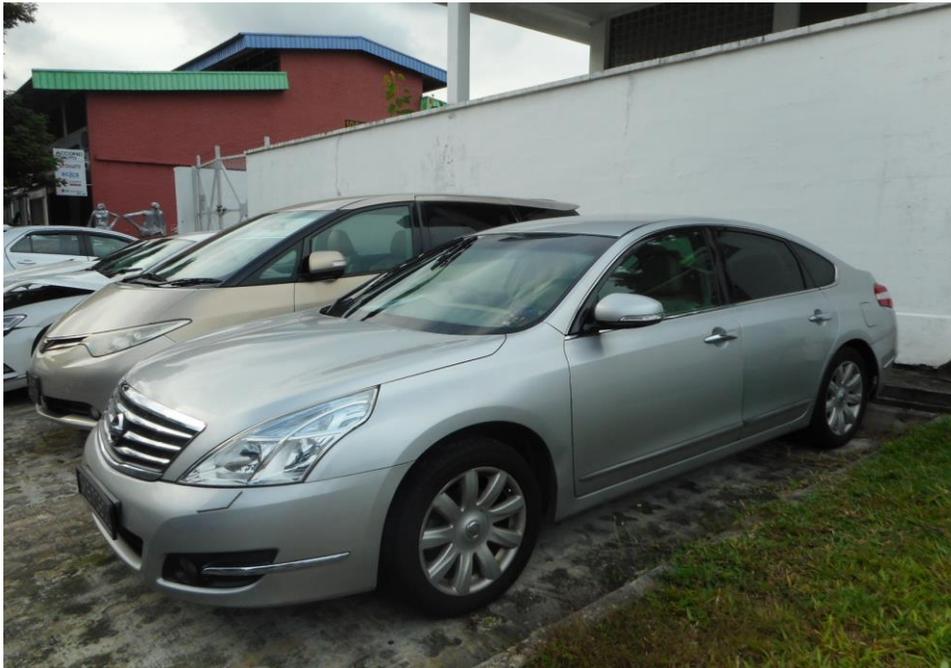
**Photo 4** shows the general view of the left portion of the Insured Vehicle at the time of our inspection. The fire damage to the Insured Vehicle was confined to its interior portion. Its exterior is observed to be unaffected by the fire.

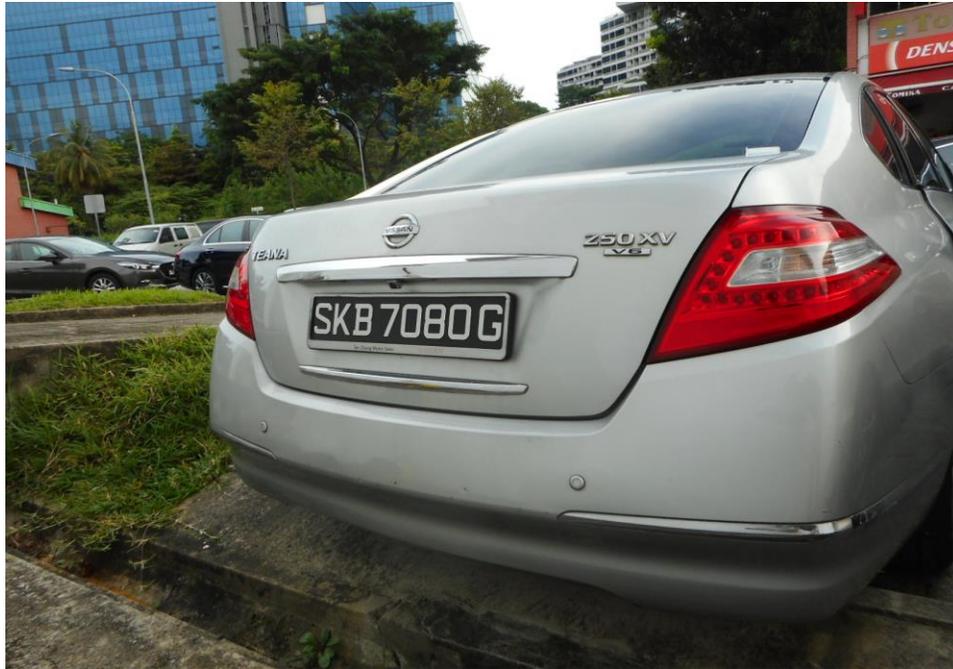
**Photo 5** shows the general view of the rear portion of the Insured Vehicle at the time of our inspection. The fire damage to the Insured Vehicle was confined to its interior portion. Its exterior is observed to be unaffected by the fire.

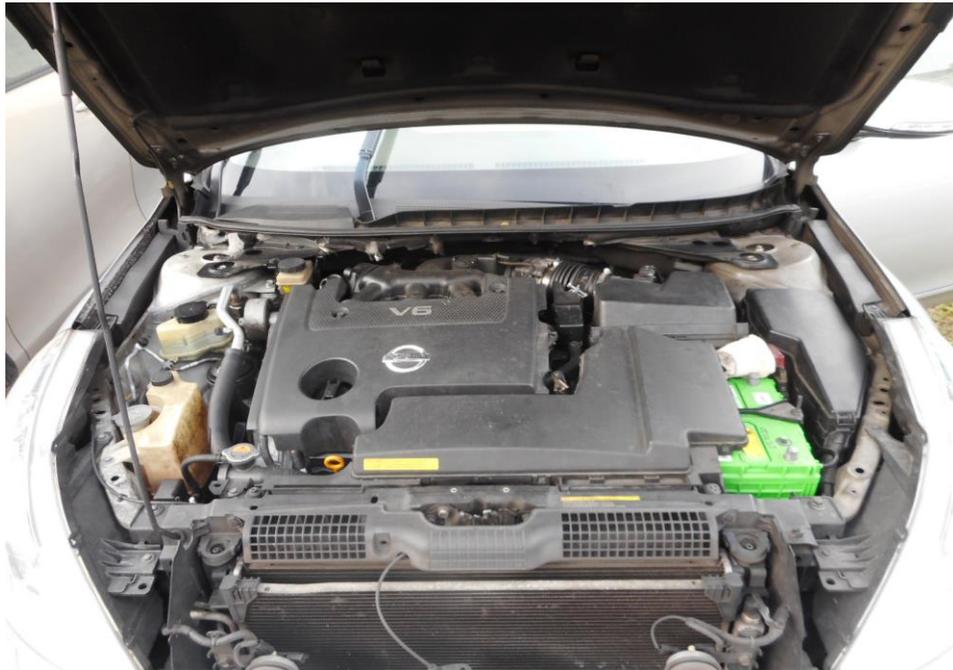
**Photo 6** shows the general view of the engine portion of the Insured Vehicle at the time of our inspection. The fire damage to the Insured Vehicle was confined to its interior portion. Its engine compartment is observed to be unaffected by the fire.

18. Given the circumstances of the incident as reported, the possibility of the cause of fire to the Insured Vehicle being due to engine overheating would seem unlikely as Mr Lim had mentioned to us there were no indications of abnormally high temperatures when he was driving the Insured Vehicle on the day of the incident. Moreover, there was no damaged of fire nature in the engine compartment.

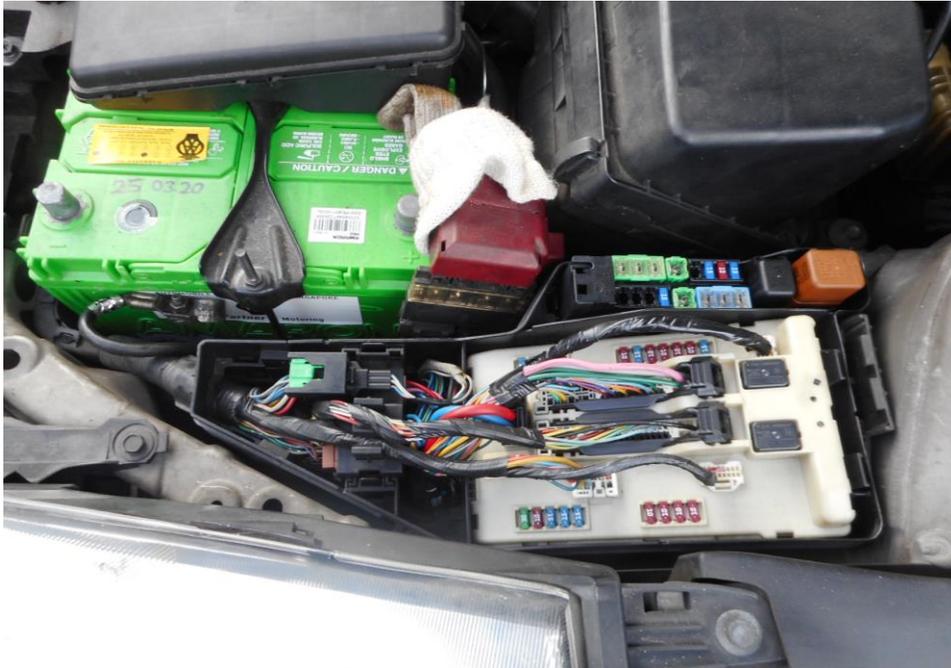
**Photo 7** shows the general view of the fuse box in the engine portion of the Insured Vehicle at the time of our inspection. The fire damage to the Insured Vehicle was confined to its interior portion. Its fuse box compartment is observed to be unaffected by the fire.

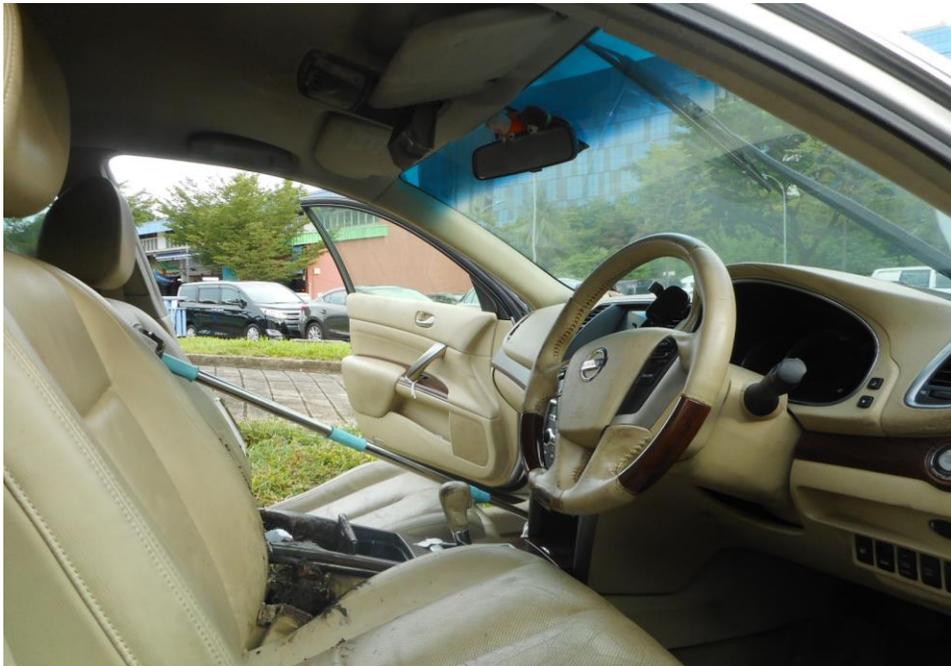
**Photo 8** shows the general view of the interior compartment of the Insured Vehicle at the time of our inspection. The fire was confined to its centre armrest storage box rear portion, however the fire had resulted in the various components located in the interior of the Insured Vehicle suffer from heat and smoke damages, this includes the front left and right seat and several parts inside the centre armrest storage box that were also observed to sustain damages included electronic components & wirings.

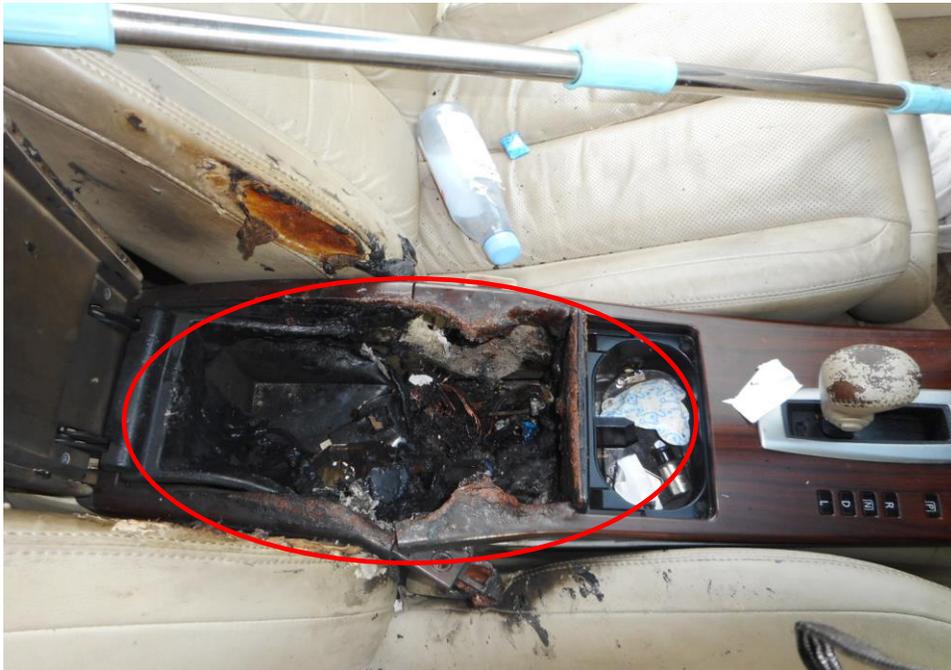
**Photo 9** shows the general view of the centre armrest storage box of the Insured Vehicle at the time of our inspection. The storage box had suffered heat and smoke damages (circled) as a result of the fire.

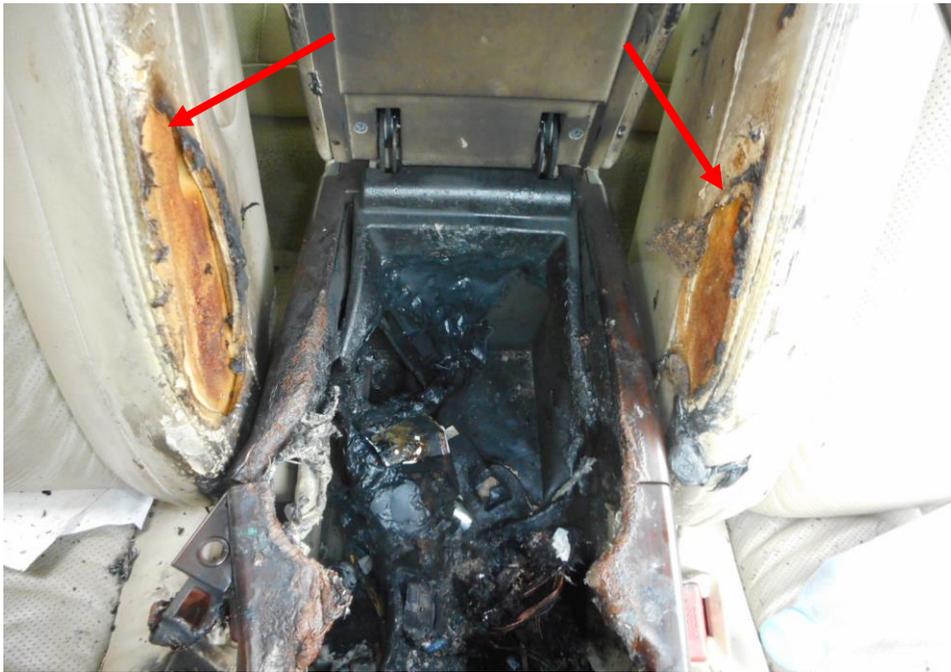
**Photo 10** shows the close up view of the centre storage box area of the Insured Vehicle at the time of our inspection. The left & right seats (arrowed) surrounding area of the storage box had also suffered heat and smoke damages as a result of the fire.

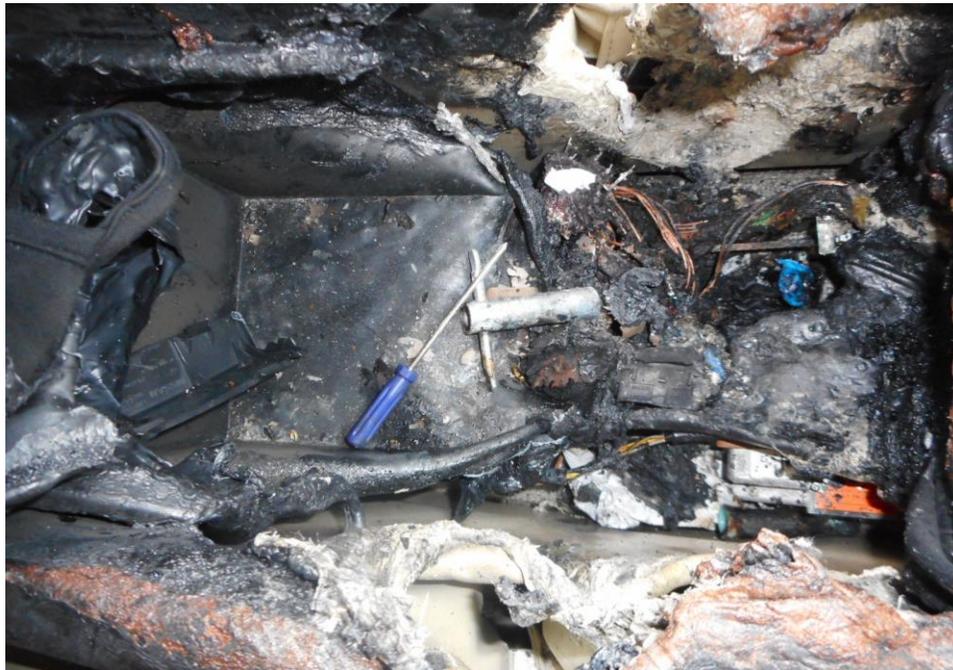
**Photo 11** shows the general inside view of the centre armrest storage box of the Insured Vehicle at the time of our inspection. Observed that the items & electrical components in the storage box had sustain heat & smoke damaged.

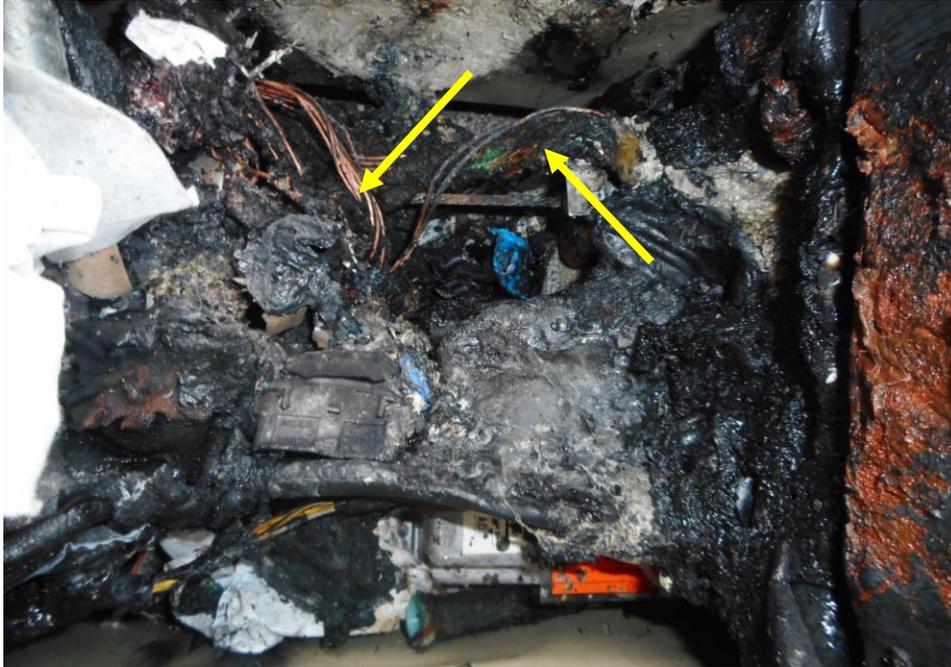
9. Upon closer observations, the wirings in the centre armrest storage box were observed to be where the fire had started, we had found traces of greenish residue on the original wirings leading from the fuse box. The wirings were original wirings fitting from manufacturer. The presence of greenish residue indicates internal heating of copper wires, a sign of an electrical short circuit occurring. The greenish residue is normally left behind from the oxidation as a result of chemical reaction involving the copper wires. This physical evidence would then appear to suggest that the cause of fire to the Insured Vehicle could have possibly been due to electrical in nature. See photo 11-14 below.

**Photo 12** shows the general inside view of the centre armrest storage box of the Insured Vehicle at the time of our inspection. Observed that the fire had likely started from the original wiring harnesses (arrowed) leading out from the fuse box as there was greenish residue on the surface. The presence of greenish residue indicates internal heating of copper wires, a sign of an electrical short circuit occurring. The greenish residue is normally left behind from oxidation as a result of chemical reaction involving the copper wires.

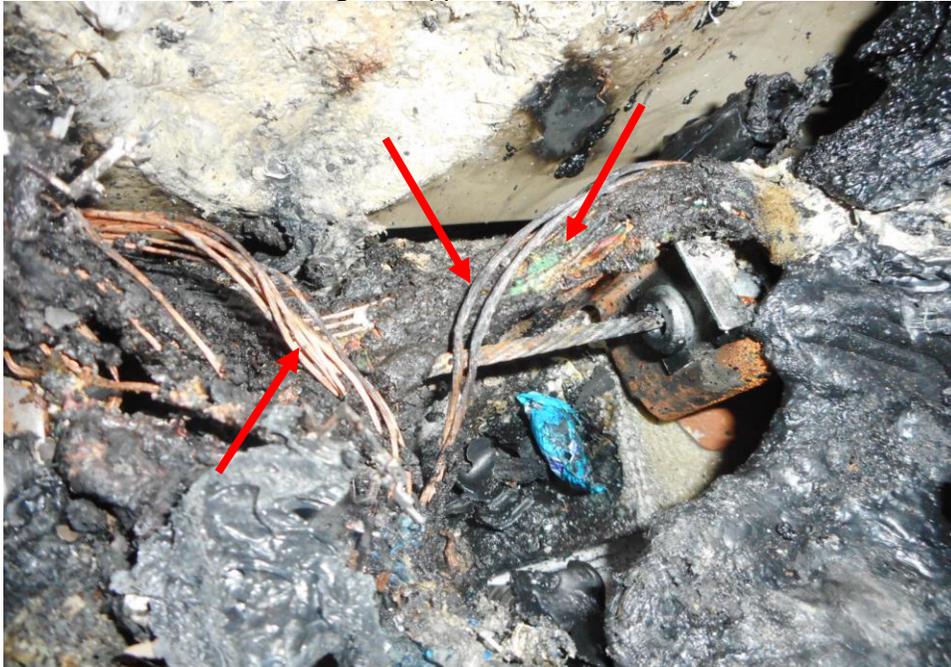
**Photo 13** shows a close up view of the original wiring harness leading from the fuse box in the centre armrest storage box compartment. The original wiring harness (arrowed) was observed with greenish residue on the surface. The presence of greenish residue indicates internal heating of copper wires, a sign of an electrical short circuit occurring. The greenish residue is normally left behind from oxidation as a result of chemical reaction involving the copper wires. This is likely where the fire had started from.

20. The possibility of the fire being due to electrical in nature would then seem more likely given that engine overheating and external factors would both seem unlikely. The fire being due to electrical nature is also supported by the condition of the wirings that were found leading from the original wirings to the fuse box on the Insured Vehicle, which was earlier discussed in paragraph 9 above.

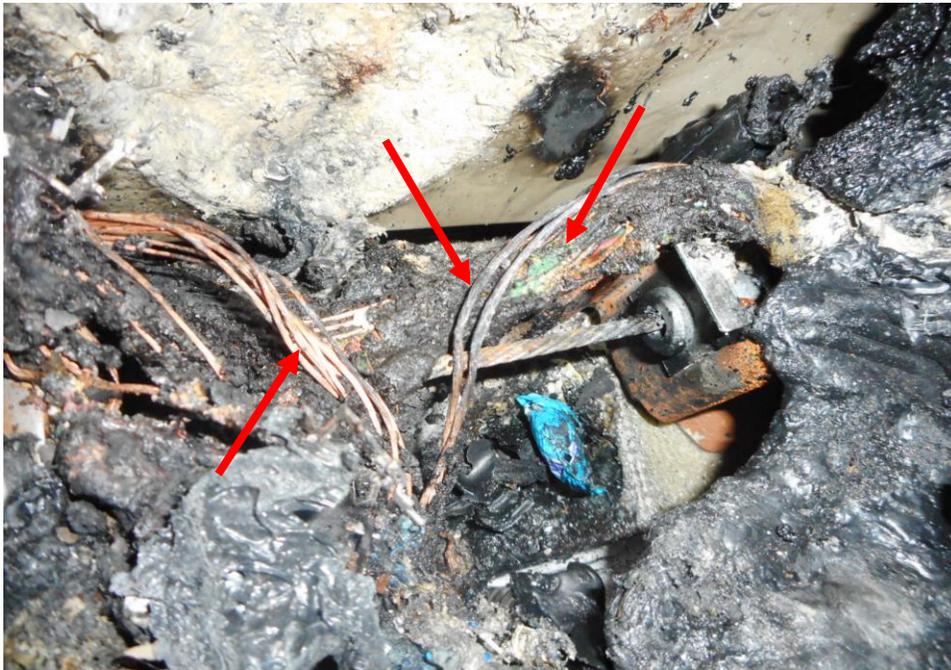
**Photo 14** shows a close up view of the original wiring harness leading from the fuse box in the centre armrest storage box compartment. The original wiring harness (arrowed) was observed with greenish residue on the surface. The presence of greenish residue indicates internal heating of copper wires, a sign of an electrical short circuit occurring. The greenish residue is normally left behind from oxidation as a result of chemical reaction involving the copper wires. This is likely where the fire had started from.

22. Having investigated and technically analysed the damages of burnt nature to the Insured Vehicle, we are of the view that the cause of fire to the Insured Vehicle was of electrical nature. For this particular case, the fire had originated along the original manufacturer wirings leading to the fuse box of the Insured Vehicle.
23. We did not find any evidence which had suggested that the cause of fire to the Insured Vehicle was due to poor maintenance and/or recurring electrical problem.
