Your Ref: Honda Civic Type R  
(chassis number SHHFK8790HU004125)  
Our Ref : CI/TP20009675/D

10 September 2020

**INSPECTION REPORT OF AN UNREGISTERD HONDA CIVIC TYPE R  
MOTOR CAR WITH CHASSIS NUMBER SHHFK8790HU004125**

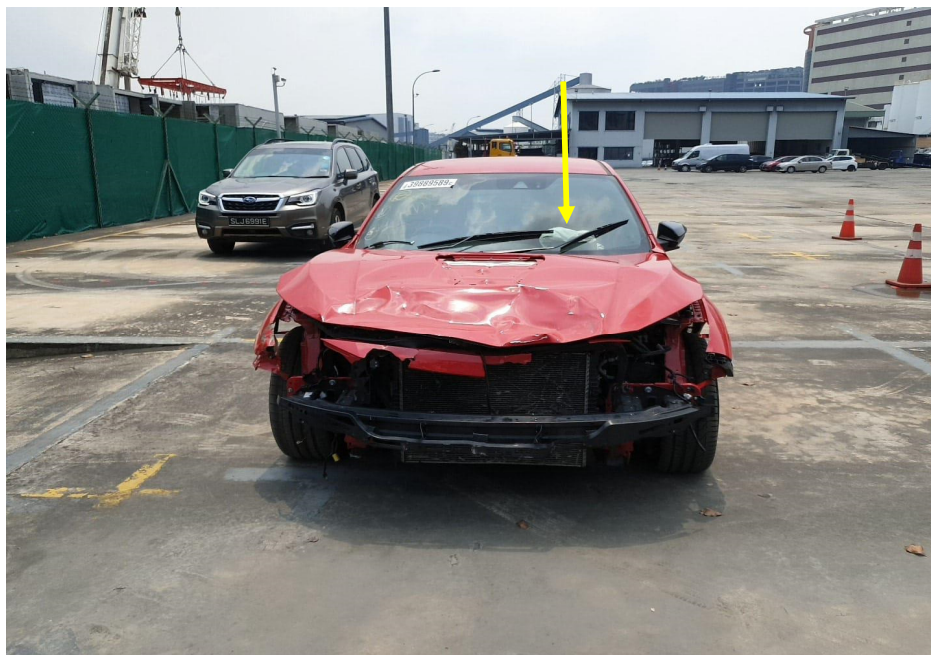
3. From the photographs provided to me, it was observed that the Motor Car had sustained damages at its frontal portion. Body parts observed to have been damaged include the front bumper, front bonnet, front headlamps, front grille, front bumper reinforcement and front fenders amongst others. The front left passenger airbag was also deployed.
4. Photograph of the Motor Car's engine compartment had showed damage to the front support panel, air hose, aircon condenser and radiator amongst others. See photo 1 & 2 below.

**Photo 1** shows the Motor Car prior to any repairs being carried out (photograph provided to me). The Motor Car was observed to have sustained damages at its frontal portion. The body parts observed to be damaged include the front bumper, front fenders, front bonnet, front bumper reinforcement and front headlamps amongst others. The front left passenger seat belt (arrowed) was also deployed.

22. The body parts at the frontal portion, and parts within the engine compartment of the Motor Car were visually examined and it was noted that the repair/restoration works carried out to the damaged area of the Motor Car (refer photograph 1 & 2 above) were reasonably adequate and in order.

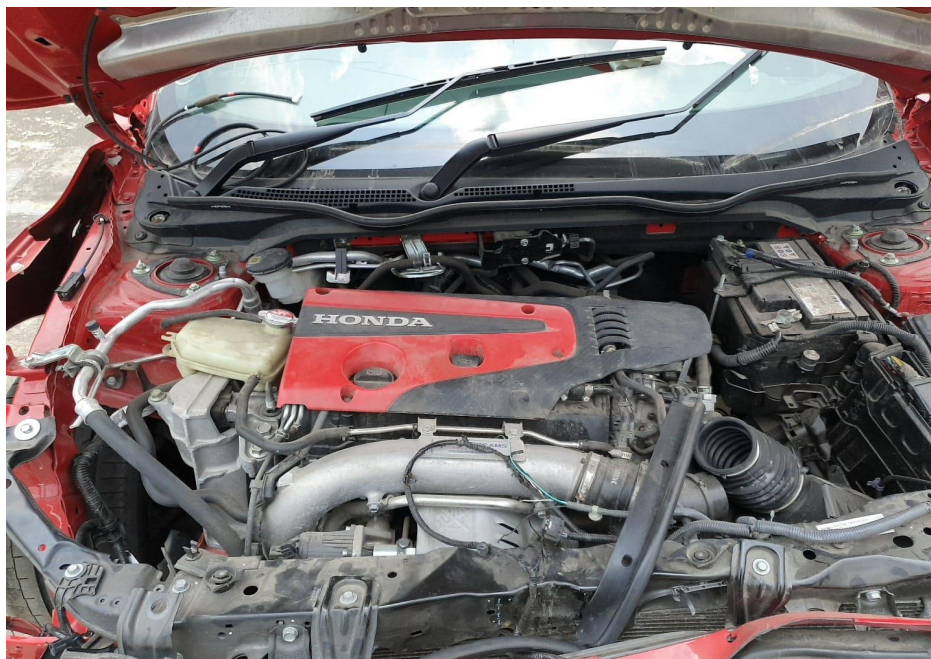
**Photo 2** shows the engine compartment of the Motor Car prior to any repairs being carried out (photograph provided to me). The front support panel, air hose, aircon condenser and radiator were amongst the parts within the engine compartment that were observed to be damaged.

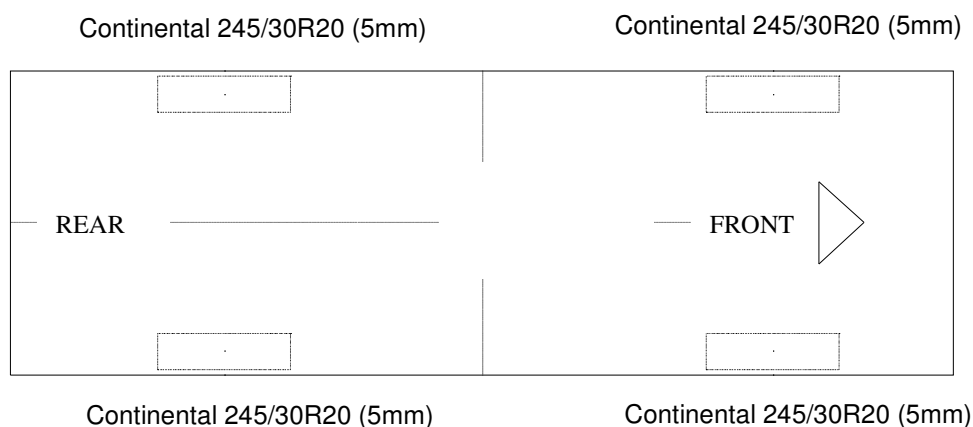
8. It was fitted with 20inch sport wheel rims that were wrapped with tyres that were observed to be of serviceable condition. The tyres were also sufficiently inflated for vehicular operation. The tyre brand, tyre size and approximate remaining tread depth of the 4 tyres of the Motor Car were recorded as follows: -

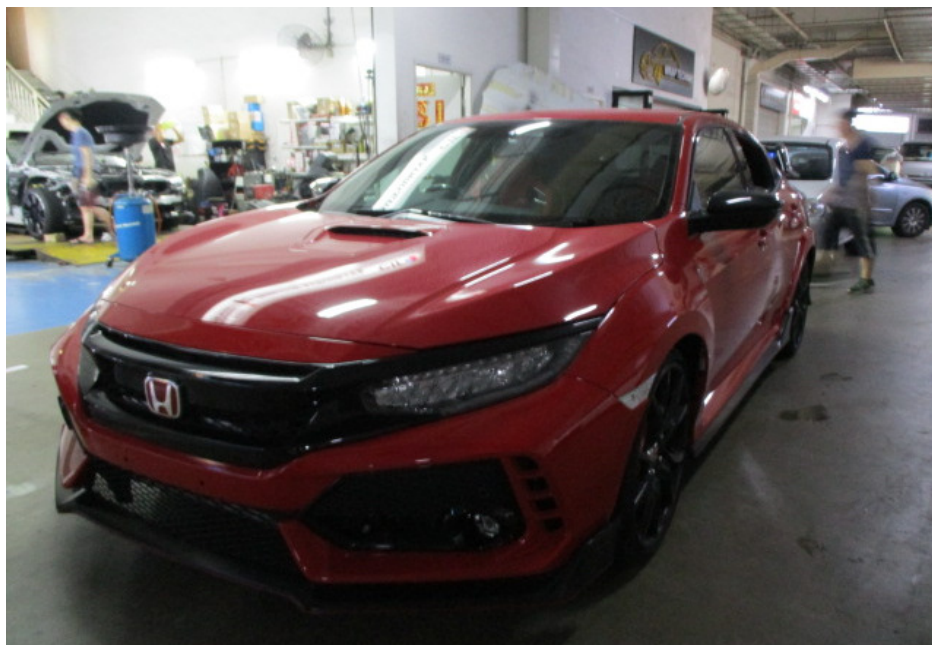
**Photo 3** shows a general view of the front left body of the Motor Car at the time of my inspection. The Motor Car was observed to be in relatively good general condition with no loose exterior fittings observed. The body parts at the frontal portion of the Motor Car were visually examined and it was observed that the repair/restoration works carried out to the damaged area of the Motor Car (refer photograph 1 above) were reasonably adequate and in order.

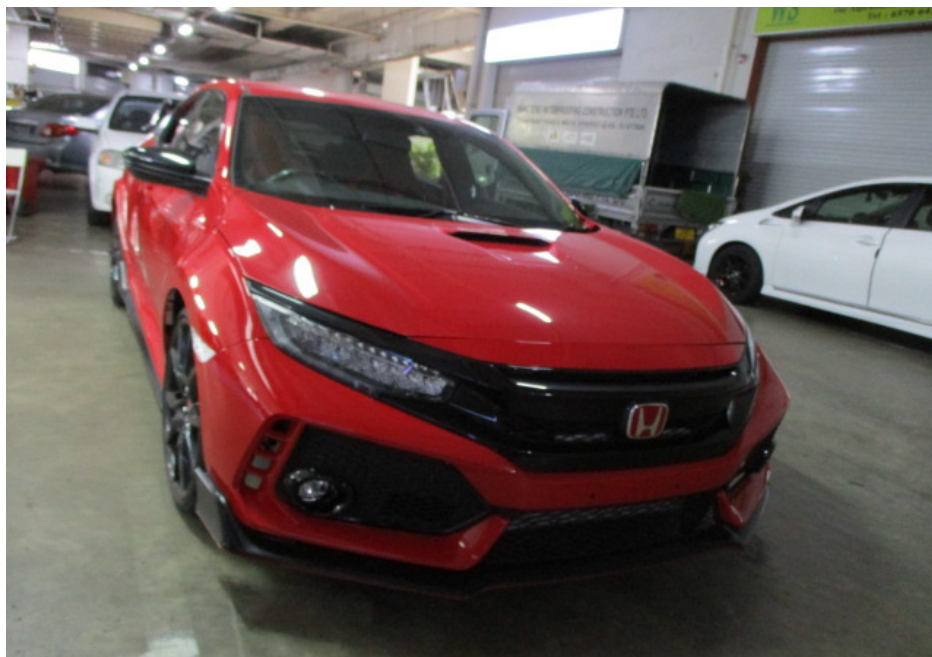
**Photo 4** shows a general view of the front right body of the Motor Car at the time of my inspection. The Motor Car was observed to be in relatively good general condition with no loose exterior fittings observed. The body parts at the frontal portion of the Motor Car were visually examined and it was observed that the repair/restoration works carried out to the damaged area of the Motor Car (refer photograph 1 above) were reasonably adequate and in order.

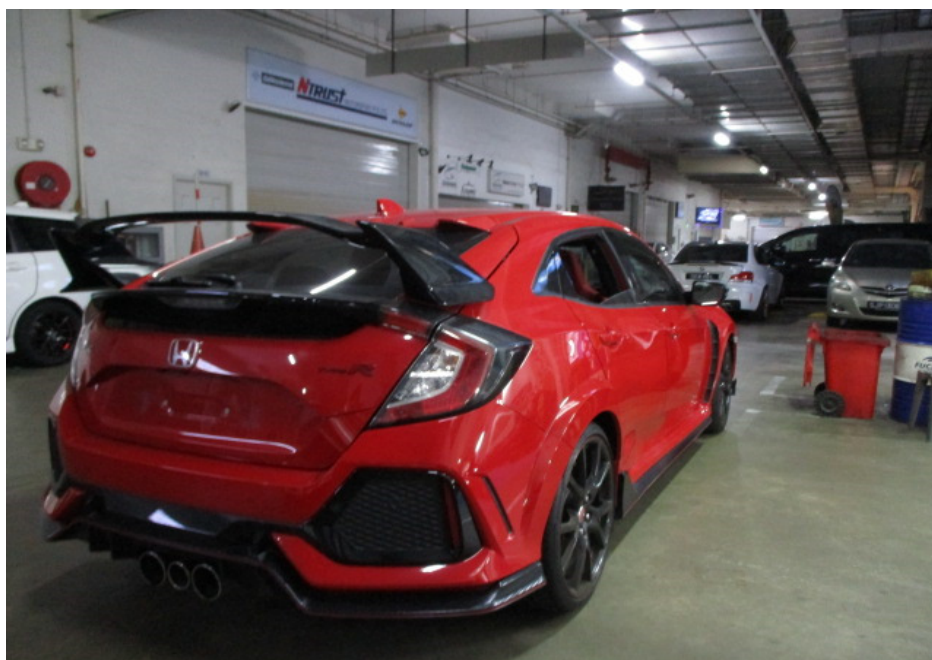
**Photo 5** shows a general view of the rear right body of the Motor Car at the time of my inspection. The Motor Car was observed to be in relatively good general condition with no loose exterior fittings observed.

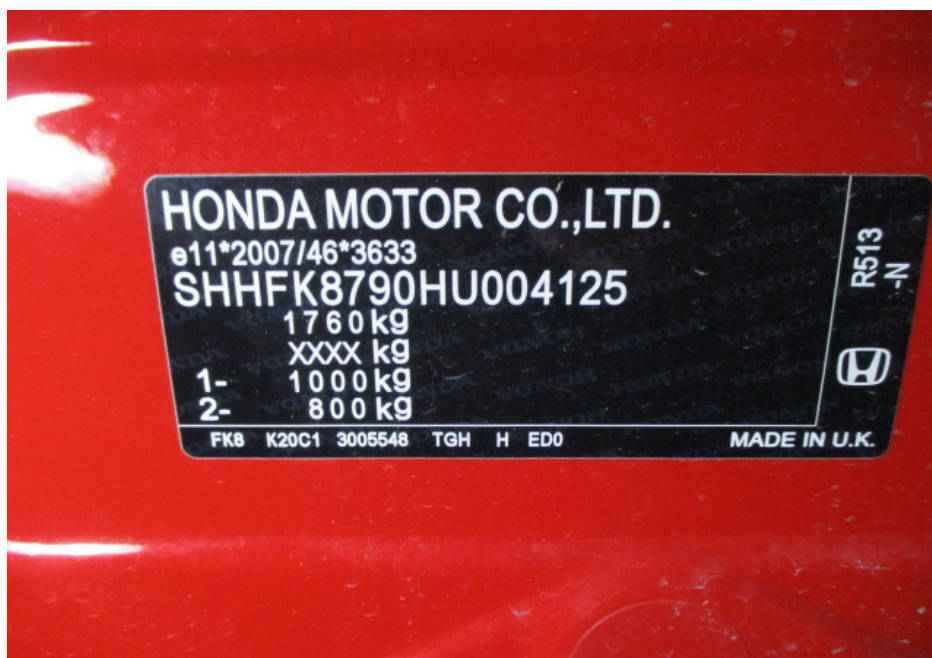
**Photo 6** shows the chassis number of the Motor Car. The chassis number recorded was SHHFK8790HU004125.

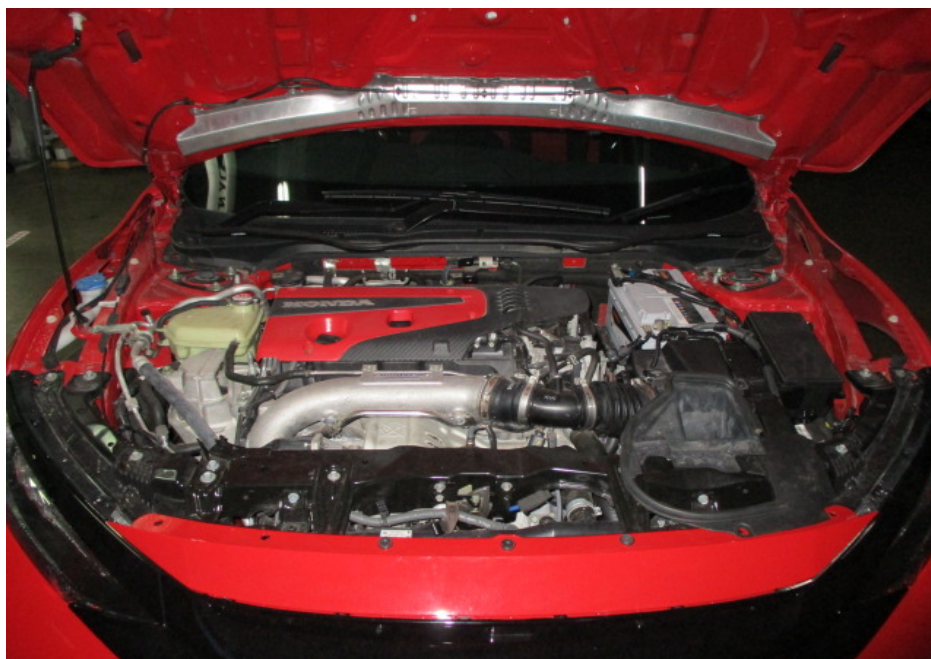
**Photo 7** shows a general view of the engine compartment of the Motor Car at the time of my inspection. The damaged parts within the engine compartment of the Motor Car (refer photograph 2 above) were visually examined and it was observed that the repair/restoration works carried out were reasonably adequate and in order. Overall, I had found the various parts and components inside the engine compartment to be intact and properly fitted. There was also no sign(s) or indication(s) of fluid leak and/or fluid stain found inside the engine compartment.

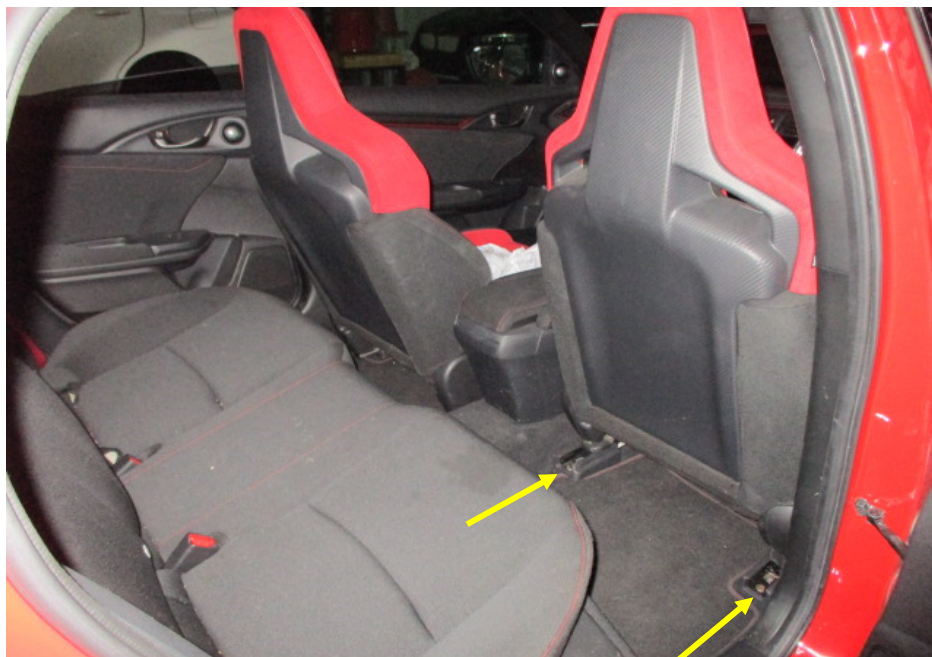
**Photo 8** shows the seats of the Motor Car, which were secured via seat rails (arrowed) to the floorboard. All the seats of the Motor Car were fitted with a retractable seat belt reel and pre-tensioner. The seat belts were tested and able to be fastened into the respective pre-tensions that were fitted on the side of each individual seat.

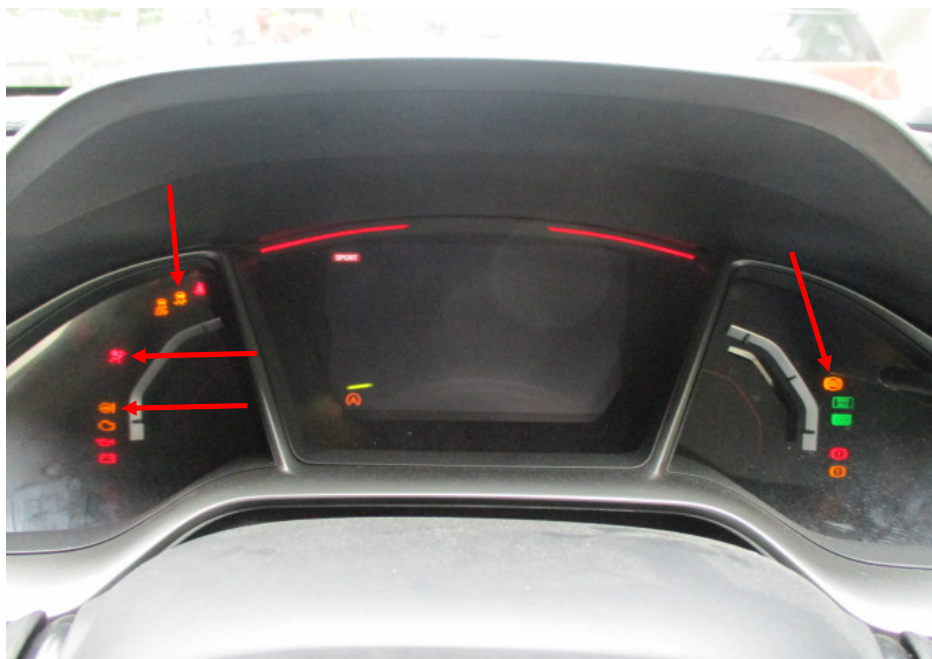
**Photo 9** shows the warning lights for the various electronic safety features appearing on the instrument panel of the Motor Car during its self-test when the engine is cranked, in particular the ABS, SRS, EPS and VSA lights (arrowed).

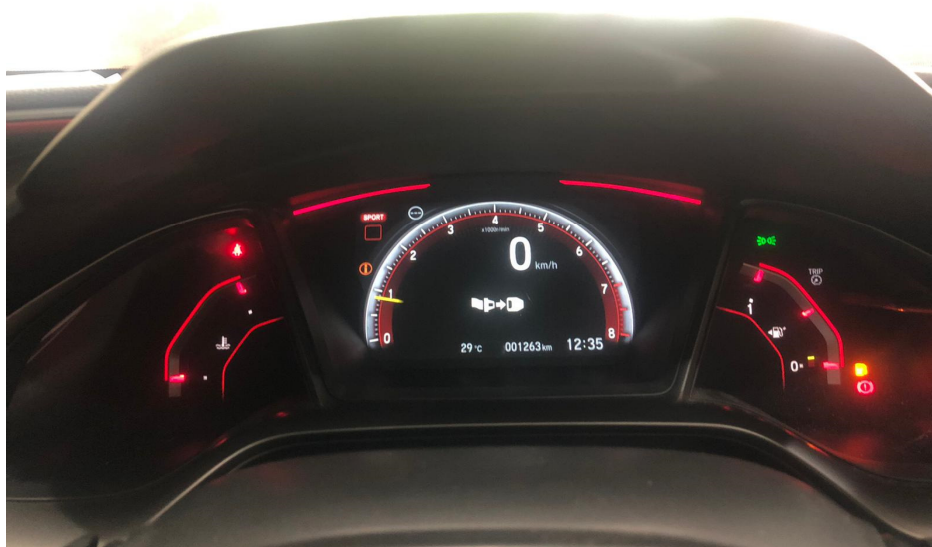
**Photo 10** shows the respective warning lights no longer illuminated after the engine was started, indicating that there was no fault detected to the ABS, SRS, EPS and VSA systems of the Motor Car during the self-test. These electronic systems were hence in working condition at the time of my inspection.

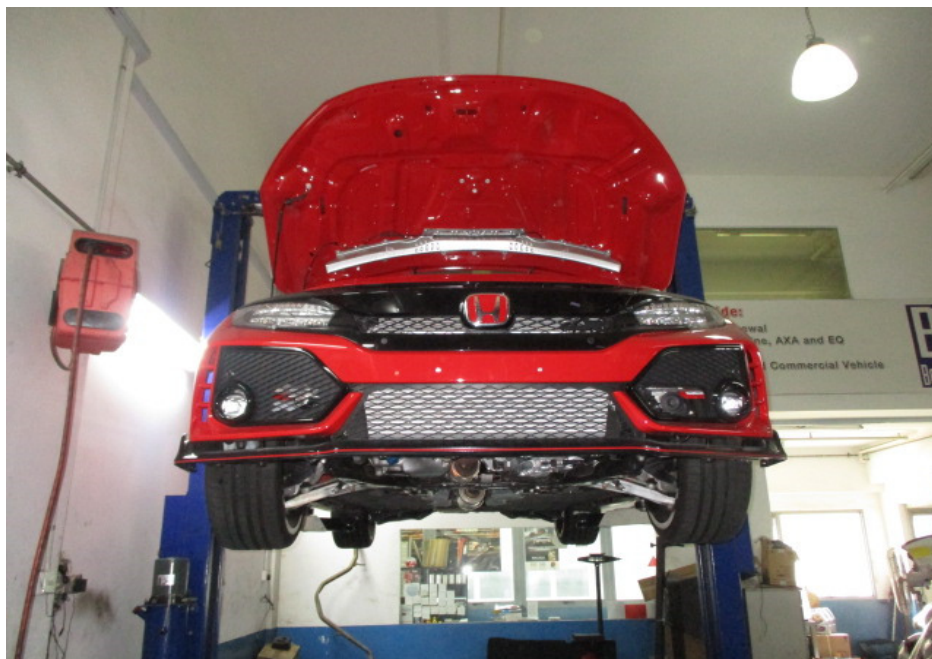
**Photo 11** shows the Motor Car hoisted up for checks on its undercarriage. There was no sign(s) or indication(s) of fluid leakage and/or fluid stain(s) on the underside of the Motor Car. The undercarriage components of the Motor Car were also all observed to be intact and secured in an appropriate manner.

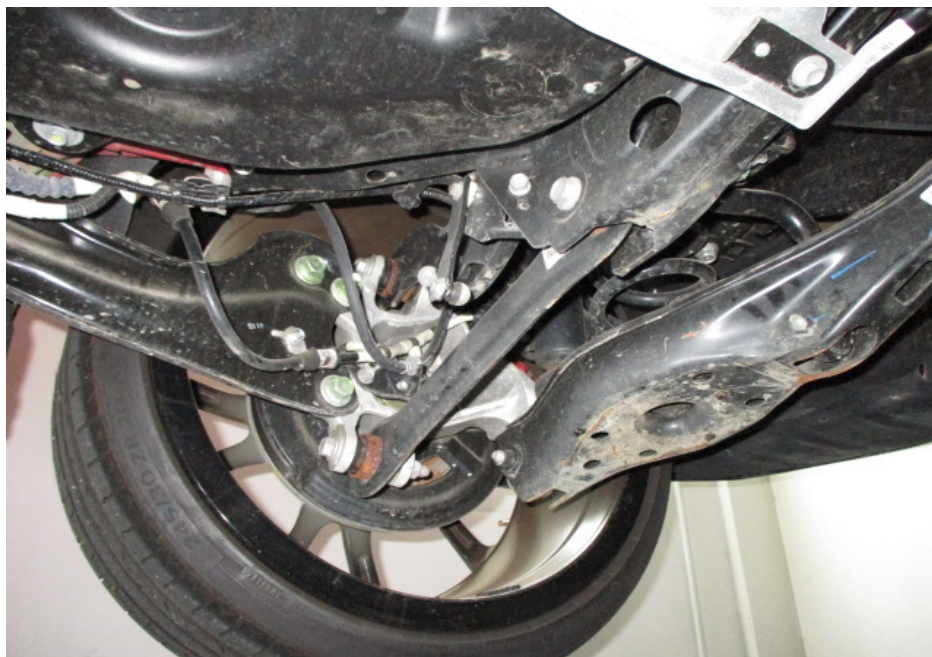
**Photo 12** shows a general view of the control arms and linkages at the rear right wheel of the Motor Car. I did not observe any fluid leak and/or fluid stain on the underside of the Motor Car. All of the Motor Car's undercarriage components were observed to be intact and secured in an appropriate manner.

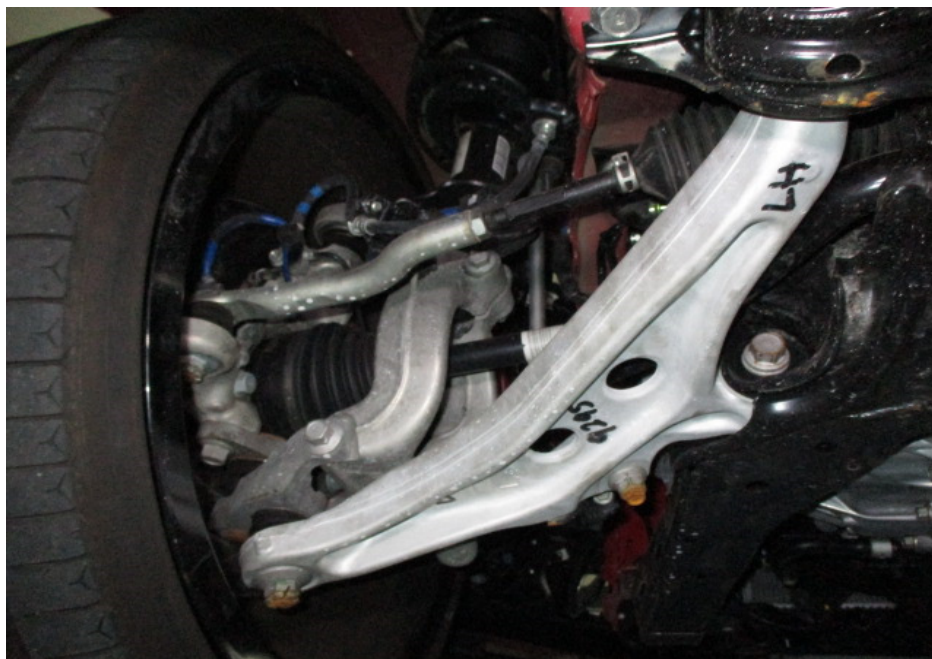
**Photo 13** shows the various undercarriage components at the front left wheel of the Motor Car. The mechanical components, control arms and linkages were all found to be intact and secured in an appropriate manner.

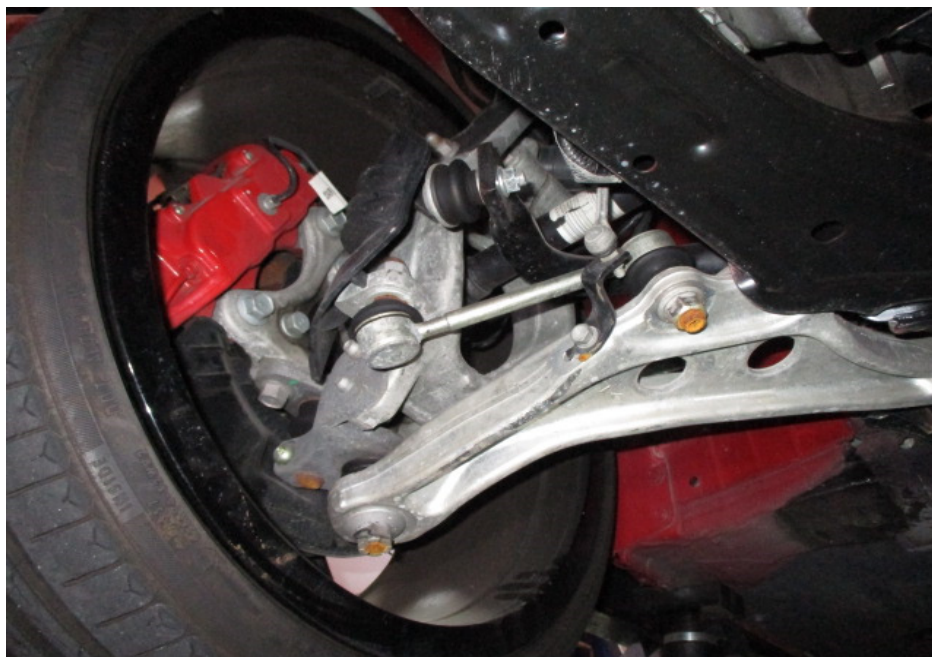
**Photo 14** shows the various undercarriage components at the front right wheel of the Motor Car. The mechanical components, control arms and linkages were all found to be intact and secured in an appropriate manner. I also did not observe any fluid leak and/or fluid stain on the underside of the Motor Car.

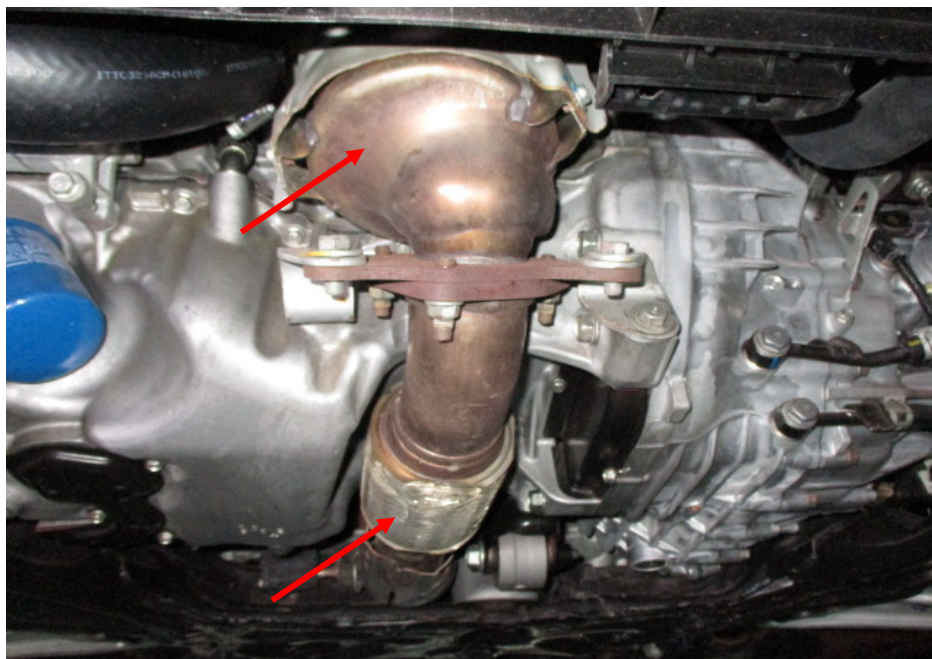
**Photo 15** shows the Motor Car's catalytic converters (arrowed). My examination of the Motor Car's exhaust system revealed no sign(s) or indication(s) of any cut or weld marks along its exhaust pipes and on its rear muffler.

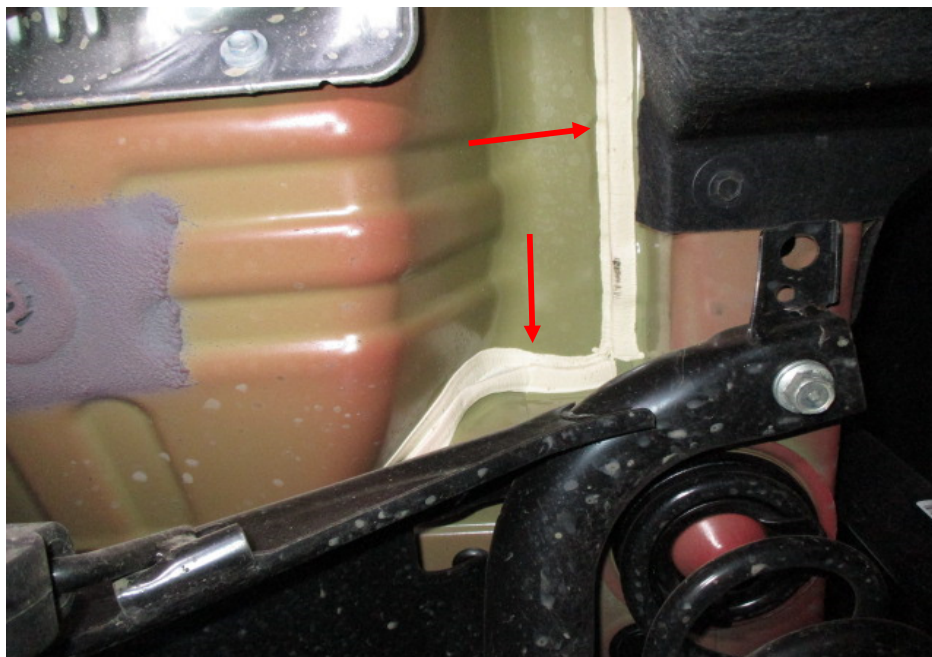
**Photo 16** shows the floorboard at the underside rear right of the Motor Car. The original factory sealant (arrowed) at the joints along the non-detachable body panels were untouched, indicating no work was done on the non-detachable body panels of the Motor Car; and that these body panels were originally fitted.

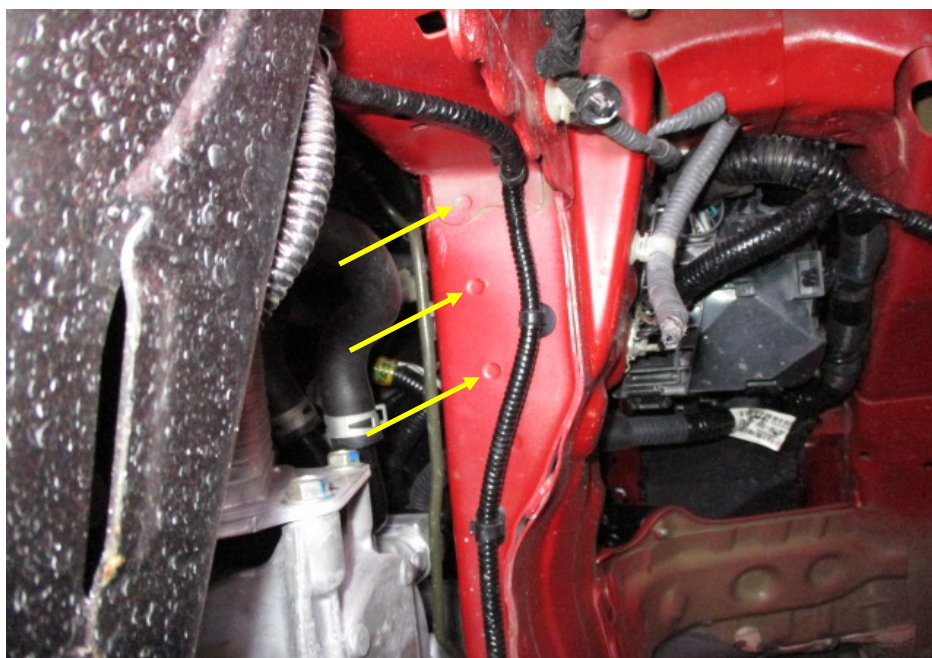
**Photo 17** shows the chassis/structural body at the underside front left of the Motor Car. Visually, I did not find any weld marks other than original spot weld marks (arrowed) on the chassis/structural body of the Motor Car, indicating no work was done on the chassis/structural body of the Motor Car and that the chassis/structural body was originally fitted.

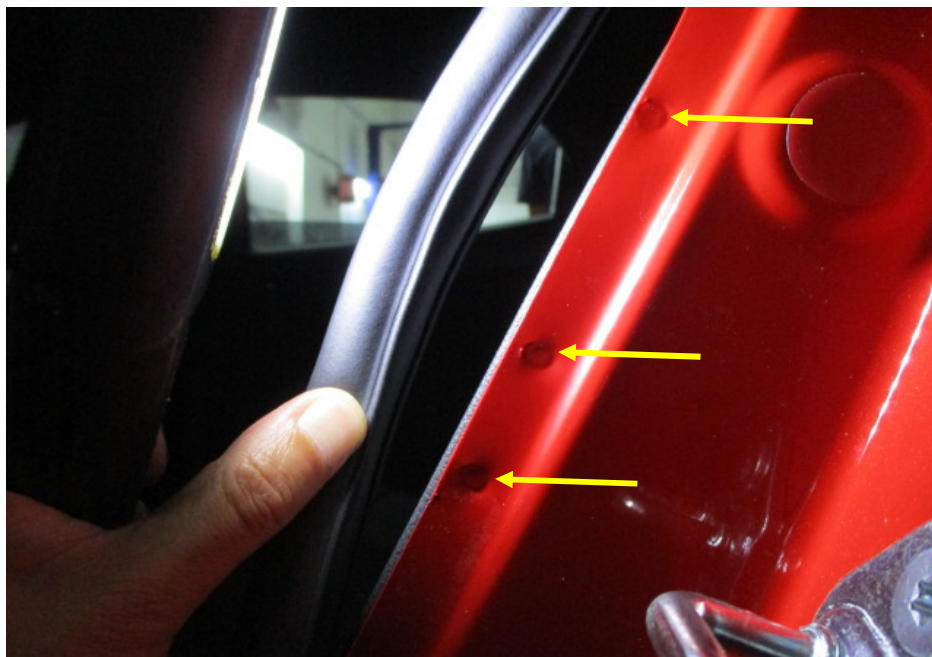
**Photo 18** shows the rear left "C" pillar of the Motor Car. I did not find any weld marks other than original spot weld marks (arrowed) on the non-detachable body panels of the Motor Car, indicating that there was no re-welding works carried out; and that the non-detachable body panels of the Motor Car were originally fitted.
