VEHICLE APPRAISAL REPORT

Our Reference: **TP18-048027-AE**
 Your Reference: -
 Vehicle Number: **SKN3669Y**

Assessment of Vehicle No: SKN3669Y
Date of Accident: 29-Mar-18
Date of Inspection: 2-Apr-18

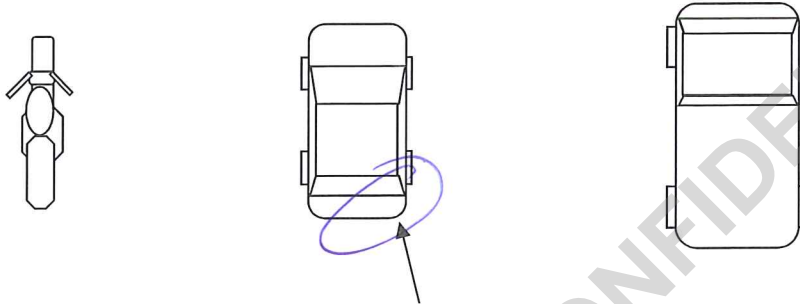
At the time of inspection, this vehicle sustained damages to the **Right rear portion**. Please see attached scheduled details.
