Your Ref: S0M02TBB
Our Ref : CS4/ASM20009786/N

15 September 2020

TECHNICAL INVESTIGATION REPORT OF FIRE INCIDENT INVOLVING THE INSURED VEHICLE SKW 451E ON 3 SEPTEMBER 2020

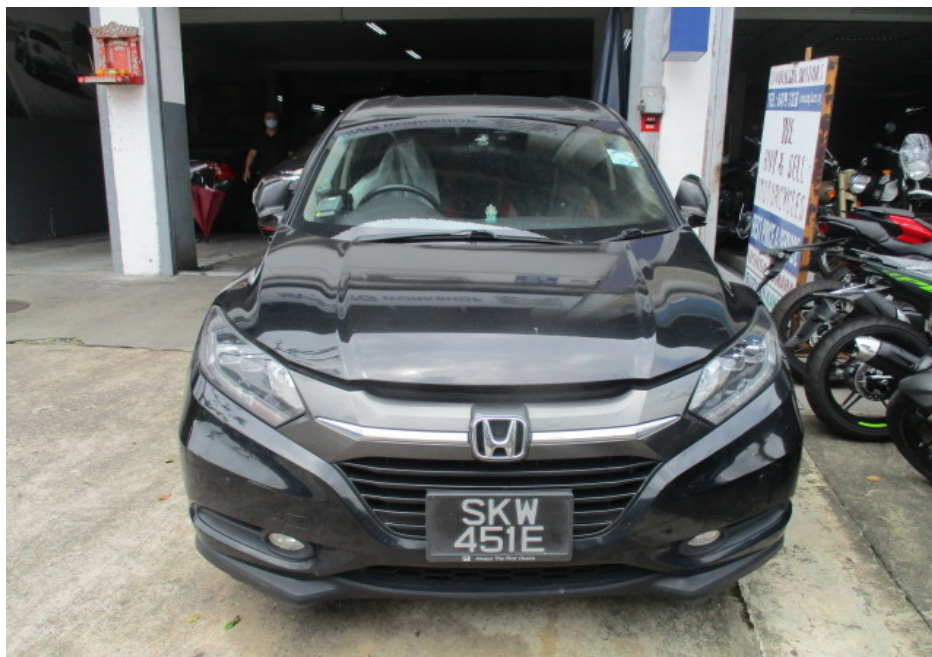
Photo 1 shows the general view of the frontal portion of the Insured Vehicle at the time of our inspection. The exterior front body and interior compartment of the Insured Vehicle sustained visible fire damage. This included its front windscreen, wiper panel, left 'A' pillar, left side panel and instrument panel.

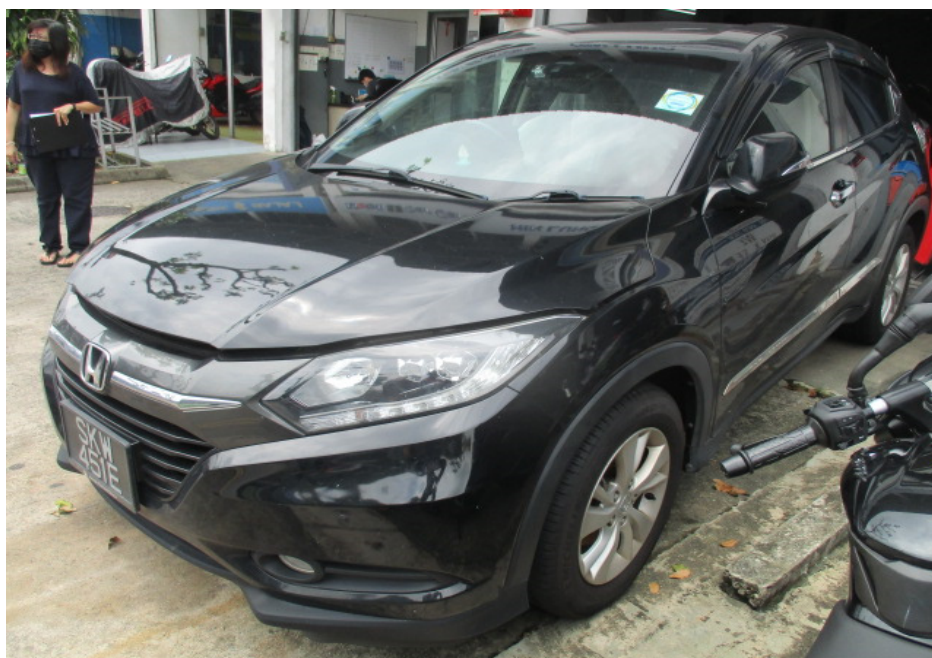
Photo 2 shows the general view of the left front portion of the Insured Vehicle at the time of our inspection. The exterior body of the Insured Vehicle had sustained visible fire damage. This included its front windscreen, wiper panel, left 'A' pillar, left side panel and instrument panel.

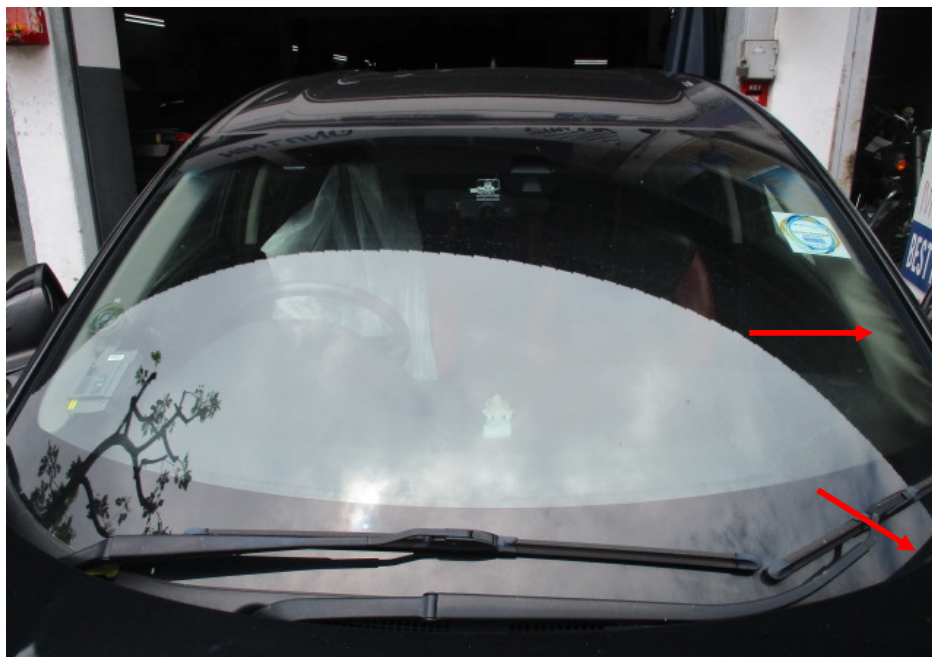
Photo 3 shows a closer view of the front windscreen of the Insured Vehicle at the time of our inspection. The front windscreen and wiper panel had sustained minimal fire damage (arrowed).

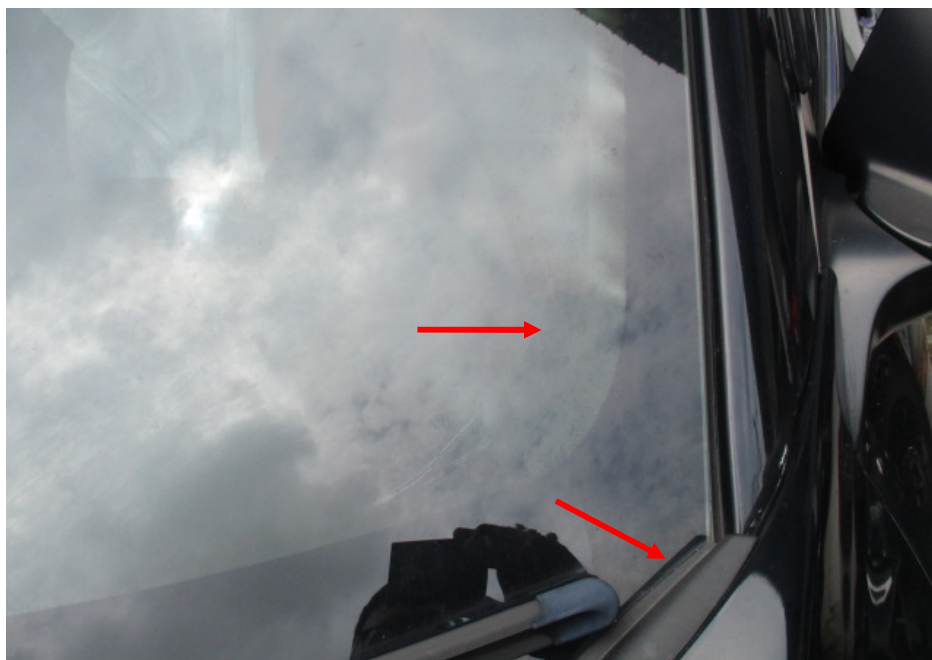
Photo 4 shows a closer view of the front windscreen and wiper panel of the Insured Vehicle which had sustained minimal fire damage (arrowed).

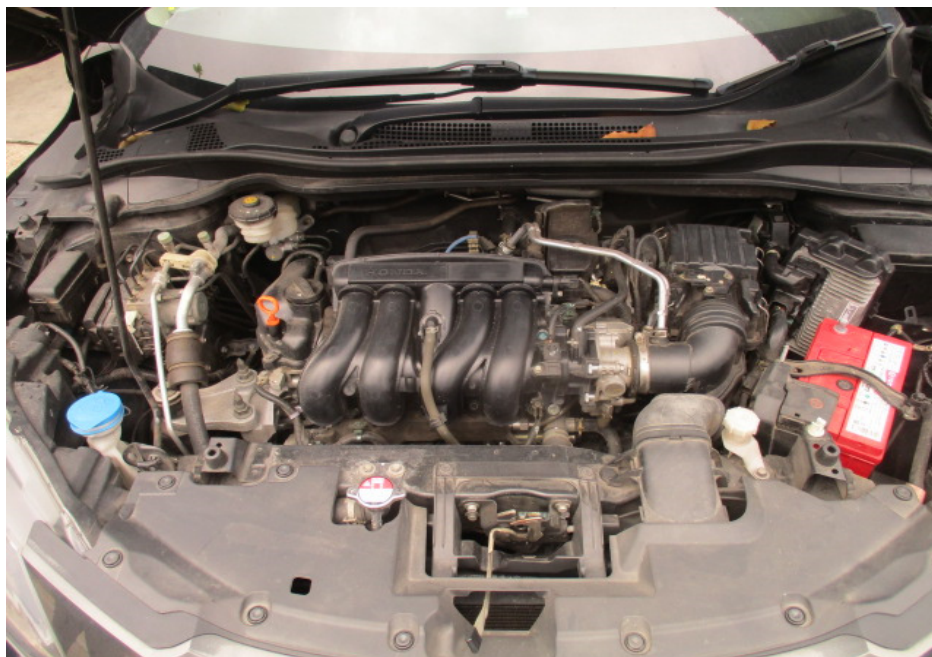
Photo 5 shows a general view of the engine compartment of the Insured Vehicle at the time of our inspection. The engine compartment was relatively unaffected by the fire.

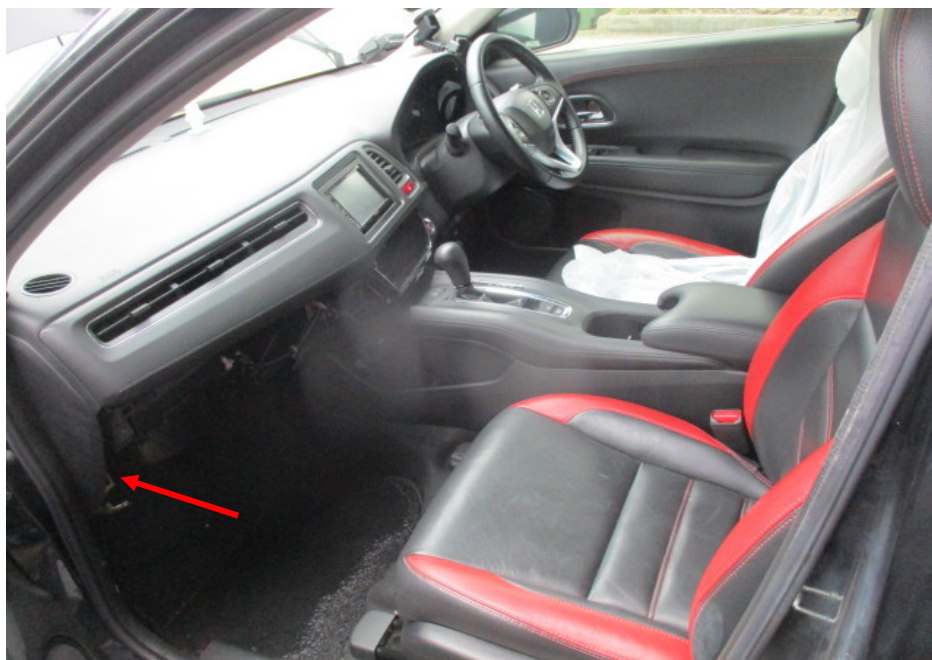
Photo 6 shows the interior compartment of the Insured Vehicle at the time of our inspection. The left portion of the interior compartment of the Insured Vehicle had sustained minimal fire damage (arrowed).

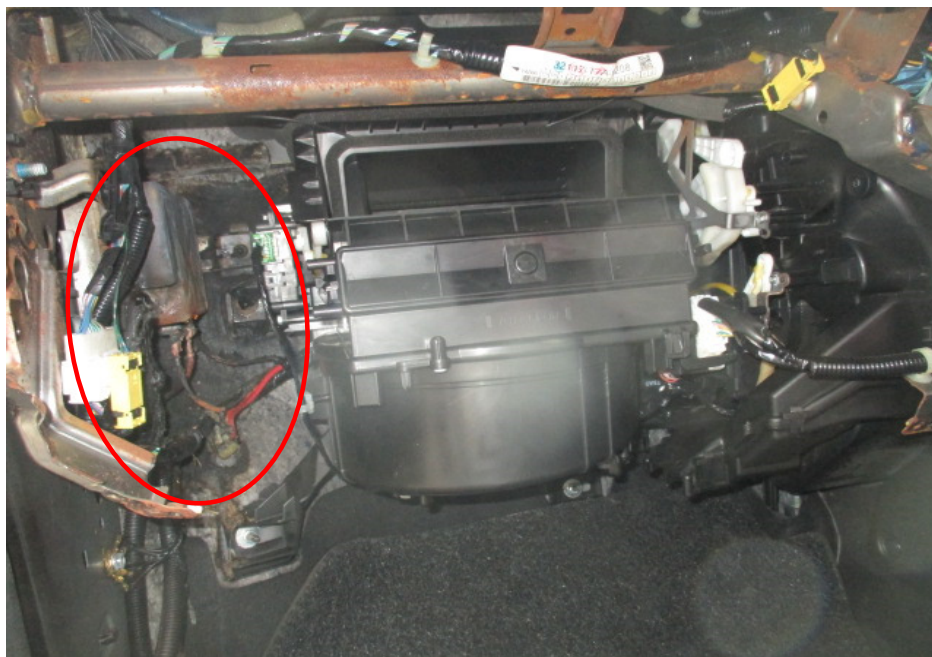
Photo 7 shows a closer view of the left portion of the interior compartment (after removing the glove compartment) of the Insured Vehicle at the time of our inspection. The left portion of the interior compartment of the Insured Vehicle had sustained fire damage (circled).

16. For this case, Mr Kumar first saw smoke coming out from the gaps surrounding the dashboard. Taking Mr Kumar's observations into consideration, the fire to the Insured Vehicle had originated around the left side of the dashboard, at or near the glove compartment area; with the cause of fire related to a defective originally fitted component. The following paragraphs discuss this aspect.
17. The Insured Vehicle was involved in a manufacturer recall campaign in year 2016. The recall was for issue relating to a capacitor used in the engine idling stop system of the Insured Vehicle, which may be insufficient to protect against an overcurrent. Notably, the records had indicated that rectification to address the issue has not been carried out to the Insured Vehicle prior to this incident. See search result below obtained from LTA.

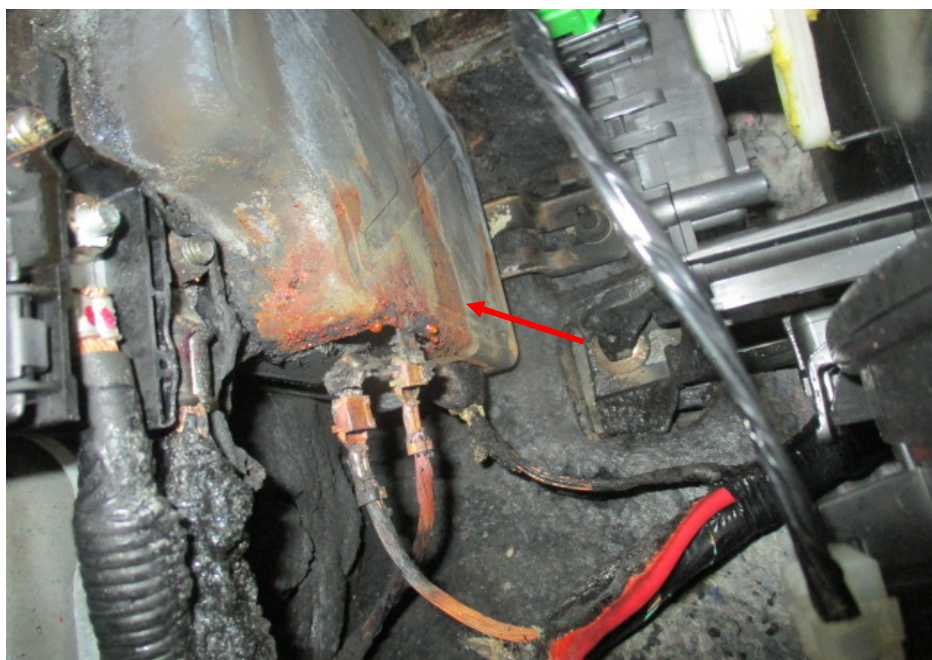
Photo 8 shows a close up view of the left portion of the interior compartment of the Insured Vehicle which had sustained fire damage (arrowed).

20. Having investigated and technically analysed the damages of burnt nature to the Insured Vehicle, we are of the view that the cause of fire to the Insured Vehicle was of electrical in nature. For this particular case, the fire was due to an originally fitted component that was defective.

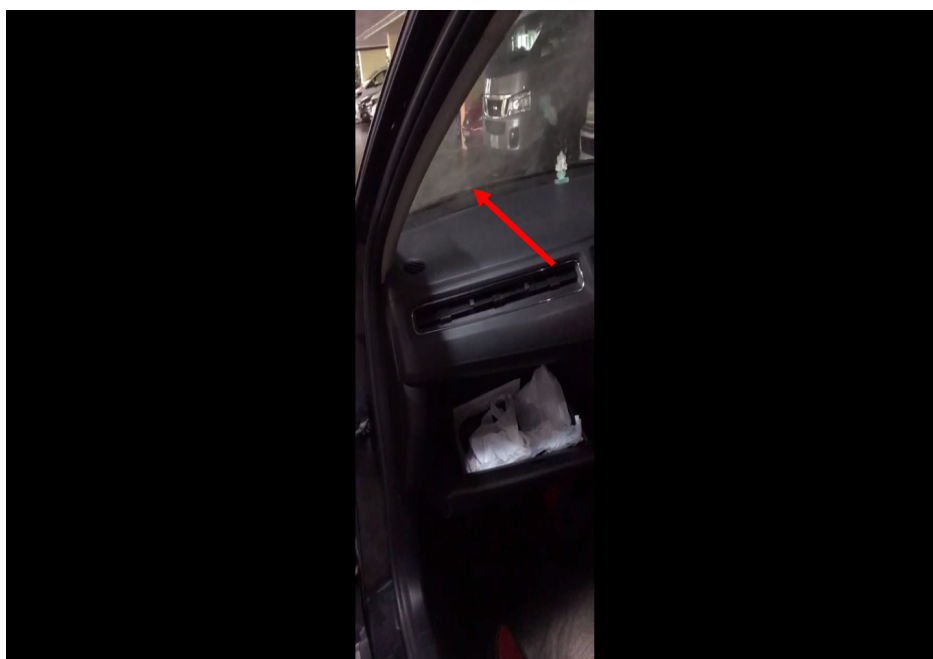
Photo 10 shows screenshot taken from the video recording that was provided by Mr Kumar. The Insured Vehicle could be seen with intense smoke emitting from the left passenger side (arrowed).

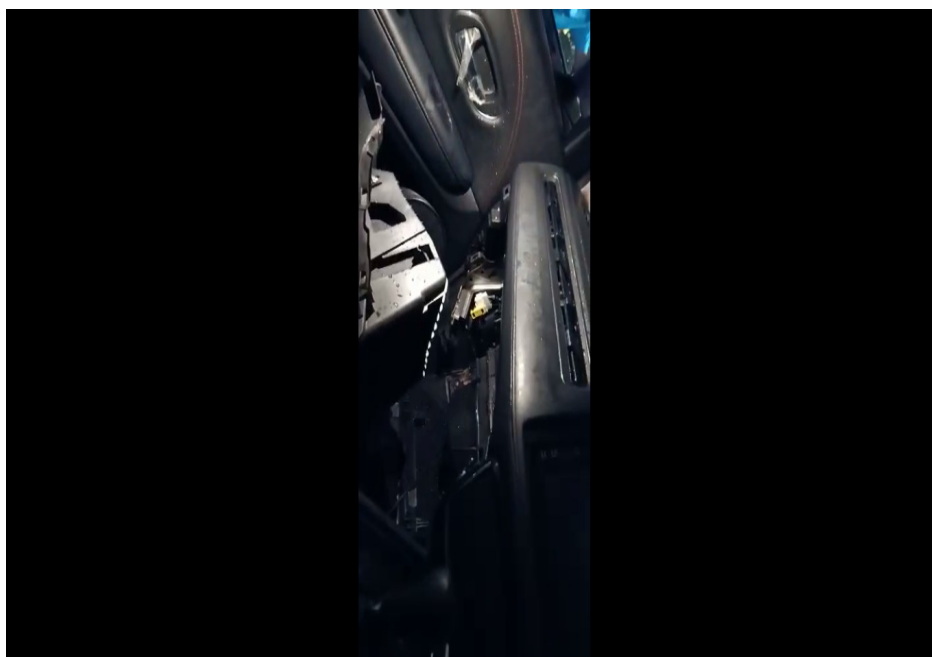
Photo 11 shows the Insured Vehicle after the fire was extinguished. Generally, the information that we were able to gather from the video recordings provided by Mr Kumar had corresponded to the information that he had related to us during our telephone conversation on 8 September 2020 which was he had managed to put out the fire with a hose reel.

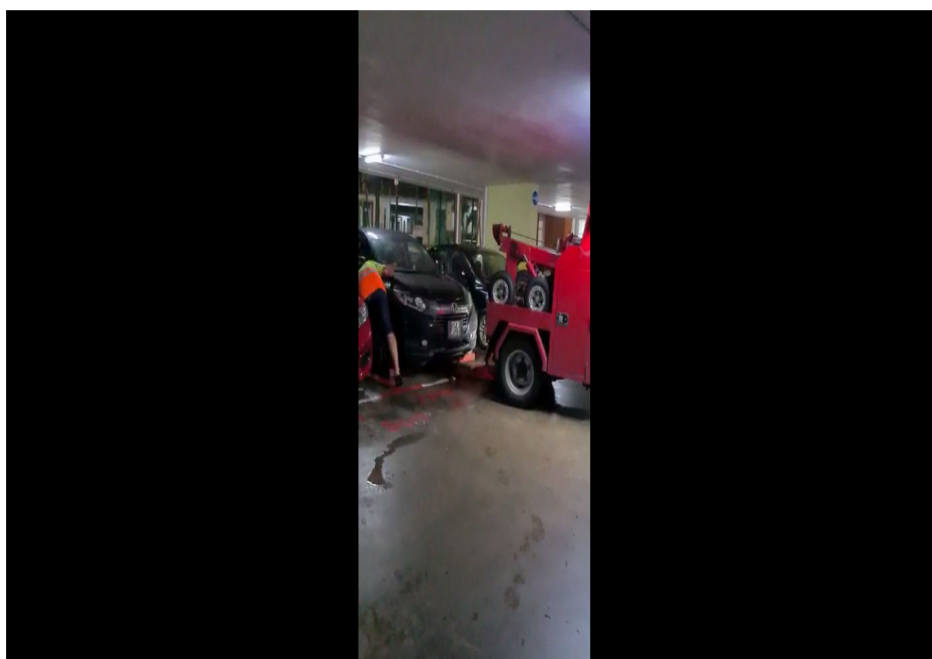
Photo 12 shows the Insured Vehicle being prepped to be towed to HLA post-incident. The extent of fire damage was similar to what we observed when we inspected the Insured Vehicle. The background seen from the photographs had also corresponded to the incident occurring at the multi storey carpark near Mr Kumar's home.

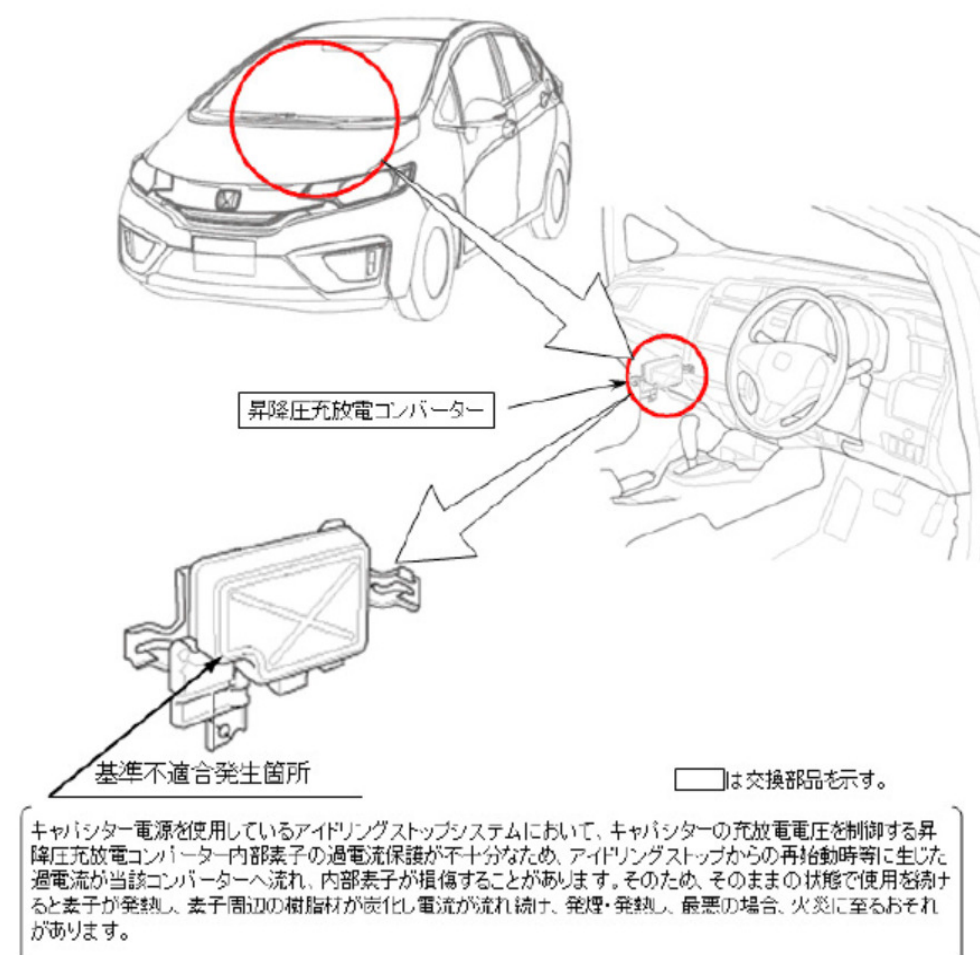
改善箇所説明図

18. Our further research and checks on the capacitor that was mentioned in the recall details of the LTA search result revealed that this capacitor is a component that is fitted onto the inner side of the Insured Vehicle's front left "A" pillar, towards the left and below the glove compartment of the Insured Vehicle. We note that this location is at or near the location where Mr Kumar had seen the most smoke. Basing on the information gathered pertaining to the capacitor; and given that no rectification to address the capacitor issue was carried out to the Insured Vehicle (as per LTA records), it can be determined that the fire to the Insured Vehicle is related to the purpose of the manufacturer recall campaign that involved the Insured Vehicle. See screenshots 1 & 2 showing the search result below gathered from our further research and checks.

Screenshot 2 shows a zoom in view of the schematic diagram pertaining to the manufacturer recall campaign of similar make and model vehicles as the Insured Vehicle. The component, circled in the schematic diagram, is the capacitor that was mentioned in the recall details of the LTA search result. The location where this component was fitted was also at or near the location where Mr Kumar had seen smoke.
