Your Ref: SLE 2335C
Our Ref : CI/TP20009789/D

AUTOMOBILE INSPECTION REPORT OF MOTOR CAR SLE 2335C

Vehicle Registration No.	: SLE 2335C
Make / Model	: Mitsubishi Evo-9 Wagon MR GTA 2.0A
Chassis No	: CT9W0100278
Year of Registration	: 2006 (November)
Mileage	: 135,245km

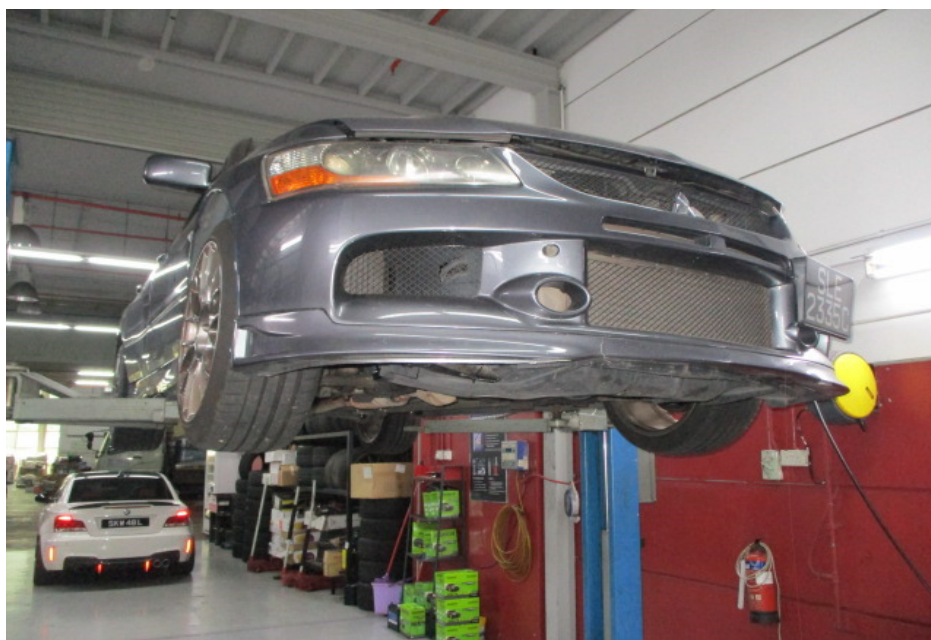
Photo 1 shows the Motor Car hoisted for checks on its undercarriage, in particular to its transmission assembly.

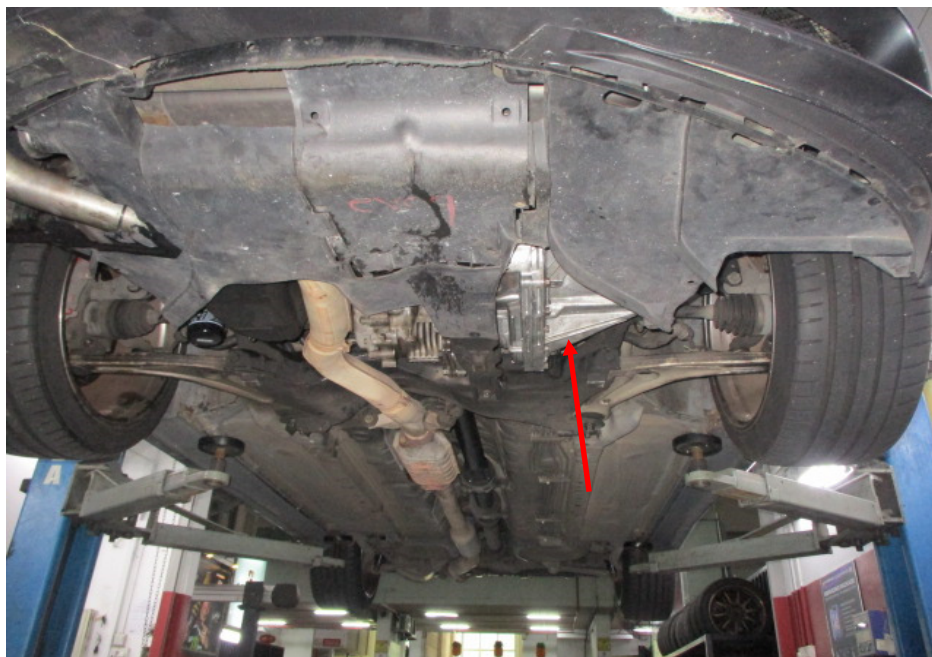
Photo 2 shows a general view of the transmission assembly (arrowed) that was fitted on the Motor Car. This was the input side of the transmission, which houses the main shaft and various gear sets. It is bolted to the crankshaft side of the engine block.

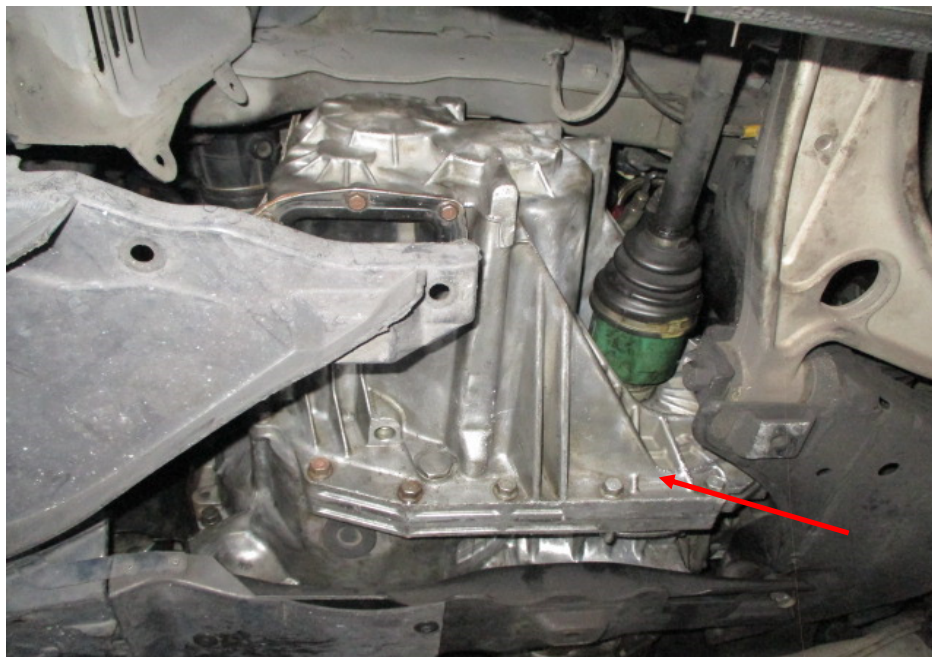
Photo 3 shows another view of the transmission assembly (arrowed) that was fitted on the Motor Car. This was the input side of the transmission, which houses the main shaft and various gear sets. There was no crack and/or hole observed on the transmission housing.

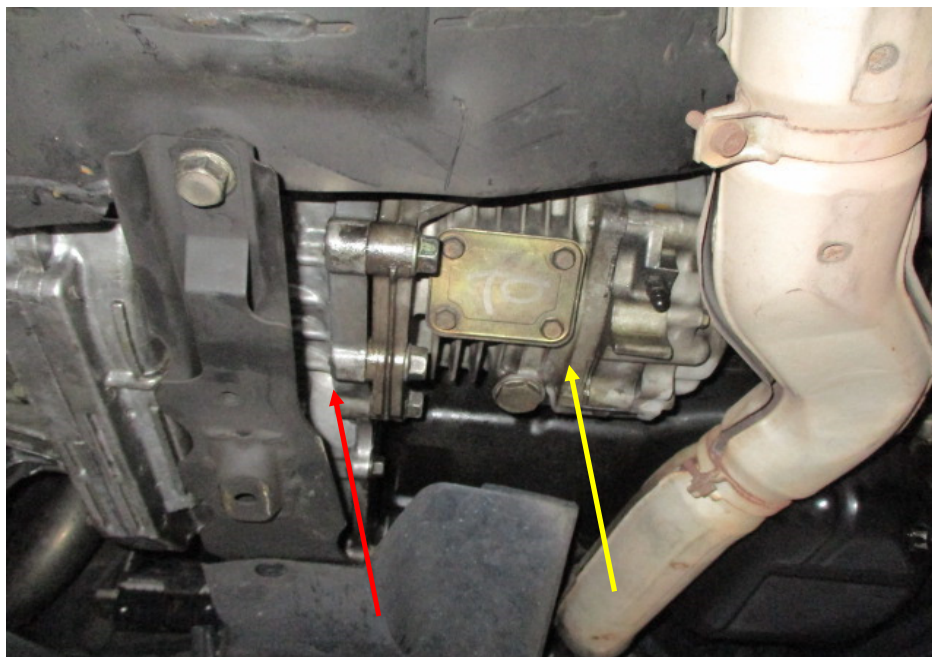
Photo 4 shows the transfer case (yellow arrow) of the Motor Car. The transfer case is also the output side of the Motor Car's transmission. The gear set in the input side of the transmission (red arrow) connects to the transfer case, which is the second of the 2 main housings of the Motor Car's transmission assembly. Drive to the front wheels of the Motor Car is provided via drive shafts that are extended from this transfer case. The transfer case also connects to the propeller shaft, which leads to the rear differential of the Motor Car.

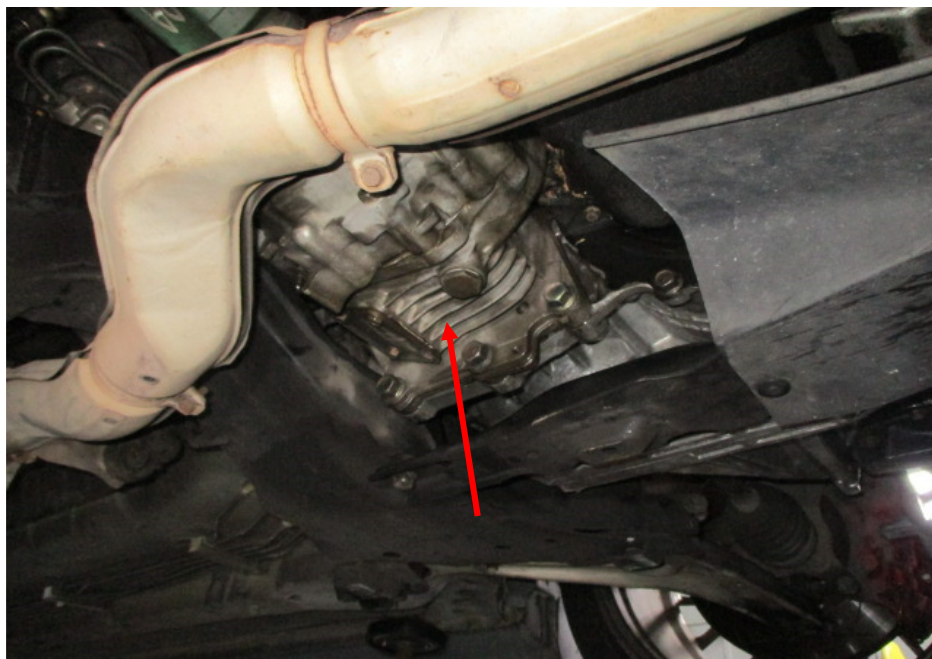
Photo 5 shows another view of the transfer case (arrowed) that was fitted on the Motor Car. The transfer case is the output side of the transmission. There was no crack and/or hole observed on the housing of the transfer case.

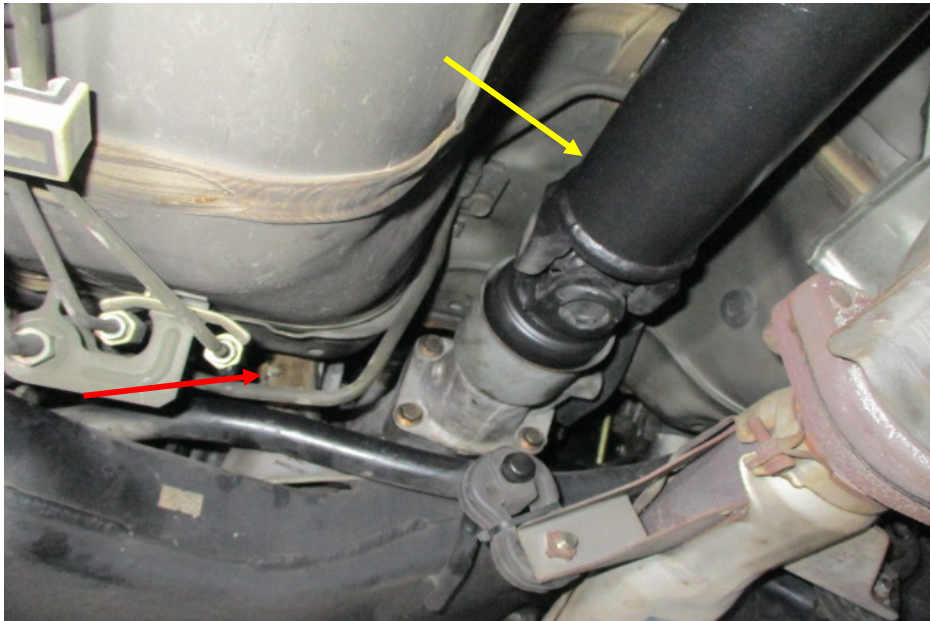
Photo 6 shows the propeller shaft (yellow arrow), which is connected to the transfer case of the Motor Car. This propeller shaft connects to the rear differential of the Motor Car, providing the drive to its rear wheels. The transmission assembly of the Motor Car is supported by 2 brackets. One at the front and one at the rear (red arrow) of the transmission assembly.

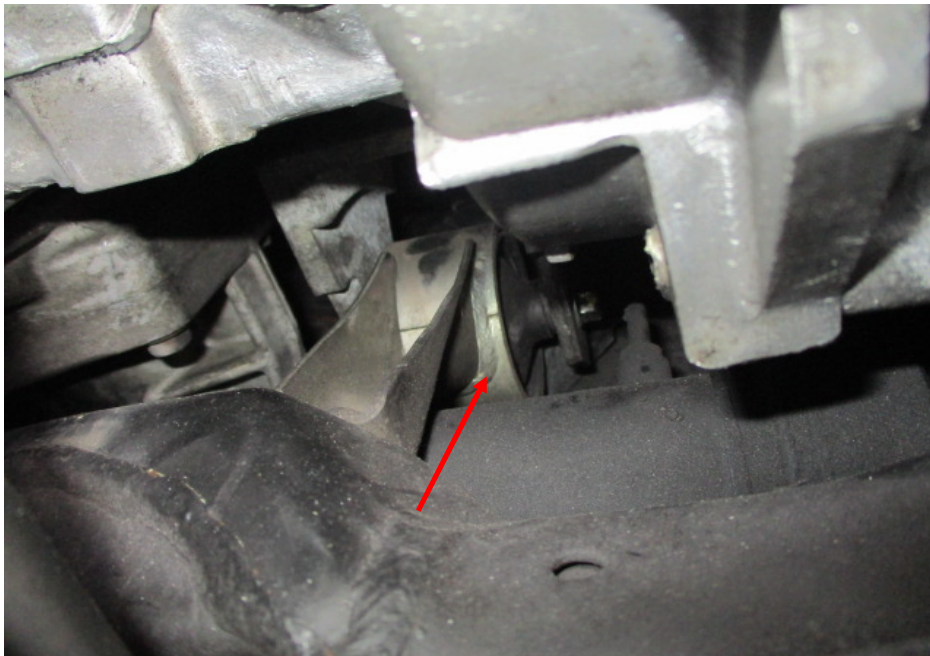
Photo 7 shows one of the 2 brackets that supports the transmission assembly of the Motor Car. This was the bracket at the rear of the transmission assembly, which was observed to be mounted onto the Motor Car's crossmember. The bracket (arrowed) was with rubber bushings, which absorbs any vibrations arising from the rotation of the transmission gears, minimising any stress to the bracket and correspondingly also minimise any stress to the crossmember that this bracket is mounted onto.

11. In general, the transmission assembly of the Motor Car was found to be secured properly. It was not mounted onto the chassis body or any integral body part of the Motor Car. The structural integrity of the Motor Car is not compromised by the fitment of this particular transmission assembly. Overall, the operating condition of the Motor Car's transmission system was satisfactory throughout the Motor Car's test drive.

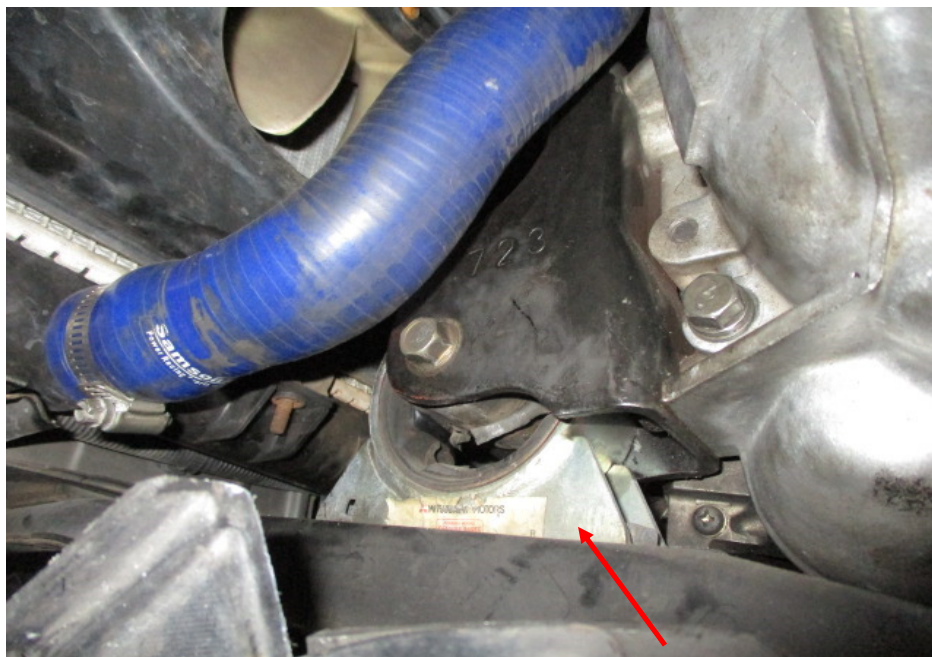
Photo 8 shows the other bracket that supports the transmission assembly of the Motor Car. This was the bracket at the front of the transmission assembly, which was also observed to be mounted onto the Motor Car's crossmember. Similar to the bracket at the rear, this bracket (arrowed) was also with rubber bushings, which absorbs any vibrations arising from the rotation of the transmission gears, minimising any stress to the bracket and correspondingly also minimise any stress to the crossmember that this bracket is mounted onto.

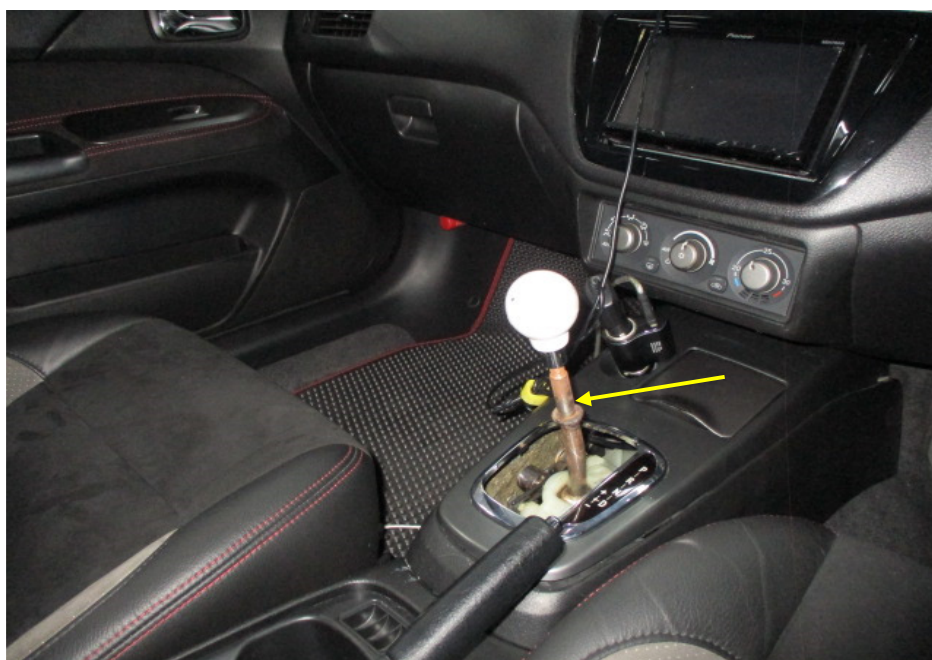
Photo 9 shows the manual gear shifter (arrowed) that was fitted on the Motor Car, for manually selecting the transmission gear to be engaged.

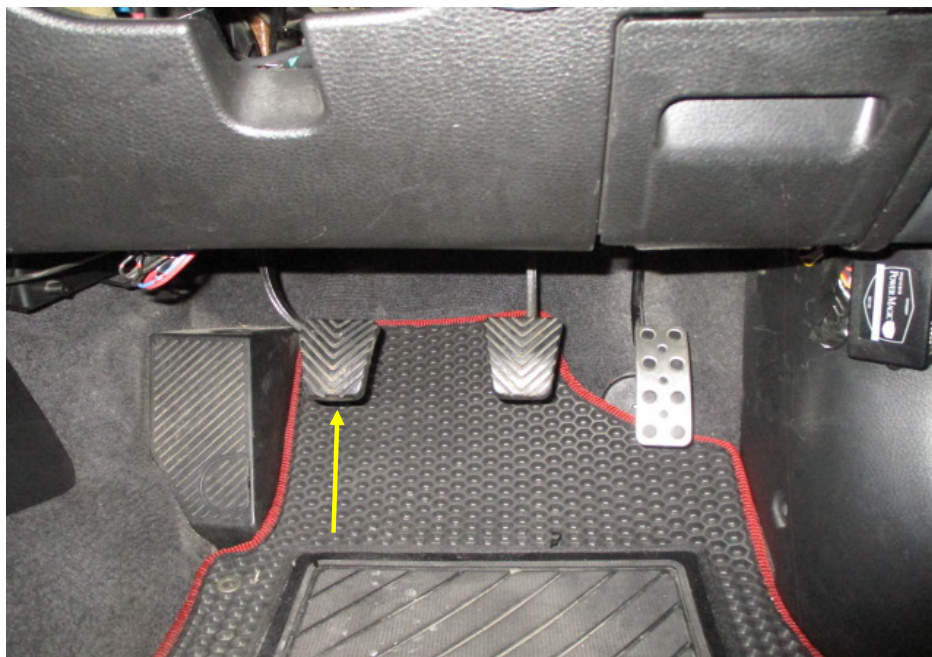
Photo 10 shows the clutch pedal (arrowed) of the Motor Car, for engaging and disengaging the transmission gears.
