LKK Auto Consultants Pte Ltd

Vehicle No. SHD 9231A
Insured Veh. SHA 1406G
Claim No. D20003676MFSH
Policy No. D-18088937MFSH
Accident Date 10/09/2020
Inspection Date 11/09/2020

ADJUSTMENT ON REPAIR COST FOR VEHICLE NO. SHD 9231A

PHOTOGRAPHS FOR VEHICLE NO. SHD 9231A

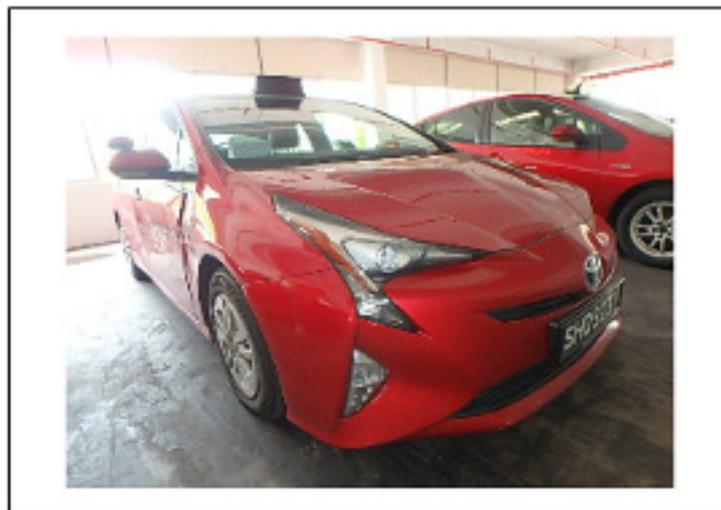
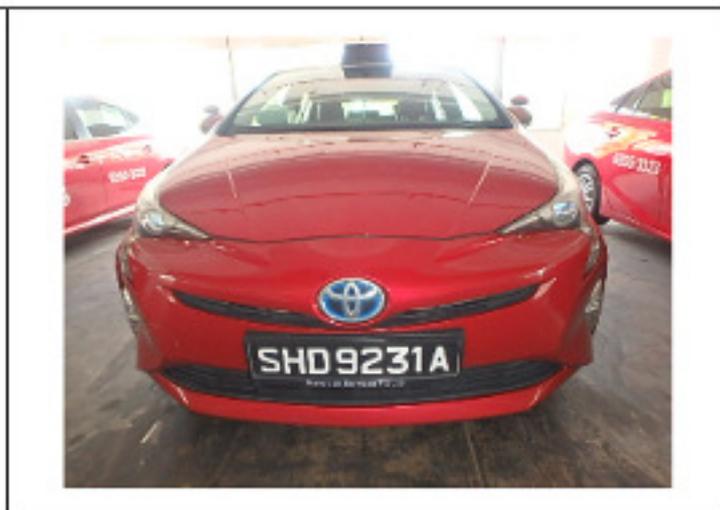
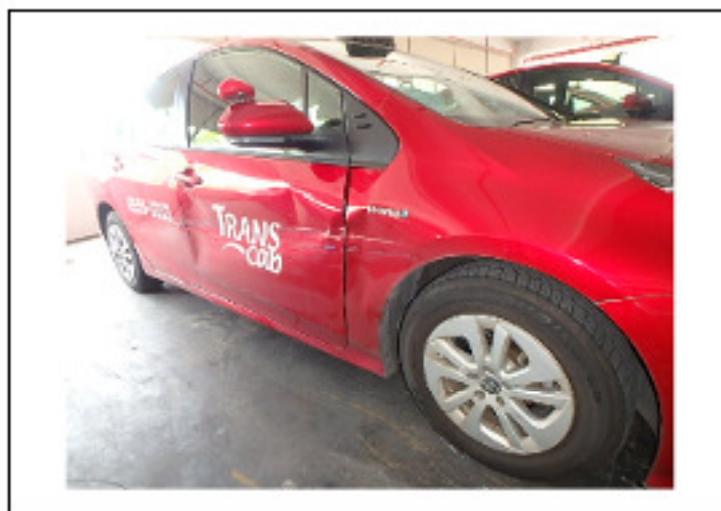
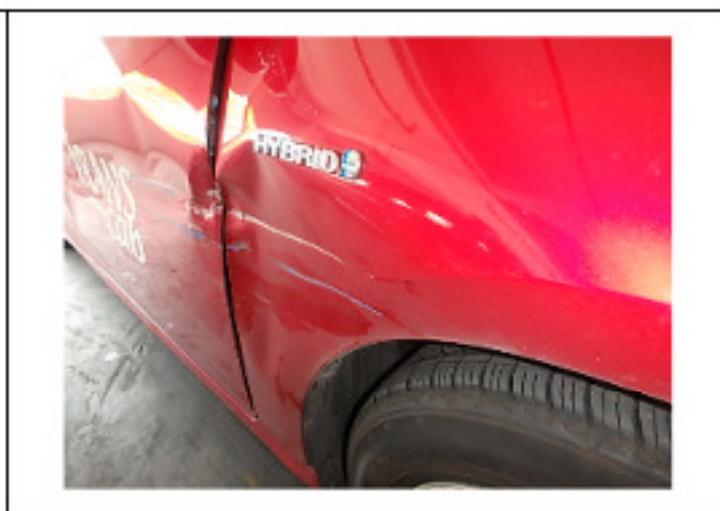
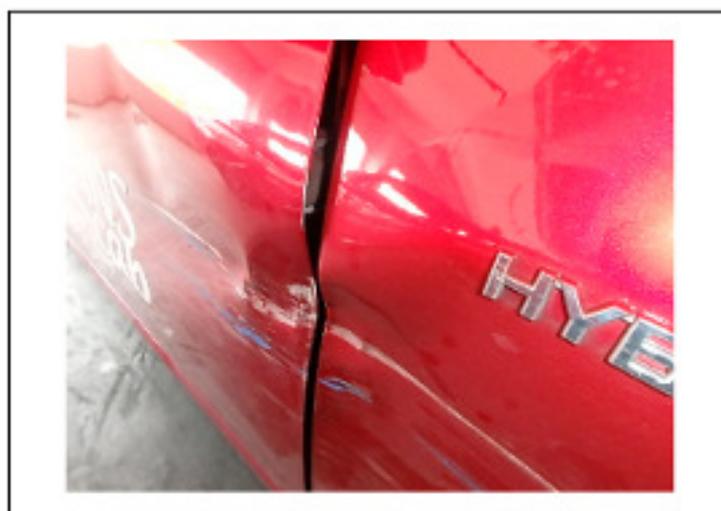
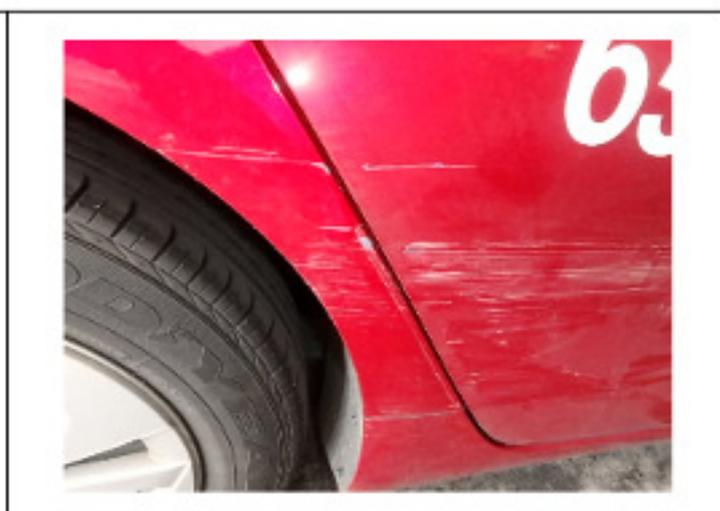
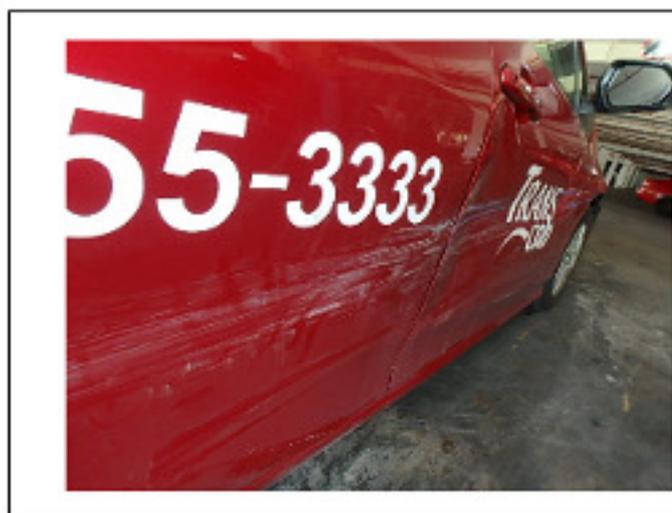
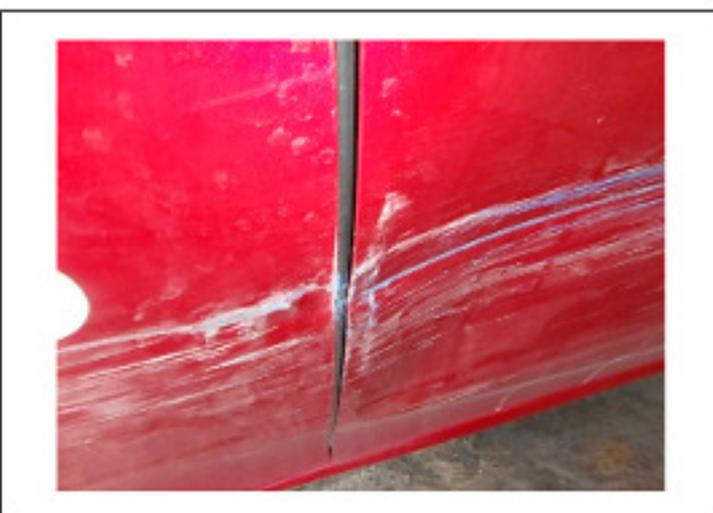
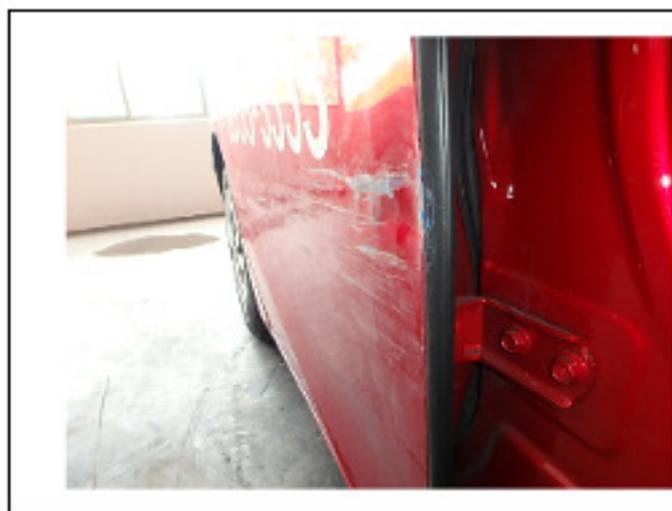
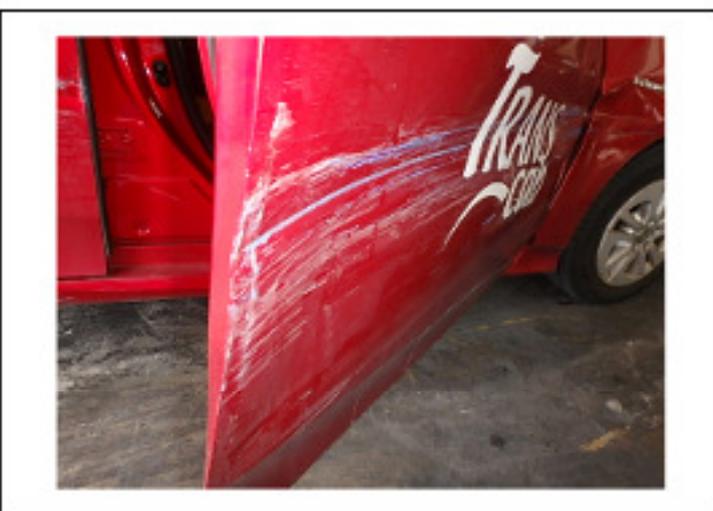
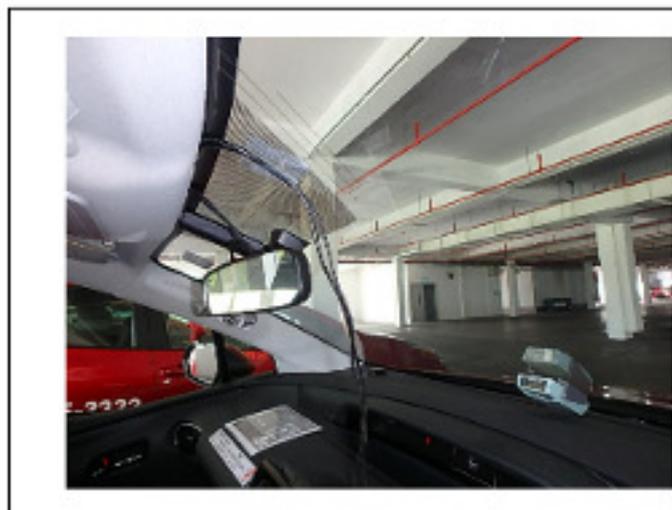
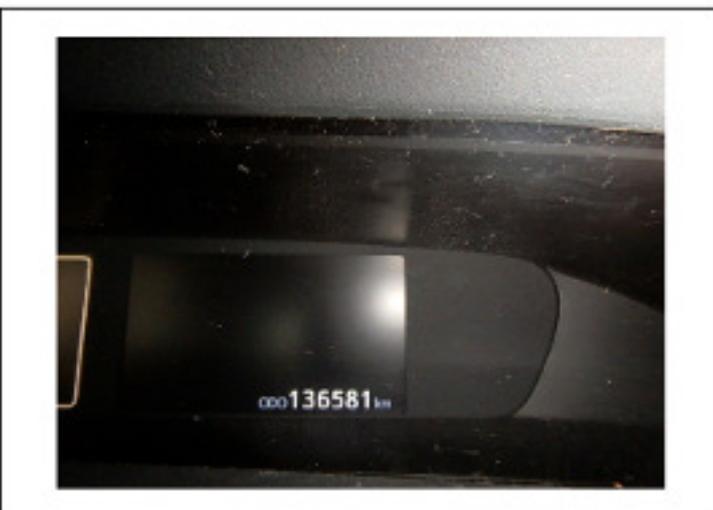
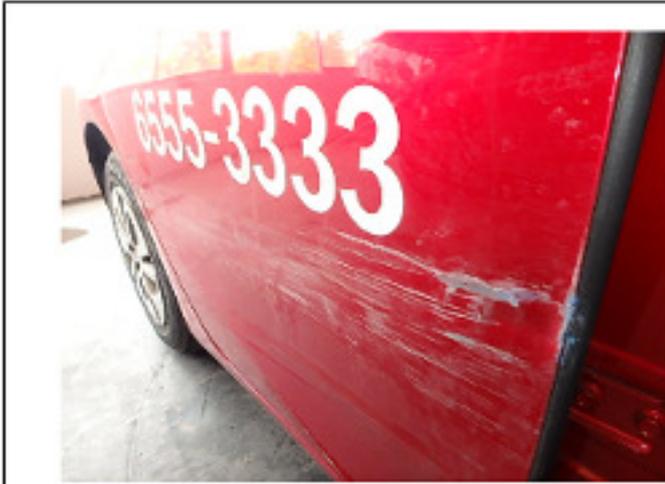
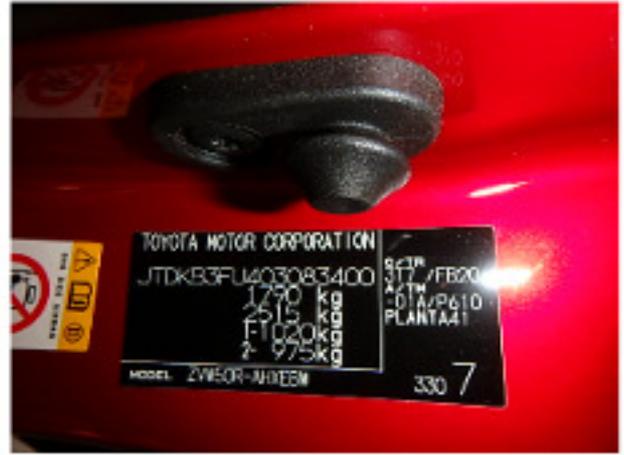
INSPECTION

THE VEHICLE SUSTAINED DAMAGES AT THE O/S BODY. DAMAGES SEE DETAILS.
--	--
