Your Ref : D20003816MFSH
Our Ref : CS4/FCI20010103/N

**TECHNICAL INVESTIGATION REPORT OF FIRE INCIDENT INVOLVING THE
INSURED VEHICLE SHD 3409U ON 18 SEPTEMBER 2020**

Vehicle Registration No.	: SHD 3409U
Make / Model	: HYUNDAI AE IONIQ HEV 1.6 DCT
Chassis No	: KMHC851CVLU189329
Year of Registration	: November 2019
Mileage	: N.A. (battery melted)

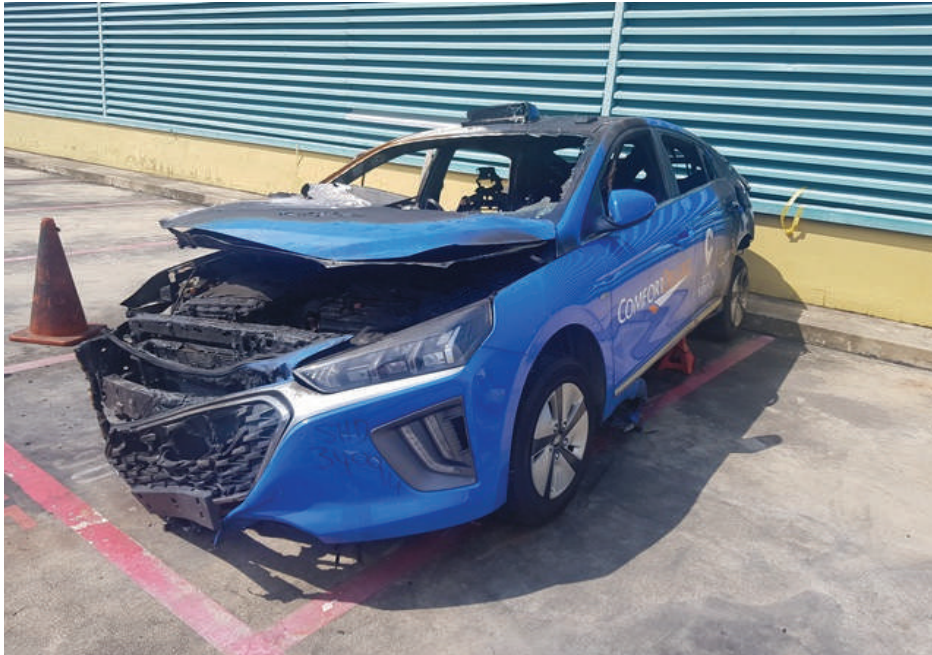
Photo 1 shows the general view of the left frontal portion of the Insured Vehicle at the time of our inspection. The left body of the Insured Vehicle was relatively unaffected by the fire.

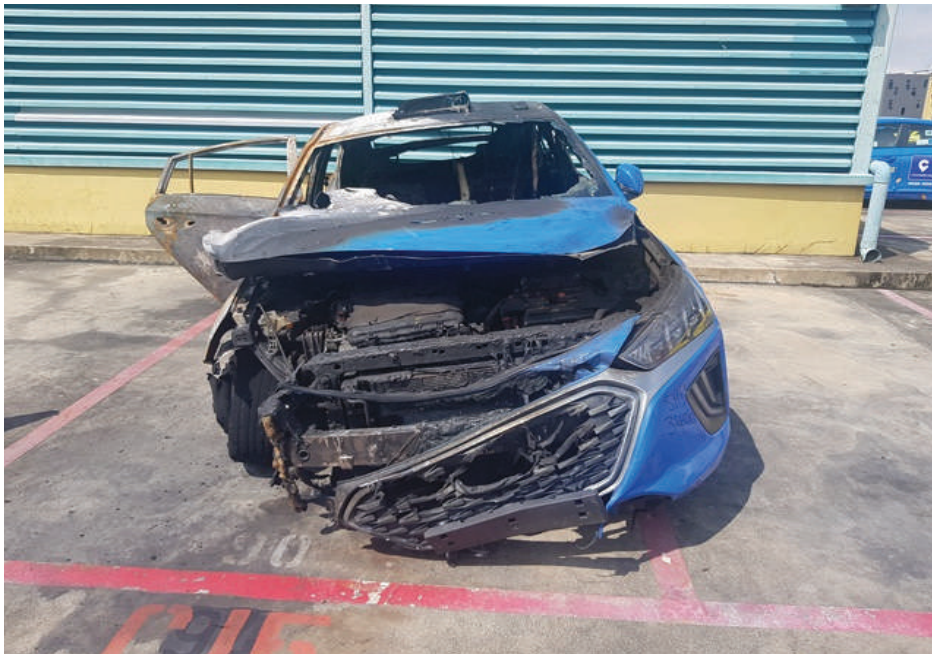
Photo 2 shows the general view of the frontal portion of the Insured Vehicle at the time of our inspection. The fire damage to the Insured Vehicle was confined to its frontal portion and right body. The entire engine compartment of the Insured Vehicle was observed to be severely burnt while the interior compartment was observed to be severely affected by the fire.

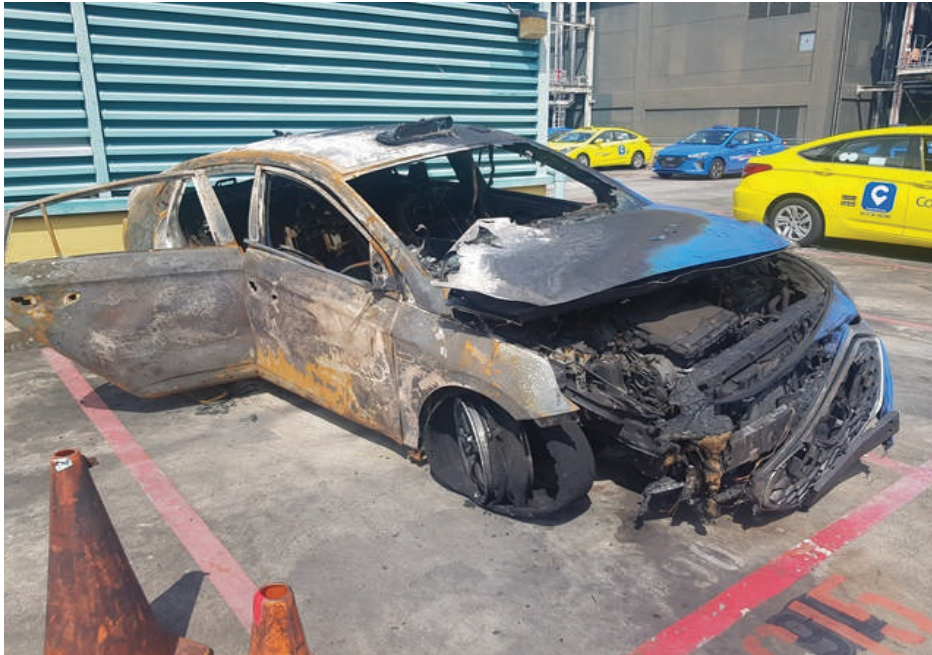
Photo 3 shows the closer view of the right front body of the Insured Vehicle at the time of our inspection. The fire damage to the Insured Vehicle was confined to its frontal portion and right body. Its front bumper, front bonnet, front support panel, front grille, front headlamps, front windscreen, right rims, right body and right tyres were amongst the body parts that were found to have been affected by the fire.

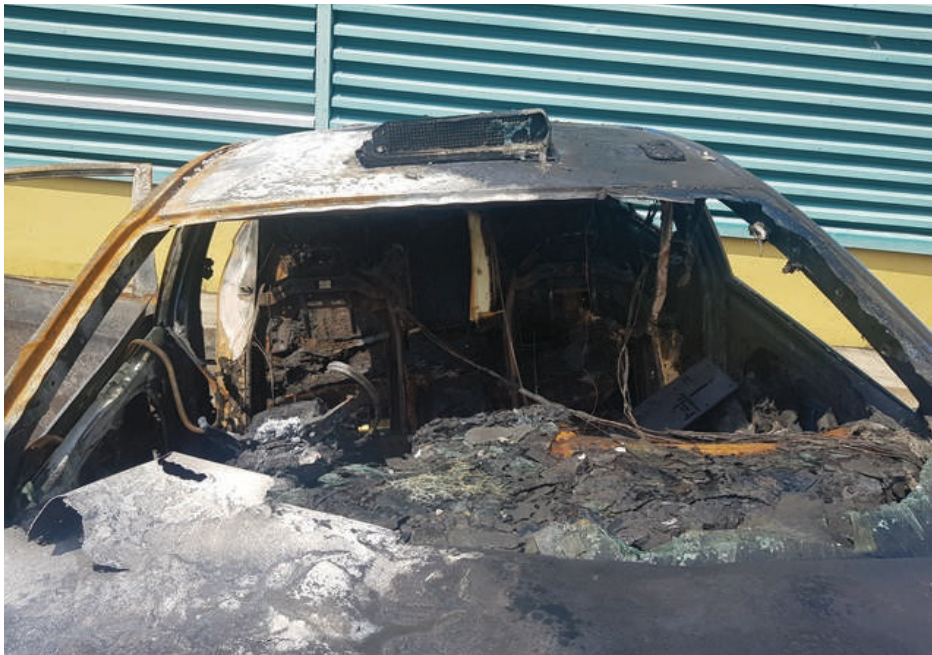
Photo 4 shows the general view of the front windscreen of the Insured Vehicle at the time of our inspection. The fire damage to the front windscreen was extensive.

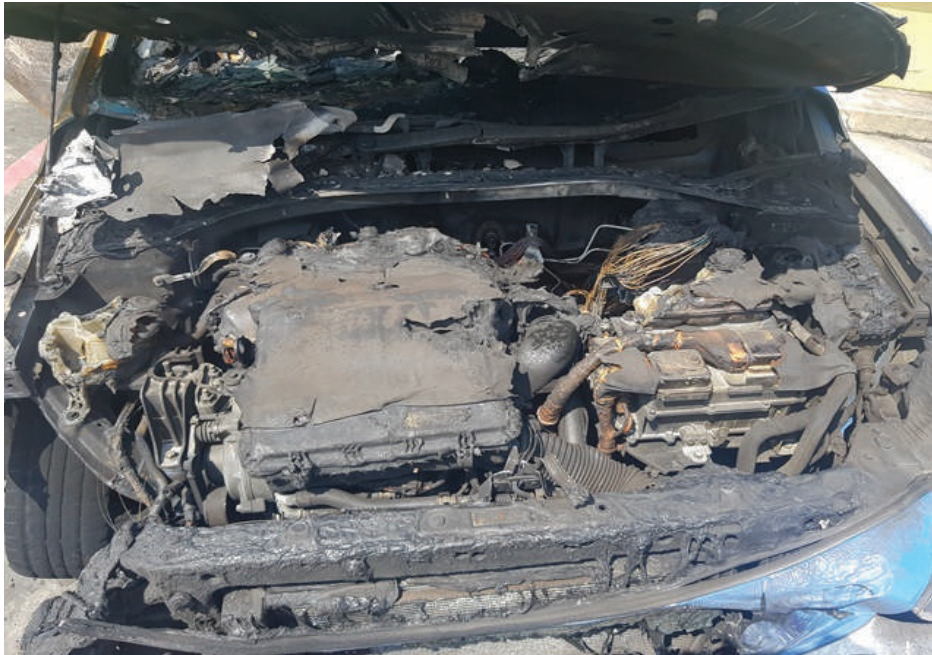
Photo 5 shows the engine compartment of the Insured Vehicle at the time of our inspection. The entire engine compartment of the Insured Vehicle was observed to be severely burnt. Most of the parts inside the engine compartment were found to be burnt and/or melted as a result of the fire.

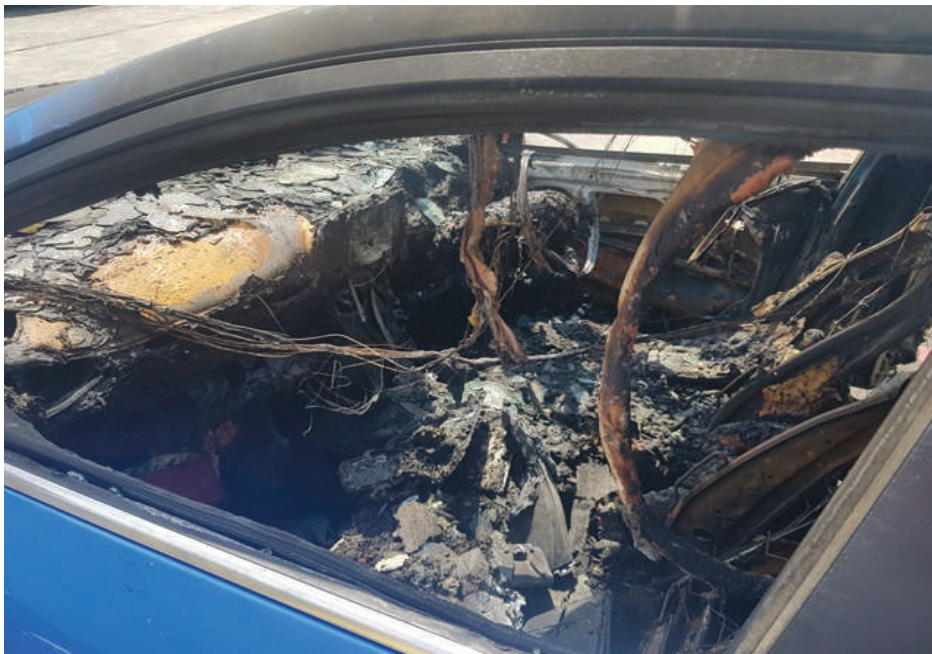
Photo 6 shows the interior compartment of the Insured Vehicle, which was severely affected by the fire.

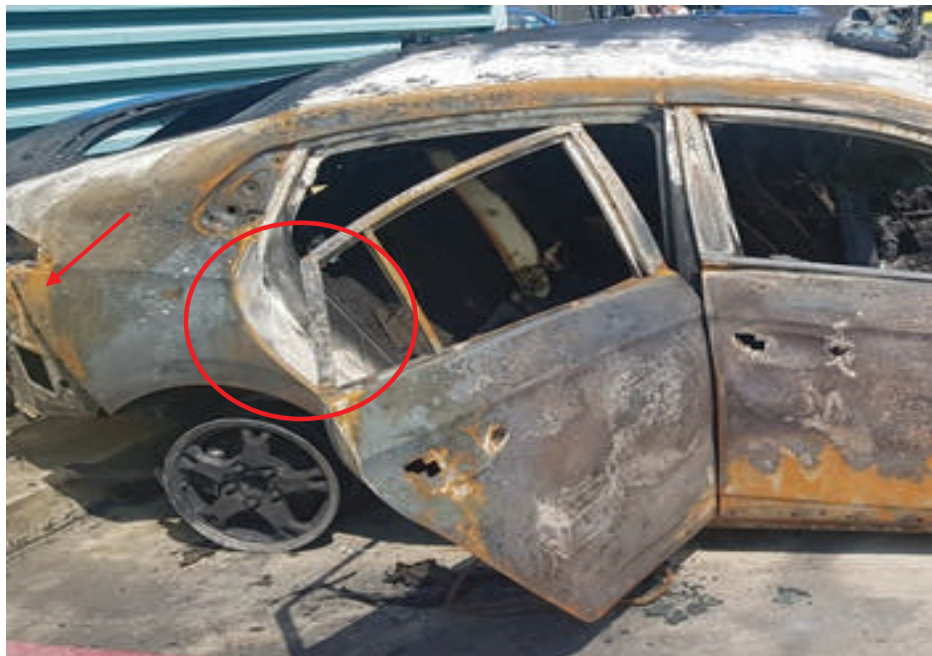
7. For this particular case, the fire appears to have originated from the exterior of the Insured Vehicle, at the right rear portion. This was determined basing on the area where the extent of fire damage was more severe, and also the high heat intensity burn marks (whitish burn marks) that were found on the exterior surface of its right rear fender. These whitish burn marks are a result of exposure to prolong heat intensity. Rust would normally start to develop around these areas soon after a fire as the prolonged exposure to high heat intensity usually causes the bare steel/metal material of the body parts to be exposed to natural environmental condition. The rust that had developed on the right rear fender, in the immediate vicinity of where these whitish burn marks were found, would also support our findings of where the fire to the Insured Vehicle had originated. See photo 7 below.

Photo 7 shows the fire damage at the right rear portion of the Insured Vehicle. The high heat intensity burn marks (whitish burn marks) found on the exterior surface of its right rear fender (circled) and rust that had developed on the right rear fender (arrowed) indicates that the fire to the Insured Vehicle had originated from the exterior of the Insured Vehicle.

18. Having investigated and technically analysed the damages of burnt nature to the Insured Vehicle, we are of the view that the cause of fire to the Insured Vehicle was likely due to external factors.
19. There was no modification(s) or additional electronic and/or electrical component(s) fitted on the Insured Vehicle at the time of our inspection of the Insured Vehicle.
20. At the time of writing this report, there was also no manufacturer recall of similar make and model vehicle as the Insured Vehicle that could possibly be related to this particular incident.

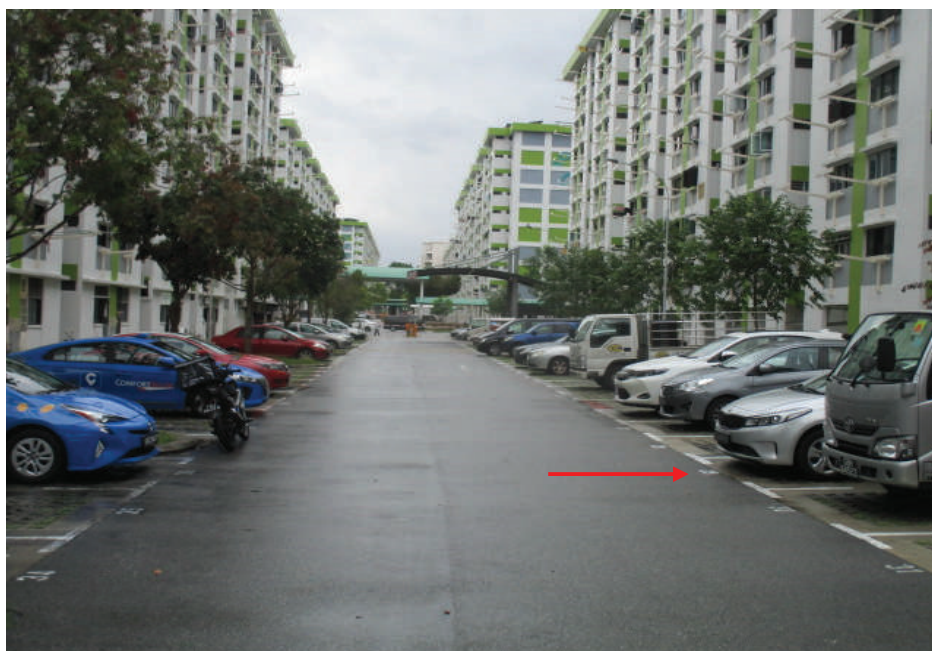
Photo 8 shows the general view of the location where the fire incident had occurred. The Insured Vehicle was parked inside parking lot number 29 (arrowed) at the material time of incident, which was at the open air public carpark at Block 201 Ang Mo Kio Avenue 3. This was carpark number AMA10, serving Blocks 201 and 202. From our observations, there was no CCTV camera(s) located in the vicinity of parking lot number 29.

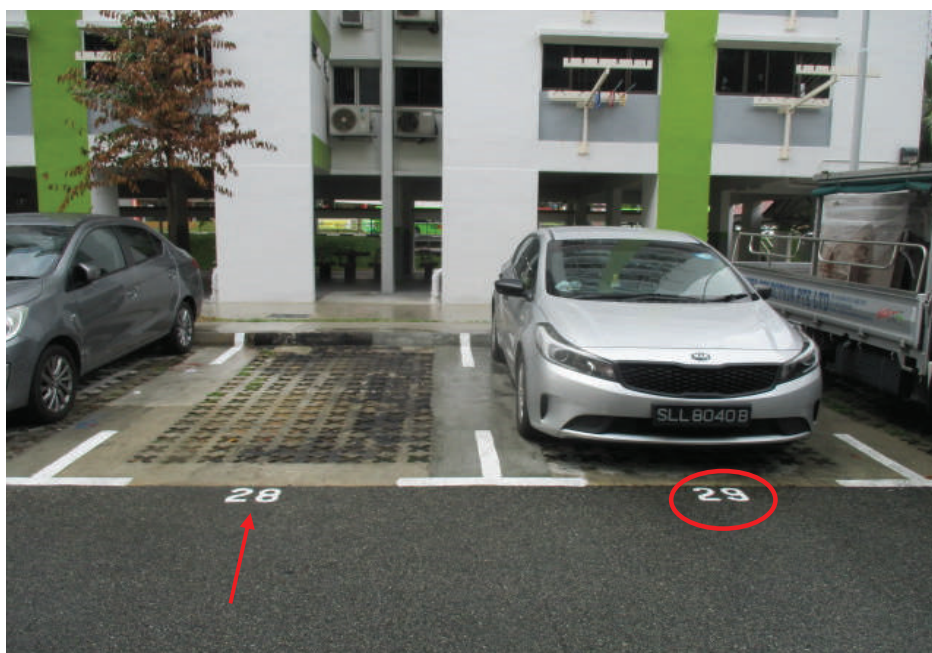
Photo 9 shows the general view of the location where the fire incident had occurred. The Insured Vehicle was parked inside parking lot number 29 (circled) at the material time of incident. The motor car which had sustained damages as a result of the fire was parked inside parking lot number 28 (arrowed).

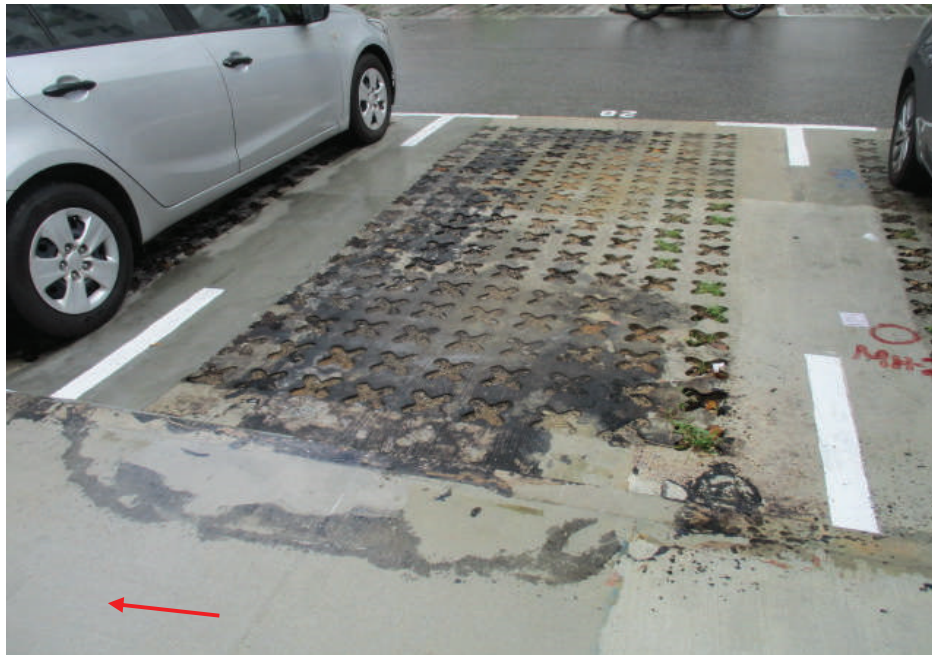
Photo 10 shows the general view around of the back of parking lots 28 and 29. There is a raised kerb behind these parking lots which act as a walkway for the HDB block behind these parking lots (arrowed).

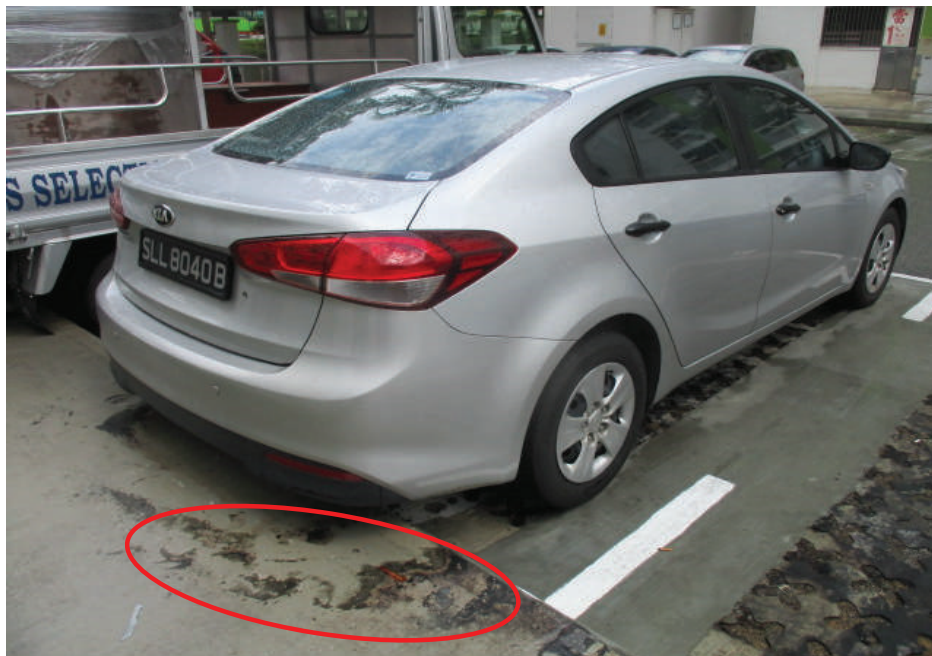
12. Upon checking the rear of parking lot 29, we had found charred residual remains on the kerb towards the rear side of parking lot 29. Standing at the back of parking lot 29 and when facing towards its front, the charred residual remains would be at the right rear portion of the Insured Vehicle when the Insured Vehicle was parked inside parking lot 29.

Photo 11 shows the charred residual remains (circled) found on the kerb towards the right rear side of parking lot 29. Standing at the back of parking lot 29 and when facing towards its front, the charred residual remains would be at the right rear portion of the Insured Vehicle when the Insured Vehicle was parked inside parking lot 29.

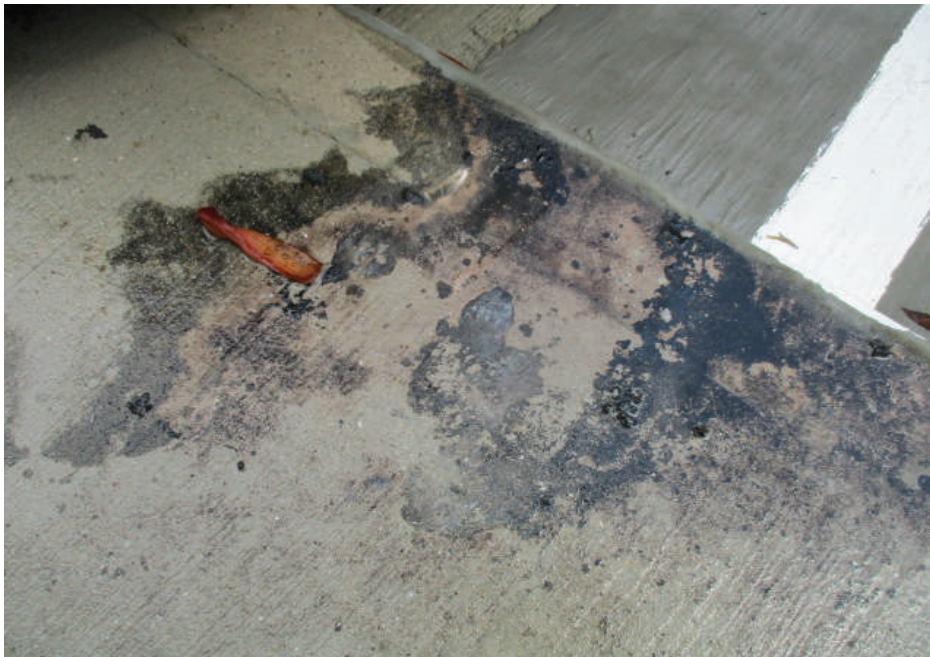
Photo 12 shows a close up view of the charred residual remains found on the kerb towards the right rear side of parking lot 29.

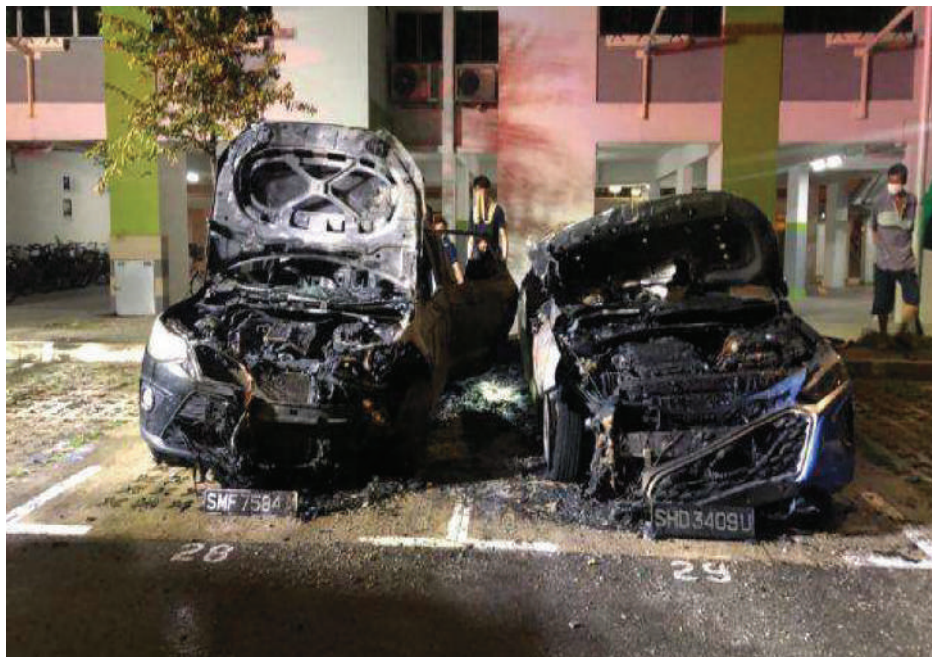
Photo 13 shows the Insured Vehicle and the other parked car at the incident scene after the fire was extinguished by SCDF personnel. The extent of damage and burn pattern to the Insured Vehicle was observed to be similar to what we had observed during our inspection of the Insured Vehicle.

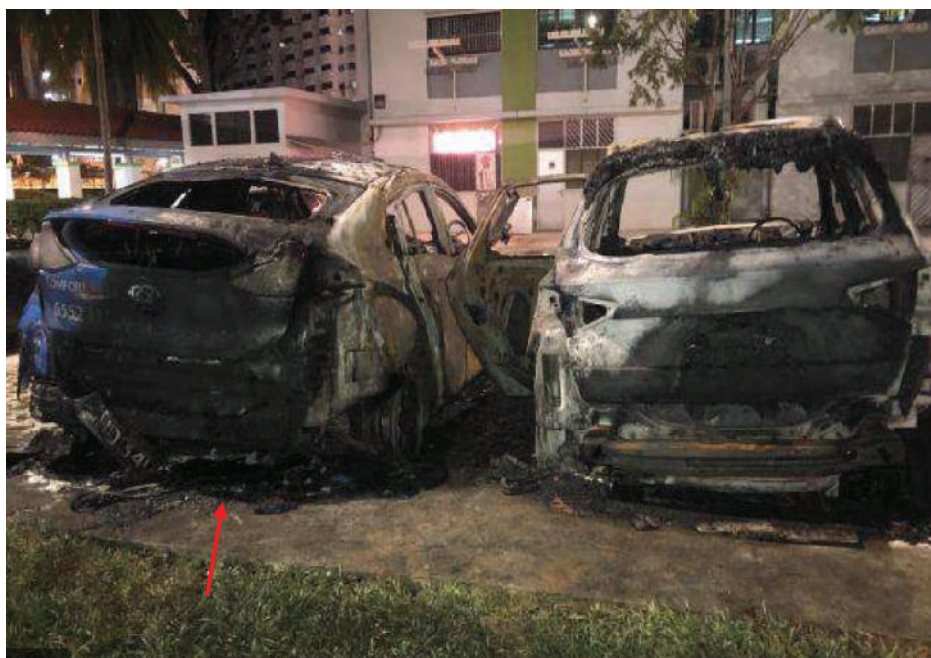
Photo 14 shows the rear portion of the Insured Vehicle and the other parked car at the incident scene after the fire was extinguished by SCDF personnel. The raised kerb directly behind the rear portion of the Insured Vehicle was observed to be burnt (arrowed).

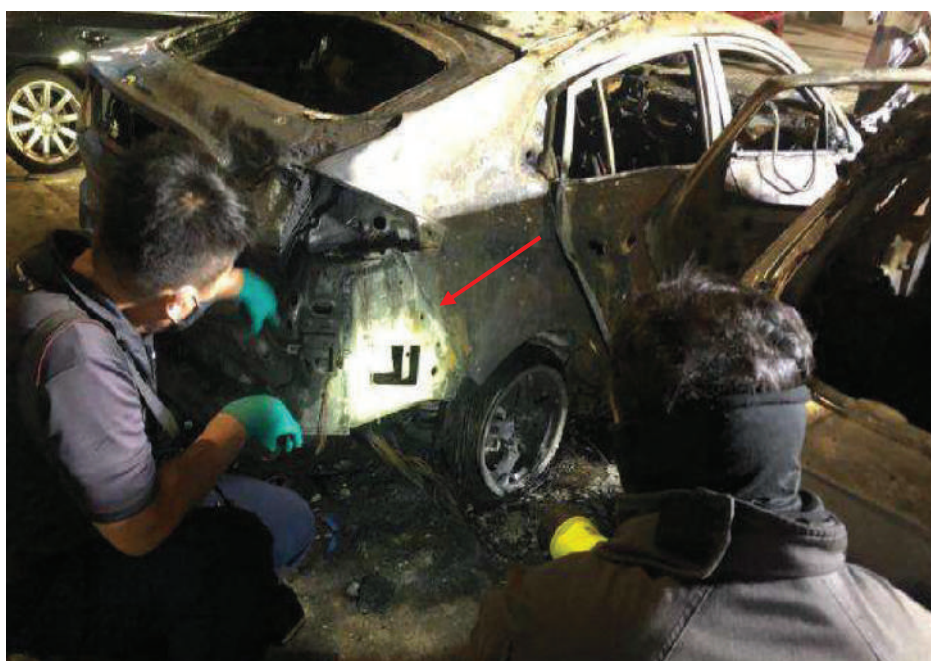
Photo 15 shows firefighters conducting preliminary investigations into the cause of fire post- incident, pointing towards the right rear tyre of the Insured Vehicle, which had corresponded to Mr Maran's account of the incident (arrowed).
