Your Ref : MC/MC Suit No. 7713 Of 2019
Our Ref : CI/LAW20010134/D

26 September 2020

ROAD TRAFFIC ACCIDENT INVOLVING SLL 601K & SLH 1575S ON 14 JANUARY 2018

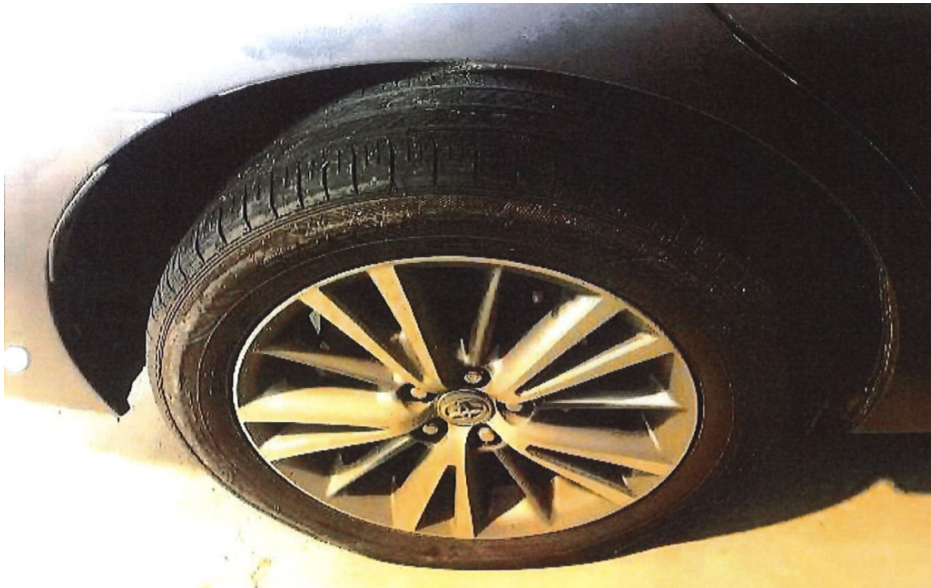
11. Firstly, the rear right tyre of the Defendant Vehicle was not available for inspection. However, the photographs attached in the Defendant's accident report, in particular the photographs exhibited at page 18, 19, 25 and 27 of DAEIC, had showed the rear right tyre of the Defendant's Vehicle punctured but still intact and wrapped around the rear right wheel rim. The rear right tyre was not torn/shredded. There was also no hole and/or cut mark(s) observed on the outer sidewall of the tyre. See photo 1 and 2 below.

Photo 1 shows the rear right tyre of the Defendant Vehicle (photograph exhibited at page 25 of DAEIC). The rear right tyre of the Defendant's Vehicle was observed to be punctured. The rear right tyre was not torn/shredded. No hole and/or cut mark(s) was observed on the outer sidewall of the tyre.

13. The lack of any impact mark(s) and/damage observed on the rear right wheel rim and exterior body parts of the Defendant Vehicle surrounding the immediate area of the rear right wheel indicates that the puncture was not a result of an accident collision and/or impact with an object.

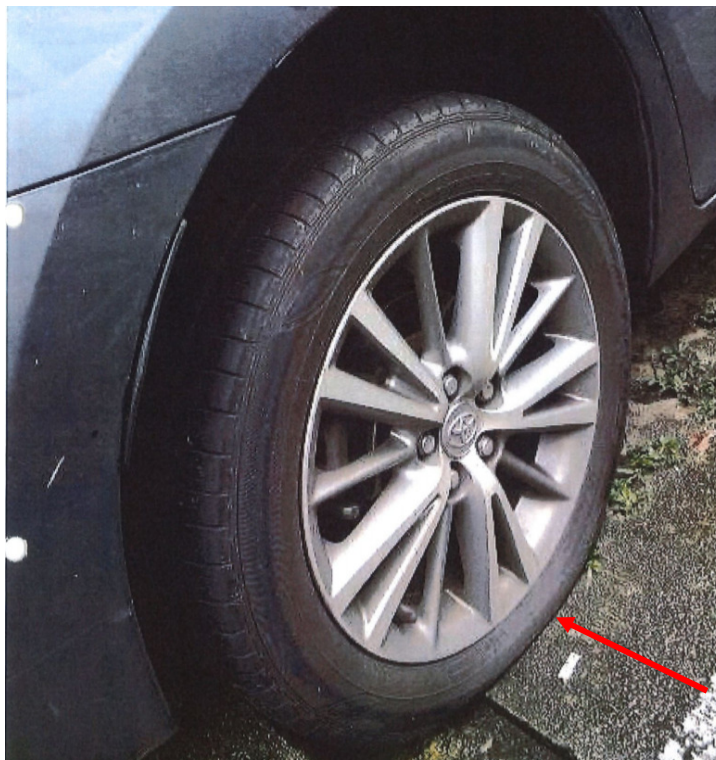
Photo 2 shows the rear right tyre of the Defendant Vehicle (photograph exhibited at page 19 of DAEIC). The rear right tyre of the Defendant's Vehicle was observed to be punctured as seen from the bulge at the area of the tyre that is resting on the ground (arrowed). The tyre was however still intact and wrapped around the rear right wheel rim.

12. Although there was no photograph(s) showing the inner sidewall and no clear photograph(s) showing the tread of the rear right tyre, the fact that the rear right tyre was still intact and wrapped around the rear right wheel rim indicates to me that there was also no hole and/or cut mark(s) on the inner sidewall of the rear right tyre. The presence of a hole(s) and/or cut mark(s) would typically lead to a rapid loss of pressurized air from within the tyre and when the vehicle is moving, the tyre will slip out from the wheel rim as the tyre will no longer be able to hold its shape around the wheel rim given the lack of pressurized air.

14. Generally, the condition of the rear right tyre of the Defendant Vehicle as seen in the photographs is a condition that one would typically see or come across when a tyre is punctured by a small sharp object like a nail or screw that has pierced into the core of the tyre at the tread area, but remain embedded in the tyre. By remaining embedded into the tyre, the object provides some sealing effect, and hence any loss of pressurized air is gradual for tyre puncture incidents. Refer to illustration below for an easy understanding of the different areas of a tyre that I had referred to and will be referring to in this report.

15. Since the rear right tyre of the Defendant Vehicle was still intact and wrapped around the rear right wheel rim without any tear or shredding and also no hole and/or cut mark(s) seen, it would then be reasonable to ascertain that the rear right tyre of the Defendant Vehicle did not burst. In other words, for this particular case, the physical condition of the rear right tyre does not seem to suggest a case where a tyre had burst but rather it would be a case akin to a typical tyre puncture.

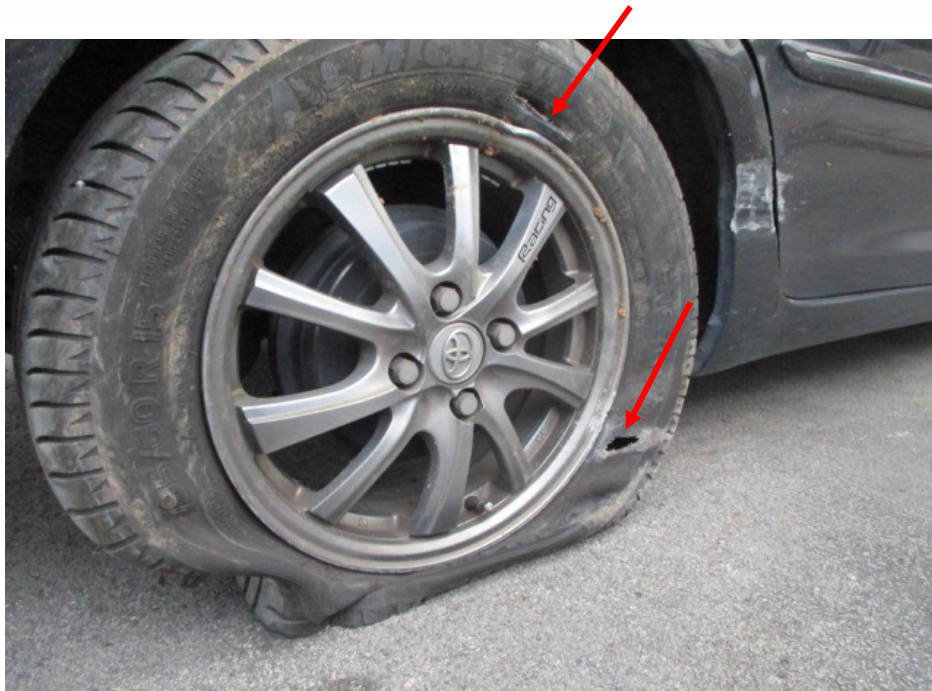
19. For punctured tyre, a driver will need to repair or replace the punctured tyre as continued driving will cause the punctured tyre to burst due to excessive heat build up from the under inflated tyre. See photo 3 below, which is purely to illustrate the physical difference of a burst tyre and a puncture tyre.

Photo 3 shows a tyre that has its outer sidewall torn (arrowed). Such physical condition is typically seen when a tyre burst. Rapid loss of pressurized air occurs when the pressurized air gushes out from the hole. A driver can lose control of a vehicle due to the sudden and rapid loss of pressurized air. Note the physical difference between this tyre and the rear right tyre of the Defendant Vehicle as shown in photograph 2 above, and other photographs exhibited in page 18, 19, 25 and 27 of DAEIC.

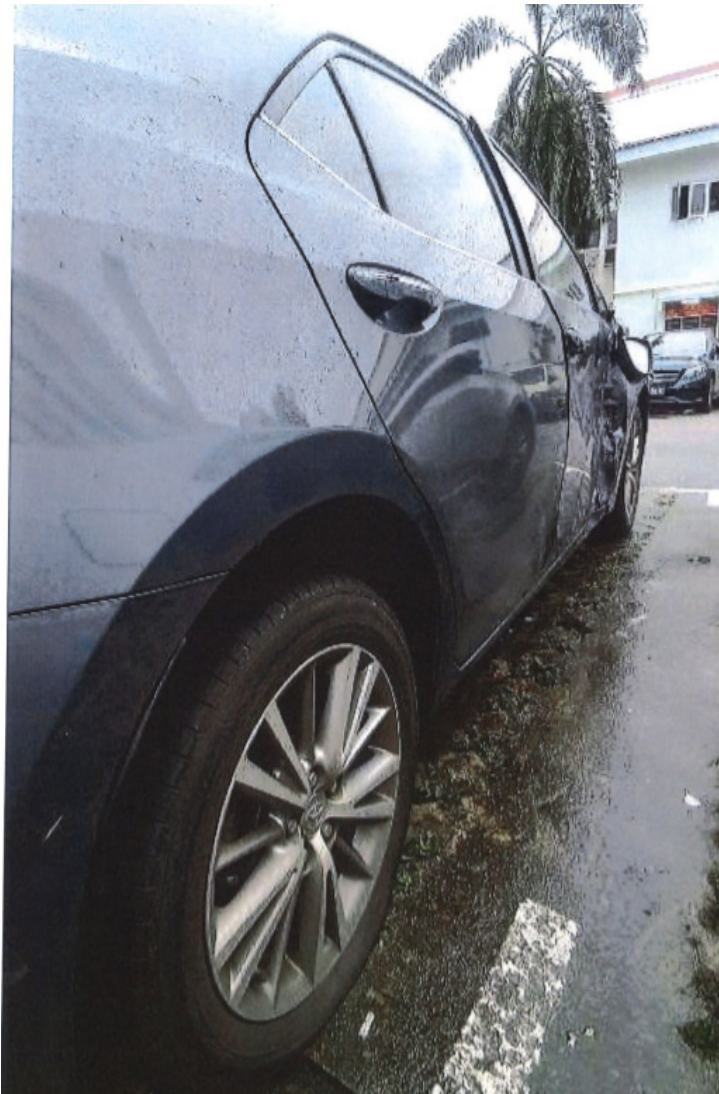
22. The ground where the Defendant Vehicle was resting and the background seen in the photographs exhibited in page 18 and 19 of DAEIC was clearly different from the ground and background seen in the photographs exhibited in page 12 to 16, and page 20 to 28 of DAEIC. Photographs at page 18 and 19, showing the puncture to the rear right tyre, seems to have been taken at an open-air public carpark, at a time when the Defendant Vehicle was reversed parked inside a parking lot whereas the photographs at page 12 to 16 were taken at the accident scene; and the photographs at page 20 to 28 appears to have been taken at a workshop. See photo 4 - 6 below.

Photo 4 shows the Defendant Vehicle (exhibited at page 18 of DAEIC), which appears to have been taken at an open-air public carpark whilst the Defendant Vehicle was reversed parked inside a parking lot. The photograph was in relation to the Defendant showing the puncture to the rear right tyre and taken after the accident as seen from the damage to the driver's door and right-wing mirror.

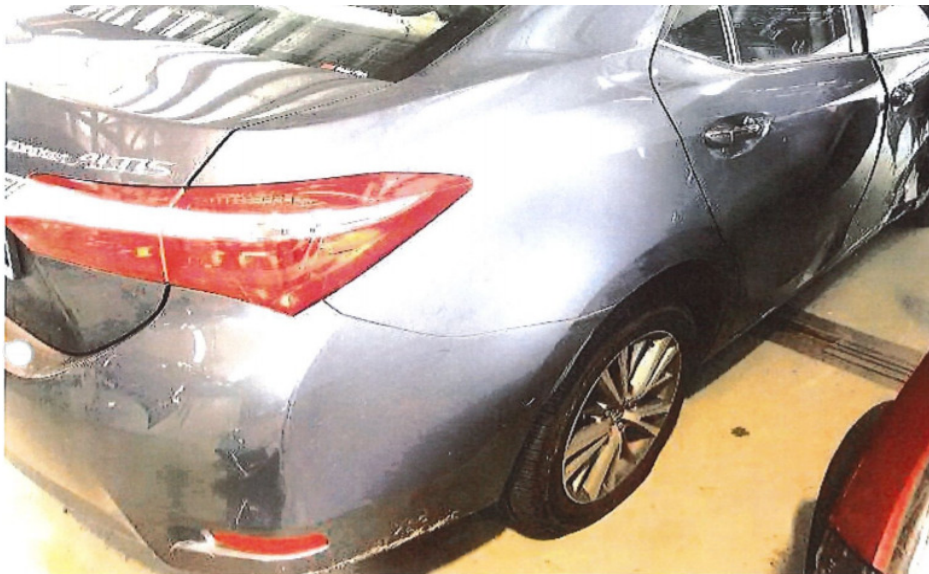
Photo 5 shows the Defendant Vehicle (exhibited at page 27 of DAEIC), which seems to have been taken at a workshop. The ground where the Defendant Vehicle was resting and background in the photographs exhibited in pages 20 to 28 of DAEIC were all different when compared with photograph 4 above, which was the photograph exhibited at page 18 of DAEIC.

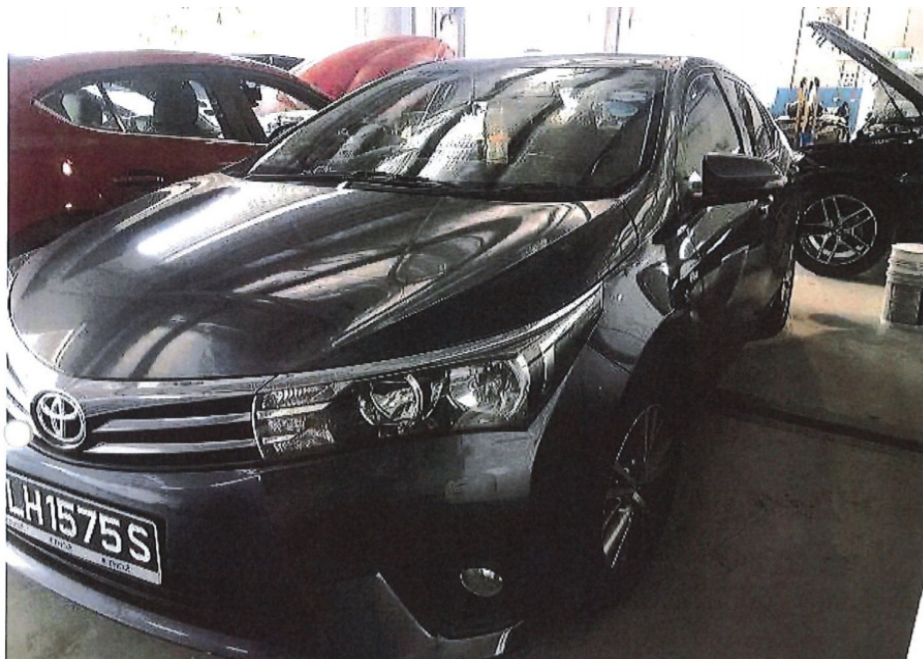
Photo 6 shows the Defendant Vehicle (exhibited at page 21 of DAEIC), which seems to have been taken at a workshop as seen from the opened and lifted front bonnet of 2 other vehicles in the background, which one would not ordinarily find in an open-air public carpark. The ground where the Defendant Vehicle was resting and background in the photographs exhibited in pages 20 to 28 of DAEIC were all different when compared with photograph 4 above, which was the photograph exhibited at page 18 of DAEIC.

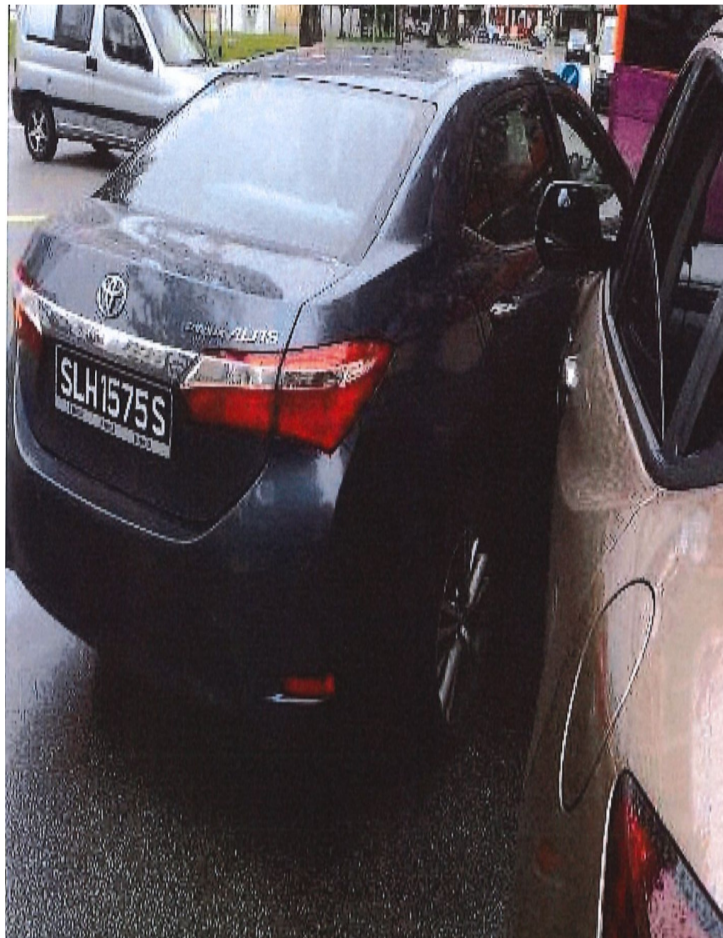
28. The Defendant had said in paragraph 8 of DAEIC that after the accident, upon alighting and inspecting the Defendant Vehicle, he realized that the rear right tyre of the Defendant Vehicle was punctured. However, the photograph at page 14 of DAEIC, which was the only photograph that showed the rear right body of the Defendant Vehicle whilst at the accident scene was unclear to establish the puncture to the rear right tyre of the Defendant Vehicle whilst at the accident scene. See photo 7 below.

Photo 7 shows the Defendant Vehicle at the accident scene (exhibited at page 14 of DAEIC). This was the only photograph that showed the rear right body of the Defendant Vehicle whilst at the accident scene and it was unclear to establish the puncture to the rear right tyre of the Defendant Vehicle whilst at the accident scene.
