Your Ref: S0M02U1Z
Our Ref: CS4/ASM20010139/P

**TECHNICAL INVESTIGATION REPORT OF FIRE INCIDENT INVOLVING THE
INSURED VEHICLE YN 3808Y ON 17th September 2020**

Vehicle Registration No.	: YN 3808Y
Make / Model	: ISUZU NPR75UH5AC
Chassis No	: JAANPR75HD7103937
Year of Registration	: 2013 (JUNE)
Mileage	: N.A. (wiring affected)

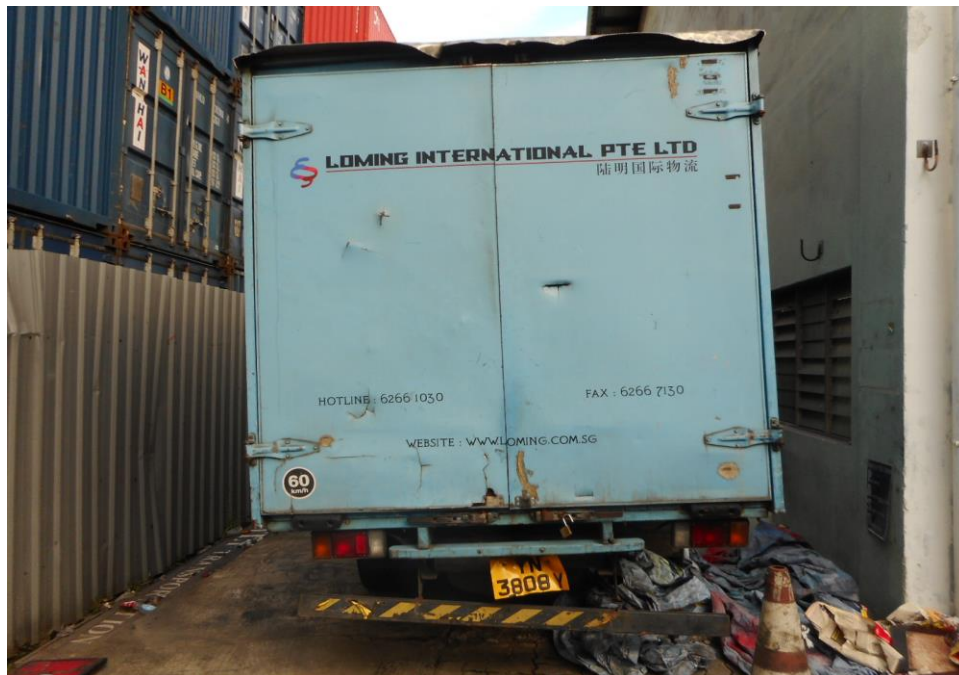
Photo 1 shows the general view of the rear portion of the Insured Vehicle at the time of our inspection. The fire damage to the Insured Vehicle was confined to its front portion. Its rear portion is observed to be unaffected by the fire.

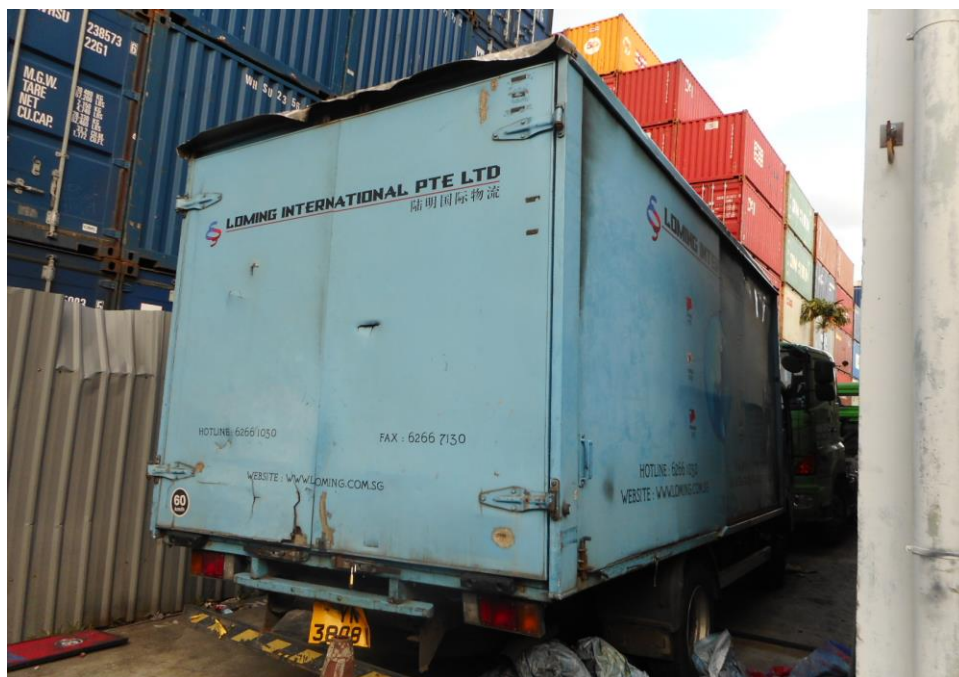
Photo 2 shows the general view of the right portion of the Insured Vehicle at the time of our inspection. The fire damage to the Insured Vehicle was confined to its front portion. Its right portion is observed to be unaffected by the fire.

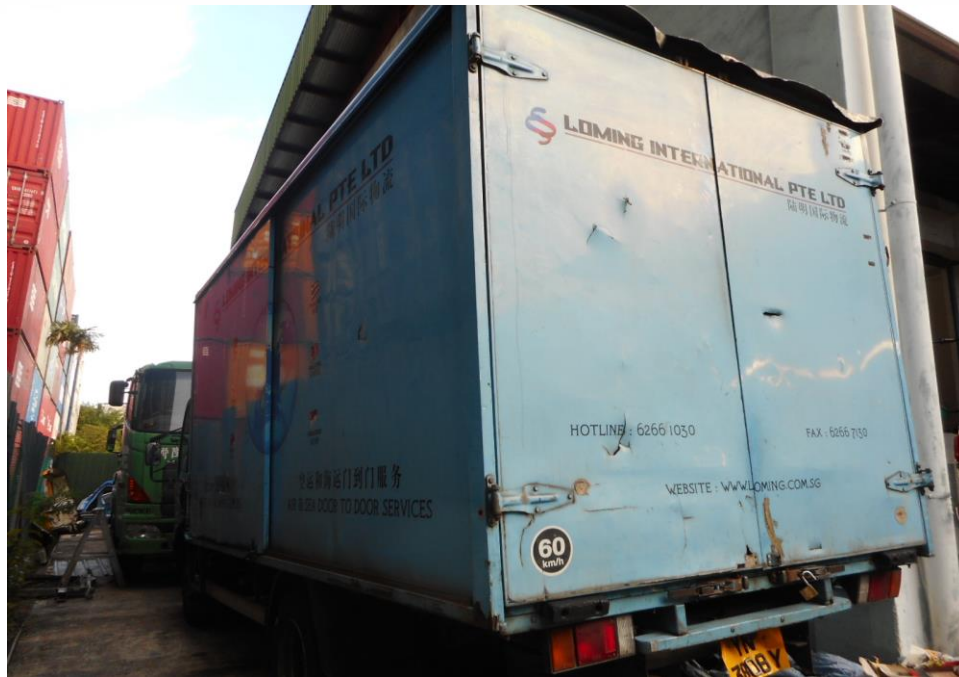
Photo 3 shows the general view of the left portion of the Insured Vehicle at the time of our inspection. The fire damage to the Insured Vehicle was confined to its front portion. Its left portion is observed to be unaffected by the fire.

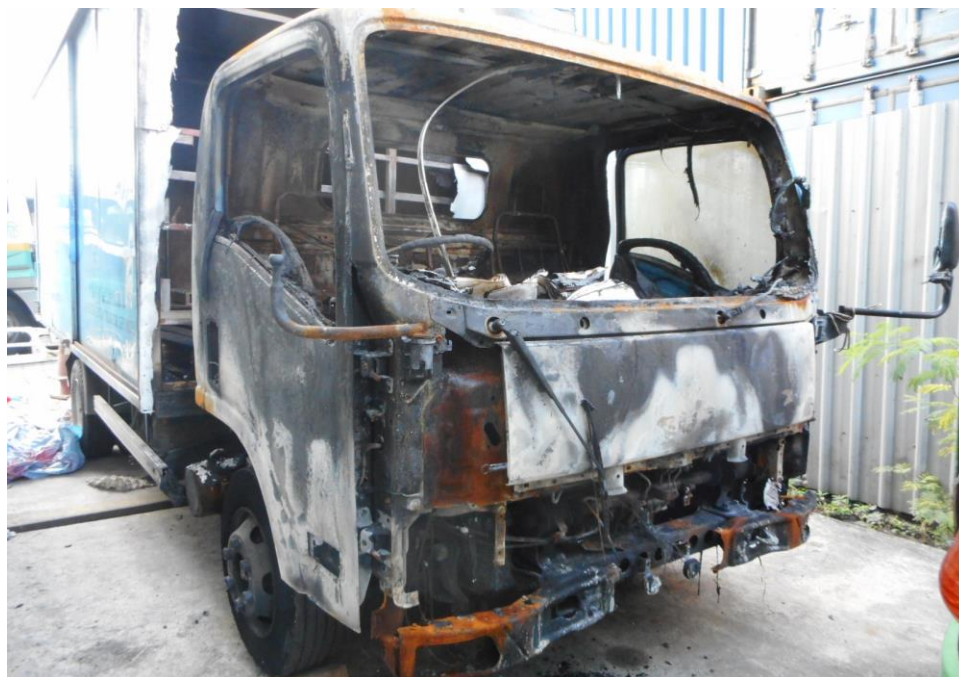
Photo 4 shows the front view of the Insured Vehicle at the time of our inspection. The fire damage to the Insured Vehicle had affected the whole front & rear cabin of the Insured Vehicle.

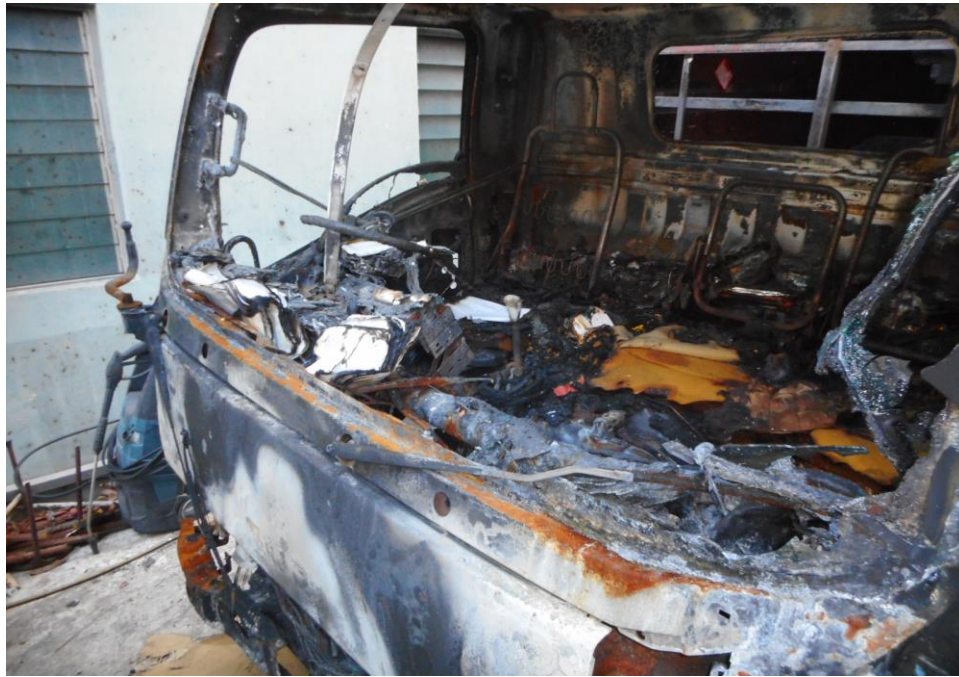
Photo 5 shows the general view of the interior compartment of the Insured Vehicle. The entire windscreen and the interior compartment have been badly burnt by the fire.

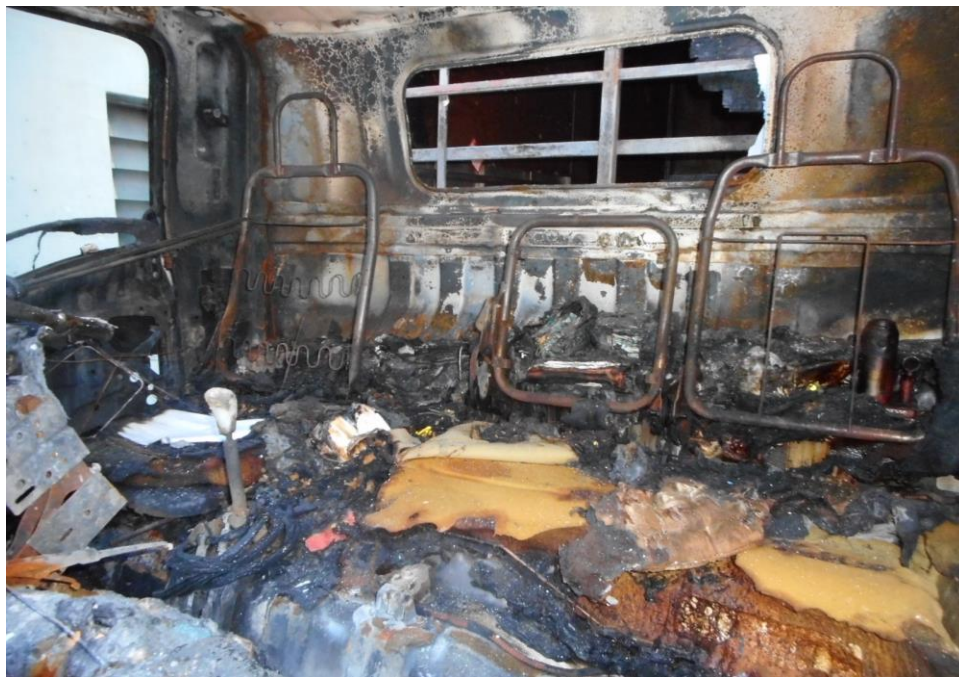
Photo 6 shows the close up view of the interior compartment of the Insured Vehicle. The interior compartment have been badly burnt by the fire.

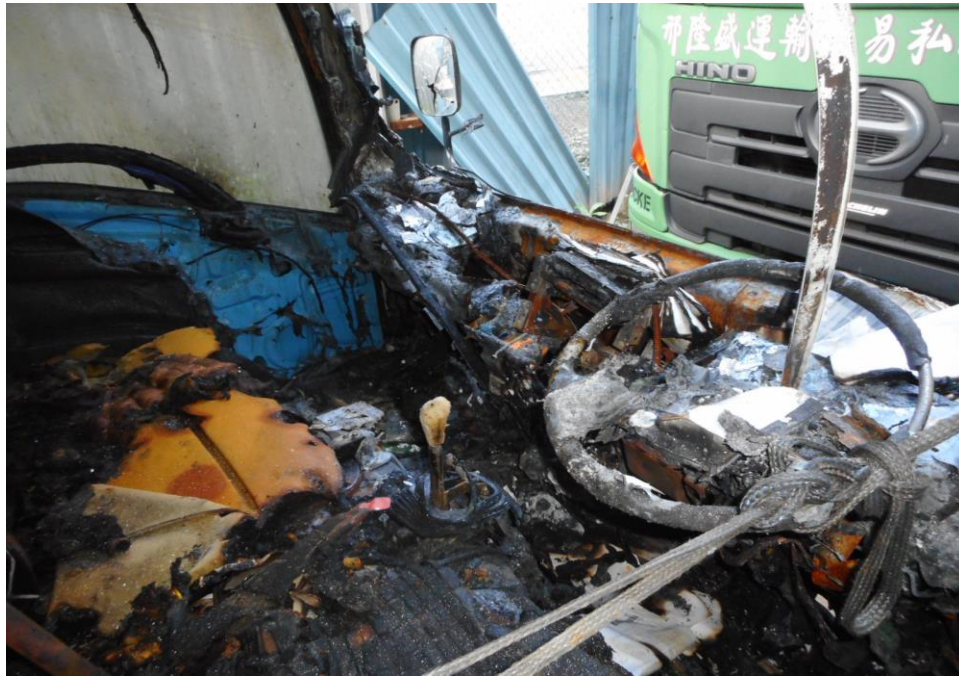
Photo 7 shows the close up view of the interior compartment of the Insured Vehicle. The interior compartment have been badly burnt by the fire.

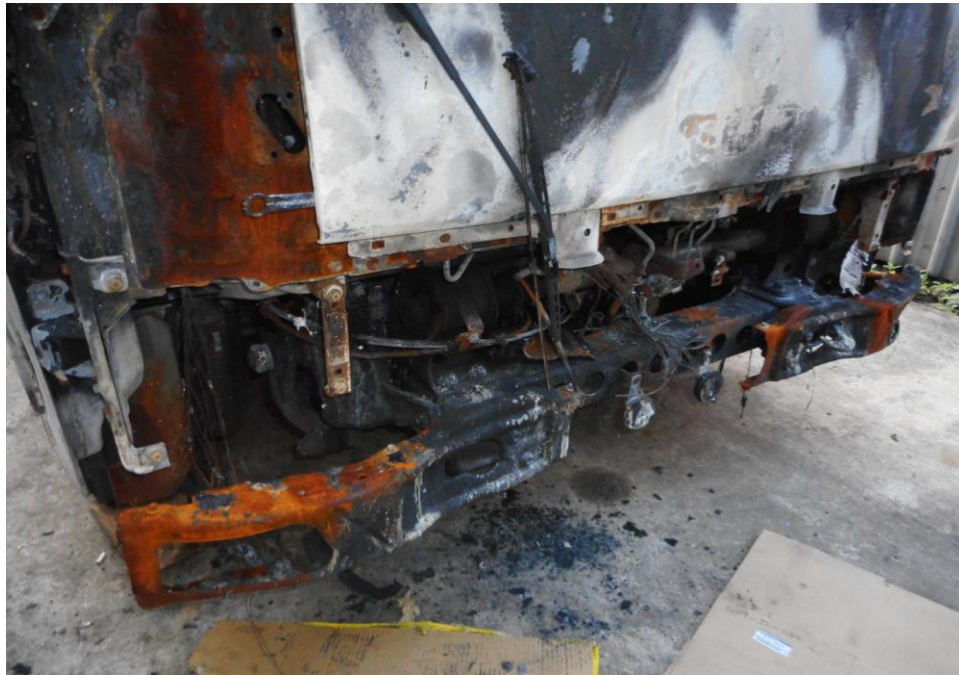
Photo 8 shows the close up view of the front cabin's exterior of the Insured Vehicle. The exterior compartment have been badly burnt by the fire.

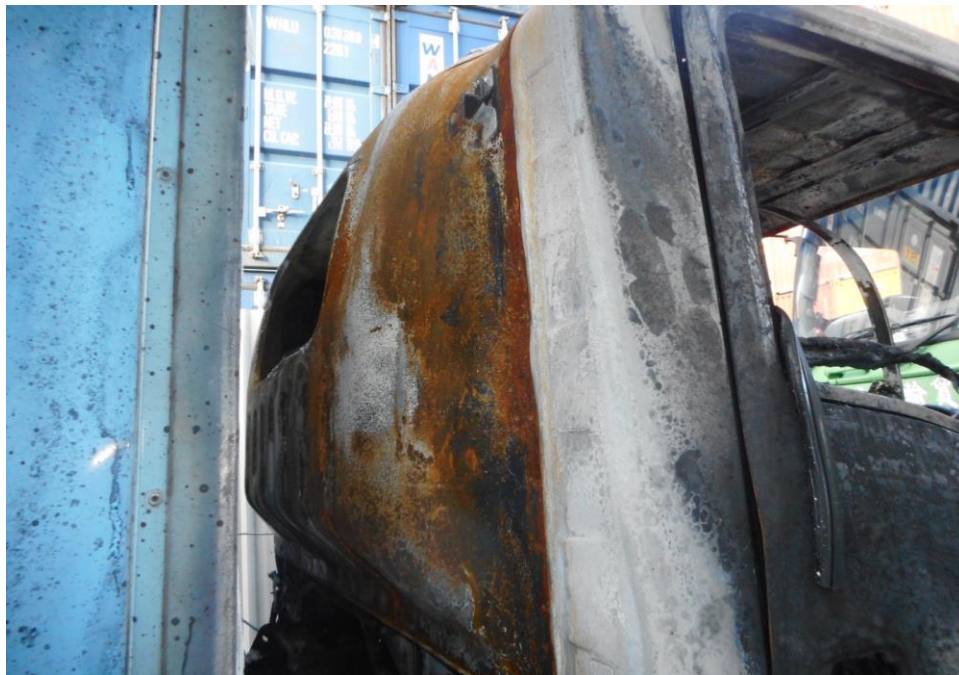
Photo 9 the close up view of the rear of the front cabin's exterior of the Insured Vehicle. The front cabin body panel have been badly burnt by the fire.

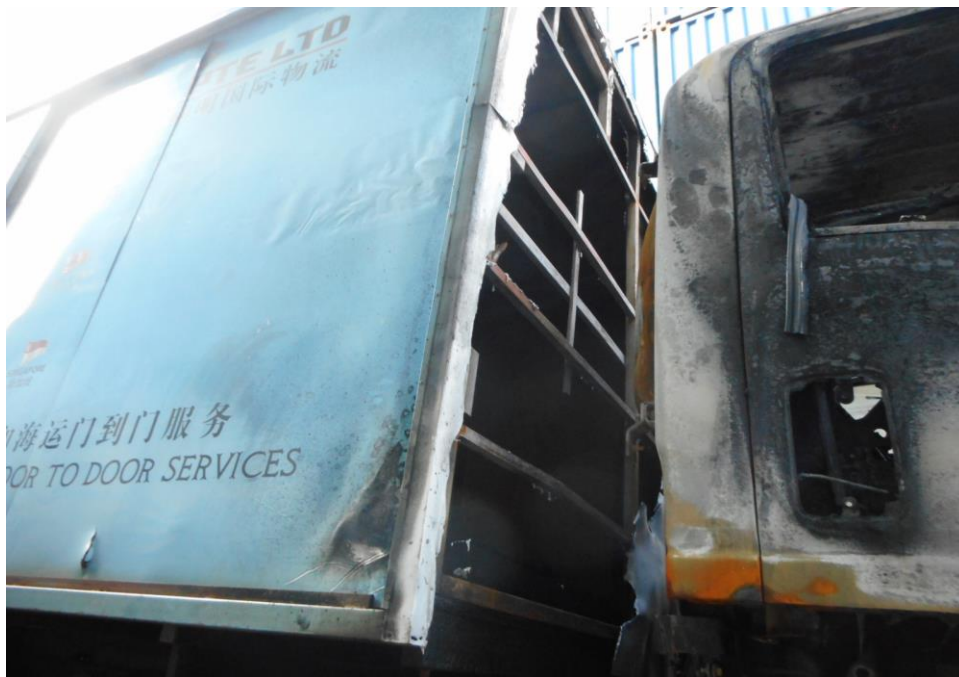
Photo 10 shows the rear cabin of the Insured Vehicle from the right side at the time of our inspection. The fire damage to the Insured Vehicle had burnt down the body panel of the rear portion and were amongst the parts that were observed to have been affected by the fire.

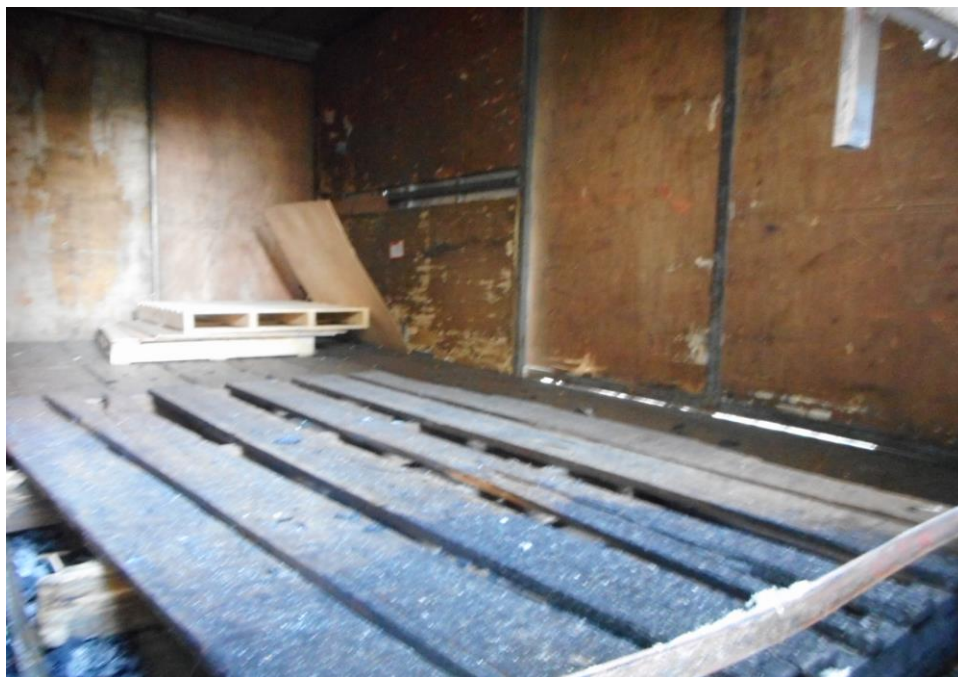
Photo 11 shows the inside of the rear cabin of the Insured Vehicle from the right side at the time of our inspection. The goods in the rear cabin that the Insured Vehicle was carrying were amongst the parts that were observed to have sustained heat & smoke damage.

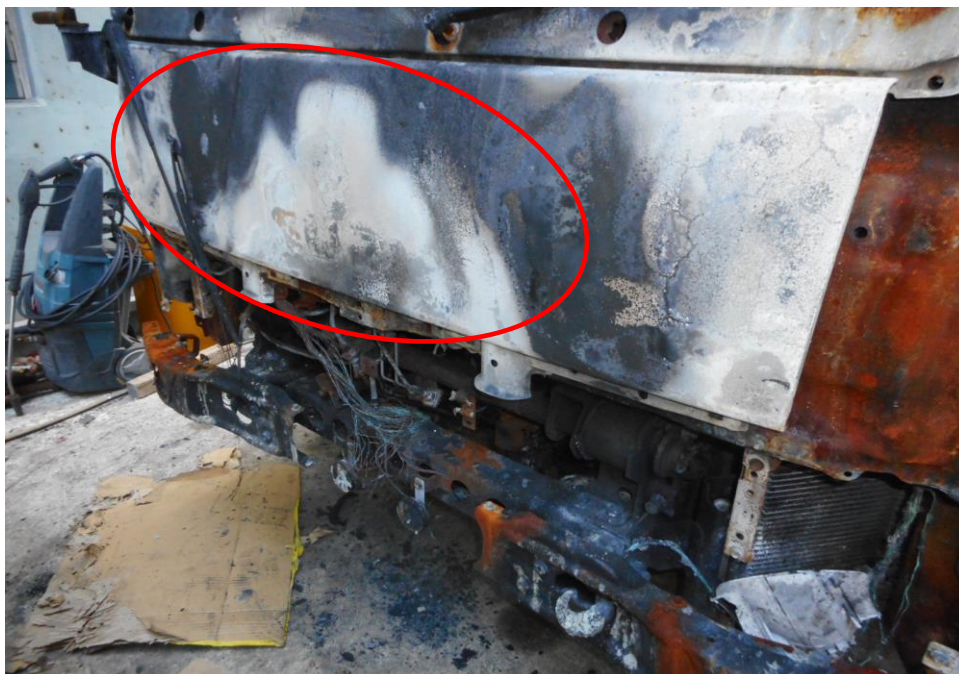
8. For this particular case, the fire appears to have originated from the front interior of the Insured Vehicle. This was determined basing on the area where the extent of fire damage was most severe which was at the front cabin compartment portion of the Insured Vehicle which metal plates and also the high heat intensity burn marks (whitish burn marks) that were found on the exterior surface of the front cabin interior of the front cabin. These whitish burn marks are a result of exposure to prolonged heat intensity. Rust would normally start to develop around these areas soon after a fire as the prolonged exposure to high heat intensity usually causes the bare steel/metal material of the body parts to be exposed to natural environmental condition. The rust that had developed on the exterior surface of the back portion of the front cabin, at the immediate vicinity where these whitish burn marks were found, would also support our findings of where the fire to the Insured Vehicle had originated. See photo 12

Photo 12 shows the front portion body panel of the Insured Vehicle at the time of our inspection. The high heat intensity burn marks (whitish burn marks) and rust that had development found on the exterior surface of the bonnet indicates that the fire had originated from the front portion of the Insured Vehicle.

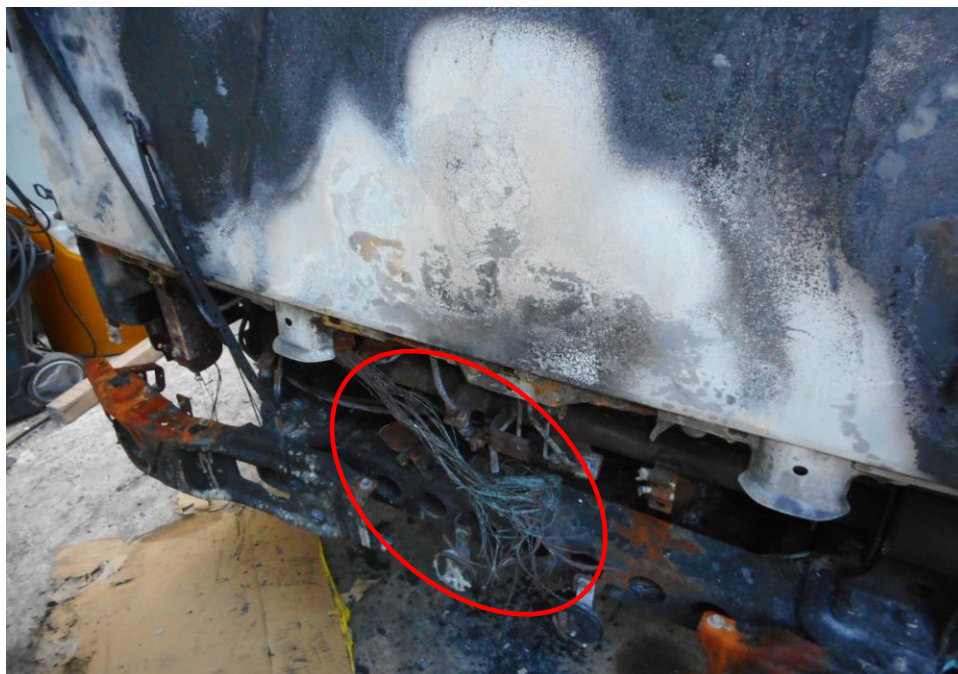
10. Upon closer examination of the front portion of the Insured Vehicle which was where the fire had started, we had found traces of greenish residue along the main wirings harnesses leading to the electrical components of the Insured Vehicle. The wirings were original wirings fitted from the manufacturer. The presence of greenish residue indicates internal heating of copper wires, a sign of an electrical short circuit occurring. The greenish residue is normally left behind from the oxidation as a result of chemical reaction involving the copper wires. This physical evidence would then appear to suggest that the cause of fire to the Insured Vehicle could have possibly been due to electrical in nature. See photos See photos 13 - 16 below.

Photo 13 shows a general view of the original wiring harness leading to the fuse box into the front cabin compartment from the front of the Insured Vehicle. The original wiring harness (red circle) was observed with greenish residue on the surface. The presence of greenish residue indicates internal heating of copper wires, a sign of an electrical short circuit occurring. The greenish residue is normally left behind from oxidation as a result of chemical reaction involving the copper wires.

24. The possibility of the fire being due to electrical in nature would then seem more likely given that engine overheating and external factors would both seem unlikely. The fire being due to electrical nature is also supported by the condition of the original wiring harnesses wirings that were found leading from the original wiring harnesses to the electrical components on the Insured Vehicle, which was earlier discussed in paragraph 9 above.

26. Having investigated and technically analysed the damages of burnt nature to the Insured Vehicle, we are of the view that the cause of fire to the Insured Vehicle was of electrical nature. For this particular case, the fire had originated along the original wiring harnesses leading to the electrical components of the Insured Vehicle.

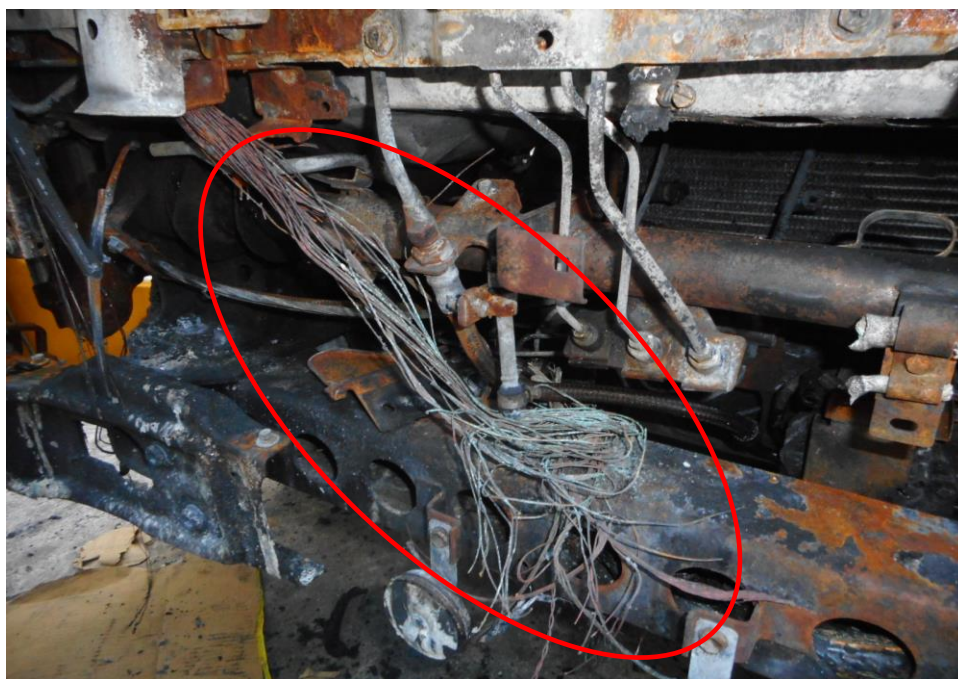
Photo 14 shows a close up view of the original wiring harness leading to the fuse box in the front cabin. The original wiring harness (red circle) was observed with greenish residue on the surface. The presence of greenish residue indicates internal heating of copper wires, a sign of an electrical short circuit occurring. The greenish residue is normally left behind from oxidation as a result of chemical reaction involving the copper wires.

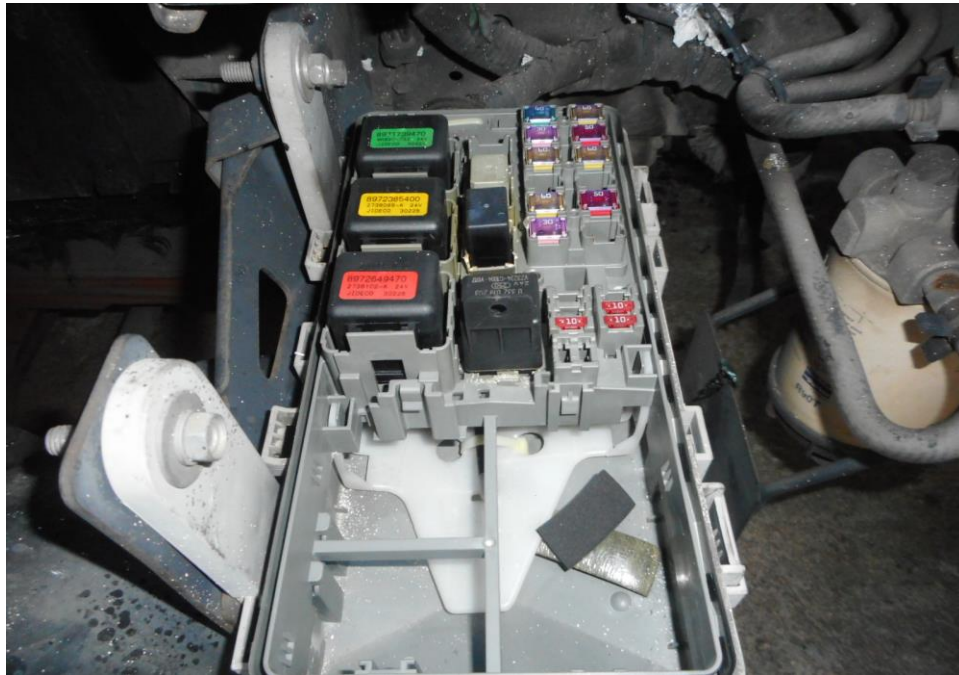
Photo 15 shows a close up view of the fuse box of the Insured Vehicle at the time of our inspection. The fire damage to the Insured Vehicle was confined to its front portion and did not affect its fuse box as it was mounted in the middle of the Insured Vehicle.

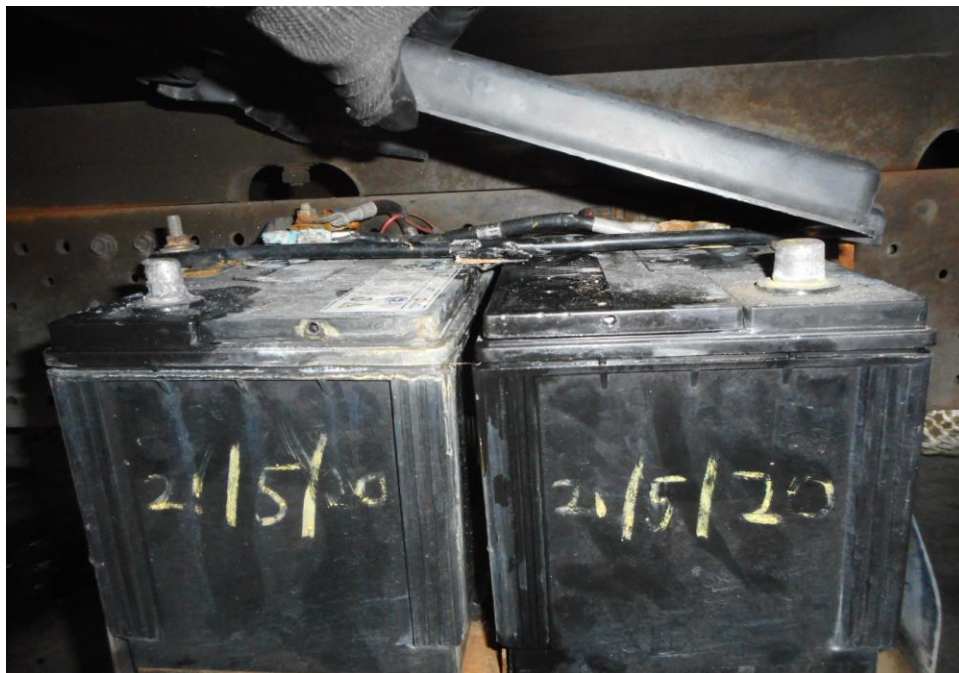
Photo 16 shows a close up view of the batteries of the Insured Vehicle at the time of our inspection. The fire damage to the Insured Vehicle was confined to its front portion and did not affect its batteries as it was mounted in the middle of the Insured Vehicle.

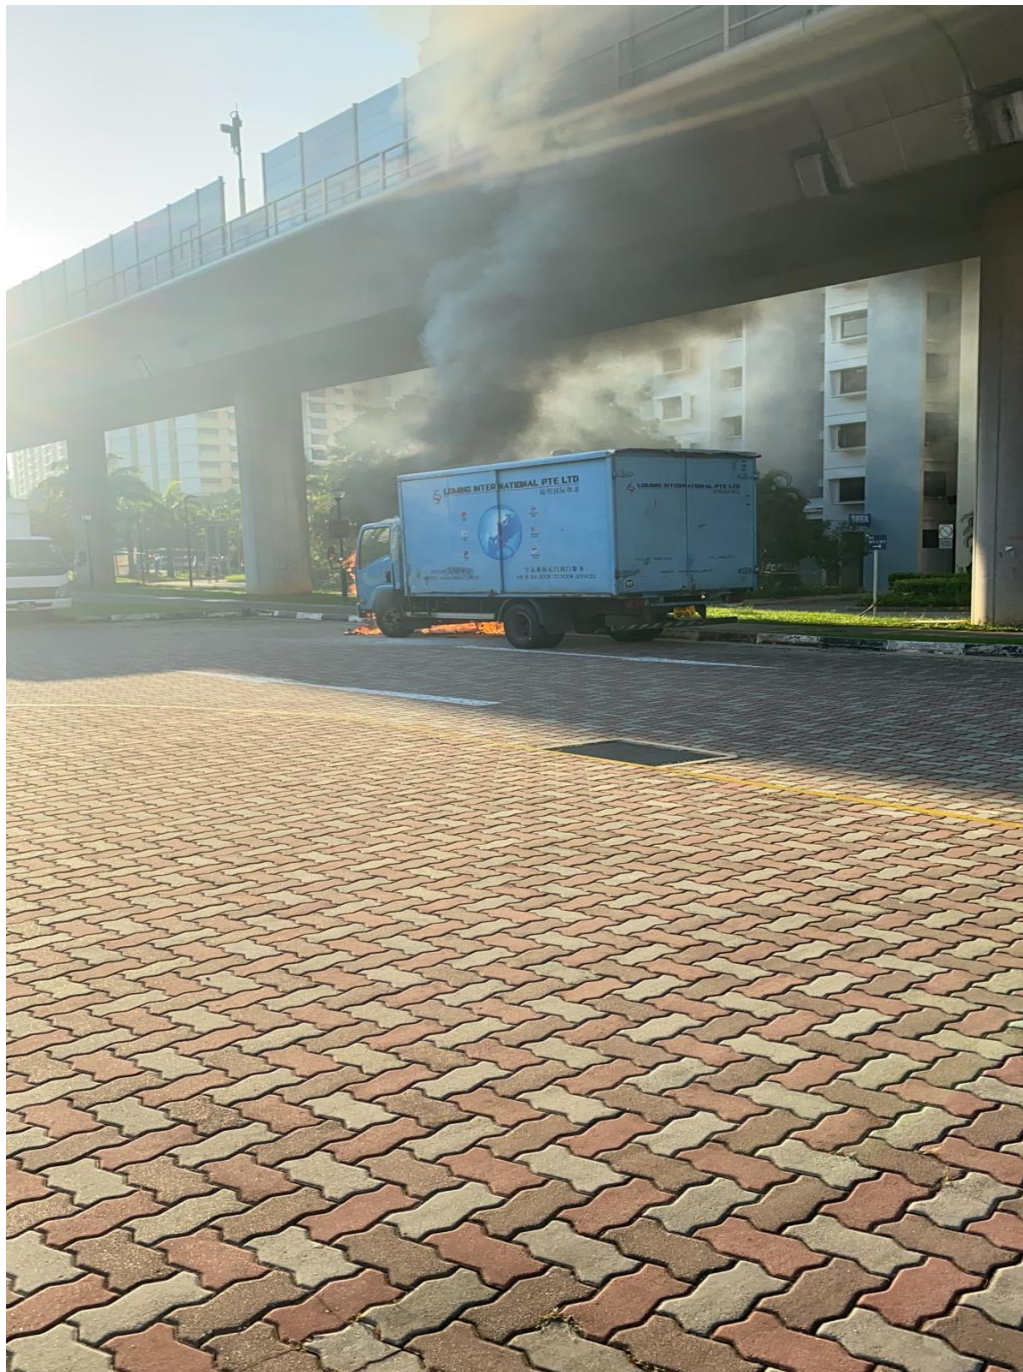
Photo 17 shows the Insured Vehicle on fire. In general, the information that could be gathered from this photograph had corresponded to the events that were related to us by Mr Wang, where the fire had started on the Insured Vehicle.

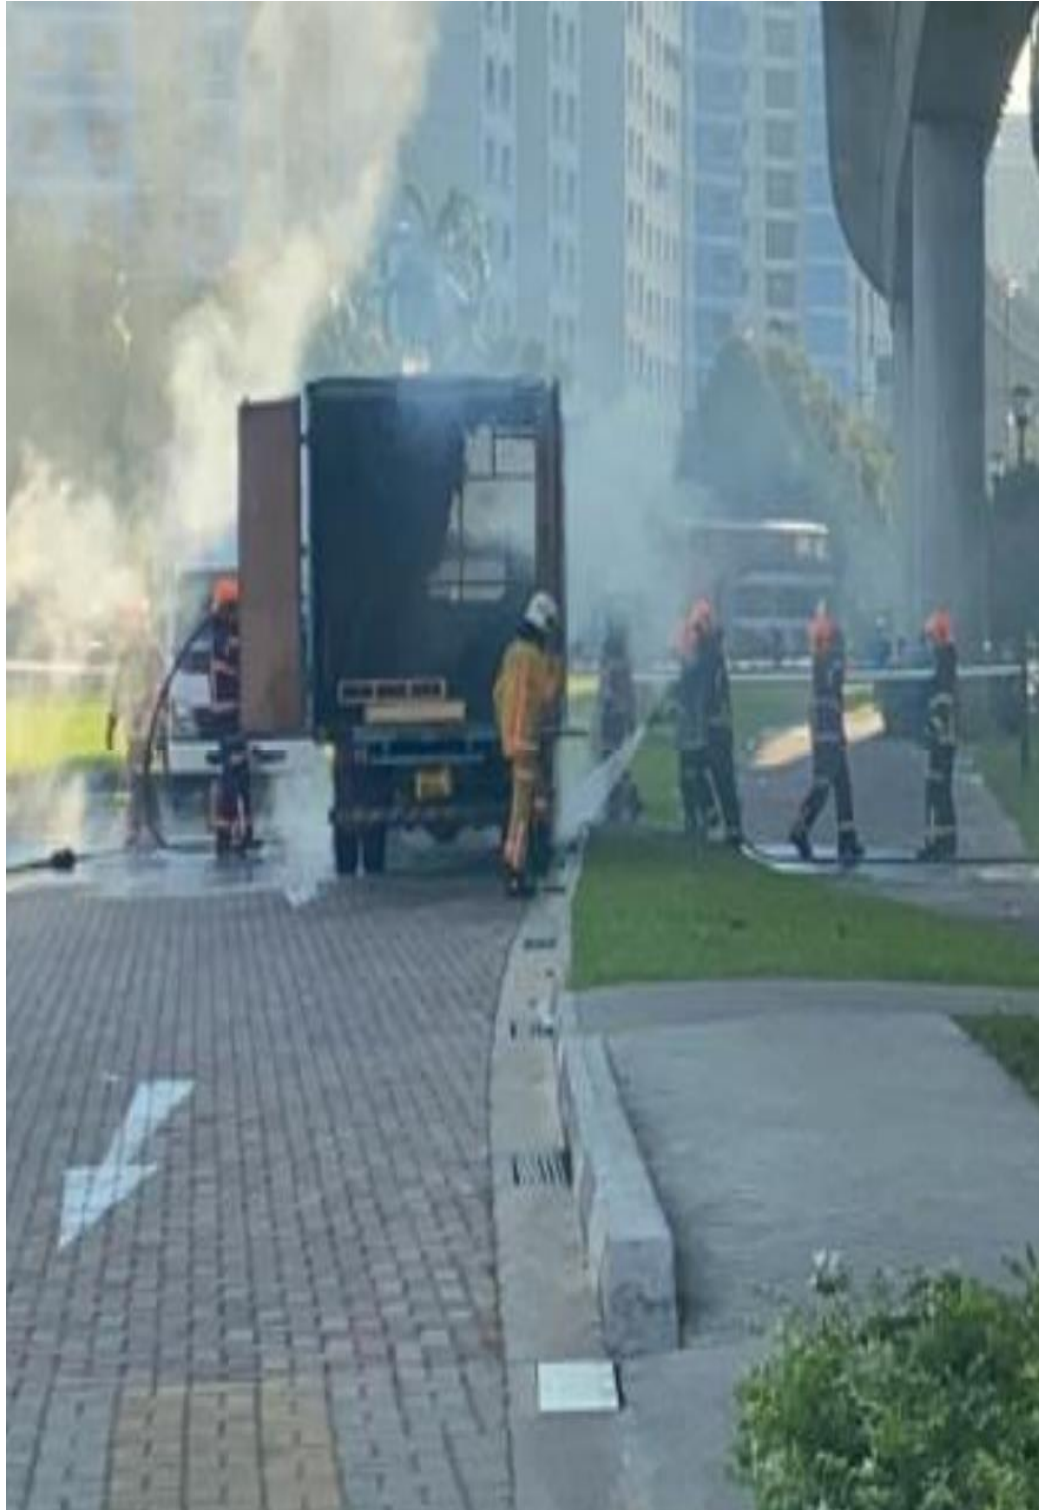
Photo 18 shows SCDF officers fighting the fire on scene, by than the fire than already burnt down the Insured Vehicle. In general, the information that could be gathered from this photograph had corresponded to the events that were related to us by Mr Wang, where the fire had started on the Insured Vehicle.

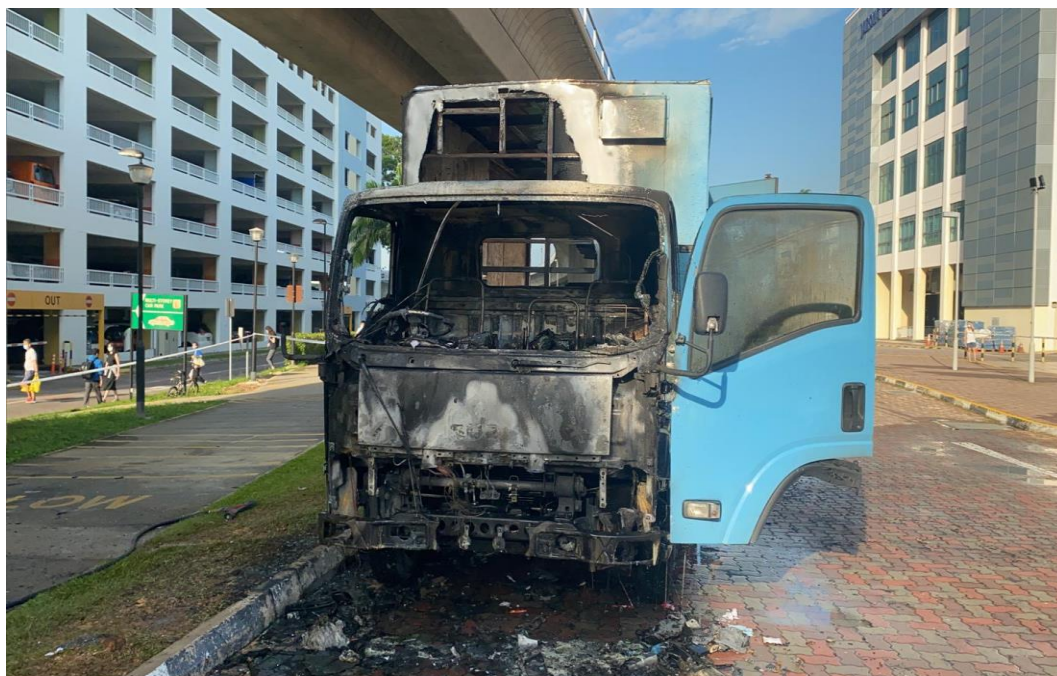
Photo 19 shows the burnt down Insured Vehicle after the fire was extinguished. In general, the information that could be gathered from this photograph had corresponded to the events that were related to us by Mr Wang, where the fire had started on the Insured Vehicle.
