Your Ref: BMW M3
(chassis number WBS8M920205J90498)
Our Ref : CI/TP20010309/D

26 September 2020

INSPECTION REPORT OF AN UNREGISTERD BMW M3 MOTOR CAR WITH CHASSIS NUMBER WBS8M920205J90498

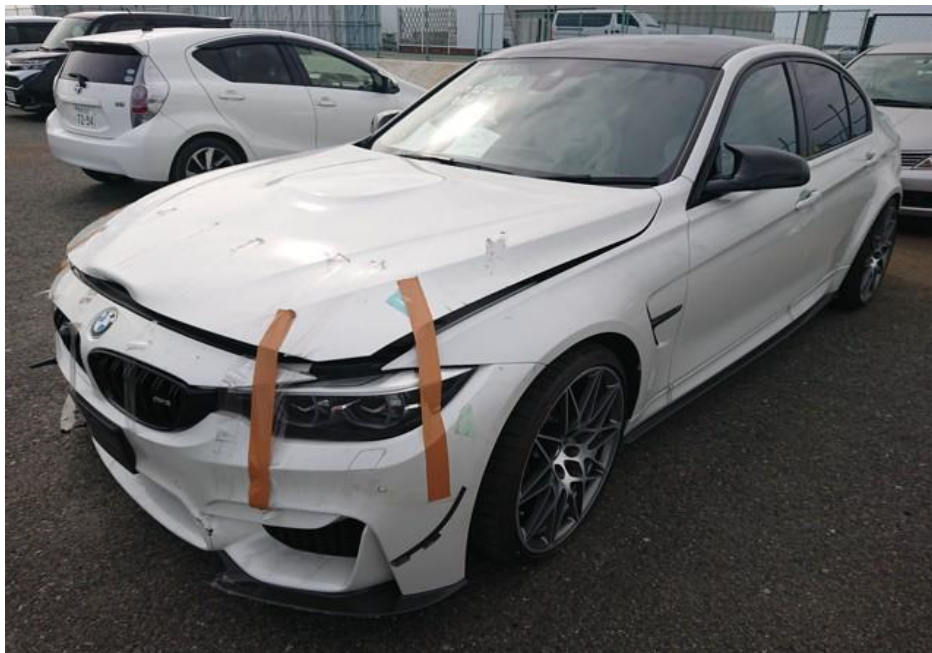
Photo 1 shows the front left body of the Motor Car prior to any repairs being carried out (photograph provided to me). The Motor Car was observed to have sustained damages at its frontal portion. The body parts observed to be damaged had included the front bumper, front grille and front bonnet. The airbags of the Motor Car were not activated as seen from the photograph.

21. The body parts at the frontal portion of the Motor Car were visually examined and it was noted that the repair/restoration works carried out to the damaged area of the Motor Car (refer photograph 1 & 2 above) were adequate and in order.

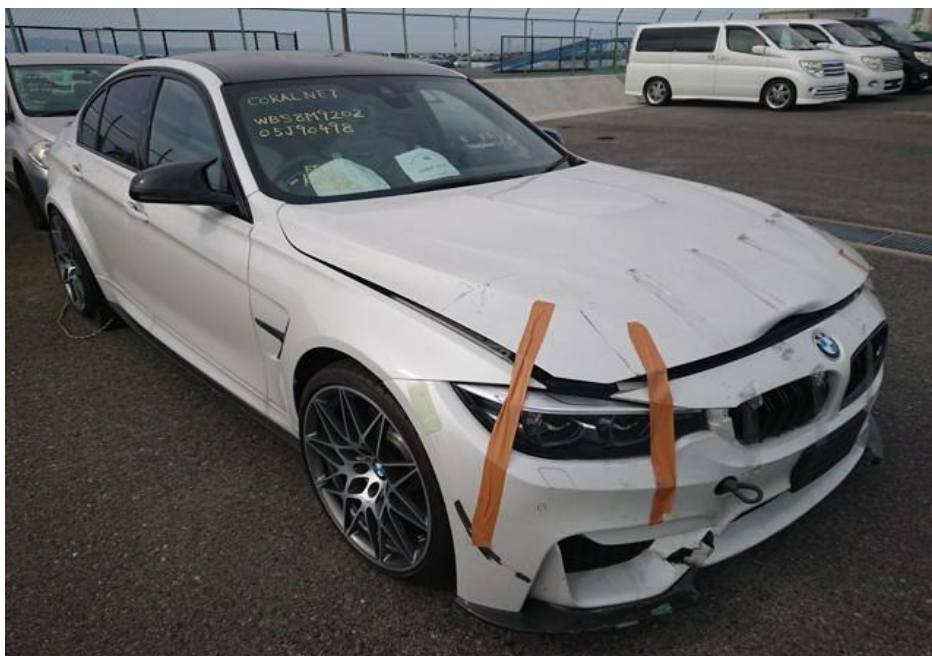
Photo 2 shows the front right body of the Motor Car prior to any repairs being carried out (photograph provided to me). The Motor Car was observed to have sustained damages at its frontal portion. The body parts observed to be damaged had included the front bumper, front grille and front bonnet. The airbags of the Motor Car were not activated as seen from the photograph.

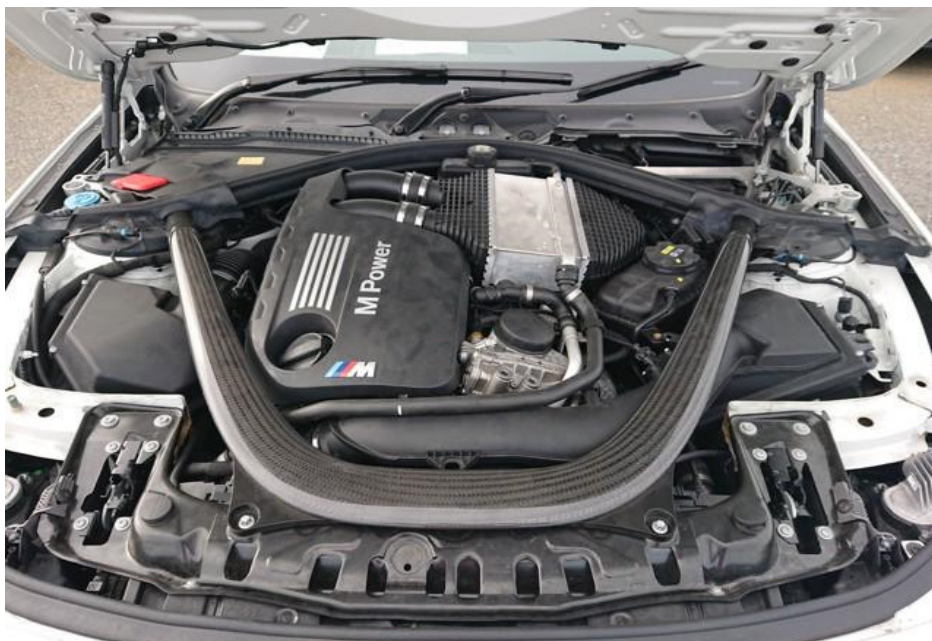
Photo 3 shows the engine compartment of the Motor Car prior to any repairs being carried out (photograph provided to me). Parts and components within the engine compartment were seen to be unaffected.

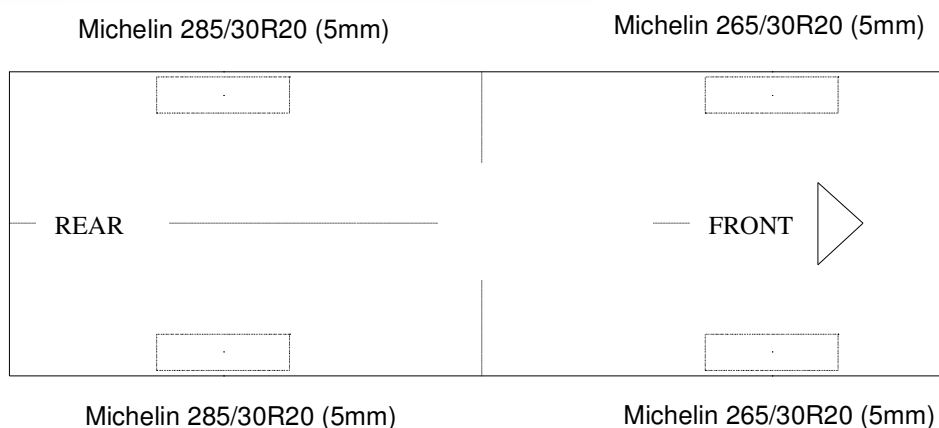
8. It was fitted with 20inch sport wheel rims that were wrapped with tyres that were observed to be of serviceable condition. The tyres were also sufficiently inflated for vehicular operation. The tyre brand, tyre size and approximate remaining tread depth of the 4 tyres of the Motor Car were recorded as follows: -

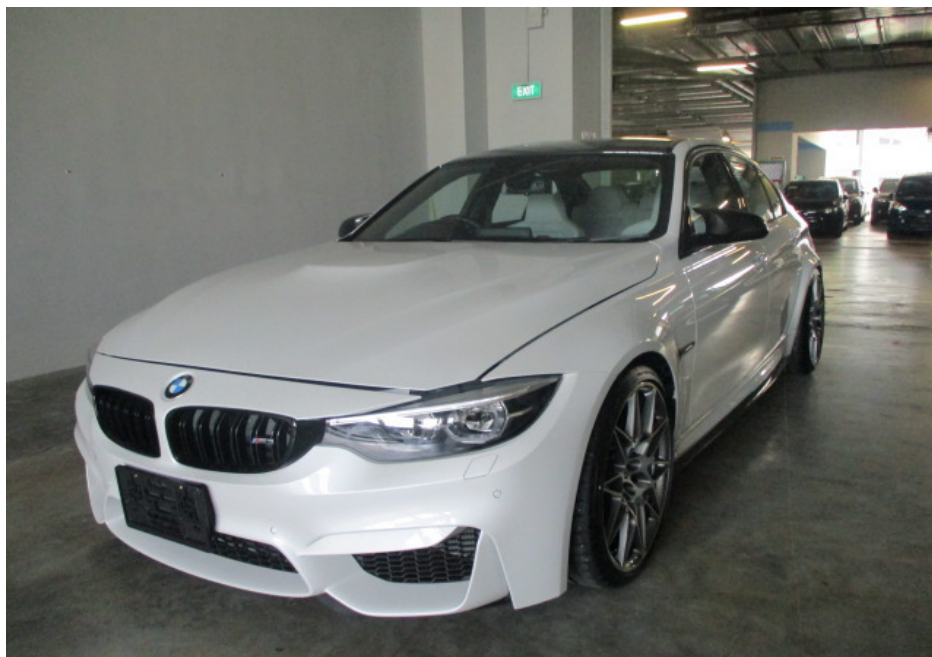
Photo 4 shows a general view of the front left body of the Motor Car at the time of my inspection. The Motor Car was observed to be in relatively good general condition with no loose exterior fittings observed. The body parts at the frontal portion of the Motor Car were visually examined and it was observed that the repair/restoration works carried out to the damaged area of the Motor Car (refer photograph 1 & 2 above) were reasonably adequate and in order.

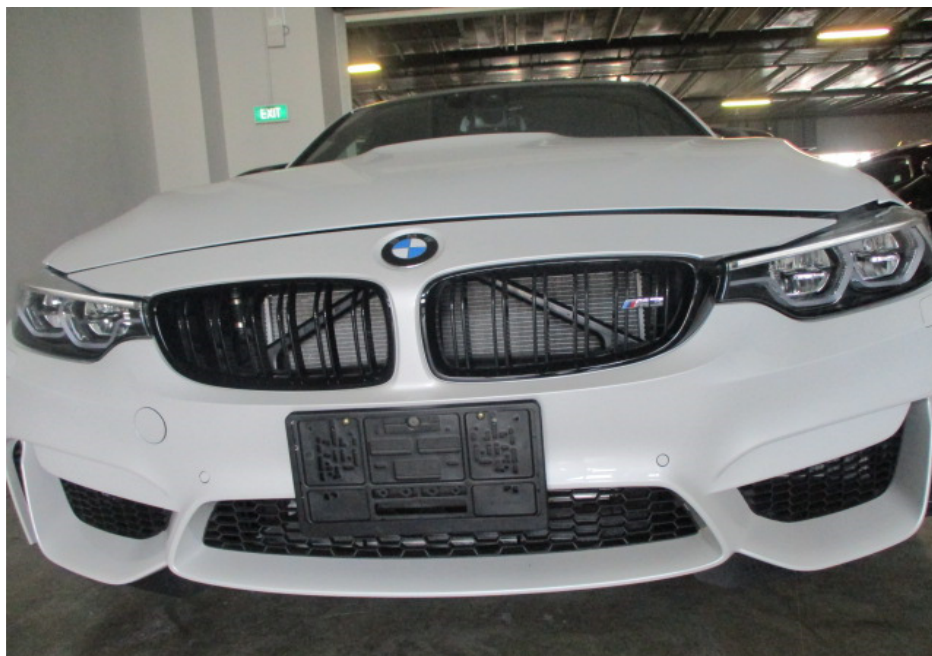
Photo 5 shows a closer view of the frontal portion of the Motor Car at the time of my inspection. The body parts at the frontal portion of the Motor Car were visually examined and it was observed that the repair/restoration works carried out to the damaged area of the Motor Car (refer photograph 1 & 2 above) were reasonably adequate and in order.

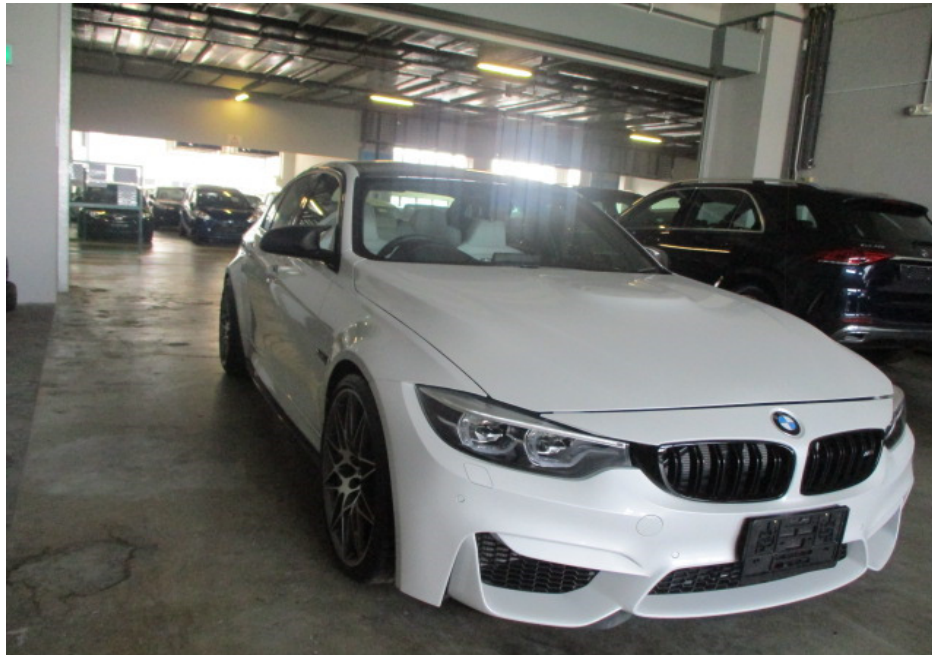
Photo 6 shows a general view of the front right body of the Motor Car at the time of my inspection. The Motor Car was observed to be in relatively good general condition with no loose exterior fittings observed. The body parts at the frontal portion of the Motor Car were visually examined and it was observed that the repair/restoration works carried out to the damaged area of the Motor Car (refer photograph 1 & 2 above) were reasonably adequate and in order.

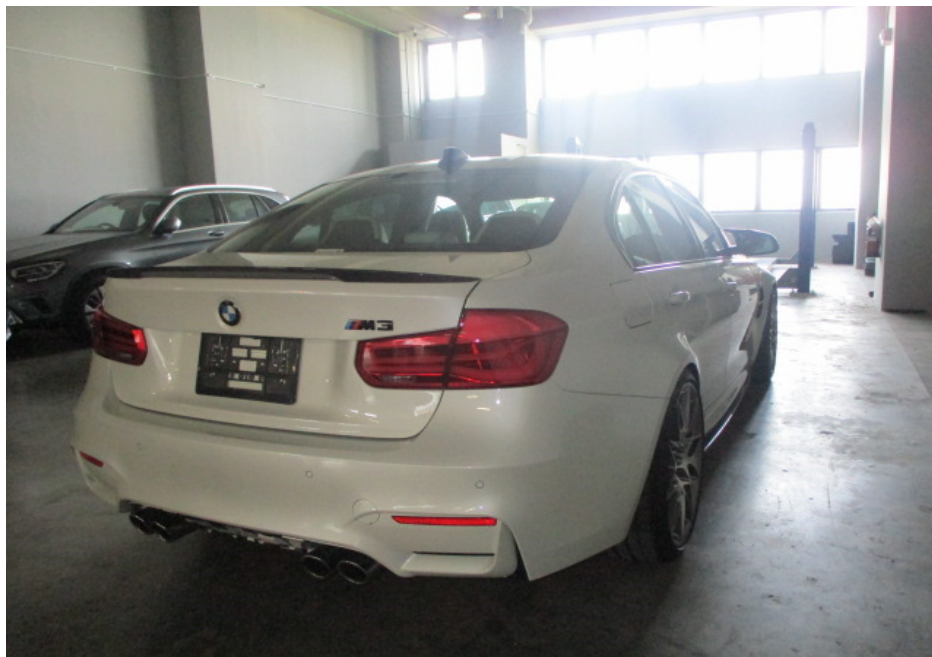
Photo 7 shows a general view of the rear right body of the Motor Car at the time of my inspection. The Motor Car was observed to be in relatively good general condition with no loose exterior fittings observed. The mileage of the Motor Car recorded at the time of my inspection was 8,331km.

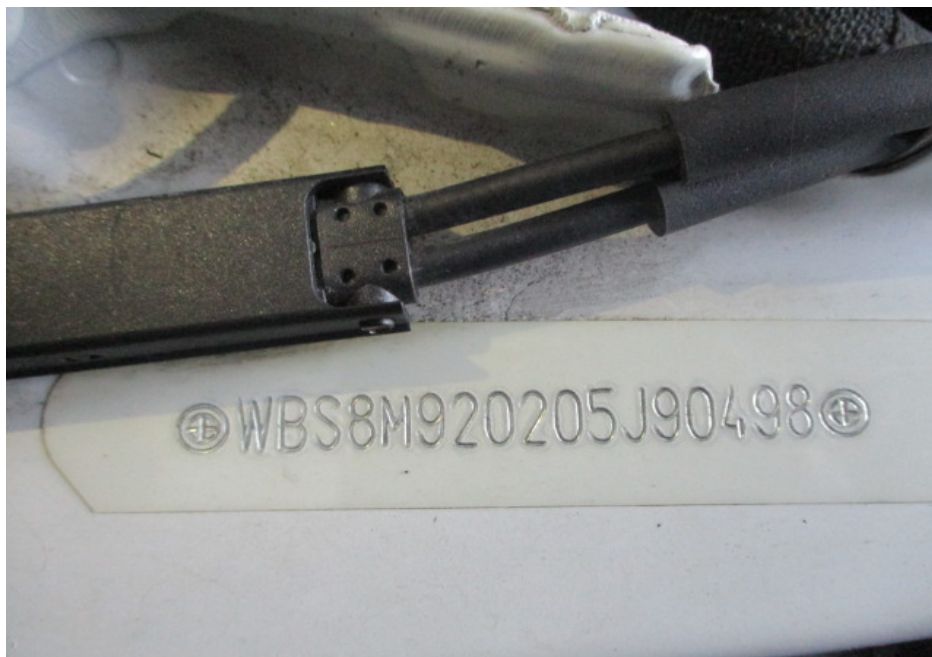
Photo 8 shows the chassis number of the Motor Car. The chassis number recorded was WBS8M920205J90498.

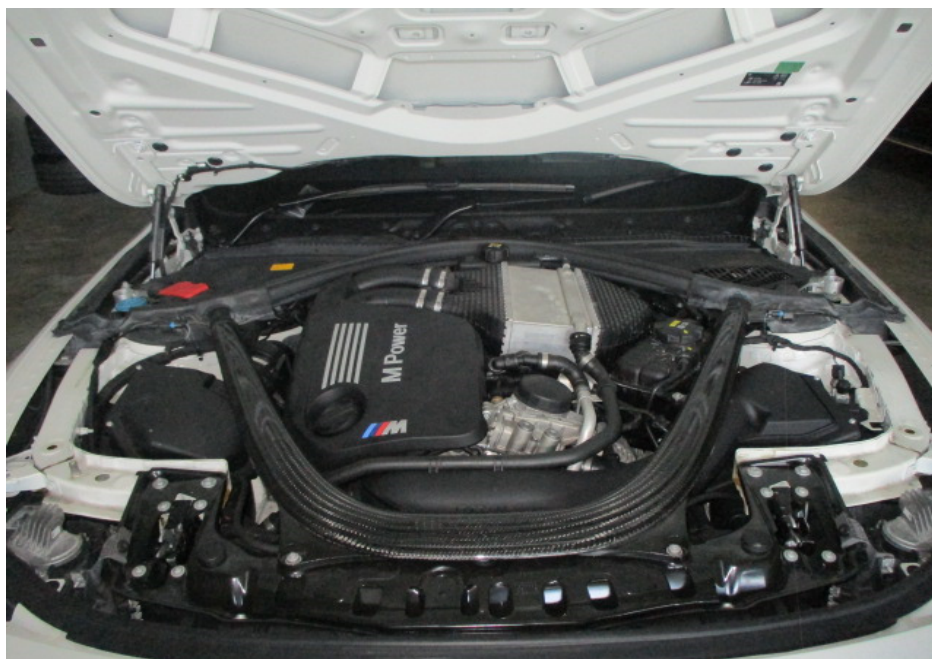
Photo 9 shows a general view of the engine compartment of the Motor Car at the time of my inspection. The various parts and components inside the engine compartment were all observed to be intact and properly fitted. There was also no sign(s) or indication(s) of fluid leak and/or fluid stain found inside the engine compartment.

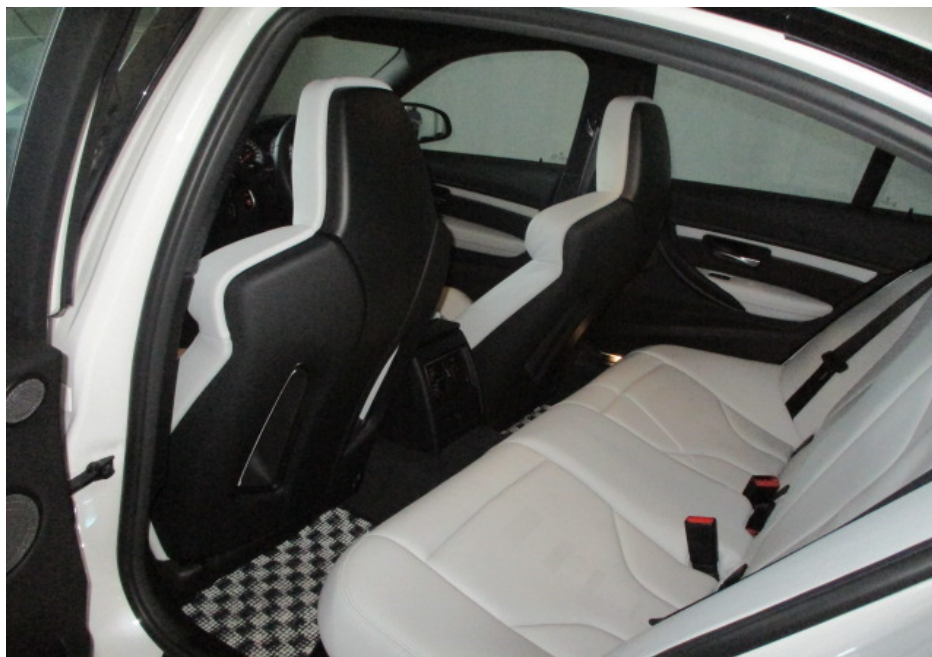
Photo 10 shows the seats of the Motor Car, which were secured via seat rails to the floorboard. All the seats of the Motor Car were fitted with a retractable seat belt reel and pre-tensioner. The seat belts were tested and able to be fastened into the respective pre-tensions that were fitted on the side of each individual seat.

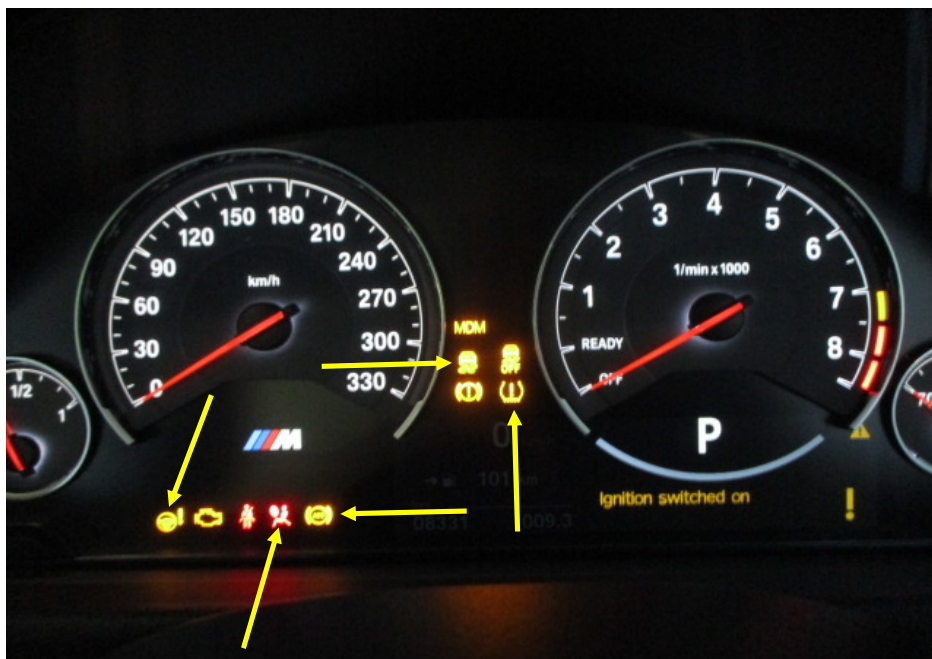
Photo 11 shows the warning lights for the various electronic safety features appearing on the instrument panel of the Motor Car during its self-test when the engine is cranked, in particular the ABS, SRS, IAS, TPM and DSC lights (arrowed).

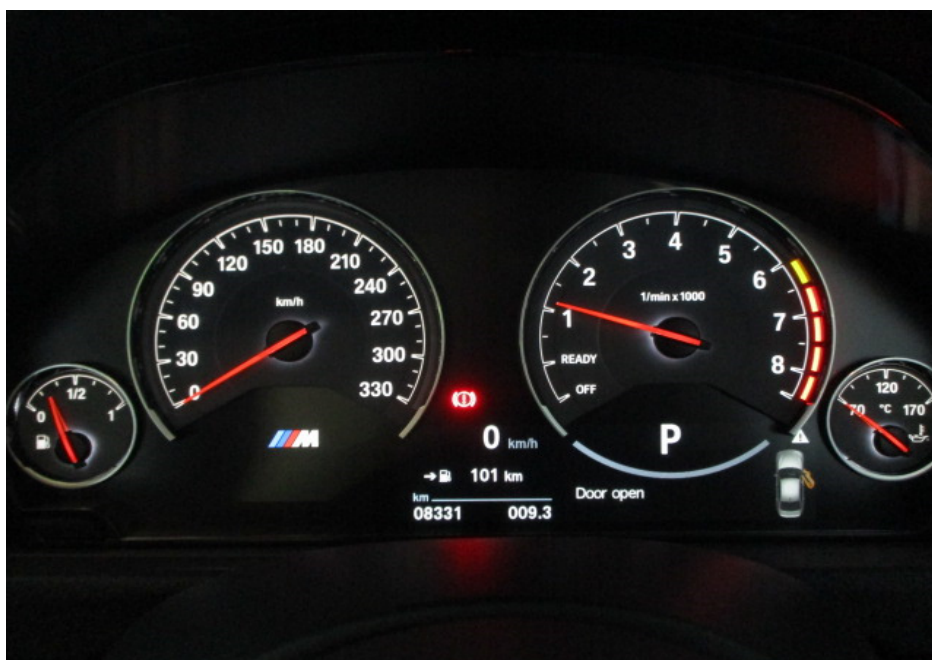
Photo 12 shows the respective warning lights no longer illuminated after the engine was started, indicating that there was no fault detected to the ABS, SRS, IAS, TPM and DSC systems of the Motor Car during the self-test. These electronic systems were hence in working condition at the time of my inspection.

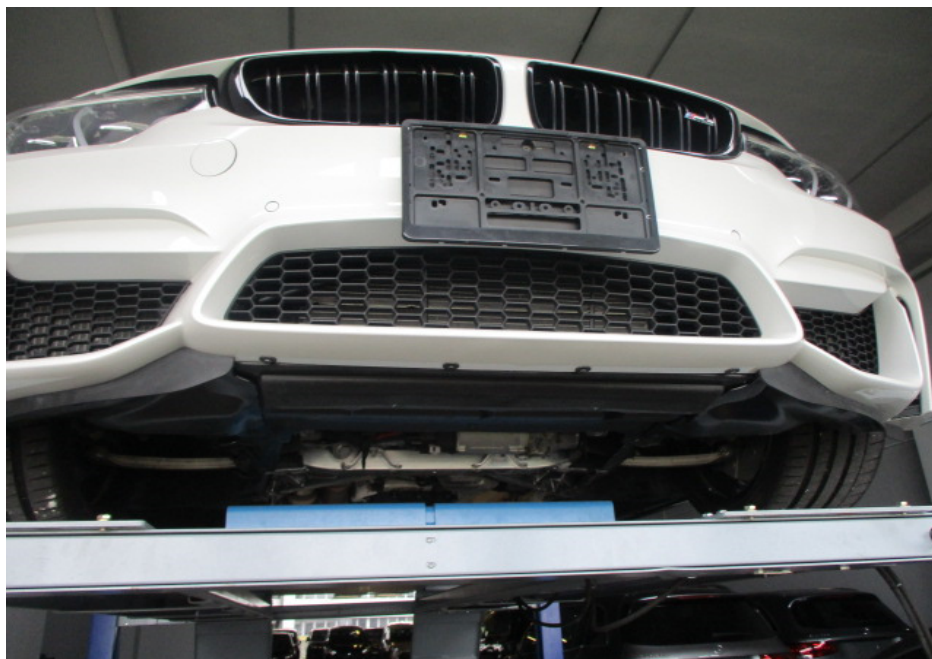
Photo 13 shows the Motor Car hoisted up for checks on its undercarriage. There was no sign(s) or indication(s) of fluid leakage and/or fluid stain(s) on the underside of the Motor Car. The undercarriage components of the Motor Car were also all observed to be intact and secured in an appropriate manner.

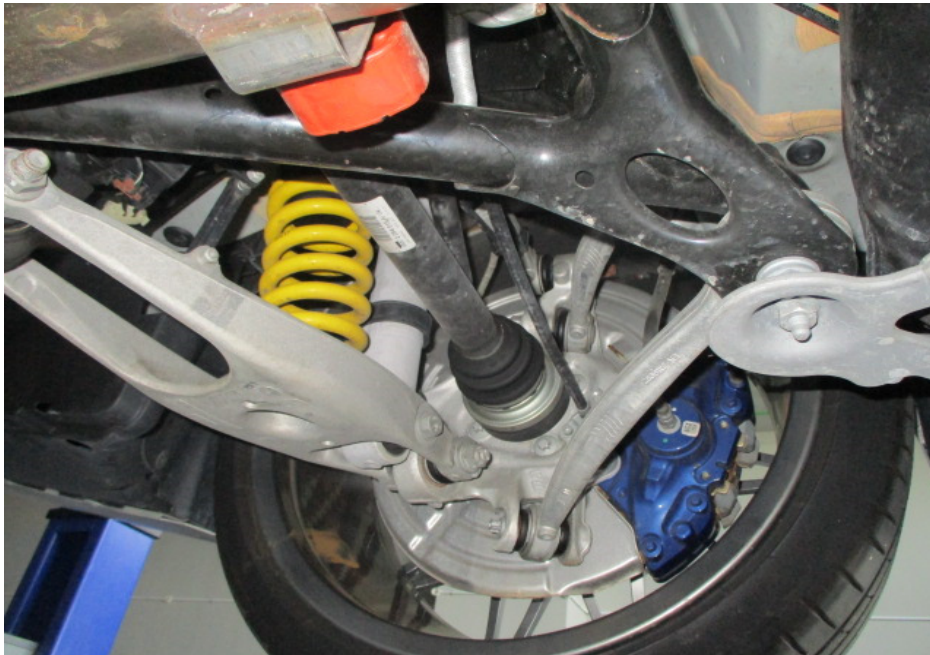
Photo 14 shows a general view of the control arms and linkages at the rear left wheel of the Motor Car. I did not observe any fluid leak and/or fluid stain on the underside of the Motor Car. All of the Motor Car's undercarriage components were observed to be intact and secured in an appropriate manner.

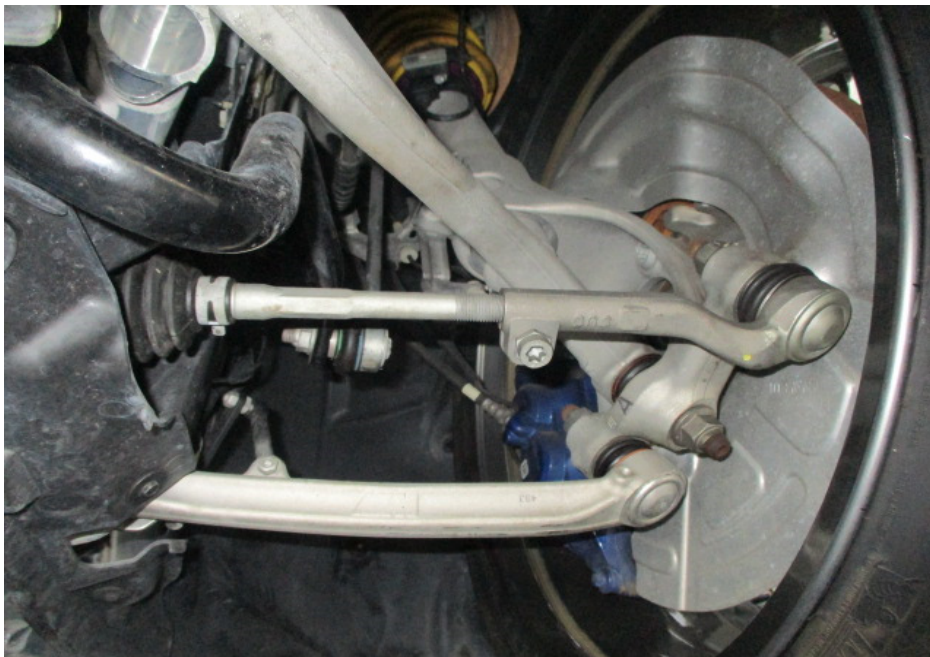
Photo 15 shows the various undercarriage components at the front left wheel of the Motor Car. The mechanical components, control arms and linkages were all found to be intact and secured in an appropriate manner.

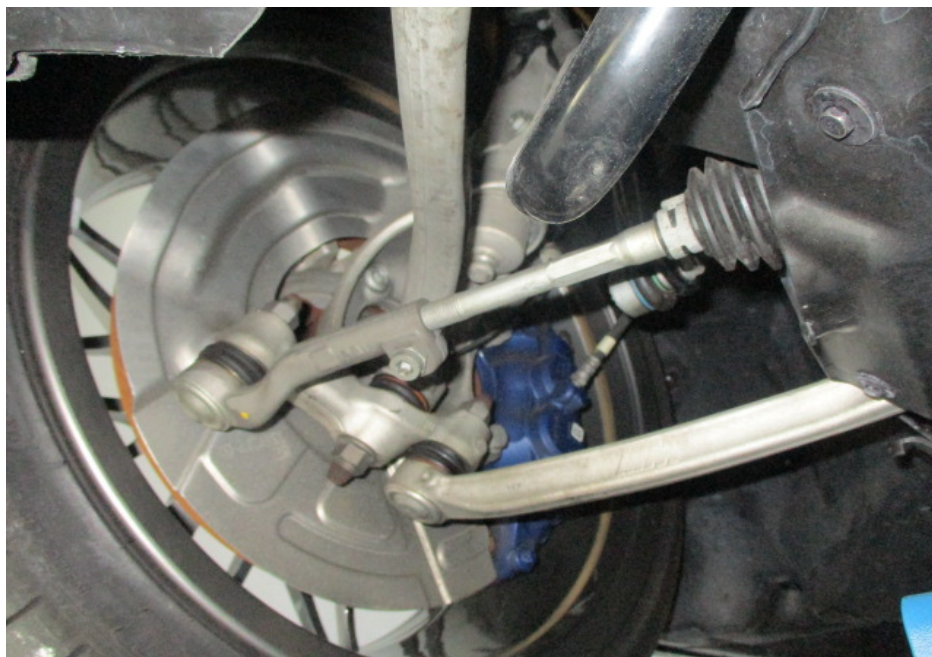
Photo 16 shows the various undercarriage components at the front right wheel of the Motor Car. The mechanical components, control arms and linkages were all found to be intact and secured in an appropriate manner. I also did not observe any fluid leak and/or fluid stain on the underside of the Motor Car.

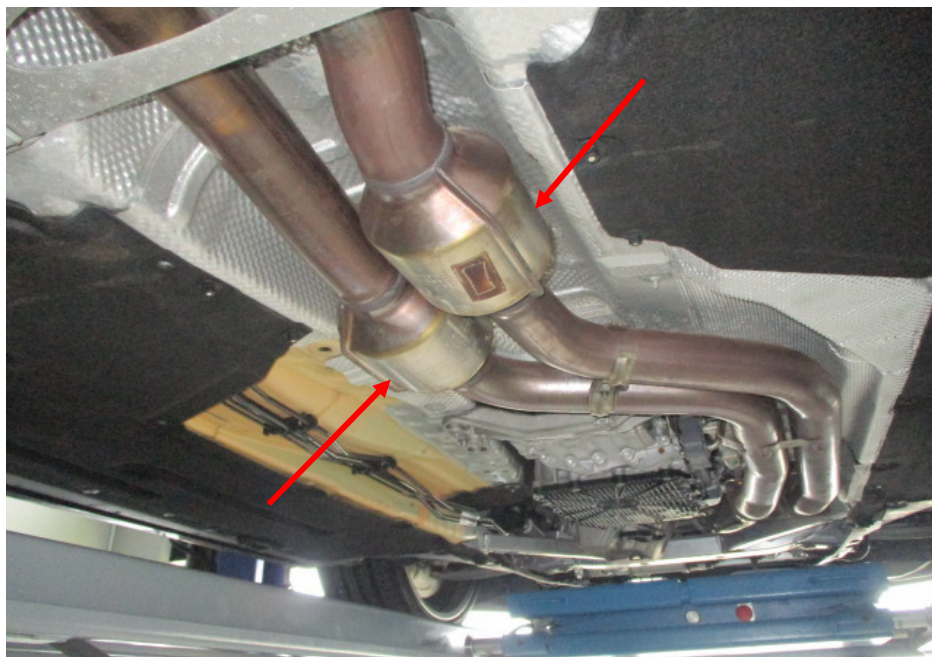
Photo 17 shows the Motor Car's centre catalytic converters (arrowed). My examination of the Motor Car's exhaust system revealed no sign(s) or indication(s) of any cut or weld marks along its exhaust pipes and on its rear mufflers.

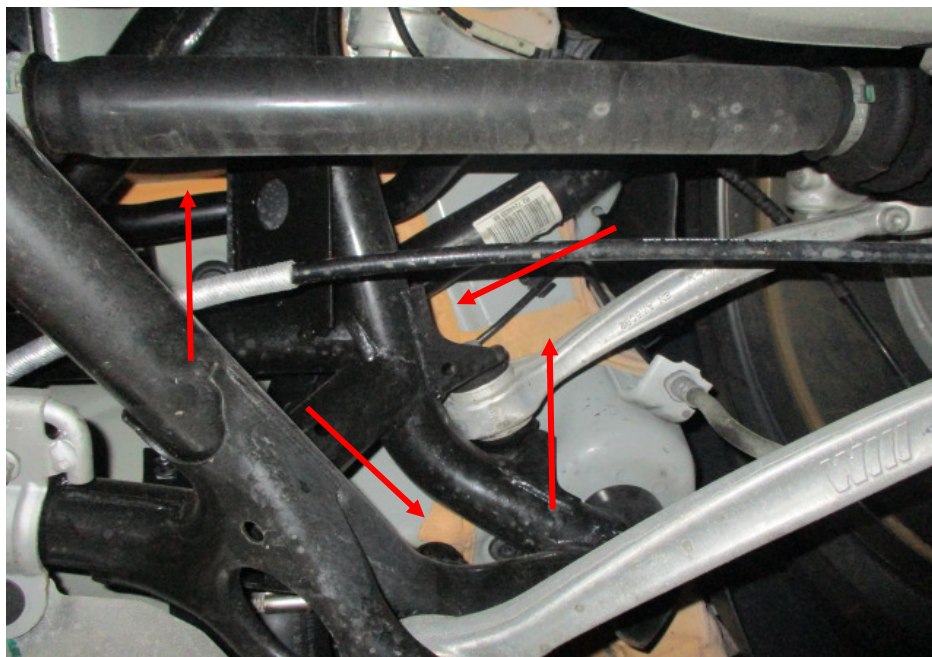
Photo 18 shows the chassis/structural body at the underside rear right of the Motor Car. I did not find any weld marks other than original spot weld marks on the chassis/structural body of the Motor Car. The original factory sealant (arrowed) at the joints along the chassis/structural body was also untouched, indicating no work was done on the chassis/structural body of the Motor Car and that the chassis/structural body was originally fitted.

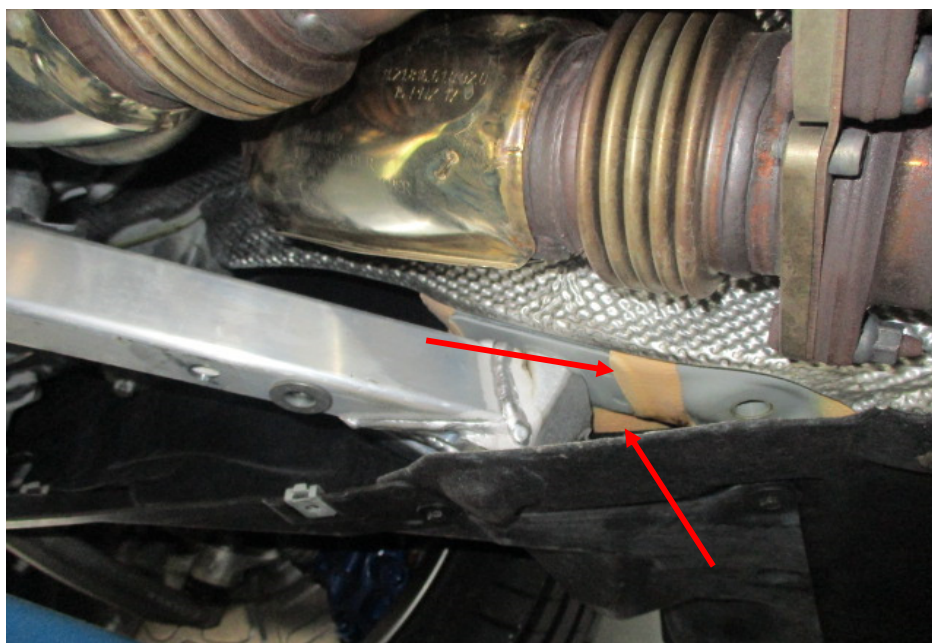
Photo 19 shows the chassis/structural body at the underside front right of the Motor Car. The original factory sealant (arrowed) at the joints along the chassis/structural body was also untouched, indicating no work was done on the chassis/structural body of the Motor Car and that the chassis/structural body was originally fitted.

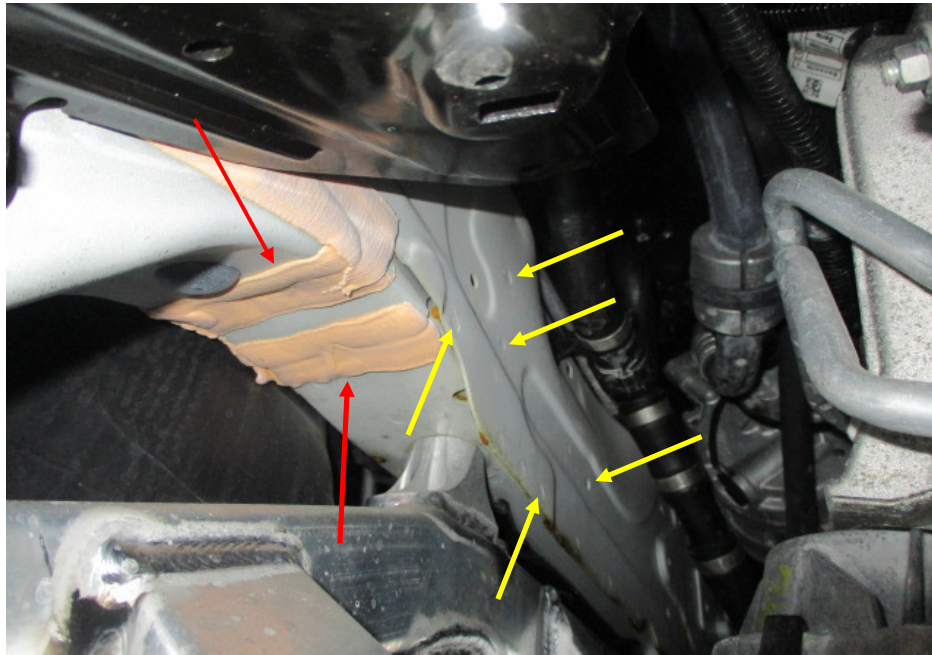
Photo 20 shows the chassis/structural body at the underside front left of the Motor Car. Visually, I did not find any weld marks other than original spot weld marks (yellow arrow) on the chassis/structural body of the Motor Car. The original factory sealant (red arrow) at the joints along the chassis/structural body was also untouched, indicating no work was done on the chassis/structural body of the Motor Car and that the chassis/structural body was originally fitted.
