## ACCIDENT VEHICLE SURVEY REPORT

Vehicle Reg No.:	SLK8494E	Odometer:	73622km
Make & Model:	Porsche Panamera	Colour:	White
Chassis number:	WPOZZZ97ZBL003273	Date of accident:	13/03/2018
Year of Regn.:	08/02/2011	Date inspected:	15/03/2018
Repairer at:	N-51 Automotive Pte Ltd 2 Kaki Bukit Ave 2 #01-18 Kaki Bukit Auto Hub Singapore 417921	Date inspected (After Repair):	23/03/2018

## AUTOMOBILE ASSESSMENT REPORT

**Assessment of Vehicle No** : **SLK 8494E**  
**Date of Accident** : **13-March-2018**  
**Date of Inspection** : **16-March-2018**  
**Address of Inspection** : **2 Kaki Bukit Ave 2 #01-17 S'417921**

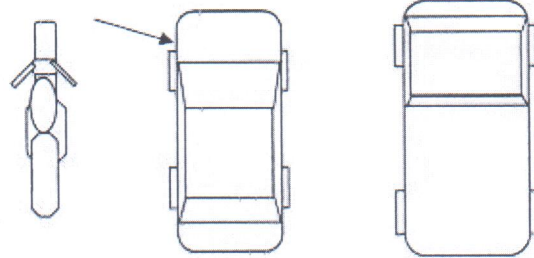
At the time of inspection, this vehicle sustained damages to the **N/S Front** portion. Please see attached scheduled for details.
