**SURVEY OF VEHICLE NO. SLK 8494E**

## AUTOMOBILE ASSESSMENT REPORT

**Assessment of Vehicle No** : **SLK 8494E**  
**Date of Accident** : **13-March-2018**  
**Date of Inspection** : **16-March-2018**  
**Address of Inspection** : **2 Kaki Bukit Ave 2 #01-17 S'417921**

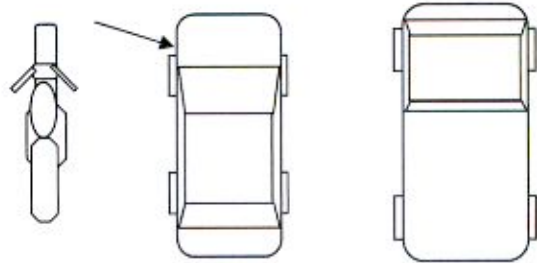
At the time of inspection, this vehicle sustained damages to the **N/S Front** portion. Please see attached scheduled for details.
