LKK Auto Consultants Pte Ltd

Vehicle No. YQ 1638T
Insured Veh. SH 9667A
Claim No. D20003881MFSH
Policy No. D-20094922MFSH
Accident Date 18/09/2020
Inspection Date 26/10/2020

ADJUSTMENT ON REPAIR COST FOR VEHICLE NO. YQ 1638T

PHOTOGRAPHS FOR VEHICLE NO. YQ 1638T

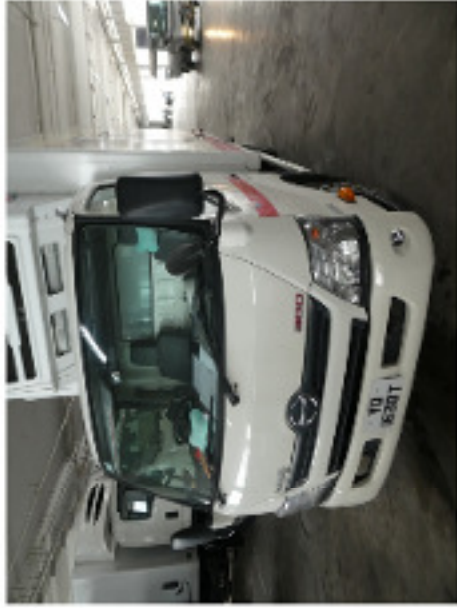
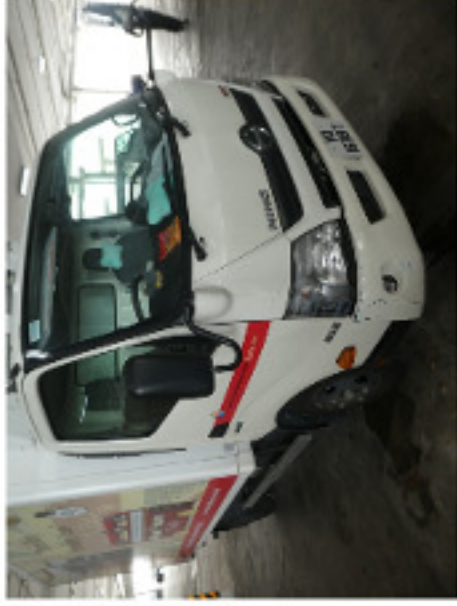
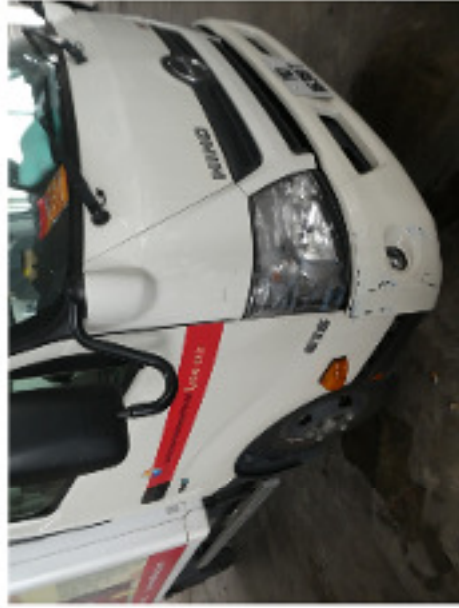
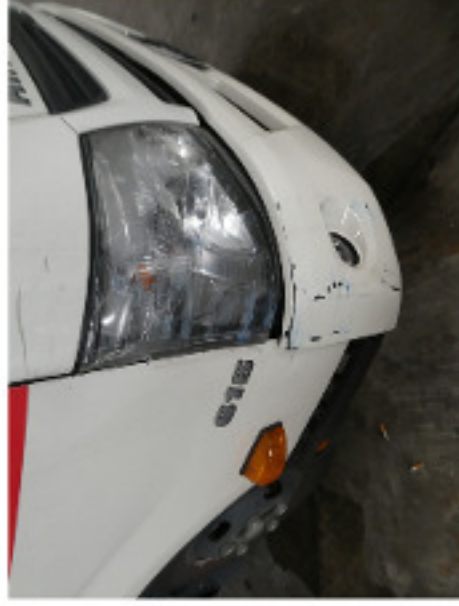
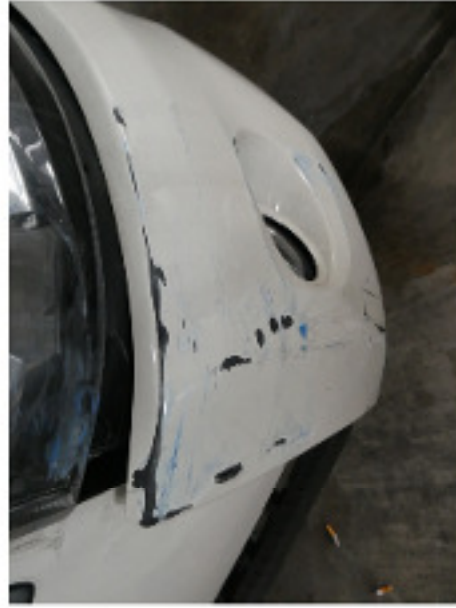
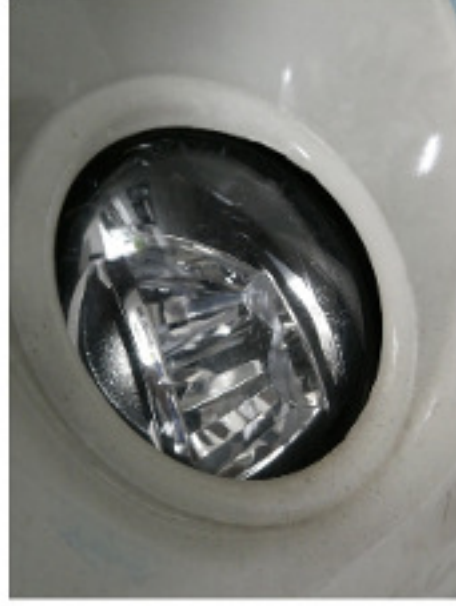
INSPECTION

THE VEHICLE SUSTAINED DAMAGES AT THE FRONT O/S PORTION. DAMAGES SEE DETAILS.

Qty	Description of Parts	Condition	Estimate By Workshop (\$)	Our Adjusted (\$)
	<u>REPLACEMENT OF PARTS</u>			
1	FRONT BUMPER	DEFORMED	720.00	720.00
1	FRONT HEAD LAMP ASSY (RH)	CRACKED	580.00	580.00
1	FRONT SIDE PANEL (RH)	CUT	320.00	320.00
	LESS 10% DISCOUNT		-	-162.00
			1,620.00	1,458.00
	<u>LABOUR</u>			
	LUMP SUM LABOUR TO REMOVE AND INSTALL ALL ABOVE ITEMS INCLUDING TOOL AND MATERIAL.		600.00	400.00
	DRIVER RIGHT DOOR & REALIGNMENT (DOOR ARM SPRING REPAIR, REMOVE GLASS PANEL, SWITCH, ARMS, INSIDE PANEL, PANEL BEATING AND REFIX).		680.00	200.00
	RESPRAY DOOR AND TRUCK CABIN.		1,200.00	600.00
	ARTWORK FOR TRUCK CABIN.		280.00	180.00
			2,760.00	1,380.00
	GRAND TOTAL		4,380.00	2,838.00
	RECOMMENDED COST OF LUMP SUM REPAIRS (TO ITS PRE-ACCIDENT CONDITION)			2,250.00
