LKK Auto Consultants Pte Ltd

Vehicle No. SLC 5470K
Insured Veh. SHC 2548M
Claim No. D20003931MFSH
Policy No. D-20094922MFSH
Accident Date 28/09/2020
Inspection Date 02/10/2020

ADJUSTMENT ON REPAIR COST FOR VEHICLE NO. SLC 5470K

PHOTOGRAPHS FOR VEHICLE NO. SLC 5470K

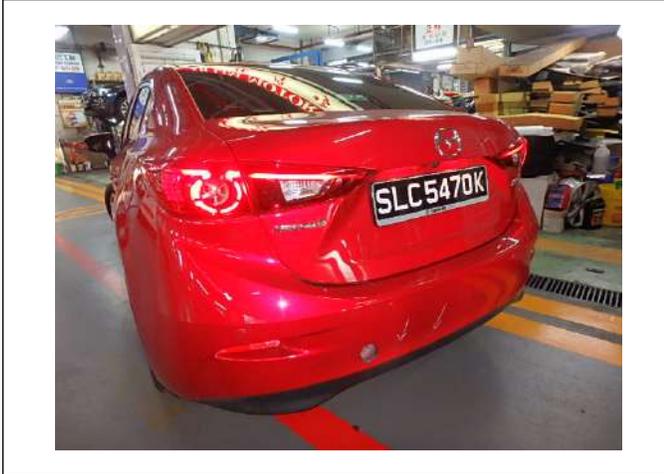
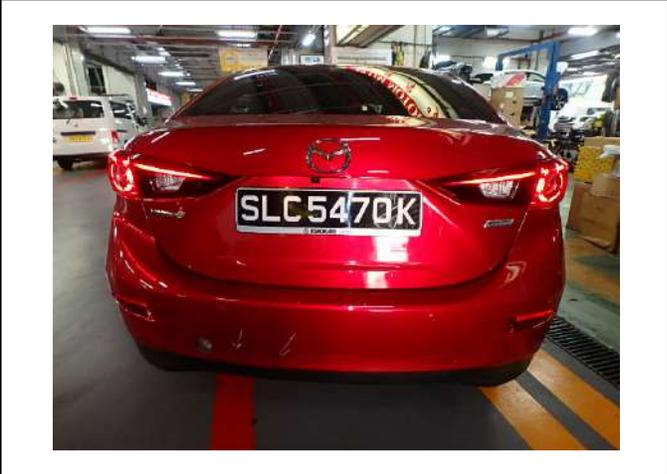
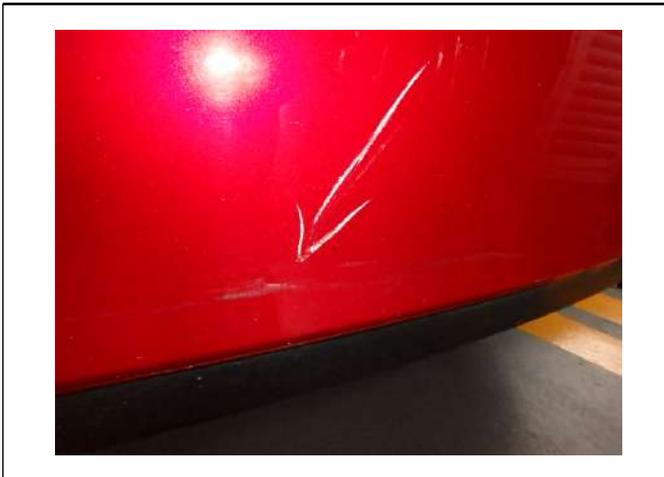
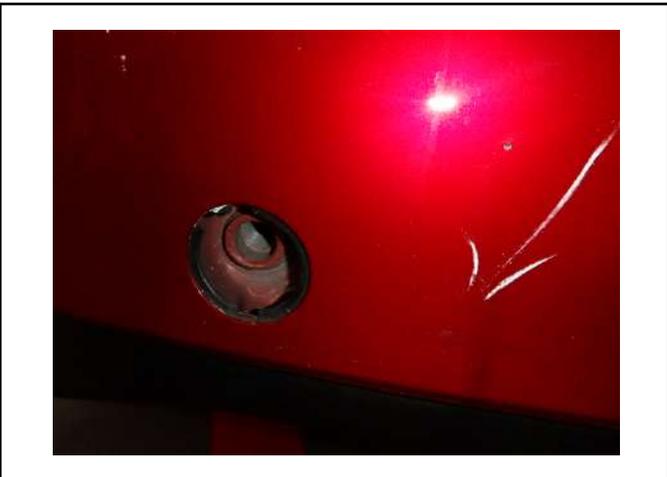
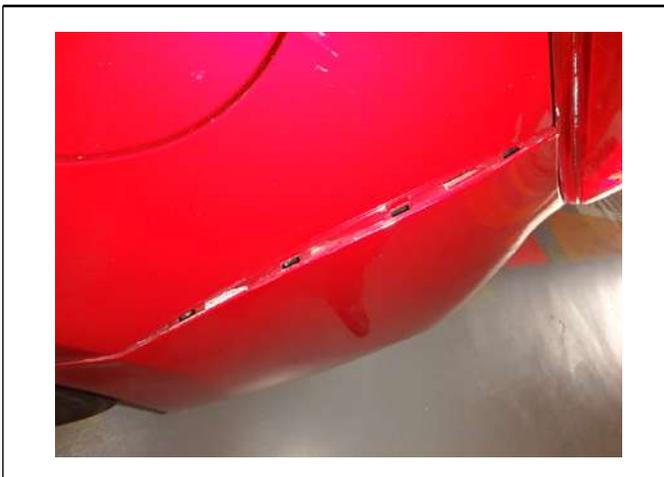
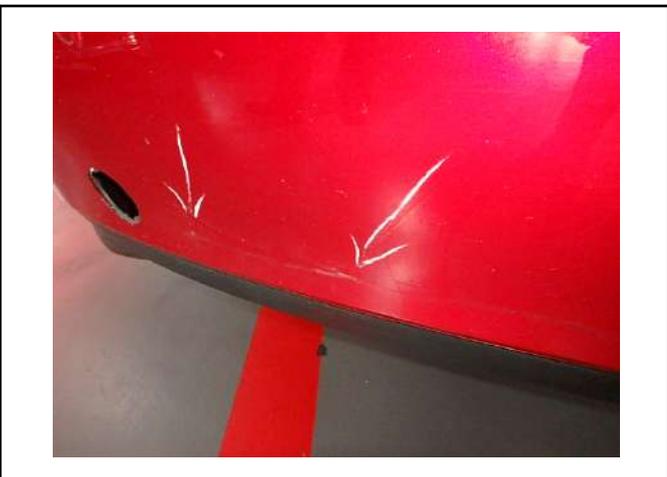
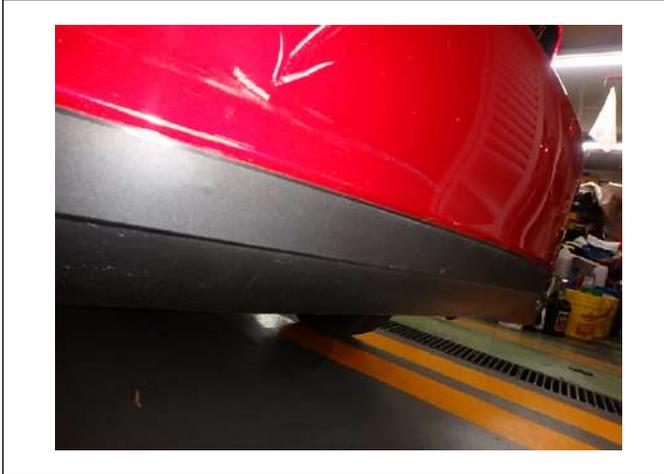
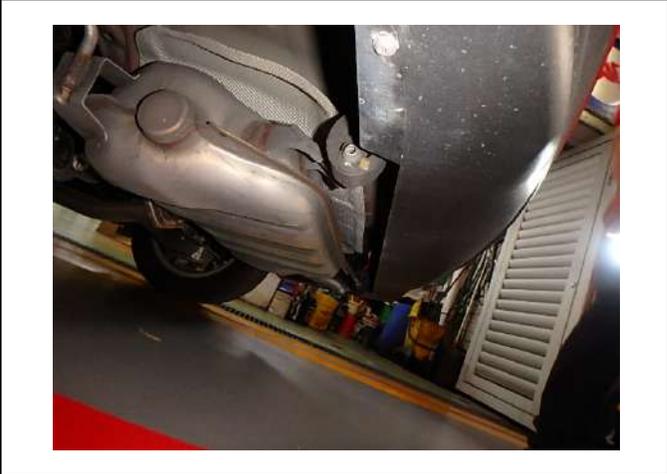
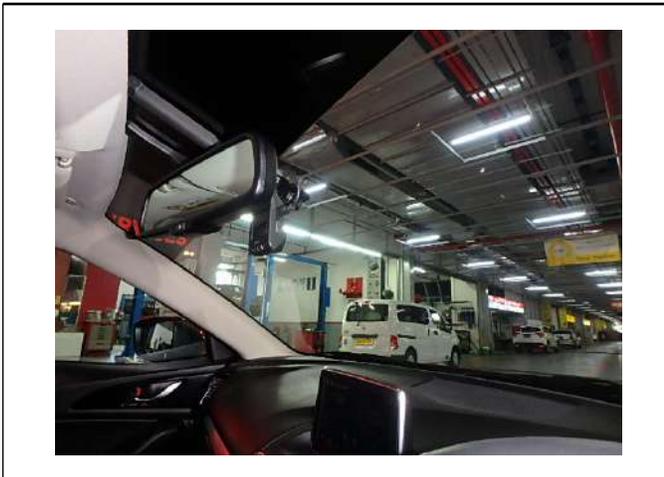
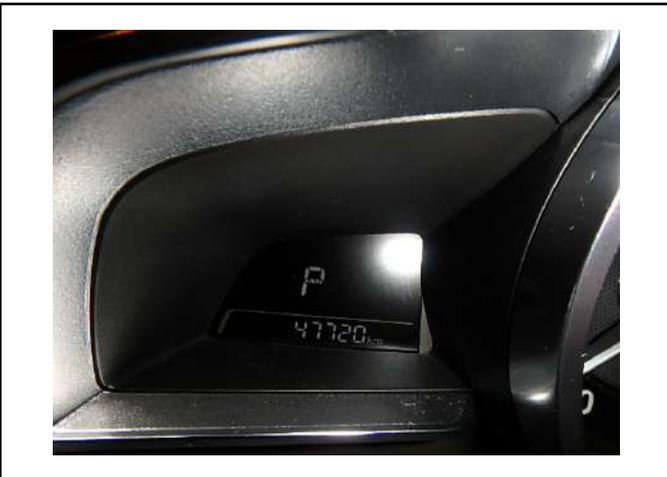
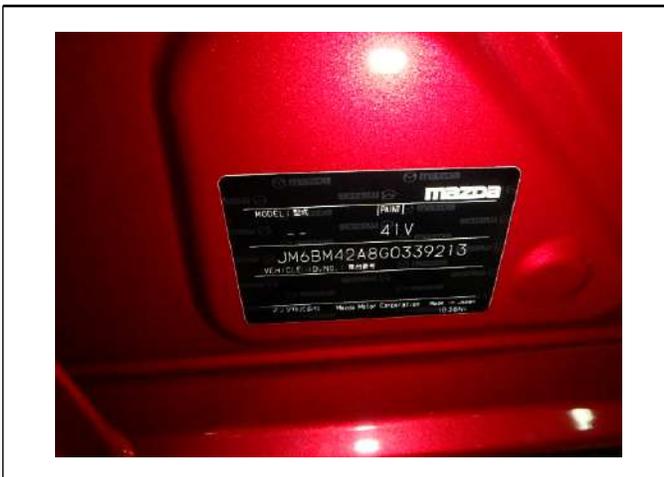
4. Description of Damages			
THE VEHICLE SUSTAINED DAMAGES AT THE REAR PORTION. DAMAGES SEE DETAILS.			
5. General Information			
Accident Date	28/09/2020	Inspection Date	02/10/2020
Survey held at	AH LIM MOTOR COMPANY NO 10 ANG MO KIO IND PK 2A #01-09 AMK AUTOPOINT SINGAPORE 568047		
5a. Remarks			
A)THE INSPECTION WAS CONDUCTED ON A"WITHOUT PREJUDICE" BASIS. B)IN ACCORDANCE TO YOUR INSTRUCTIONS, WE HAVE NOT AUTHORISED REPAIRS.			
5b. Estimate Days of Repair			
ESTIMATED NORMAL PERIOD FOR REPAIR:		2 Working Days

Qty	Description of Parts	Condition	Estimate By Workshop (\$)	Our Adjusted (\$)
REPLACEMENT OF PARTS				
1	REAR BUMPER	BUCKLED / DENTED	996.70	996.70
1	REAR BUMPER TOW COVER LH	MISSING	16.50	16.50
1	REAR BUMPER SIDE RETAINER LH	CRACKED	38.00	38.00
12	REAR BUMPER CLIPS	NECESSARY	36.00	36.00
1	REAR BUMPER REINFORCEMENT	BENT	564.20	564.20
2	REVERSE SENSOR INNER LH & RH	SERVICEABLE	407.20	-
1	REVERSE SENSOR HOLDER	SERVICEABLE	72.80	-
1	REAR BOOT LOCK	TO REPAIR SEE LABOUR	160.70	-
1	REAR FENDER COWLING LH	SERVICEABLE	153.10	-
4	REAR FENDER COWLING CLIPS	NOT NECESSARY	12.00	-
1	TAILAMP LH	SERVICEABLE	866.80	-
	LESS 20% DISCOUNT		-664.80	-330.28
			2,659.20	1,321.12
LABOUR				
	TO DISCONNECT AND CHECK ELECTRICAL WIRING ,WIRE SOCKETS AND ETC .TO REMOVE AND REINSTALL DAMAGED ELECTRICAL UNITS ,TEST AND RECTIFY FOR PROPER FUNCTIONING .		40.00	10.00
	TO REMOVE AND REINSTALL /REPLACE FRONT /REAR BUMPER SENSORS.		60.00	50.00

TO SPRAY ANTI-RUST COATING ON AFFECTED AREAS.	NOT NECESSARY	60.00	-
	TO DISMANTLE ALL DAMAGED PARTS .TO CUT & WELD ,TO KNOCK & REPAIR END PANEL ,RR FENDER LH INNER PANELS AND AFFECTED AREAS .TO REFIT LISTED PARTS BACK SAME.INCLUSIVE OF THE REPAIR OF REAR BOOT LOCK .		500.00	200.00
	TO SPRAY REAR BUMPER ,REAR FENDER LH ,AND PANEL.		600.00	220.00
			1,260.00	480.00
GRAND TOTAL			3,919.20	1,801.12
