Your Ref: Mercedes Benz C43
(chassis number WDD2050642R505232)
Our Ref : CI/TP20010580/D

01 October 2020

**INSPECTION REPORT OF AN UNREGISTERD MERCEDES BENZ C43
MOTOR CAR WITH CHASSIS NUMBER WDD2050642R505232**

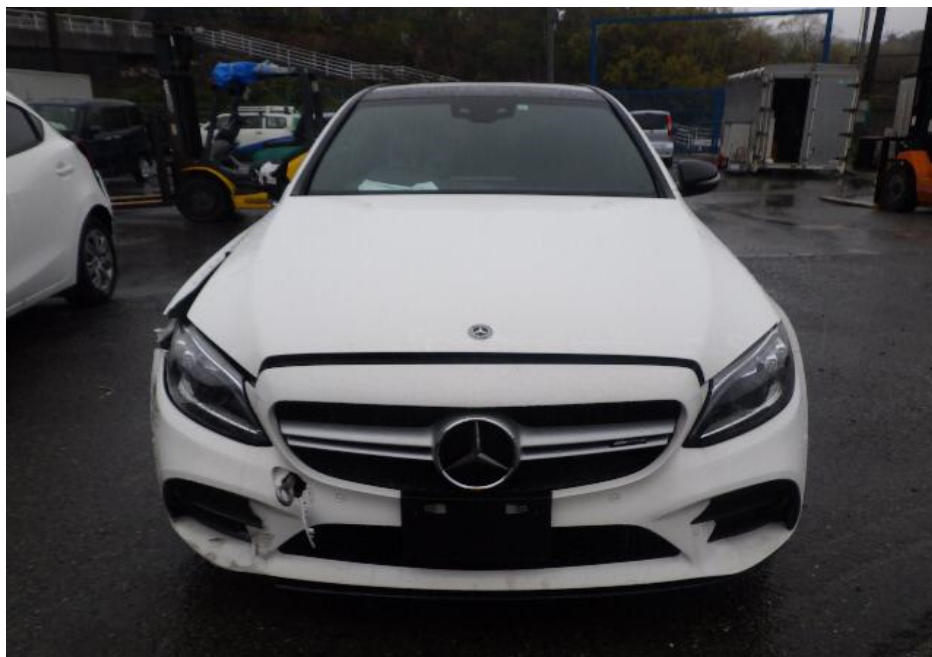
Photo 1 shows the frontal portion of the Motor Car prior to any repairs being carried out (photograph provided to me). The Motor Car was observed to have sustained damages at its front right portion. Body parts observed to have been damaged include its front bumper and front right fender.

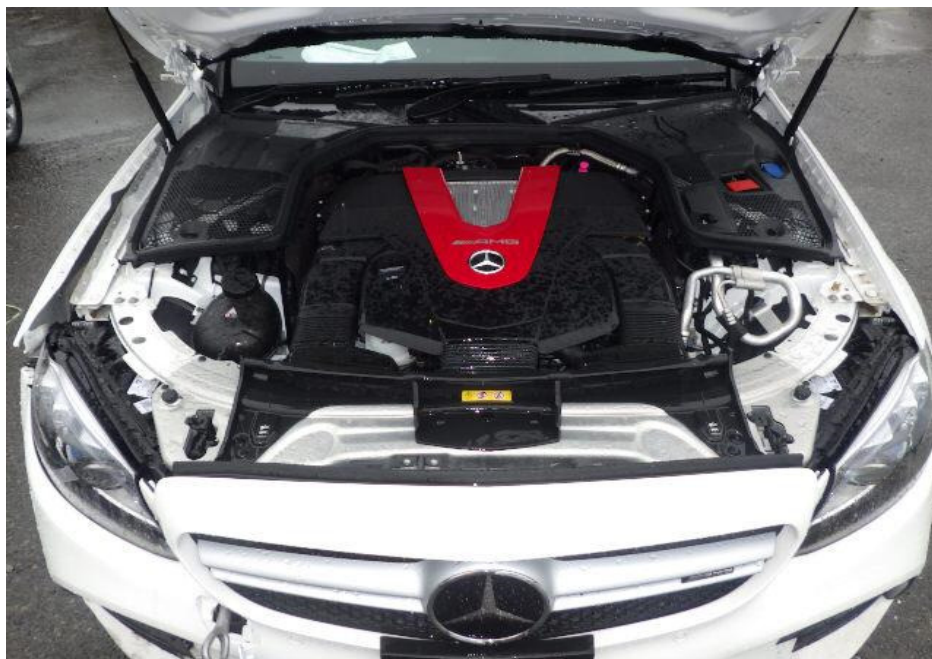
Photo 2 shows the engine compartment of the Motor Car prior to any repairs being carried out (photograph provided to me). There appears to be no damage to part(s) and component(s) within the engine compartment of the Motor Car.

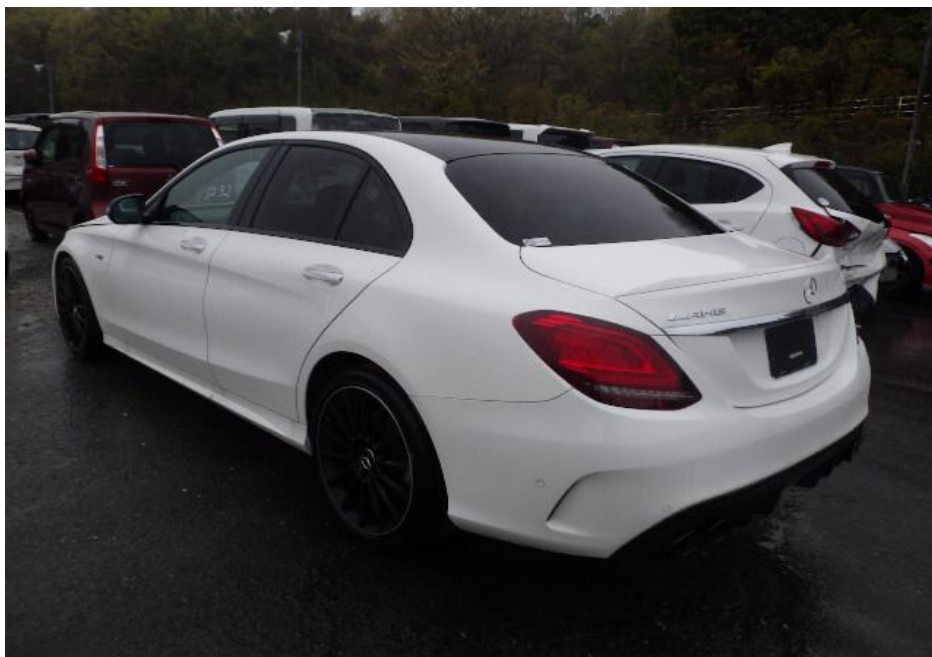
Photo 3 shows the left rear body of the Motor Car prior to any repairs being carried out (photograph provided to me). In general, my examination of the photographs provided had indicated that the Motor Car had sustained damages that were confined to its front right portion. The airbags of the Motor Car were also not activated.

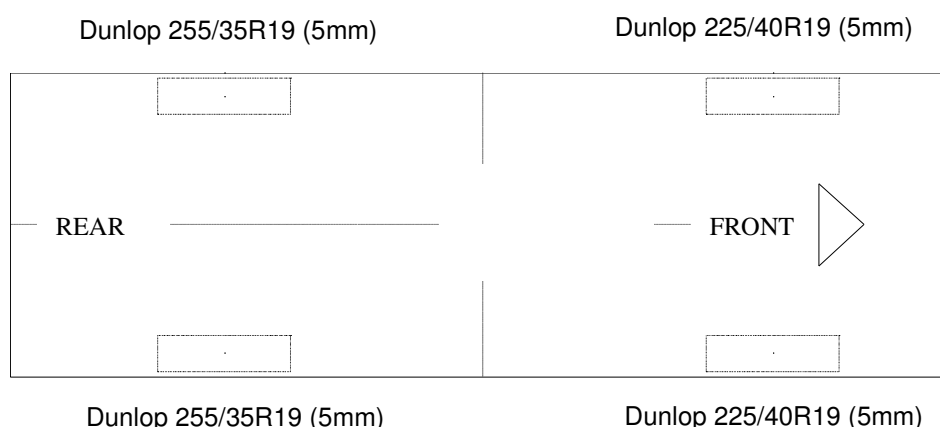
8. It was fitted with 19inch sport wheel rims that were wrapped with tyres that were observed to be of serviceable condition. The tyres were also sufficiently inflated for vehicular operation. The tyre brand, tyre size and approximate remaining tread depth of the 4 tyres of the Motor Car were recorded as follows: -

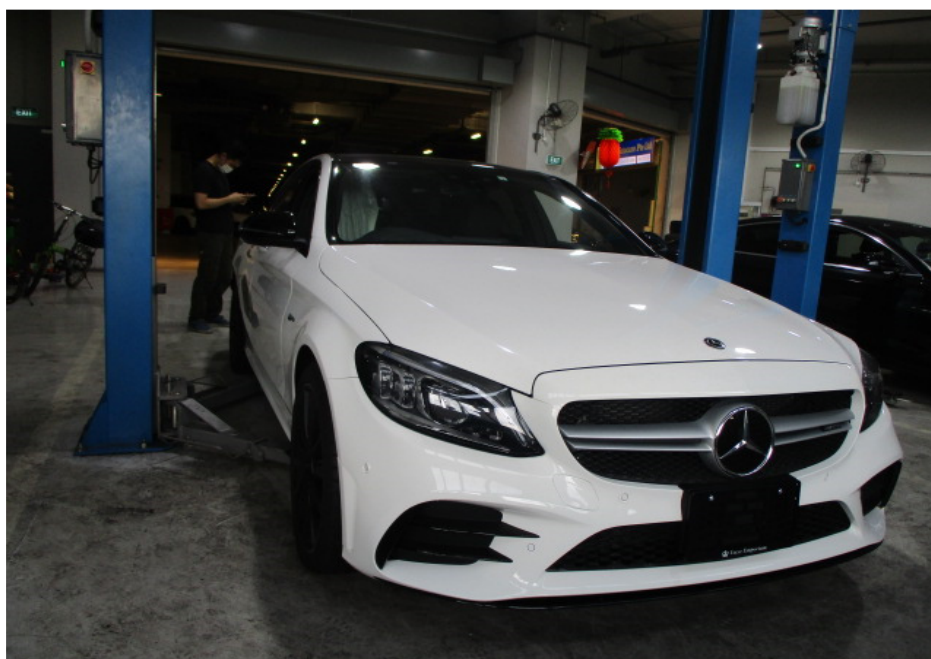
Photo 4 shows a general view of the front right body of the Motor Car at the time of my inspection. The Motor Car was observed to be in a relatively good general condition with no loose exterior fittings observed. The body parts at the front right portion of the Motor Car were visually examined and it was observed that the repair/restoration works carried out to the damaged area of the Motor Car (refer photograph 1 above) were reasonably adequate and in order.

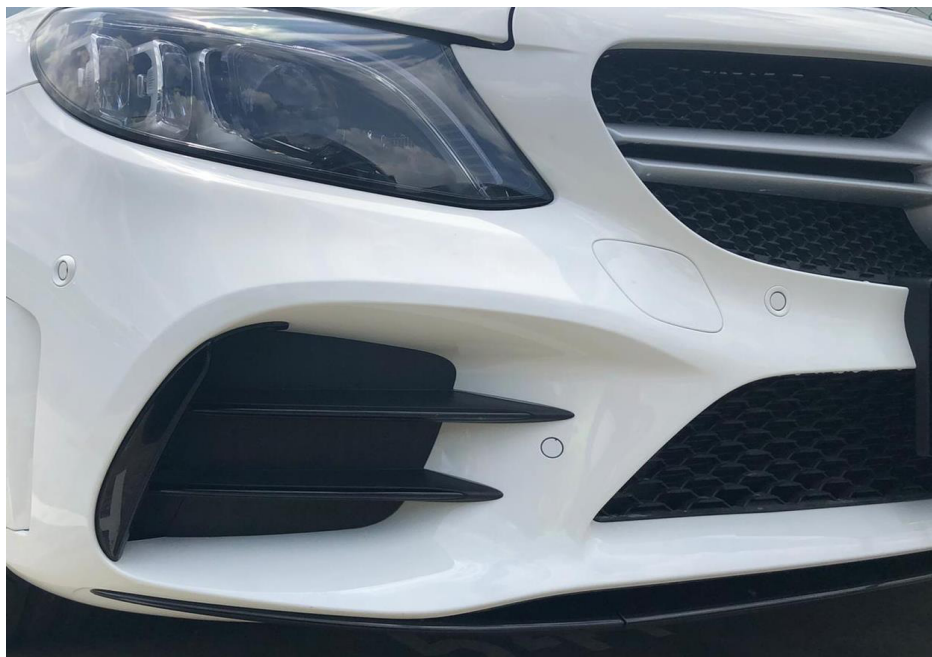
Photo 5 shows a closer view of the front right portion of the Motor Car. The body parts at the front right portion of the Motor Car were visually examined and it was observed that the repair/restoration works carried out to the damaged area of the Motor Car (refer photograph 1 above) were reasonably adequate and in order

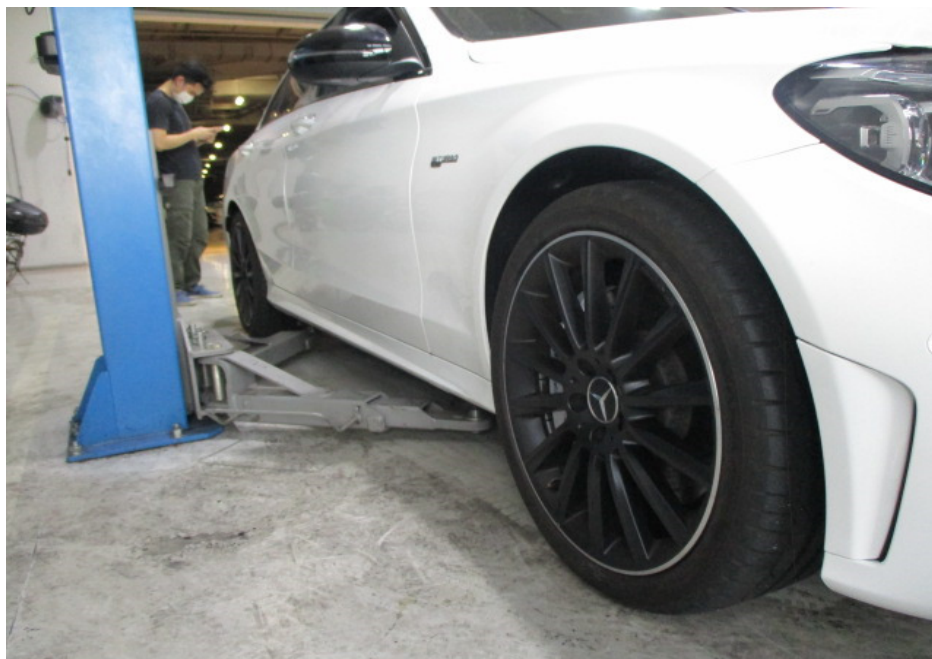
Photo 6 shows a closer view of the front right portion of the Motor Car. The body parts at the front right portion of the Motor Car were visually examined and it was observed that the repair/restoration works carried out to the damaged area of the Motor Car (refer photograph 1 above) were reasonably adequate and in order

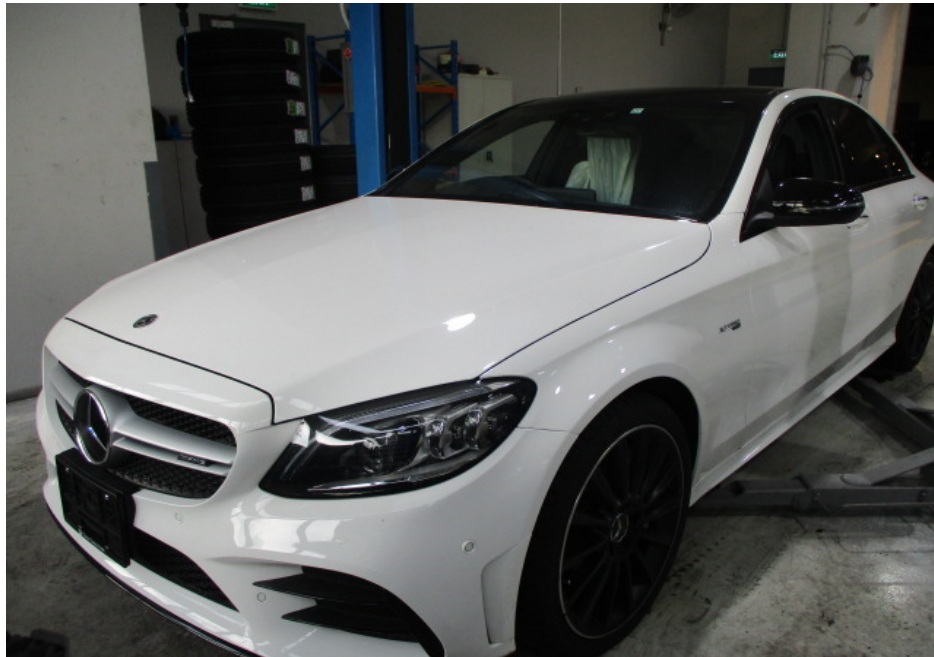
Photo 7 shows a general view of the front left body of the Motor Car at the time of my inspection. The Motor Car was observed to be in a relatively good general condition with no loose exterior fittings observed.

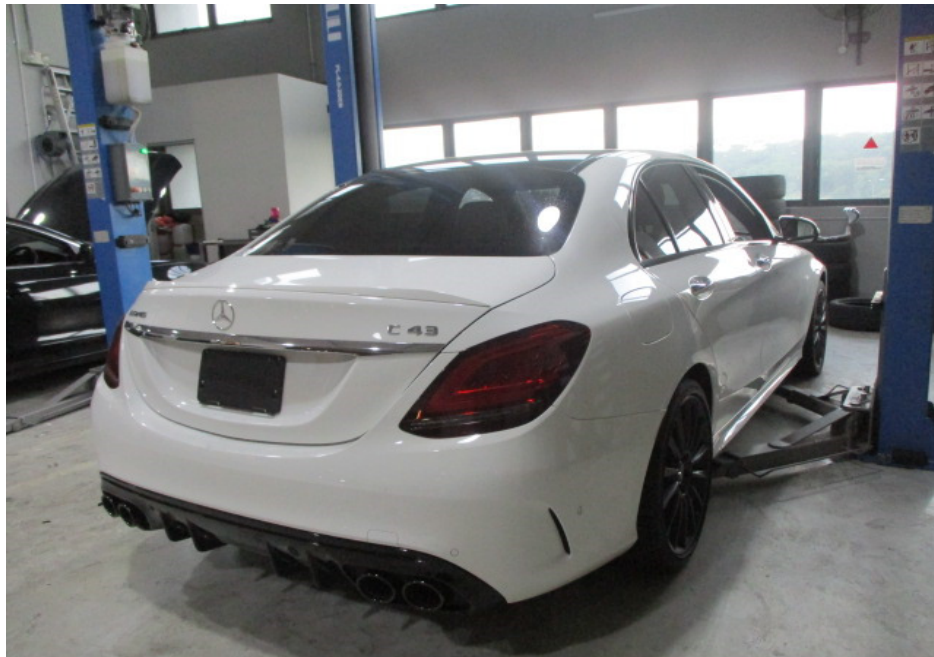
Photo 8 shows a general view of the rear right body of the Motor Car at the time of my inspection. The Motor Car was observed to be in a relatively good general condition with no loose exterior fittings observed. The mileage of the Motor Car recorded at the time of my inspection was 2,435km.

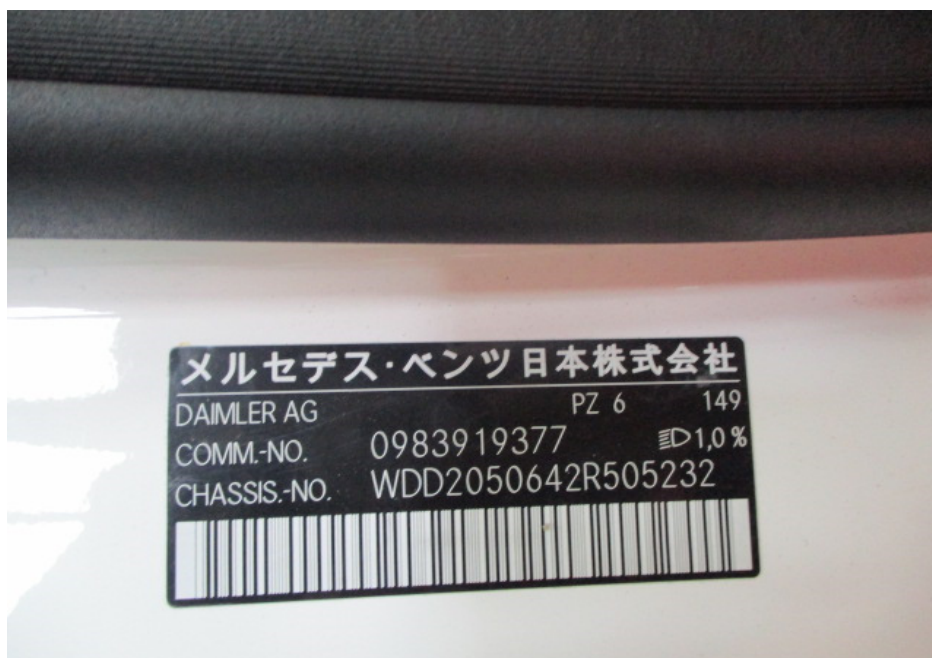
Photo 9 shows the chassis number of the Motor Car. The chassis number recorded was WDD2050642R505232.

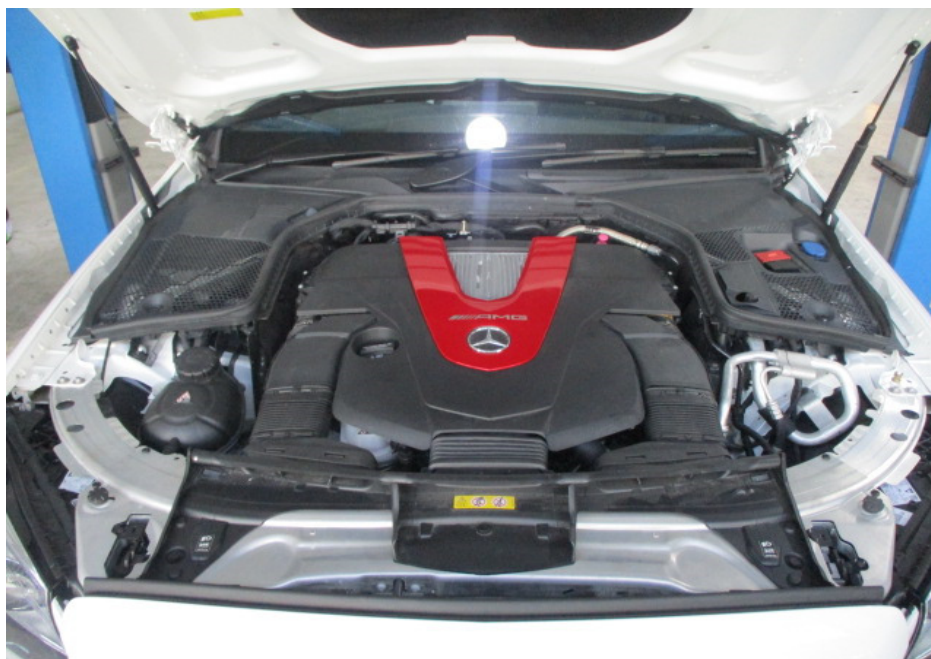
14. My examination of the engine compartment of the Motor Car revealed that the various parts and components inside the engine compartment were all intact and properly fitted. The engine oil, brake fluid and engine coolant were all found to be of sufficient level for operating purposes. Visually, there was also no contamination found to these fluids.
15. My checks on the underside of the Motor Car revealed no sign(s) or indication(s) of fluid leakage and/or fluid stain(s). The engine block and automatic transmission assembly were both secured properly. They were not mounted onto the chassis/structural body or any integral body part of the Motor Car. All undercarriage components of the Motor Car were also observed to be intact and secured in an appropriate manner.

Photo 10 shows a general view of the engine compartment of the Motor Car at the time of my inspection. The various parts and components inside the engine compartment were all observed to be intact and properly fitted. There was also no sign(s) or indication(s) of fluid leak and/or fluid stain found inside the engine compartment.

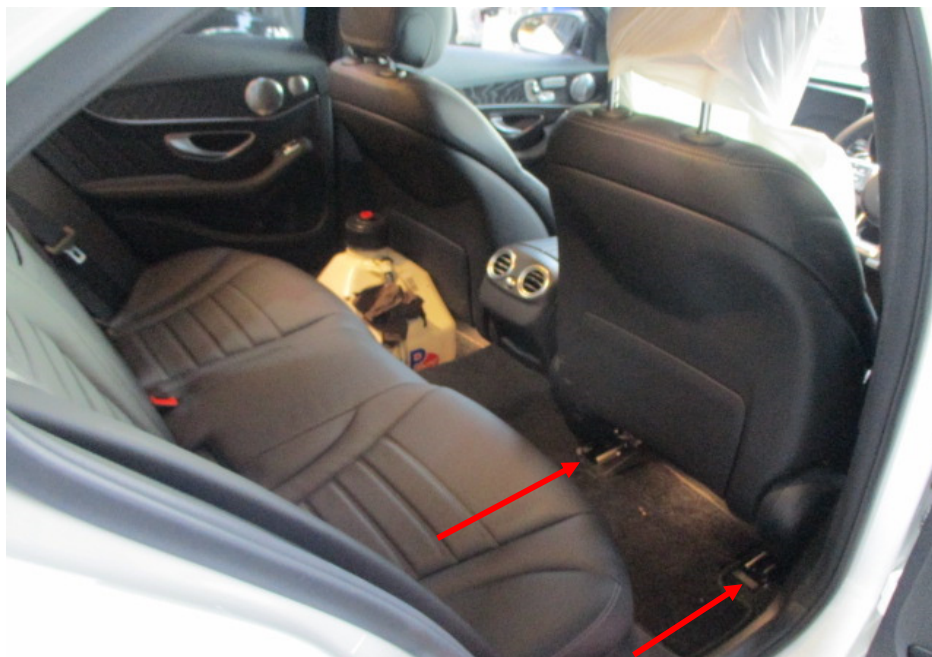
12. The seats of the Motor Car were found to be secured to the floorboard of the Motor Car via seat rails bolted onto the floorboard. Retractable seat belt reels and pre-tensioners were fitted on all seats of the Motor Car. The seat belt reels were tested and were able to be fastened securely into the respective pre-tensioners that were fixed to the side of all the seats.

Photo 11 shows the seats of the Motor Car, which were secured via seat rails (arrowed) to the floorboard. All the seats of the Motor Car were fitted with a retractable seat belt reel and pre-tensioner. The seat belt reels were tested and able to be fastened into the respective pre-tensions that were fitted on the side of each individual seat.

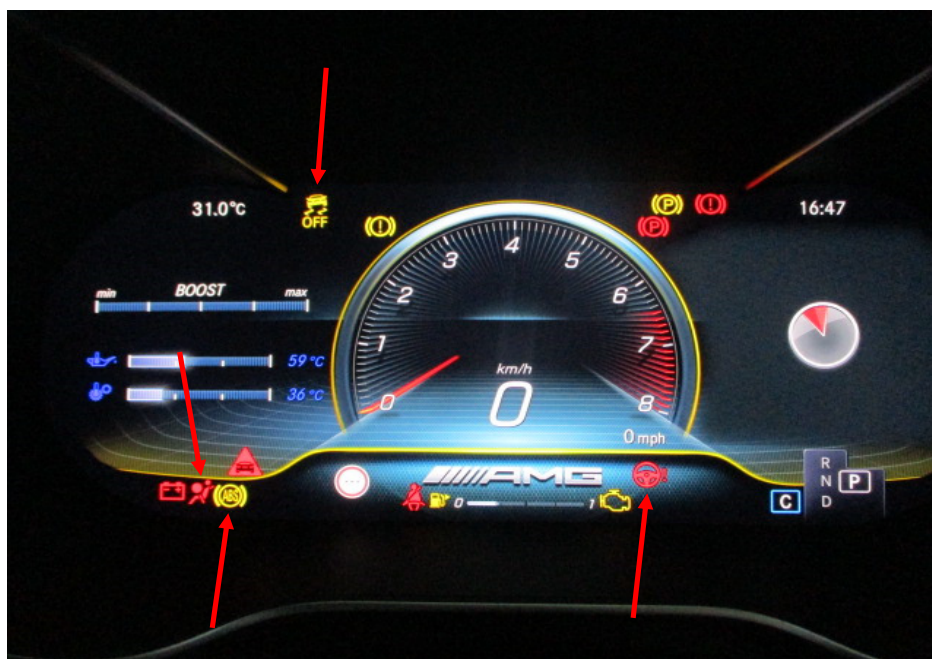
Photo 12 shows the warning lights for the various electronic safety features appearing on the instrument panel of the Motor Car during its self-test when the engine is cranked, in particular the ABS, SRS, EPS and ESP lights (arrowed).

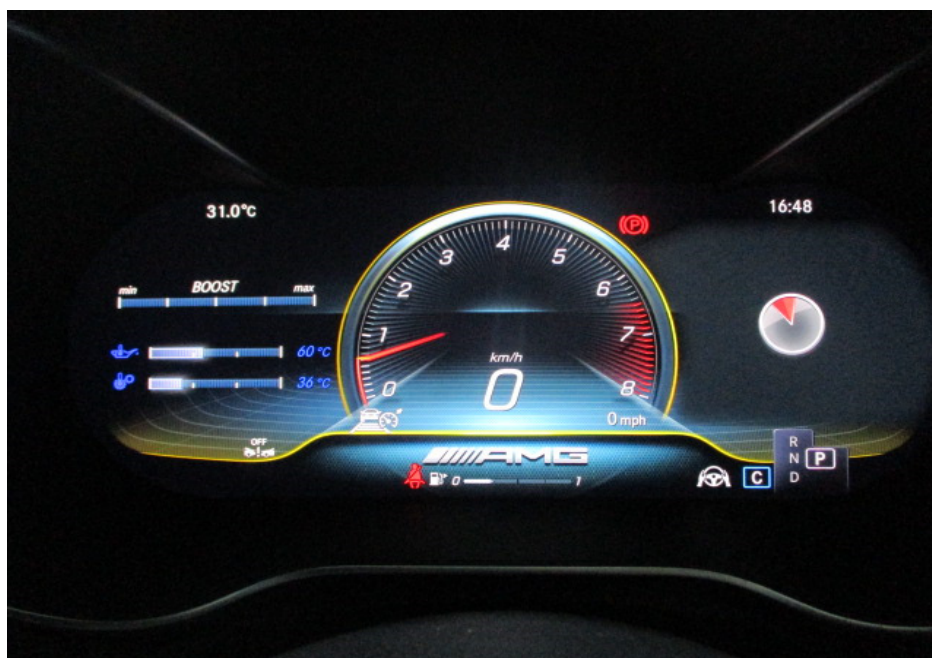
13. The Motor Car's automatic self-test of the functionality of its various electronic safety features like the Anti-Lock Brake System (ABS), Supplemental Restraint System (SRS), Electric Power Steering (EPS) and Electronic Stability Program (ESP) during cranking of the engine had indicated that these electronic systems were in working condition. This was determined from the respective warning lights disappearing from the instrument panel after the self-test.

Photo 13 shows the respective warning lights no longer illuminated, indicating that there is no fault detected to the ABS, SRS, EPS and ESP systems of the Motor Car during the self-test. These electronic systems were hence in working condition at the time of my inspection.

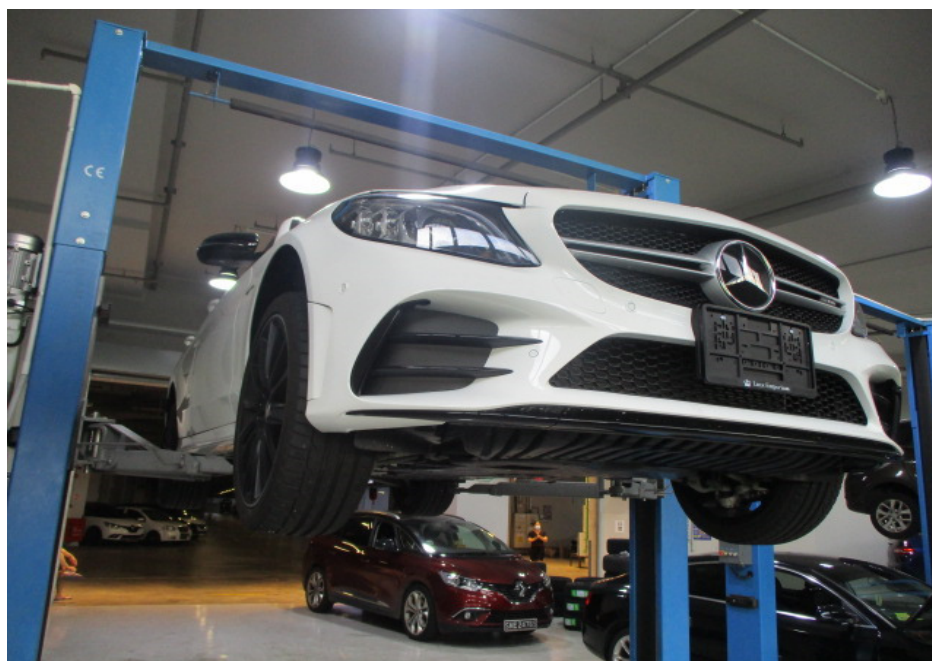
Photo 14 shows the Motor Car hoisted up for checks on its undercarriage. There was no sign(s) or indication(s) of fluid leakage and/or fluid stain(s) on the underside of the Motor Car. The undercarriage components of the Motor Car were also all observed to be intact and secured in an appropriate manner.

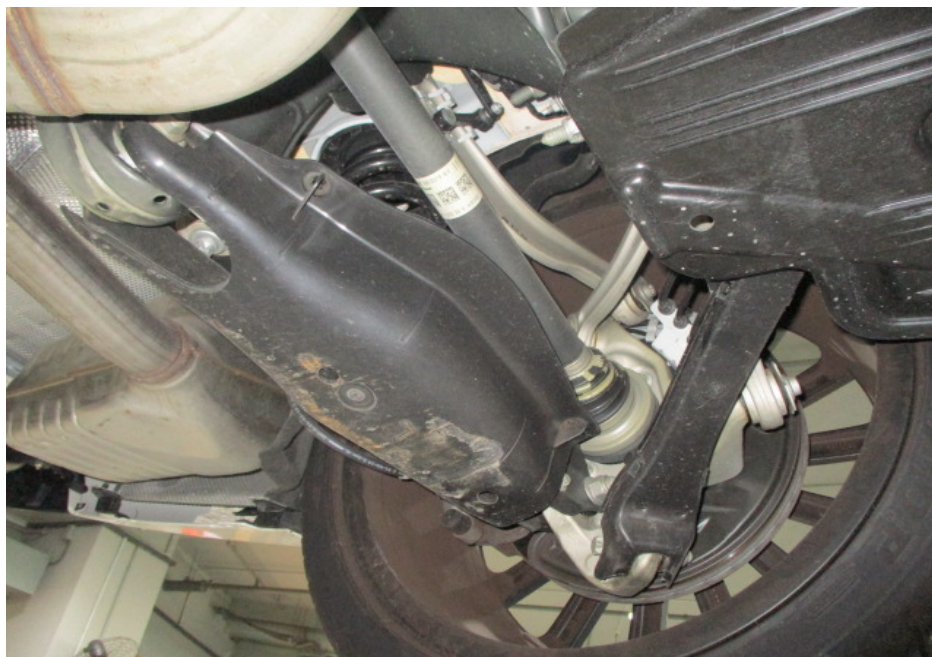
Photo 15 shows a general view of the control arms and linkages at the rear left wheel of the Motor Car. I did not observe any fluid leak and/or fluid stain on the underside of the Motor Car. All of the Motor Car's undercarriage components were observed to be intact and secured in an appropriate manner.

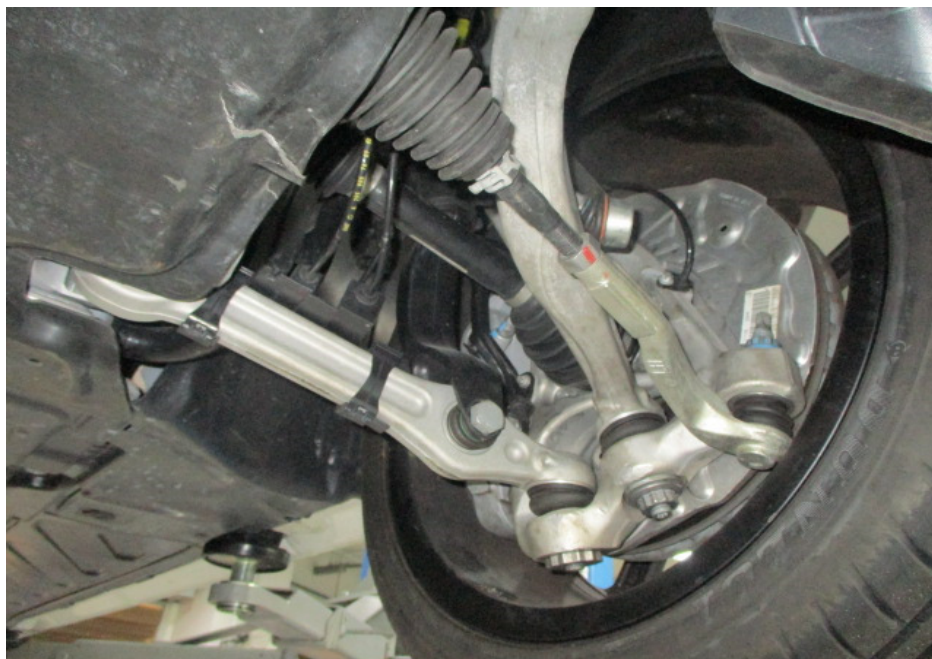
Photo 16 shows the various undercarriage components at the front left wheel of the Motor Car. The mechanical components, control arms and linkages were all found to be intact and secured in an appropriate manner.

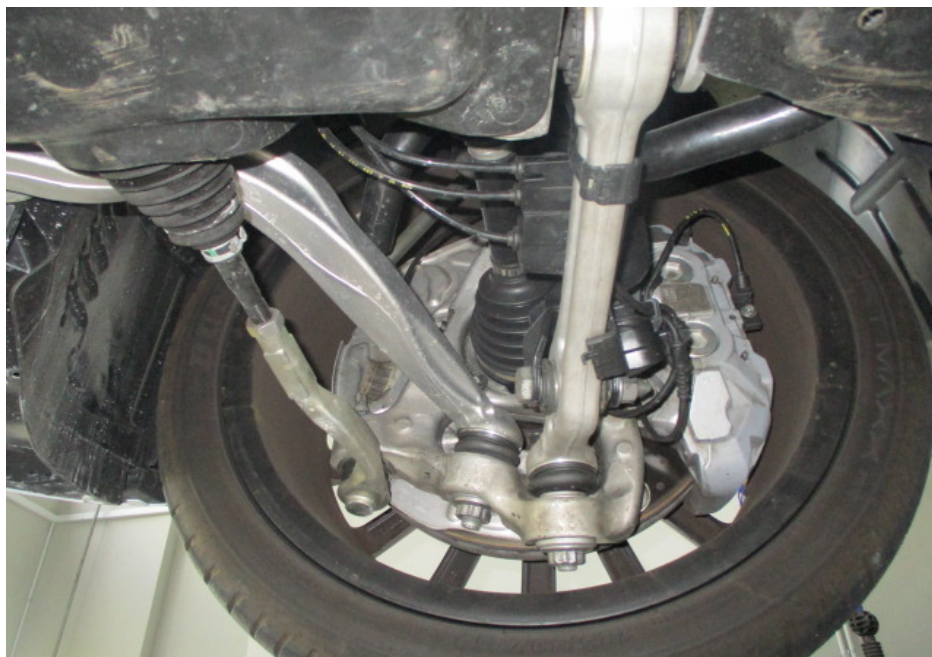
Photo 17 shows the various undercarriage components at the front right wheel of the Motor Car. The mechanical components, control arms and linkages were all found to be intact and secured in an appropriate manner. I also did not observe any fluid leak and/or fluid stain on the underside of the Motor Car.

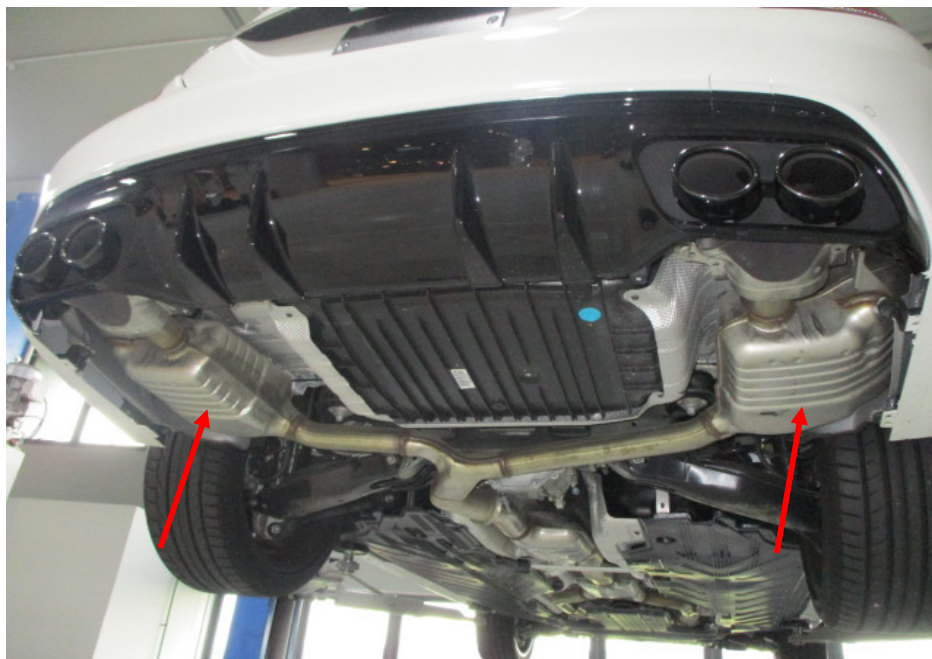
Photo 18 shows the Motor Car's rear mufflers (arrowed). My examination of the Motor Car's exhaust system revealed no sign(s) or indication(s) of any cut or weld marks along its exhaust pipes and on its catalytic converters.

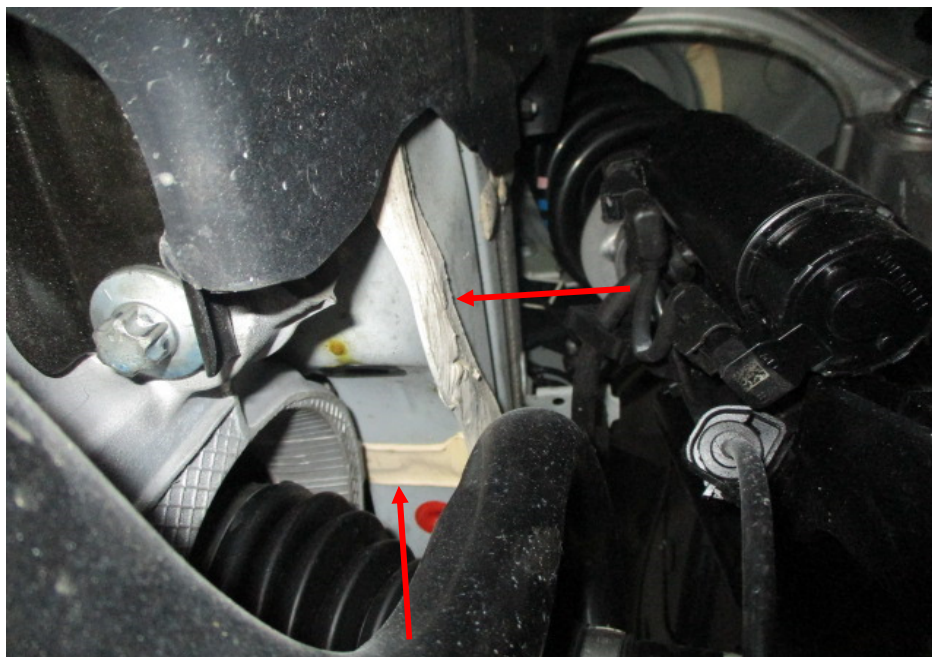
11. Visually, I did not find any weld marks, other than the original spot weld marks, on the chassis/structural body of the Motor Car. The original factory sealant at the joints along the chassis/structural body was also untouched, again indicating that no replacement of the chassis/structural body was carried out; and that the chassis/structural body was originally fitted.

Photo 19 shows the chassis/structural body at the underside front right of the Motor Car. Visually. The original factory sealant (arrowed) at the joints along the chassis/structural body was observed to be untouched, indicating no work was done on the chassis/structural body of the Motor Car and that the chassis/structural body was originally fitted.

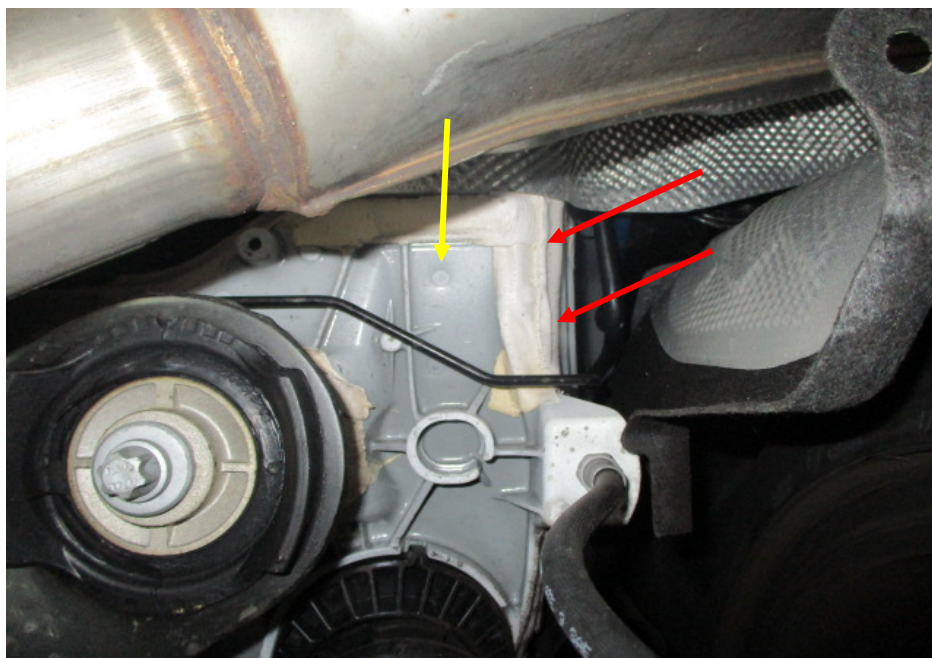
Photo 20 shows the chassis/structural body at the underside rear right of the Motor Car. Visually. I did not find any weld marks other than original spot weld marks (yellow arrow) on the chassis/structural body of the Motor Car. The original factory sealant (red arrow) at the joints along the chassis/structural body was also untouched, indicating no work was done on the chassis/structural body of the Motor Car and that the chassis/structural body was originally fitted.

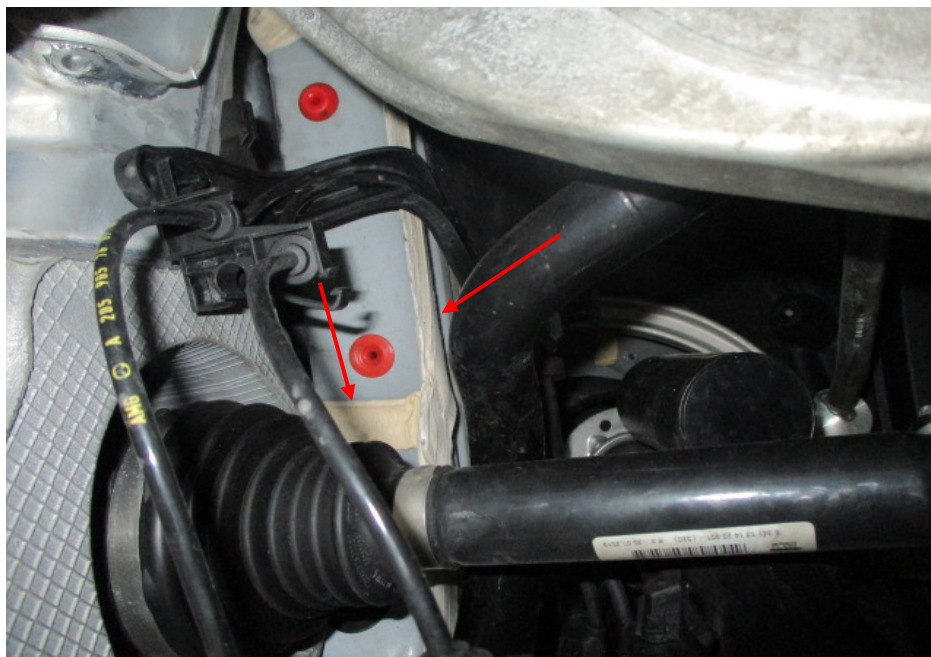
Photo 21 shows the chassis/structural body at the underside front left of the Motor Car. Visually. The original factory sealant (arrowed) at the joints along the chassis/structural body was observed to be untouched, indicating no work was done on the chassis/structural body of the Motor Car and that the chassis/structural body was originally fitted.
