Your Ref: BMW M5  
(chassis number WBSJF02020GA04800)  
Our Ref : CI/TP20010581/D

01 October 2020

**INSPECTION REPORT OF AN UNREGISTERED BMW M5 MOTOR CAR WITH CHASSIS NUMBER WBSJF02020GA04800**

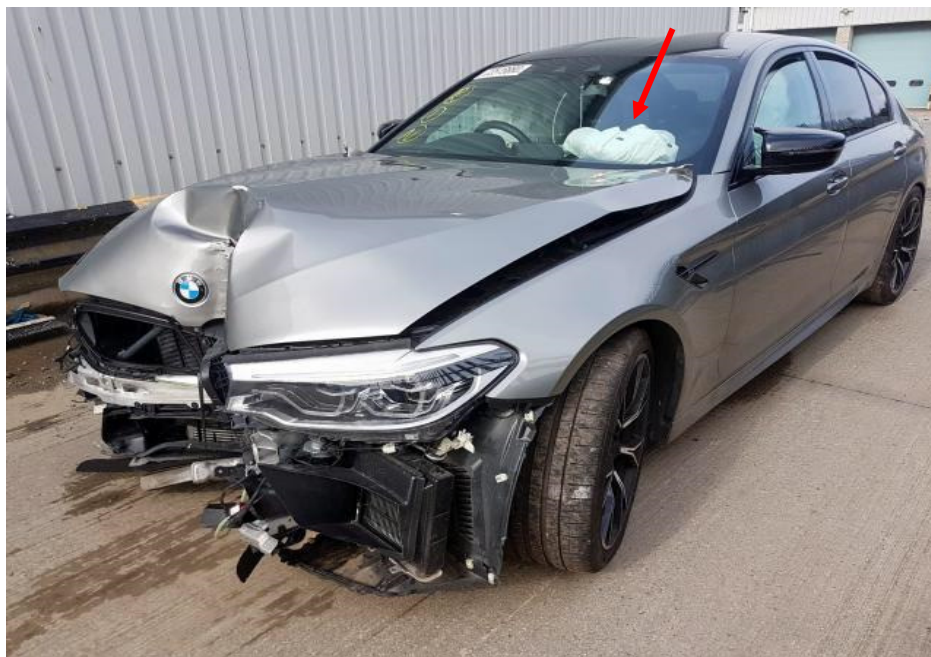
3. From the photographs provided to me, it was observed that the Motor Car had sustained damages at its frontal portion. Body parts observed to have been damaged include the front bumper, front right fender, front bonnet, front bonnet lock, front headlamps, front grille, front bumper reinforcement, front support panel, oil cooler, radiator and aircon condenser amongst others.
4. It was also observed from the photographs provided that the front left passenger airbag was deployed. The rear portion, right side and left side of the Motor Car were unaffected as seen from the photographs that were provided to me. See photo 1 – 3 below.

**Photo 1** shows the front left body of the Motor Car prior to any repairs being carried out (photograph provided to me). The Motor Car was observed to have sustained damages at its frontal portion. The body parts observed to be damaged had included the front bumper, front bonnet and front left headlamp amongst others. The front left passenger airbag was also observed to be deployed (arrowed).

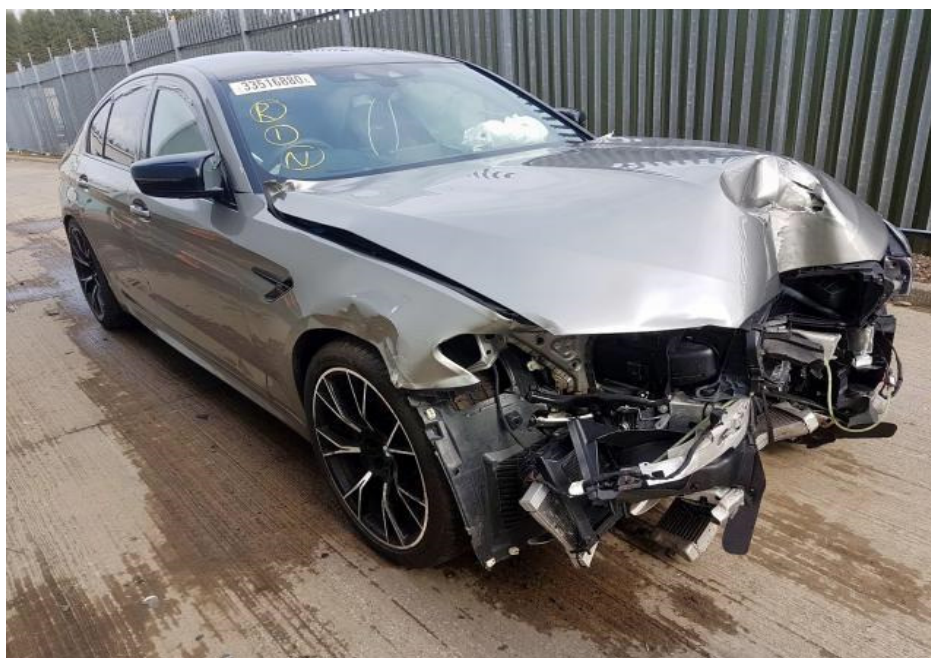
**Photo 2** shows the front right body of the Motor Car prior to any repairs being carried out (photograph provided to me). The Motor Car was observed to have sustained damages at its frontal portion. The body parts observed to be damaged had included the front bumper, front bonnet, front right headlamp and front right fender amongst others.

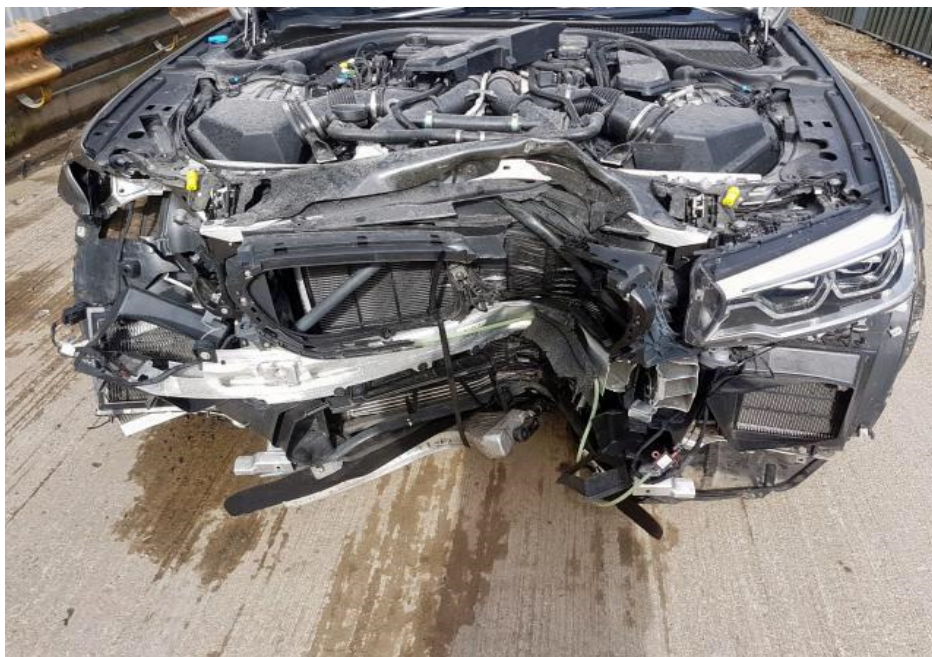
**Photo 3** shows the engine compartment of the Motor Car prior to any repairs being carried out (photograph provided to me). As seen from the photographs provided, the front grille, front bumper reinforcement, oil cooler, radiator, aircon condenser and front support panel were amongst the parts that were observed to be damaged.

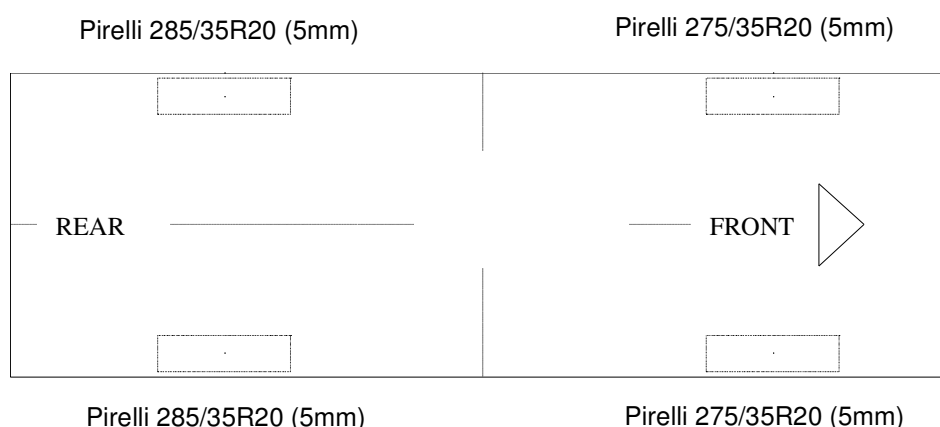
8. It was fitted with 20inch sport wheel rims that were wrapped with tyres that were observed to be of serviceable condition. The tyres were also sufficiently inflated for vehicular operation. The tyre brand, tyre size and approximate remaining tread depth of the 4 tyres of the Motor Car were recorded as follows: -

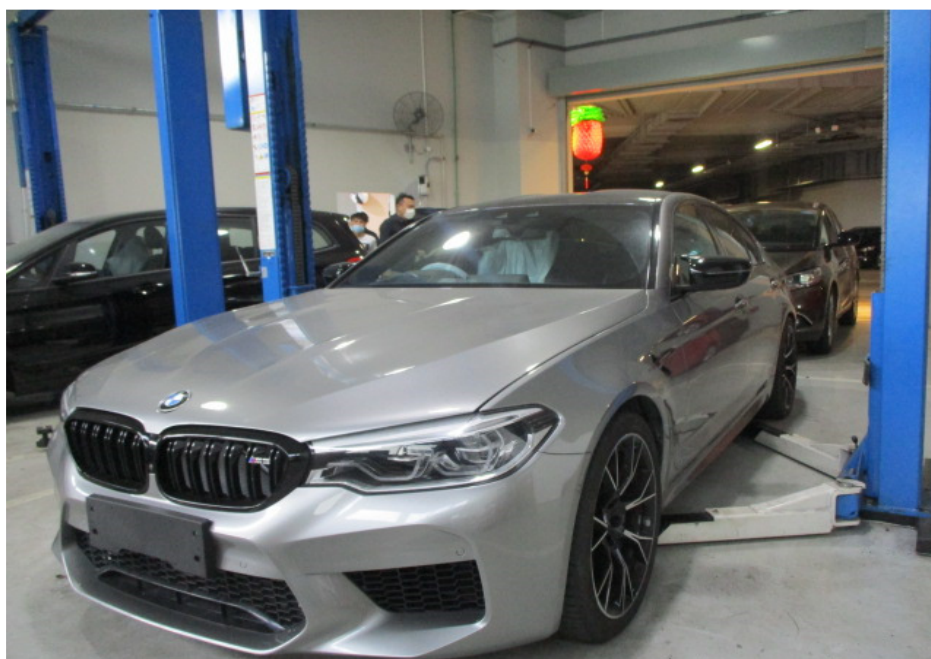
**Photo 4** shows a general view of the front left body of the Motor Car at the time of my inspection. The Motor Car was observed to be in relatively good general condition with no loose exterior fittings observed. The body parts at the frontal portion of the Motor Car were visually examined and it was observed that the repair/restoration works carried out to the damaged area of the Motor Car (refer photograph 1 & 2 above) were reasonably adequate and in order.

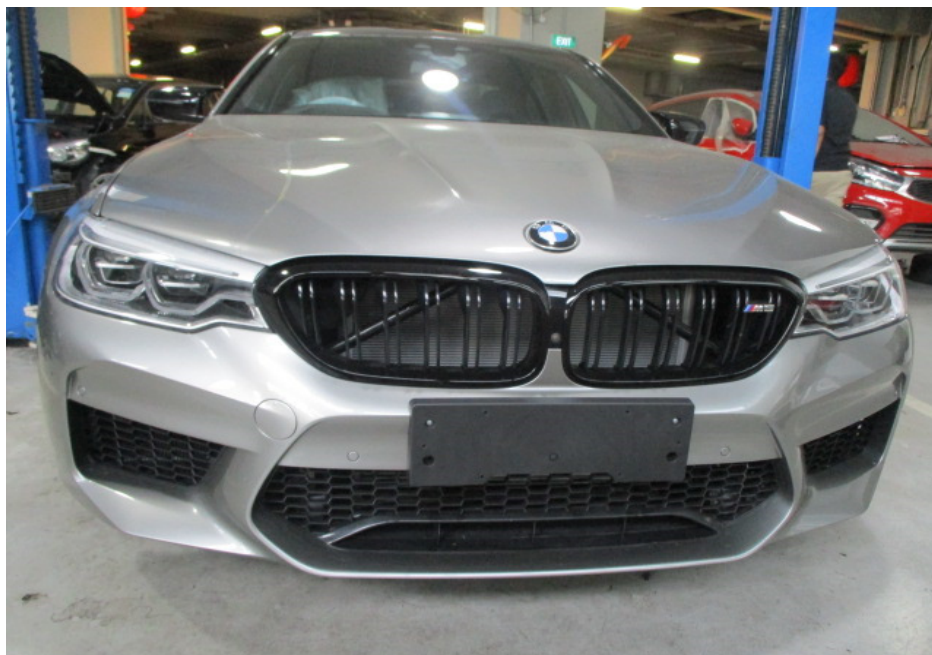
**Photo 5** shows a closer view of the frontal portion of the Motor Car at the time of my inspection. The body parts at the frontal portion of the Motor Car were visually examined and it was observed that the repair/restoration works carried out to the damaged area of the Motor Car (refer photograph 1 & 2 above) were reasonably adequate and in order.

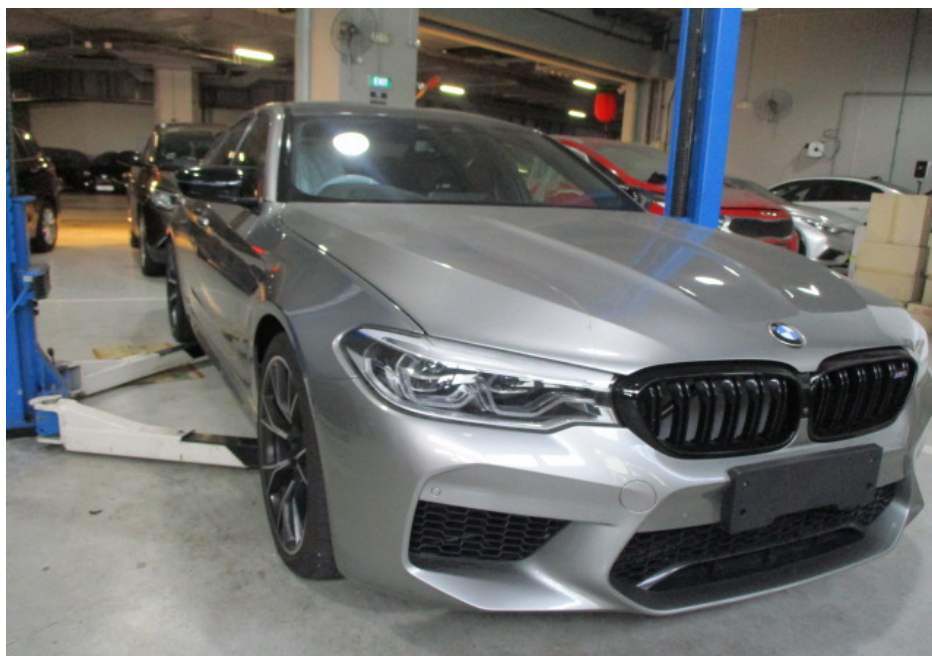
**Photo 6** shows a general view of the front right body of the Motor Car at the time of my inspection. The Motor Car was observed to be in relatively good general condition with no loose exterior fittings observed. The body parts at the frontal portion of the Motor Car were visually examined and it was observed that the repair/restoration works carried out to the damaged area of the Motor Car (refer photograph 1 & 2 above) were reasonably adequate and in order.

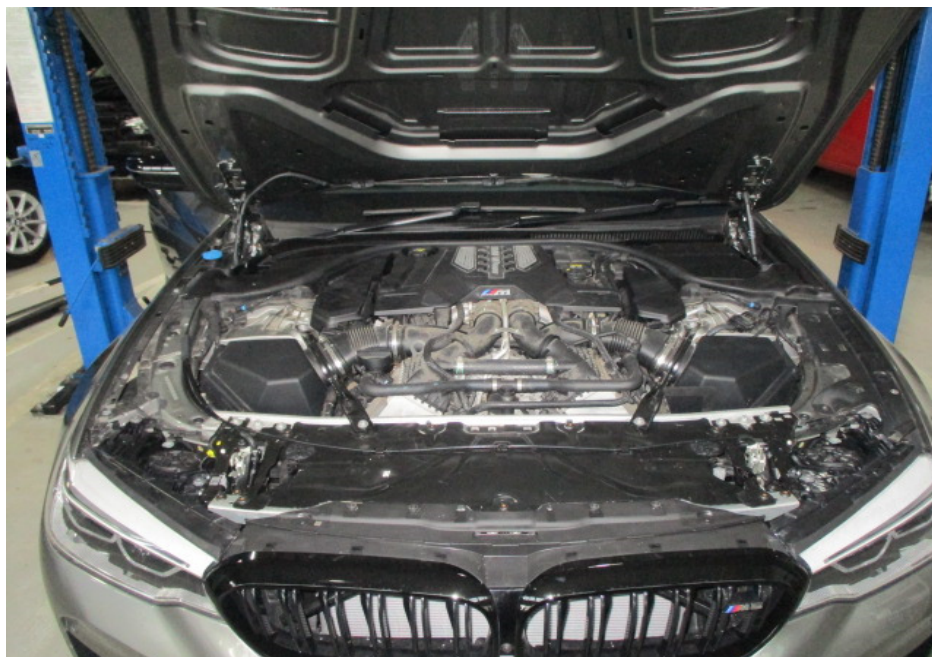
**Photo 7** shows a general view of the engine compartment of the Motor Car at the time of my inspection. The damaged parts and components within the engine compartment of the Motor Car (refer photograph 3 above) were visually examined and it was observed that the repair/restoration works carried out were reasonably adequate and in order. Overall, I had found the various parts and components inside the engine compartment to be intact and properly fitted. There was also no sign(s) or indication(s) of fluid leak and/or fluid stain found inside the engine compartment.

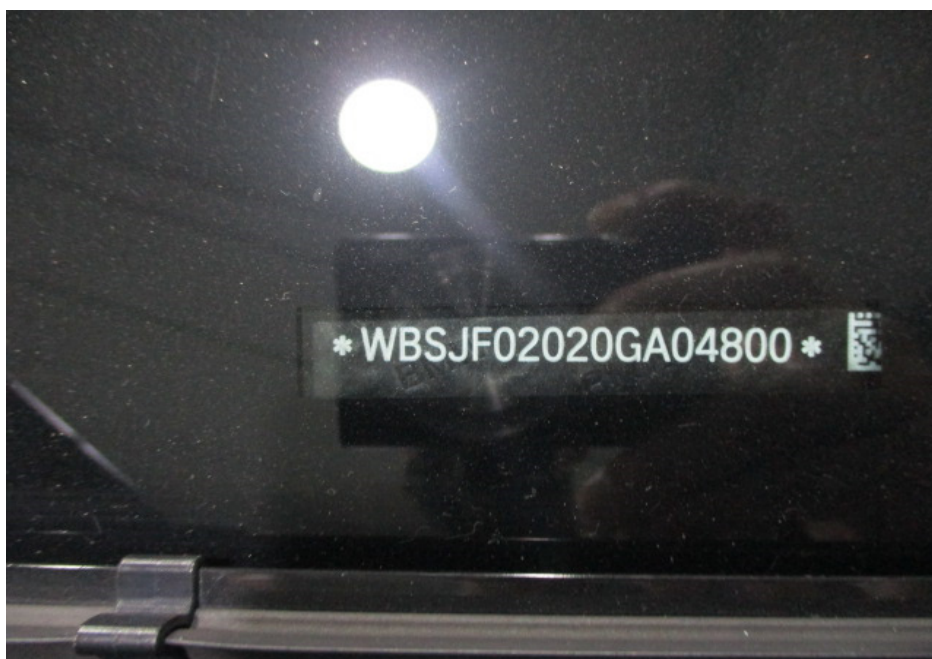
**Photo 8** shows the chassis number of the Motor Car. The chassis number recorded was WBSJF02020GA04800.

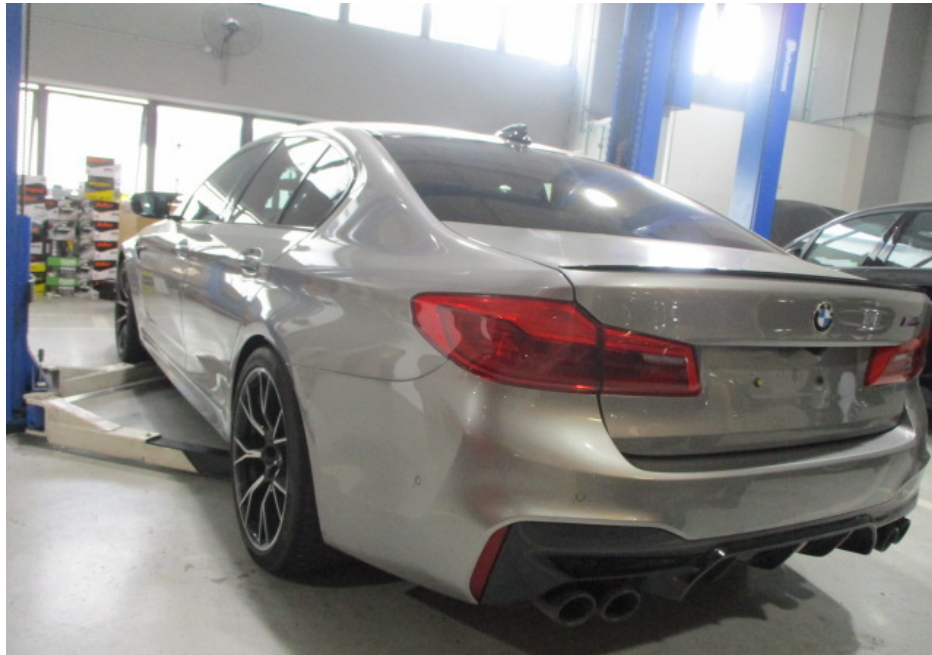
**Photo 9** shows a general view of the rear left body of the Motor Car at the time of my inspection. The Motor Car was observed to be in relatively good general condition with no loose exterior fittings observed. The mileage of the Motor Car recorded at the time of my inspection was 3,050km.

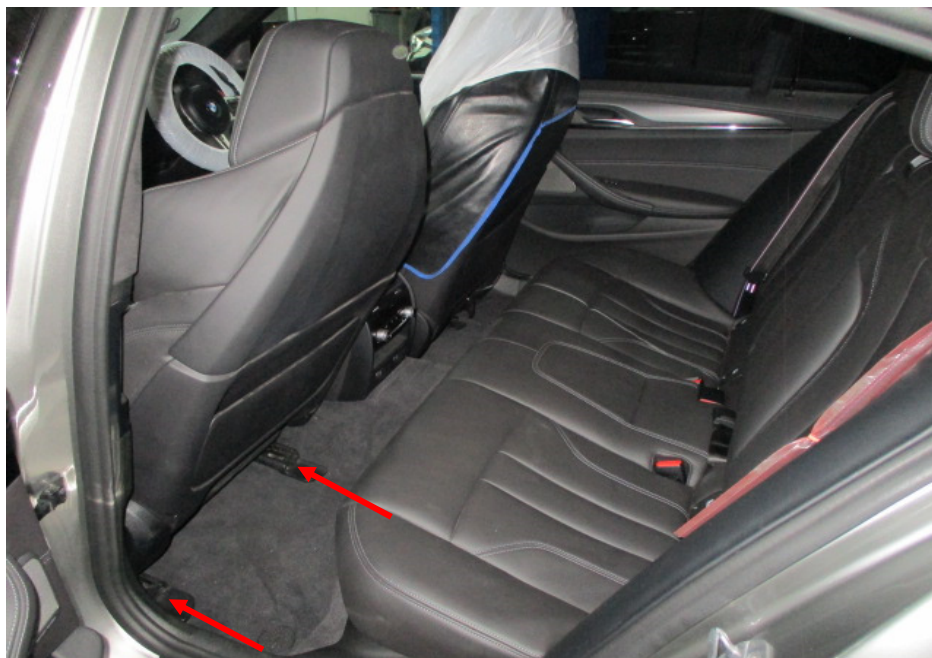
**Photo 10** shows the seats of the Motor Car, which were secured via seat rails (arrowed) to the floorboard. All the seats of the Motor Car were fitted with a retractable seat belt reel and pre-tensioner. The seat belt reels were tested and were able to be fastened securely into the respective pre-tensioners that were fixed to the side of all the seats.

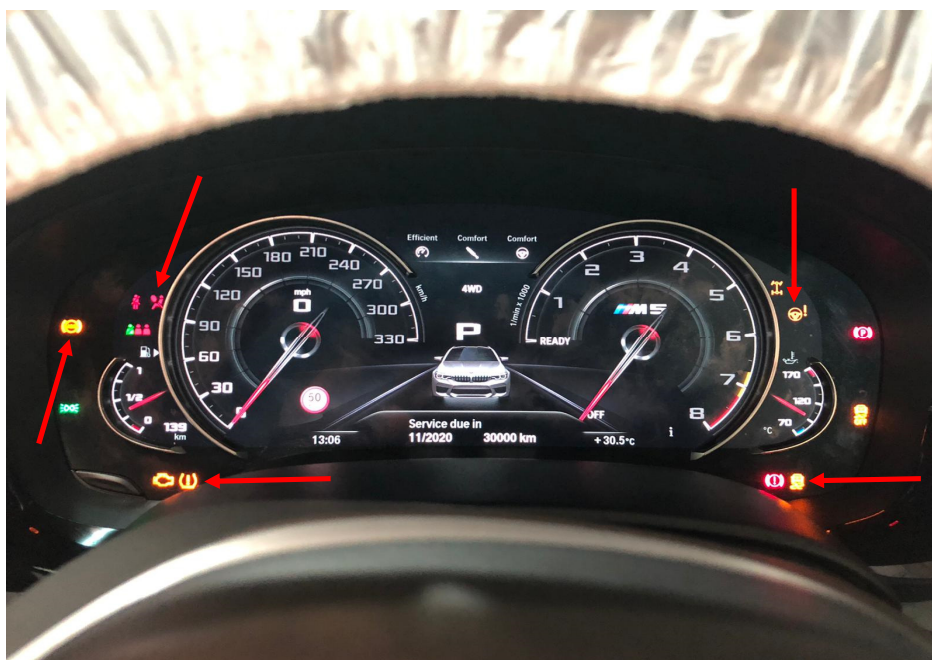
**Photo 11** shows the warning lights for the various electronic safety features appearing on the instrument panel of the Motor Car during its self-test when the engine is cranked, in particular the ABS, SRS, IAS, TPM and DSC lights (arrowed).

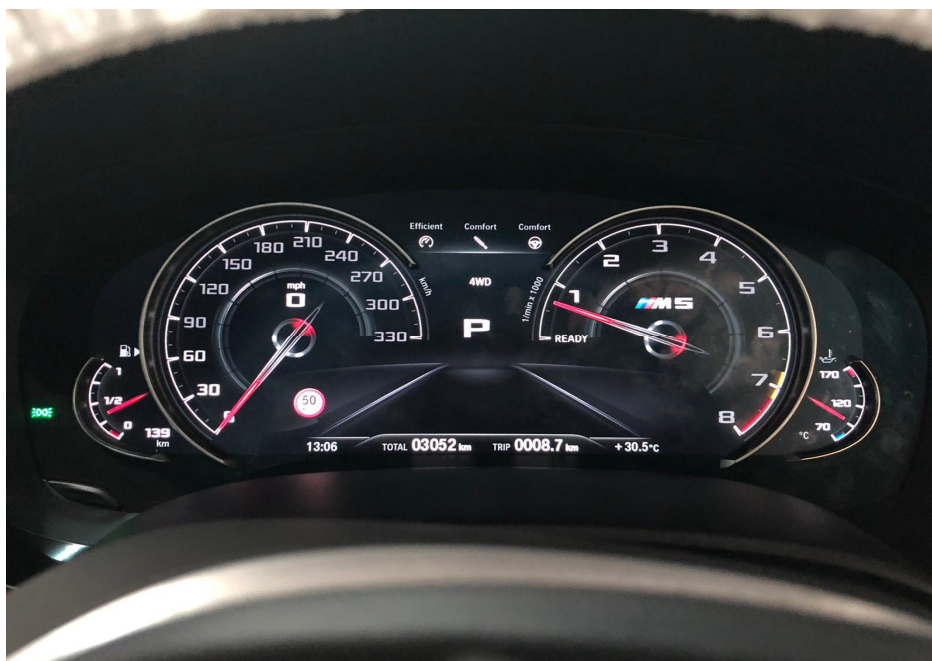
**Photo 12** shows the respective warning lights no longer illuminated after the engine was started, indicating that there was no fault detected to the ABS, SRS, IAS, TPM and DSC systems of the Motor Car during the self-test. These electronic systems were hence in working condition at the time of my inspection.

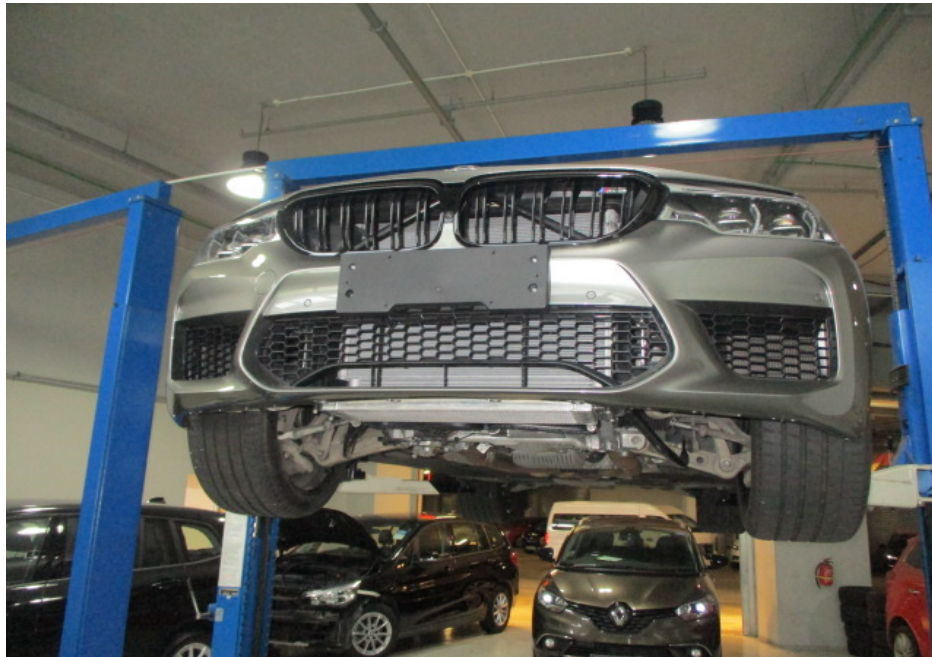
**Photo 13** shows the Motor Car hoisted up for checks on its undercarriage. There was no sign(s) or indication(s) of fluid leakage and/or fluid stain(s) on the underside of the Motor Car. The undercarriage components of the Motor Car were also all observed to be intact and secured in an appropriate manner.

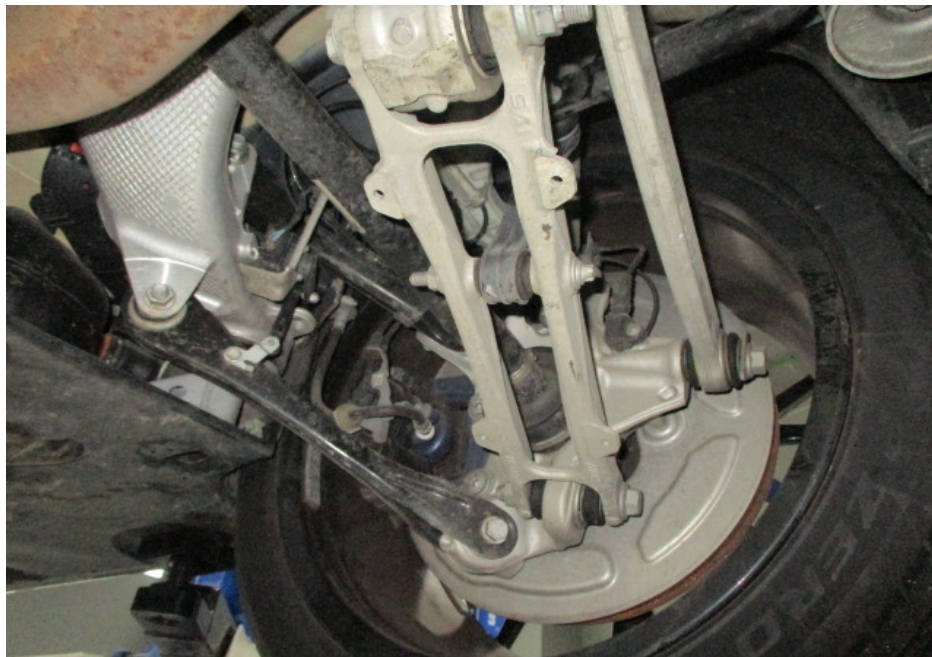
**Photo 14** shows a general view of the control arms and linkages at the rear right wheel of the Motor Car. I did not observe any fluid leak and/or fluid stain on the underside of the Motor Car. All of the Motor Car's undercarriage components were observed to be intact and secured in an appropriate manner.

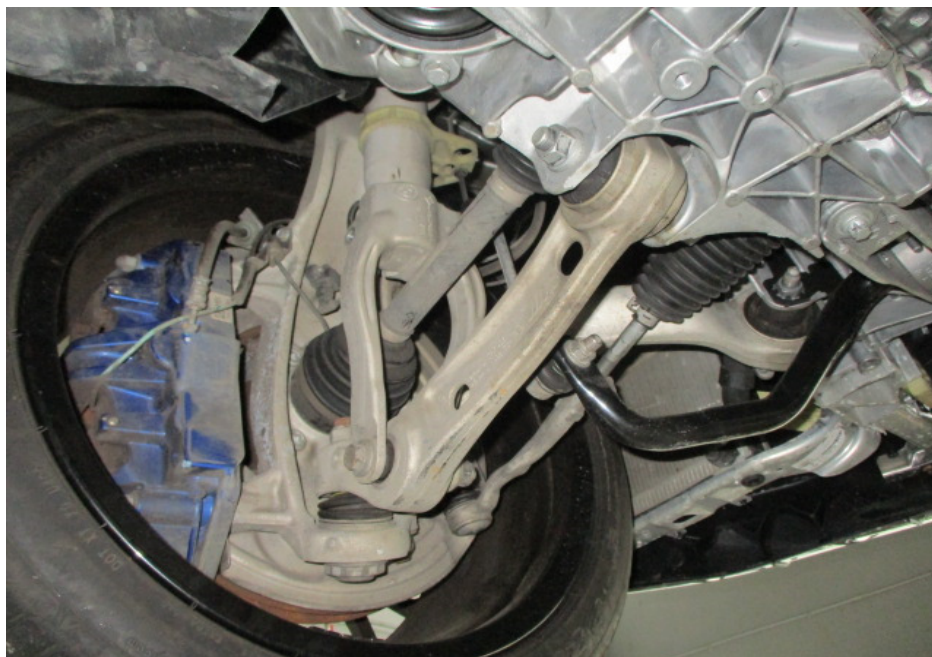
**Photo 15** shows the various undercarriage components at the front left wheel of the Motor Car. The mechanical components, control arms and linkages were all found to be intact and secured in an appropriate manner.

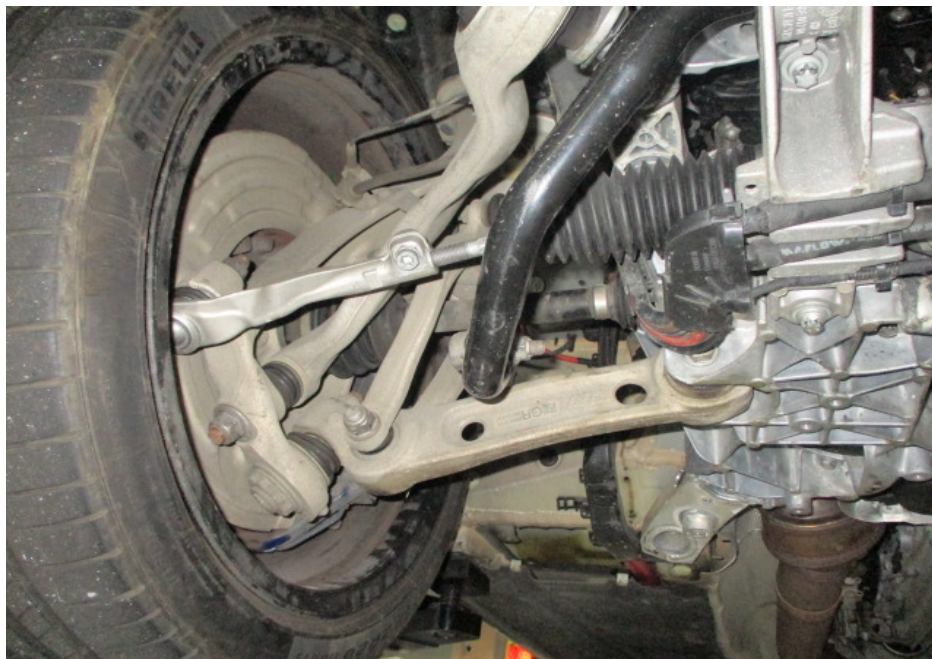
**Photo 16** shows the various undercarriage components at the front right wheel of the Motor Car. I did not observe any fluid leak and/or fluid stain on the underside of the Motor Car. All of the Motor Car's undercarriage components were observed to be intact and secured in an appropriate manner.

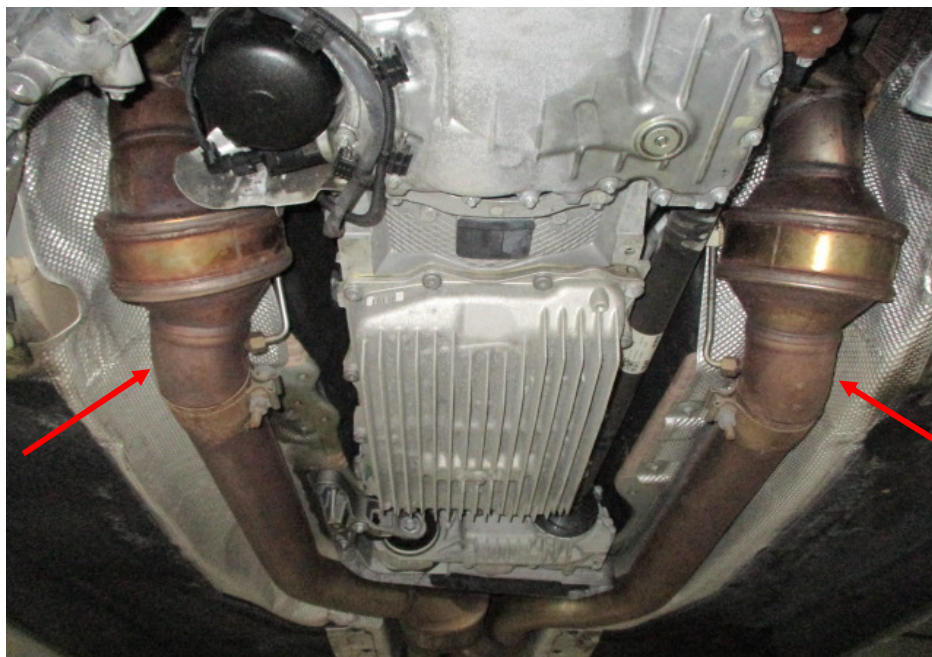
**Photo 17** shows the Motor Car's 2 exhaust downpipes (arrowed) from the exhaust manifold to the rear mufflers. My examination of the Motor Car's exhaust system revealed no sign(s) or indication(s) of any cut or weld marks along its exhaust pipes and on its rear mufflers.

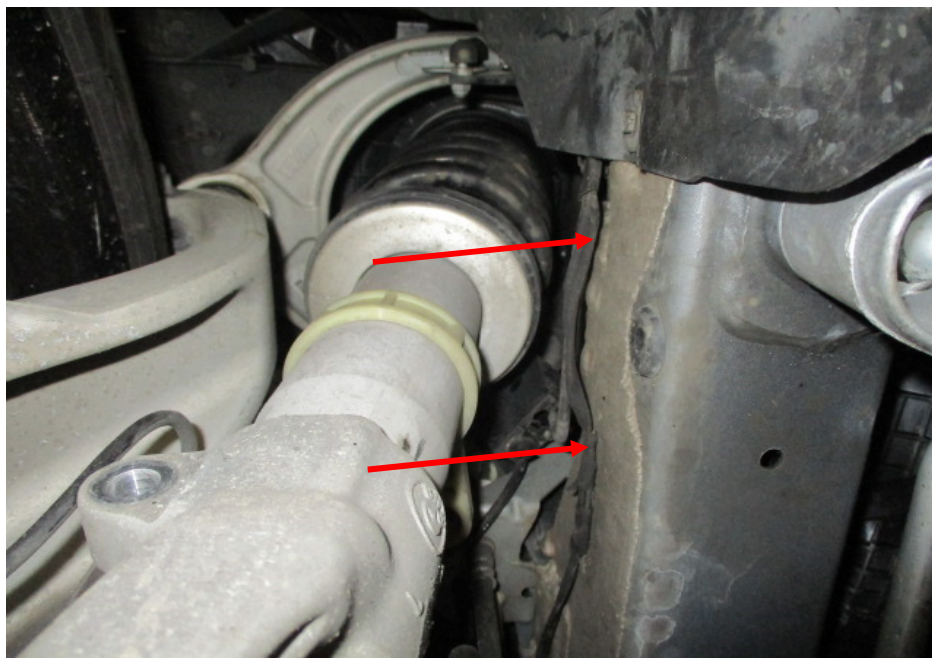
**Photo 18** shows the chassis/structural body at the underside front left of the Motor Car. I did not find any weld marks other than original spot weld marks on the chassis/structural body of the Motor Car. The original factory sealant (arrowed) at the joints along the chassis/structural body was also untouched, indicating no work was done on the chassis/structural body of the Motor Car and that the chassis/structural body was originally fitted.

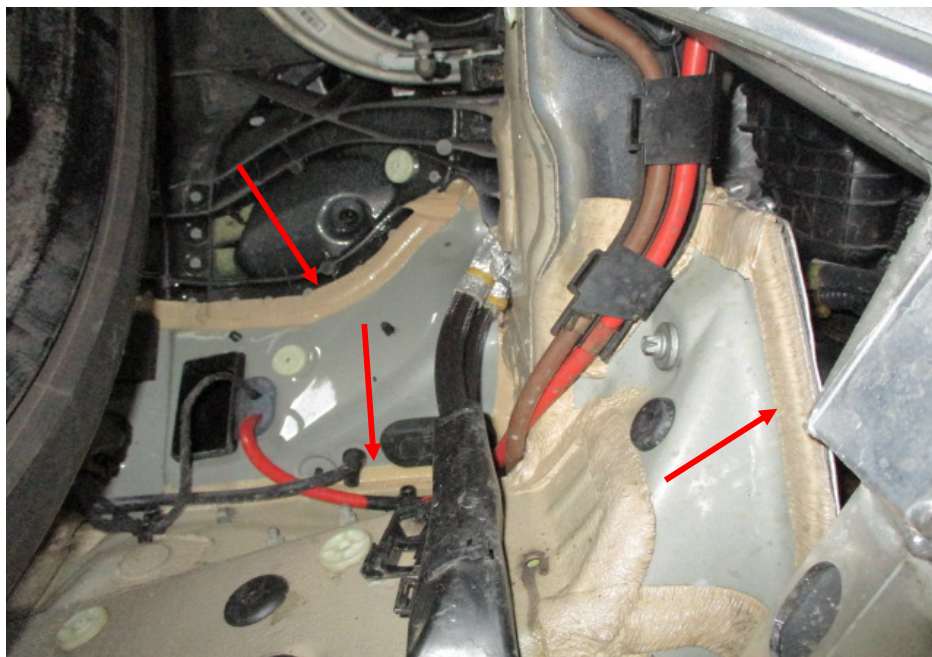
**Photo 19** shows the front right wheelhouse panel of the Motor Car. The original factory sealant (arrowed) at the joints along the non-detachable body panels were untouched, indicating no work was done on the non-detachable body panels of the Motor Car; and that these body panels were originally fitted.

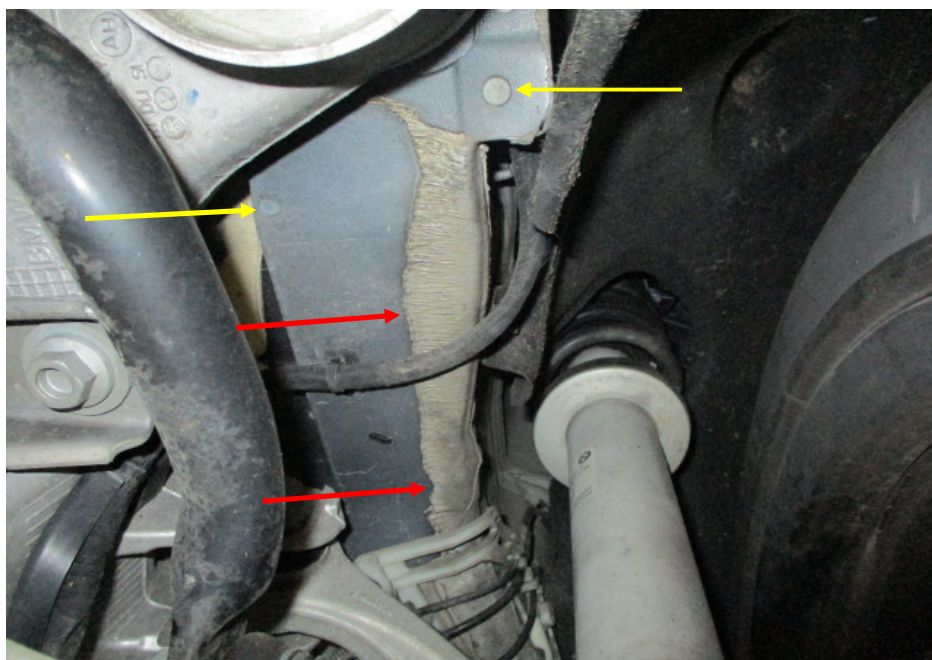
**Photo 20** shows the chassis/structural body at the underside rear right of the Motor Car. Visually, I did not find any weld marks other than original spot weld marks (yellow arrow) on the chassis/structural body of the Motor Car. The original factory sealant (red arrow) at the joints along the chassis/structural body was also untouched, indicating no work was done on the chassis/structural body of the Motor Car and that the chassis/structural body was originally fitted.

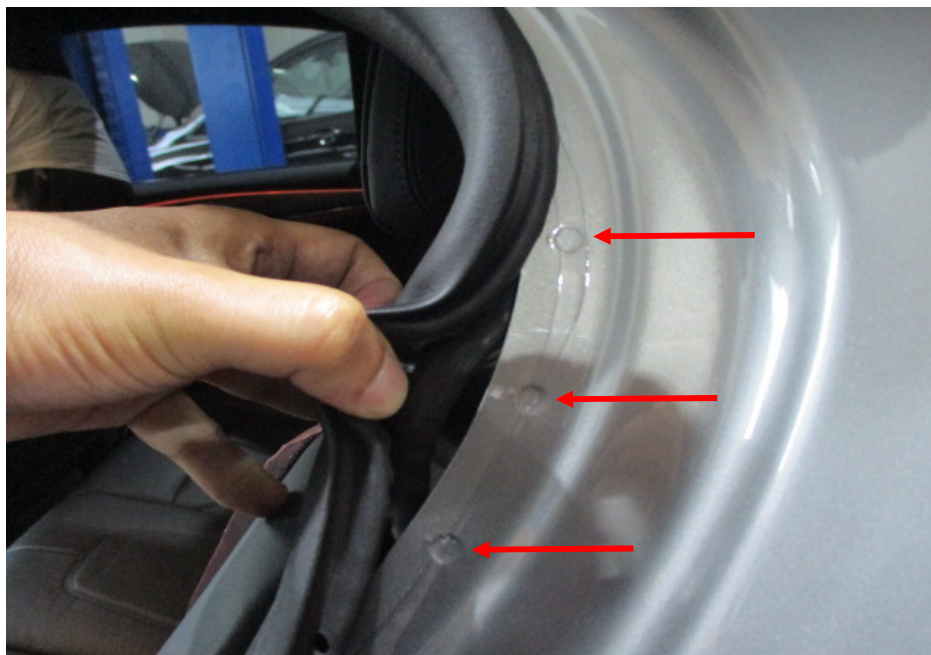
**Photo 21** shows the rear left "C" pillar of the Motor Car. I did not find any weld marks other than original spot weld marks (arrowed) on the rear left "C" pillar of the Motor Car. In general, I had found the non-detachable body panels of the Motor Car to be originally fitted at the time of my inspection.
