Your Ref: Mercedes Benz A180  
(chassis number WDD1770842V027416)  
Our Ref : CI/TP20010582/D

03 October 2020

**INSPECTION REPORT OF AN UNREGISTERD MERCEDES BENZ A180  
MOTOR CAR WITH CHASSIS NUMBER WDD1770842V027416**

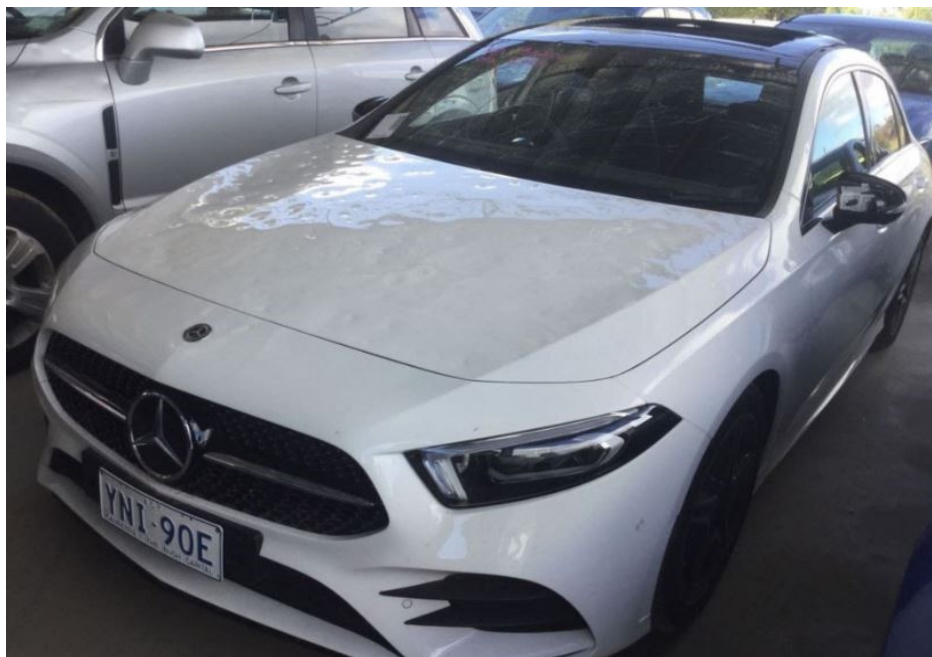
**Photo 1** shows the front left body of the Motor Car prior to any repairs being carried out (photograph provided to me). The Motor Car was observed to have sustained damages of indentation nature to multiple exterior body parts like its front bumper and front bonnet. As seen from the photographs provided, the indentation was relatively minor. The panoramic sunroof glass was also observed to be broken.

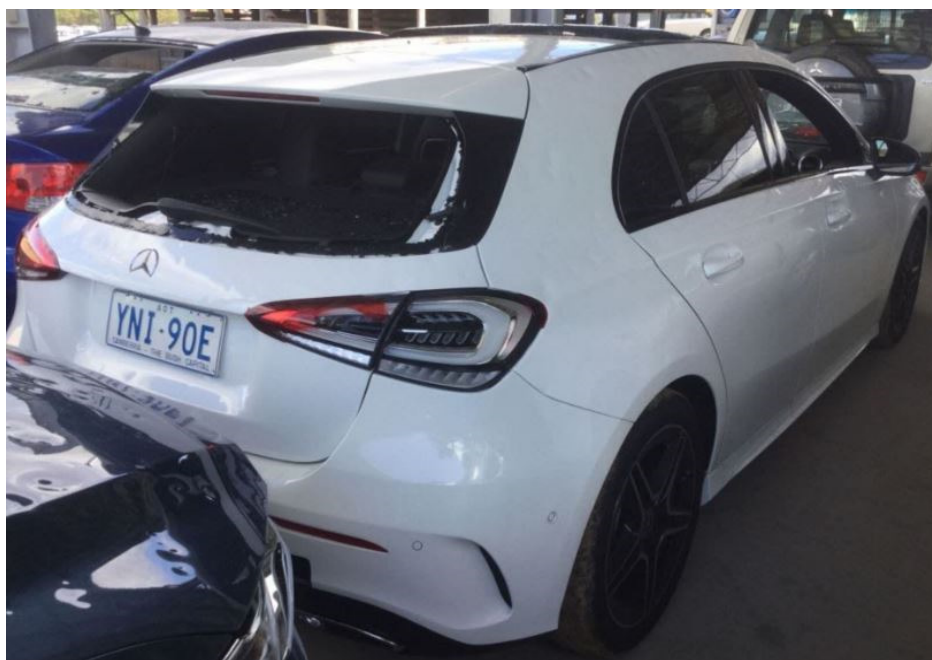
**Photo 2** shows the rear right body of the Motor Car prior to any repairs being carried out (photograph provided to me). Relatively minor indentation damage was seen on the rear right fender and other exterior body parts of the Motor Car. The rear right taillamps were also observed to be broken.

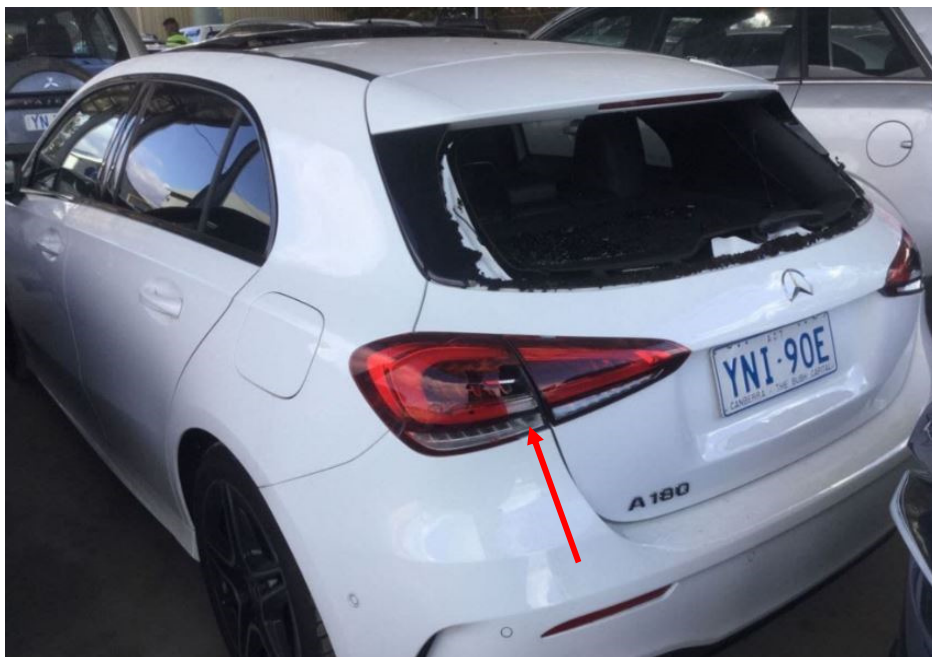
**Photo 3** shows the rear left body of the Motor Car prior to any repairs being carried out (photograph provided to me). The rear windscreen glass and rear right taillamp (arrowed) were observed to be broken along with relatively minor indentation nature of damage to multiple exterior body parts like the front bumper, front bonnet, roof panel, front fenders, rear fenders and doors of the Motor Car. The interior compartment and engine compartment were unaffected as seen from the photographs that were provided to me.

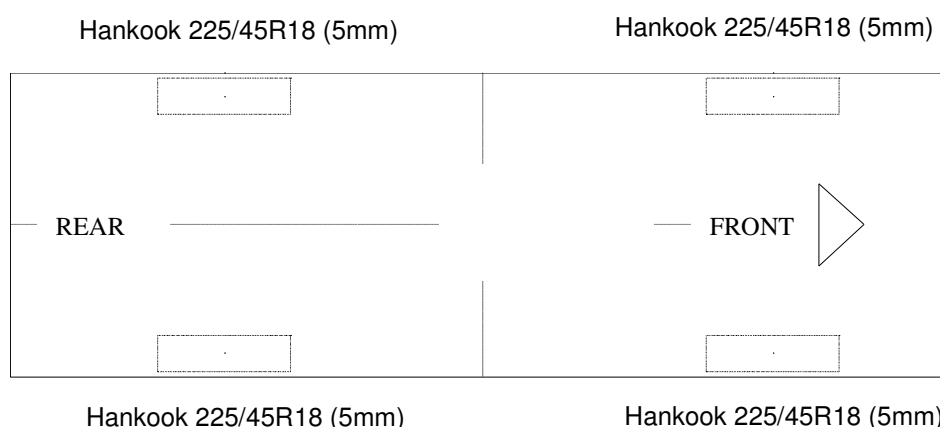
8. It was fitted with 18inch sport wheel rims that were wrapped with tyres that were observed to be of serviceable condition. The tyres were also sufficiently inflated for vehicular operation. The tyre brand, tyre size and approximate remaining tread depth of the 4 tyres of the Motor Car were recorded as follows: -

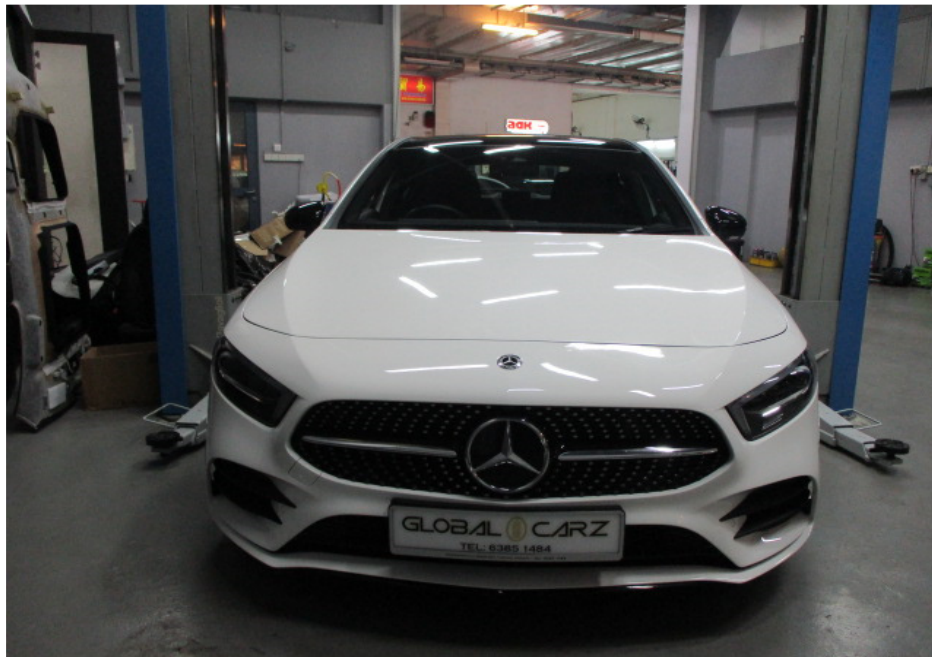
**Photo 4** shows a general view of the frontal body of the Motor Car at the time of my inspection. The Motor Car was observed to be in a relatively good general condition with no loose exterior fittings observed. The exterior body parts at the frontal body of the Motor Car, like the front bumper, front bonnet and front fenders, were visually examined and it was observed that the repair/restoration works carried out to the damaged area of the Motor Car (refer photograph 1 above) were reasonably adequate and in order.

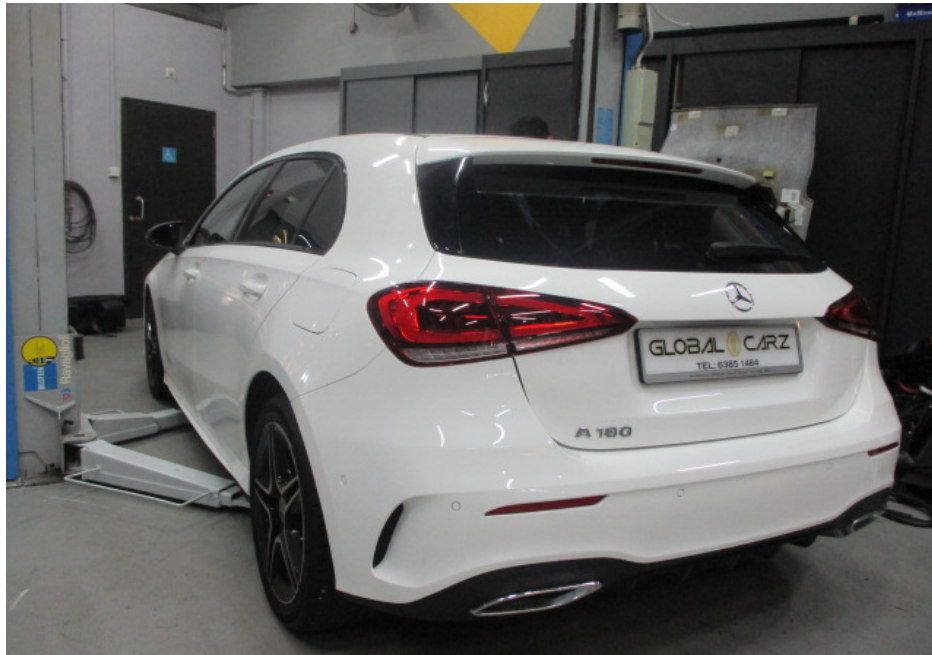
**Photo 5** shows a general view of the rear left body of the Motor Car at the time of my inspection. The Motor Car was observed to be in a relatively good general condition with no loose exterior fittings observed. The exterior body parts of the Motor Car were visually examined, and it was observed that the repair/restoration works carried out to the damaged area of the Motor Car (refer photograph 3 above) were reasonably adequate and in order.

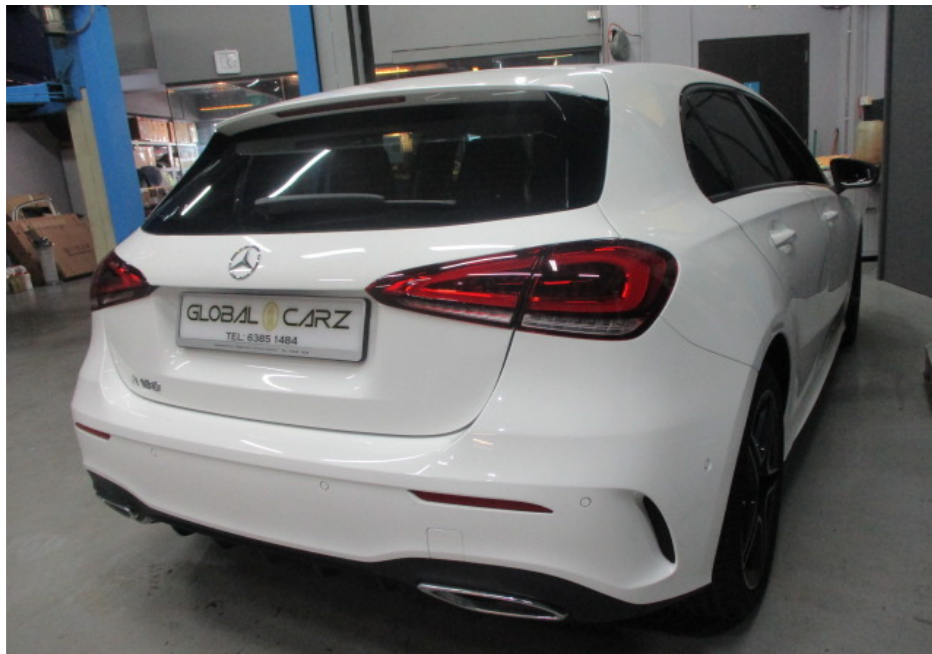
**Photo 6** shows a general view of the rear right body of the Motor Car at the time of my inspection. The exterior body parts of the Motor Car were visually examined, and it was observed that the repair/restoration works carried out to the damaged area of the Motor Car (refer photograph 2 above) were reasonably adequate and in order.

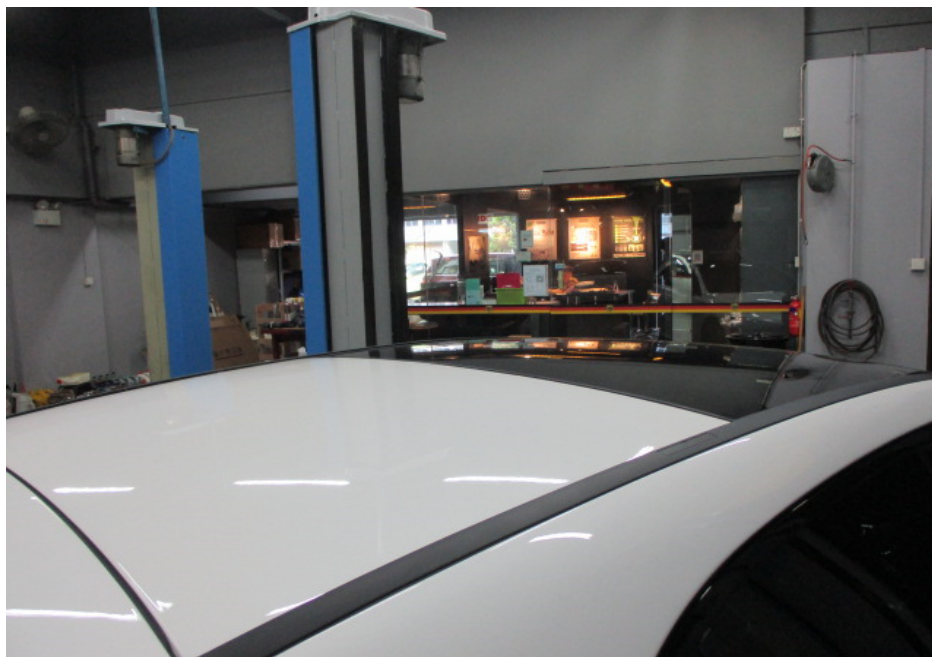
**Photo 7** shows the roof panel and panoramic sunroof of the Motor Car at the time of my inspection. In general, I had found that the repair/restoration works carried out to the damaged area of the Motor Car (refer photograph 1 - 3 above) were reasonably adequate and in order.

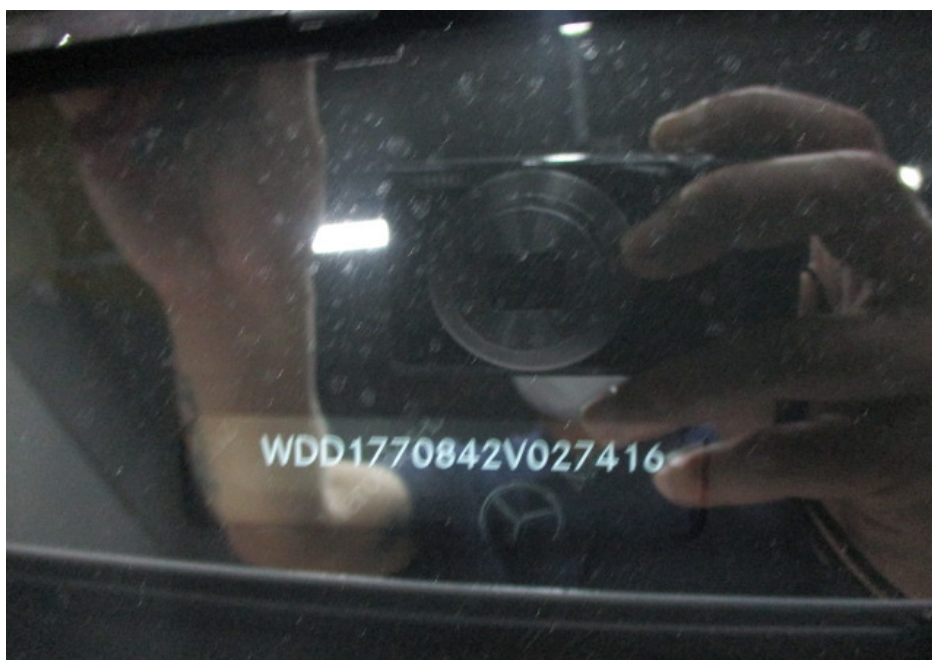
**Photo 8** shows the chassis number of the Motor Car. The chassis number recorded was WDD1770842V027416.

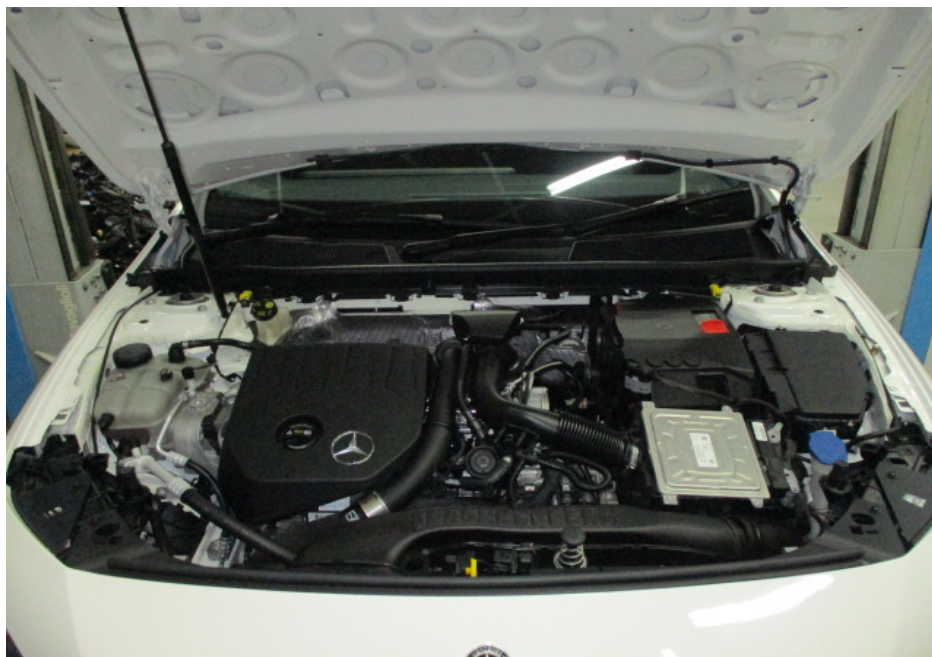
**Photo 9** shows a general view of the engine compartment of the Motor Car at the time of my inspection. The various parts and components inside the engine compartment were all observed to be intact and properly fitted. There was also no sign(s) or indication(s) of fluid leak and/or fluid stain found inside the engine compartment.

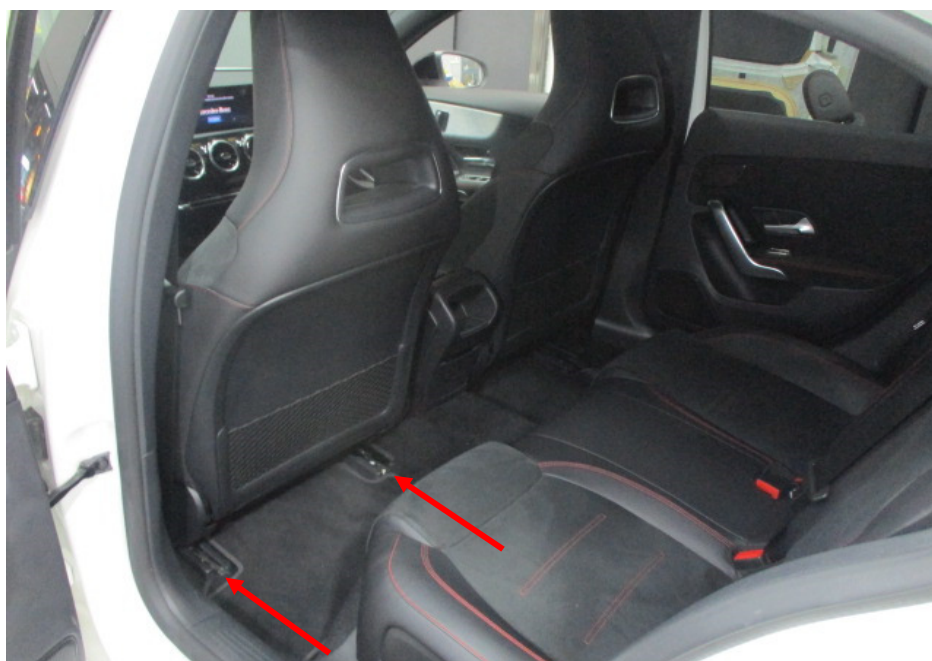
**Photo 10** shows the seats of the Motor Car, which were secured via seat rails (arrowed) to the floorboard. All the seats of the Motor Car were fitted with a retractable seat belt reel and pre-tensioner. The seat belt reels were tested and were able to be fastened securely into the respective pre-tensioners that were fixed to the side of all the seats.

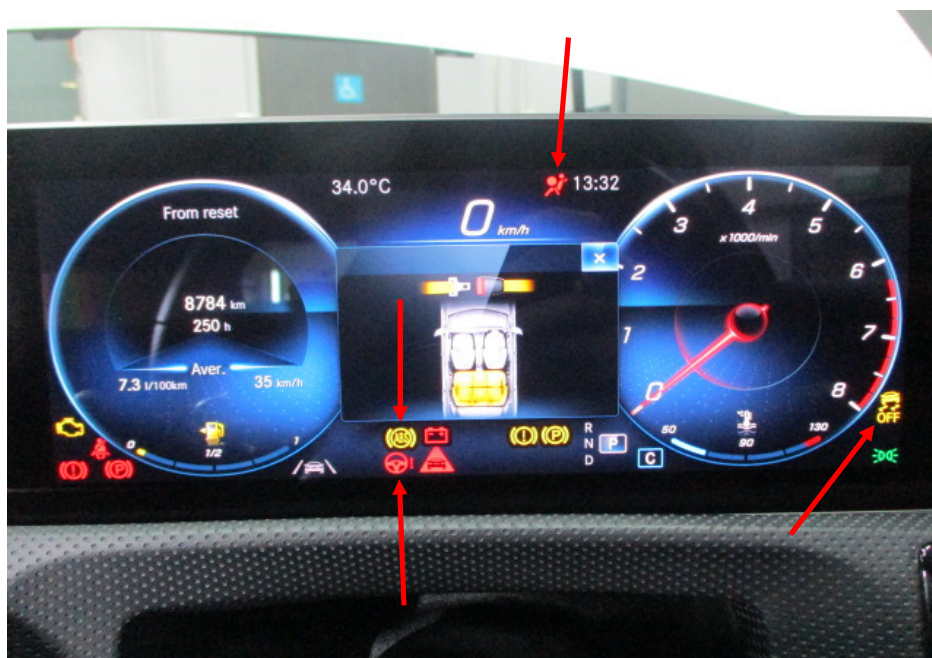
**Photo 11** shows the warning lights for the various electronic safety features appearing on the instrument panel of the Motor Car during its self-test when the engine is cranked, in particular the ABS, SRS, EPS and ESP lights (arrowed).

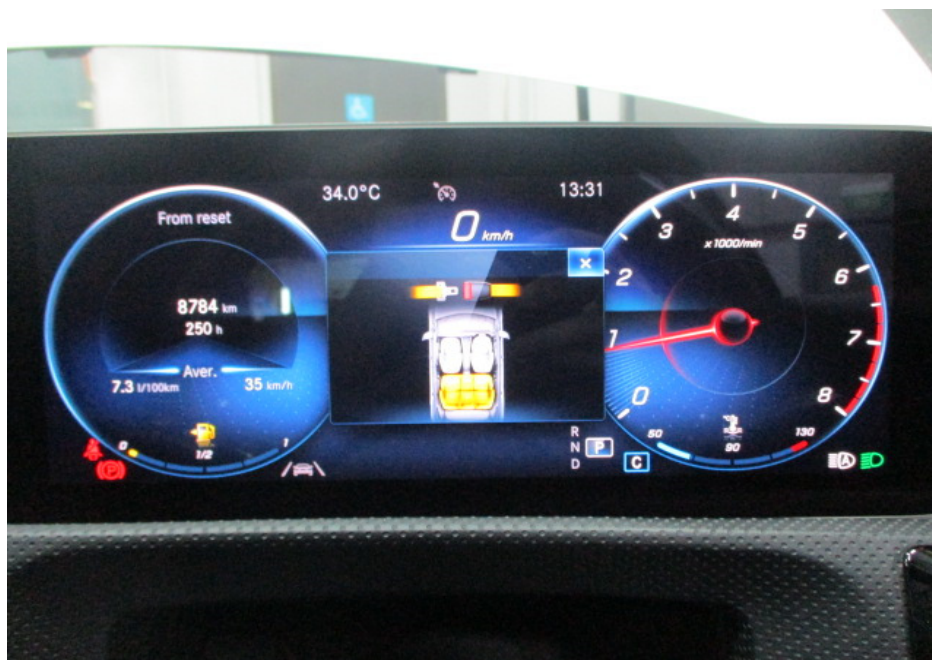
**Photo 12** shows the respective warning lights no longer illuminated, indicating that there is no fault detected to the ABS, SRS, EPS and ESP systems of the Motor Car during the self-test. These electronic systems were hence in working condition at the time of my inspection.

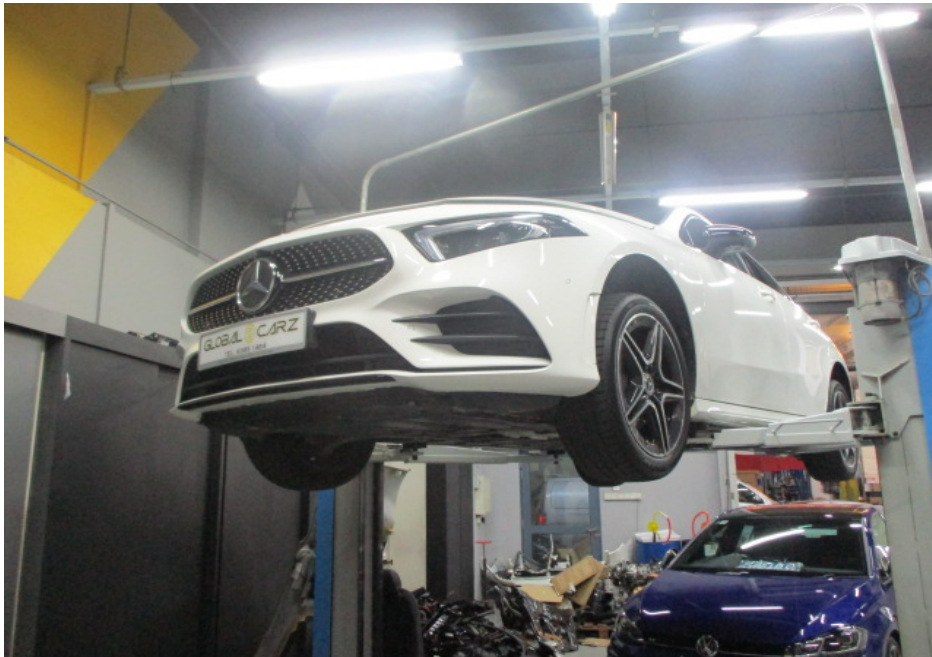
**Photo 13** shows the Motor Car hoisted up for checks on its undercarriage. There was no sign(s) or indication(s) of fluid leakage and/or fluid stain(s) on the underside of the Motor Car. The undercarriage components of the Motor Car were also all observed to be intact and secured in an appropriate manner.

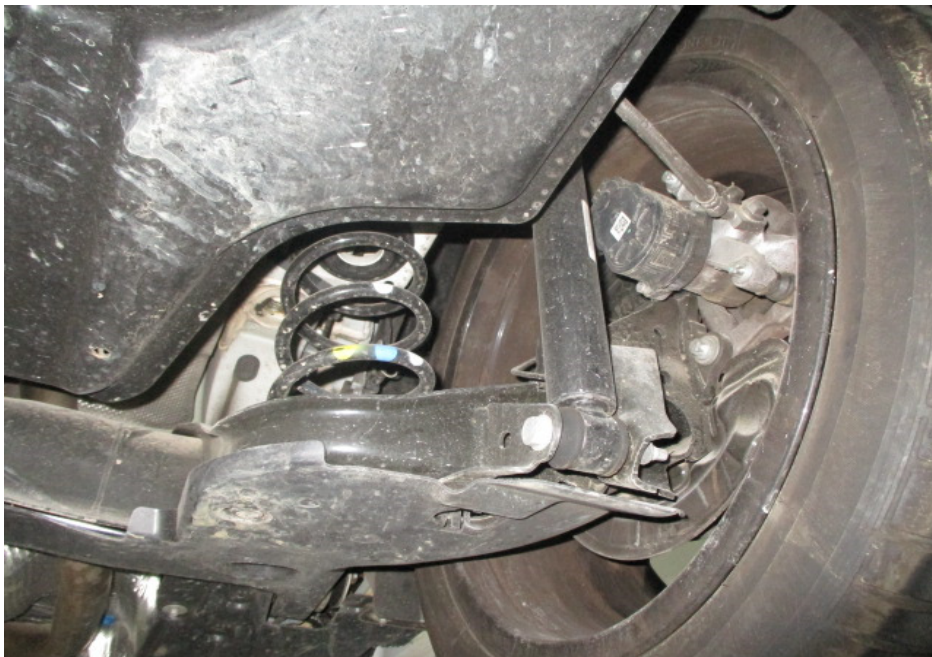
**Photo 14** shows a general view of the control arms and linkages at the rear right wheel of the Motor Car. I did not observe any fluid leak and/or fluid stain on the underside of the Motor Car. All the Motor Car's undercarriage components were observed to be intact and secured in an appropriate manner.

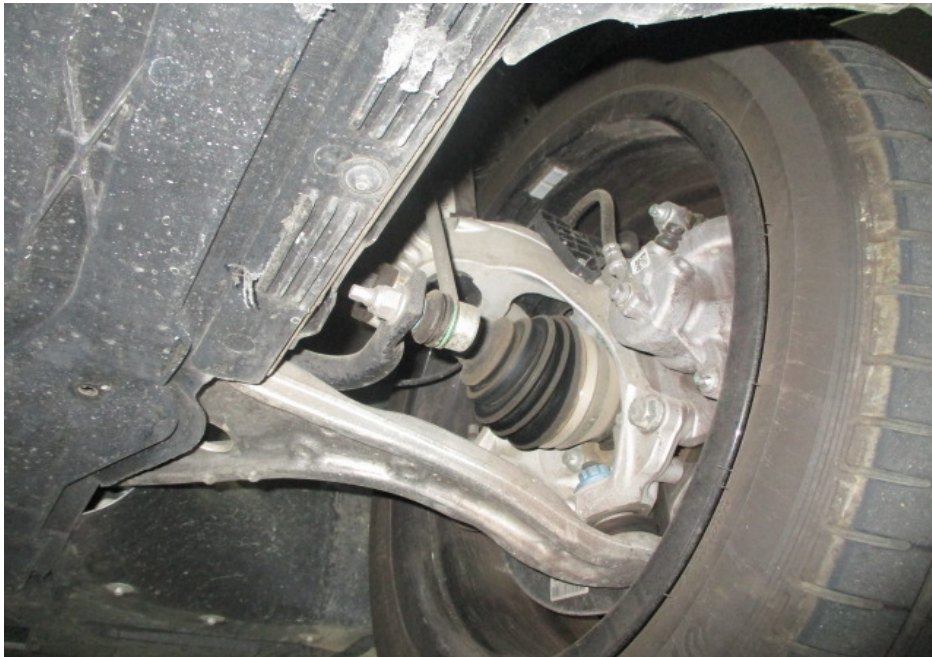
**Photo 15** shows the various undercarriage components at the front left wheel of the Motor Car. The mechanical components, control arms and linkages were all found to be intact and secured in an appropriate manner.

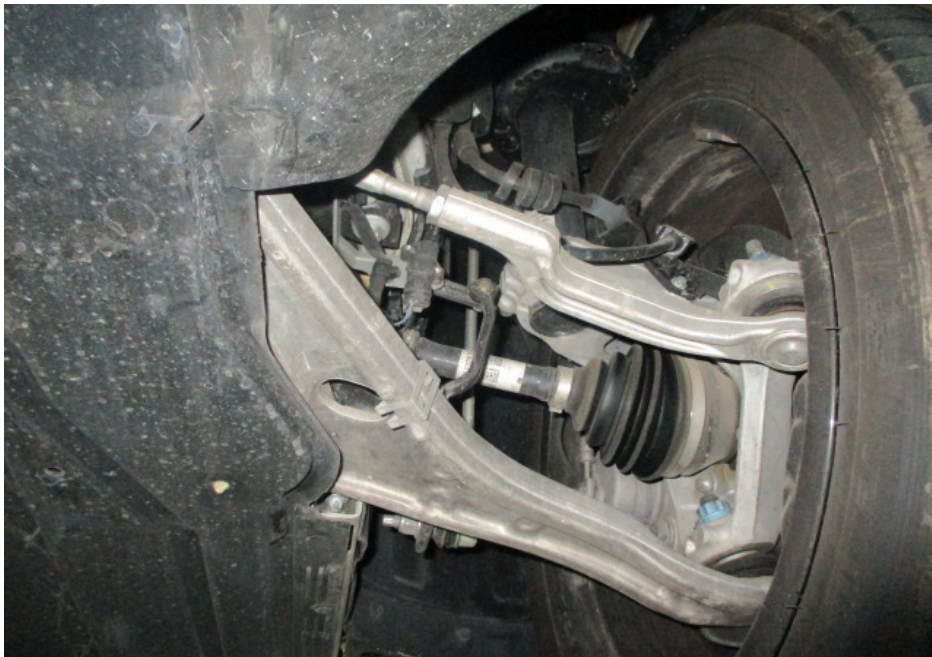
**Photo 16** shows the various undercarriage components at the front right wheel of the Motor Car. The mechanical components, control arms and linkages were all found to be intact and secured in an appropriate manner. I also did not observe any fluid leak and/or fluid stain on the underside of the Motor Car.

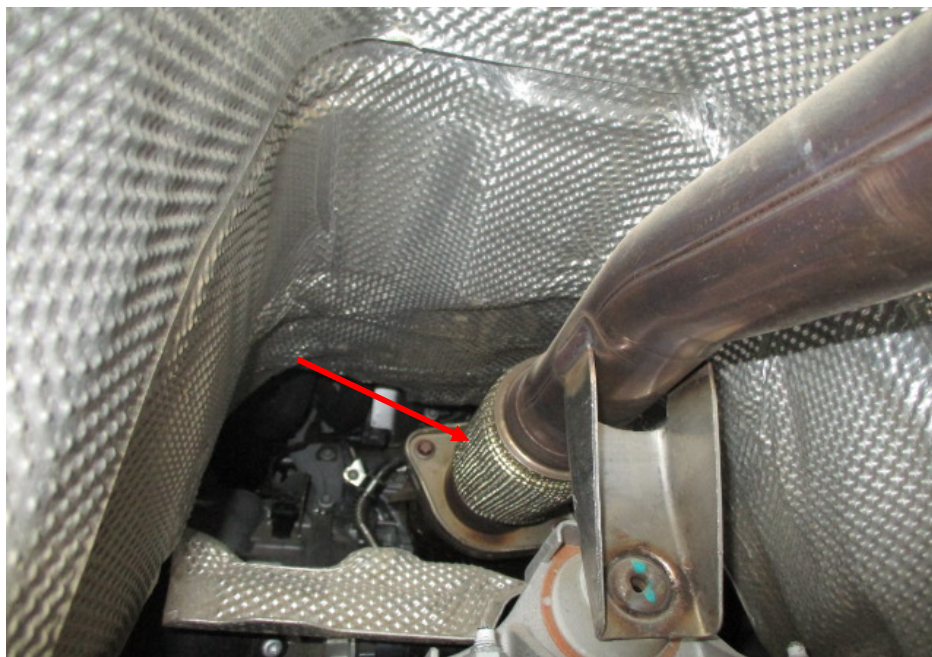
**Photo 17** shows the Motor Car's catalytic converter (arrowed). My examination of the Motor Car's exhaust system revealed no sign(s) or indication(s) of any cut or weld marks along its exhaust pipes and on its rear muffler.

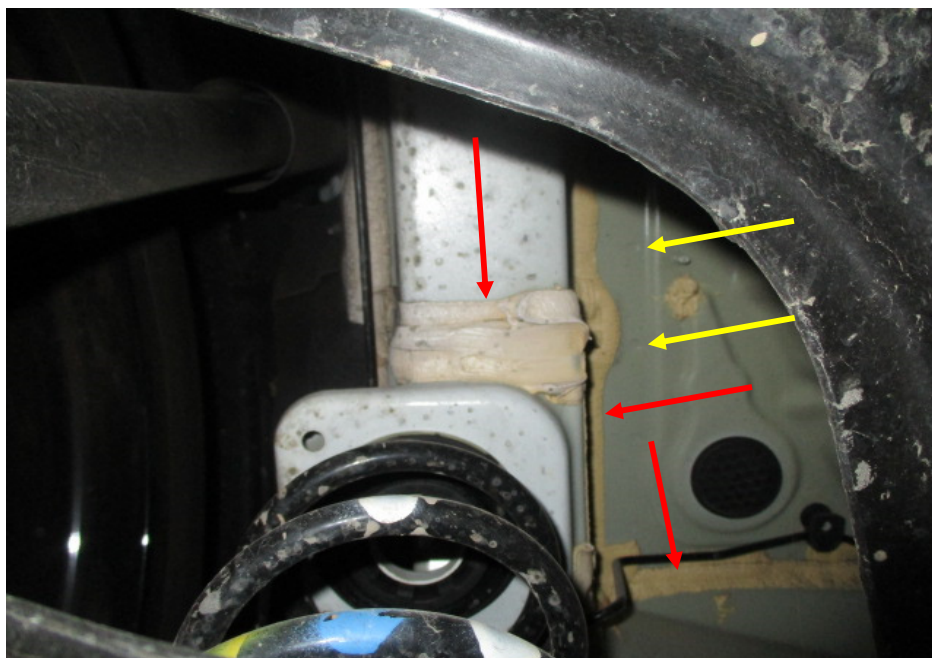
11. Visually, I did not find any weld marks, other than the original spot weld marks, on the chassis/structural body of the Motor Car. The original factory sealant at the joints along the chassis/structural body was also untouched, indicating that no replacement of the chassis/structural body was carried out; and that the chassis/structural body was originally fitted.

**Photo 18** shows the chassis/structural body at the underside rear left of the Motor Car. Visually, I did not find any weld marks other than original spot weld marks (yellow arrow) on the chassis/structural body of the Motor Car. The original factory sealant (red arrow) at the joints along the chassis/structural body was also untouched, indicating no work was done on the chassis/structural body of the Motor Car and that the chassis/structural body was originally fitted.

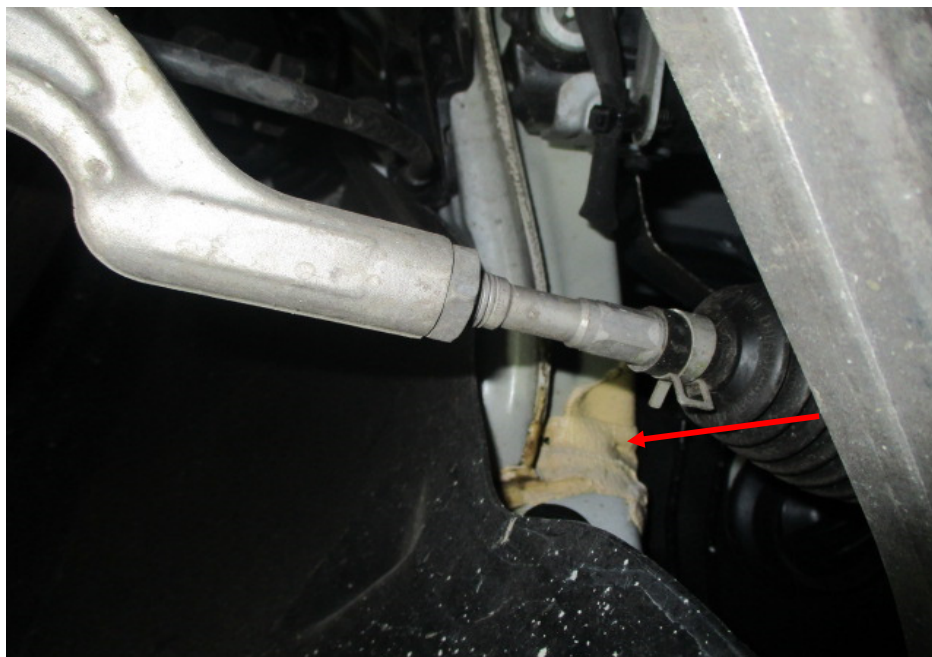
**Photo 19** shows the chassis/structural body at the underside front right of the Motor Car. Visually. The original factory sealant (arrowed) at the joints along the chassis/structural body was untouched, indicating no work was done on the chassis/structural body of the Motor Car and that the chassis/structural body was originally fitted.

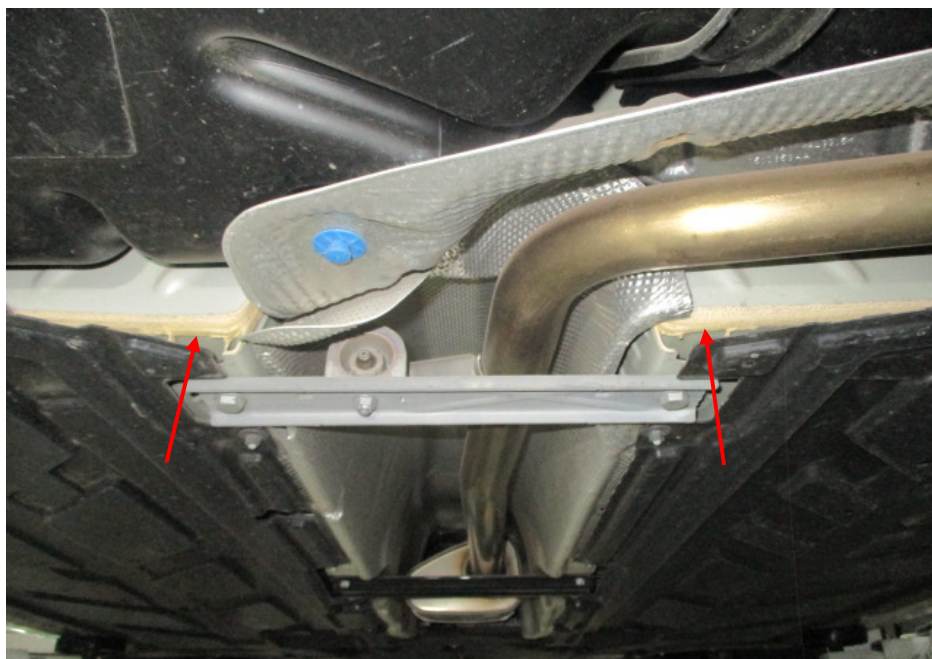
**Photo 20** shows the floorboard at the underside centre of the Motor Car. The original factory sealant (arrowed) at the joints along the non-detachable body panels were untouched, indicating no work was done on the non-detachable body panels of the Motor Car; and that these body panels were originally fitted.

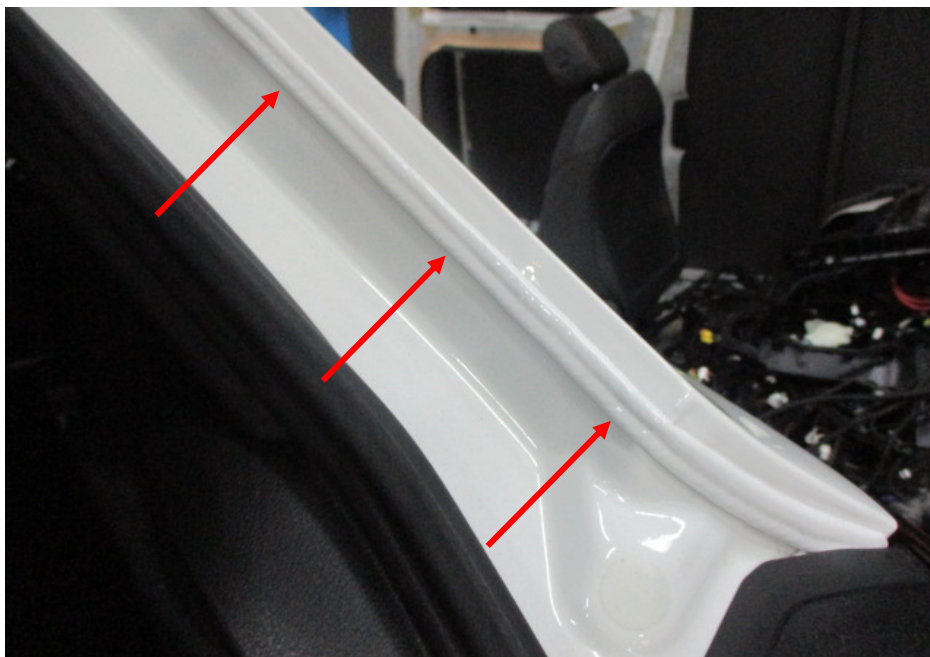
**Photo 21** shows the rear right body panel of the Motor Car. The original factory sealant (arrowed) was observed on the rear right body panel, indicating that the rear body panel was originally fitted. In general, I had found the non-detachable body panels of the Motor Car to be originally fitted at the time of my inspection.
