Your Ref: Volkswagen Golf R
(chassis number WVVZZZAUZLW020755)
Our Ref : CI/TP20010583/D

**INSPECTION REPORT OF AN UNREGISTERED VOLKSWAGEN GOLF R
MOTOR CAR WITH CHASSIS NUMBER WVVZZZAUZLW020755**

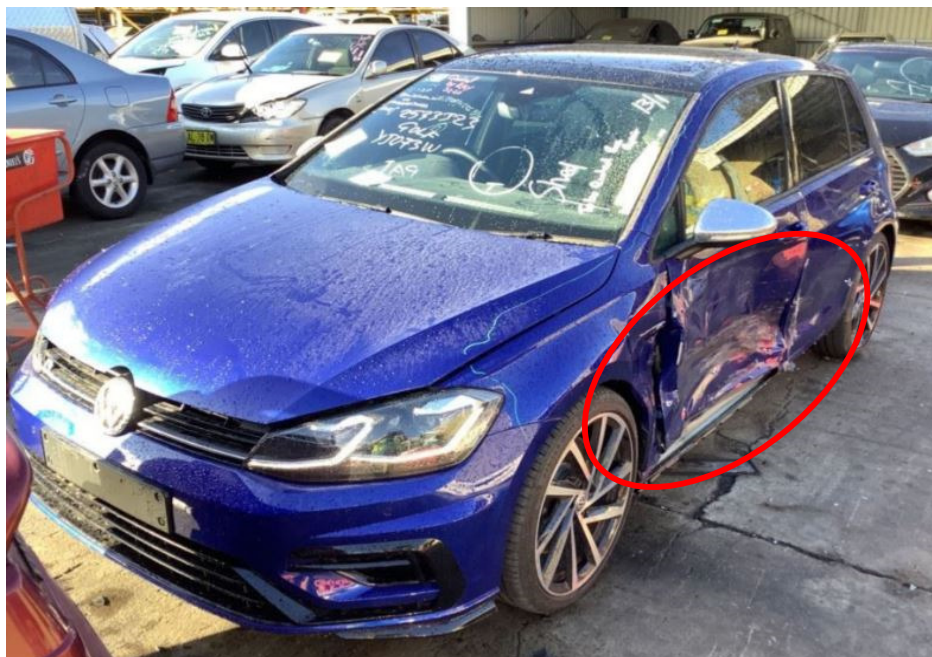
Photo 1 shows the front left body of the Motor Car prior to any repairs being carried out (photograph provided to me). The Motor Car was observed to have sustained damages at its left body (circled). Body parts observed to be damaged include its front left fender, left side rocker panel garnish, front left door, rear left door.

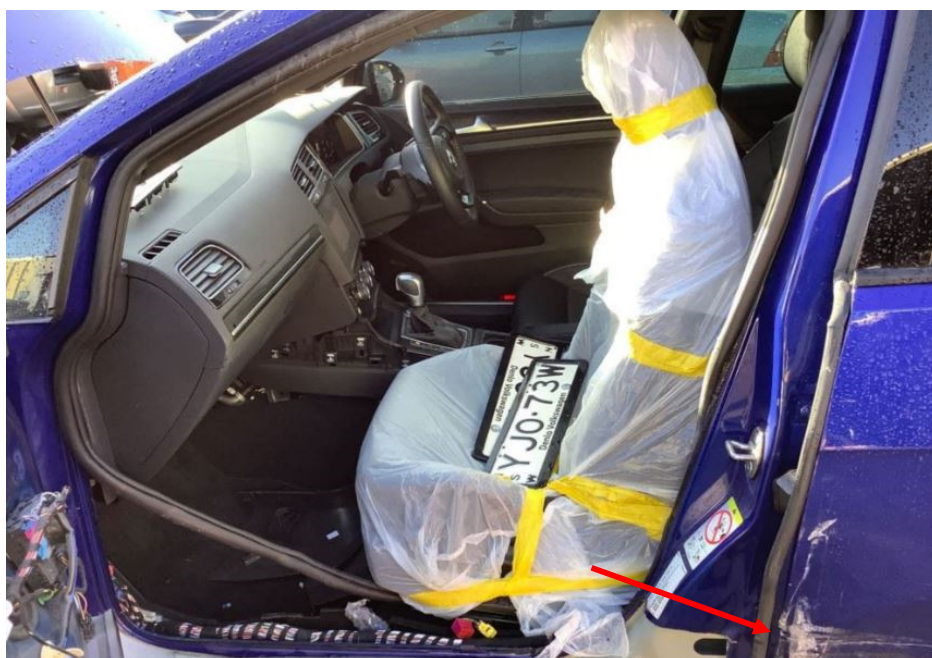
Photo 2 shows the interior compartment of the Motor Car prior to any repairs being carried out (photograph provided to me). The damage to the Motor Car was mainly confined to its exterior body like the rear left door (arrowed) amongst others. Part(s) and component(s) within the interior compartment were seen to be undamaged. The airbags of the Motor Car were also not activated.

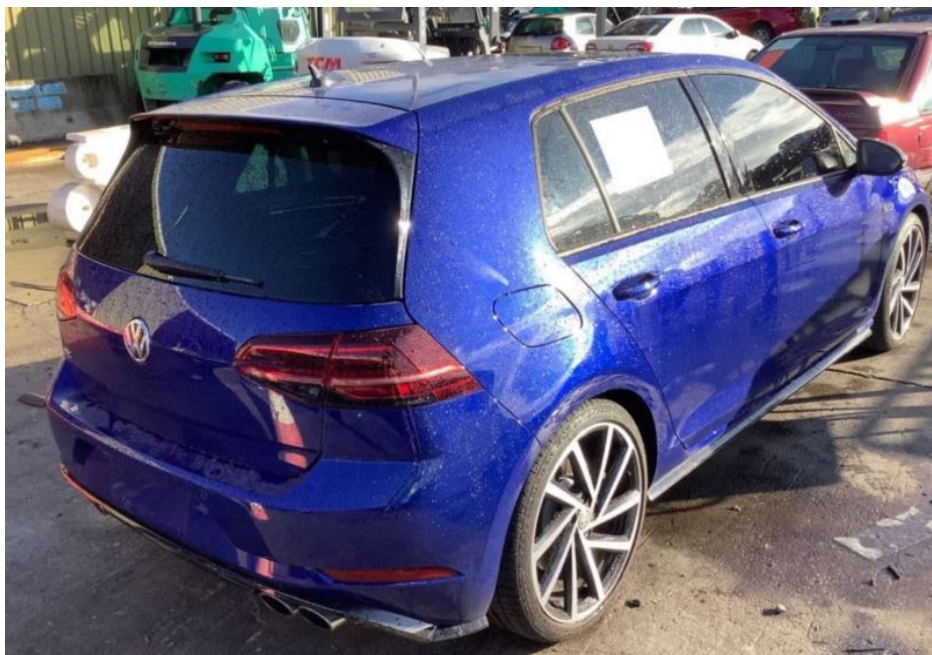
Photo 3 shows the rear right body of the Motor Car prior to any repairs being carried out (photograph provided to me). No damage was seen on the right body of the Motor Car. In general, apart for the damage at the left body, there was no damage to other areas of the Motor Car as seen from the photographs that were provided to me.

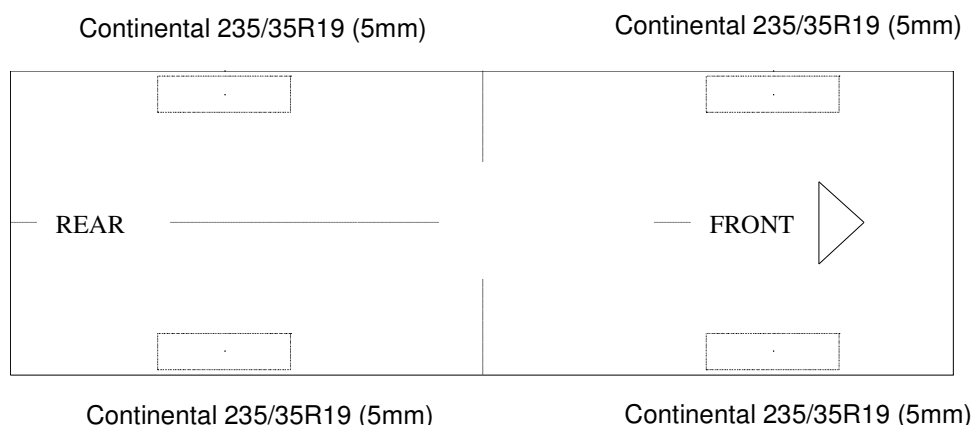
8. It was fitted with 19inch sport wheel rims that were wrapped with tyres that were observed to be of serviceable condition. The tyres were also sufficiently inflated for vehicular operation. The tyre brand, tyre size and approximate remaining tread depth of the 4 tyres of the Motor Car were recorded as follows: -

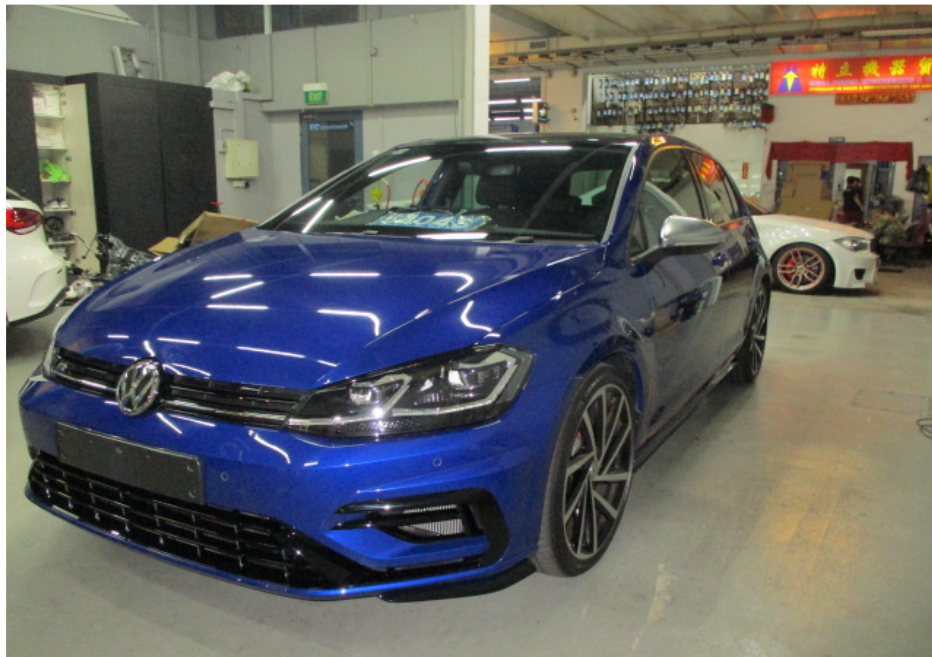
Photo 4 shows a general view of the front left body of the Motor Car at the time of my inspection. The Motor Car was observed to be in a relatively good general condition with no loose exterior fittings observed. The body parts at the left body of the Motor Car were visually examined and it was observed that the repair/restoration works carried out to the damaged area of the Motor Car (refer photograph 1 & 2 above) were reasonably adequate and in order.

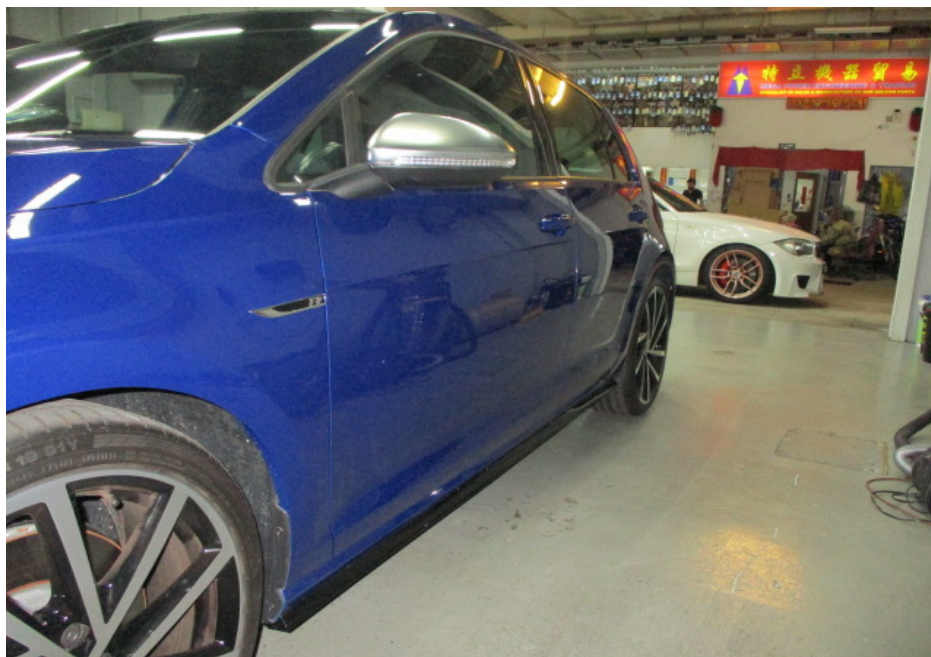
Photo 5 shows the front left fender, front left door and left side rocker panel garnish of the Motor Car at the time of my inspection. The body parts at the left body of the Motor Car were visually examined and it was observed that the repair/restoration works carried out to the damaged area of the Motor Car (refer photograph 1 & 2 above) were reasonably adequate and in order.

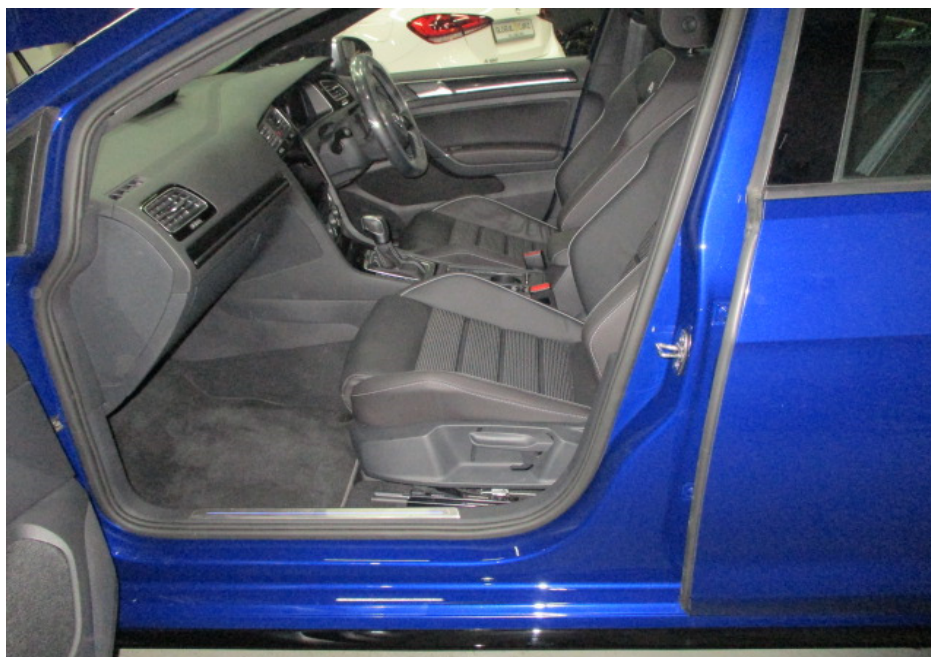
Photo 6 shows the interior compartment and rear left door of the Motor Car at the time of my inspection. The damaged area at the left body of the Motor Car were visually examined (refer to photograph 2 above) and it was observed that the repair/restoration works carried out were reasonably adequate and in order.

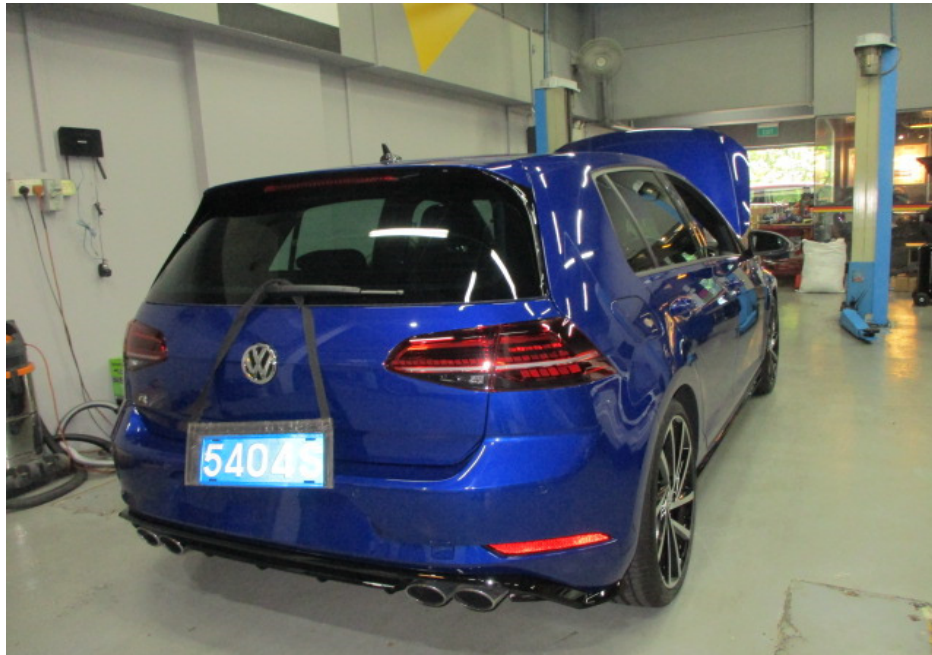
Photo 7 shows a general view of the rear right body of the Motor Car at the time of my inspection. The Motor Car was observed to be in a relatively good general condition with no loose exterior fittings observed. The mileage of the Motor Car recorded at the time of my inspection was 1,676km.

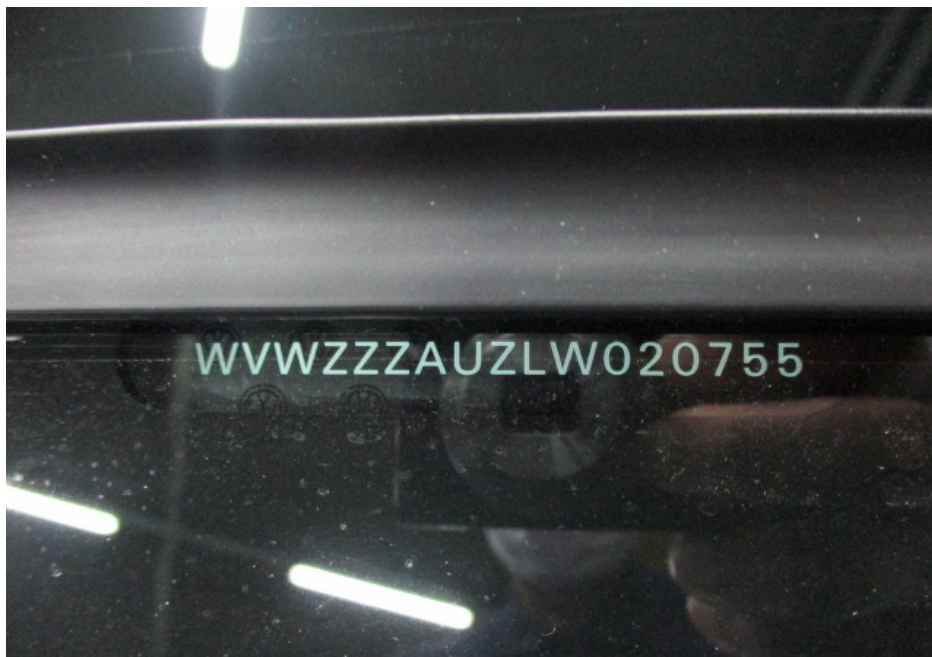
Photo 8 shows the chassis number of the Motor Car. The chassis number recorded was WVWZZZAUZLW020755.

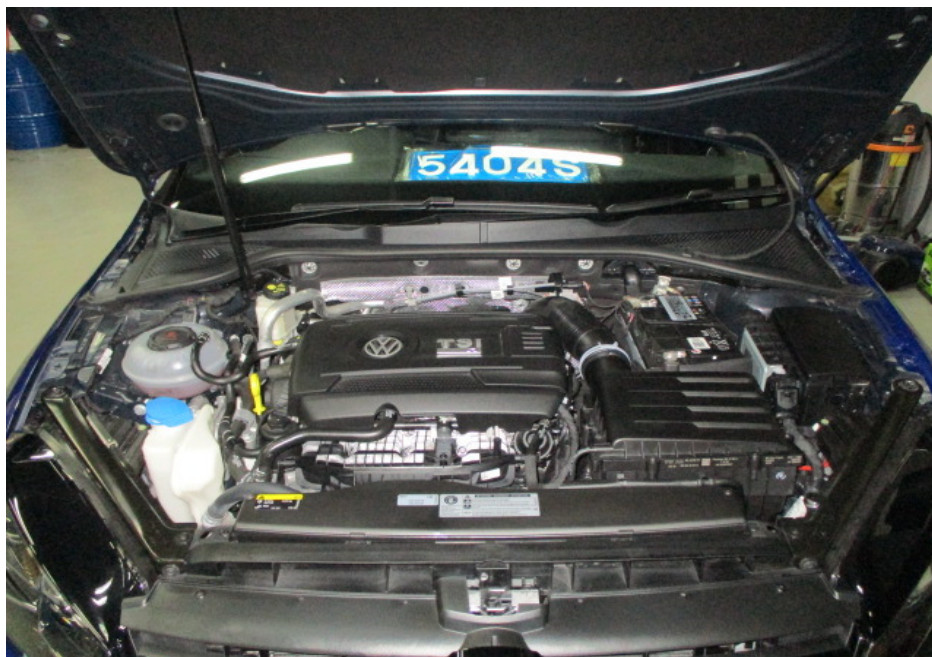
Photo 9 shows a general view of the engine compartment of the Motor Car at the time of my inspection. The various parts and components inside the engine compartment were all observed to be intact and properly fitted. There was also no sign(s) or indication(s) of fluid leak and/or fluid stain found inside the engine compartment.

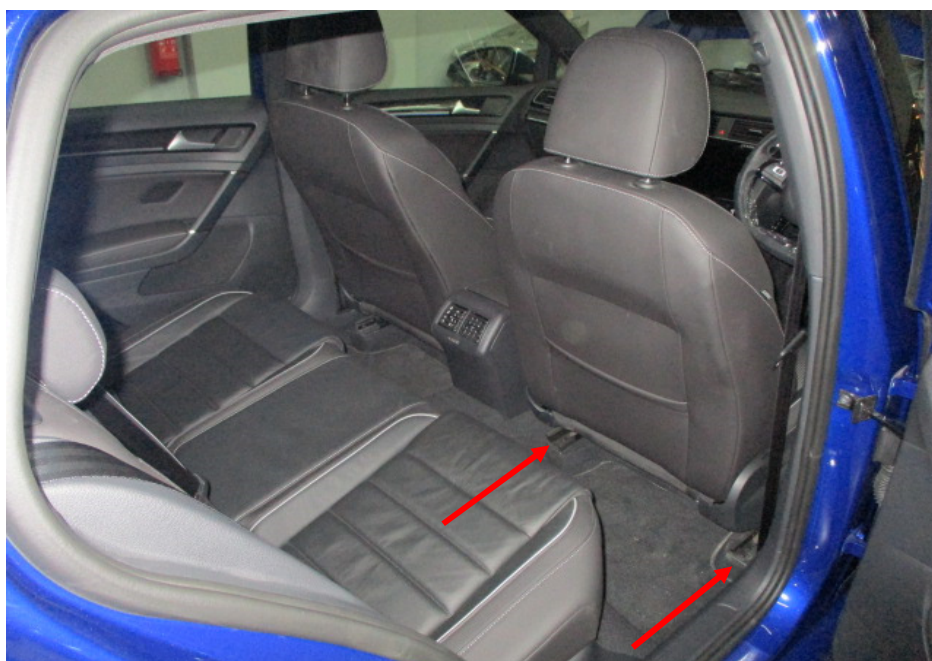
Photo 10 shows the seats of the Motor Car, which were secured via seat rails (arrowed) to the floorboard. All the seats of the Motor Car were fitted with a retractable seat belt reel and pre-tensioner. The seat belt reels were tested and were able to be fastened securely into the respective pre-tensioners that were fixed to the side of all the seats.

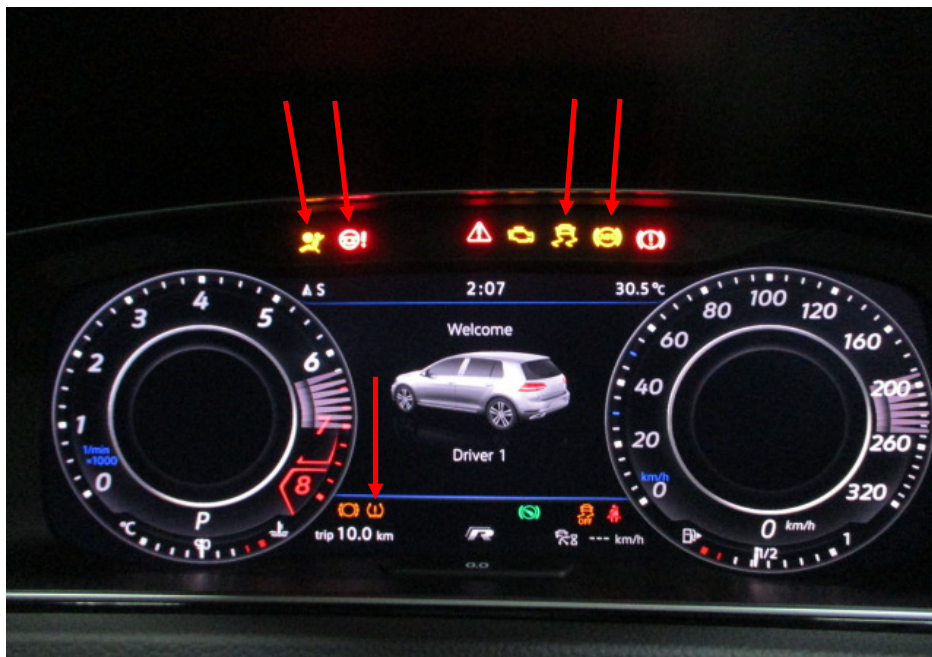
Photo 11 shows the warning lights for the various electronic safety features appearing on the instrument panel of the Motor Car during its self-test when the engine is cranked, in particular the ABS, SRS, EPS, ESP and TPM lights (arrowed).

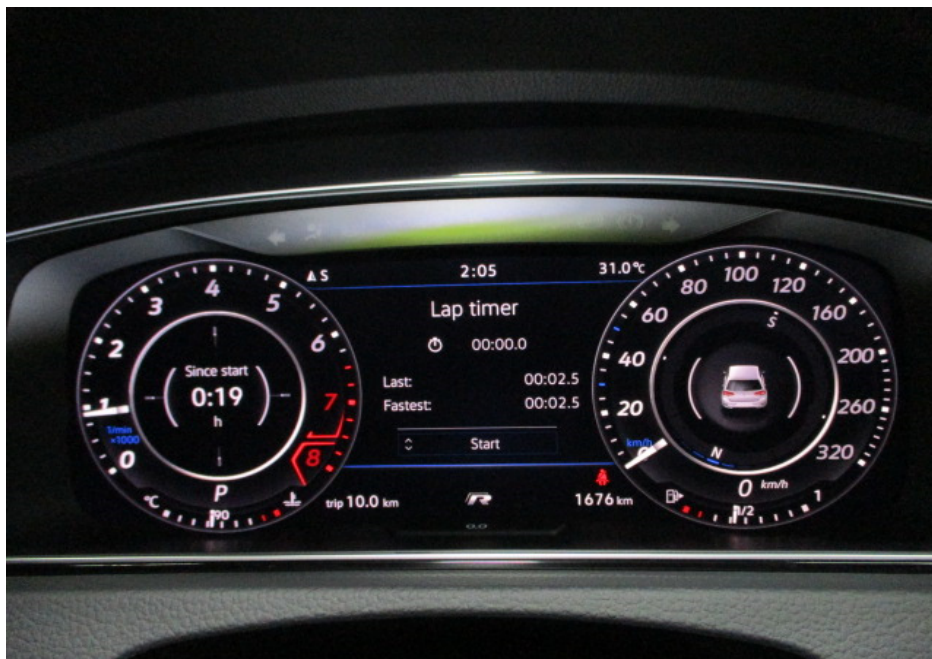
Photo 12 shows the respective warning lights no longer illuminated, indicating that there is no fault detected to the ABS, SRS, EPS, ESP and TPM systems of the Motor Car during the self-test. These electronic systems were hence in working condition at the time of my inspection.

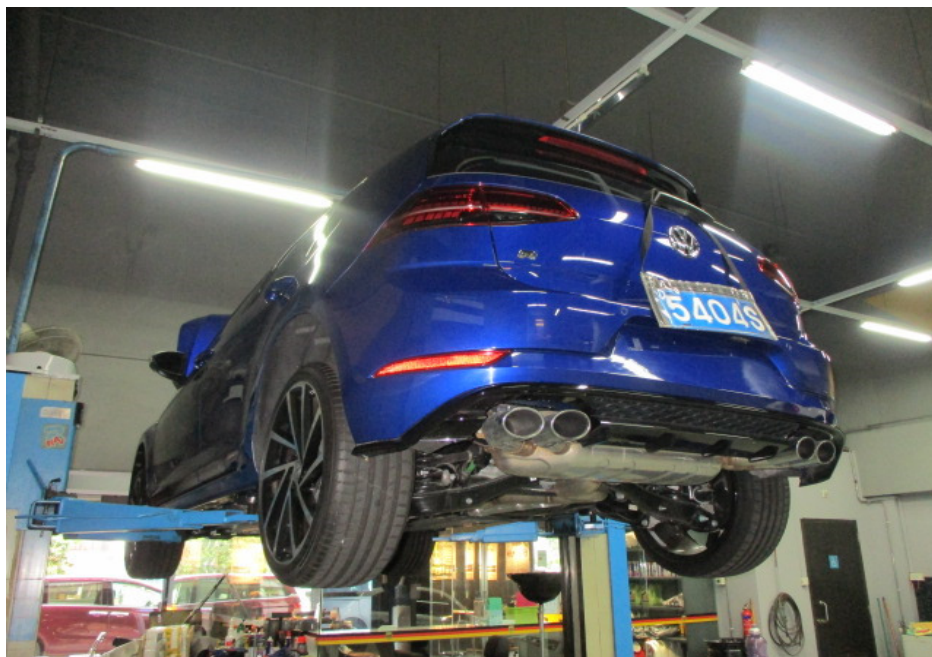
Photo 13 shows the Motor Car hoisted up for checks on its undercarriage. There was no sign(s) or indication(s) of fluid leakage and/or fluid stain(s) on the underside of the Motor Car. The undercarriage components of the Motor Car were also all observed to be intact and secured in an appropriate manner.

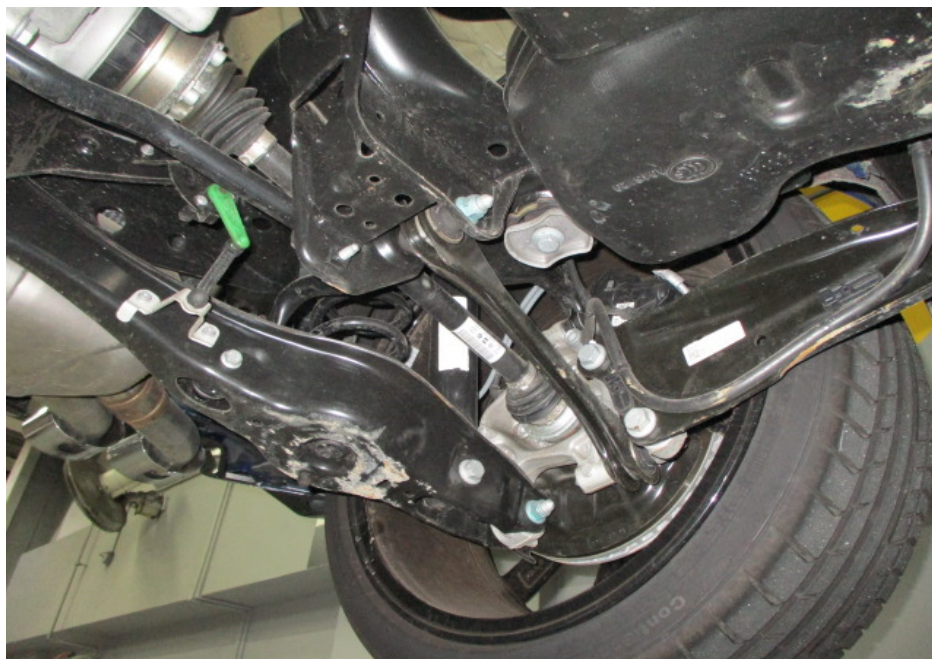
Photo 14 shows a general view of the control arms and linkages at the rear left wheel of the Motor Car. I did not observe any fluid leak and/or fluid stain on the underside of the Motor Car. All of the Motor Car's undercarriage components were observed to be intact and secured in an appropriate manner.

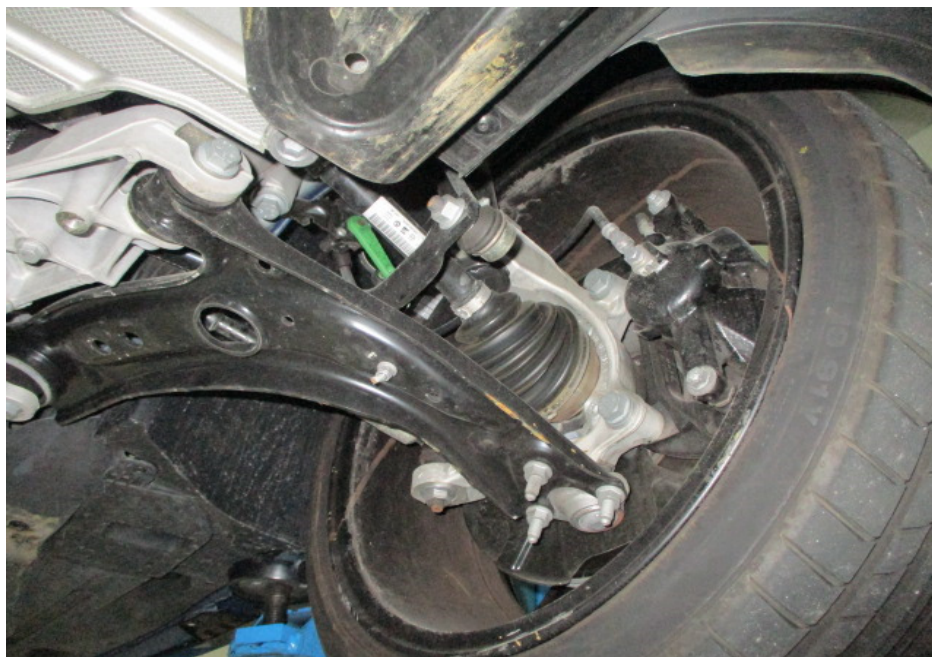
Photo 15 shows the various undercarriage components at the front left wheel of the Motor Car. The mechanical components, control arms and linkages were all found to be intact and secured in an appropriate manner.

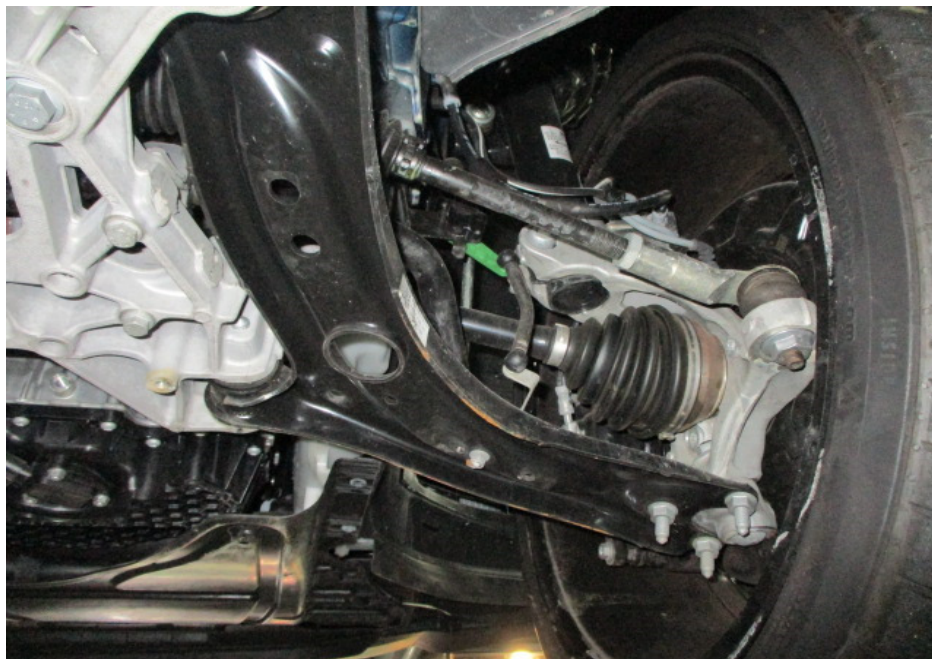
Photo 16 shows the various undercarriage components at the front right wheel of the Motor Car. The mechanical components, control arms and linkages were all found to be intact and secured in an appropriate manner. I also did not observe any fluid leak and/or fluid stain on the underside of the Motor Car.

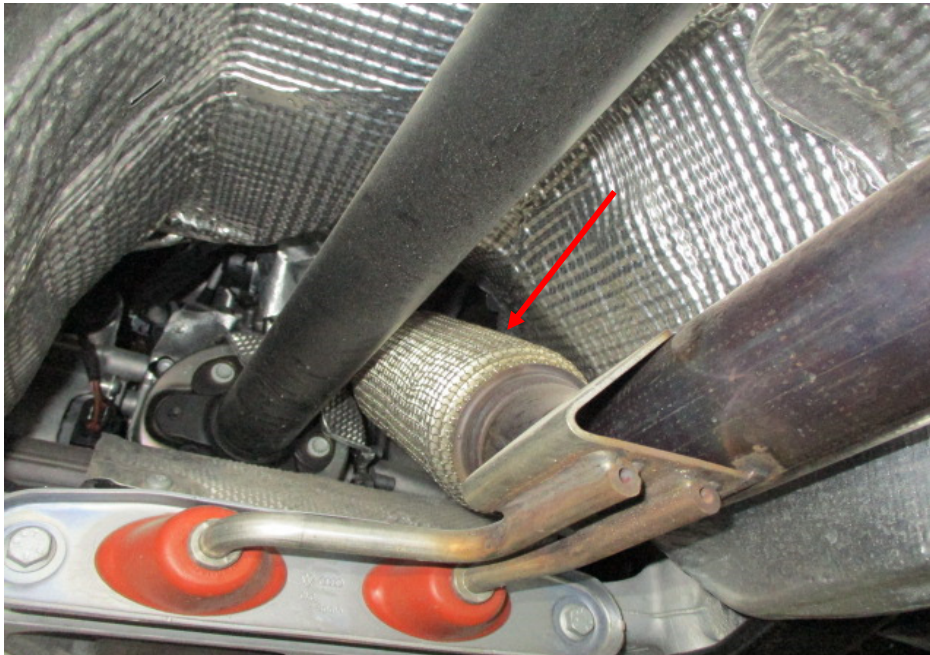
Photo 17 shows the Motor Car's catalytic converter (arrowed). My examination of the Motor Car's exhaust system revealed no sign(s) or indication(s) of any cut or weld marks along its exhaust pipes and on its rear muffler.

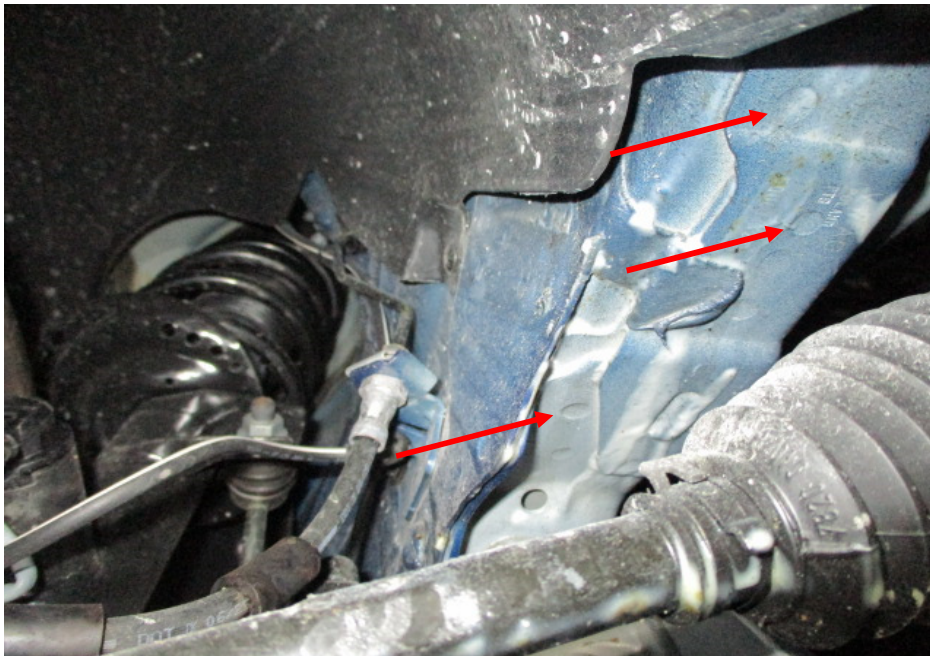
11. Visually, I did not find any weld marks, other than the original spot weld marks, on the chassis/structural body of the Motor Car. The original factory sealant at the joints along the chassis/structural body was also untouched, indicating that no replacement of the chassis/structural body was carried out; and that the chassis/structural body was originally fitted.

Photo 18 shows the chassis/structural body at the underside front left of the Motor Car. Visually, I did not find any weld marks other than original spot weld marks (arrowed) on the chassis/structural body of the Motor Car. The original factory sealant at the joints along the chassis/structural body was also untouched, indicating no work was done on the chassis/structural body of the Motor Car and that the chassis/structural body was originally fitted.

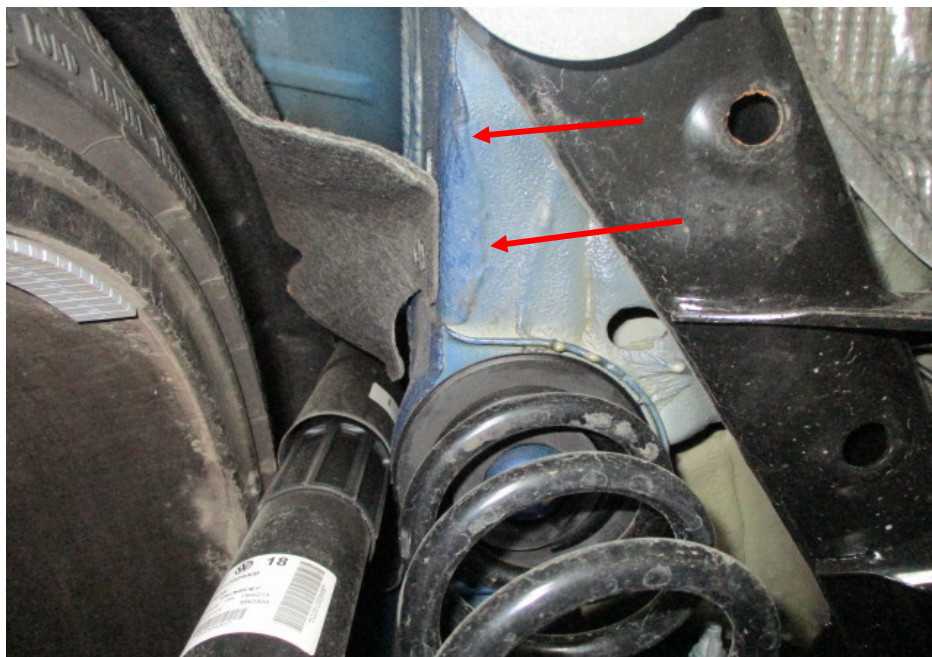
Photo 19 shows the chassis/structural body at the underside rear left of the Motor Car. The original factory sealant (arrowed) at the joints along the chassis/structural body was untouched, indicating no work was done on the chassis/structural body of the Motor Car and that the chassis/structural body was originally fitted.

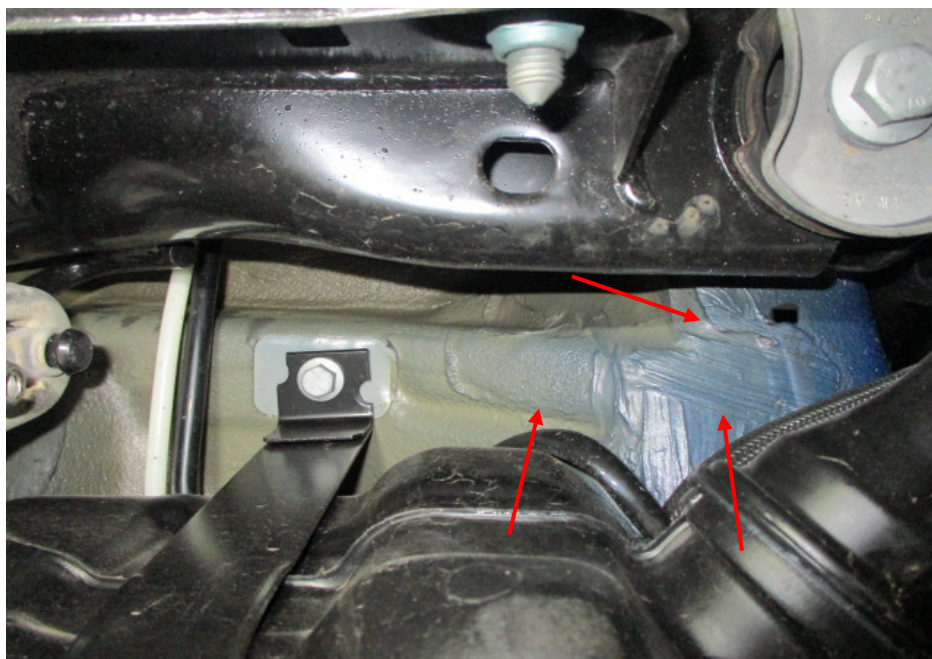
Photo 20 shows the floorboard at the underside rear of the Motor Car. The original factory sealant (arrowed) at the joints along the non-detachable body panels were untouched, indicating no work was done on the non-detachable body panels of the Motor Car; and that these body panels were originally fitted.

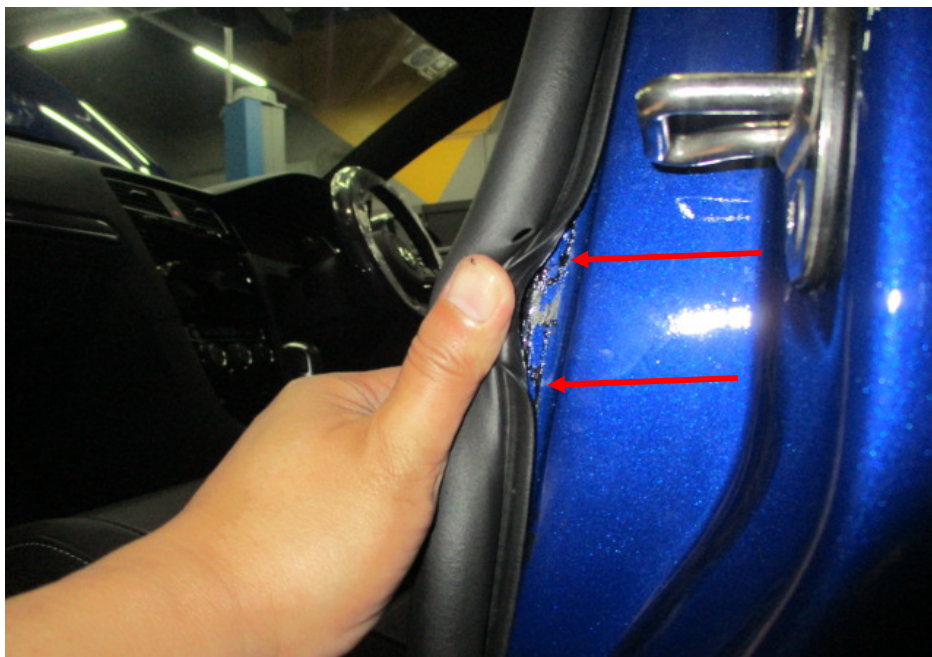
Photo 21 shows the left side "B" pillar of the Motor Car. The original rubber gum (arrowed) was seen at the left side "B" pillar when the front left door weatherstrip was pulled aside, indicating that the left side "B" pillar was originally fitted. In general, I had found the non-detachable body panels of the Motor Car to be originally fitted at the time of my inspection.
