Your Ref: Porsche 718 Boxster S
(chassis number WP0ZZZ98ZKS221047)
Our Ref : CI/TP20010735/D

06 October 2020

**INSPECTION REPORT OF AN UNREGISTERD PORSCHE 718 BOXSTER S
MOTOR CAR WITH CHASSIS NUMBER WP0ZZZ98ZKS221047**

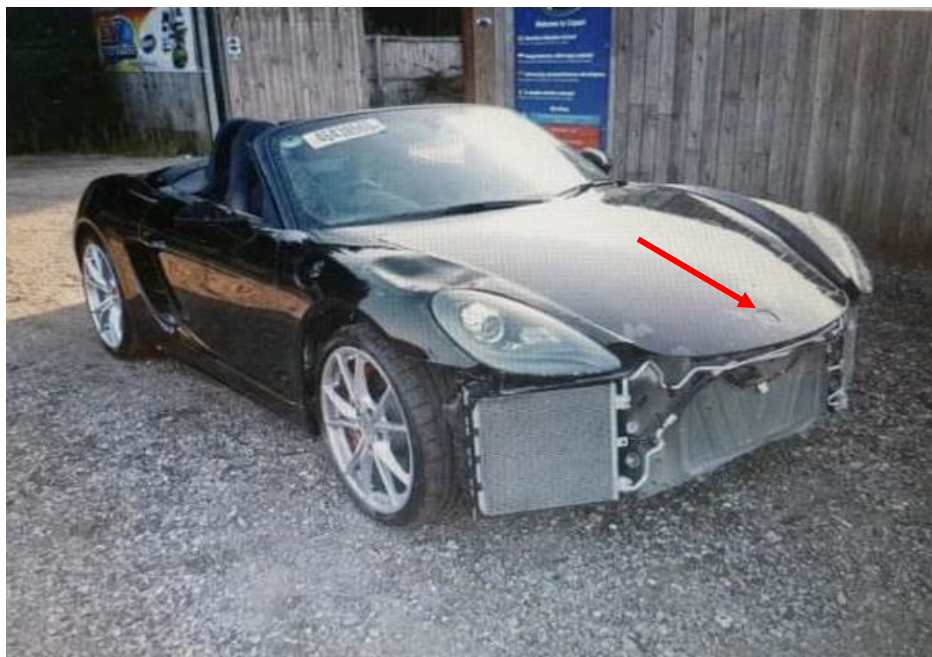
3. From the photographs provided to me, it was observed that the Motor Car's front bumper and its related attachments were dislodged/missing. The related attachments include the fog lamps and grilles amongst others. The front bonnet emblem was also observed to be missing.
4. There appears to be no visible damage observed to the Motor Car as seen from the photographs that were provided to me. The airbags were also not activated. See photo 1 – 3 below.

Photo 1 shows the front right body of the Motor Car (photograph provided to me). There appears to be no visible damage observed to the Motor Car as seen from the photographs that were provided to me. I had however observed that the Motor Car's front bumper and its related attachments were dislodged/missing. The front bonnet emblem (arrowed) was also missing.

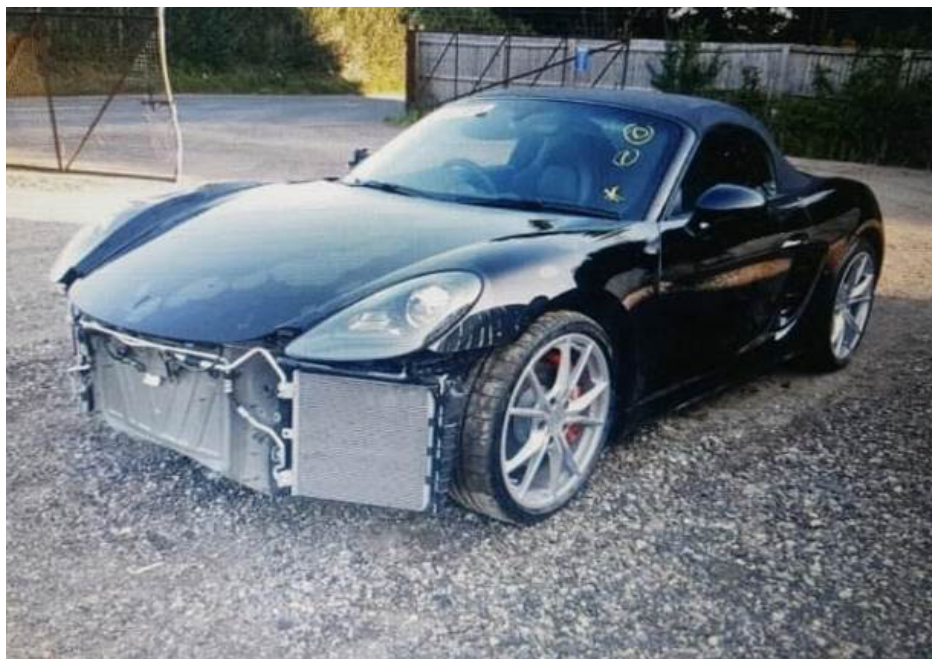
Photo 2 shows the front left body of the Motor Car (photograph provided to me). There appears to be no visible damage observed to the Motor Car as seen from the photographs that were provided to me. I had however observed that the Motor Car's front bumper and its related attachments were dislodged/missing.

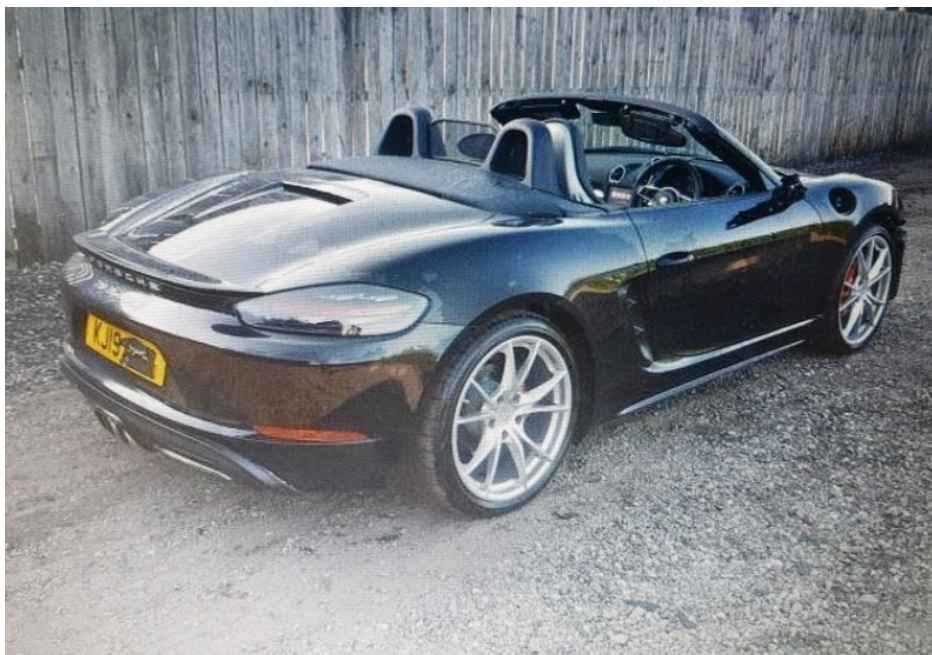
Photo 3 shows the rear right body of the Motor Car (photograph provided to me). There appears to be no visible damage observed to the Motor Car as seen from the photographs that were provided to me. The airbags were also not activated

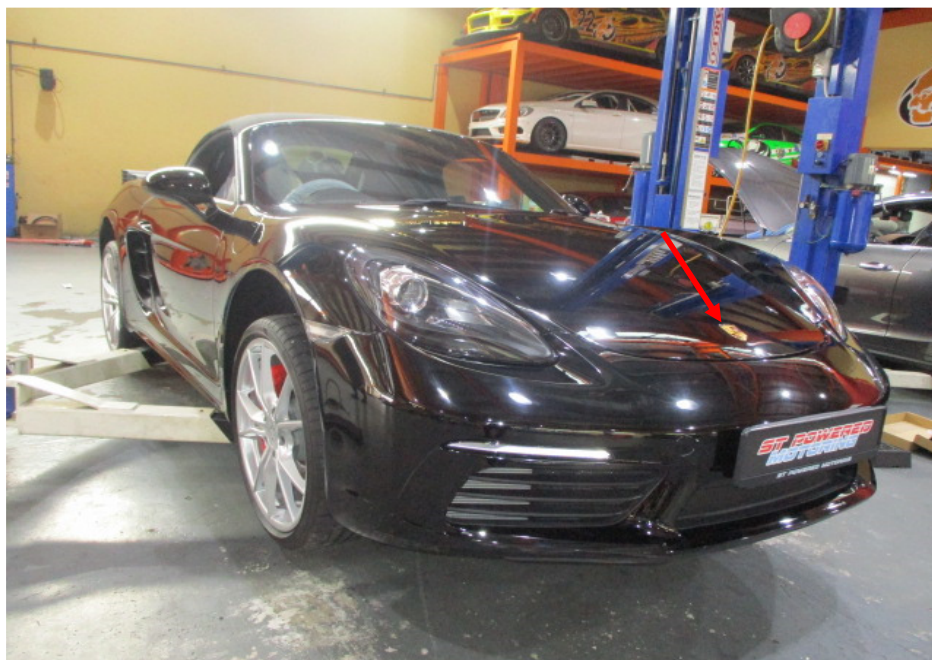
Photo 4 shows a general view of the front right body of the Motor Car at the time of my inspection. The Motor Car was observed to be in a relatively good general condition with no loose exterior fittings observed. The Motor Car's front bumper and its related attachments were visually examined at the time of my inspection and it was noted that the fitment of the front bumper and its related attachments were in order. The Motor Car was also fitted with the front bonnet emblem (arrowed) at the time of my inspection.

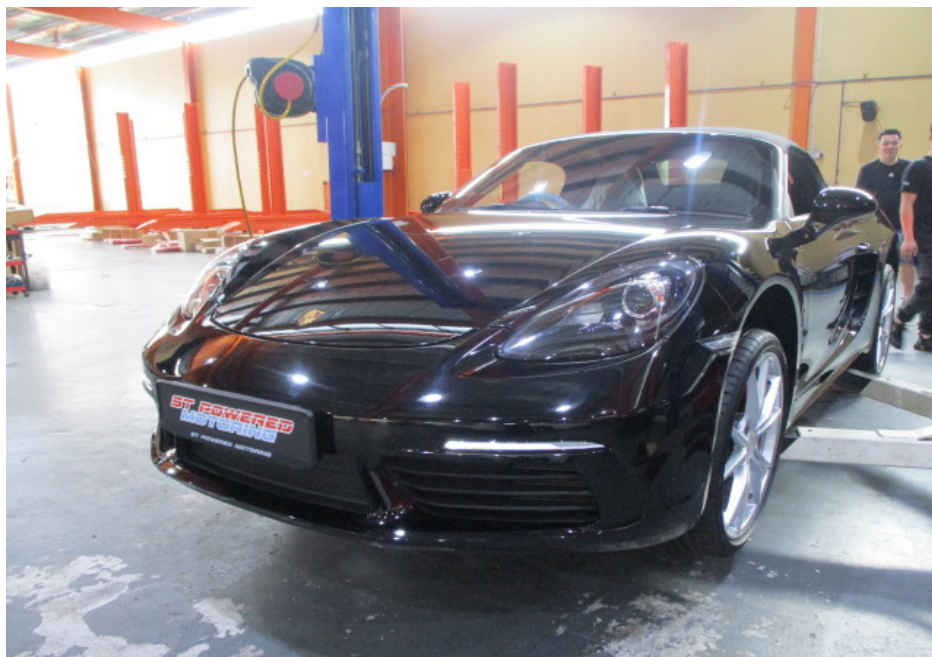
Photo 5 shows a general view of the front left body of the Motor Car at the time of my inspection. The Motor Car was observed to be in a relatively good general condition with no loose exterior fittings observed. The Motor Car's front bumper and its related attachments were visually examined at the time of my inspection and it was noted that the fitment of the front bumper and its related attachments were in order.

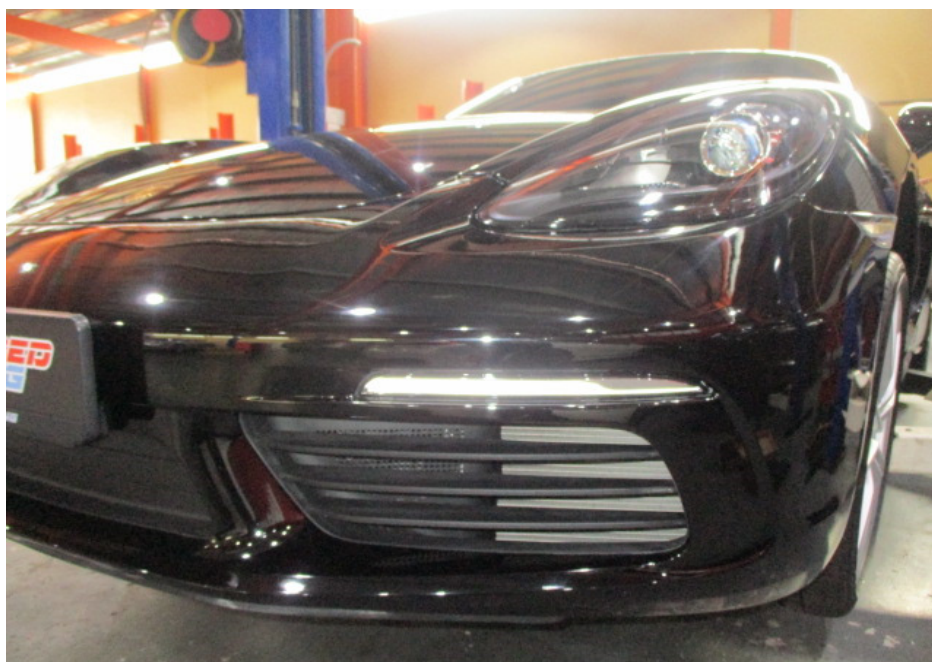
Photo 6 shows a closer view of the Motor Car's front bumper at the time of my inspection. The fitment of the front bumper and its related attachments, like the front left fog lamp and front left lower grille, were observed to be in order.

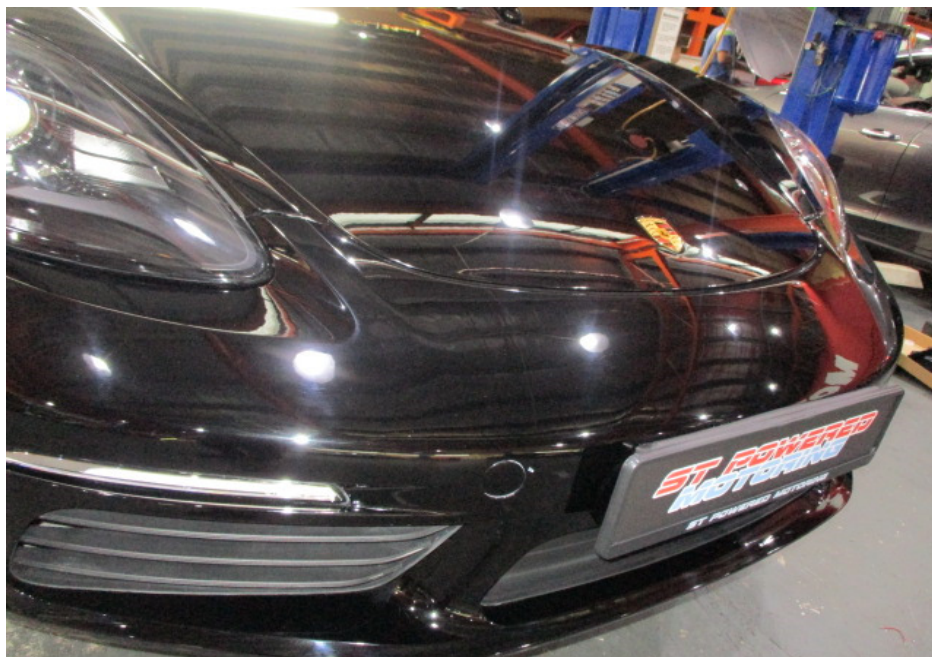
Photo 7 shows a closer view of the Motor Car's front bumper at the time of my inspection. The fitment of the front bumper and its related attachments, like the front right fog lamp, front right lower grille, tow hook cover and front centre lower grille, were observed to be in order.

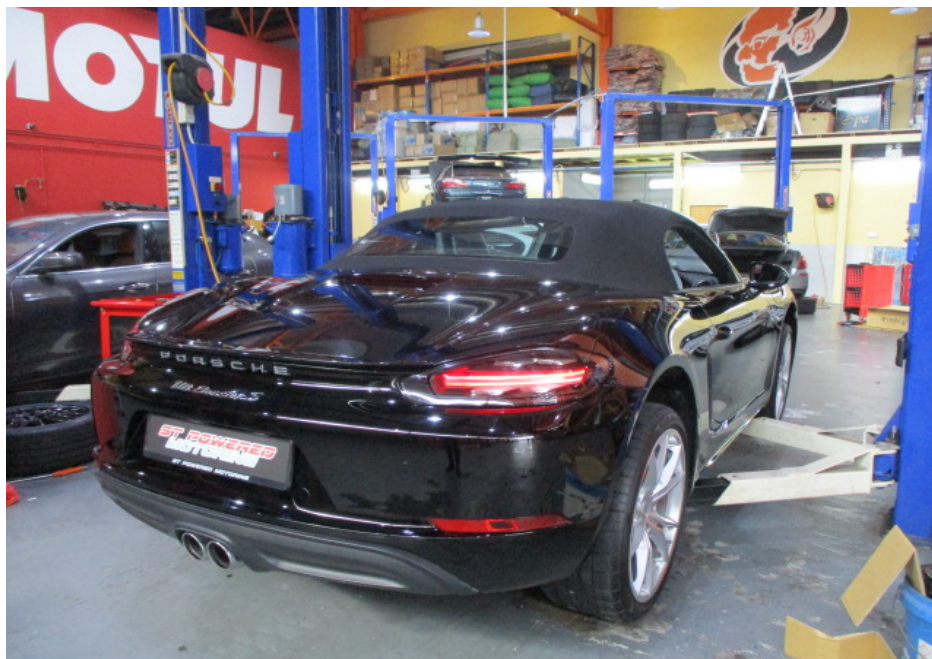
Photo 8 shows a general view of the rear right body of the Motor Car at the time of my inspection. The Motor Car was observed to be in a relatively good general condition with no loose exterior fittings observed. The mileage of the Motor Car recorded at the time of my inspection was 6,685km.

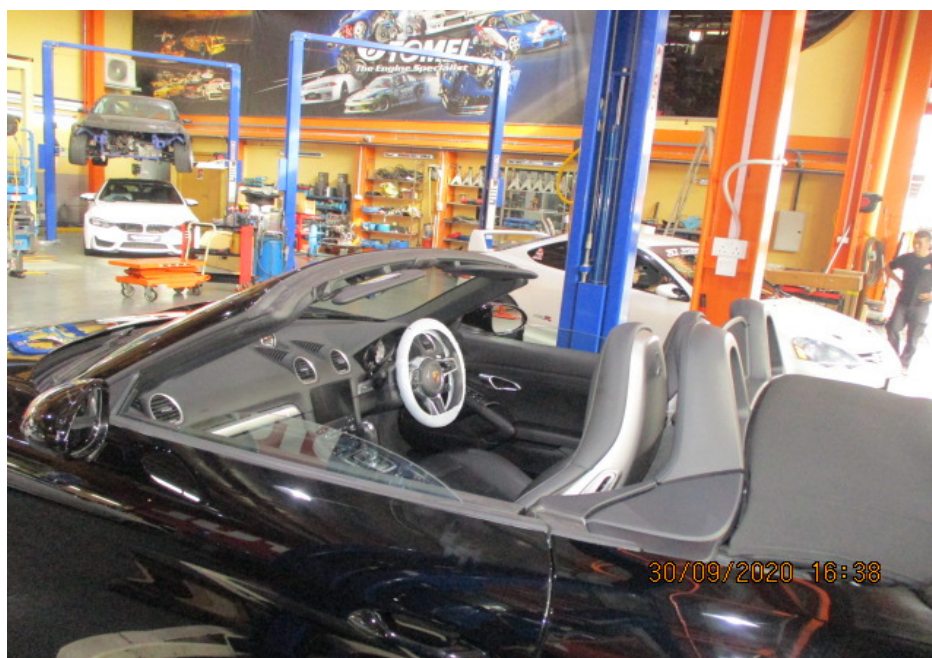
Photo 9 shows the Motor Car with its soft top roof folded. During my inspection of the Motor Car, I had tested the soft top roof and it was observed that the soft top roof was able to fold and unfold without any difficulty. It was also observed that during the folding and unfolding process, the soft top roof did not extend laterally beyond the Motor Car's body. In general, the soft top roof of the Motor Car was found to be in a normal working condition.

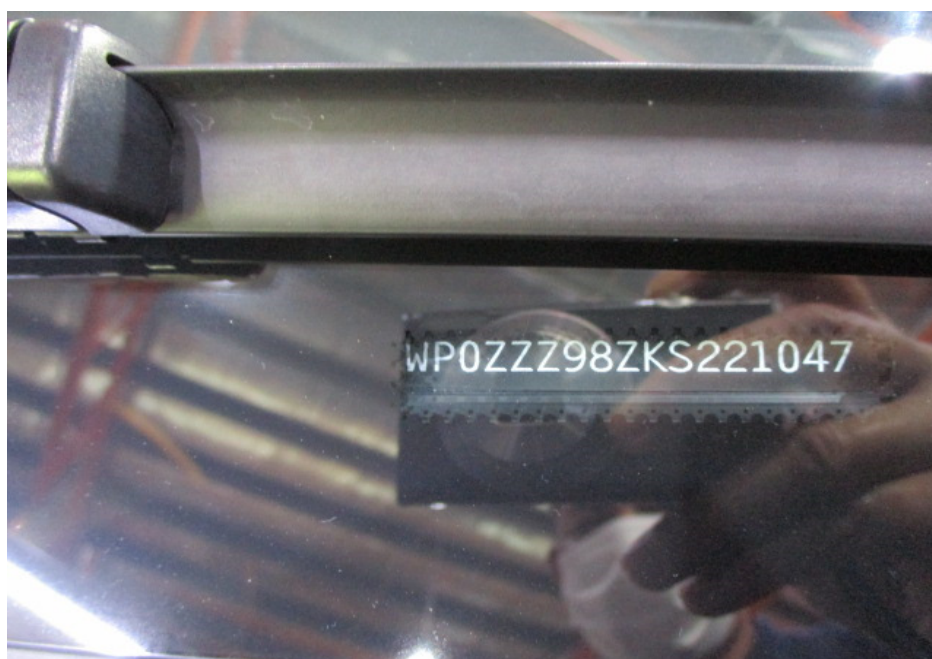
Photo 10 shows the chassis number of the Motor Car. The chassis number recorded was WP0ZZZ98ZKS221047.

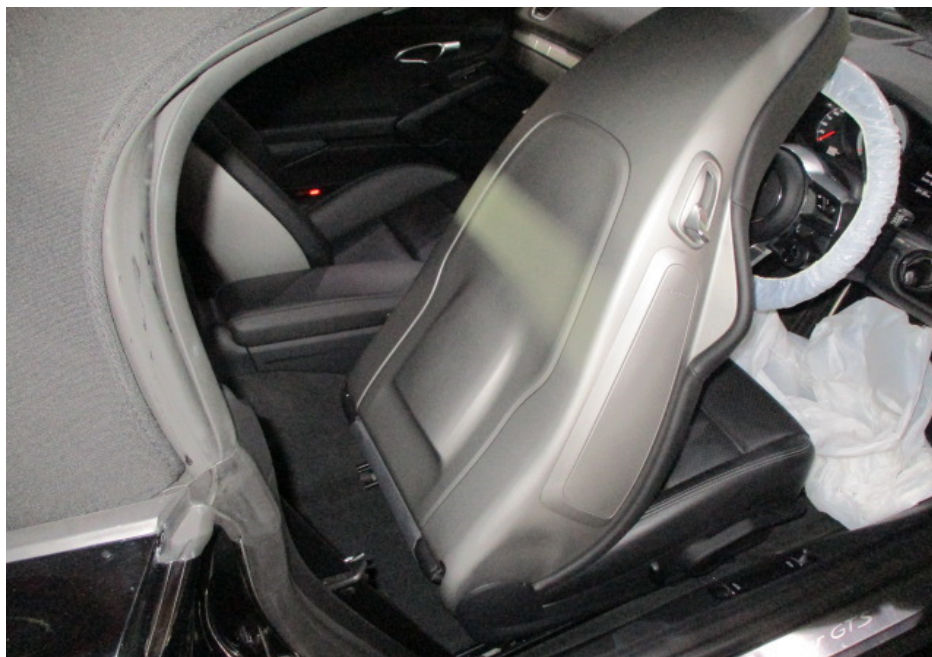
Photo 11 shows the seats of the Motor Car, which were secured via seat rails to the floorboard. All the seats of the Motor Car were fitted with a retractable seat belt reel and pre-tensioner. The seat belts were tested and able to be fastened into the respective pre-tensions that were fitted on the side of each individual seat.

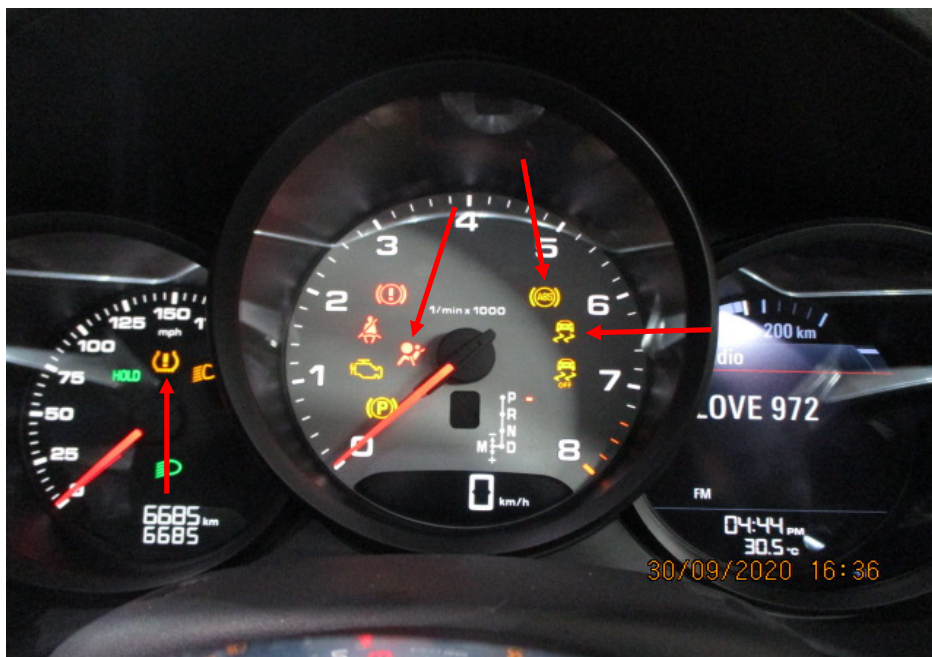
Photo 12 shows the warning lights for the various electronic safety features appearing on the instrument panel of the Motor Car during its self-test when the engine is cranked, in particular the ABS, SRS, TPM and TCS lights (arrowed).

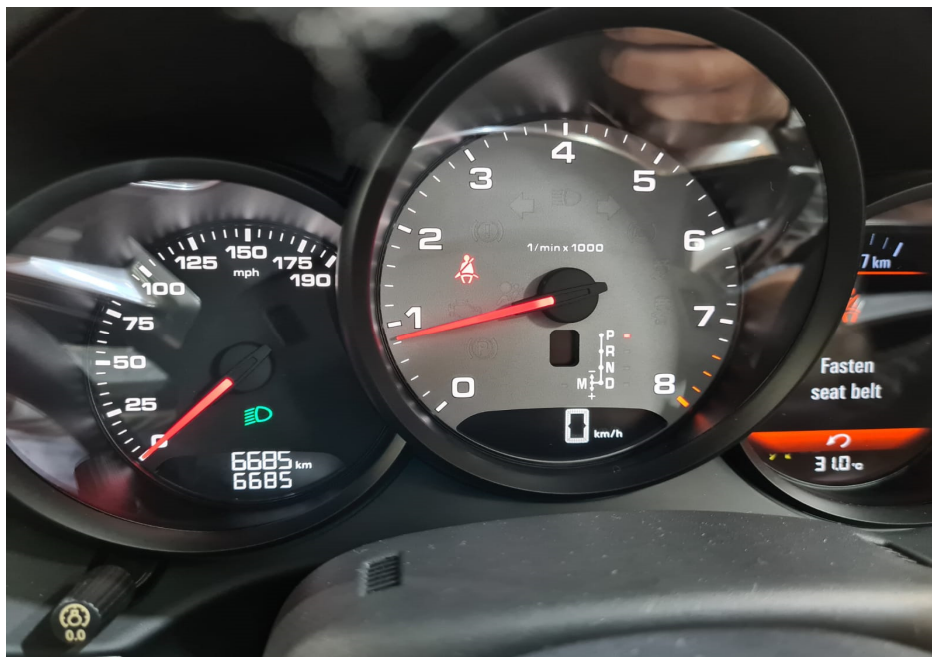
Photo 13 shows the respective warning lights no longer illuminated, indicating that there is no fault detected to the ABS, SRS, TPM and TCS systems of the Motor Car during the self-test. These electronic systems were hence in working condition at the time of my inspection.

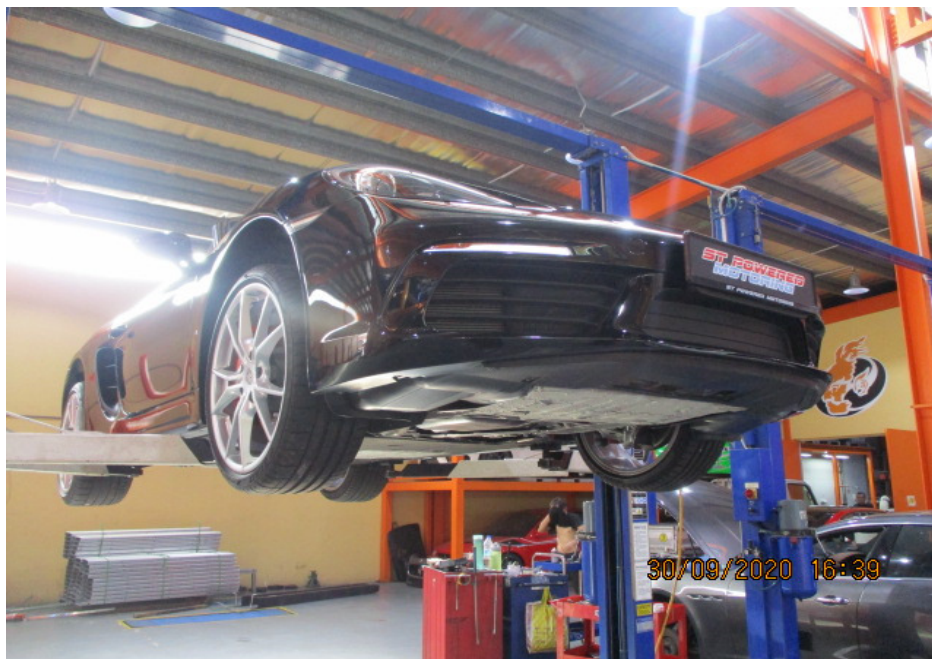
Photo 14 shows the Motor Car hoisted up for checks on its undercarriage. There was no sign(s) or indication(s) of fluid leakage and/or fluid stain(s) on the underside of the Motor Car. The undercarriage components of the Motor Car were also all observed to be intact and secured in an appropriate manner.

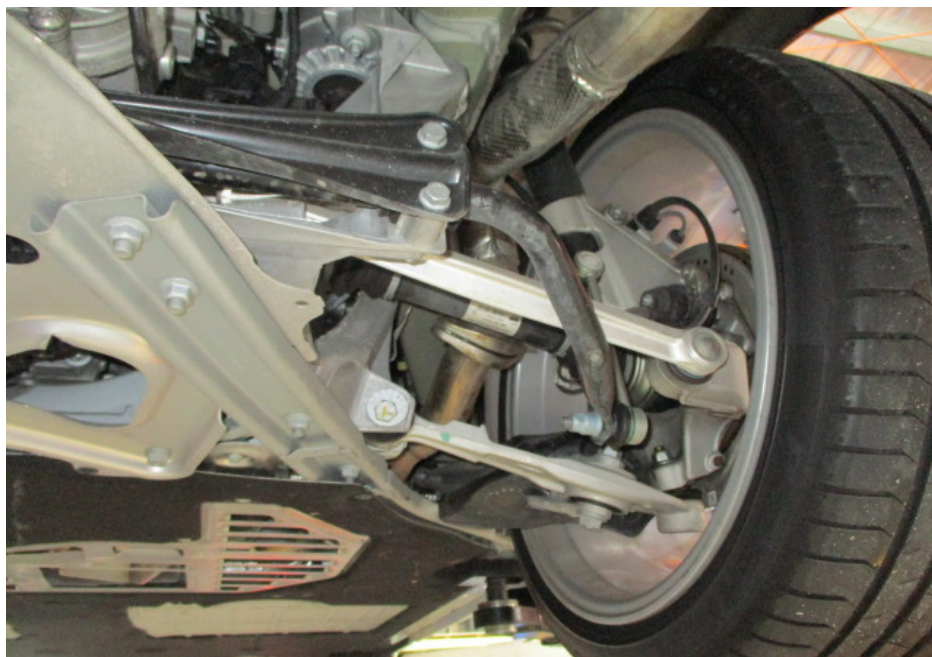
Photo 15 shows a general view of the control arms and linkages at the rear right wheel of the Motor Car. I did not observe any fluid leak and/or fluid stain on the underside of the Motor Car. All the Motor Car's undercarriage components were observed to be intact and secured in an appropriate manner.

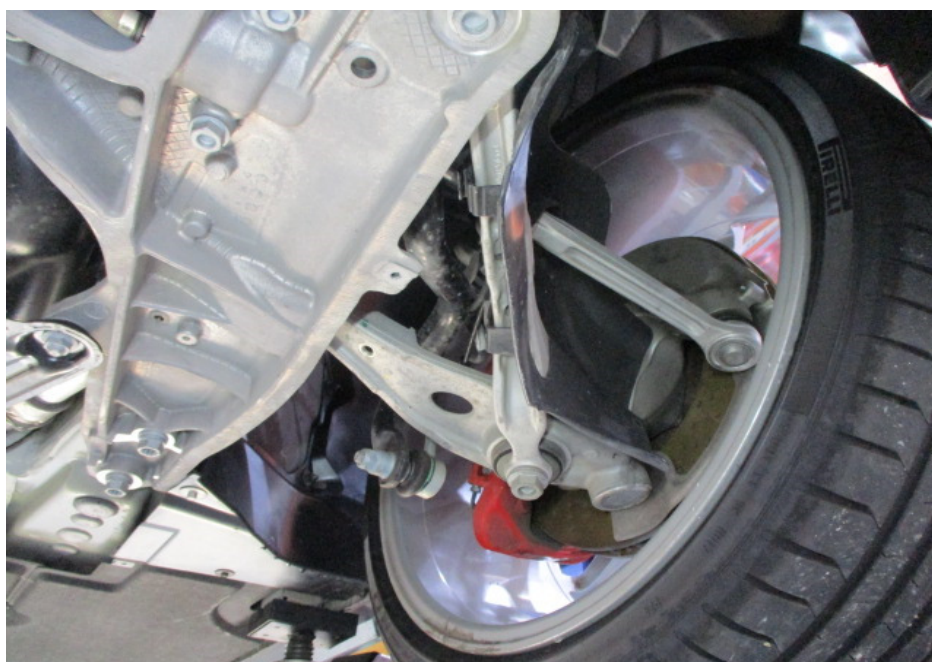
Photo 16 shows the various undercarriage components at the front left wheel of the Motor Car. The mechanical components, control arms and linkages were all found to be intact and secured in an appropriate manner.

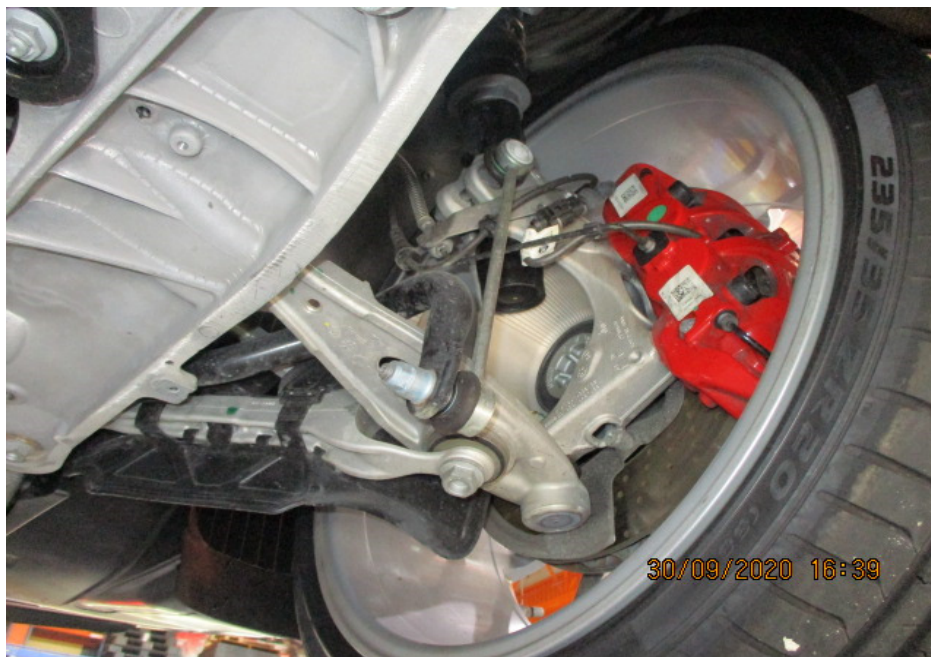
Photo 17 shows the various undercarriage components at the front right wheel of the Motor Car. The mechanical components, control arms and linkages were all found to be intact and secured in an appropriate manner. I also did not observe any fluid leak and/or fluid stain on the underside of the Motor Car.

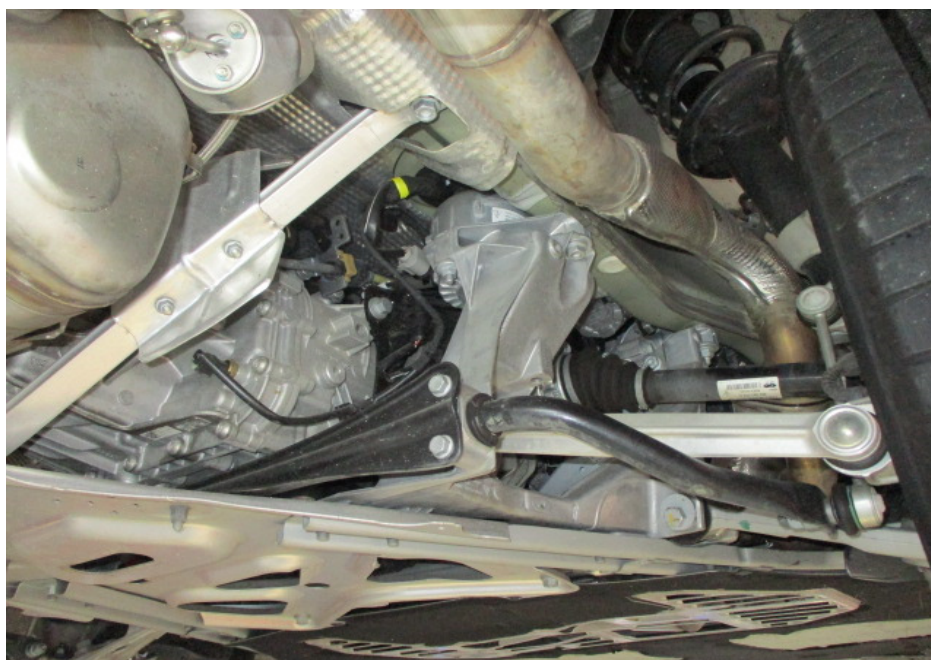
Photo 18 shows a general view of the engine compartment of the Motor Car at the time of my inspection. The engine compartment was at the rear underside of the Motor Car. The various parts and components inside the engine compartment were all observed to be intact and properly fitted. There was also no sign(s) or indication(s) of fluid leak and/or fluid stain found inside the engine compartment.

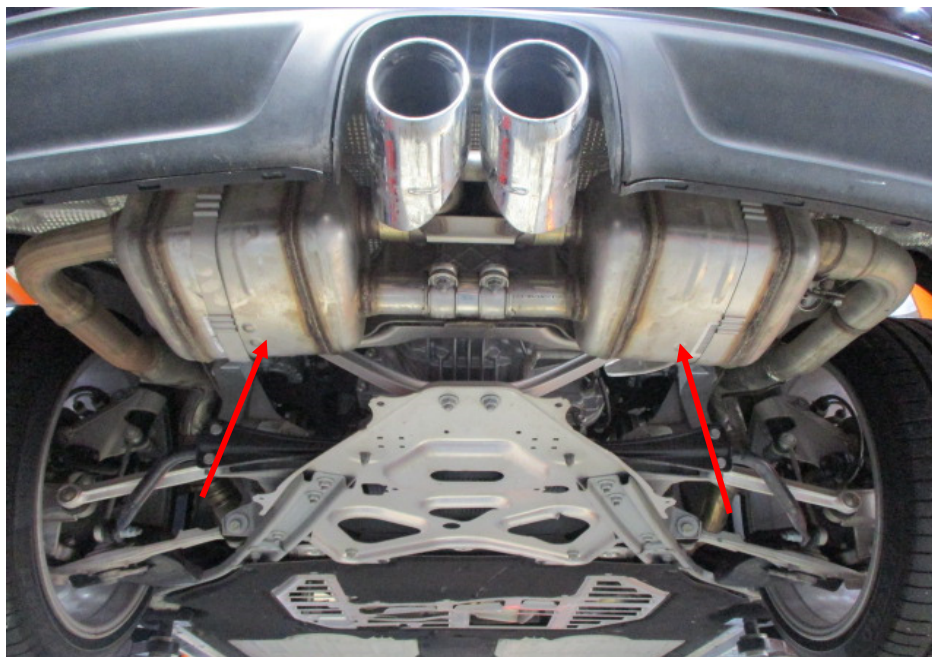
Photo 19 shows the Motor Car's rear mufflers (arrowed). My examination of the Motor Car's exhaust system revealed no sign(s) or indication(s) of any cut or weld marks along its exhaust pipes and on its catalytic converters.

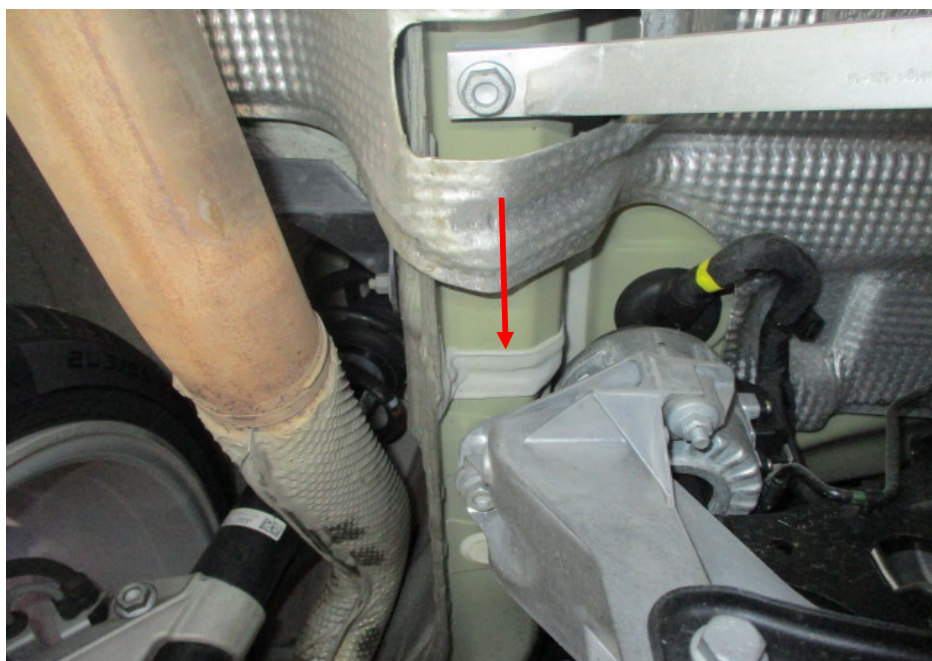
Photo 20 shows the chassis/structural body at the underside rear left of the Motor Car. The original factory sealant (arrowed) at the joints along the chassis/structural body was observed to be untouched, indicating no work was done on the chassis/structural body of the Motor Car and that the chassis/structural body was originally fitted.

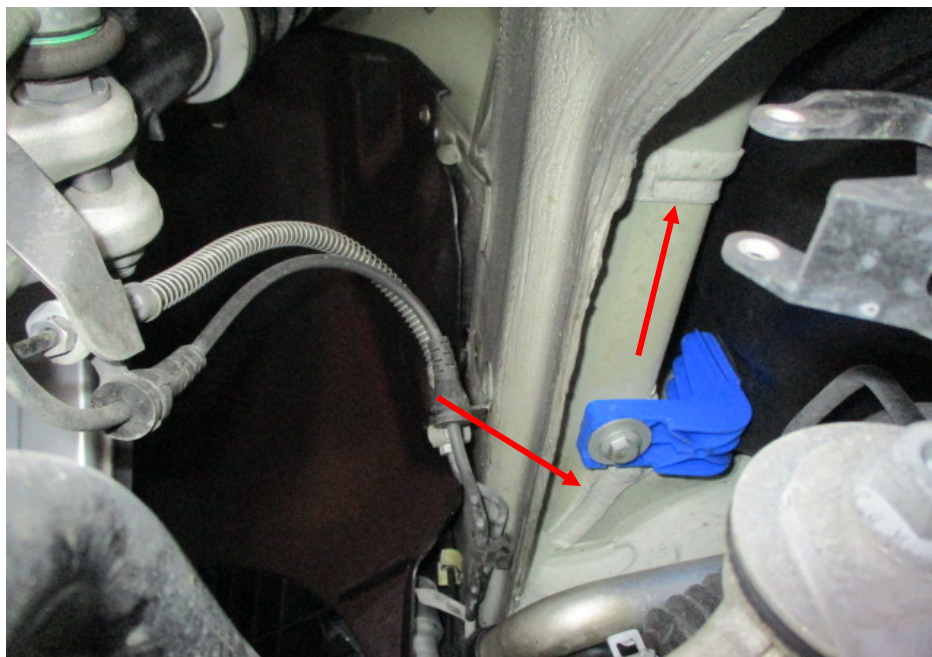
Photo 21 shows the chassis/structural body at the underside front left of the Motor Car. The original factory sealant (arrowed) at the joints along the chassis/structural body was observed to be untouched, indicating no work was done on the chassis/structural body of the Motor Car and that the chassis/structural body was originally fitted.

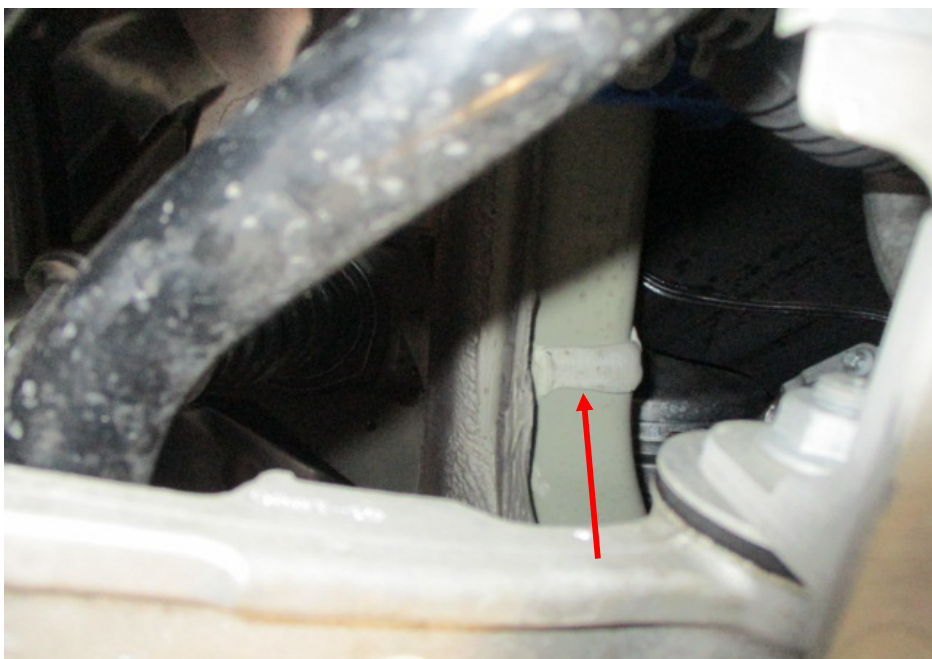
Photo 22 shows the chassis/structural body at the underside front right of the Motor Car. The original factory sealant (arrowed) at the joints along the chassis/structural body was observed to be untouched, indicating no work was done on the chassis/structural body of the Motor Car and that the chassis/structural body was originally fitted.

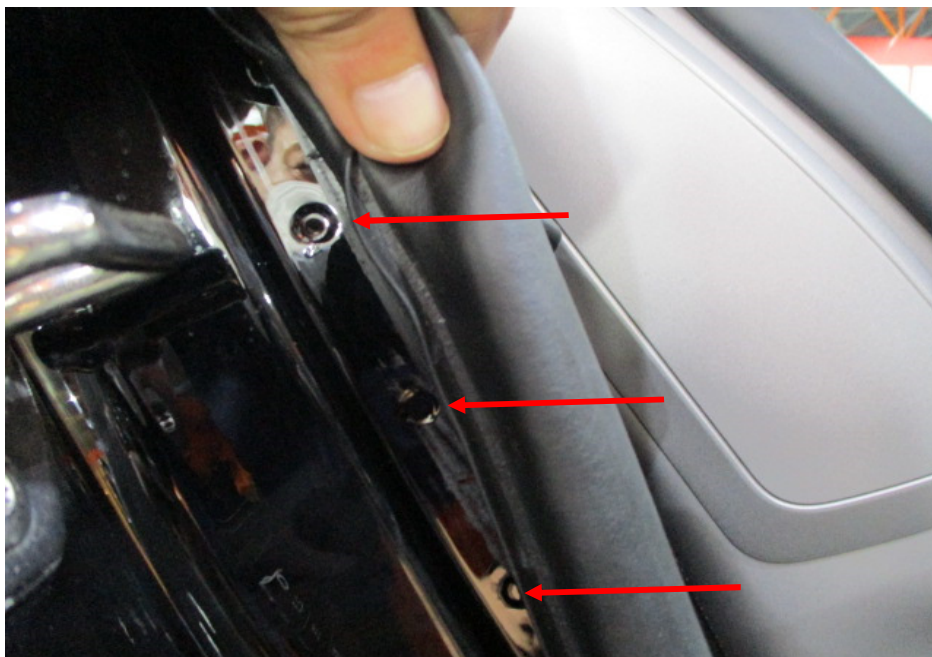
Photo 23 shows the right body panel of the Motor Car. I did not find any weld marks other than original spot weld marks (arrowed) on the non-detachable body panels of the Motor Car, indicating that there was no re-welding works carried out; and that the non-detachable body panels of the Motor Car were originally fitted. In general, I had found all the non-detachable body panels of the Motor Car to be originally fitted at the time of my inspection.
