## Shirley Hiew (LKK Auto)

**Subject:** XE 3905J Fire Case

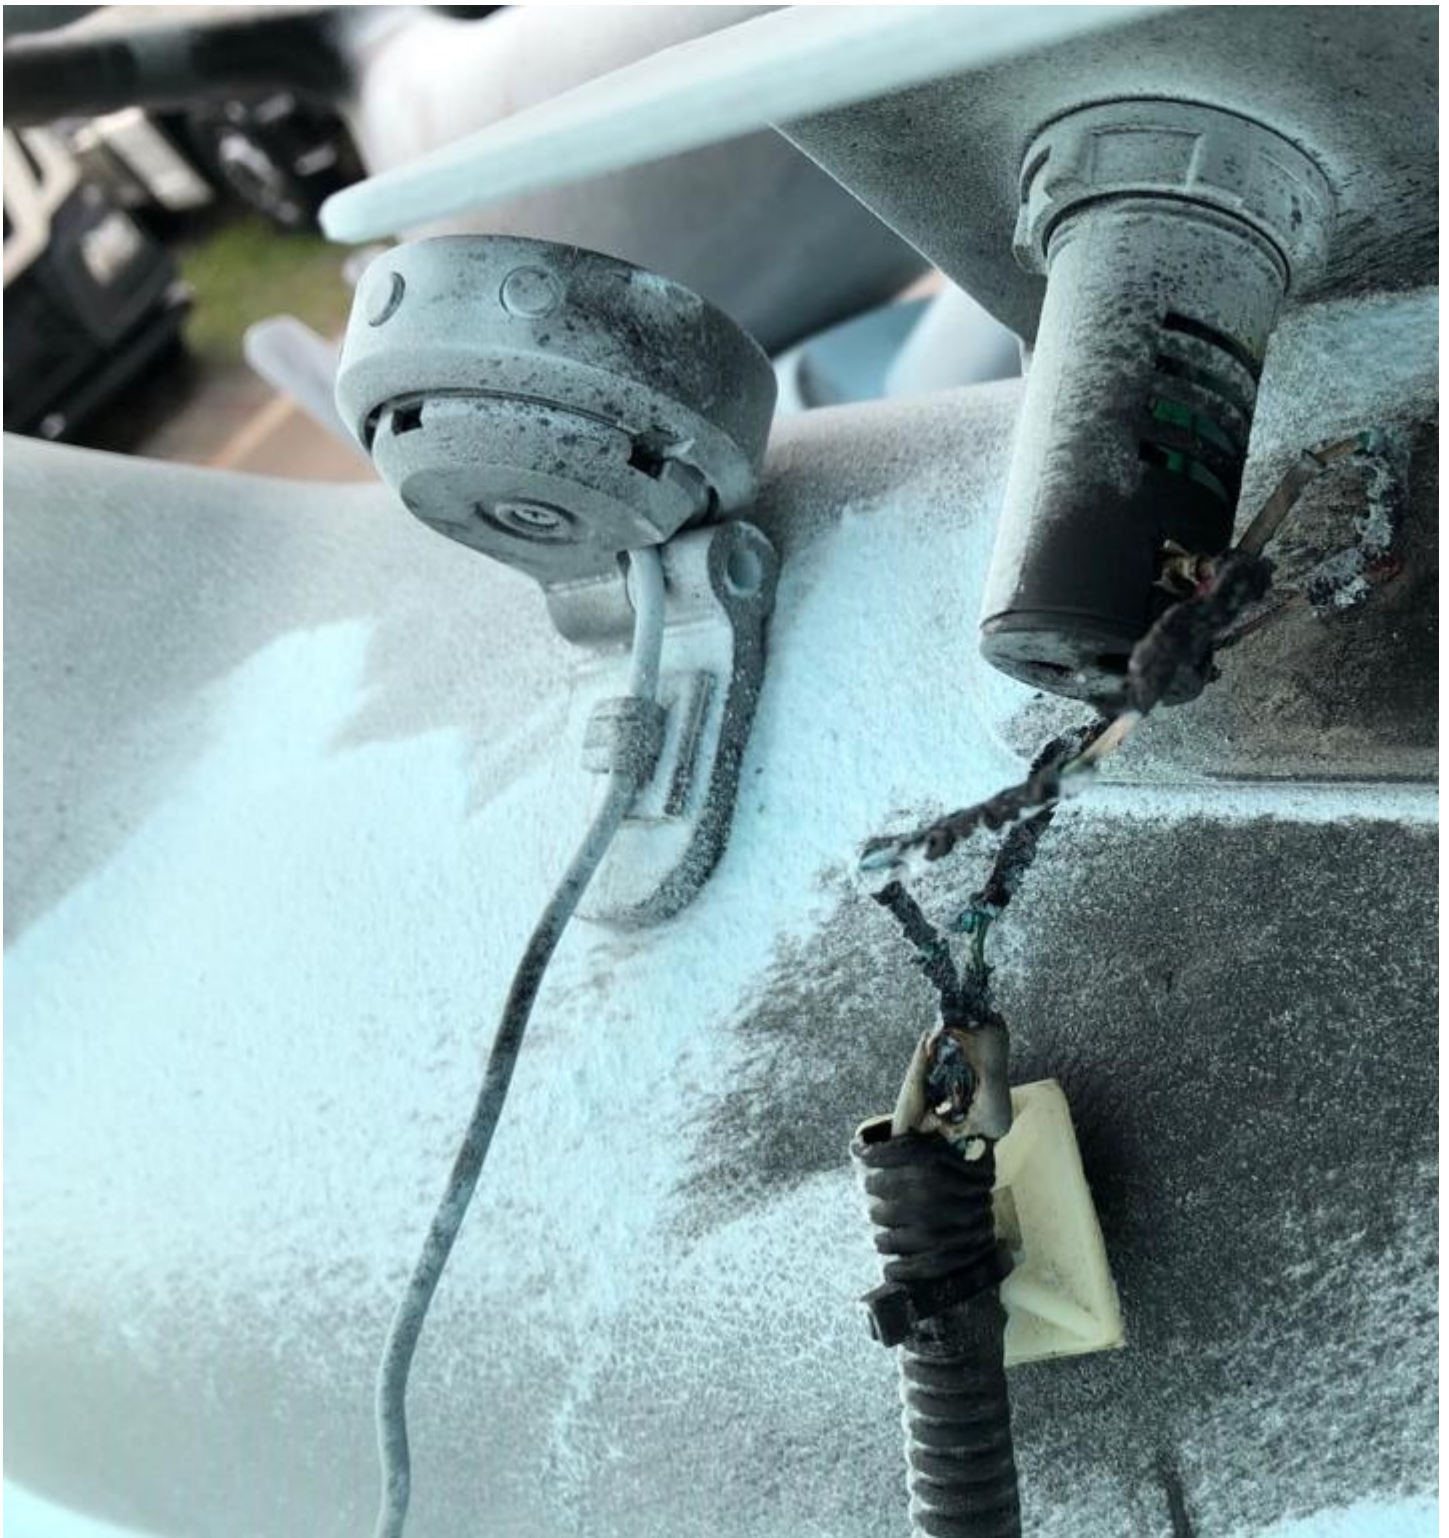
We have surveyed the vehicle again, this time with the estimate provided. However, we have been told by Mr Su Tho of MAN that the faulty component (which could be from where the fire started) is not part of the MAN lorry. This means that it could possibly be part of the crane assembly. Kindly advise on the next course of action.

We have inspected the Insured Vehicle. Our preliminary findings revealed the cause of fire to be electrical. We found a faulty component inside the dashboard which could be from where the fire started. However, we are unable to determine if the component is part of the lorry or the mobile crane. Refer to the attached picture below.

We confirmed that you may proceed to advise workshop to proceed with the repair subject to check items to be verified and approve.
