Your Ref: M2004905-CK
Our Ref : CS4/TMI20010785/N

31 December 2020

TECHNICAL INVESTIGATION REPORT OF FIRE INCIDENT INVOLVING THE MOTOR VEHICLE XE 3905J ON 30 SEPTEMBER 2020

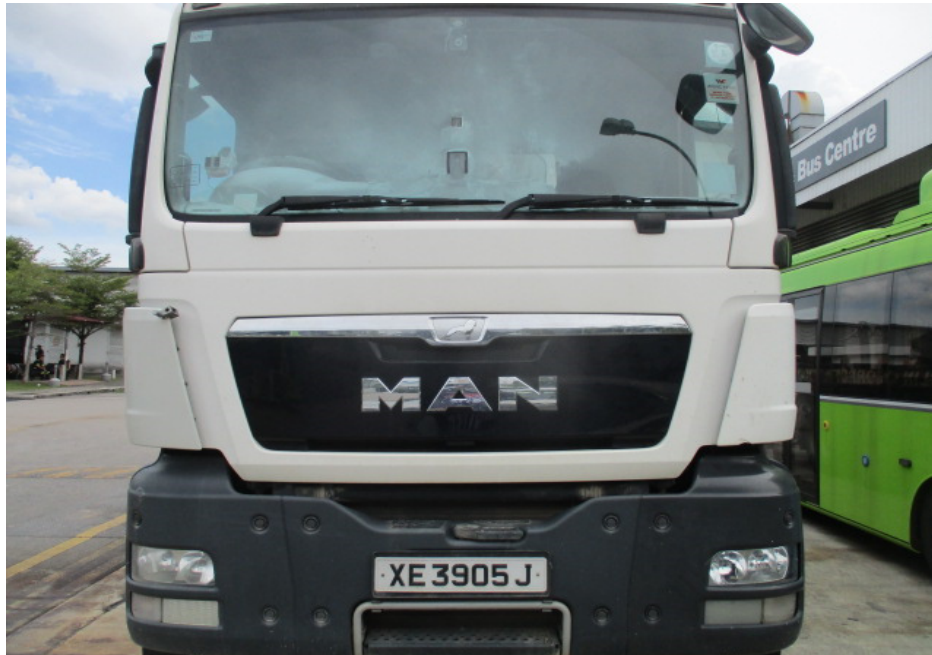
Photo 1 shows the front view of the Insured Vehicle at the time of our inspection. The fire damage to the Insured Vehicle was confined to its interior compartment. Most parts of the front portion were unaffected by the fire except for the front windscreen.

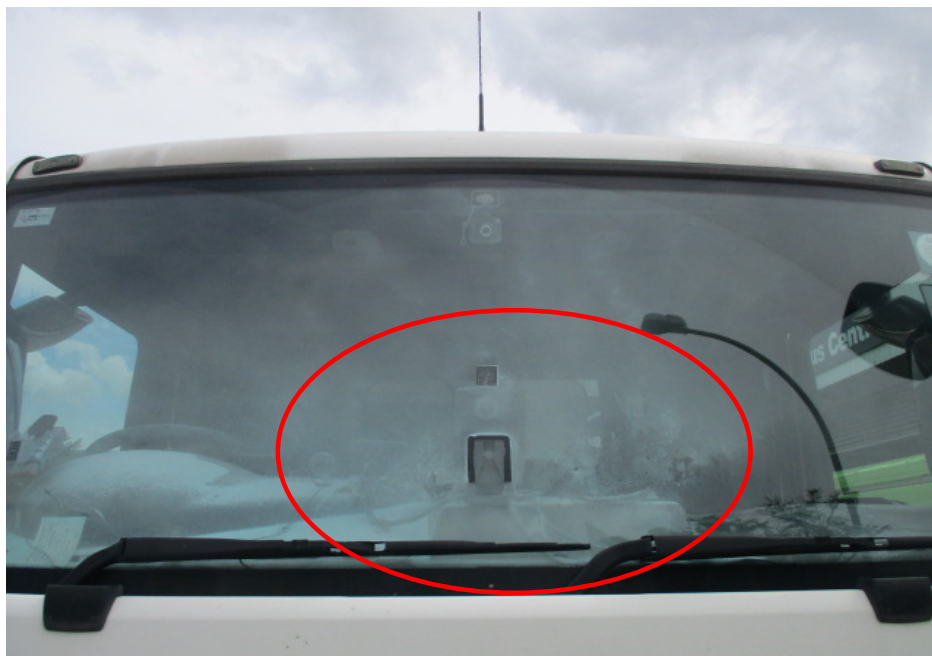
Photo 2 shows the general view of the front windscreen of the Insured Vehicle. The centre portion of the windscreen seemed to have sustained visible fire damage (circled).

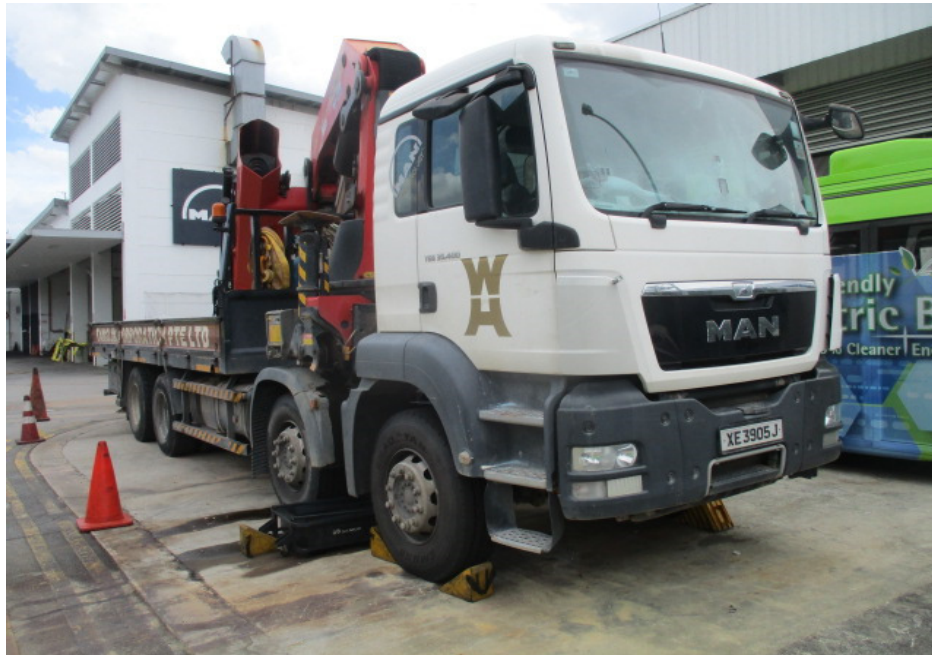
Photo 3 shows the right side view of the Insured Vehicle at the time of our inspection. The fire damage to the Insured Vehicle was confined to its interior compartment. The right body was observed to have been unaffected by the fire.

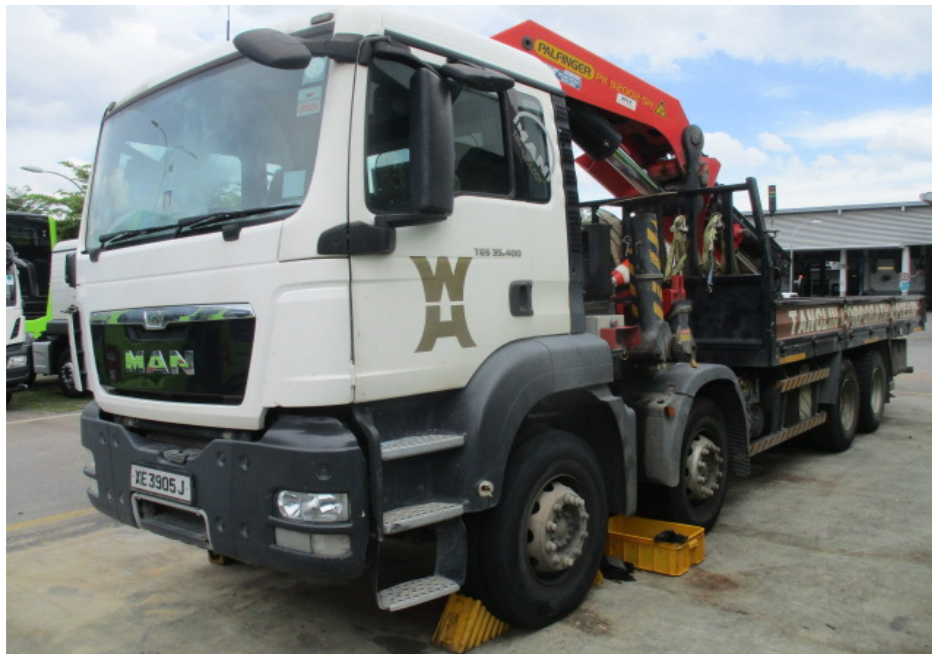
Photo 4 shows the left side view of the Insured Vehicle at the time of our inspection. The fire damage to the Insured Vehicle was confined to its interior compartment. The left body was observed to have been unaffected by the fire.

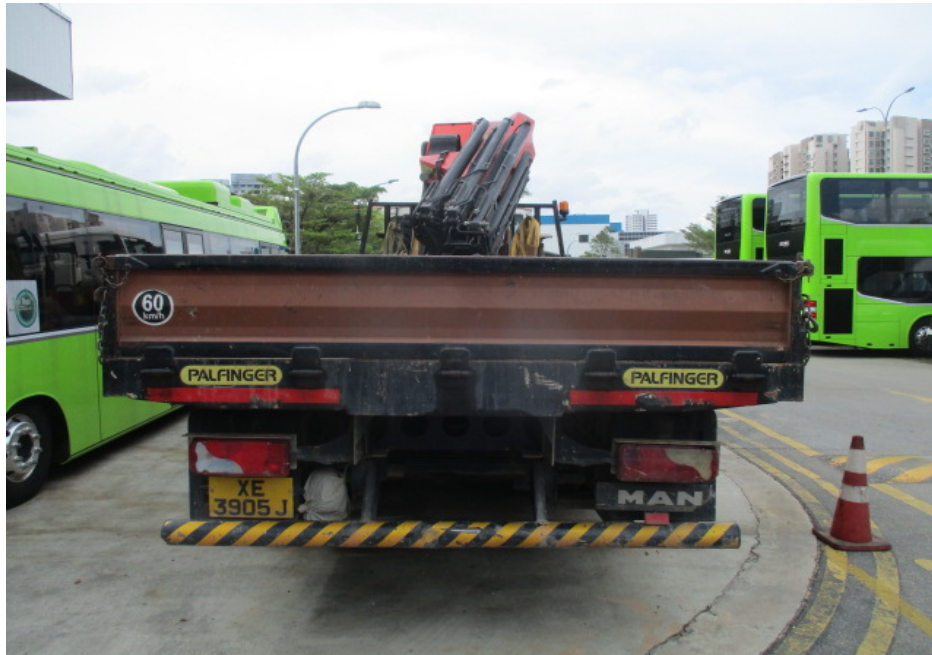
Photo 5 shows the rear view of the Insured Vehicle at the time of our inspection. The fire damage to the Insured Vehicle was confined to its interior compartment. The rear portion was observed to have been unaffected by the fire.

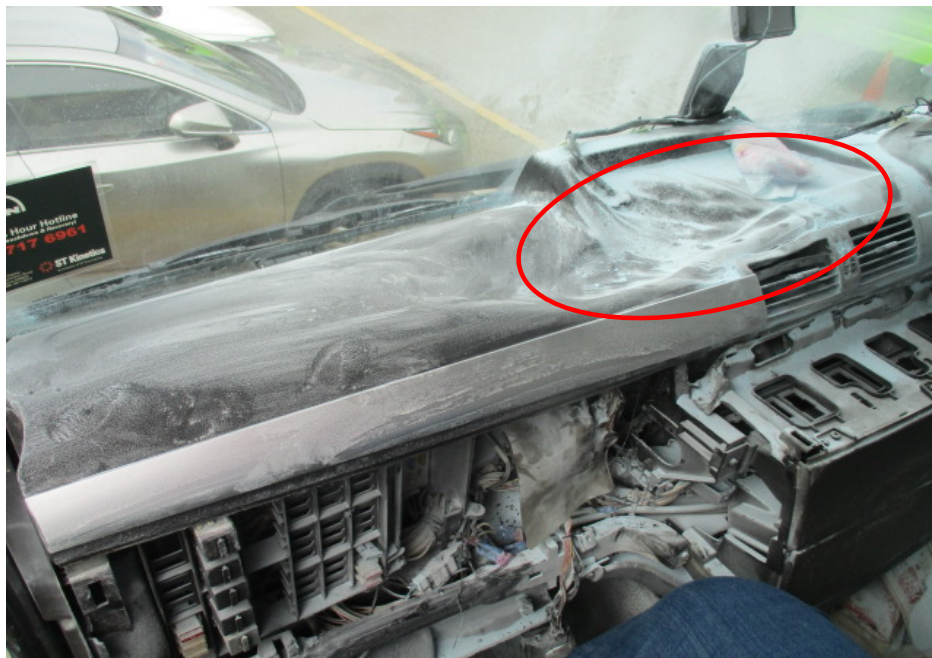
Photo 6 shows the interior compartment of the Insured Vehicle at the time of inspection. Most of the components in the centre of the dashboard (circled) were found to be burnt and/or melted as a result of the fire.

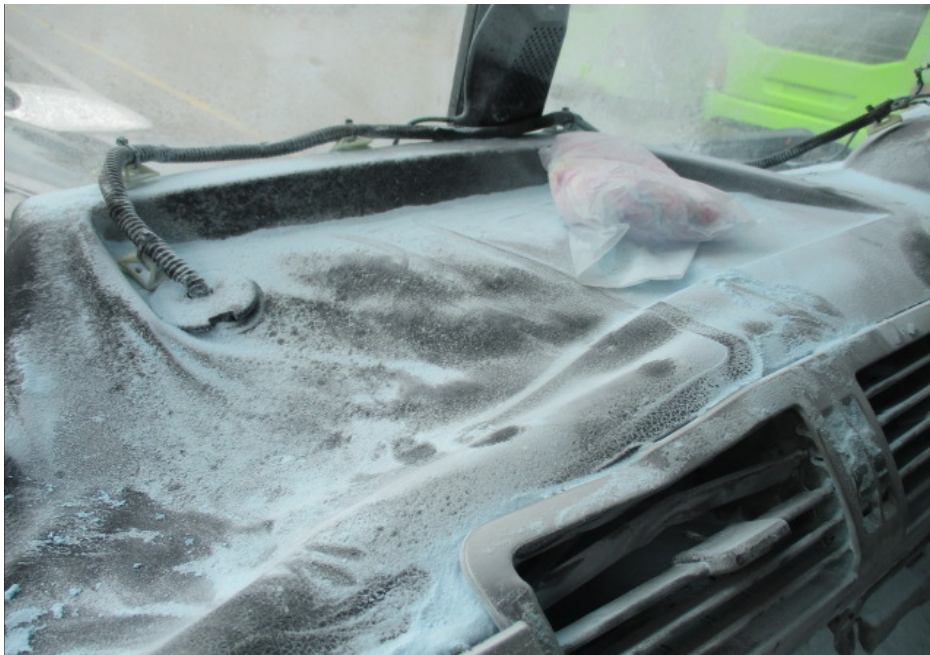
7. For this particular case, the fire appears to have started from the centre of the dashboard. This can be determined basing on the area where the extent of fire damage was most severe which was the centre portion of the instrument panel. Various components of the instrument panel were observed to have been burnt and/or partly melted from prolonged exposure to high heat intensity which included the upper and central parts of the instrument panel assembly, air outlet assembly, beaker holder assembly and carrier assembly, amongst others. See photos 7 - 9 below.

Photo 7 shows the centre of the dashboard of the Insured Vehicle. The fire seemed to have originated from the centre portion of the instrument panel basing on the area where the extent of fire damage was most severe. Various components of the instrument panel were observed to have been burnt and/or partly melted from prolonged exposure to high heat intensity which included the upper and central parts of the instrument panel assembly, air outlet assembly, beaker holder assembly and carrier assembly, amongst others.

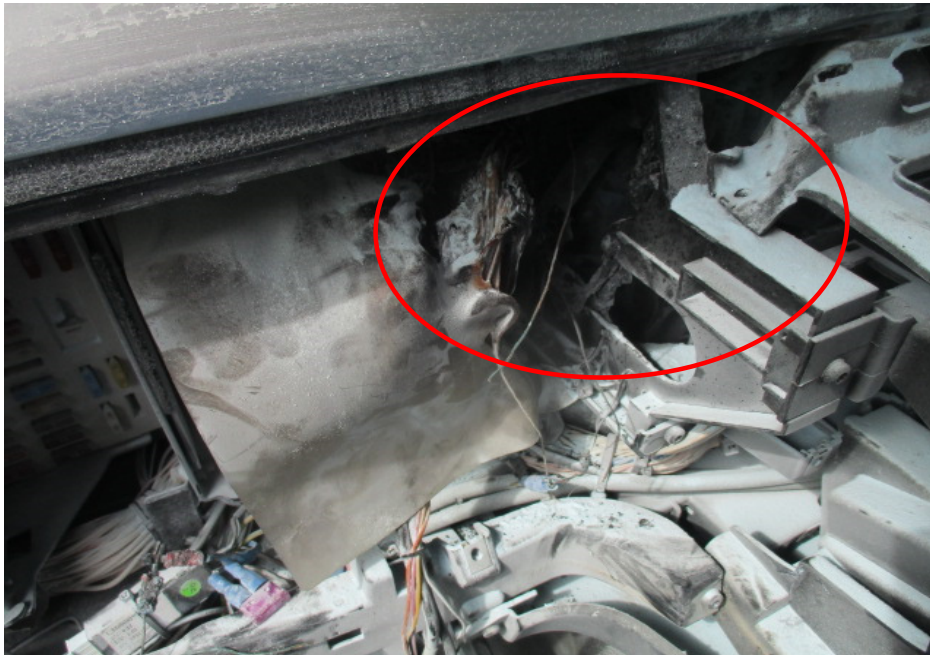
Photo 8 shows a closer view of the centre portion of the instrument panel. Various components of the instrument panel were observed to have been burnt and/or partly melted from prolonged exposure to high heat intensity which included the upper and central parts of the instrument panel assembly, air outlet assembly, beaker holder assembly and carrier assembly, amongst others (circled).

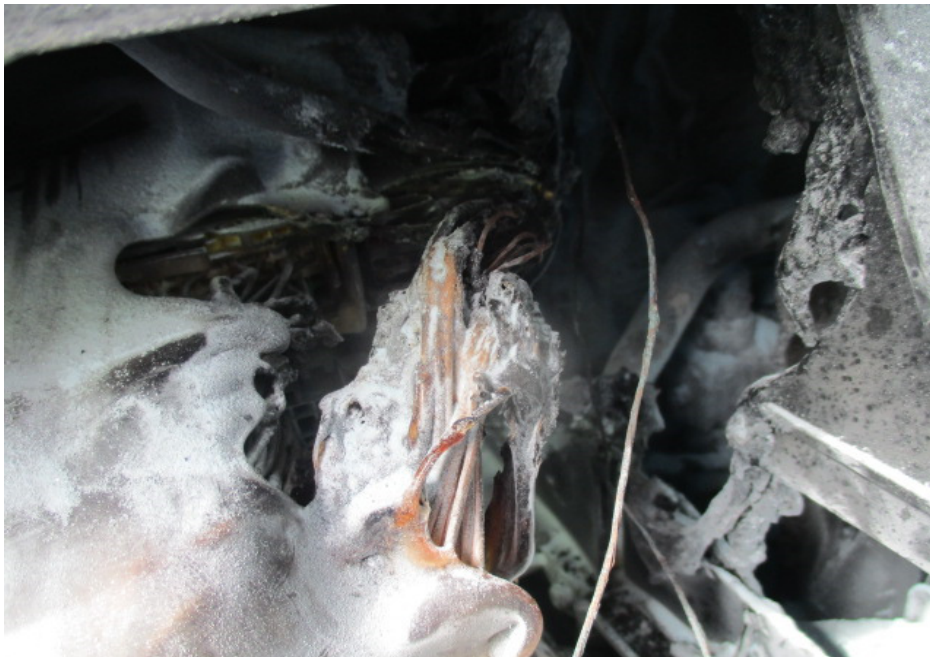
Photo 9 shows a close up view of the centre portion of the instrument panel. Most of the components of the instrument panel were observed to have been burnt and/or partly melted from prolonged exposure to high heat intensity.

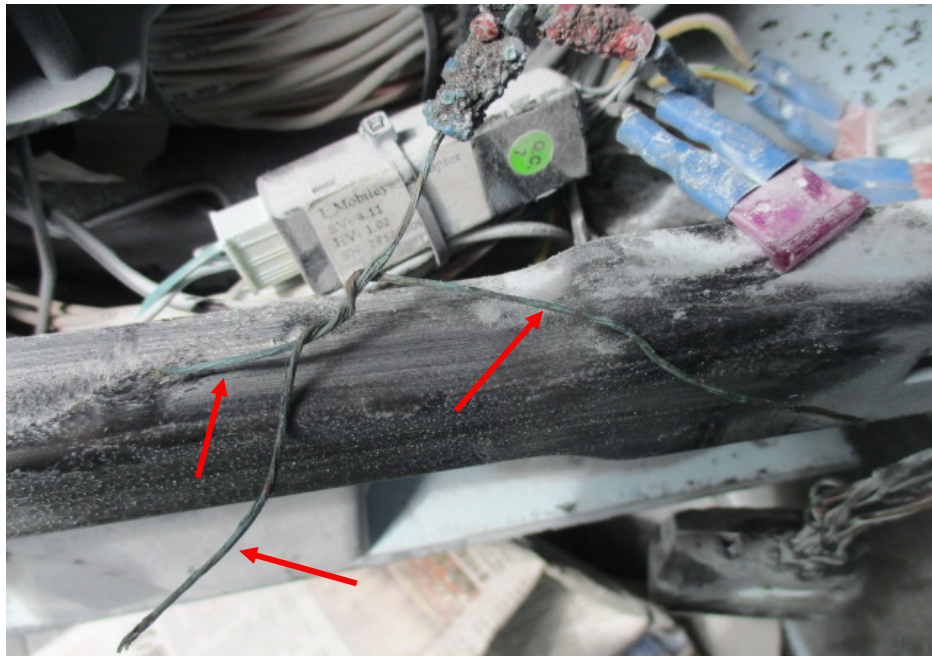
8. Upon closer examination of the various components contained within the centre portion of the instrument panel, which was where the fire to the Insured Vehicle had likely started, we had found greenish residue on some of the wirings leading to a component that belonged to the mobile crane of the Insured Vehicle. The presence of greenish residue indicates internal heating of copper wires, a sign of an electrical short circuit occurring. The greenish residue is normally left behind from oxidation as a result of chemical reaction involving the copper wires. This physical evidence would then appear to suggest that the cause of fire to the Insured Vehicle could have possibly been due to electrical in nature. See photos 10 - 12 below.

Photo 10 shows greenish residue on some wirings leading to a component that belonged to the mobile crane of the Insured Vehicle (arrowed). The presence of such greenish residue suggests occurrence of an electrical short circuit.

25. The possibility of the fire being due to electrical in nature would then seem more likely given that engine overheating and external factors would both seem unlikely. The fire being due to electrical nature is also supported by the condition of the wirings that were found inside the centre portion of the instrument panel of the Insured Vehicle, which was earlier discussed in paragraph 8 above.

27. Having investigated and technically analysed the damages of burnt nature to the Insured Vehicle, we are of the view that the cause of fire to the Insured Vehicle was of electrical in nature. For this particular case, the fire had originated from the wirings within the centre portion of the instrument panel of the Insured Vehicle. The wirings were part of a component that belonged to the mobile crane of the Insured Vehicle.

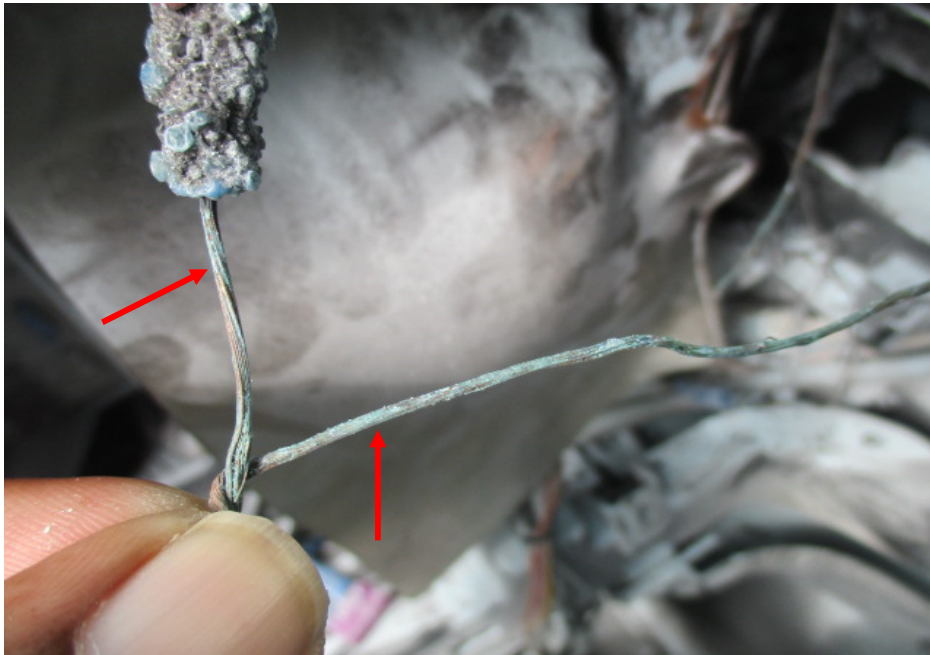
Photo 11 shows a closer view of the greenish residue (arrowed) on some wirings leading to a component that belonged to the mobile crane of the Insured Vehicle. The presence of such greenish residue suggests occurrence of an electrical short circuit.

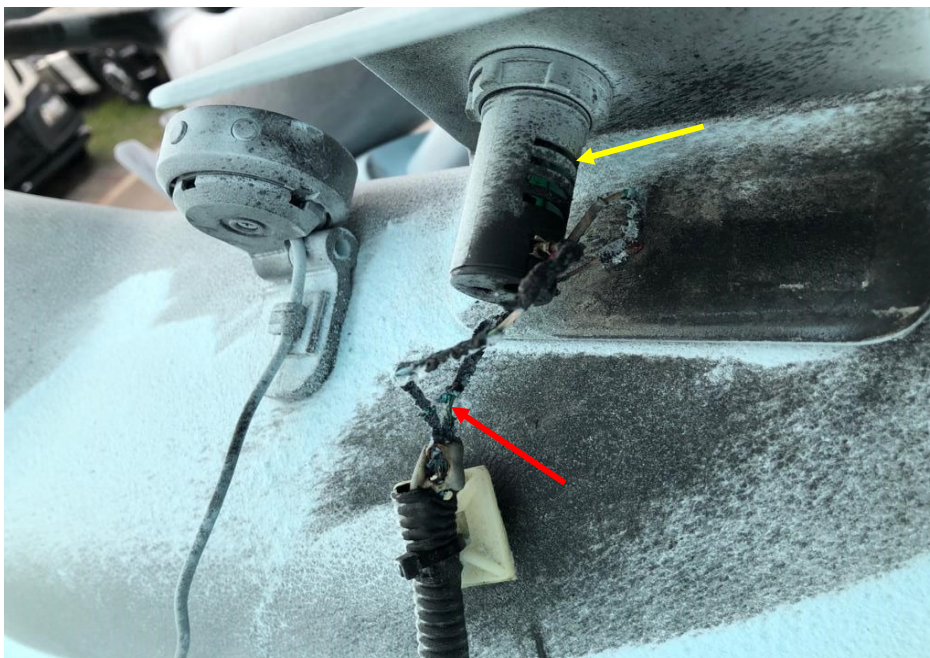
Photo 12 shows a close up view of the greenish residue (red arrow) on some wirings leading to a component that belonged to the mobile crane of the Insured Vehicle (yellow arrow). The presence of such greenish residue suggests occurrence of an electrical short circuit.

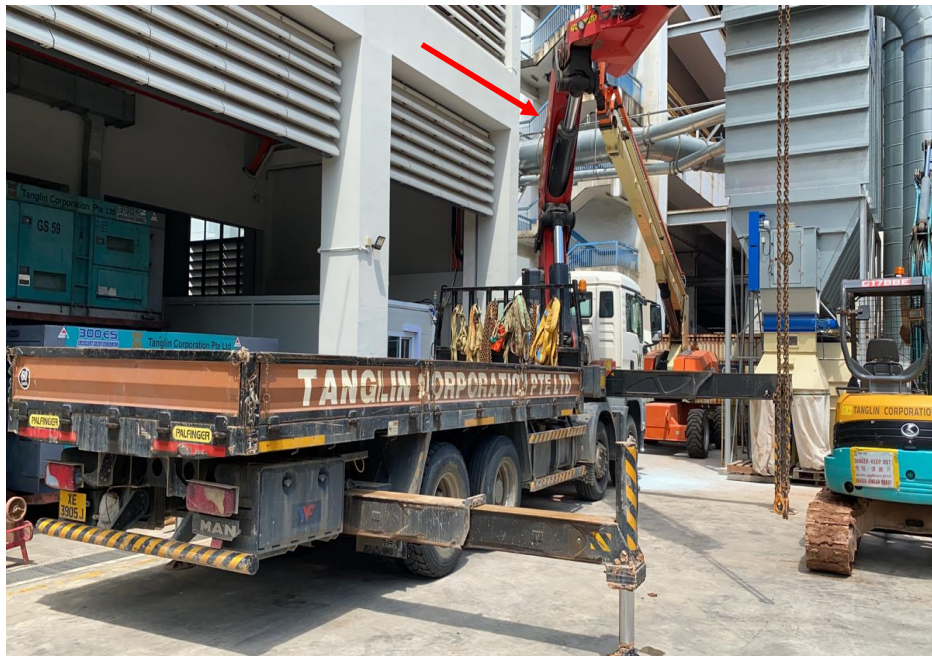
Photo 13 shows a general view of the Insured Vehicle post- incident. The Insured Vehicle could be seen parked at Tanglin. Generally, the information that could be gathered from the incident scene photographs provided by Mr Yong had corresponded to the events that he had related to us, which was the mobile crane had ceased operation midway before the fire occurred (arrowed).

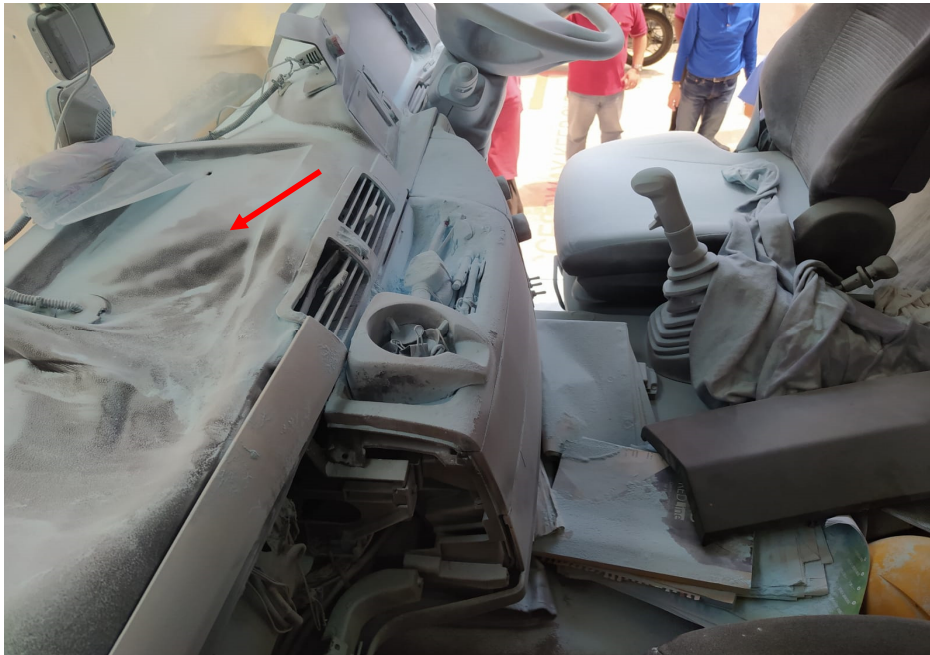
Photo 14 shows interior compartment of the Insured Vehicle at the incident scene after the fire was put out. Generally, the information that could be gathered from the incident scene photographs provided by Mr Yong had corresponded to the events that he had related to us, which is the fire had started from the centre portion of the dashboard of the Insured Vehicle (arrowed)
