Your Ref: BMW 420i  
(chassis number WBA4H32000BP28167)  
Our Ref : CI/TP20010799/D

**INSPECTION REPORT OF AN UNREGISTERD BMW 420i MOTOR CAR WITH CHASSIS NUMBER WBA4H32000BP28167**

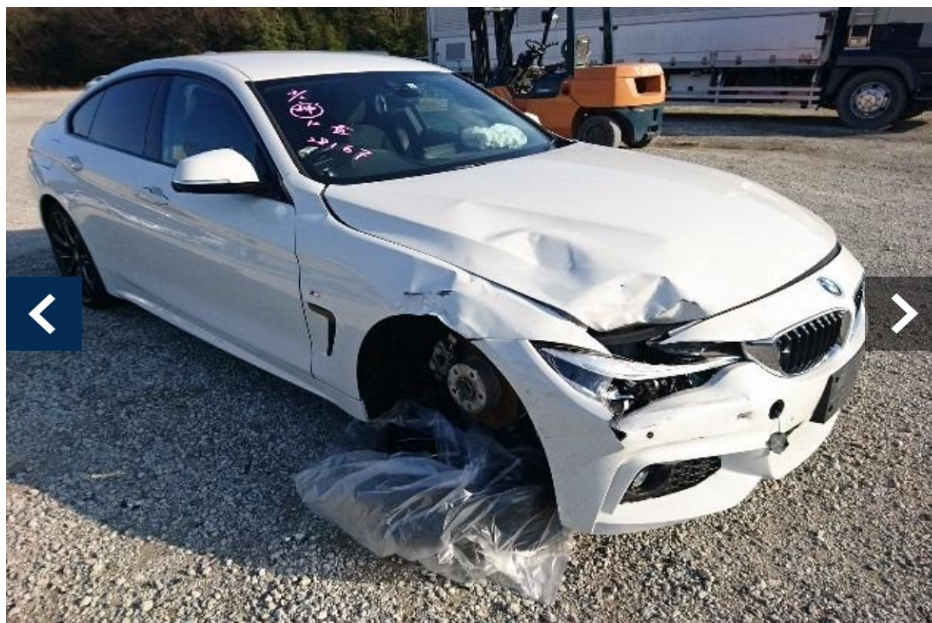
**Photo 1** shows the front right body of the Motor Car prior to any repairs being carried out (photograph provided to me). The Motor Car was observed to have sustained damages at its front right portion. The body parts observed to be damaged had include its front bumper, front right headlamp, front bonnet and front right fender amongst others. The front right wheel rim and front right tyre were observed to be missing, as seen from the photographs that were provided to me.

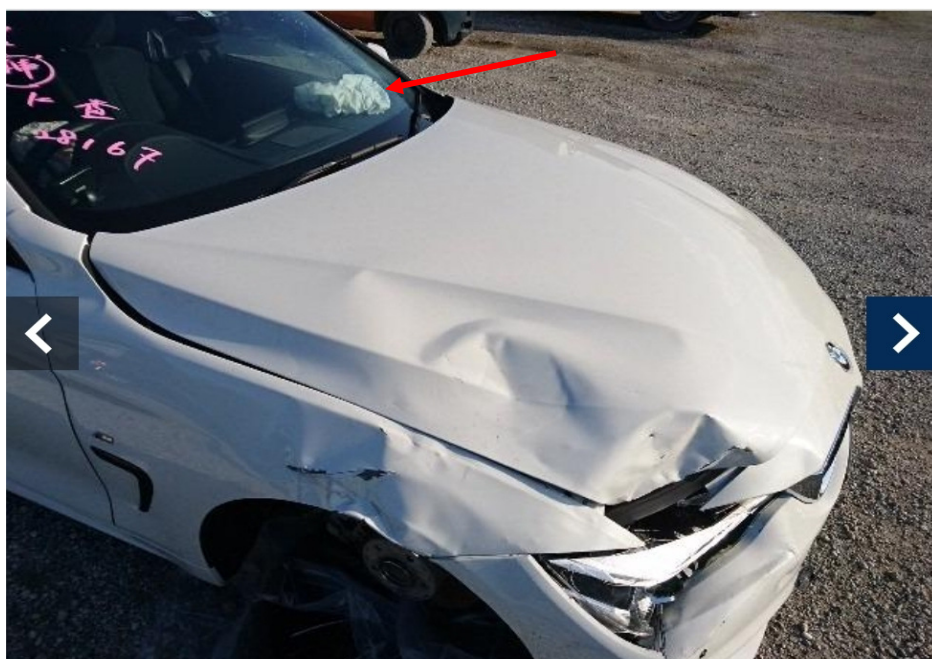
**Photo 2** shows the damage to the front right portion of the Motor Car prior to any repairs being carried out (photograph provided to me). The front bonnet, front right headlamp and front right fender were amongst the body parts that were observed to be damaged. The front left passenger airbag (arrowed) were also observed to have been deployed.

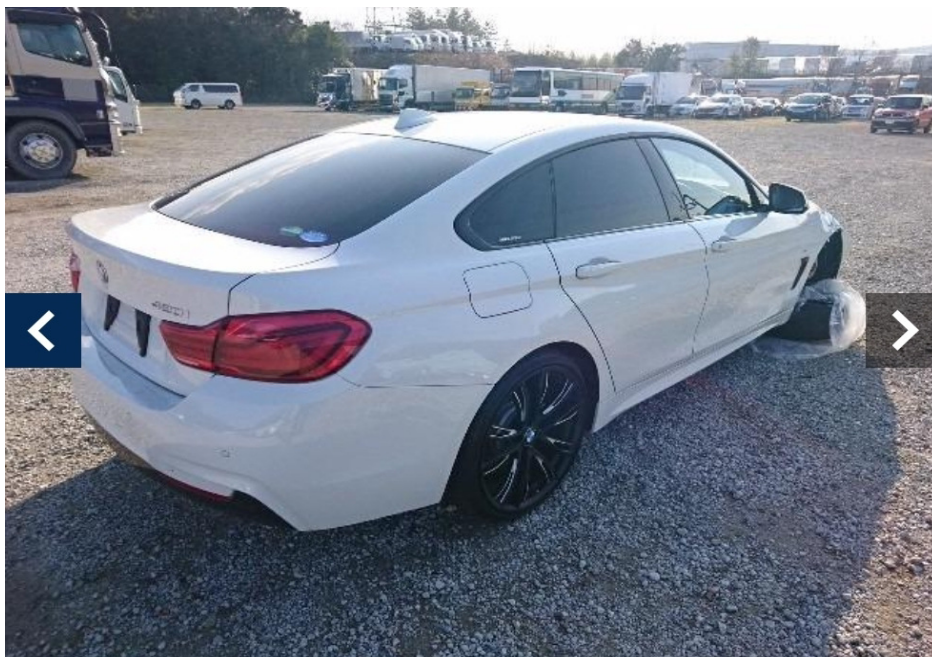
**Photo 3** shows the rear right body of the Motor Car prior to any repairs being carried out (photograph provided to me). Apart for the damage at the front right portion of the Motor Car, there was no visible damage observed to other areas of the Motor Car.

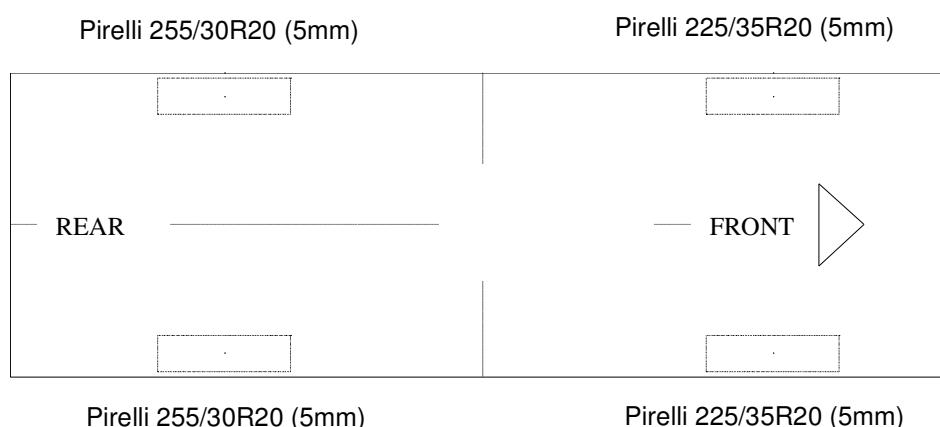
8. It was fitted with 20inch sport wheel rims that were wrapped with tyres that were observed to be of serviceable condition. The tyres were also sufficiently inflated for vehicular operation. The tyre brand, tyre size and approximate remaining tread depth of the 4 tyres of the Motor Car were recorded as follows: -

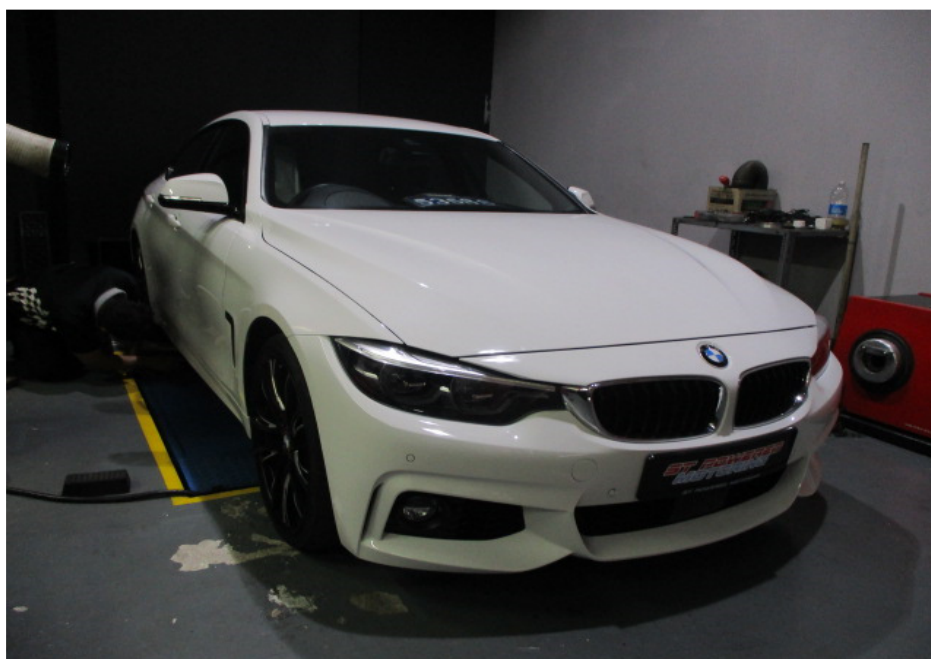
**Photo 4** shows a general view of the front right body of the Motor Car at the time of my inspection. The Motor Car was observed to be in a relatively good general condition with no loose exterior fittings observed. The body parts at the front right portion of the Motor Car were visually examined and it was observed that the repair/restoration works carried out to the damaged area of the Motor Car (refer to photograph 1 & 2 above) were reasonably adequate and in order.

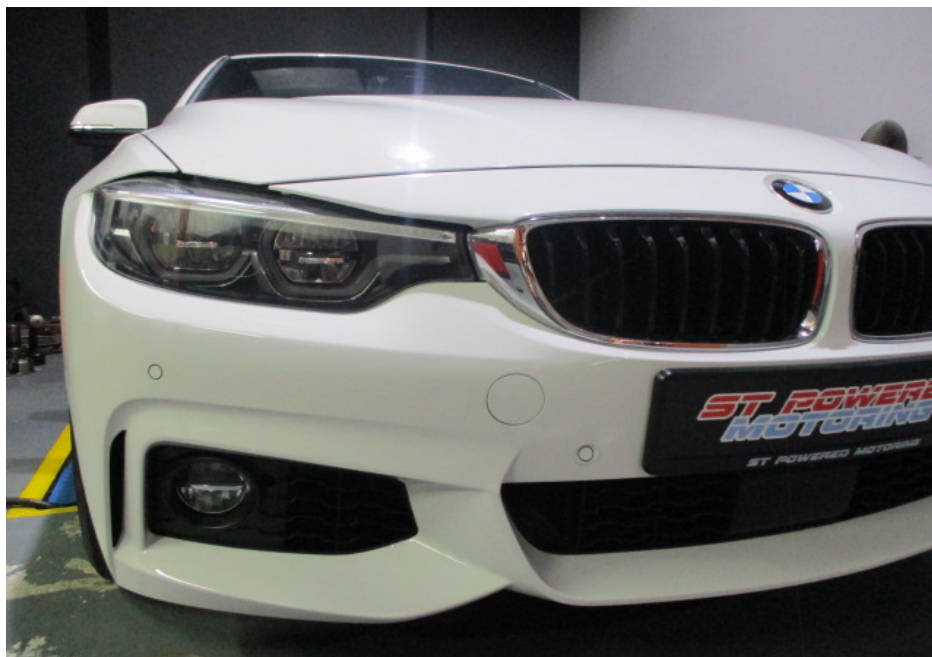
**Photo 5** shows a closer view of the front bumper, front right headlamp and front bonnet of the Motor Car at the time of my inspection. The body parts at the front right portion of the Motor Car were visually examined and it was observed that the repair/restoration works carried out to the damaged area of the Motor Car (refer to photograph 1 & 2 above) were reasonably adequate and in order.

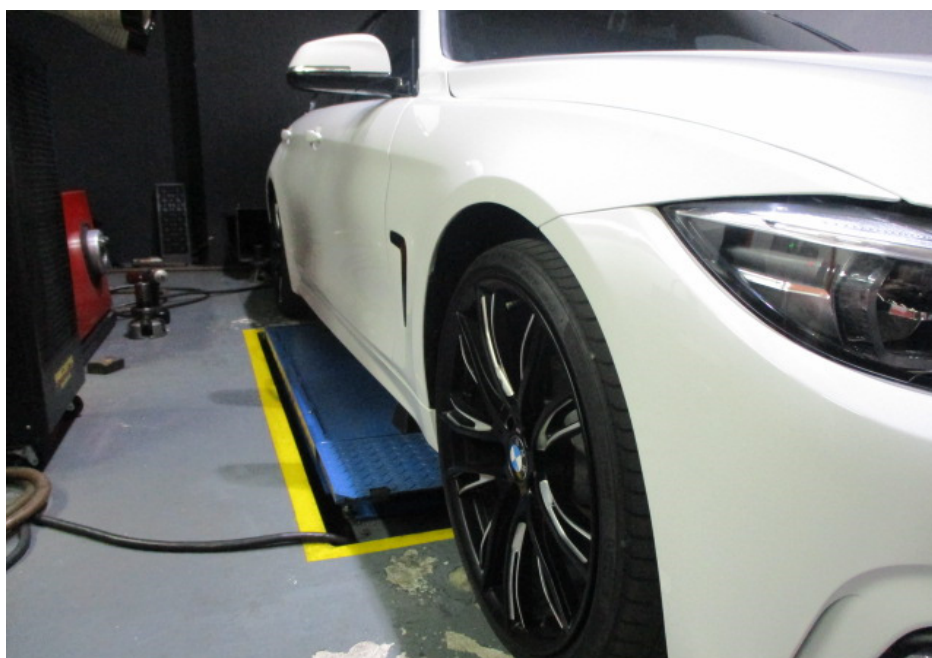
**Photo 6** shows a closer view of the front bumper, front right headlamp and front right fender of the Motor Car at the time of my inspection. The body parts at the front right portion of the Motor Car were visually examined and it was observed that the repair/restoration works carried out to the damaged area of the Motor Car (refer to photograph 1 & 2 above) were reasonably adequate and in order.

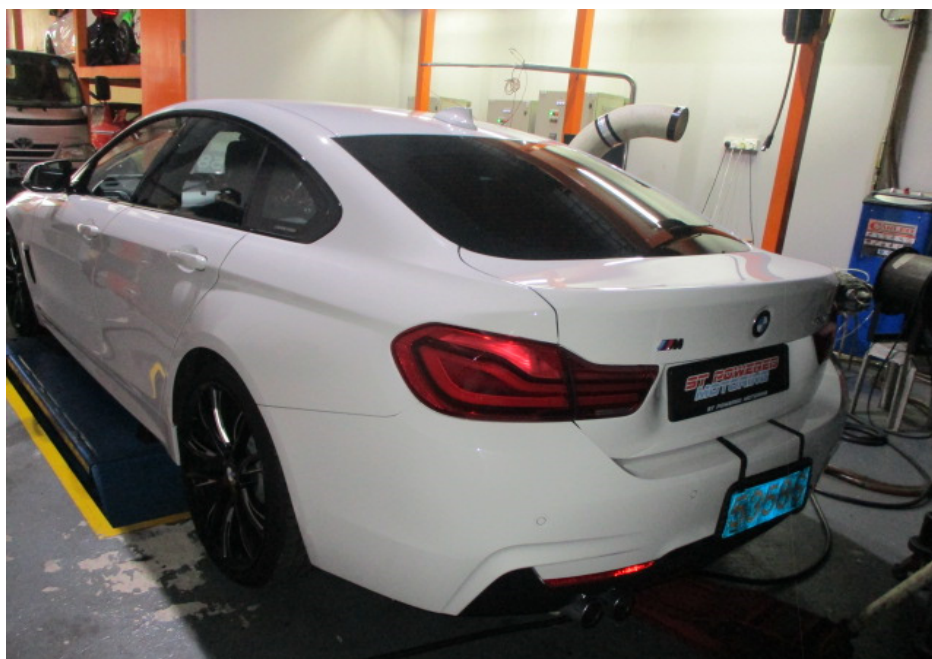
**Photo 7** shows a general view of the rear left body of the Motor Car at the time of my inspection. The Motor Car was observed to be in a relatively good general condition with no loose exterior fittings observed. The mileage of the Motor Car recorded at the time of my inspection was 6,656km.

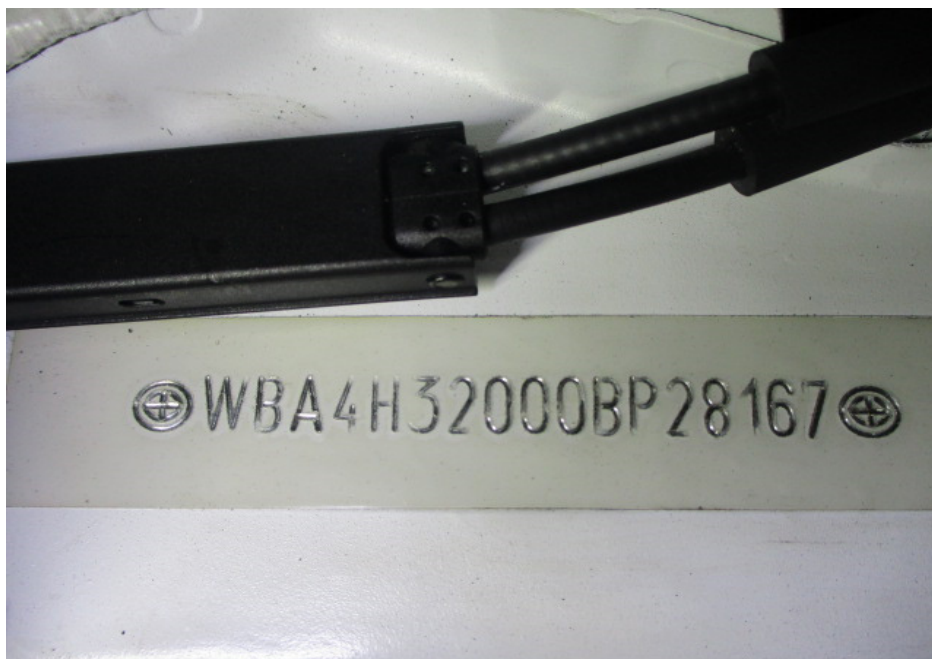
**Photo 8** shows the chassis number of the Motor Car. The chassis number recorded was WBA4H32000BP28167

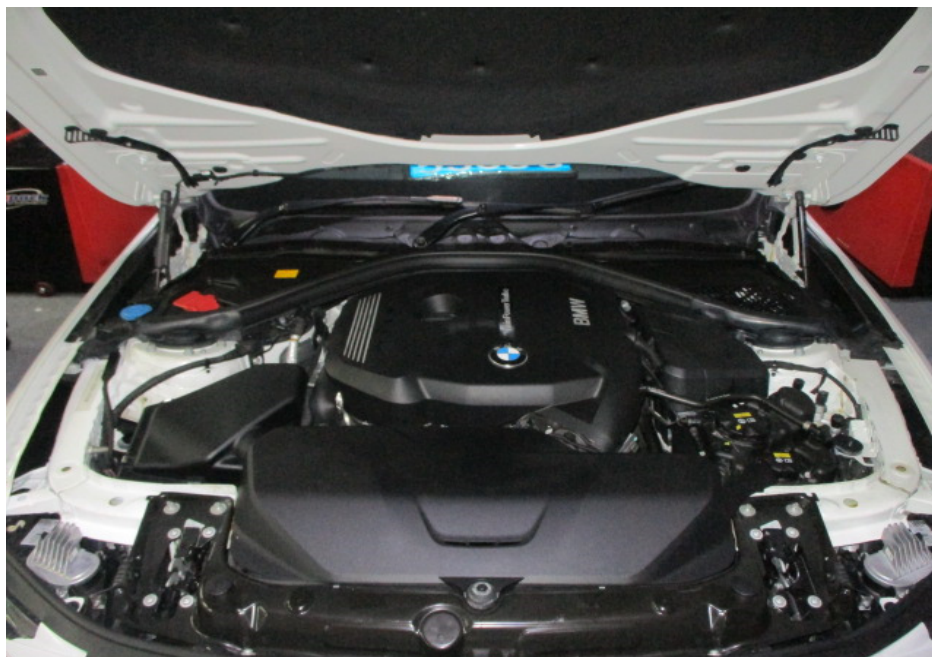
**Photo 9** shows a general view of the engine compartment of the Motor Car at the time of my inspection. The various parts and components inside the engine compartment were all observed to be intact and properly fitted. There was also no sign(s) or indication(s) of fluid leak and/or fluid stain found inside the engine compartment.

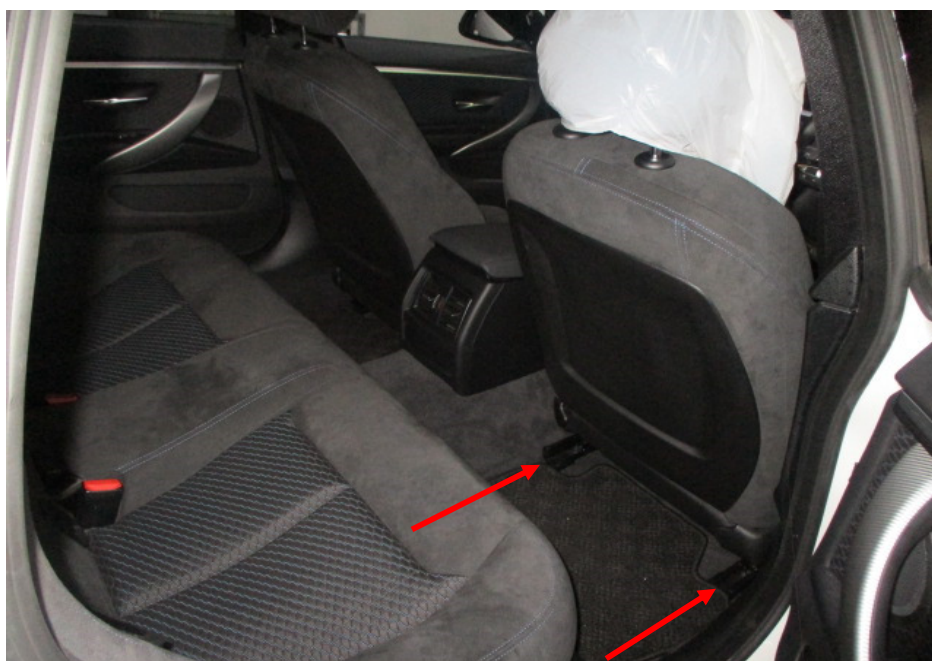
**Photo 10** shows the seats of the Motor Car, which were secured via seat rails (arrowed) to the floorboard. All the seats of the Motor Car were fitted with a retractable seat belt reel and pre-tensioner. The seat belts were tested and able to be fastened into the respective pre-tensions that were fitted on the side of each individual seat.

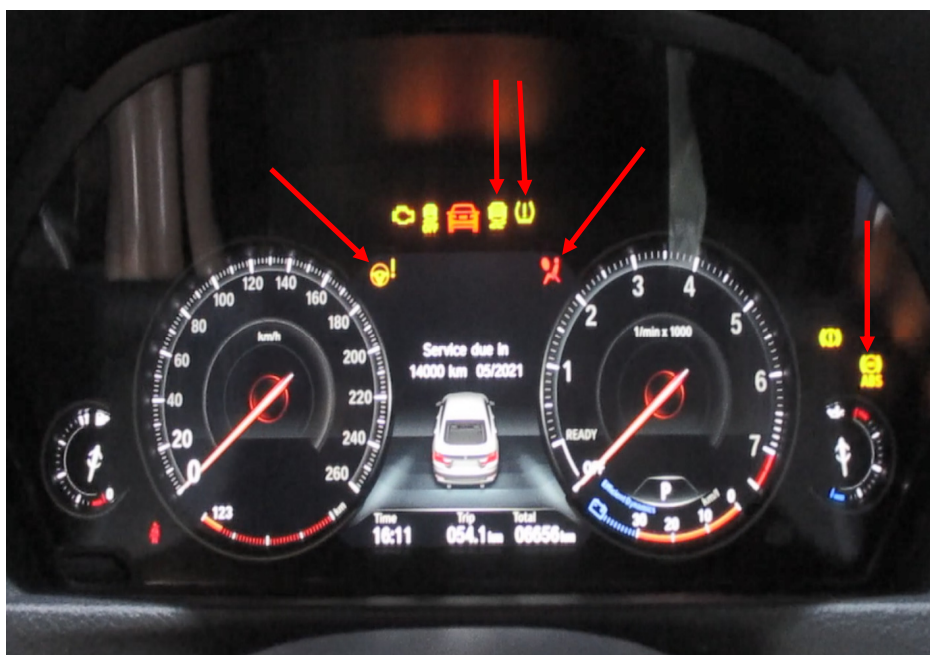
**Photo 11** shows the warning lights for the various electronic safety features appearing on the instrument panel of the Motor Car during its self-test when the engine is cranked, in particular the ABS, SRS, IAS, TPM and DSC lights (arrowed).

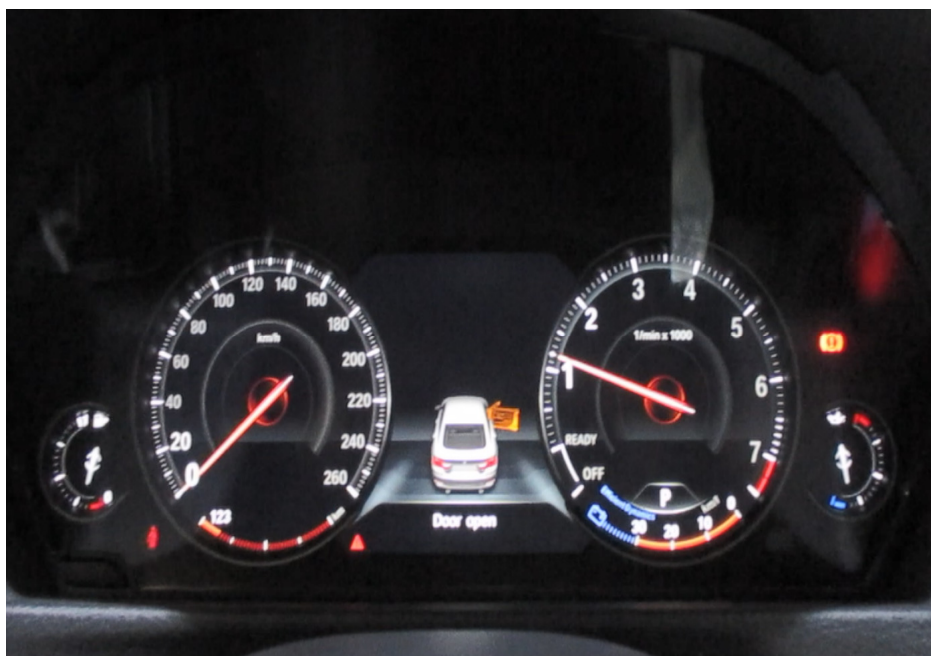
**Photo 12** shows the respective warning lights no longer illuminated, indicating that there is no fault detected to the ABS, SRS, IAS, TPM and DSC systems of the Motor Car during the self-test. These electronic systems were hence in working condition at the time of my inspection.

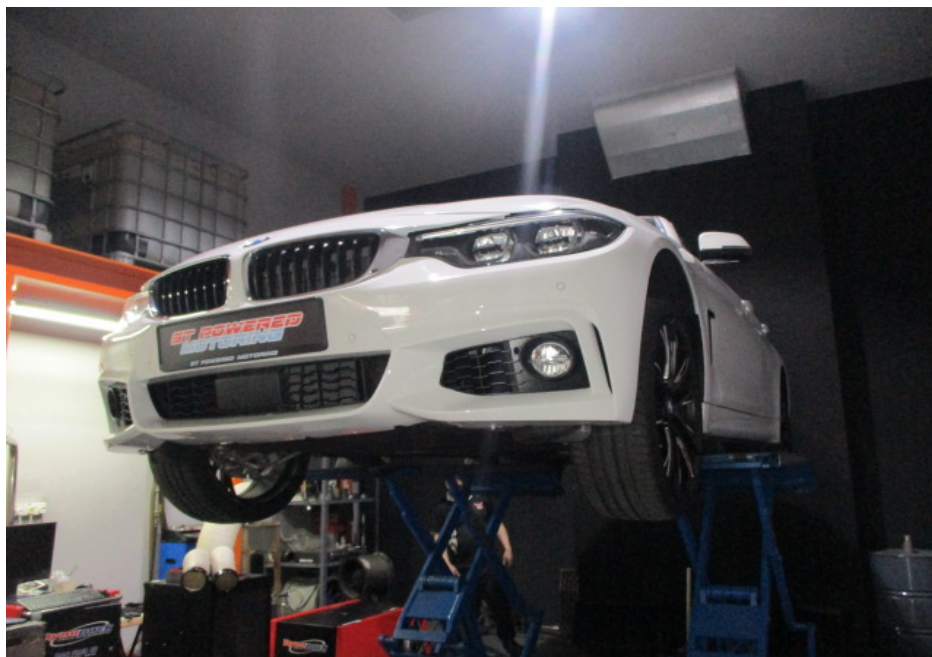
**Photo 13** shows the Motor Car hoisted up for checks on its undercarriage. There was no sign(s) or indication(s) of fluid leakage and/or fluid stain(s) on the underside of the Motor Car. The undercarriage components of the Motor Car were also all observed to be intact and secured in an appropriate manner.

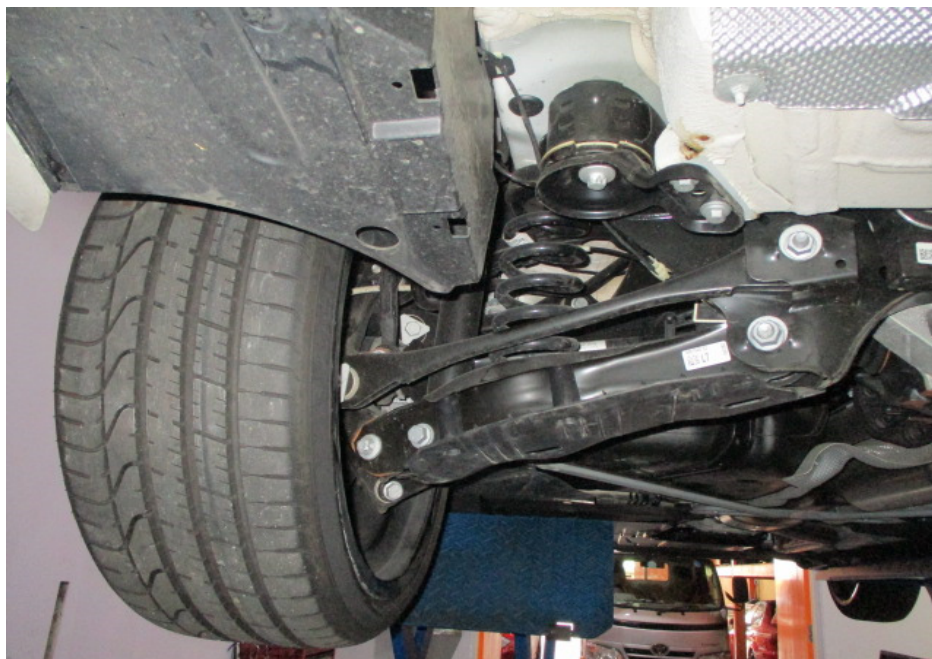
**Photo 14** shows a general view of the control arms and linkages at the rear left wheel of the Motor Car. I did not observe any fluid leak and/or fluid stain on the underside of the Motor Car. All of the Motor Car's undercarriage components were observed to be intact and secured in an appropriate manner.

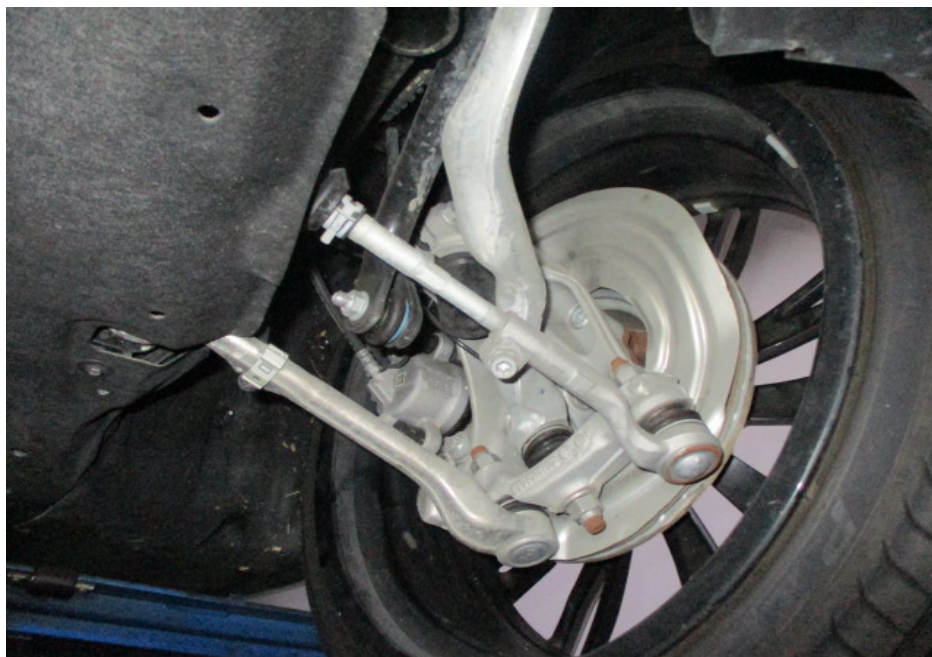
**Photo 15** shows the various undercarriage components at the front left wheel of the Motor Car. The mechanical components, control arms and linkages were all found to be intact and secured in an appropriate manner.

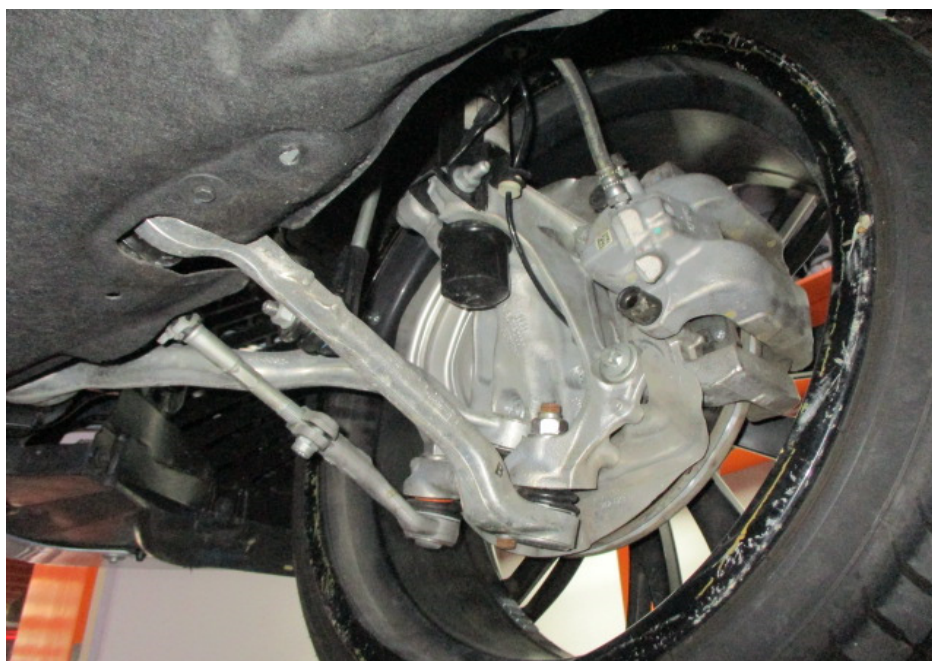
**Photo 16** shows the various undercarriage components at the front right wheel of the Motor Car. The mechanical components, control arms and linkages were all found to be intact and secured in an appropriate manner. I also did not observe any fluid leak and/or fluid stain on the underside of the Motor Car.

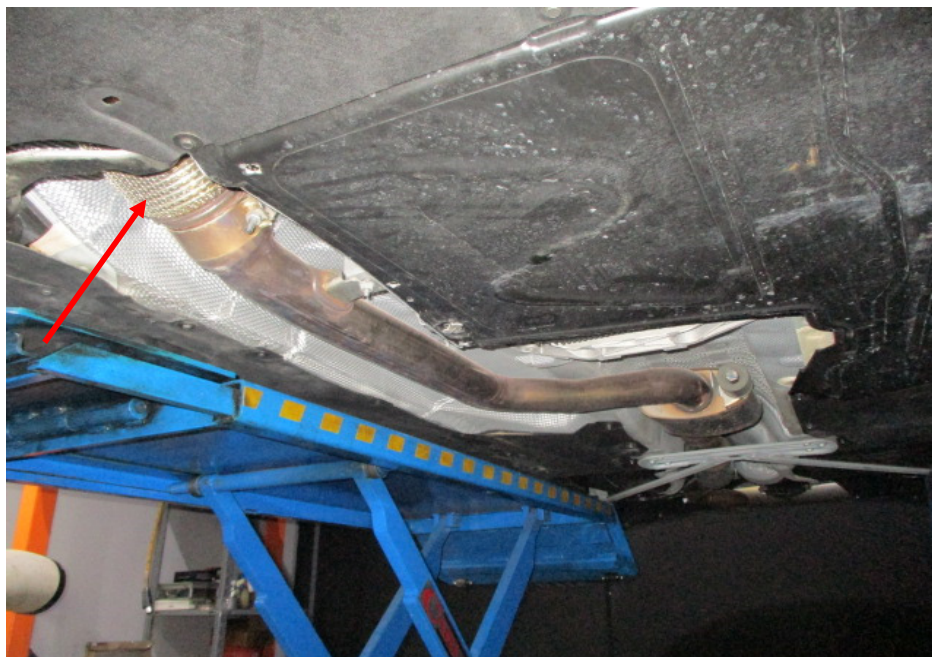
**Photo 17** shows the Motor Car's catalytic convertor (arrowed). My examination of the Motor Car's exhaust system revealed no sign(s) or indication(s) of any cut or weld marks along its exhaust pipes and on its rear muffler.

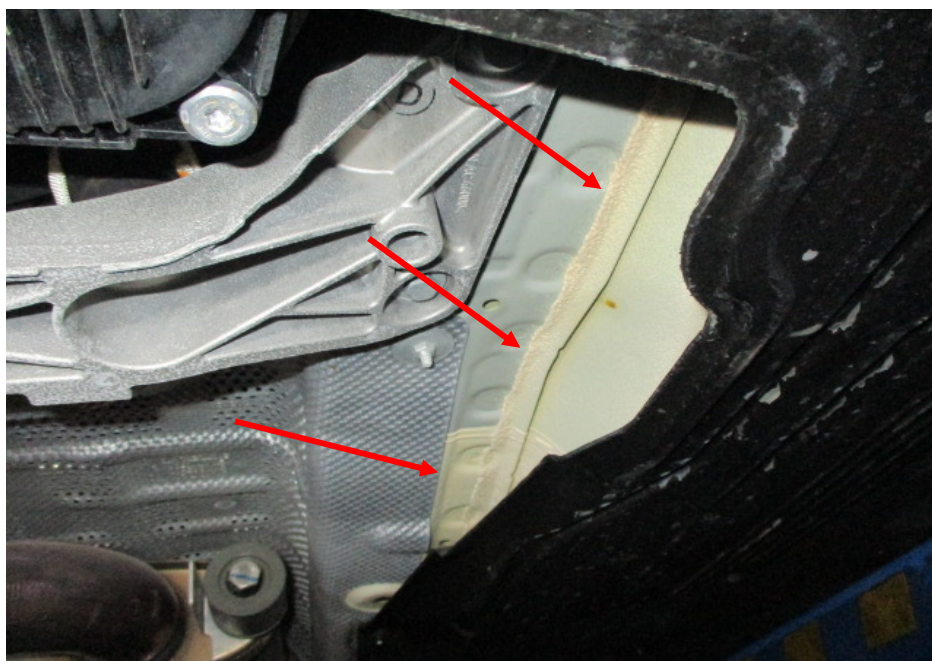
**Photo 18** shows the floorboard at the underside centre left of the Motor Car. The original factory sealant at the joints along the non-detachable body panels were untouched, indicating no work was done on the non-detachable body panels of the Motor Car; and that these body panels were originally fitted.

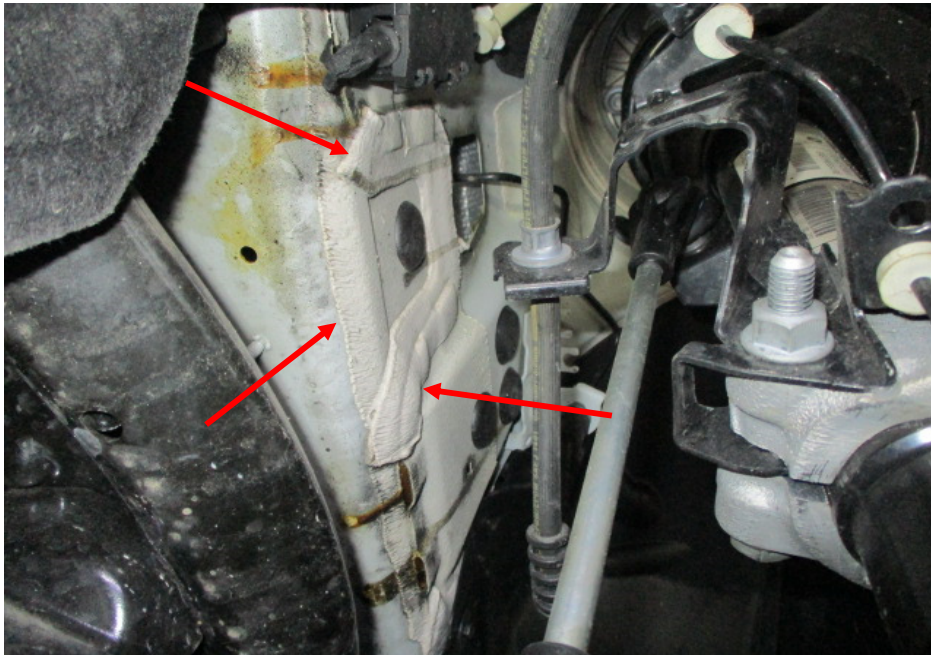
**Photo 19** shows the chassis/structural body at the underside front right of the Motor Car. The original factory sealant (arrowed) at the joints along the chassis/structural body was also untouched, indicating no work was done on the chassis/structural body of the Motor Car and that the chassis/structural body was originally fitted.

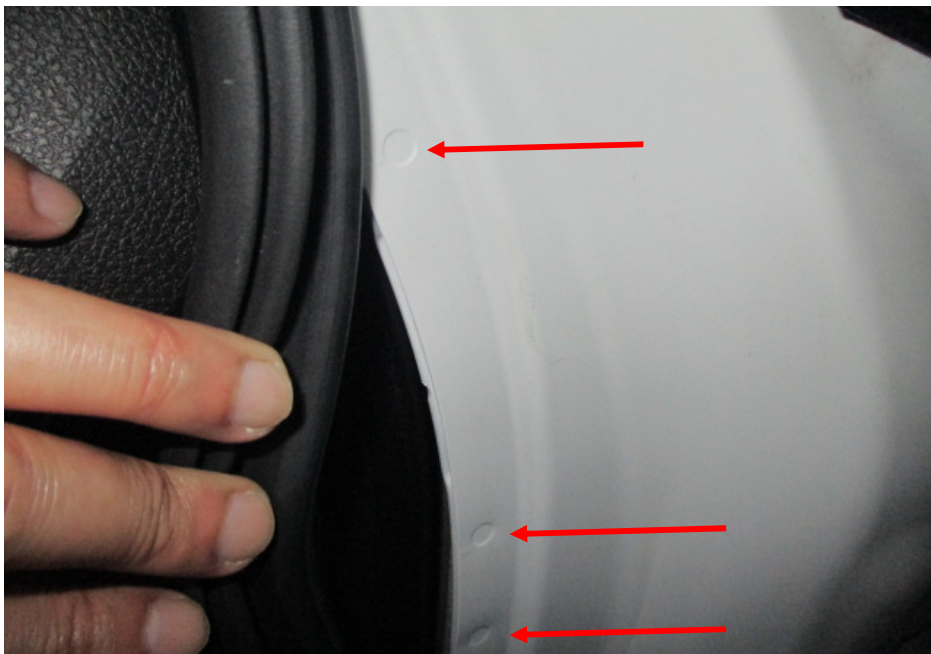
**Photo 20** shows the right side "A" pillar of the Motor Car. I did not find any weld marks other than original spot weld marks (arrowed) on the non-detachable body panels of the Motor Car, indicating that there was no re-welding works carried out; and that the non-detachable body panels of the Motor Car were originally fitted.

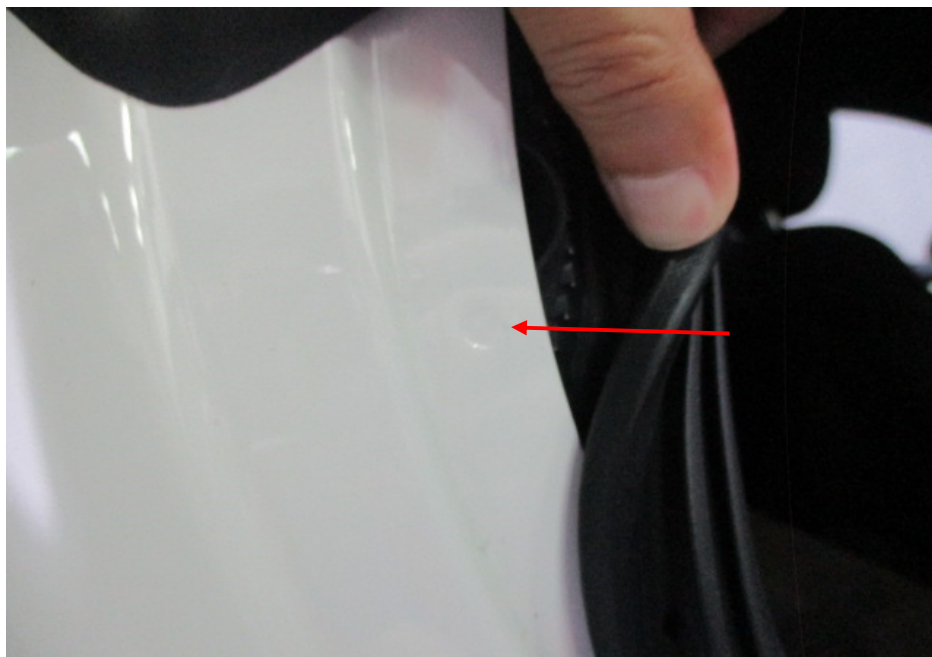
**Photo 21** shows the right side “C” pillar of the Motor Car. I did not find any weld marks other than original spot weld marks (arrowed) on the non-detachable body panels of the Motor Car, indicating that there was no re-welding works carried out; and that the non-detachable body panels of the Motor Car were originally fitted. In general, I had found all the non-detachable body panels of the Motor Car to be originally fitted at the time of my inspection.
