Vehicle No. SML 992U

## LKK Auto Consultants Pte Ltd

## ADJUSTMENT ON REPAIR COST FOR VEHICLE NO. SML 992U

### PHOTOGRAPHS FOR VEHICLE NO. SML 992U

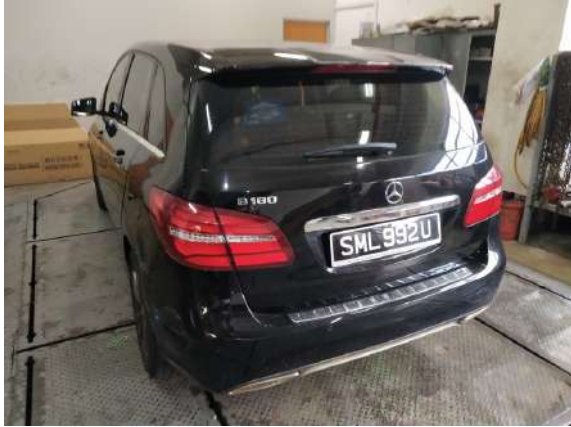
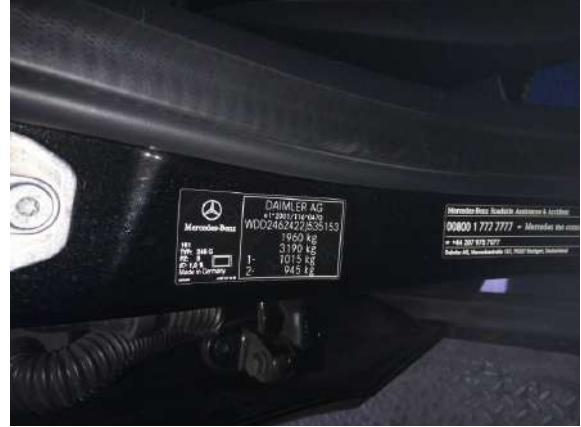
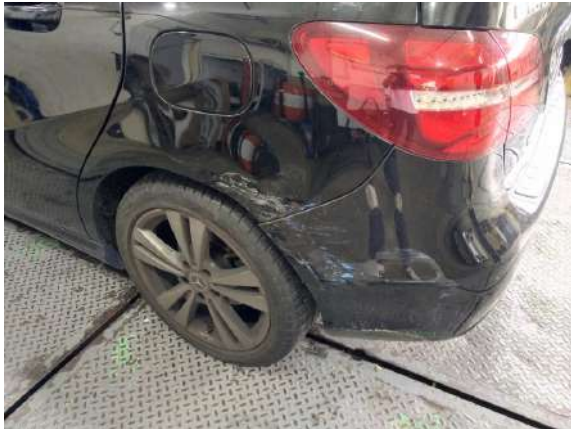
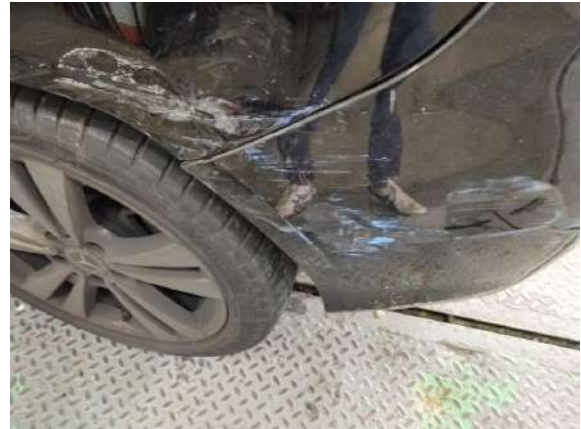
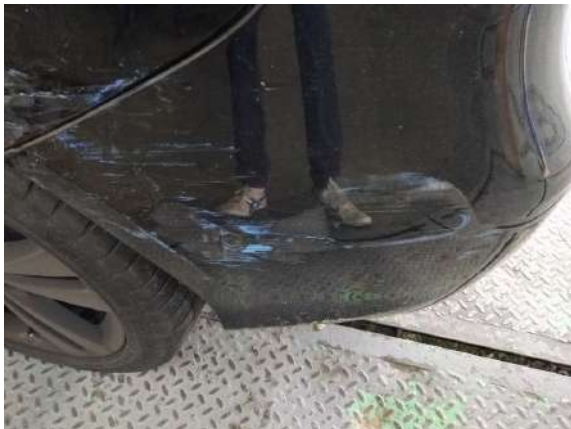
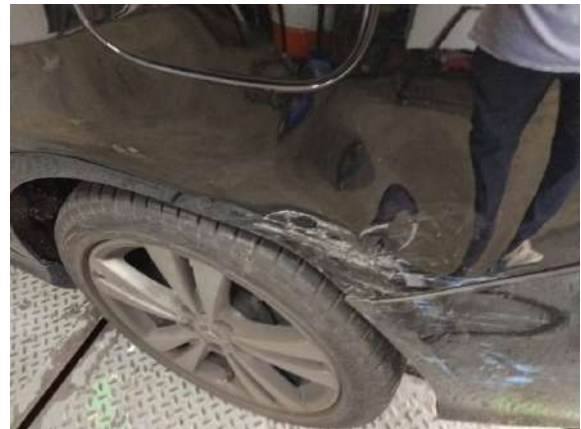
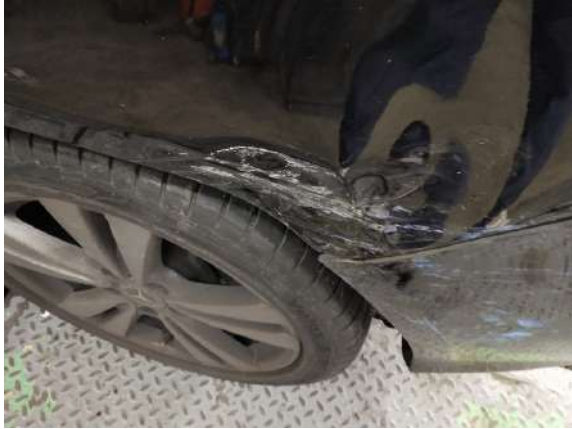
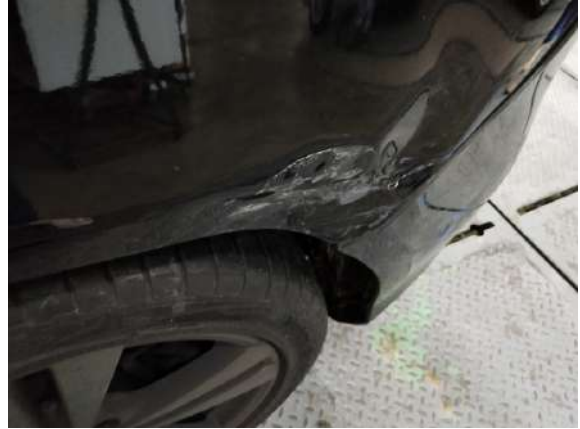
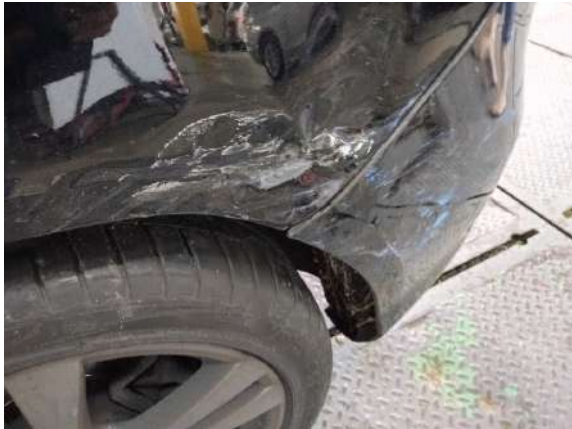
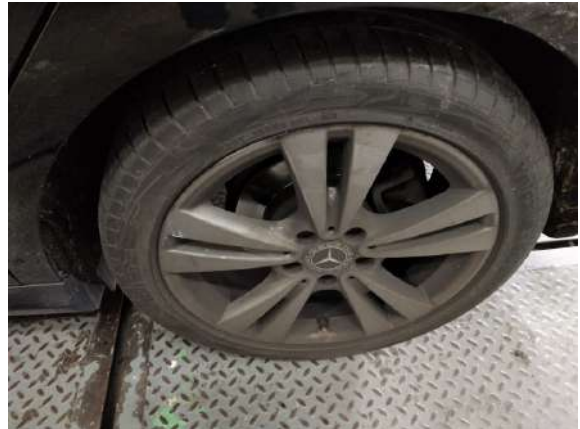
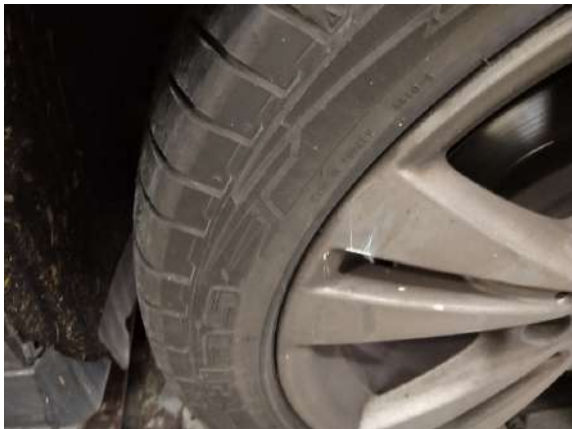
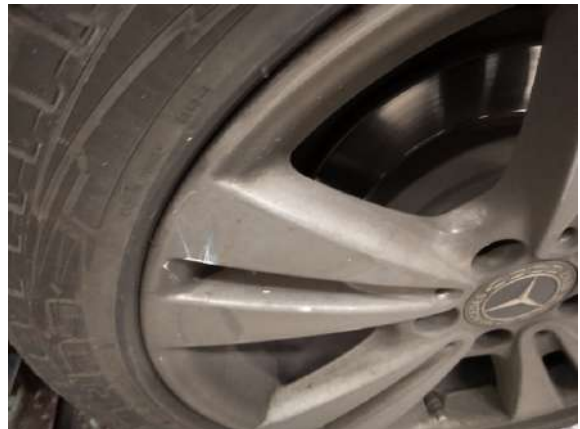
<b>R/H Front Tyre</b>	225/45 R17	PETLAS	6 mm
	<b>L/H Front Tyre</b>	225/45 R17	PETLAS	6 mm
	<b>R/H Rear Tyre</b>	225/45 R17	PETLAS	6 mm
	<b>L/H Rear Tyre</b>	225/45 R17	PETLAS	6 mm
<b>4. Description of Damages</b>				
	THE VEHICLE SUSTAINED DAMAGES AT THE REAR N/S PORTION.  DAMAGES SEE DETAILS.			
<b>5. General Information</b>				
	<b>Accident Date</b>	06/10/2020	<b>Inspection Date</b>	08/10/2020
	<b>Survey held at</b>	MG SOLUTION PTE LTD 23 KAKI BUKIT AVE 4 (SOUTH WING) #02-03B VICOM INSPECTION CENTRE, SINGAPORE 415933		
<b>5a. Remarks</b>				
	A)THE INSPECTION WAS CONDUCTED ON A"WITHOUT PREJUDICE" BASIS. B)IN ACCORDANCE TO YOUR INSTRUCTIONS, WE HAVE NOT AUTHORISED REPAIRS.			
<b>5b. Estimate Days of Repair</b>				
	ESTIMATED NORMAL PERIOD FOR REPAIR:		<b>5 Working Days</b>

Qty	Description of Parts	Condition	Estimate By Workshop (\$)	Our Adjusted (\$)
	<b><u>REPLACEMENT OF PARTS</u></b>			
1	REAR BUMPER	DEFORMED	1,654.00	1,458.00
1	REAR BUMPER SIDE RETAINER	NECESSARY	94.50	94.50
1	REAR FENDER	DENTED	1,855.90	1,855.90
1	REAR QUARTER GLASS MOULDING	NECESSARY	155.60	155.60
1	REVERSE SENSOR	DAMAGED	320.00	250.00
1	REVERSE SENSOR RUBBER	NECESSARY	30.00	30.00
1	REVERSE SENSOR HOLDER	NECESSARY	60.00	25.00
	LESS 10% DISCOUNT		-417.00	-386.90
			3,753.00	3,482.10
	<b><u>SPECIAL NETT ITEMS</u></b>			
1	SET REAR BUMPER CLIP (SN)	NECESSARY	30.00	30.00
1	REAR QUARTER GLASS SEALANT (SN)	NECESSARY	100.00	40.00
1	WHEEL TYRE (SN)	NOT NECESSARY	550.00	-
1	WHEEL RIM (SN)	CUT	1,400.00	650.00
			2,080.00	720.00
	<b><u>LABOUR</u></b>			
	TO PANEL BEAT ,WELD ,CUT ,KNOCK STRAIGHTEN ,ADJUST GRAZE JOINT.		1,000.00	600.00
	TO PUTTY ,SRPAY PAINT ,POLISH,WAX AFFECTED PARTS AND PANELS .		1,000.00	500.00
	TUFF COAT.		250.00	60.00
