Your Ref: Mercedes Benz C180  
(chassis number WDD2050402F885501)  
Our Ref : CI/TP20010902/D

09 October 2020

**INSPECTION REPORT OF AN UNREGISTERD MERCEDES BENZ C180  
MOTOR CAR WITH CHASSIS NUMBER WDD2050402F885501**

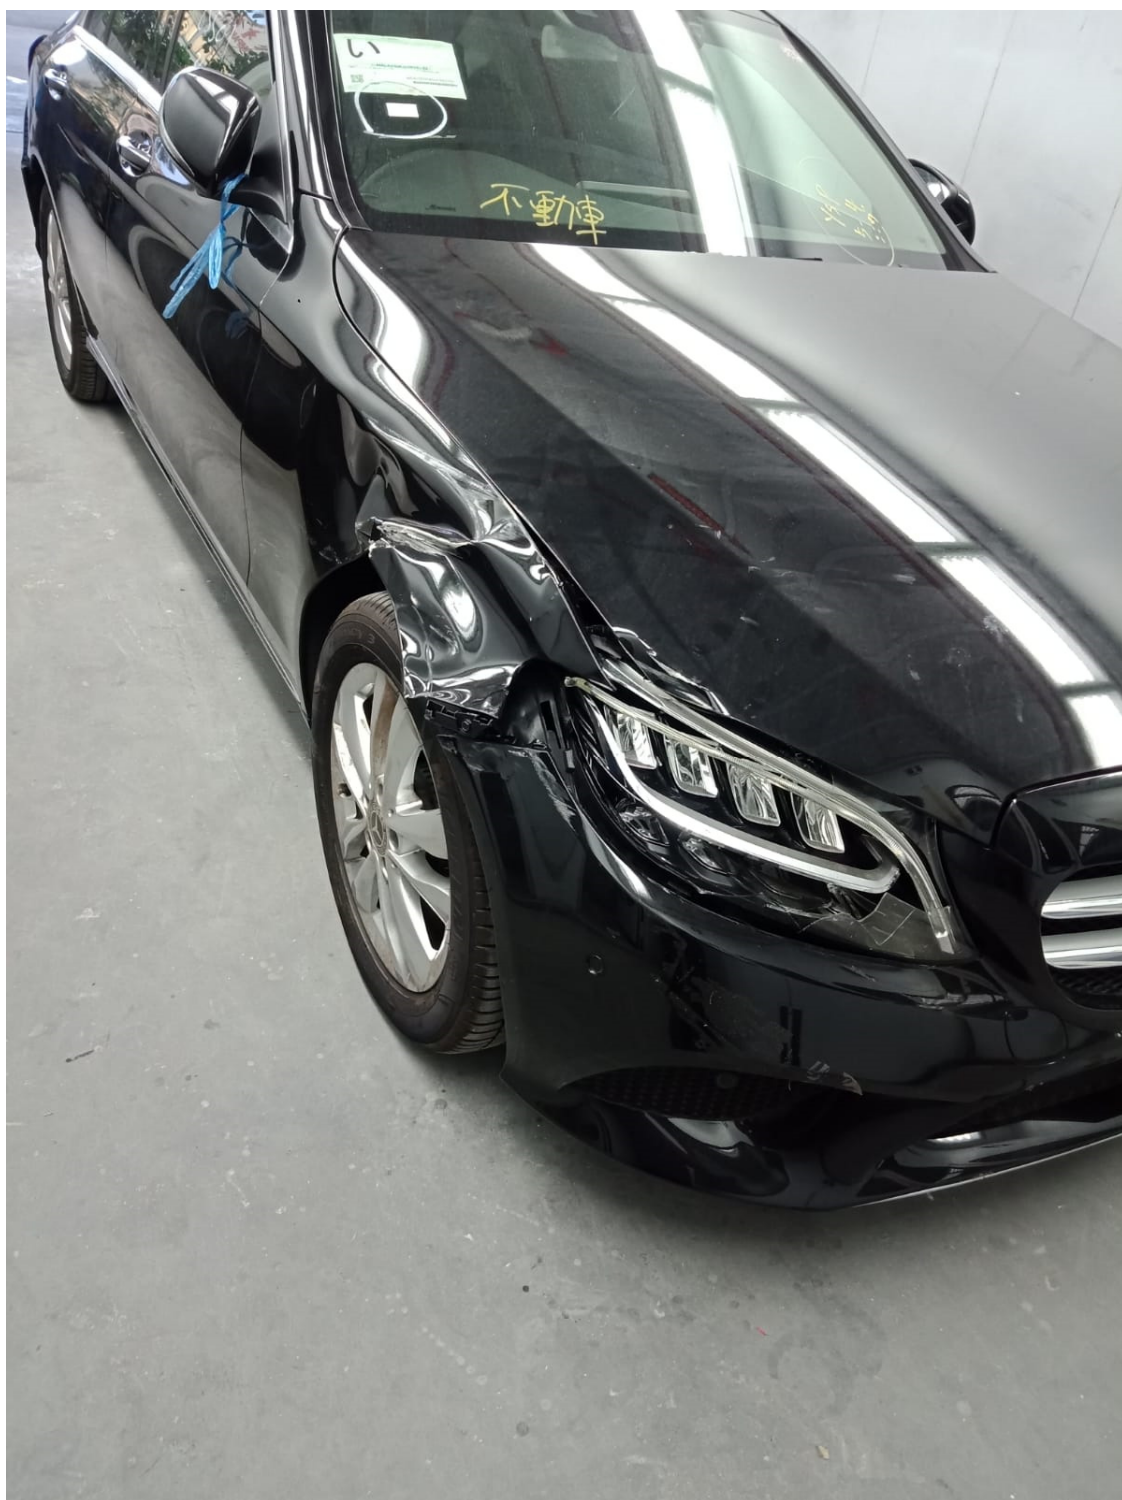
**Photo 1** shows the front right body of the Motor Car prior to any repairs being carried out (photograph provided to me). The Motor Car had sustained damages at its front right portion and rear portion. For the front right portion, the body parts observed to be damaged include its front bumper, front right headlamp, front bonnet and front right fender amongst others. The airbags of the Motor Car were not activated, as seen from the photographs that were provided to me.

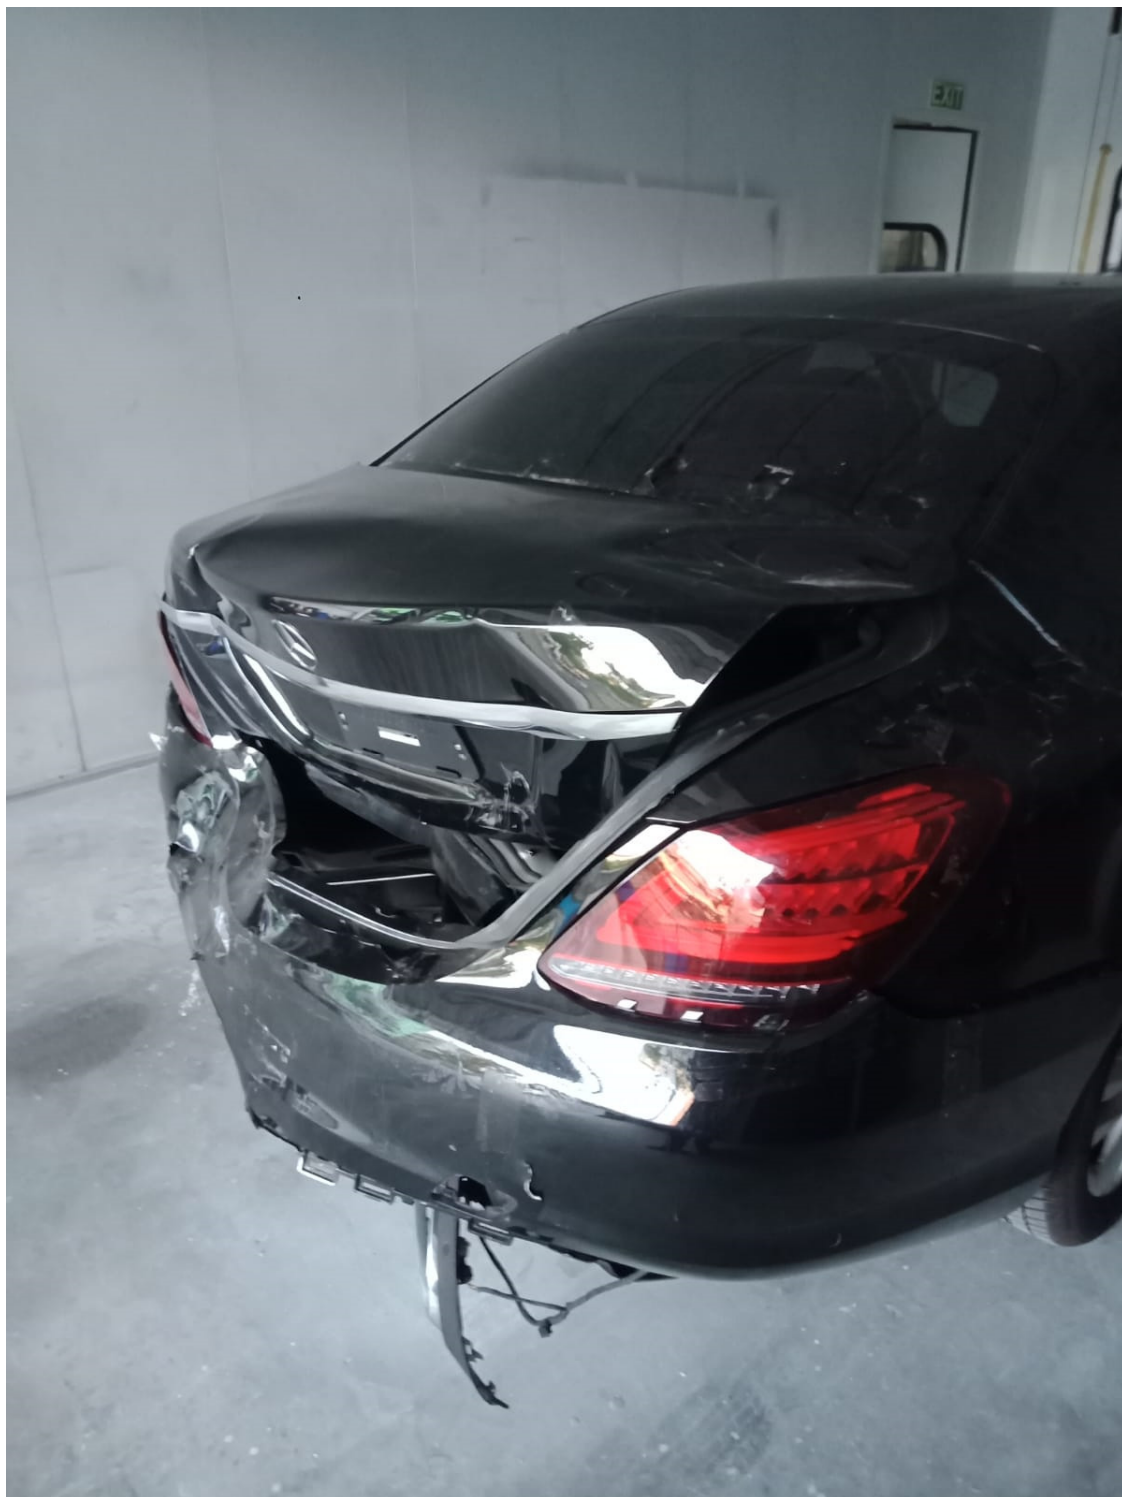
**Photo 2** shows the rear right portion of the Motor Car prior to any repairs being carried out (photograph provided to me). Apart for the front right portion, the Motor Car had also sustained damage at its rear portion. The body parts observed to be damaged at the rear portion include the rear bumper, rear bootlid, rear bootlid chrome moulding and rear exhaust muffler amongst others.

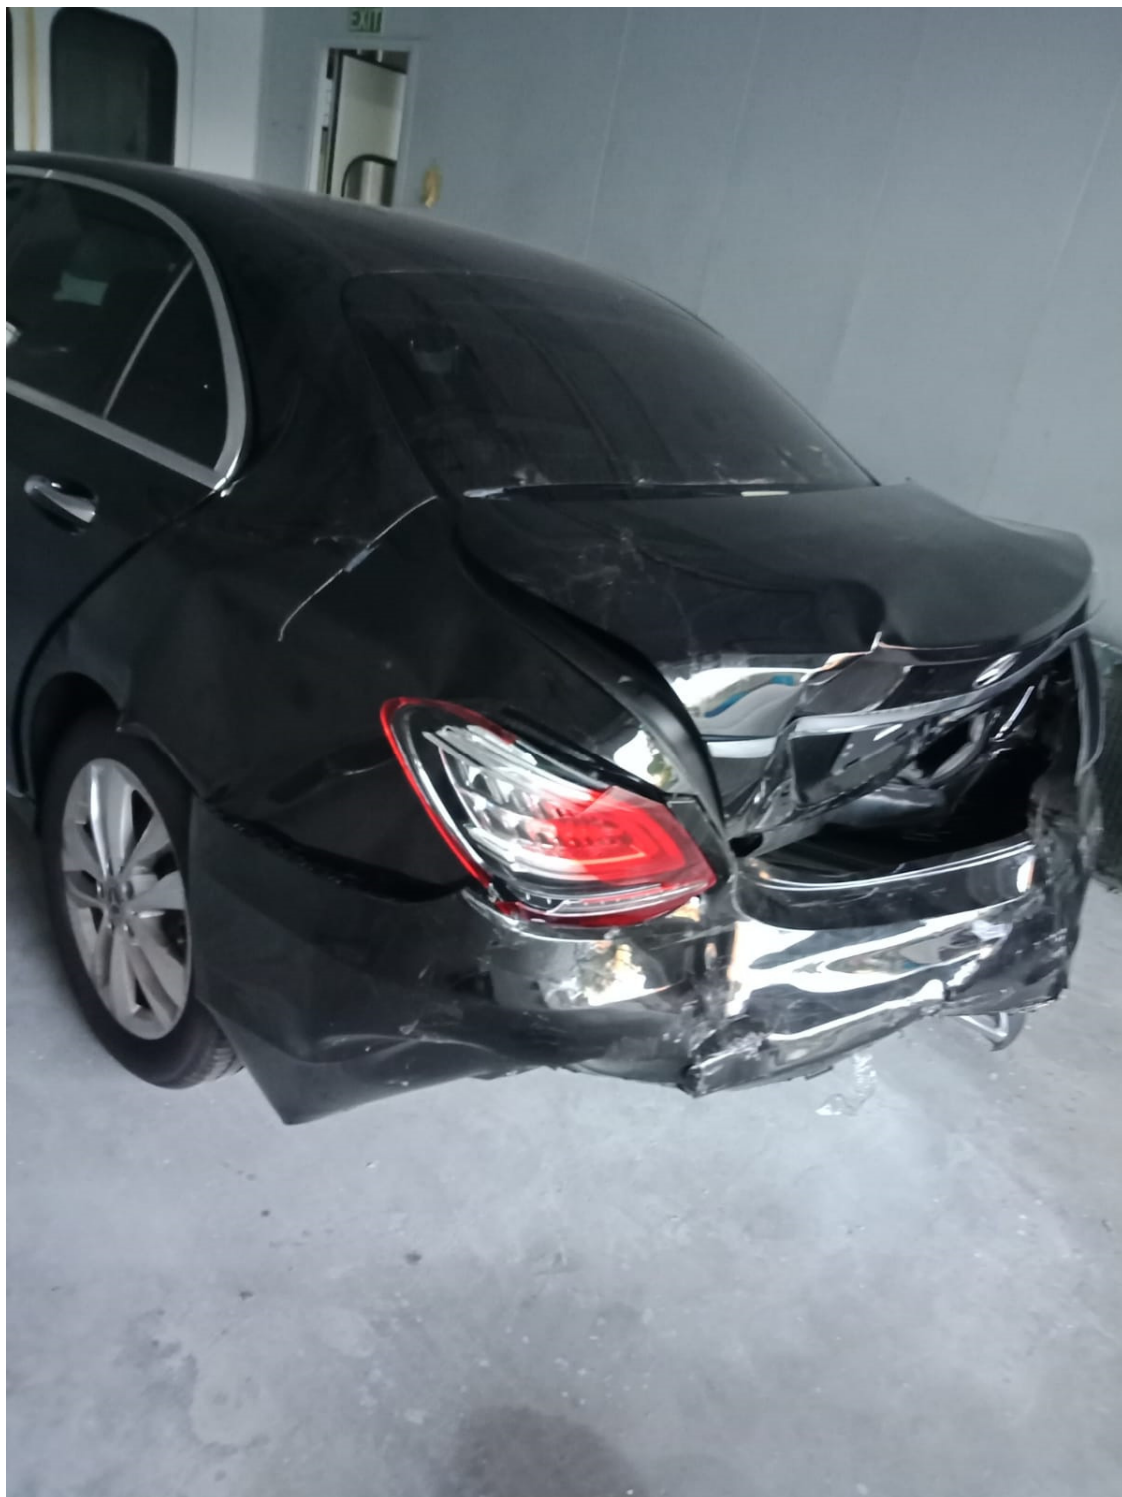
**Photo 3** shows the rear left portion of the Motor Car prior to any repairs being carried out (photograph provided to me). Apart for the front right portion, the Motor Car had also sustained damage at its rear portion. The body parts observed to be damaged at the rear portion include the rear bumper, rear bootlid, rear left taillamp and rear left fender amongst others.

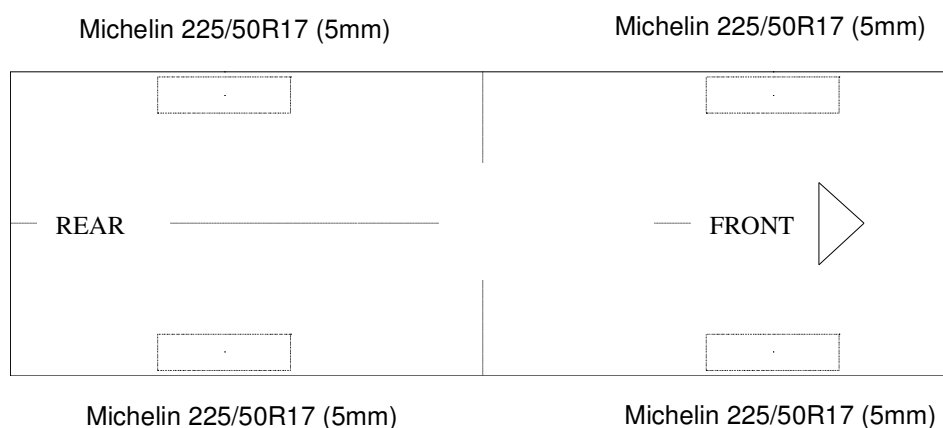
8. It was fitted with 17inch sport wheel rims that were wrapped with tyres that were observed to be of serviceable condition. The tyres were also sufficiently inflated for vehicular operation. The tyre brand, tyre size and approximate remaining tread depth of the 4 tyres of the Motor Car were recorded as follows: -

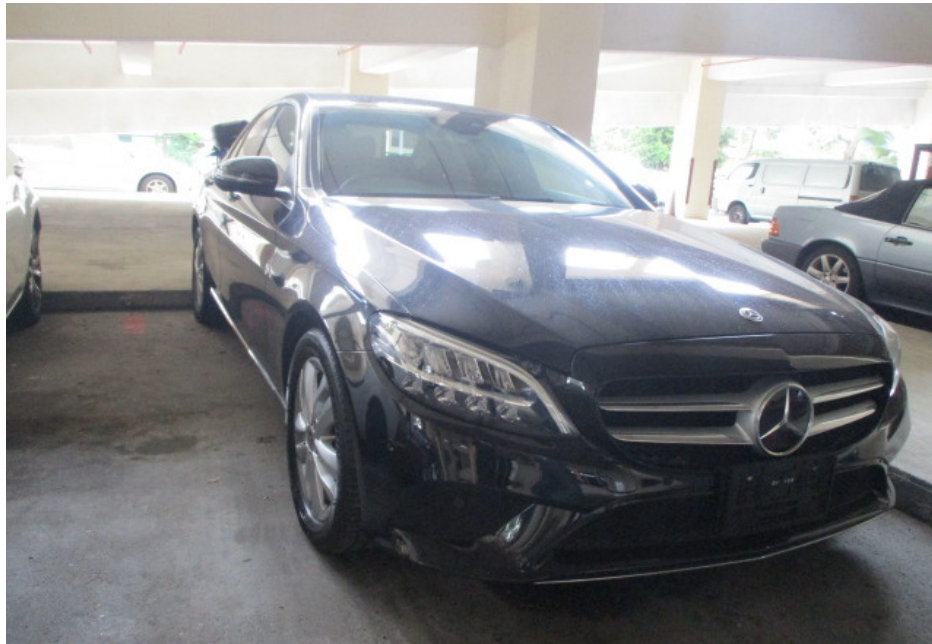
**Photo 4** shows a general view of the front right body of the Motor Car at the time of my inspection. The Motor Car was observed to be in a relatively good general condition with no loose exterior fittings observed. The body parts at the front right portion of the Motor Car were visually examined and it was observed that the repair/restoration works carried out to the damaged area of the Motor Car (refer to photograph 1 above) were reasonably adequate and in order.

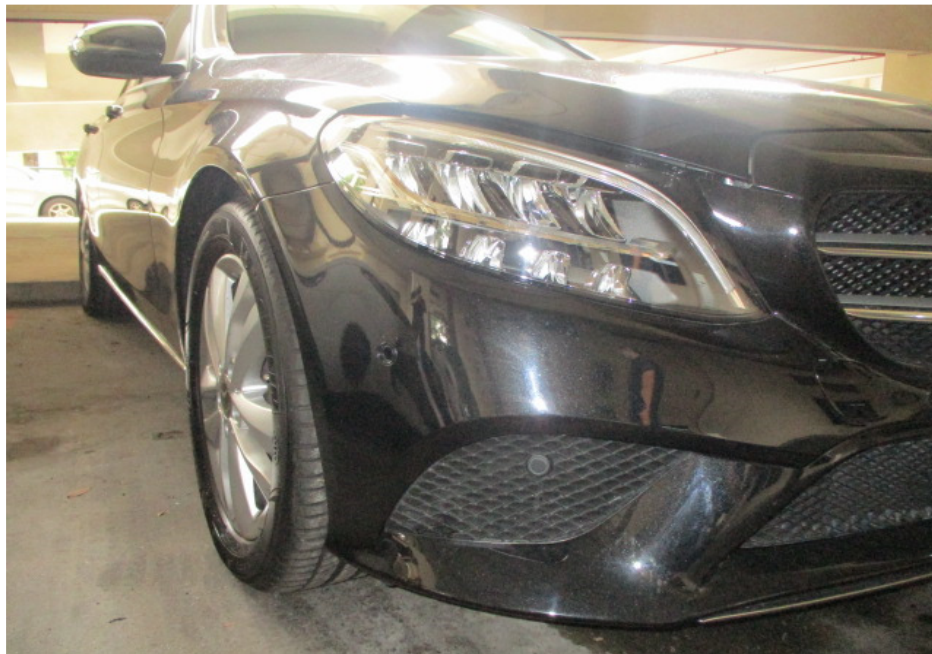
**Photo 5** shows a closer view of the front bumper, front right headlamp and front bonnet of the Motor Car at the time of my inspection. The body parts at the front right portion of the Motor Car were visually examined and it was observed that the repair/restoration works carried out to the damaged area of the Motor Car (refer to photograph 1 above) were reasonably adequate and in order.

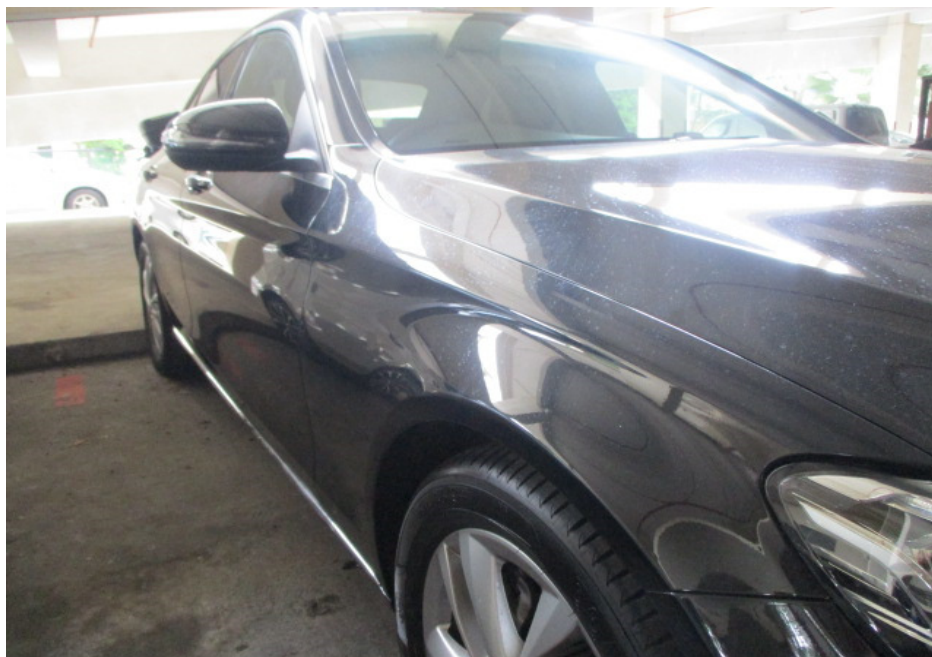
**Photo 6** shows a closer view of the front bonnet and front right fender of the Motor Car at the time of my inspection. The body parts at the front right portion of the Motor Car were visually examined and it was observed that the repair/restoration works carried out to the damaged area of the Motor Car (refer to photograph 1 above) were reasonably adequate and in order.

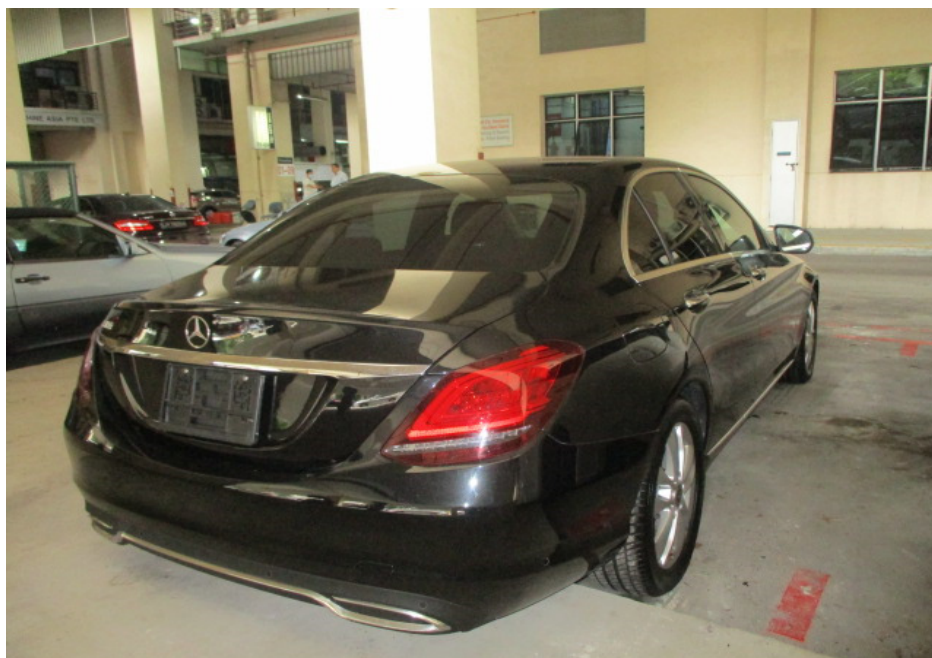
**Photo 7** shows a general view of the rear right body of the Motor Car at the time of my inspection. The Motor Car was observed to be in a relatively good general condition with no loose exterior fittings observed. The body parts at the rear portion of the Motor Car were visually examined and it was observed that the repair/restoration works carried out to the damaged area of the Motor Car (refer to photograph 2 & 3 above) were reasonably adequate and in order.

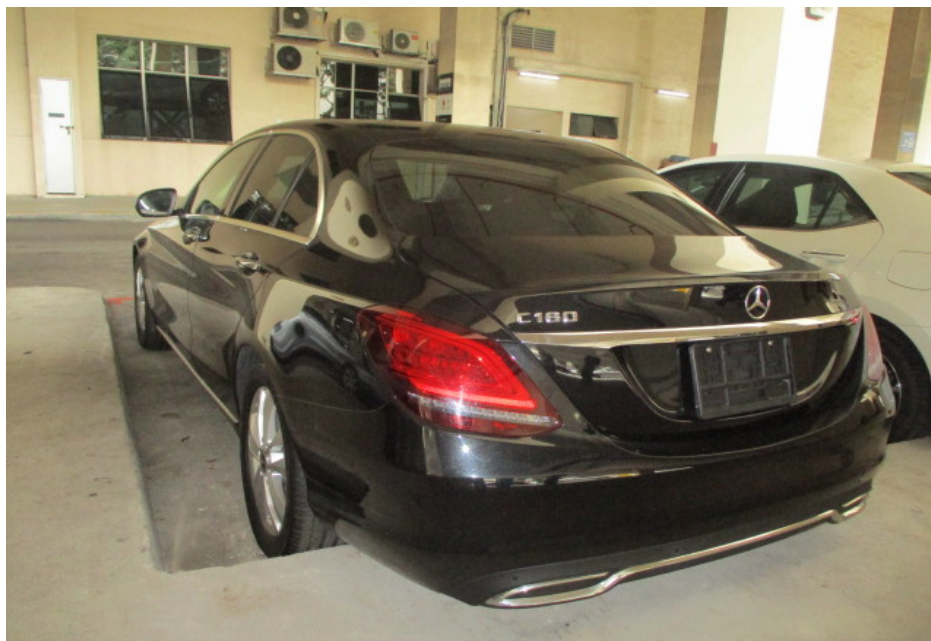
**Photo 8** shows a general view of the rear left body of the Motor Car at the time of my inspection. The Motor Car was observed to be in a relatively good general condition with no loose exterior fittings observed. The body parts at the rear portion of the Motor Car were visually examined and it was observed that the repair/restoration works carried out to the damaged area of the Motor Car (refer to photograph 2 & 3 above) were reasonably adequate and in order.

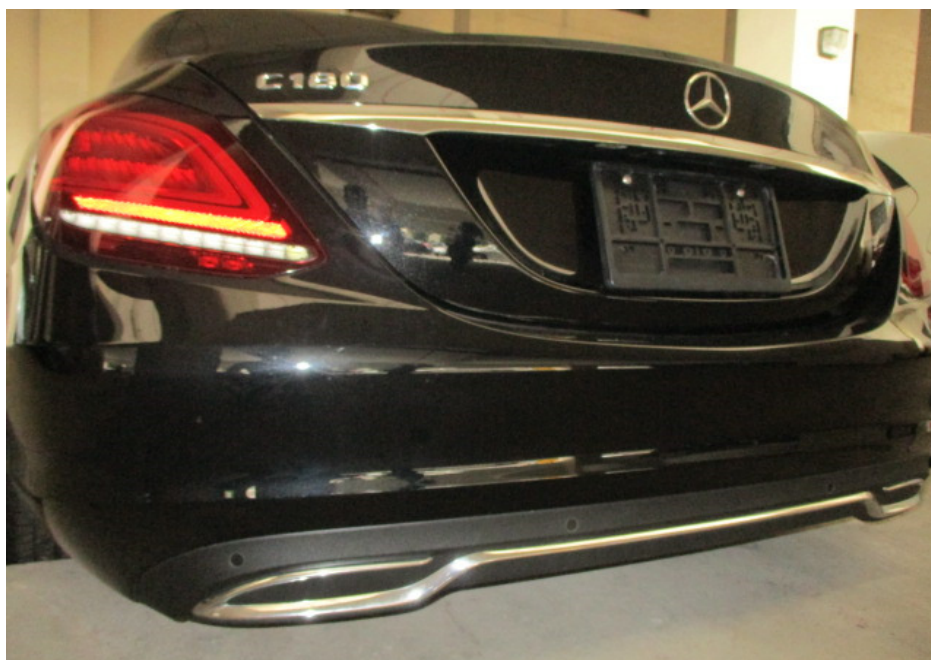
**Photo 9** shows a closer view of the rear bumper, rear bootlid and rear left taillamp of the Motor Car at the time of my inspection. The body parts at the rear portion of the Motor Car were visually examined and it was observed that the repair/restoration works carried out to the damaged area of the Motor Car (refer to photograph 1 & 2 above) were reasonably adequate and in order.

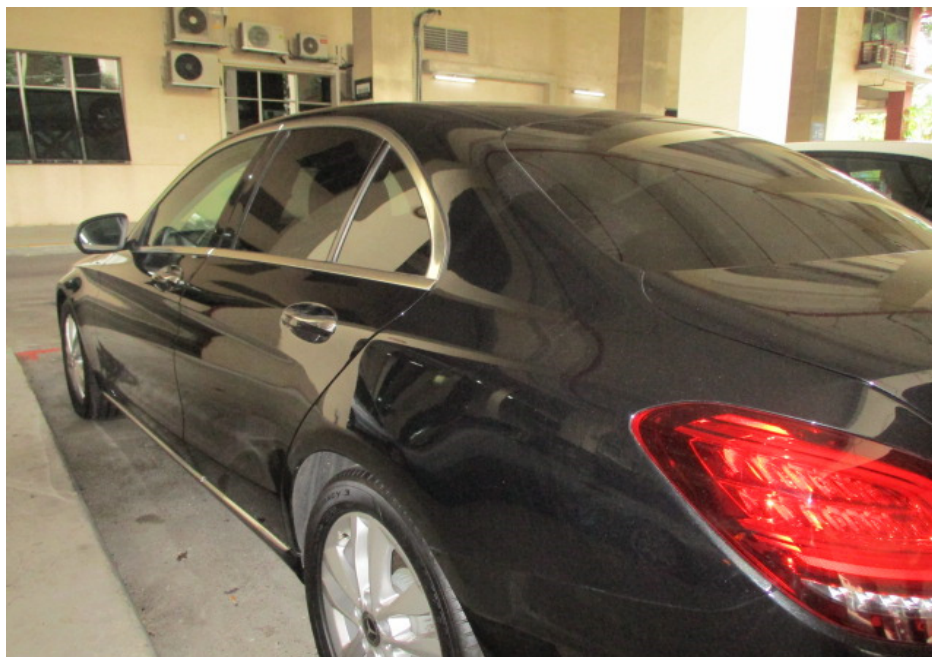
**Photo 10** shows the rear left fender and rear left taillamp of the Motor Car at the time of my inspection. The body parts at the rear portion of the Motor Car were visually examined and it was observed that the repair/restoration works carried out to the damaged area of the Motor Car (refer to photograph 1 & 2 above) were reasonably adequate and in order.

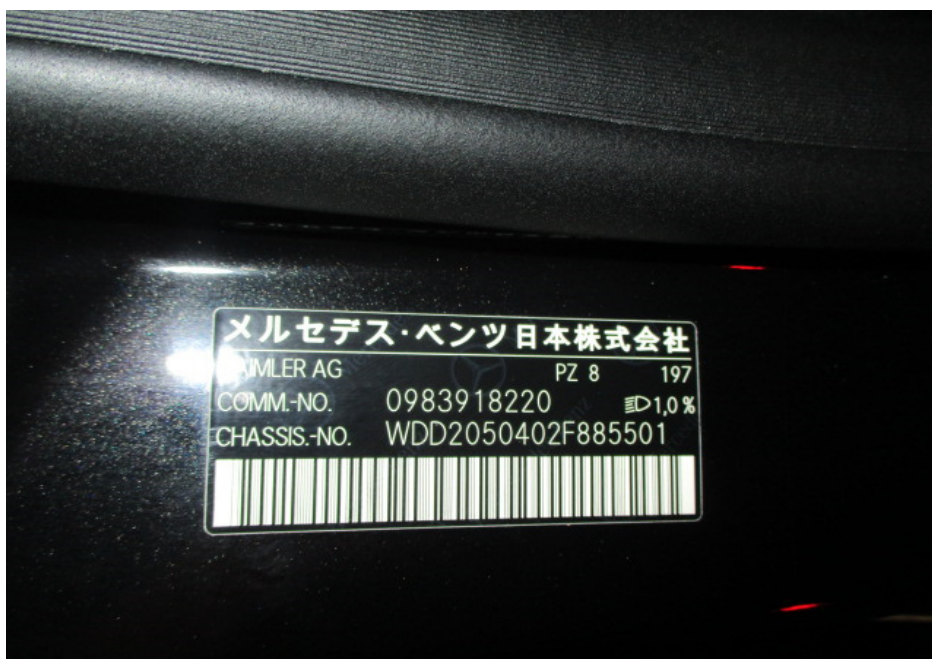
**Photo 11** shows the chassis number of the Motor Car. The chassis number recorded was WDD2050402F885501

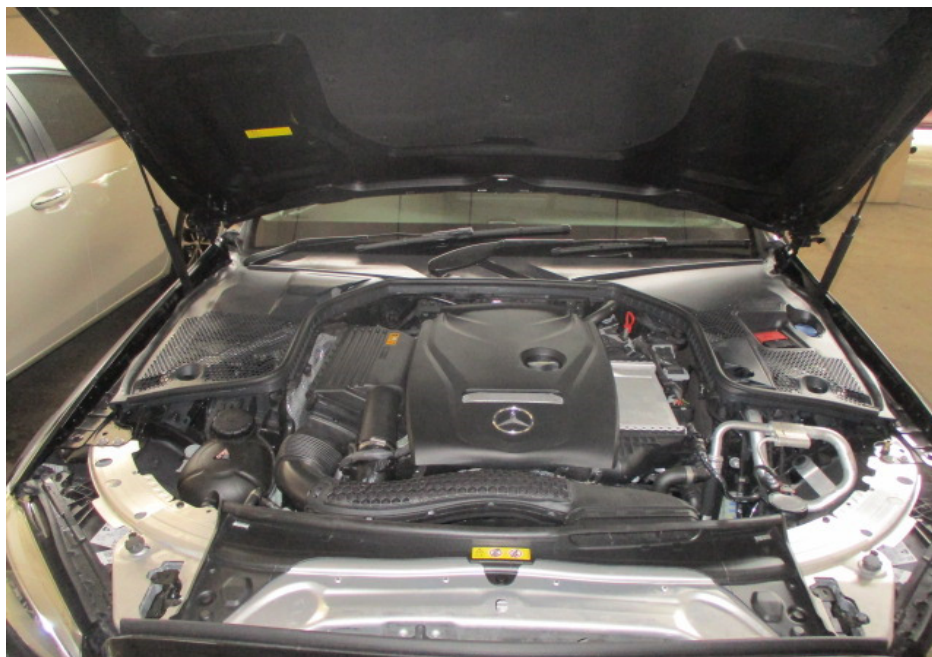
**Photo 12** shows a general view of the engine compartment of the Motor Car at the time of my inspection. The various parts and components inside the engine compartment were all observed to be intact and properly fitted. There was also no sign(s) or indication(s) of fluid leak and/or fluid stain found inside the engine compartment.

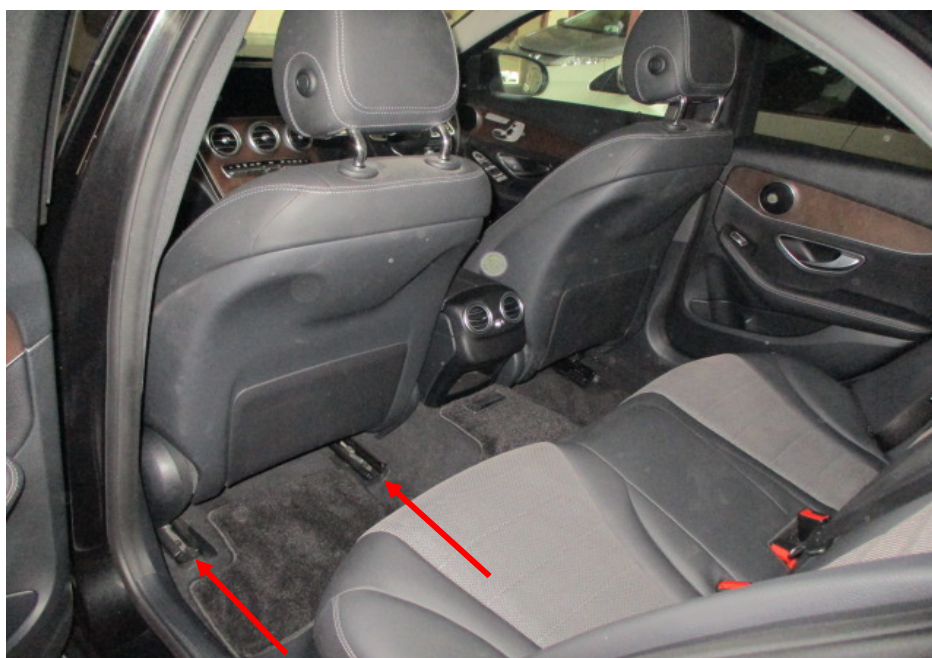
**Photo 13** shows the seats of the Motor Car, which were secured via seat rails (arrowed) to the floorboard. All the seats of the Motor Car were fitted with a retractable seat belt reel and pre-tensioner. The seat belts were tested and able to be fastened into the respective pre-tensions that were fitted on the side of each individual seat.

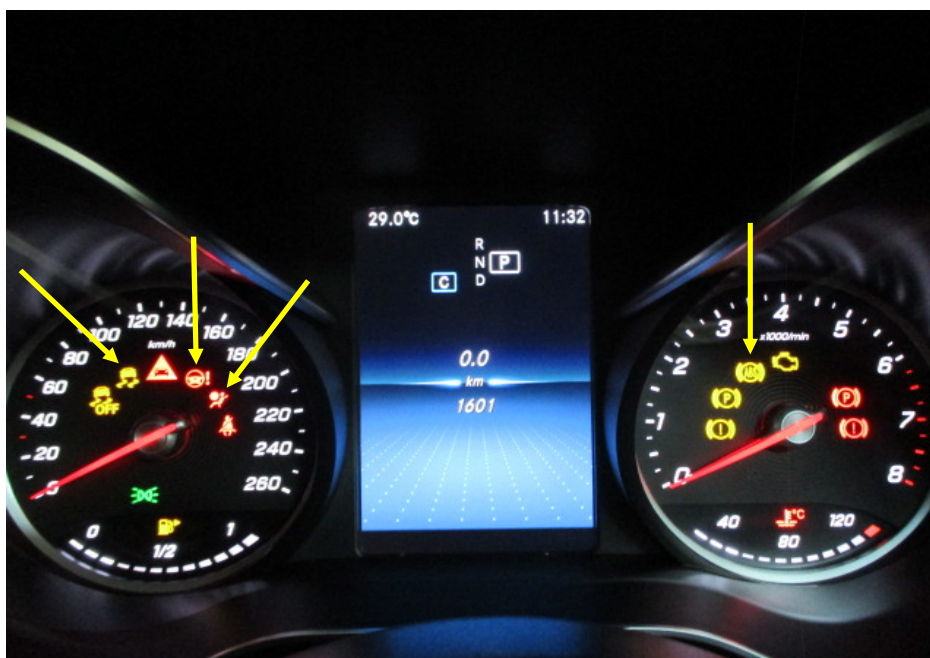
**Photo 14** shows the warning lights for the various electronic safety features appearing on the instrument panel of the Motor Car during its self-test when the engine is cranked, in particular the ABS, SRS, EPS and TCS lights (arrowed).

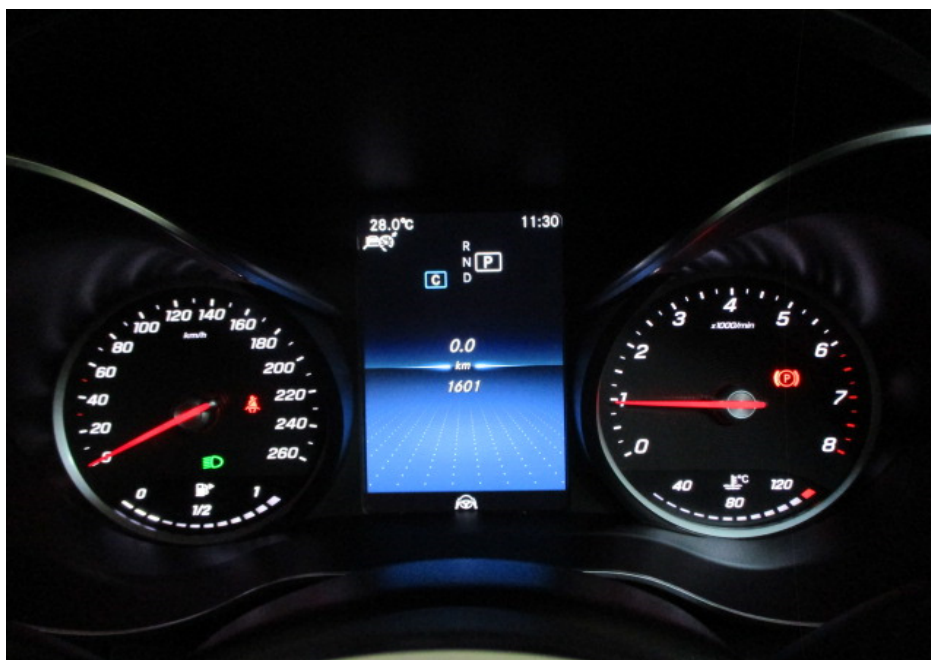
**Photo 15** shows the respective warning lights no longer illuminated, indicating that there is no fault detected to the ABS, SRS, EPS and TCS lights systems of the Motor Car during the self-test. These electronic systems were hence in working condition at the time of my inspection.

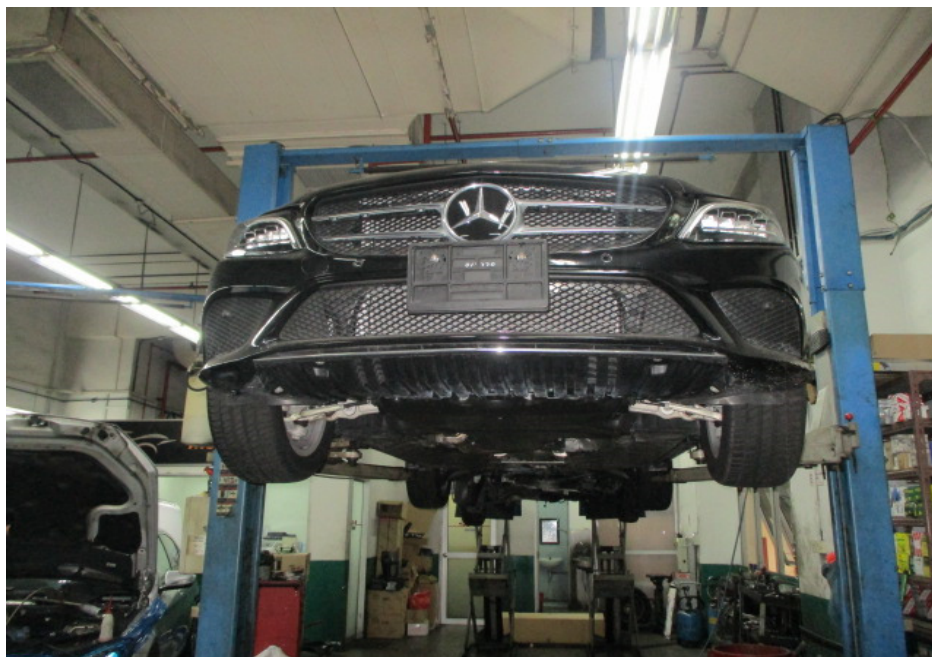
**Photo 16** shows the Motor Car hoisted up for checks on its undercarriage. There was no sign(s) or indication(s) of fluid leakage and/or fluid stain(s) on the underside of the Motor Car. The undercarriage components of the Motor Car were also all observed to be intact and secured in an appropriate manner.

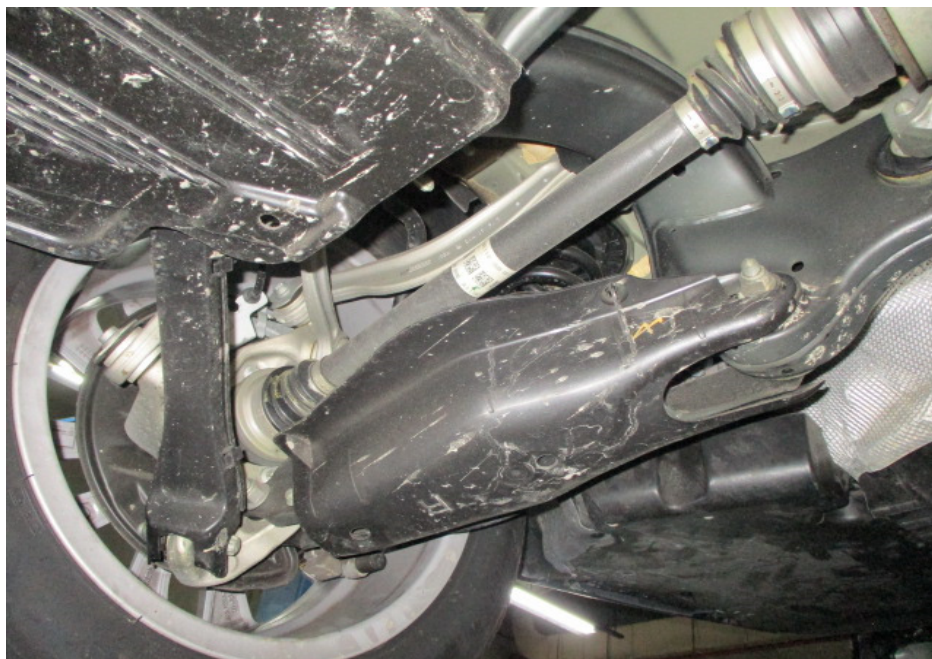
**Photo 17** shows a general view of the control arms and linkages at the rear right wheel of the Motor Car. I did not observe any fluid leak and/or fluid stain on the underside of the Motor Car. All of the Motor Car's undercarriage components were observed to be intact and secured in an appropriate manner.

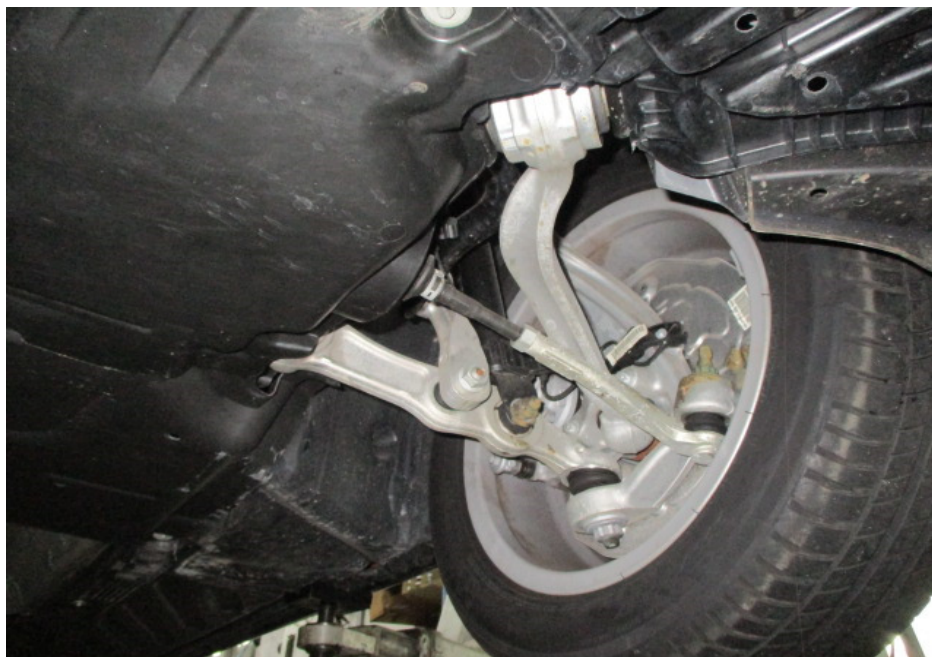
**Photo 18** shows the various undercarriage components at the front left wheel of the Motor Car. The mechanical components, control arms and linkages were all found to be intact and secured in an appropriate manner.

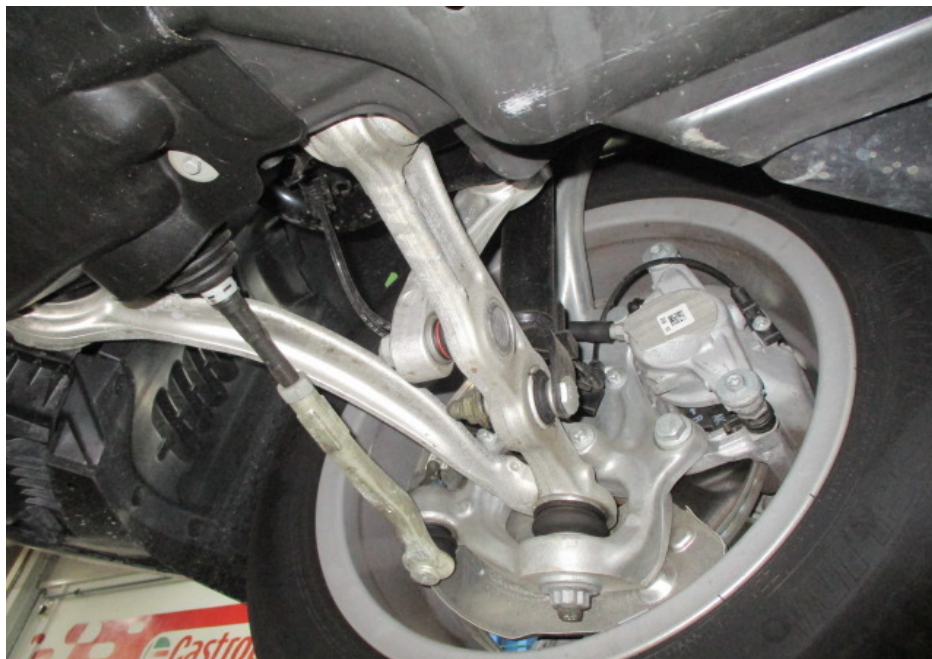
**Photo 19** shows the various undercarriage components at the front right wheel of the Motor Car. The mechanical components, control arms and linkages were all found to be intact and secured in an appropriate manner. I also did not observe any fluid leak and/or fluid stain on the underside of the Motor Car.

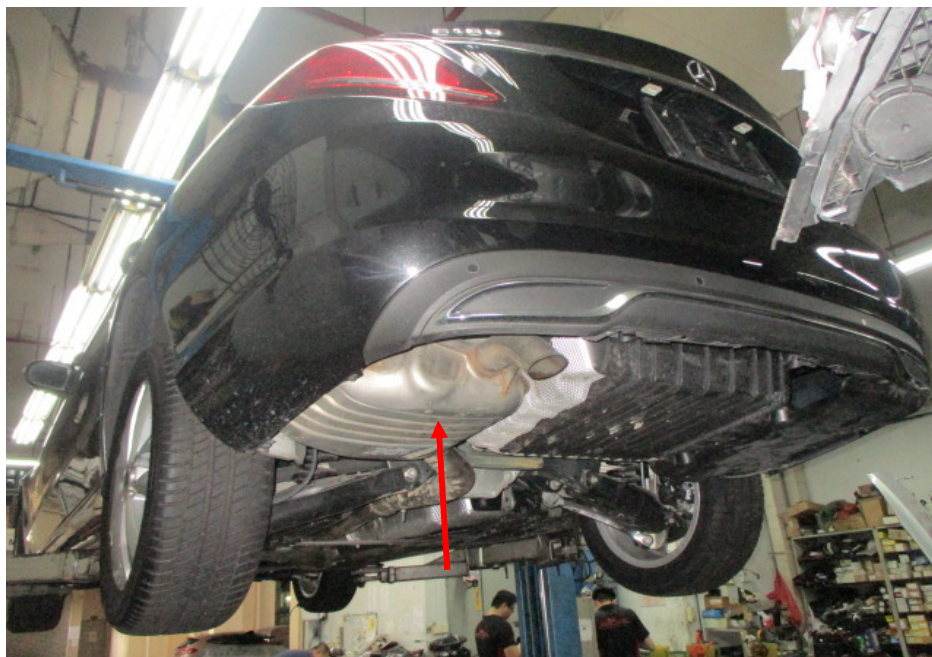
**Photo 20** shows the Motor Car's rear muffler (arrowed). My examination of the Motor Car's exhaust system revealed no sign(s) or indication(s) of any cut or weld marks along its exhaust pipes and on its catalytic convertor.

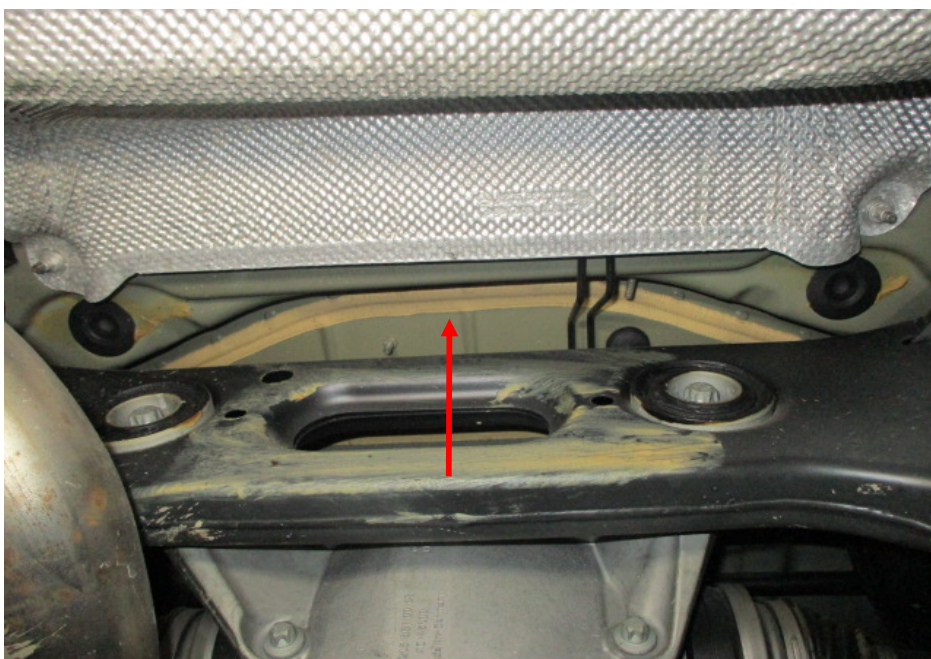
**Photo 21** shows the floorboard at the underside rear centre of the Motor Car. The original factory sealant (arrowed) at the joints along the non-detachable body parts at the underside of the Motor Car was untouched, indicating no work was done on the floorboard of the Motor Car and that the floorboard was originally fitted.

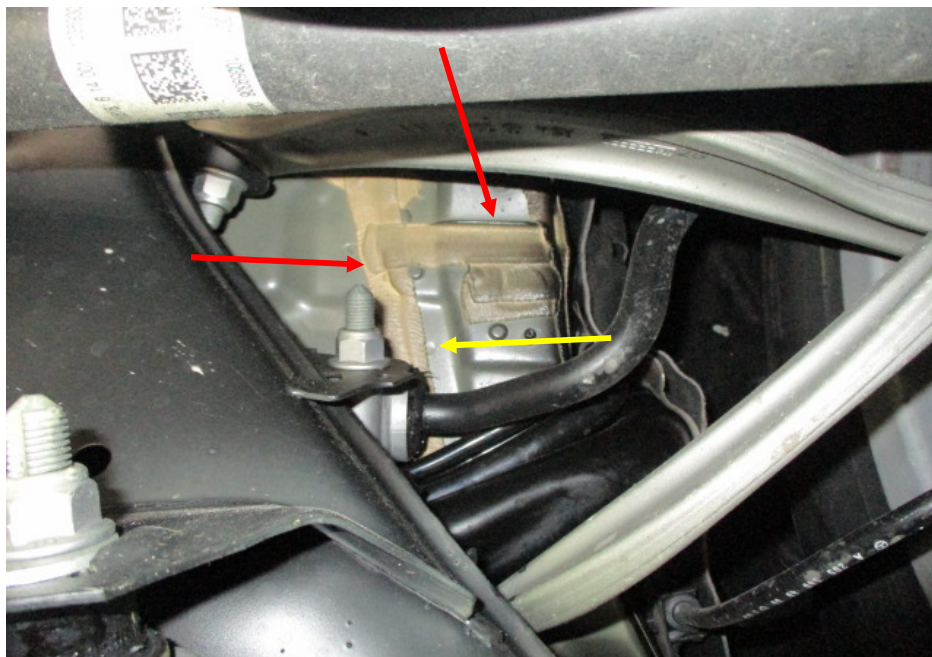
**Photo 22** shows the chassis/structural body at the underside rear right of the Motor Car. Visually, I did not find any weld marks other than original spot weld marks (yellow arrow) on the chassis/structural body of the Motor Car. The original factory sealant (red arrow) at the joints along the chassis/structural body was also untouched, except for the end section of the rear left chassis (refer to photograph 24 below).

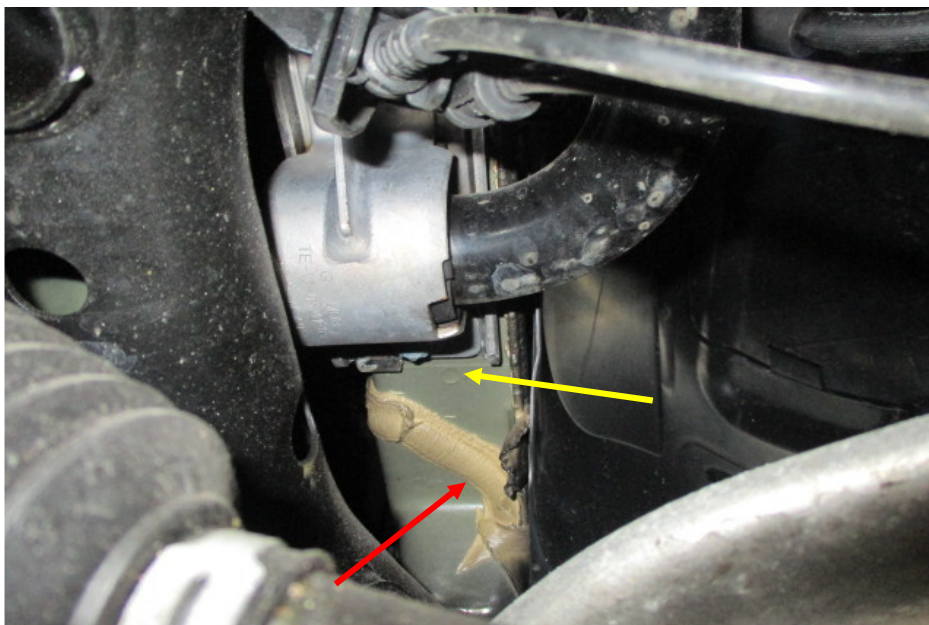
**Photo 23** shows the chassis/structural body at the underside front right of the Motor Car. Visually, I did not find any weld marks other than original spot weld marks (yellow arrow) on the chassis/structural body of the Motor Car. The original factory sealant (red arrow) at the joints along the chassis/structural body was also untouched, except for the end section of the rear left chassis (refer to photograph 24 below).

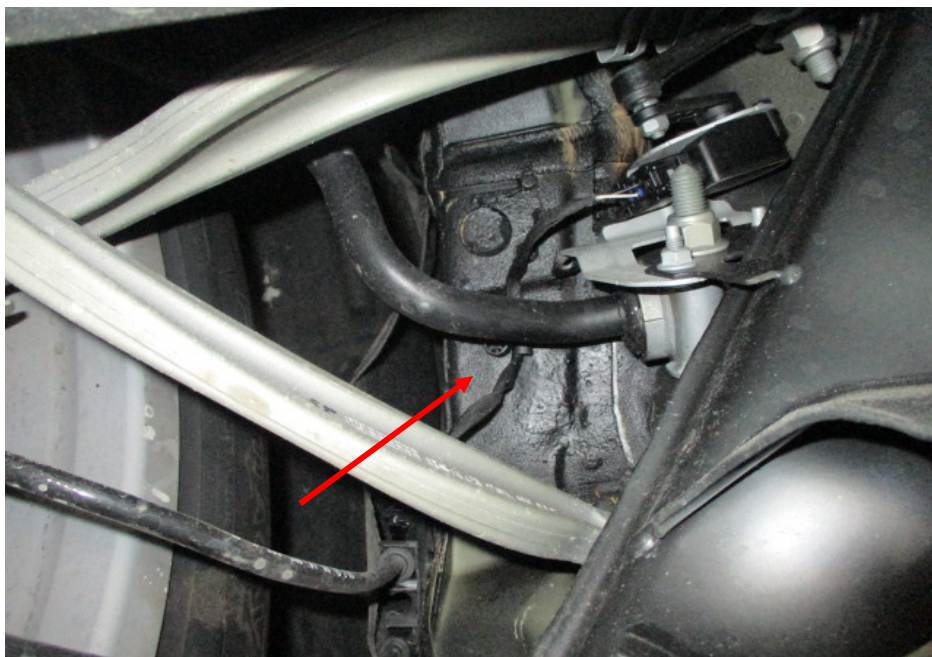
11. Visually, I did not find any weld marks, other than the original spot weld marks, on the chassis/structural body of the Motor Car. The original factory sealant at the joints along the chassis/structural body was also untouched, indicating that no replacement of the chassis/structural body was carried out; and that the chassis/structural body was originally fitted. I did however find signs of repair work carried out to the end section of the Motor Car's rear left chassis (refer to photograph 24 below).

23. I had found signs of repair work carried out to the end section of the Motor Car's rear left chassis. The repairs carried out were in order as the repairs did not involve any cutting and/or re-welding of the Motor Car's original chassis/structural body. Furthermore, lower body chassis alignment measurements carried out by STA Inspection Pte Ltd also showed the chassis/structural measurements of the Motor Car to be within acceptable tolerance (refer to Appendix 1 at page 21 of this report).

**Photo 24** shows the chassis/structural body at the underside rear left of the Motor Car. The end section of the chassis/structural body at the underside rear left was found sprayed with anti-corrosion protection. This is an indication that repair works were carried out at the end section of the chassis/structural body at the underside rear left. However, the rear left chassis of the Motor Car was still observed to be an originally fitted part.

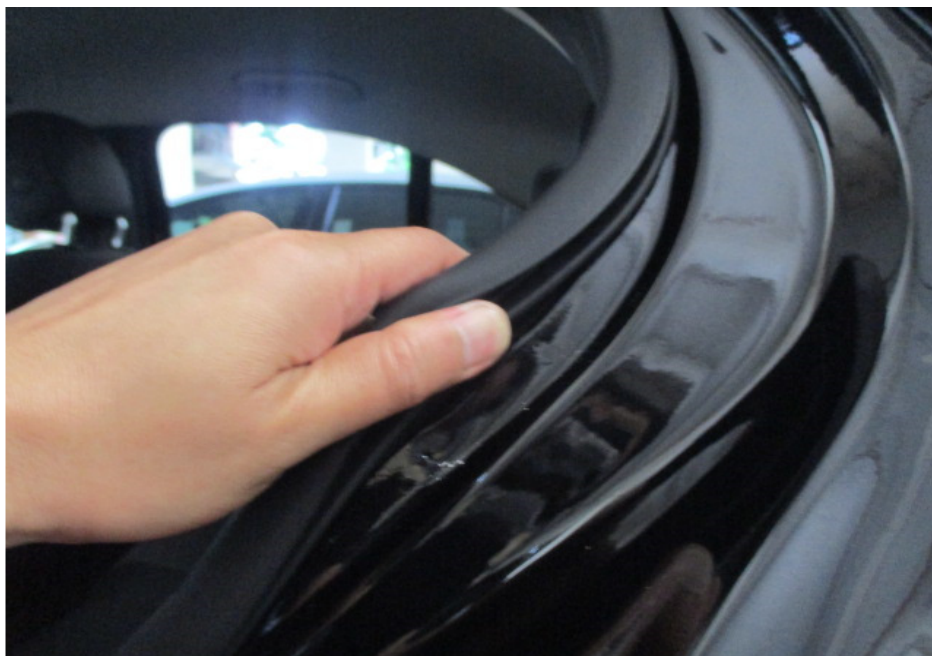
9. The detachable body panels of the Motor Car like the front fenders, front bumper, rear bumper, doors, bonnet and rear bootlid amongst others were all found to be fitted securely.
10. Checks on the non-detachable body panels like the rear fenders, floorboard, roof panel, pillars and rocker panels amongst others, revealed that these body panels were spot welded onto the chassis/structural body of the Motor Car. The original factory sealant at the joints of the non-detachable body panels was all untouched indicating no replacement of the non-detachable body panels was carried out; and that these body panels were all originally fitted except for the rear left fender and rear right fender, which were found to be replaced (refer to photograph 25 & 26 below).

**Photo 25** shows the left side "C" pillar of the Motor Car. I did not find any original weld marks at the left side "C" pillar of the Motor Car, indicating that the rear left fender of the Motor Car was replaced. The lack of original weld marks seen was due to replacement work when the replaced rear left fender was re-welded onto the Motor Car and smoothen for re-spraying work.

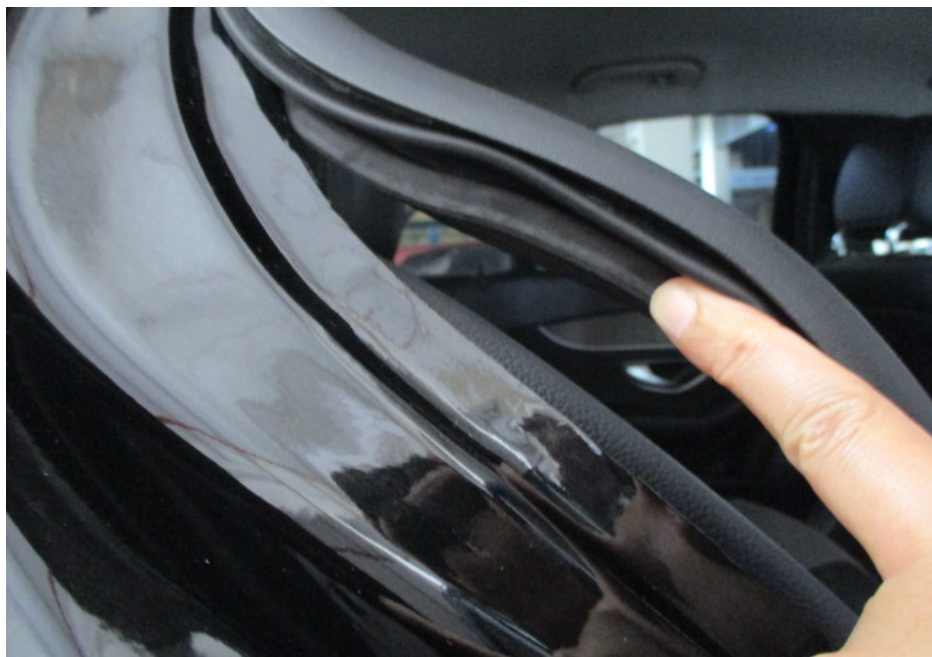
**Photo 26** shows the right side "C" pillar of the Motor Car. I did not find any original weld marks at the right side "C" pillar of the Motor Car, indicating that the rear right fender of the Motor Car was replaced. The lack of original weld marks seen was due to replacement work when the replaced rear right fender was re-welded onto the Motor Car and smoothen for re-spraying work.
