Your Ref: Mercedes Benz C180  
(chassis number WDD2050402F885501)  
Our Ref : CI/TP20010902/D

09 October 2020

**INSPECTION REPORT OF AN UNREGISTERD MERCEDES BENZ C180  
MOTOR CAR WITH CHASSIS NUMBER WDD2050402F885501**

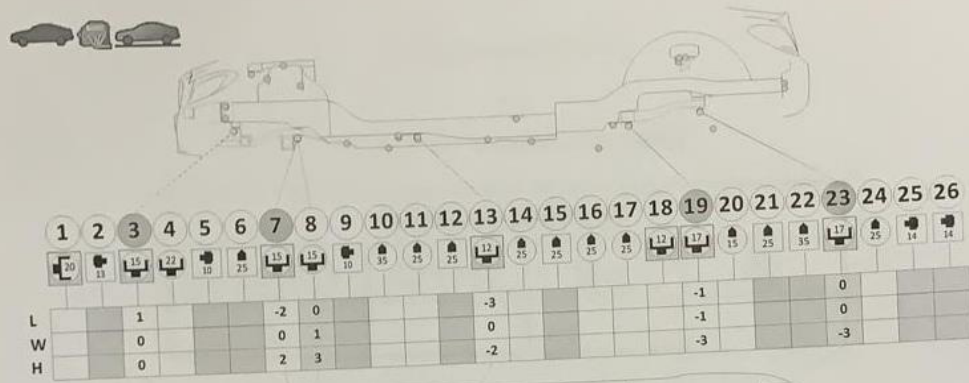
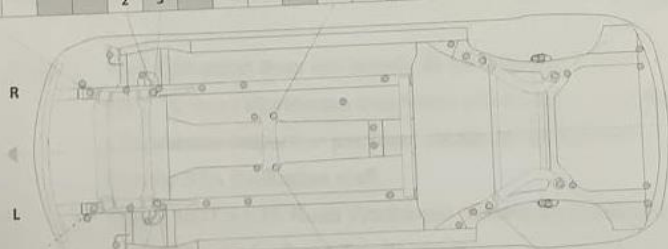
## Appendix 1

BodyShop	Notes
Company STA Evaluation Address 302 Sin Ming Road City SINGAPORE State E-mail baydennis@stegg.com Zip 575627 Phone +65 6453 0200	WITHIN ACCEPTABLE TOLERANCE

Appendix 1 shows the lower body chassis measurements of the Motor Car (red arrow) that was carried out by STA Inspection Pte Ltd. I note that the chassis/structural measurements of the Motor Car were within acceptable tolerance (yellow arrow).
