Your Ref: S9M026Z1
Our Ref : CI/AXA20010912/D

28 August 2020

Damage Consistency Report of the Insured Motor Car SKF 5120S

**Requested By
AXA Insurance Pte Ltd
8 Shenton Way #24-01
AXA Tower
Singapore 068811**

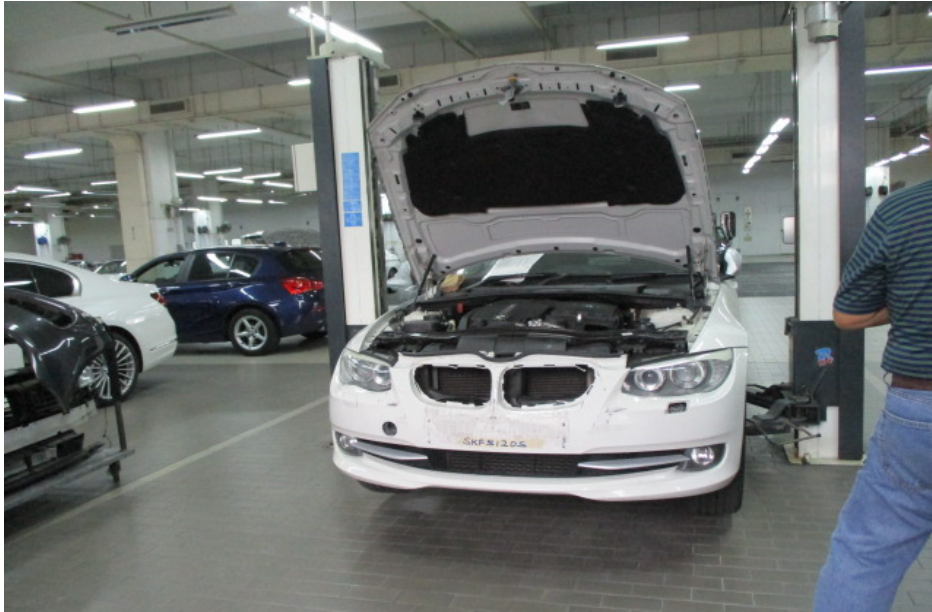
Photo 1 shows a general view of the frontal portion of the Insured Vehicle at the time of the joint inspection on 20 January 2020.

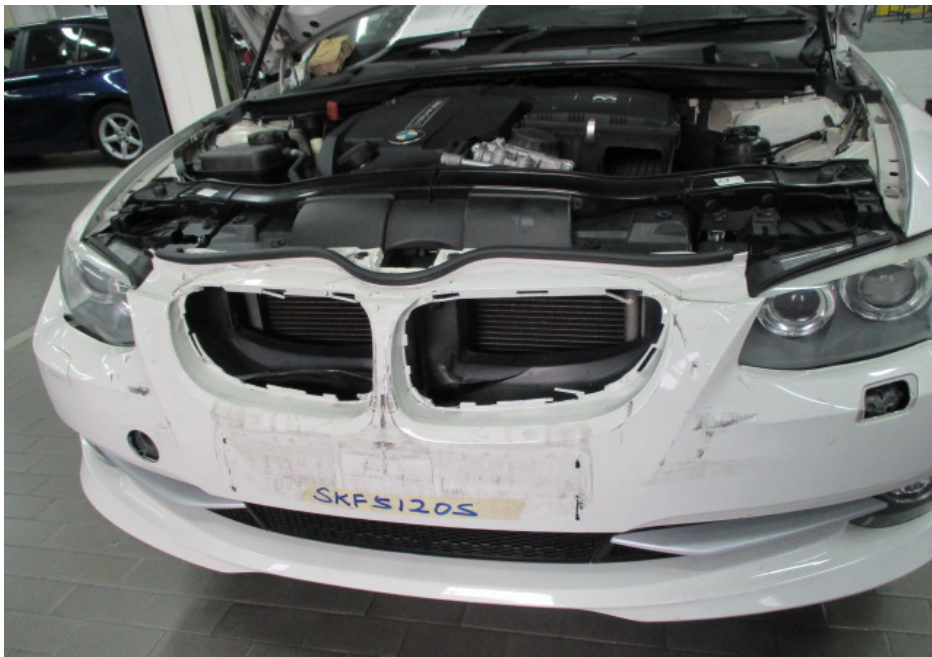
Photo 2 shows a closer view of the frontal portion of the Insured Vehicle. The front bumper, front grilles, front bonnet and front number plate were amongst the exterior body parts that were found to be with visible damage.

20. The damage seen on the exterior of the Insured Vehicle is consistent to a front to rear collision where the front of the Insured Vehicle had collided into the rear portion of another motor vehicle.

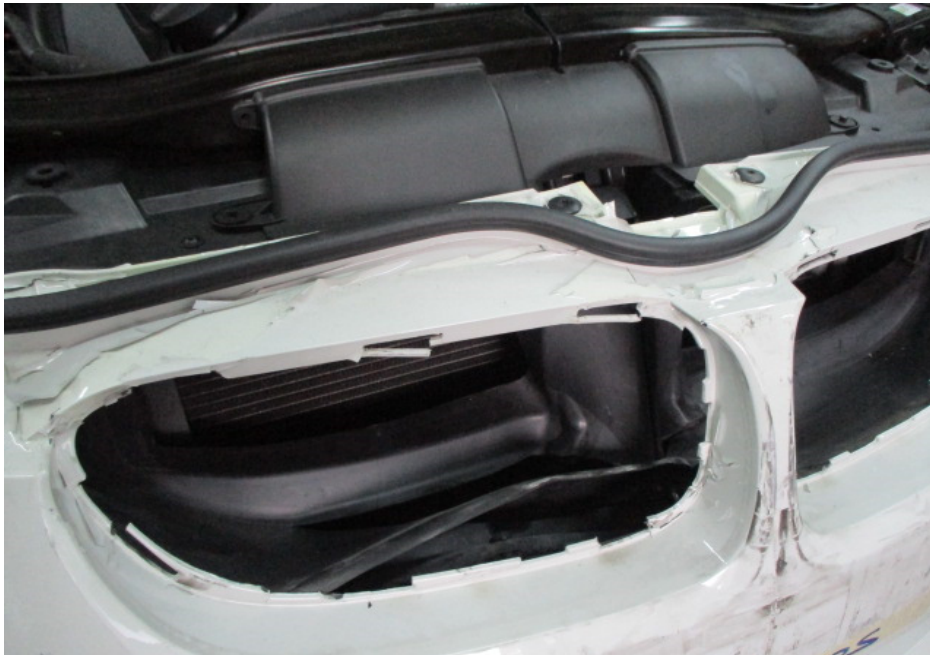
Photo 3 shows another view of the frontal portion of the Insured Vehicle. The front bumper, front grilles, front bonnet and front number plate were amongst the exterior body parts that were found to be with visible damage.

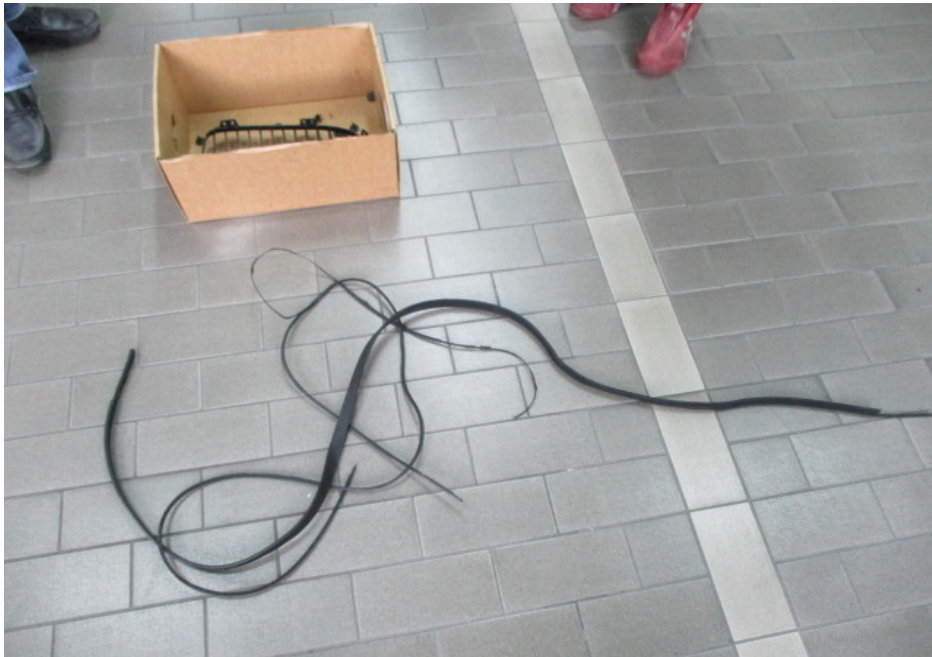
Photo 4 shows the drive belt of the Insured Vehicle, which was observed to be torn/shredded.

41. In all likelihood, when the bolt sheared, the power steering pump sunk downwards, and this caused the drive belt to be stretched, displaced, entangled etc and eventually tear/shred. Similarly, the idler pulley was also pulled downwards by the sudden sinking downwards of the power steering pump, leading to it being detached or broken off from its mounting location and ultimately caused the engine housing to chip.

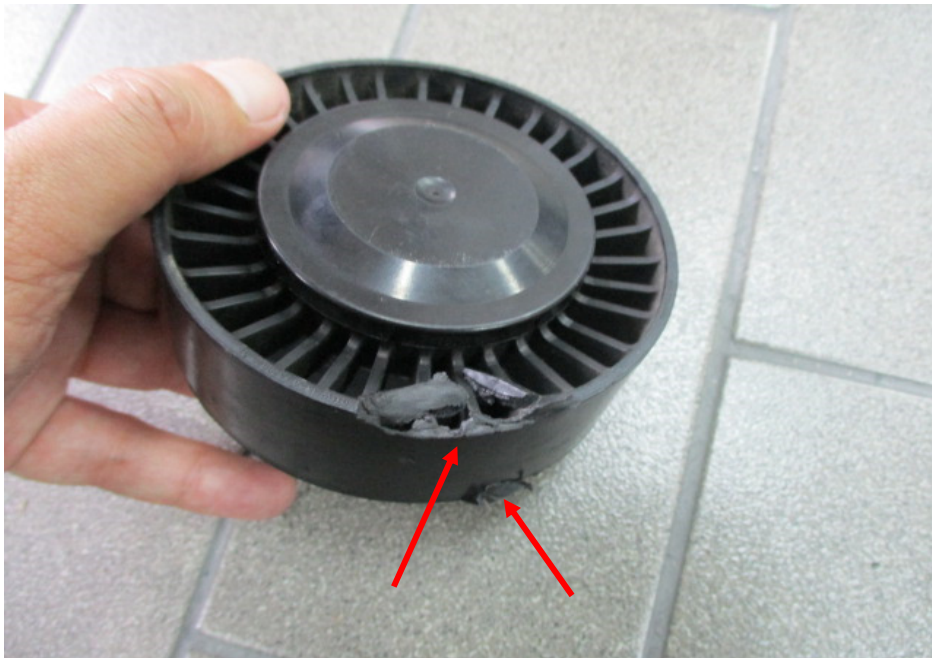
Photo 5 shows the front side of the idler pulley of the Insured Vehicle. A section of the circumference edge was observed to be broken at both the front side and rear side (arrowed).

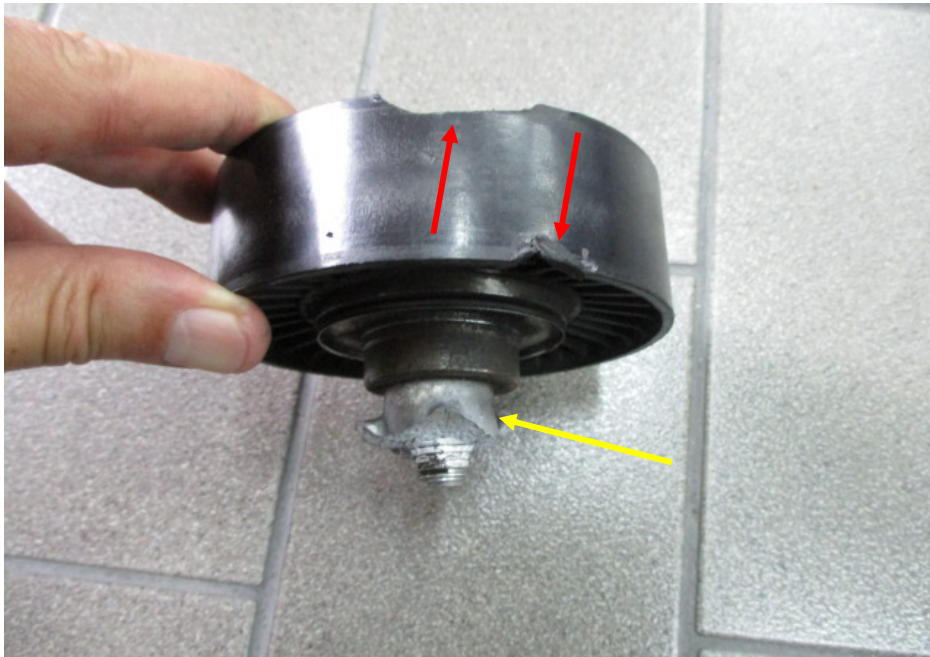
Photo 6 shows the rear side of the idler pulley of the Insured Vehicle. A section of the circumference edge was observed to be broken at both the front side and rear side (red arrow). The rear side of this idler pulley was mounted onto the engine housing of the Insured Vehicle and I had noted that a small part of the engine housing had chipped off (yellow arrow).

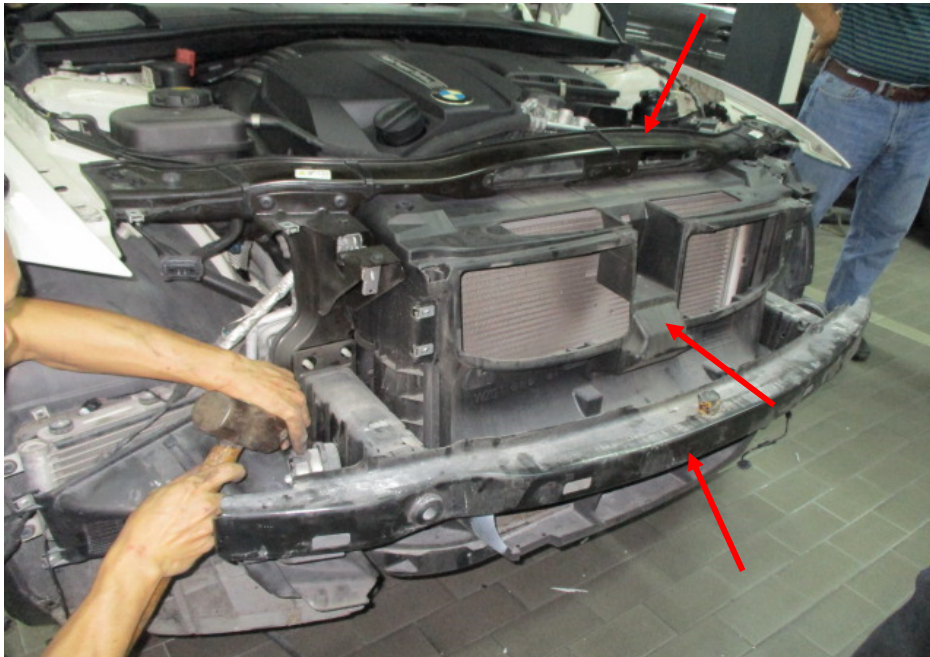
Photo 7 shows the Insured Vehicle during partial dismantling of the parts at its frontal portion on 20 January 2020. The front bumper reinforcement, radiator air guide and front support panel were amongst the parts (arrowed) that were found to be damaged.

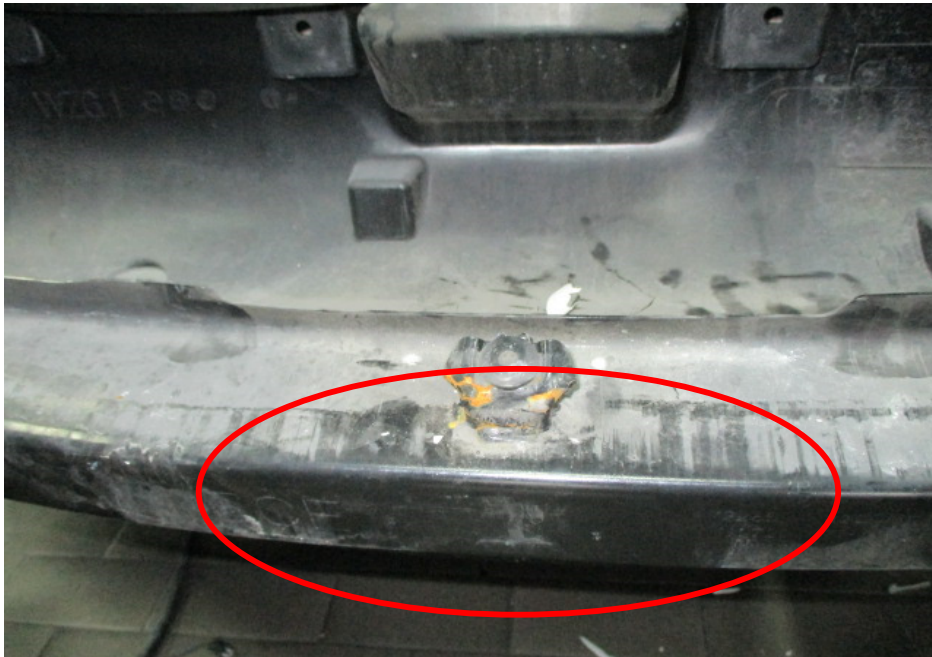
Photo 8 shows the front bumper reinforcement of the Insured Vehicle, which was observed to be dented (circled) at the centre. The indentation was inwards of the Insured Vehicle.

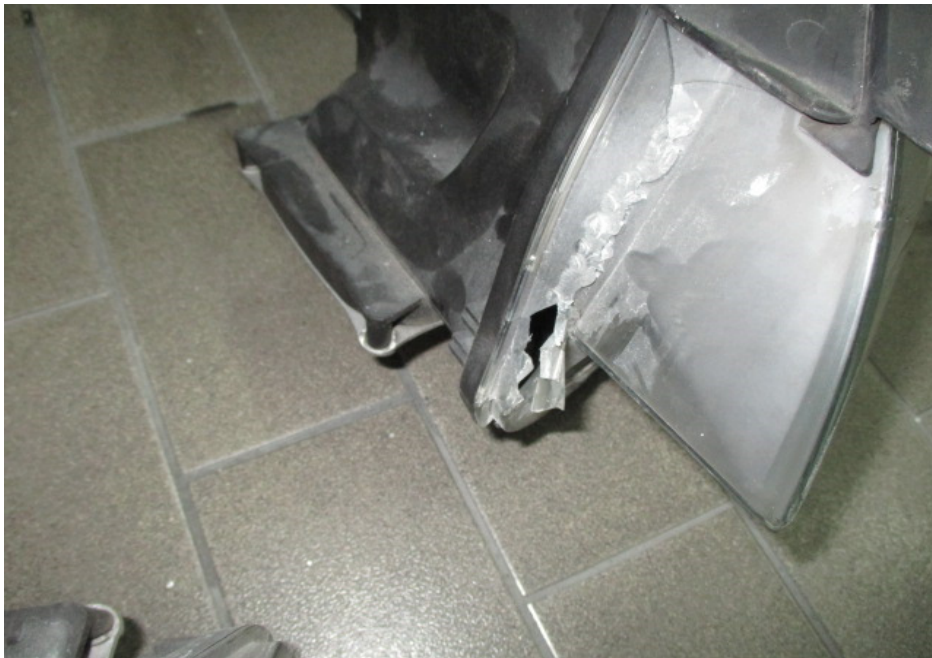
Photo 9 shows the front left headlamp of the Insured Vehicle, which was found to be cracked/broken at the corner edge. When fitted on the Insured Vehicle, this corner edge is located slightly towards the left from the centre of the Insured Vehicle.

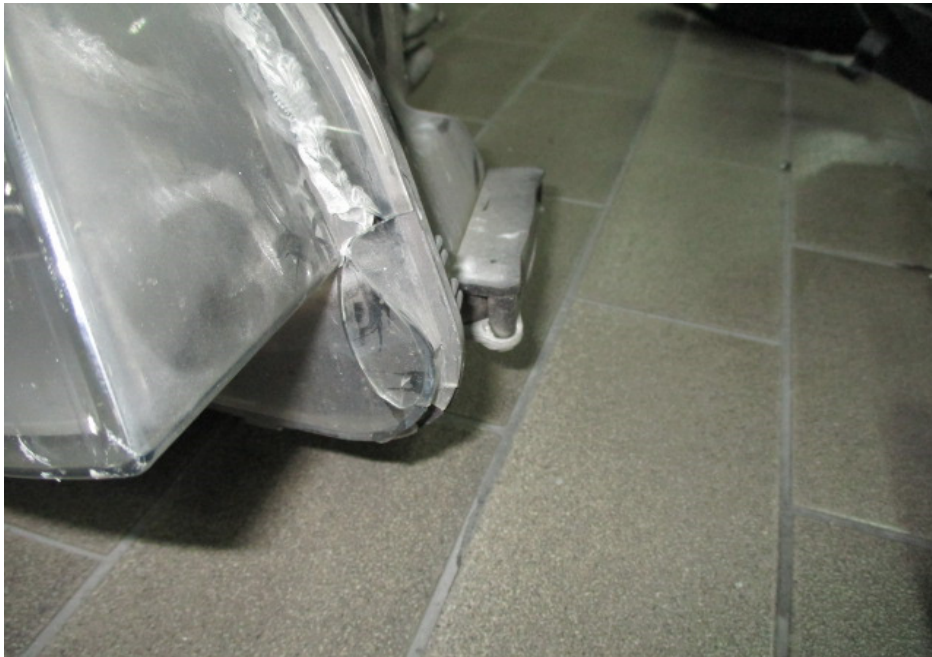
Photo 10 shows the front right headlamp of the Insured Vehicle, which was found to be cracked/broken at the corner edge. When fitted on the Insured Vehicle, this corner edge is located slightly towards the right from the centre of the Insured Vehicle.

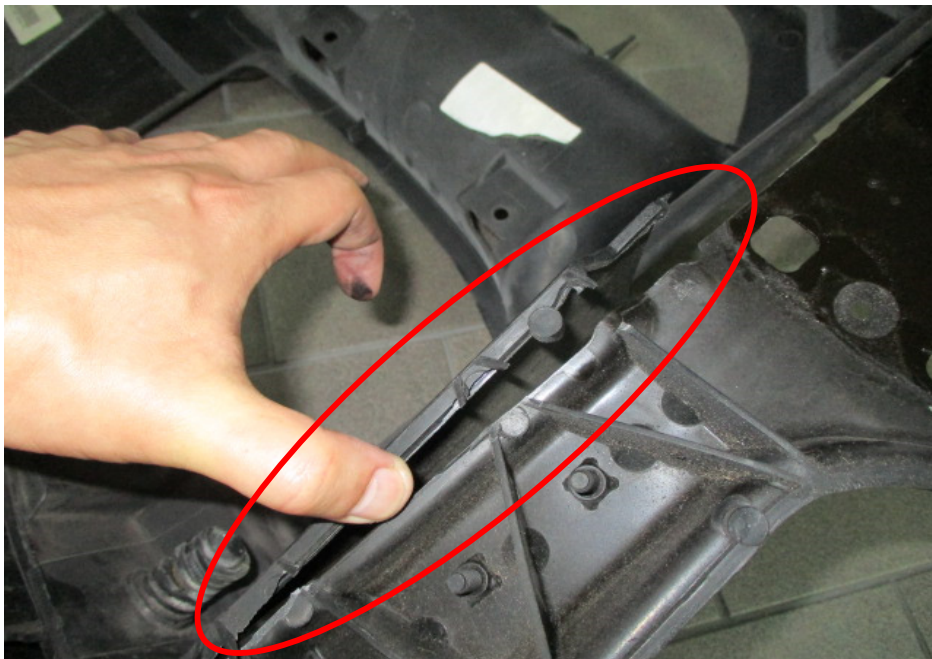
Photo 11 shows the front support panel of the Insured Vehicle, which was observed to be broken (circled). When fitted on the Insured Vehicle, this broken area is located slightly towards the left from the centre of the Insured Vehicle.

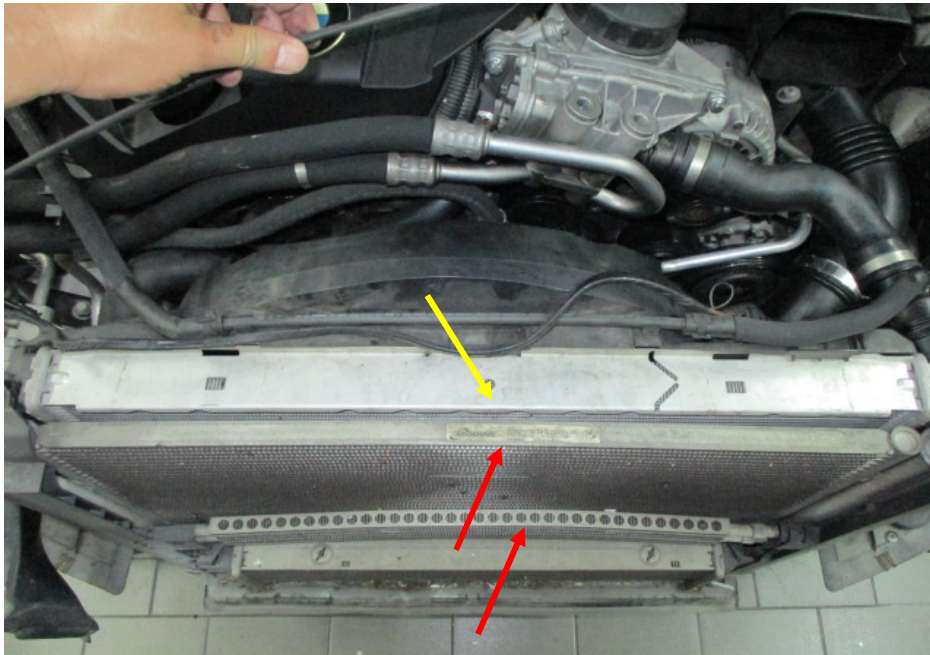
Photo 12 shows the oil cooler, aircon condenser and radiator of the Insured Vehicle. When still fitted on the Insured Vehicle, these parts were seen to bent inwards of the Insured Vehicle (red arrow). The bending of the radiator (yellow arrow) was less obvious as compared to the oil cooler and aircon condenser.

43. Furthermore, energy dissipation diminishes as it flows further away from the point of impact as parts/components surrounding the point of impact absorb the energy, giving rise to physical damage. For this case, the physical damage to the radiator was lesser as compared to the oil cooler and aircon condenser (refer to photograph 12 above). This was because the radiator was exposed to lesser energy dissipation due to the oil cooler, aircon condenser and other parts at the front of the Insured Vehicle absorbing significant amount of energy and therefore as the energy flows further away from the point of impact, it becomes weaker.

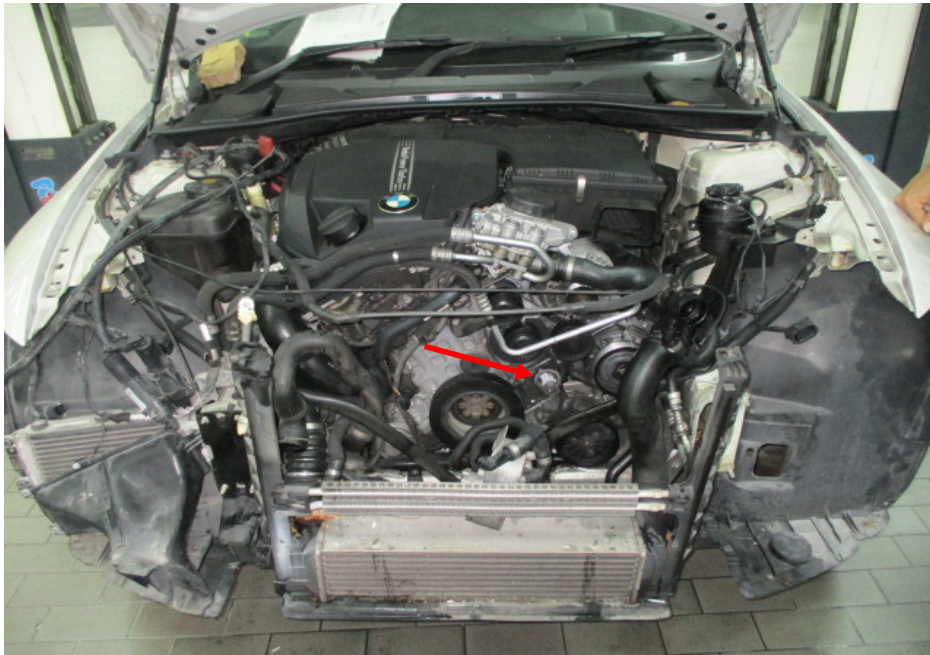
Photo 13 shows the Insured Vehicle during the re-inspection on 21 January 2020. The aircon condenser, radiator and radiator fan were dismantled and removed. The engine block of the Insured Vehicle, at the location where the idler pulley as mounted (arrowed), was observed to be broken/chipped off.

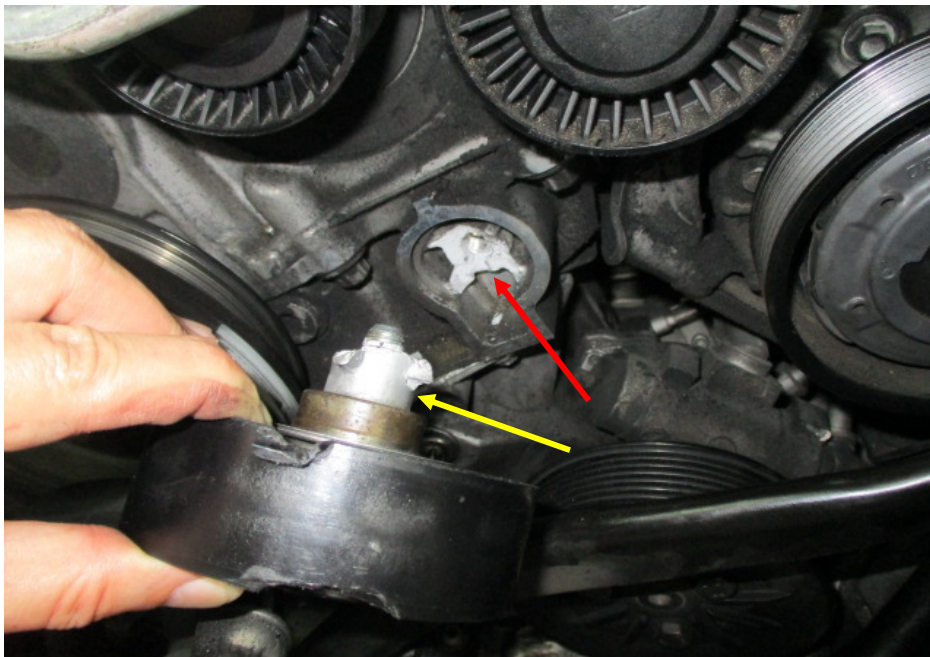
Photo 14 shows a closer view of the broken/chipped off engine block of the Insured Vehicle. The rear side of the idler pulley (yellow arrow) is mounted onto the broken/chipped of area (red arrow) of the engine block.

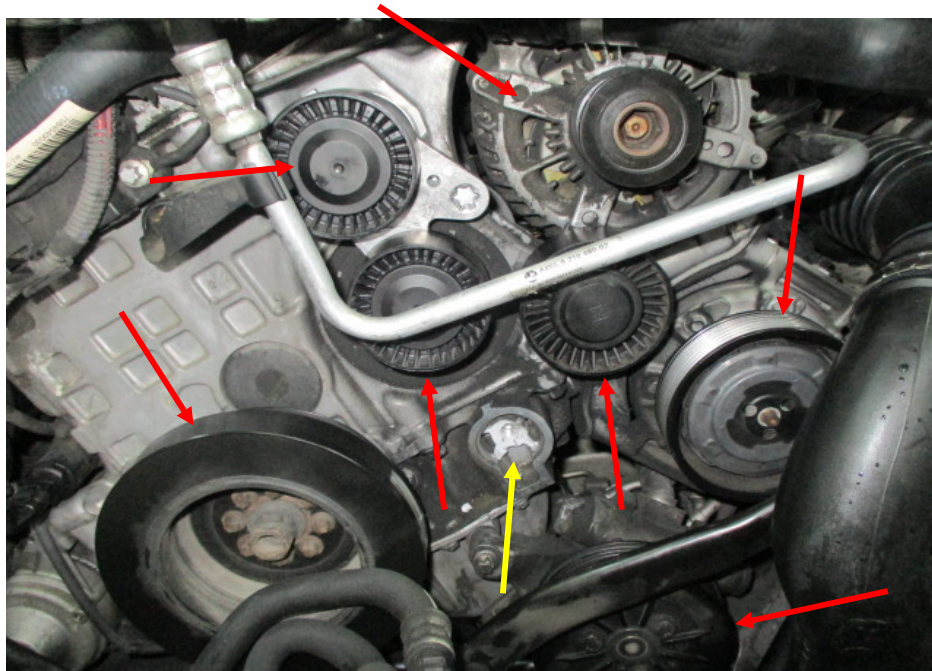
Photo 15 shows a general view of the various pulleys and components that form the drive belt system of the Insured Vehicle. These components include the alternator, aircon compressor, water pump and power steering pump amongst others. Under normal circumstance, the torn/shredded drive belt of the Insured Vehicle wraps around these components (red arrow) and the detached idler pulley (location highlighted by the yellow arrow).

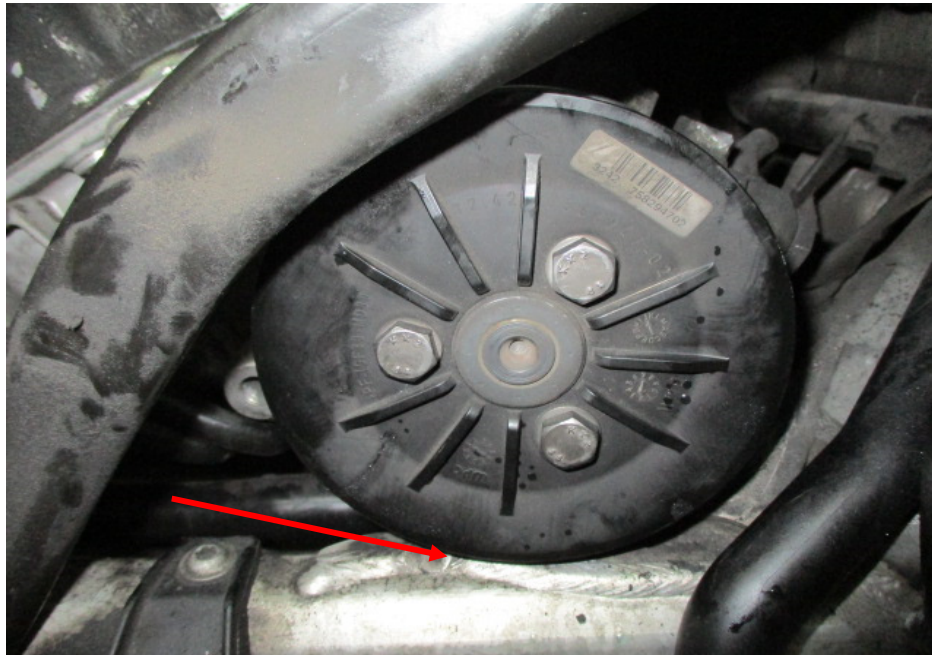
26. Upon checking the various pulleys and components, like the alternator, aircon compressor, water pump and power steering pump, that form the drive belt system of the Insured Vehicle, I had noted that the power steering pump had sunk downwards and was resting on the engine subframe of the Insured Vehicle whilst the other pulleys and components were still securely mounted onto their respective locations, less the idler pulley which was detached from its mounting location. Under normal circumstance, the drive belt of the Insured Vehicle that was found to be torn/shredded, wraps around these components allowing the respective motors to operate for these components to perform their respective functions.

Photo 16 shows the power steering pump of the Insured Vehicle, which is located at the bottom of the drive belt system. Upon my examination of the power steering pump, I had noted that the bottom side (arrowed) of the power steering pump was resting on the engine cross member of the Insured Vehicle.

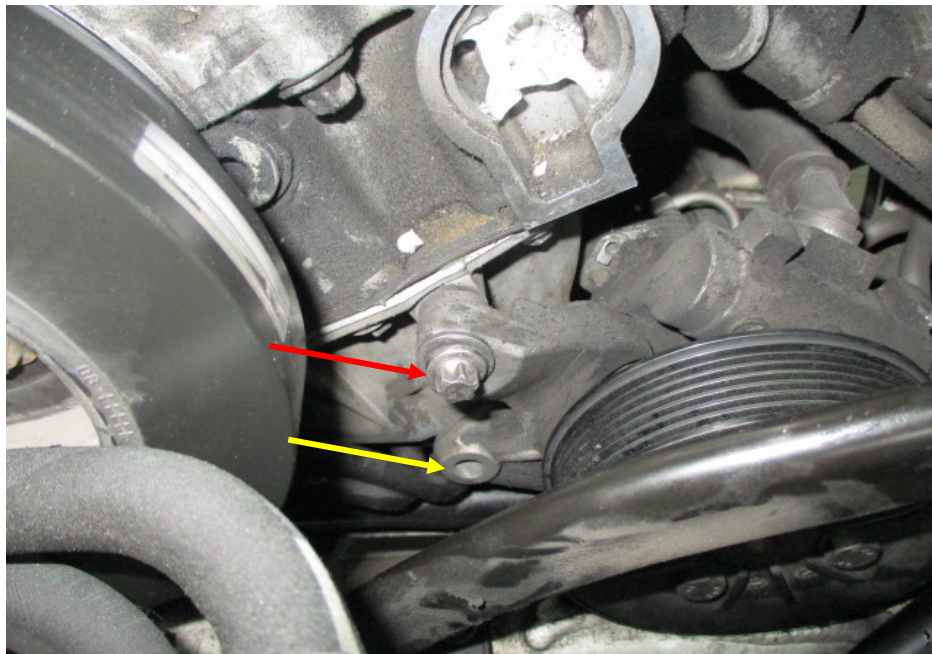
27. My close examination of the power steering pump revealed that the cause of the power steering pump sinking downwards was due to inadequate support. The power steering pump should be secured in place by 3 bolts however only 1 bolt was found securing the power steering pump. For the remaining 2 bolts, 1 bolt was found to be sheared off while the other was found to be missing. See photo 15 – 18 below.

Photo 17 shows 2 of the 3 bolts that secures the power steering pump to its position. It was observed that the cause of the power steering pump sinking downwards was due to inadequate support. At the time of my inspection on 21 January 2020, the power steering pump was secured by only 1 bolt (red arrow). One bolt was observed to be missing (yellow arrow) while another bolt was observed to be sheared off (refer to photograph 18 below).

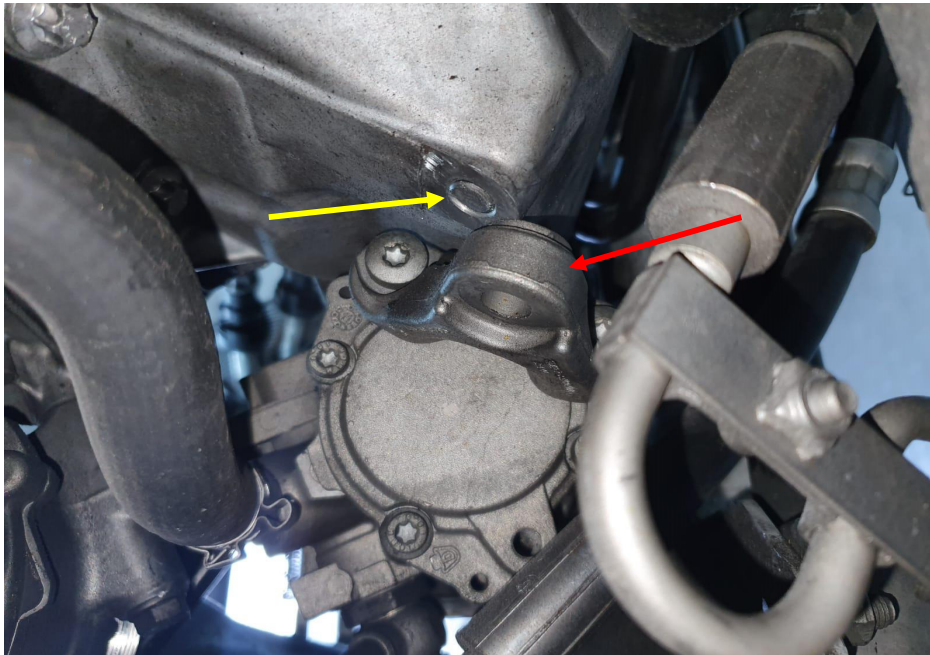
Photo 18 shows the sheared off bolt of the Insured Vehicle's power steering pump. This was located towards the bottom, at the back of the power steering pump (view from the bottom towards the top of the Insured Vehicle). Part of the sheared off bolt was still within the bolt hole at the mounting location (yellow arrow). The red arrow highlights the mounting location of the power steering pump where the sheared off bolt is supposed to hold the power steering pump in place. As seen from the photograph above, the power steering pump was shifted downwards from its original position.

40. The sheared off bolt of the power steering pump was a result of this material stress that the bolt was exposed to for a period of time and had eventually gave way. Such phenomenon is normally referred to as material failure or material fatigue.

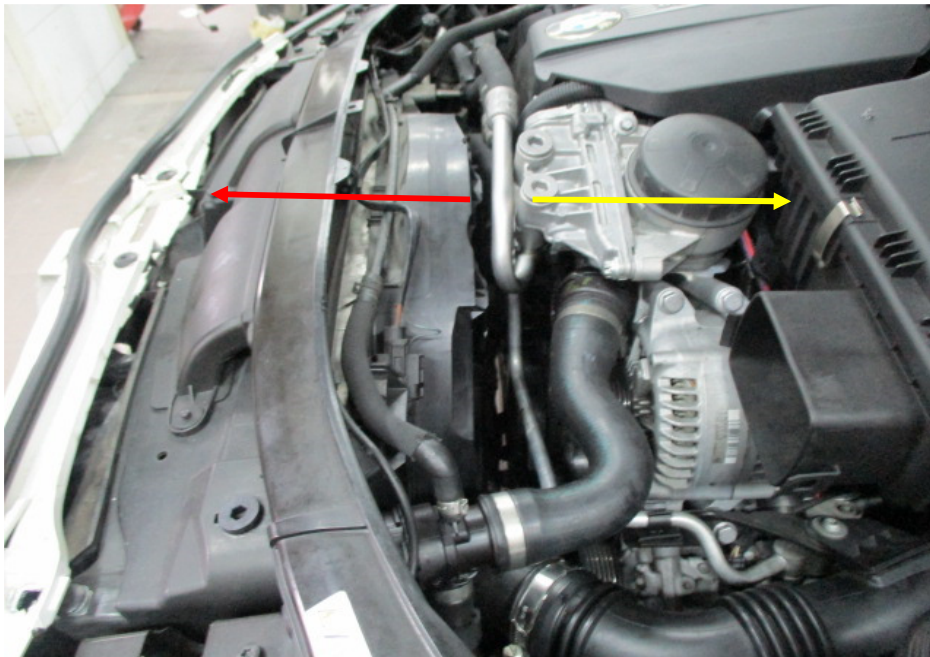
Photo 19 shows the side view perspective of the Insured Vehicle's engine compartment. The idler pulley, drive belt and power steering pump were located inwards of the Insured Vehicle's frontal portion (at approximately the start of the area highlighted by the yellow arrow). The idler pulley, drive belt and power steering pump are not link or attach to the parts at the frontal portion of the Insured Vehicle (highlighted by the red arrow area). In other words, there is a gap/spacing between the idler pulley, drive belt and power steering pump, and the parts link or attach to the frontal portion of the Insured Vehicle.

33. Given that there was a gap/spacing still present even after the accident, it can be reasonable to ascertain that the damage to the idler pulley, drive belt and power steering pump of the Insured Vehicle are not induced/indirect type of damage arising from the accident collision on 13 November 2019. In paragraph 29 above, induced/indirect damage occurs when body parts are damaged by contact from some other part(s) of the same vehicle.

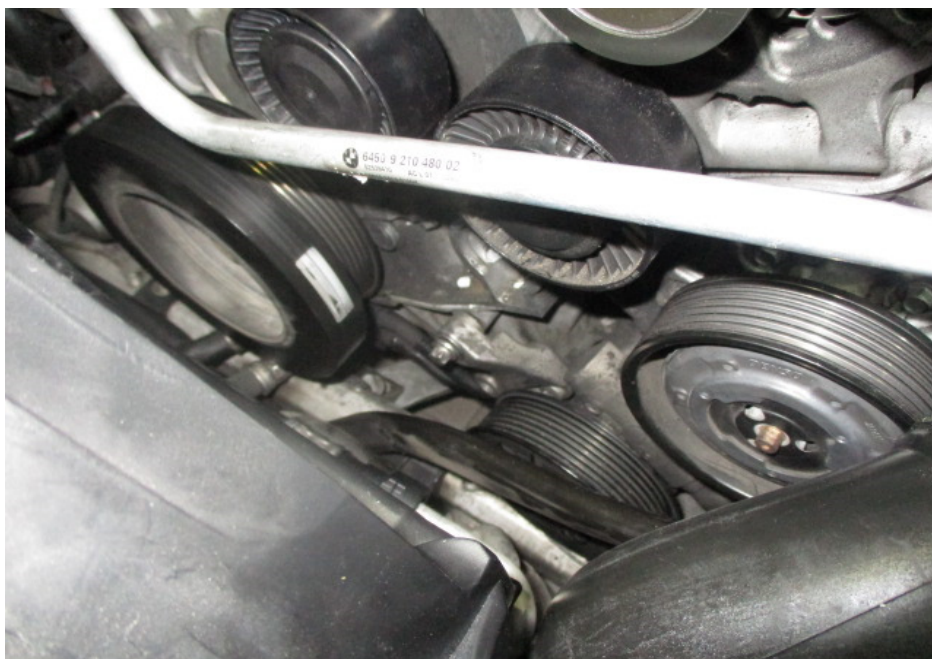
34. In this case, the gap/spacing indicates that the idler pulley, drive belt and power steering pump did not come into contact with the parts located directly at their front, for example the radiator fan cowling, aircon pipe and support brace. If there was any contact, I would expect the radiator fan cowling, aircon pipe and support brace to be damaged and/or bent inwards and/or possibly to be still in contact with the idler pulley, drive belt and/or power steering pump. Damage due to energy dissipation is also not possible as the flow path of the energy is broken by the gap/spacing. See photo 20 below.

Photo 20 shows no contact between the drive belt system of the Insured vehicle and the parts directly in front.

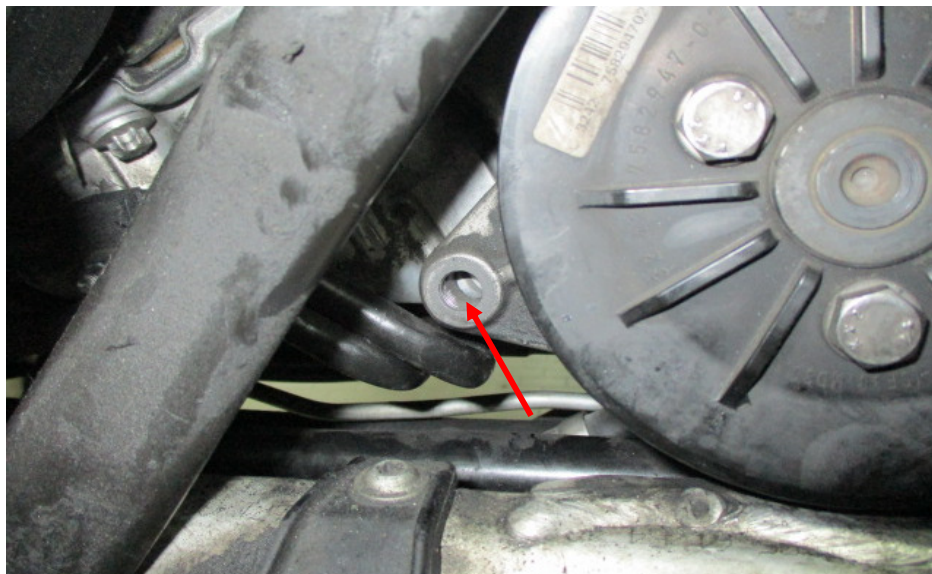
38. My observations of the bolt hole at the mounting point of the missing bolt appear to indicate the bolt was missing for a period of time. This was because the bolt hole was observed to be with dark dust accumulation. If the bolt was missing at or around the time of accident, I would expect the bolt hole to be clean or with slight light-coloured dust within the bolt hole. See photo 21 below.

Photo 21 shows the dark dust accumulation (arrowed) that was observed within the bolt hole at the mounting point of the bolt that was observed to be missing. The presence of dark dust accumulation indicates that the bolt has been missing for a period of time.
