Your Ref: S9M01G23
Our Ref : CS4/ASM20010979/N

5 April 2021

MECHANICAL INSPECTION REPORT OF MOTOR CAR SJQ 5827R

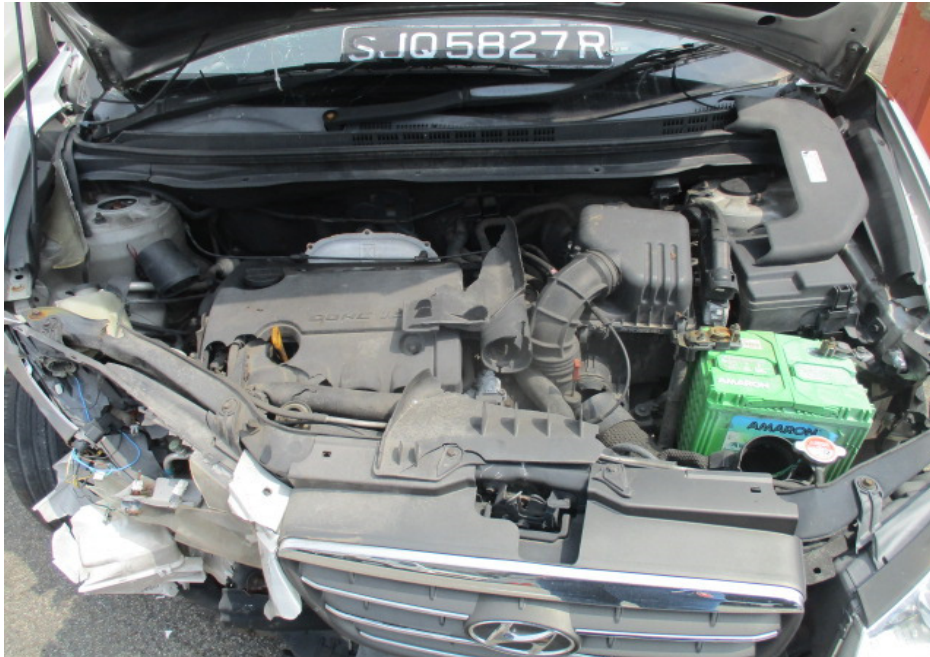
Photo 16 shows a general view of the Motor Car's engine compartment. The impact from the collision had affected the engine compartment of the Motor Car. Parts towards the front of the engine compartment were observed to be damaged.

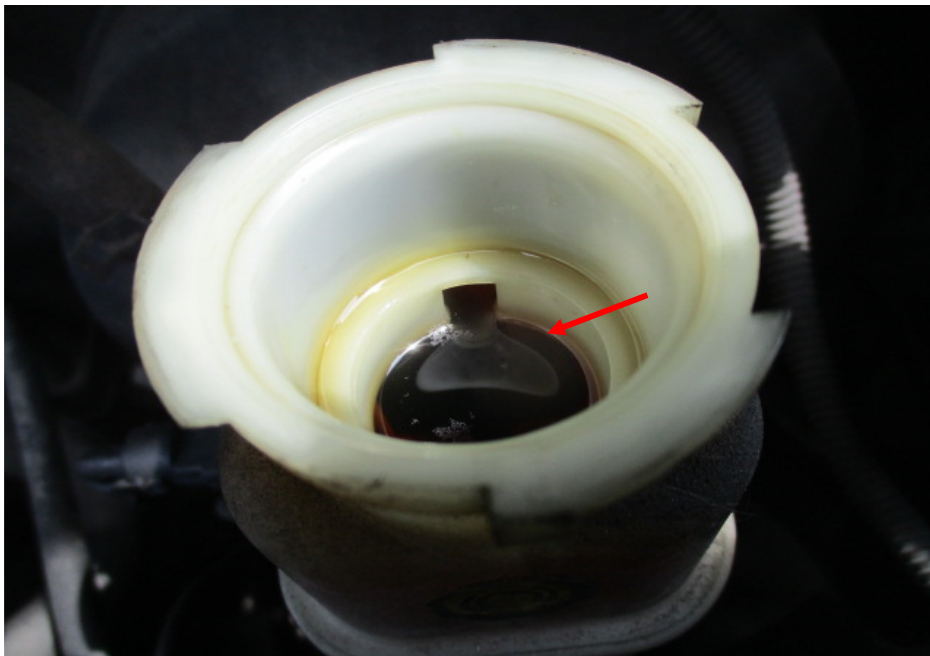
Photo 17 shows the brake fluid reservoir of the Motor Car at the time of our inspection. The brake fluid was observed to be of sufficient level for operational purposed (arrowed) and without any visible contamination.

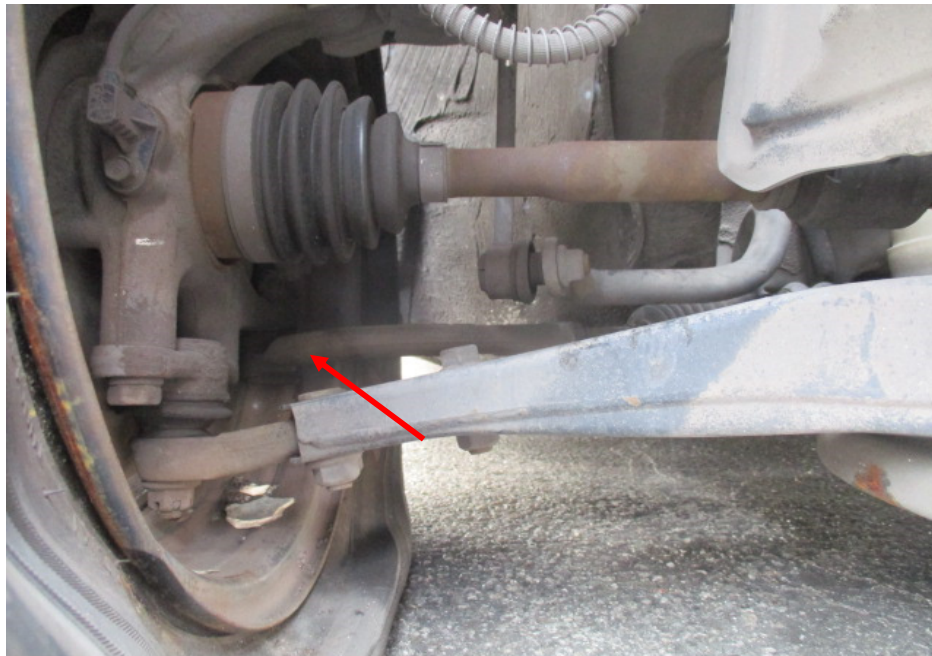
Photo 22 shows the undercarriage components at the front right wheel of the Motor Car. Our checks on the underside of the Motor Car revealed damage to the various undercarriage components. The steering rack and pinion, tie rods, tie rod ends and ball joints (arrowed) revealed that these components were all generally in good condition.

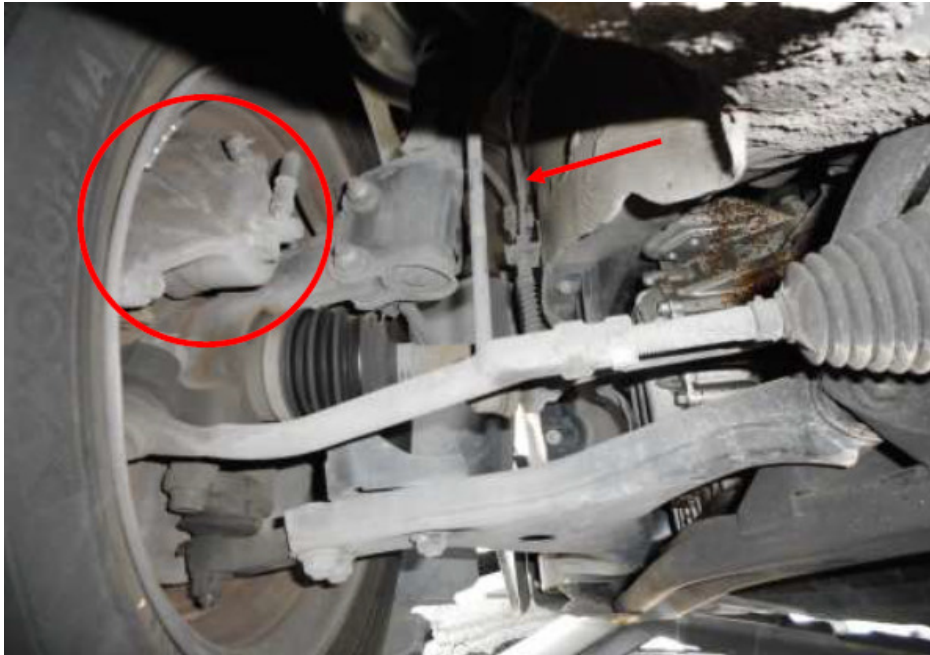
Photo 25 shows the brake hose (arrowed) at the front left wheel of the Motor Car. We did not observe any leakage of brake fluid at the 4 wheels of the Motor Car. Our visual inspection of the various mechanical components of the Motor Car's braking system, including its brake caliper (circled), revealed all to be intact and without visible damage.
