Your Ref: TP/IP/13095/2019  
Our Ref : CS/ASM20010979/N

5 April 2021

### **MECHANICAL INSPECTION REPORT OF MOTOR CAR SJQ 5827R**

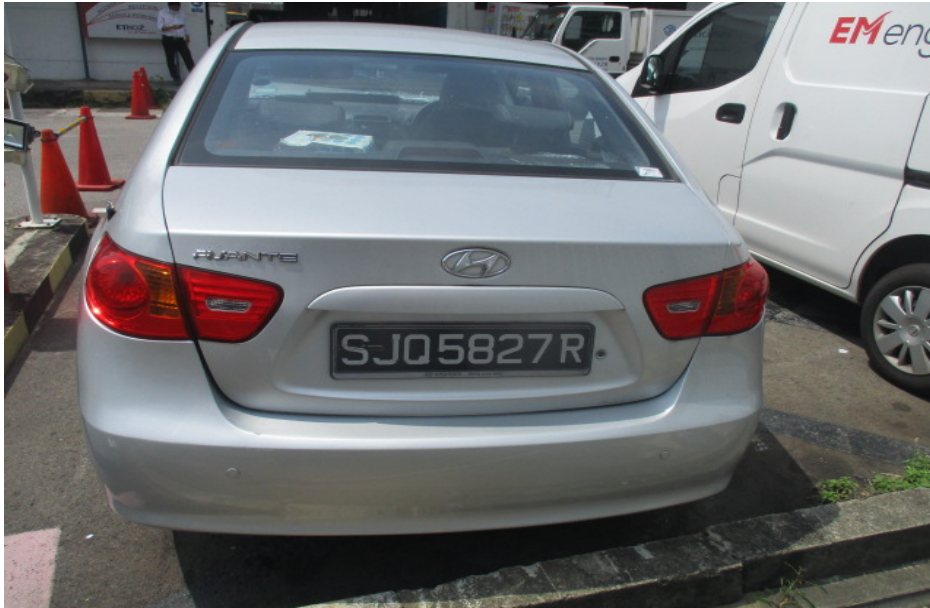
**Photo 1** shows a general view of the rear portion of the Motor Car at the time of our inspection. The rear portion of the Motor Car was observed to have been unaffected by the accident.

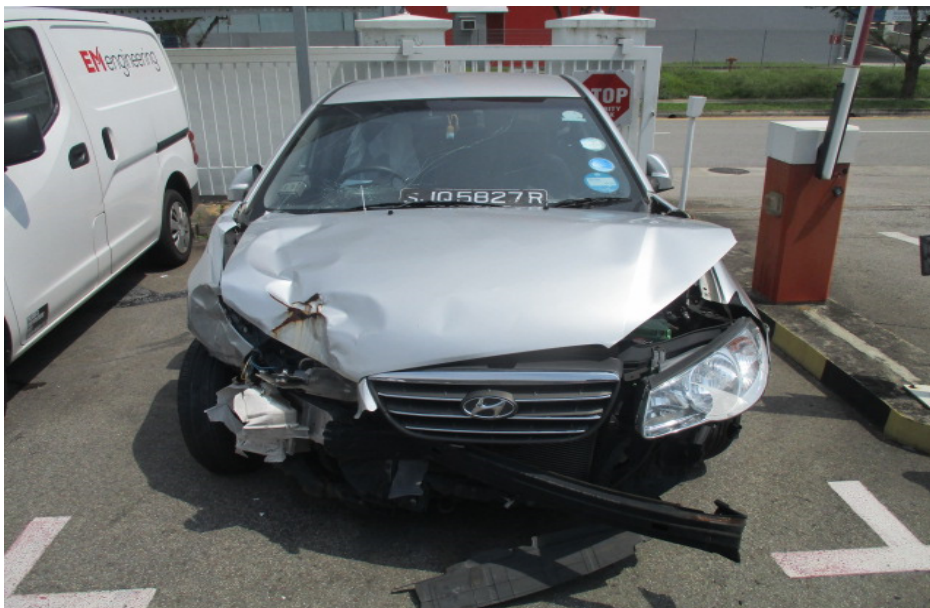
**Photo 2** shows a general view of the front portion of the Motor Car at the time of our inspection. The Motor Car was also observed to have sustained extensive impact damage at its frontal and undercarriage portion.

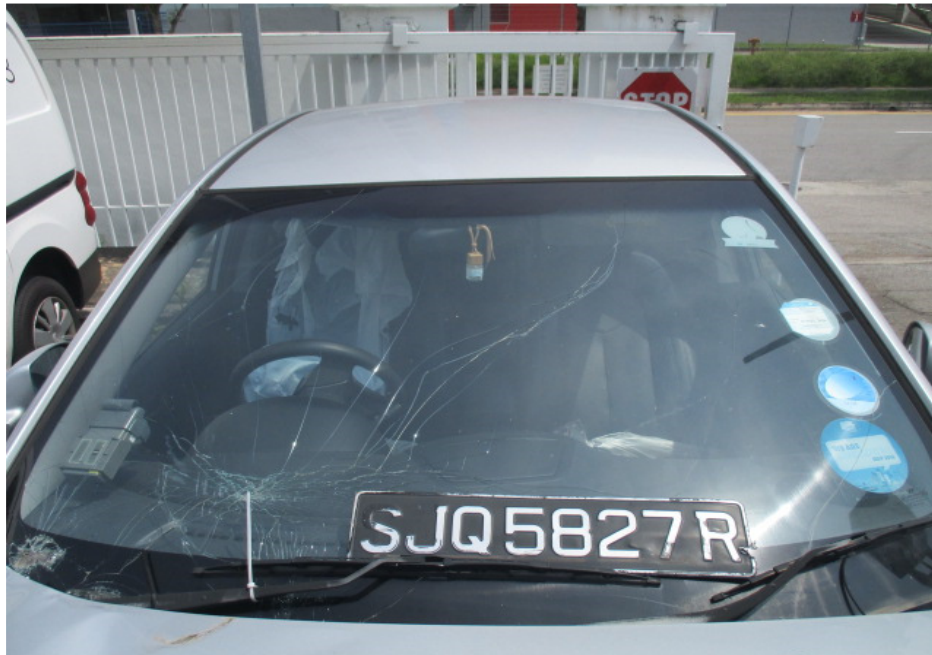
**Photo 3** shows a close up view of the front windscreen of the Motor Car at the time of our inspection. The front windscreen of the Motor Car was observed to have been damaged as a result of the accident.

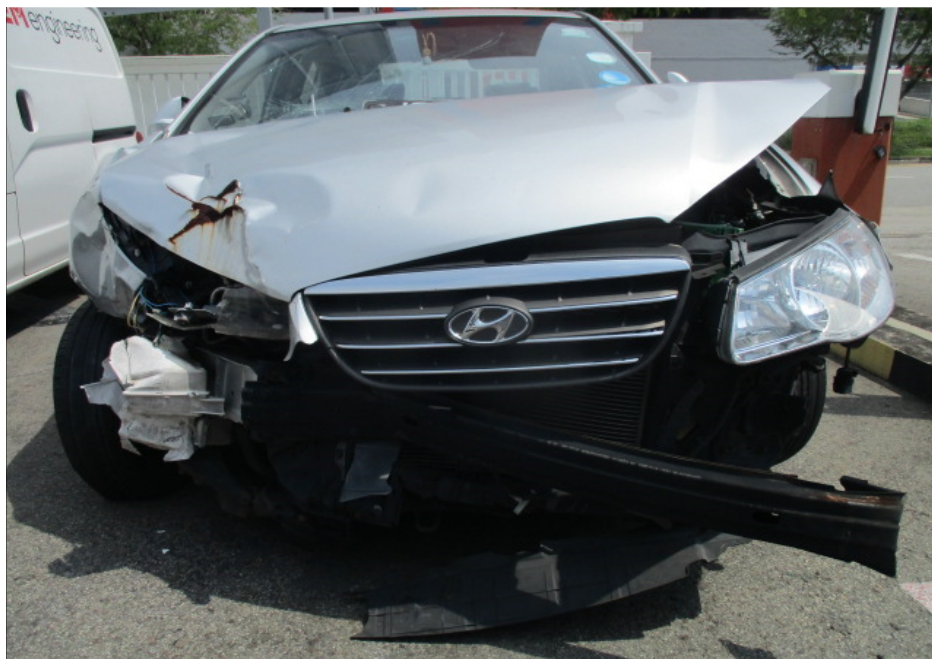
**Photo 4** shows a general view of the front right portion of the Motor Car at the time of our inspection. The Motor Car was also observed to have sustained extensive impact damage at its frontal portal, damaged parts had included its front bonnet, front bumper, right fender, engine system, radiator and front right headlamp were amongst the body parts that were observed to have been damaged as a result of the accident.

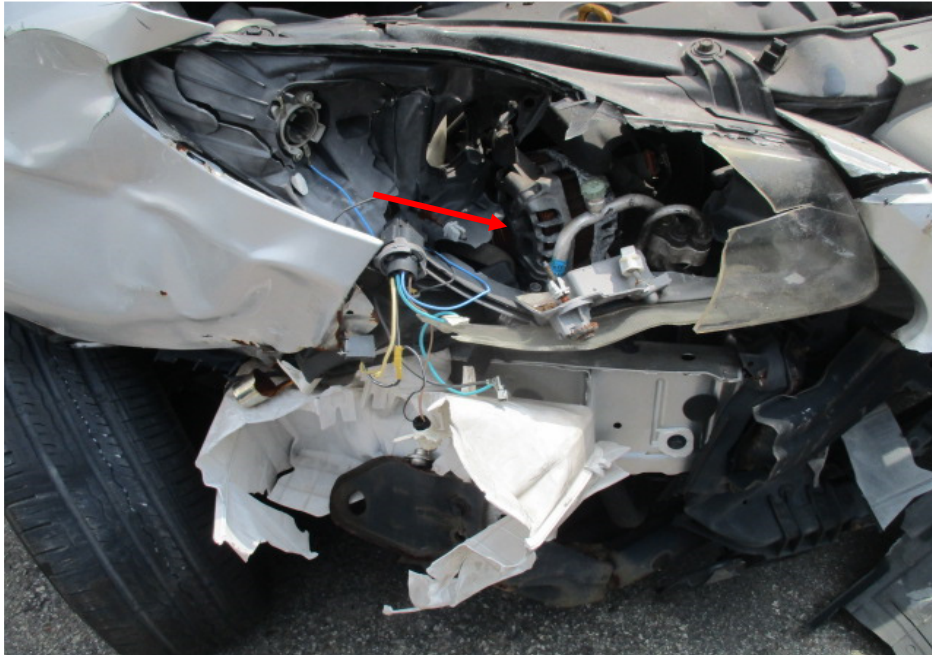
**Photo 5** shows a close up view of the front portion of the Motor Car at the time of our inspection. The engine system (arrowed) of the Motor Car was observed to have been damaged as a result of the accident.

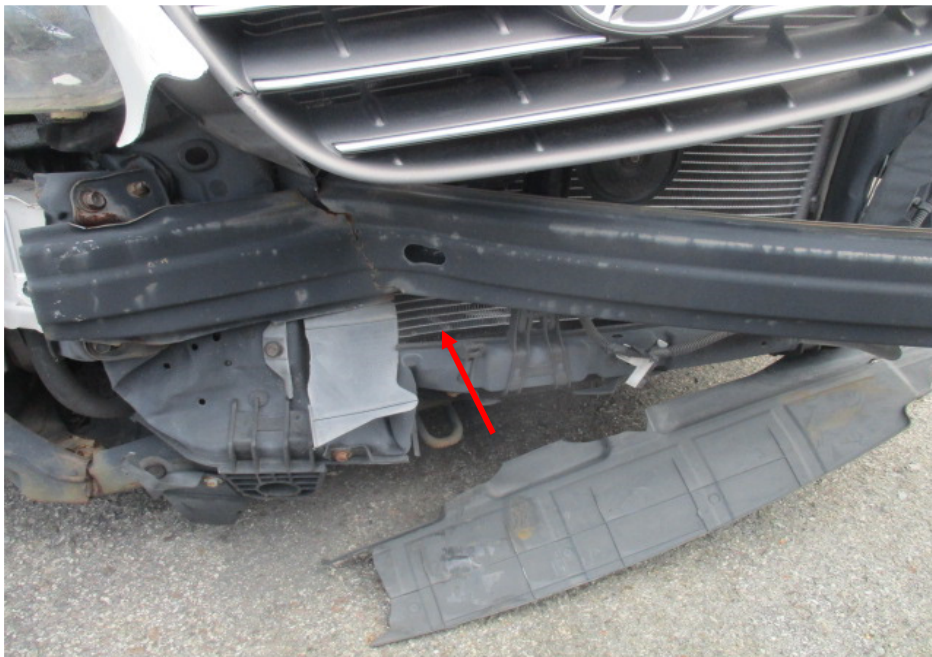
**Photo 6** shows a close up view of the front portion of the Motor Car at the time of our inspection. The radiator of the Motor Car was observed to have been damaged by an induced impact as a result of the accident (arrowed).

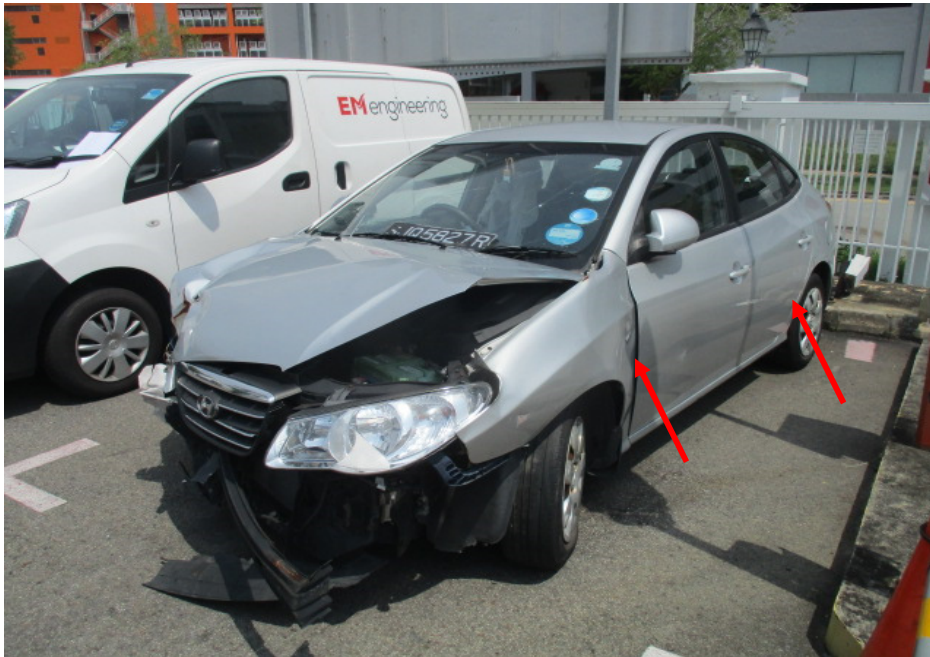
**Photo 7** shows a general view of the front left portion of the Motor Car at the time of our inspection. The front left fender and the rear left body panel (arrowed) of the Motor Car was observed to have been damaged as a result of the accident.

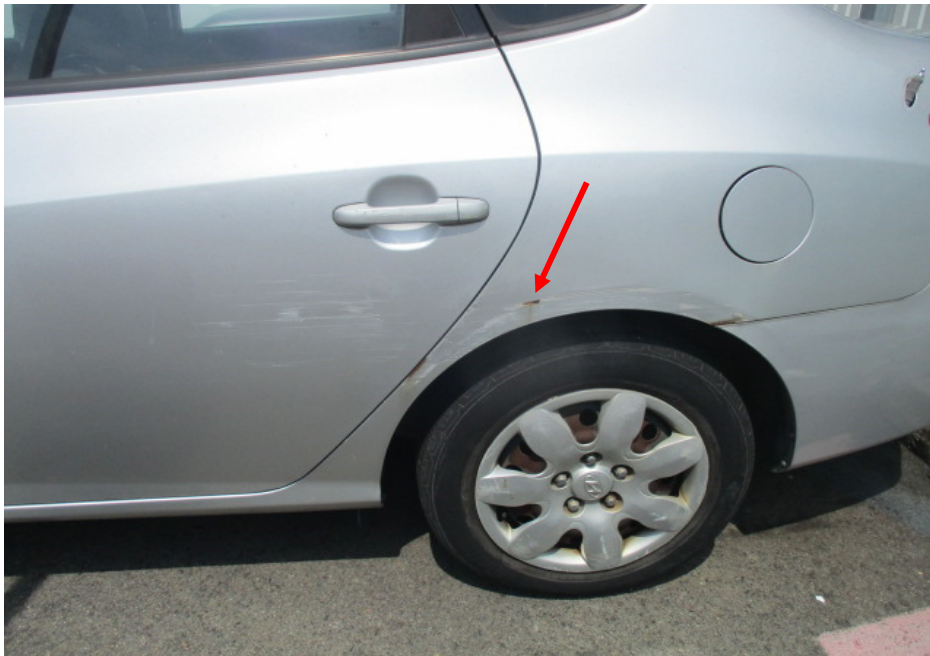
**Photo 8** shows the close up view of the rear left panel portion of the Motor Car at the time of our inspection. The left rear body panel (arrowed) of the Motor Car was observed to have been damaged as a result of the accident.

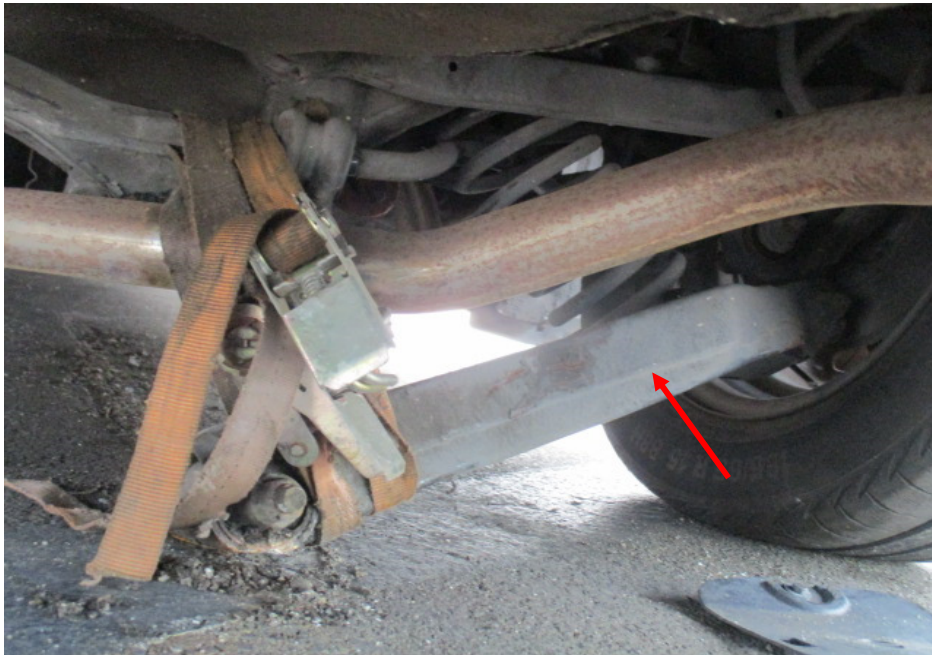
**Photo 9** shows the close up view of the rear right suspension system of the Motor Car at the time of our inspection. The rear right lower arm (arrowed) of the Motor Car was observed to have been damaged as a result of the accident.

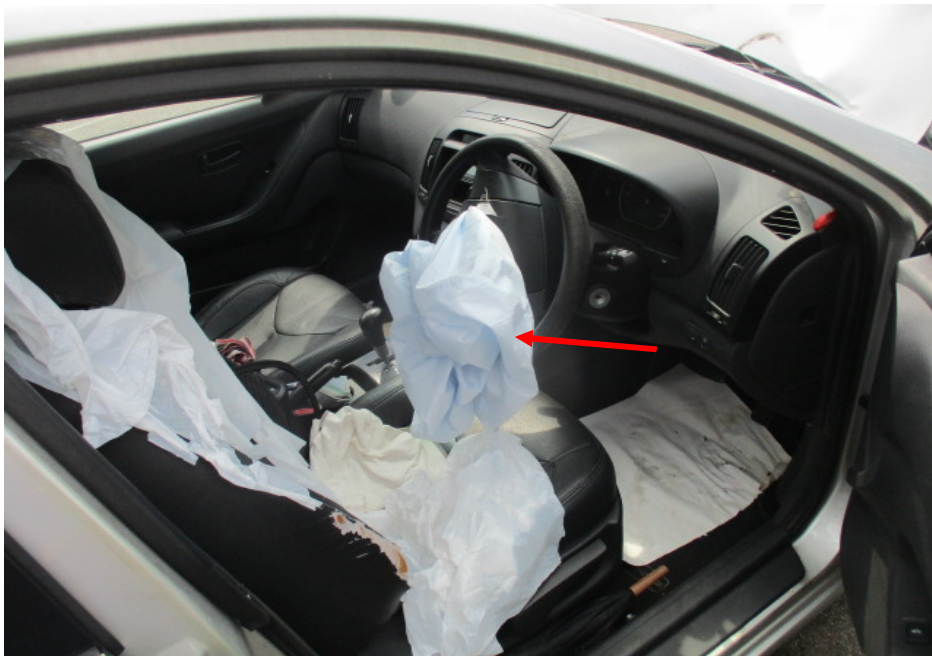
**Photo 10** shows a general view of the Motor Car's interior compartment. The driver's air bag was also deployed as a result of the accident (arrowed).

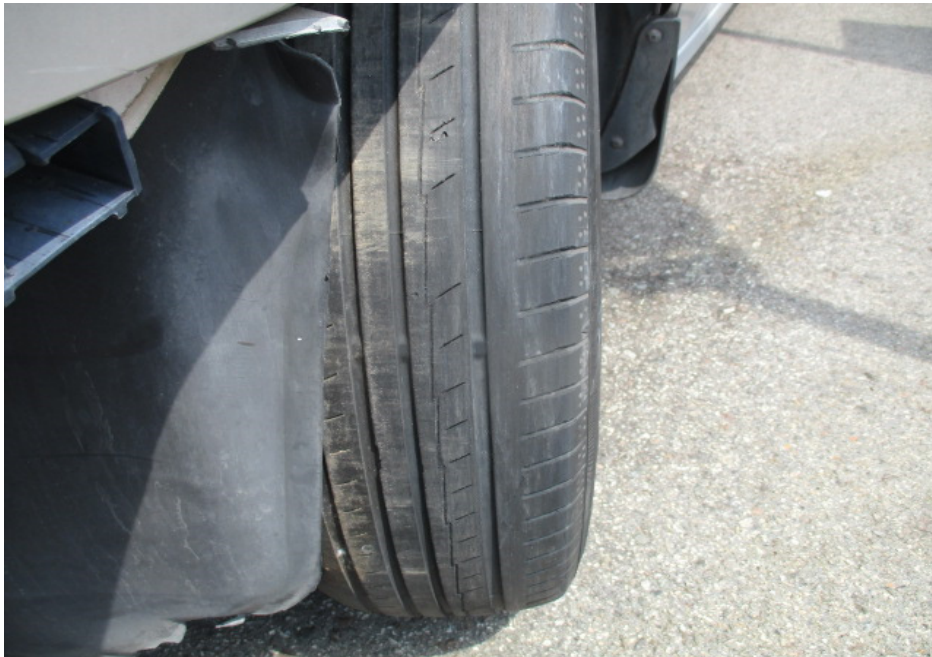
**Photo 11** shows the condition of the front left tyre of the Motor Car, which was observed to be in serviceable condition with remaining tread depth of approximately 4mm. There was no tear, cut or burst mark(s) on the outer and the inner sidewalls as well as across the tread of this tyre.

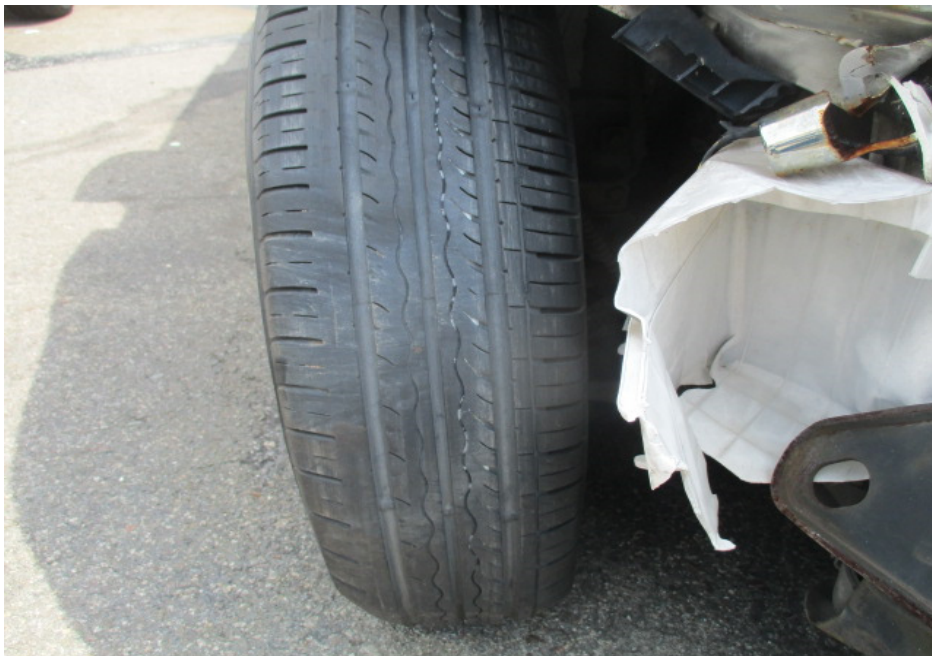
**Photo 12** shows the condition of the front right tyre of the Motor Car, which was observed to be in serviceable condition with remaining tread depth of approximately 4mm. The tyre, which was wrapped around standard alloy wheel rim, was also observed to be deflated as a result of the accident.

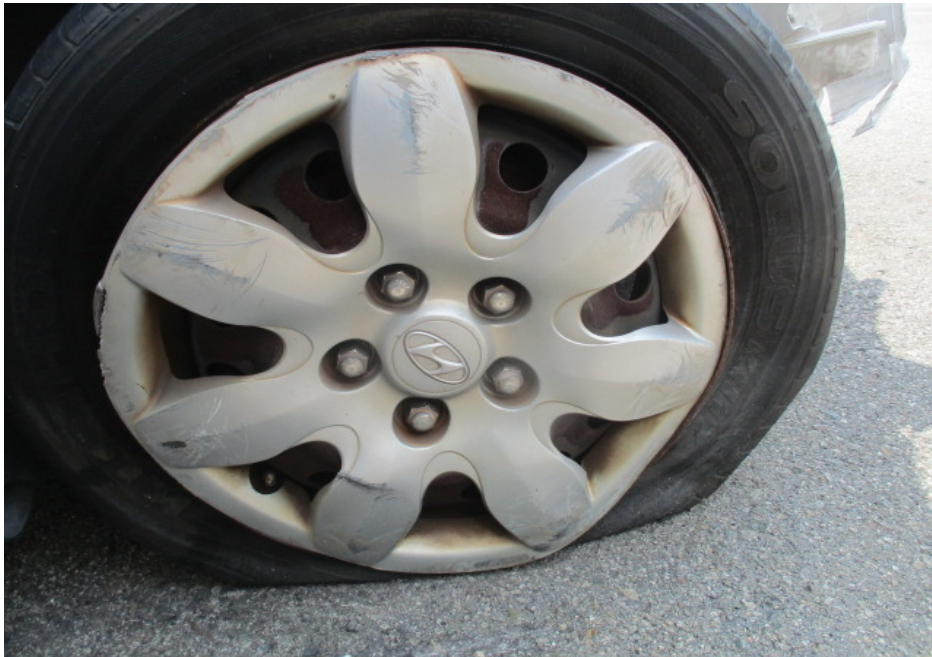
**Photo 13** shows the condition of the front right wheel rim of the Motor Car, The right front tyre was observed to sustained damage, dislodged from the rim and deflated as a result of the accident.

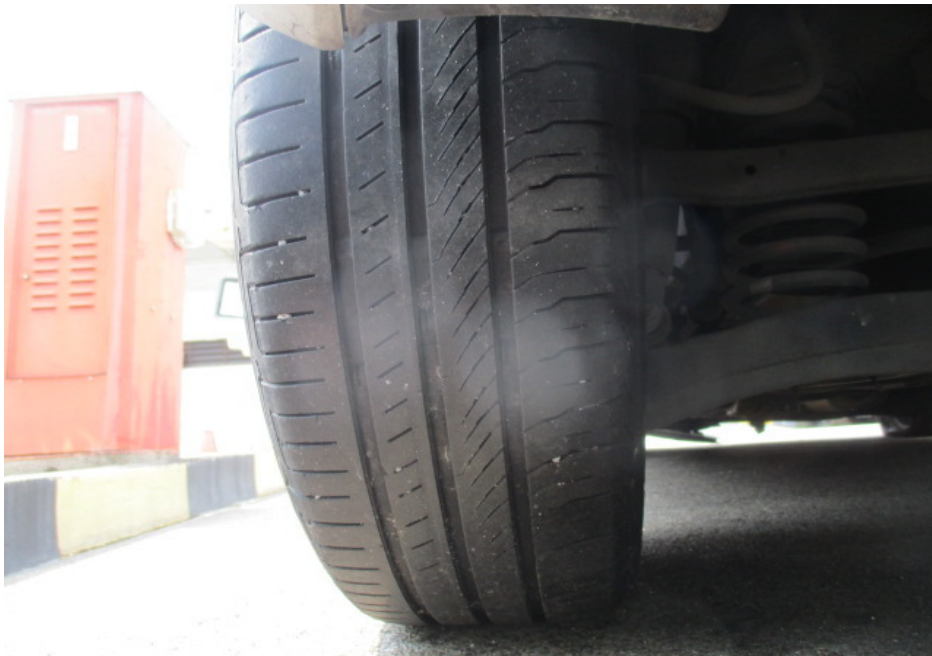
**Photo 14** shows the condition of the rear left tyre of the Motor Car, which was observed to be in serviceable condition with remaining tread depth of approximately 5mm. There was no tear, cut or burst mark(s) on the outer and the inner sidewalls as well as across the tread of this tyre.

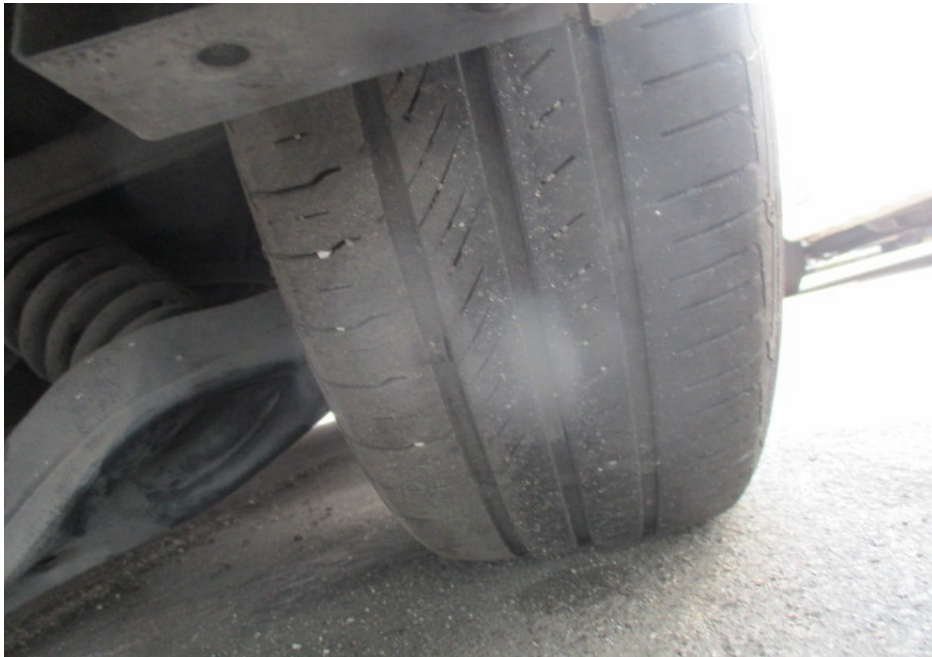
**Photo 15** shows the condition of the rear right tyre of the Motor Car, which were observed to be in serviceable condition with remaining tread depth of approximately 7mm. There was also no tear, cut or burst mark(s) on the outer and the inner sidewalls as well as across the tread of the 4 tyres that were fitted on the Motor Car.

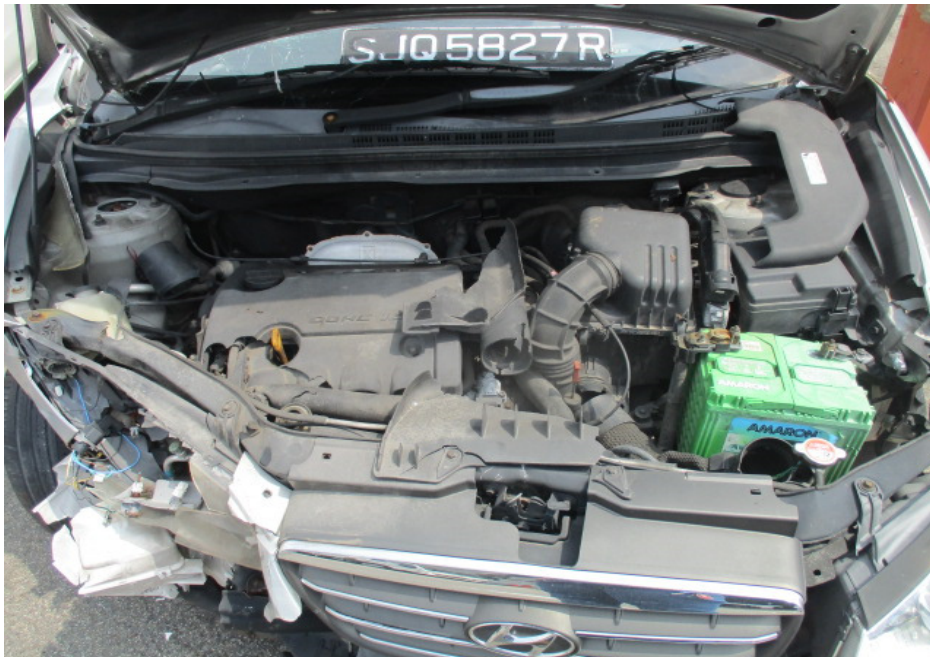
**Photo 16** shows a general view of the Motor Car's engine compartment. The impact from the collision had affected the engine compartment of the Motor Car. Parts towards the front of the engine compartment were observed to be damaged.

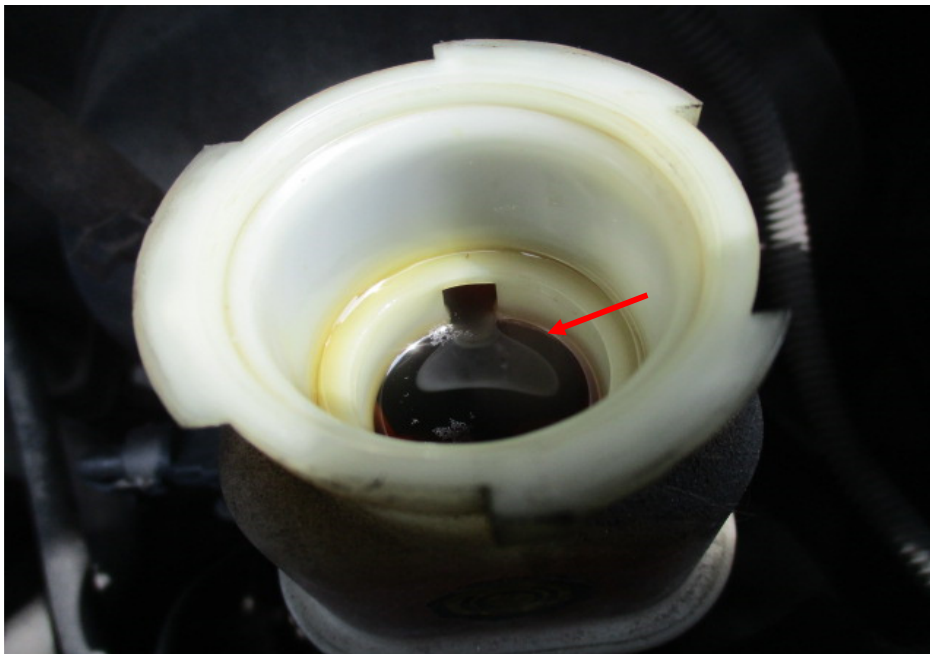
**Photo 17** shows the brake fluid reservoir of the Motor Car at the time of our inspection. The brake fluid was observed to be of sufficient level for operational purposed (arrowed) and without any visible contamination.

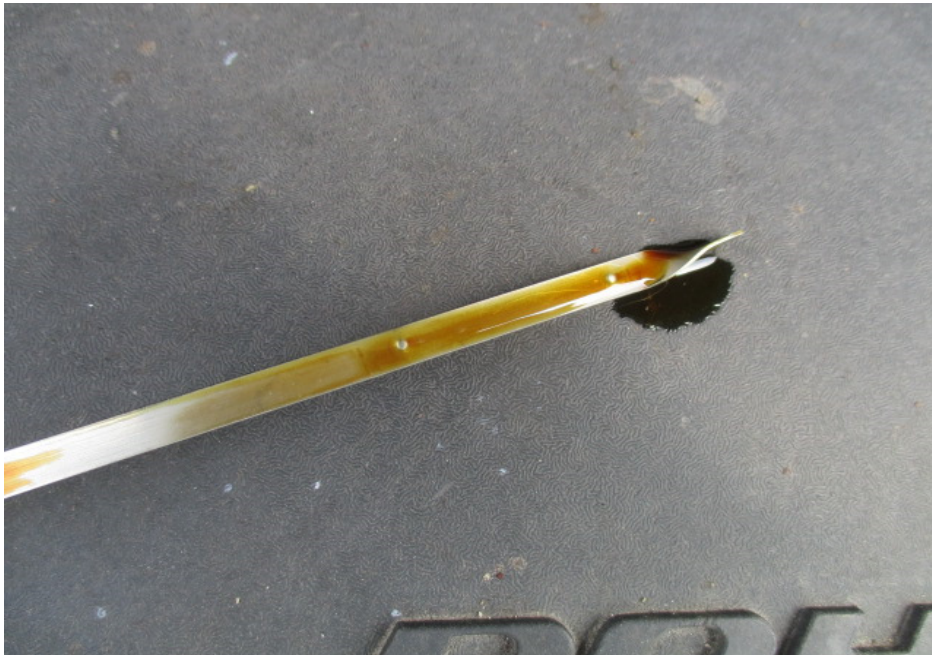
**Photo 18** shows the engine oil dip stick of the Motor Car at the time of our inspection. The engine oil was observed to be of sufficient level for operational purposes and without any visible contamination.

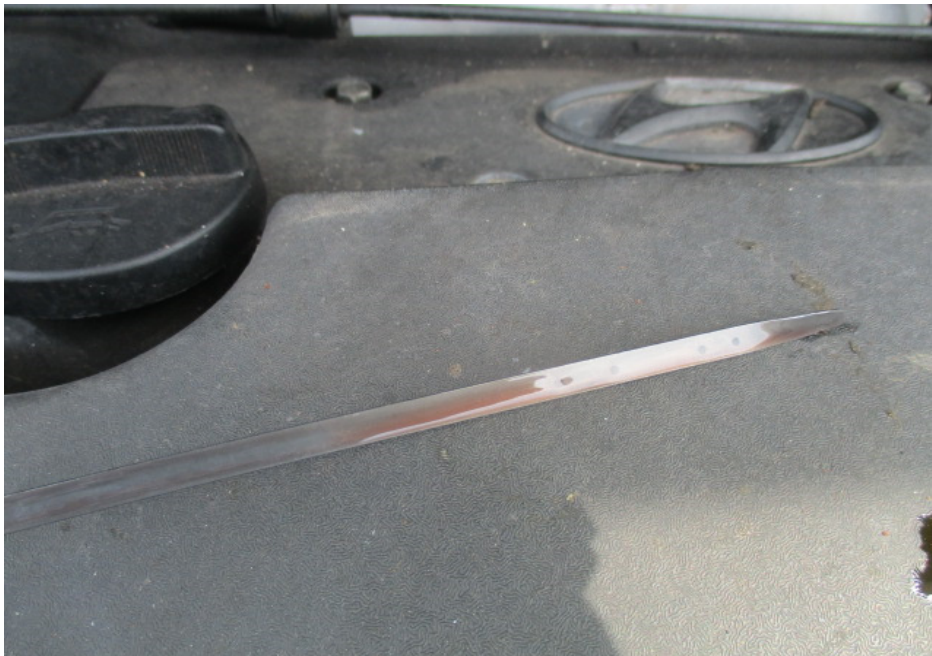
**Photo 19** shows the ATF dip stick of the Motor Car at the time of our inspection. The ATF was observed to be of sufficient level for operational purposes and without any visible contamination.

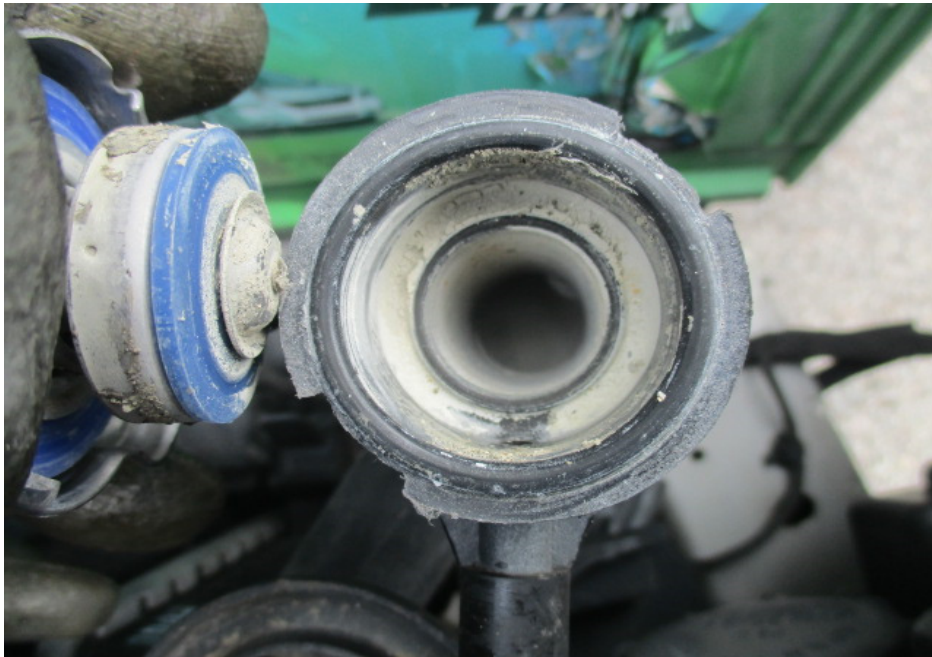
**Photo 20** shows the radiator of the Motor Car at the time of our inspection. The radiator was observed to be empty most likely due to damages sustained as a result of the accident.

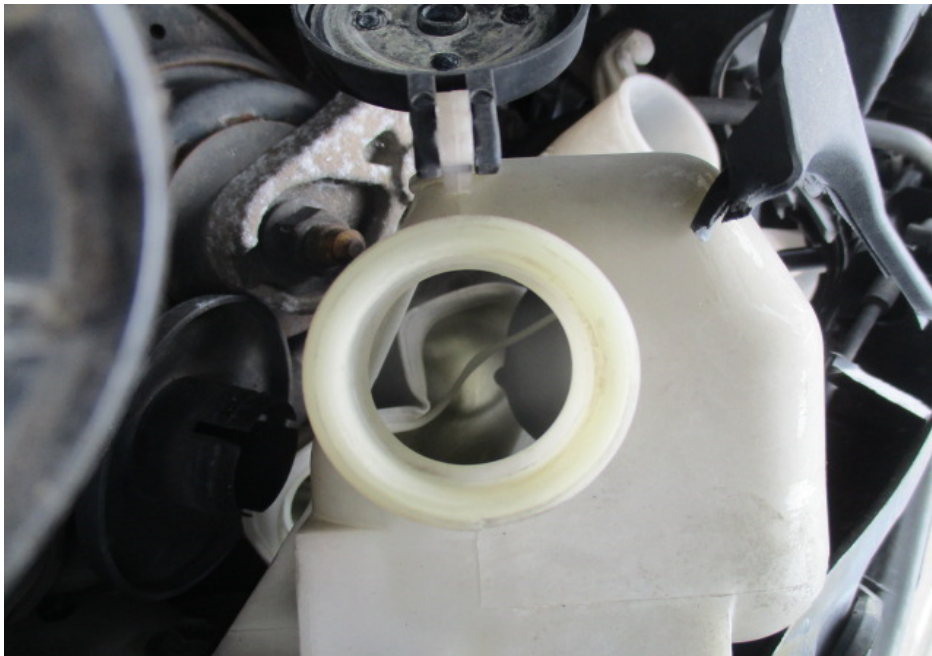
**Photo 21** shows checks being carried out to the engine coolant of the Motor Car at the time of our inspection. The reserve engine coolant reservoir was observed to be cracked due to damages sustained as a result of the accident.

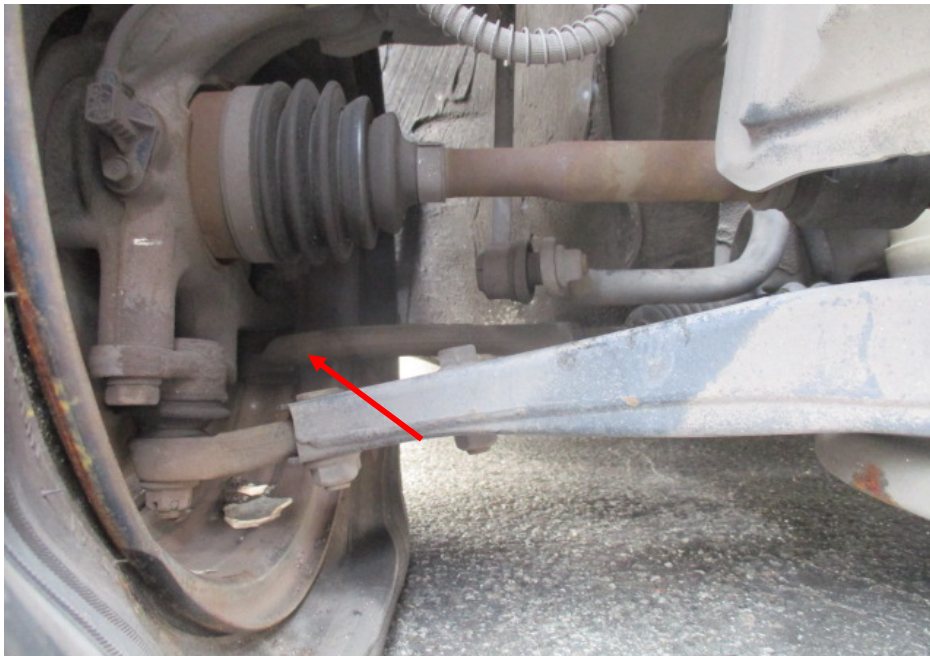
**Photo 22** shows the undercarriage components at the front right wheel of the Motor Car. Our checks on the underside of the Motor Car revealed damage to the various undercarriage components. The steering rack and pinion, tie rods, tie rod ends and ball joints (arrowed) revealed that these components were all generally in good condition.

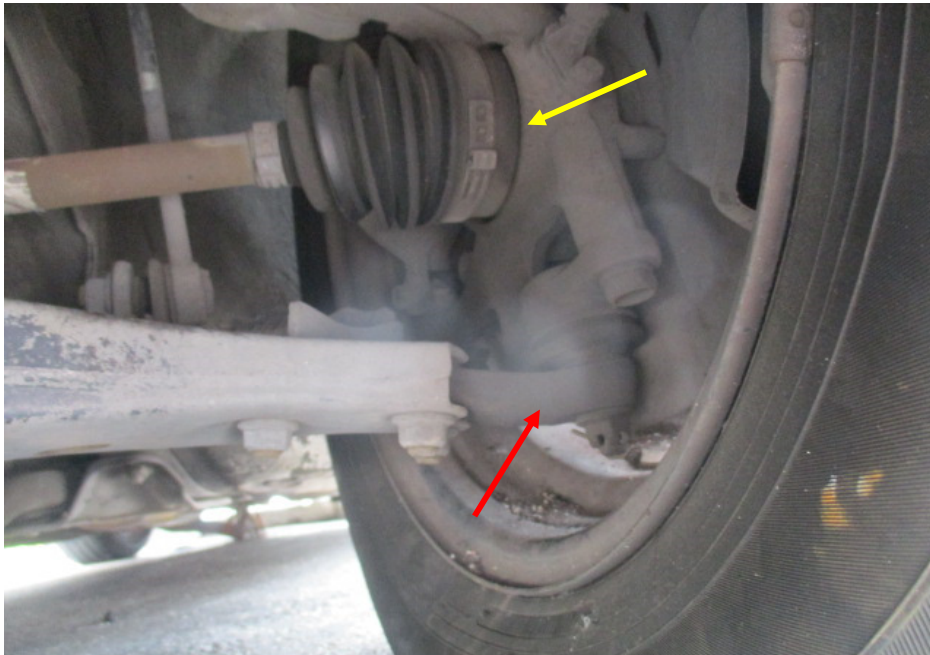
**Photo 23** shows the various undercarriage components at the front left wheel of the Motor Car, which had included the steering tie rod (red arrow) and front left drive shaft (yellow arrow). The various undercarriage components of the Motor Car were all found to be intact without any visible damage.

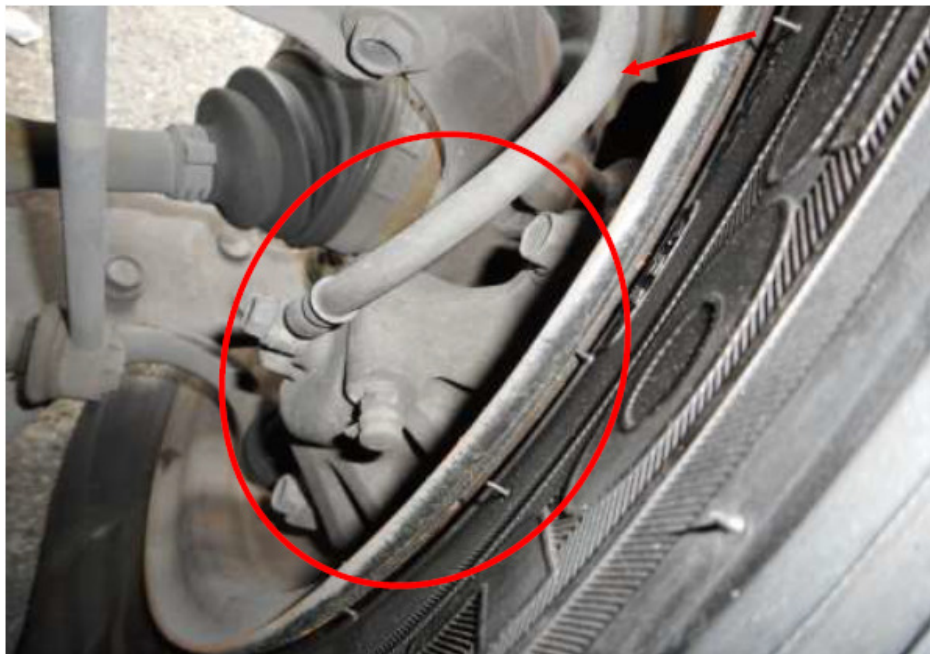
**Photo 25** shows the brake hose (arrowed) at the front left wheel of the Motor Car. We did not observe any leakage of brake fluid at the 4 wheels of the Motor Car. Our visual inspection of the various mechanical components of the Motor Car's braking system, including its brake caliper (circled), revealed all to be intact and without visible damage.

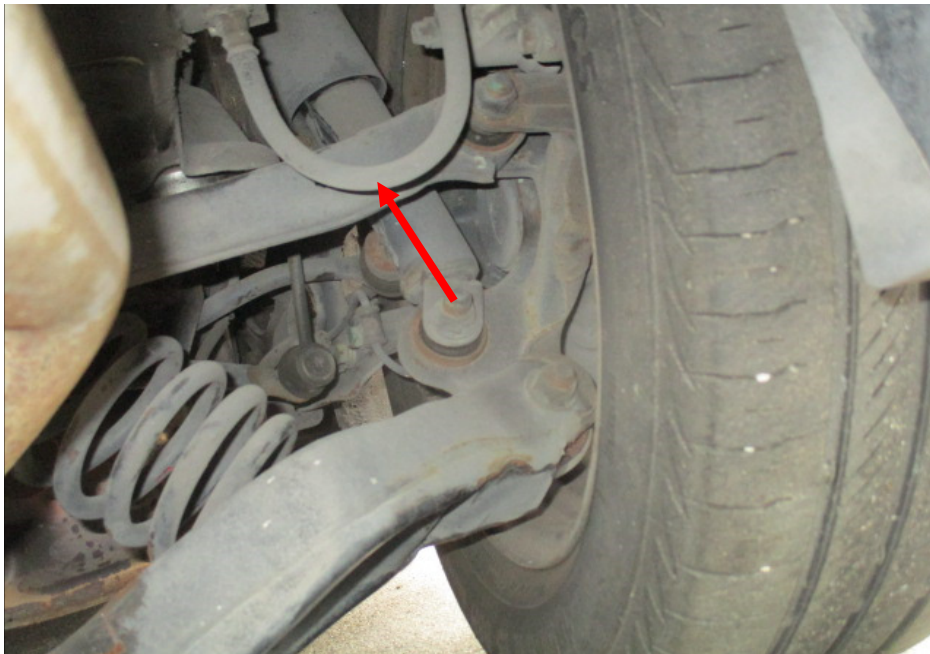
**Photo 26** shows the various undercarriage components at the rear right wheel of the Motor Car, in particular the brake hose (arrowed). We did not observe any leakage of brake fluid at the 4 wheels of the Motor Car. Our visual inspection of the various mechanical components of the Motor Car's braking system revealed all to be intact and without visible damage.

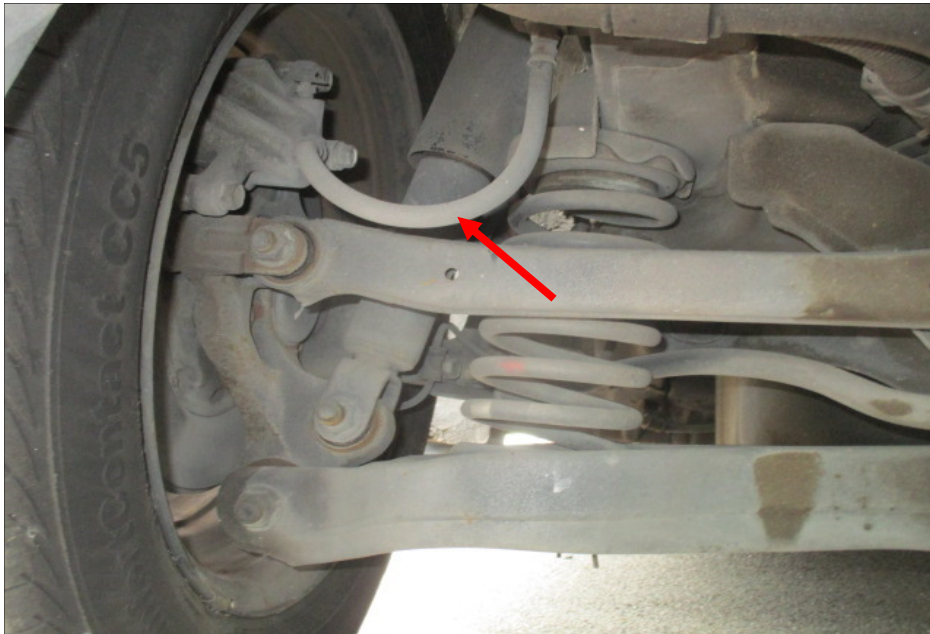
**Photo 27** shows the various undercarriage components at the rear left wheel of the Motor Car, in particular the brake hose (arrowed). We did not observe any leakage of brake fluid at the 4 wheels of the Motor Car. Our visual inspection of the various mechanical components of the Motor Car's braking system revealed all to be intact and without visible damage.
