Your Ref: TP/IP/23759/2020  
Our Ref : CI/TPD20011019/P

15<sup>th</sup> December 2020

### **MECHANICAL INSPECTION REPORT OF MOTOR LORRY YQ 1397M**

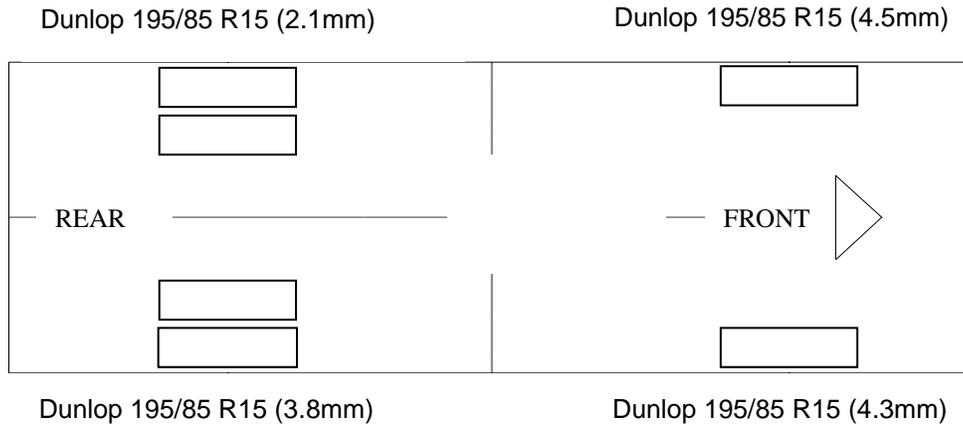
6. The 6 tyres of the Motor Lorry were observed to be in serviceable condition and sufficiently inflated for vehicular operation. I did not find any tear, cut or burst mark(s) on the outer and the inner sidewalls as well as across the tread of the 6 tyres. The tyre brand, tyre size and remaining tread depth of the 6 tyres of the Motor Lorry were recorded as follows:-

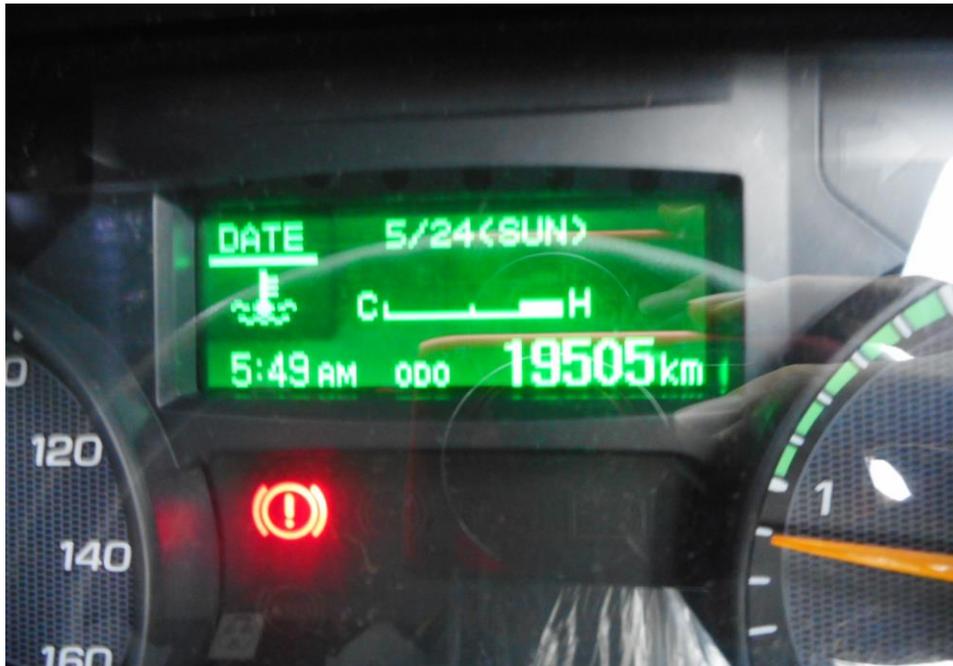
**Photo 1** shows a general view of the instrument cluster of the Motor Lorry at the time of my inspection. The mileage of the Motor Lorry was 19,505km

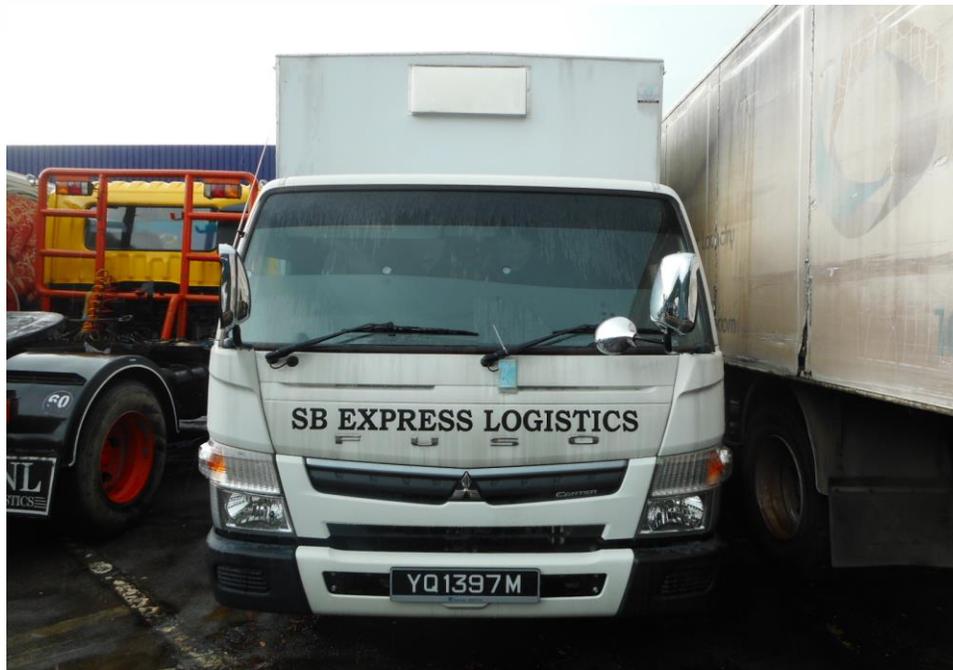
**Photo 2** shows a general view of the Motor Lorry at the time of my inspection. The Motor Lorry was observed to be intact and unaffected by the accident.

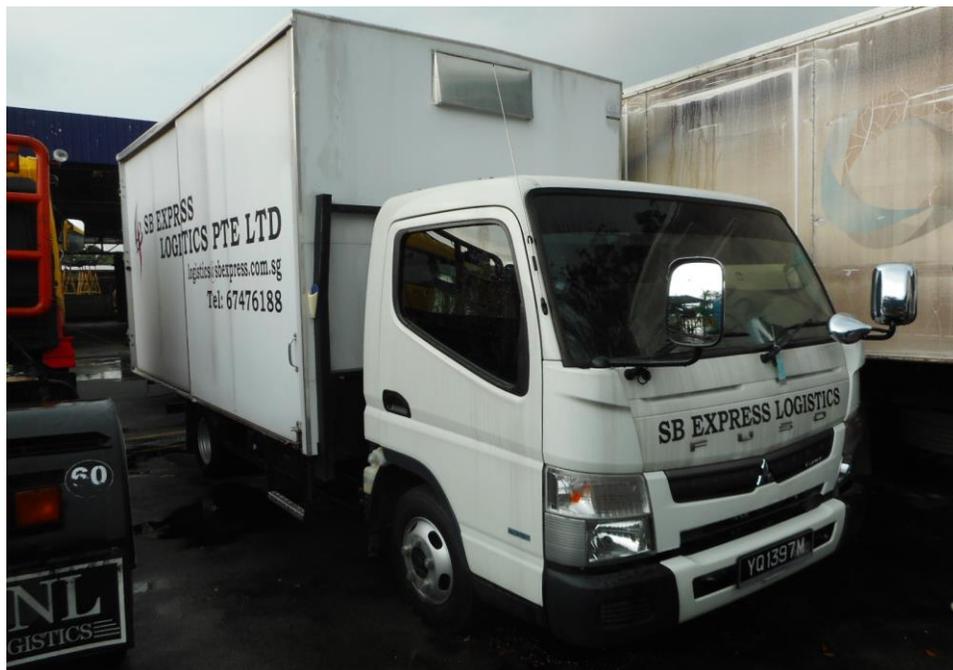
**Photo 3** shows a general view of the right body of the Motor Lorry at the time of my inspection. The Motor Lorry was observed to be intact and unaffected by the accident.

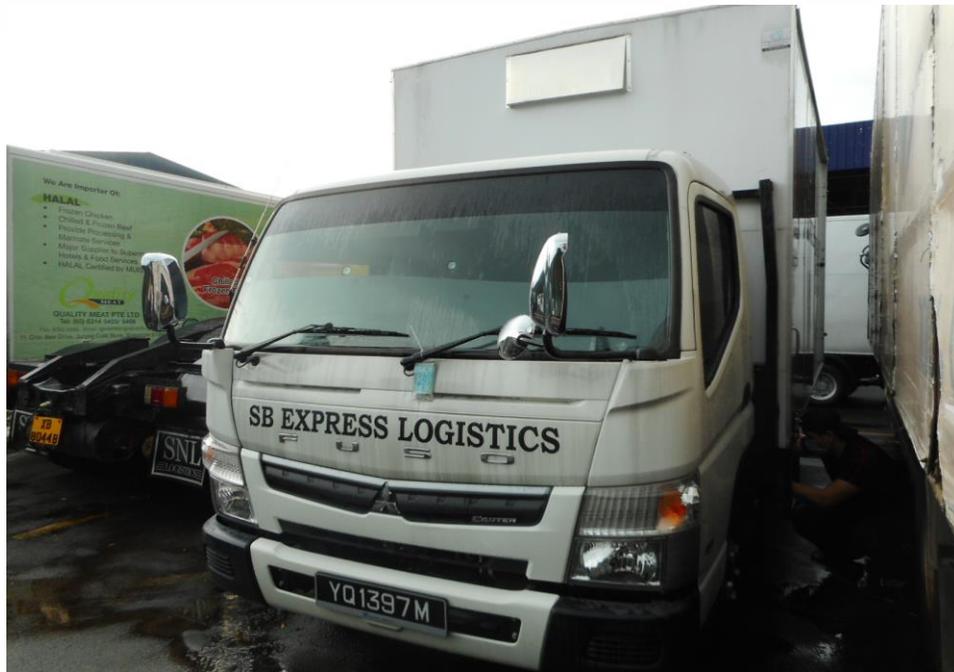
**Photo 4** shows a general view of the left body of the Motor Lorry at the time of my inspection. The Motor Lorry was observed to be intact and unaffected by the accident.

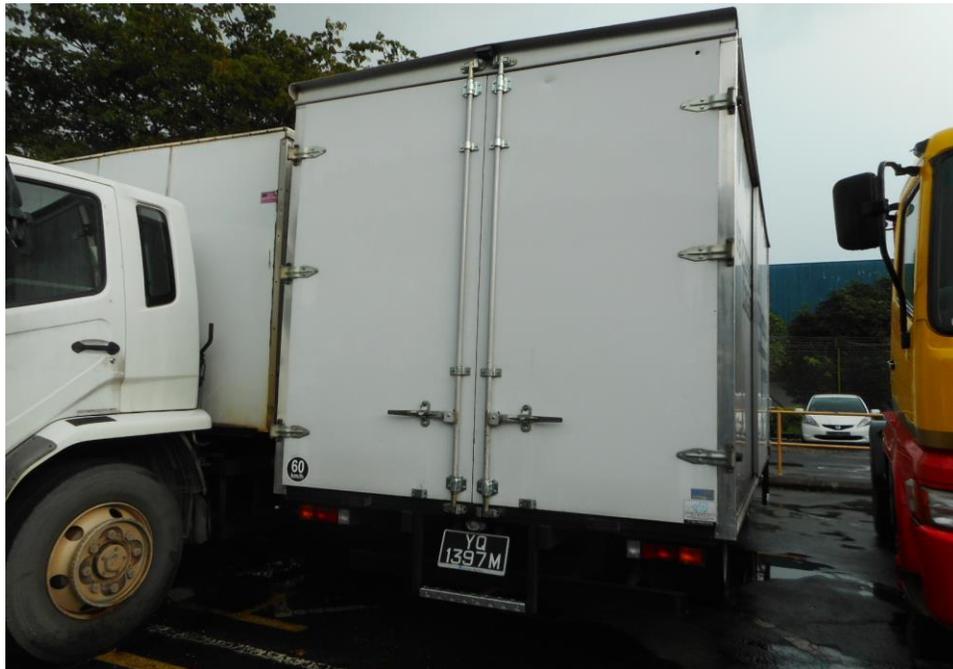
**Photo 5** shows a general view of the rear body of the Motor Lorry at the time of my inspection. The Motor Lorry was observed to be intact and unaffected by the accident.

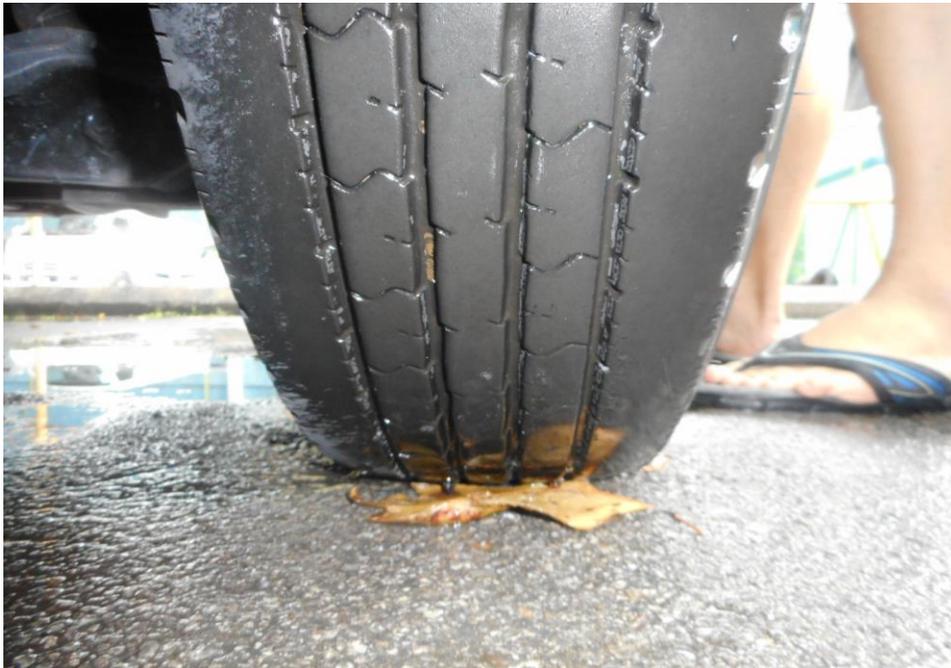
**Photo 6** shows the condition of the front right tyre of the Motor Lorry, which was observed to be in serviceable condition with remaining tread depth of approximately 4.3mm. The tyre, which was wrapped around standard alloy wheel rim, was also observed to be sufficiently inflated for vehicular operation. There was no tear, cut or burst mark(s) on the outer and the inner sidewalls as well as across the tread of the 4 tyres that were fitted on the Motor Lorry.

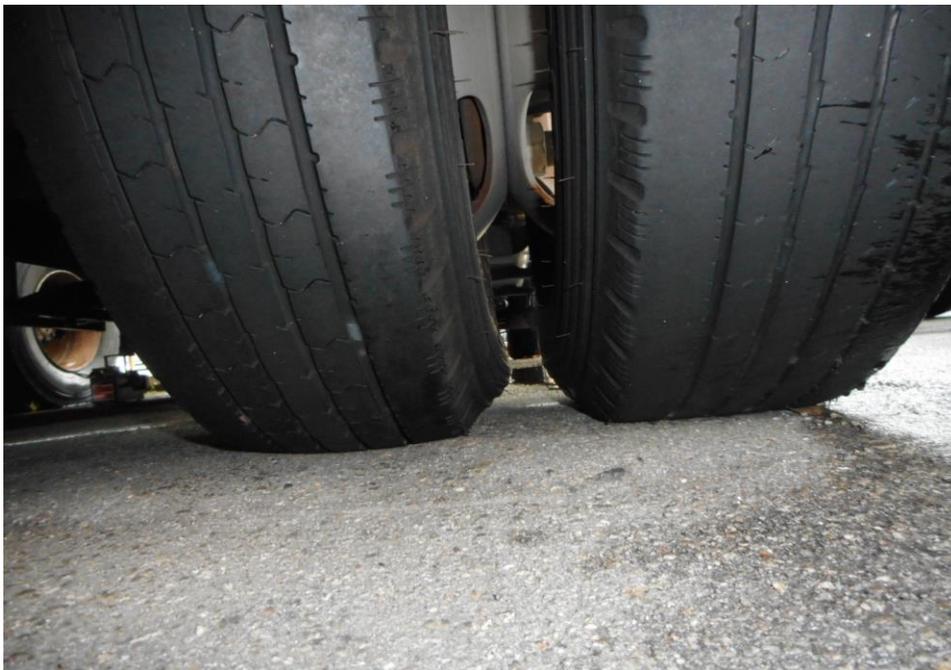
**Photo 7** shows the condition of the rear right tyre of the Motor Lorry, which was observed to be in serviceable condition with remaining tread depth of approximately 3.8mm. The tyre, which was wrapped around standard alloy wheel rim, was also observed to be sufficiently inflated for vehicular operation.

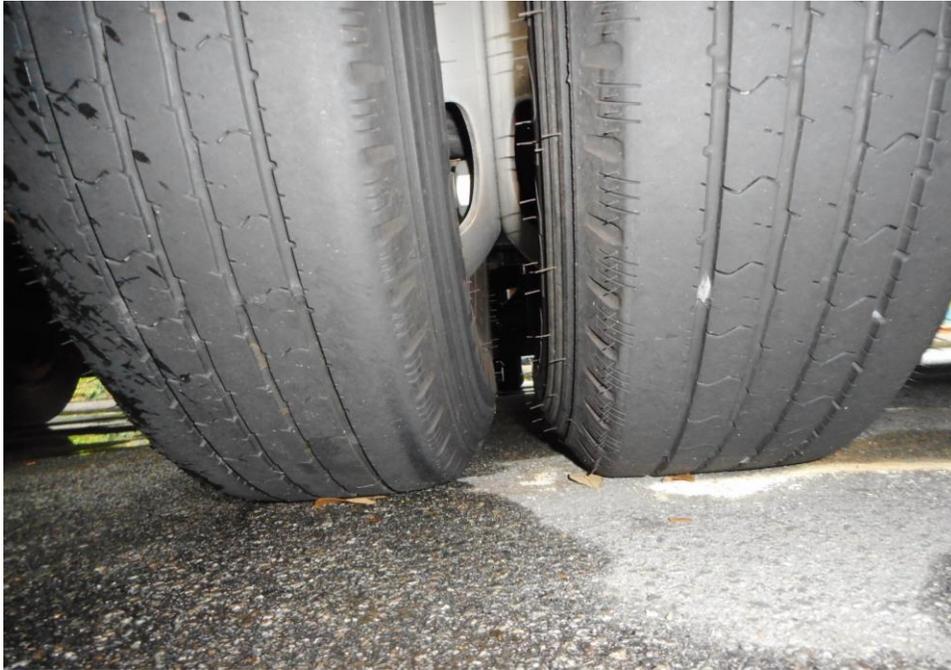
**Photo 8** shows the condition of the rear left tyres of the Motor Lorry, which was observed to be in serviceable condition with remaining tread depth of approximately 2.1mm. The tyres, which were wrapped around standard alloy wheel rim, were also observed to be sufficiently inflated for vehicular operation. There was also no damage found on all 4 alloy wheel rims of the Motor Lorry.

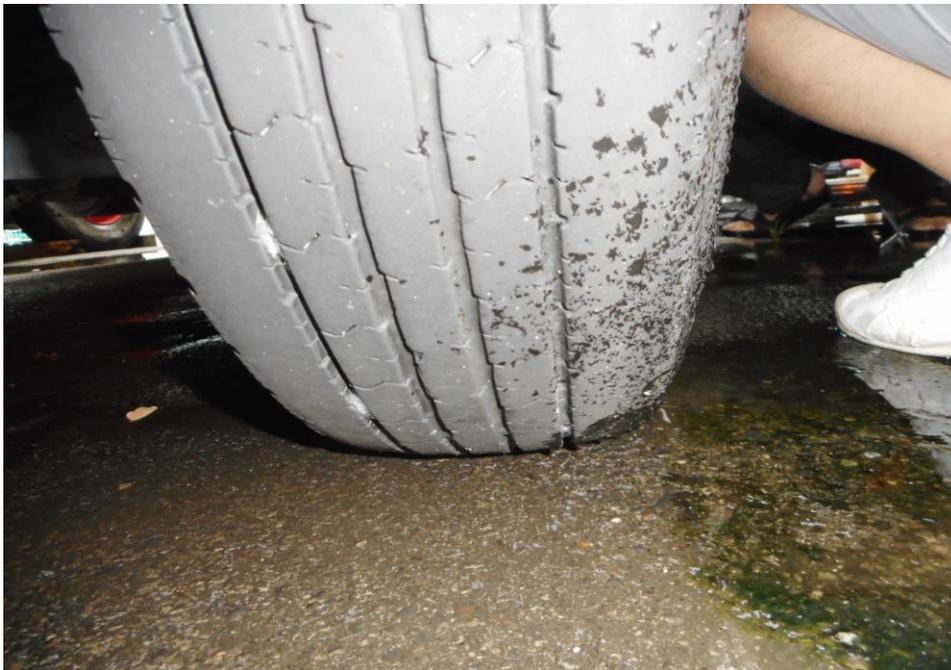
**Photo 9** shows the condition of the rear right tyres of the Motor Lorry, which were observed to be in serviceable condition with remaining, tread depth of approximately 4.5mm. There was also no tear, cut or burst mark(s) on the outer and the inner sidewalls as well as across the tread of the 4 tyres that were fitted on the Motor Lorry.

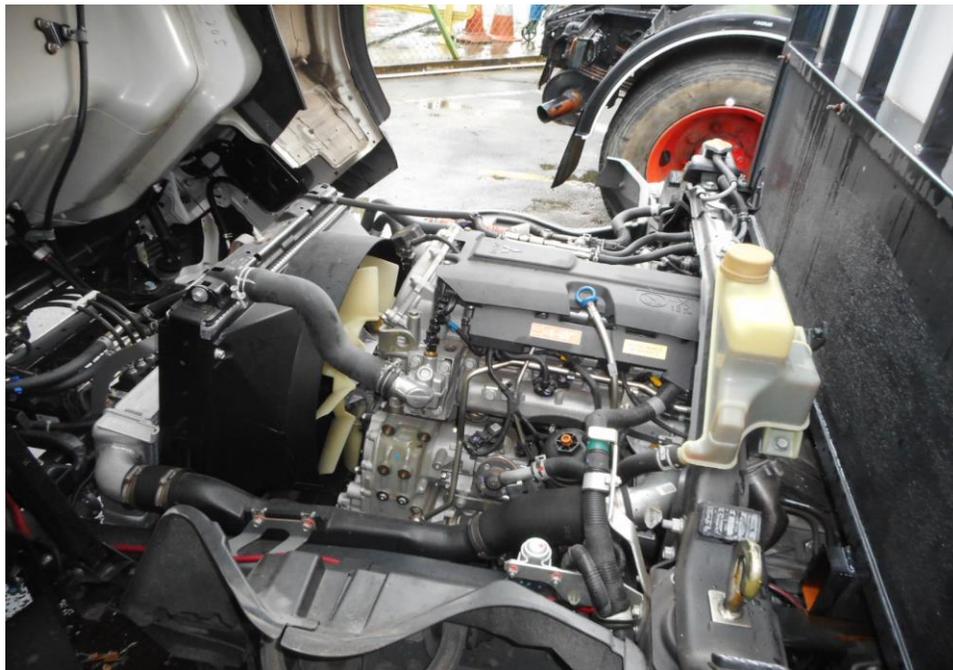
**Photo 10** shows a general view of the Motor Lorry's engine compartment, which was accessed by lifting the front cabin of the Motor Lorry. The various parts and components inside the engine compartment were unaffected by the accident. There was also no sign(s) or indication(s) of fresh fluid leakage and/or fluid stain within the engine compartment

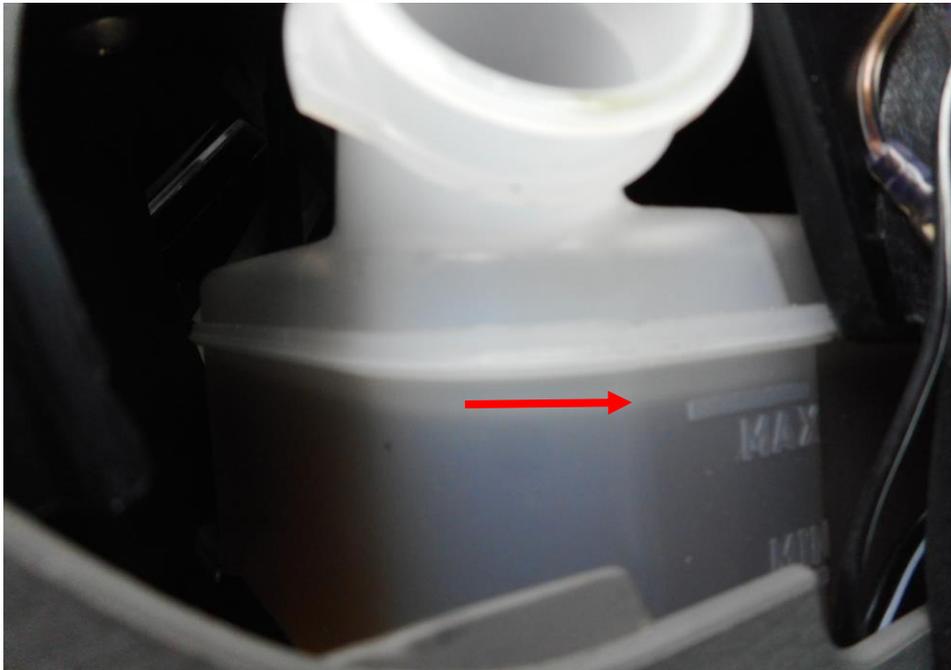
**Photo 11** shows the brake fluid reservoir of the Motor Lorry at the time of my inspection. The brake fluid was observed to be of sufficient level (arrowed) and without any visible contamination.

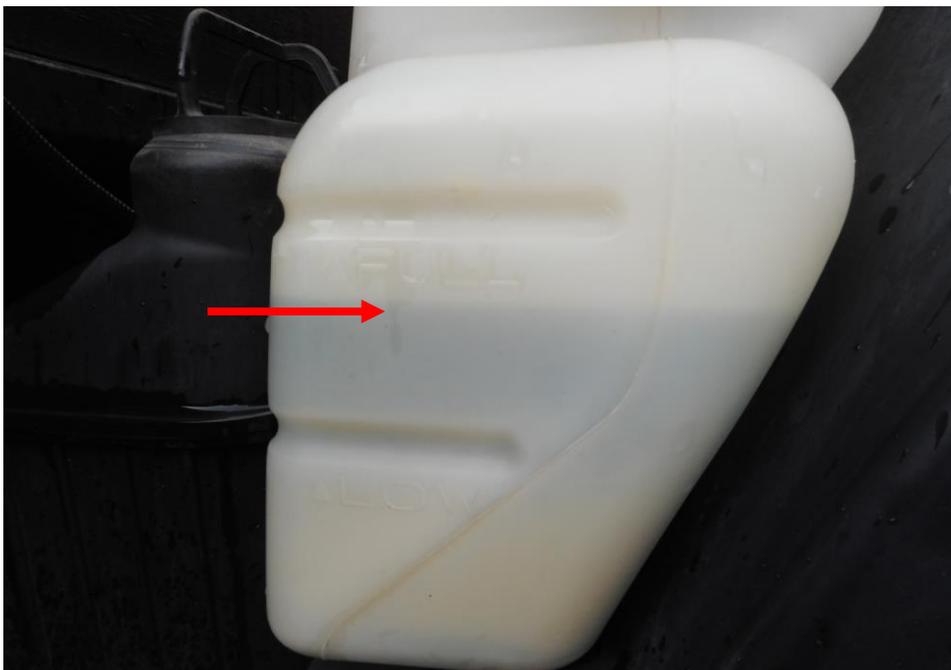
**Photo 12** shows the engine coolant reservoir of the Motor Lorry at the time of my inspection. The engine coolant was observed to be of sufficient level (arrowed) and without any visible contamination.

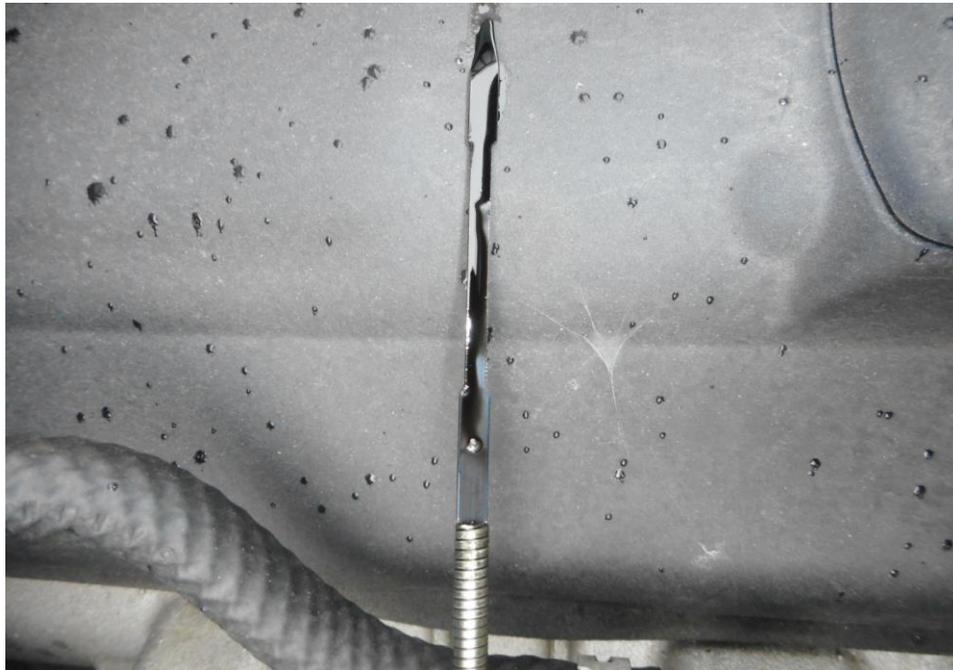
**Photo 13** shows the engine oil dip stick of the Motor Lorry at the time of my inspection. The engine oil was observed to be of sufficient level and without any visible contamination.

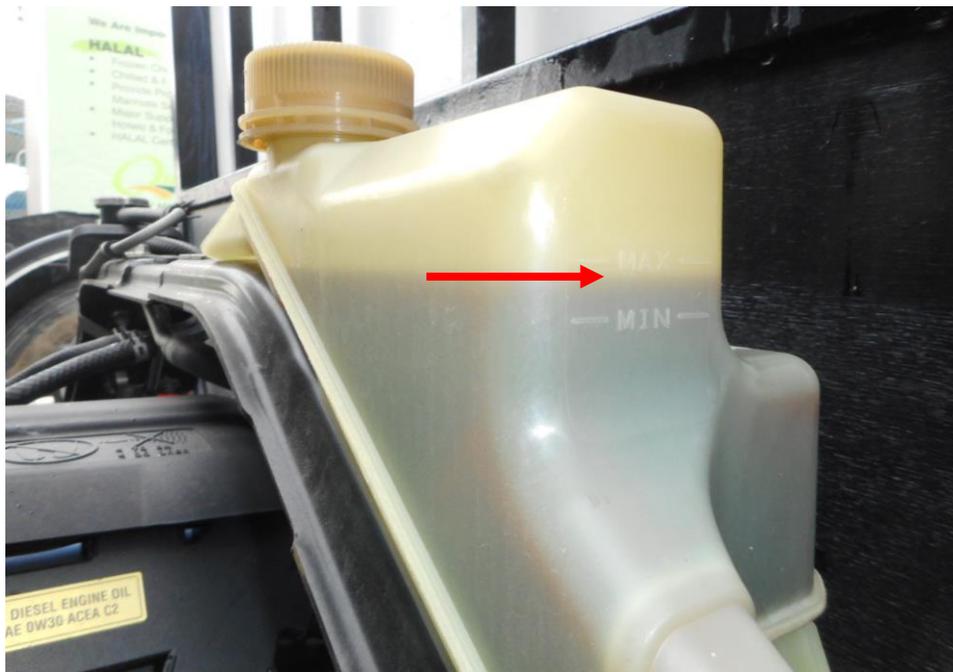
**Photo 14** shows the power steer fluid reservoir of the Motor Lorry at the time of my inspection. The power steering fluid was observed to be of sufficient level (arrowed) and without any visible contamination.

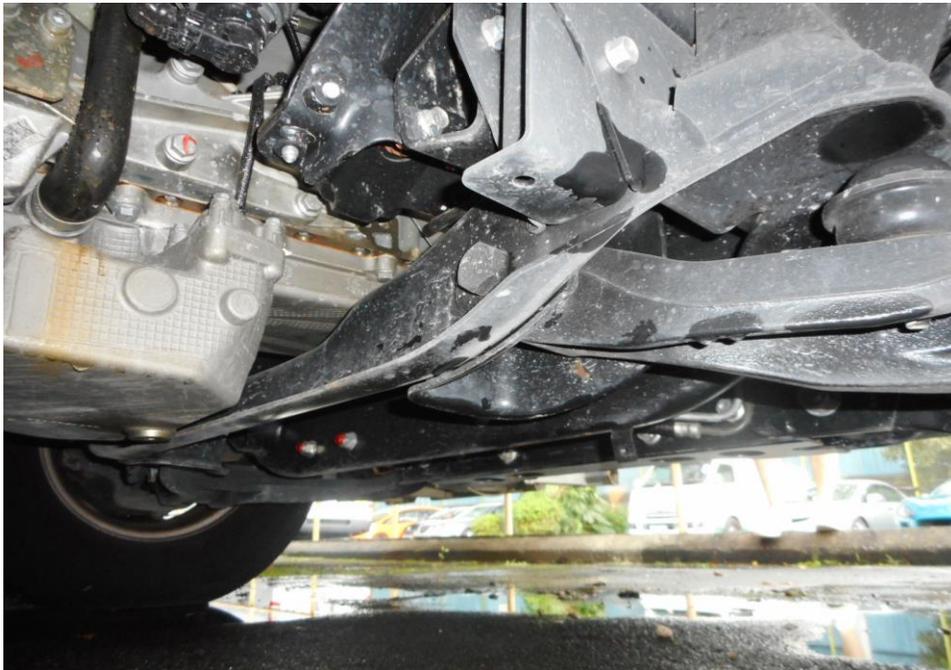
**Photo 15** shows the undercarriage of the Motor Lorry, at the area where the engine housing and transmission housing are located. . I did not find any sign(s) or indication(s) of fluid leak and/or fluid stain(s) on the underside of the Motor Lorry.

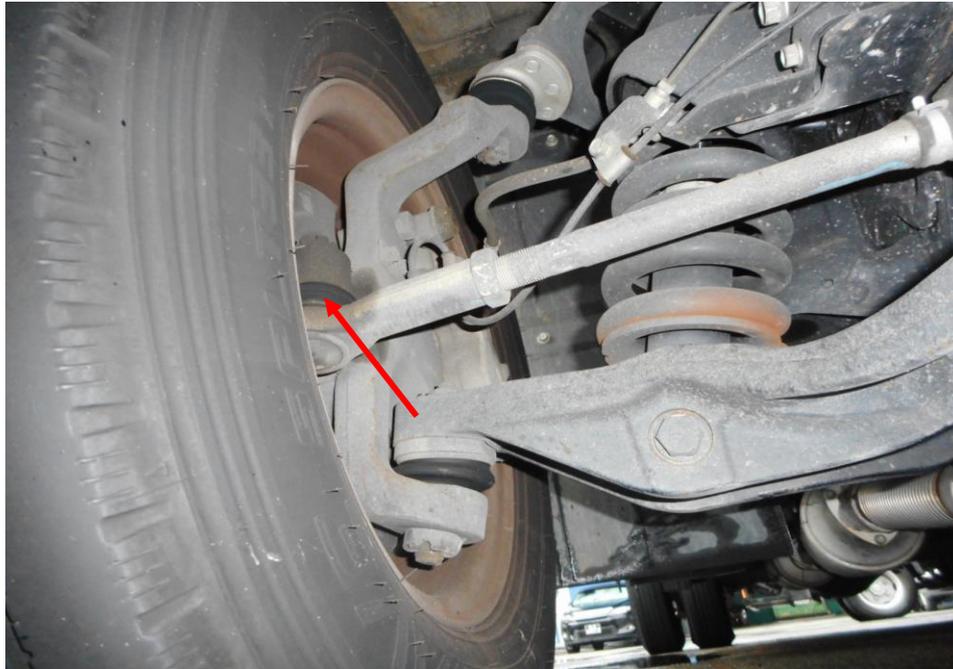
**Photo 16** shows the various undercarriage components at the front right wheel of the Motor Lorry, in particular the steering tie rod end (arrowed). The various steering components were all found to be intact, suggesting that the steering system of the Motor Lorry was likely to be in serviceable condition at the material time of accident. There was also no sign of fluid stain(s) observed on the various undercarriage components.

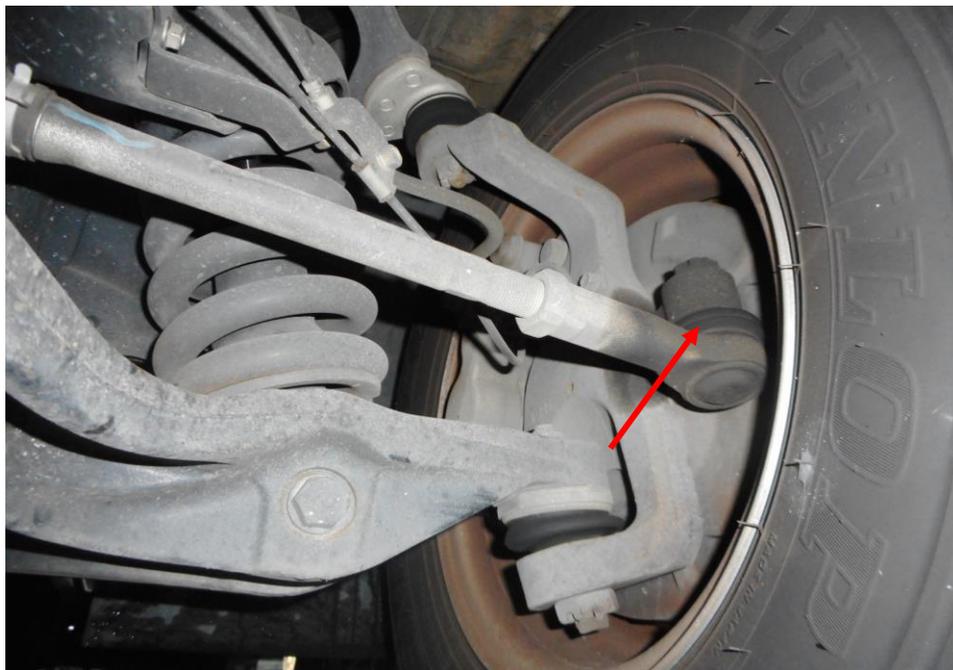
**Photo 17** shows the various undercarriage components at the front left wheel of the Motor Lorry, in particular the steering tie rod end (arrowed). The various Undercarriage components of the Motor Lorry were all found to be intact without any visible damage. There was also no sign of fluid stain(s) observed on the various undercarriage components.

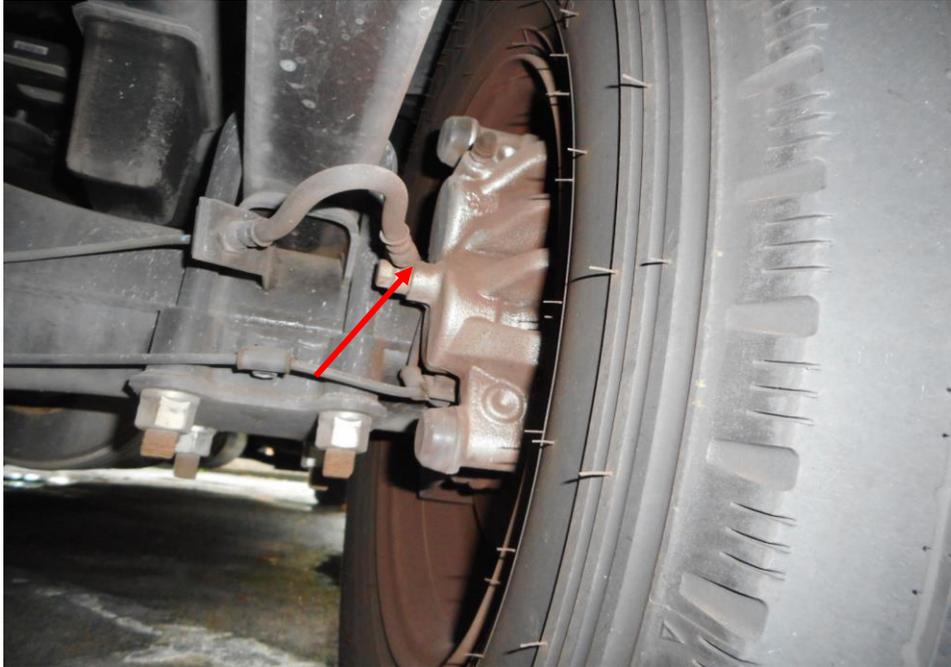
**Photo 18** shows the brake pipe (arrowed) at the rear right wheel of the Motor Lorry. I did not observe any leakage of brake fluid at the time of my inspection of the Motor Lorry. My static tests of the Motor Lorry's braking system, along with my visual examination of the various mechanical components in the braking system, had indicated that there was no internal leakage of pressure/vacuum. Hence the braking system of the Motor Lorry was likely to be in serviceable condition at the material time of accident.

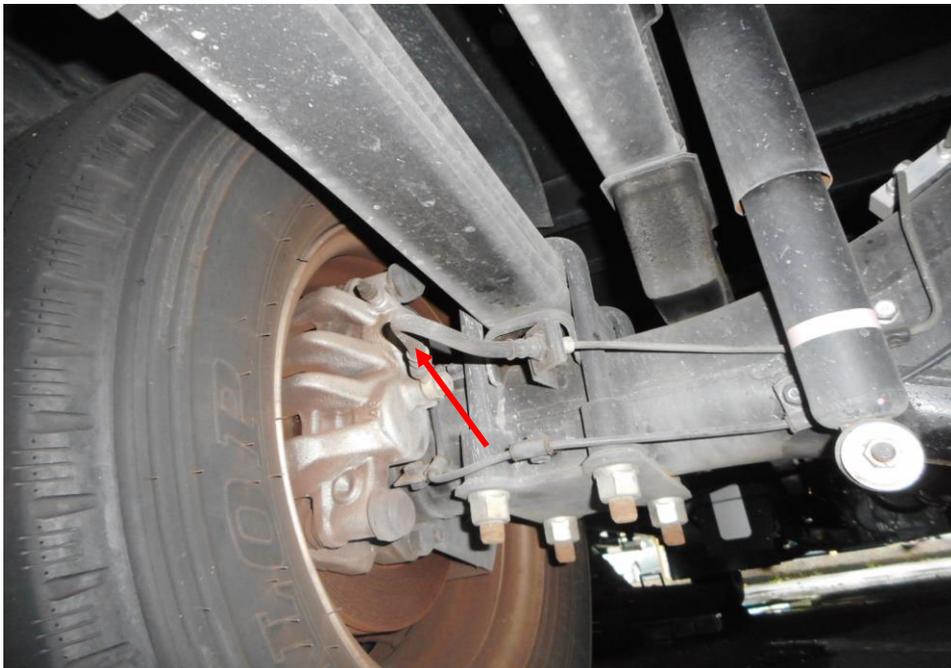
**Photo 19** shows the brake pipe (arrowed) at the rear left wheel of the Motor Lorry. I did not observe any leakage of brake fluid at the time of my inspection of the Motor Lorry. My static tests of the Motor Lorry's braking system, along with my visual examination of the various mechanical components in the braking system had indicated that there was no internal leakage of pressure/vacuum. Hence the braking system of the Motor Lorry was likely to be in serviceable condition at the material time of accident.

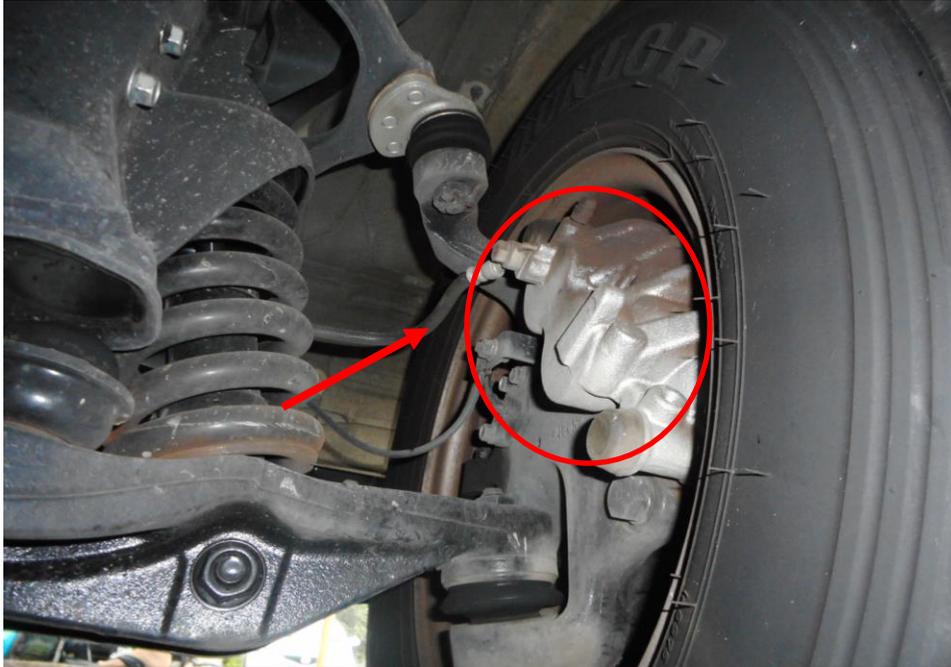
**Photo 20** shows the brake hose/pipe (arrowed) at the front right wheel of the Motor Lorry. No leakage of brake fluid was observed. Visual examination of the various components of the braking system like the brake caliper (circled), brake booster, brake pedal etc had revealed all to be intact and without visible damage at the time of accident. There was also no sign of fluid stain(s) observed on the various undercarriage components.

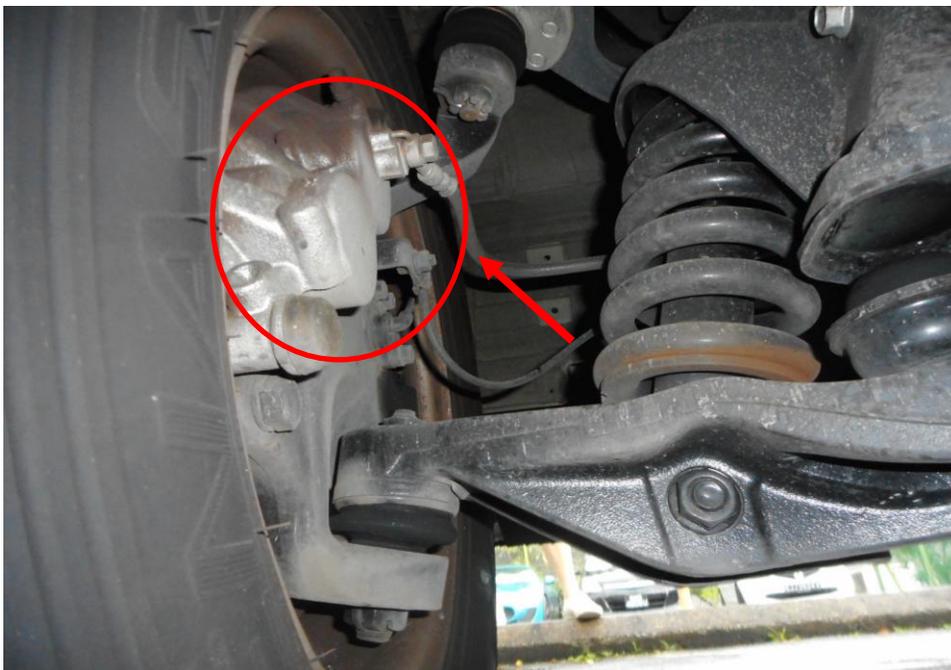
**Photo 21** shows the brake hose/pipe (arrowed) at the front left wheel of the Motor Lorry. No leakage of brake fluid was observed. Visual examination of the various components of the braking system like the brake caliper (circled), brake booster, brake pedal etc had revealed all to be intact and without visible damage at the time of accident. There was also no sign of fluid stain(s) observed on the various undercarriage components.

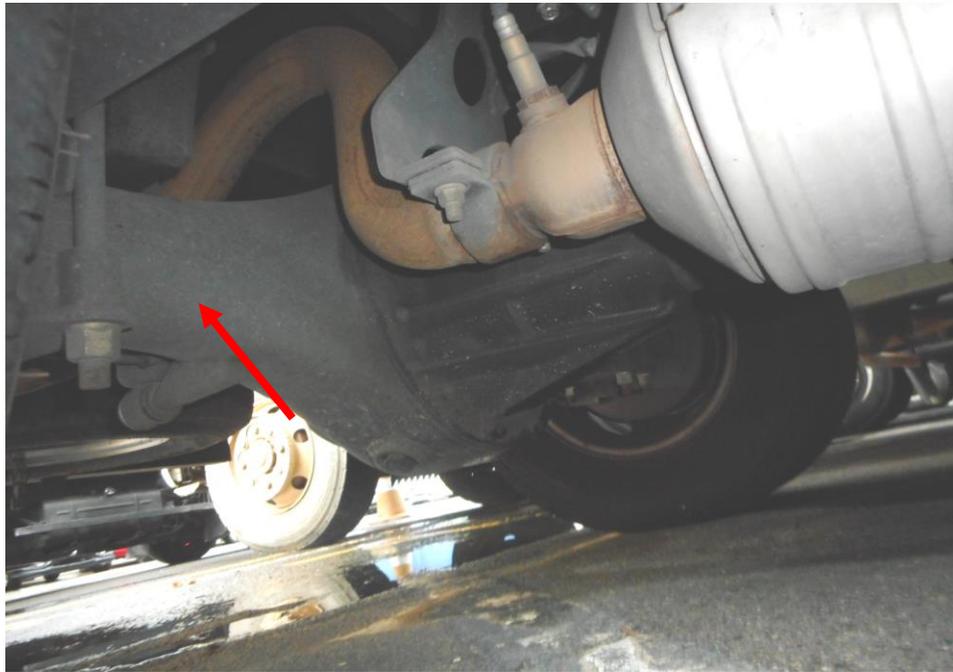
**Photo 22** shows the various undercarriage components at the rear right wheel of the Motor Lorry, in particular the drive shaft (arrowed). The various steering components were all found to be intact, suggesting that the steering system of the Motor Lorry was likely to be in serviceable condition at the material time of accident. There was also no sign of fluid stain(s) observed on the various undercarriage components.

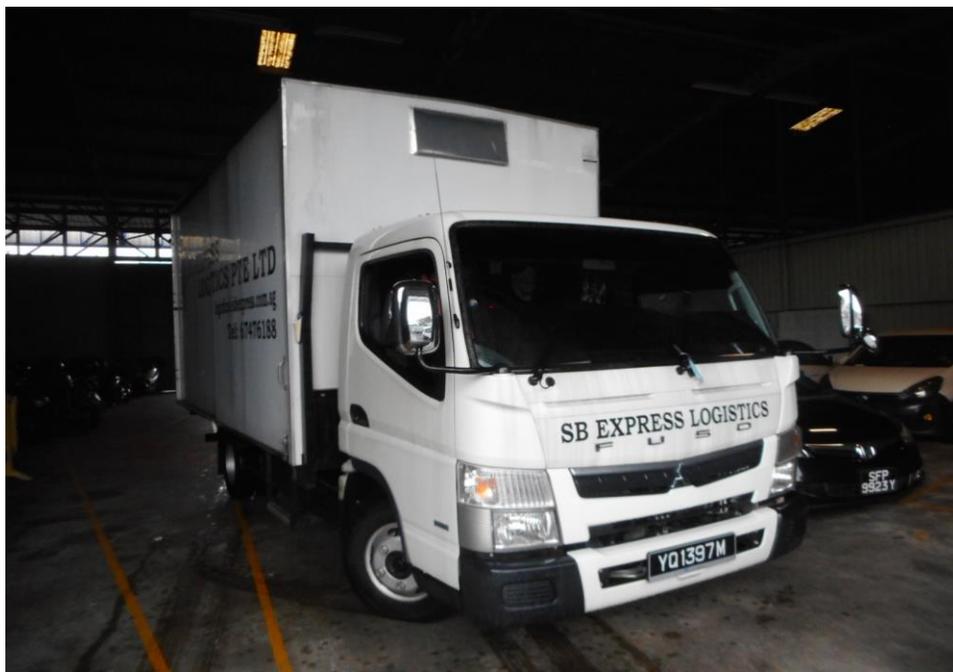
**Photo 23** shows the front right wheel of the Motor Lorry turned to its full left. During my steering system test, I did not experience any abnormal free play and/or resistance when I had turned the steering wheel towards full left and full right. This would suggest that the steering system of the Motor Lorry was likely to be in serviceable condition at the material time of accident.

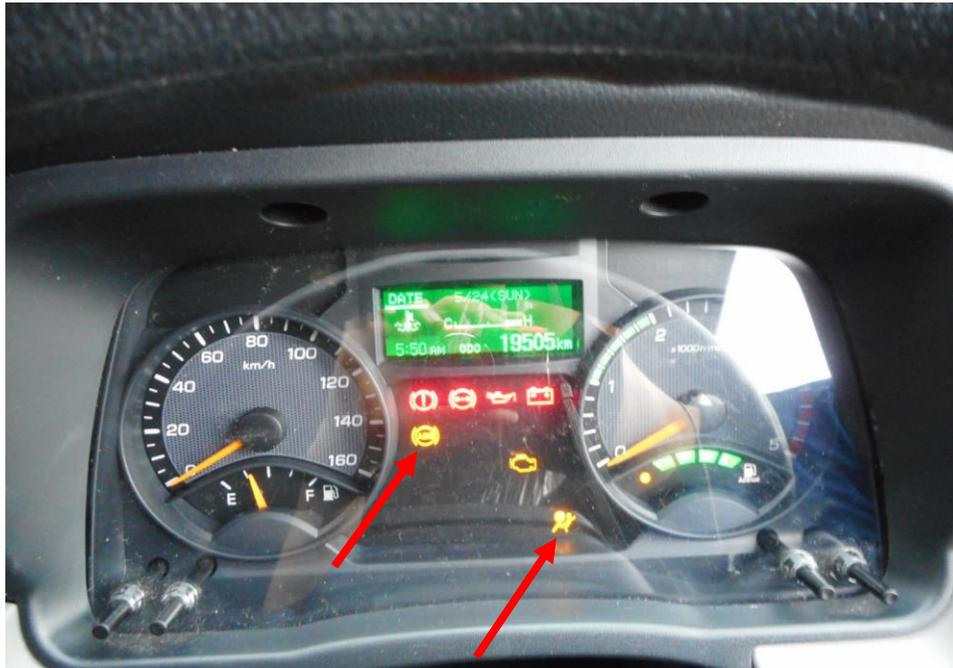
**Photo 24** shows the warning light for Anti-Lock Brake System (ABS) and Supplemental Restraint System (SRS) appearing on the instrument panel of the Motor Lorry during the self-test of its various electronic operating systems when its engine was cranked.

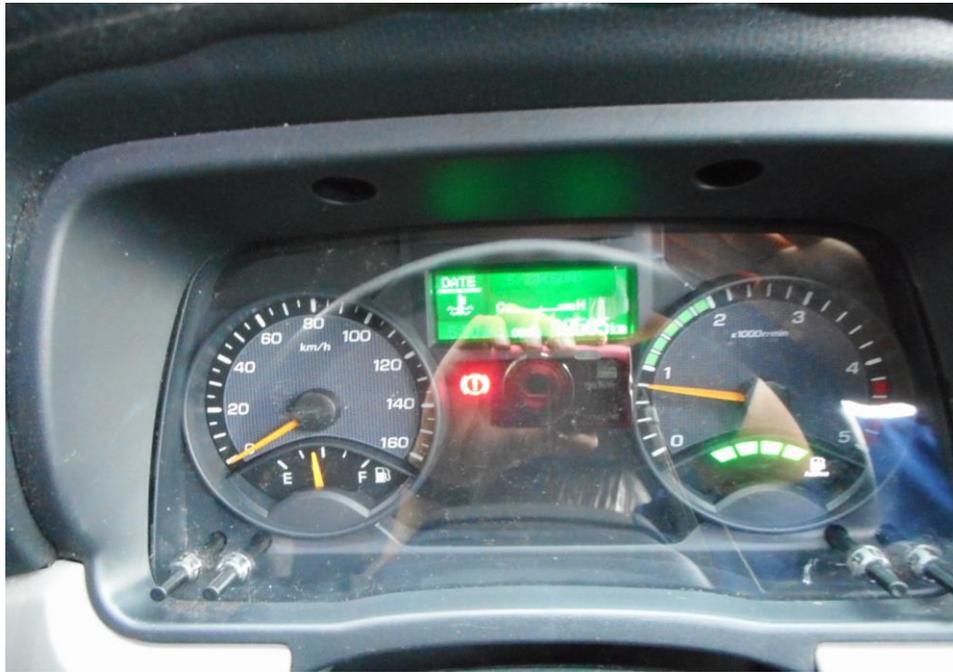
**Photo 25** shows no warning lights illuminated on the instrument panel of the Motor Lorry after the engine was cranked. This would suggest that there was no abnormality to the various electronic operating systems of the Motor Lorry, like the ABS and SRS.
