You're Ref: TP/IP/41703/2020  
Our Ref: CI/TPD20011021/P

**General Investigation Team**

**MECHANICAL INSPECTION REPORT OF MOTOR CAR SMS 6055Z**

1. I refer to your request on 12<sup>th</sup> October 2020 to conduct a physical inspection of a Motor Car bearing registration number SMS 6055Z (herein referred to as "**Motor Car**"), which was involved in a road traffic accident on 24<sup>th</sup> September 2020.
2. The objective of the inspection is to determine if there was any possible mechanical failure to the Motor Car that may have contributed to the accident.
3. Following the request, I had carried out a physical inspection of the Motor Car on 3<sup>rd</sup> November 2020 at the premises of Traffic Police vehicle pound, 517 Airport Road Singapore 539942. I now set out below my observations and comments with respect to this inspection.

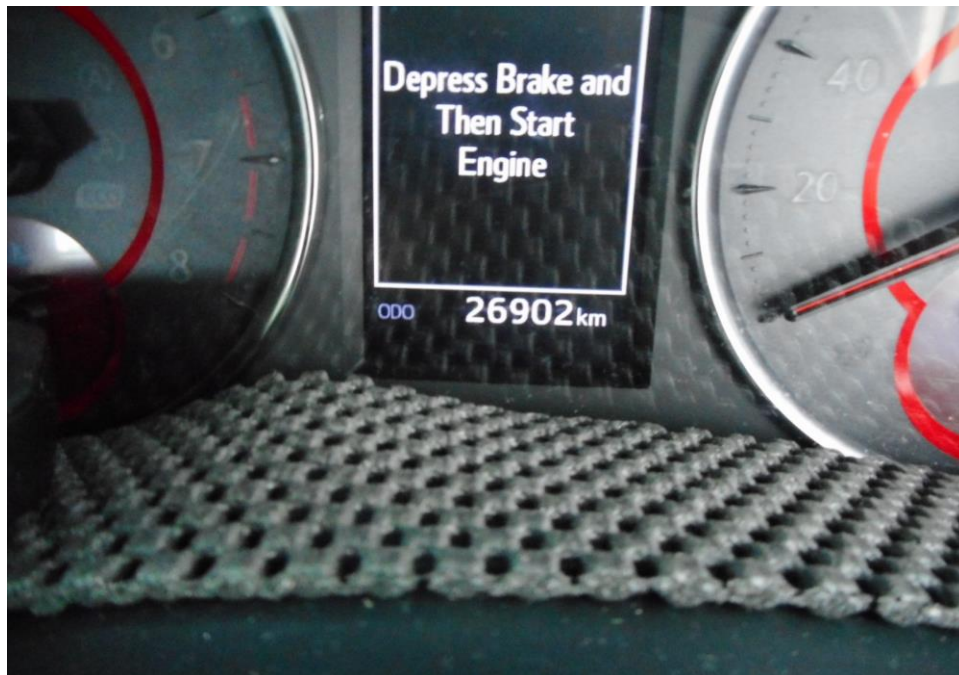
**Photo 1** shows the mileage of the Motor Car at the time of my inspection. The mileage observed was 26,902km.

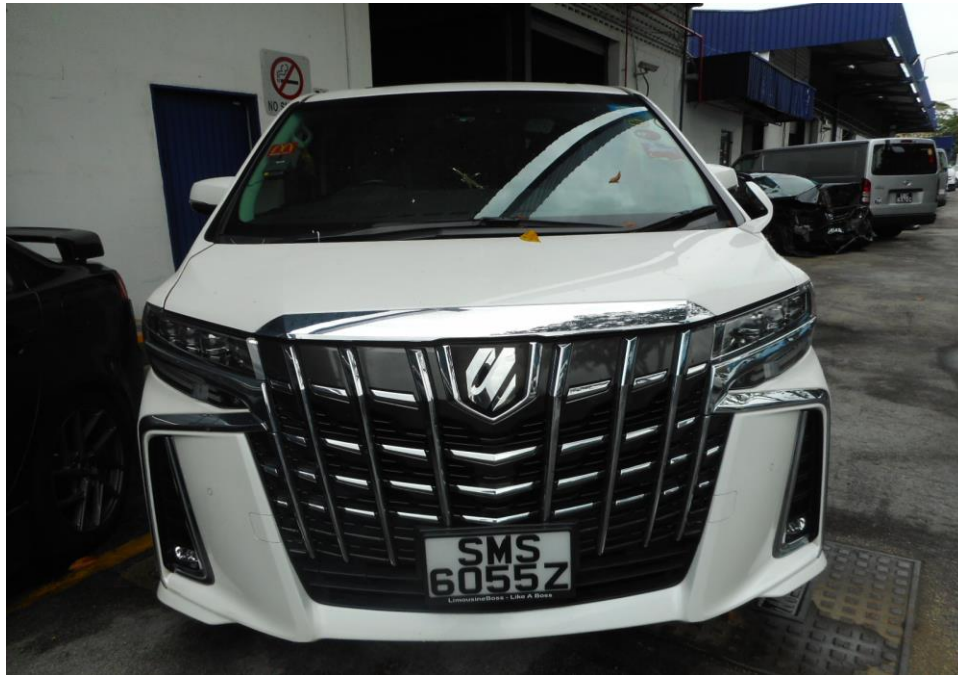
**Photo 2** shows a general view of the Motor Car's front body at the time of my inspection. The front portion of the Motor Car was observed to have sustained damage. Its front bumper was the only body part that were damaged as a result of the accident.

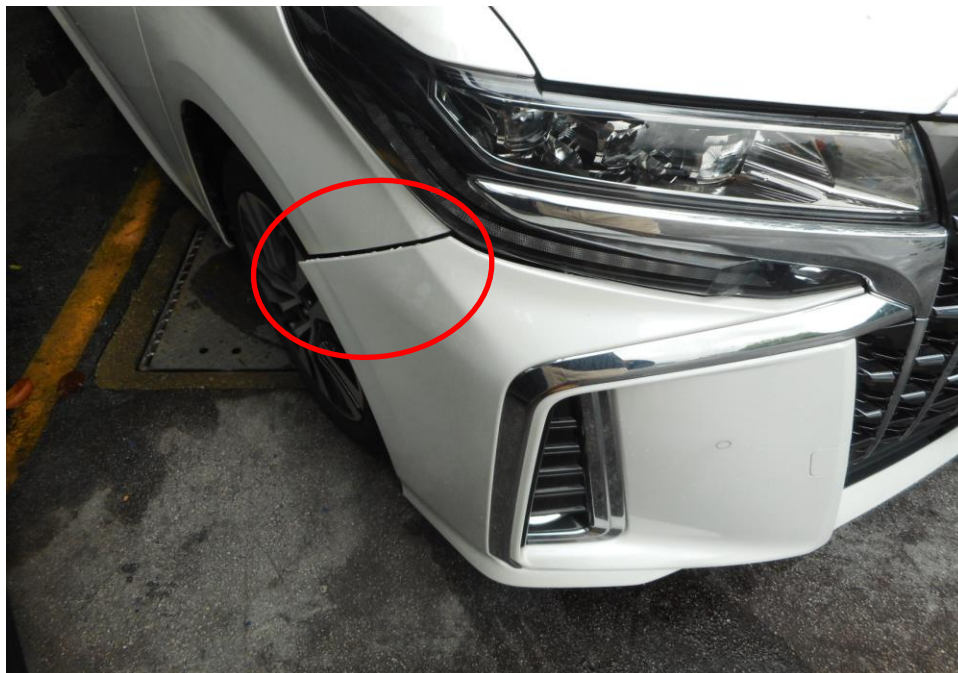
**Photo 3** shows the general area view of the Motor Car's front bonnet at the time of my inspection. The Motor Car was observed to have sustained damage at its front bumper (circled) as a result of the accident.

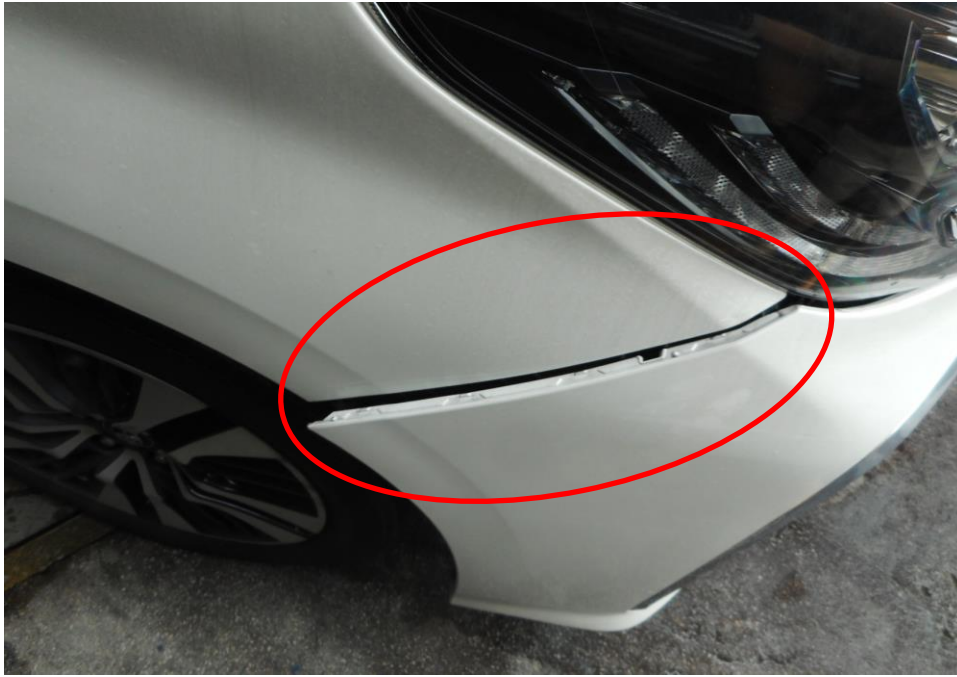
**Photo 4** shows the close up view of the Motor Car's front body at the time of my inspection. The Motor Car was observed to have sustained damage at its front bumper (circled) as a result of the accident.

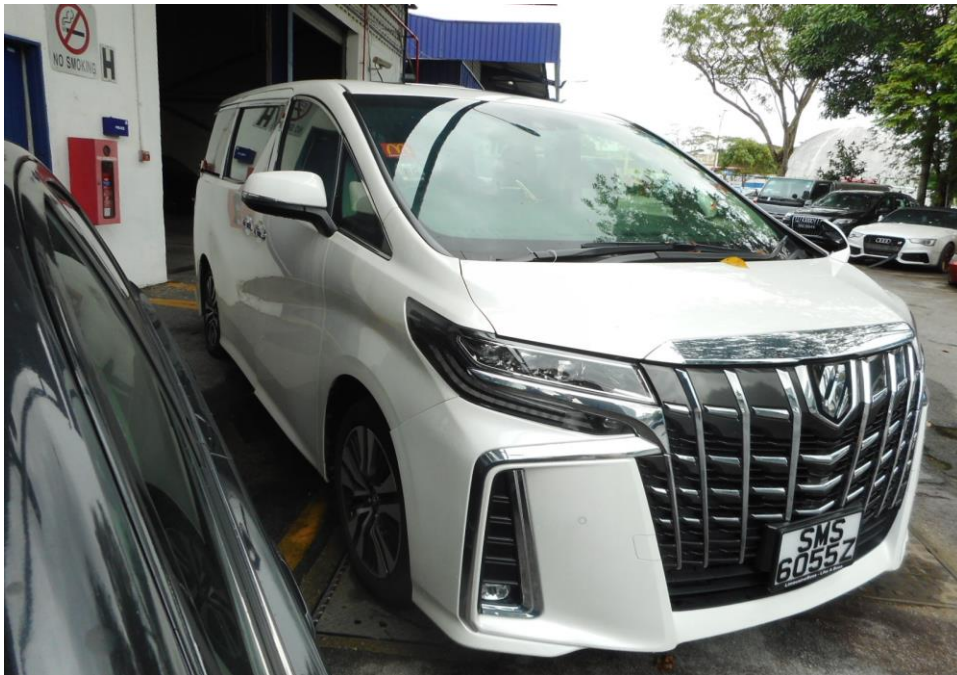
**Photo 5** shows a general view of the Motor Car's right body at the time of my inspection. The right portion of the Motor Car was observed to have been unaffected by the accident.

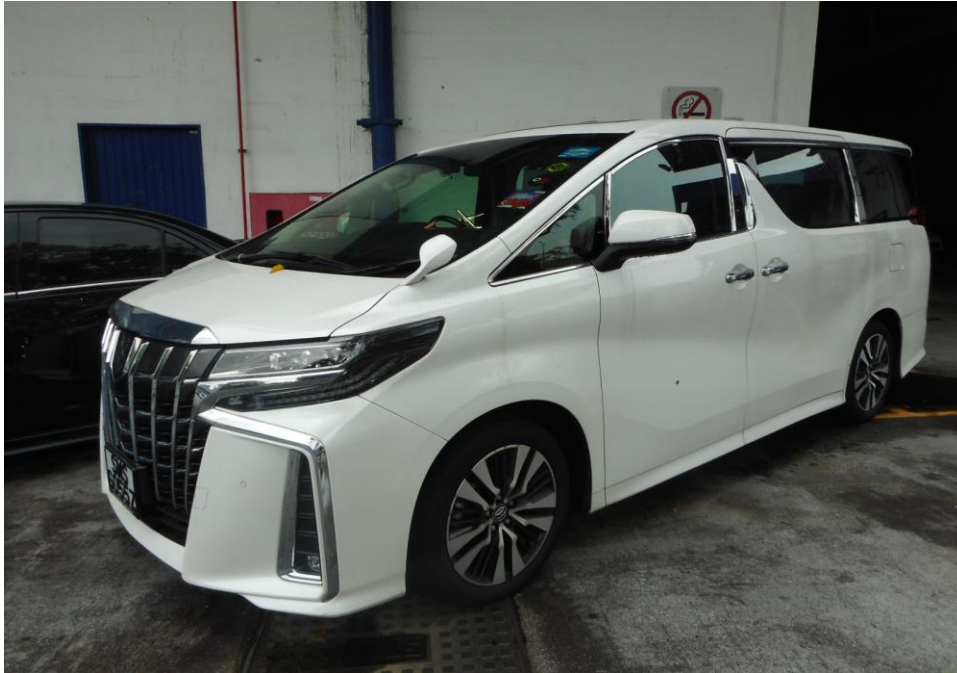
**Photo 6** shows a general view of the Motor Car's left body at the time of my inspection. The left portion of the Motor Car was observed to have been unaffected by the accident.

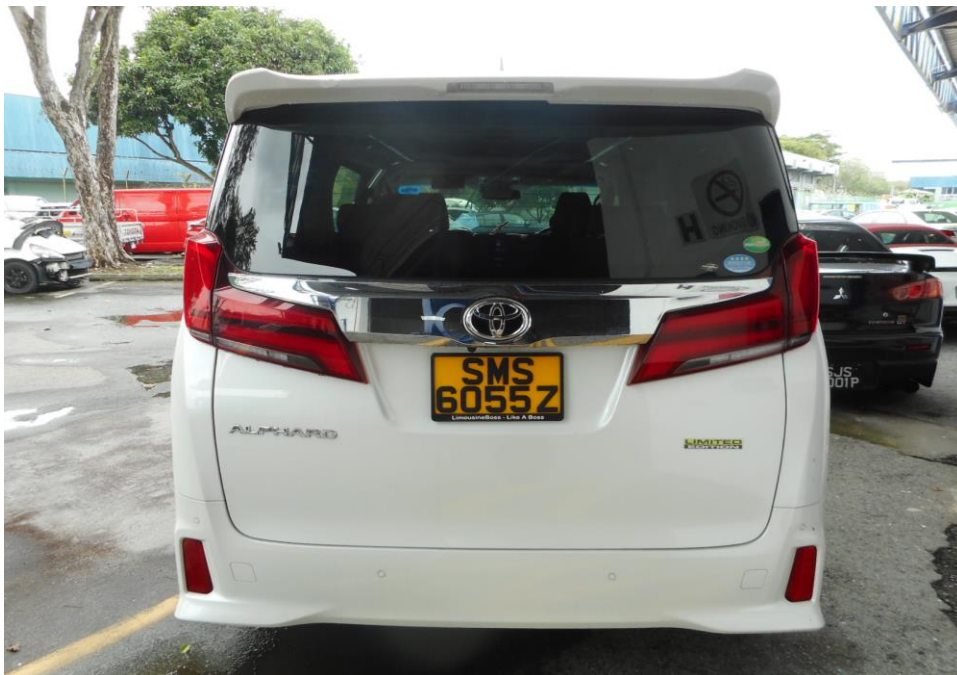
**Photo 7** shows the general view of the Motor Car's rear body at the time of my inspection. The Motor Car rear was observed to be unaffected by the accident.

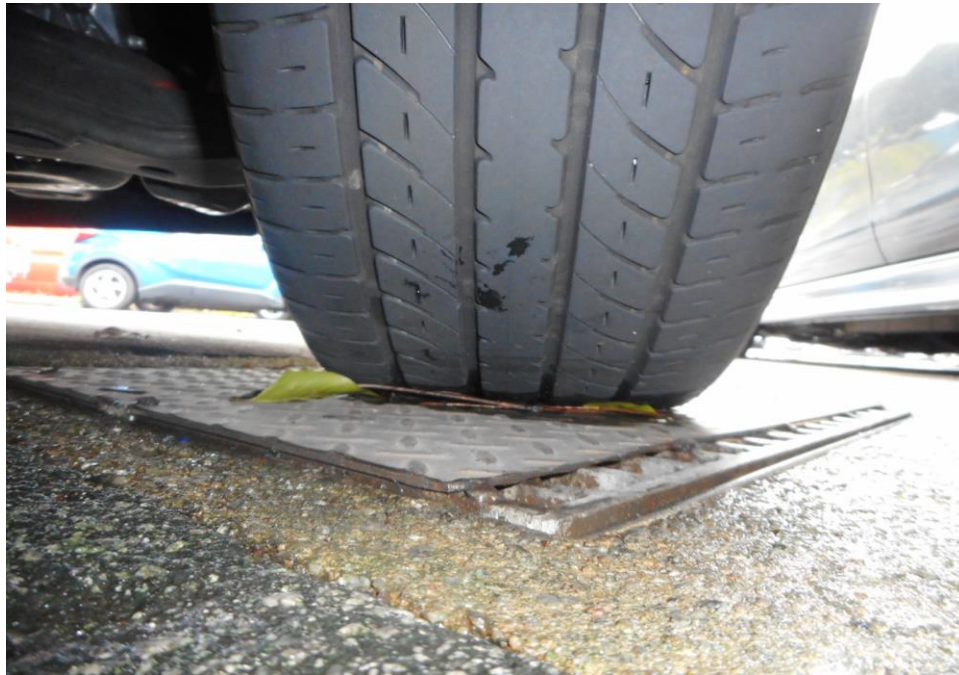
**Photo 8** shows the condition of the front right tyre of the Motor Car, which was observed to be in serviceable condition with remaining tread depth of approximately 3.2mm. The tyre was sufficiently inflated for vehicular operation with no tear, cut or burst mark(s) on the outer and the inner sidewalls as well as across the tread. The 4 tyres of the Motor Car were wrapped around standard steel wheel rims without any damage.

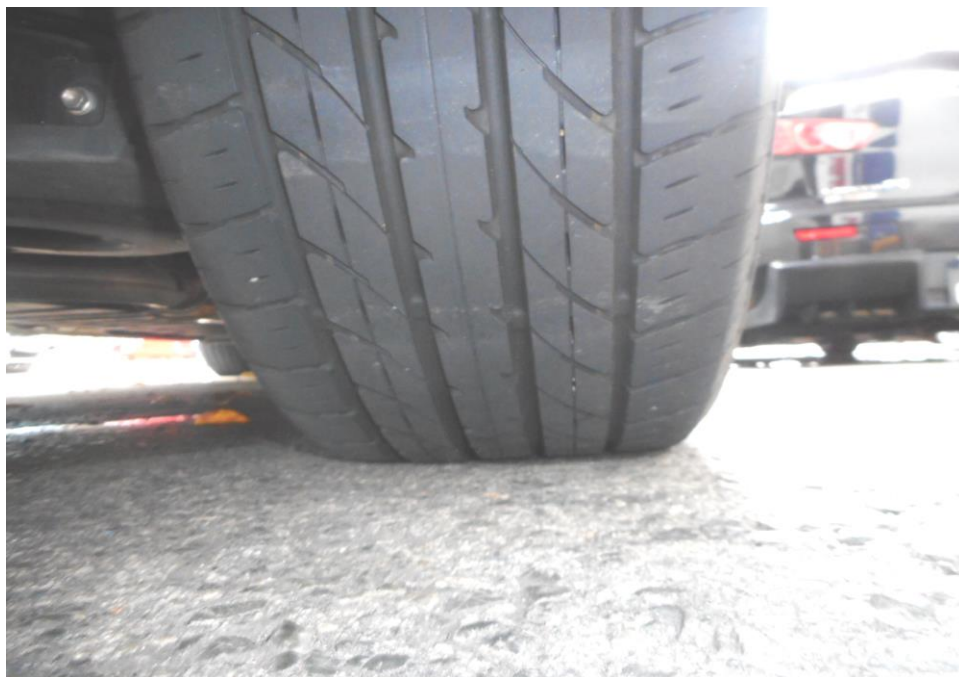
**Photo 9** shows the condition of the rear right tyre of the Motor Car, which was observed to be in serviceable condition with remaining tread depth of approximately 6mm. The tyre was also observed to be sufficiently inflated for vehicular operation with no tear, cut or burst mark(s).

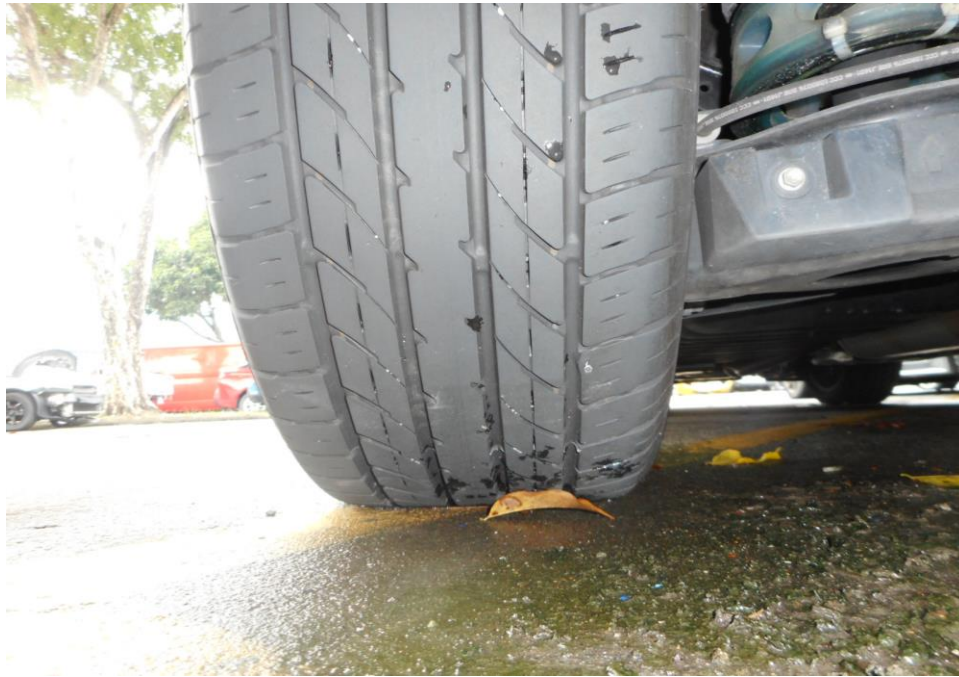
**Photo 10** shows the condition of the rear left tyre of the Motor Car, which was observed to be in serviceable condition with remaining tread depth of approximately 5.4mm. The tyre, which was wrapped around steel wheel rim, was also observed to be sufficiently inflated for vehicular operation. The 4 tyres of the Motor Car were wrapped around standard steel wheel rims.

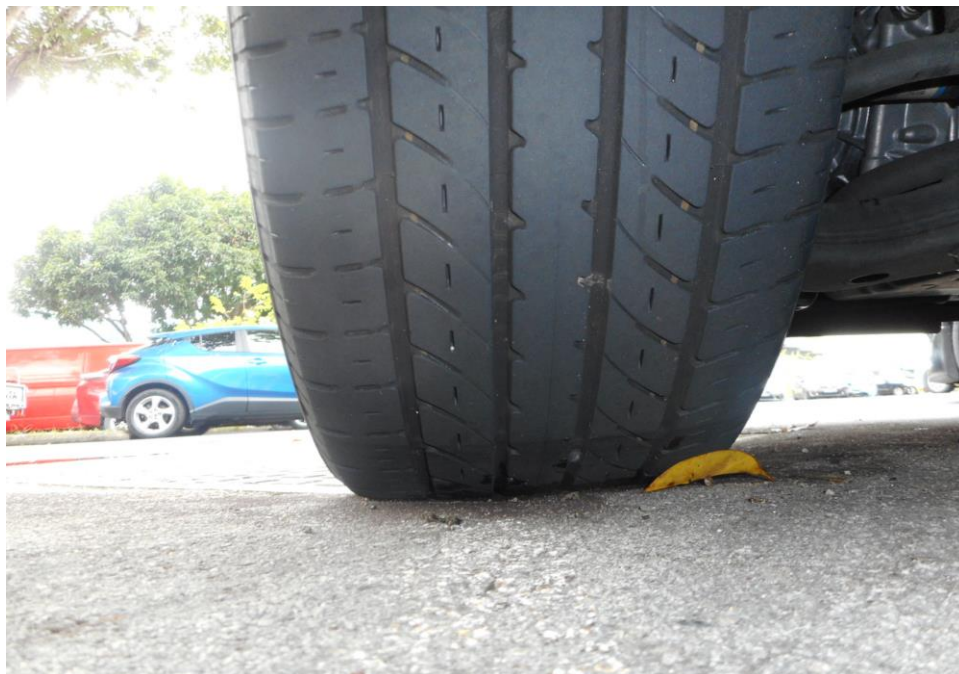
**Photo 11** shows the condition of the front left tyre of the Motor Car, which was observed to be in serviceable condition with remaining tread depth of approximately 4.4mm. The tyre, which was wrapped around steel wheel rim, was also observed to be sufficiently inflated for vehicular operation. The 4 tyres of the Motor Car were wrapped around standard steel wheel rims.

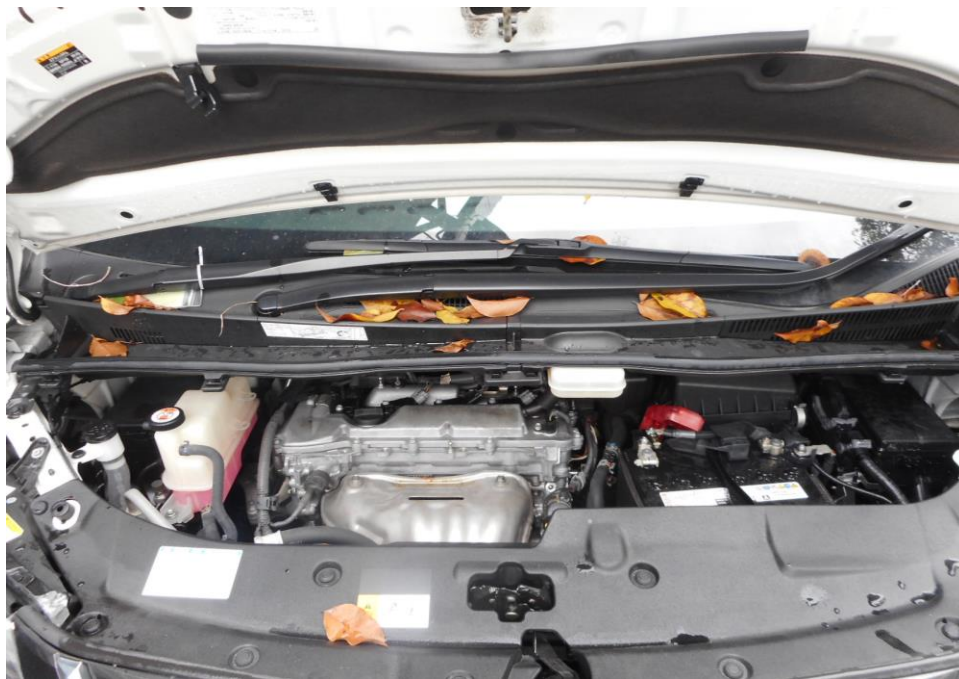
**Photo 12** shows a general view of the Motor Car's engine compartment. The various parts and components inside the engine compartment were unaffected by the accident. There was also no sign(s) or indication(s) of fluid leakage and/or fluid stain within the engine compartment.

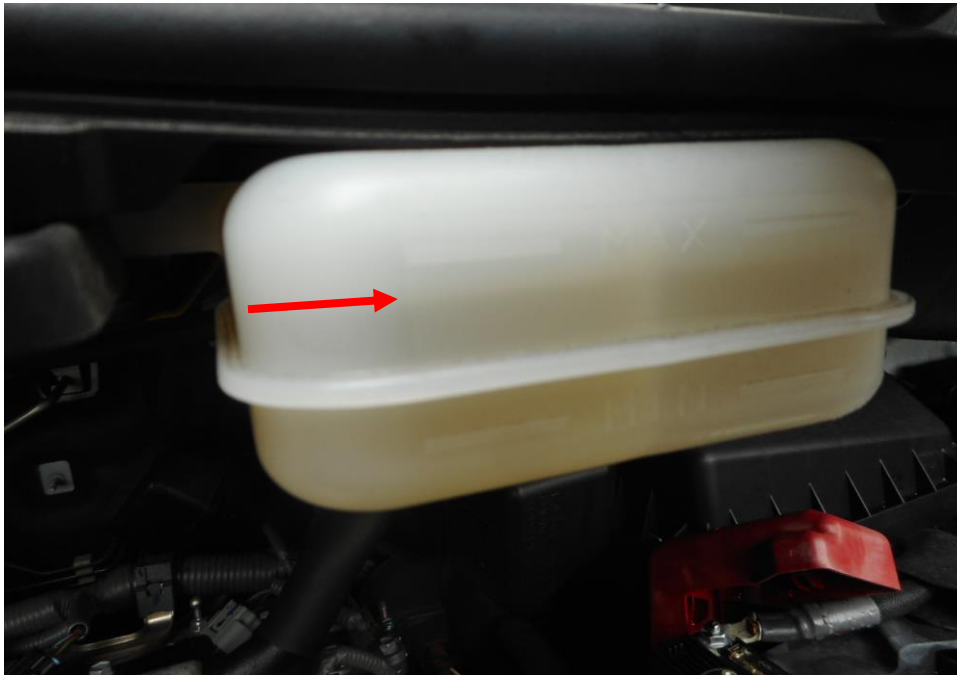
**Photo 13** shows the brake fluid reservoir of the Motor Car at the time of my inspection. The brake fluid was observed to be of sufficient level (arrowed) and without any visible contamination.

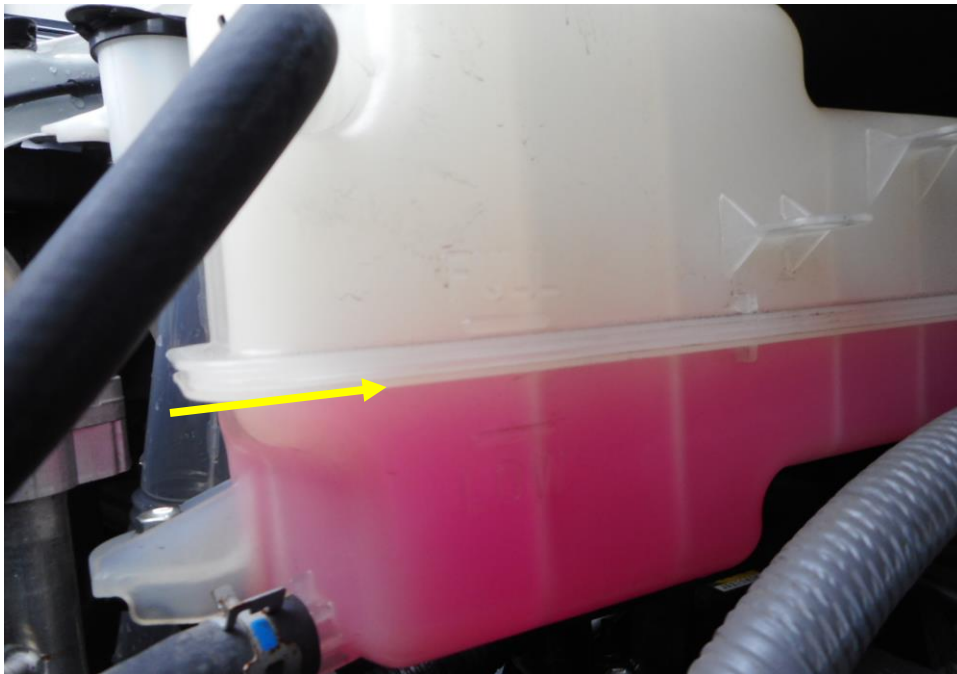
**Photo 14** shows checks being carried out to the engine coolant of the Motor Car at the time of my inspection. The engine coolant was observed to be of insufficient level (arrowed) likely due to the damaged to the front radiator which caused the leakage of coolant.

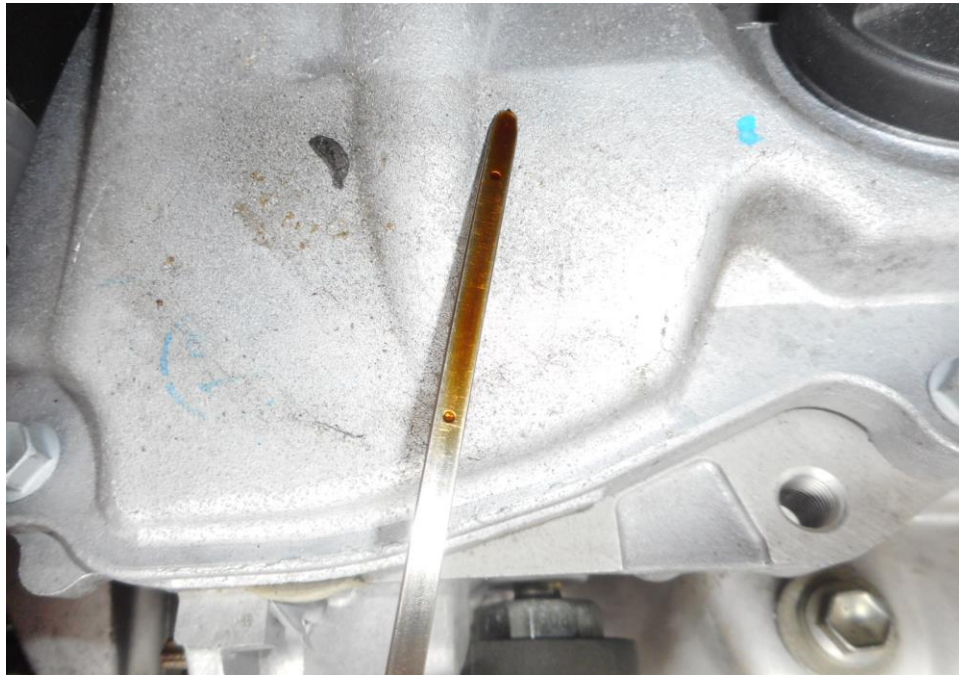
**Photo 15** shows the engine oil dip stick of the Motor Car at the time of my inspection. The engine oil was observed to be of sufficient level and without any visible contamination.

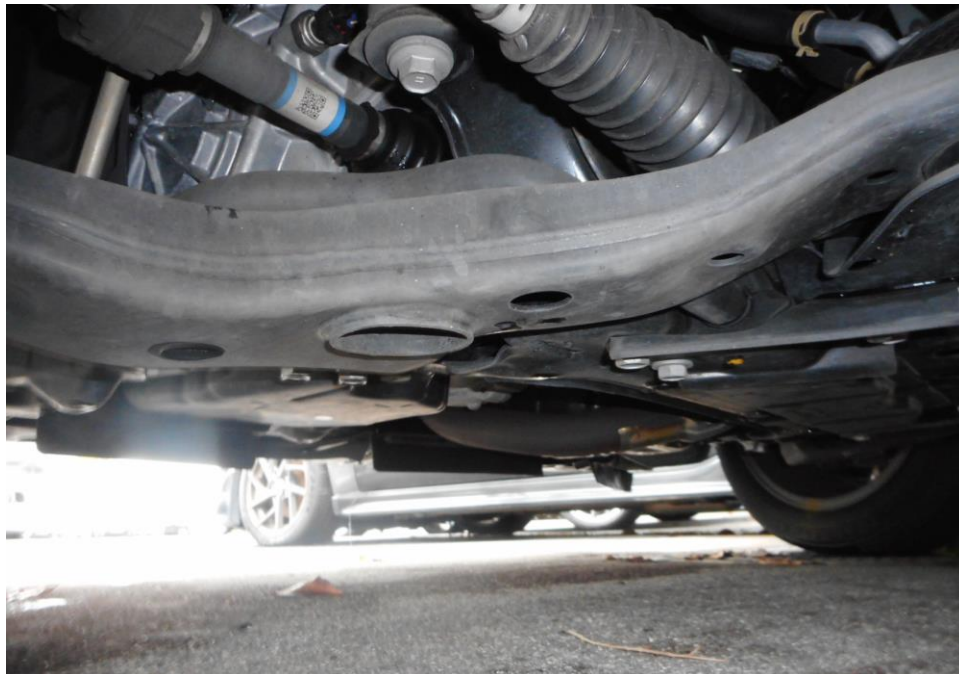
**Photo 16** shows the undercarriage of the Motor Car, at the area where the engine housing and transmission housing are located. I did not find any sign(s) or indication(s) of fluid leak and/or fluid stain(s) on the underside of the Motor Car.

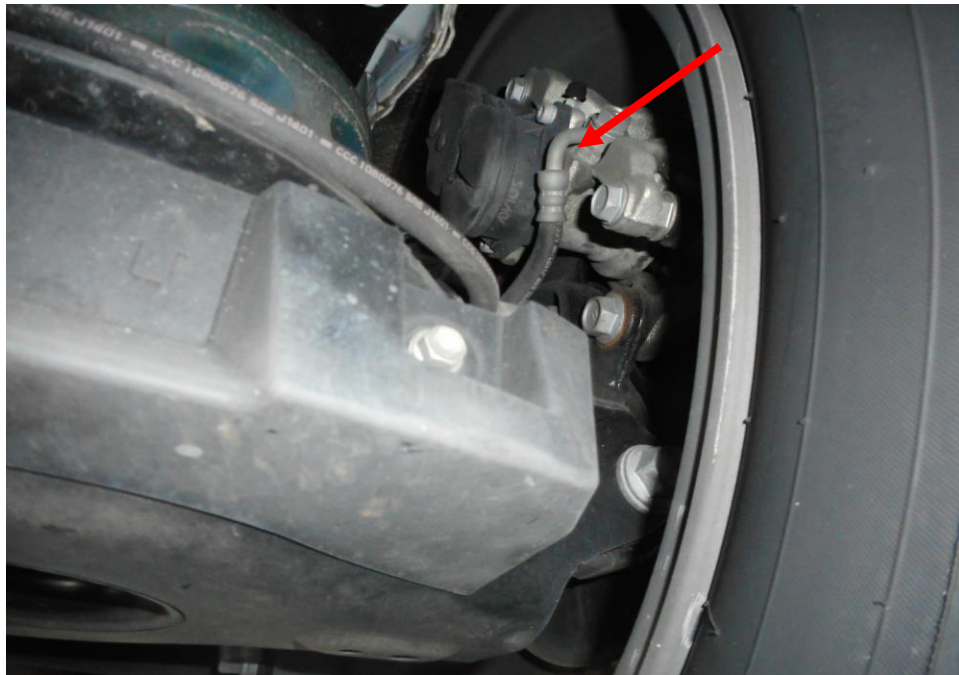
**Photo 17** shows the brake hose/pipe (arrowed) at the rear right wheel of the Motor Car. No leakage of brake fluid was observed. Visual examination of the various components of the braking system like the drum brake, brake booster, brake pedal etc. had revealed all to be intact and without visible damage.

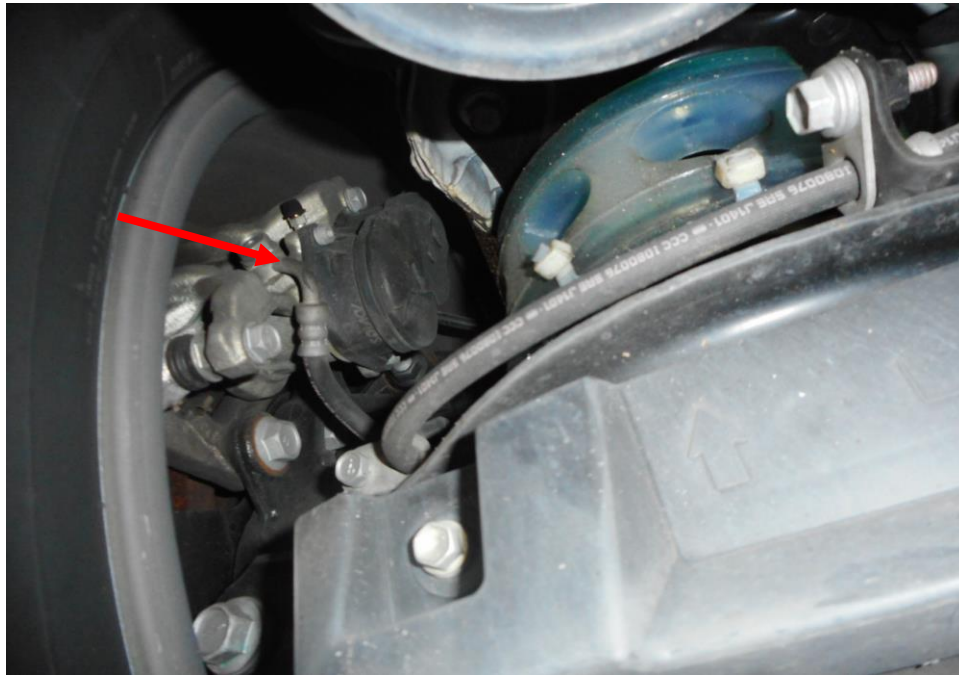
**Photo 18** shows the brake hose/pipe (arrowed) at the rear left wheel of the Motor Car. I did not observe any leakage of brake fluid at the time of my inspection of the Motor Car. Static tests of the Motor Car's braking system had indicated that there was no internal leakage of pressure/vacuum. The undercarriage components of the Motor Car were also all found to be intact and without any visible damage.

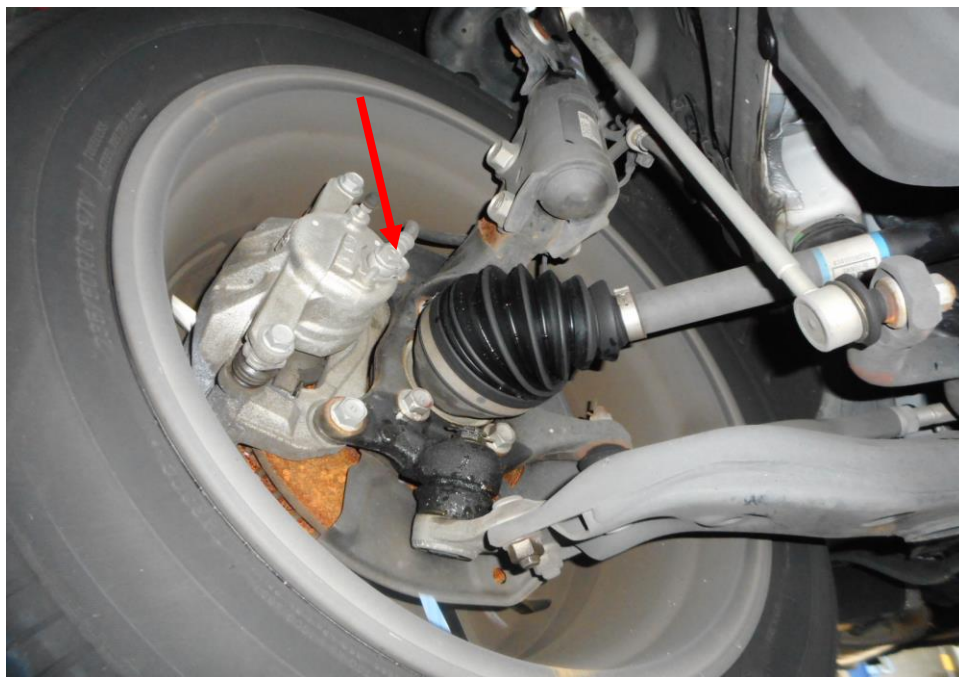
**Photo 19** shows the brake hose/pipe (arrowed) at the front right wheel of the Motor Car. I did not observe any leakage of brake fluid at the time of my inspection of the Motor Car. Static tests of the Motor Car's braking system had indicated that there was no internal leakage of pressure/vacuum. The undercarriage components of the Motor Car were also all found to be intact and without any visible damage.

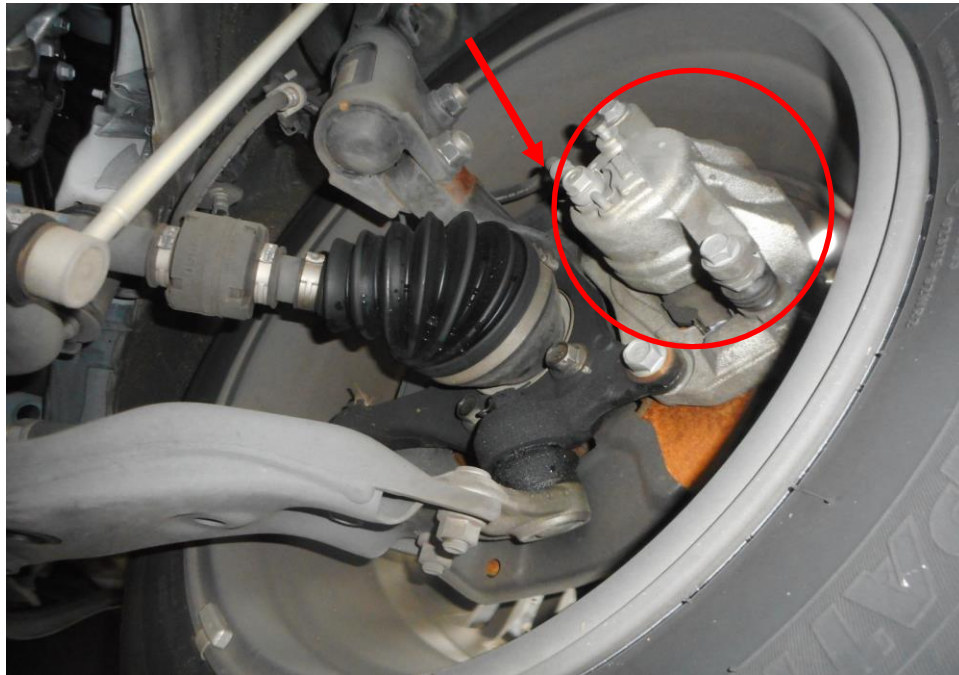
**Photo 20** shows the brake hose/pipe (arrowed) at the front left wheel of the Motor Car. No leakage of brake fluid was observed. Visual examination of the various components of the braking system like the brake caliper (circled), brake booster, brake pedal etc had revealed all to be intact and without visible damage.

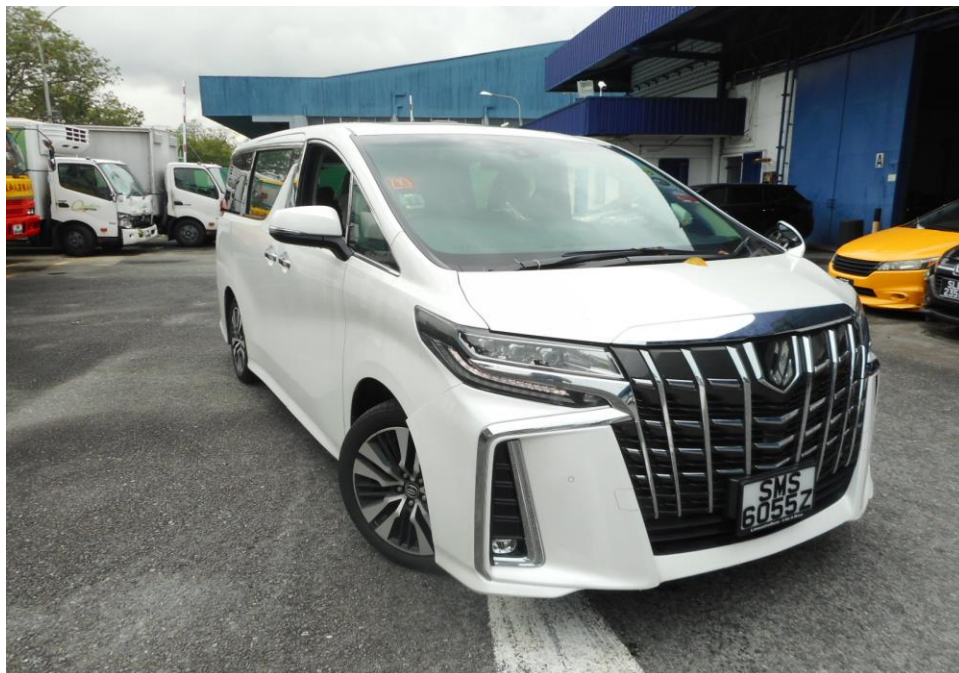
**Photo 21** shows the front right wheel of the Motor Car turned to its full left. During my steering system test, I did not experience any abnormal free play and/or resistance when I had turned the steering wheel towards the left and right. This would suggest that the steering system of the Motor Car was likely to be in serviceable condition at the material time of accident.

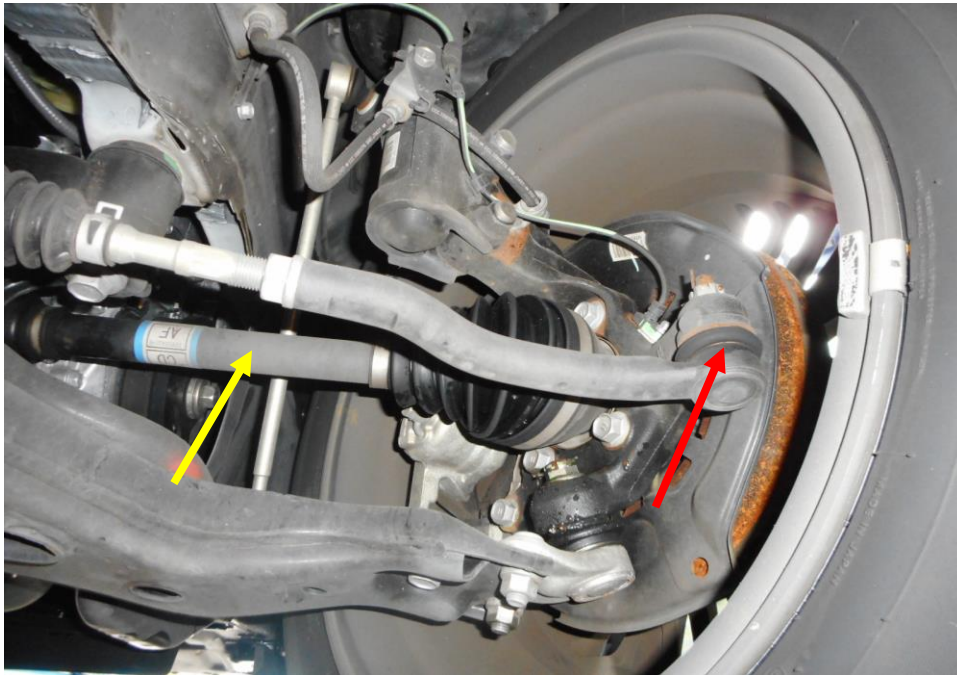
**Photo 22** shows the various undercarriage components at the front right wheel of the Motor Car, in particular the steering tie rod (red arrow) and drive shaft (yellow arrow). The various steering components were all found to be intact, suggesting that the steering system of the Motor Car was likely to be in serviceable condition at the material time of accident. There was also no sign of fluid stain observed on the various undercarriage components at the front right wheel of the Motor Car.

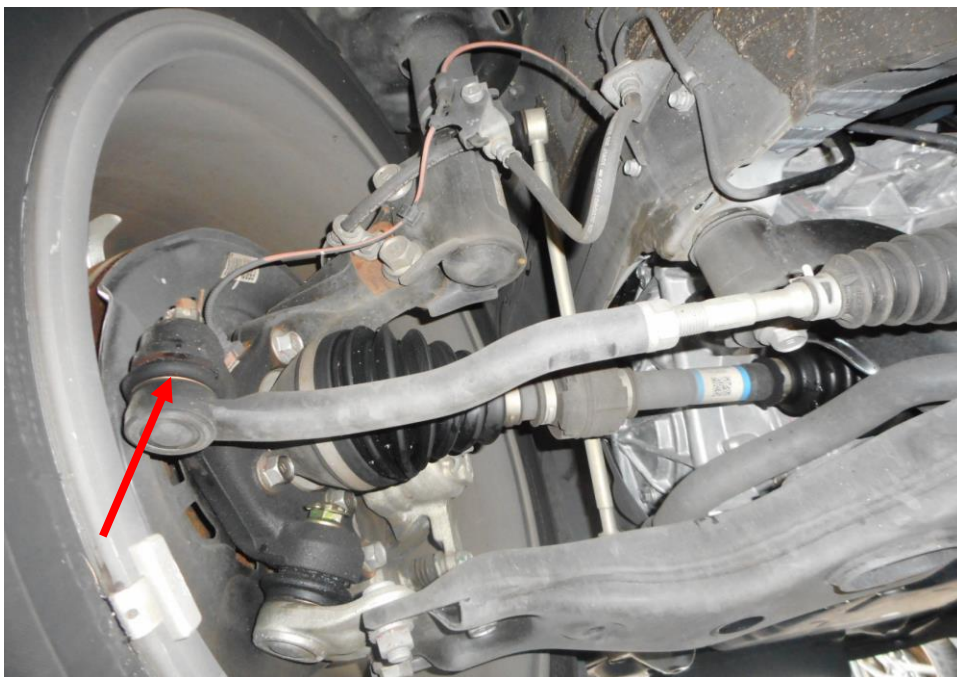
**Photo 23** shows the various undercarriage components at the front left wheel of the Motor Car, which had included the steering tie rod (red arrow). The various undercarriage components of the Motor Car were all found to be intact without any visible damage.

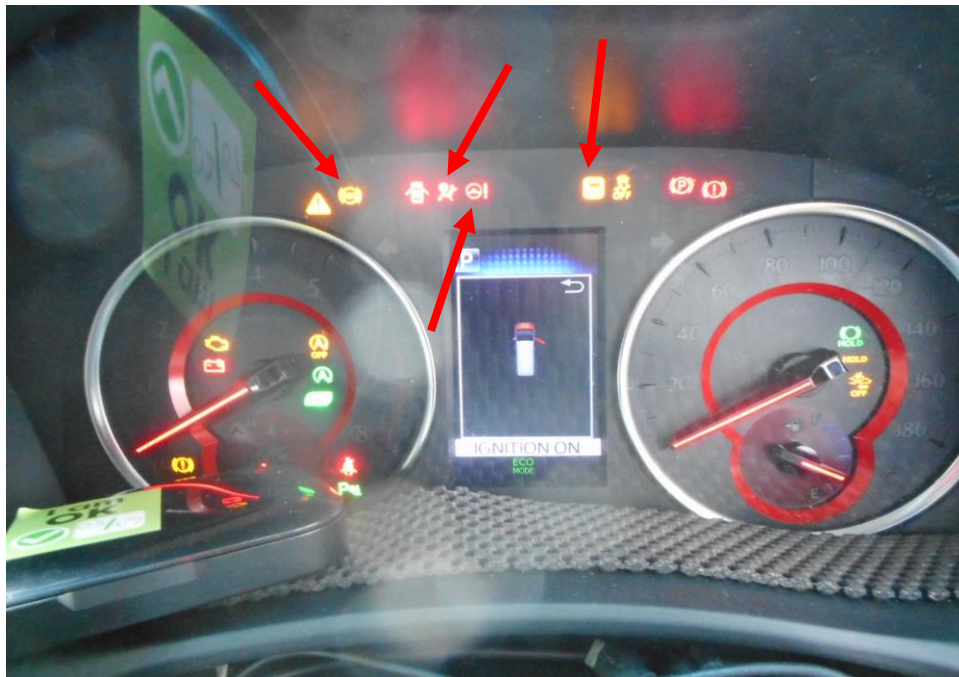
**Photo 24** shows the warning light for Anti-Lock Brake System (ABS) and Power Steering System (EPS), Supplemental Restraint System (SRS) and Traction Control (TC) (arrowed) appearing on the instrument panel of the Motor Car during the self-test of its various electronic operating systems when its engine was cranked.

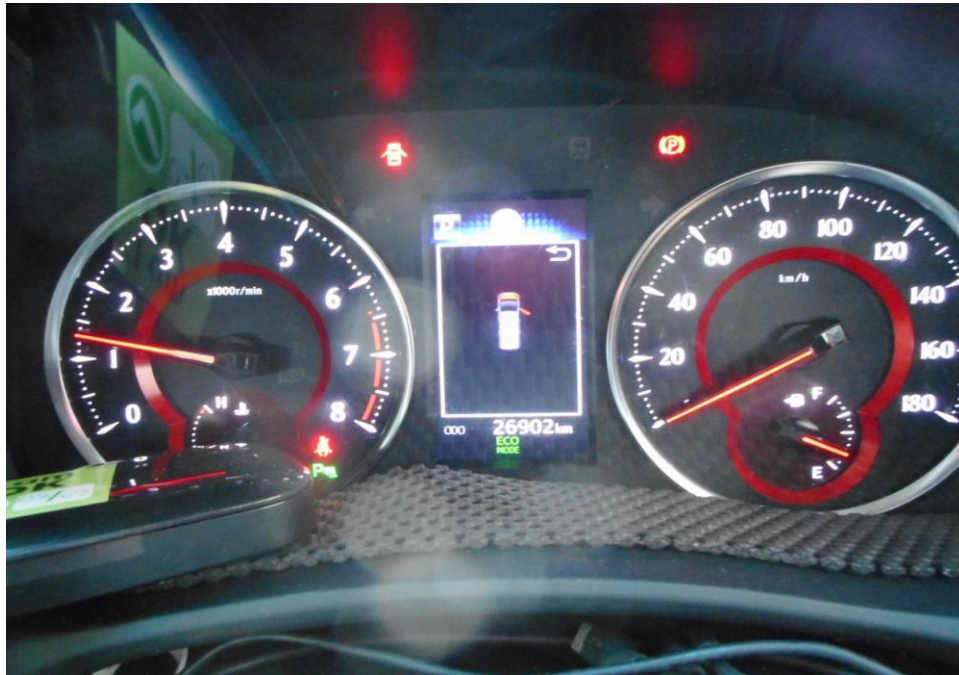
**Photo 25** shows no warning lights illuminated on the instrument panel of the Motor Car after the engine was cranked. This would suggest that there was no abnormality to the electronic operating system of the Motor Car, like the ABS, EPS, TC and SRS etc.
