Your Ref: TP/IP/42901/2020
Our Ref : CI/TPD20011022/P

9th December 2020

MECHANICAL INSPECTION REPORT OF MOTOR CAR SJH 2723Z

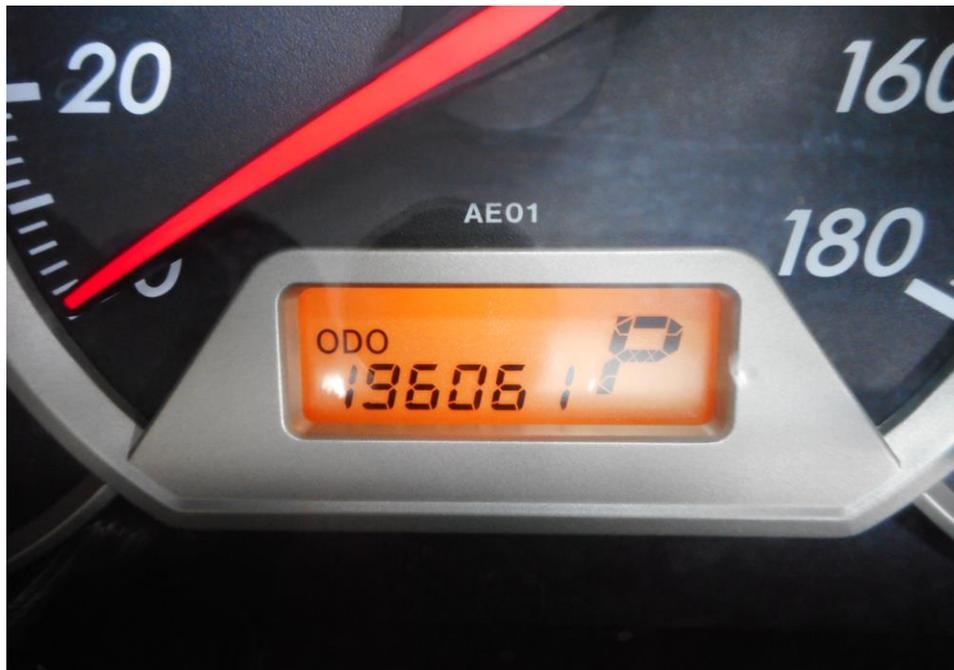
4. The mileage of the Motor Car at the time of my inspection was 196,061km.
5. The Motor Car was observed to have sustained damage at its rear portion. Its rear bonnet and bumper was the body part that were damaged as a result of the accident.

Photo 1 shows a general view of the instrument cluster of the Motor Car at the time of my inspection. The mileage of the Motor Car was 196,061km

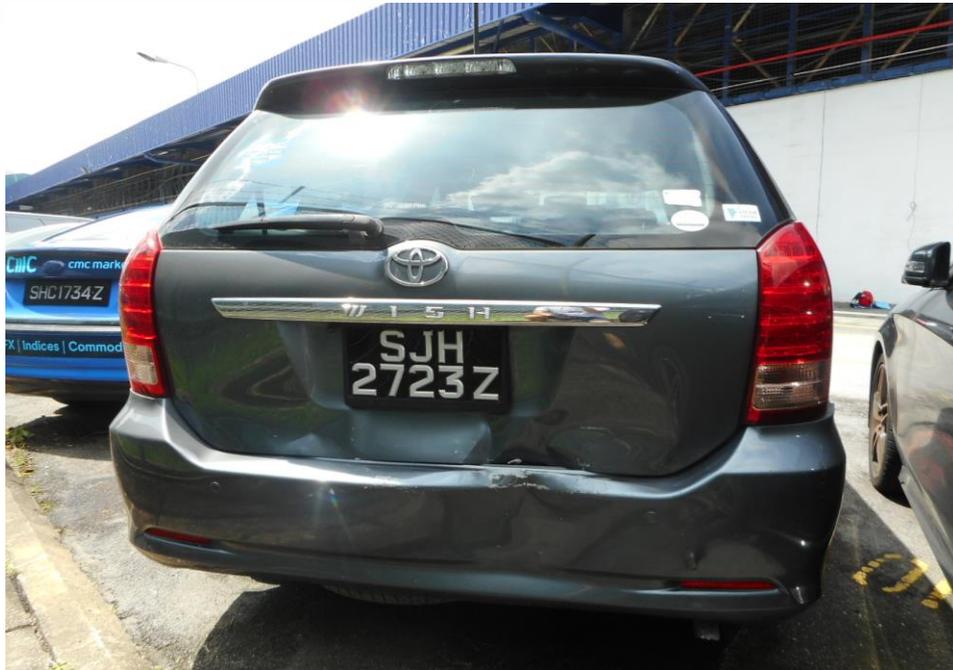
Photo 2 shows a general view of the Motor Car rear portion at the time of my inspection. The Motor Car was observed to visually sustain damage at its rear bonnet and rear bumper at the time of inspection.

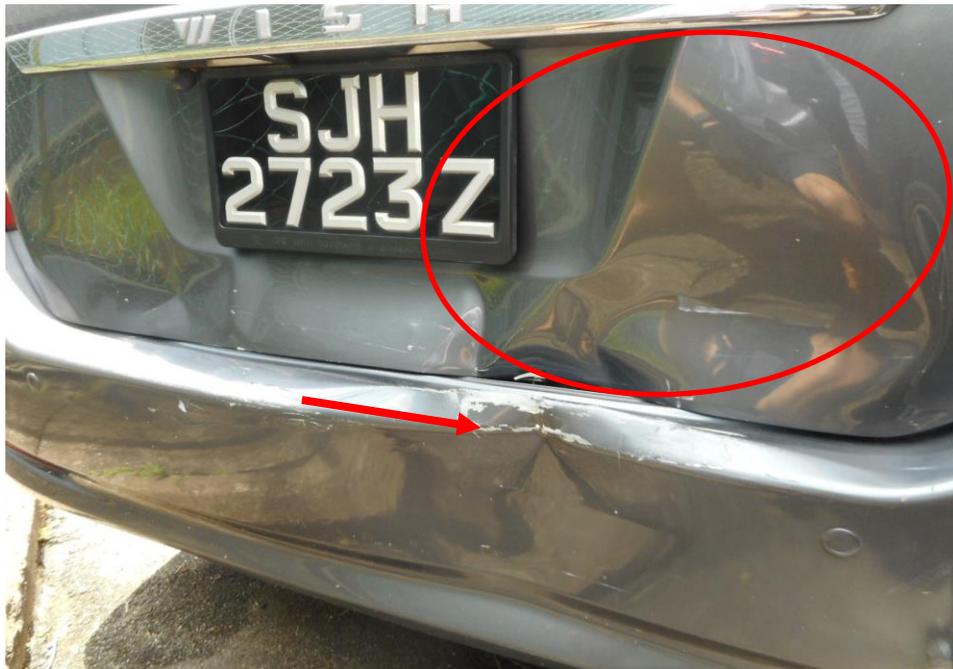
Photo 3 shows a close up view of the rear body of the Motor Car at the time of my inspection. The Motor Car was observed to visually sustain damage at its rear bonnet (circled) and rear bumper (arrowed) at the time of inspection.

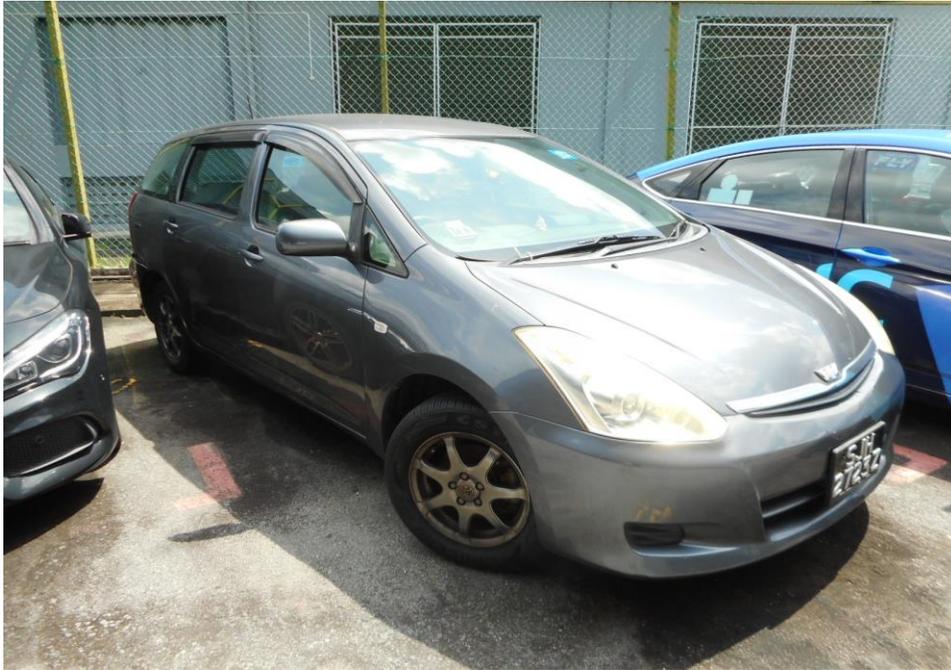
Photo 4 shows a general view of the right body of the Motor Car at the time of my inspection. The Motor Car was observed to be intact and unaffected by the accident.

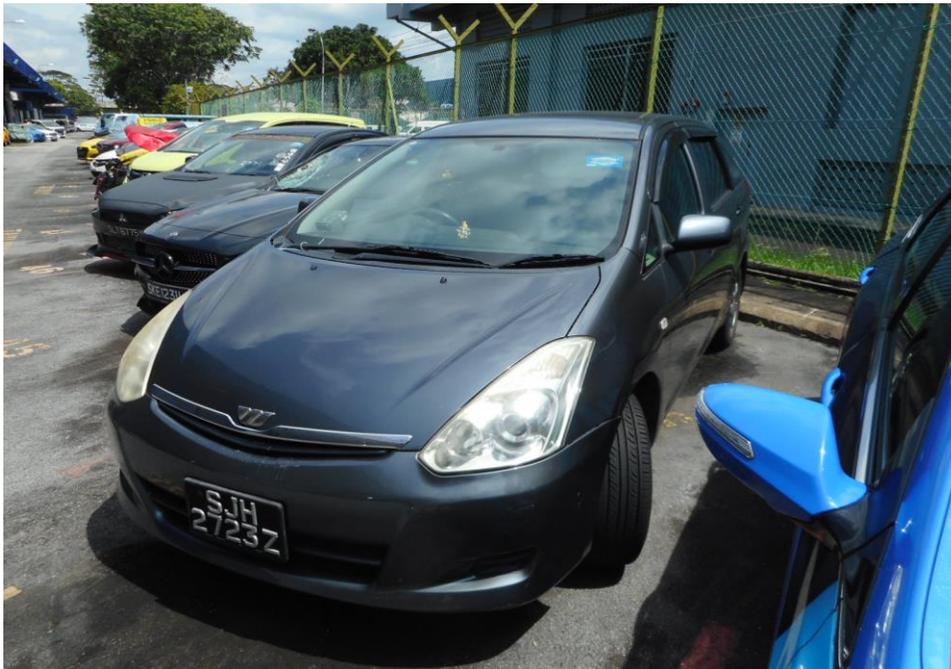
Photo 5 shows a general view of the left body of the Motor Car at the time of my inspection. The Motor Car was observed to be intact and unaffected by the accident.

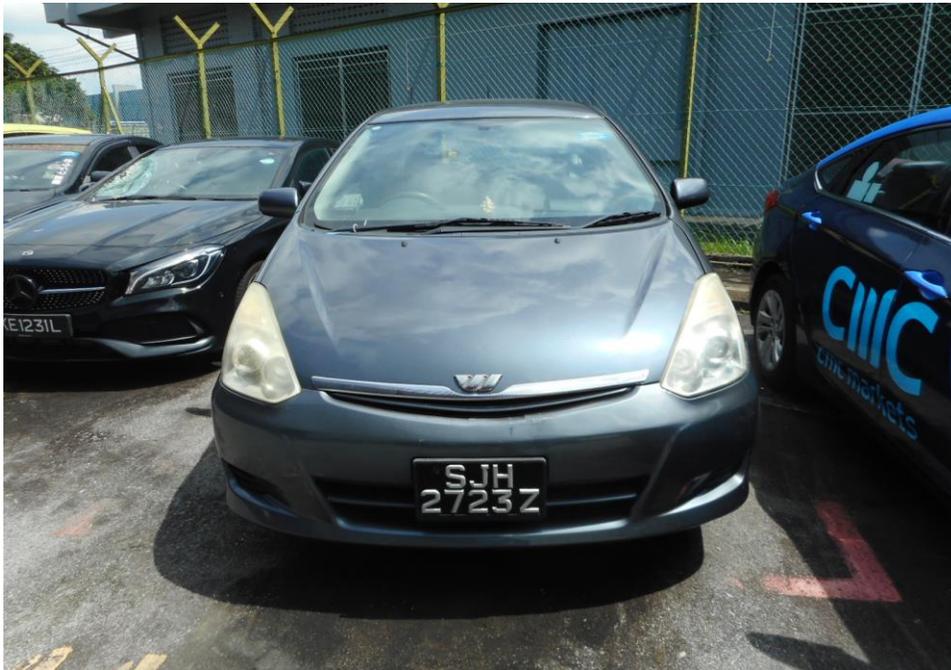
Photo 6 shows a general view of the front body of the Motor Car at the time of my inspection. The Motor Car was observed to be intact and unaffected by the accident.

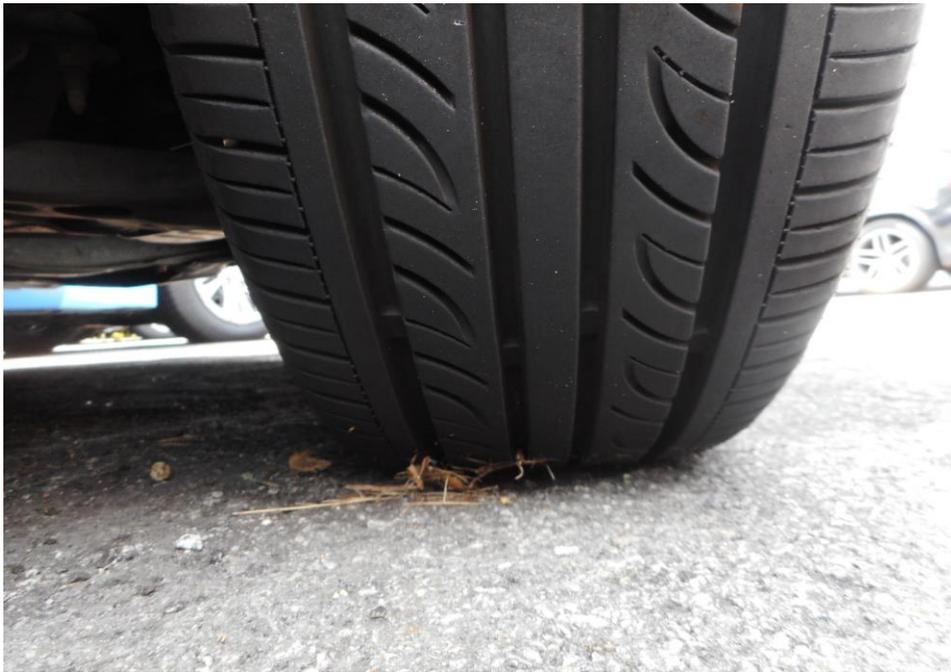
Photo 7 shows the condition of the front right tyre of the Motor Car, which was observed to be in serviceable condition with remaining tread depth of approximately 6.5mm. The tyre, which was wrapped around standard alloy wheel rim, was also observed to be sufficiently inflated for vehicular operation. There was no tear, cut or burst mark(s) on the outer and the inner sidewalls as well as across the tread of the 4 tyres that were fitted on the Motor Car.

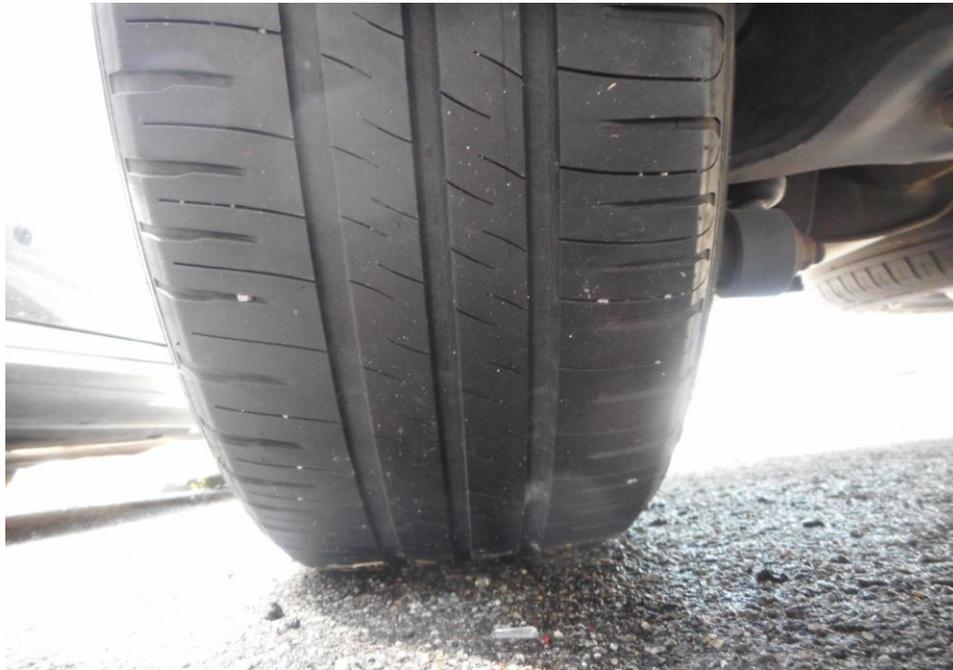
Photo 8 shows the condition of the rear right tyre of the Motor Car, which was observed to be in serviceable condition with remaining tread depth of approximately 3.3mm. The tyre, which was wrapped around standard alloy wheel rim, was also observed to be sufficiently inflated for vehicular operation.

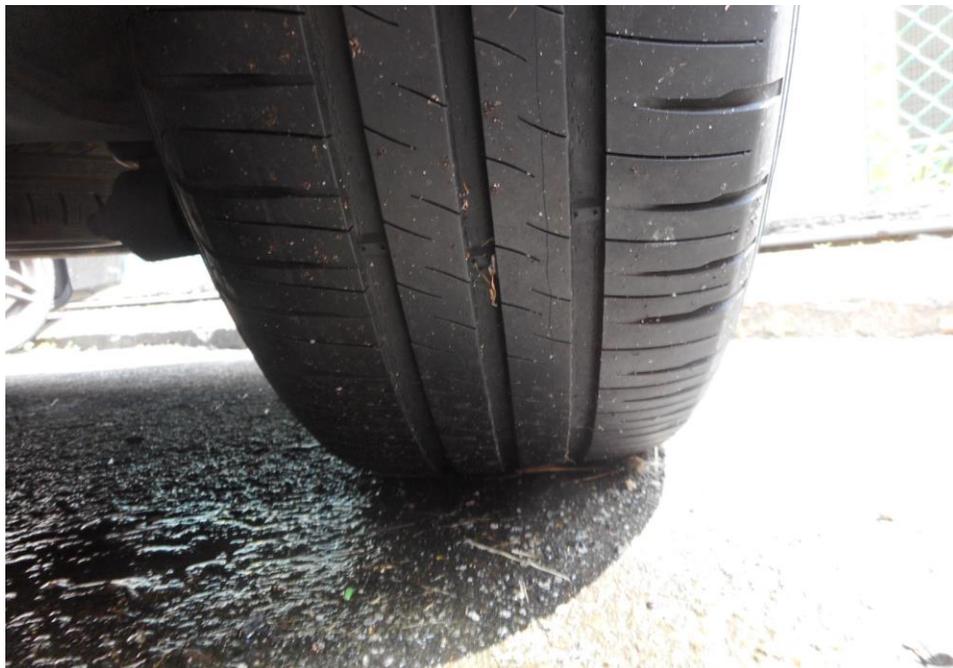
Photo 9 shows the condition of the rear left tyres of the Motor Car, which was observed to be in serviceable condition with remaining tread depth of approximately 4.2mm. The tyres, which were wrapped around standard alloy wheel rim, were also observed to be sufficiently inflated for vehicular operation. There was also no damage found on all 4 alloy wheel rims of the Motor Car.

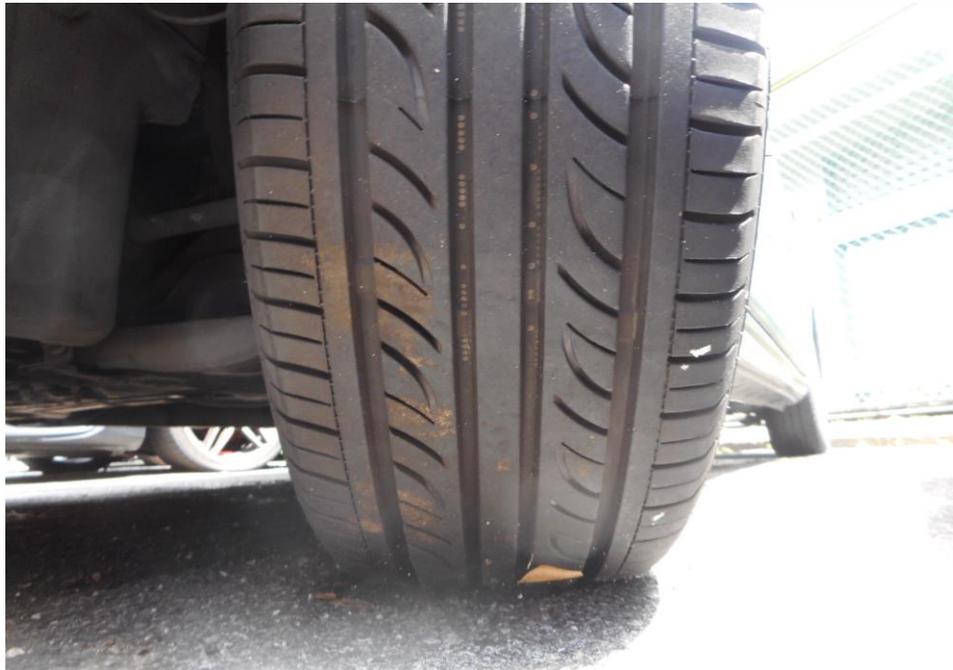
Photo 10 shows the condition of the rear right tyres of the Motor Car, which were observed to be in serviceable condition with remaining, tread depth of approximately 4.9 mm. There was also no tear, cut or burst mark(s) on the outer and the inner sidewalls as well as across the tread of the 4 tyres that were fitted on the Motor Car.

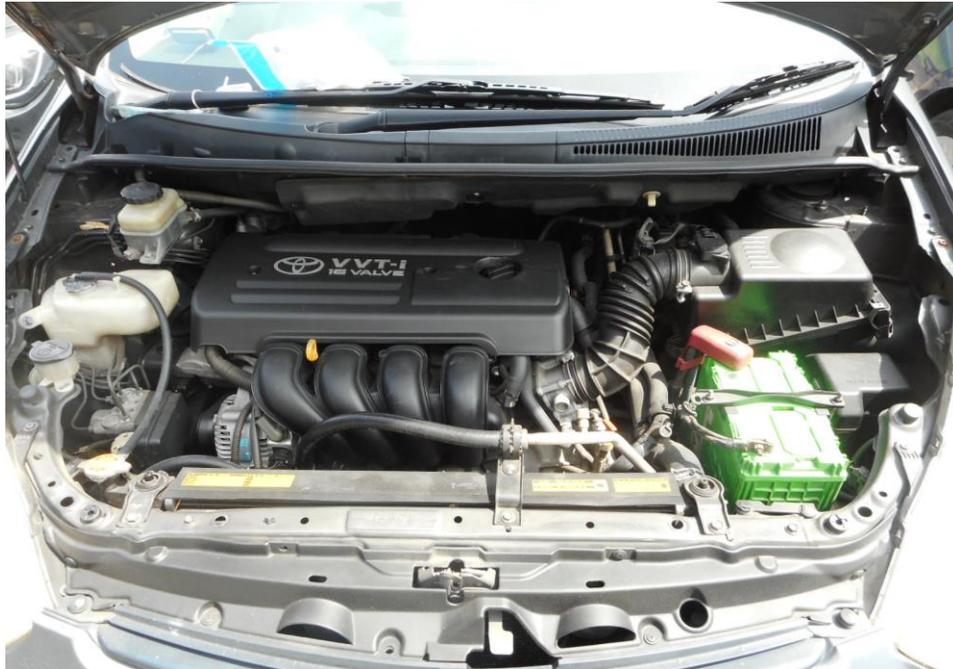
Photo 11 shows a general view of the Motor Car's engine compartment, which was accessed by lifting the front cabin of the Motor Car. The various parts and components inside the engine compartment were unaffected by the accident. There was also no sign(s) or indication(s) of fresh fluid leakage and/or fluid stain within the engine compartment

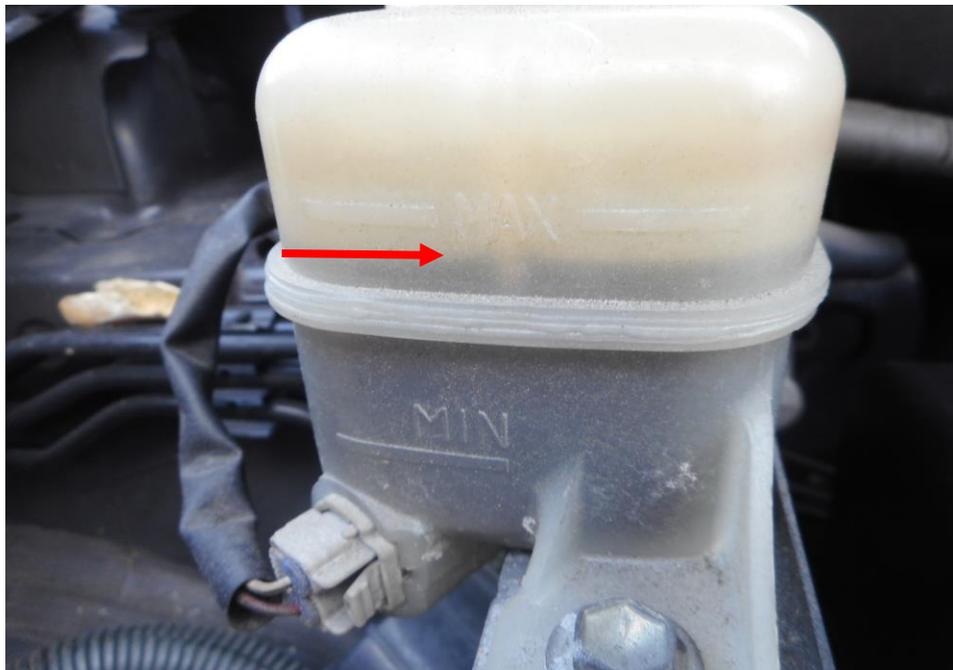
Photo 12 shows the brake fluid reservoir of the Motor Car at the time of my inspection. The brake fluid was observed to be of sufficient level (arrowed) and without any visible contamination.

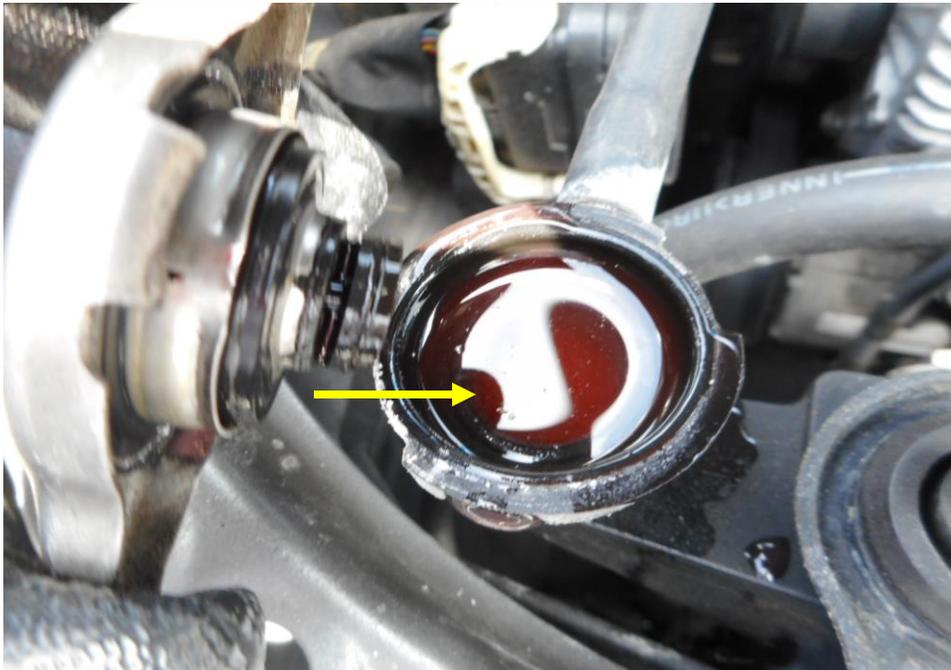
Photo 13 shows the engine coolant reservoir of the Motor Car at the time of my inspection. The engine coolant was observed to be of sufficient level (arrowed) and without any visible contamination.

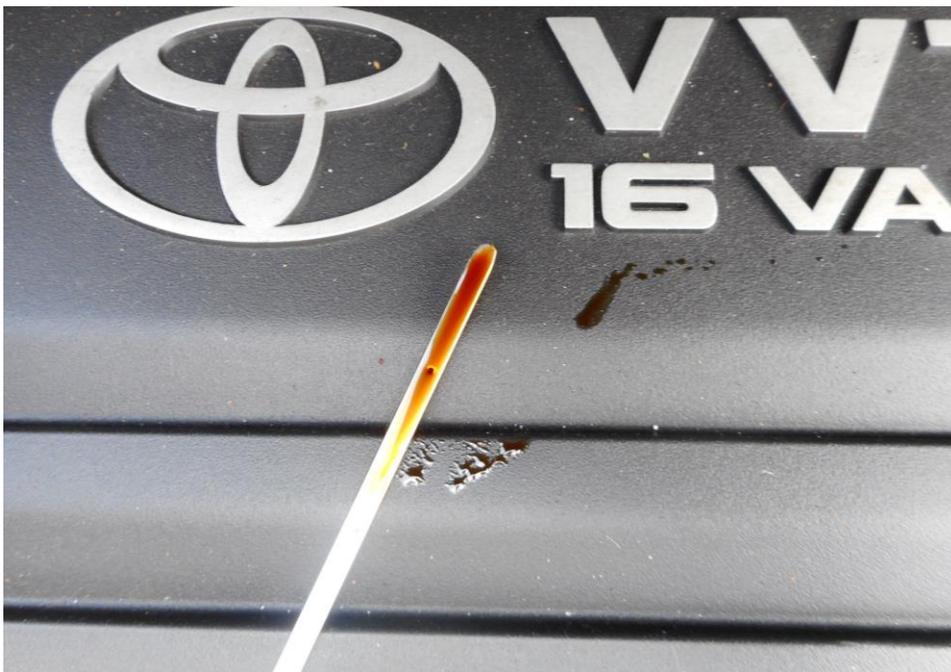
Photo 14 shows the engine oil dip stick of the Motor Car at the time of my inspection. The engine oil was observed to be of sufficient level and without any visible contamination.

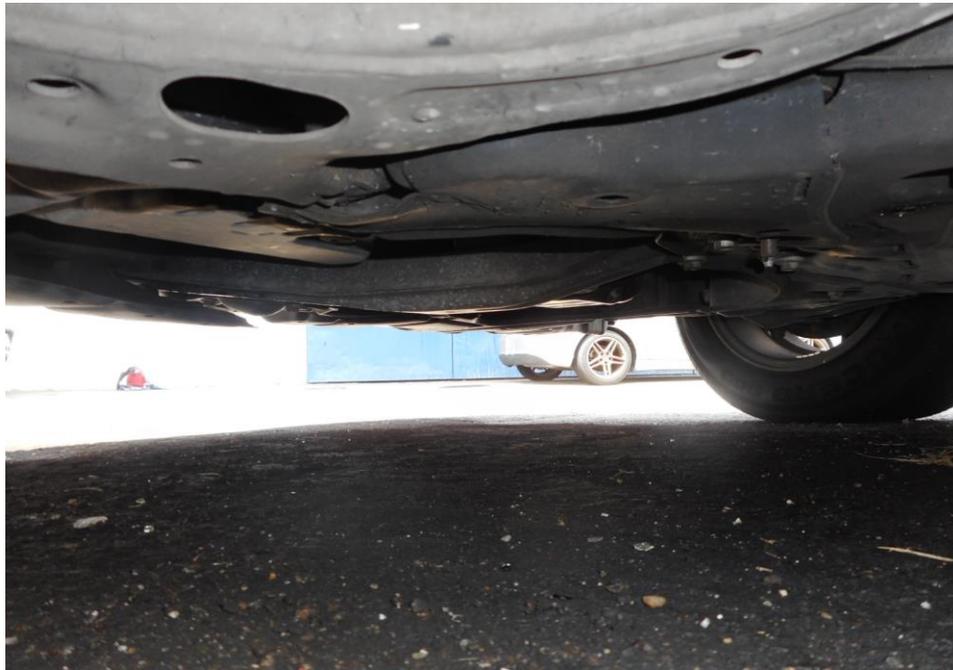
Photo 15 shows the undercarriage of the Motor Car, at the area where the engine housing and transmission housing are located. . I did not find any sign(s) or indication(s) of fluid leak and/or fluid stain(s) on the underside of the Motor Car.

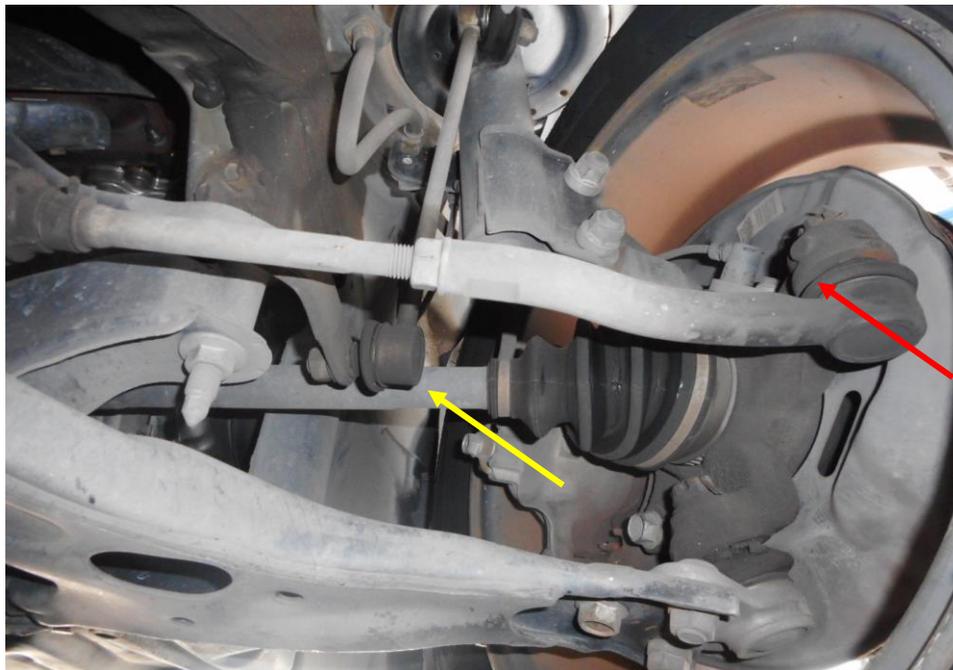
Photo 16 shows the various undercarriage components at the front right wheel of the Motor Car, in particular the steering tie rod end (red arrow) and drive shaft (yellow arrow). The various steering components were all found to be intact, suggesting that the steering system of the Motor Car was likely to be in serviceable condition at the material time of accident. There was also no sign of fluid stain(s) observed on the various undercarriage components.

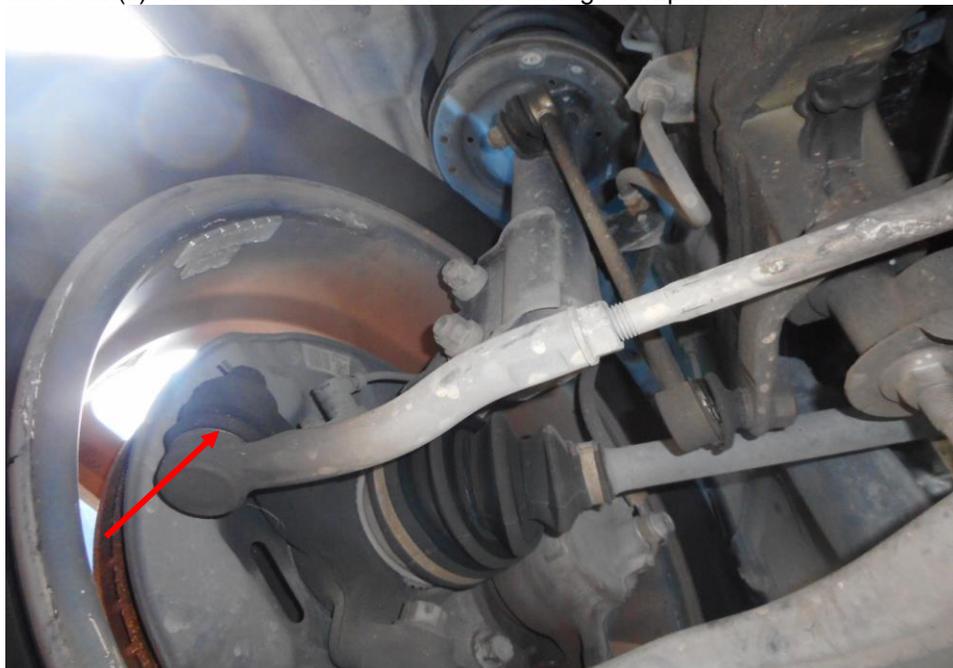
Photo 17 shows the various undercarriage components at the front left wheel of the Motor Car, in particular the steering tie rod end (arrowed). The various Undercarriage components of the Motor Car were all found to be intact without any visible damage. There was also no sign of fluid stain(s) observed on the various undercarriage components.

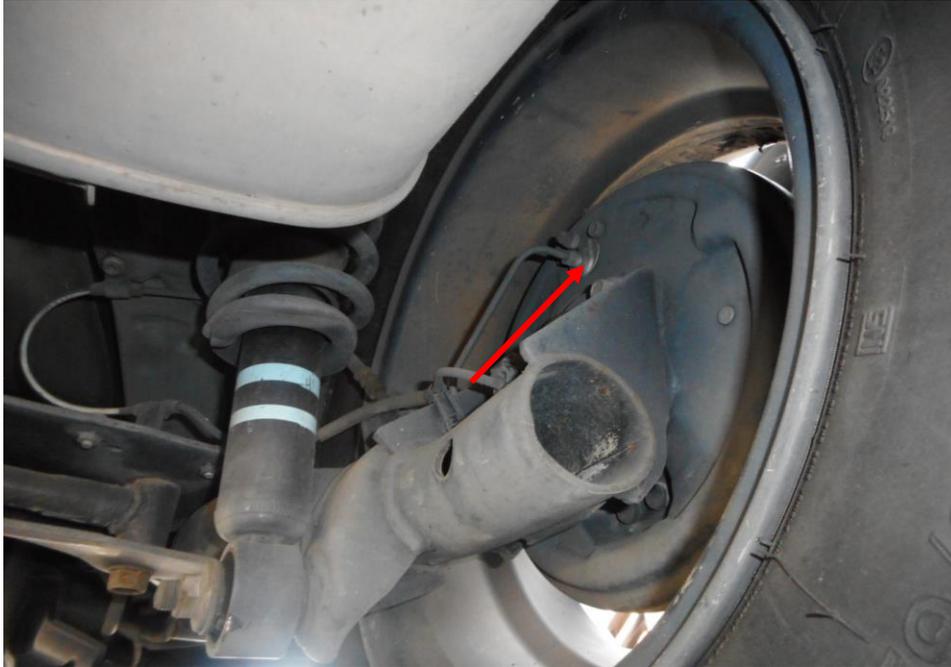
Photo 18 shows the brake pipe (arrowed) at the rear right wheel of the Motor Car. I did not observe any leakage of brake fluid at the time of my inspection of the Motor Car. My static tests of the Motor Car's braking system, along with my visual examination of the various mechanical components in the braking system, had indicated that there was no internal leakage of pressure/vacuum. Hence the braking system of the Motor Car was likely to be in serviceable condition at the material time of accident.

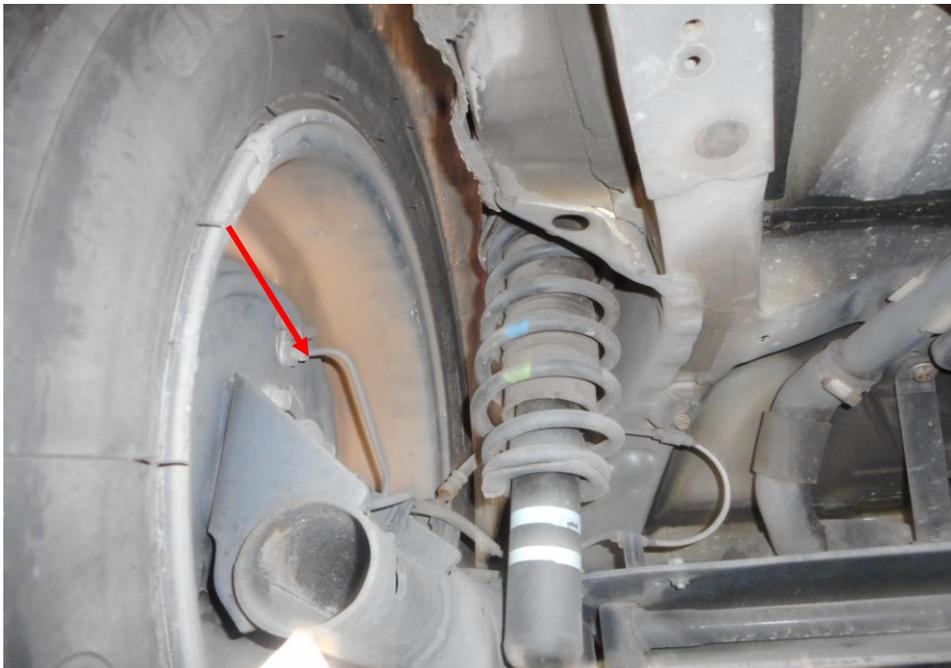
Photo 19 shows the brake pipe (arrowed) at the rear left wheel of the Motor Car. I did not observe any leakage of brake fluid at the time of my inspection of the Motor Car. My static tests of the Motor Car's braking system, along with my visual examination of the various mechanical components in the braking system had indicated that there was no internal leakage of pressure/vacuum. Hence the braking system of the Motor Car was likely to be in serviceable condition at the material time of accident.

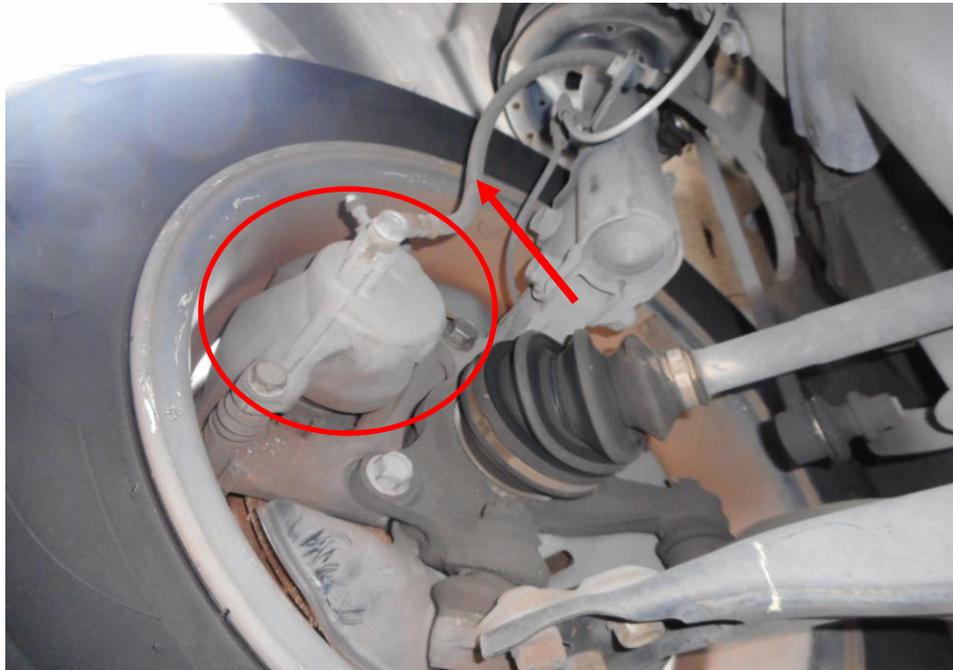
Photo 20 shows the brake hose/pipe (arrowed) at the front right wheel of the Motor Car. No leakage of brake fluid was observed. Visual examination of the various components of the braking system like the brake caliper (circled), brake booster, brake pedal etc had revealed all to be intact and without visible damage at the time of accident. There was also no sign of fluid stain(s) observed on the various undercarriage components.

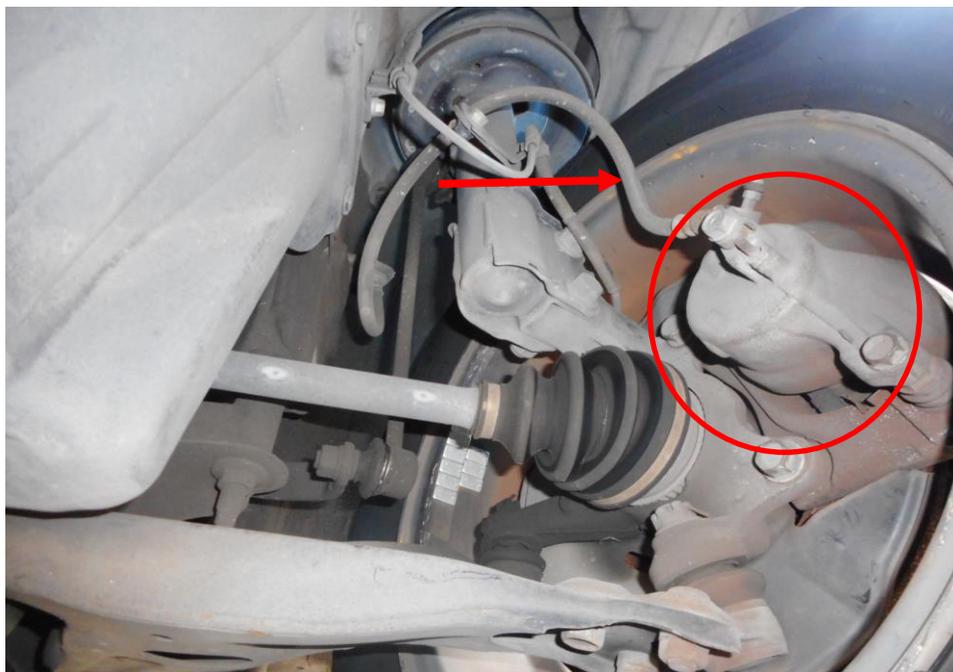
Photo 21 shows the brake hose/pipe (arrowed) at the front left wheel of the Motor Car. No leakage of brake fluid was observed. Visual examination of the various components of the braking system like the brake caliper (circled), brake booster, brake pedal etc had revealed all to be intact and without visible damage at the time of accident. There was also no sign of fluid stain(s) observed on the various undercarriage components.

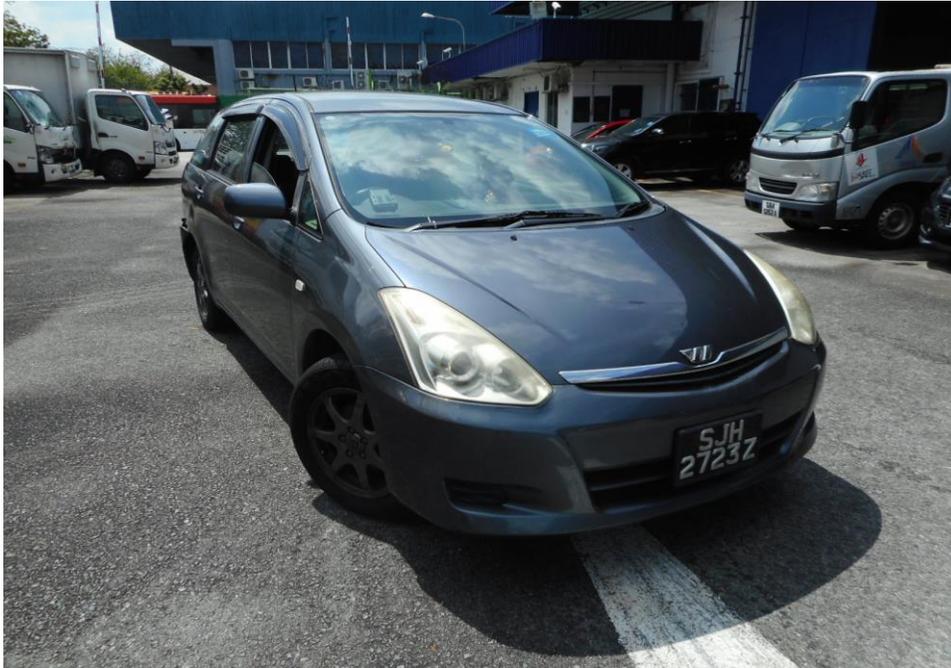
Photo 22 shows the front right wheel of the Motor Car turned to its full left. During my steering system test, I did not experience any abnormal free play and/or resistance when I had turned the steering wheel towards full left and full right. This would suggest that the steering system of the Motor Car was likely to be in serviceable condition at the material time of accident.

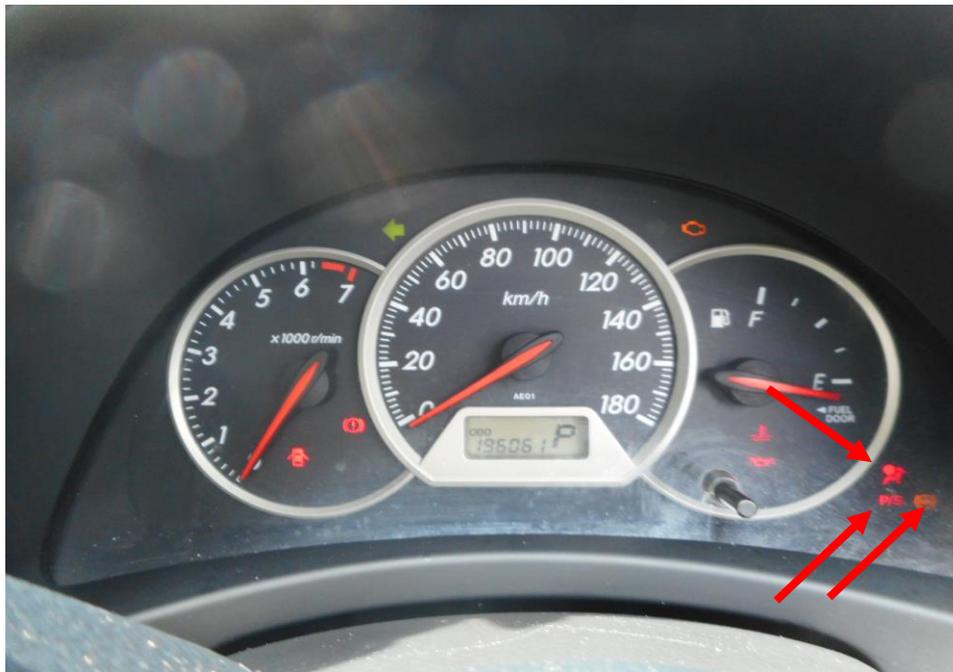
13. Motor Car's automatic self-test of the functionality of its various electronic operating systems like the Anti-Lock Brake System (ABS), Supplemental Restraint System (SRS) and Electric Power Steering System (EPS) during cranking of the engine had indicated that these systems were in working condition and without abnormality. This can be established from the warning lights disappearing from the instrument panel after the self-test. See photo 23 & 24 below.

Photo 23 shows the warning light for Anti-Lock Brake System (ABS), Supplemental Restraint System (SRS) Electric Power Steering System (EPS) appearing on the instrument panel of the Motor Car during the self-test of its various electronic operating systems when its engine was cranked.

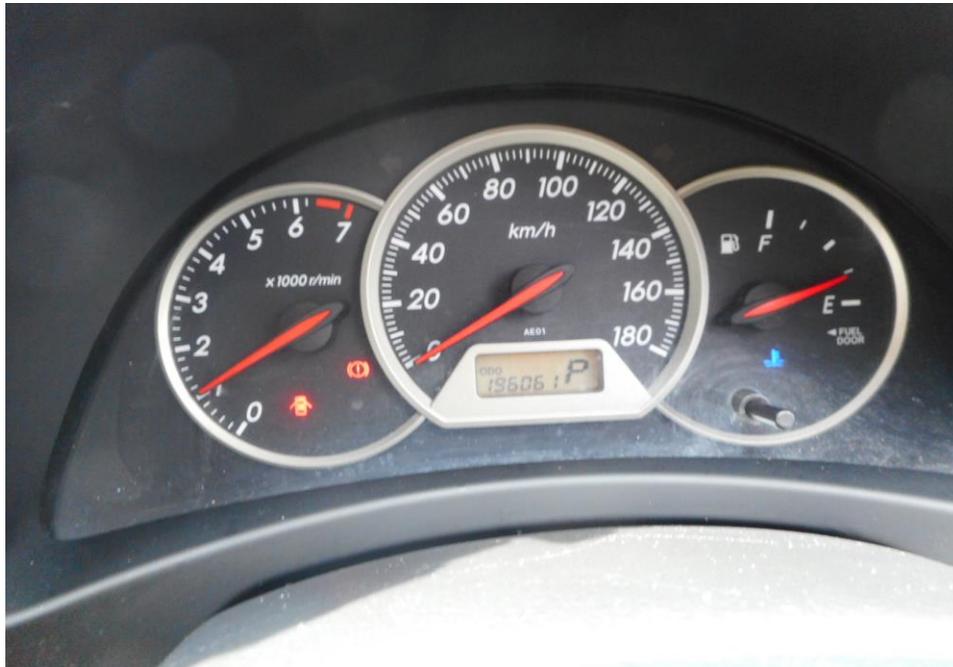
Photo 24 shows no warning lights illuminated on the instrument panel of the Motor Car after the engine was cranked. This would suggest that there was no abnormality to the various electronic operating systems of the Motor Car, like the ABS, SRS and EPS.
