Your Ref: TP/IP/43023/2020  
Our Ref: CI/TPD20011023/P

13<sup>th</sup> January 2021

**General Investigation Team**

**MECHANICAL INSPECTION REPORT OF MOTOR LORRY WITH CRANE  
XD 6513S**

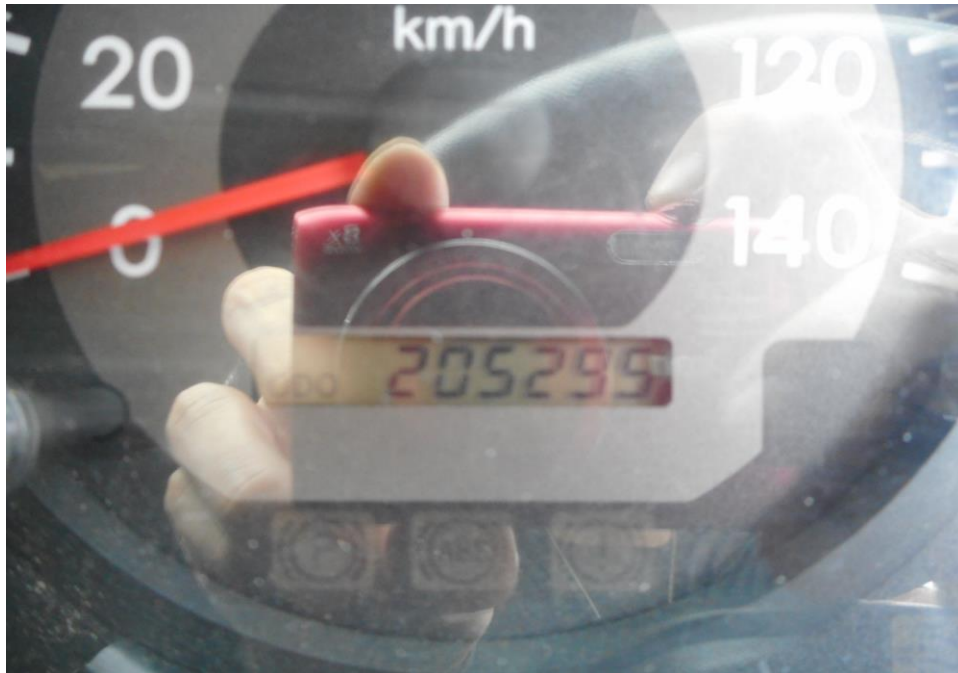
**Photo 1** shows a general view of the instrument cluster of the Motor Lorry at the time of my inspection. The mileage of the Motor Lorry was 205,295km

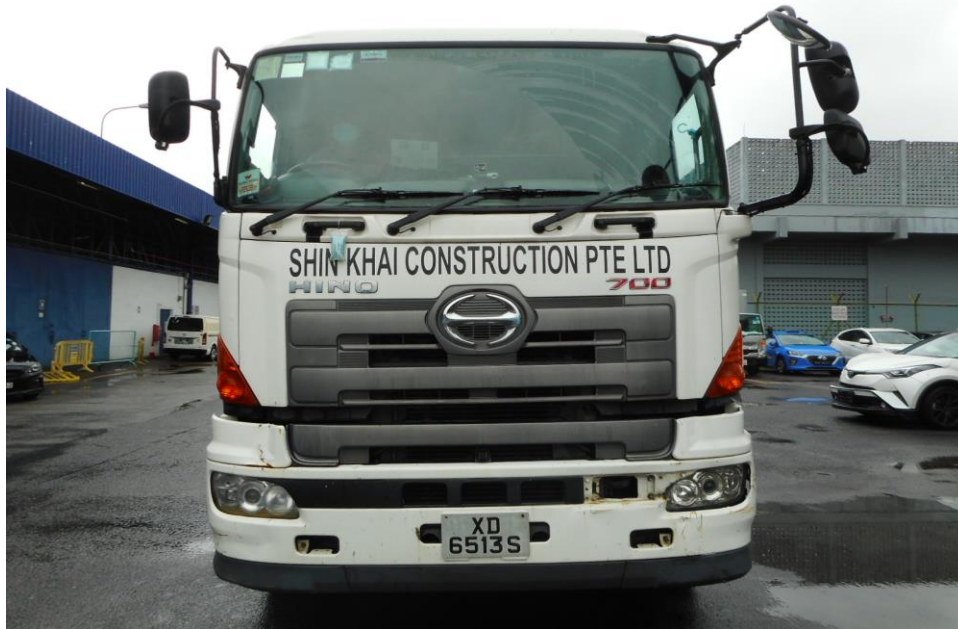
**Photo 2** shows a general view of the Motor Lorry at the time of my inspection. The Motor Lorry was observed to be intact and unaffected by the accident.

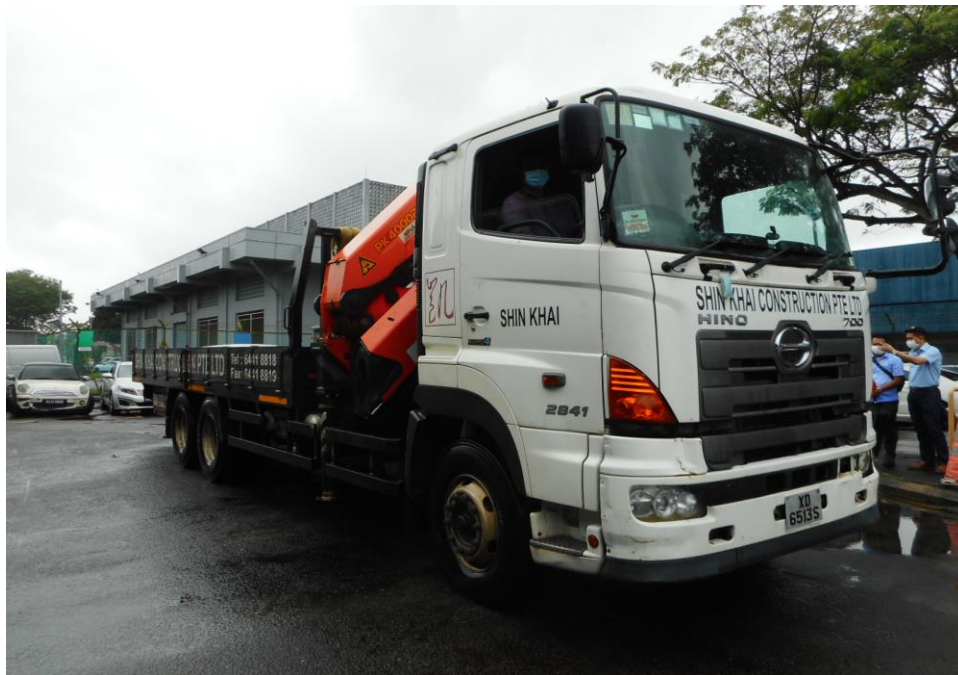
**Photo 3** shows a general view of the right body of the Motor Lorry at the time of my inspection. The Motor Lorry was observed to be intact and unaffected by the accident.

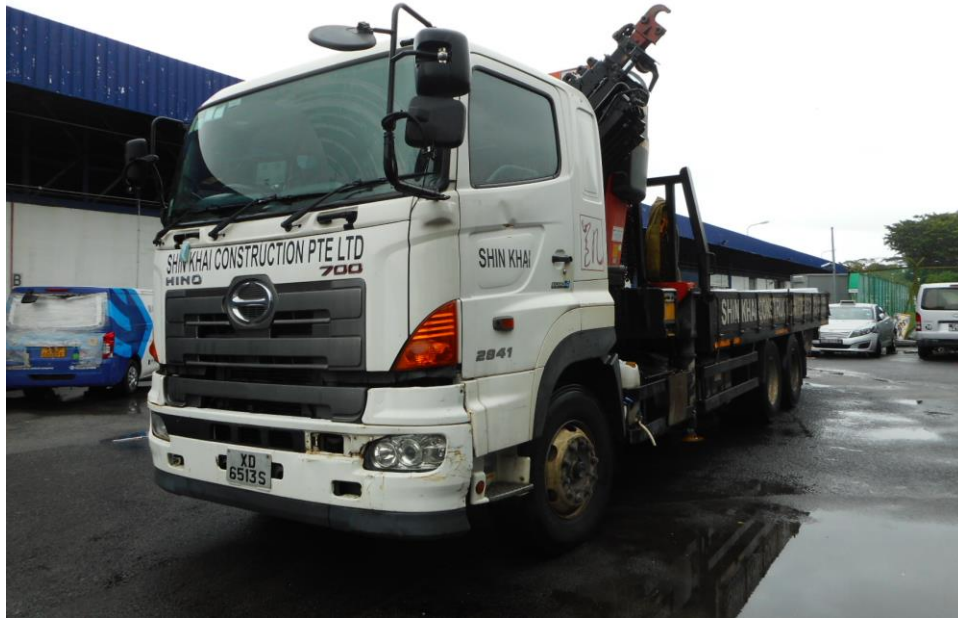
**Photo 4** shows a general view of the left body of the Motor Lorry at the time of my inspection. The Motor Lorry was observed to be intact and unaffected by the accident.

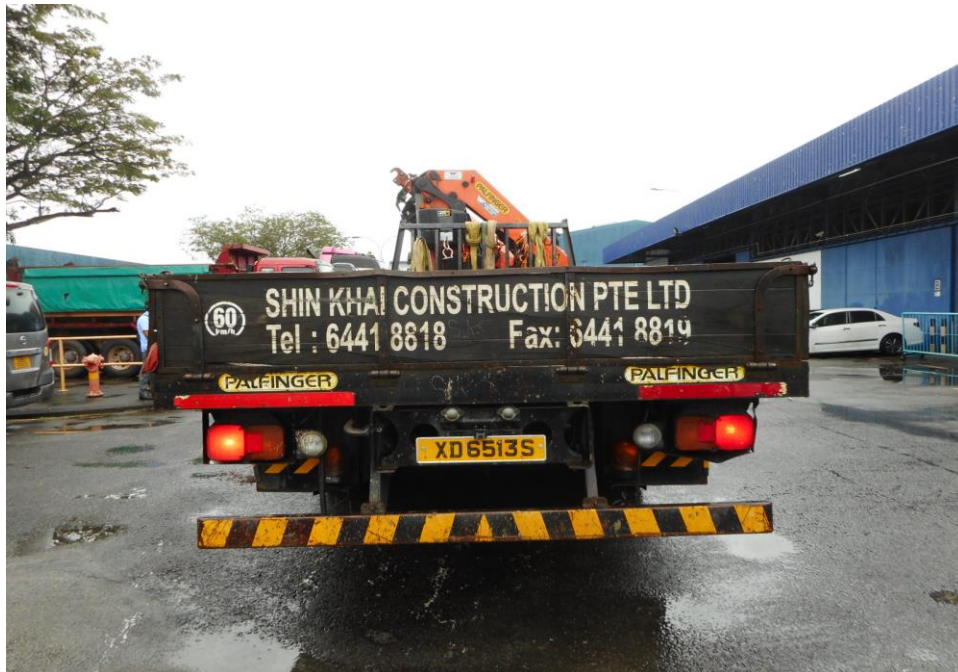
**Photo 5** shows a general view of the rear body of the Motor Lorry at the time of my inspection. The Motor Lorry was observed to be intact and unaffected by the accident.

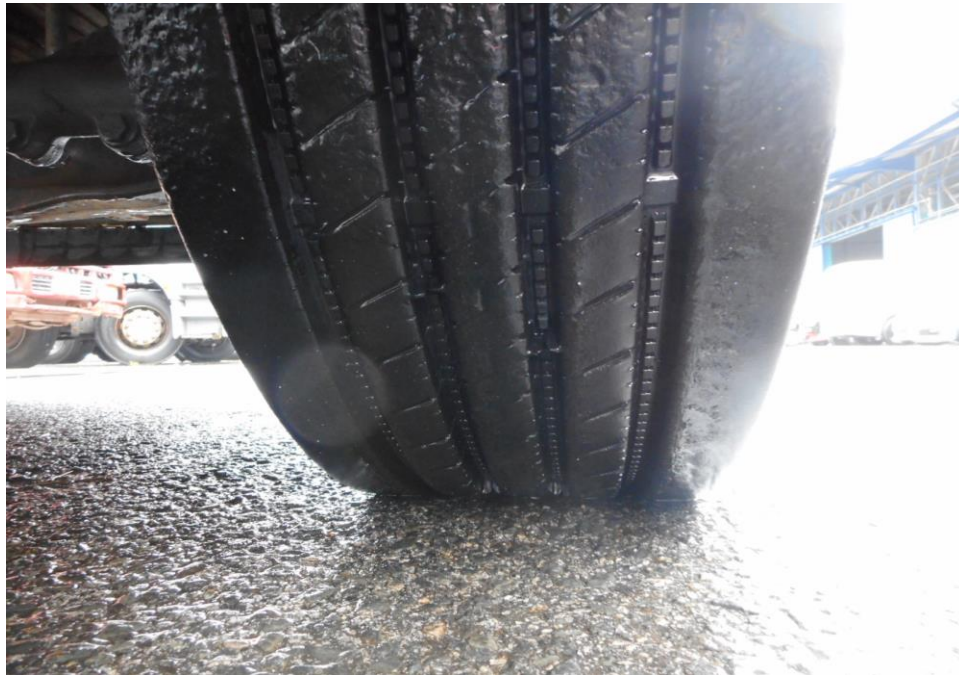
**Photo 6** shows the condition of the front right tyre of the Motor Lorry, which was observed to be in serviceable condition with remaining tread depth of approximately 13.5mm. The tyre, which was wrapped around standard steel wheel rim, was also observed to be sufficiently inflated for vehicular operation. There was no tear, cut or burst mark(s) on the outer and the inner sidewalls as well as across the tread of the 10 tyres that were fitted on the Motor Lorry.

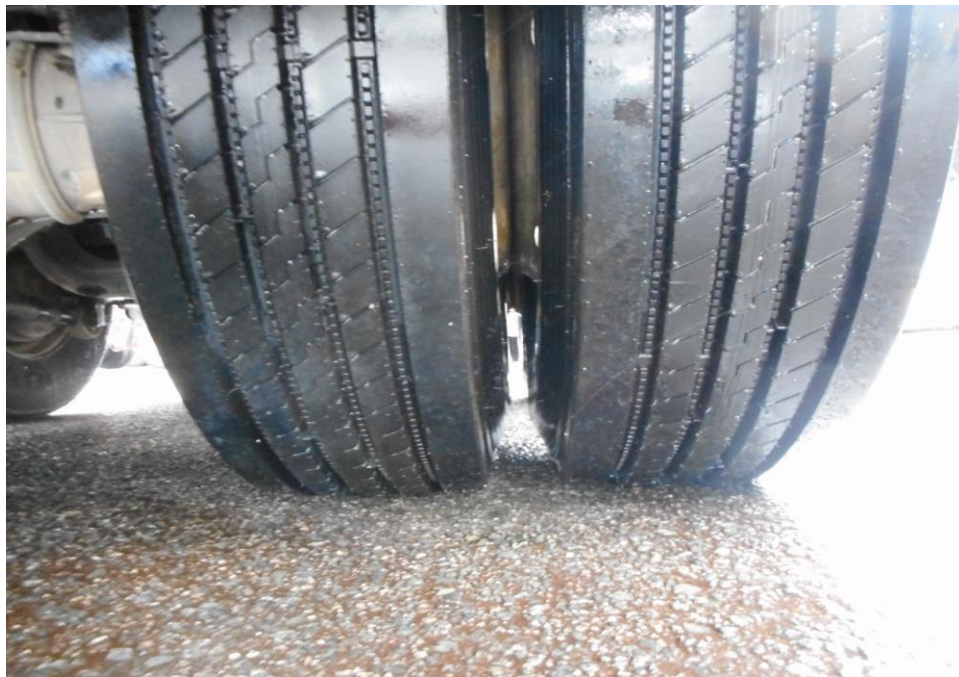
**Photo 7** shows the condition of the rear right tyre of the Motor Lorry, which was observed to be in serviceable condition with remaining tread depth of approximately 10.9mm. The tyre, which was wrapped around standard steel wheel rim, was also observed to be sufficiently inflated for vehicular operation.

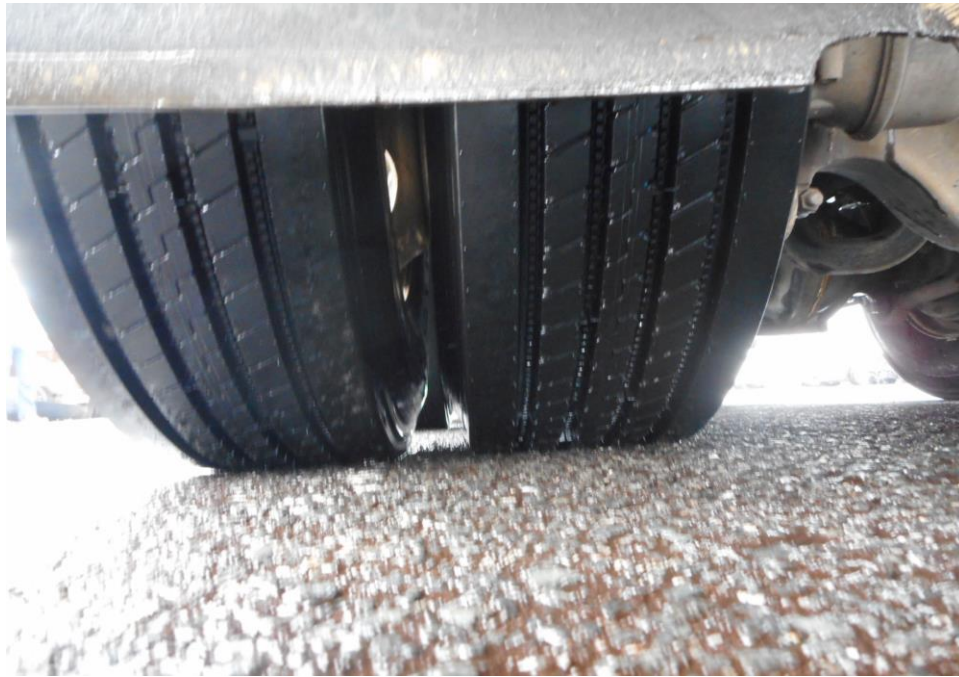
**Photo 8** shows the condition of the rear left tyres of the Motor Lorry, which was observed to be in serviceable condition with remaining tread depth of approximately 11.4mm. The tyres, which were wrapped around standard steel wheel rim, were also observed to be sufficiently inflated for vehicular operation. There was also no damage found on all 10 steel wheel rims of the Motor Lorry.

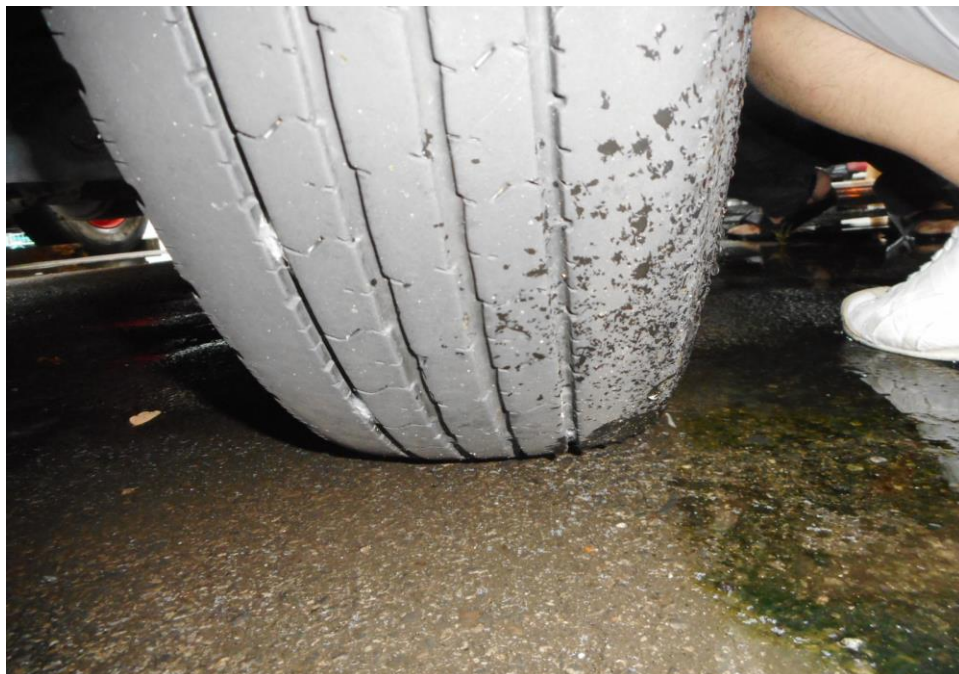
**Photo 9** shows the condition of the rear right tyres of the Motor Lorry, which were observed to be in serviceable condition with remaining, tread depth of approximately 4.5mm. There was also no tear, cut or burst mark(s) on the outer and the inner sidewalls as well as across the tread of the 10 tyres that were fitted on the Motor Lorry.

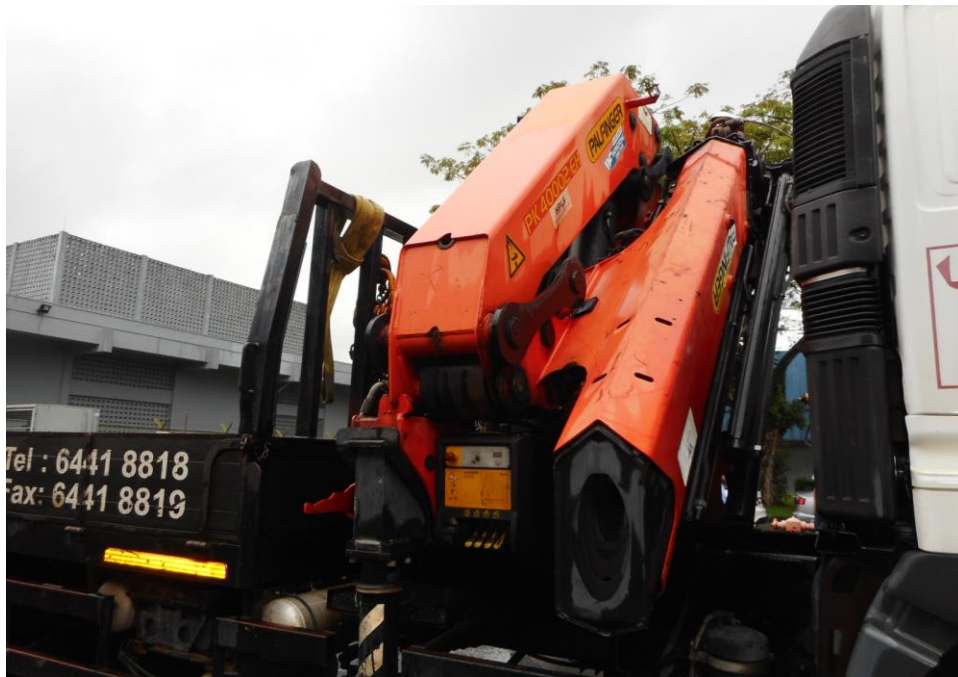
**Photo 10** shows a general view of the Motor Lorry's Crane from the right side at the time of my inspection. The Crane was observed to be intact and unaffected by the accident.

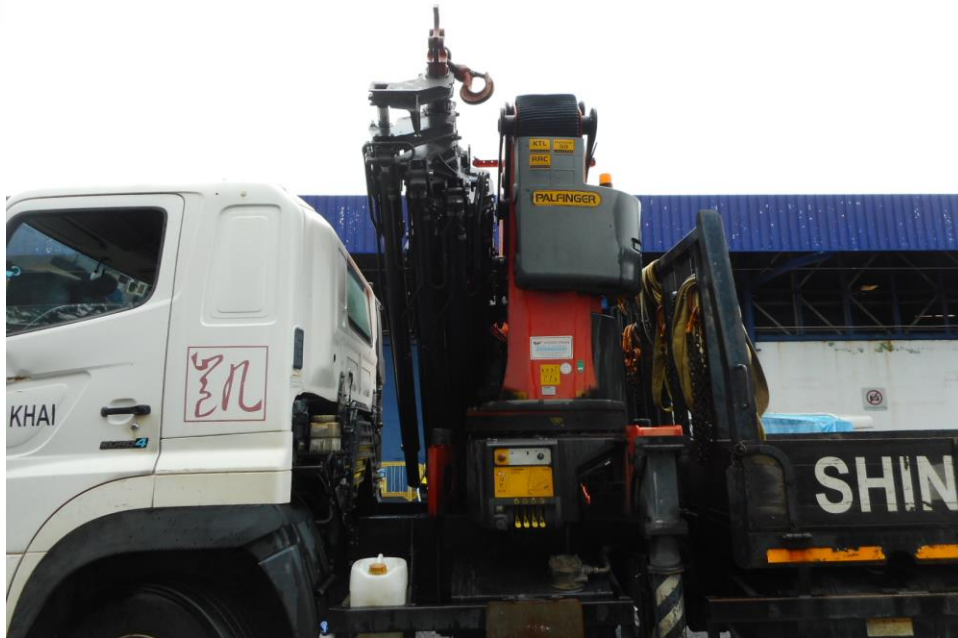
**Photo 11** shows a general view of the Motor Lorry's Crane from the right side at the time of my inspection. The Crane was observed to be intact and unaffected by the accident.

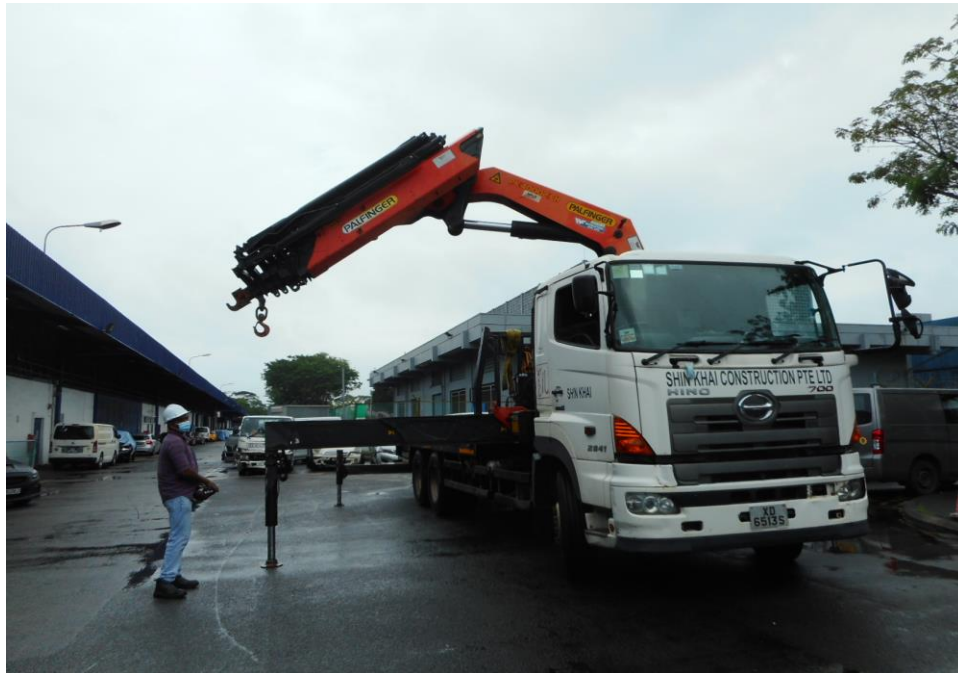
**Photo 12** shows a general view of the Motor Lorry's Crane at the time of my inspection. The Crane was observed to be operational and did not have any abnormalities when operating.

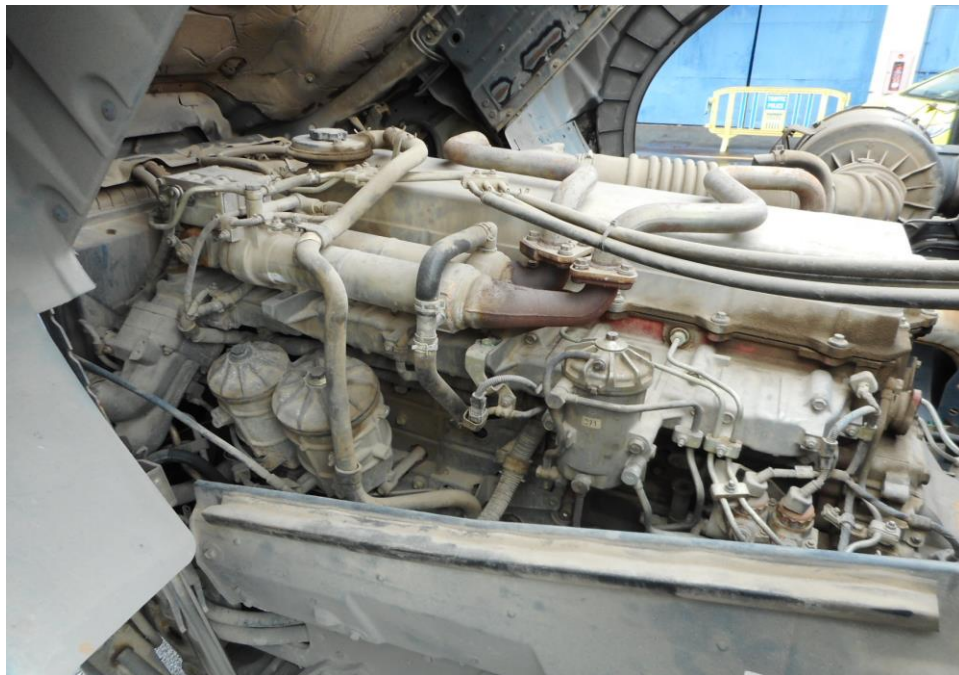
**Photo 13** shows a general view of the Motor Lorry's engine compartment, which was accessed by lifting the front cabin of the Motor Lorry. The various parts and components inside the engine compartment were unaffected by the accident. There was also no sign(s) or indication(s) of fresh fluid leakage and/or fluid stain within the engine compartment

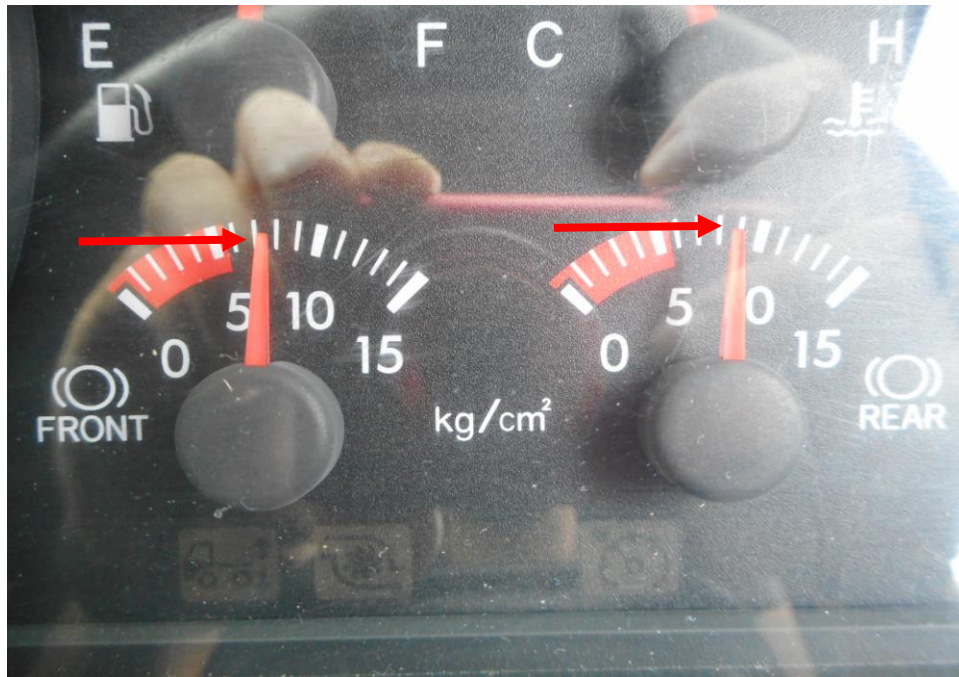
**Photo 14** shows the air-brake reservoir of the Motor Lorry at the time of my inspection. The air-brake was observed to be of sufficient level (arrowed) and without any visible contamination.

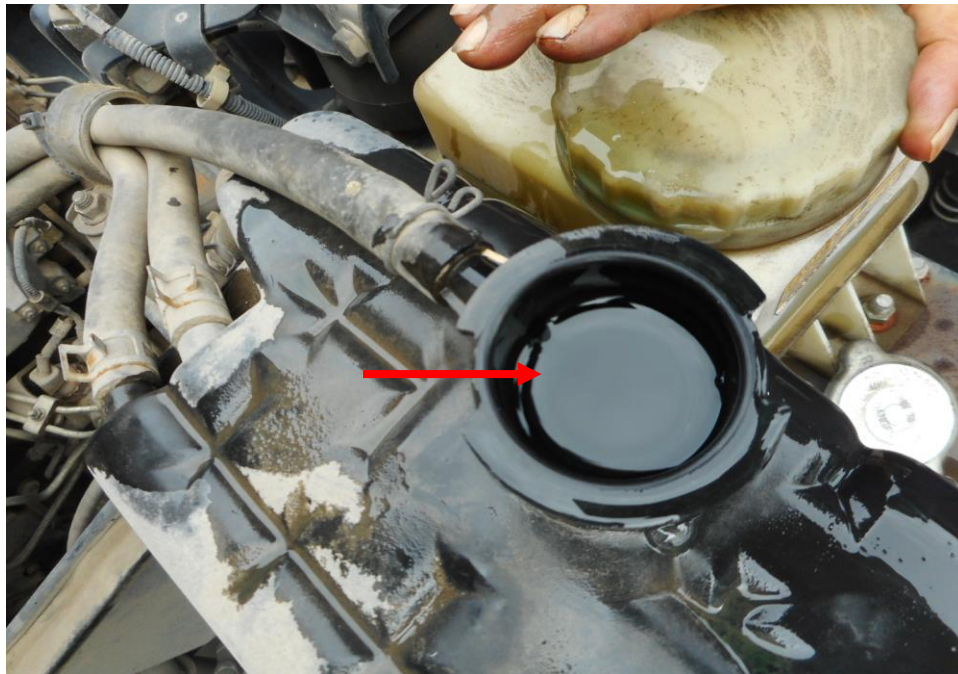
**Photo 15** shows the engine coolant reservoir of the Motor Lorry at the time of my inspection. The engine coolant was observed to be of sufficient level (arrowed) and without any visible contamination.

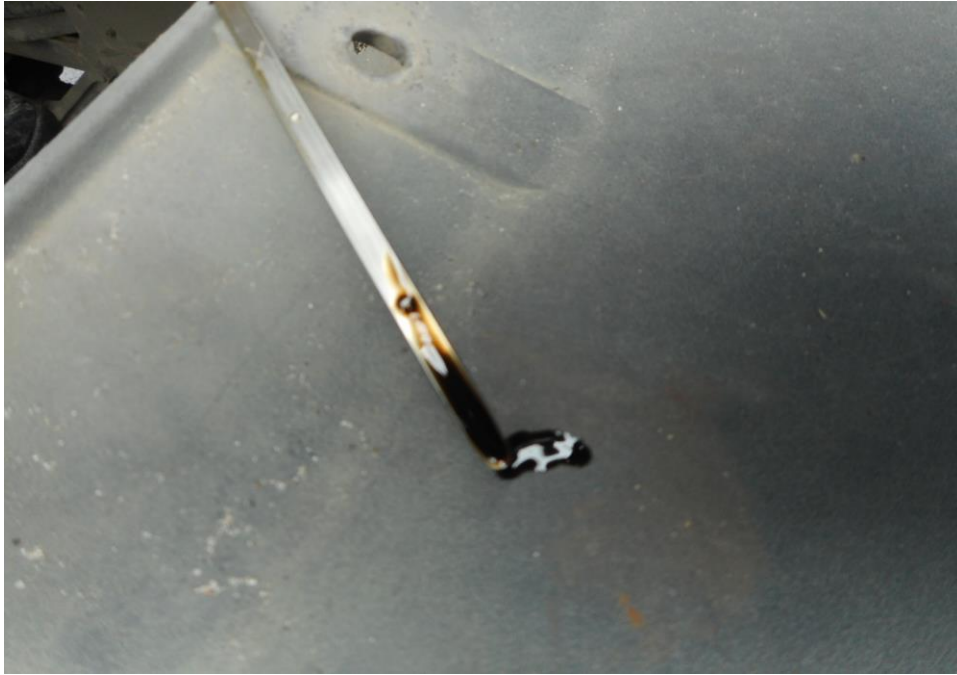
**Photo 16** shows the engine oil dip stick of the Motor Lorry at the time of my inspection. The engine oil was observed to be of sufficient level and without any visible contamination.

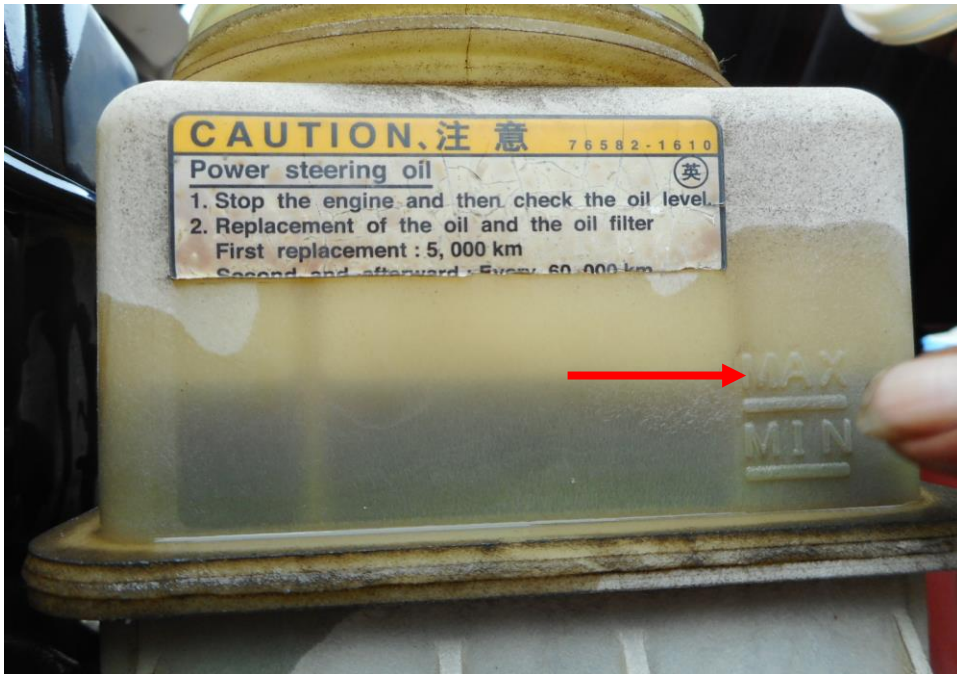
**Photo 17** shows the power steer fluid reservoir of the Motor Lorry at the time of my inspection. The power steering fluid was observed to be of sufficient level (arrowed) and without any visible contamination.

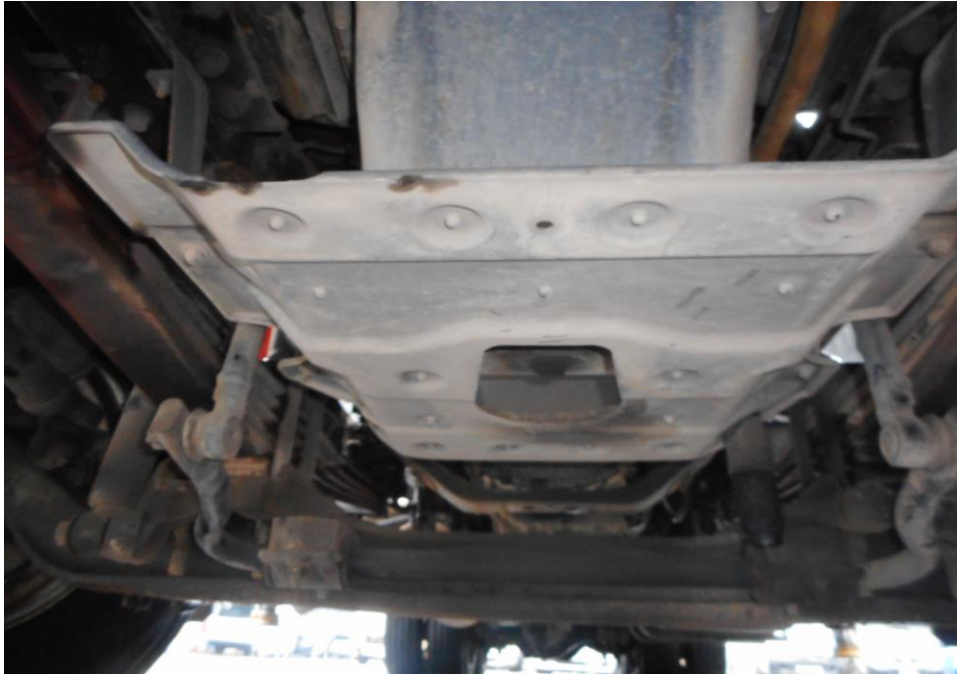
**Photo 18** shows the undercarriage of the Motor Lorry, at the area where the engine housing and transmission housing are located. I did not find any sign(s) or indication(s) of fluid leak and/or fluid stain(s) on the underside of the Motor Lorry.

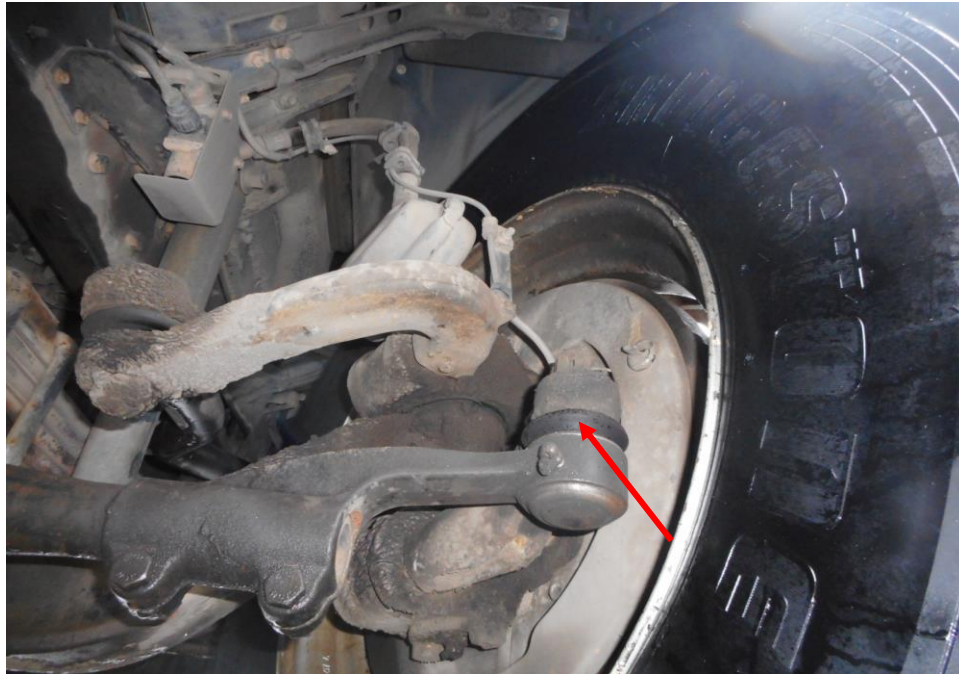
**Photo 19** shows the various undercarriage components at the front right wheel of the Motor Lorry, in particular the steering tie rod end (arrowed). The various steering components were all found to be intact, suggesting that the steering system of the Motor Lorry was likely to be in serviceable condition at the material time of accident. There was also no sign of fluid stain(s) observed on the various undercarriage components.

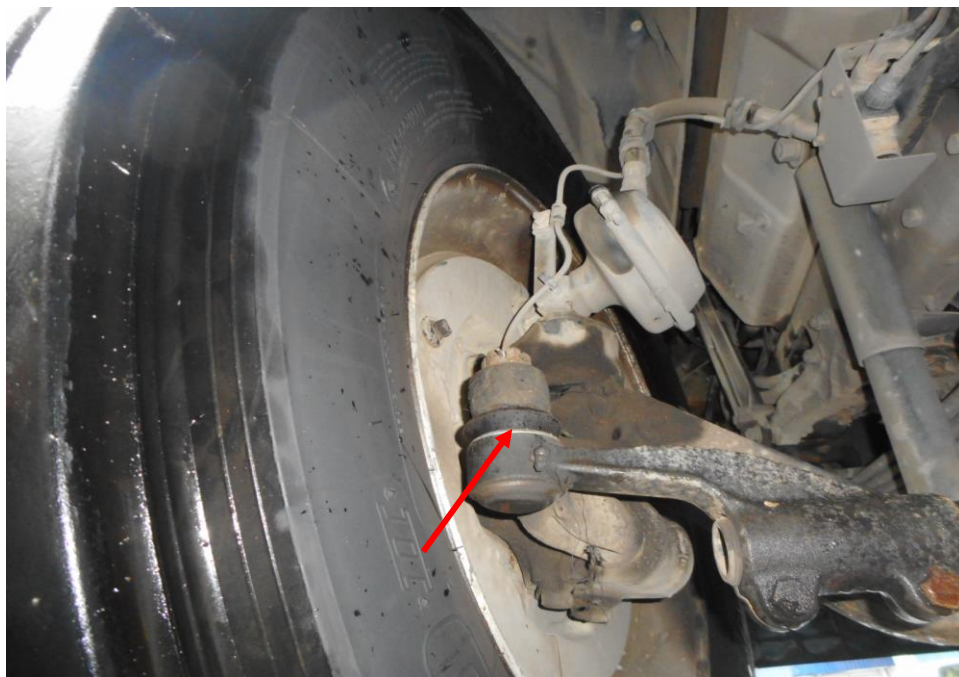
**Photo 20** shows the various undercarriage components at the front left wheel of the Motor Lorry, in particular the steering tie rod end (arrowed). The various Undercarriage components of the Motor Lorry were all found to be intact without any visible damage. There was also no sign of fluid stain(s) observed on the various undercarriage components.

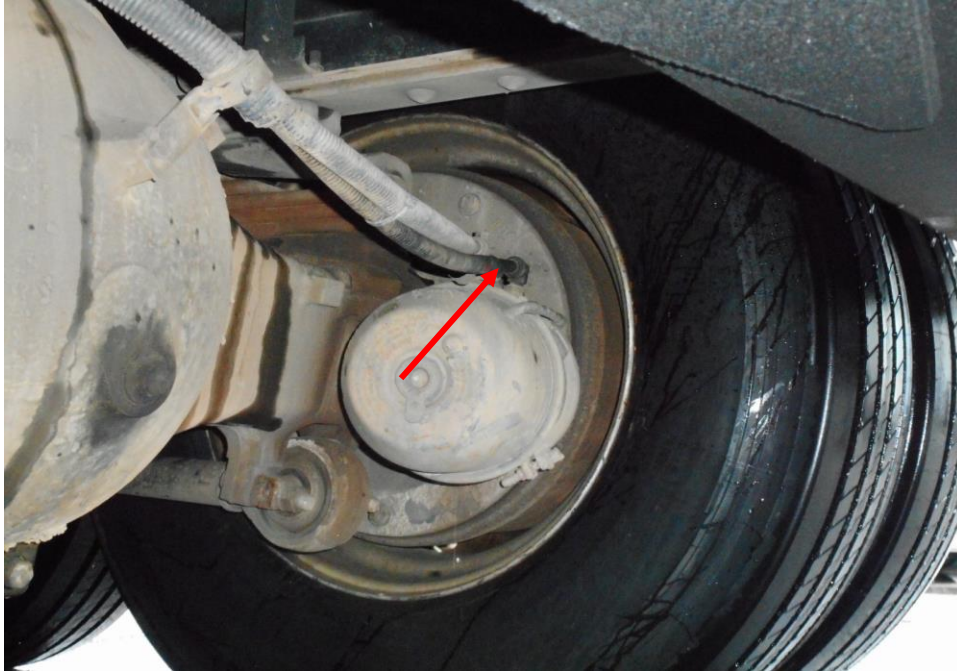
**Photo 21** shows the brake pipe (arrowed) at the rear right wheel of the Motor Lorry. I did not observe any leakage of brake fluid at the time of my inspection of the Motor Lorry. My static tests of the Motor Lorry's braking system, along with my visual examination of the various mechanical components in the braking system had indicated that there was no internal leakage of pressure/vacuum. Hence the braking system of the Motor Lorry was likely to be in serviceable condition at the material time of accident.

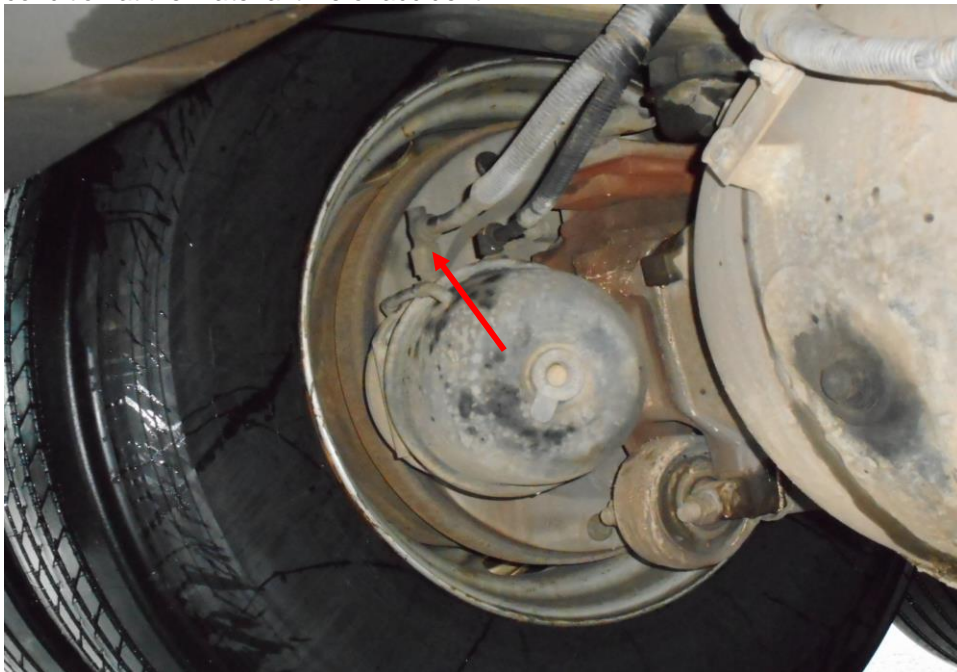
**Photo 22** shows the brake pipe (arrowed) at the rear left wheel of the Motor Lorry. I did not observe any leakage of brake fluid at the time of my inspection of the Motor Lorry. My static tests of the Motor Lorry's braking system, along with my visual examination of the various mechanical components in the braking system had indicated that there was no internal leakage of pressure/vacuum. Hence the braking system of the Motor Lorry was likely to be in serviceable condition at the material time of accident.

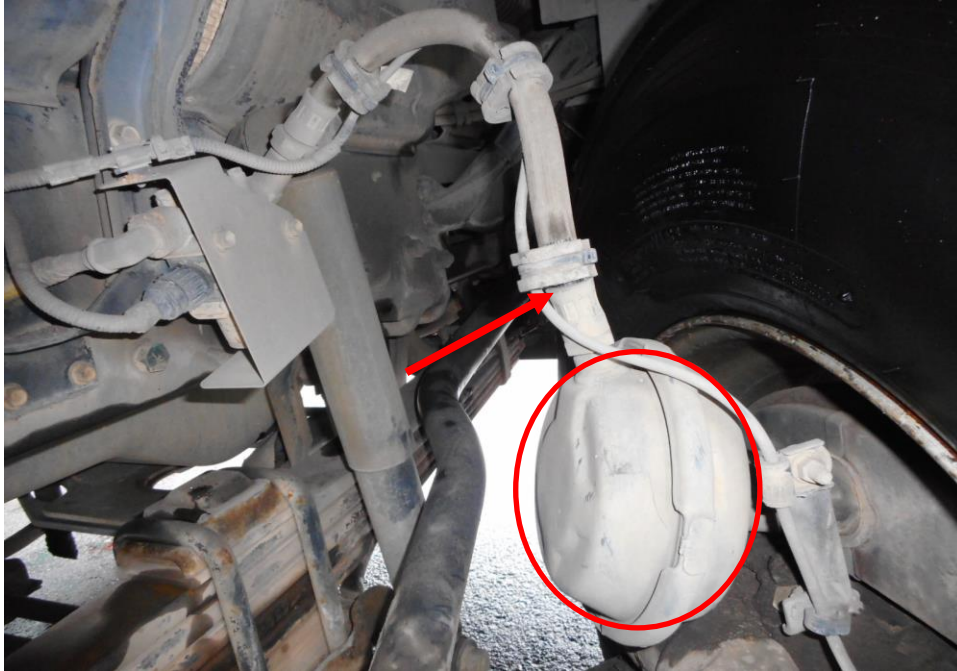
**Photo 23** shows the brake hose/pipe (arrowed) at the front right wheel of the Motor Lorry. I did not observe any leakage of brake fluid at the time of my inspection of the Motor Lorry. My static tests of the Motor Lorry's braking system, along with my visual examination of the various mechanical components in the braking system had indicated that there was no internal leakage of pressure/vacuum. Hence the braking system of the Motor Lorry was likely to be in serviceable condition at the material time of accident.

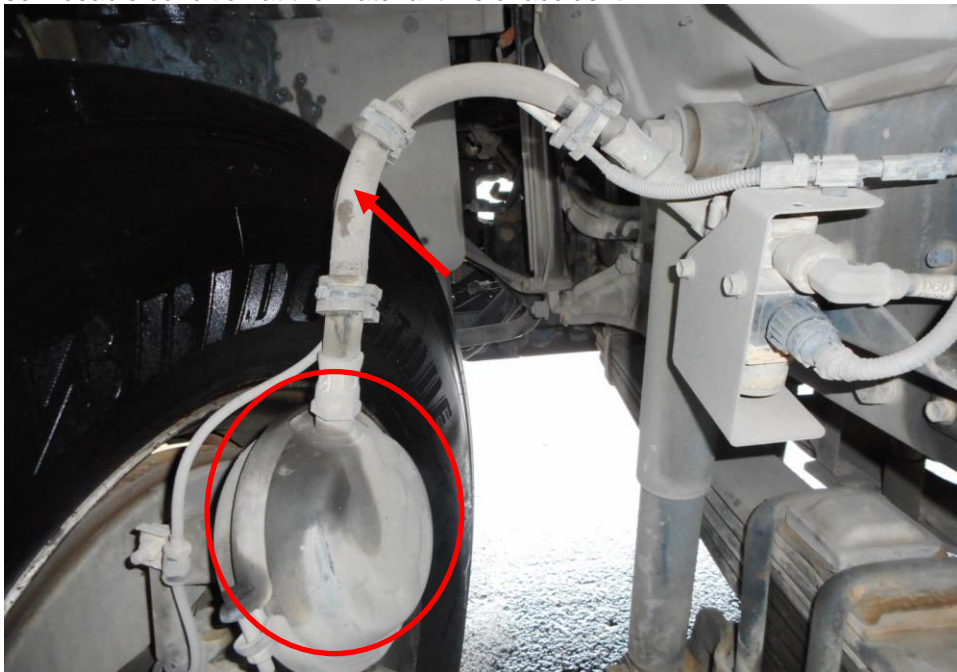
**Photo 24** shows the brake hose/pipe (arrowed) at the front left wheel of the Motor Lorry. I did not observe any leakage of brake fluid at the time of my inspection of the Motor Lorry. My static tests of the Motor Lorry's braking system, along with my visual examination of the various mechanical components in the braking system had indicated that there was no internal leakage of pressure/vacuum. Hence the braking system of the Motor Lorry was likely to be in serviceable condition at the material time of accident.

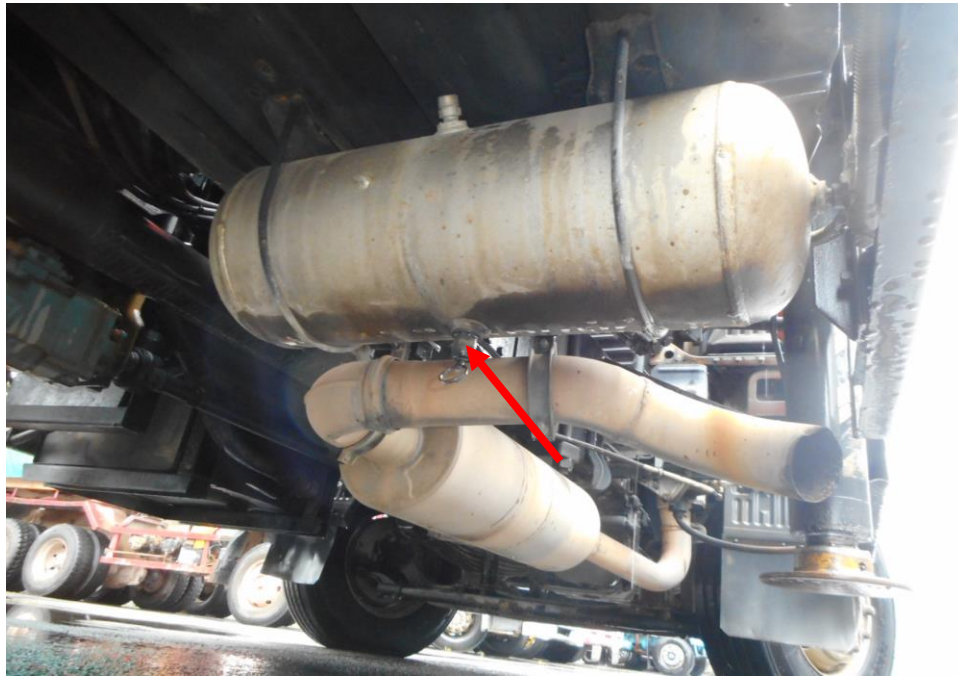
**Photo 25** shows the air brake cylinders (arrowed) at the undercarriage of the Motor Lorry. I did not observe any leakage of air brake fluid at the time of my inspection of the Motor Lorry. My static tests of the Motor Lorry's braking system, along with my visual examination of the various mechanical components in the braking system had indicated that there was no internal leakage of pressure/vacuum. Hence the braking system of the Motor Lorry was likely to be in serviceable condition at the material time of accident.

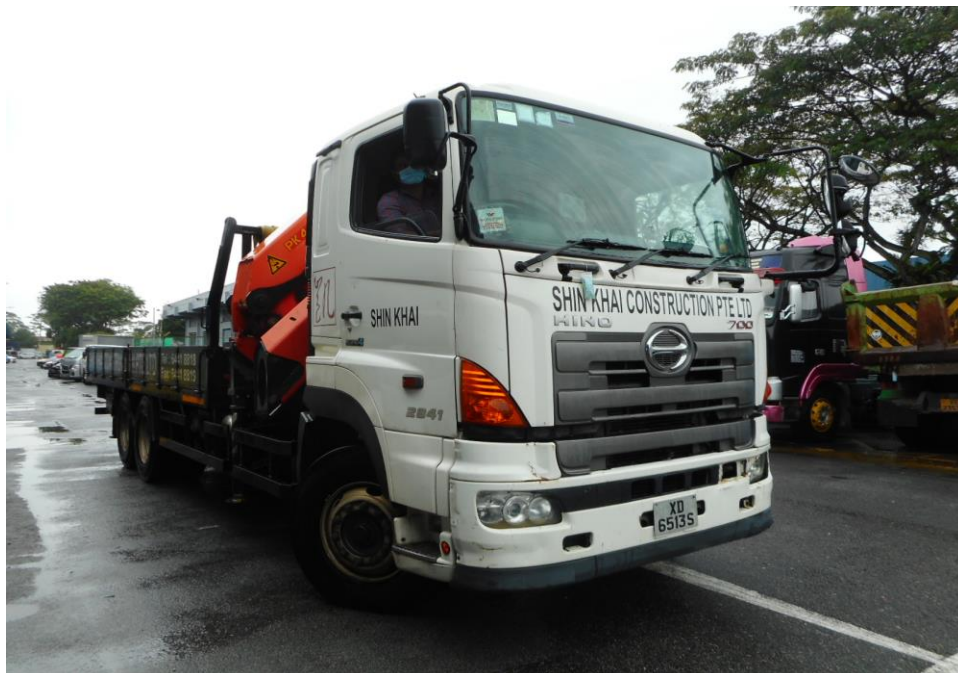
**Photo 26** shows the front right wheel of the Motor Lorry turned to its full left. During my steering system test, I did not experience any abnormal free play and/or resistance when I had turned the steering wheel towards full left and full right. This would suggest that the steering system of the Motor Lorry was likely to be in serviceable condition at the material time of accident.

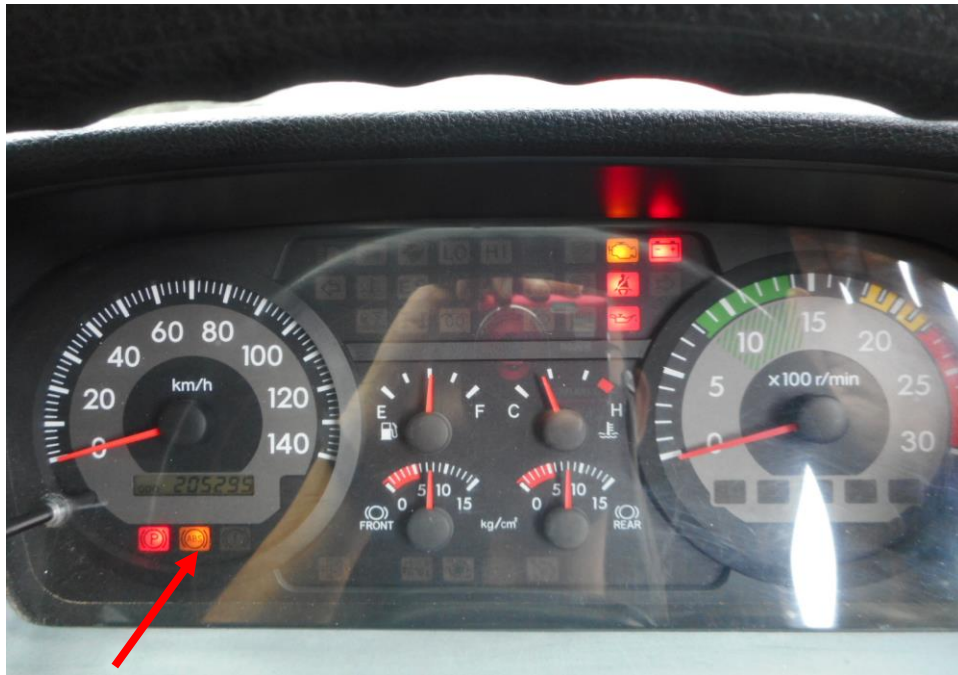
**Photo 27** shows the warning light for Anti-Lock Brake System (ABS) appearing on the instrument panel of the Motor Lorry during the self-test of its various electronic operating systems when its engine was cranked.

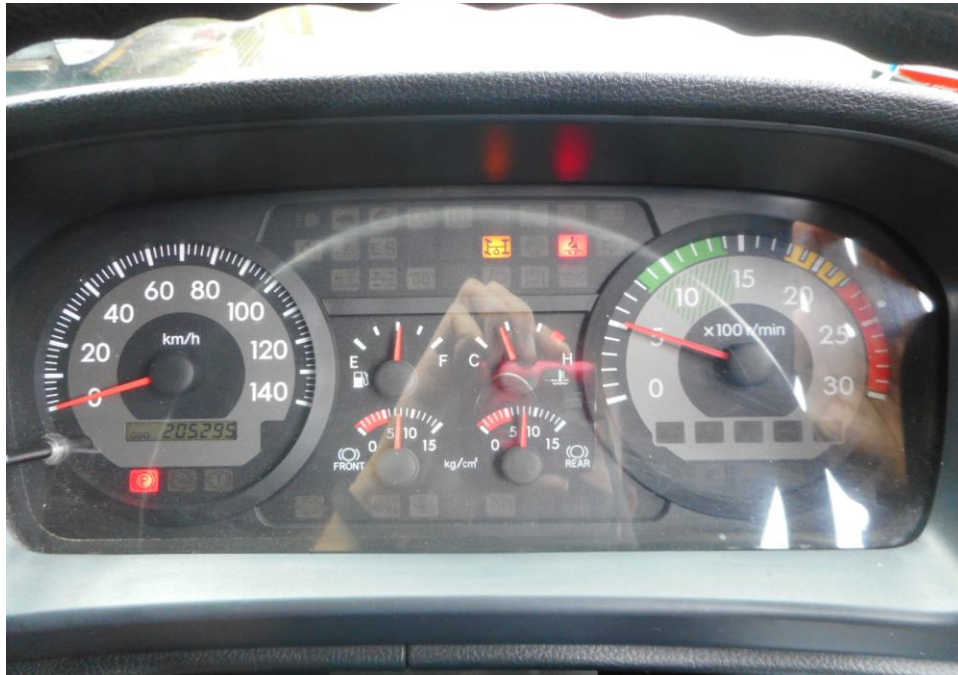
**Photo 28** shows no warning lights illuminated on the instrument panel of the Motor Lorry after the engine was cranked. This would suggest that there was no abnormality to the various electronic operating systems of the Motor Lorry, like the ABS.
