Your Ref: TP/IP/ 28223/2020  
Our Ref : CI/TPD20011119/P

**General Investigation Team**

**MECHANICAL INSPECTION REPORT OF MOTOR TAXI SHC 1614L**

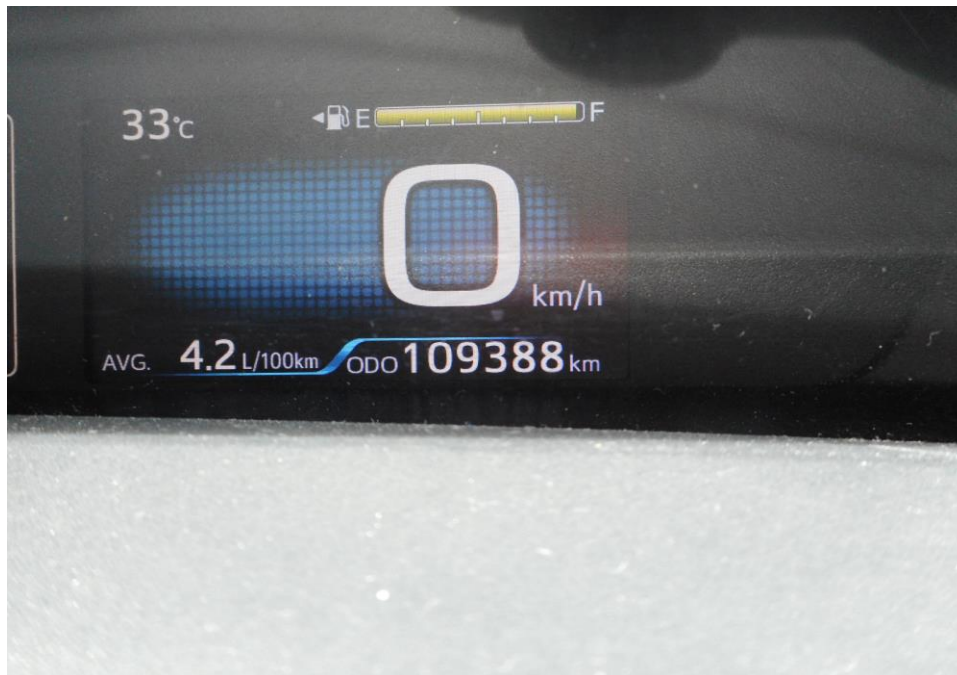
**Photo 1** shows the mileage of the Motor Taxi at the time of my inspection. The mileage observed was 109,388km.

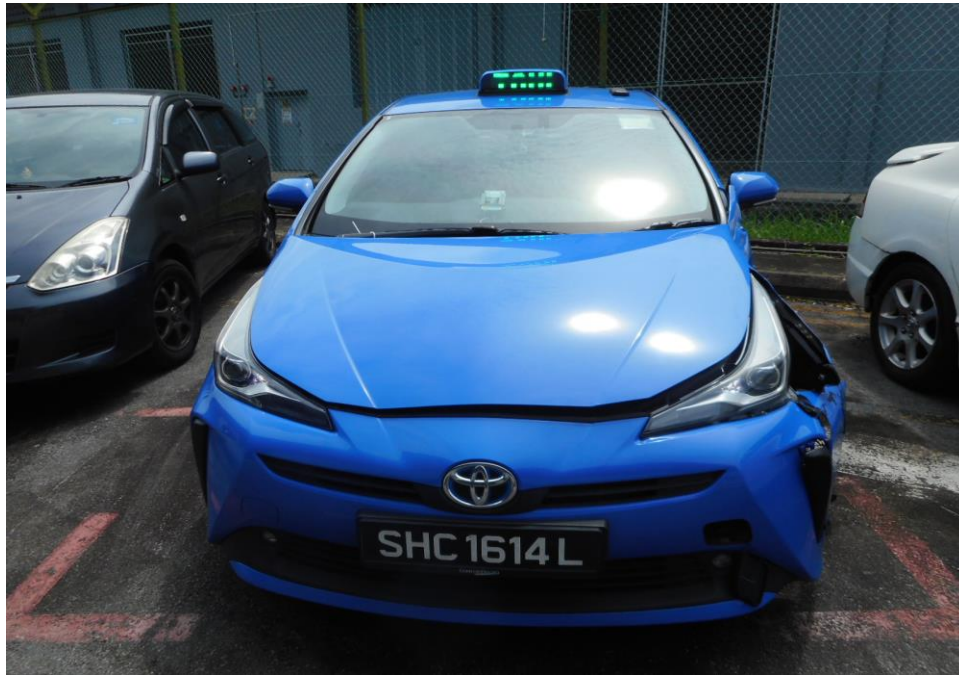
4. The mileage of the Motor Taxi at the time of my inspection was 109,388km.
5. The Motor Taxi was observed to have sustained damage at its front and left portion. Its front bonnet, front bumper and front left fender were amongst the body parts that were damaged as a result of the accident.

**Photo 2** shows a general view of the Motor Taxi's front body at the time of my inspection. The Motor Taxi was observed to have sustained damage at its front and left portion. Its front bonnet, front bumper and front left fender were amongst the body parts that were damaged as a result of the accident.

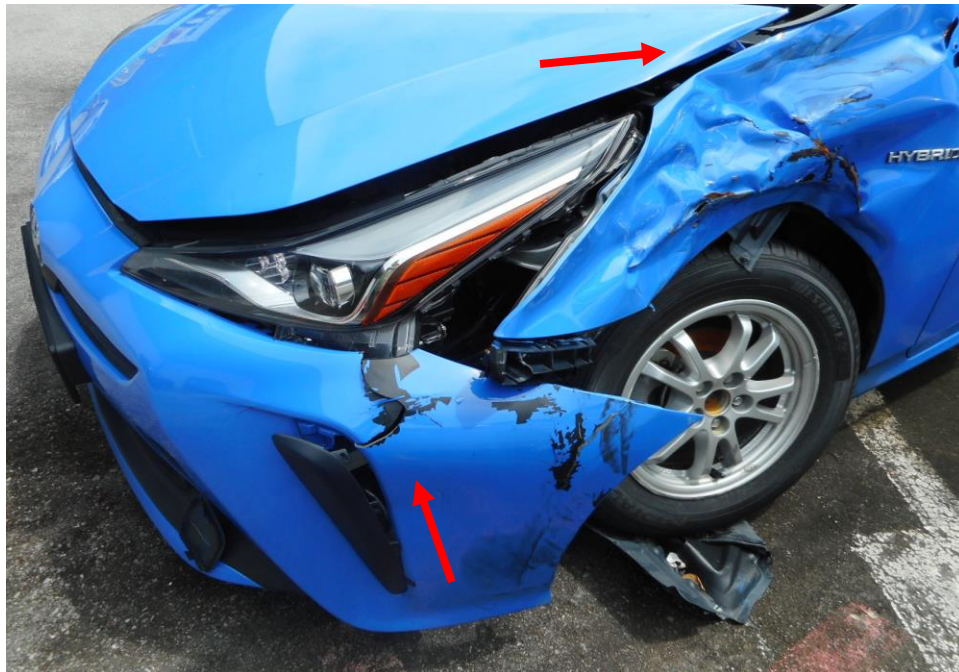
**Photo 3** shows the close up view of the Motor Taxi's front portion at the time of my inspection. The Motor Taxi was observed to have sustained damage at its front bonnet and front bumper (red arrows) were amongst the body parts that were damaged as a result of the accident.

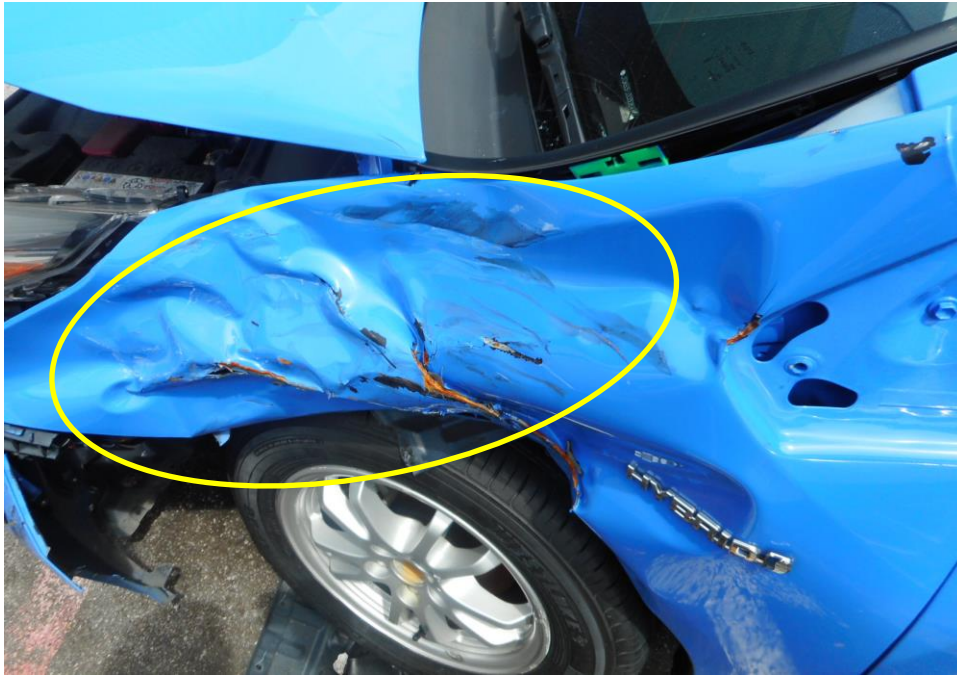
**Photo 4** shows the close up view of the Motor Taxi's front left body at the time of my inspection. The Motor Taxi was observed to have sustained damage at its front left fender (circled) were amongst the body parts that were damaged as a result of the accident.

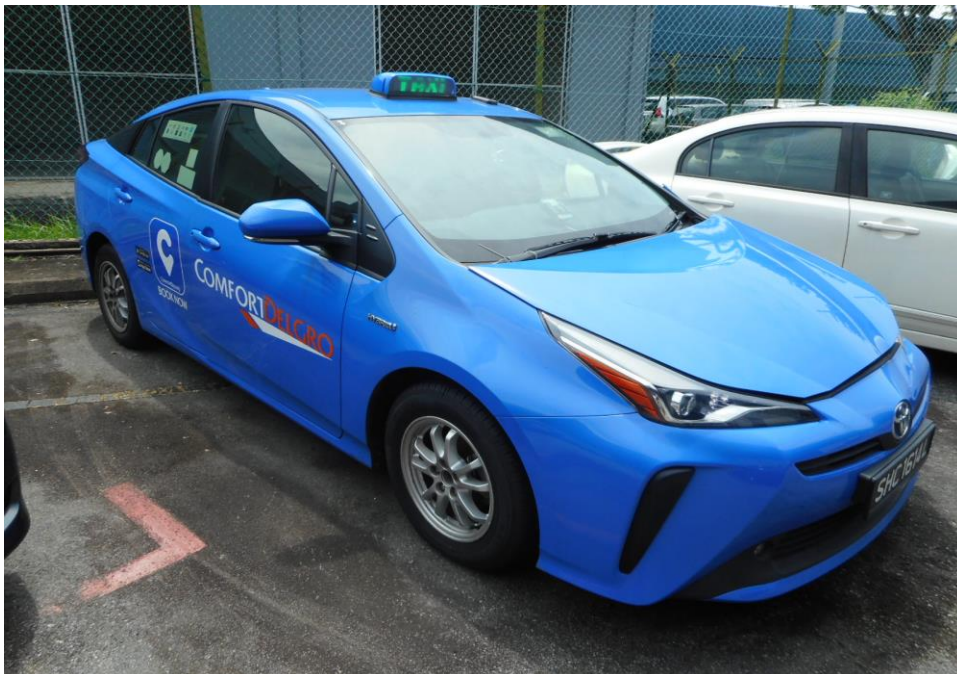
**Photo 5** shows a general view of the Motor Taxi's right body at the time of my inspection. The right portion of the Motor Taxi was observed to have been unaffected by the accident.

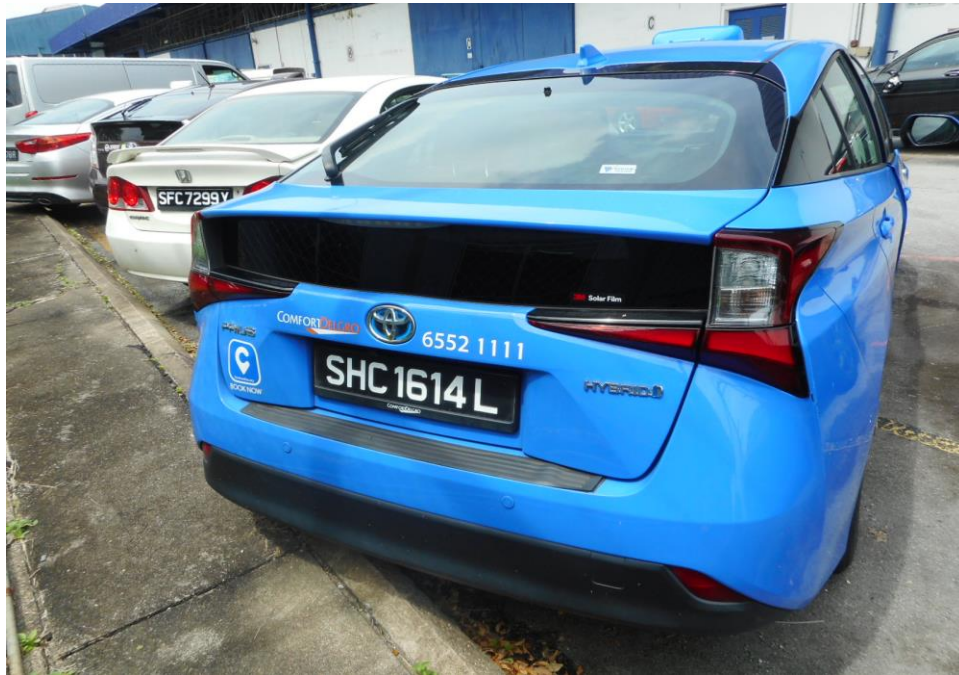
**Photo 6** shows the general view of the Motor Taxi's rear body at the time of my inspection. The Motor Taxi rear was observed to be unaffected by the accident.

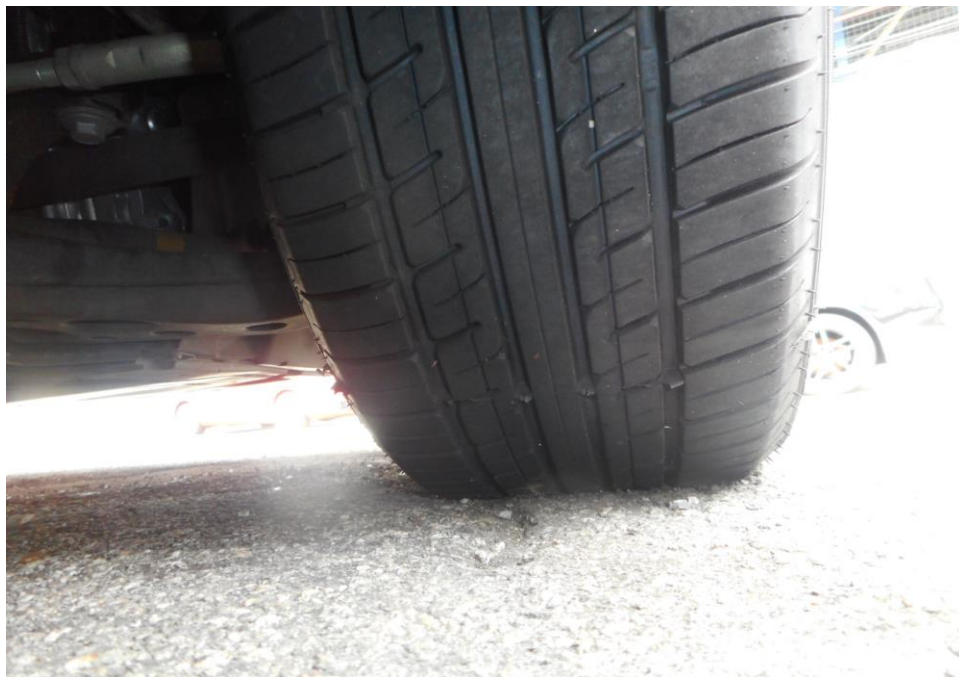
**Photo 7** shows the condition of the front right tyre of the Motor Taxi, which was observed to be in serviceable condition with remaining tread depth of approximately 6.8mm. The tyre was sufficiently inflated for vehicular operation with no tear, cut or burst mark(s) on the outer and the inner sidewalls as well as across the tread. The 4 tyres of the Motor Taxi were wrapped around standard steel wheel rims without any damage.

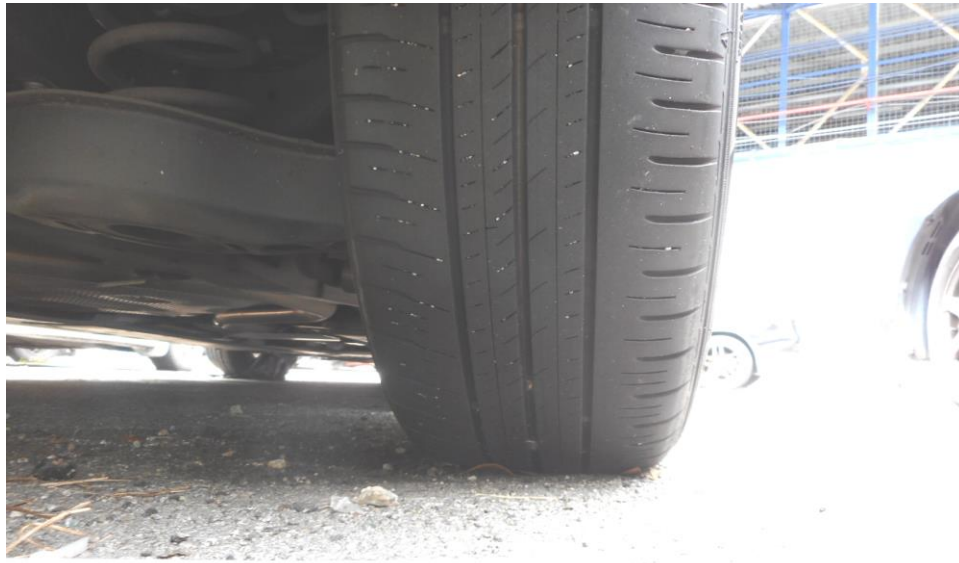
**Photo 8** shows the condition of the rear right tyre of the Motor Taxi, which was observed to be in serviceable condition with remaining tread depth of approximately 2.5mm. The tyre was also observed to be sufficiently inflated for vehicular operation with no tear, cut or burst mark(s).

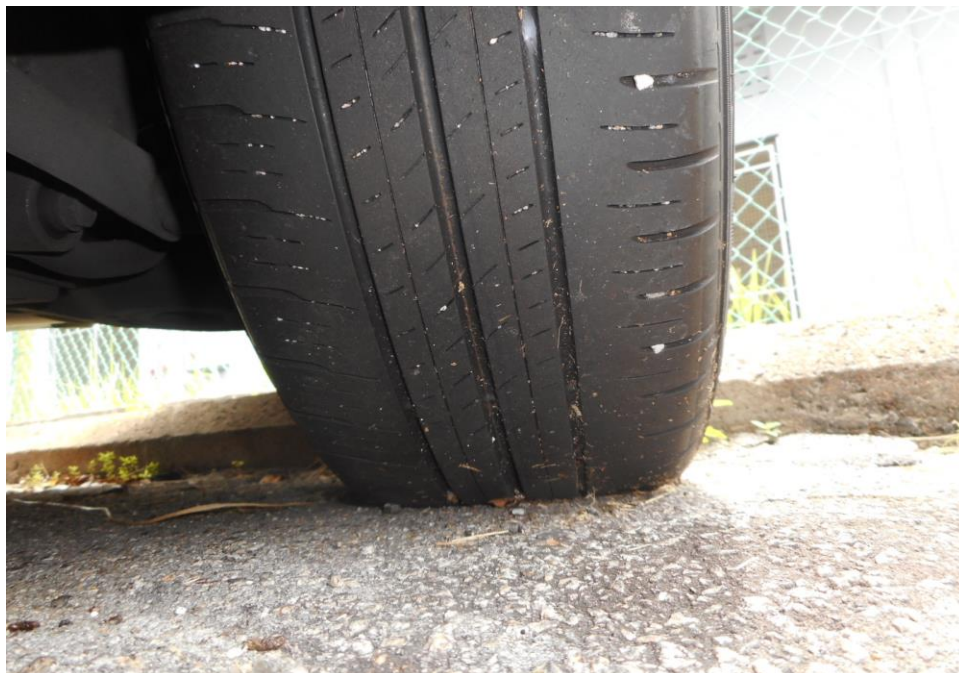
**Photo 9** shows the condition of the rear left tyre of the Motor Taxi, which was observed to be in serviceable condition with remaining tread depth of approximately 4.1mm. The tyre, which was wrapped around steel wheel rim, was also observed to be sufficiently inflated for vehicular operation. The 4 tyres of the Motor Taxi were wrapped around standard steel wheel rims.

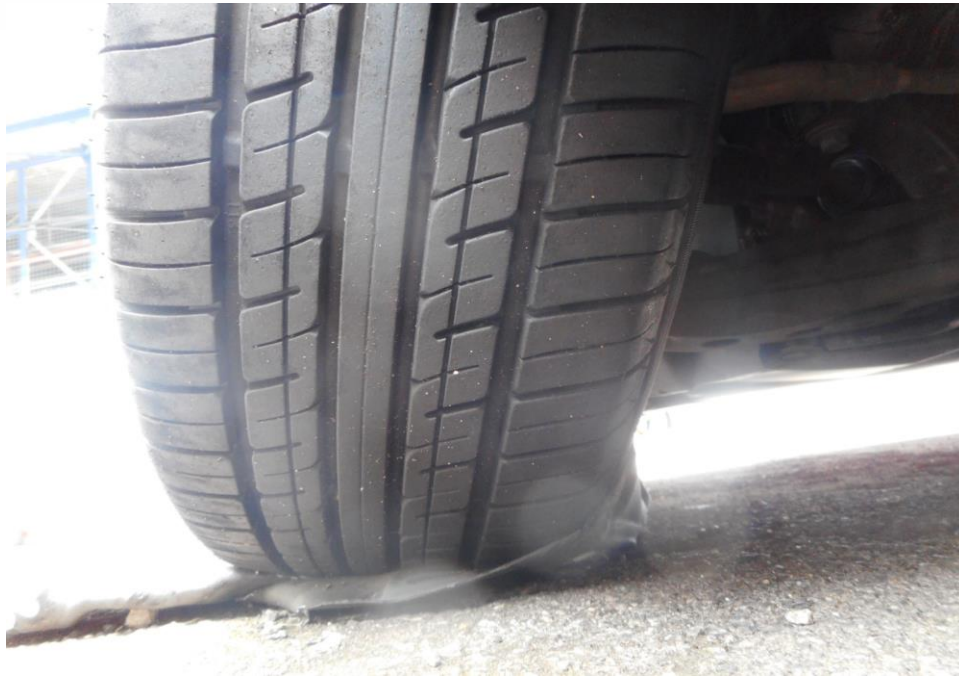
**Photo 10** shows the condition of the front left tyre of the Motor Taxi, which was observed to be in serviceable condition with remaining tread depth of approximately 6.1mm. There was also no tear, cut or burst mark(s) on the outer and the inner sidewalls as well as across the tread of the Motor Taxi's 4 tyres.

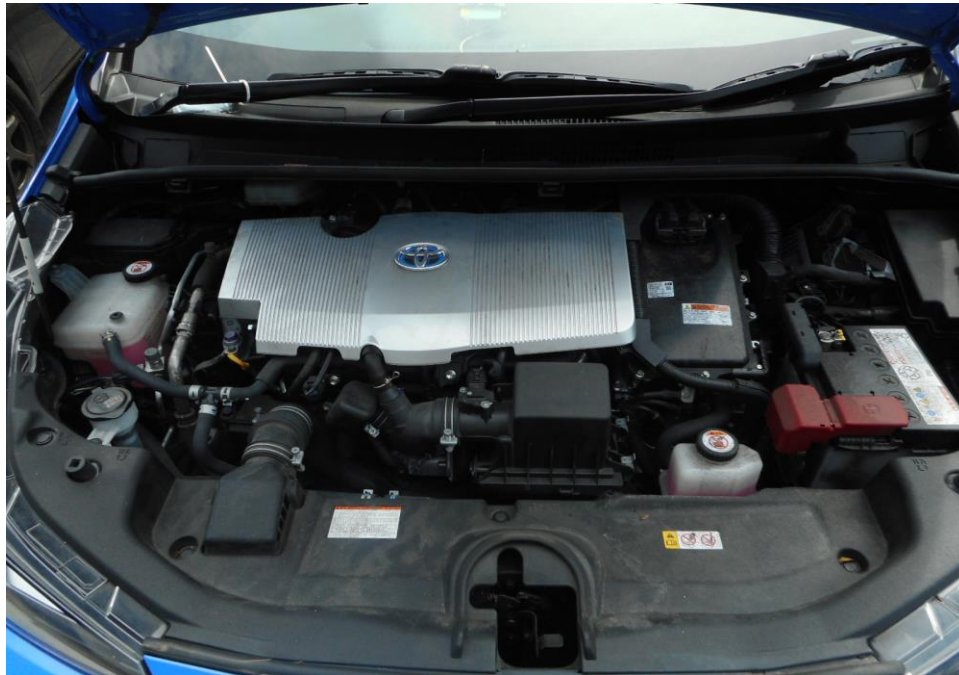
**Photo 11** shows a general view of the Motor Taxi's engine compartment. The various parts and components inside the engine compartment were unaffected by the accident. There was also no sign(s) or indication(s) of fluid leakage and/or fluid stain within the engine compartment.

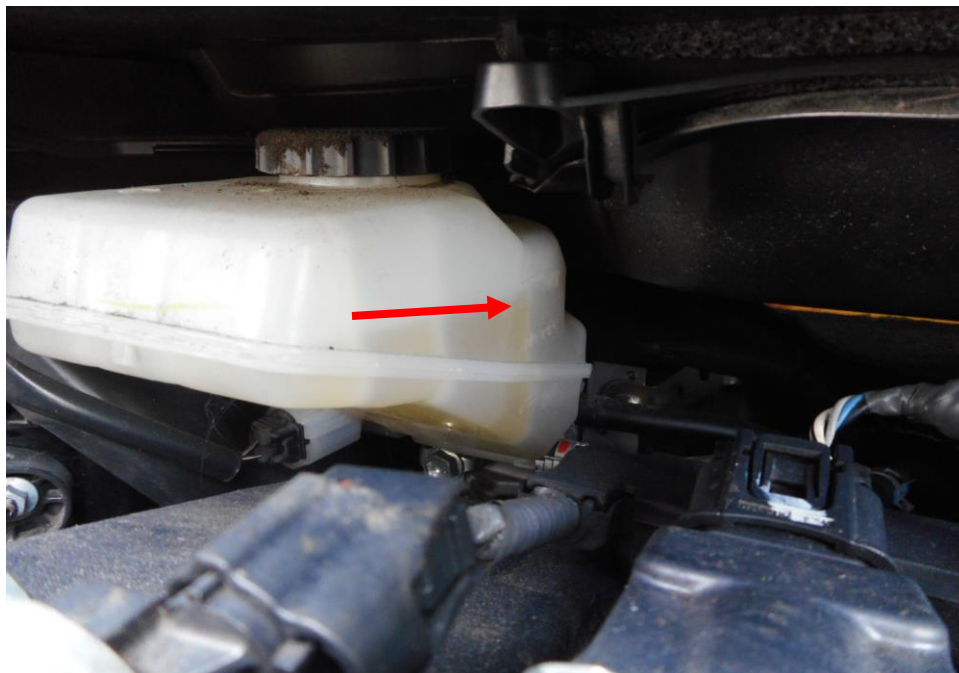
**Photo 12** shows the brake fluid reservoir of the Motor Taxi at the time of my inspection. The brake fluid was observed to be of sufficient level (arrowed) and without any visible contamination.

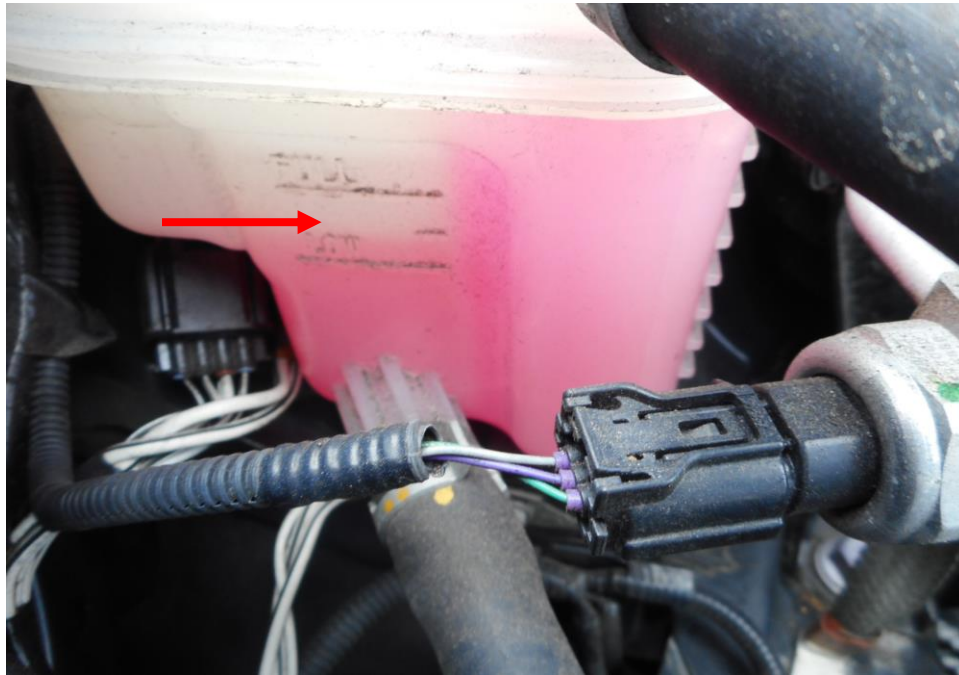
**Photo 13** shows checks being carried out to the engine coolant of the Motor Taxi at the time of my inspection. The engine coolant was observed to be of sufficient level (arrowed) and without any visible contamination.

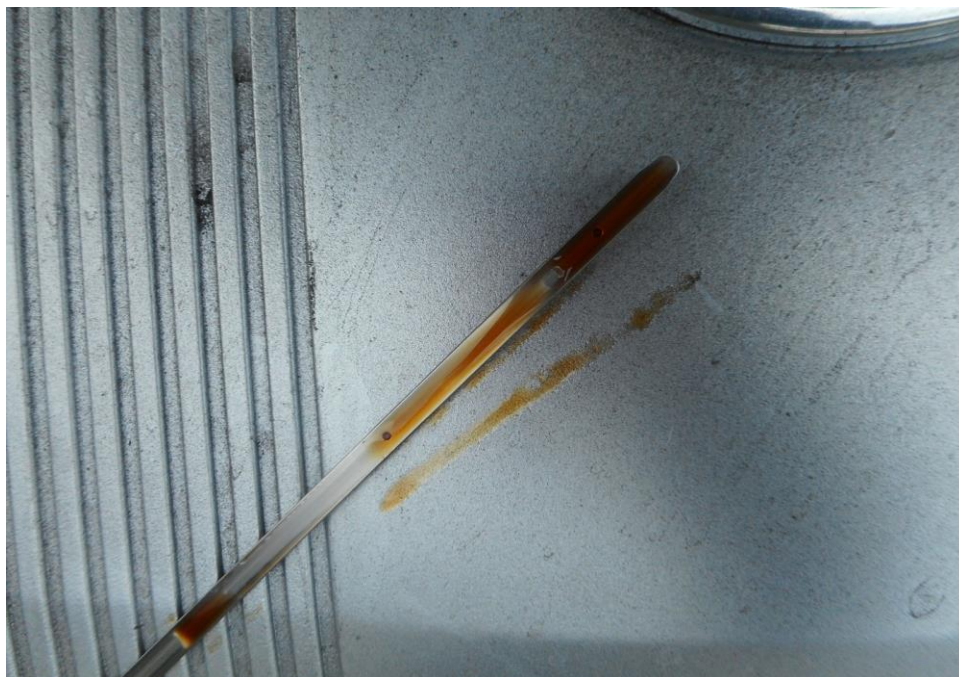
**Photo 14** shows the engine oil dip stick of the Motor Taxi at the time of my inspection. The engine oil was observed to be of sufficient level and without any visible contamination.

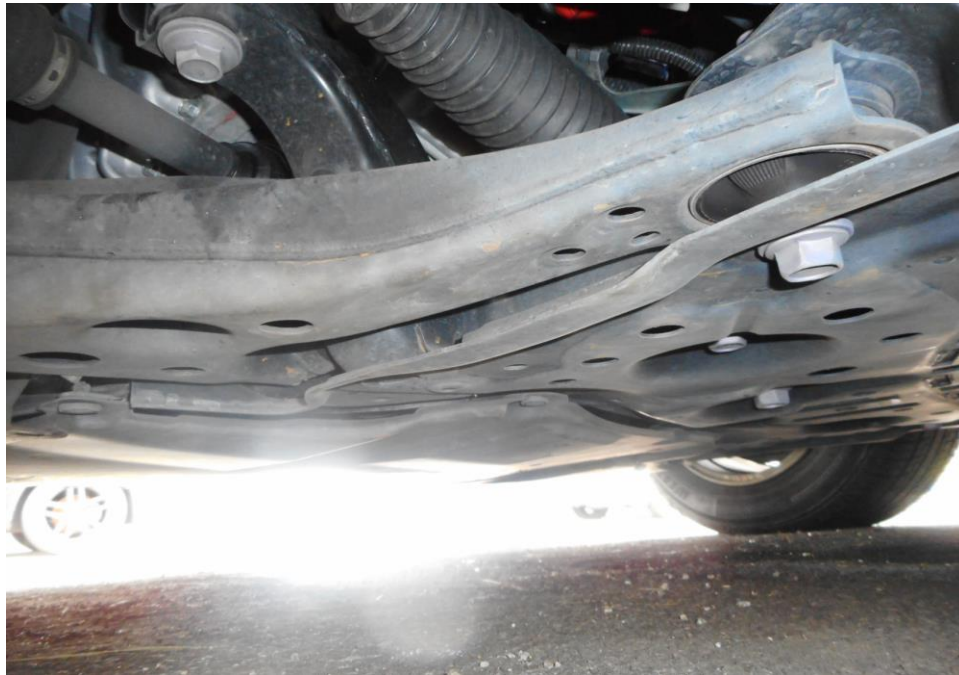
**Photo 15** shows the undercarriage of the Motor Taxi, at the area where the engine housing and transmission housing are located. I did not find any sign(s) or indication(s) of fluid leak and/or fluid stain(s) on the underside of the Motor Taxi.

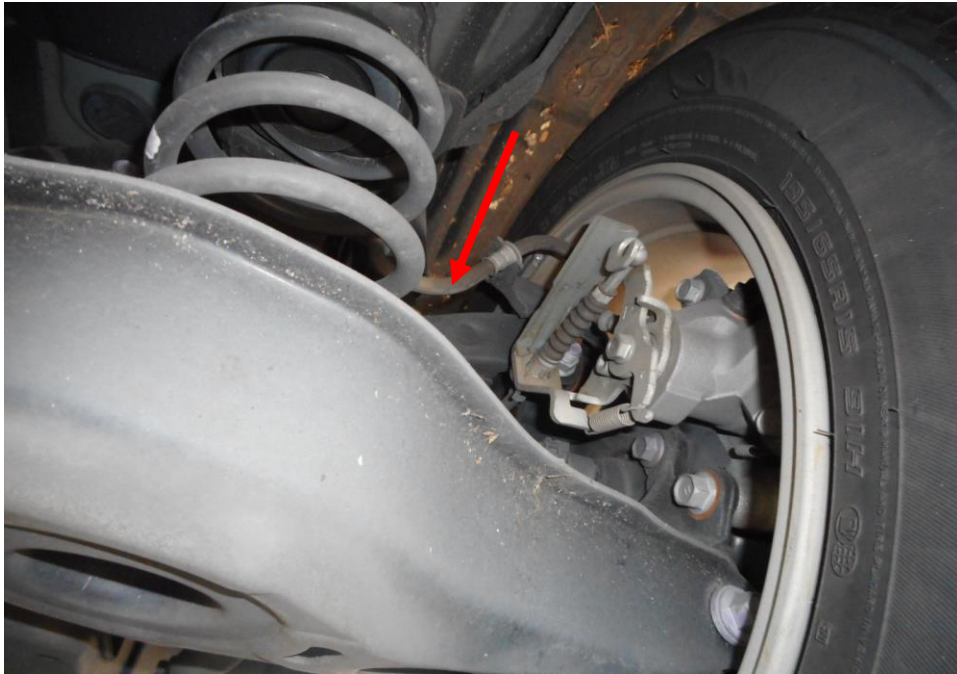
**Photo 16** shows the brake hose/pipe (arrowed) at the rear right wheel of the Motor Taxi. No leakage of brake fluid was observed. Visual examination of the various components of the braking system like the drum brake, brake booster, brake pedal etc. had revealed all to be intact and without visible damage.

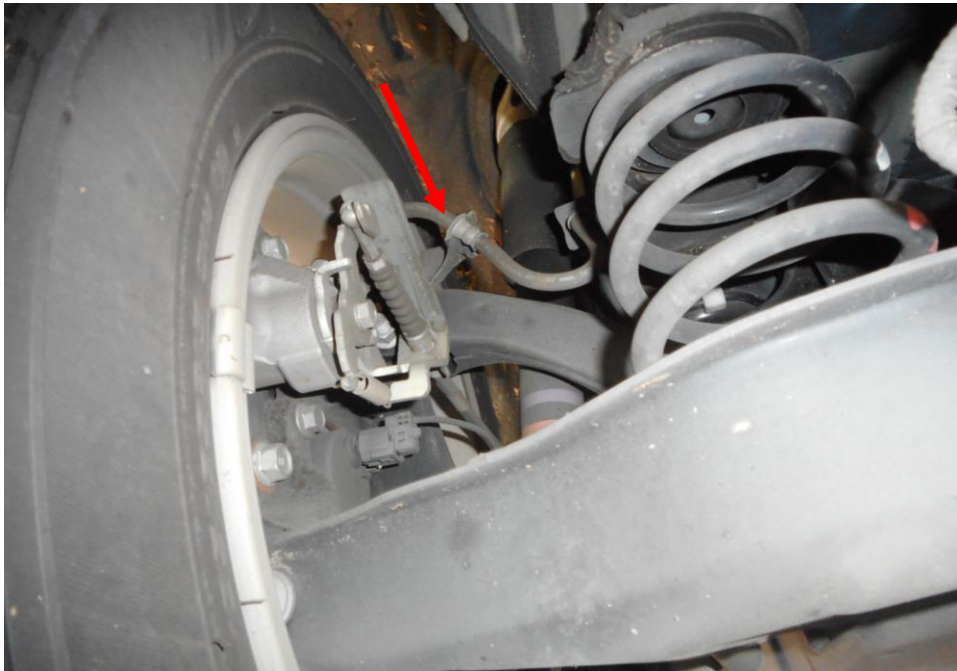
**Photo 17** shows the brake hose/pipe (arrowed) at the rear left wheel of the Motor Taxi. I did not observe any leakage of brake fluid at the time of my inspection of the Motor Taxi. Static tests of the Motor Taxi's braking system had indicated that there was no internal leakage of pressure/vacuum. The undercarriage components of the Motor Taxi were also all found to be intact and without any visible damage.

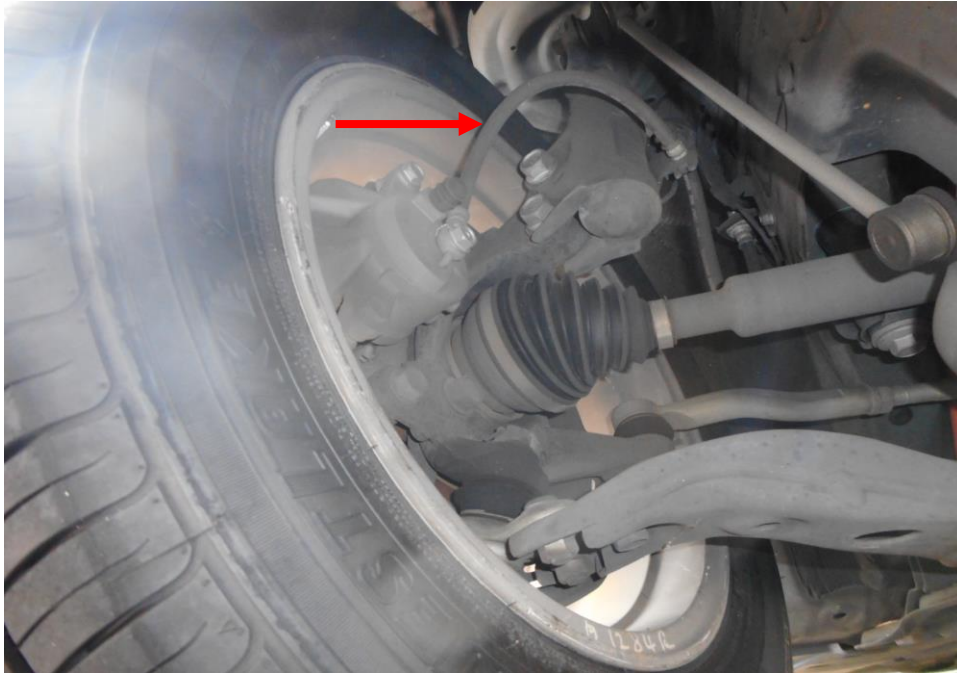
**Photo 18** shows the brake hose/pipe (arrowed) at the front right wheel of the Motor Taxi. I did not observe any leakage of brake fluid at the time of my inspection of the Motor Taxi. Static tests of the Motor Taxi's braking system had indicated that there was no internal leakage of pressure/vacuum. The undercarriage components of the Motor Taxi were also all found to be intact and without any visible damage.

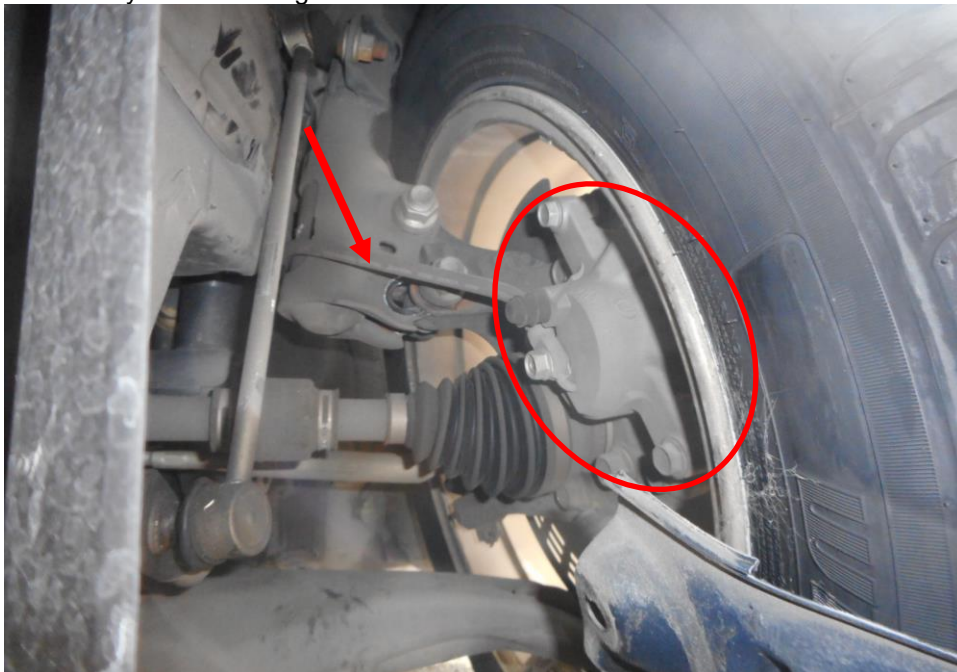
**Photo 19** shows the brake hose/pipe (arrowed) at the front left wheel of the Motor Taxi. No leakage of brake fluid was observed. Visual examination of the various components of the braking system like the brake caliper (circled), brake booster, brake pedal etc had revealed all to be intact and without visible damage.

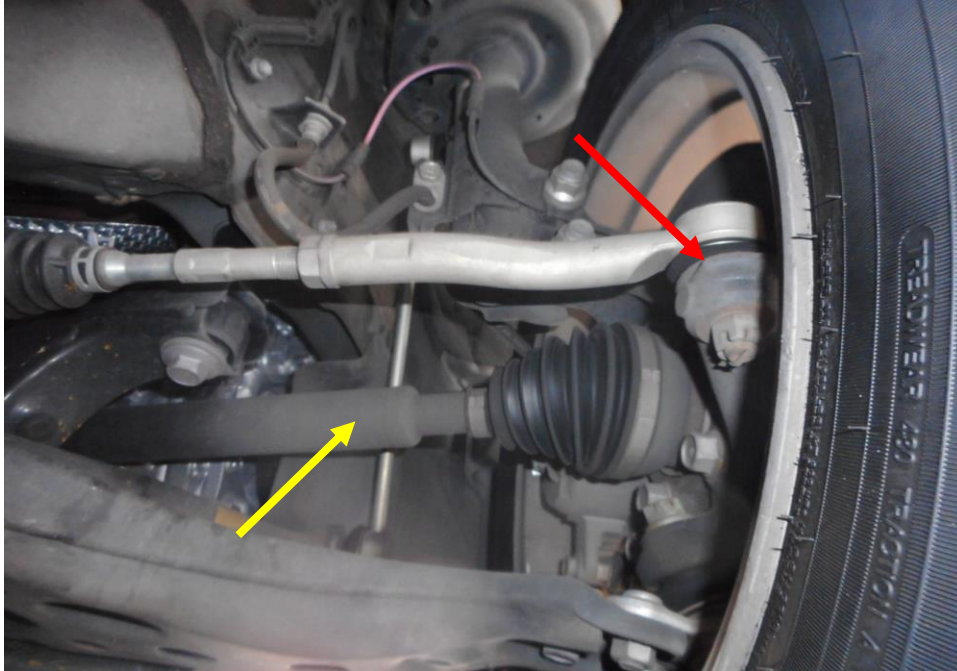
**Photo 20** shows the various undercarriage components at the front right wheel of the Motor Taxi, in particular the steering tie rod (red arrow) and drive shaft (yellow arrow). The various steering components were all found to be intact, suggesting that the steering system of the Motor Taxi was likely to be in serviceable condition at the material time of accident. There was also no sign of fluid stain observed on the various undercarriage components at the front right wheel of the Motor Taxi.

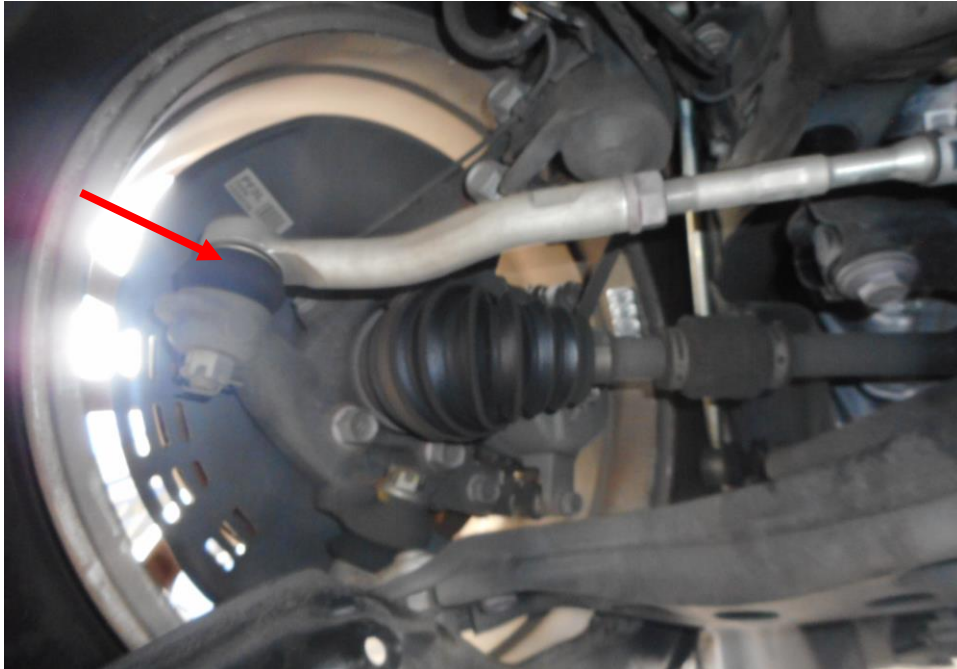
**Photo 21** shows the various undercarriage components at the front left wheel of the Motor Taxi, in particular the steering tie rod (red arrow) and drive shaft (yellow arrow). The various steering components were all found to be intact, suggesting that the steering system of the Motor Taxi was likely to be in serviceable condition at the material time of accident. There was also no sign of fluid stain observed on the various undercarriage components at the front left wheel of the Motor Taxi.

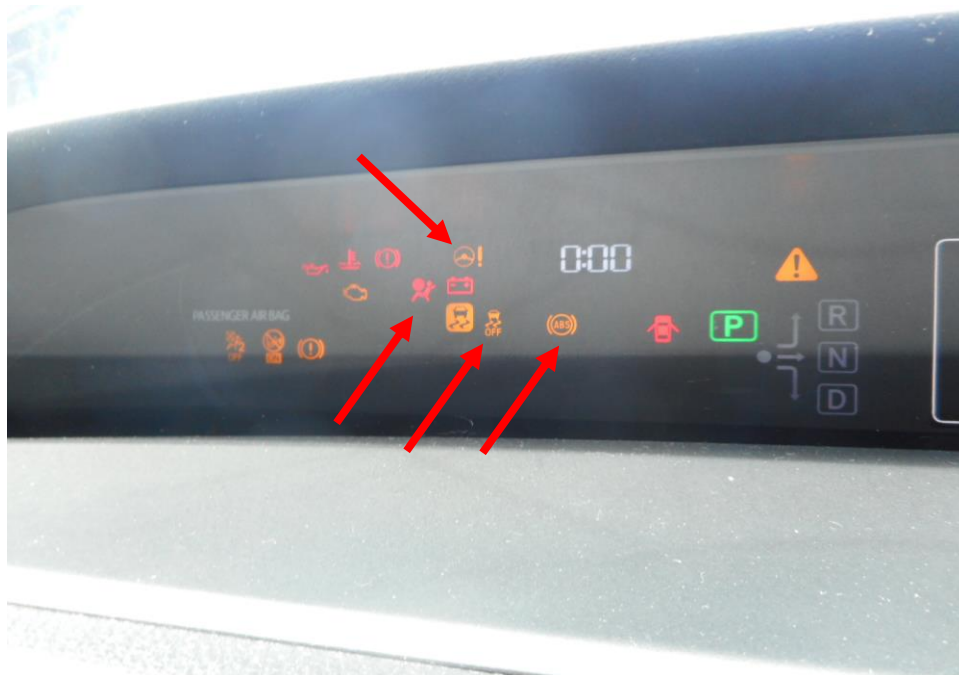
**Photo 22** shows the warning light for the Supplemental Restraint System (SRS), Electric Power Steering System (EPS), Anti-Lock Brake System (ABS) and Traction Control System (arrowed) appearing on the instrument panel of the Motor Taxi during the self-test of its various electronic operating systems when its engine was cranked.

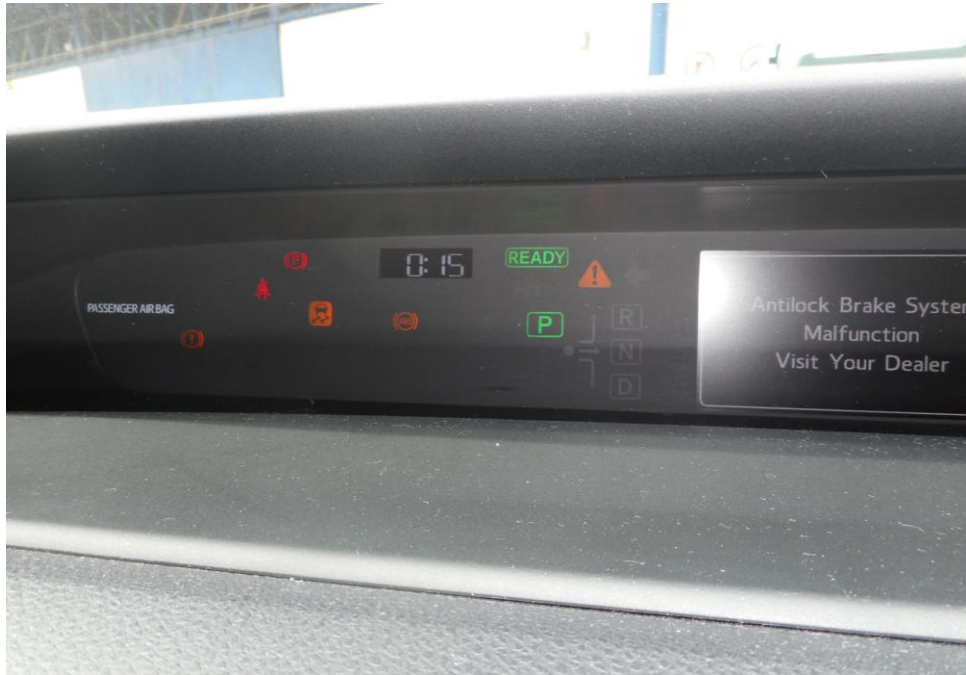
13. The Motor Taxi's automatic self-test of the functionality of its electronic operating systems like the Supplemental Restraint System (SRS) and Electric Power Steering System (EPS) during cranking of the engine had indicated that the system were in working condition and without abnormality. This can be established from the warning lights disappearing from the instrument panel after the self-test. However, the Anti-Lock Brake System (ABS) and Traction Control System (TC) light remained illuminated up, this is likely cause by the result of the accident. See photo 22 & 23 below.

**Photo 23** However, the Anti-Lock Brake System (ABS) and Traction Control System (arrowed) lights remained illuminated on the instrument panel of the Motor Taxi after the engine was cranked. This was likely caused by the result of the accident.

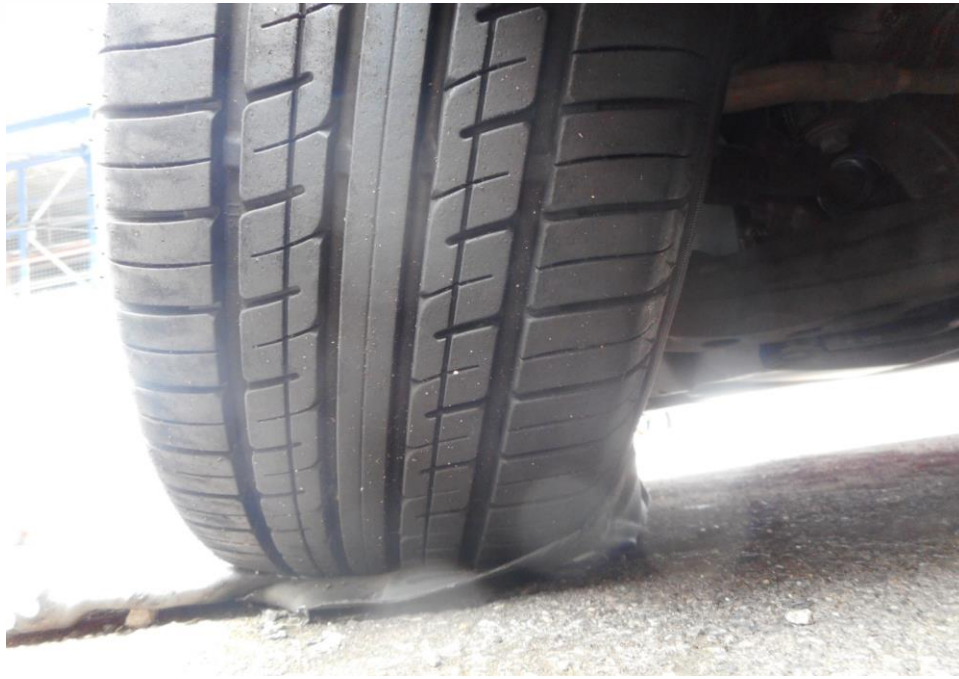
15. A Operational test by driving the Motor Taxi to primarily determine whether there was any abnormality to the engine system, transmission system and braking system of the Motor Car could not be conducted given the extent of damage that it had sustained (The front left and the front left Suspension system of the Motor Car was damaged and stuck together as a result of the accident.). See Photo 24 & 25 below.

**Photo 24** shows general view of the front left wheel and the front left suspension system was stuck together as a result of the accident

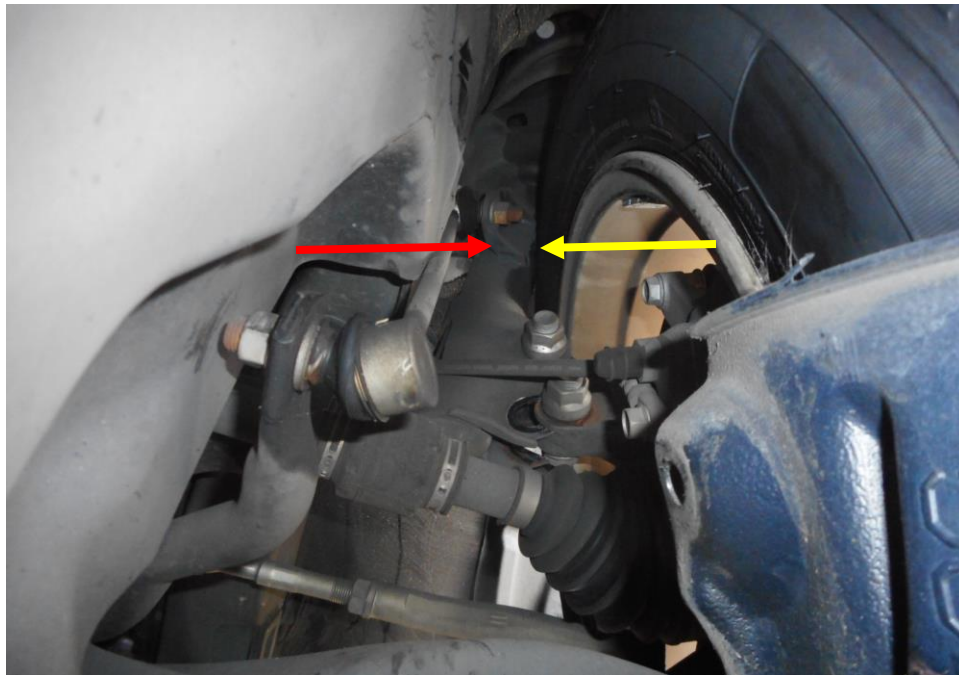
**Photo 25** shows the close up view of the damaged caused to the front left wheel (yellow arrow) and the front left suspension system (red arrow) resulting to both to be stuck together (arrowed) as a result of the induced impact from the accident.

16. For this particular case, from my visual inspection of the Motor Taxi, the front left wheel and the front left suspension system was likely damaged as a result of the accident and the extent of damage that it had sustained had prevented me from carrying out any operational test, however it appears that its engine system, transmission system and braking system were all in found to be in serviceable condition at the material time. I did not find any evidence(s) to suggest that there was possible mechanical failure and/or abnormal behaviour to the Motor Taxi that may have caused and/or contributed to the accident.
