You're Ref: TP/IP/21353/2020  
Our Ref: CI/TPD20011120/P

**Fatal Accident Investigation Team**

**MECHANICAL INSPECTION REPORT OF MOTOR CAR SLU 9036K**

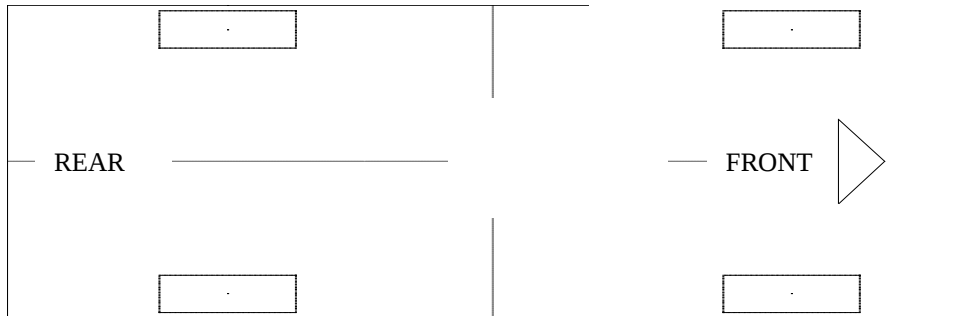
6. The condition of the Motor Car's 4 tyres was observed to be in serviceable condition. I did not find any tear, cut or burst mark(s) on the outer and the inner sidewalls as well as across the tread of the 4 tyres. The 4 tyres were also observed to be sufficiently inflated for vehicular operation. The tyre brand, tyre size and remaining tread depth of the 4 tyres were recorded as follows:-

Tourador 215/60 R17 (6mm)

Tourador 215/60 R17 (6.5mm)

Tourador 215/60 R17 (6.3mm)

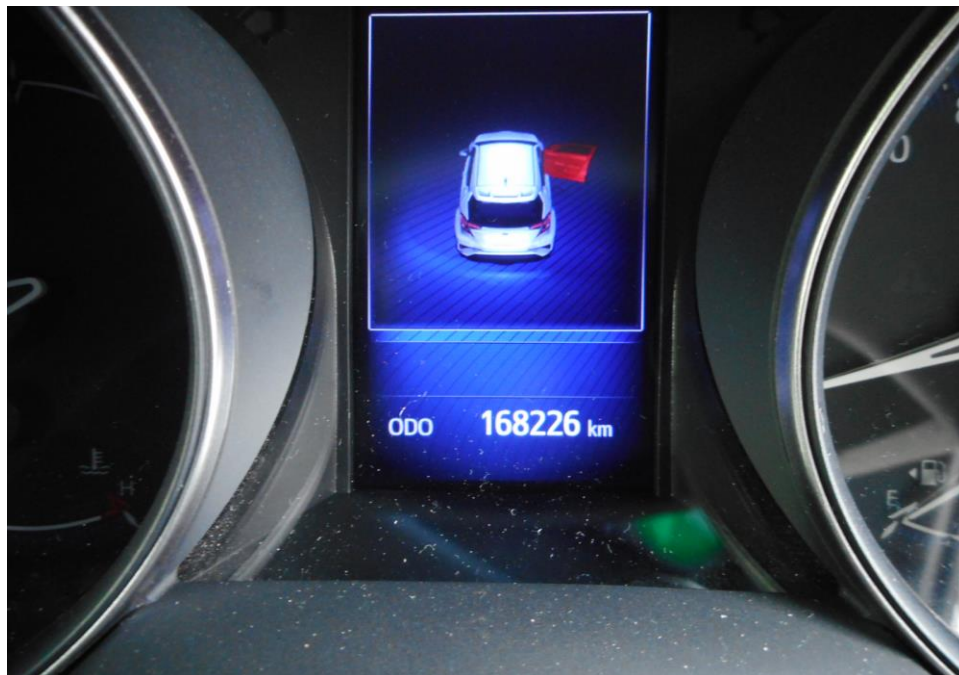
**Photo 1** shows the mileage of the Motor Car at the time of my inspection. The mileage observed was 168,226km.

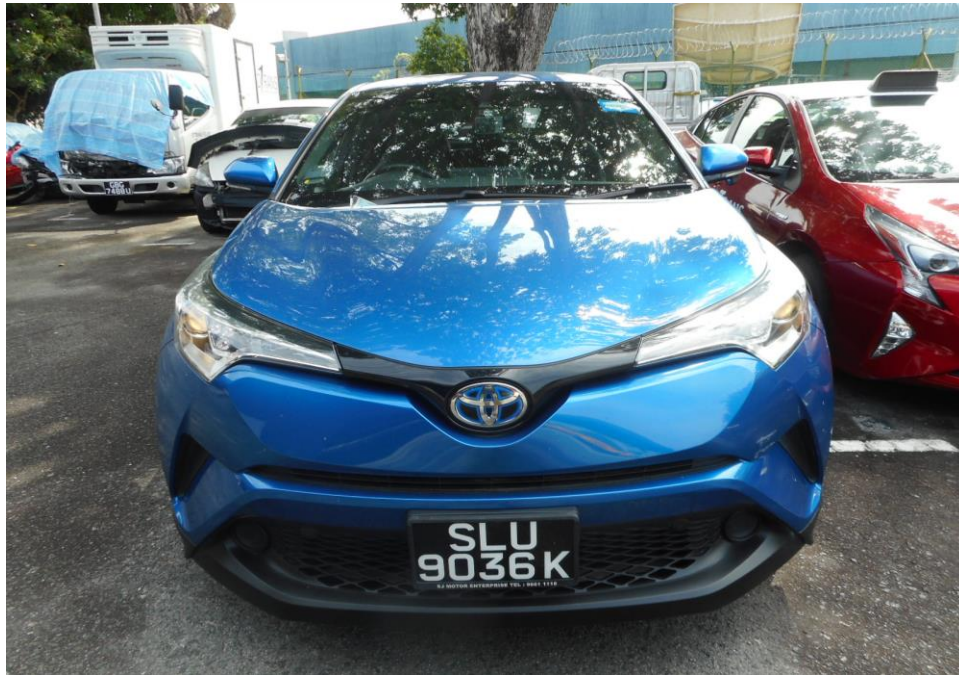
4. The mileage of the Motor Car at the time of my inspection was 168,226km.
5. The Motor Car was observed to have sustained damage at its front portion. Its front bonnet was the body part that were damaged as a result of the accident.

**Photo 2** shows a general view of the Motor Car's front body at the time of my inspection. The front portion of the Motor Car was observed to have sustained damage. Its front bonnet was the body part that were damaged as a result of the accident.

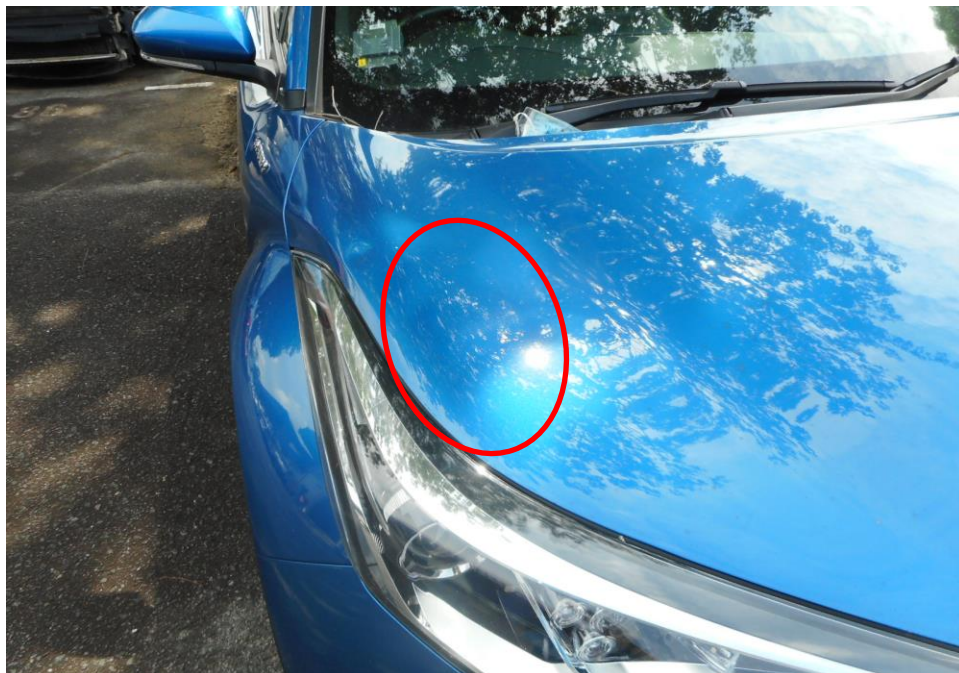
**Photo 3** shows the general area view of the Motor Car's front bonnet at the time of my inspection. The Motor Car was observed to have sustained damage at its front bonnet (circled) as a result of the accident.

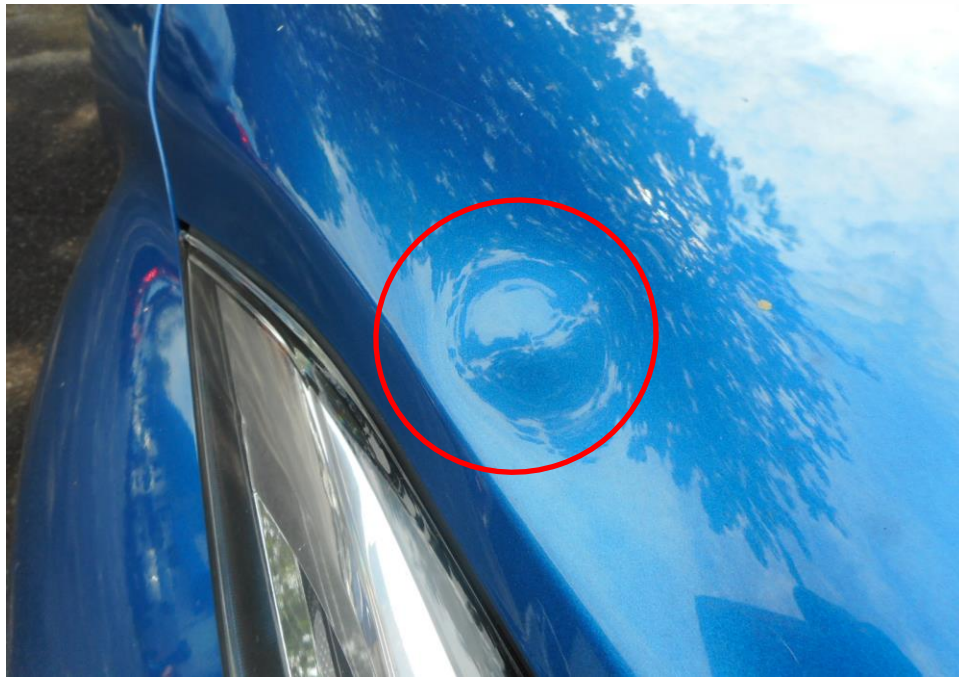
**Photo 4** shows the close up view of the Motor Car's front body at the time of my inspection. The Motor Car was observed to have sustained damage at its front bonnet (circled) as a result of the accident.

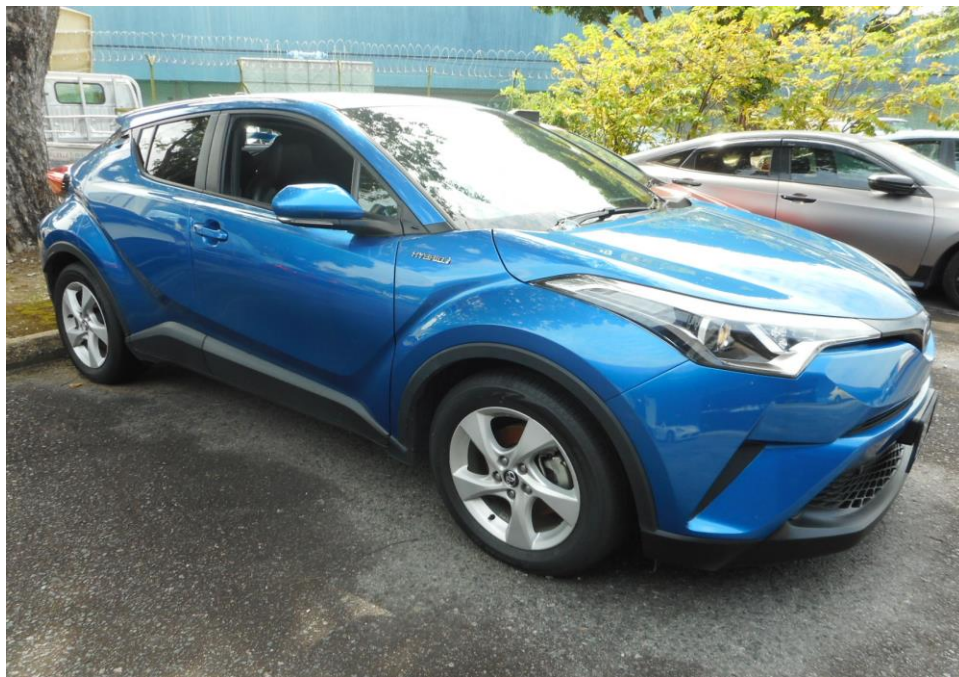
**Photo 5** shows a general view of the Motor Car's right body at the time of my inspection. The right portion of the Motor Car was observed to have been unaffected by the accident.

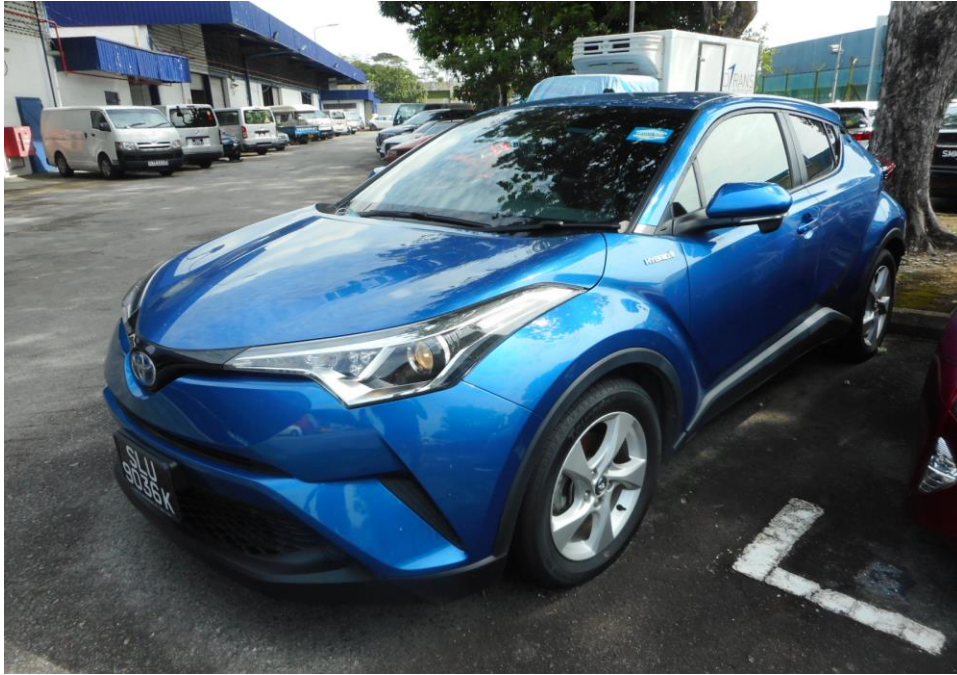
**Photo 6** shows a general view of the Motor Car's left body at the time of my inspection. The left portion of the Motor Car was observed to have been unaffected by the accident.

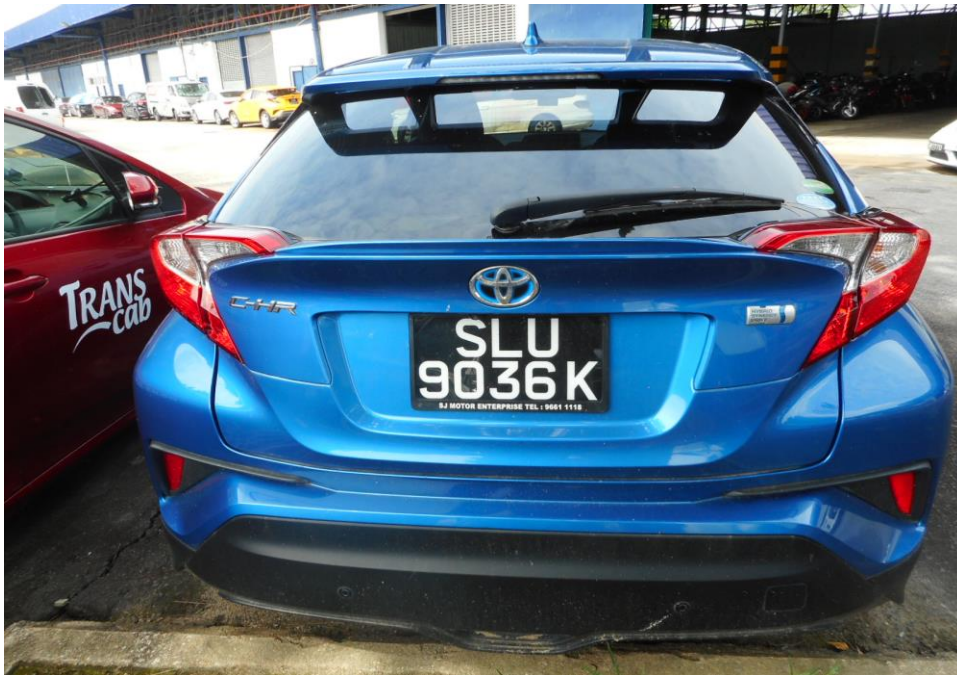
**Photo 7** shows the general view of the Motor Car's rear body at the time of my inspection. The Motor Car rear was observed to be unaffected by the accident.

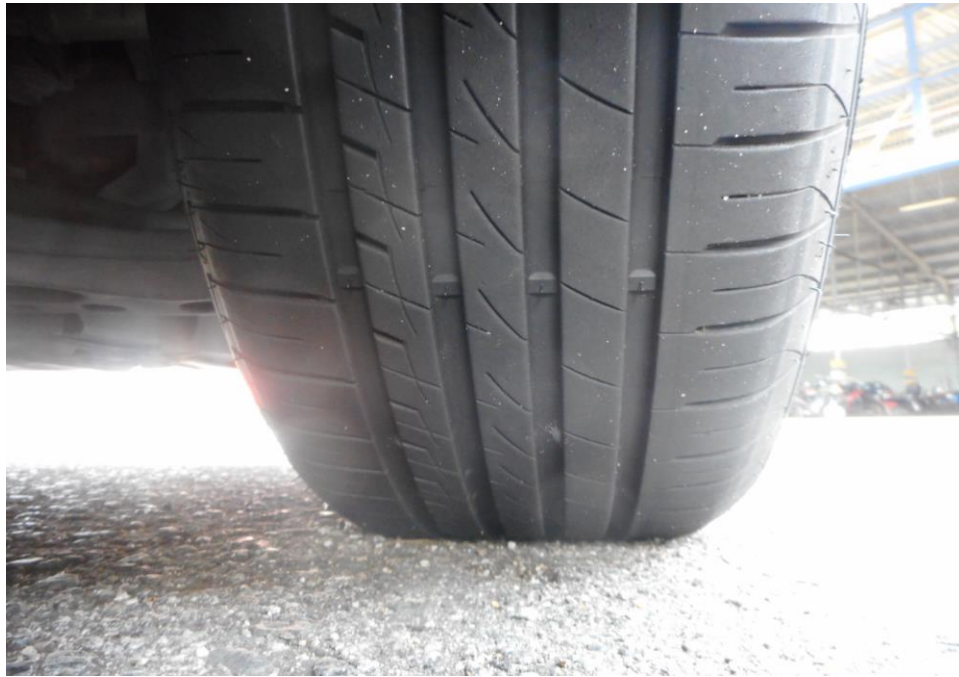
**Photo 8** shows the condition of the front right tyre of the Motor Car, which was observed to be in serviceable condition with remaining tread depth of approximately 6.5mm. The tyre was sufficiently inflated for vehicular operation with no tear, cut or burst mark(s) on the outer and the inner sidewalls as well as across the tread. The 4 tyres of the Motor Car were wrapped around standard steel wheel rims without any damage.

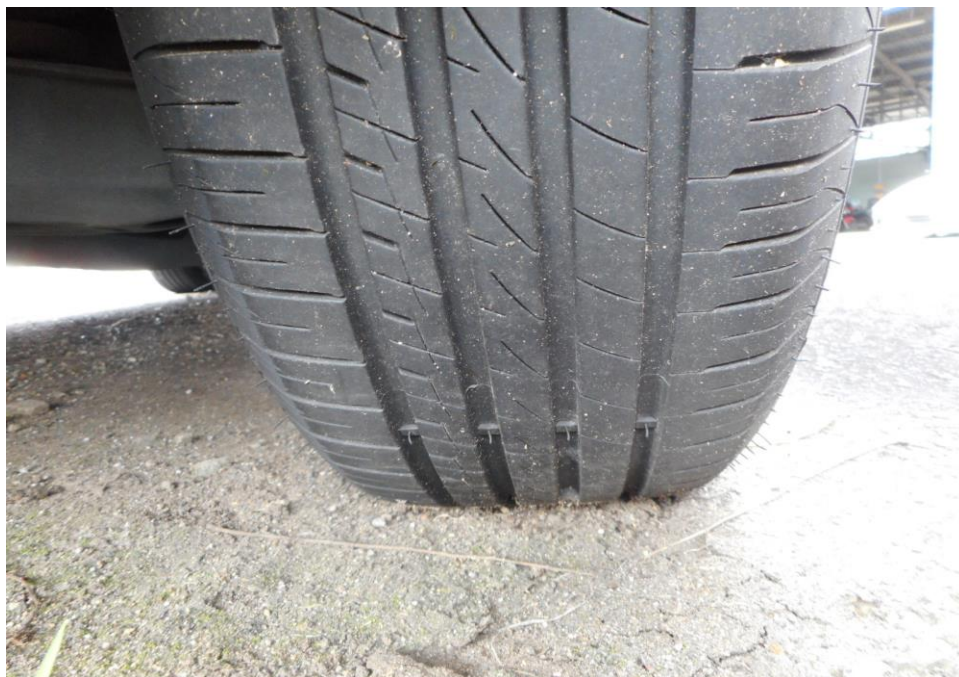
**Photo 9** shows the condition of the rear right tyre of the Motor Car, which was observed to be in serviceable condition with remaining tread depth of approximately 6.3mm. The tyre was also observed to be sufficiently inflated for vehicular operation with no tear, cut or burst mark(s).

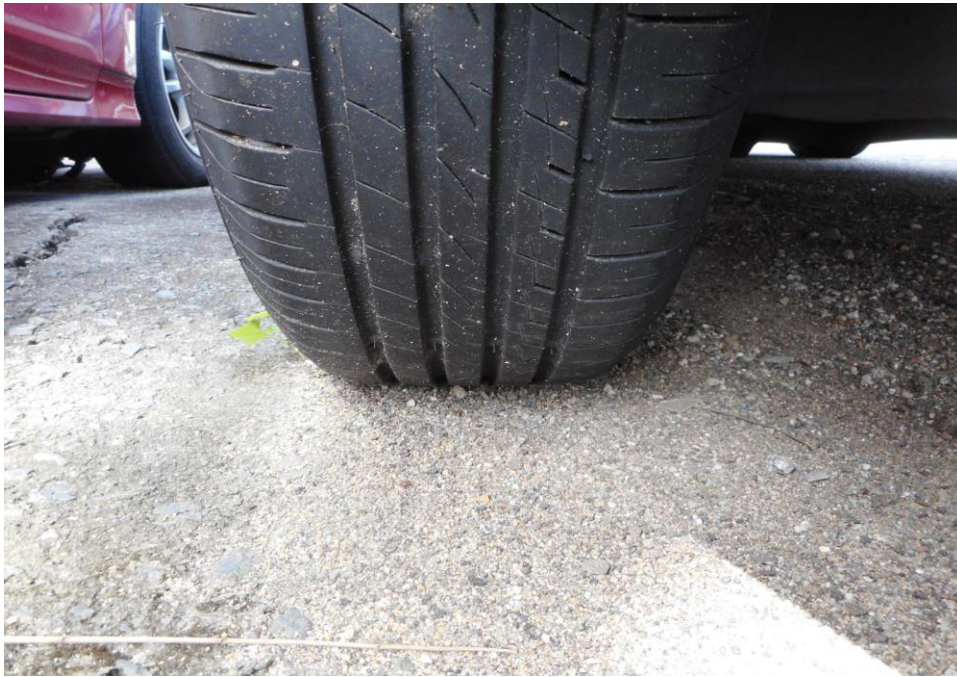
**Photo 10** shows the condition of the rear left tyre of the Motor Car, which was observed to be in serviceable condition with remaining tread depth of approximately 6mm. The tyre, which was wrapped around steel wheel rim, was also observed to be sufficiently inflated for vehicular operation. The 4 tyres of the Motor Car were wrapped around standard steel wheel rims.

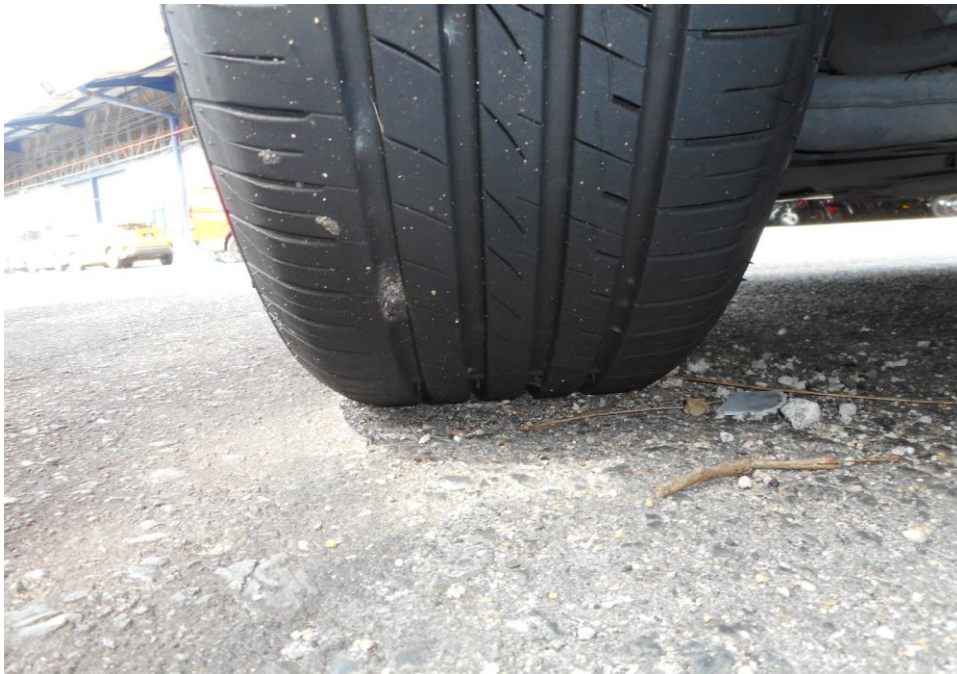
**Photo 11** shows the condition of the front left tyre of the Motor Car, which was observed to be in serviceable condition with remaining tread depth of approximately 6.5mm. The tyre, which was wrapped around steel wheel rim, was also observed to be sufficiently inflated for vehicular operation. The 4 tyres of the Motor Car were wrapped around standard steel wheel rims.

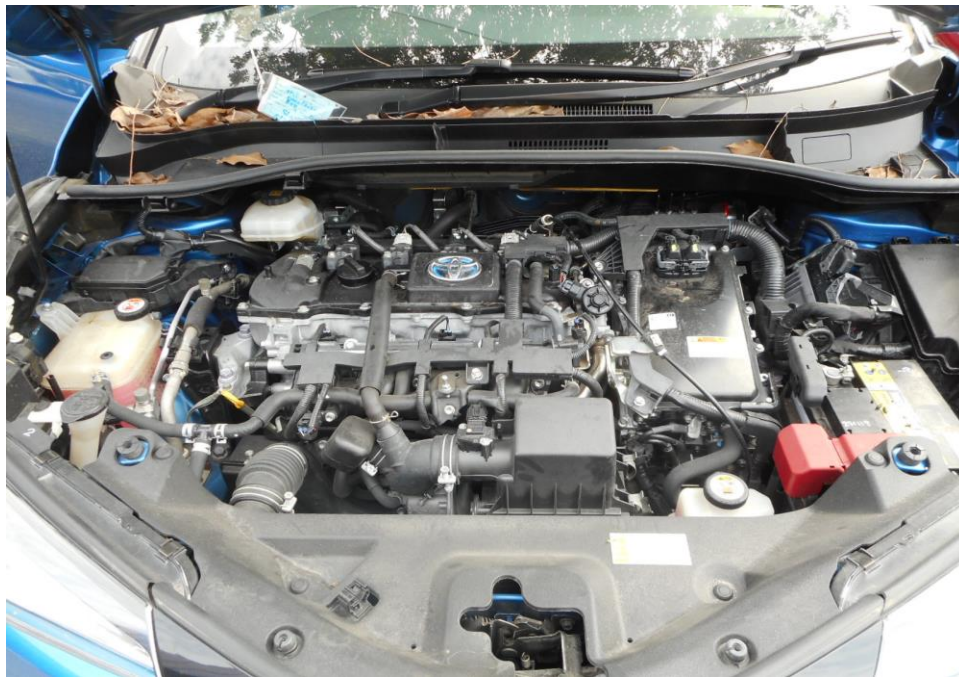
**Photo 12** shows a general view of the Motor Car's engine compartment. The various parts and components inside the engine compartment were unaffected by the accident. There was also no sign(s) or indication(s) of fluid leakage and/or fluid stain within the engine compartment.

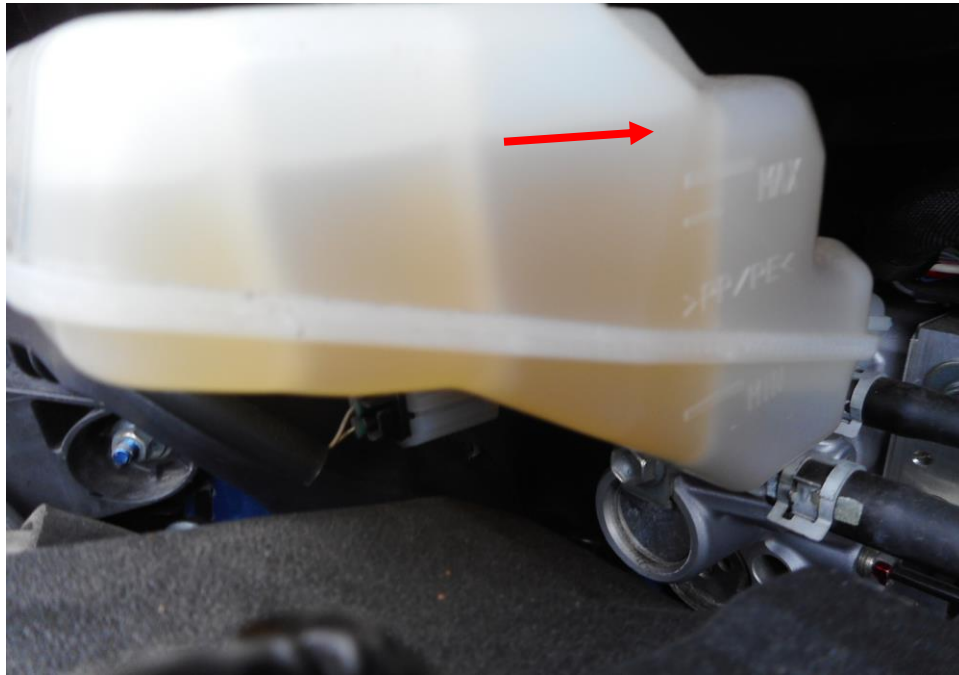
**Photo 13** shows the brake fluid reservoir of the Motor Car at the time of my inspection. The brake fluid was observed to be of sufficient level (arrowed) and without any visible contamination.

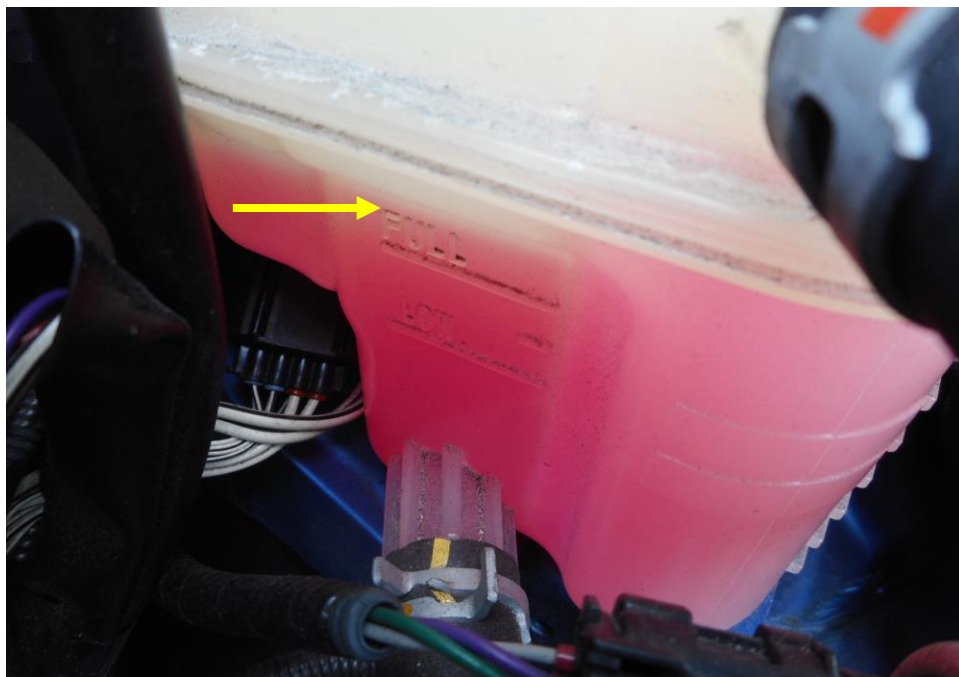
**Photo 14** shows checks being carried out to the engine coolant of the Motor Car at the time of my inspection. The engine coolant was observed to be of insufficient level (arrowed) likely due to the damaged to the front radiator which caused the leakage of coolant.

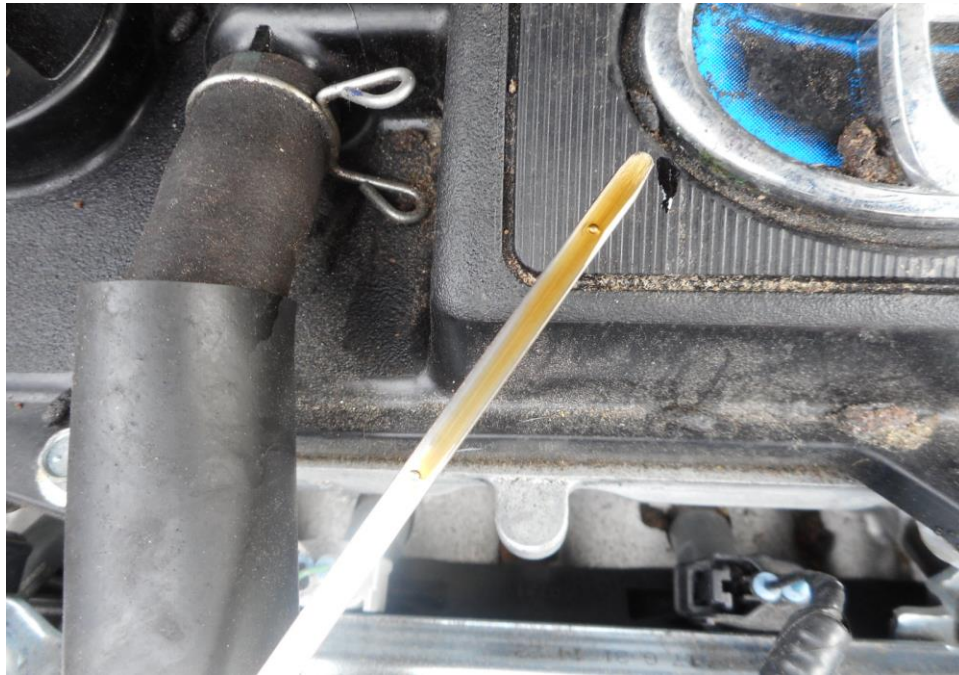
**Photo 15** shows the engine oil dip stick of the Motor Car at the time of my inspection. The engine oil was observed to be of sufficient level and without any visible contamination.

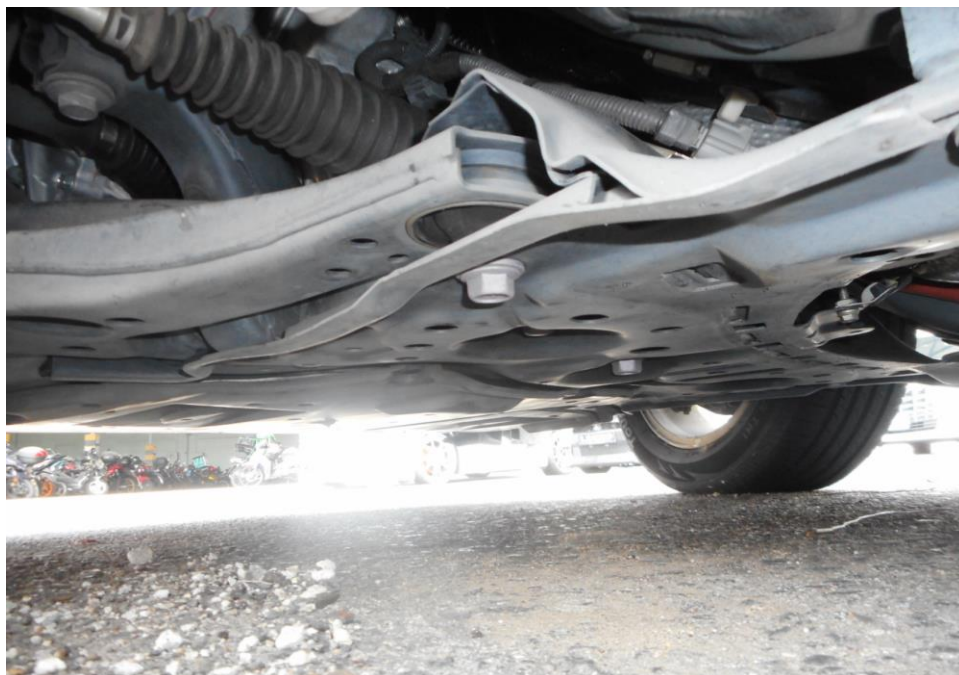
**Photo 16** shows the undercarriage of the Motor Car, at the area where the engine housing and transmission housing are located. I did not find any sign(s) or indication(s) of fluid leak and/or fluid stain(s) on the underside of the Motor Car.

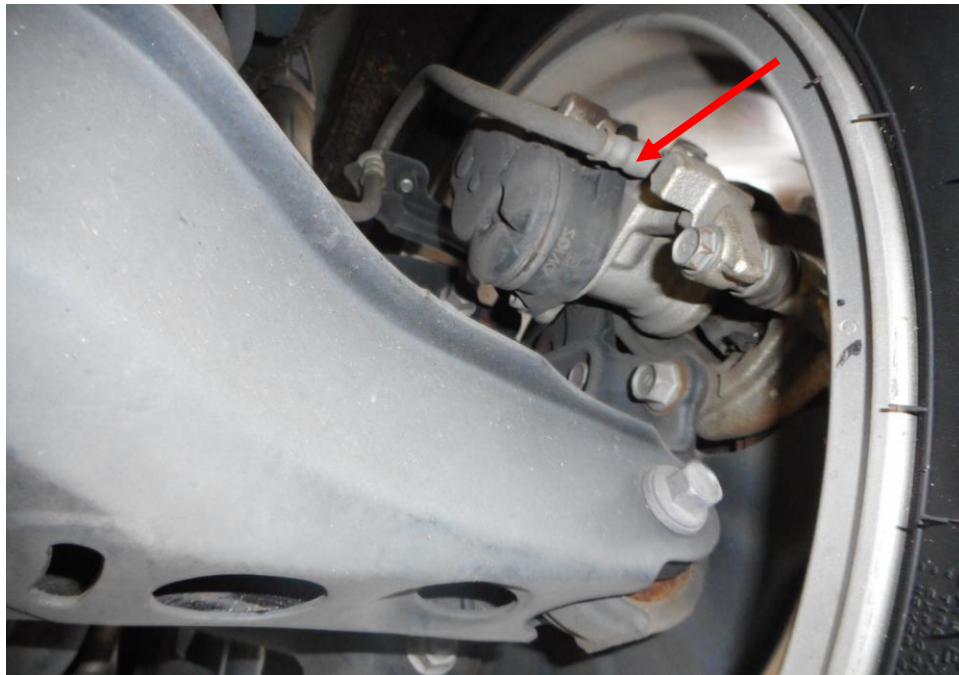
**Photo 17** shows the brake hose/pipe (arrowed) at the rear right wheel of the Motor Car. No leakage of brake fluid was observed. Visual examination of the various components of the braking system like the drum brake, brake booster, brake pedal etc. had revealed all to be intact and without visible damage.

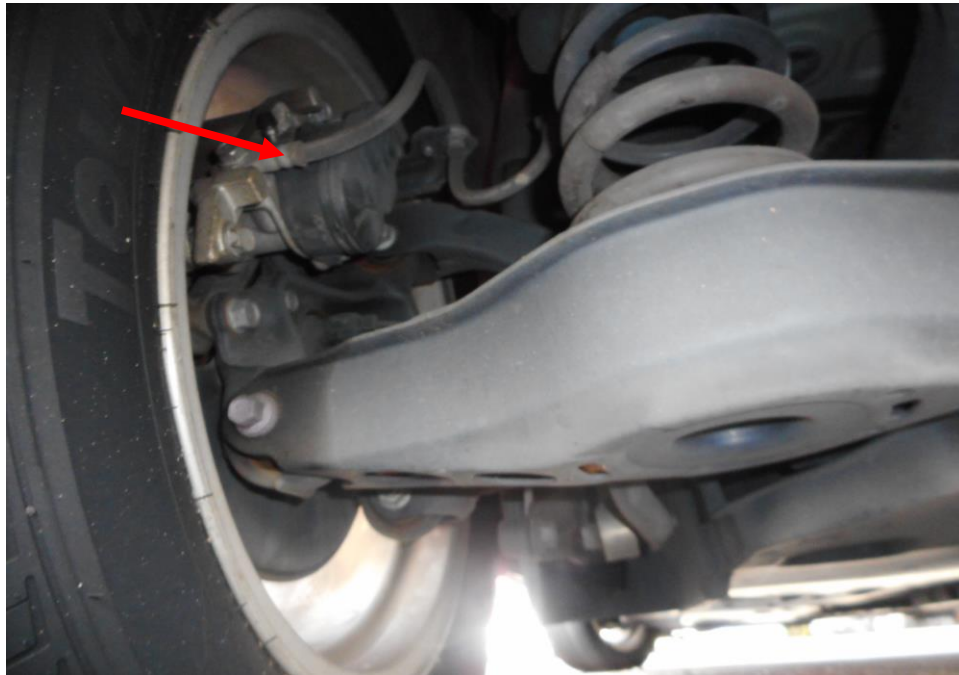
**Photo 18** shows the brake hose/pipe (arrowed) at the rear left wheel of the Motor Car. I did not observe any leakage of brake fluid at the time of my inspection of the Motor Car. Static tests of the Motor Car's braking system had indicated that there was no internal leakage of pressure/vacuum. The undercarriage components of the Motor Car were also all found to be intact and without any visible damage.

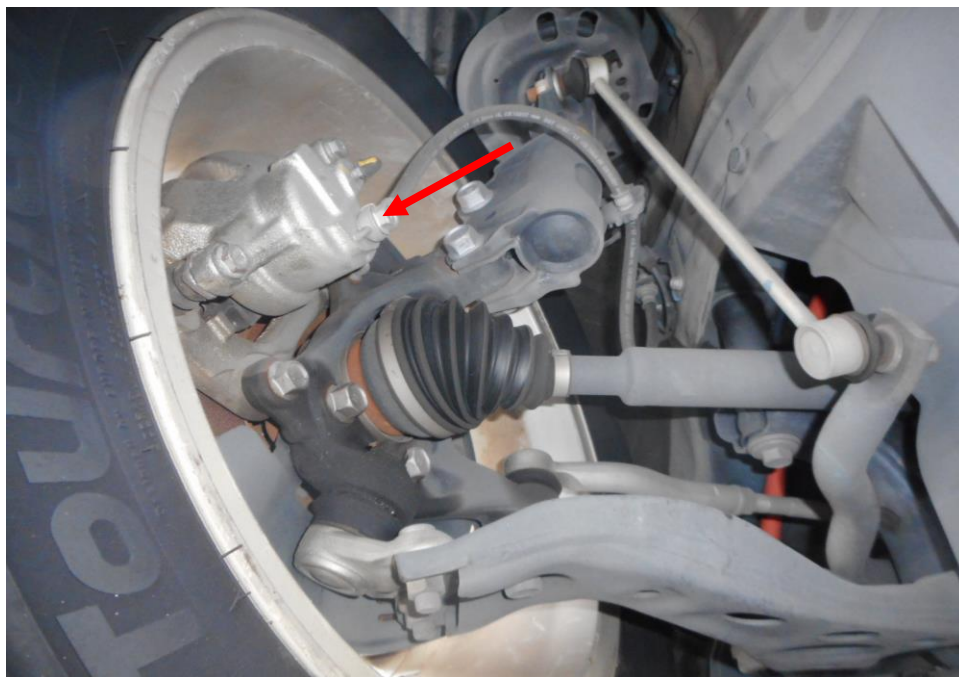
**Photo 19** shows the brake hose/pipe (arrowed) at the front right wheel of the Motor Car. I did not observe any leakage of brake fluid at the time of my inspection of the Motor Car. Static tests of the Motor Car's braking system had indicated that there was no internal leakage of pressure/vacuum. The undercarriage components of the Motor Car were also all found to be intact and without any visible damage.

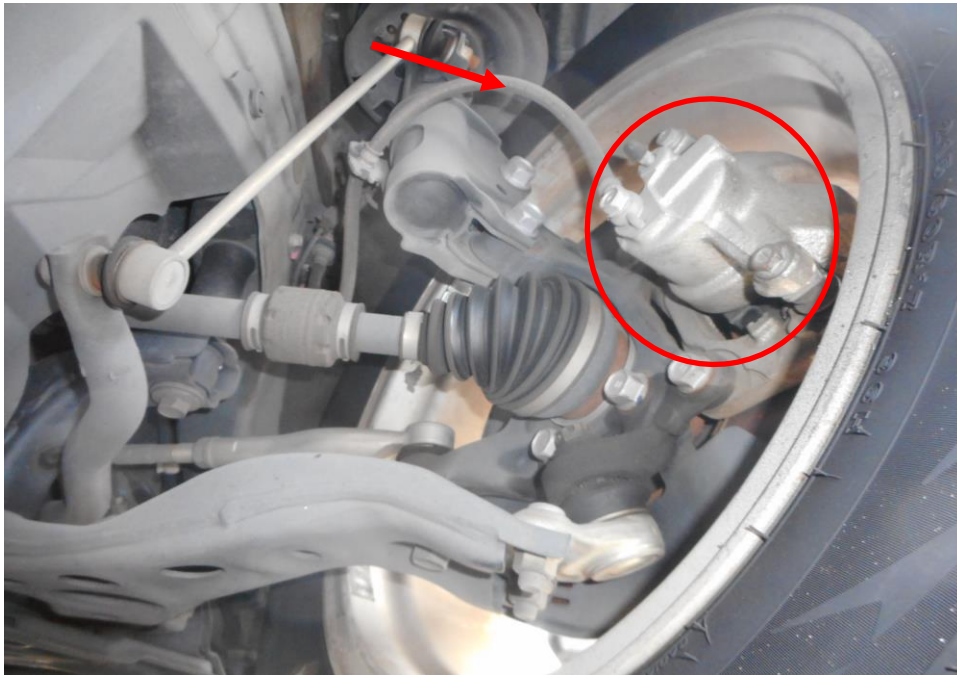
**Photo 20** shows the brake hose/pipe (arrowed) at the front left wheel of the Motor Car. No leakage of brake fluid was observed. Visual examination of the various components of the braking system like the brake caliper (circled), brake booster, brake pedal etc had revealed all to be intact and without visible damage.

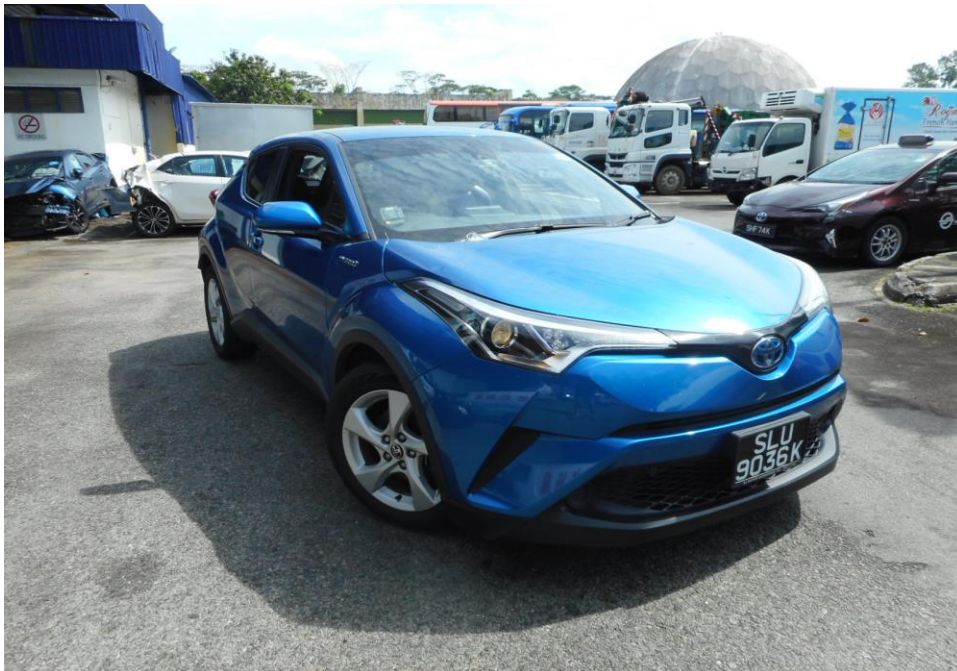
**Photo 21** shows the front right wheel of the Motor Car turned to its full left. During my steering system test, I did not experience any abnormal free play and/or resistance when I had turned the steering wheel towards the left and right. This would suggest that the steering system of the Motor Car was likely to be in serviceable condition at the material time of accident.

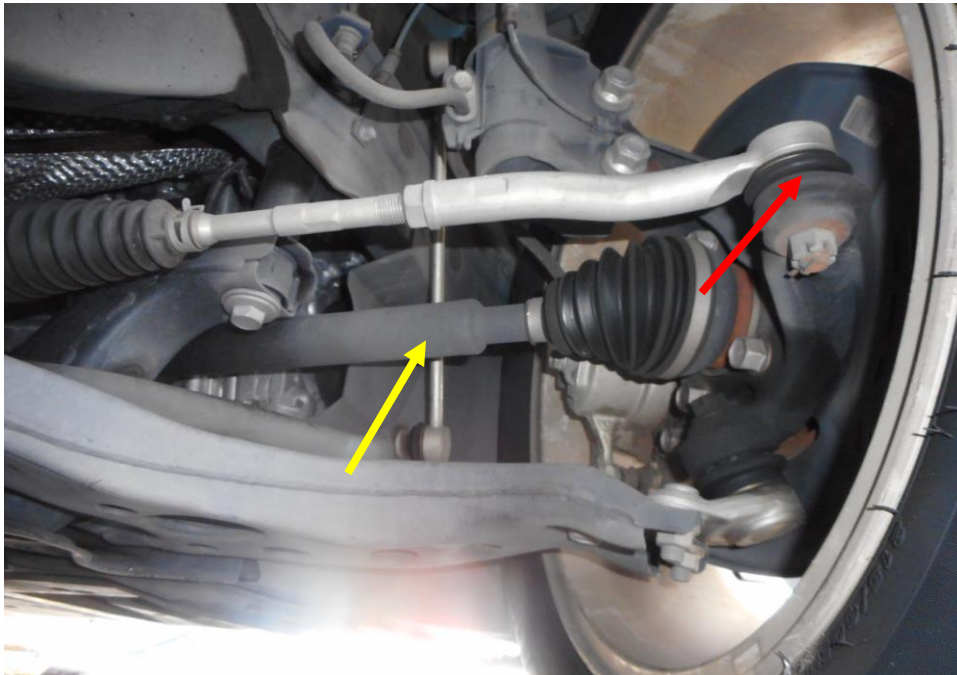
**Photo 22** shows the various undercarriage components at the front right wheel of the Motor Car, in particular the steering tie rod (red arrow) and drive shaft (yellow arrow). The various steering components were all found to be intact, suggesting that the steering system of the Motor Car was likely to be in serviceable condition at the material time of accident. There was also no sign of fluid stain observed on the various undercarriage components at the front right wheel of the Motor Car.

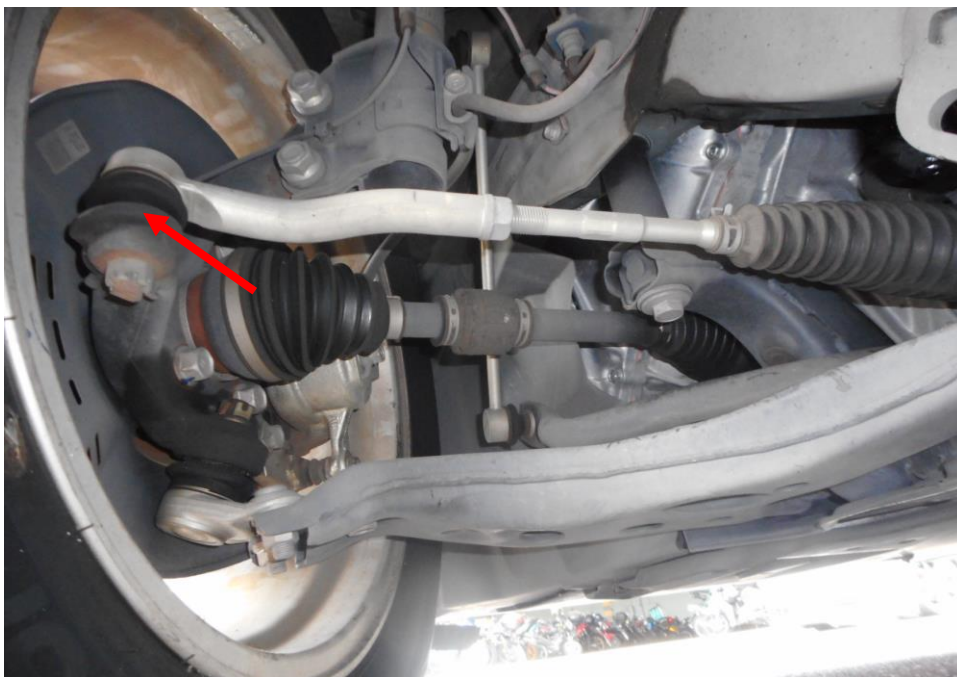
**Photo 23** shows the various undercarriage components at the front left wheel of the Motor Car, which had included the steering tie rod (red arrow). The various undercarriage components of the Motor Car were all found to be intact without any visible damage.

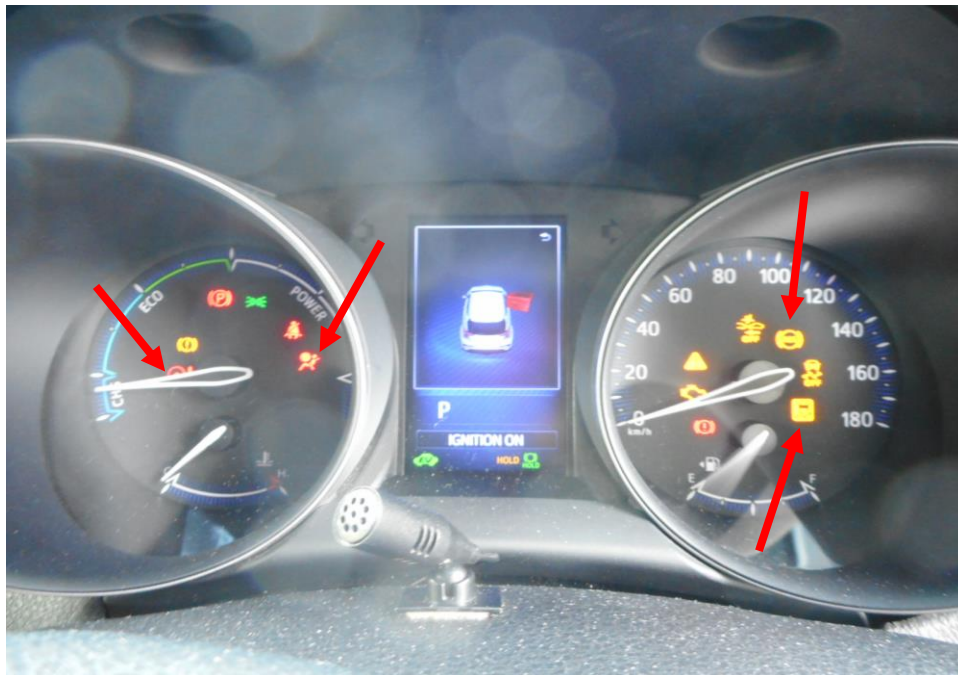
**Photo 24** shows the warning light for Anti-Lock Brake System (ABS) and Power Steering System (EPS), Supplemental Restraint System (SRS) and Traction Control (TC) (arrowed) appearing on the instrument panel of the Motor Car during the self-test of its various electronic operating systems when its engine was cranked.

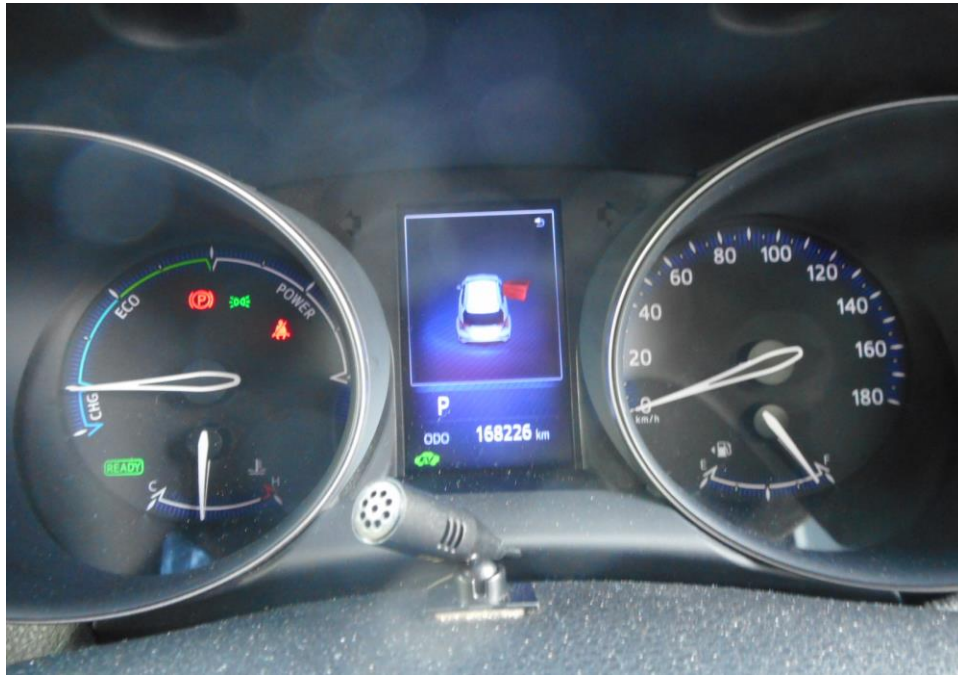
**Photo 25** shows no warning lights illuminated on the instrument panel of the Motor Car after the engine was cranked. This would suggest that there was no abnormality to the electronic operating system of the Motor Car, like the ABS, EPS, TC and SRS etc.
