Your Ref: TP/IP/26385/2020  
Our Ref : CI/TPD20011129/N

**Fatal Accident Investigation Team**

**INSPECTION REPORT OF E- BIKE  
TRAFFIC POLICE POUND REPORT NO. 1775/2020**

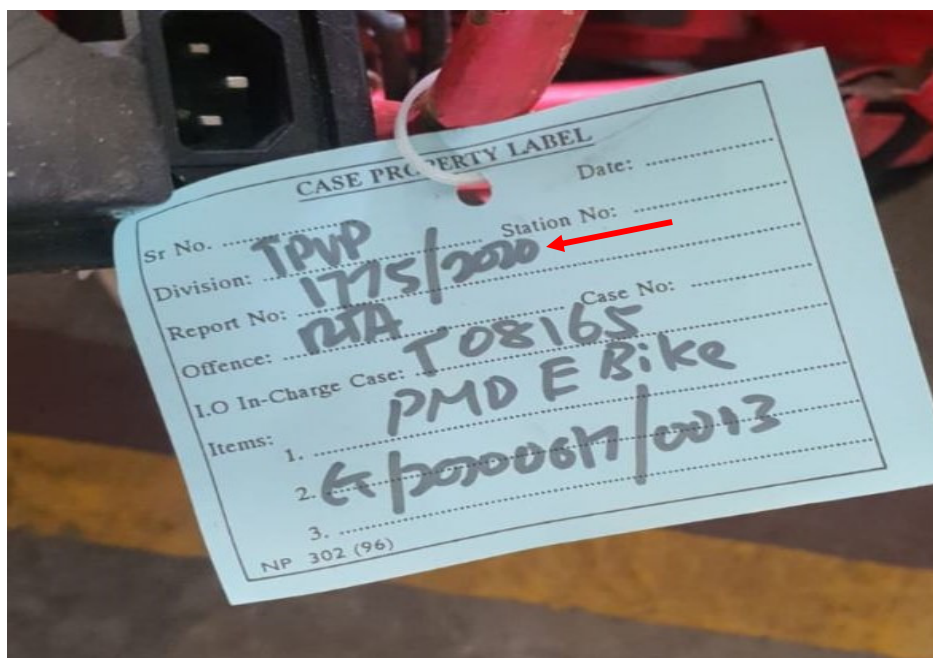
**Photo 1** shows the identification of the E-bike with reference to Traffic Police Pound Report No. 1775/2020 (arrowed).

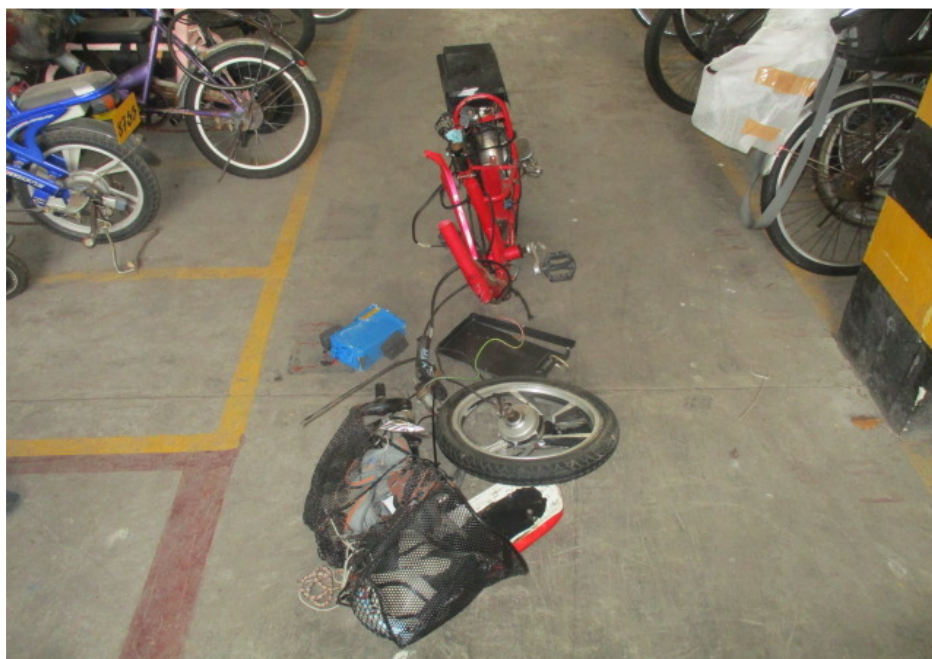
4. The E- Bike had sustained damages all around. The body parts that were found to have been damaged include its fork assembly, hand brake levers, handlebar, basket, front wheel rim, seat, body frame and rear mudguard, amongst others as a result of the accident. See photos 1 - 10 below.

**Photo 2** shows the frontal portion of the E-bike at the time of our inspection. The E-bike was observed to have sustained damages all around.

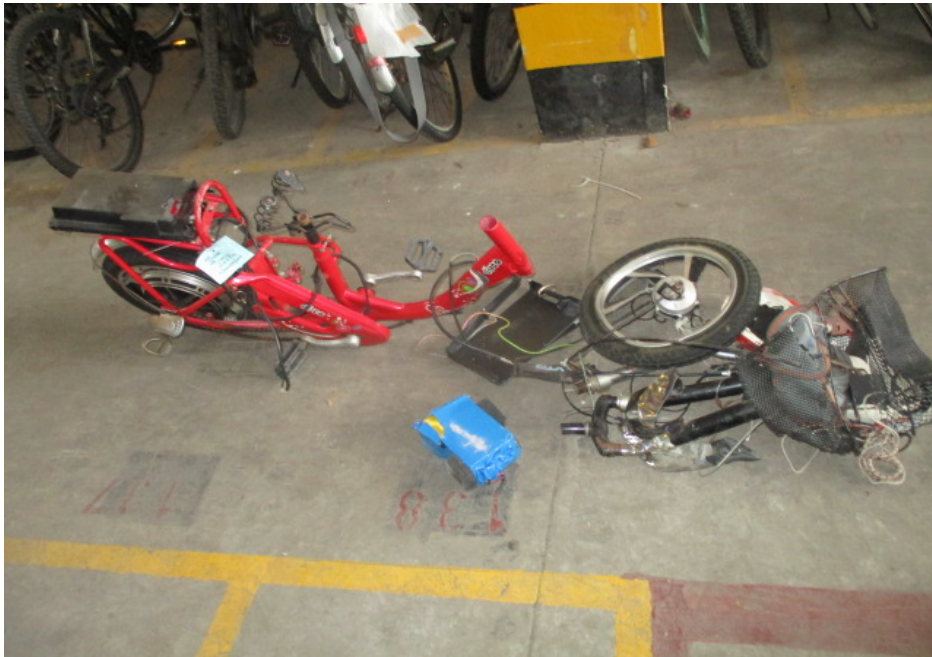
**Photo 3** shows the right body of the E-bike at the time of our inspection. The E-bike was observed to have sustained damages all around.

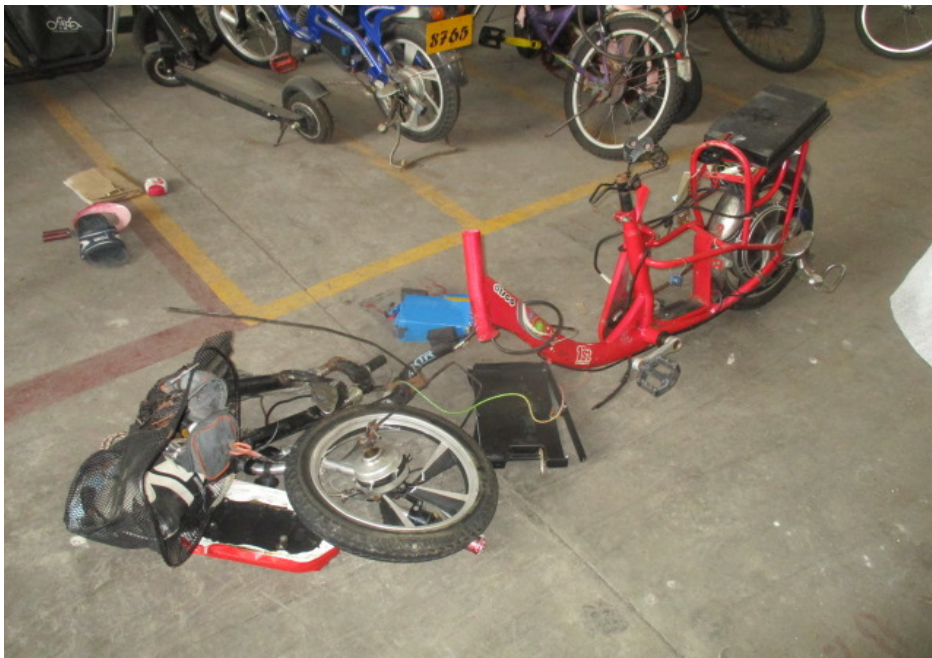
**Photo 4** shows the left body of the E-bike at the time of our inspection. The E-bike was observed to have sustained damages all around.

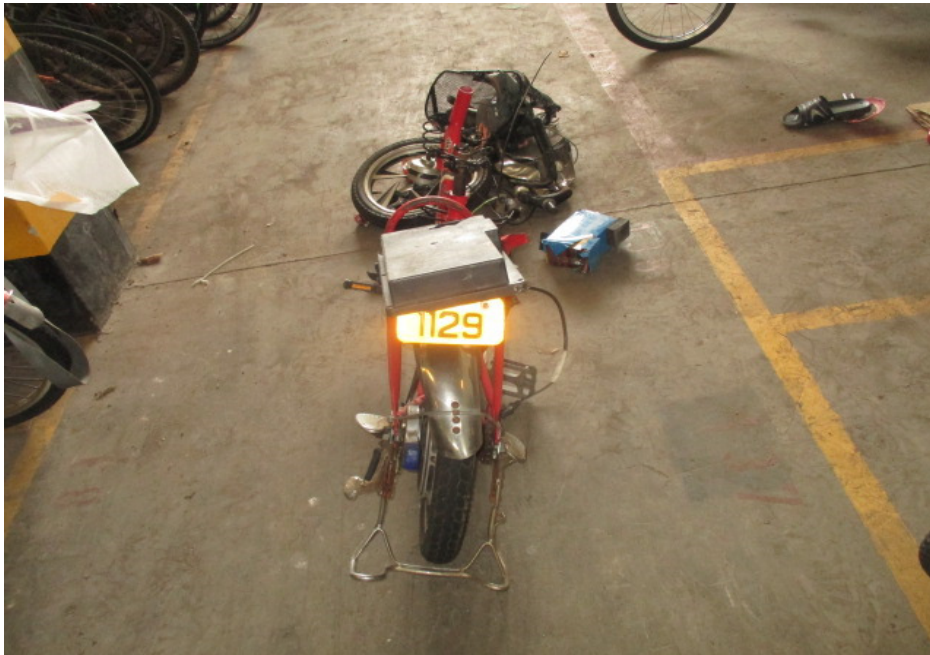
**Photo 5** shows the rear portion of the E-bike at the time of our inspection. The E-bike was observed to have sustained damages all around. The body parts that were found to have been damaged include its fork assembly, hand brake levers, handlebar, basket, front wheel rim, seat, body frame and rear mudguard, amongst others as a result of the accident.

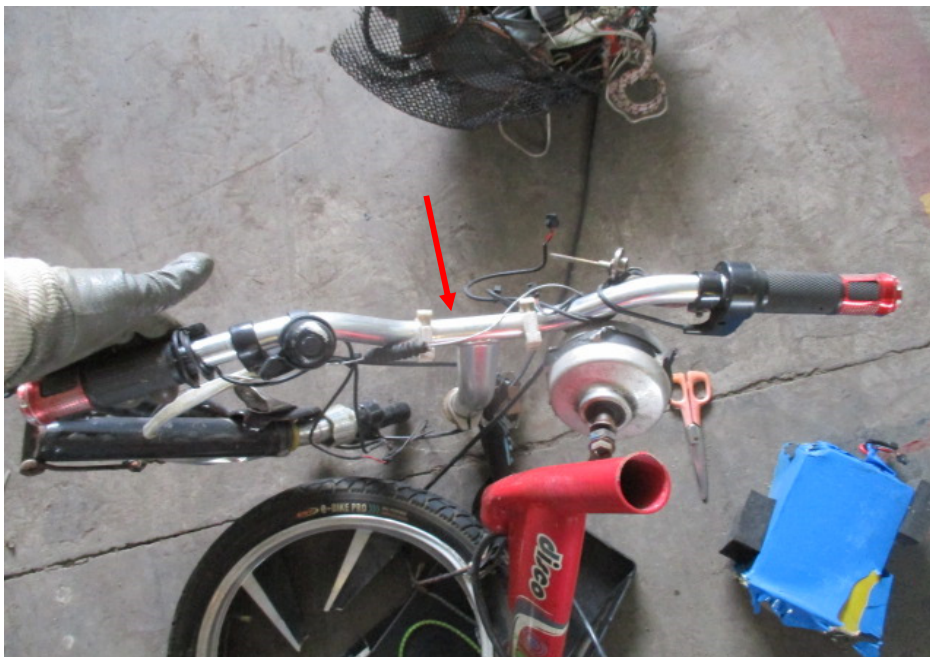
**Photo 6** shows the dislodged handlebar (arrowed) of the E-bike as a result of the accident.

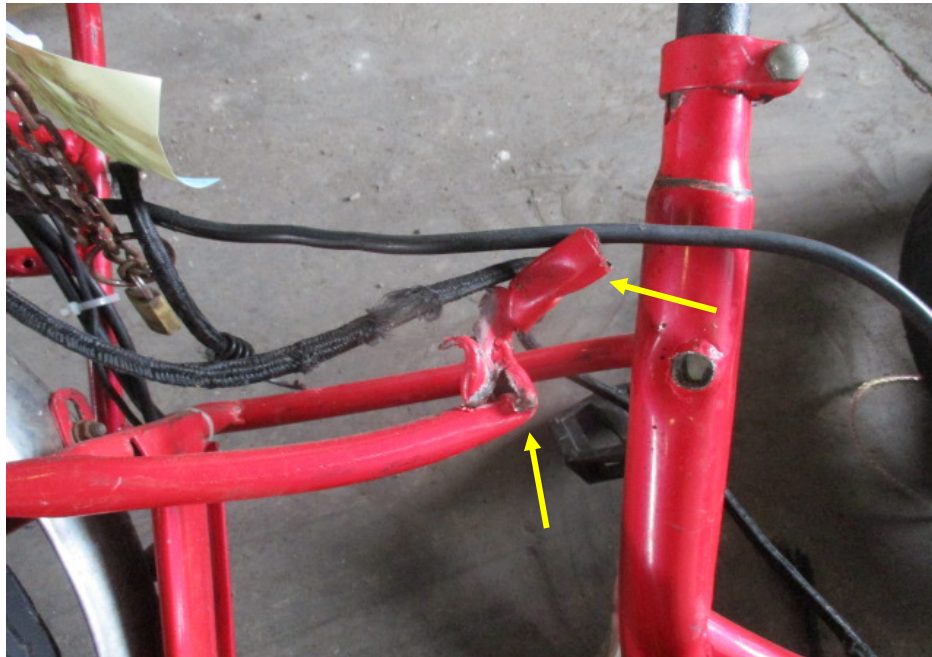
**Photo 7** shows the damages on the body frame of the E-bike as a result of the accident (arrowed).

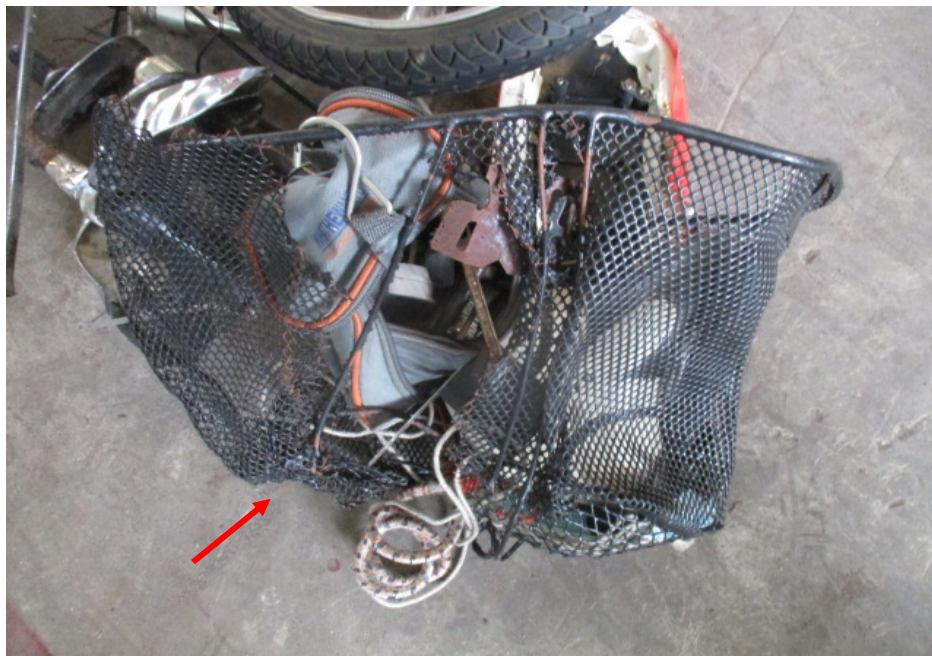
**Photo 8** shows the deformed basket of the E-bike as a result of the accident (arrowed).

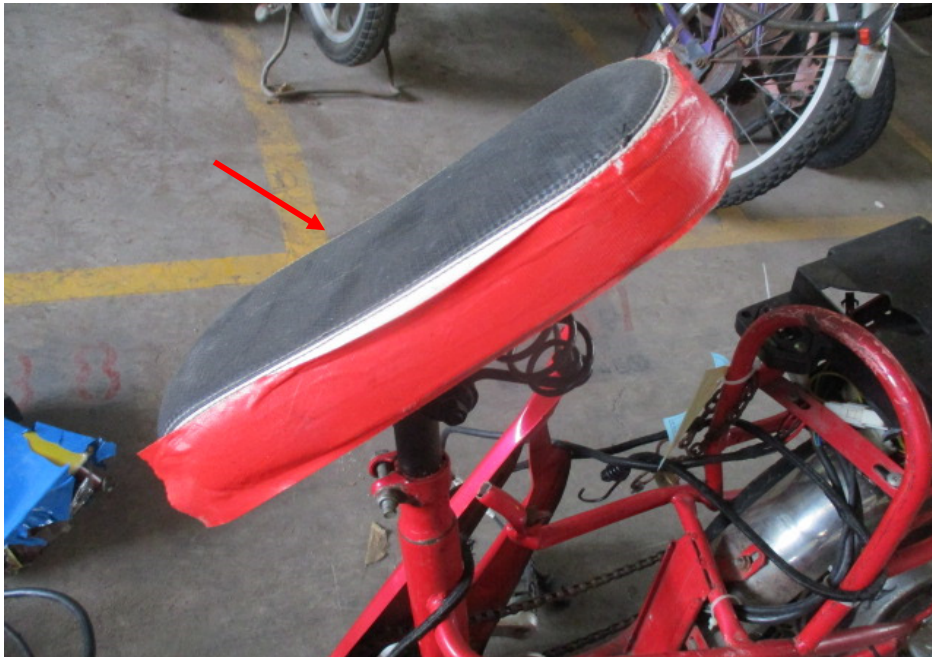
**Photo 9** shows the deformed seat of the E-bike as a result of the accident (arrowed).

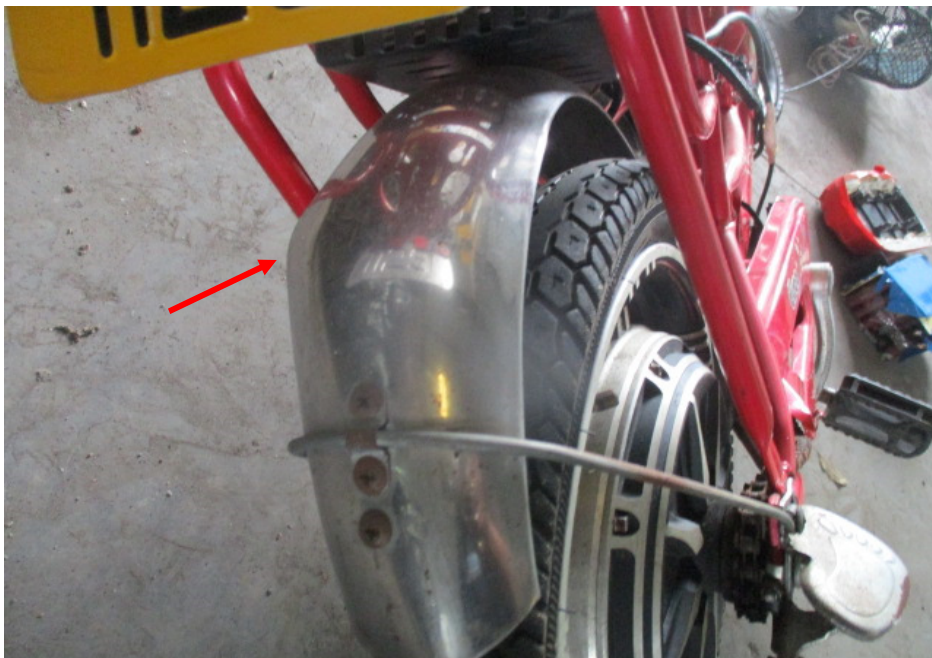
**Photo 10** shows the deformed rear mudguard of the E-bike as a result of the accident (arrowed).

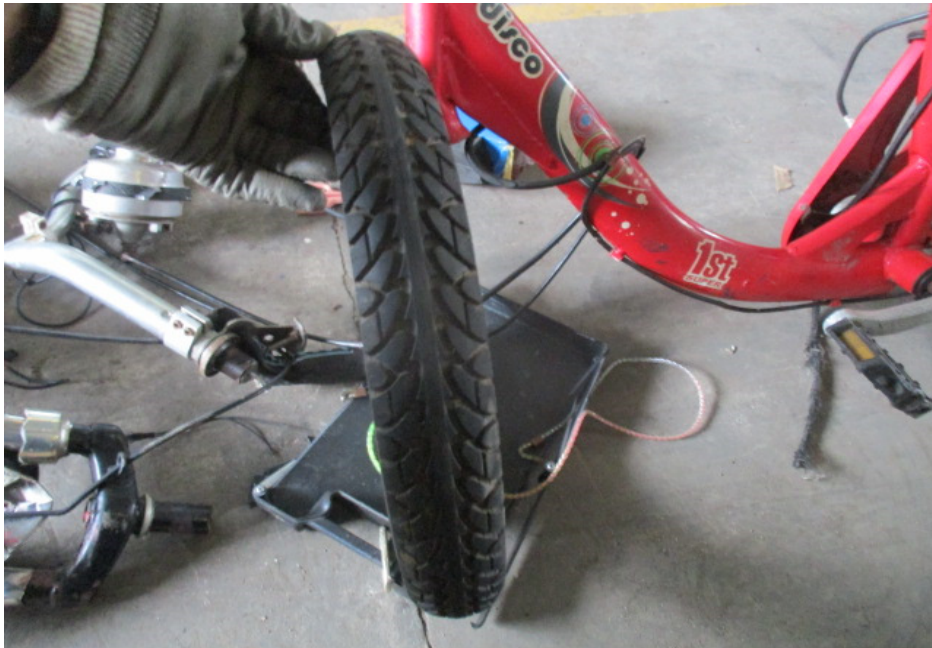
5. The condition of the E- Bike's 2 tyres was observed to be in serviceable condition. The tread pattern of the 2 tyres was clearly visible. We did not observe any tear, burst mark(s) and/or punctured hole(s) on the sidewalls as well as across the tread of the 2 tyres. The 2 tyres were both observed to be sufficiently inflated for vehicular operation. The tyre brand, tyre size and remaining tread depth of the 2 tyres were recorded as follows:-

**Photo 11** shows the front tyre of the E-bike at the time of our inspection. The front tyre was observed to be in serviceable condition with remaining tread depth of approximately 3mm. The tyre was also observed to be sufficiently inflated for vehicular operation. We did not observe any tear, burst mark(s) and/or punctured hole(s) on the sidewalls as well as across the tread of the front tyre.

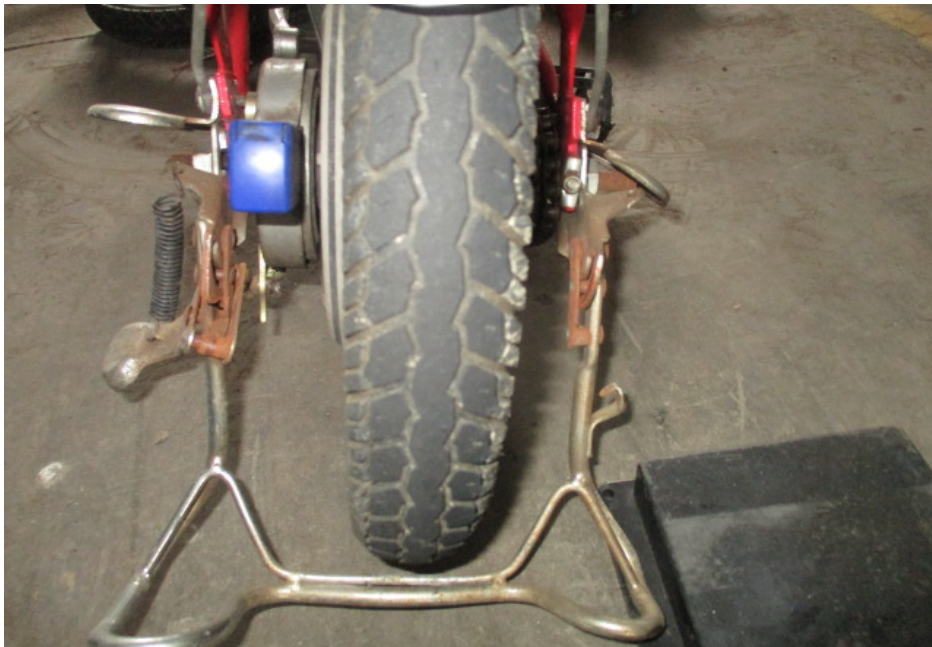
**Photo 12** shows the rear tyre of the E-bike at the time of our inspection. The rear tyre was observed to be in serviceable condition with remaining tread depth of approximately 3mm. We did not observe any tear, burst mark(s) and/or punctured hole(s) on the sidewalls as well as across the tread of the rear tyre. The tyre was also observed to be sufficiently inflated for vehicular operation.

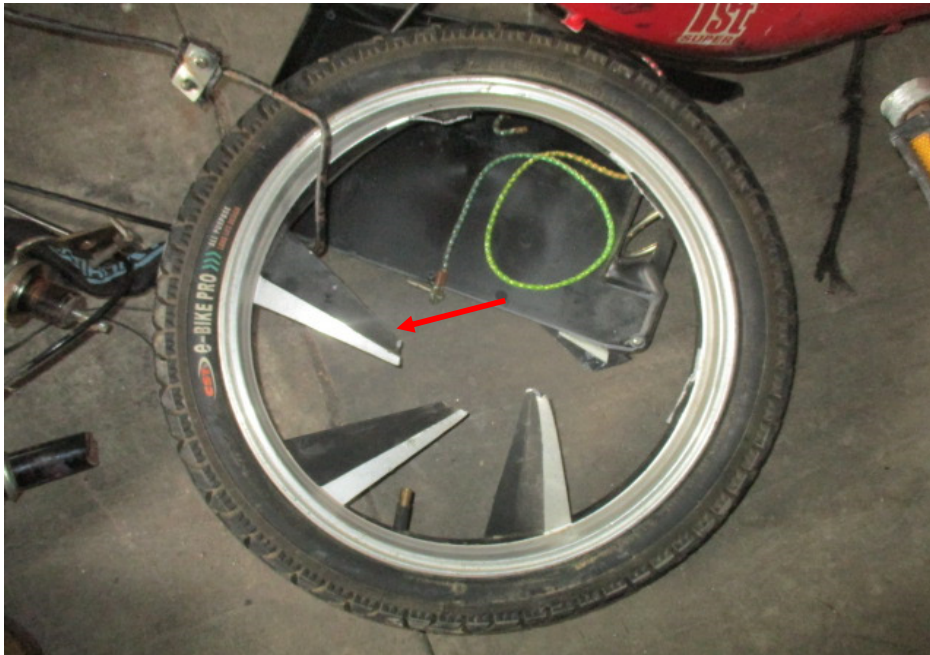
6. The tyres were wrapped around alloy wheel rims. The rear wheel rim was found to be without any significant damage. However the front wheel rim was observed to be broken as a result of the accident. See photos 11 - 13 below.

**Photo 13** shows the broken front wheel rim of the E-bike as a result of the accident (arrowed).

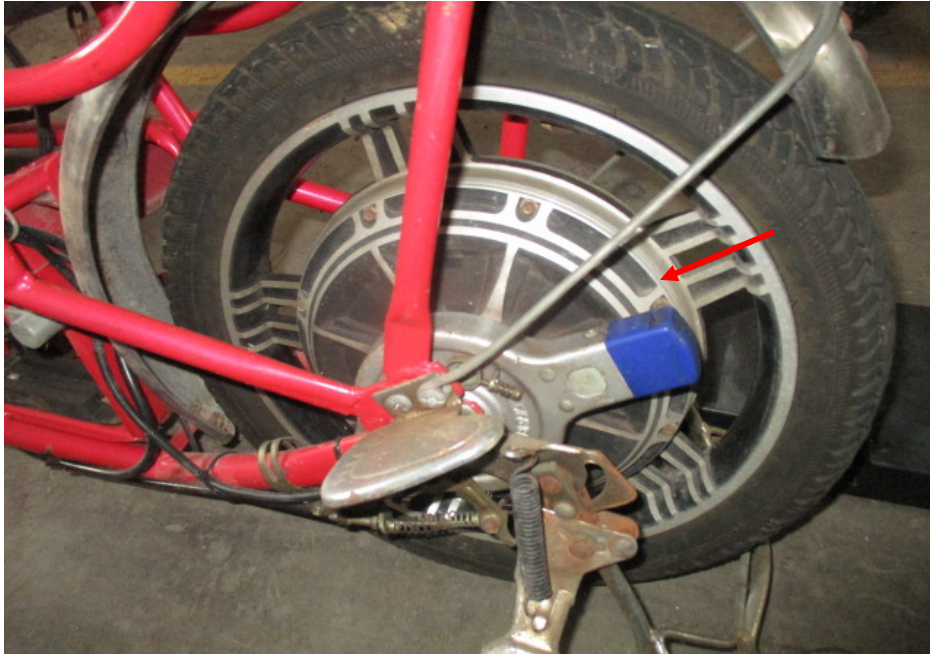
7. The E- bike was controlled by a motor and gear train to drive the rear tyre. The motor was originally installed on the rear portion of the rear tyre & found adequately acceptable. The motor of the E- bike was found to be intact without any misalignment or damages. However it was observed not to be in operational condition due to the dislodged battery as a result of the accident. The gear train of the E- bike was also found to be intact without any misalignment. It was also adequately lubricated for operating purposes. However the chain was observed to be dislodged from the gear train most likely as a result of the accident. See photos 14 - 17 below.

**Photo 14** shows the general view of the drive motor (arrowed) of the E-bike which was observed to be intact with no misalignment. However it was observed not to be in operational condition due to the dislodged battery as a result of the accident.

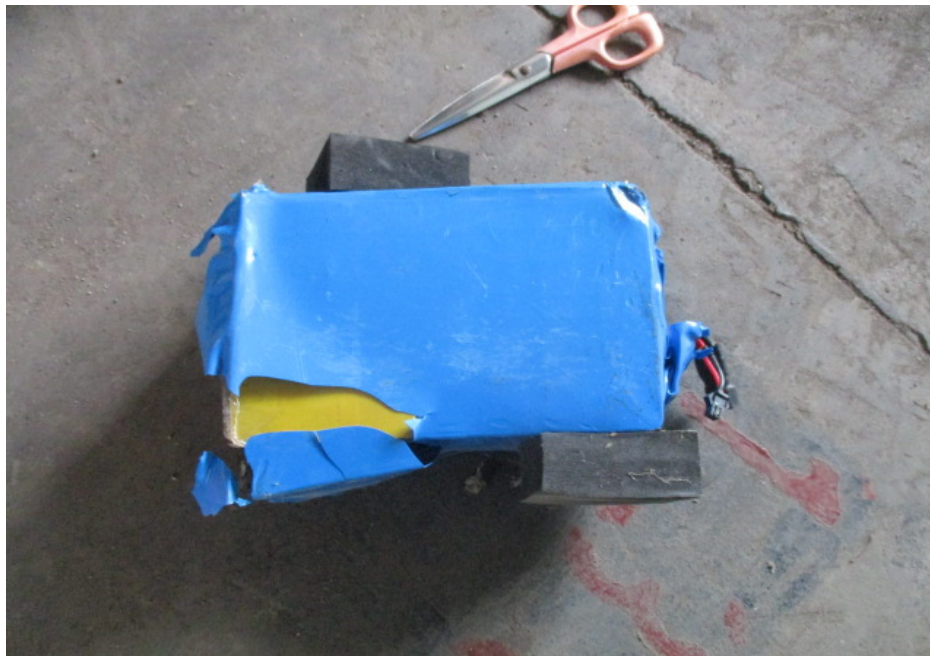
**Photo 15** shows a closer view of the dislodged battery of the E-bike as a result of the accident.

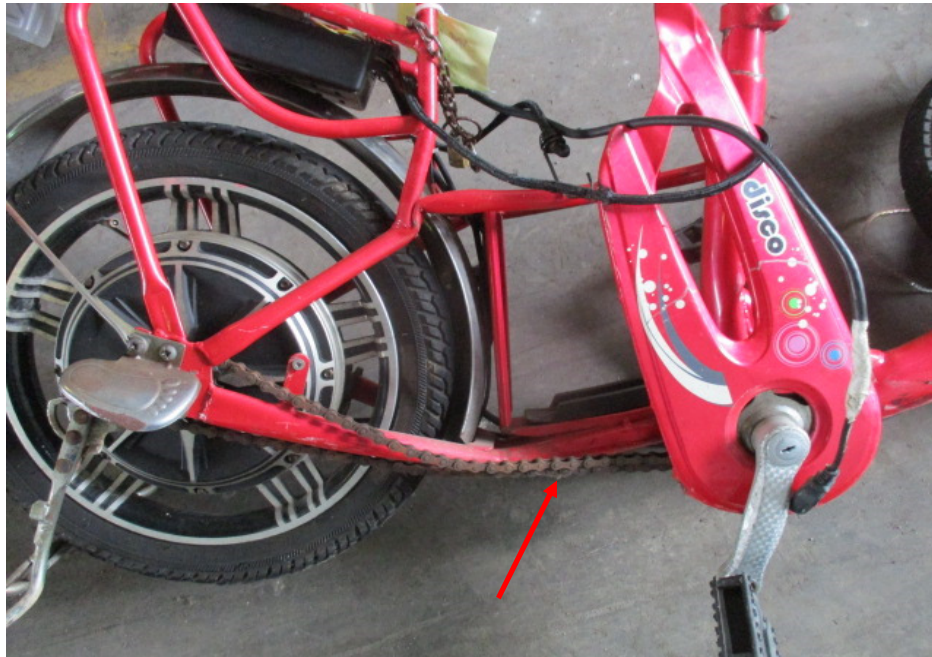
**Photo 16** shows the general view of the gear train of the E-bike, which was observed to be intact with no misalignment. It was also adequately lubricated for operating purposes. However the chain was observed to be dislodged from the gear train most likely as a result of the accident (arrowed).

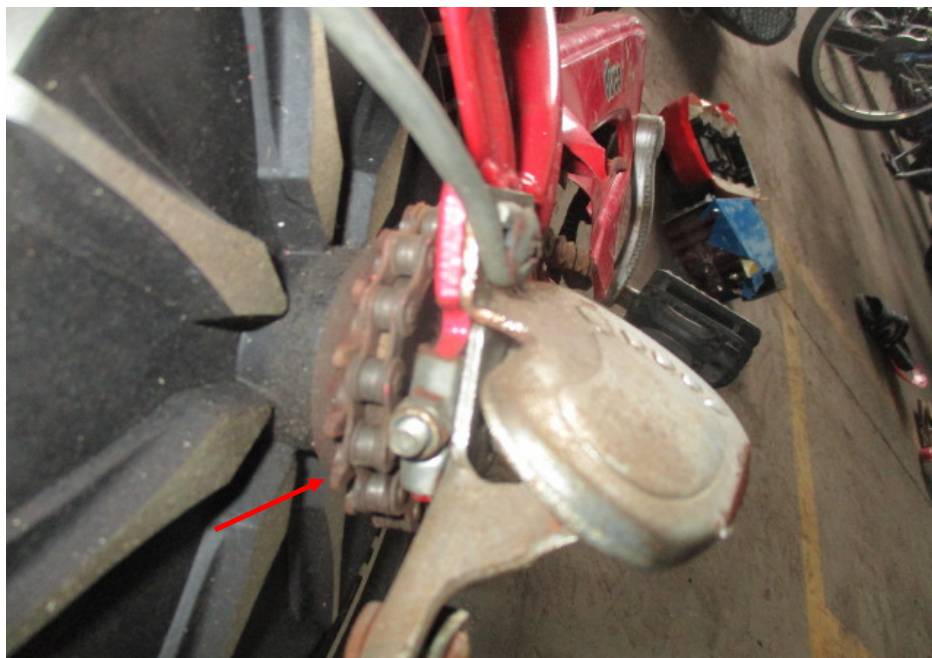
**Photo 17** shows a closer view of the dislodged chain from the gear train of the E-bike, most likely as a result of the accident (arrowed). It was found to be adequately lubricated for operating purposes.

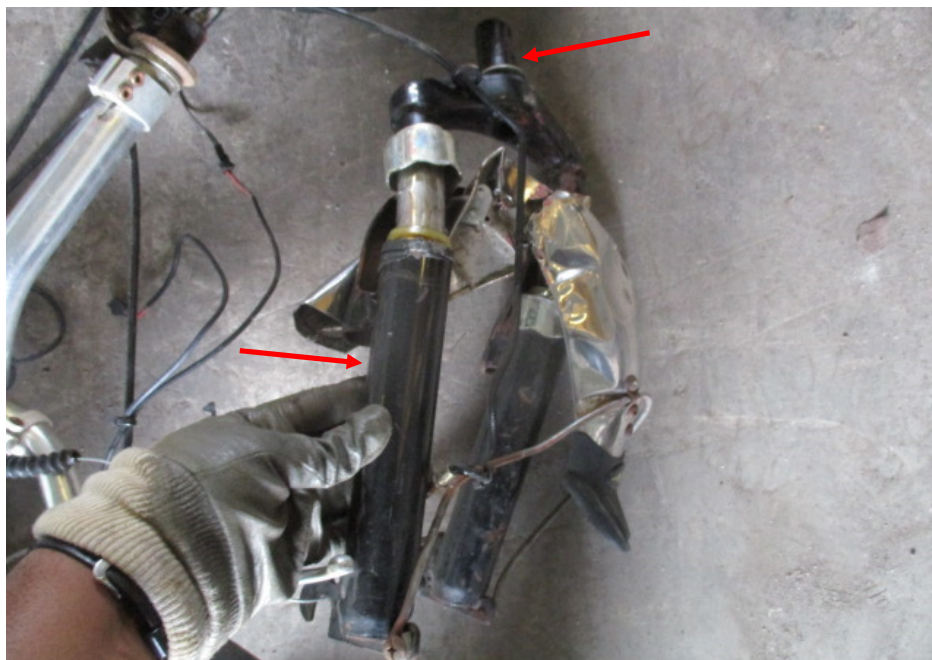
8. For this case, we were not able to conduct any test(s) on the steering system of the E- Bike due to the damages on its front fork. The front fork was found to be bent and dislodged as a result of the accident. Furthermore, the front wheel rim was dislodged as a result of the accident, hence rendering the E- bike immobile for any static or operational tests.

**Photo 18** shows the front forks of the E-bike. The front forks were observed to be bent and dislodged (arrowed) as a result of the accident. We were hence not able to conduct any tests on the steering system of the E-bike.

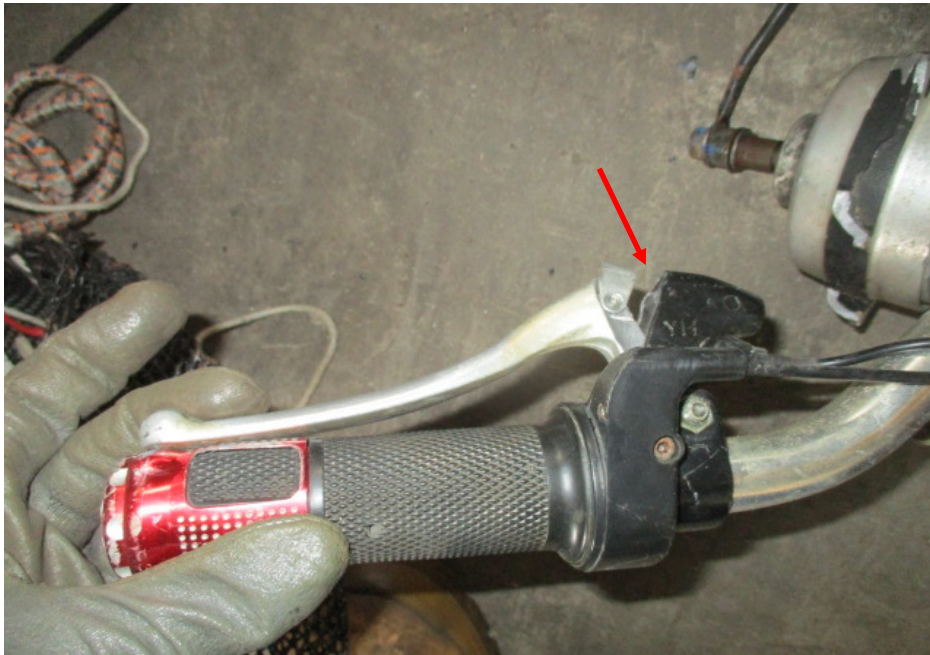
9. The brake system of the E- Bike was controlled by mechanical means (cables and springs). Our visual examination of the various components in the brake system, like the hand brake levers (left & right) and drum revealed some of these components sustained damages. The left hand brake lever was found to be bent as a result of the accident. We did not observe any visible tear or cut on the connecting cables. However the brake cable for the right hand brake lever was observed to be dislodged as a result of the accident. Hence, we were not able to conduct any static tests on the braking system of the E- Bike. See photos 18 - 21 below.

**Photo 19** shows the right hand brake lever of the E-bike when depressed. The brake cable was observed to be dislodged as a result of the accident (arrowed). Hence a static brake test could not be conducted on the E-bike's braking system.

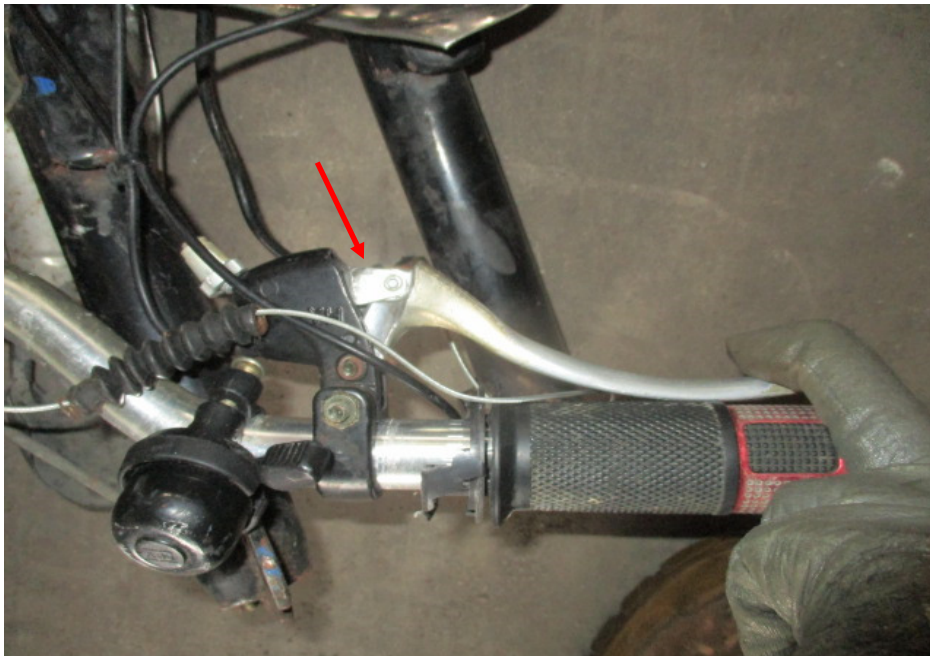
**Photo 20** shows the bent left hand brake lever of the E-bike as a result of the accident (arrowed). Hence a static brake test could not be conducted on the E-Bike's braking system.

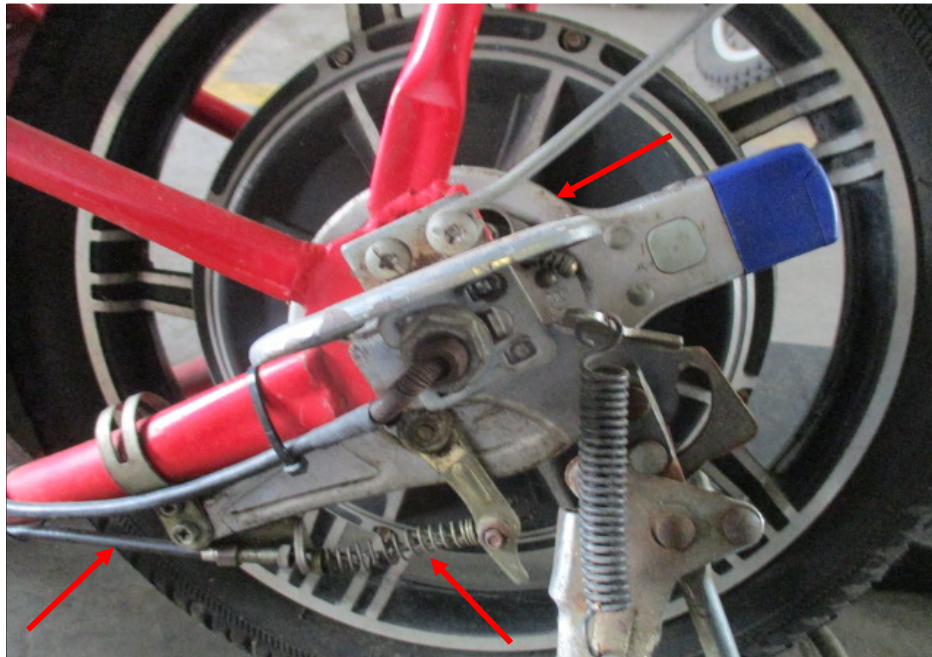
**Photo 21** shows the rear wheel of the E-bike. The type of brake system for the rear wheel was of a mechanical type. Our checks on the cable, spring and drum which are all part of the components in the rear brake system of the E-bike reveal all to be intact and without damage (arrowed).
