Your Ref: TP/IP/25833/2020
Our Ref : CI/TPD20011130/N

2 November 2020

INSPECTION REPORT OF MOTORCYCLE JSW 5766

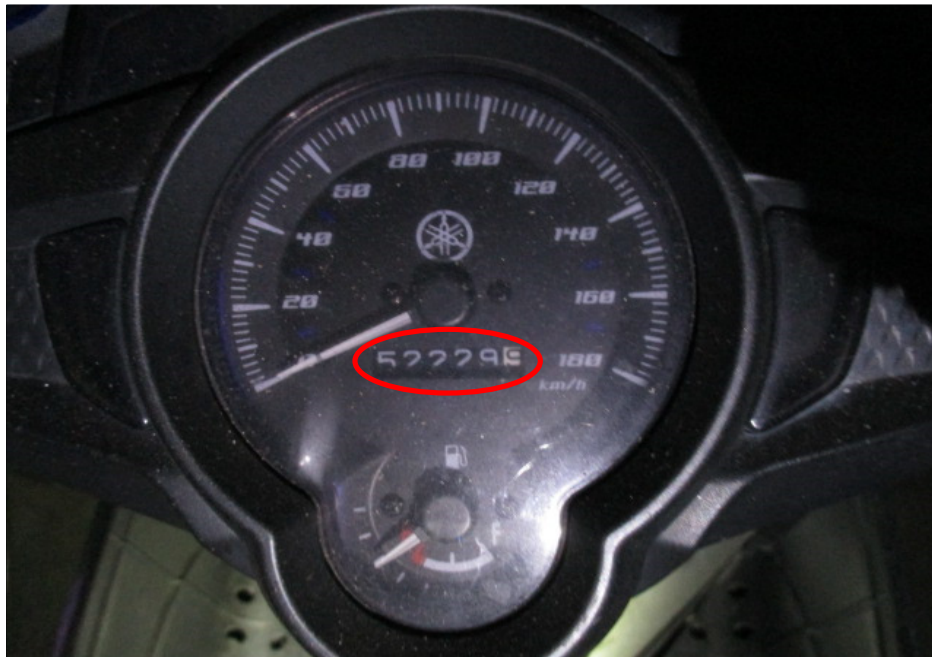
Photo 1 shows the speedometer gauge of the Motorcycle. The mileage of the Motorcycle at the time of our inspection was 52, 229km (circled).

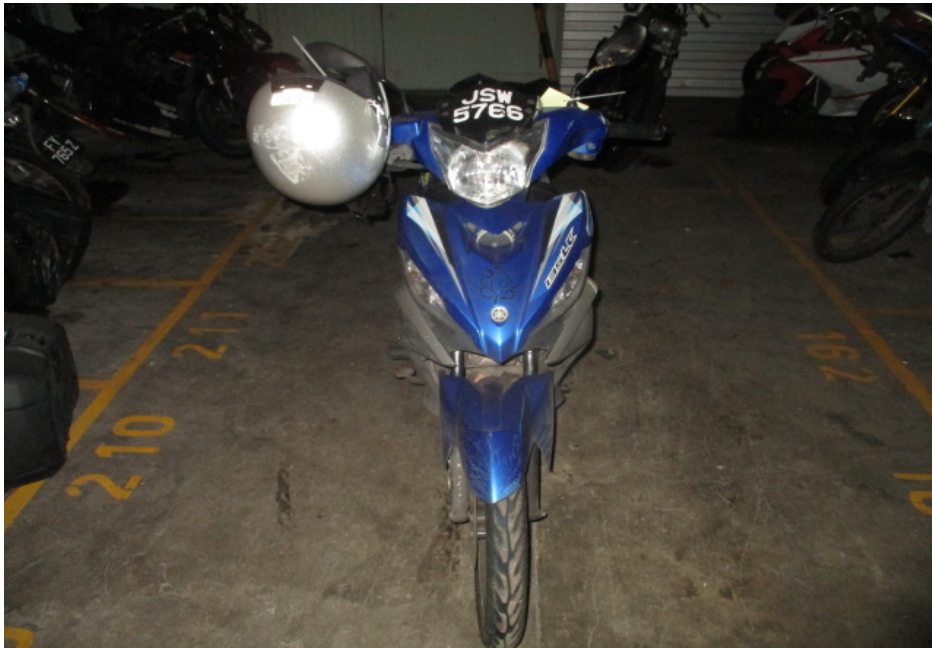
Photo 2 shows a general view of the frontal portion of the Motorcycle at the time of our inspection. The Motorcycle was observed to have sustained damages at its frontal portion and left body.

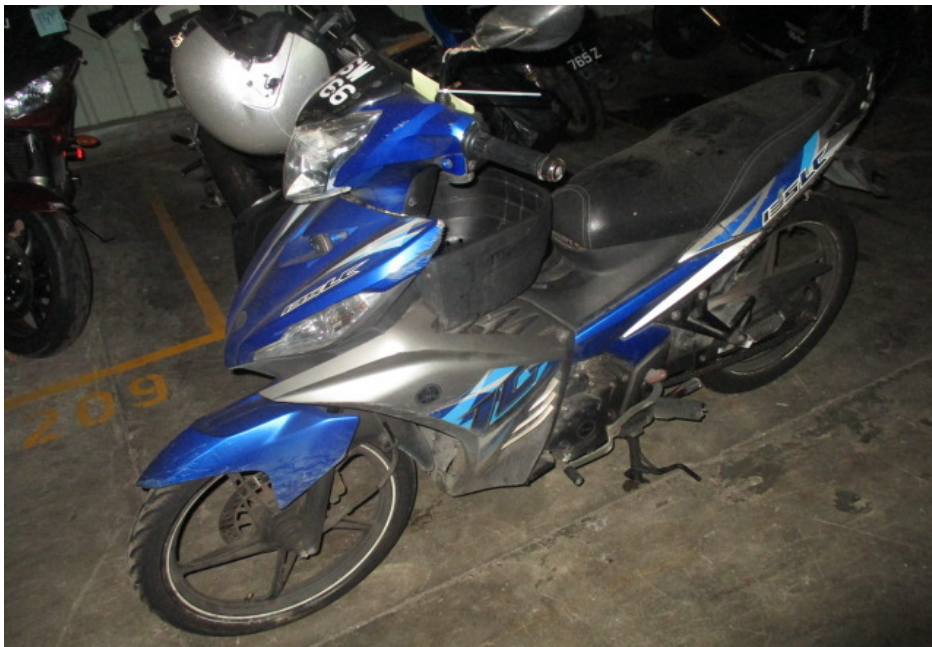
Photo 3 shows a general view of the left body of the Motorcycle at the time of our inspection. The Motorcycle was observed to have sustained damages at its frontal portion and left body. Amongst the body parts that were found to have been damaged include its windshield, headlight assembly, head cowl, front cowl, front mudguard, left cowl, left handlebar end, left side mirror, gear shift pedal, left front footrest, left rear side cover and pillion grab rail, amongst others.

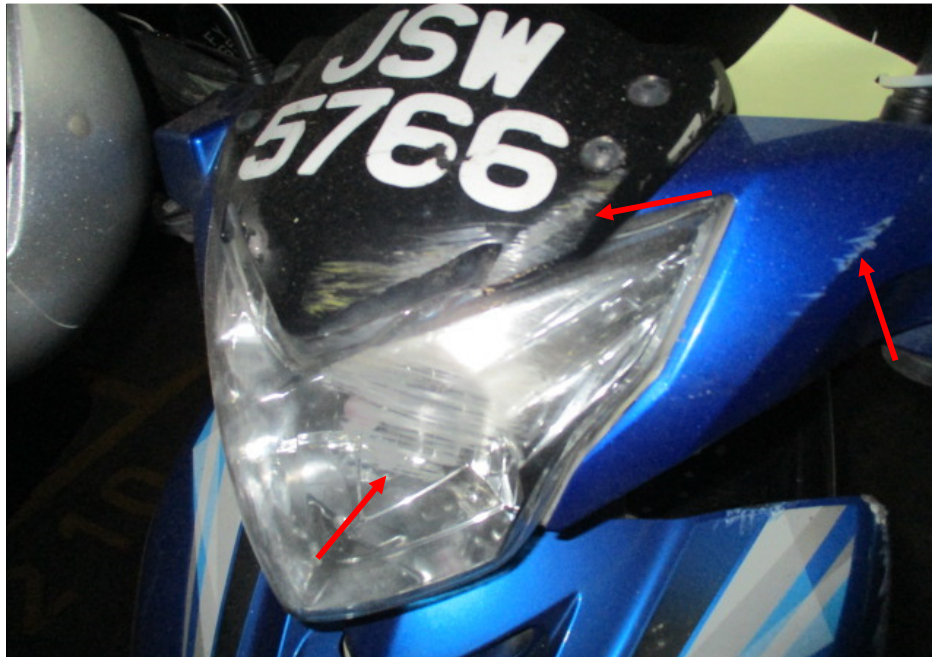
Photo 4 shows a close up view of the windshield, headlight assembly and head cowl which was amongst the body parts at the front of the Motorcycle that had sustained damage as a result of the accident (arrowed).

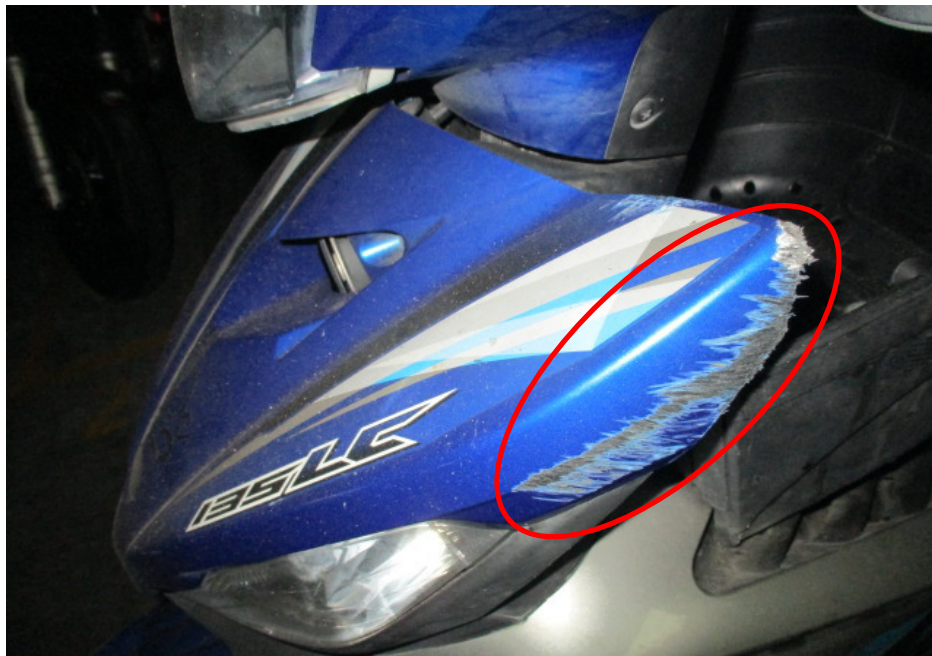
Photo 5 shows a closer view of the front cowling which was amongst the body parts of the Motorcycle that had sustained damage as a result of the accident (circled).

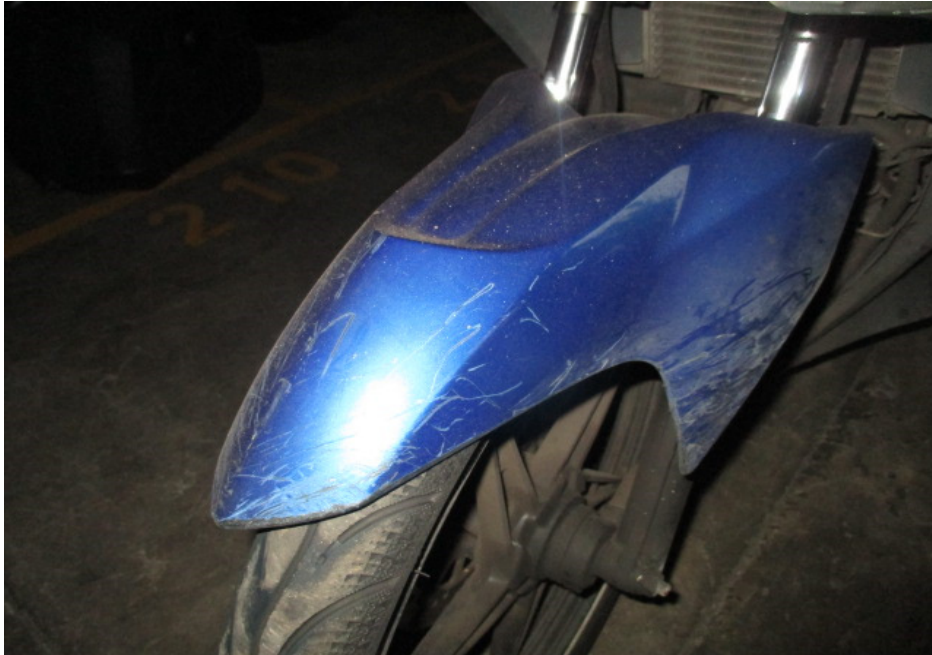
Photo 6 shows a closer view of the front mudguard which was amongst the body parts of the Motorcycle that had sustained damage as a result of the accident.

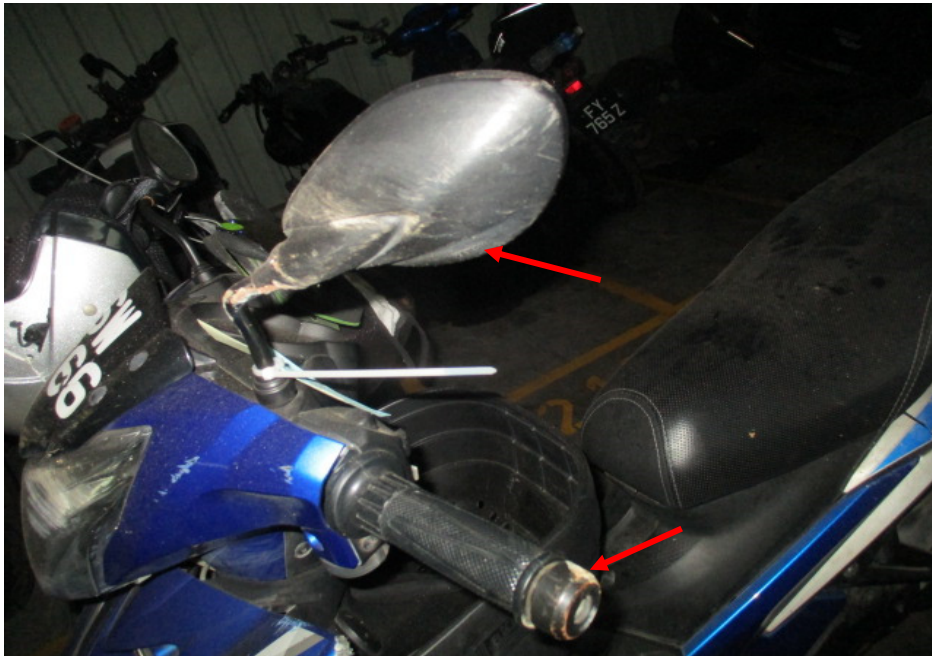
Photo 7 shows the left handlebar end and left side mirror (arrowed), which were amongst the body parts of the Motorcycle that had sustained damage as a result of the accident.

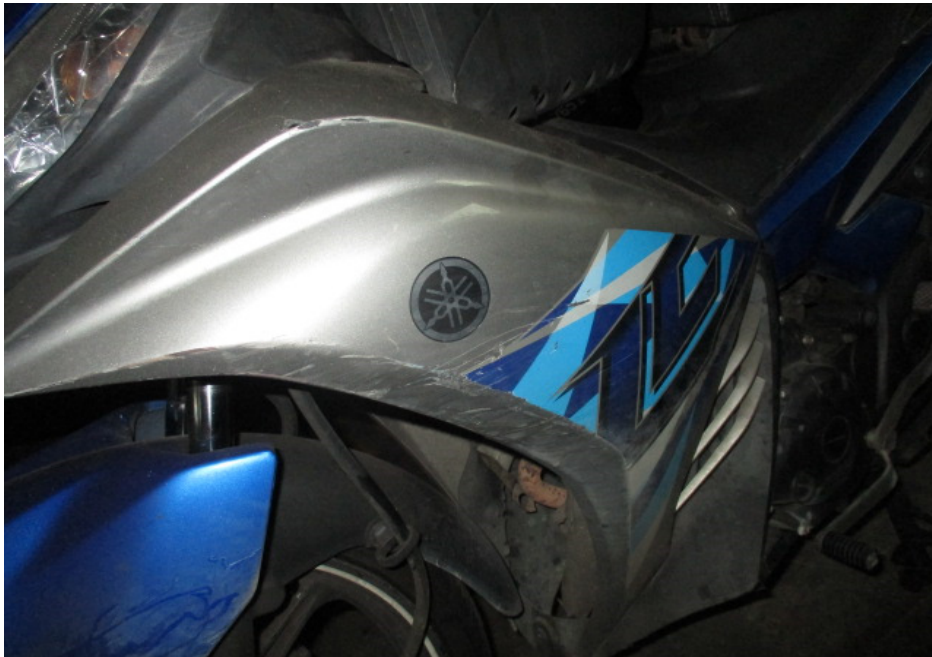
Photo 8 shows the left cowling which was amongst the body parts of the Motorcycle that had sustained damage as a result of the accident.

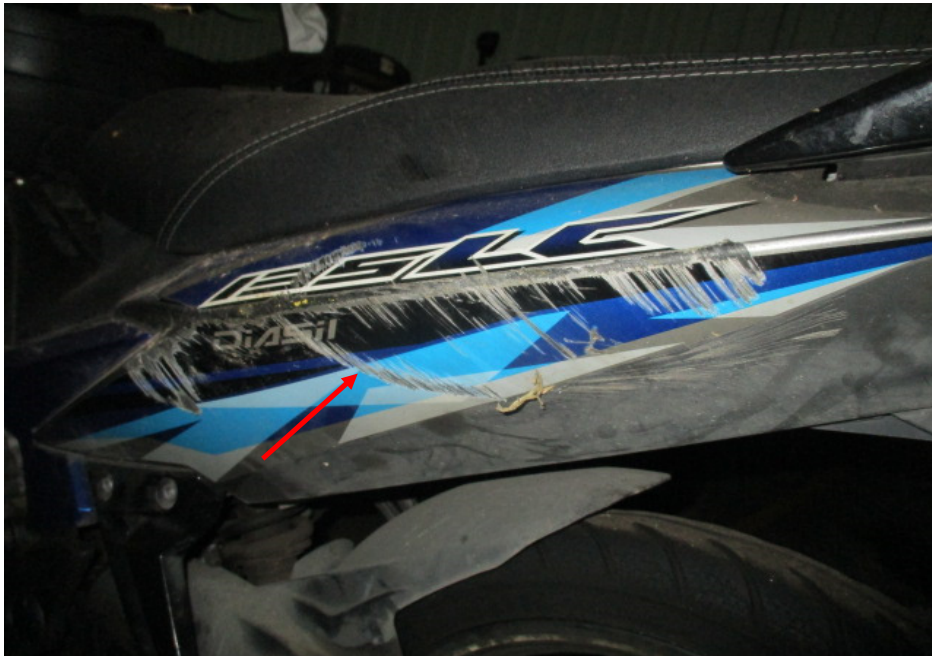
Photo 9 shows a closer view of the left rear side cover which was amongst the body parts of the Motorcycle that had sustained damages of grazing nature as a result of the accident (arrowed).

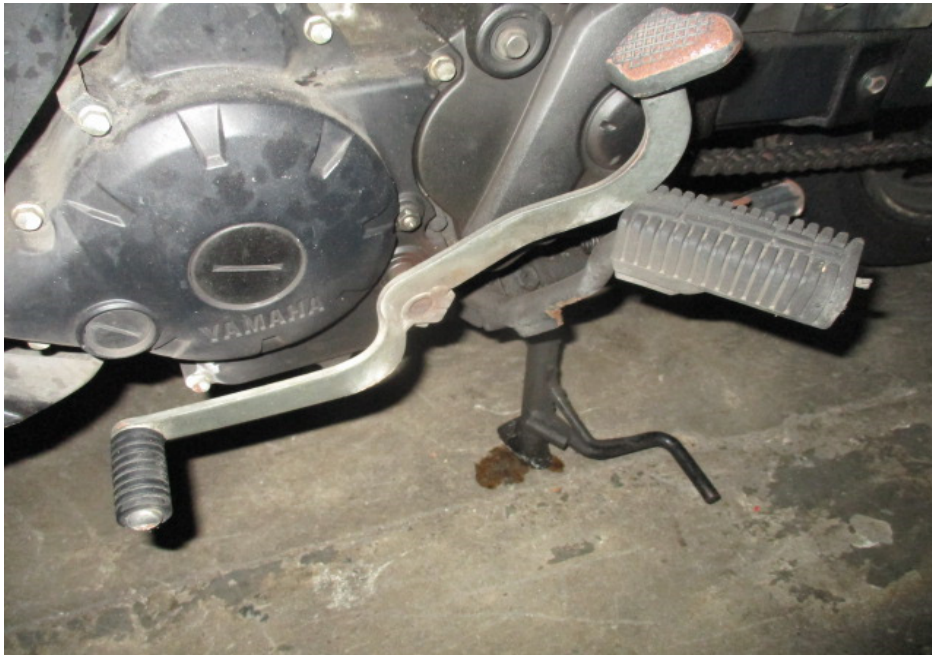
Photo 10 shows the gear shift pedal and left front footrest of the Motorcycle that had sustained damage as a result of the accident.

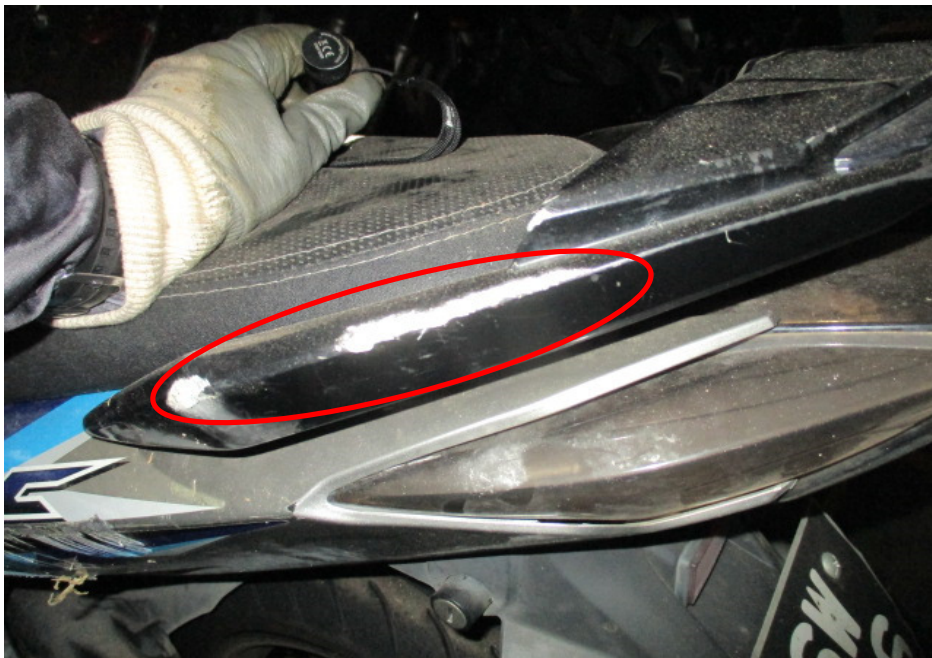
Photo 11 shows the pillion grab rail of the Motorcycle that had sustained damage as a result of the accident (circled).

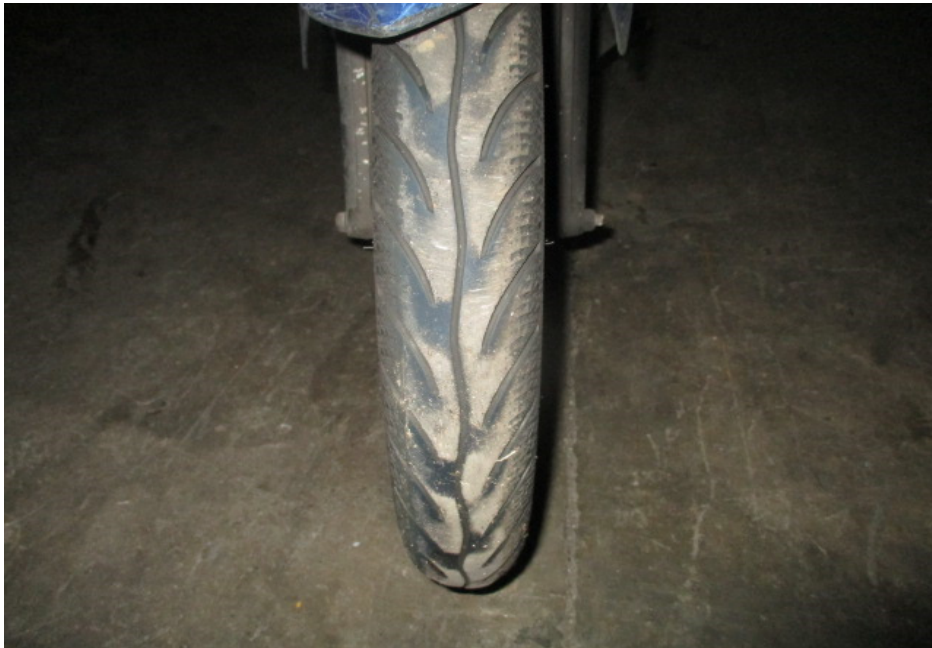
Photo 12 shows the front tyre of the Motorcycle at the time of our inspection. The front tyre was observed to be in serviceable condition with remaining tread depth of approximately 3mm. The pattern of the tread was also clearly visible. There was no tear, burst mark(s) and/or punctured hole(s) on the sidewalls as well as across the tread of the front tyre.

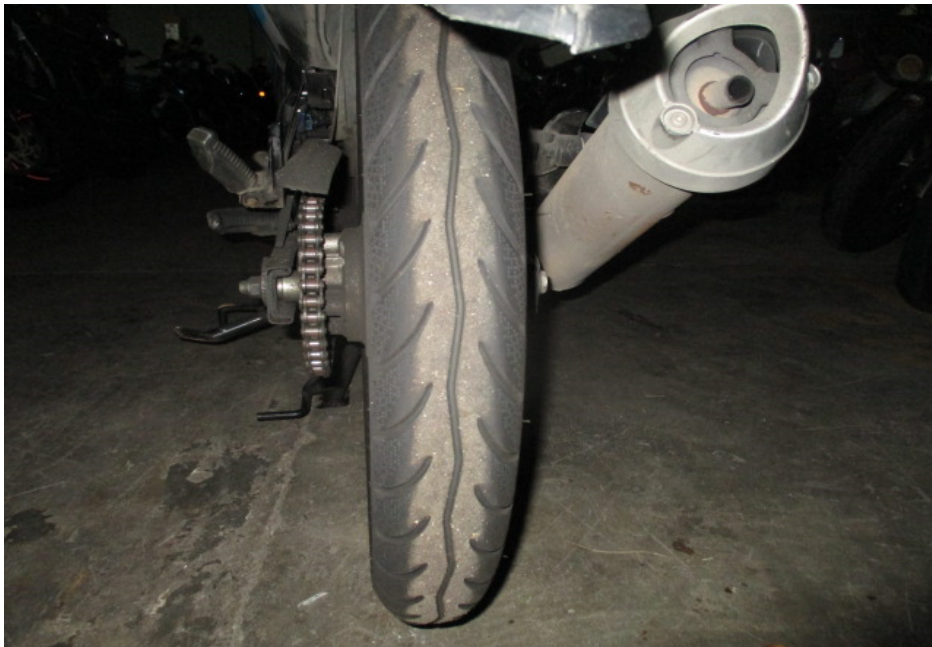
Photo 13 shows the condition of the Motorcycle's rear tyre. The rear tyre was observed to be in serviceable condition with remaining tread depth of approximately 3mm. The tyre was also observed to be sufficiently inflated for vehicular operation. We did not observe any tear, burst mark(s) and/or punctured hole(s) on the sidewalls as well as across the tread of the rear tyre.

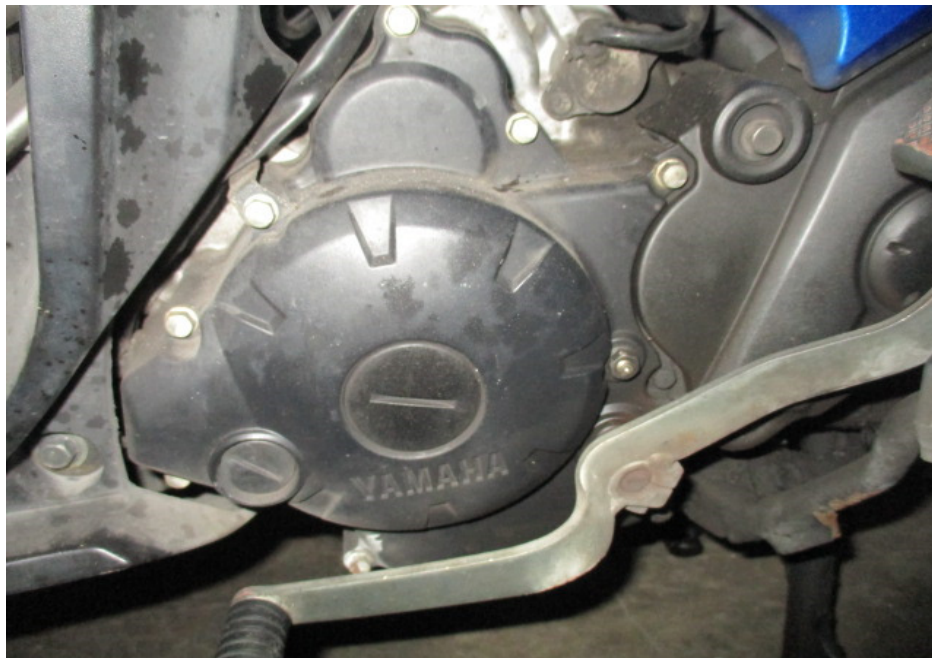
Photo 14 shows the left side of the engine of the Motorcycle at the time of our inspection. The various engine related parts and components were found to be intact with no visible damage. There was also no sign(s) or indication(s) of fluid leak observed around the left engine area of the Motorcycle.

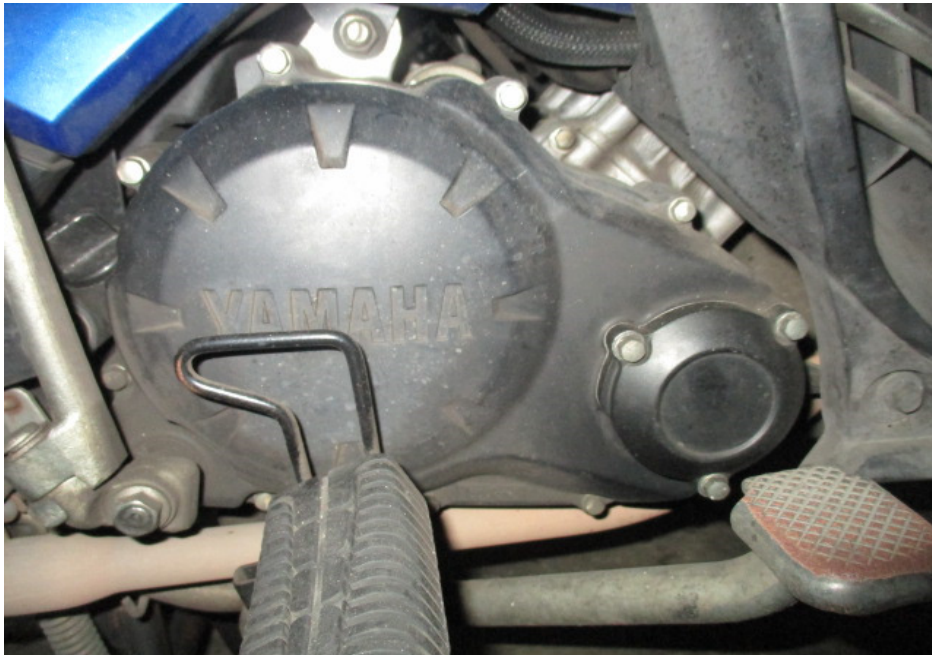
Photo 15 shows the right side of the engine of the Motorcycle at the time of our inspection. The various engine related parts and components were found to be intact with no visible damage. There was also no sign(s) or indication(s) of fluid leak observed around the right engine area of the Motorcycle.

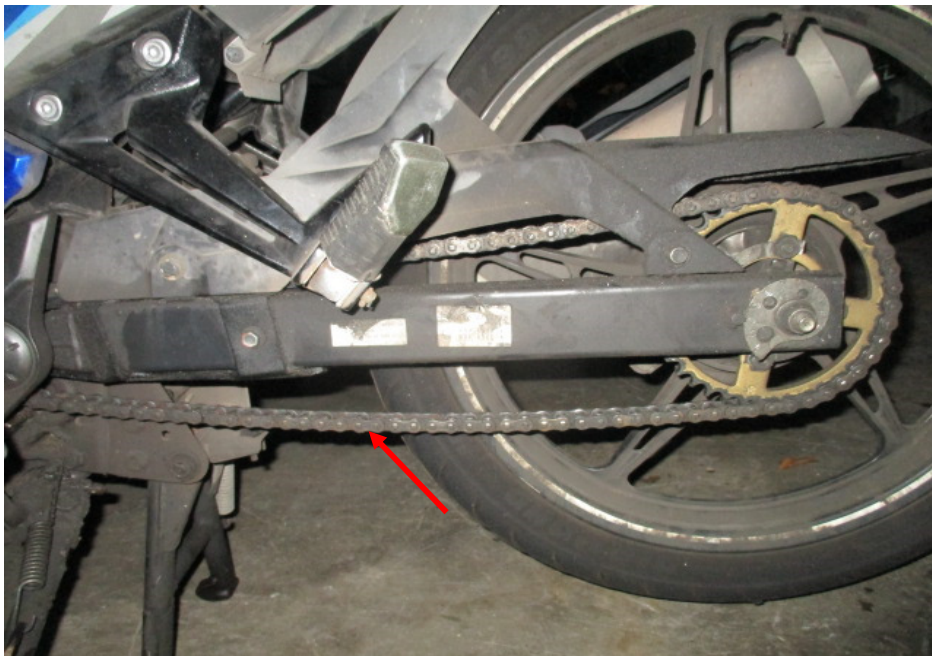
Photo 16 shows the general view of the gear train (arrowed) of the Motorcycle, which was observed to be intact with no misalignment. It was also adequately lubricated for operating purposes.

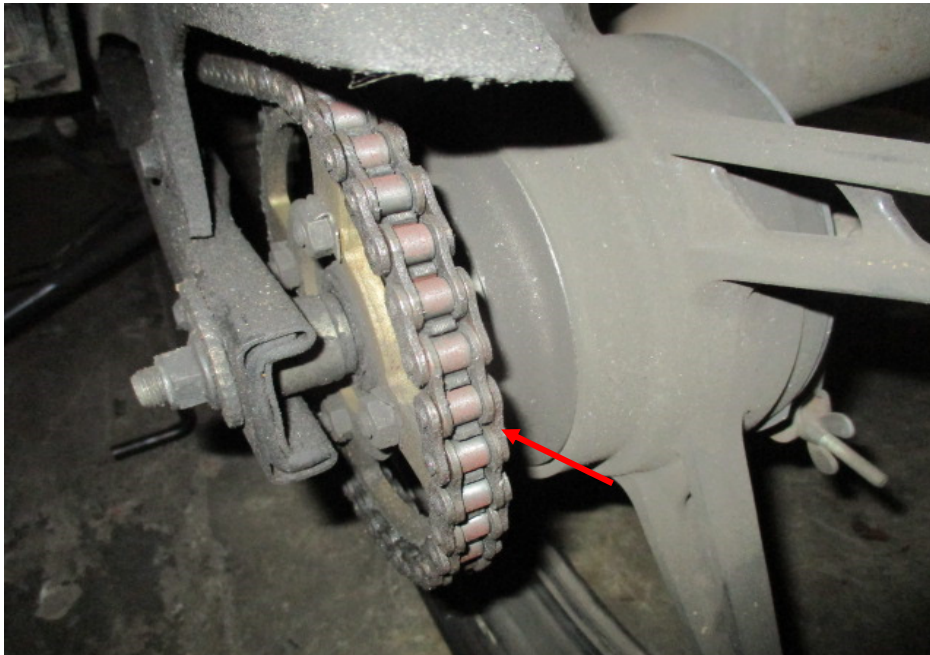
Photo 17 shows a closer view of the gear train (arrowed) of the Motorcycle, which was observed to be intact with no misalignment. It was also adequately lubricated for operating purposes.

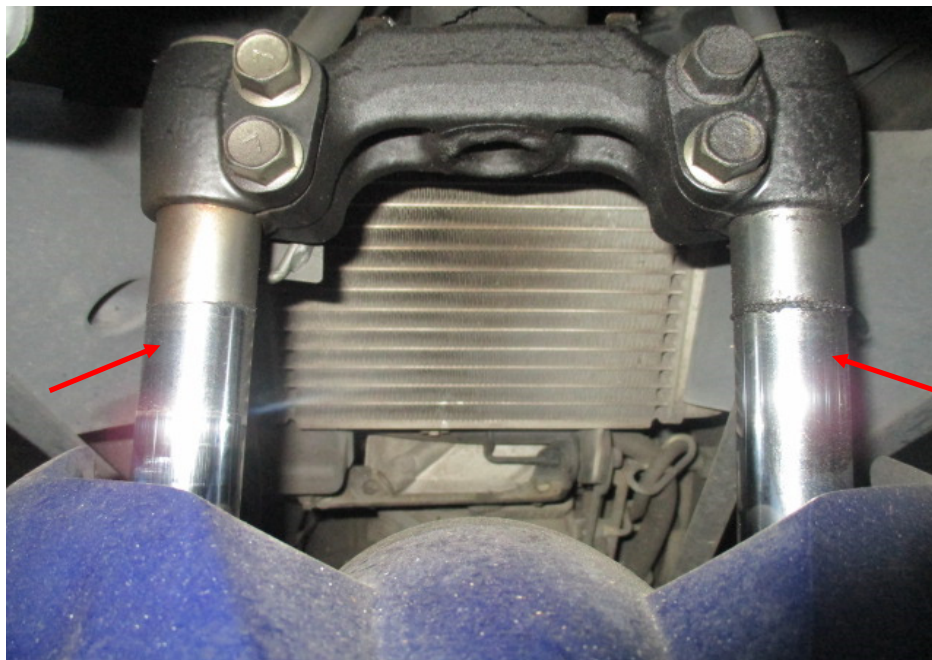
Photo 18 shows the front fork (arrowed) of the Motorcycle. The front fork and fork bracket of the Motorcycle were both found to be intact and undamaged. Turning the Motorcycle's handle bar towards the left and right did not produce any abnormal free play. The steering system of the Motorcycle was in serviceable condition at the time of our inspection.

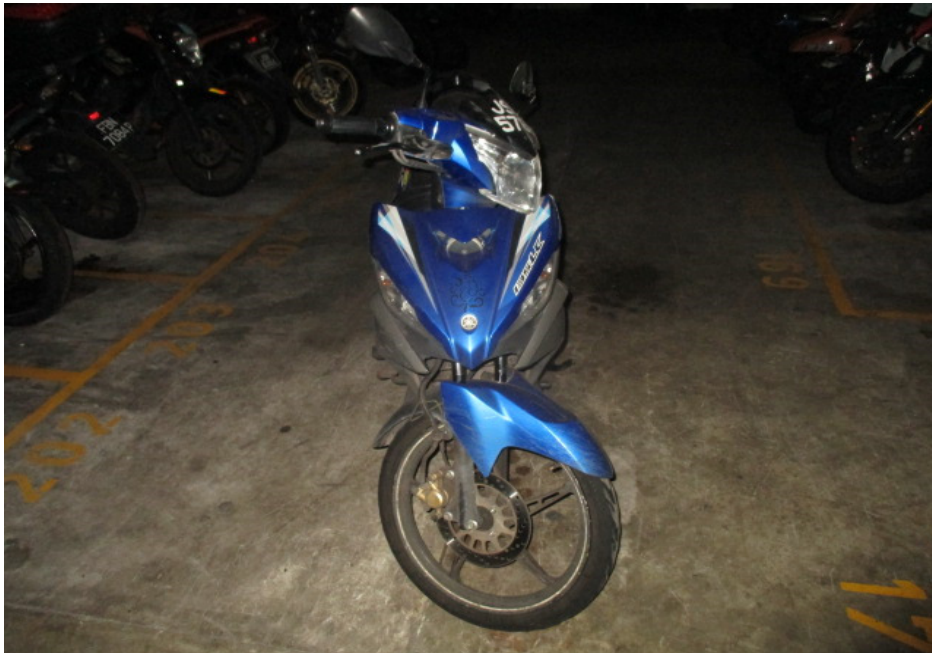
Photo 19 shows the front wheel of the Motorcycle turned towards its full left. Turning the Motorcycle's handle bar towards the left did not produce any abnormal free play and/or resistance. This would indicate that the steering system of the Motorcycle was in serviceable condition at the time of our inspection.

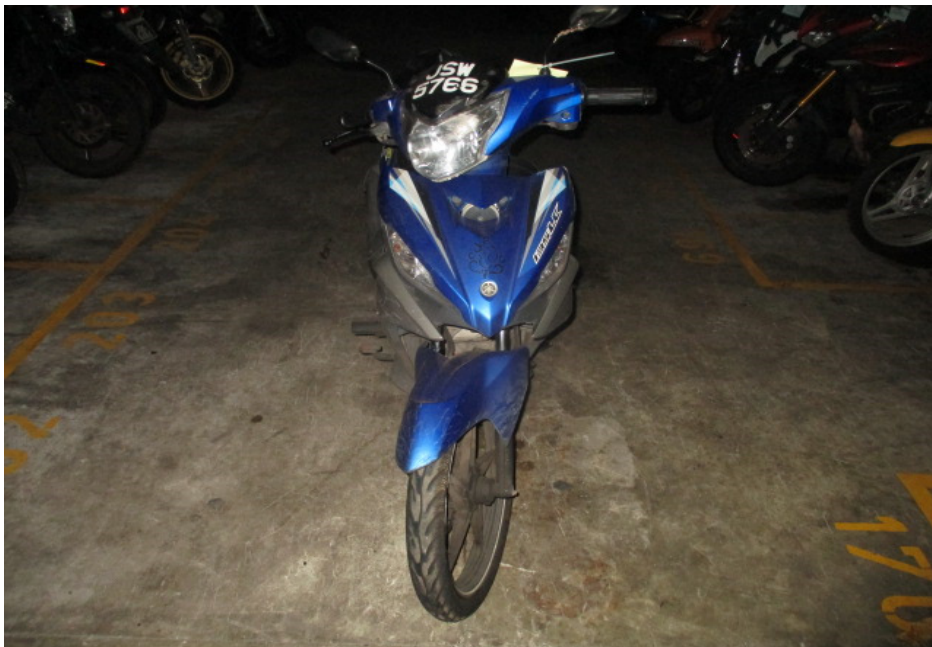
Photo 20 shows the front wheel of the Motorcycle turned towards its full right. Turning the Motorcycle's handle bar towards the right did not produce any abnormal free play and/or resistance. This would indicate that the steering system of the Motorcycle was in serviceable condition at the time of our inspection.

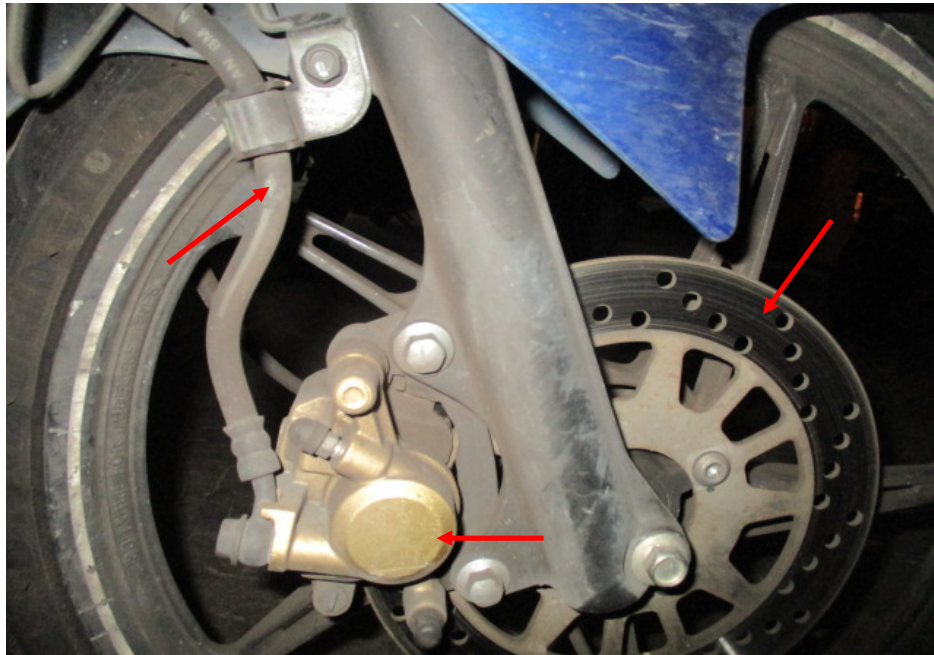
Photo 21 shows a close up view of the front brake caliper, front brake disc and front brake hose (arrowed) of the Motorcycle, which are all part of the components in the hydraulic front brake system of the Motorcycle. Our visual checks of these various components had revealed all to be intact with no visible damage. No leakage of brake fluid was also observed.

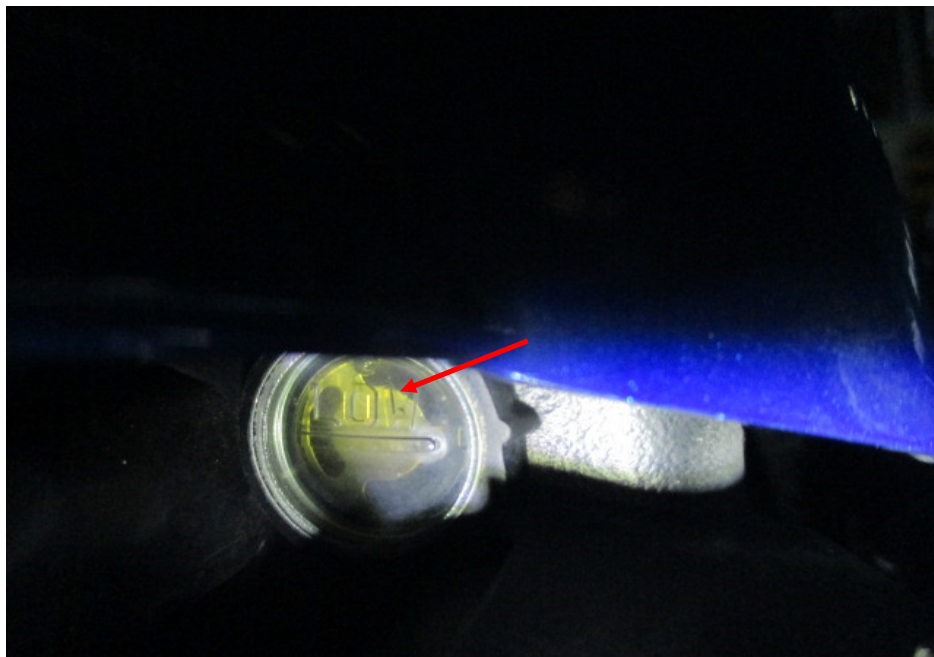
Photo 22 shows the brake fluid reservoir for the front brake of the Motorcycle. The brake fluid was found not to be contaminated and to be of sufficient level for operating purposes (arrowed).

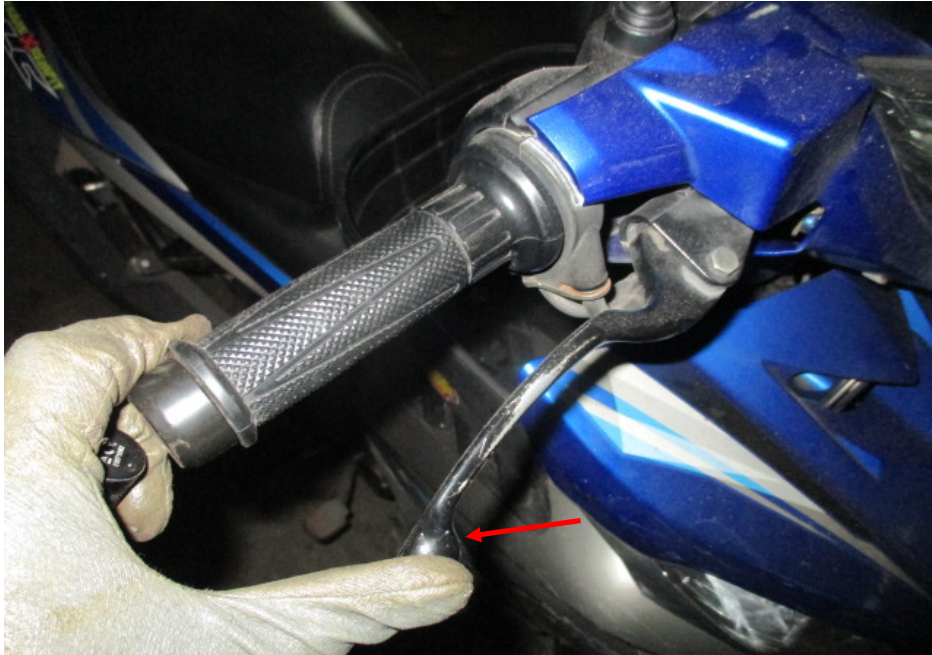
Photo 23 shows the front brake lever being depressed. There was some resistance felt (spongy like feel) upon pressing the front brake lever (arrowed). This would indicate that there is no leakage of pressure/vacuum in the front brake system.

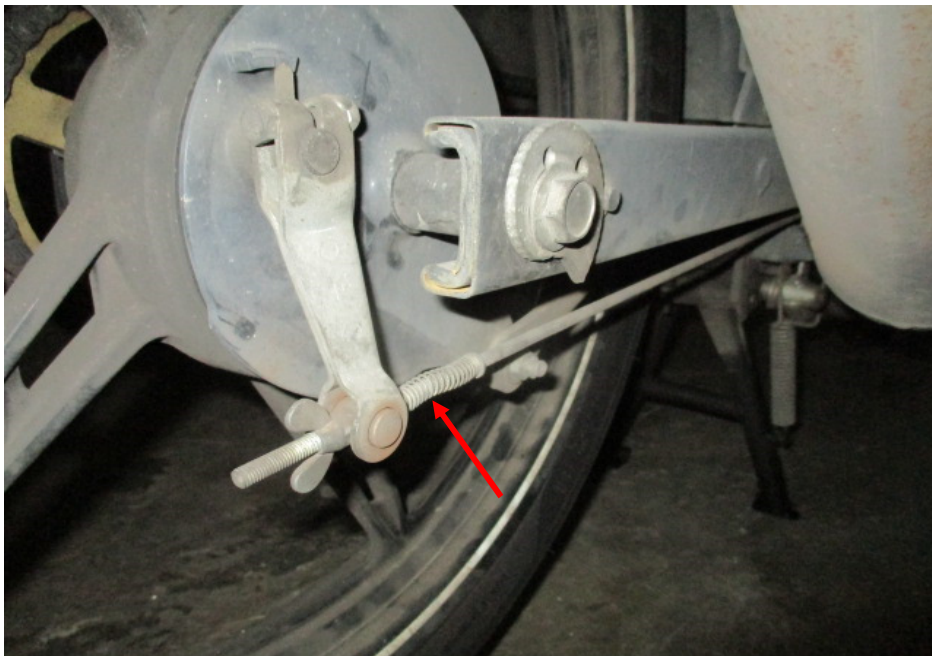
Photo 24 shows the rear wheel of the Motorcycle. The type of brake system for the rear wheel was of a mechanical type, controlled by the brake foot pedal of the Motorcycle. Our checks of the cable (arrowed), spring and drum which are all part of the components in the rear brake system of the Motorcycle reveal all to be intact and without damage.
