Your Ref: TP/IP/35181/2020
Our Ref : CI/TPD20011134/N

Fatal Accident Investigation Team

INSPECTION REPORT OF MOTORCYCLE FBB 5193J

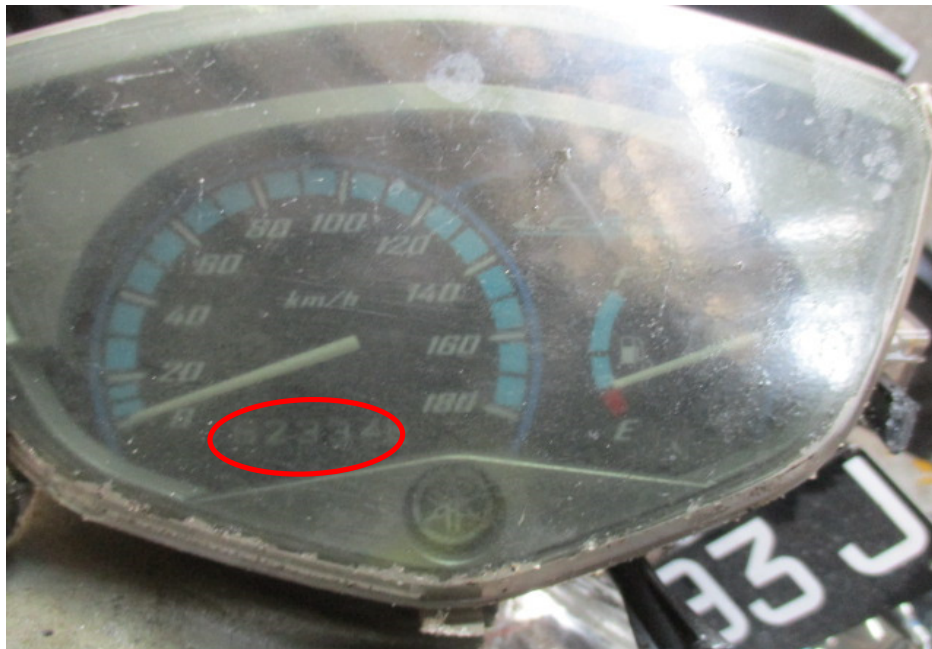
Photo 1 shows the speedometer gauge of the Motorcycle. The mileage of the Motorcycle at the time of our inspection was 62, 334km (circled).

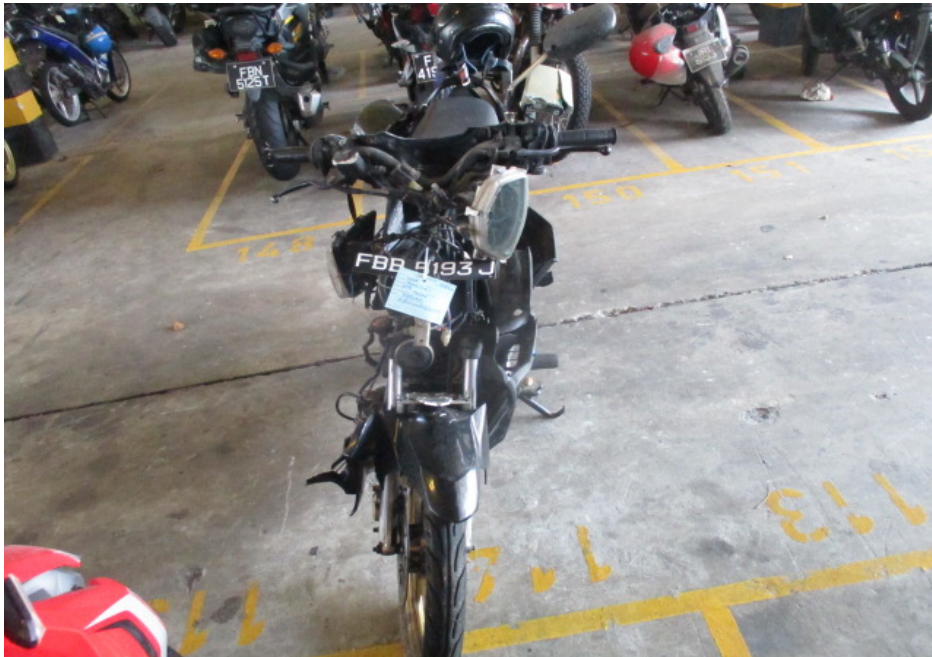
Photo 2 shows a general view of the frontal portion of the Motorcycle at the time of our inspection. The Motorcycle was observed to have sustained damages all around.

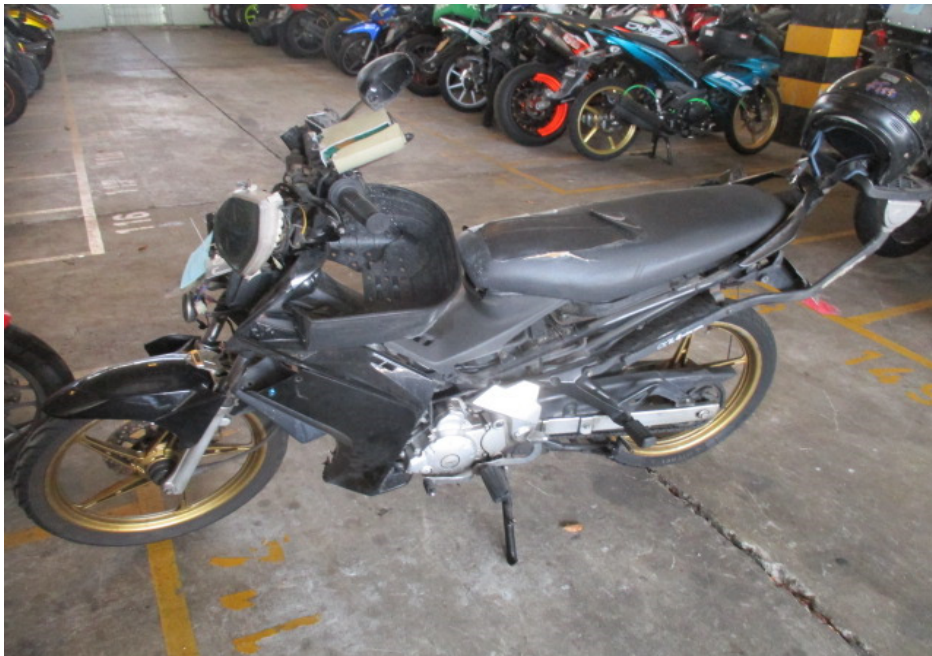
Photo 3 shows a general view of the left body of the Motorcycle at the time of our inspection. The Motorcycle was observed to have sustained damages all around body. Amongst the body parts that were found to have been damaged include its headlight assembly, front cowlings, front mudguard, side cowlings, front brake lever, clutch lever, rear side covers and tail light assembly, amongst others.

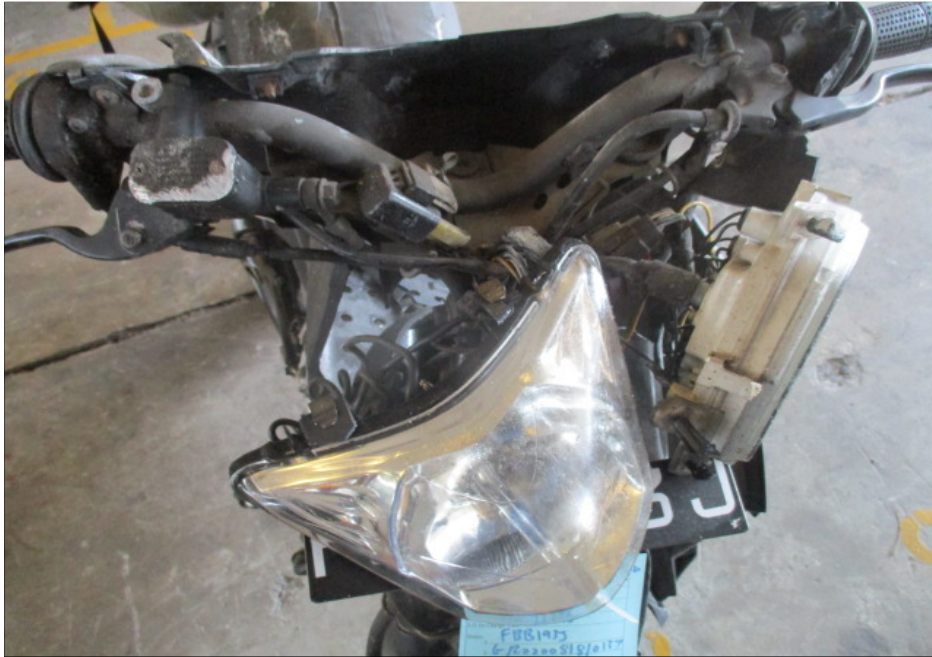
Photo 4 shows a close up view of the head cowl and headlight assembly which were amongst the body parts at the front of the Motorcycle that had sustained damage as a result of the accident.

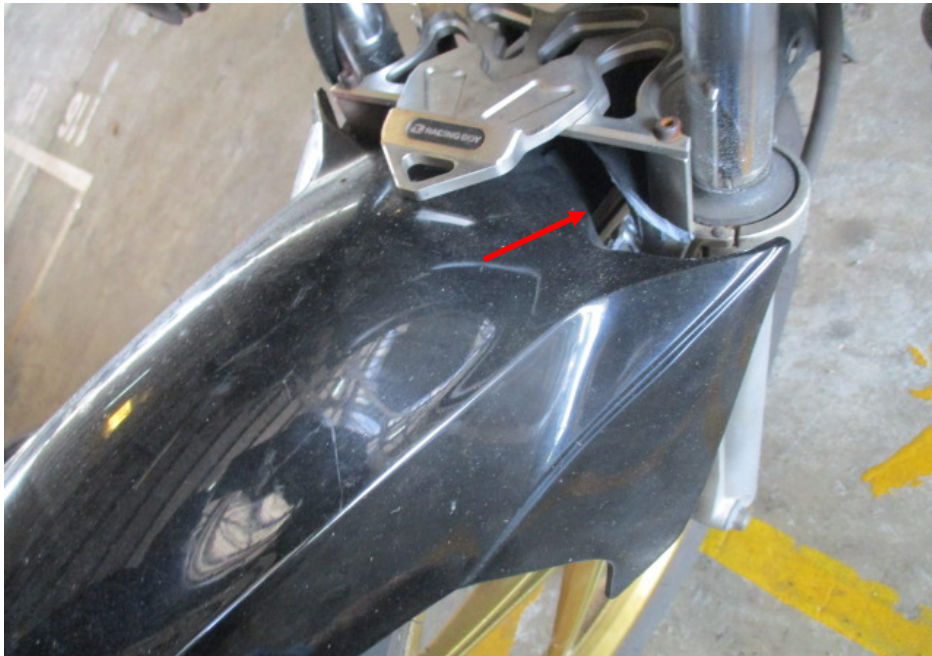
Photo 5 shows a closer view of the cracked front mudguard which was amongst the body parts of the Motorcycle that had sustained damage as a result of the accident.

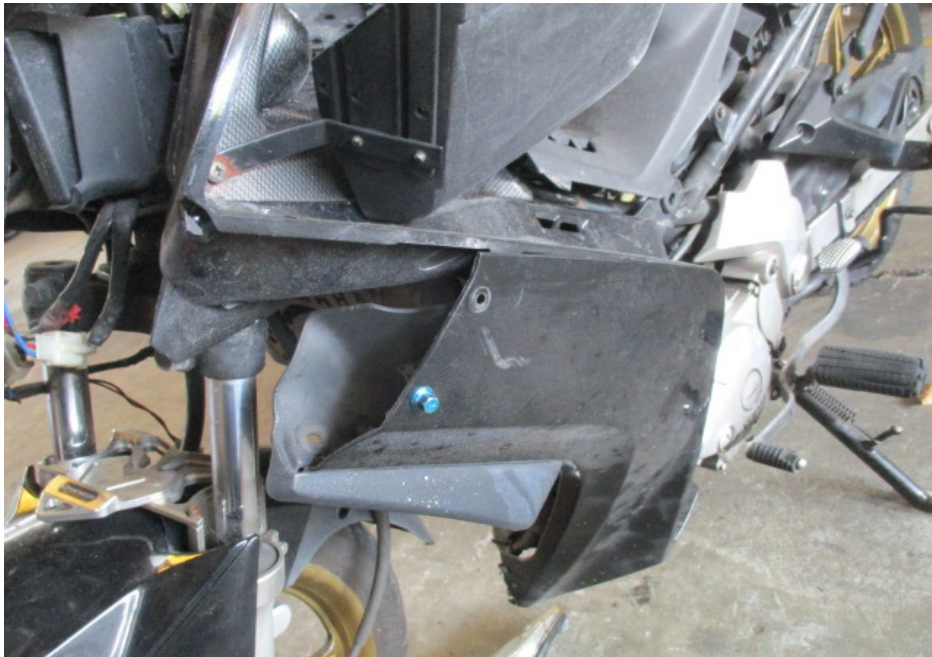
Photo 6 shows a closer view of the cracked left cowling of the Motorcycle as a result of the accident.

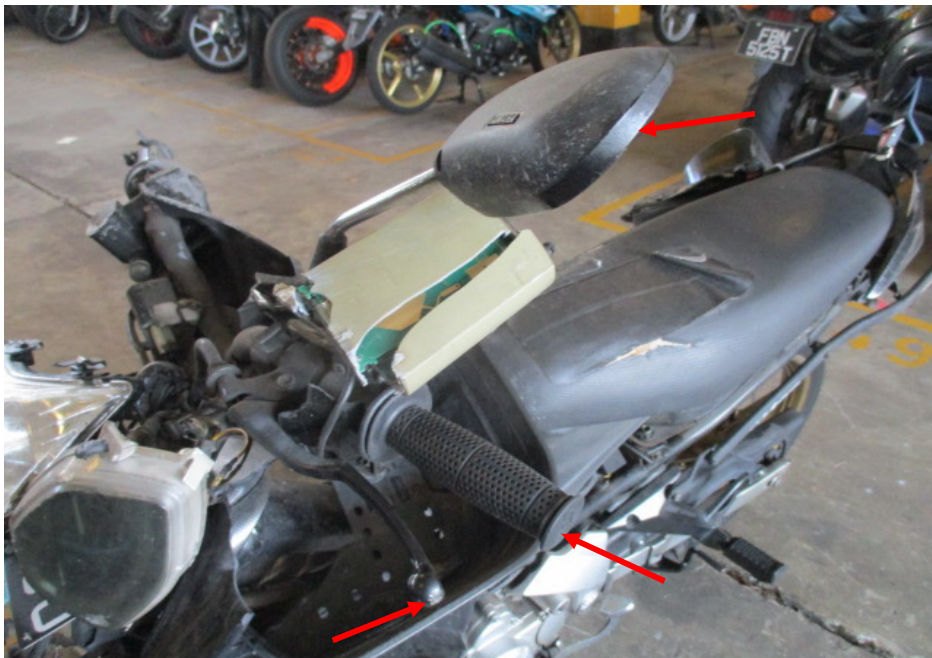
Photo 7 shows the left handlebar end, clutch lever and left side mirror (arrowed), which were amongst the body parts of the Motorcycle that had sustained damage as a result of the accident.

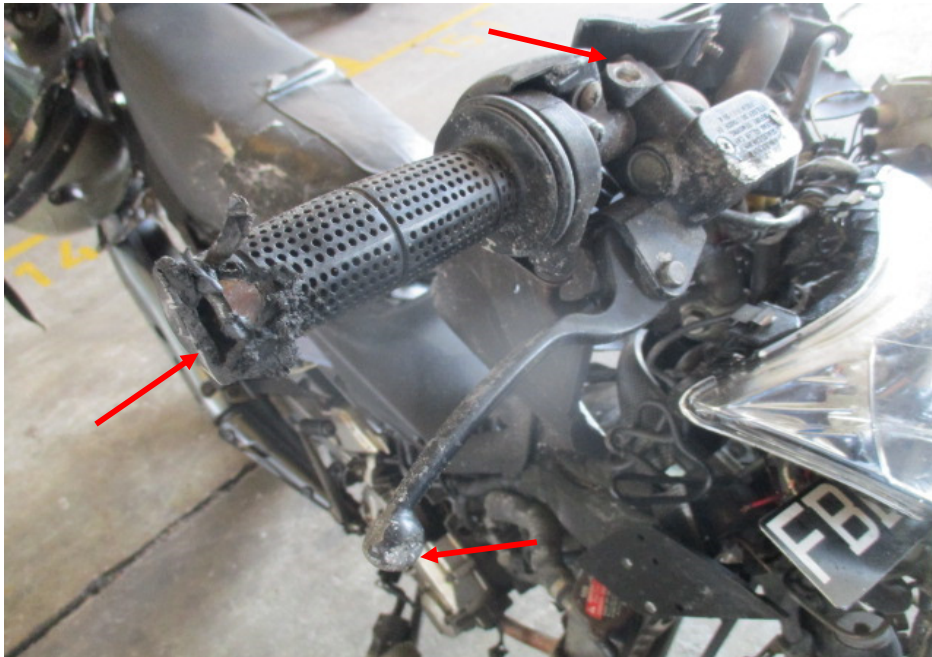
Photo 8 shows the right handlebar grip, missing right side mirror and front brake lever (arrowed), which were amongst the body parts of the Motorcycle that had sustained damage as a result of the accident.

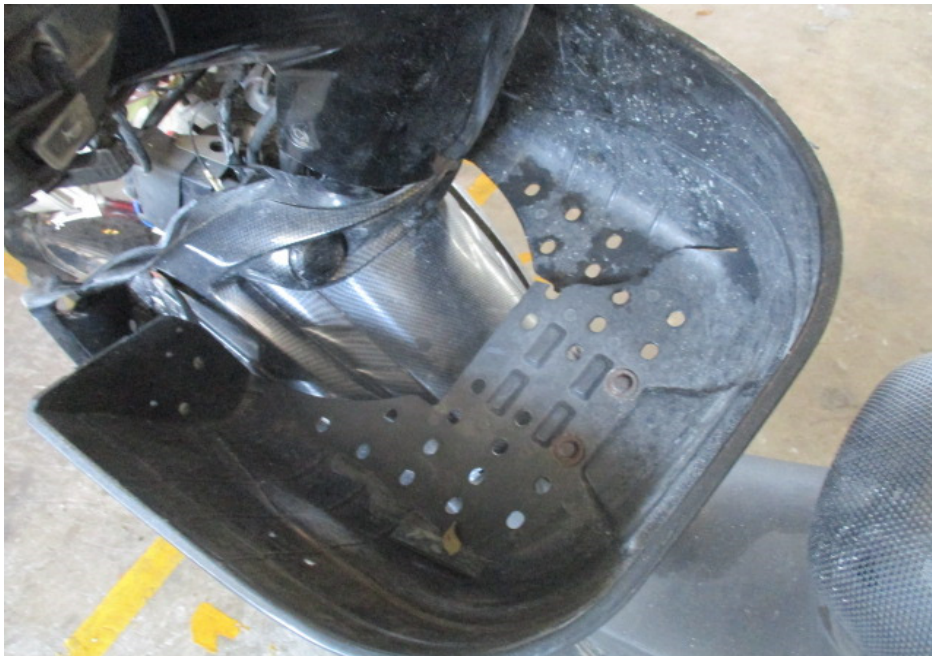
Photo 9 shows a closer view of the cracked front basket of the Motorcycle as a result of the accident.

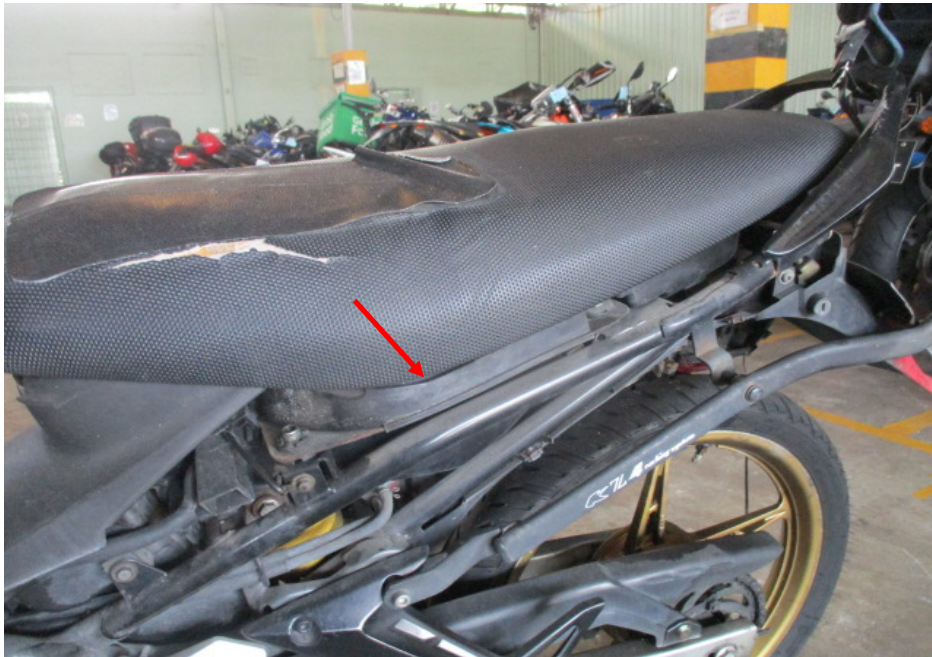
Photo 10 shows a closer view of the missing left rear side cover of the Motorcycle as a result of the accident (arrowed).

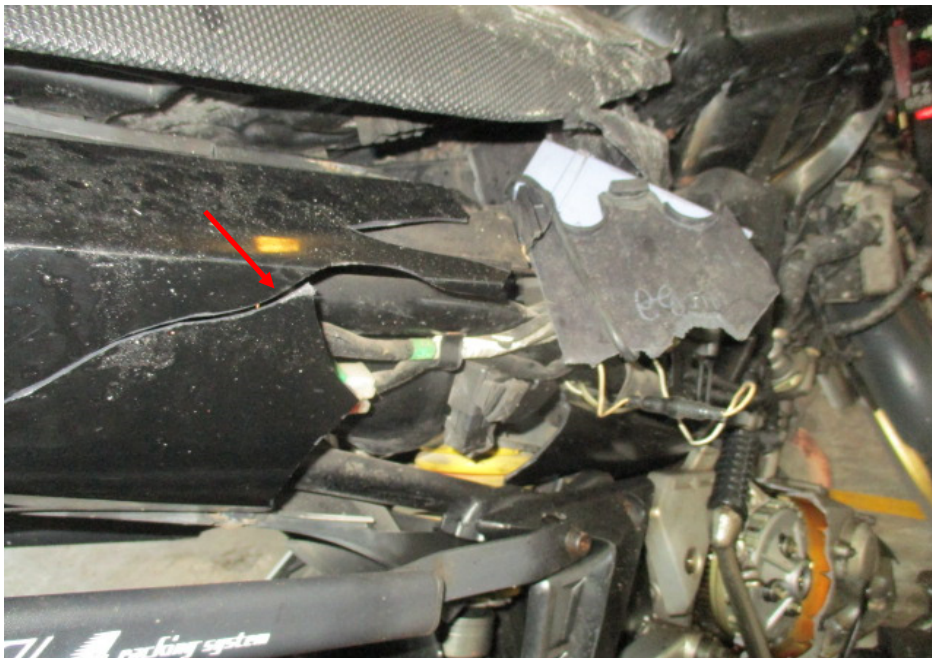
Photo 11 shows a closer view of the cracked right rear side cover of the Motorcycle as a result of the accident (arrowed).

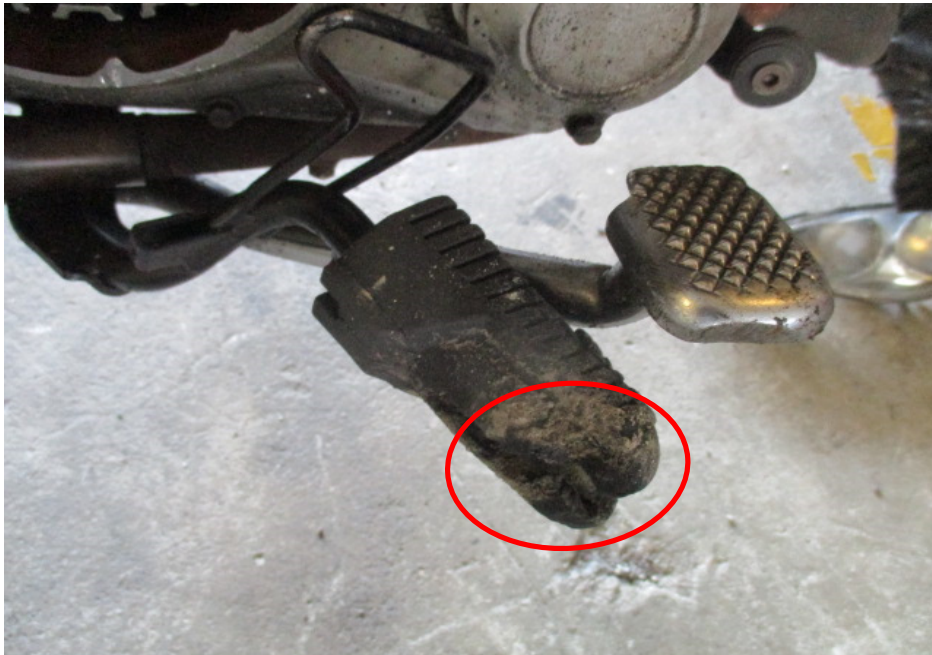
Photo 12 shows a closer view of the right front footrest which was amongst the body parts of the Motorcycle that had sustained damages as a result of the accident (circled).

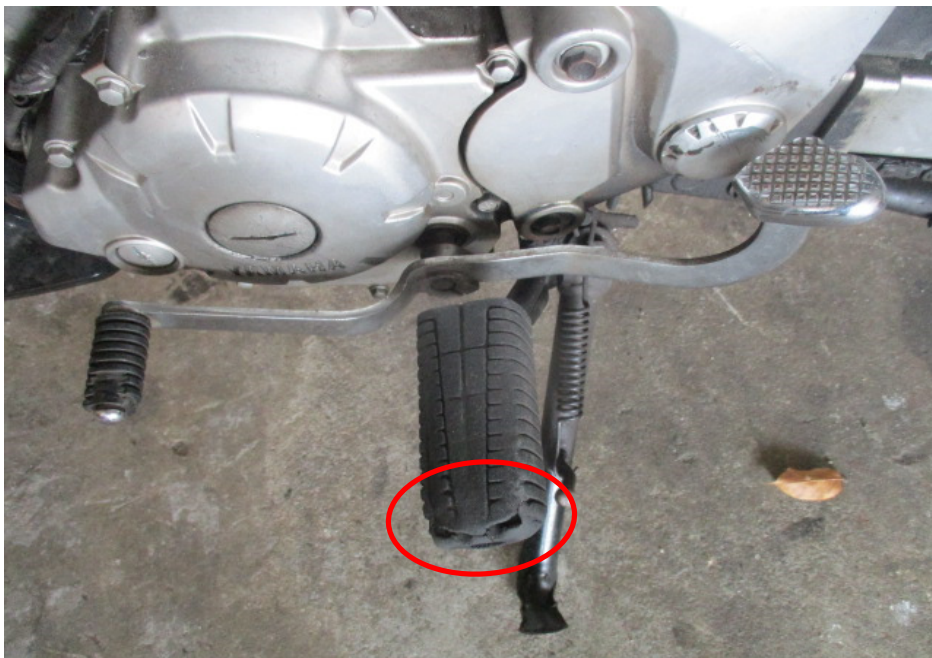
Photo 13 shows the left front footrest of the Motorcycle that had sustained damage as a result of the accident (circled).

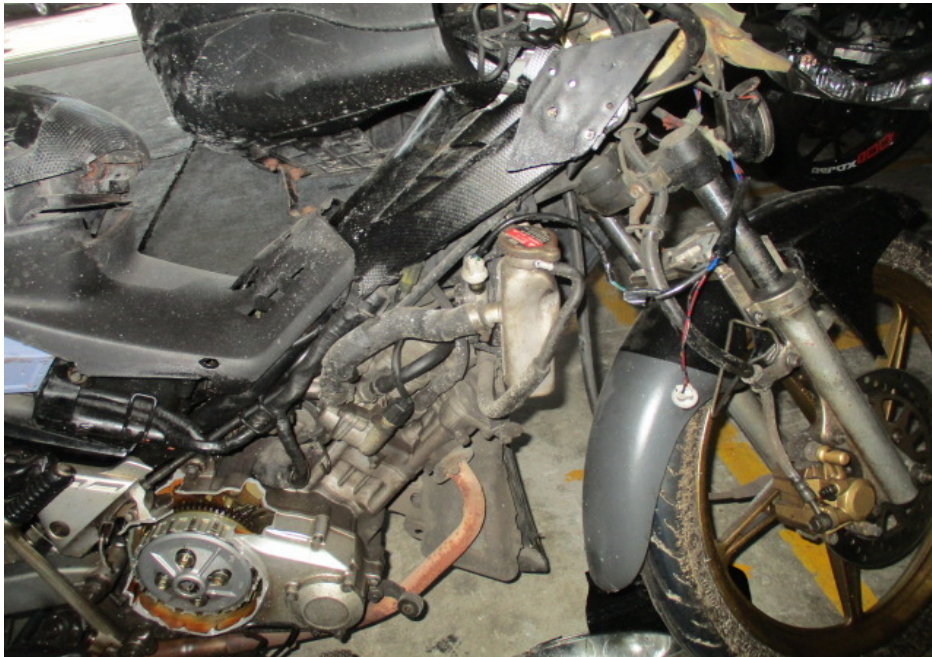
Photo 14 shows the missing right cowling of the Motorcycle that had sustained damage as a result of the accident.

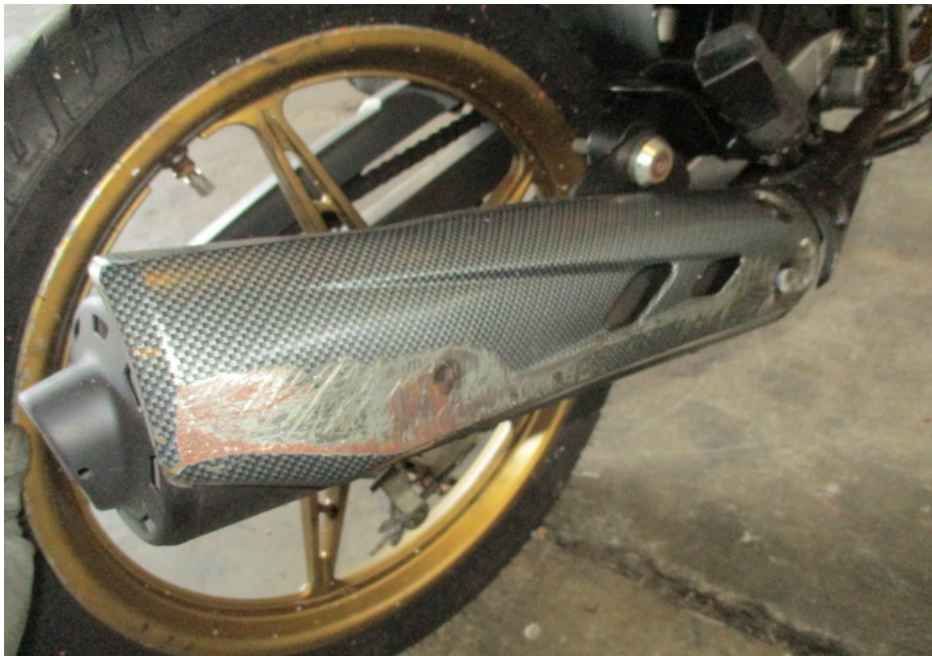
Photo 15 shows the exhaust muffler heat shield of the Motorcycle that had sustained damages of grazing nature as a result of the accident.

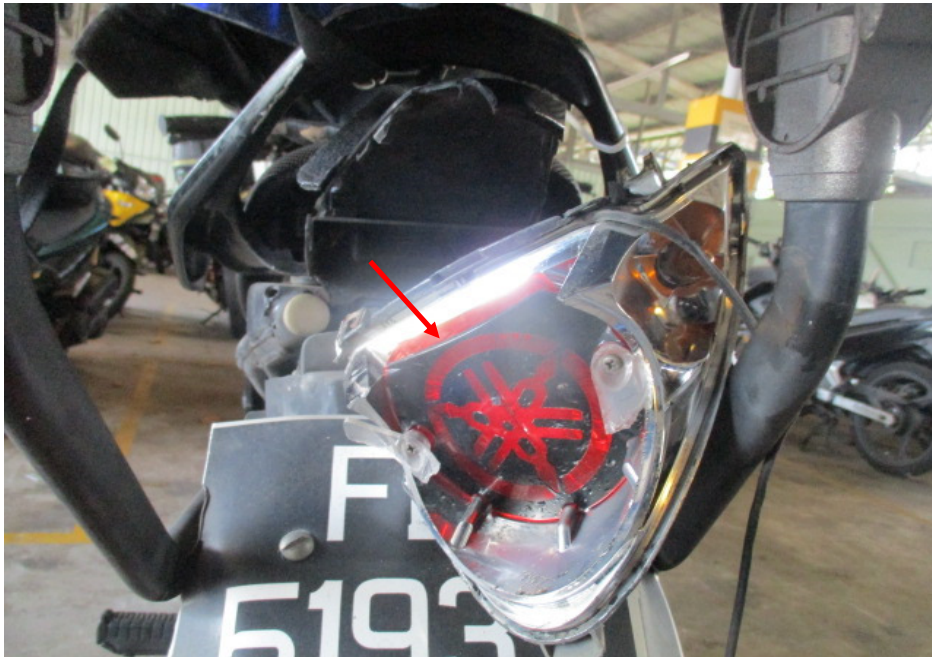
Photo 16 shows a closer view of the cracked tail light assembly of the Motorcycle as a result of the accident (arrowed).

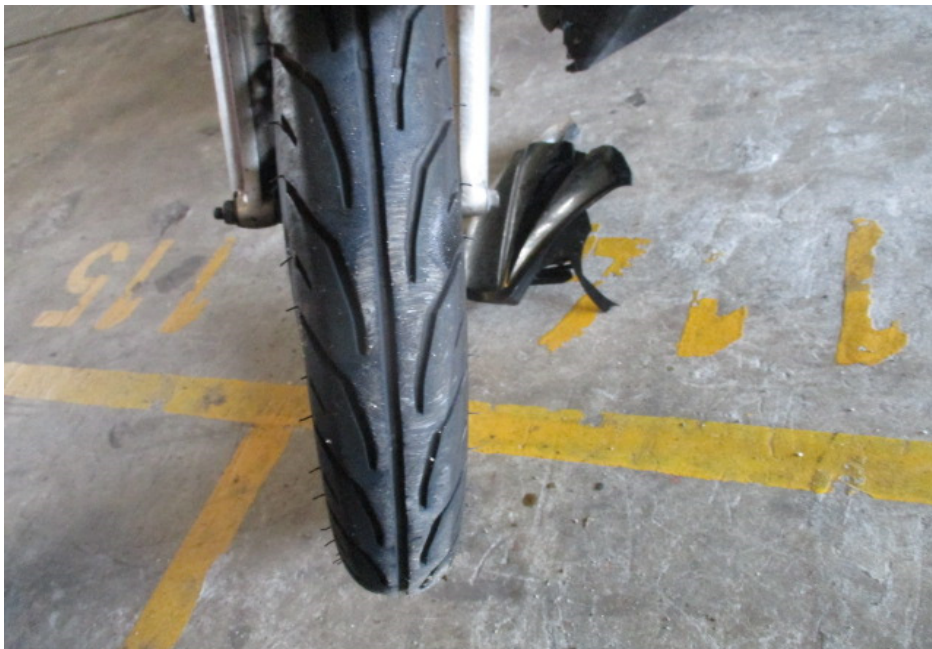
Photo 17 shows the front tyre of the Motorcycle at the time of our inspection. The front tyre was observed to be in serviceable condition with remaining tread depth of approximately 4mm. The pattern of the tread was also clearly visible. There was no tear, burst mark(s) and/or punctured hole(s) on the sidewalls as well as across the tread of the front tyre.

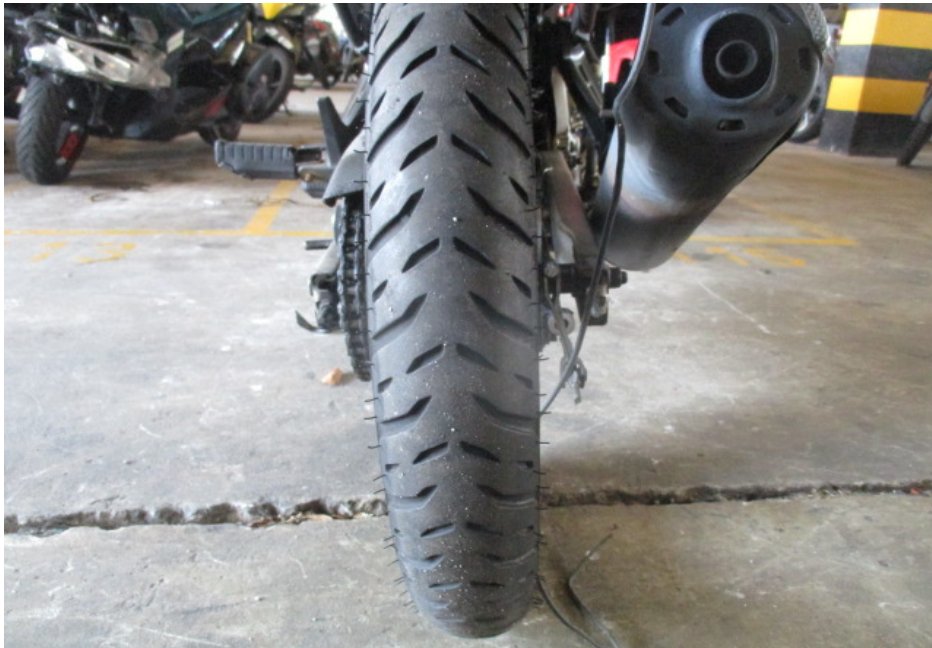
Photo 18 shows the condition of the Motorcycle's rear tyre. The rear tyre was observed to be in serviceable condition with remaining tread depth of approximately 4mm. The rear tyre was observed to be deflated as a result of the accident. We did not observe any tear, burst mark(s) and/or punctured hole(s) on the sidewalls as well as across the tread of the rear tyre.

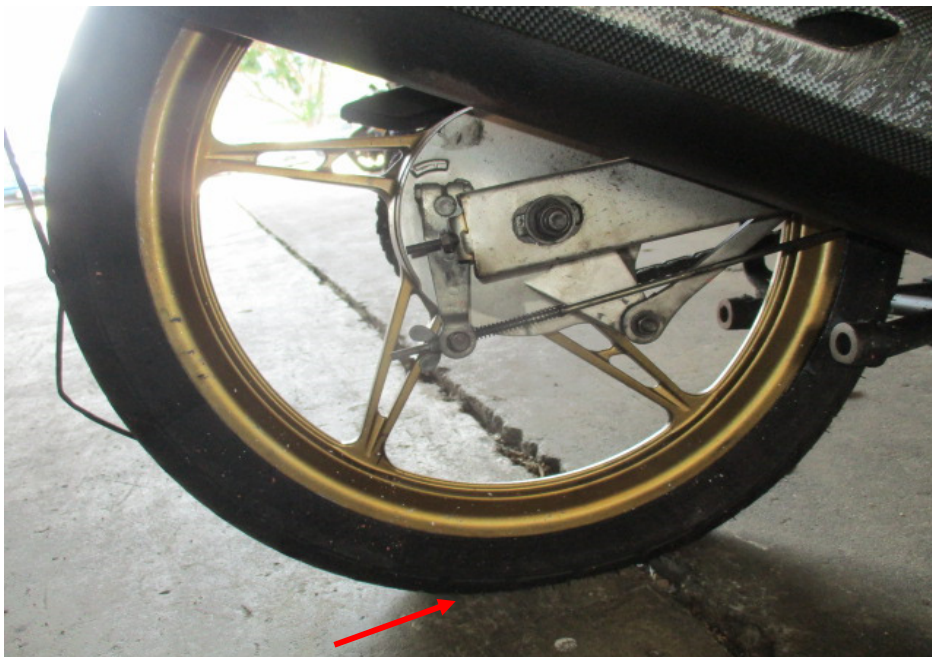
Photo 19 shows a closer view of the deflated rear tyre of the Motorcycle as a result of the accident (arrowed).

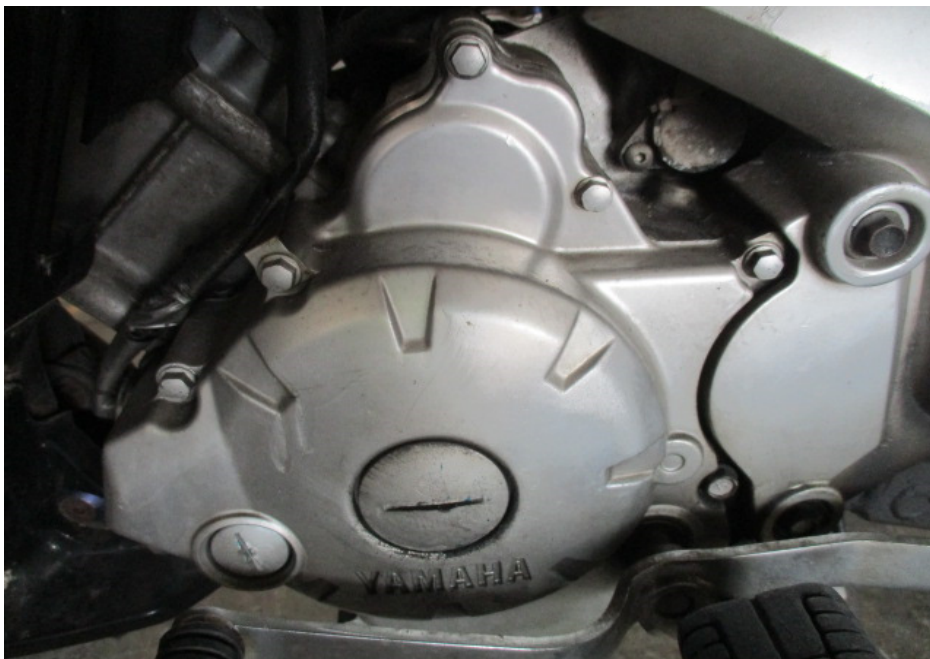
Photo 20 shows the left side of the engine of the Motorcycle at the time of our inspection. The various engine related parts and components were found to be intact with no visible damage. There was also no sign(s) or indication(s) of fluid leak observed around the left engine area of the Motorcycle.

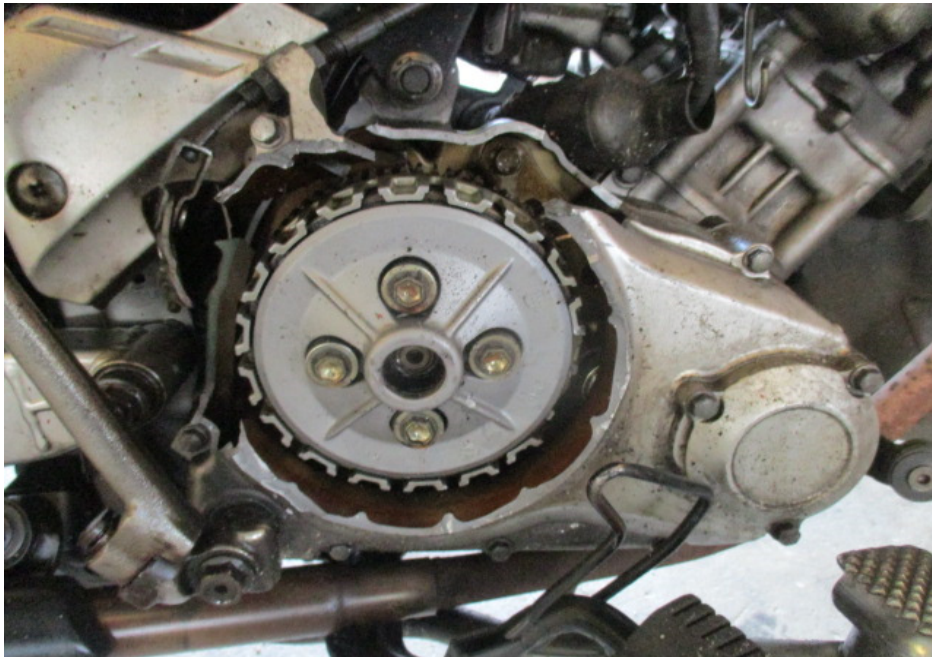
9. Upon examination of the Motorcycle's engine area, we had observed that the left engine related parts and components were intact with no visible damage. However the right engine cover of the Motorcycle was observed to be cracked as a result of the accident.
10. The gear chain of the Motorcycle was found to be intact without any misalignment. It was also adequately lubricated for operating purposes. See photos 20 – 23 below.

Photo 21 shows the right side of the engine of the Motorcycle at the time of our inspection. The right engine cover was observed to be cracked as a result of the accident.

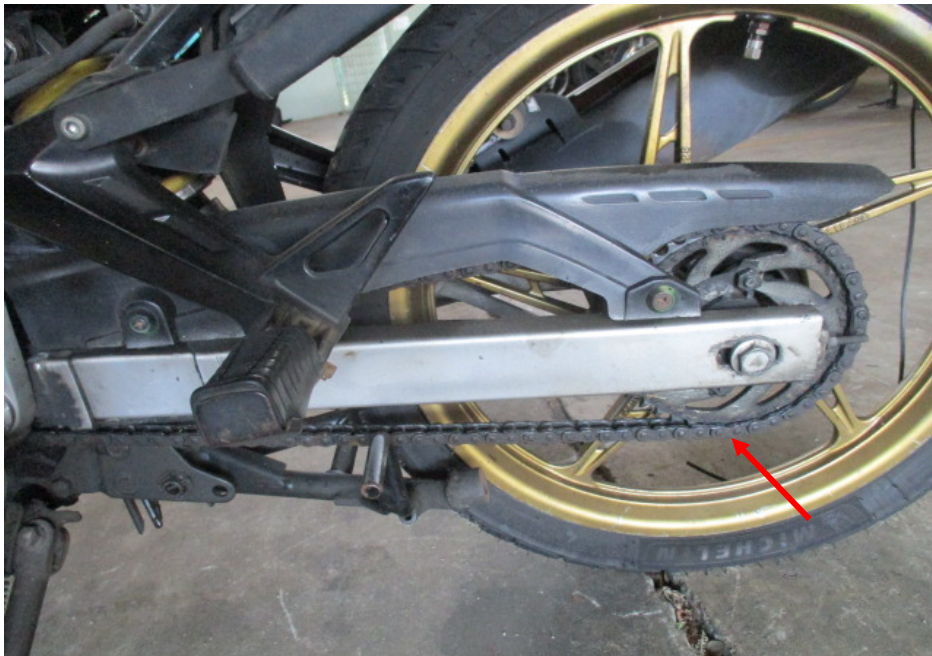
Photo 22 shows the general view of the gear train (arrowed) of the Motorcycle, which was observed to be intact with no misalignment. It was also adequately lubricated for operating purposes.

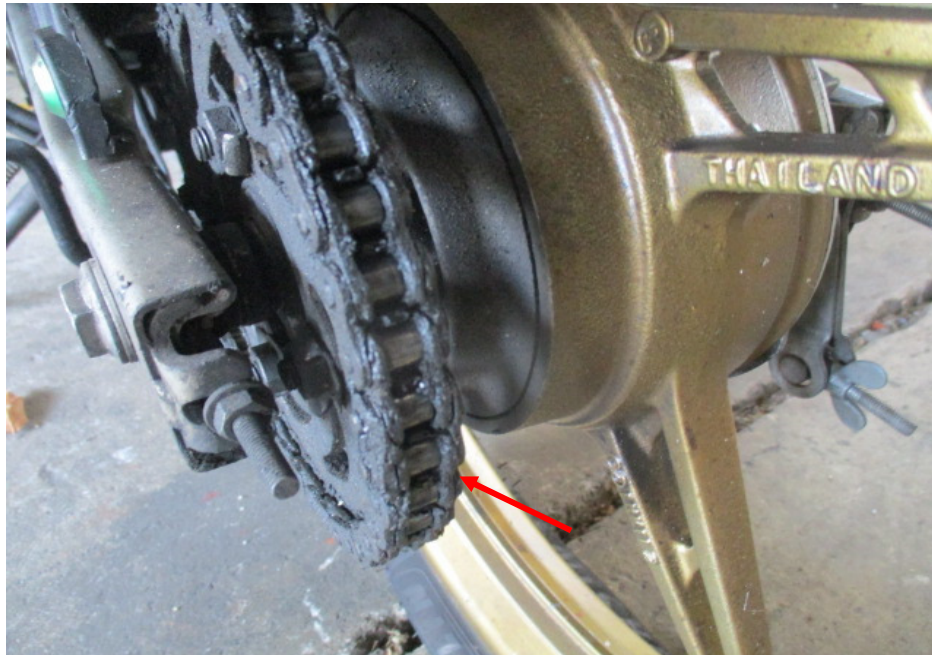
Photo 23 shows a closer view of the gear train (arrowed) of the Motorcycle, which was observed to be intact with no misalignment. It was also adequately lubricated for operating purposes.

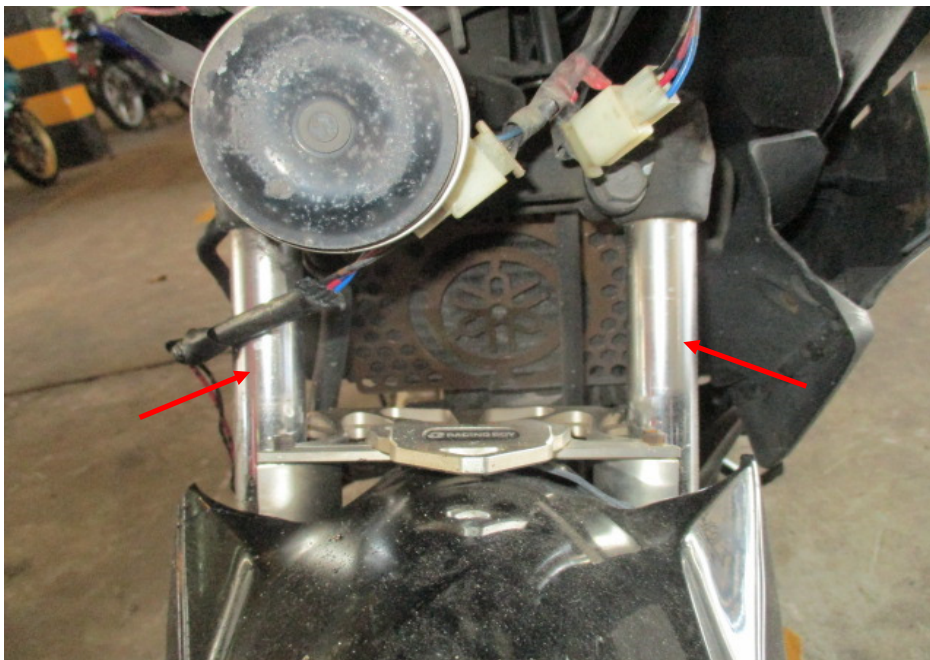
Photo 24 shows the front fork (arrowed) of the Motorcycle. The front fork and fork bracket of the Motorcycle were both found to be intact and undamaged. Turning the Motorcycle's handle bar towards the left and right did not produce any abnormal free play. The steering system of the Motorcycle was in serviceable condition at the time of our inspection.

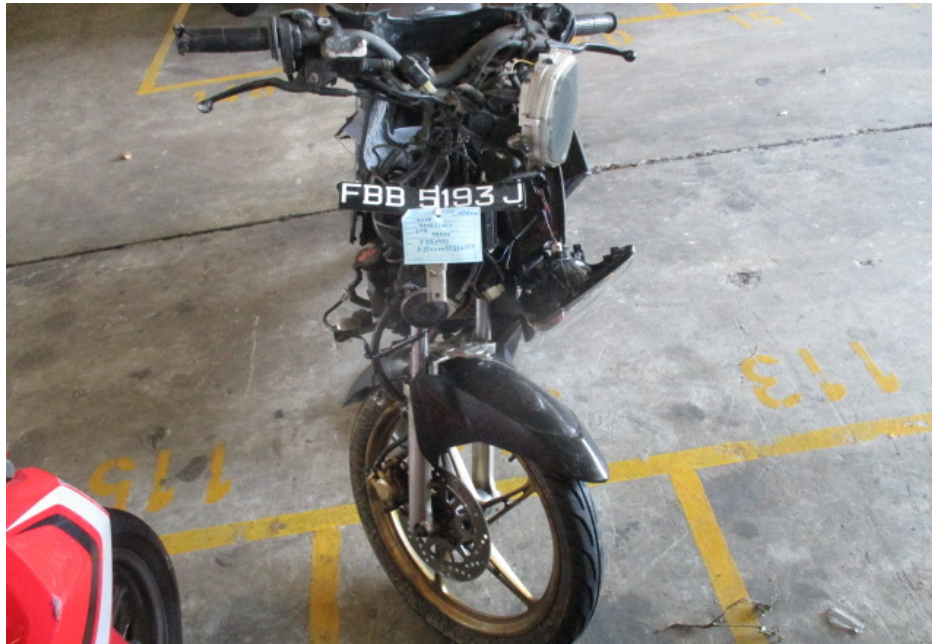
Photo 25 shows the front wheel of the Motorcycle turned towards its full left. Turning the Motorcycle's handle bar towards the left did not produce any abnormal free play and/or resistance. This would indicate that the steering system of the Motorcycle was in serviceable condition at the time of our inspection.

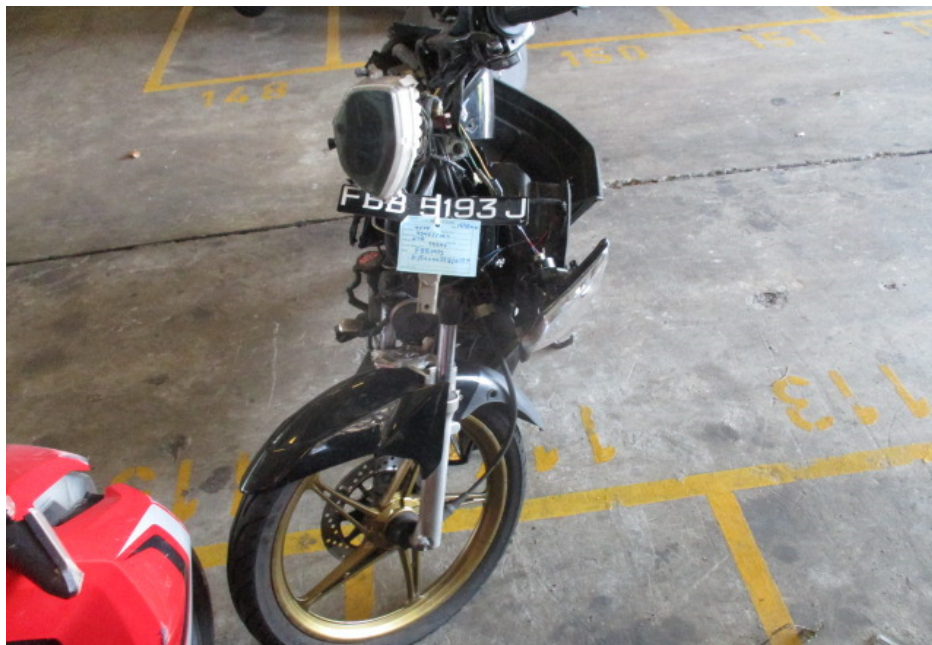
Photo 26 shows the front wheel of the Motorcycle turned towards its full right. Turning the Motorcycle's handle bar towards the right did not produce any abnormal free play and/or resistance. This would indicate that the steering system of the Motorcycle was in serviceable condition at the time of our inspection.

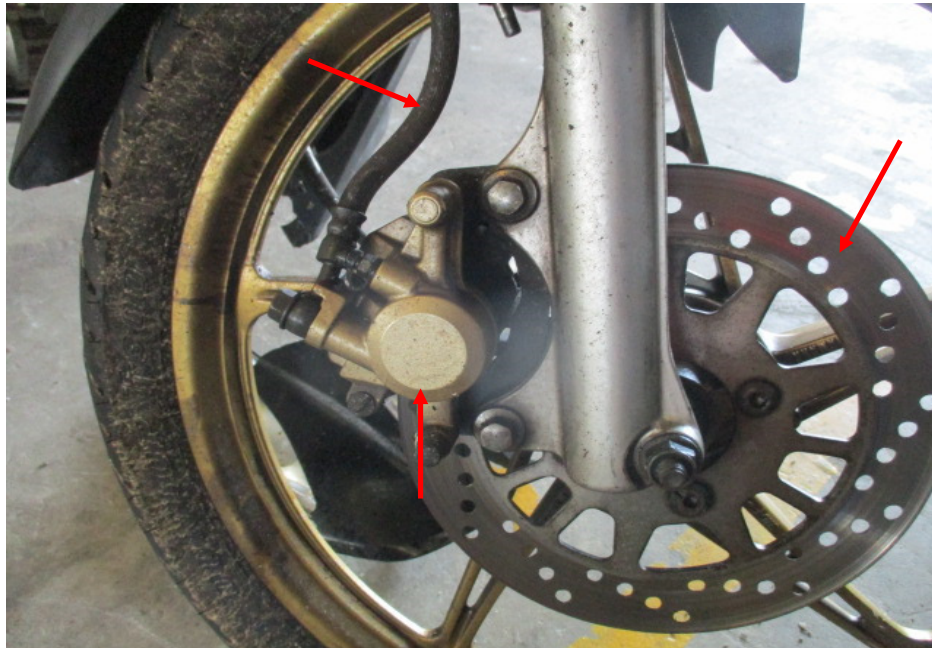
Photo 27 shows a close up view of the front brake caliper, front brake disc and front brake hose (arrowed) of the Motorcycle, which are all part of the components in the hydraulic front brake system of the Motorcycle. Our visual checks of these various components had revealed all to be intact with no visible damage. No leakage of brake fluid was also observed.

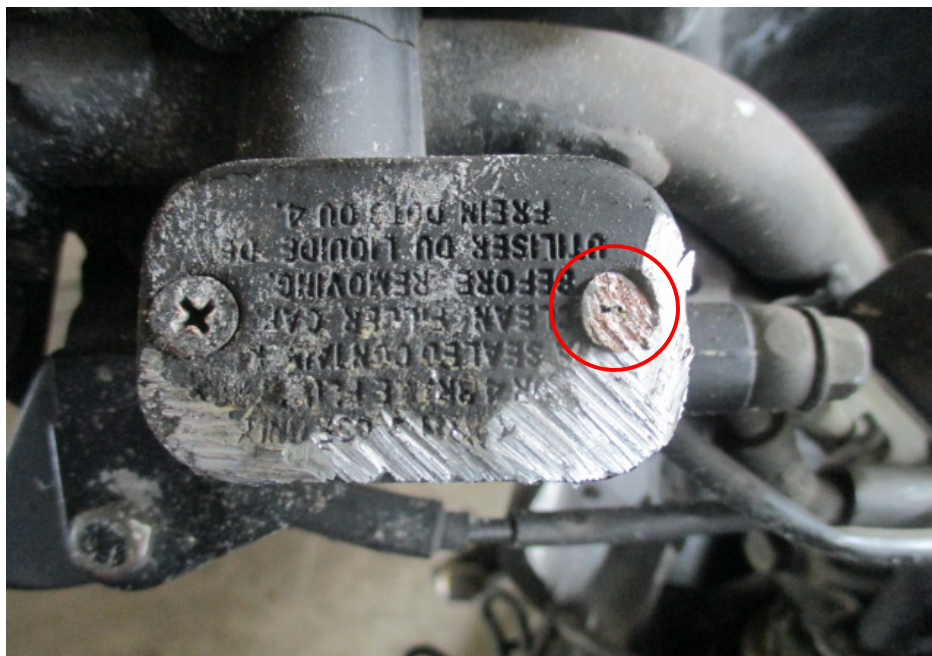
Photo 28 shows the brake fluid reservoir cover for the front brake of the Motorcycle. We were unable to examine whether the brake fluid was of sufficient level and without contamination for operational purposes due to the worn out screw (circled).

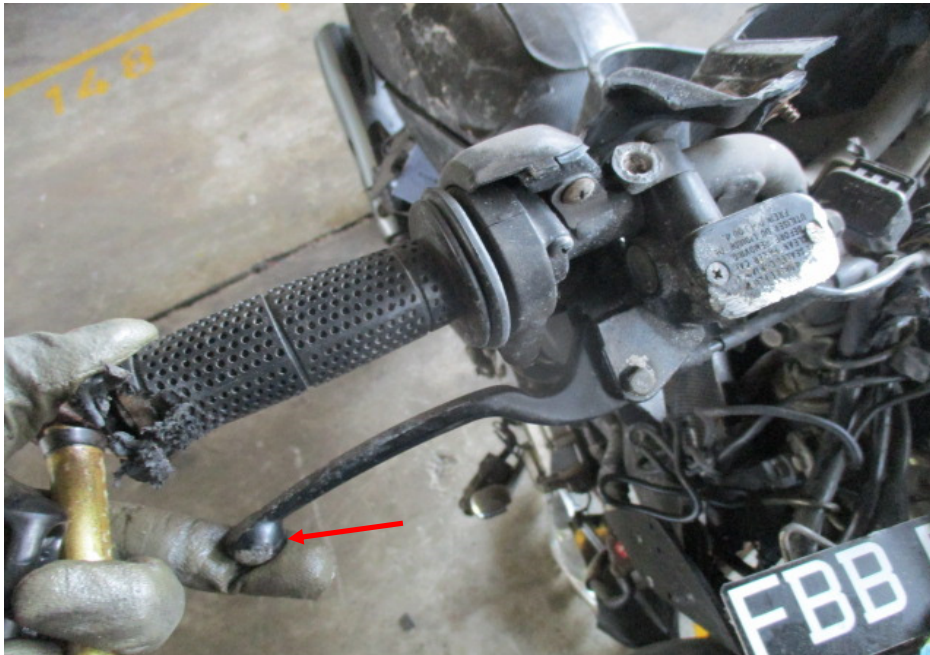
Photo 29 shows the front brake lever being depressed. There was some resistance felt (spongy like feel) upon pressing the front brake lever (arrowed). This would indicate that there is no leakage of pressure/vacuum in the brake system.

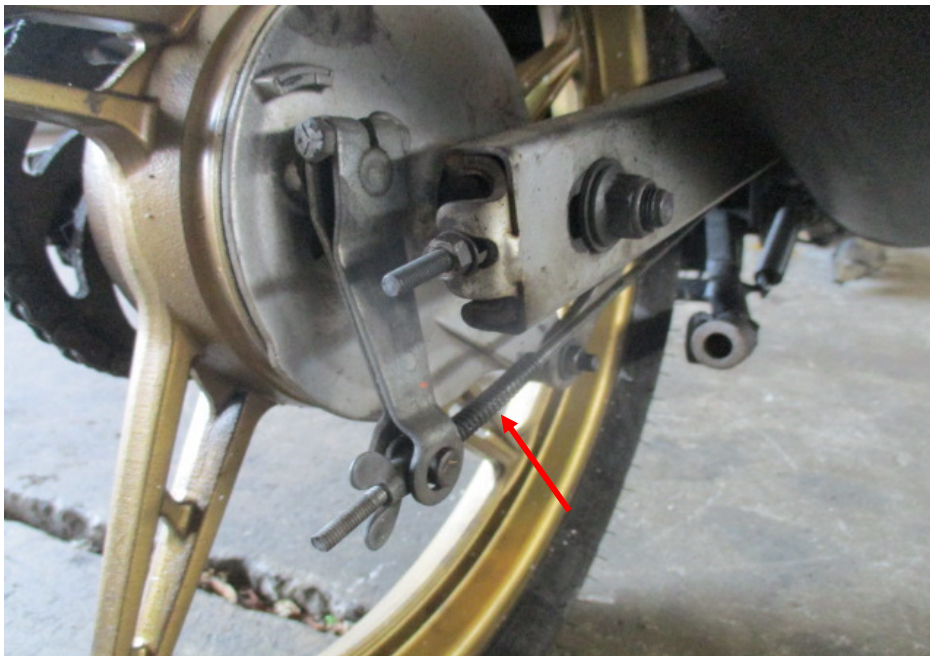
Photo 30 shows the rear wheel of the Motorcycle. The type of brake system for the rear wheel was of a mechanical type, controlled by the brake foot pedal of the Motorcycle. Our checks of the cable (arrowed), spring and drum which are all part of the components in the rear brake system of the Motorcycle reveal all to be intact and without damage.
