MECHANICAL INSPECTION REPORT OF MOTORCYCLE FBL 6399Z

1. We refer to your request on 18 September 2020 to conduct a physical inspection of a motorcycle bearing registration number FBL 6399Z (herein referred to as "**Motorcycle**"), which was involved in a fatal road traffic accident on 23 August 2020.
2. The objective of the inspection is to determine if there was any possible mechanical failure to the Motorcycle that may have contributed to the accident.
3. Following the request, we had carried out a physical inspection of the Motorcycle on 2 November 2020 at the premises of Traffic Police vehicle pound, 517 Airport Road Singapore 539942. We now set out below our observations and comments with respect to this inspection.

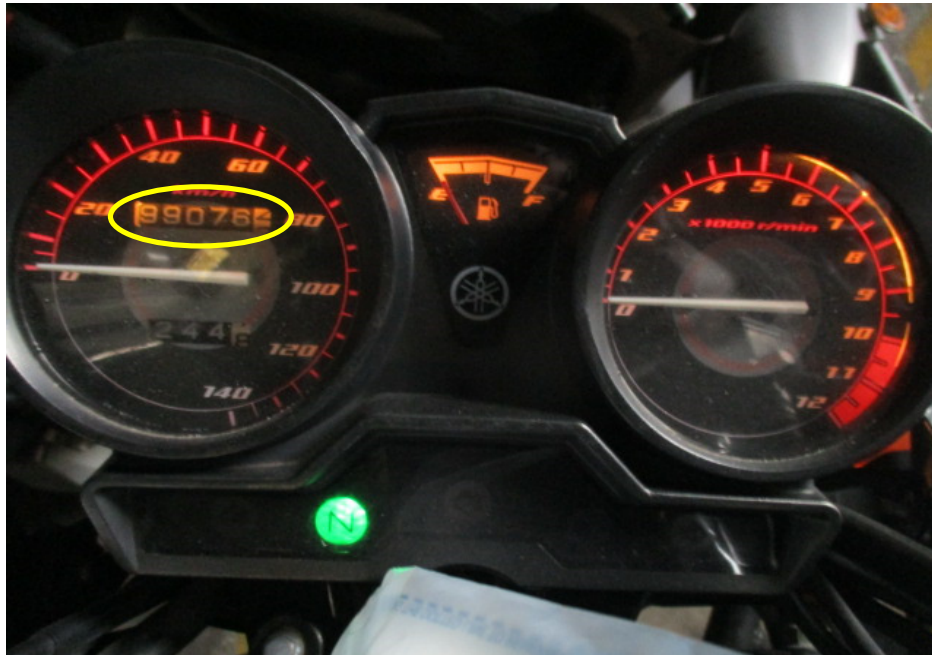
Photo 1 shows the speedometer gauge of the Motorcycle where the mileage recorded at the time of our inspection was 99, 076km (circled).

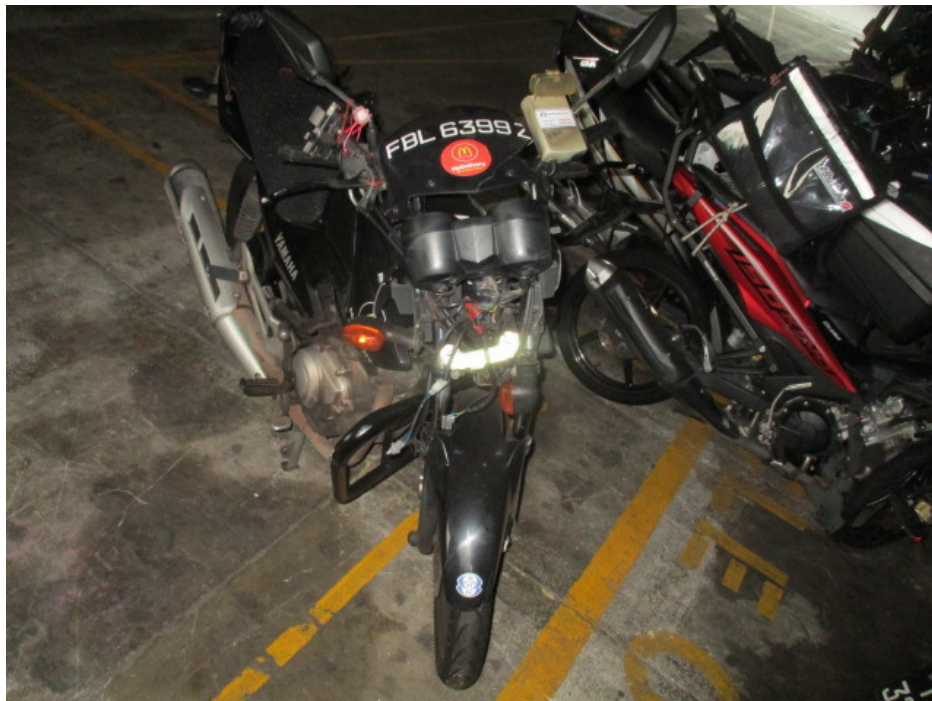
Photo 2 shows a general view of the frontal portion of the Motorcycle at the time of our inspection. The Motorcycle had sustained damages all around.

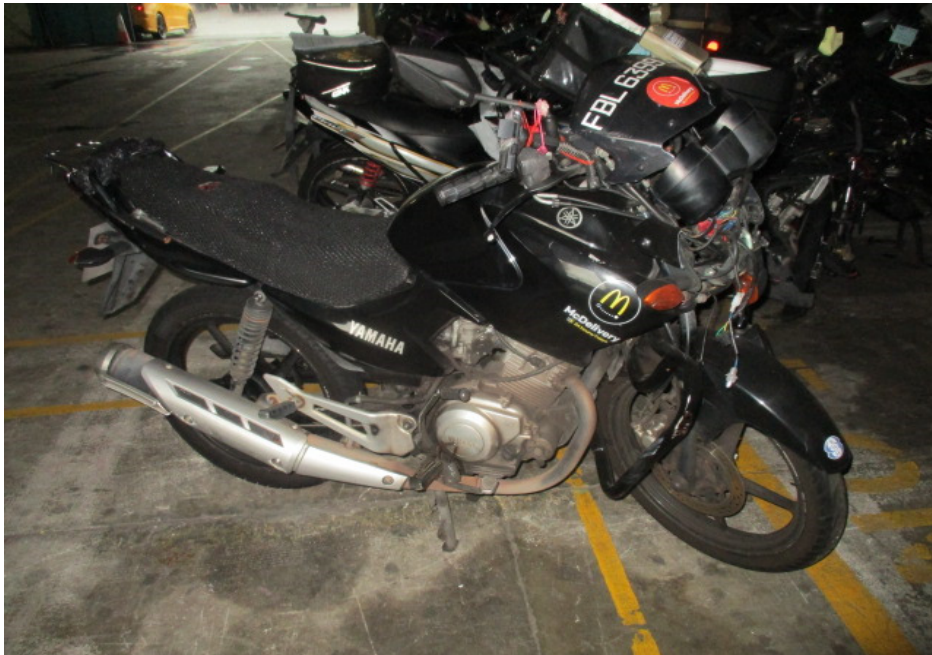
Photo 3 shows a general view of the right body of the Motorcycle at the time of our inspection. The Motorcycle had sustained damages all around. Body parts that were found to have been damaged include its headlight assembly, front fork assembly, front mudguard, left cowl, crash bars, side mirrors, front brake lever, clutch lever, handlebar ends, rear brake pedal, right front footrest and exhaust muffler, amongst others.

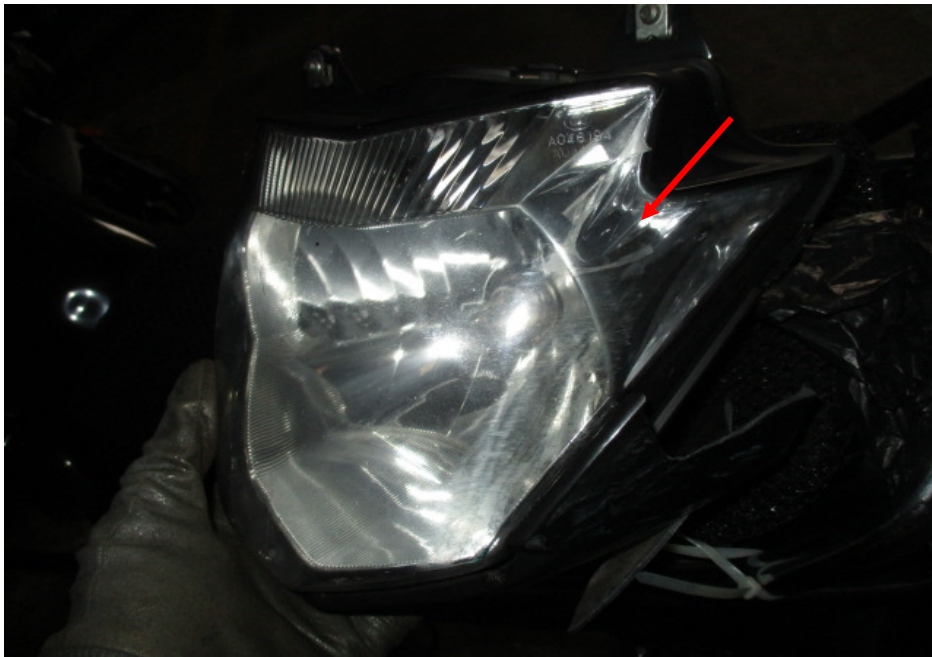
Photo 4 shows a closer view of the cracked headlight assembly of the Motorcycle as a result of the accident (arrowed).

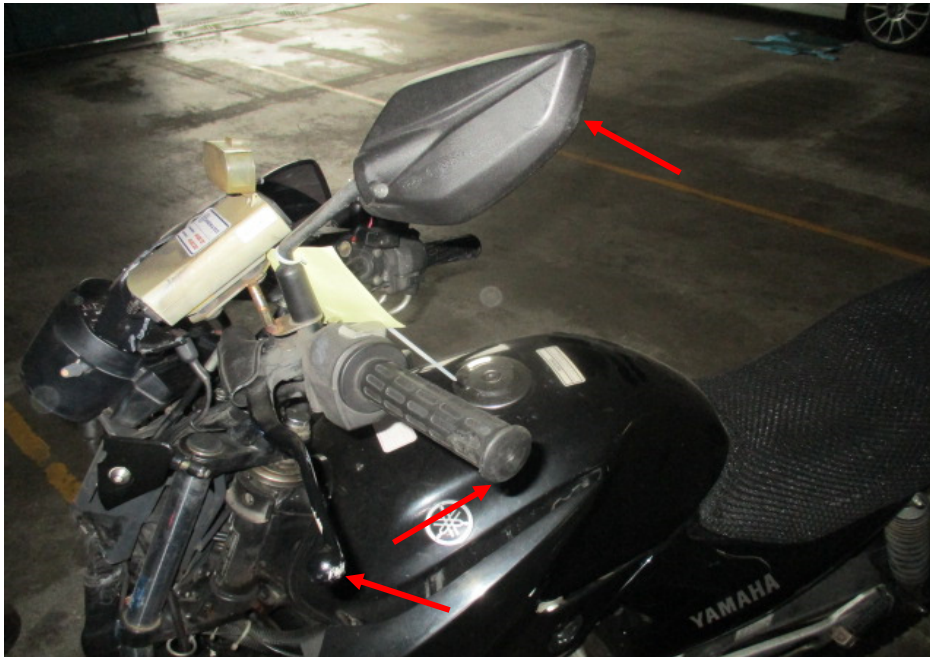
Photo 5 shows a closer view of the clutch lever, left side mirror and left handlebar end (arrowed) of the Motorcycle. These parts were amongst the body parts of the Motorcycle which were damaged as a result of the accident.

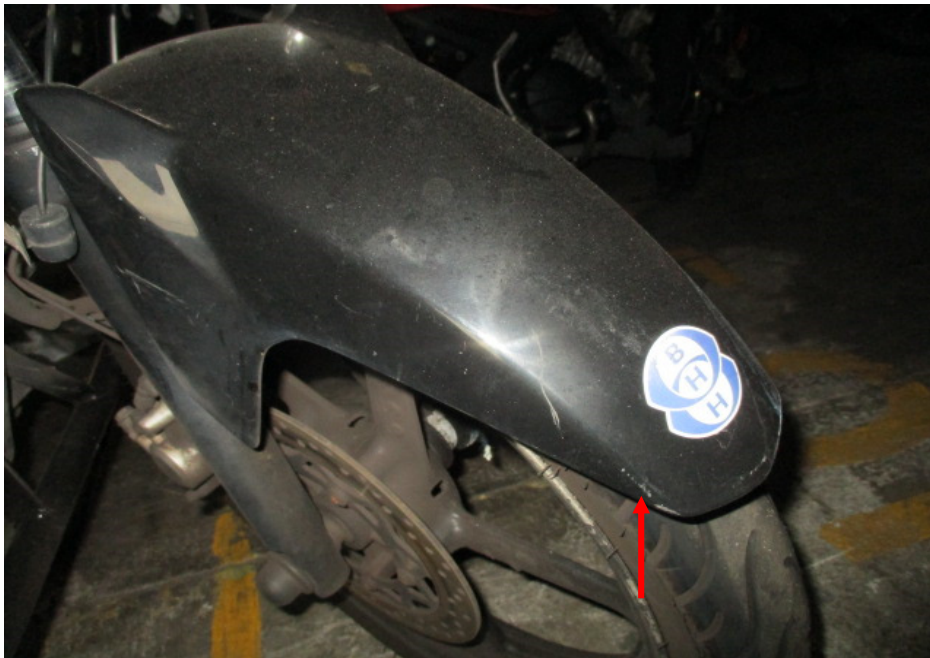
Photo 6 shows a closer view of the front mudguard, which was amongst the body parts of the Motorcycle that had sustained damage as a result of the accident (arrowed).

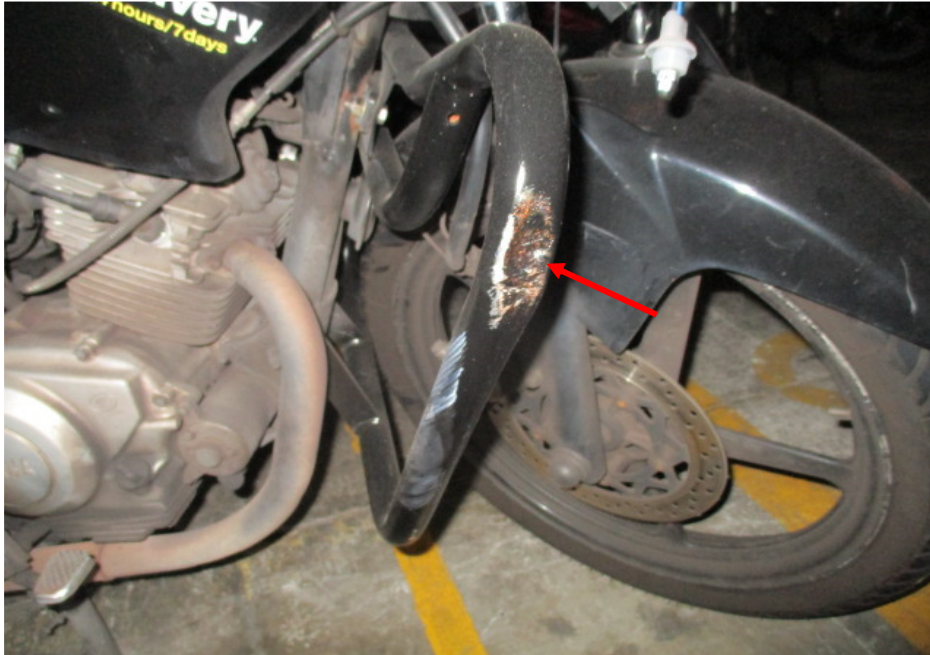
Photo 7 shows a closer view of the deformed right crash bar which was amongst the body parts of the Motorcycle that had sustained damages as a result of the accident (arrowed).

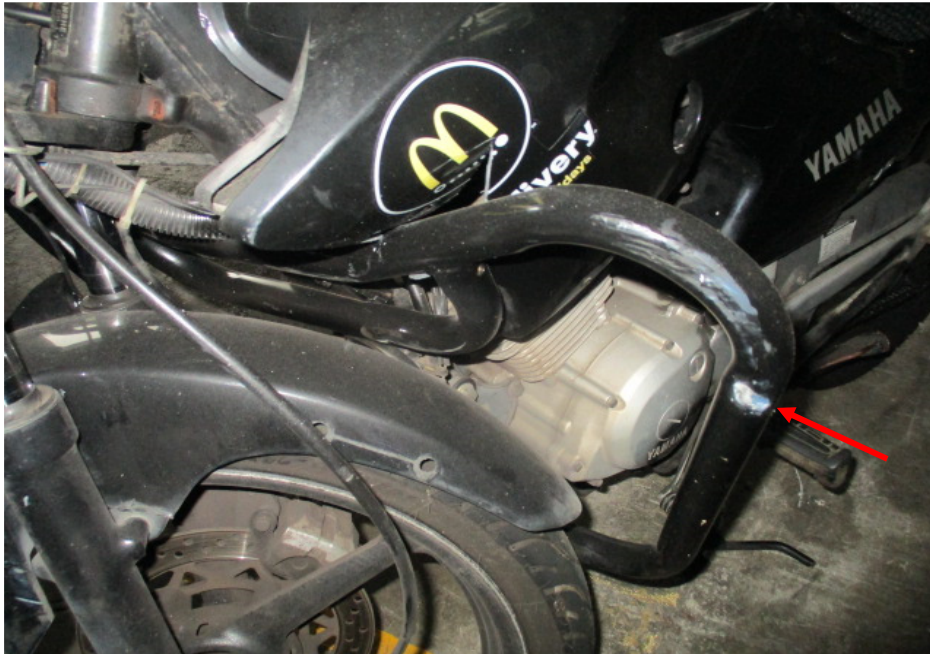
Photo 8 shows a closer view of the deformed left crash bar which was amongst the body parts of the Motorcycle that had sustained damages as a result of the accident (arrowed).

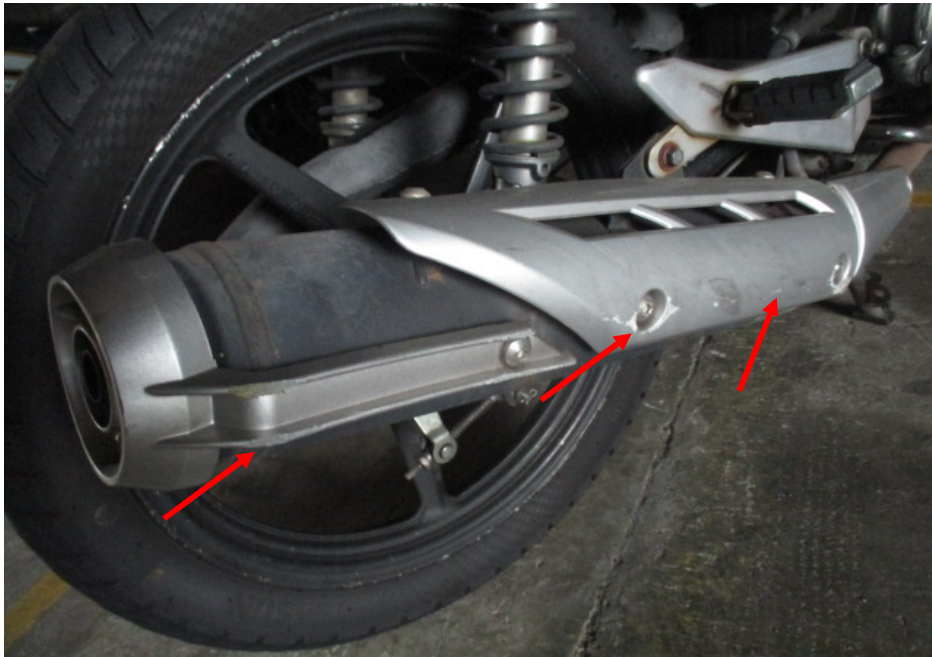
Photo 9 shows a closer view of the exhaust muffler which was amongst the body parts of the Motorcycle that had sustained damages as a result of the accident (arrowed).

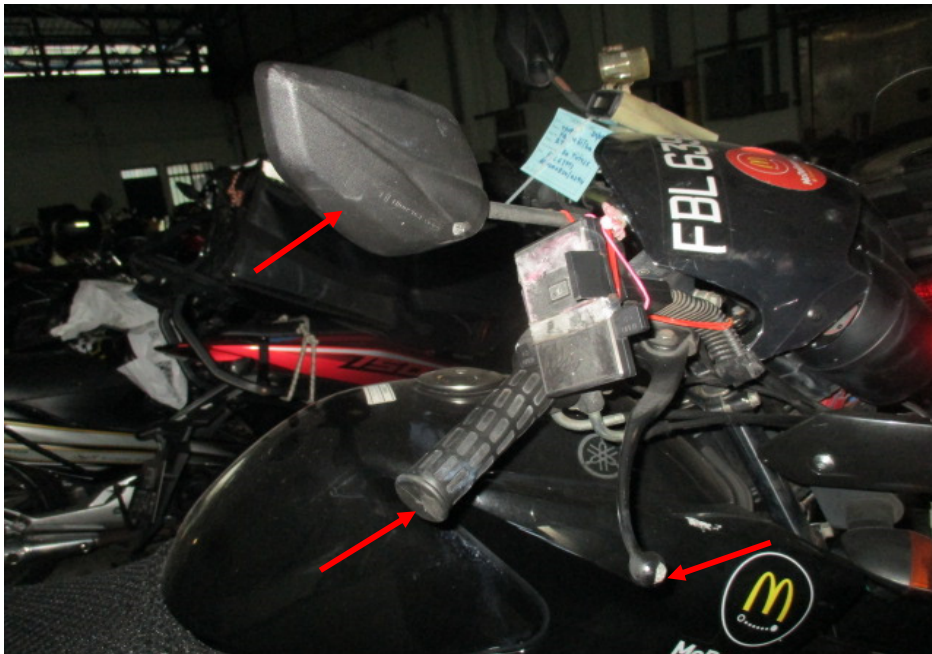
Photo 10 shows a closer view of the right side mirror and right handlebar end and front brake lever (arrowed), which were amongst the body parts of the Motorcycle that had sustained damage as a result of the accident.

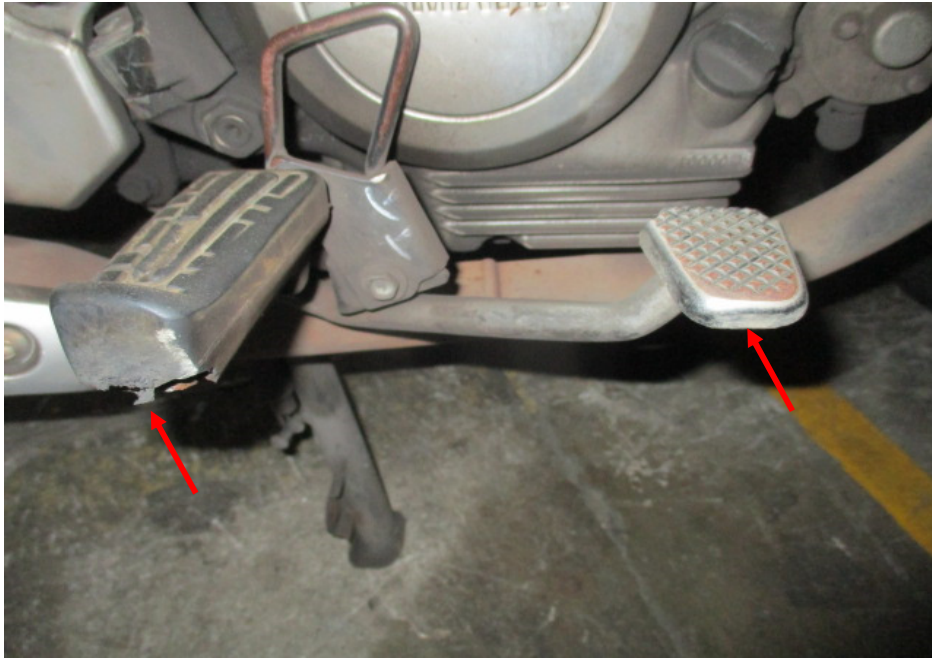
Photo 11 shows the rear brake pedal and right front footrest of the Motorcycle which sustained damages of grazing nature as a result of the accident (arrowed).

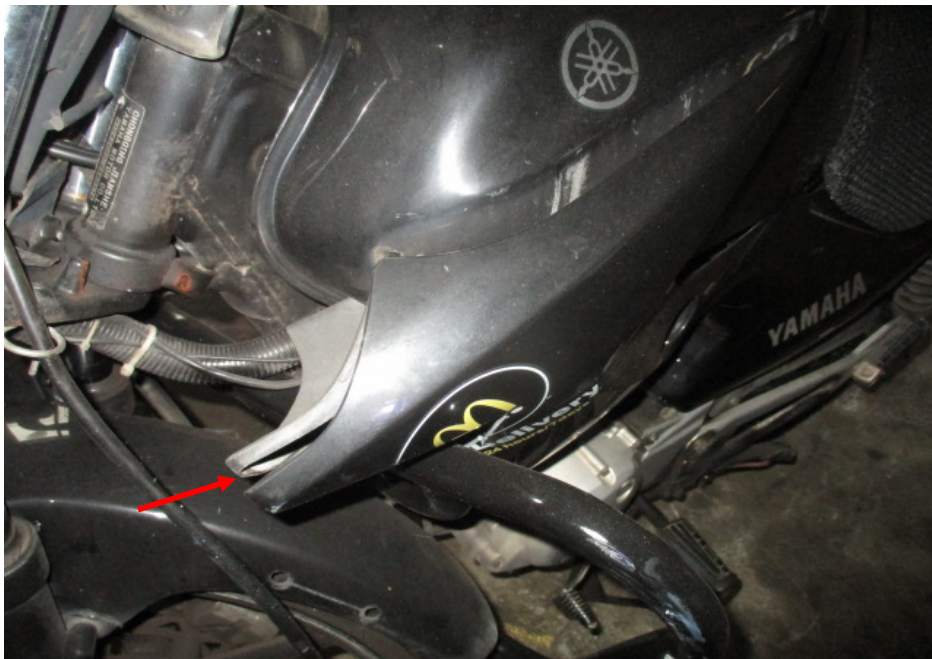
Photo 12 shows the deformed left cowling of the Motorcycle as a result of the accident at the time of our inspection (arrowed).

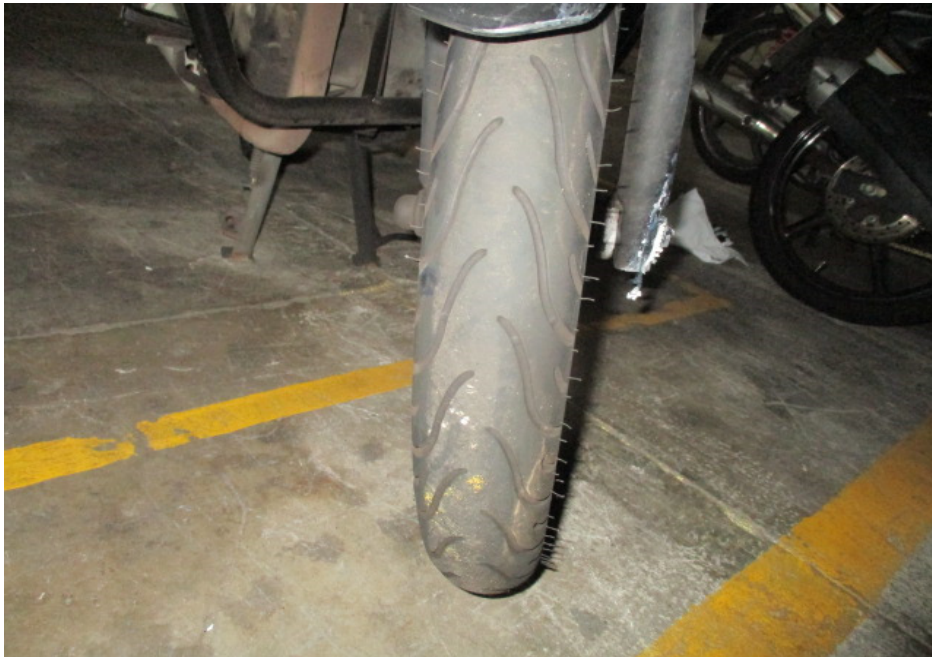
Photo 13 shows the front tyre of the Motorcycle at the time of our inspection. The front tyre was observed to be in serviceable condition with remaining tread depth of approximately 3mm. The pattern of the tread was also clearly visible. There was no tear, burst mark(s) and/or punctured hole(s) on the sidewalls as well as across the tread of the front tyre.

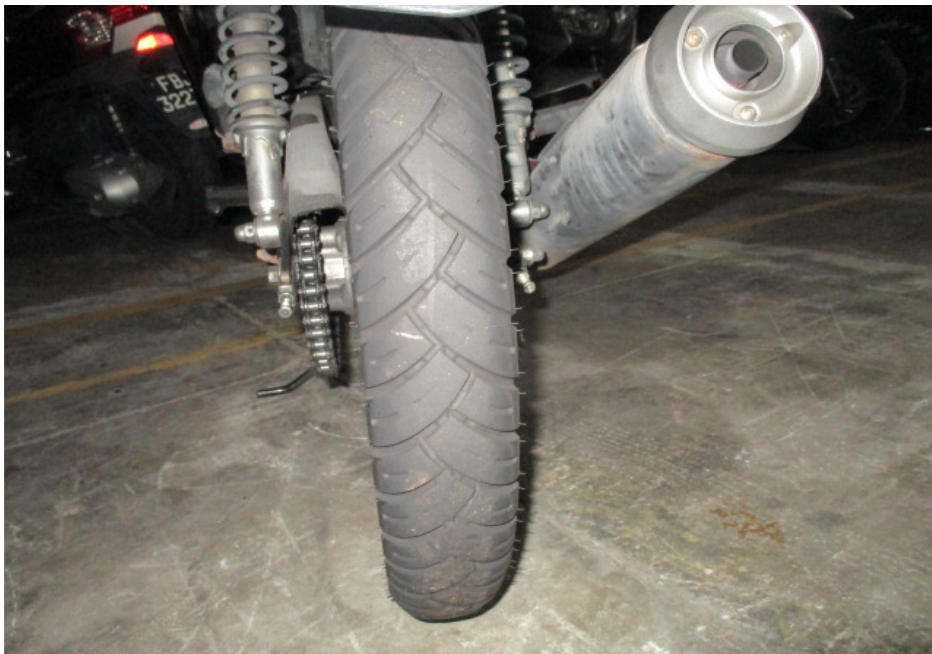
Photo 14 shows the condition of the Motorcycle's rear tyre. The rear tyre was observed to be in serviceable condition with remaining tread depth of approximately 4mm. The tyre was also observed to be sufficiently inflated for vehicular operation. We did not observe any tear, burst mark(s) and/or punctured hole(s) on the sidewalls as well as across the tread of the rear tyre.

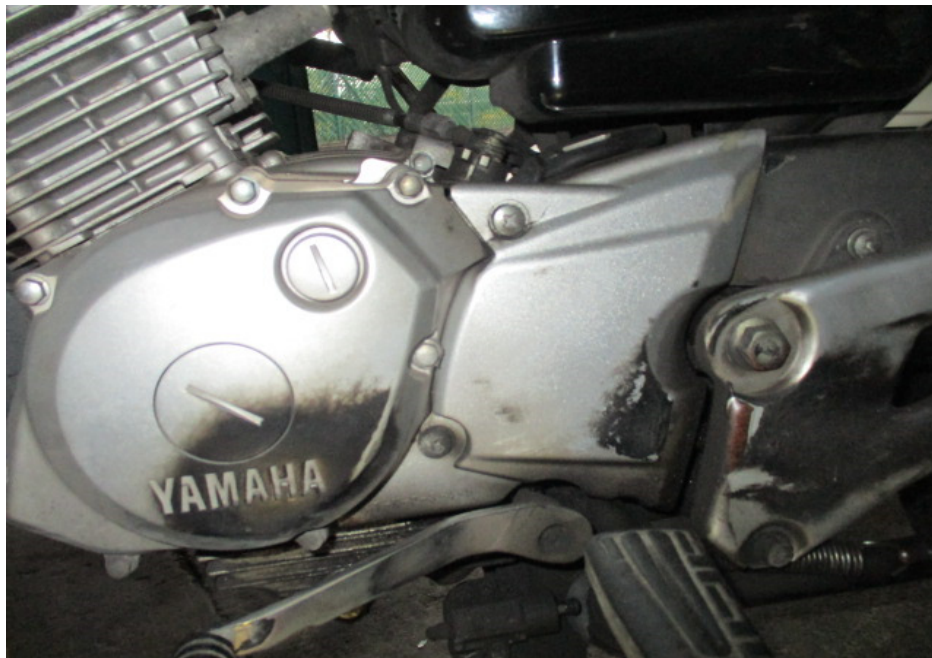
Photo 15 shows the left side of the engine of the Motorcycle at the time of our inspection. The various engine related parts and components were found to be intact with no visible damage. There was also no sign(s) or indication(s) of fluid leak observed around the left engine area of the Motorcycle.

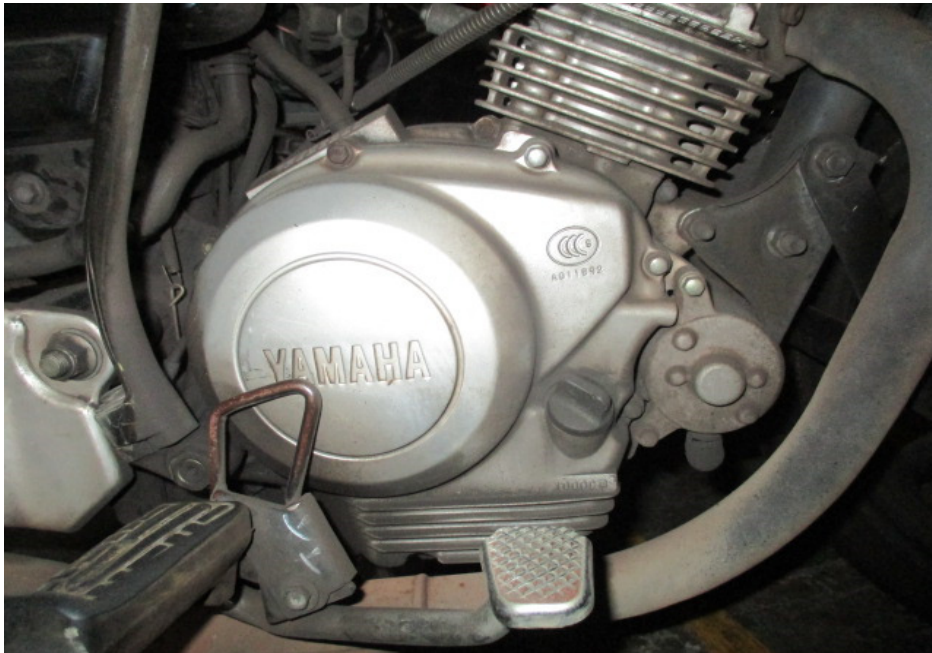
Photo 16 shows the right side of the engine of the Motorcycle at the time of our inspection. The various engine related parts and components were found to be intact with no visible damage. There was also no sign(s) or indication(s) of fluid leak observed around the right engine area of the Motorcycle.

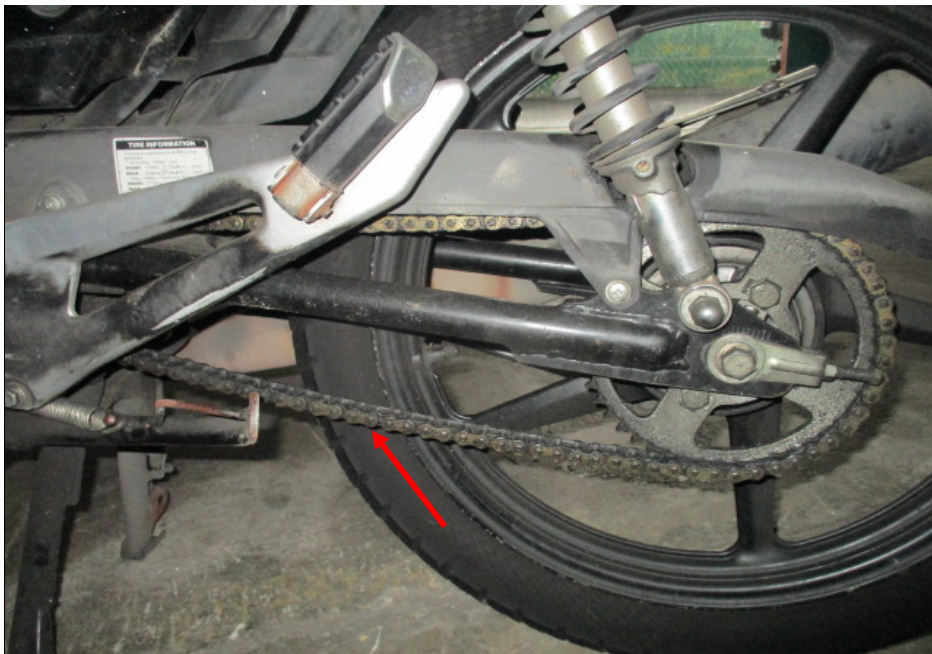
Photo 17 shows the gear chain (arrowed) of the Motorcycle, which was observed to be intact with no misalignment. It was also adequately lubricated for operating purposes. The gear chain rotates the rear wheel of the Motorcycle.

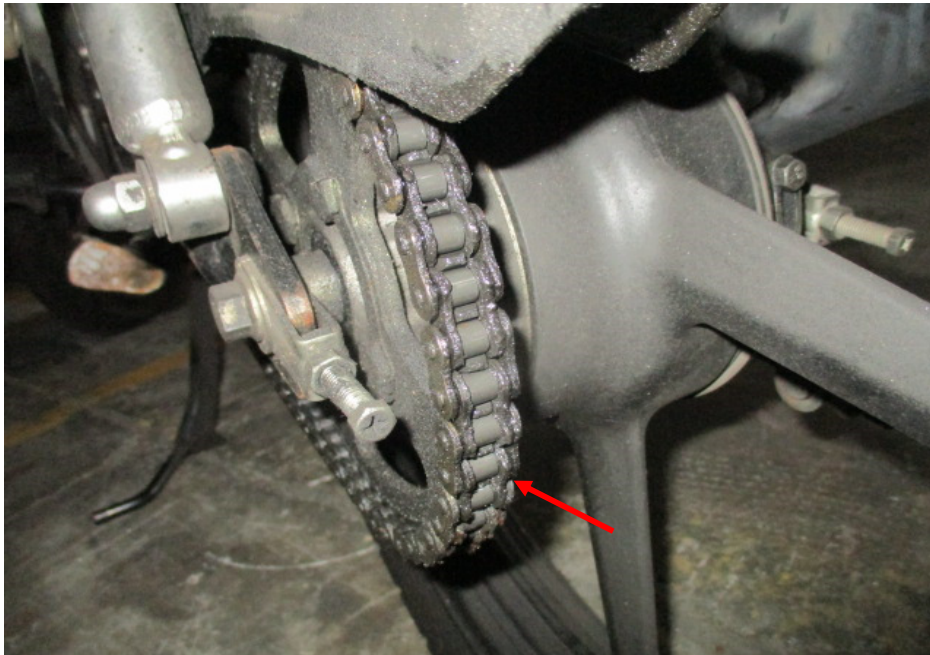
Photo 18 shows the closer view of the gear chain (arrowed) of the Motorcycle, which was observed to be intact with no misalignment. It was also adequately lubricated for operating purposes.

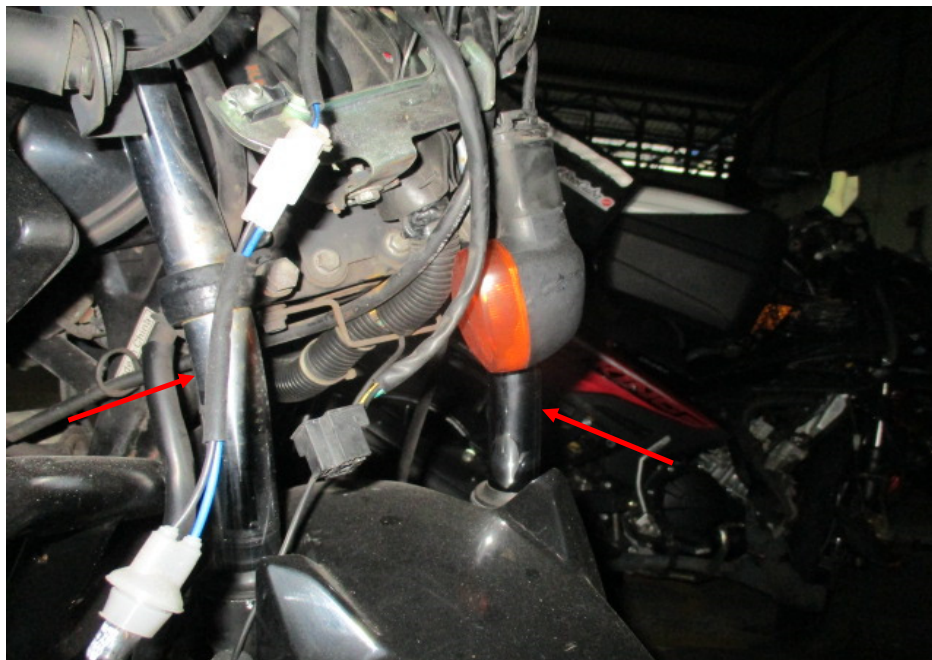
11. For this case, we were not able to conduct any test(s) on the steering system of the Motorcycle due to the damage of its front forks and steering stem. The front forks were found to be bent inwards as a result of the accident.

Photo 19 shows the front forks of the Motorcycle. The front forks were observed to be bent inwards as a result of the accident (arrowed). We were hence not able to conduct any tests on the steering system of the Motorcycle.

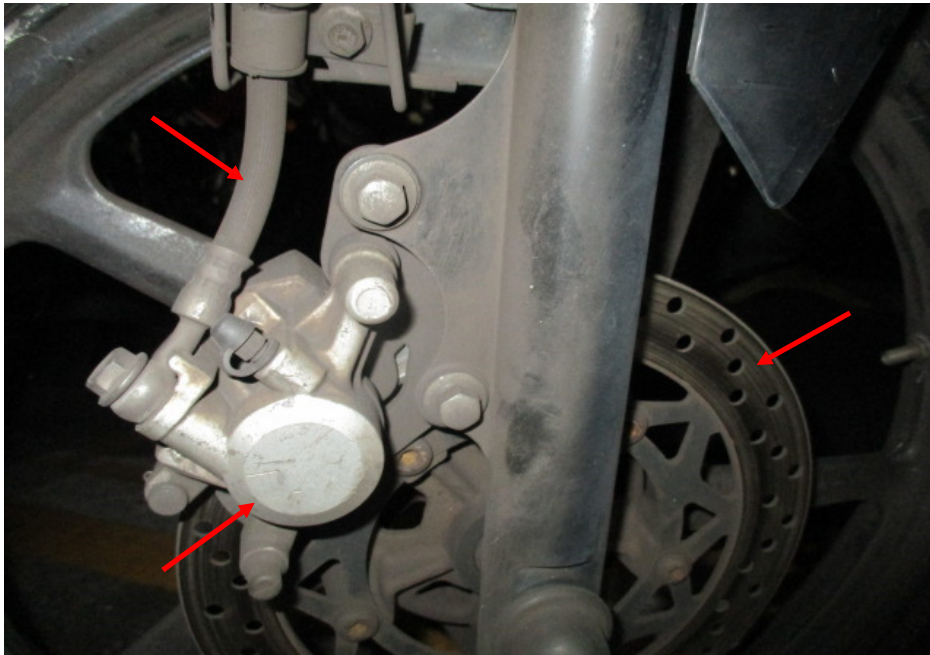
Photo 20 shows a close up view of the front brake caliper, front brake disc and front brake hose (arrowed) of the Motorcycle, which are all part of the components in the hydraulic front brake system of the Motorcycle. Our visual checks of these various components had revealed all to be intact with no visible damage. No leakage of brake fluid was also observed.

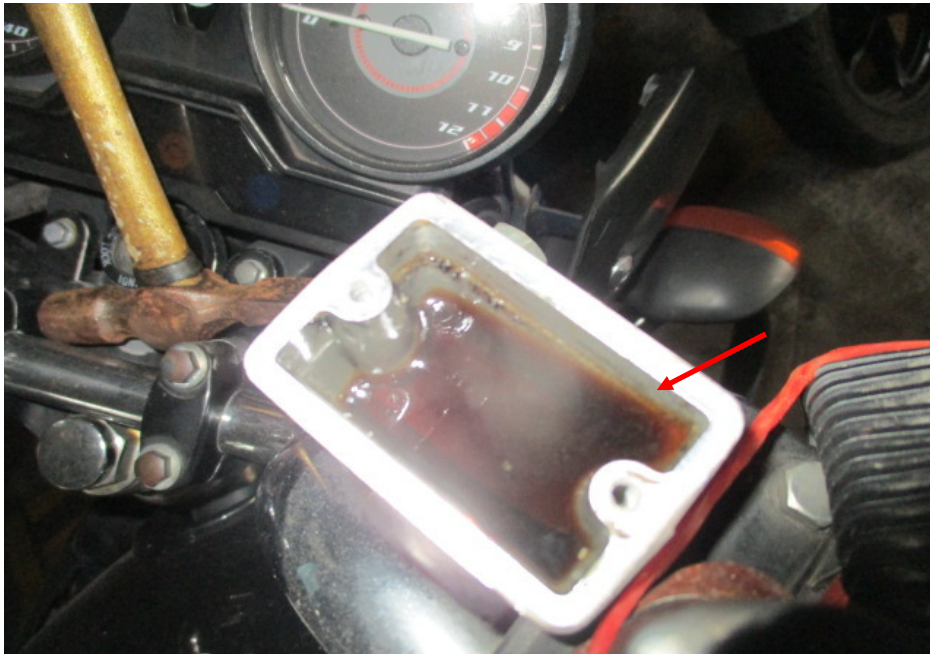
Photo 21 shows the brake fluid reservoir for the front brake of the Motorcycle. The brake fluid was found to be of sufficient level for operating purposes. However the brake fluid was found to be slightly contaminated (arrowed).

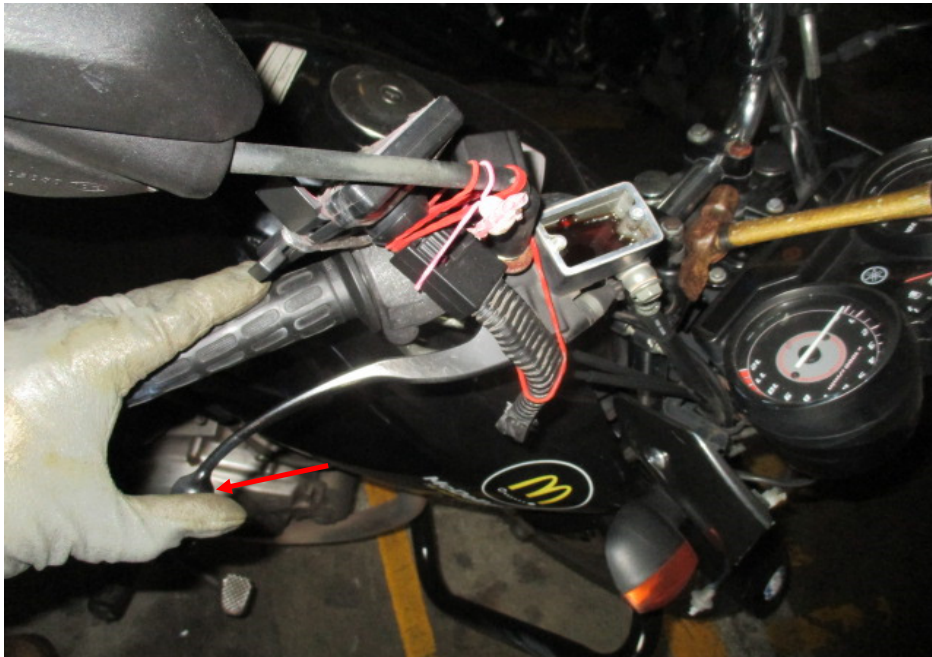
Photo 22 shows the front brake lever being depressed. There was some resistance felt (spongy like feel) upon pressing the front brake lever (arrowed). This would indicate that there is no leakage of pressure/vacuum in the brake system.

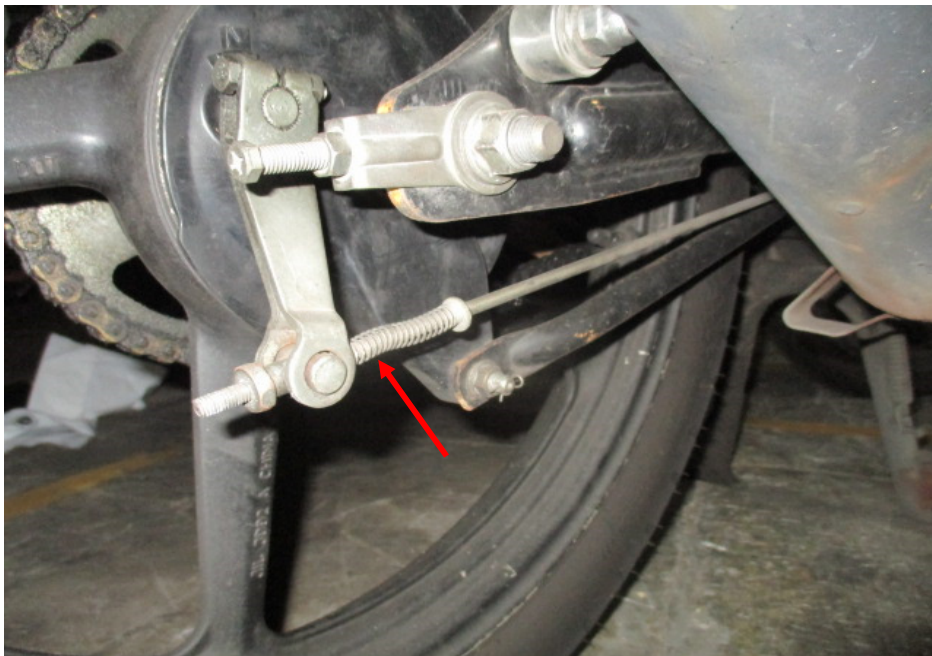
Photo 23 shows the rear wheel of the Motorcycle. The type of brake system for the rear wheel was of a mechanical type, controlled by the brake foot pedal of the Motorcycle. Our checks of the cable (arrowed), spring and drum which are all part of the components in the rear brake system of the Motorcycle reveal all to be intact and without damage.
