Your Ref: TP/IP/25271/2020  
Our Ref : CI/TPD20011140/P

**Fatal Accident Investigation Team**

**MECHANICAL INSPECTION REPORT OF MOTOR VAN GBE 1000T**

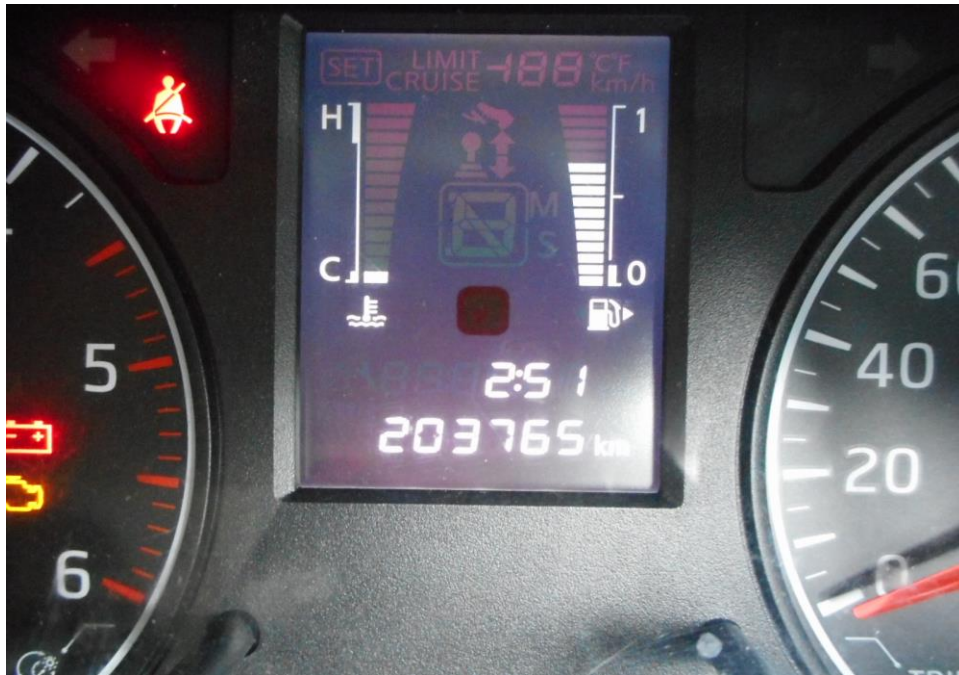
4. The mileage of the Motor Van at the time of my inspection was 203,765km.
5. There was no visible damage observed on Motor Van at the time of my inspection.

**Photo 1** shows a general view of the instrument cluster of the Motor Van at the time of my inspection. The mileage of the Motor Van was 203,765km

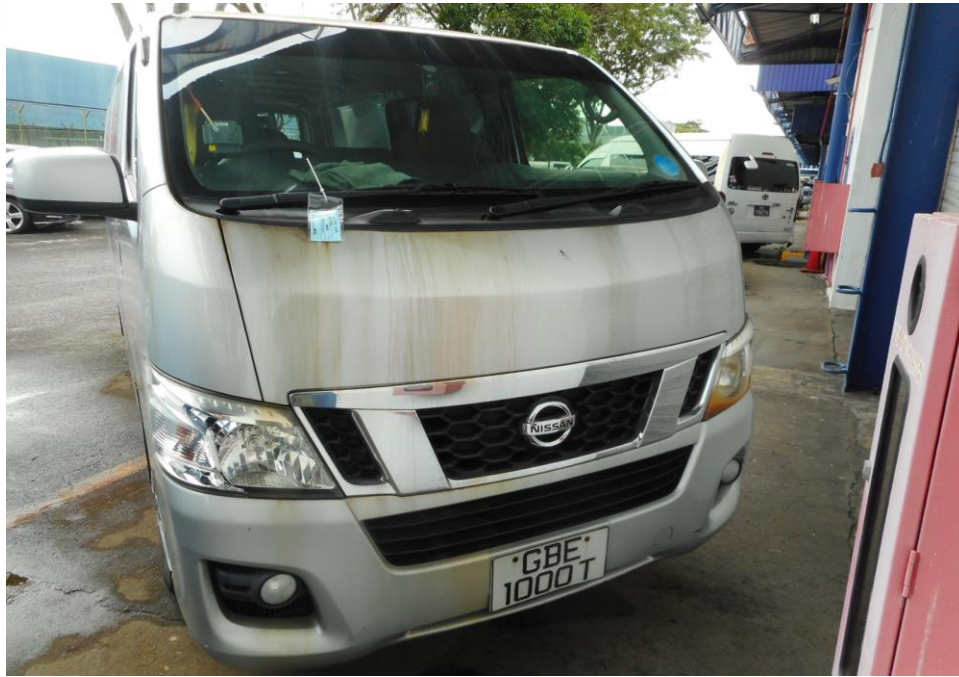
**Photo 2** shows a general view of the front portion of the Motor Van at the time of my inspection. The Motor Van was observed to be intact and unaffected by the accident.

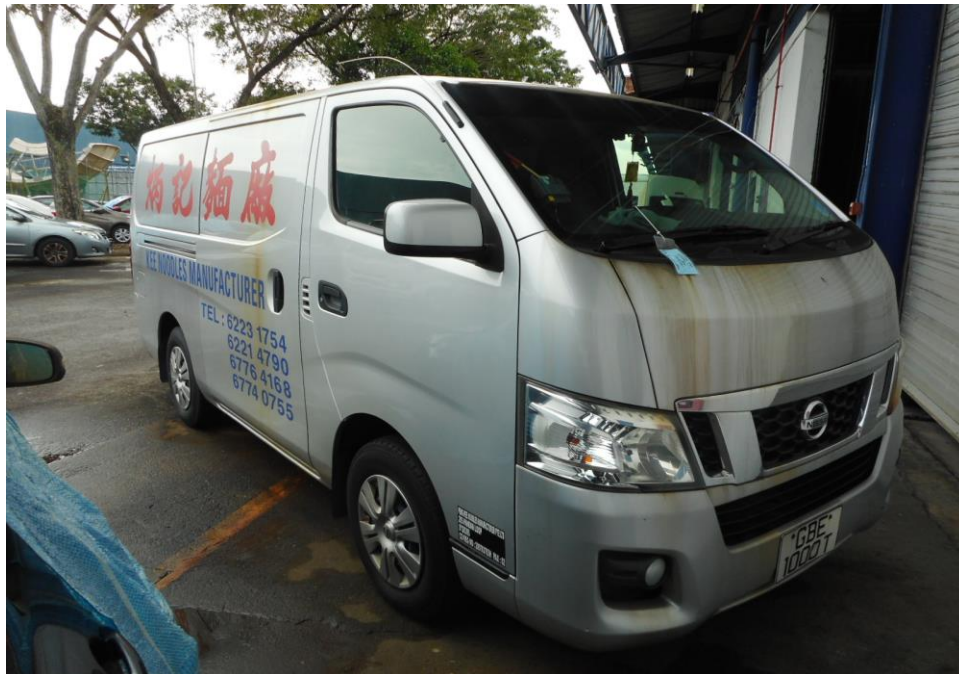
**Photo 3** shows a general view of the right body of the Motor Van at the time of my inspection. The Motor Van was observed to be intact and unaffected by the accident.

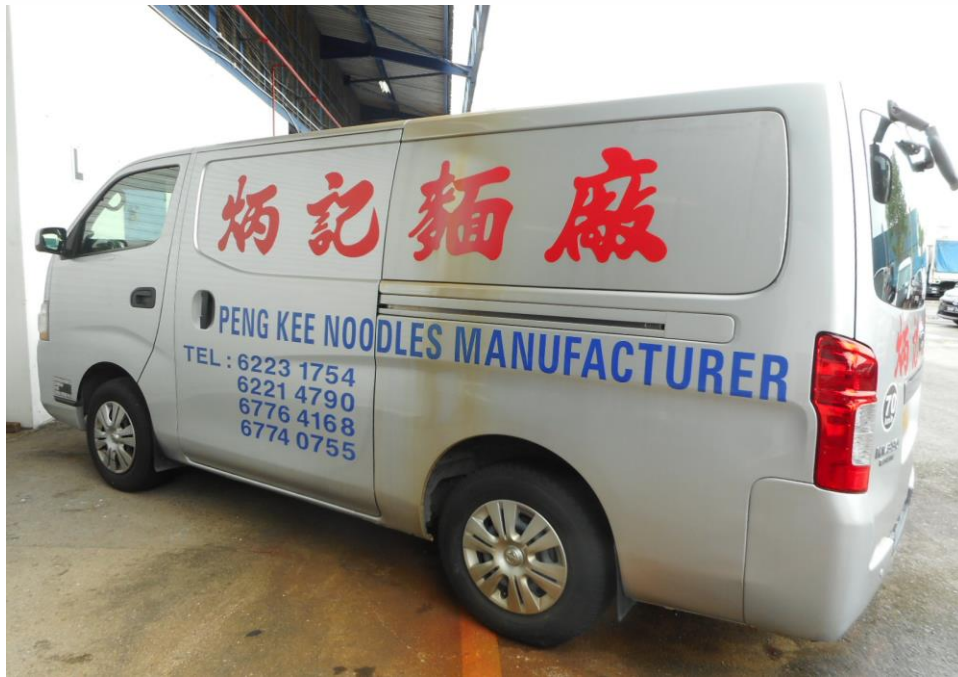
**Photo 4** shows a general view of the left body of the Motor Van at the time of my inspection. The Motor Van was observed to be intact and unaffected by the accident.

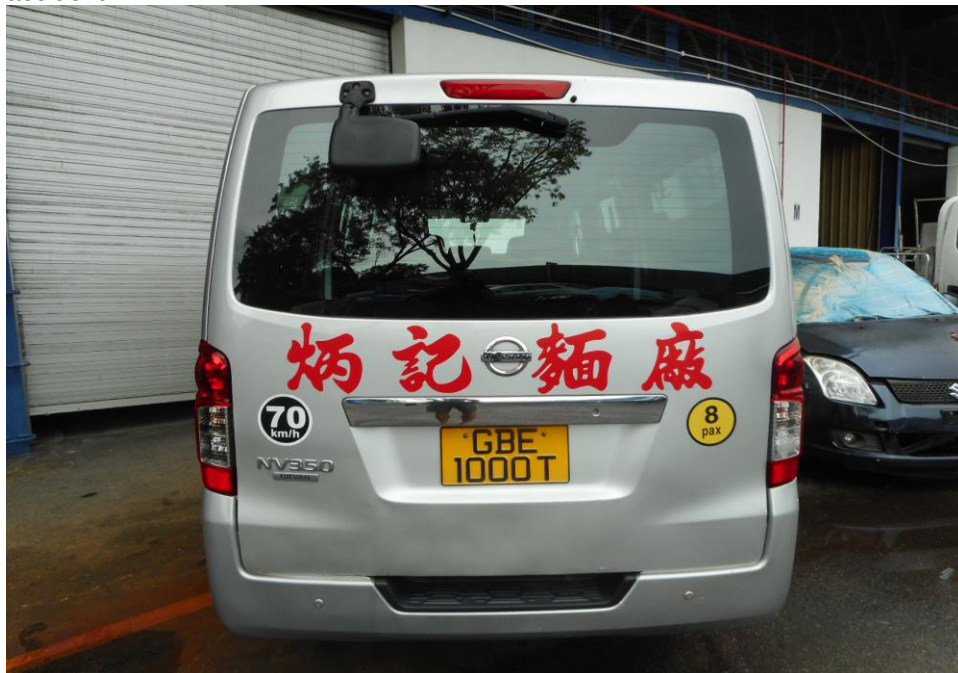
**Photo 5** shows a general view of the rear body of the Motor Van at the time of my inspection. The Motor Van was observed to be intact and unaffected by the accident.

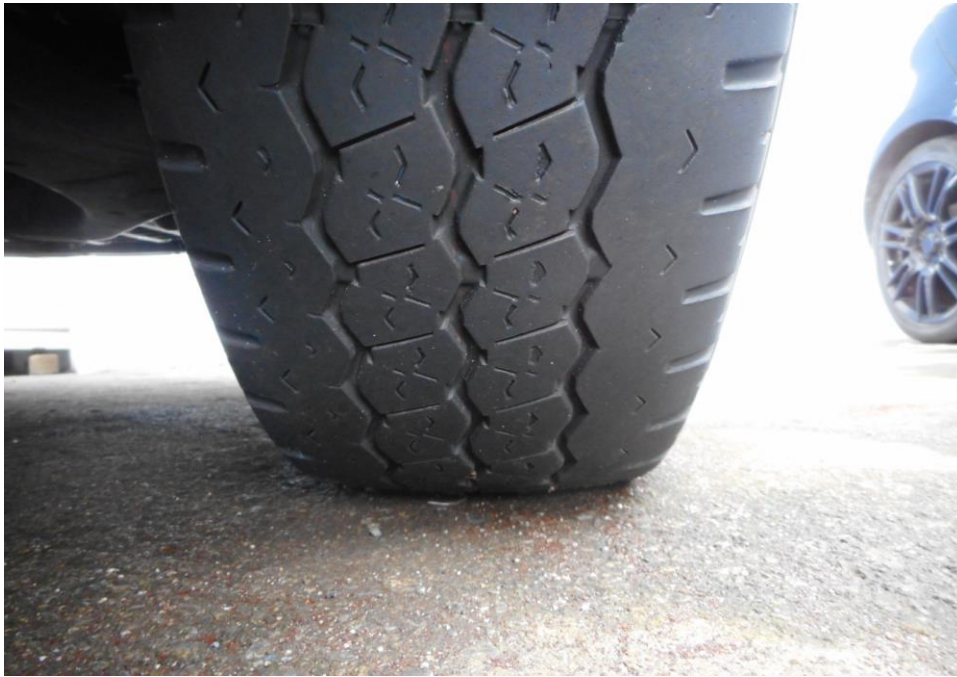
**Photo 6** shows the condition of the front right tyre of the Motor Van, which was observed to be in serviceable condition with remaining tread depth of approximately 3.8mm. The tyre, which was wrapped around standard steel wheel rim, was also observed to be sufficiently inflated for vehicular operation. There was no tear, cut or burst mark(s) on the outer and the inner sidewalls as well as across the tread of the 4 tyres that were fitted on the Motor Van.

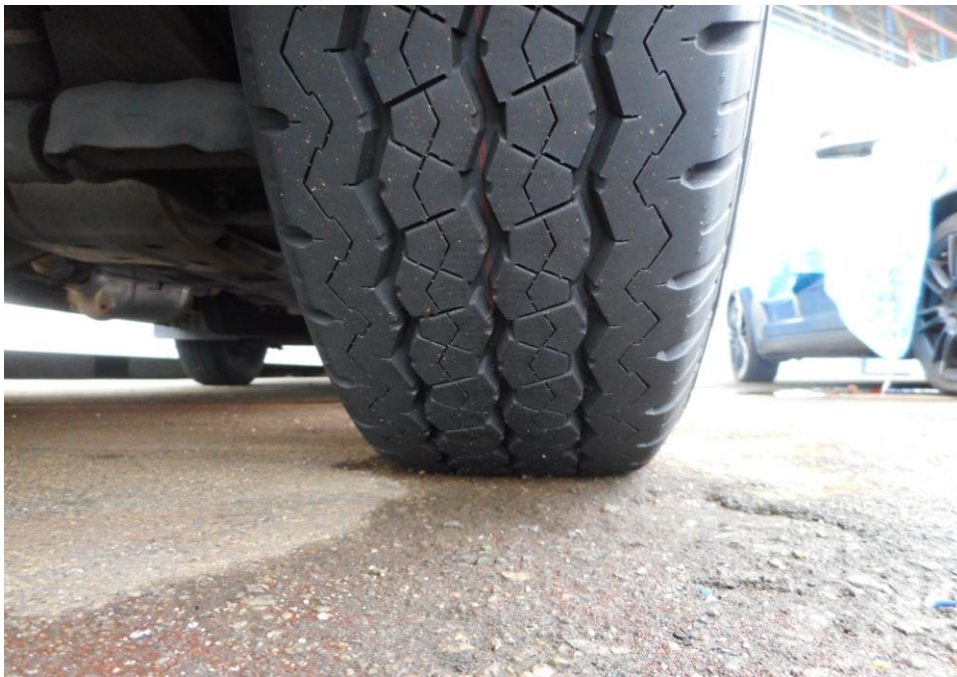
**Photo 7** shows the condition of the rear right tyre of the Motor Van, which was observed to be in serviceable condition with remaining tread depth of approximately 7.4mm. The tyre, which was wrapped around standard steel wheel rim, it was observed to be sufficiently inflated for vehicular operation.

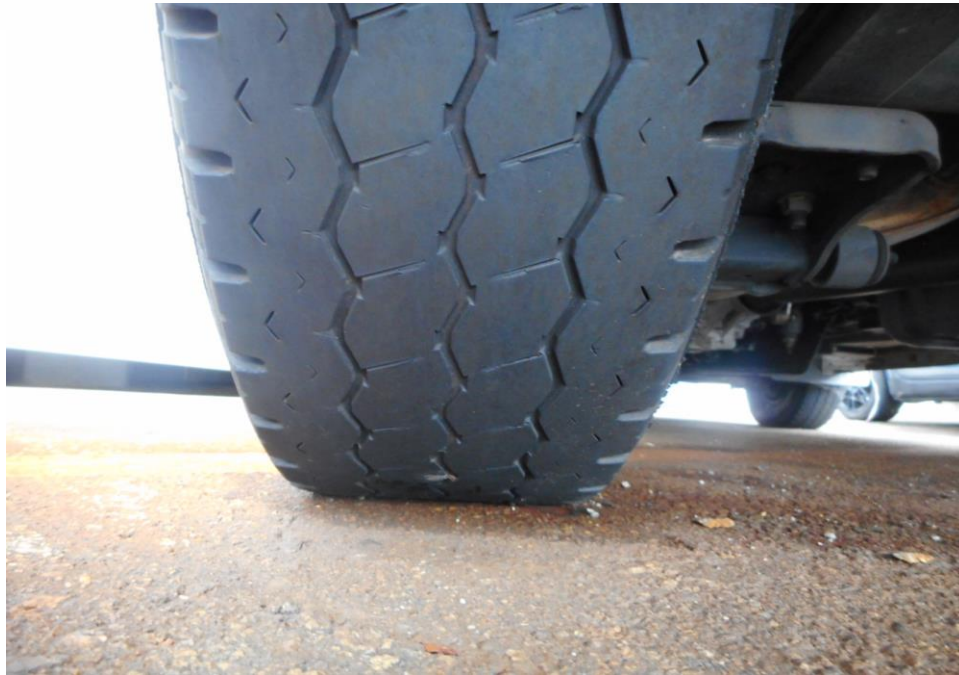
**Photo 8** shows the condition of the rear left tyres of the Motor Van, which was observed to be in serviceable condition with remaining tread depth of approximately 1.8mm. The tyres, which were wrapped around standard steel wheel rim, were also observed to be sufficiently inflated for vehicular operation. There was also no damage found on all 4 steel wheel rims of the Motor Van.

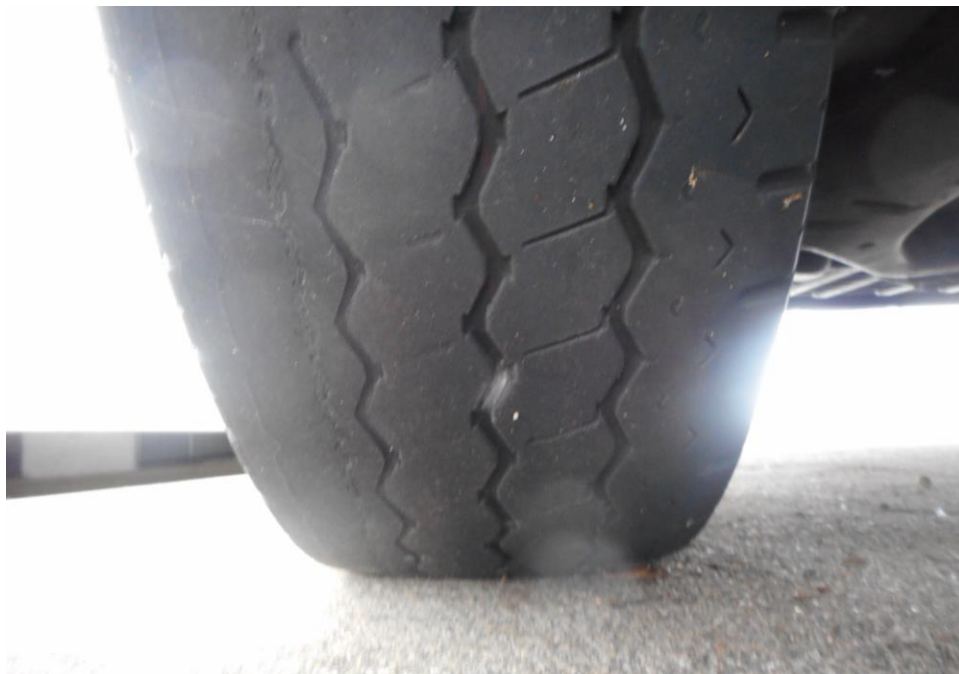
**Photo 9** shows the condition of the rear right tyres of the Motor Van, which were observed to be in serviceable condition with remaining, tread depth of approximately 2mm. There was also no tear, cut or burst mark(s) on the outer and the inner sidewalls as well as across the tread of the 4 tyres that were fitted on the Motor Van.

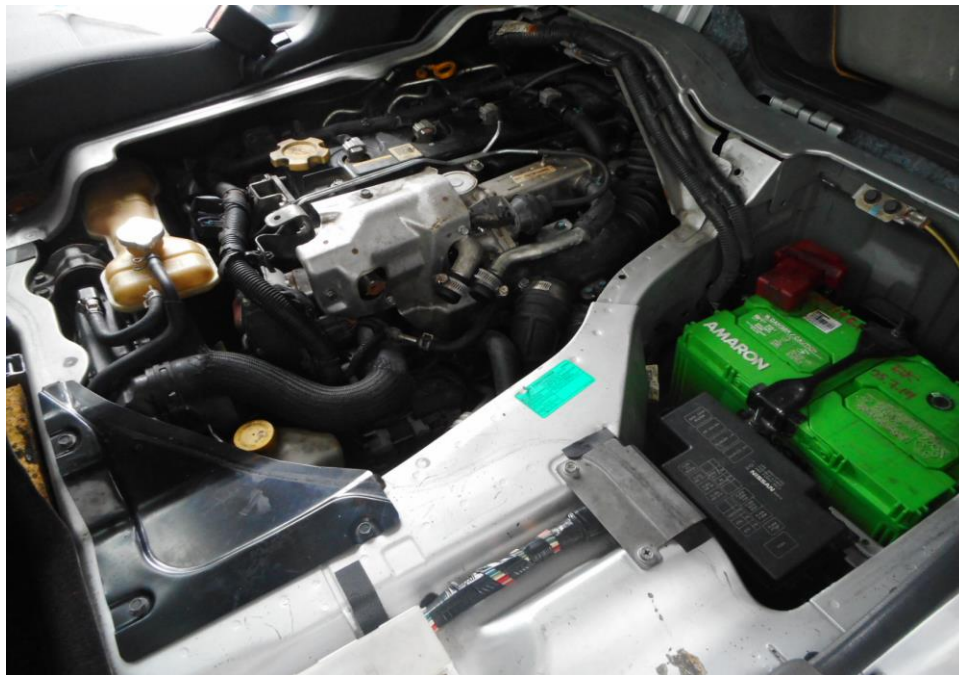
**Photo 10** shows a general view of the Motor Van's engine compartment, which was accessed by lifting the front cabin of the Motor Van. The various parts and components inside the engine compartment were unaffected by the accident. There was also no sign(s) or indication(s) of fresh fluid leakage and/or fluid stain within the engine compartment

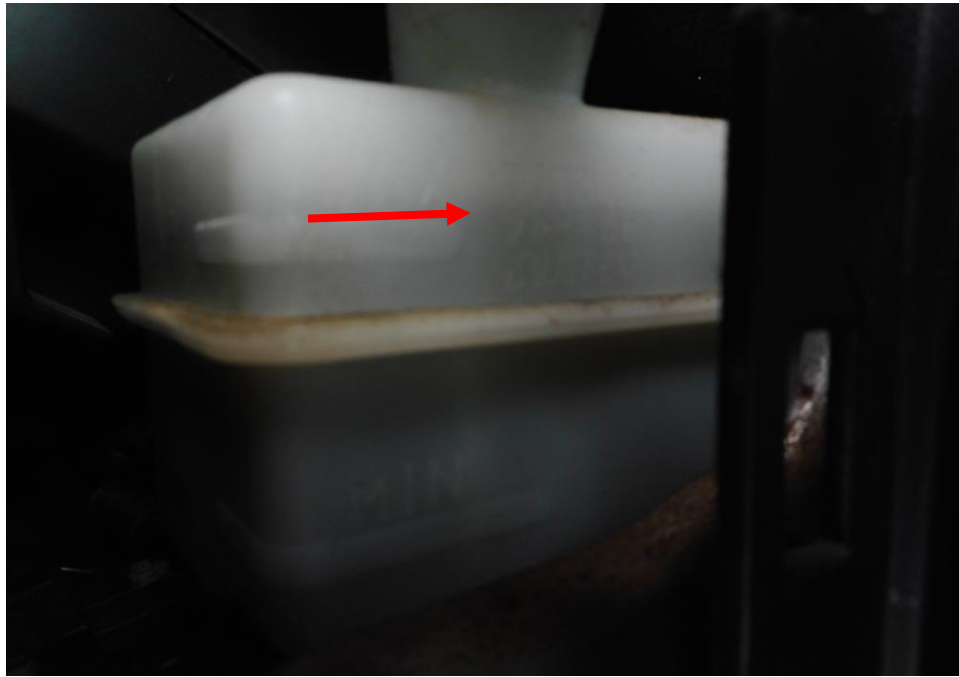
**Photo 11** shows the brake fluid reservoir of the Motor Van at the time of my inspection. The brake fluid was observed to be of sufficient level (arrowed) and without any visible contamination.

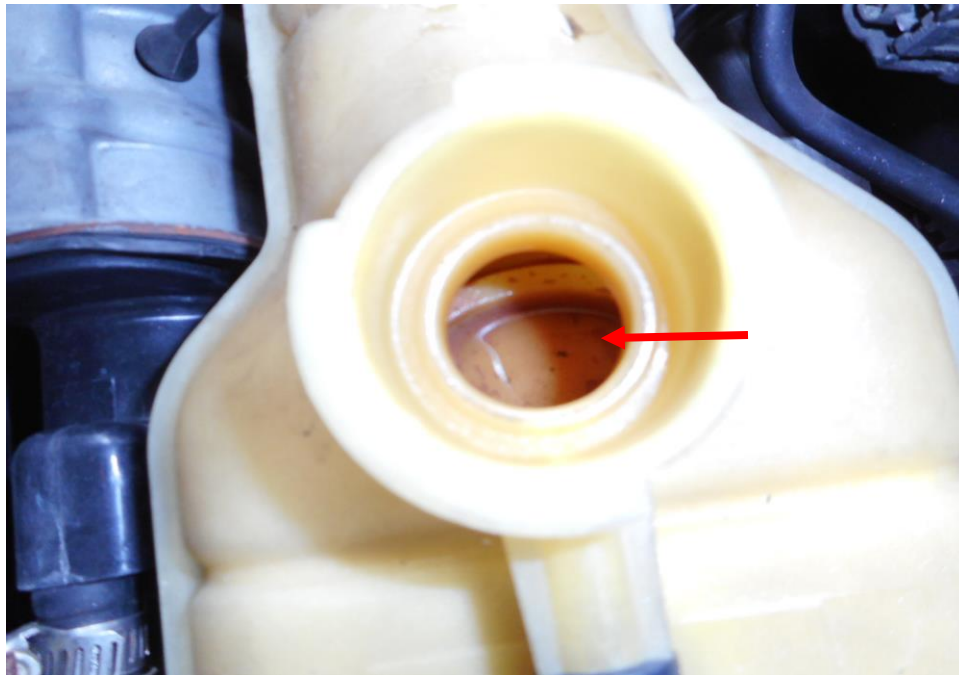
8. Upon examination of the Motor Van's engine compartment, I had observed all the parts and components inside the engine compartment to be intact and unaffected by the accident. The engine coolant was observed to be insufficient, however the brake fluid and engine oil were all found to be of sufficient level for operating purposes. Visually, there was also no contamination found to these fluids.
9. Further examination of the engine compartment revealed, there was no sign(s) or indication(s) of fresh fluid leakage and/or fluid stain within the engine compartment of the Motor Van.
10. My subsequent checks on the underside of the Motor Van also revealed no fluid stain. Visually, the various undercarriage components of the Motor Van were all observed to be intact and without any visible damage. See photo 10 – 14 below.

**Photo 12** shows the engine coolant reservoir of the Motor Van at the time of my inspection. The engine coolant was observed to be of insufficient level (arrowed).

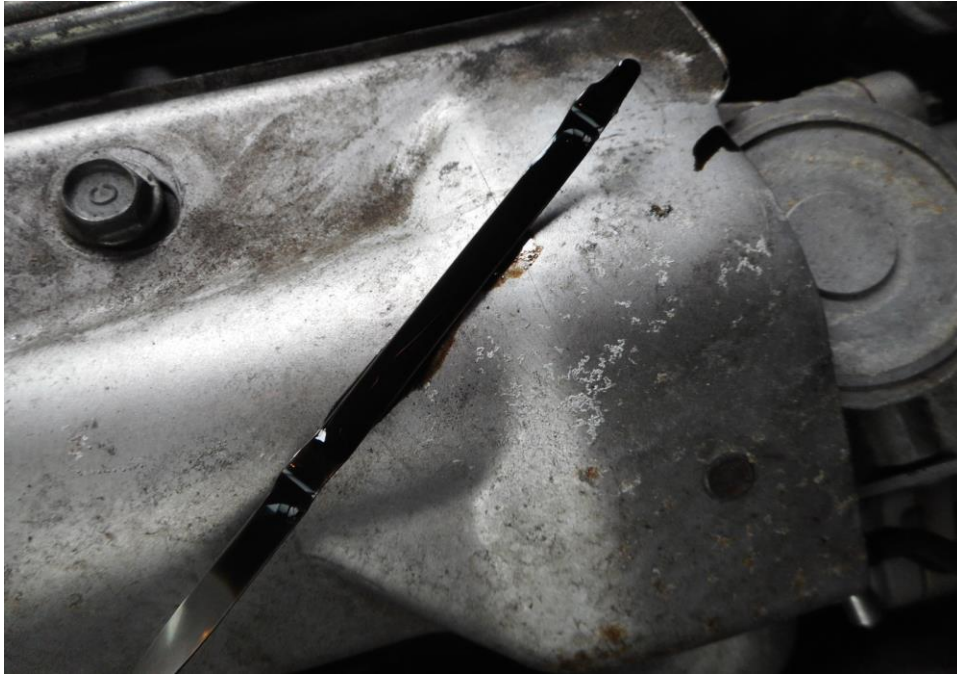
**Photo 13** shows the engine oil dip stick of the Motor Van at the time of my inspection. The engine oil was observed to be of sufficient level and without any visible contamination.

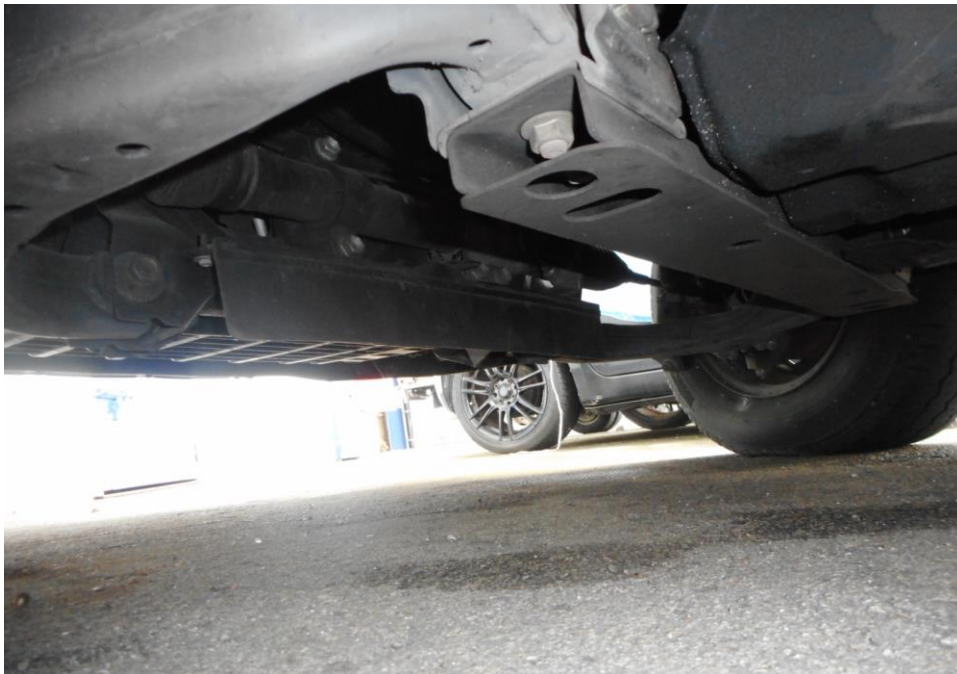
**Photo 14** shows the undercarriage of the Motor Van, at the area where the engine housing and transmission housing are located. . I did not find any sign(s) or indication(s) of fluid leak and/or fluid stain(s) on the underside of the Motor Van.

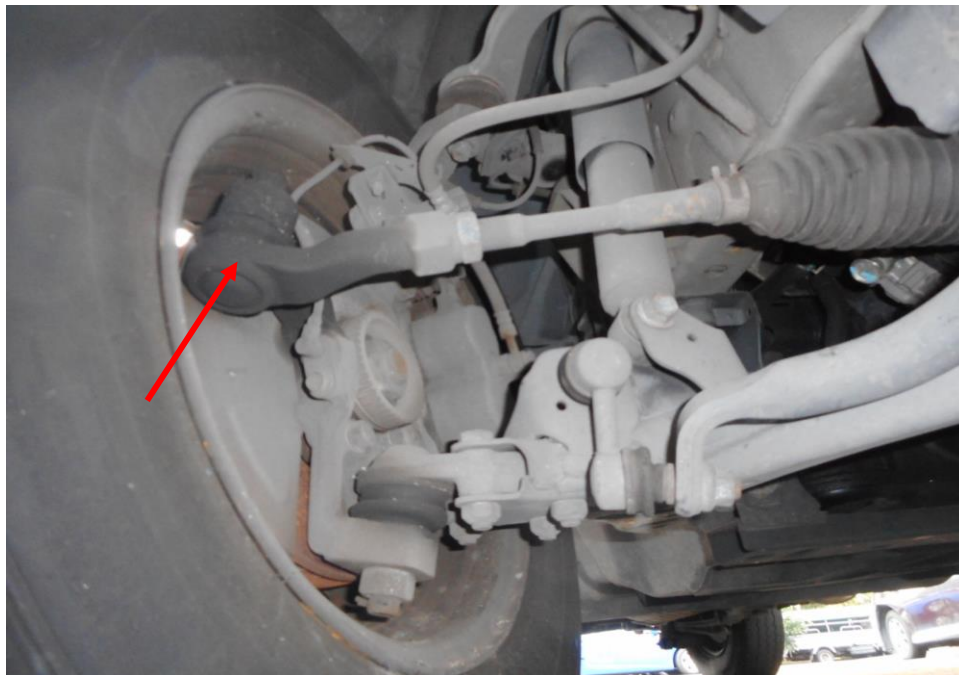
**Photo 15** shows the various undercarriage components at the front right wheel of the Motor Van, in particular the steering tie rod end (arrowed). The various steering components were all found to be intact, suggesting that the steering system of the Motor Van was likely to be in serviceable condition at the material time of accident. There was also no sign of fluid stain(s) observed on the various undercarriage components.

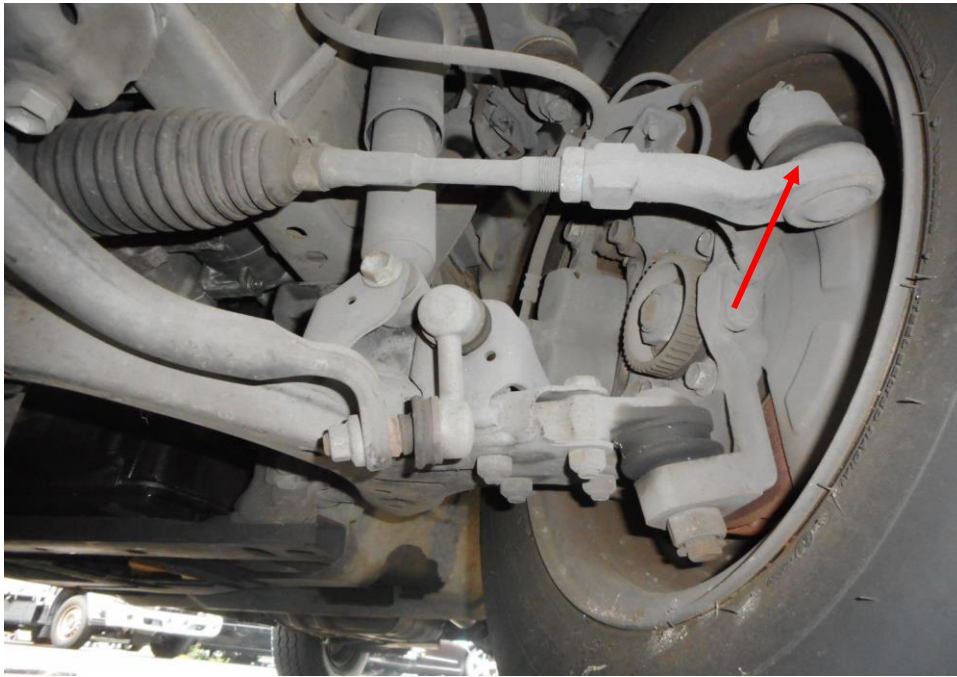
**Photo 16** shows the various undercarriage components at the front left wheel of the Motor Van, in particular the steering tie rod end (arrowed). The various undercarriage components of the Motor Van were all found to be intact without any visible damage. There was also no sign of fluid stain(s) observed on the various undercarriage components.

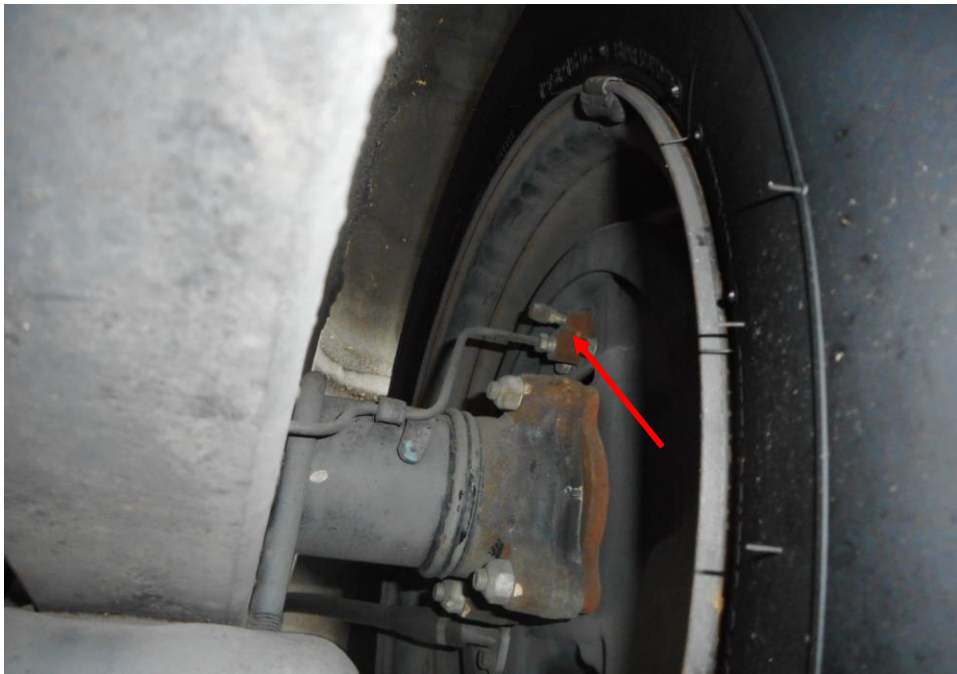
**Photo 17** shows the brake pipe (arrowed) at the rear right wheel of the Motor Van. I did not observe any leakage of brake fluid at the time of my inspection of the Motor Van. My static tests of the Motor Van's braking system, along with my visual examination of the various mechanical components in the braking system, had indicated that there was no internal leakage of pressure/vacuum. Hence the braking system of the Motor Van was likely to be in serviceable condition at the material time of accident.

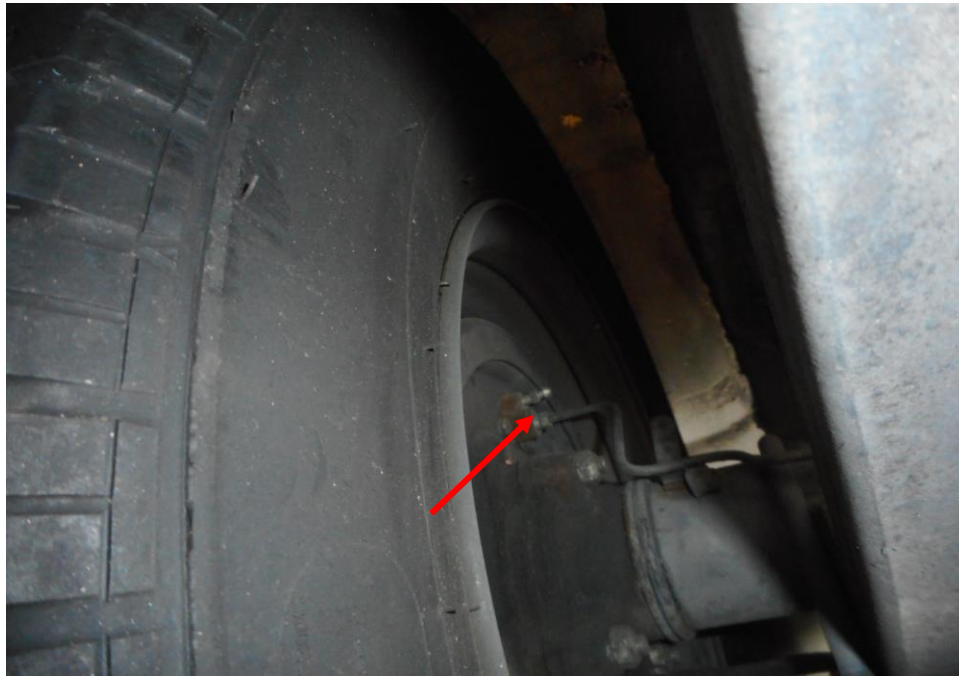
**Photo 18** shows the brake pipe (arrowed) at the rear left wheel of the Motor Van. I did not observe any leakage of brake fluid at the time of my inspection of the Motor Van. My static tests of the Motor Van's braking system, along with my visual examination of the various mechanical components in the braking system had indicated that there was no internal leakage of pressure/vacuum. Hence the braking system of the Motor Van was likely to be in serviceable condition at the material time of accident.

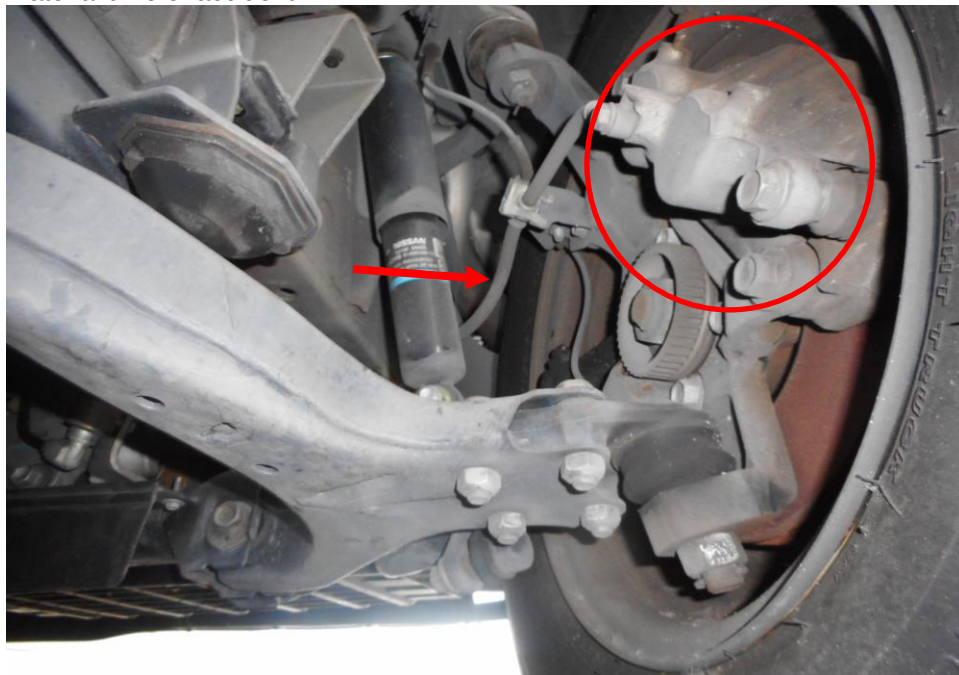
**Photo 19** shows the brake hose/pipe (arrowed) at the front right wheel of the Motor Van. No leakage of brake fluid was observed. Visual examination of the various components of the braking system like the brake caliper (circled), brake booster, brake pedal etc had revealed all to be intact and without visible damage at the time of accident. There was also no sign of fluid stain(s) observed on the various undercarriage components.

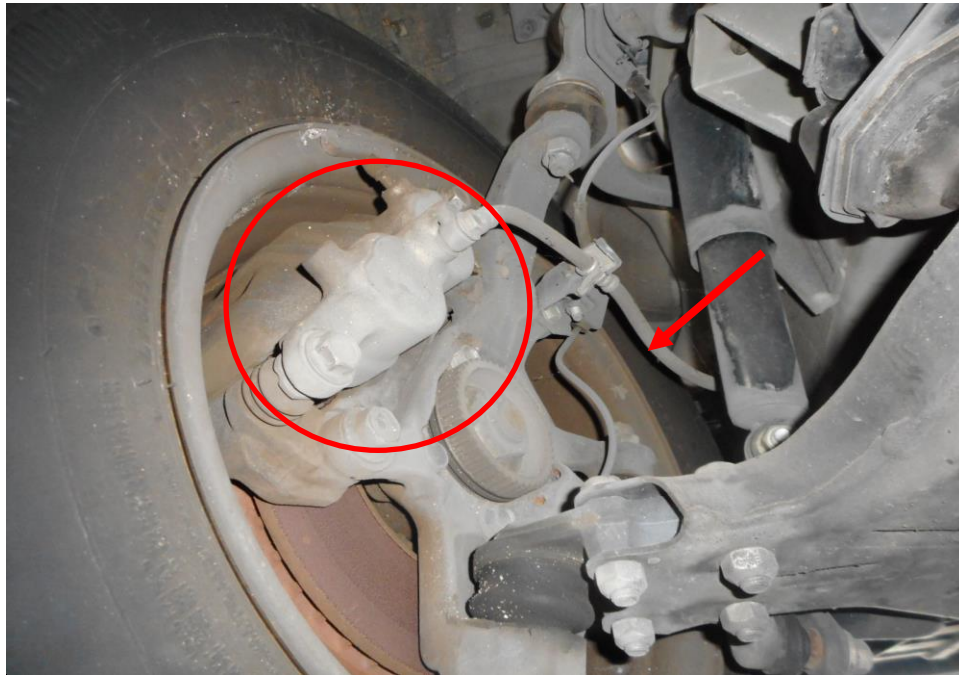
**Photo 20** shows the brake hose/pipe (arrowed) at the front left wheel of the Motor Van. No leakage of brake fluid was observed. Visual examination of the various components of the braking system like the brake caliper (circled), brake booster, brake pedal etc had revealed all to be intact and without visible damage at the time of accident. There was also no sign of fluid stain(s) observed on the various undercarriage components.

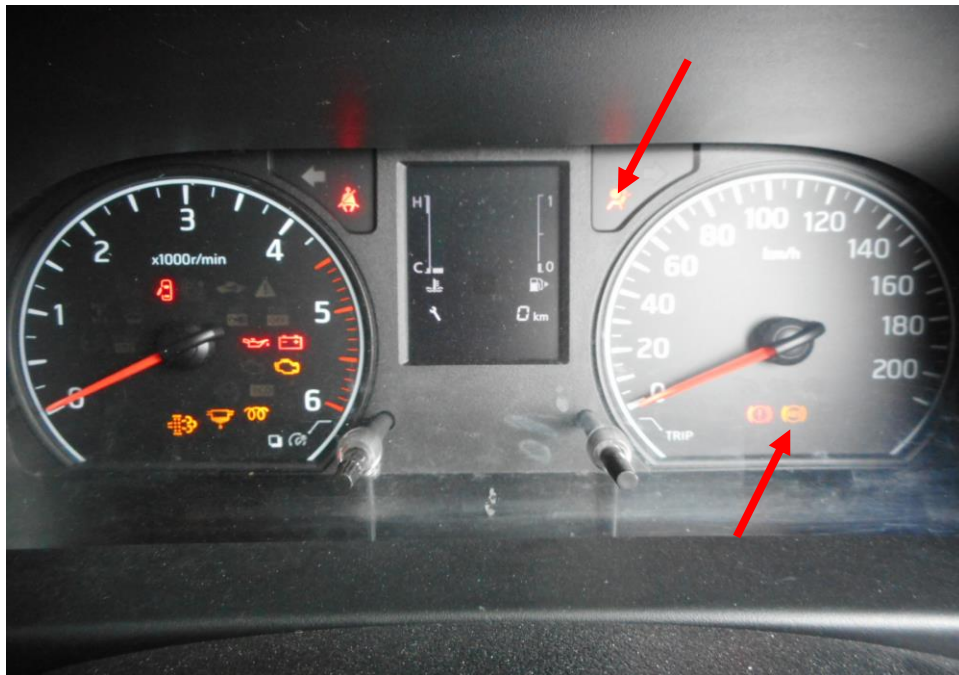
**Photo 22** shows the warning light for Anti-Lock Brake System (ABS) and Supplemental Restraint System (SRS) (arrowed) appearing on the instrument panel of the Motor Van during the self-test of its various electronic operating systems when its engine was cranked.

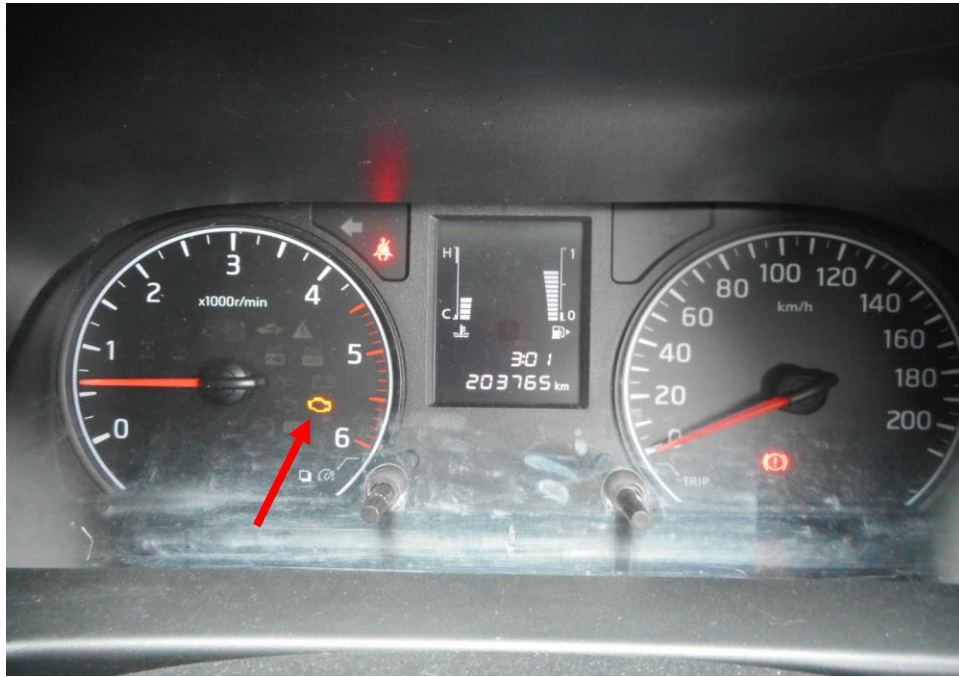
13. Motor Van's automatic self-test of the functionality of its electronic operating systems like the Anti-Lock Brake System (ABS) and Supplemental Restraint System (SRS) during cranking of the engine had indicated that the system were in working condition and without abnormality. This can be established from the warning lights disappearing from the instrument panel after the self-test. However, only the engine warning light remained illuminated as this is likely a result of the insufficient engine coolant. See photo 22 & 23 below.

**Photo 23** shows no warning lights illuminated on the instrument panel of the Motor Van after the engine was cranked. This would suggest that there was no abnormality to the electronic operating system of the Motor Van, like the ABS and SRS etc. However, only the engine warning light remained illuminated as this is a likely a result of the insufficient engine coolant (arrowed).
