Your Ref: TP/IP/36003/2020
Our Ref : CI/TPD20011144/P

General Investigation Team

MECHANICAL INSPECTION REPORT OF MOTOR VAN QX 4820X

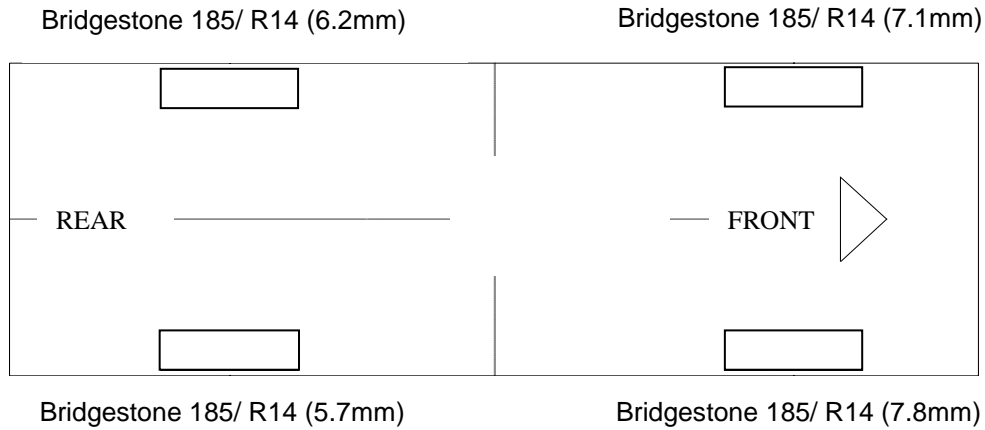
6. The 4 tyres of the Motor Van were observed to be in serviceable condition and sufficiently inflated for vehicular operation. I did not find any tear, cut or burst mark(s) on the outer and the inner sidewalls as well as across the tread of the 4 tyres. The tyre brand, tyre size and remaining tread depth of the 4 tyres of the Motor Van were recorded as follows:-

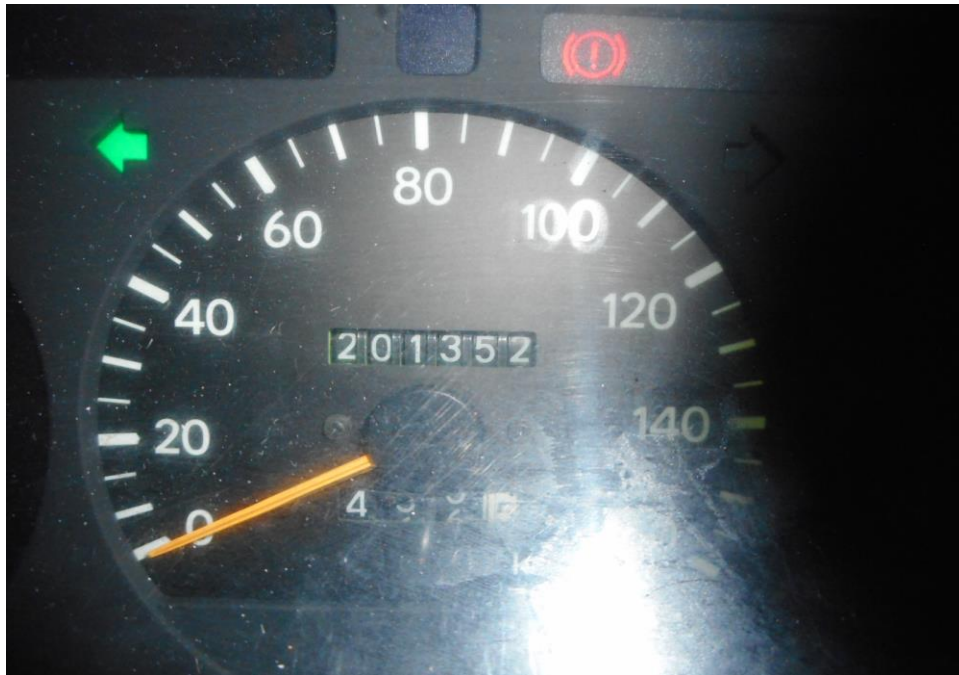
Photo 1 shows a general view of the instrument cluster of the Motor Van at the time of my inspection. The mileage of the Motor Van was 201,352km

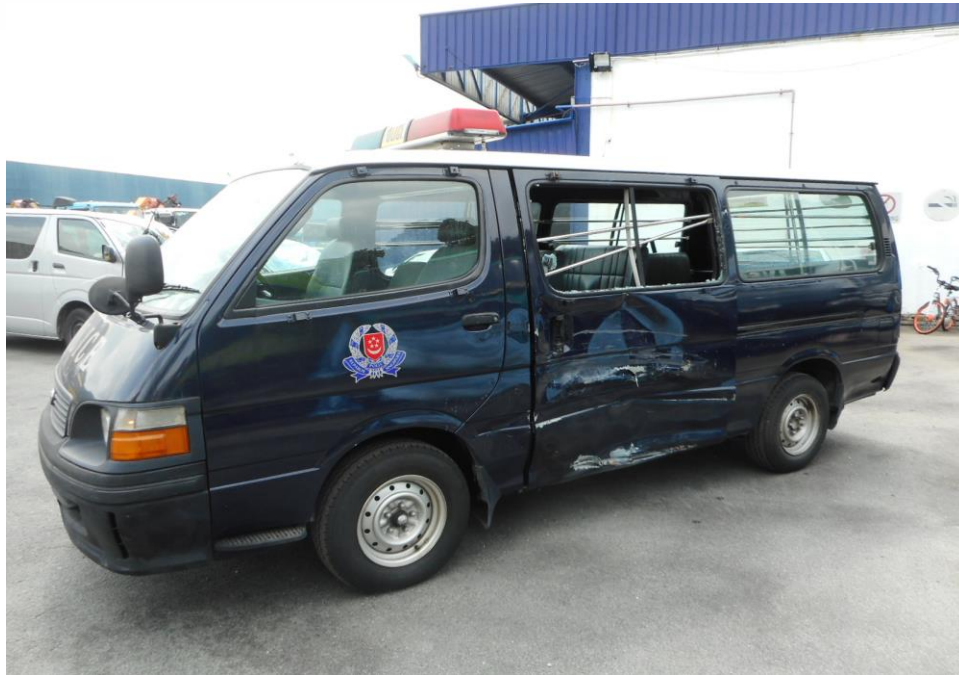
4. The mileage of the Motor Van at the time of my inspection was 201,352km.
5. The Motor Van was observed to have sustained damage at its left portion. Its left body panel were damaged as a result of the accident.

Photo 2 shows a general view of the left body of the Motor Van left portion at the time of my inspection. It appeared to have sustained damage at its left portion. Its left body panel were damaged as a result of the accident.

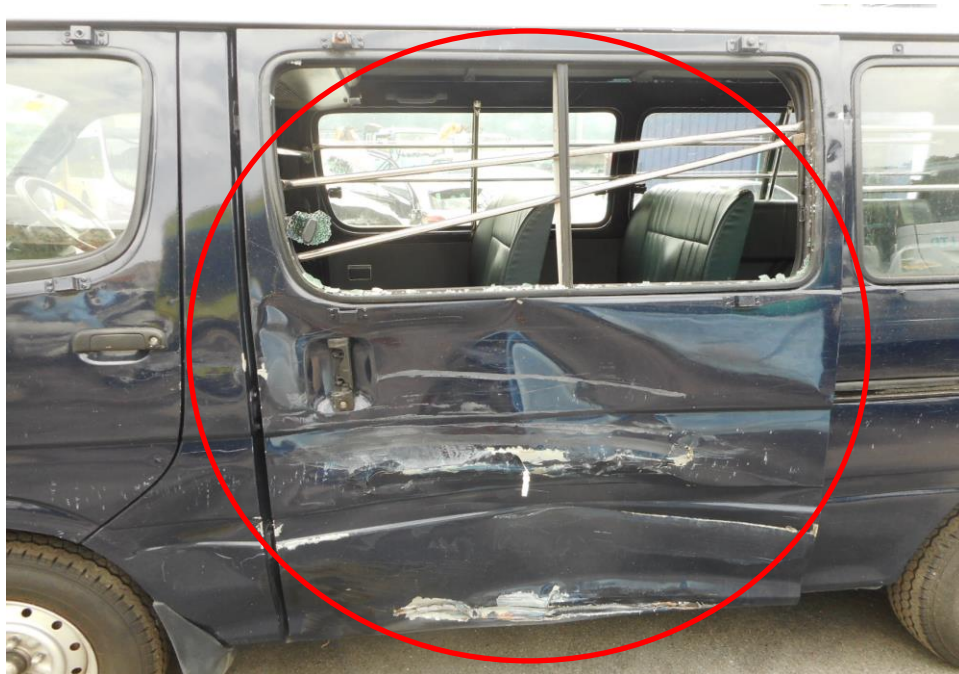
Photo 3 shows a close up view of the left body of the Motor Van left portion at the time of my inspection. It appeared to have sustained damage at its left portion. Its left body panel (circled) were damaged as a result of the accident.

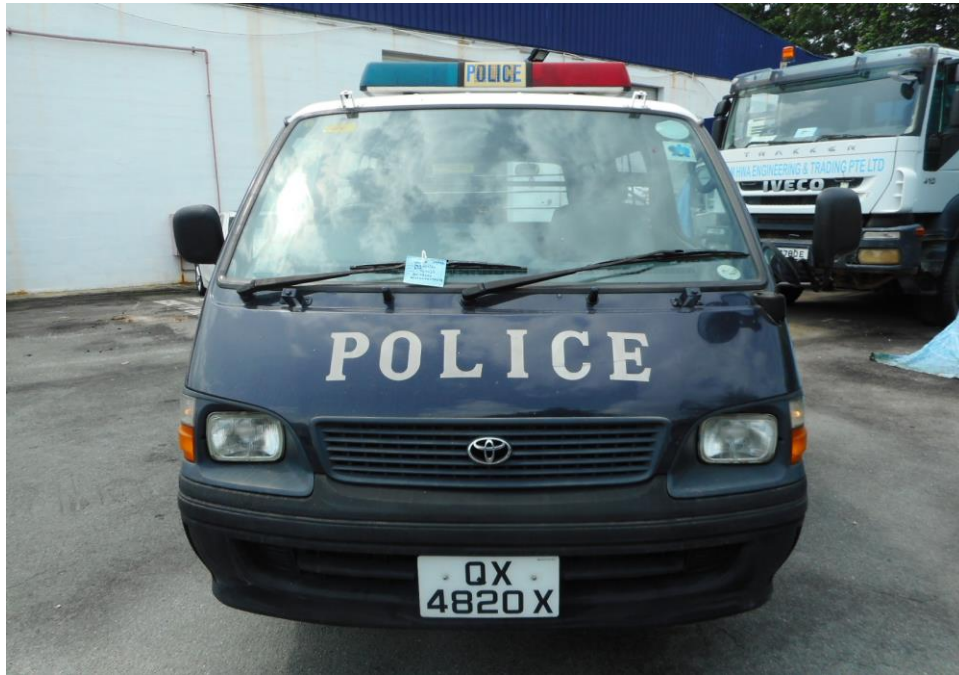
Photo 4 shows a general view of the front portion of the Motor Van at the time of my inspection. The Motor Van was observed to be intact and unaffected by the accident.

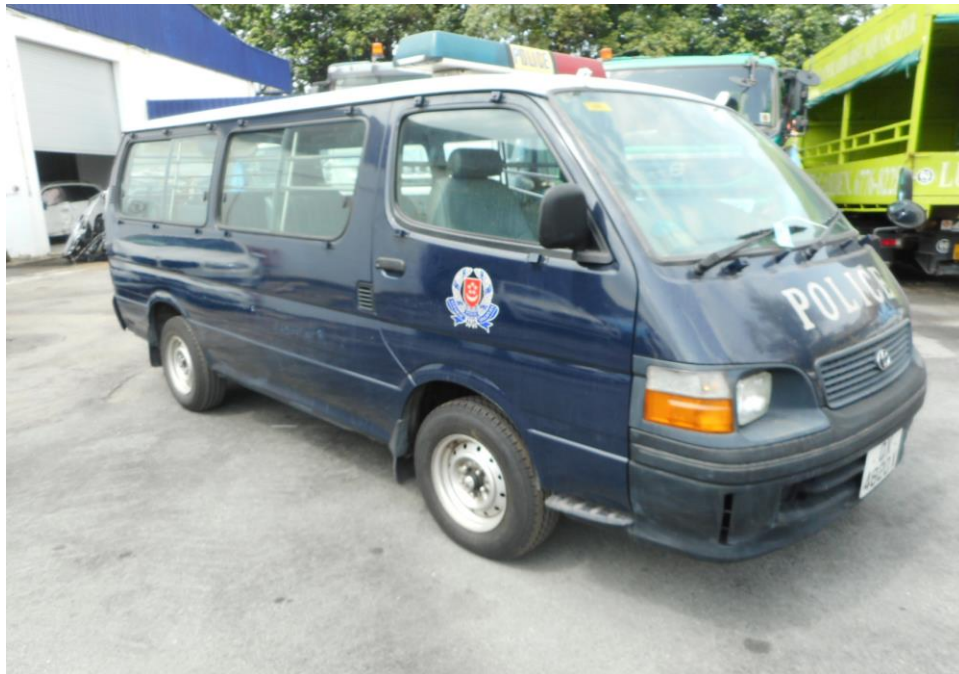
Photo 5 shows a general view of the right body of the Motor Van at the time of my inspection. The Motor Van was observed to be intact and unaffected by the accident.

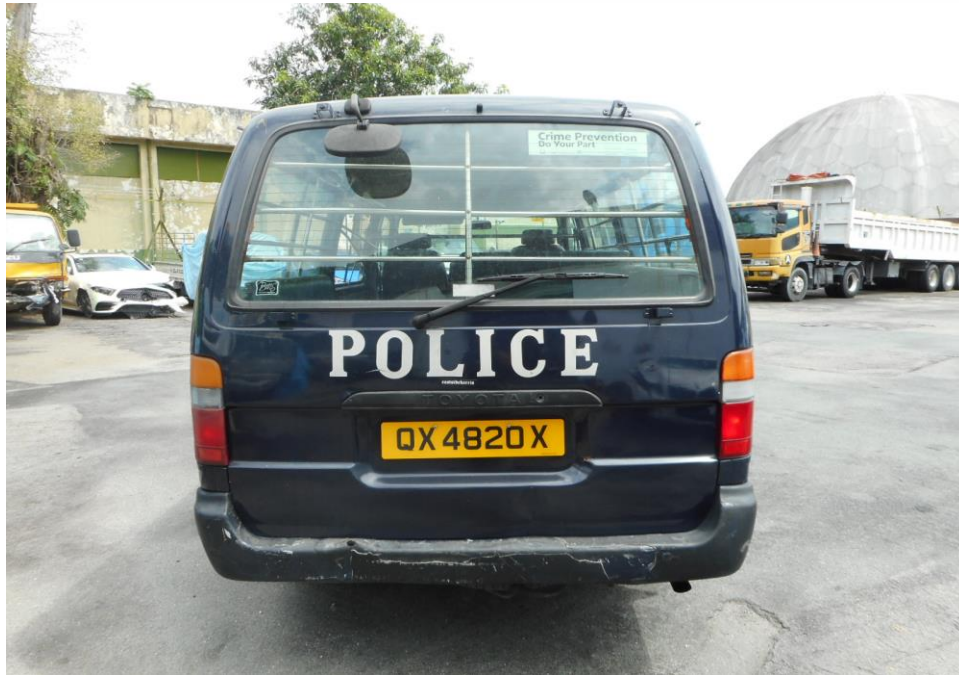
Photo 6 shows a general view of the rear body of the Motor Van at the time of my inspection. The Motor Van was observed to be intact and unaffected by the accident.

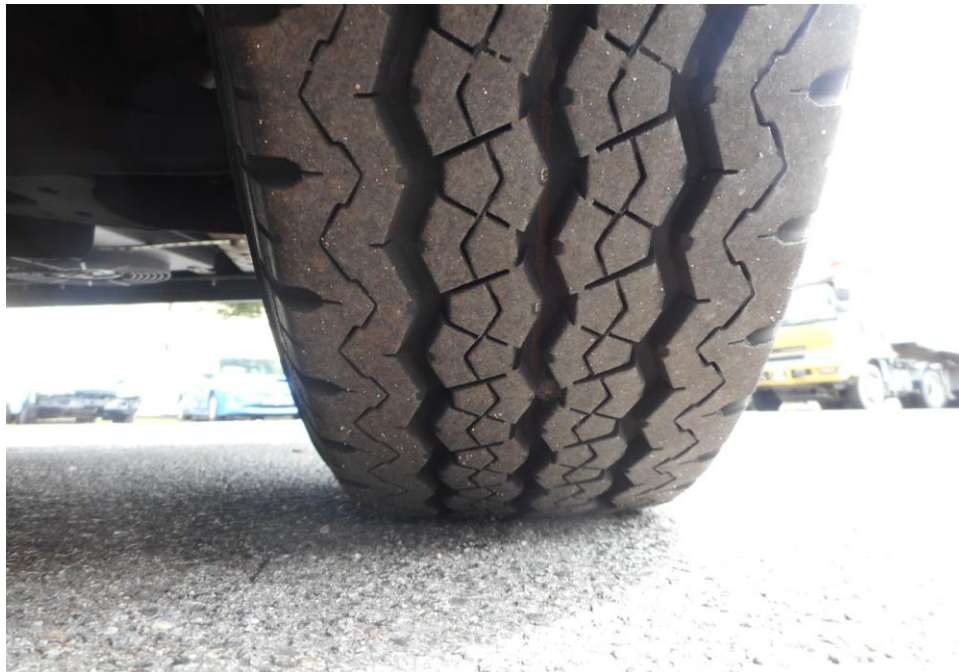
Photo 7 shows the condition of the front right tyre of the Motor Van, which was observed to be in serviceable condition with remaining tread depth of approximately 7.8mm. The tyre, which was wrapped around standard steel wheel rim, was also observed to be sufficiently inflated for vehicular operation. There was no tear, cut or burst mark(s) on the outer and the inner sidewalls as well as across the tread of the 4 tyres that were fitted on the Motor Van.

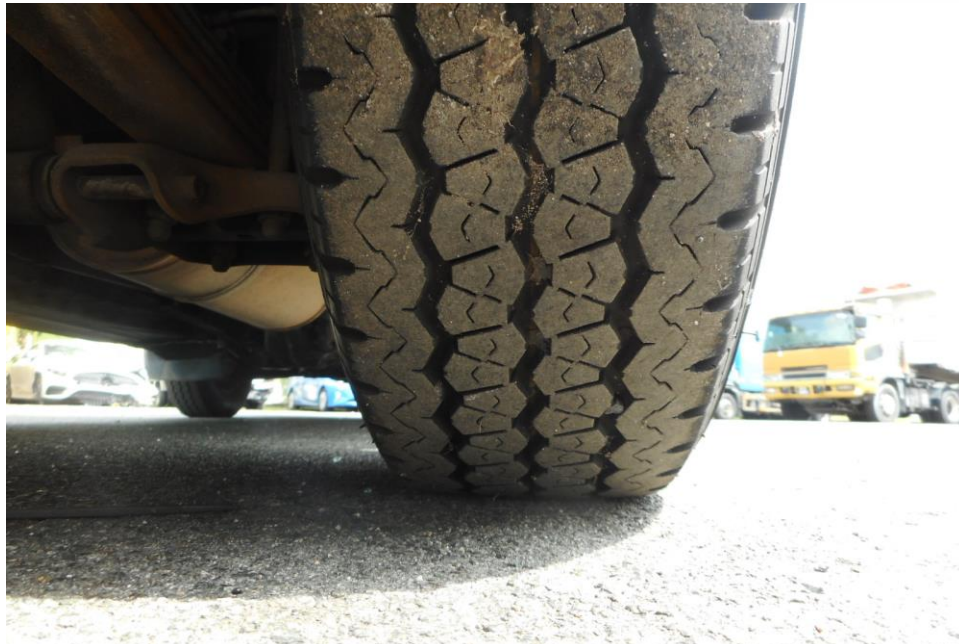
Photo 8 shows the condition of the rear right tyre of the Motor Van, which was observed to be in serviceable condition with remaining tread depth of approximately 5.7mm. The tyre, which was wrapped around standard steel wheel rim, it was observed to be sufficiently inflated for vehicular operation.

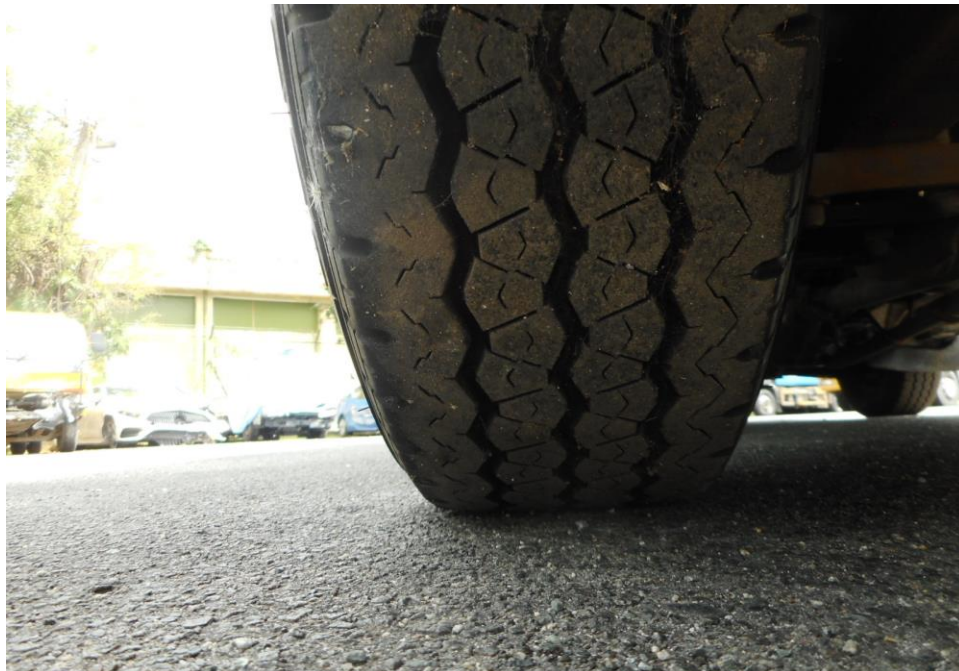
Photo 9 shows the condition of the rear left tyres of the Motor Van, which was observed to be in serviceable condition with remaining tread depth of approximately 6.2mm. The tyres, which were wrapped around standard steel wheel rim, were also observed to be sufficiently inflated for vehicular operation. There was also no damage found on all 4 steel wheel rims of the Motor Van.

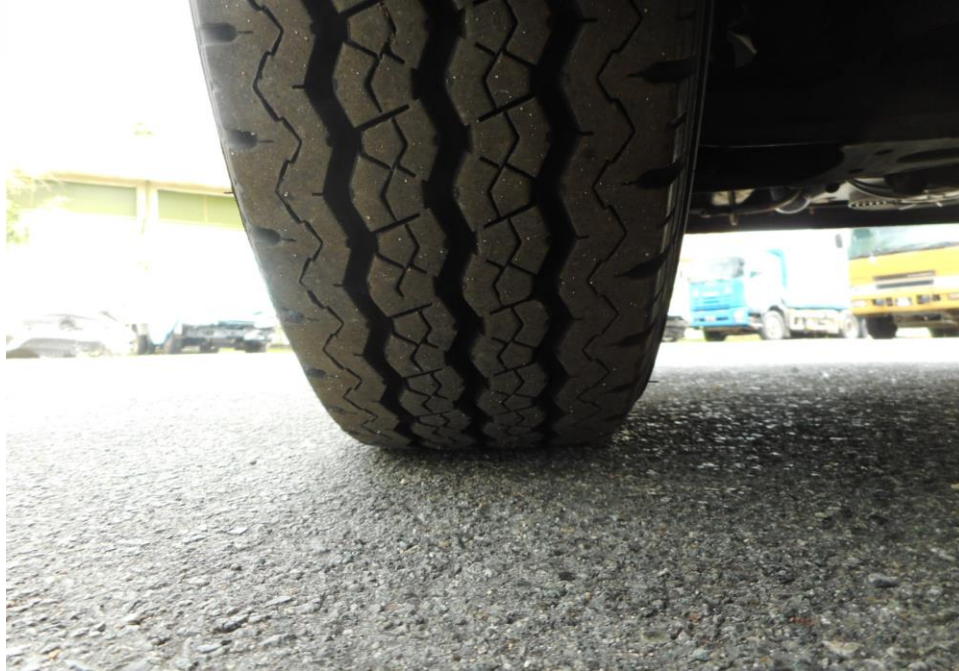
Photo 10 shows the condition of the rear right tyres of the Motor Van, which were observed to be in serviceable condition with remaining, tread depth of approximately 7.1mm. There was also no tear, cut or burst mark(s) on the outer and the inner sidewalls as well as across the tread of the 4 tyres that were fitted on the Motor Van.

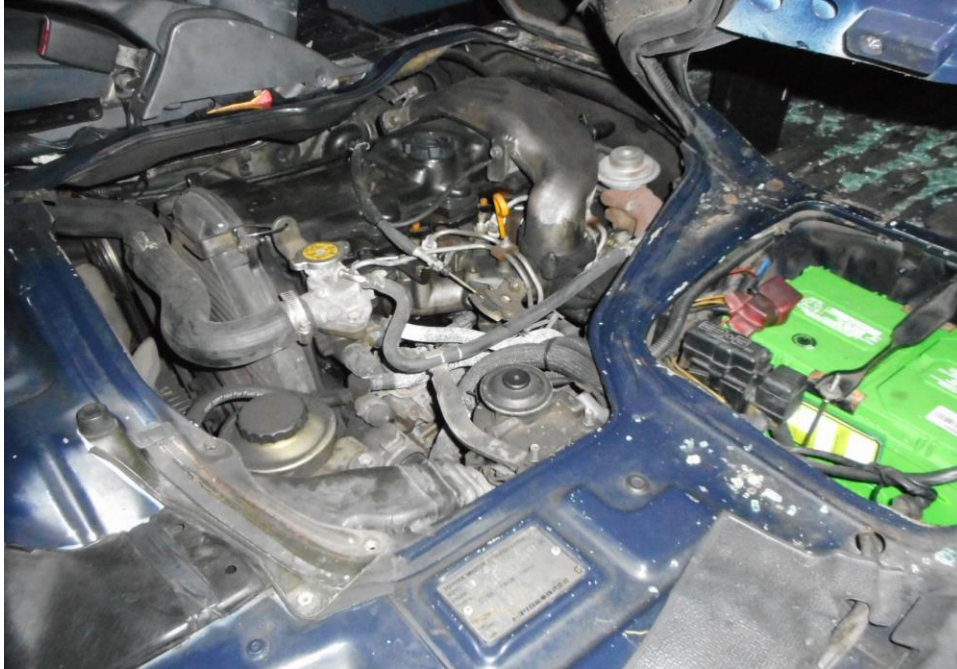
Photo 11 shows a general view of the Motor Van's engine compartment, which was accessed by lifting the front cabin of the Motor Van. The various parts and components inside the engine compartment were unaffected by the accident. There was also no sign(s) or indication(s) of fresh fluid leakage and/or fluid stain within the engine compartment

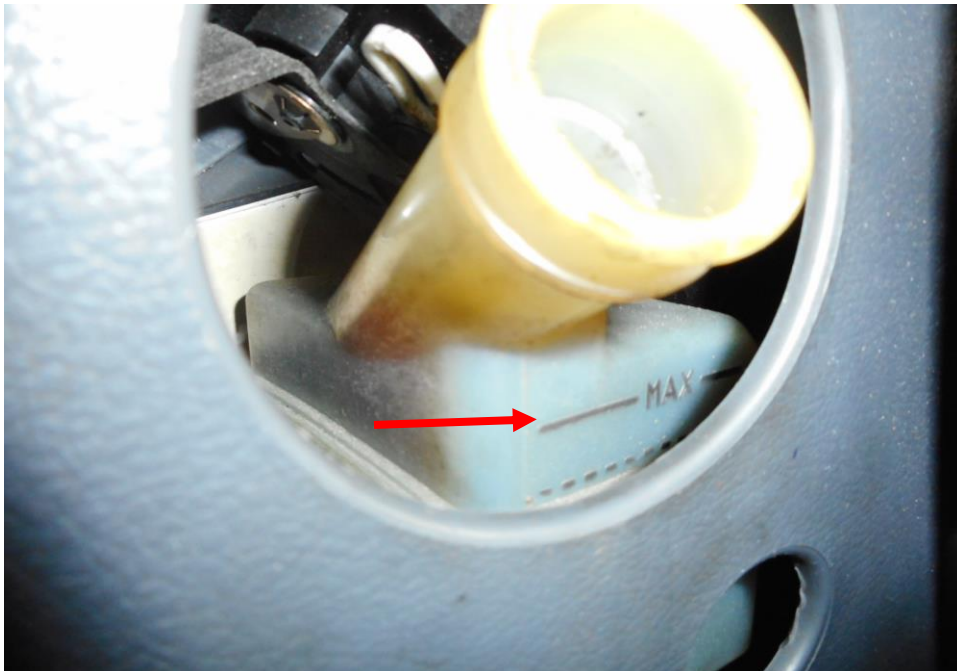
Photo 12 shows the brake fluid reservoir of the Motor Van at the time of my inspection. The brake fluid was observed to be of sufficient level (arrowed) and without any visible contamination.

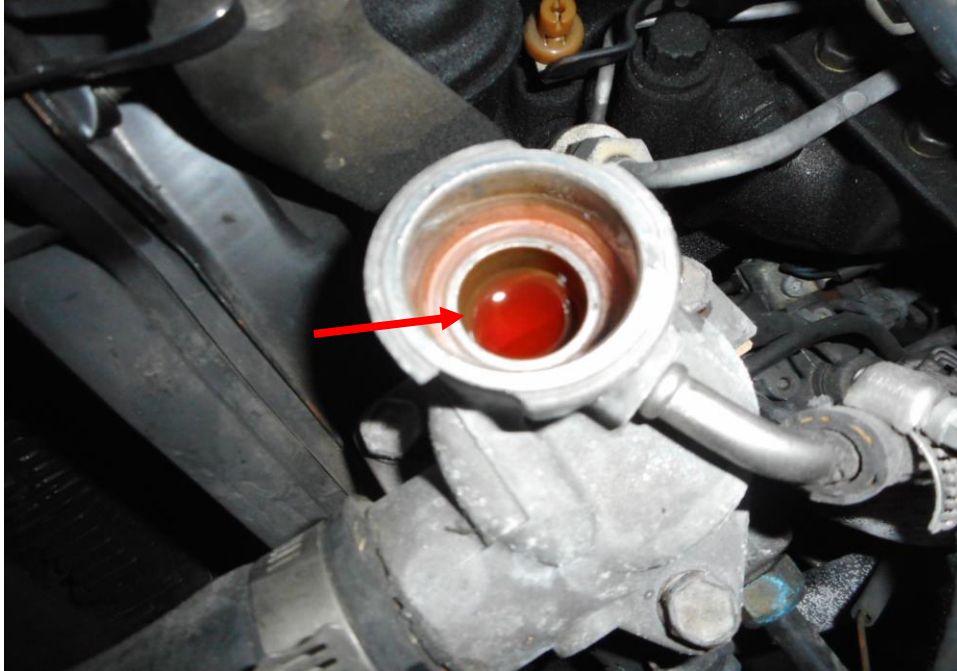
Photo 13 shows the engine coolant reservoir of the Motor Van at the time of my inspection. The engine coolant was observed to be of insufficient level (arrowed).

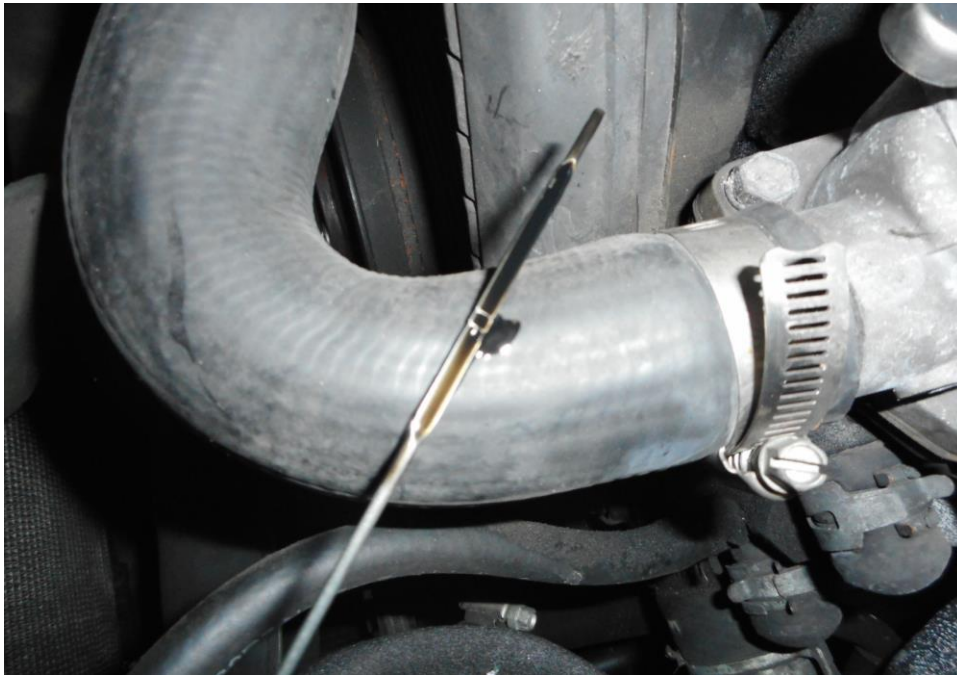
Photo 14 shows the engine oil dip stick of the Motor Van at the time of my inspection. The engine oil was observed to be of sufficient level and without any visible contamination.

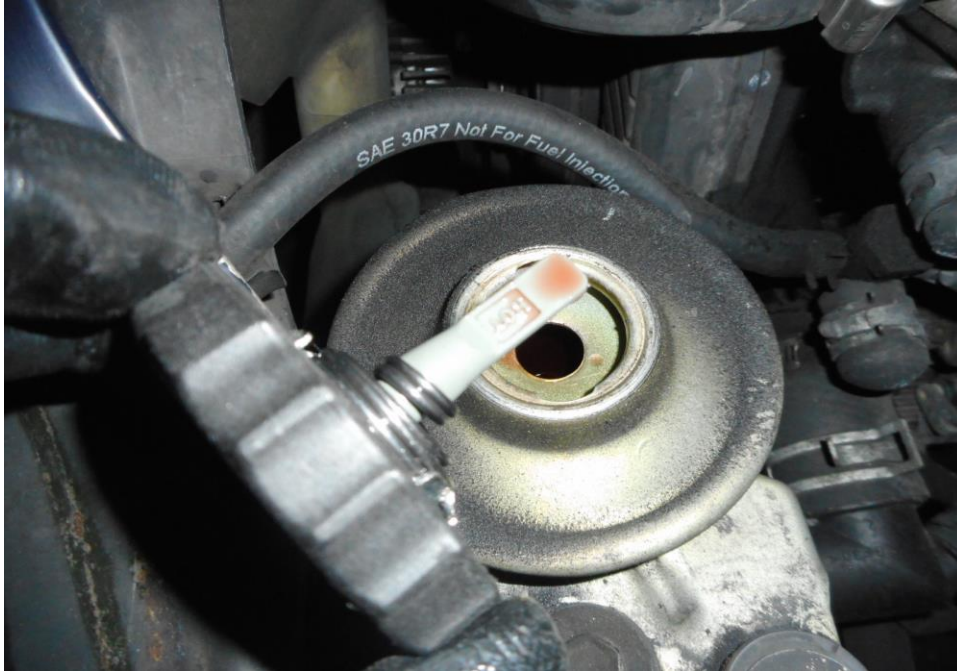
Photo 15 shows the power steering fluid dip stick of the Motor Van at the time of my inspection. The power steering fluid was observed to be of sufficient level and without any visible contamination.

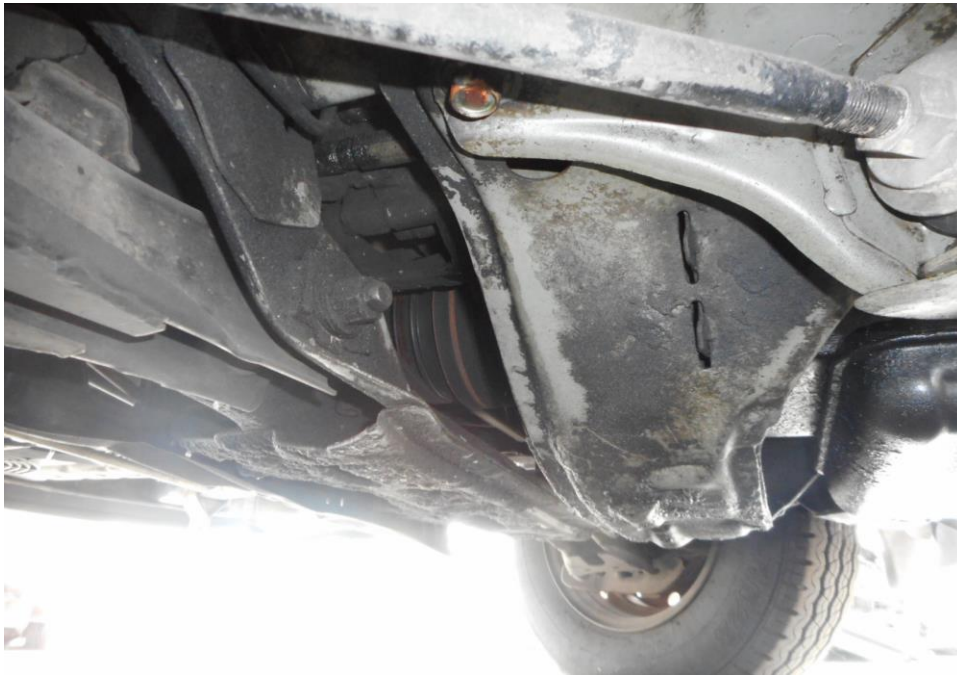
Photo 16 shows the undercarriage of the Motor Van, at the area where the engine housing and transmission housing are located. . I did not find any sign(s) or indication(s) of fluid leak and/or fluid stain(s) on the underside of the Motor Van.

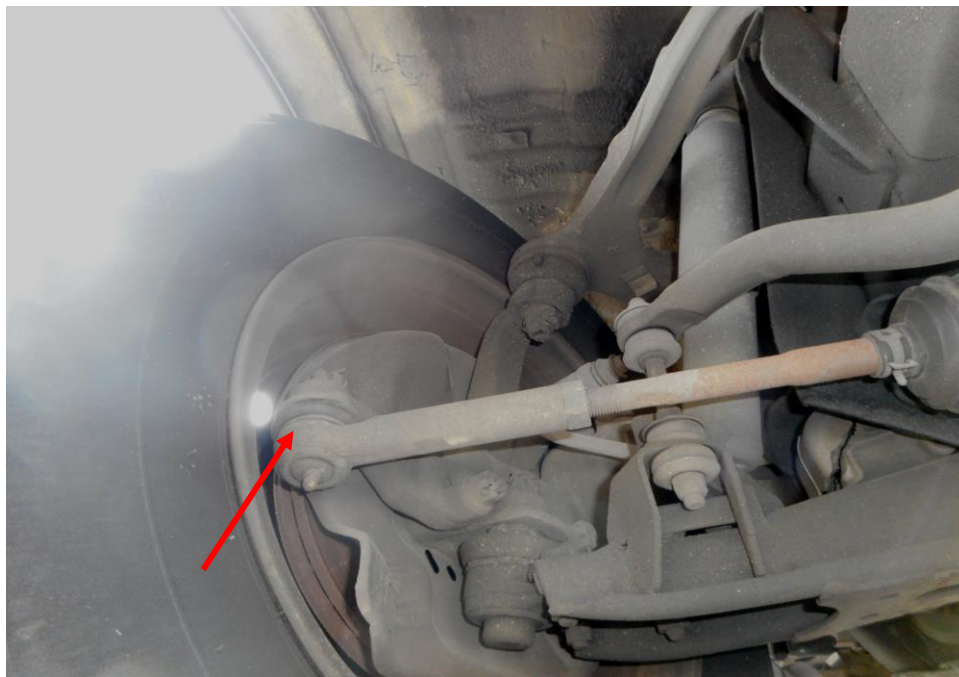
Photo 17 shows the various undercarriage components at the front right wheel of the Motor Van, in particular the steering tie rod end (arrowed). The various steering components were all found to be intact, suggesting that the steering system of the Motor Van was likely to be in serviceable condition at the material time of accident. There was also no sign of fluid stain(s) observed on the various undercarriage components.

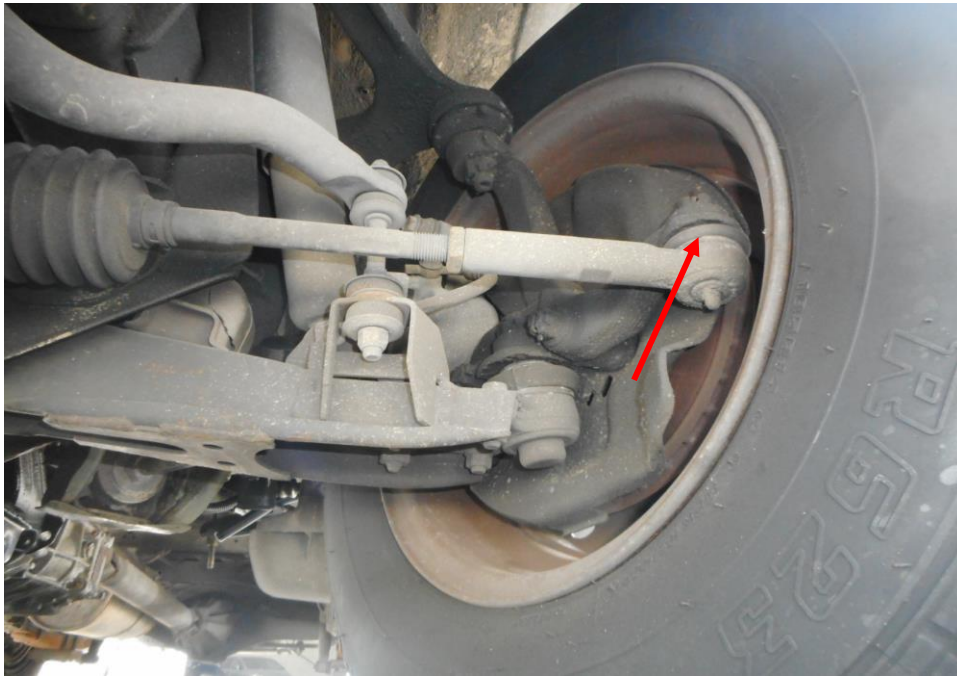
Photo 18 shows the various undercarriage components at the front left wheel of the Motor Van, in particular the steering tie rod end (arrowed). The various undercarriage components of the Motor Van were all found to be intact without any visible damage. There was also no sign of fluid stain(s) observed on the various undercarriage components.

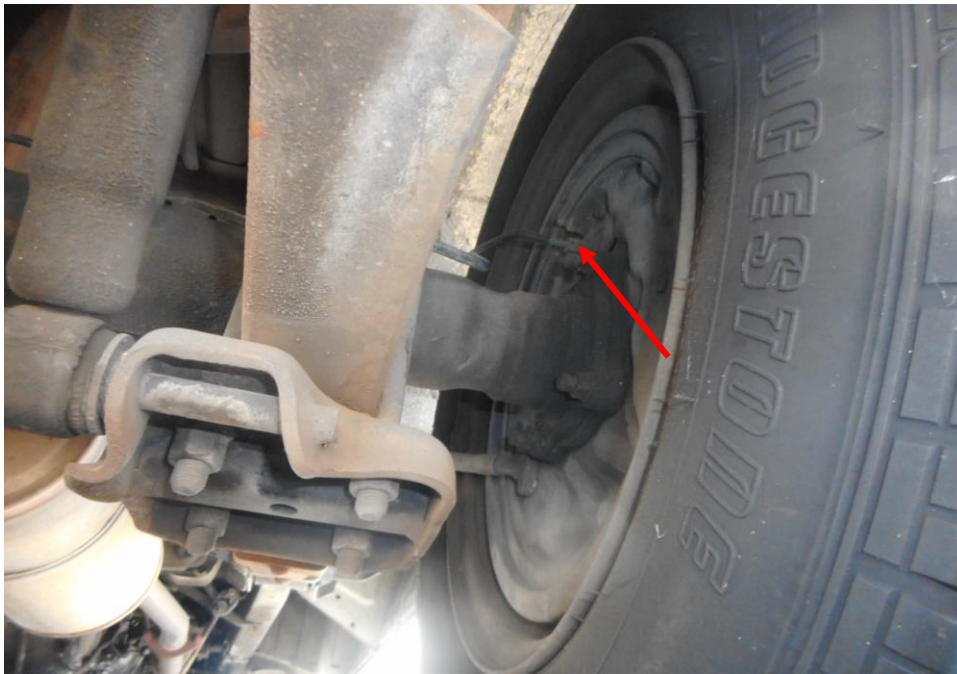
Photo 19 shows the brake pipe (arrowed) at the rear right wheel of the Motor Van. I did not observe any leakage of brake fluid at the time of my inspection of the Motor Van. My static tests of the Motor Van's braking system, along with my visual examination of the various mechanical components in the braking system, had indicated that there was no internal leakage of pressure/vacuum. Hence the braking system of the Motor Van was likely to be in serviceable condition at the material time of accident.

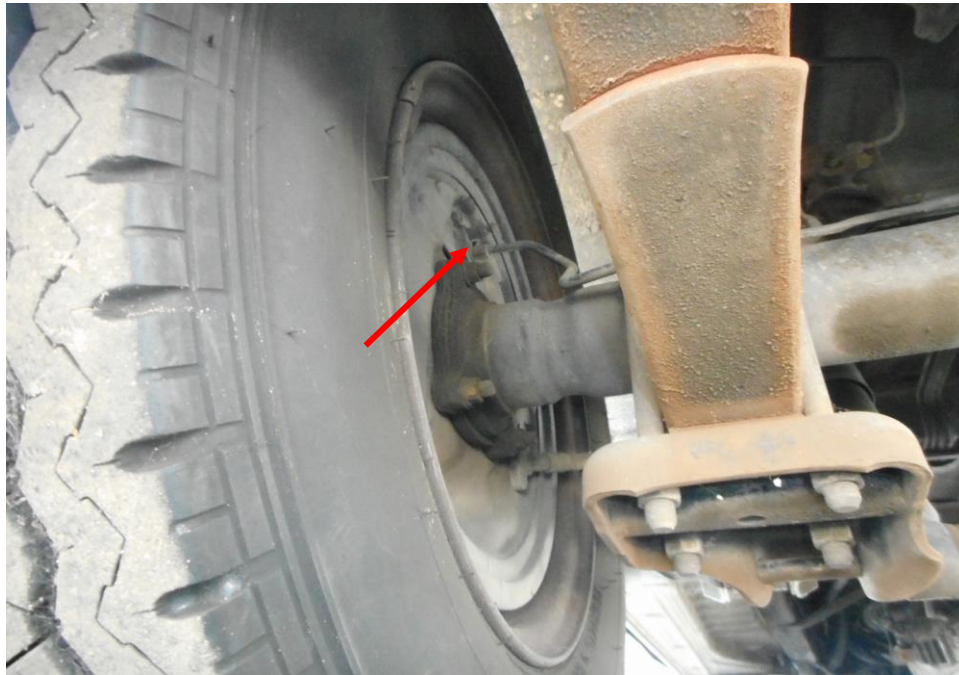
Photo 20 shows the brake pipe (arrowed) at the rear left wheel of the Motor Van. I did not observe any leakage of brake fluid at the time of my inspection of the Motor Van. My static tests of the Motor Van's braking system, along with my visual examination of the various mechanical components in the braking system had indicated that there was no internal leakage of pressure/vacuum. Hence the braking system of the Motor Van was likely to be in serviceable condition at the material time of accident.

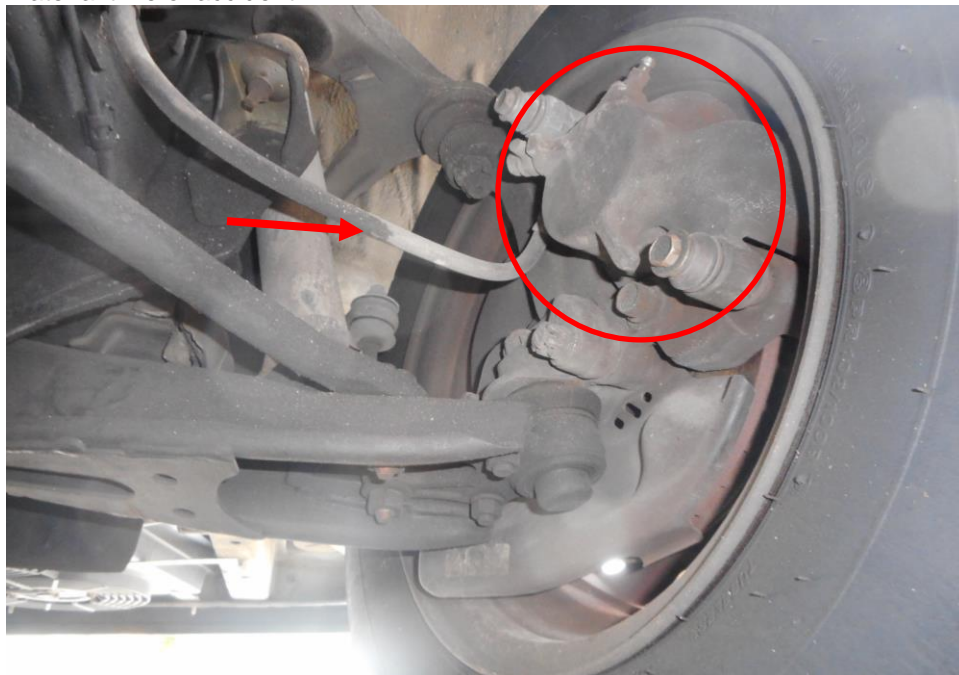
Photo 21 shows the brake hose/pipe (arrowed) at the front right wheel of the Motor Van. No leakage of brake fluid was observed. Visual examination of the various components of the braking system like the brake caliper (circled), brake booster, brake pedal etc had revealed all to be intact and without visible damage at the time of accident. There was also no sign of fluid stain(s) observed on the various undercarriage components.

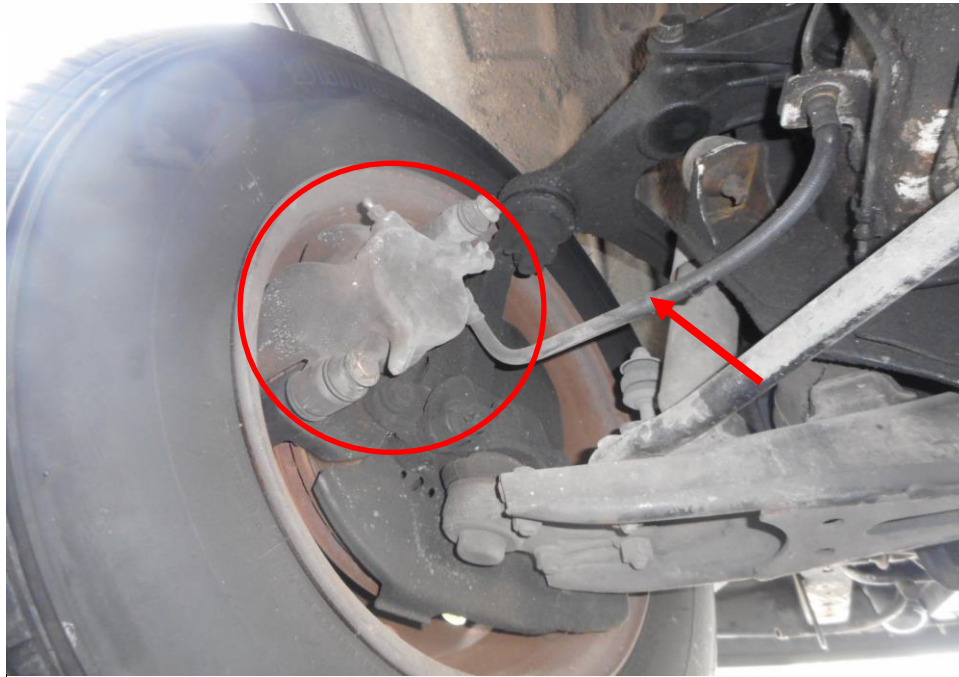
Photo 22 shows the brake hose/pipe (arrowed) at the front left wheel of the Motor Van. No leakage of brake fluid was observed. Visual examination of the various components of the braking system like the brake caliper (circled), brake booster, brake pedal etc had revealed all to be intact and without visible damage at the time of accident. There was also no sign of fluid stain(s) observed on the various undercarriage components.

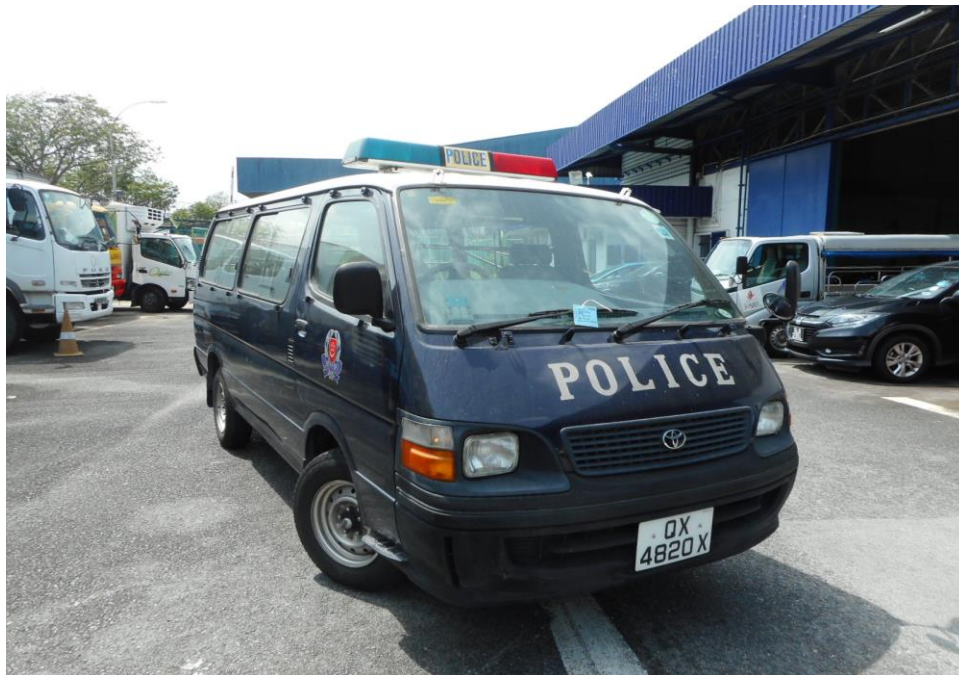
Photo 23 shows the front right wheel of the Motor Van turned to its full left. During my steering system test, I did not experience any abnormal free play and/or resistance when I had turned the steering wheel towards full left and full right. This would suggest that the steering system of the Motor Van was likely to be in serviceable condition at the material time of accident.
