Your Ref: Mercedes Benz E450 Coupe  
(chassis number WDD2383682F078082)

Our Ref : CI/TP20011145/D

**Focus Auto Pte Ltd**

**INSPECTION REPORT OF AN UNREGISTERD MERCEDES BENZ E450  
COUPE MOTOR CAR WITH CHASSIS NUMBER WDD2383682F078082**

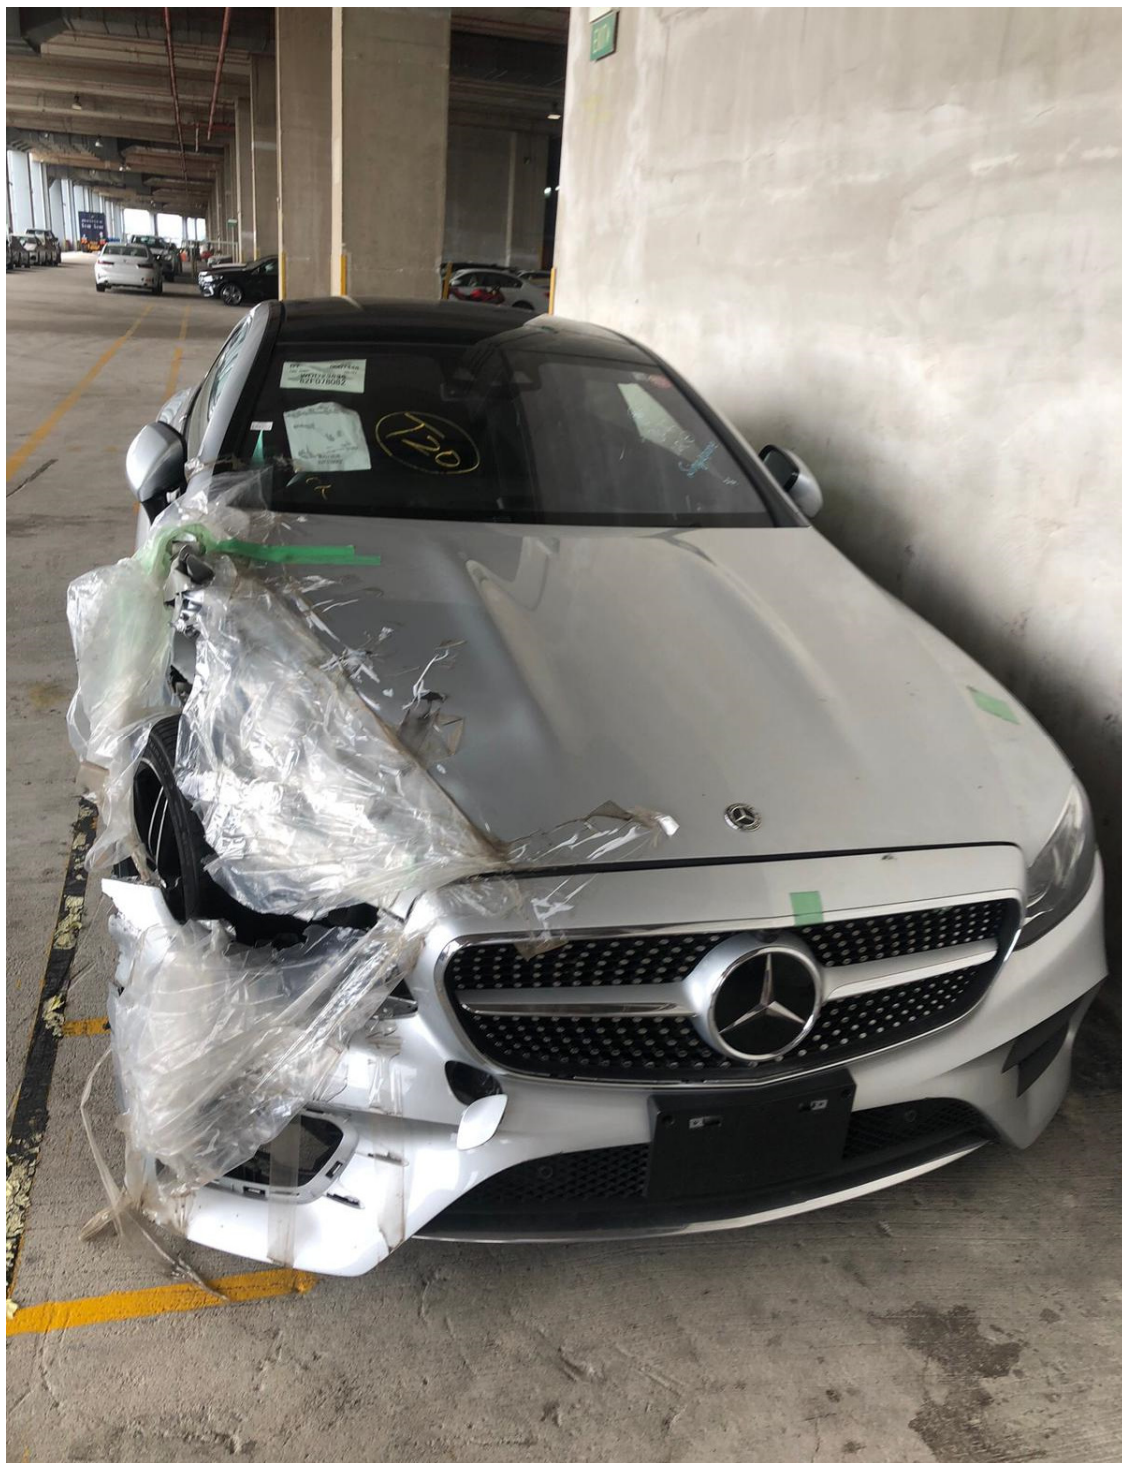
3. From the photographs provided to me, it was observed that the Motor Car had sustained damages at its front right portion. Body parts damaged include the front bumper, front bumper lower right grille, front right headlamp, front bonnet, front right fender, front right fender inner panel, front right door, right side rocker panel garnish, and front right wheel rim amongst others. The right side curtain airbag was also observed to be activated.
4. Parts and components within the engine compartment were observed to be unaffected as seen from the photographs that were provided to me. See photo 1 – 3 below.

**Photo 1** shows the front right body of the Motor Car prior to any repairs being carried out (photograph provided to me). The Motor Car was observed to have sustained damages at its front right portion. The body parts observed to be damaged had include its front bumper, front bumper lower right grille, front right headlamp, front bonnet and front right fender amongst others.

22. The body parts at the front right portion of the Motor Car were visually examined and it was noted that the repair/restoration works carried out to the damaged area of the Motor Car (refer photograph 1 & 2 above) were reasonably adequate and in order.

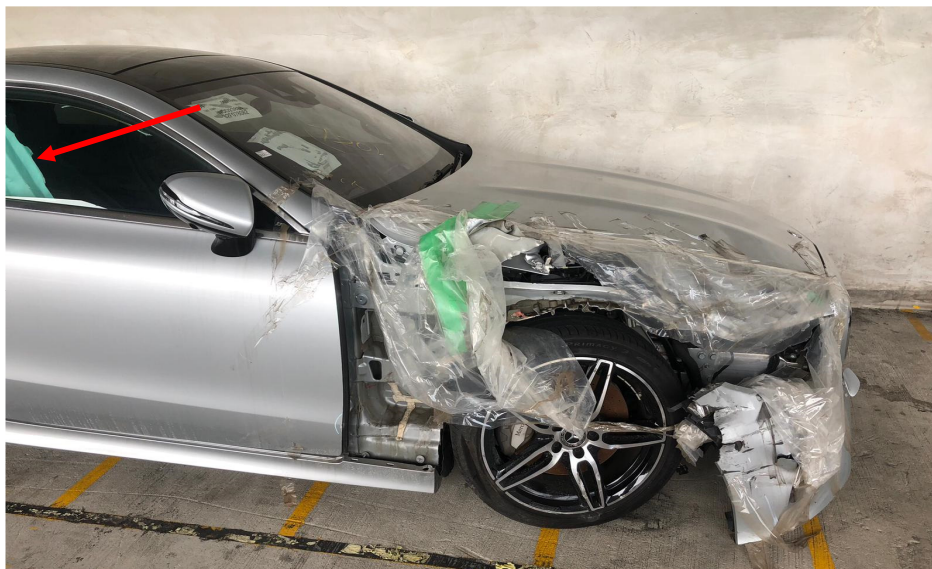
**Photo 2** shows the right front portion of the Motor Car prior to any repairs being carried out (photograph provided to me). The front right fender, front right fender inner panel, front right door and right side rocker panel garnish were observed to be damaged. The right side curtain airbag (arrowed) was also observed to be activated.

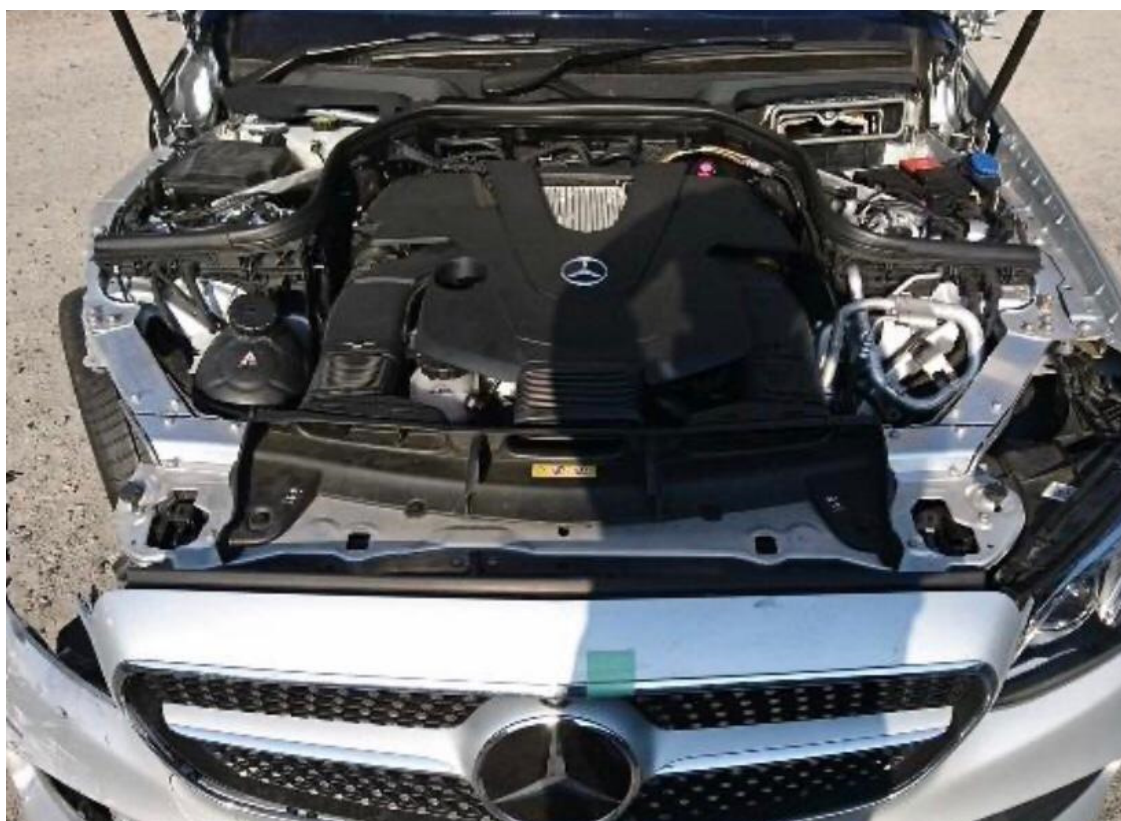
**Photo 3** shows the engine compartment of the Motor Car prior to any repairs being carried out (photograph provided to me). Parts and components within the engine compartment were observed to be unaffected.

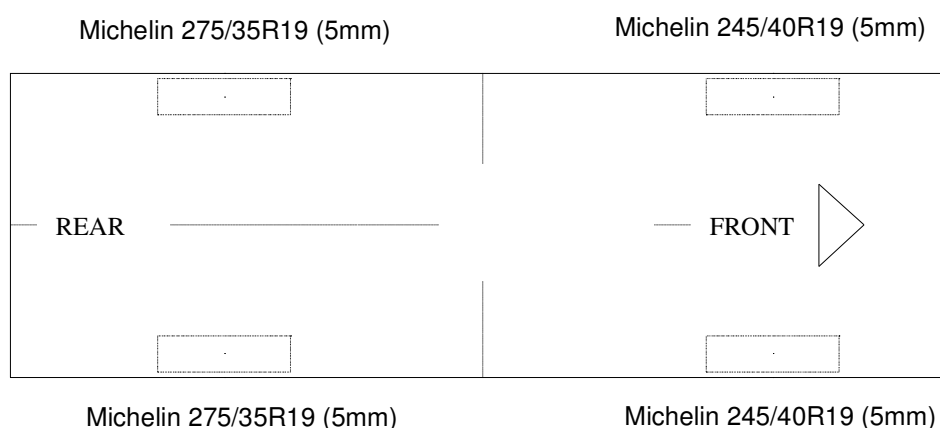
8. It was fitted with 19inch sport wheel rims that were wrapped with tyres that were observed to be of serviceable condition. The tyres were also sufficiently inflated for vehicular operation. The tyre brand, tyre size and approximate remaining tread depth of the 4 tyres of the Motor Car were recorded as follows: -

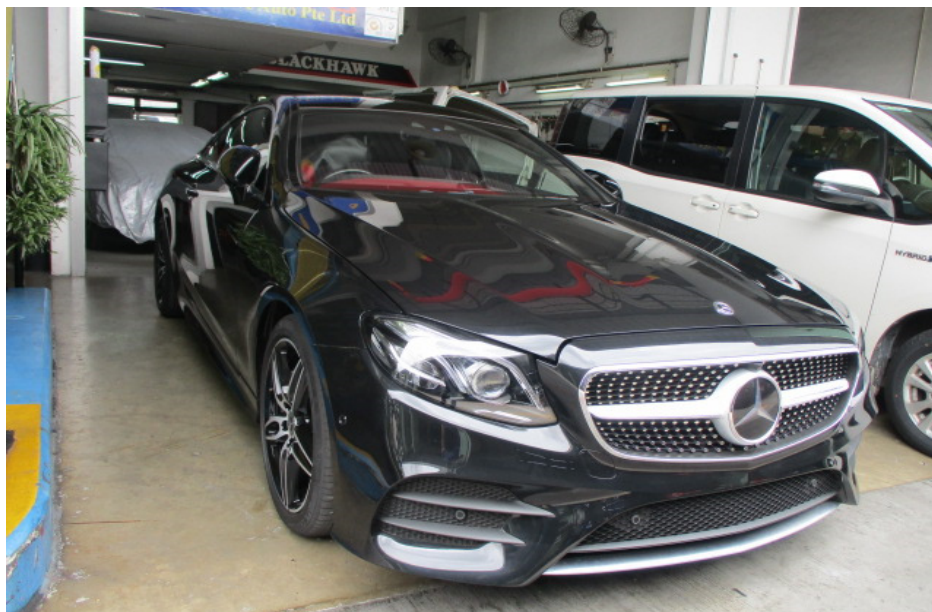
**Photo 4** shows a general view of the front right body of the Motor Car at the time of my inspection. The Motor Car was observed to be in a relatively good general condition with no loose exterior fittings observed. The body parts at the front right portion of the Motor Car were visually examined and it was observed that the repair/restoration works carried out to the damaged area of the Motor Car (refer to photograph 1 & 2 above) were reasonably adequate and in order.

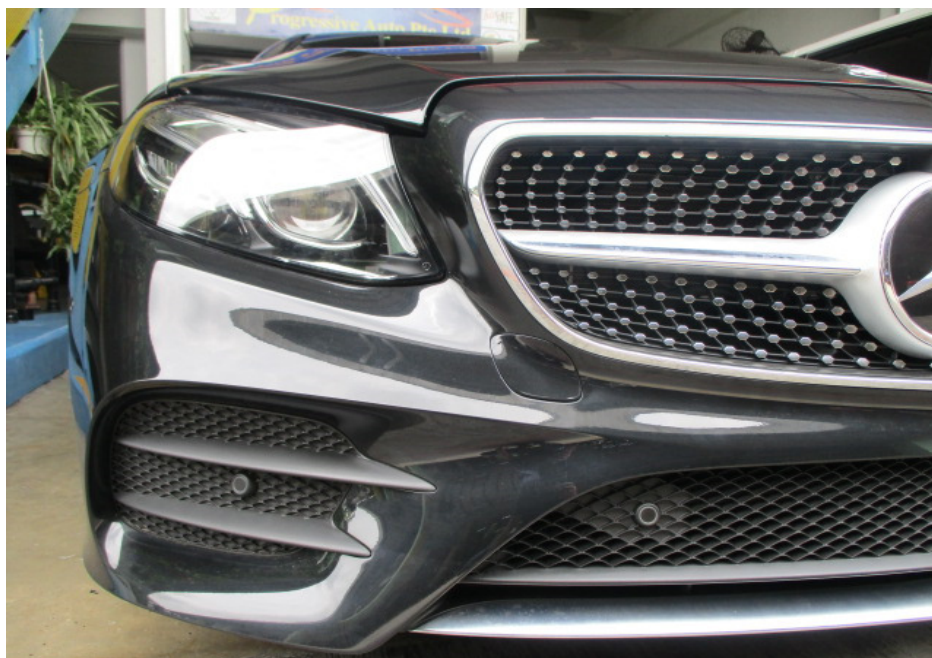
**Photo 5** shows a closer view of the Motor Car's front bumper, front bumper lower right grille and front right headlamp at the time of my inspection. The body parts at the front right portion of the Motor Car were visually examined and it was observed that the repair/restoration works carried out to the damaged area of the Motor Car (refer to photograph 1 & 2 above) were reasonably adequate and in order.

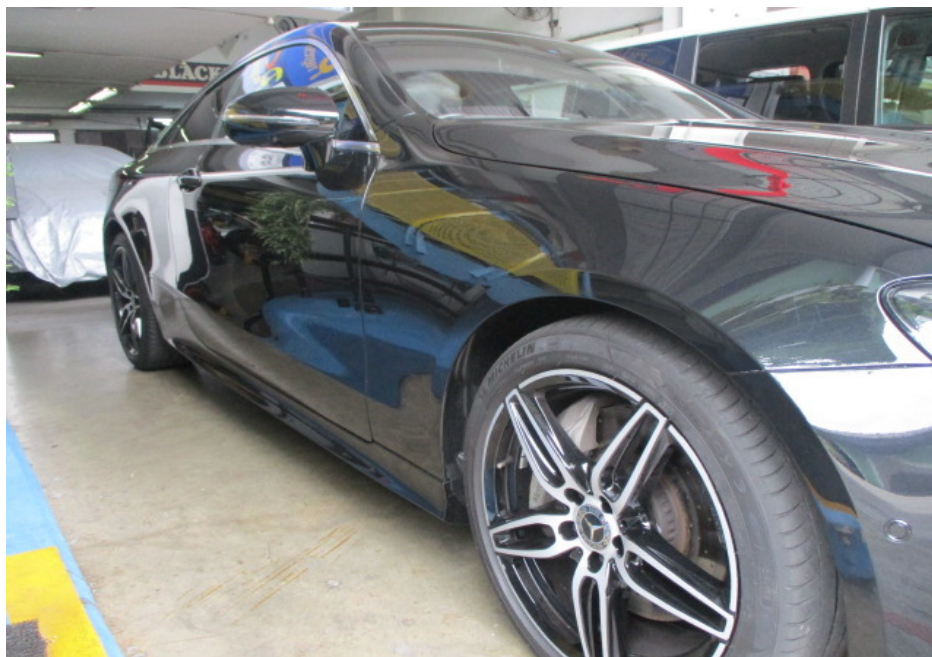
**Photo 6** shows a closer view of the Motor Car's front right fender and front right wheel rim. The body parts at the front right portion of the Motor Car were visually examined and it was observed that the repair/restoration works carried out to the damaged area of the Motor Car (refer to photograph 1 & 2 above) were reasonably adequate and in order.

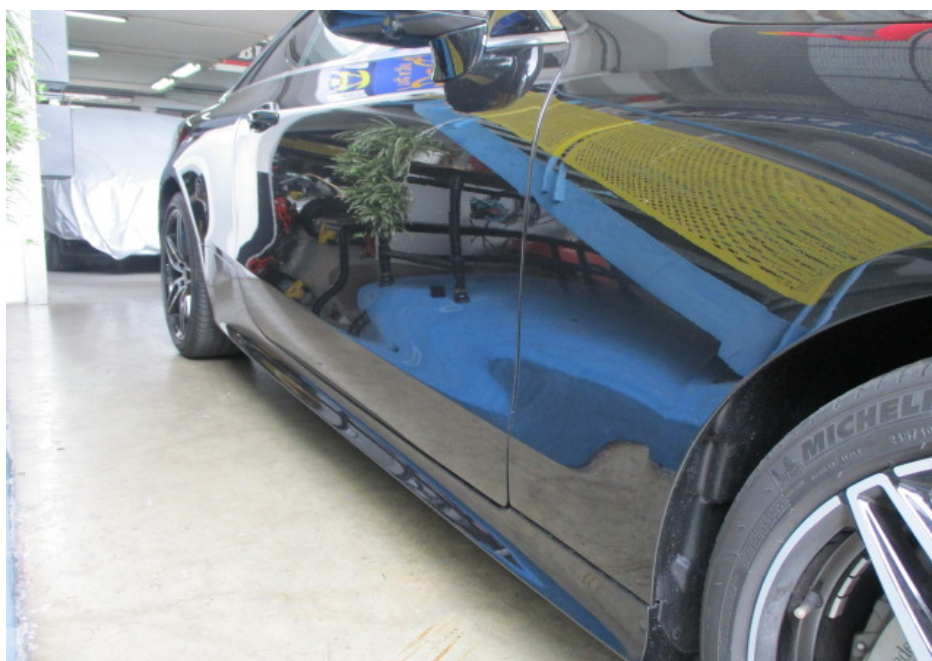
**Photo 7** shows a closer view of the Motor Car's front right door, front right fender and right side rocker panel garnish. The body parts at the front right portion of the Motor Car were visually examined and it was observed that the repair/restoration works carried out to the damaged area of the Motor Car (refer to photograph 1 & 2 above) were reasonably adequate and in order.

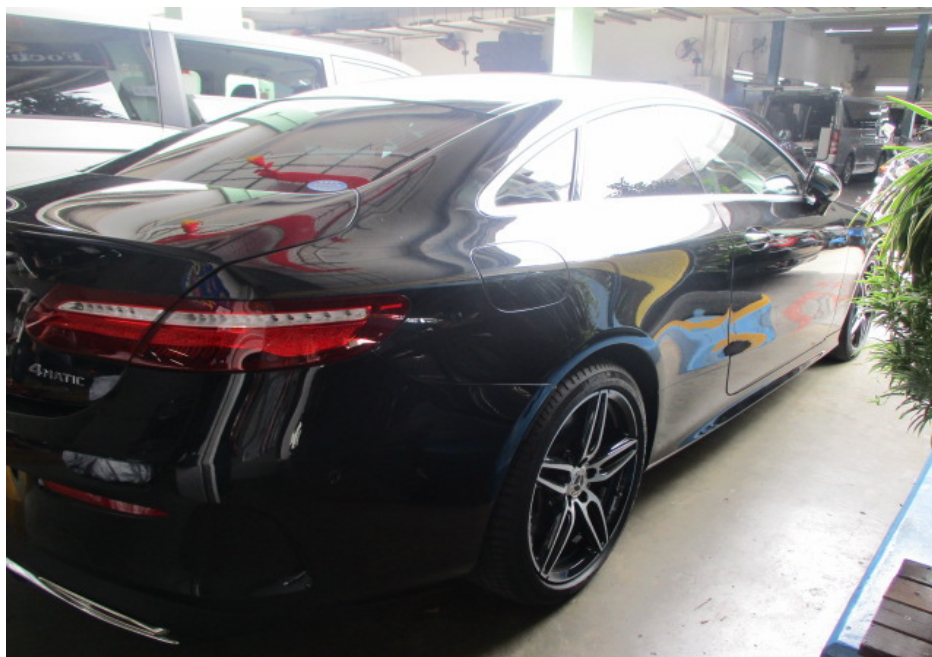
**Photo 8** shows a general view of the rear right body of the Motor Car at the time of my inspection. The Motor Car was observed to be in a relatively good general condition with no loose exterior fittings observed. The mileage of the Motor Car recorded at the time of my inspection was 18,057km. I had also noted that the body colour of the Motor Car was changed from silver colour to black colour.

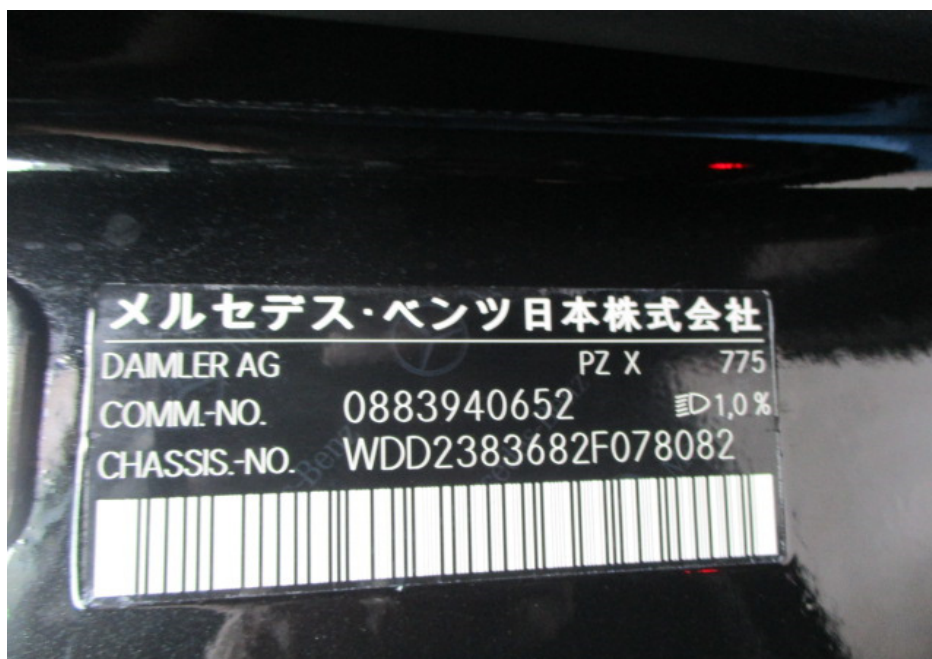
**Photo 9** shows the chassis number of the Motor Car. The chassis number recorded was WDD2383682F078082

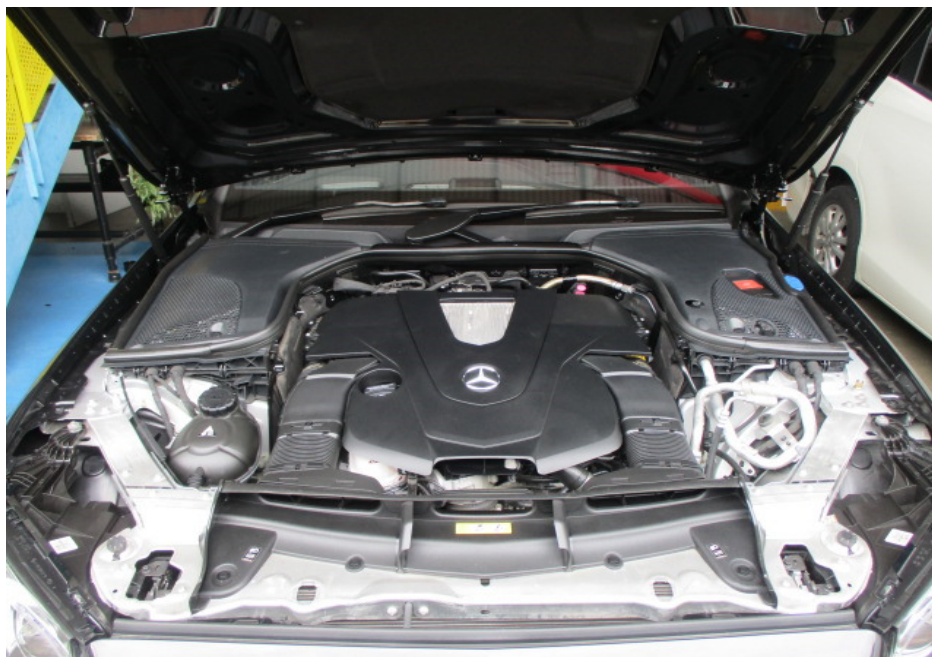
**Photo 10** shows a general view of the engine compartment of the Motor Car at the time of my inspection. The various parts and components inside the engine compartment were all observed to be intact and properly fitted. There was also no sign(s) or indication(s) of fluid leak and/or fluid stain found inside the engine compartment.

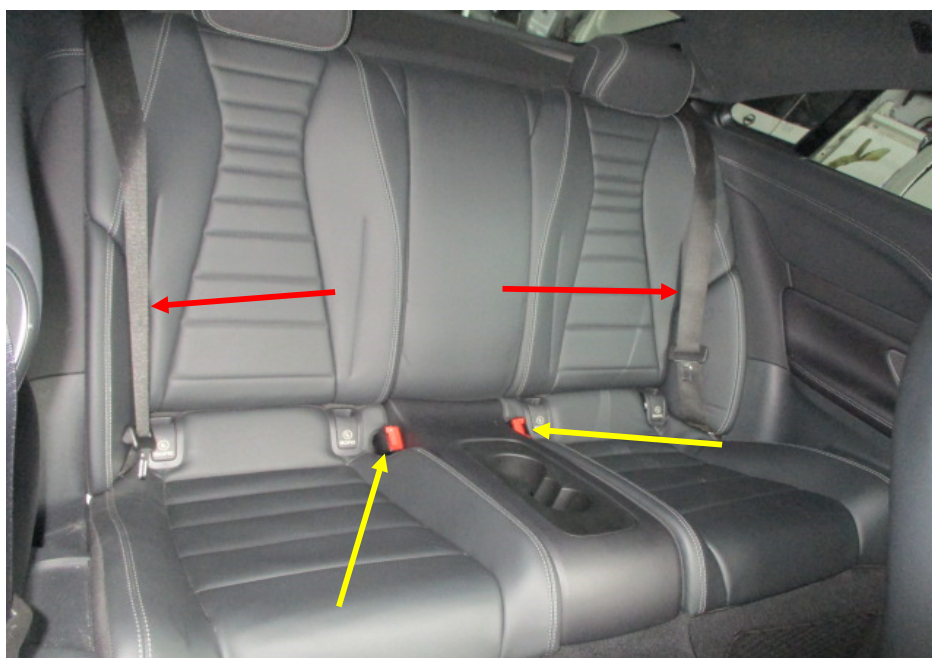
**Photo 11** shows the rear seats of the Motor Car. All the seats of the Motor Car were secured via seat rails to the floorboard. They were each fitted with a retractable seat belt reel (red arrow) and a pre-tensioner (yellow arrow). The seat belt reels were tested and able to be fastened into the respective pre-tensioners that were fitted on the side of each individual seat.

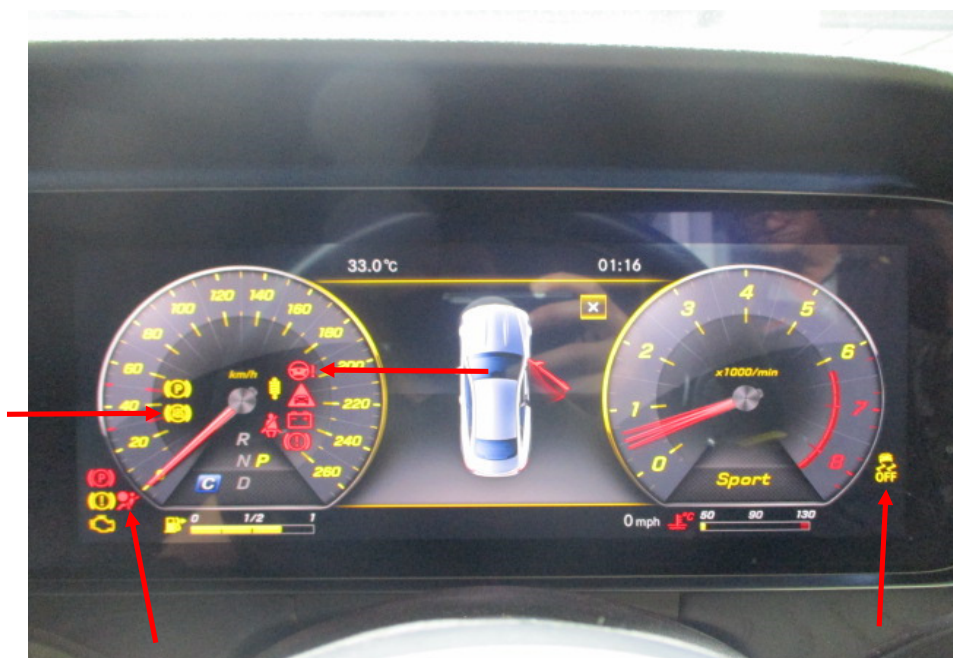
**Photo 12** shows the warning lights for the various electronic safety features appearing on the instrument panel of the Motor Car during its self-test when the engine is cranked, in particular the ABS, SRS, EPS and ESP lights (arrowed).

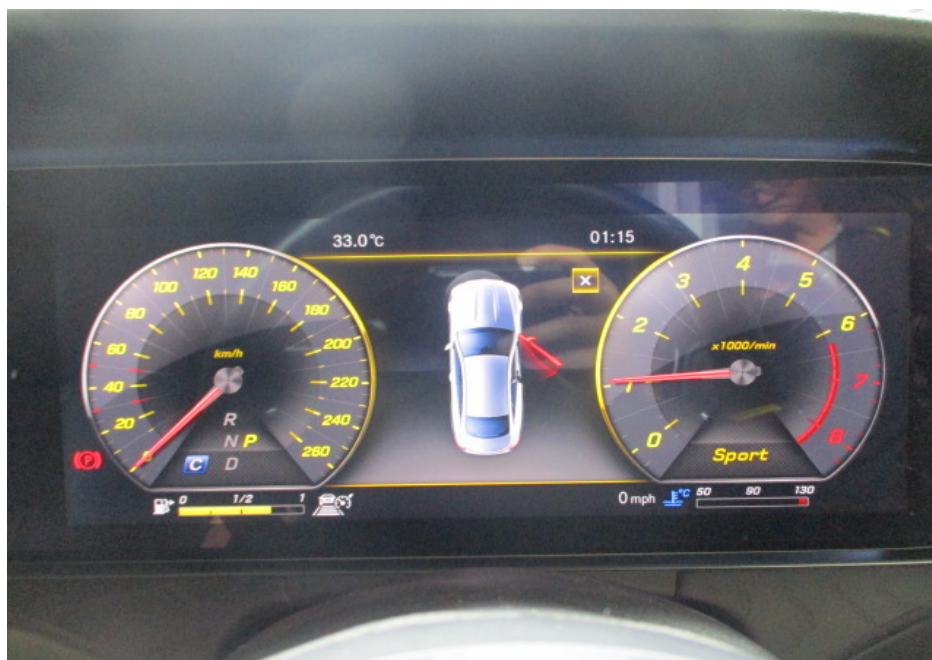
**Photo 13** shows the respective warning lights no longer illuminated, indicating that there is no fault detected to the ABS, SRS, EPS and ESP systems of the Motor Car during the self-test. These electronic systems were hence in working condition at the time of my inspection.

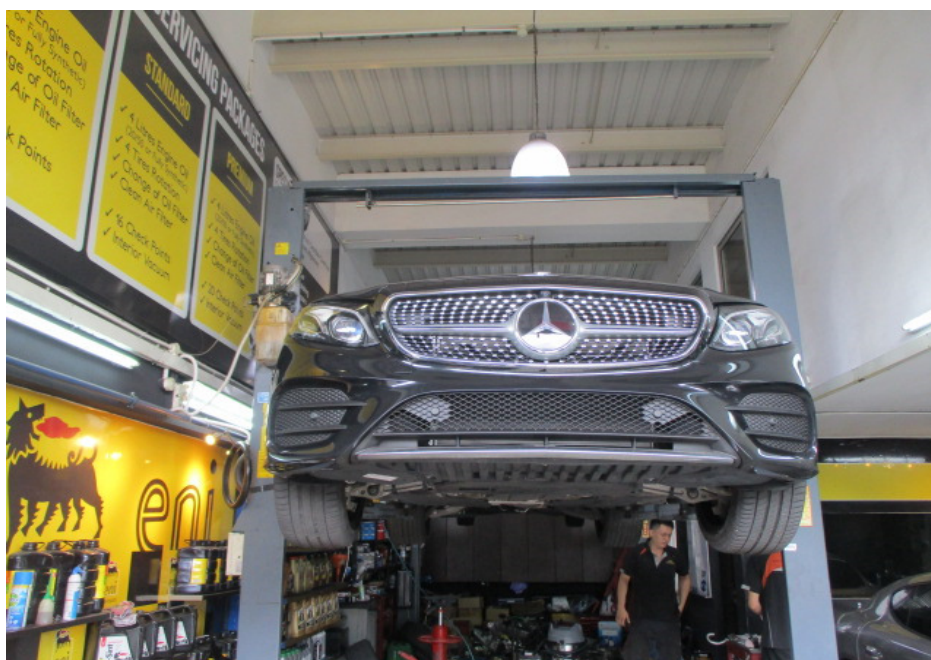
**Photo 14** shows the Motor Car hoisted up for checks on its undercarriage. There was no sign(s) or indication(s) of fluid leakage and/or fluid stain(s) on the underside of the Motor Car. The undercarriage components of the Motor Car were also all observed to be intact and secured in an appropriate manner.

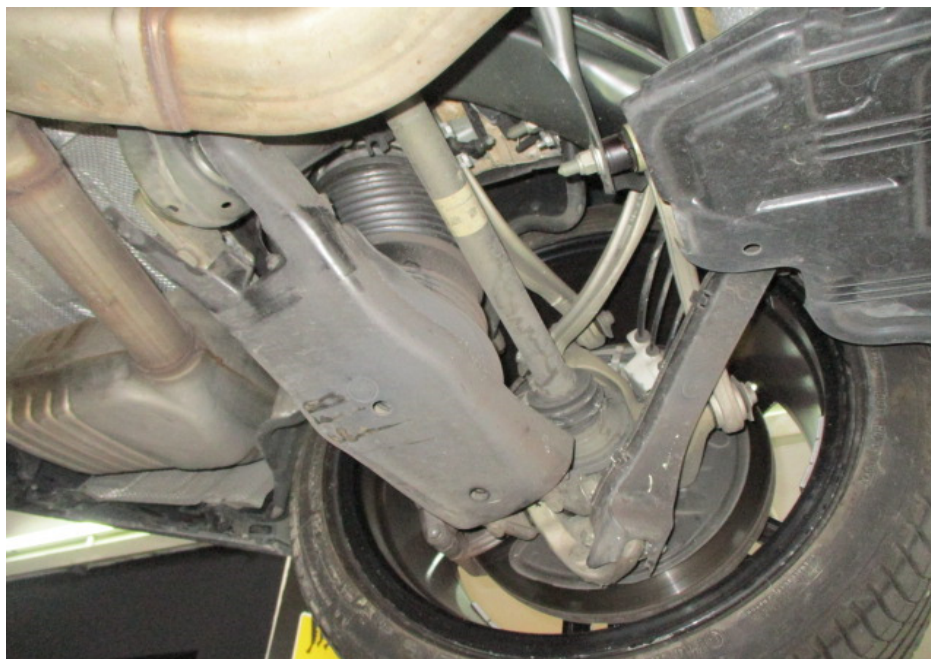
**Photo 15** shows a general view of the control arms and linkages at the rear left wheel of the Motor Car. I did not observe any fluid leak and/or fluid stain on the underside of the Motor Car. All the Motor Car's undercarriage components were observed to be intact and secured in an appropriate manner.

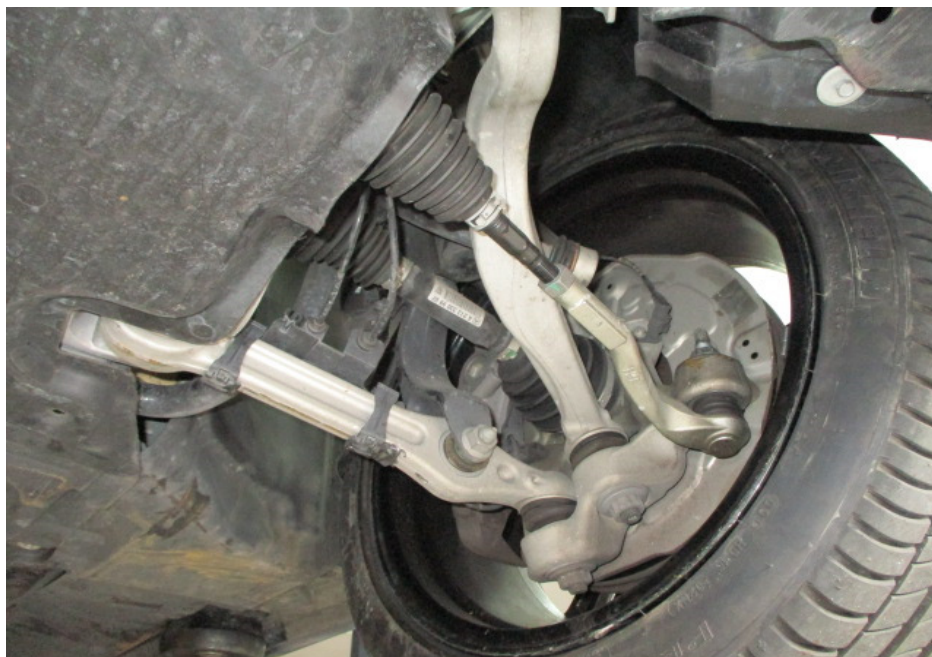
**Photo 16** shows the various undercarriage components at the front left wheel of the Motor Car. The mechanical components, control arms and linkages were all found to be intact and secured in an appropriate manner.

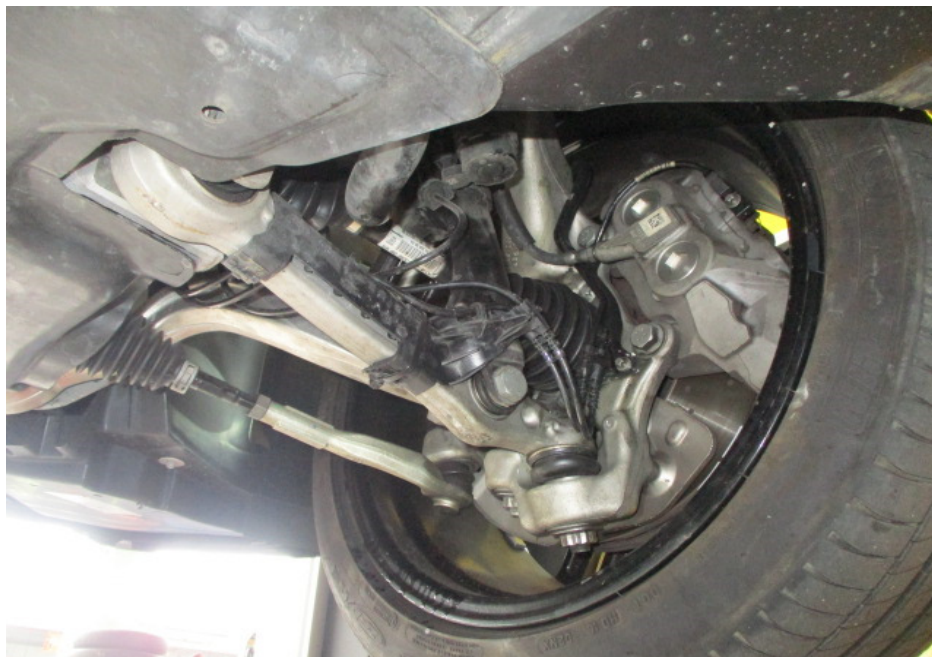
**Photo 17** shows the various undercarriage components at the front right wheel of the Motor Car. The mechanical components, control arms and linkages were all found to be intact and secured in an appropriate manner. I also did not observe any fluid leak and/or fluid stain on the underside of the Motor Car.

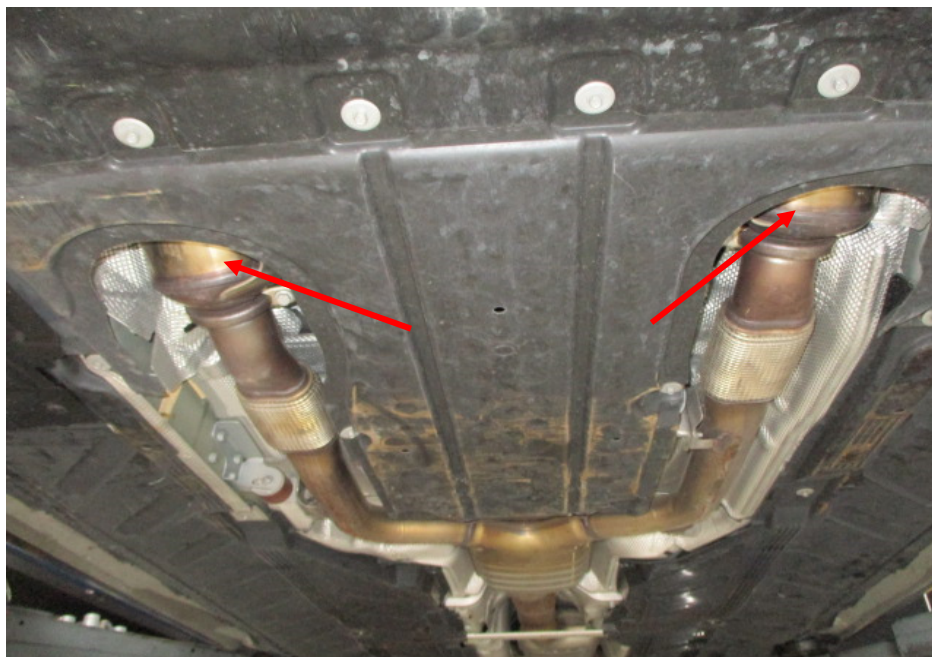
**Photo 18** shows the Motor Car's catalytic converters (arrowed). My examination of the Motor Car's exhaust system revealed no sign(s) or indication(s) of any cut or weld marks along its exhaust pipes and on its rear mufflers/.

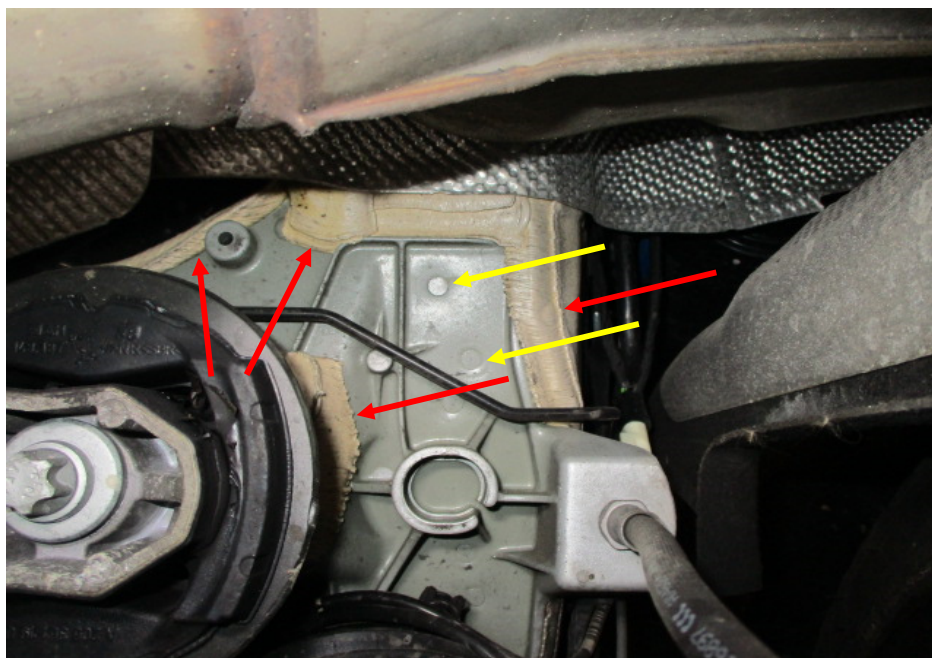
**Photo 19** shows the chassis/structural body at the underside rear right of the Motor Car. Visually, I did not find any weld marks other than original spot weld marks (yellow arrow) on the chassis/structural body of the Motor Car. The original factory sealant (red arrow) at the joints along the chassis/structural body was also untouched, indicating no work was done on the chassis/structural body of the Motor Car and that the chassis/structural body was originally fitted.

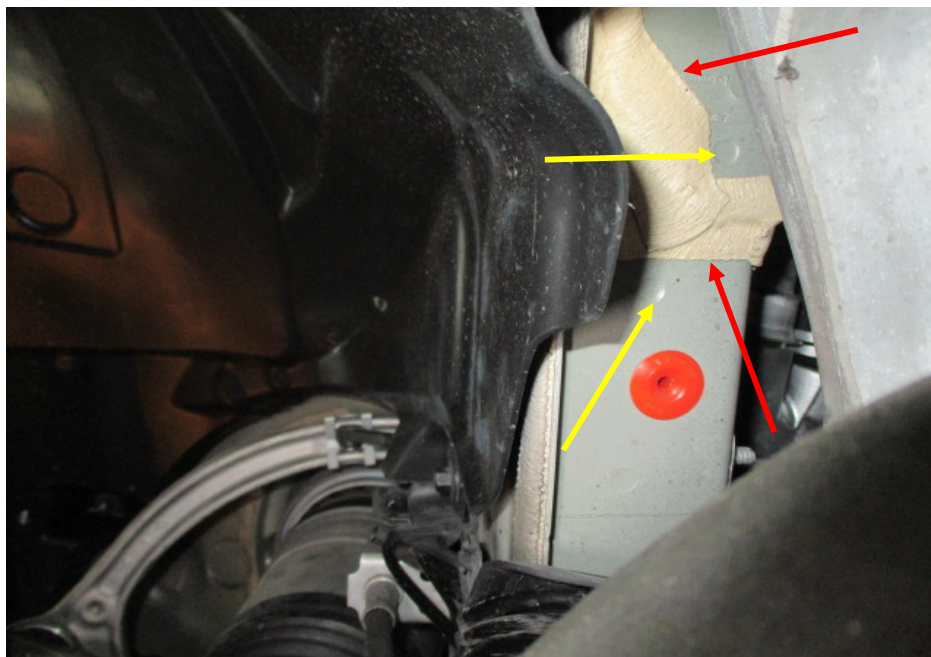
**Photo 20** shows the chassis/structural body at the underside front right of the Motor Car. Visually, I did not find any weld marks other than original spot weld marks (yellow arrow) on the chassis/structural body of the Motor Car. The original factory sealant (red arrow) at the joints along the chassis/structural body was also untouched, indicating no work was done on the chassis/structural body of the Motor Car and that the chassis/structural body was originally fitted.

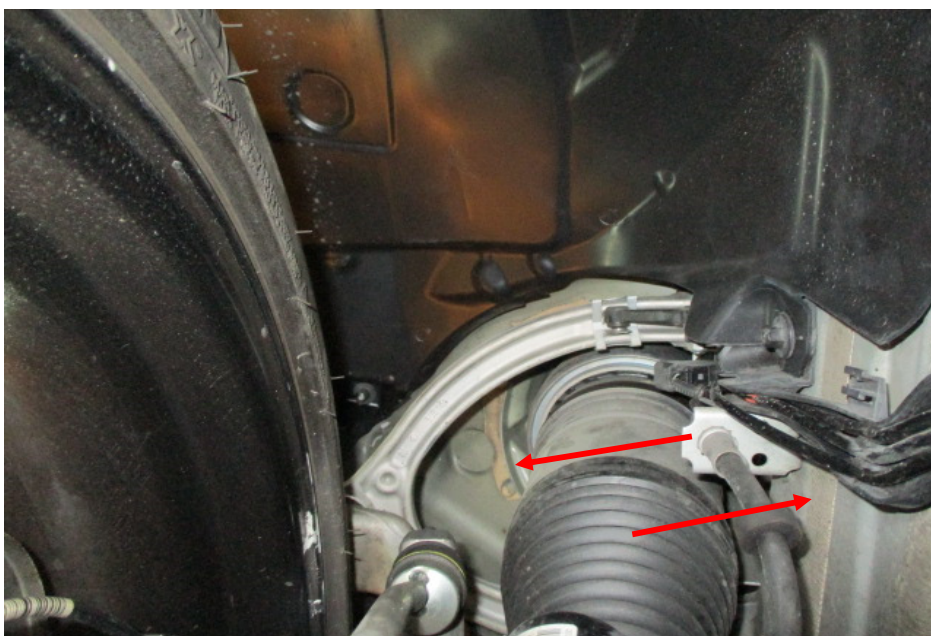
**Photo 21** shows the front right wheelhouse panel of the Motor Car. The original factory sealant (arrowed) at the joints along the non-detachable body panels were untouched, indicating no work was done on the non-detachable body panels of the Motor Car. In general, I had found the non-detachable body panels of the Motor Car to be originally fitted at the time of my inspection.

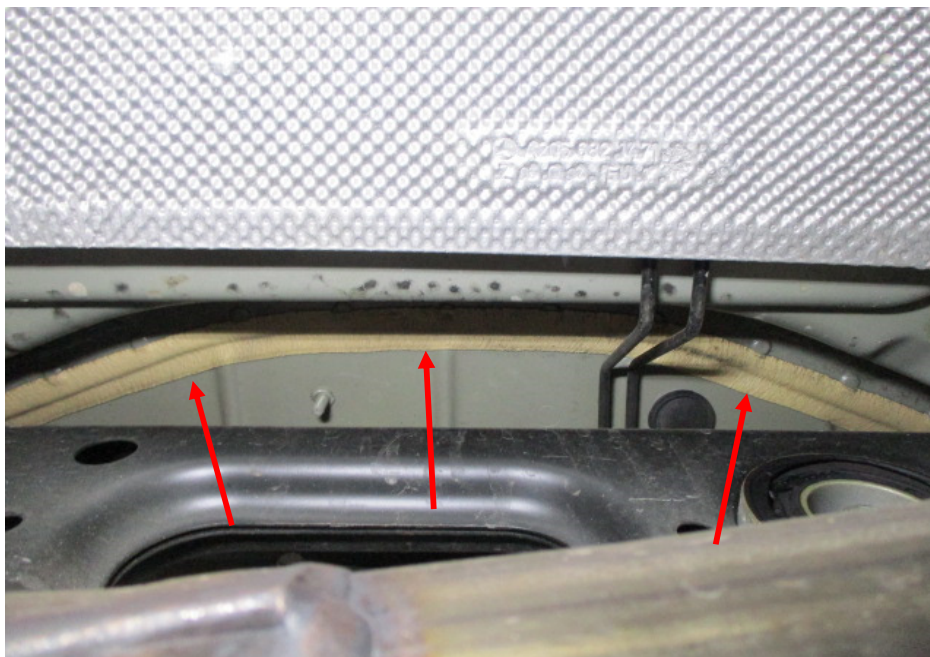
**Photo 22** shows the underside rear centre floorboard panel of the Motor Car. The original factory sealant (arrowed) at the joints along the non-detachable body panels were untouched, indicating no work was done on the non-detachable body panels of the Motor Car. In general, I had found the non-detachable body panels of the Motor Car to be originally fitted at the time of my inspection.
