Your Ref: C10007574
Our Ref : CI/AGI20011160/P

**TECHNICAL INVESTIGATION REPORT OF INSURED VEHICLE SJR 7087R
INVOLVED IN AN ACCIDENT ON 10 OCTOBER 2020**

Registration Number : SJR 7087R
Make & Model : KIA PICANTO-1.1 (A)
Year of Registration : April 2009
Chassis Number : KNABA24339T736731
Speedo Reading : 259,055KM

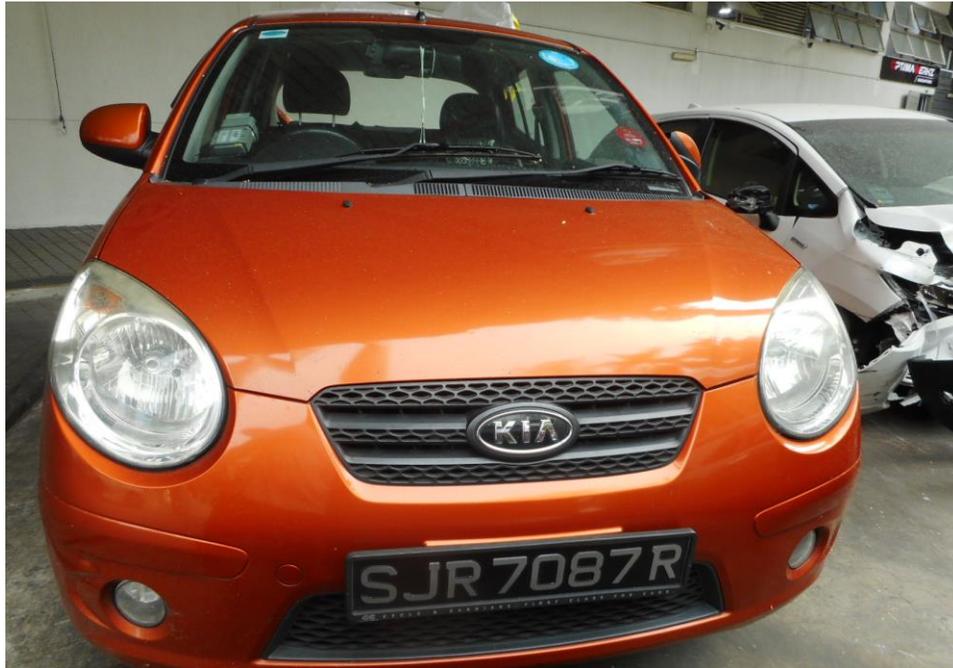
Photo 1 shows the general view of the front portion of the insured vehicle at the time of my inspection its unaffected by the accident.

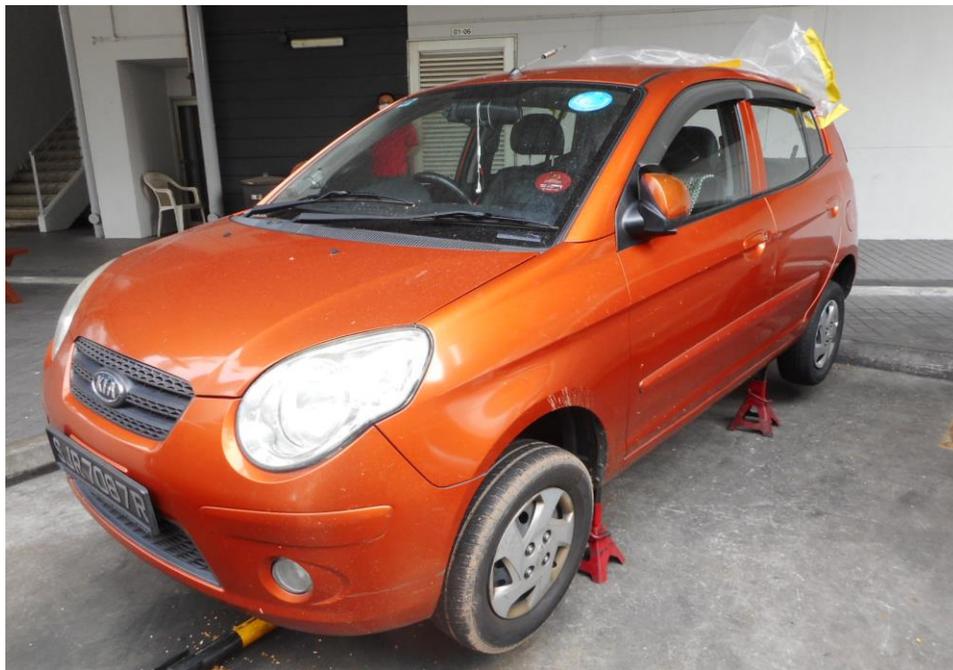
Photo 2 shows the general view of the left portion of the insured vehicle at the time of my inspection its unaffected by the accident.

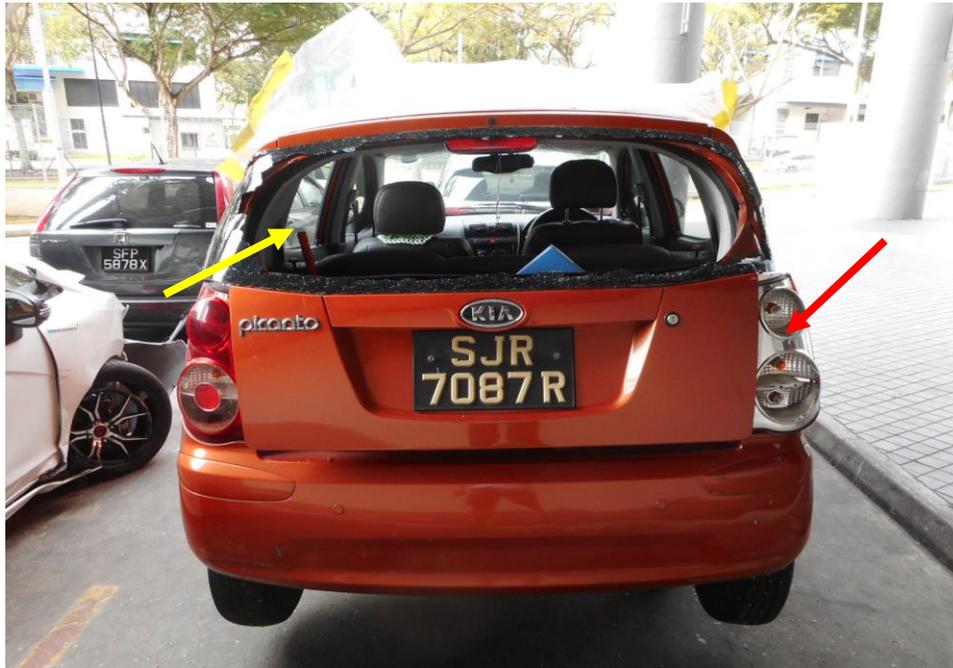
5. The insured vehicle was observed to have sustained impact damages on its right and rear portion. Its right body and door panel, rear right brake lamp and rear windscreen were amongst the exterior body parts which were observed to have been damaged as a result of the accident. See photo 1 – 5 below.

Photo 3 shows the general view of the rear portion of the insured vehicle at the time of my inspection its rear portion was observed to be affected by the accident. Its rear windscreen (yellow arrow) and rear right brake lamp (red arrow) was damaged as a result of the accident.

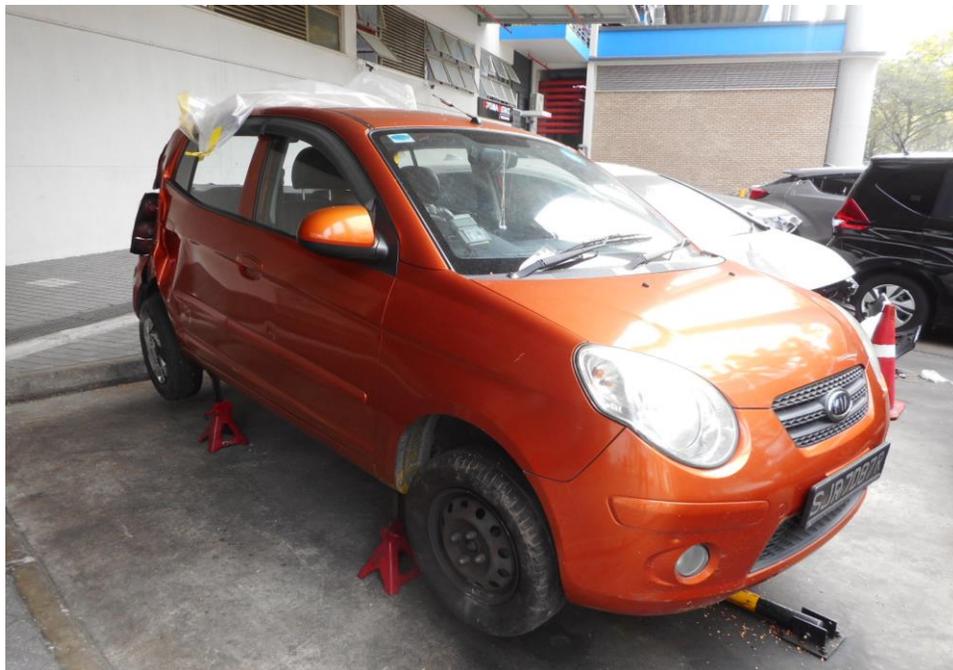
Photo 4 shows the general view of the right portion of the insured vehicle at the time of my inspection its right portion was observed to be affected by the accident. Its body and door panel was damaged as a result of the accident.

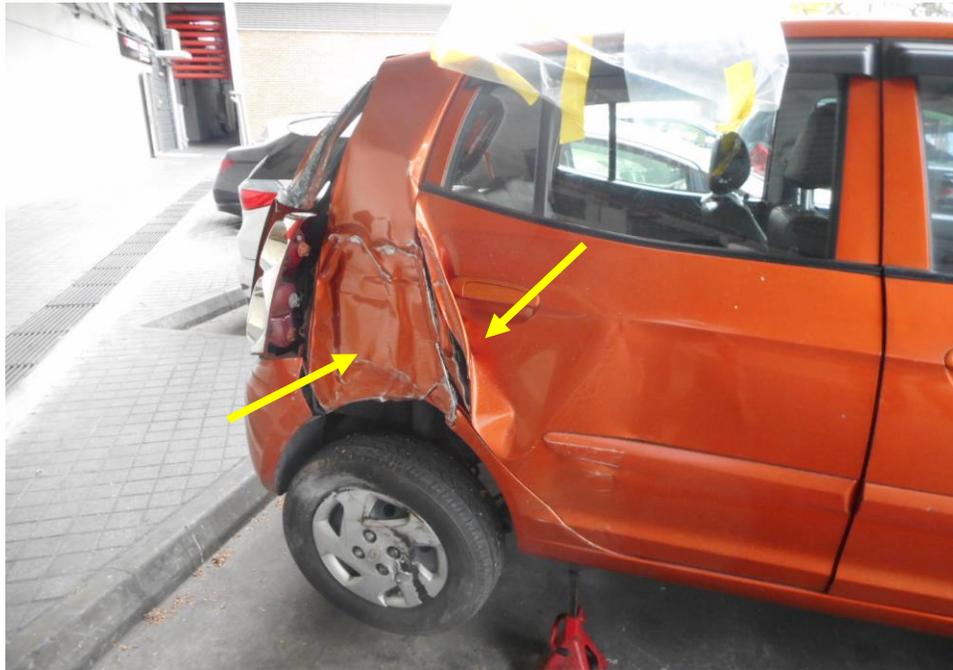
Photo 5 shows the close up view of the right portion of the insured vehicle at the time of my inspection its right portion was observed to be affected by the accident. Its body and door (arrowed) panel was damaged as a result of the accident.

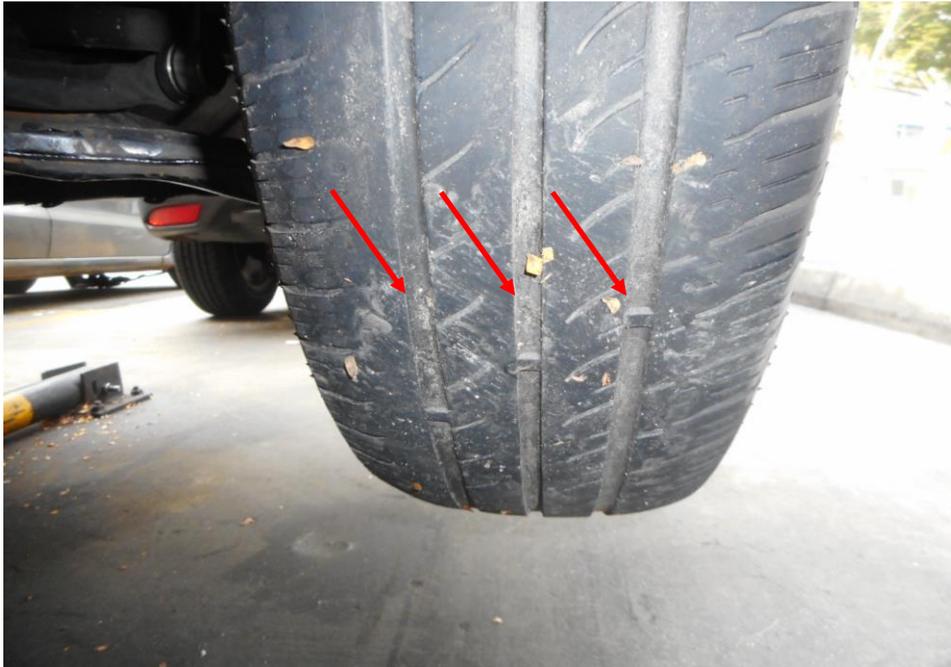
6. The front and rear right tyres of the insured vehicle was found to be in serviceable condition. The pattern of the tread was generally still visible. The tyre wear indicators, normally built into the groove of the tread pattern, were also observed to be not flushed with the tread pattern. The remaining depth of the tread was measured to be approximately 2.8mm and 5.2mm. See photo 6 -9.

Photo 6 shows the front right tyre of the of the Insured Vehicle, which was observed to be in serviceable condition with remaining tread depth of approximately 2.8mm. The pattern of the tread was generally still visible. The tyre wear indicators (arrowed), normally built into the groove of the tread pattern, and were also observed to be not flushed with the tread pattern.

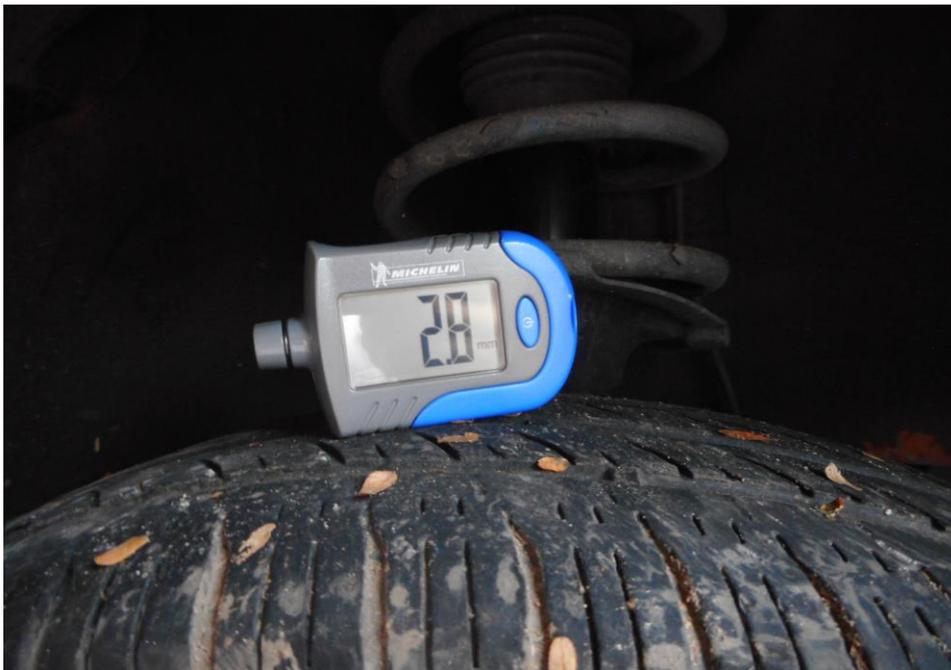
Photo 7 shows measurements being conducted on the remaining tread depth of the rear right tyre of the insured vehicle. The remaining tread depth was measured to be approximately 2.8mm.

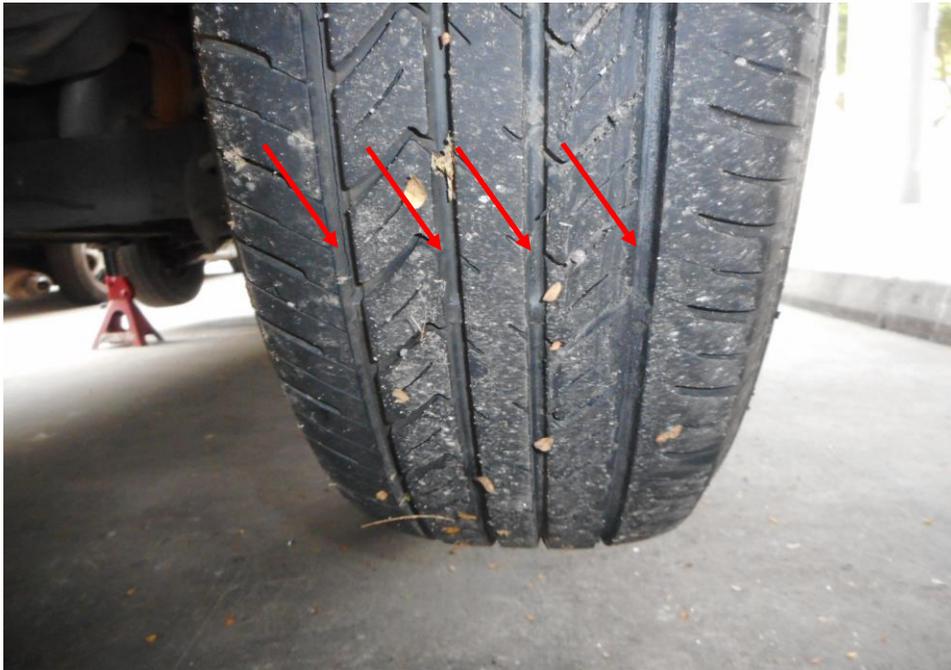
Photo 8 shows the condition of the rear right tyre of the Insured Vehicle, which was observed to be in serviceable condition with remaining tread depth of approximately 5.2mm. The pattern of the tread was generally still visible. The tyre wear indicators (arrowed), normally built into the groove of the tread pattern, and were also observed to be not flushed with the tread pattern.

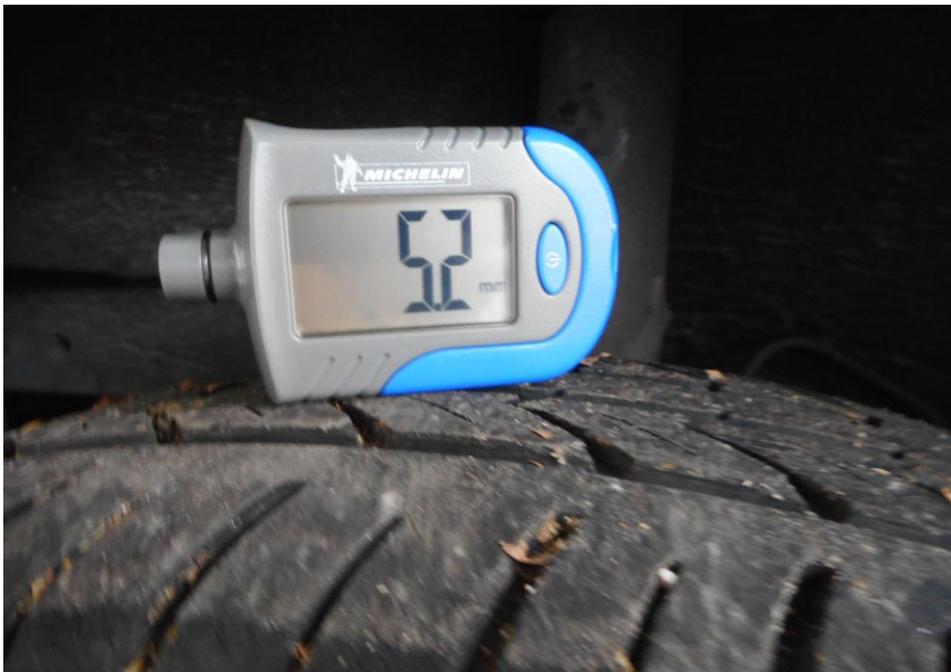
Photo 9 shows measurements being conducted on the remaining tread depth of the rear right tyre of the insured vehicle. The remaining tread depth was measured to be approximately 5.2mm.

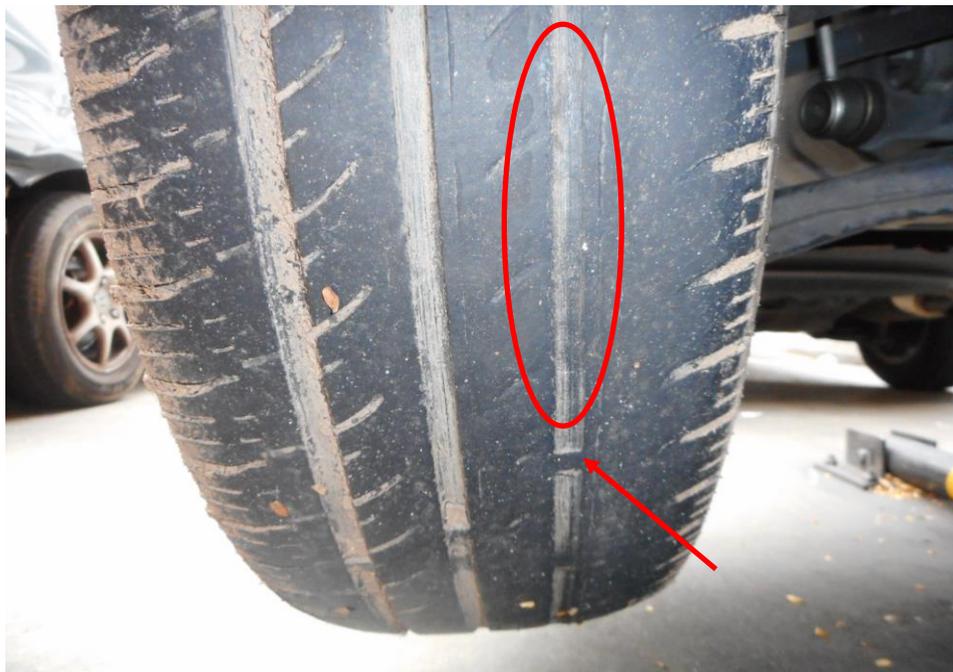
7. Upon examination of the front and rear left tyres of the insured vehicle, we had observed that the rubber at the inner side of the tread was partially worn. The pattern at some areas at the inner side of the tread was vaguely visible due to worn rubber however the reinforcing belts that are found within the tyre were not exposed at the time of our inspection. The pattern at the inner side of the tread was also observed to be flushed with the tyre wear indicator. The remaining tread depth of the both front and rear left tyres was measured to be approximately 0.7mm to 2.1mm. See photos 10 - 15 below.

Photo 10 shows the front left tyre of the insured vehicle at the time of our inspection. The rubber at the inner side of the tread (circled) was partially worn. The pattern at some areas on the inner side of the tread was vaguely visible due to worn rubber and flushed with the tyre wear indicator (arrowed) however the reinforcing belts that are found within the tyre were not exposed at the time of our inspection.

8. In general, having physically inspected the insured vehicle, we are of view that the condition of the front and rear left tyres of the insured vehicle was observed at 50% which was slightly within the requirements of SECTION 109(f) CAP 276 of THE MOTOR VEHICLES (CONSTRUCTION AND USE) RULES, 1974, 1978 OF THE ROAD TRAFFIC ACT. Under this section it states that “no person shall use, or cause or permit to be used on a road any motor vehicle or trailer, a wheel of which is fitted with a pneumatic tyre, where the tyre is fitted to the wheel of any other motor vehicle or any trailer, the tread pattern (excluding any tie-bar) of the tyre does not have a depth of at least one millimetre throughout at least 75% of the breadth of the tread and round the entire outer circumference of the tyre.

9. The condition of the front and rear left tyres of the insured vehicle would have also likely affected the road worthiness of the Insured Vehicle as the traction/frictional grip between the Insured Vehicle and the road surface would have been lessen, especially during wet weather condition, when travelling at high speed or cruising speed, cornering and braking amongst others.

10. Given the circumstances of accident and wet weather condition as reported in the Police report T/20201010/7000, I am of the view that the condition of the front and rear left tyres of the insured vehicle would have affected the expulsion of water from its tyres and in a wet weather condition. Considering that the insured vehicle was negotiating the right turn, the weight of the vehicle would have been transferred onto the lesser tread front and rear left tyres causing the vehicle to go into an uncontrolled spin.

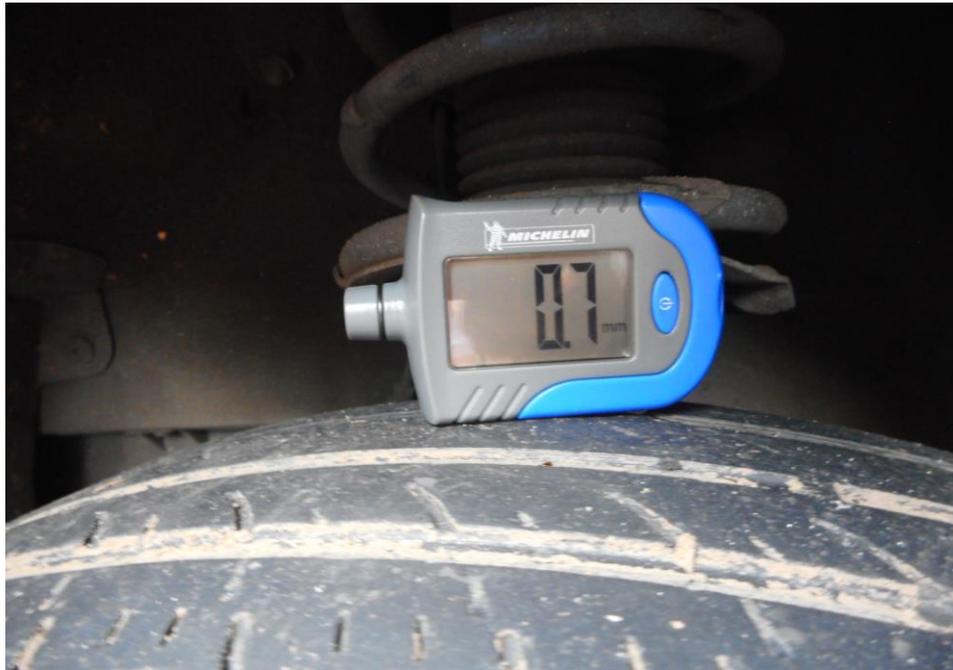
Photo 11 shows measurements being conducted on the inner side of the tread on the front left tyre of the insured vehicle. The remaining tread depth was measured to be approximately 0.7mm.

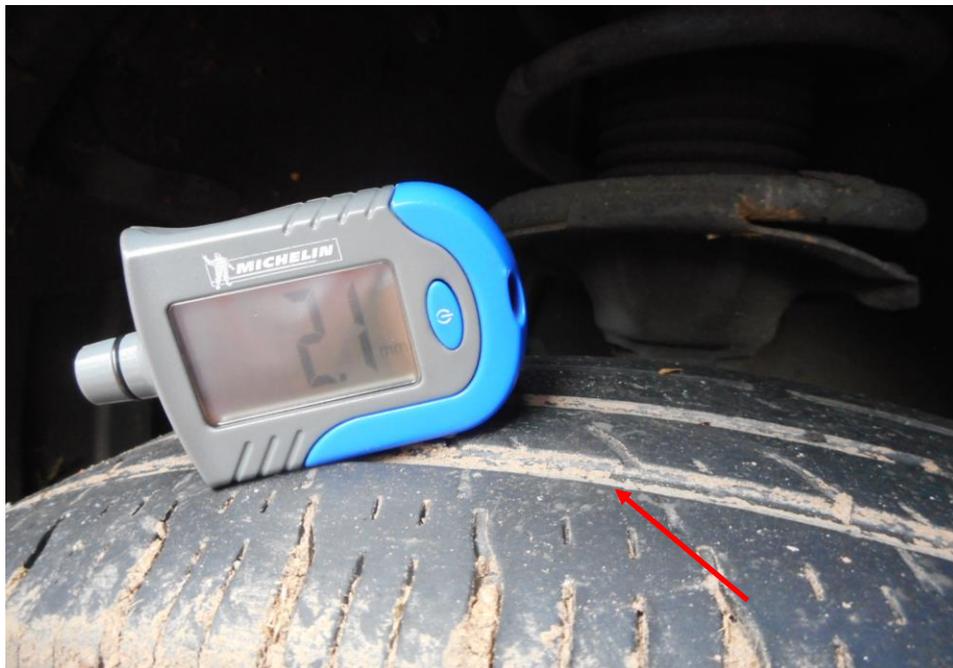
Photo 12 shows measurements being conducted on the outer side of the tread on the front left tyre of the insured vehicle. The remaining tread depth was measured to be approximately 2.1mm.

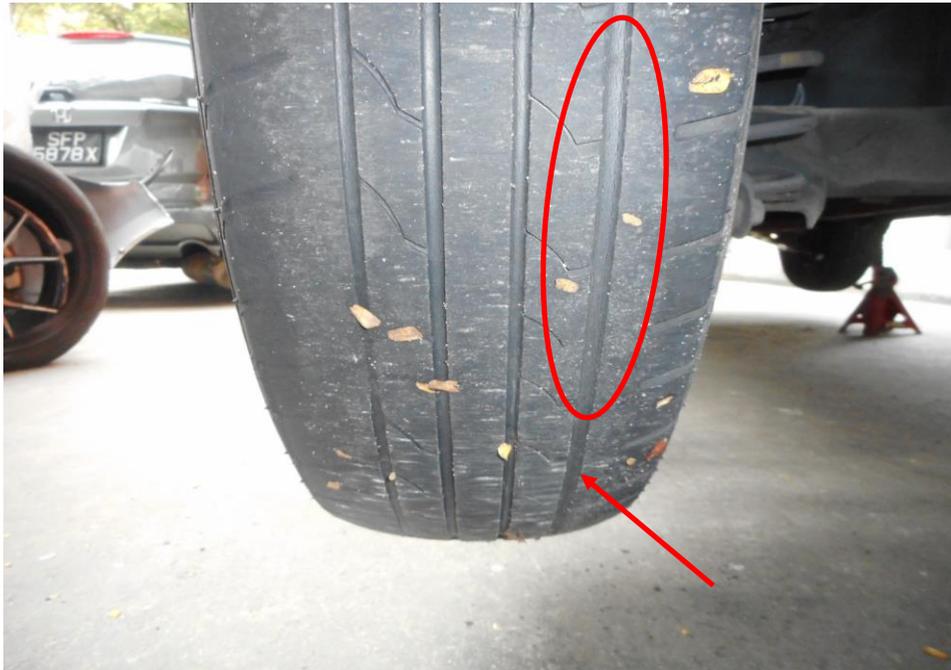
Photo 13 shows the rear left tyre of the insured vehicle at the time of our inspection. The rubber at the inner side of the tread (circled) was partially worn. The pattern at some areas on the inner side of the tread was vaguely visible due to worn rubber and flushed with the tyre wear indicator (arrowed) however the reinforcing belts that are found within the tyre were not exposed at the time of our inspection.

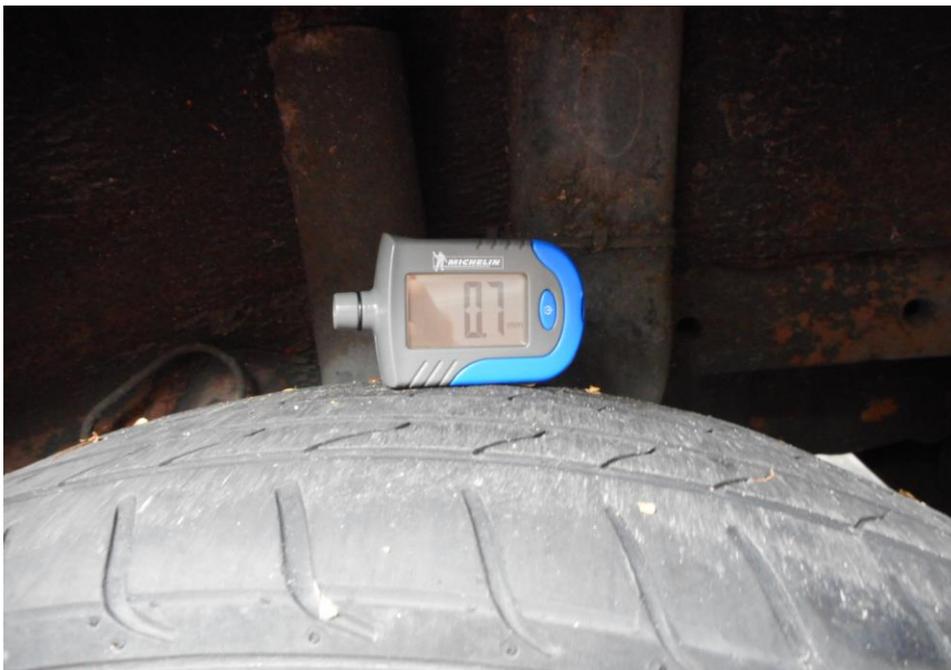
Photo 14 shows measurements being conducted on the inner side of the tread on the rear left tyre of the insured vehicle. The remaining tread depth was measured to be approximately 0.7mm.

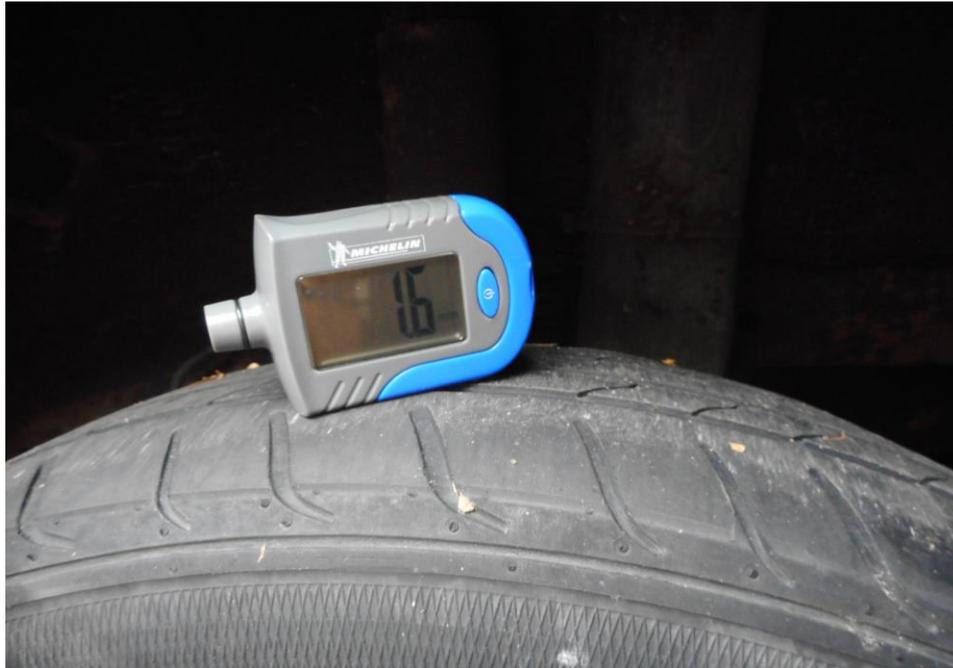
Photo 15 shows measurements being conducted on the outer side of the tread on the rear left tyre of the insured vehicle. The remaining tread depth was measured to be approximately 1.6mm.
